Ty'r Wern, Llan Ffestiniog
Desk Top Study and Building Record

Commissioned by
Rhys Llwyd Davies

EAS Client Report 2023/05

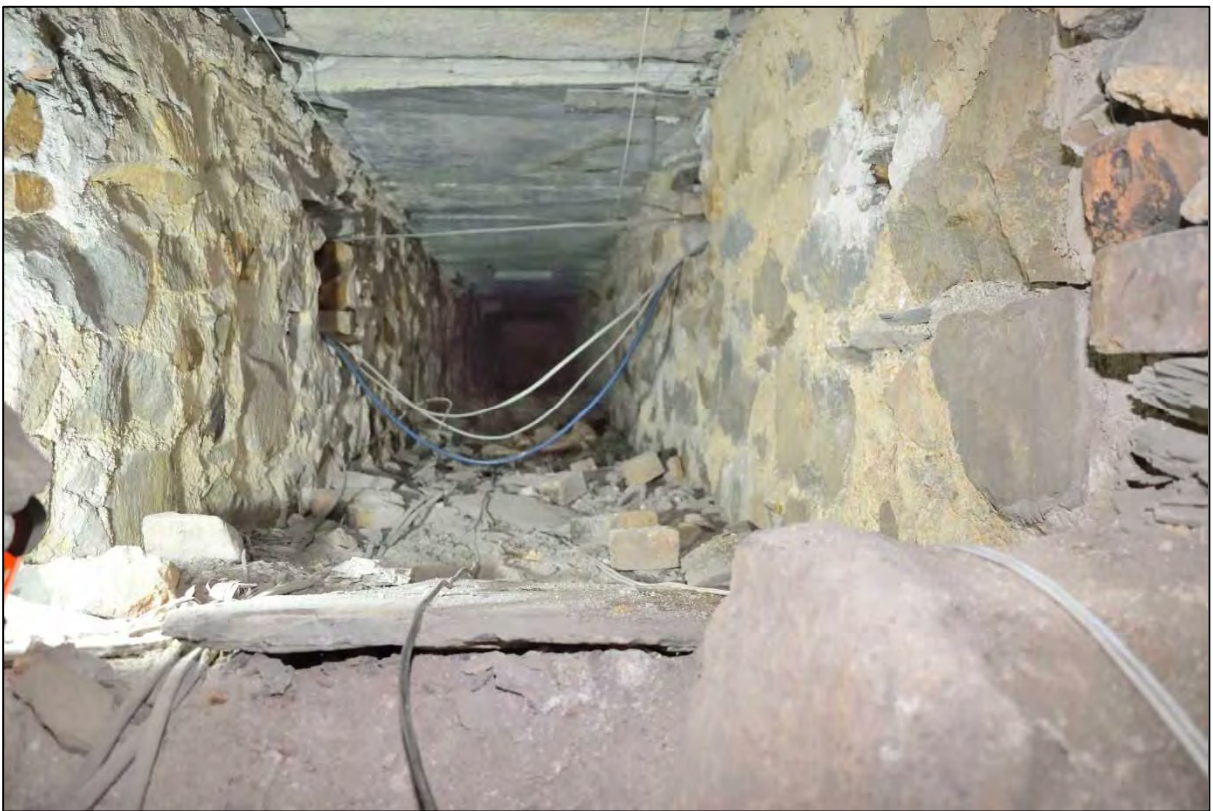
Plate 84: Central passage

Extending from the western side of the cellar are three tunnels or passages (Figure 14, Plates 83 – 85). Originally up to 2 m high these passages are partially blocked with dumps of soil and building debris. The central passage runs along the centre line of the church and ends just below the eastern face of the gallery. The western end of the passage was not investigated, however plan 347(1)03 by Rhys Llwyd Davies (Figure 23) suggests there is a chamber at the other end of the passage. The roofs of the passages are generally of slate slabs, however there are bricks above the northern passage (Plate 86), presumably to support the raised floor in front of the chancel arch.
