**BRYN SEIONT HOSPITAL, CAERNARFON
LEVEL 3 RECORDING**

Client: Mario Kreft

September 2013

Govannon Report GC318

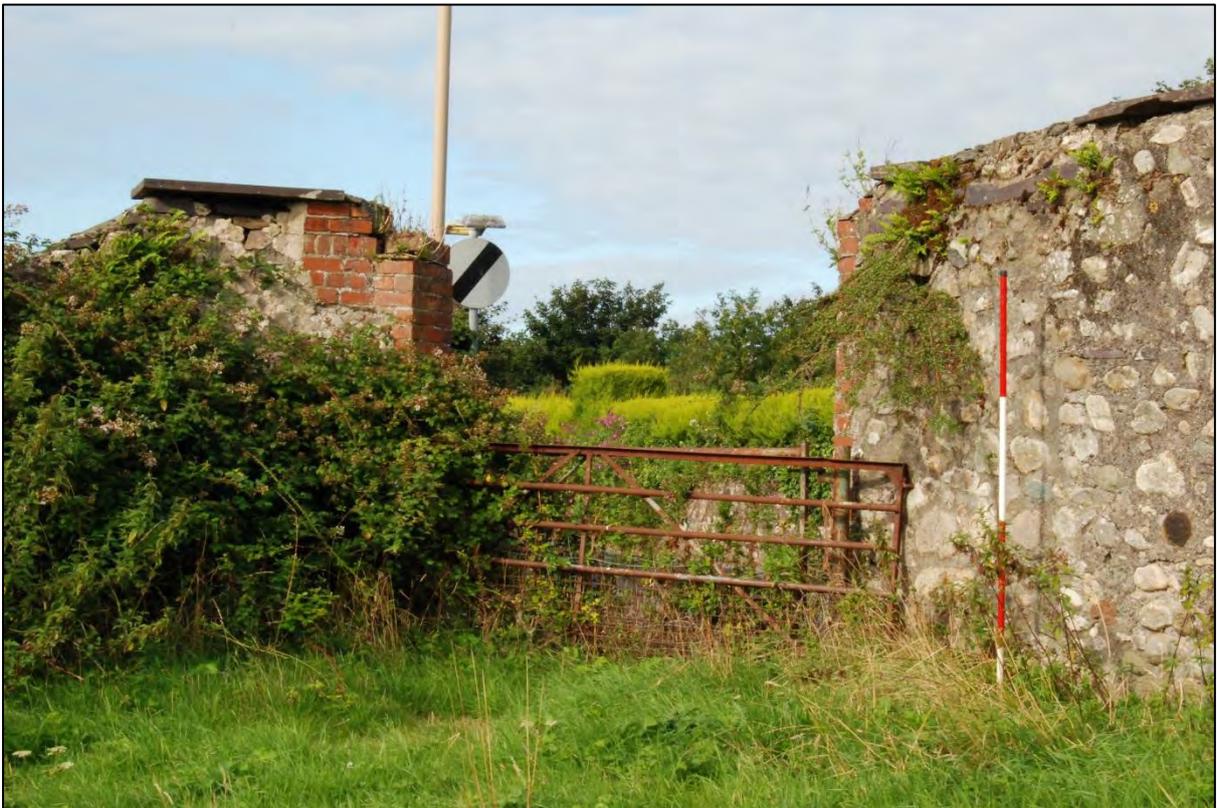
The southern end of the proposed development area is defined by the remains of a walled garden (Plate 50). Surrounded on three sides by stone walling, this area is now used as a paddock. The western wall (Plate 51) is constructed of random stonework with some cement render in places and stands up to 2.4 m above the current ground level. It is constructed of stones typically 200 x 150 mm in size, although they reach sizes of 350 mm x 250 mm in places. The top of the wall is capped by a series of slate slabs which have sawn edges sawn with a Greave's saw. The wall also incorporates the occasional slate block also with sawn edges. In the southwest corner there is a gateway (Plate 52) which appears to be a later feature of the garden, possibly when the garden was converted into a paddock. The gateway is marked by a series of brick quoins which appear to be a secondary feature.

Plate 51: Typical section of the western wall of the Walled Garden

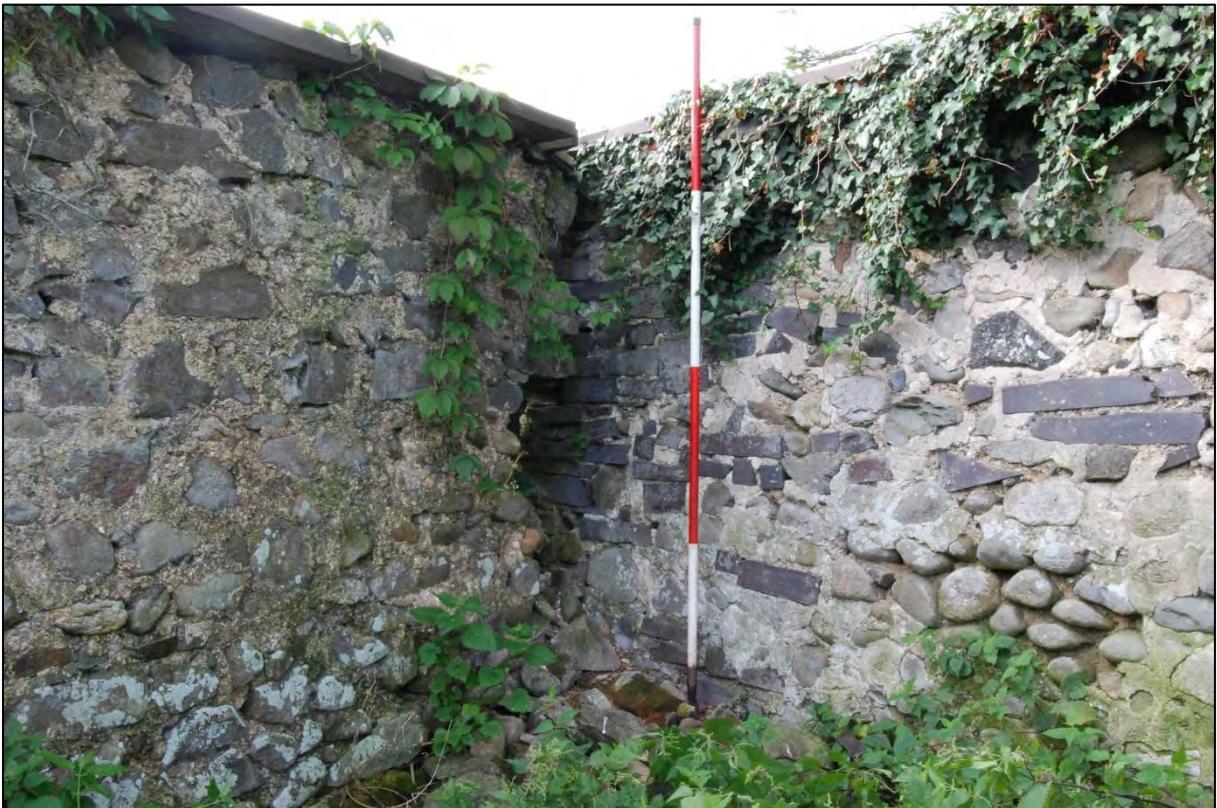
Embedded in the top half of the southern wall is a brick structure consisting of a series of brick piers linked by recessed brick walling (Figure 3, Plate 53) set at a height of 1.34 m above the current ground level. The brickwork reaches a further height of 0.66 m and spreads for a total length of 12.7 m along the southern wall. Given its position, it is assumed that this structure is associated with a glass house which was probably attached to the wall at this point.

Plate 53: Possible glass house structure in the southern wall of the Walled Garden

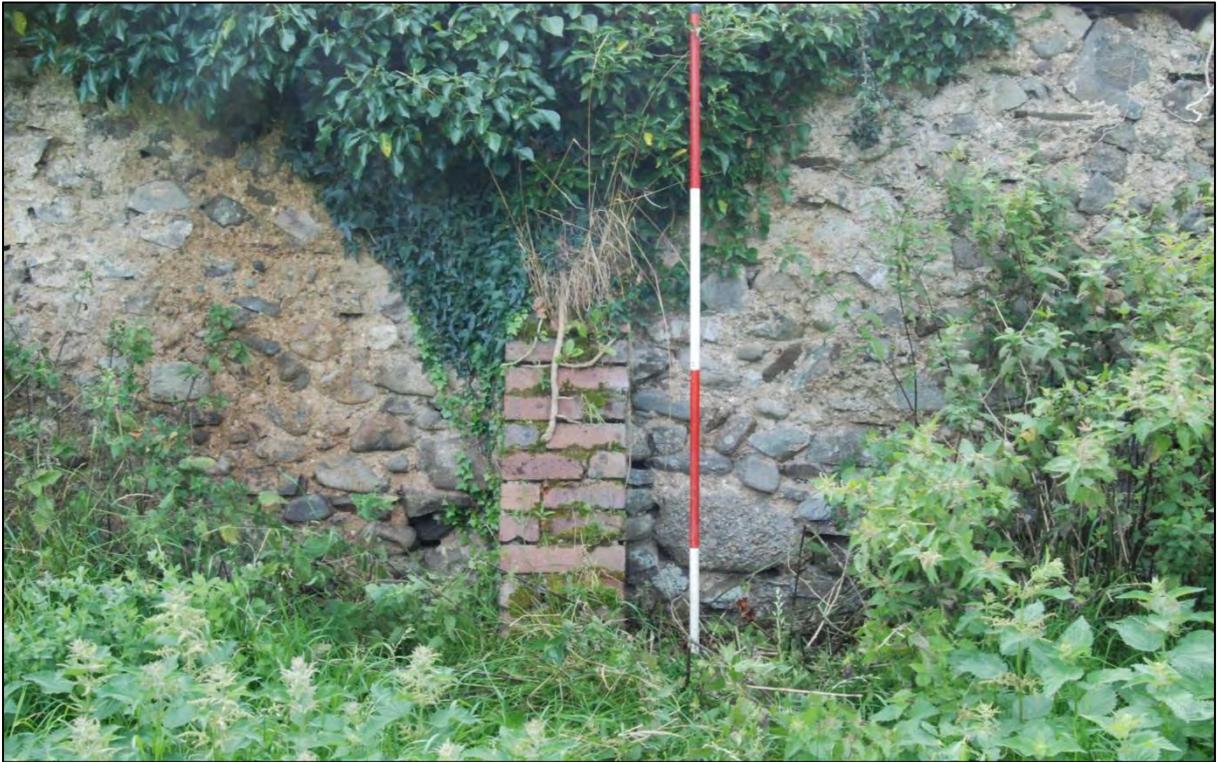
The eastern wall is a similar height to that to the south of the garden at around 2.0 m. It was not, however integrated into the southern wall and the joint is now moving apart (Plate 54). The inclusion of slate blocks with sawn edges low down in the in the southern wall may suggest that the southern wall has been re-built.

Plate 54: The joint between the southern and eastern walls of the Walled Garden

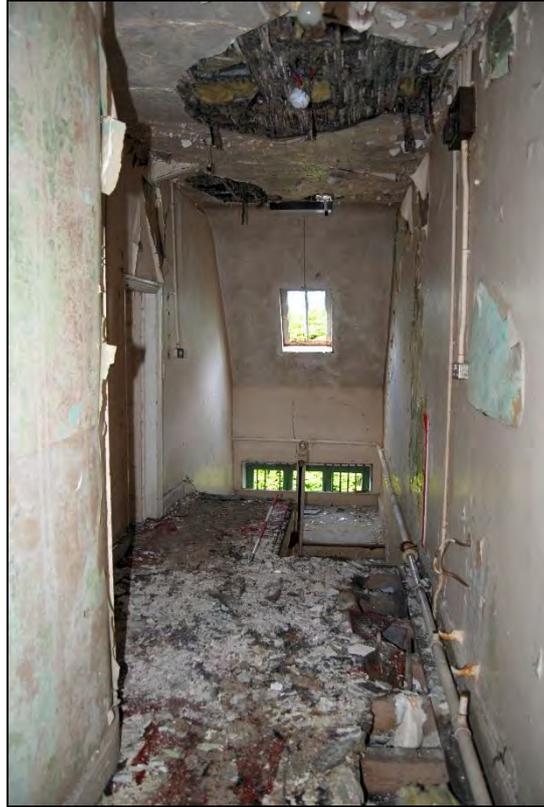
Plate 164: Corridor from the back stairs in the attic

Accessed only from the back staircase the attics consist of three corridors and nine distinct rooms. There is also an area without floor boards (Room A14) which held the water tanks. The back staircase gives access to a corridor (Room A 1, Plate 164) linking Rooms A2, A3 and A4 which appear to be the major rooms in the attic as these all have fireplaces.

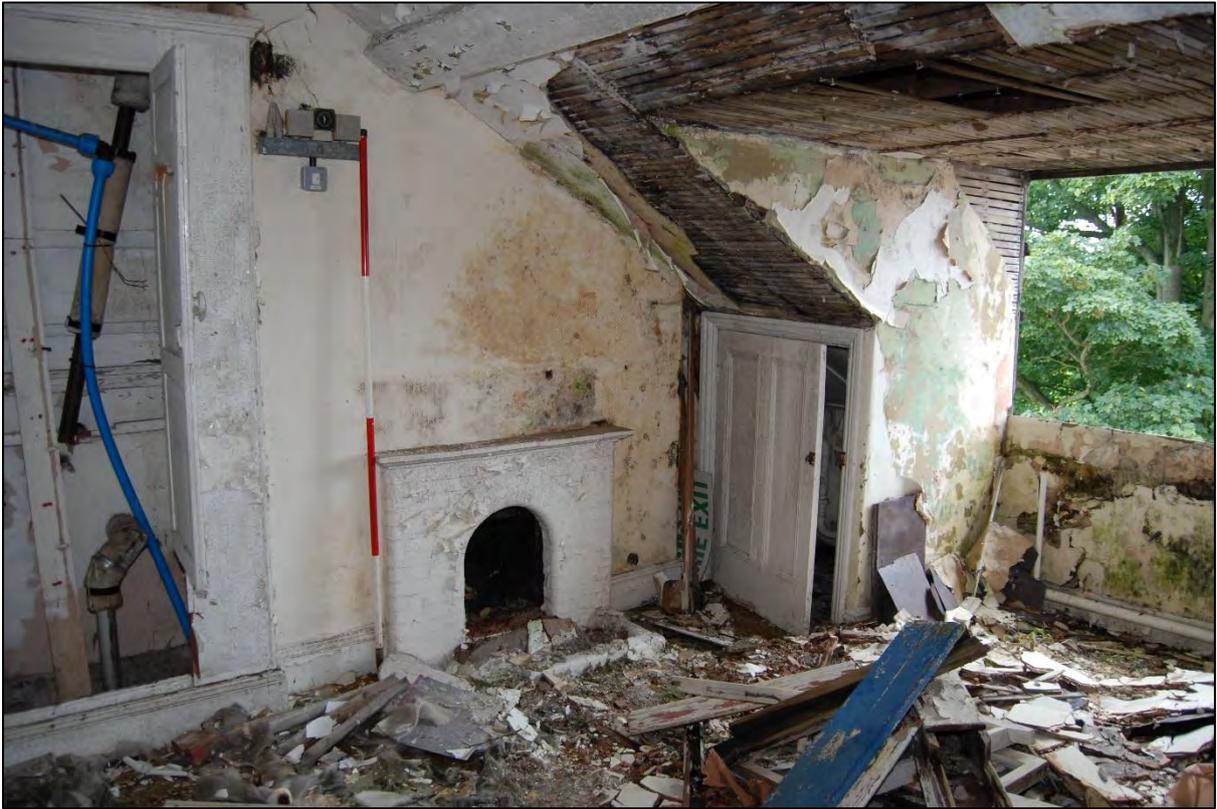
Plate 172: Room A4, looking SE

Room A4 (Plate 172) has a fireplace on its eastern wall with a brick surround which has been subsequently painted white (Plate 173). To the north is a built in cupboard which hid some of the water supply system (Plate 174). The room is dominated by a later dormer window (Plate 175) with smaller cupboards below.

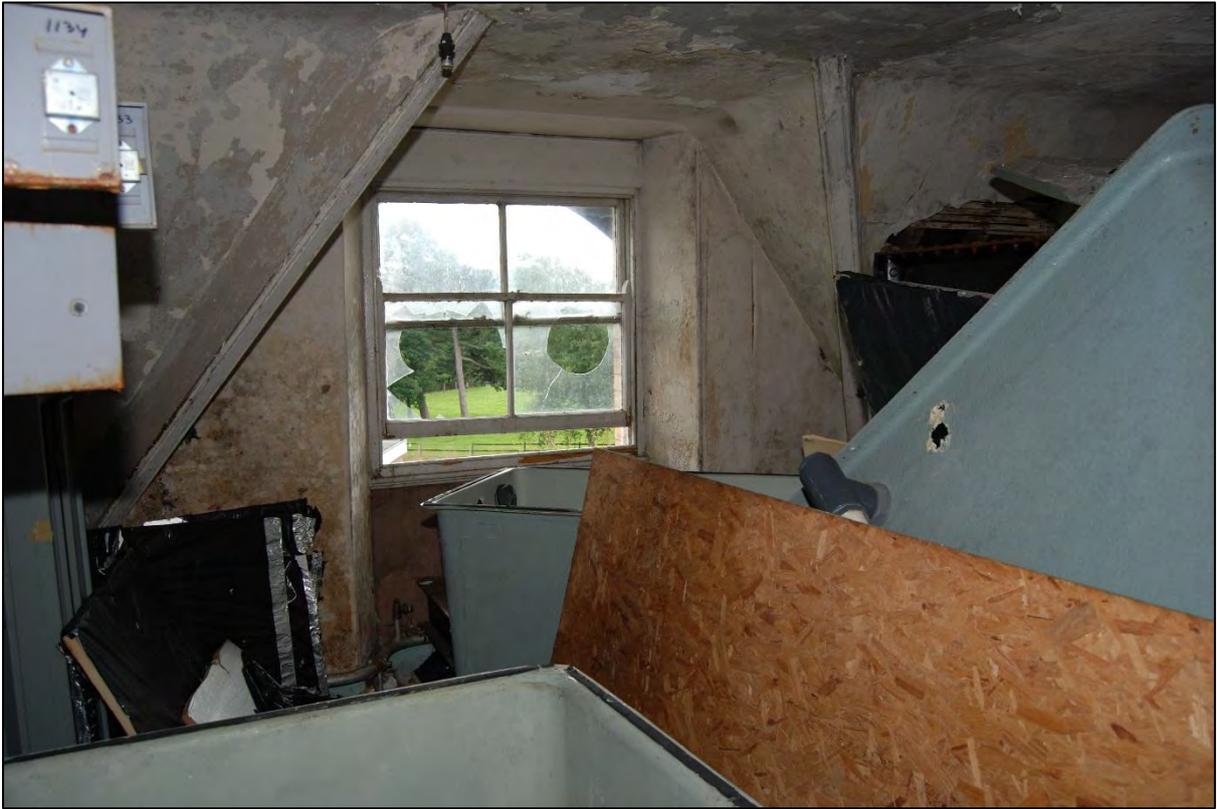
Plate 176: Room A7, looking SE

The second corridor runs parallel with the corridor from the back stairs (A1) and is accessed from three steps at the eastern end of corridor A1. It runs to the east before turning north linking rooms A7 – A12. Much of this area has been modified to divide it into a series of smaller rooms with few original features. Indeed some of these modifications took place after Plan 24-1 was drawn, probably in the 1970s. This is particularly seen in Room A7 which is marked as two separate 'Staff Bedrooms', although it now houses a water storage tank. The sash window in the eastern wall of this room, however, (Plate 176) is probably original as are the two smaller sash windows in the southern wall.

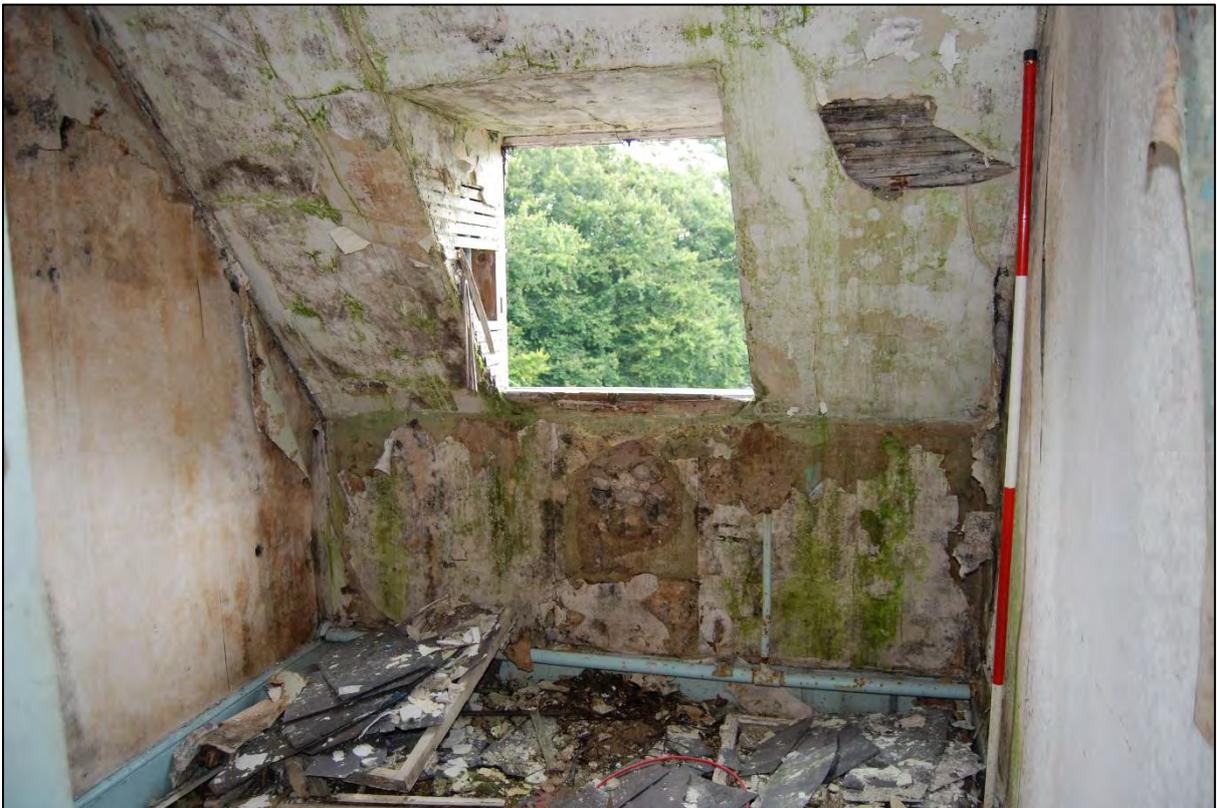
Plate 177: Room A8, looking east

Room A8 has suffered considerably since the building has been abandoned, however it retains the frame for a dormer window (Plate 177) which is assumed to be a later addition. Room A9 has also been modified with the replacement of the window with a fire door (Plate 178).

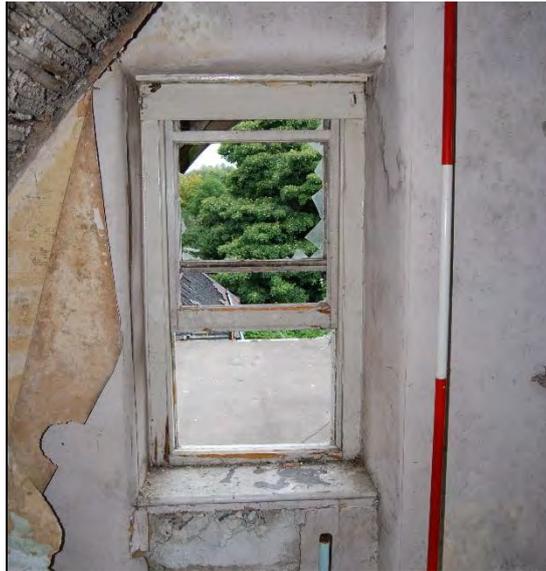
Plate 180: One of the flanking windows in Room A10

Room A10 is the only other attic room to include a fireplace (Plate 179). It is placed on the northern gable wall of this range and is flanked by sash windows which appear to be part of the 1872 house design (Plate 180). Unfortunately the fire surround in this room is missing. The position of the hearth would suggest that it relates to a room which was much bigger than the current size of A 10 and confirms that the current layout of rooms in this range is a relatively modern arrangement.

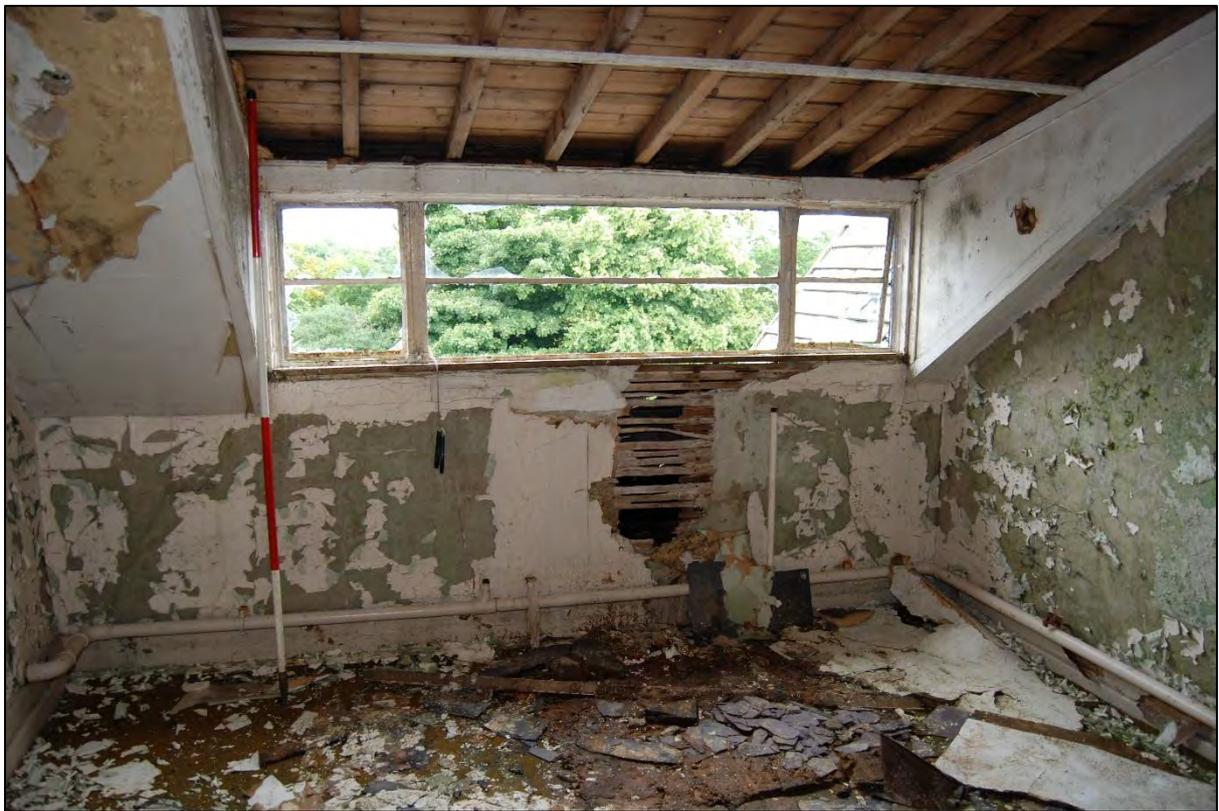
Plate 181: Room A11, looking north

Rooms A11 and A12 also have been heavily modified with the addition of a dormer window in Room A11 (Plate 181) and the modification of A12 as a bathroom (Plate 182). The corridor (A13) from the western end of A5 only links the centre of the attic complex to a WC (A14) passing the tank area (A14).

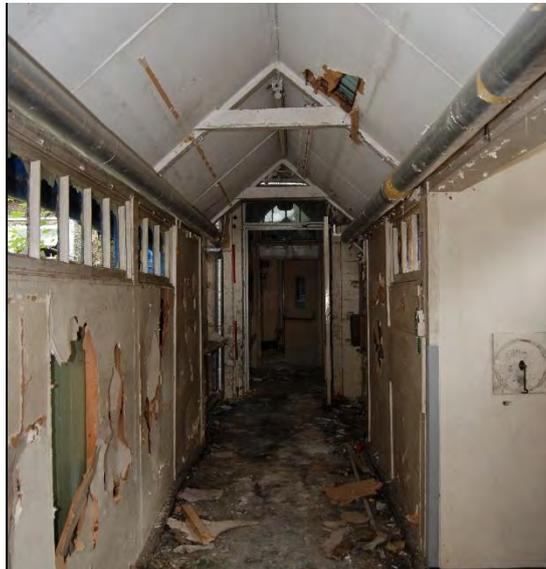
Plate 187: Corridor (33) looking south

The house is linked to the later 'Terminal Care Unit' and the Geriatric Unit by a series of corridors. These can be conveniently divided into three areas. The corridor linked to the porch (Room 33) is of a different construction to the rest of the corridors having a peaked roof (Plate 187). It was constructed of wooden planking with a series of rectangular windows just below the eaves (Plate 188). The style of construction would suggest that this is part of an earlier corridor than the others links to the wards. It is possible that this may be part of the corridors seen on the pre-1930 manuscript additions to the ordnance survey linking the house to a range now occupied by the Terminal Care Unit.

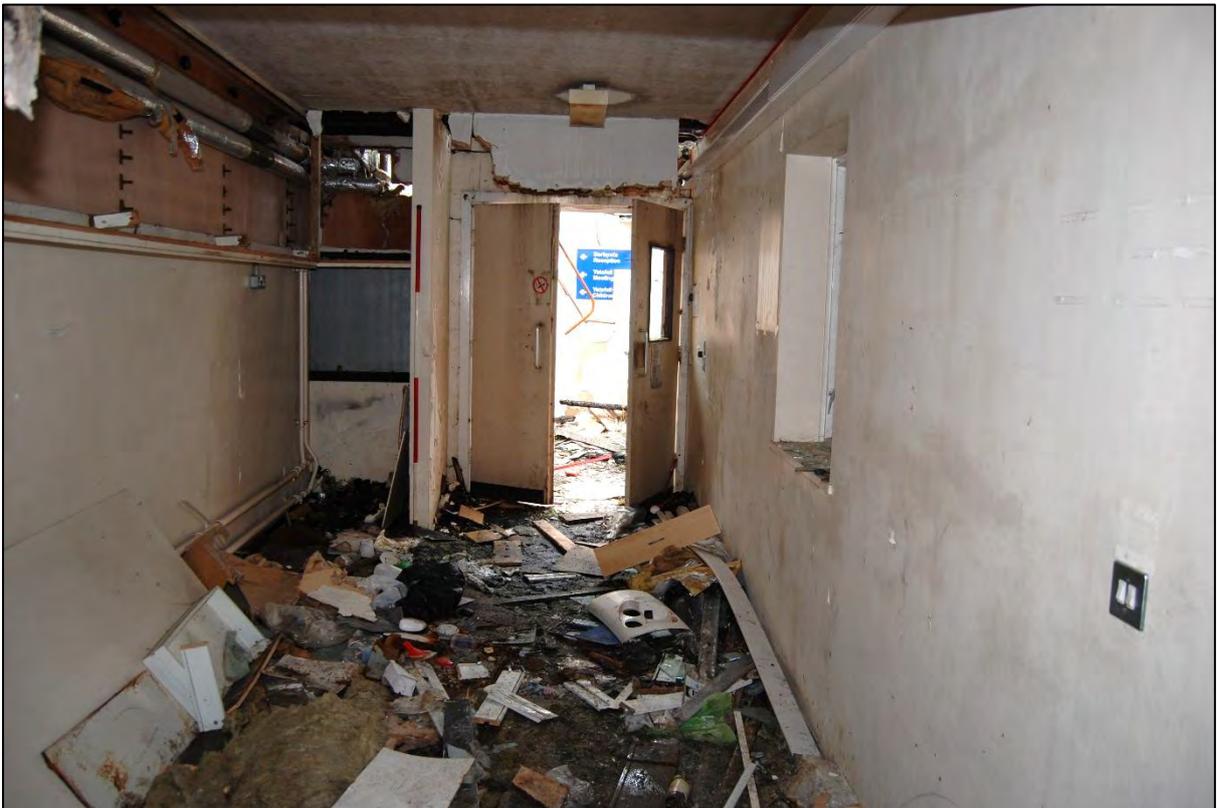
Plate 189: Corridor (Room 34) looking north

The other two corridors are wider, that to the 'Terminal Care Unit' (Room 34, Plate 189) being constructed of brick whilst that to the Geriatric Unit (Room 71, Plate 190) is a much light construction with boards supported with a wooden framed partition.

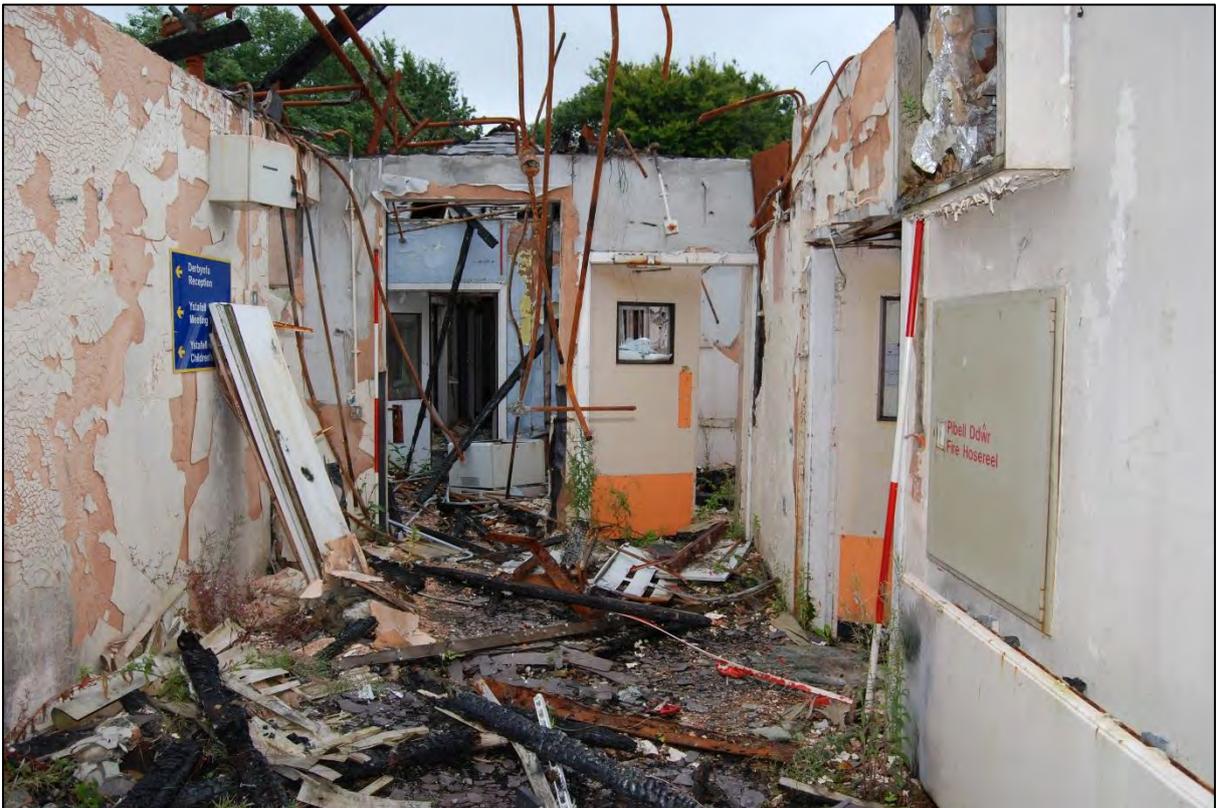
Plate 191: The lobby to the "Terminal Care Unit" (Room 35) looking east

The entrance lobby (Room 35, Plate 191) gives access to both the north south range and the main block. This area of the building has been heavily burnt removing the roof over Rooms 35, 47, 54, 55 and 56. The main block and the north south range had gabled roofs whilst the later extension to the east has a flat roof. The last phase of use for the Terminal Care Unit would be appear to be as offices as shown by the labels on some of the doors.

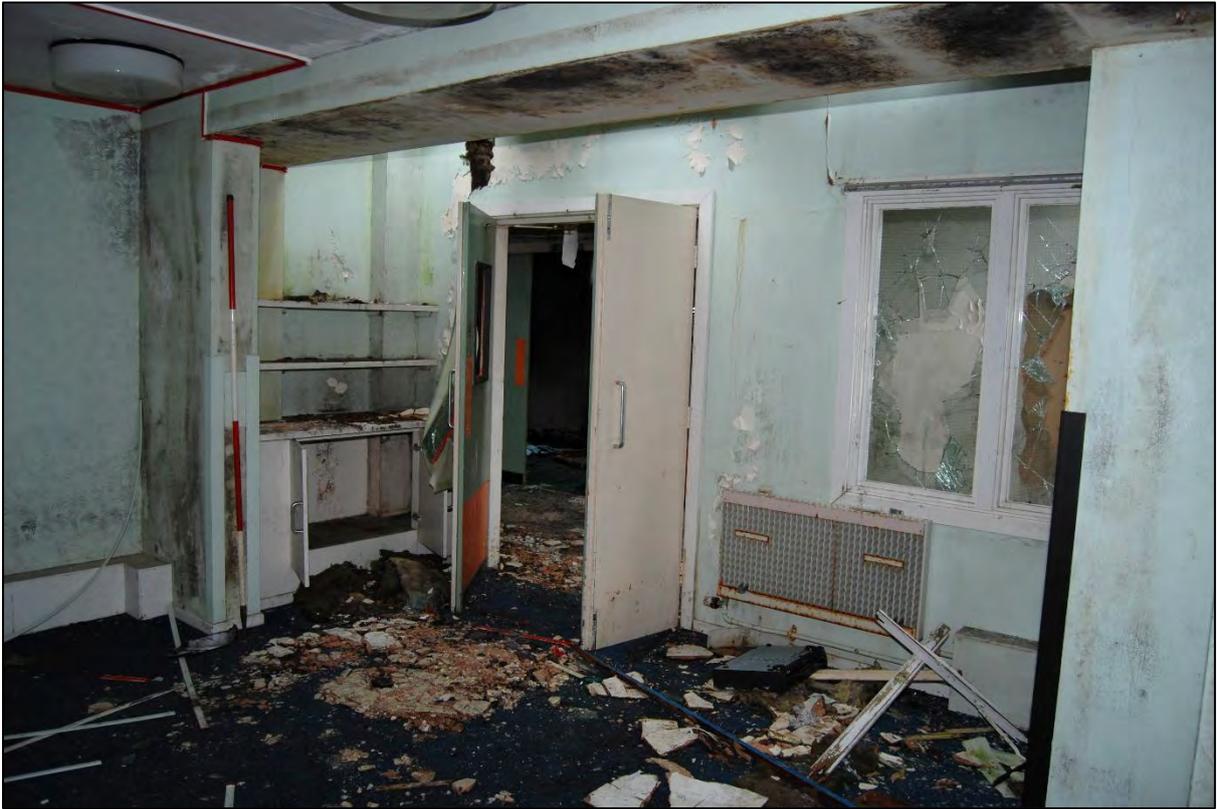
Plate 192: Room 41, looking NW

The main block has a central corridor (Room 40) from which all other rooms are accessed. To the south of the corridor are two larger rooms (Rooms 41 and 42) which are later additions to a pre-existing block. Room 41 (Plate 192) is partly divided by short stub walls which might reflect the position of the veranda which probably occupied the northern section of this room. It has two external windows and a fire door to the south and an internal window onto the corridor together with a door to the north. Room 42 (Plate 193) is also subdivided, this time by built in furniture. The label on the door defined this room as the 'Reception', presumably as part of the final use of the building which contained a series of offices including the Child Development Services. Although Room 43 (Plate 194) is labelled as a 'Meeting Room' on the Plan 24-1 it is shown as a ward demonstrating the change in use of this range.
