Historic Building Assessment of

ST DUNSTAN'S OUTBUILDINGS

For St Dunstan's Enterprises Ltd

Doc Ref: LPI264C-HBA-v1.4

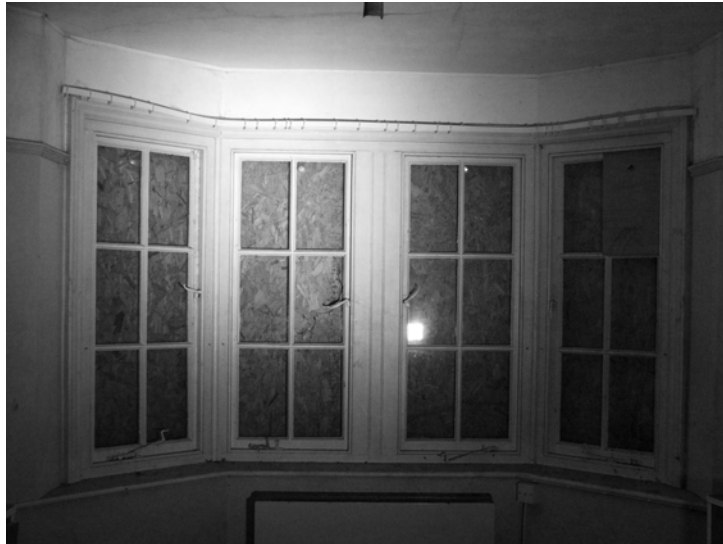
Plate 11 - Cant bay window in L6, looking north

4.3.21. To the north of L5 is L6, which is thought to have been the parlour. This room has a cant bay window to the north, which appears to have its original frame and fixings *in situ* (PLATE 11).

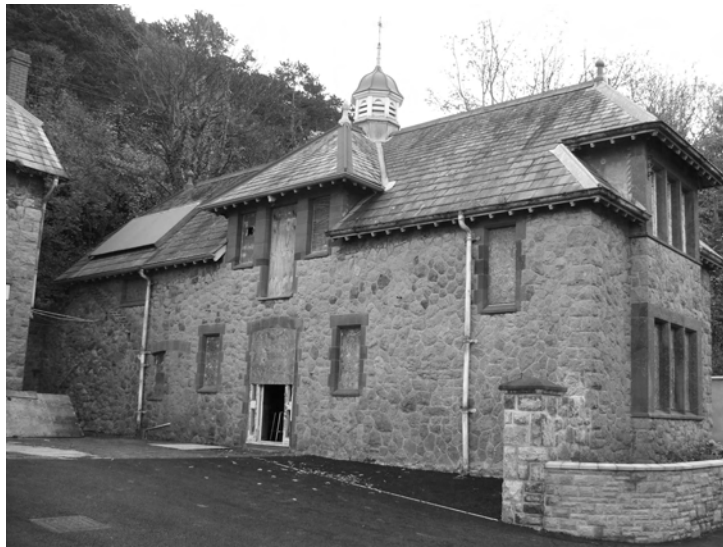
Plate 13 - Stable block, looking southeast

4.4.2. Located centrally along the roof apex is an octagonal louvre vent below a copper cupola with a decorative weather vane. Also located centrally along the northern elevation is a hipped roof dormer (PLATE 13). This dormer has a central loading door with flanking windows. These are all set within red sandstone dressing with intrinsic sandstone lintels and sloped sills, however the sill below the door is of grey stone.

4.4.4. To the east of the doorway a third window can be seen (PLATE 13). This is a modification to the original structure. The arched lintel extends more than

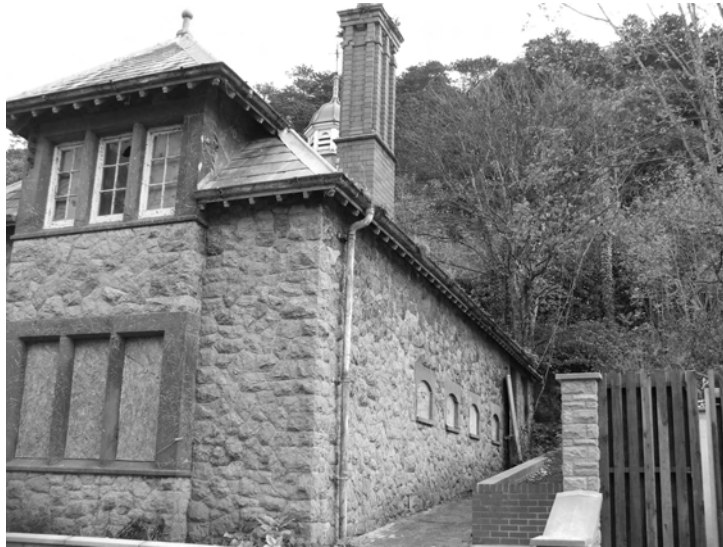
Plate 17 - Southern elevation, looking northeast

4.4.10. The southern elevation is also of random coursed grey brown rock faced stone. A series of four, unevenly spaced, arched windows are visible on this elevation (PLATE 17).

4.4.11. The arched windows are set within a sandstone dressing with flat arched lintels, flat protruding sills and flanking quoins. These appear to respect a now missing internal division.

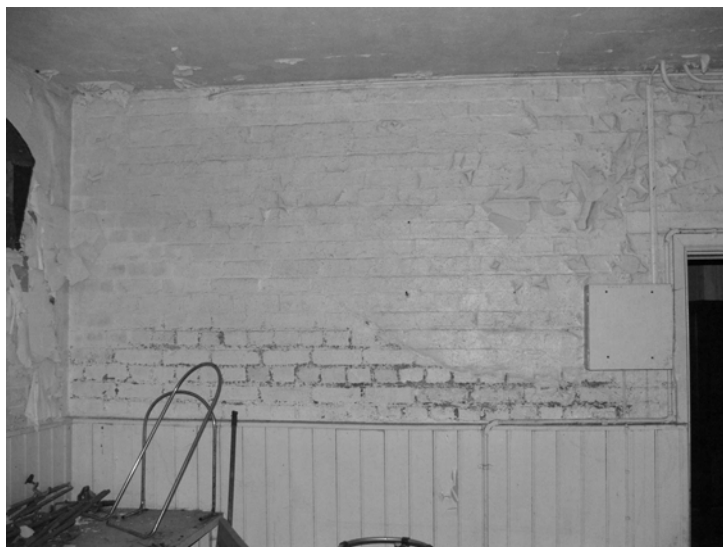
Plate 22 - Stable ghosting on western wall

4.4.23. To the south of the doorway ghosting of a previous internal feature can be seen on the wall. A curving mark, barely visible, can be seen above the panelling (PLATE 22). The form of the ghosting is reminiscent of stable

4.4.24. The layout and features within S1 indicate that this room was originally designed as stables. The half panelling, high windows and ghosting on the western wall are all evidence of this. It is likely that the floor below the carpet and tiles retains features, such as gulleys, associated with the stabling function.

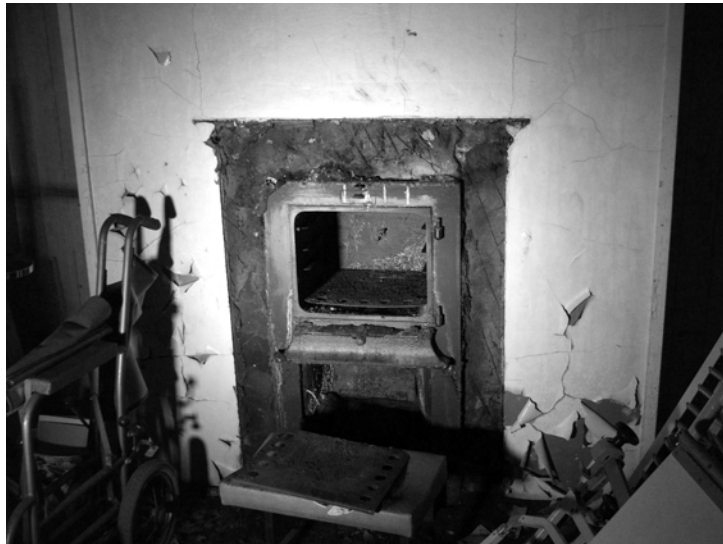
Plate 23 - Mini range in S2, looking south

4.4.25. To the west of S1 was a small office, S2. This room was used for storage of hospital equipment, however features could still be identified. On the south wall was the remains of a small fireplace in the form of a mini range. The front of the fireplace was missing, however the structural components behind were still intact. The lower section was a cast iron firebox, above which a small oven box is located (PLATE 23). The scar on the wall surrounding the fire shows a typical late Victorian and Edwardian overmantle and surround style.

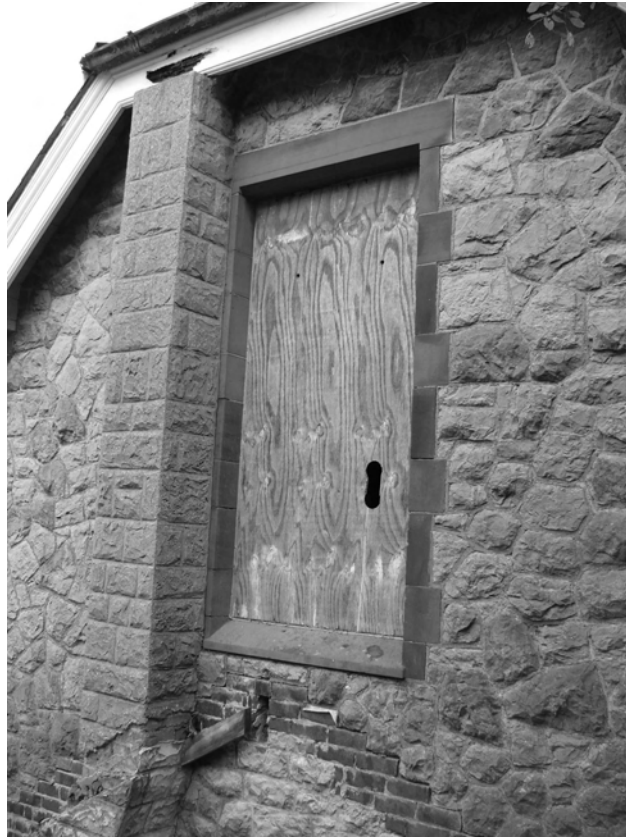
Plate 29 - Southern elevation of laundry block,
looking northwest

4.5.12. The southern elevation was a single bay wide and of the same grey brown random coursed stone. At first floor level was a double height window with sandstone quoins, lintel and sill. To the west of the doorway a chimney breast was evident. This is a later addition to the structure and obscures the western quoins of the window (PLATE 29).

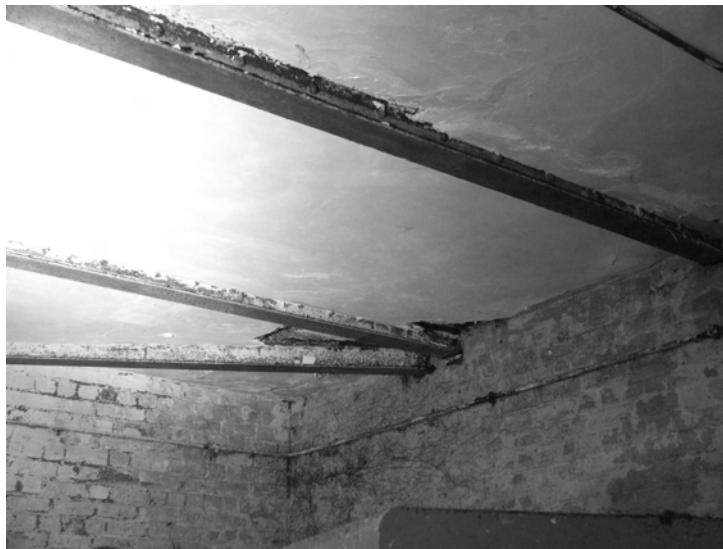
Plate 31 - Ceiling in E1, looking northeast

4.5.15. Room E1 was identified as a garage and was accessed via the large door at the southern end of the western elevation. The room was of brick construction in English bond with a concrete floor and no sub divisions. It was being used for storage but is thought to have been a coach house or garage previously. The ceiling showed the construction for the first floor as it had exposed steel joists and cross struts, with inset concrete panels (PLATE 31).

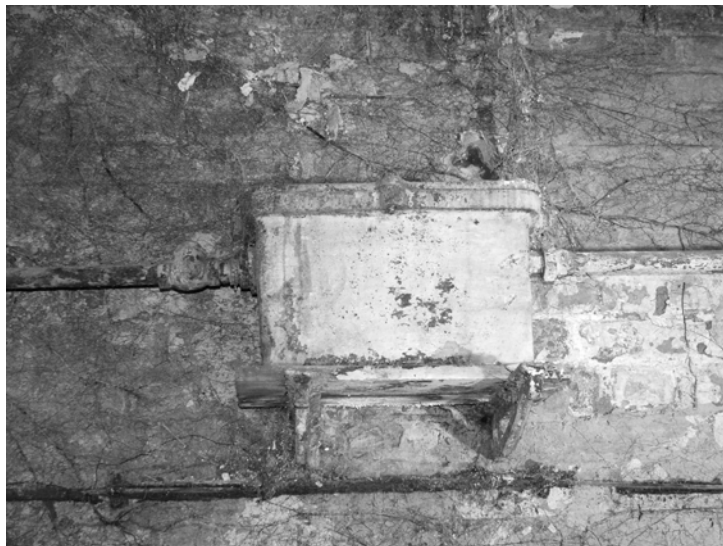
Plate 33 - Cistern in E3

4.5.18. On the eastern wall of E3 was a cistern linked to two pipes. One running south to E4 and the other north to E5 (PLATE 33).

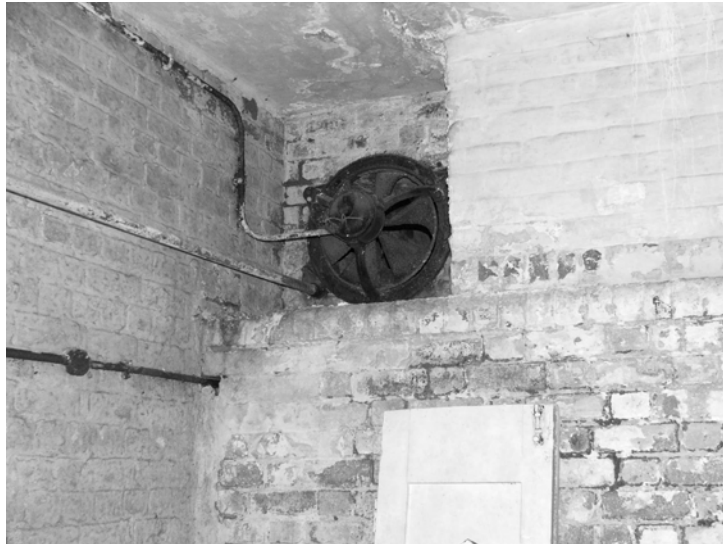
Plate 34 - Fan between E3 and the lower section of E8

4.5.19. Also within E3 was a powered fan, allowing air flow between E3 and the lowered floor section of E8 (PLATE 34).

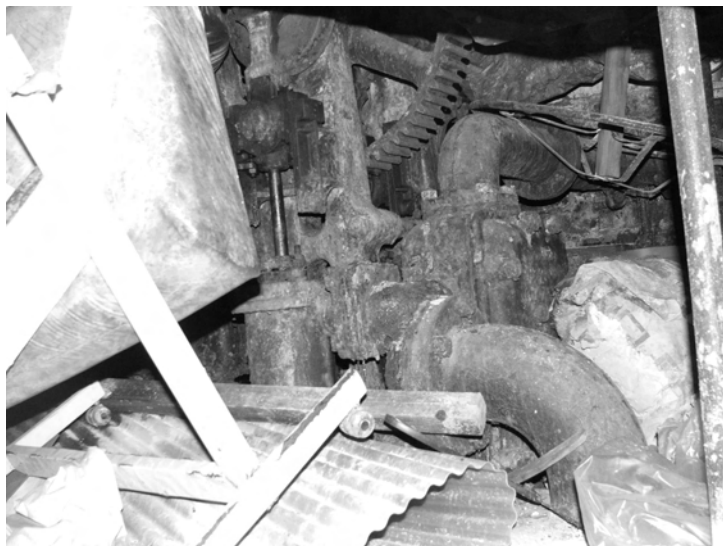
Plate 35 - Gears within E4

4.5.21. The eastern half of E4 had a lowered ceiling, supported on steel joists. This must relate to a function on the first floor, discussed below (4.5.34). As room E4 was used for storage access was problematic, however behind some of the items stored machinery was visible (PLATE 35). This appears to be gears associated with supplying power to the main property.

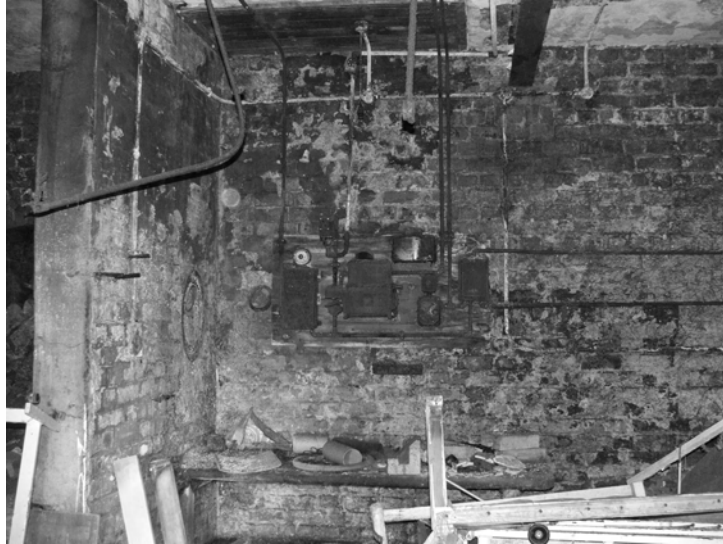
Plate 36 - E5, looking east from doorway

4.5.23. Room E5 was located at the northern end of the ground floor of the laundry block. This was a large open plan room with a short stub wall extending from the eastern wall, approximately centrally, to sub divide the room into two (PLATE 36).

4.5.24. On the stub wall was a blocked metal ring that appears to have been a functional element in the past. The pipes from the cistern in E3 supply a control unit on the eastern wall within E5.

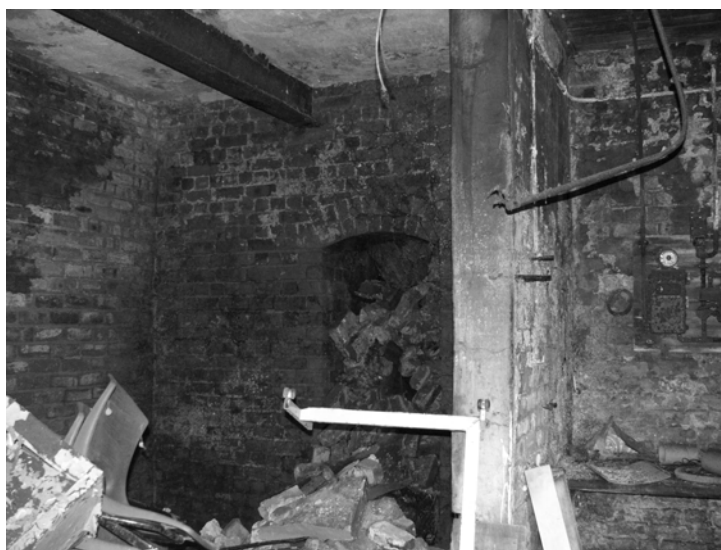
Plate 38 - Alcove in E5, looking east

4.5.26. At the northeast corner of the room was an arched alcove, which was inaccessible at the time of assessment (PLATE 38).

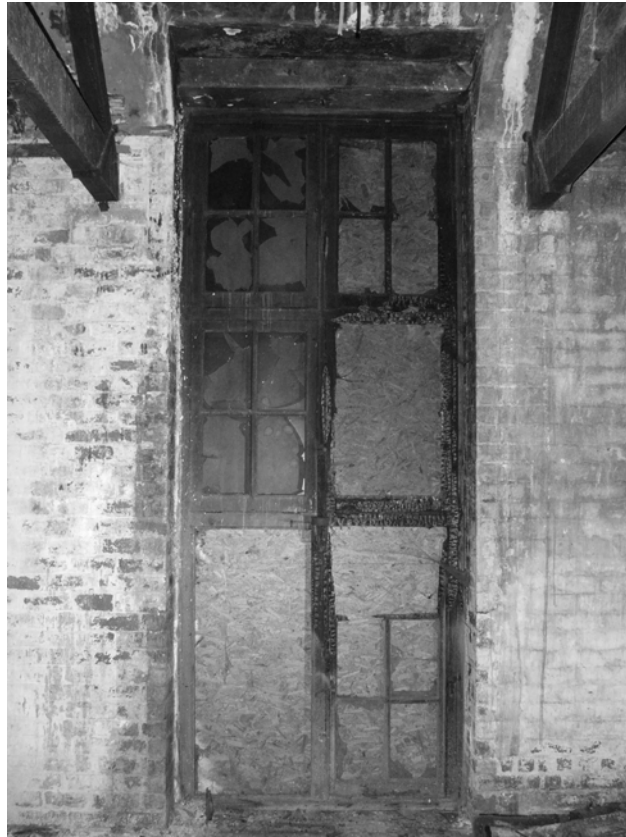
Plate 39 - Full height window on east wall of E8

4.5.31. E8 was a large open plan area with full height windows on both east and west walls allowing a great deal of light in. At the time of survey these were

boarded up, however the window frames were visible from the inside (PLATE 39). The frames are wooden 28 pane windows with central hopper lights.

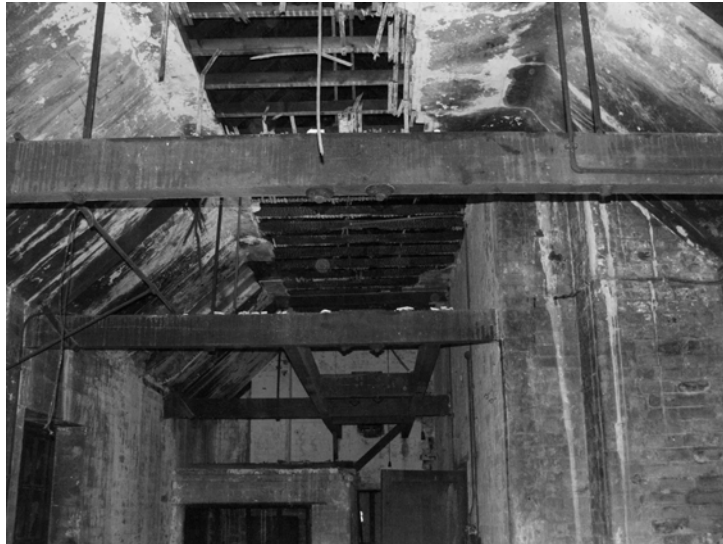
Plate 40 - Roof system in E8, looking south

4.5.33. The roof structure visible in E8 was of simple construction with tie beams spanning the width of the room. An electrical conduit also spans the rooms and can be seen attached to the tie beams. Located in front of E6 and E7 was a heavy wood frame built into the tie beams. This appears to have held some sort of machinery (PLATE 40).

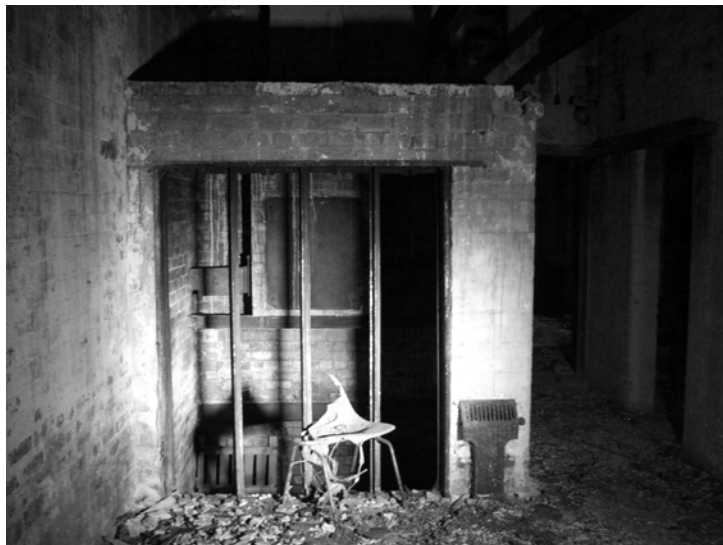
Plate 41 - Brick division within E8, looking south

4.5.34. At the southeastern corner of E8 was an area divided from the rest of the room by a brick wall with metal grate on the north face. This had a lowered floor, seen as the lowered ceiling in E4 on the ground floor, and was open at the top (PLATE 41).

4.5.35. On the north wall of this feature was a small metal vent which appeared to be linked to ducting on the south wall of the feature. This was manufactured by Bradford & Co of Manchester. Thomas Bradford and Co were known from the Victorian and Edwardian period for manufacturing and fitting steam boilers.

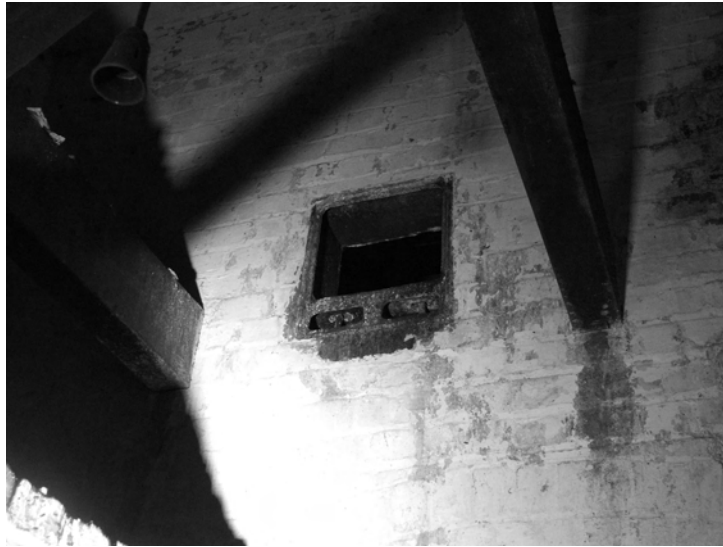
Plate 42 - Bearing box on south wall of E8

4.5.36. On the south wall of E8 was a feature that is likely associated with the original function of the building. A metal casing formed a void in the wall between E8

and E9, usually seen in industrial buildings, these bearing boxes allow transmission of power from one area of the building to another (PLATE 42).

4.5.37. The layout of the room, as an open plan area with large windows and evidence of power transfer systems such as the bearing box indicate that this may have been the ironing and packing room. A breakdown of the systems employed in large scale laundries of this date can be found in section 4.5.46.

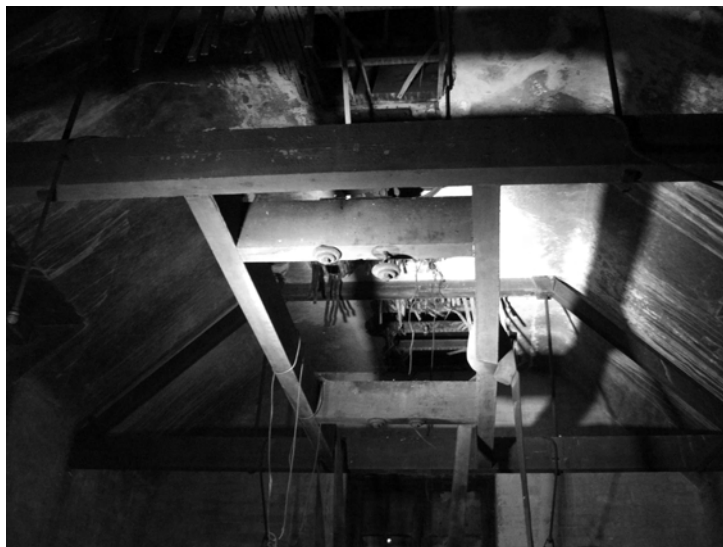
Plate 43 - Roof system, E9, looking south

4.5.39. To the south of E8 was E9. This room was smaller in scale than E8, however it had the same roof system as E8, with tie beams spanning the width of the room and a central, heavy duty, wood frame support for some form of

machinery (PLATE 43).

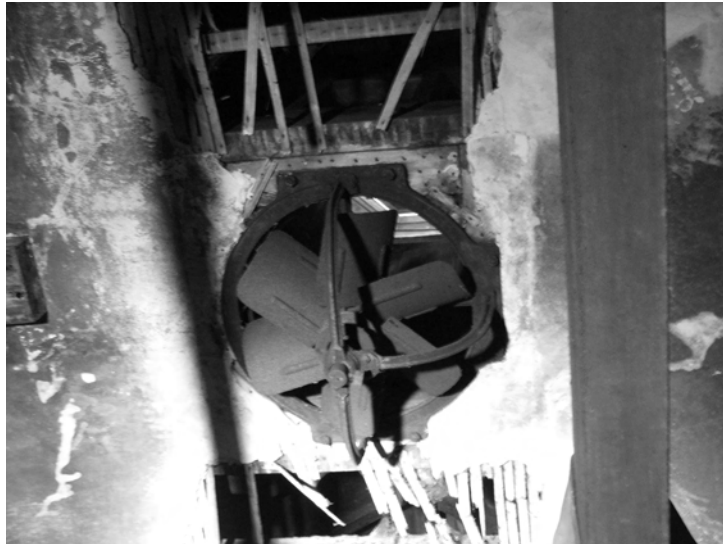
Plate 44 - Fan below louvred vent in E9

4.5.40. Above the wooden frame, located centrally to the room, was the opening for the louvred vent on the roof. This had a powered fan attached to it to create a better air flow than it would have created naturally (PLATE 44).

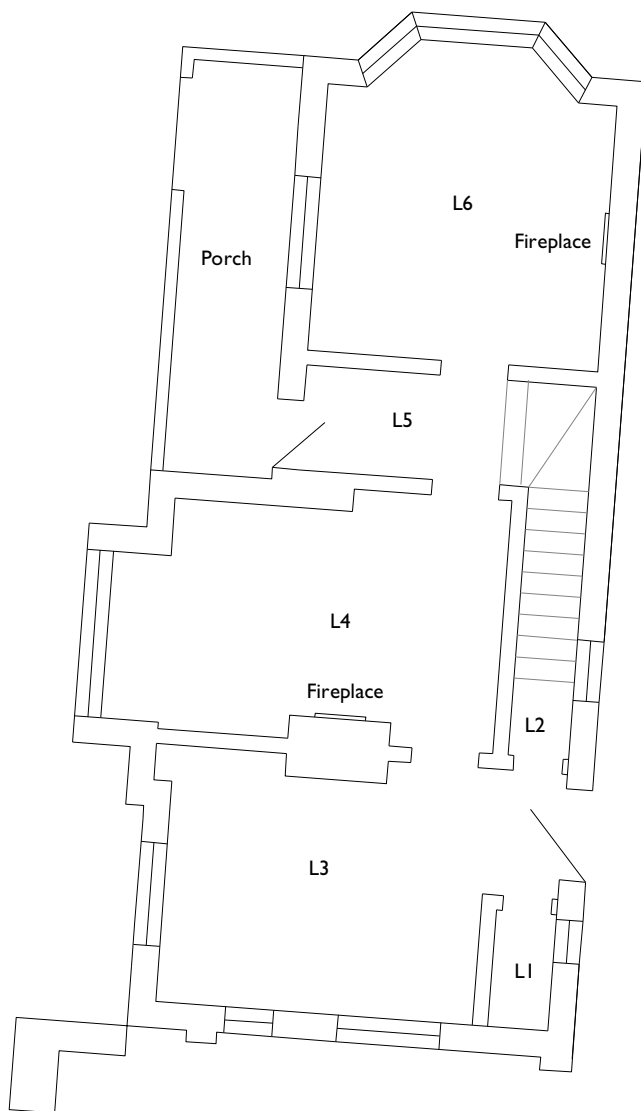
FIGURE 7 // Gate Lodge Plan

4.3.14. The gate lodge was in a poor state of repair and as such the first floor was not accessible. The remaining stairs could not support any weight and it is thought that the floorboards on the first floor are dangerous. As such only the ground

4.3.15. The ground floor comprises six distinct areas, labelled as L1 to L6 (FIGURE 7). Access to the building was gained via the rear door on the eastern elevation. Immediately to the south was a small toilet (L1) and to the north was an under stair cupboard (L2).

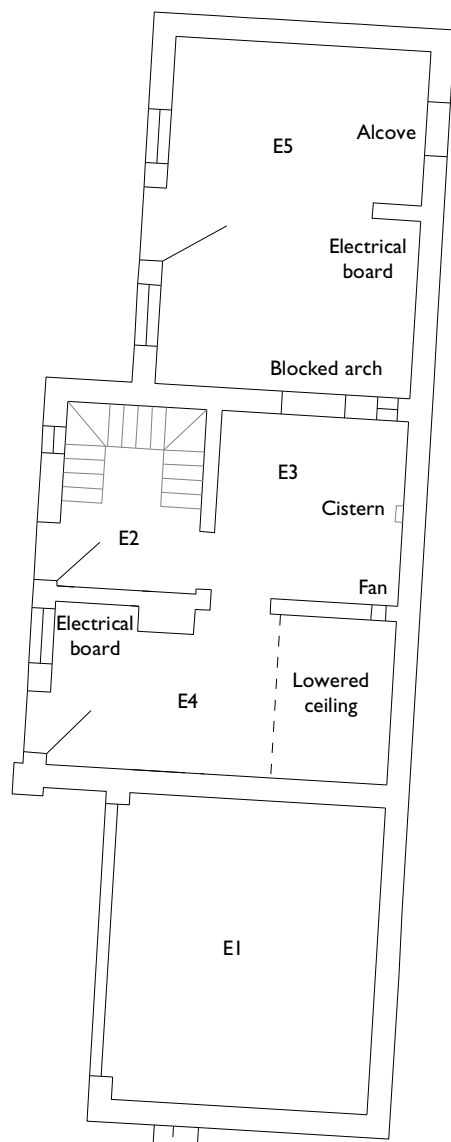
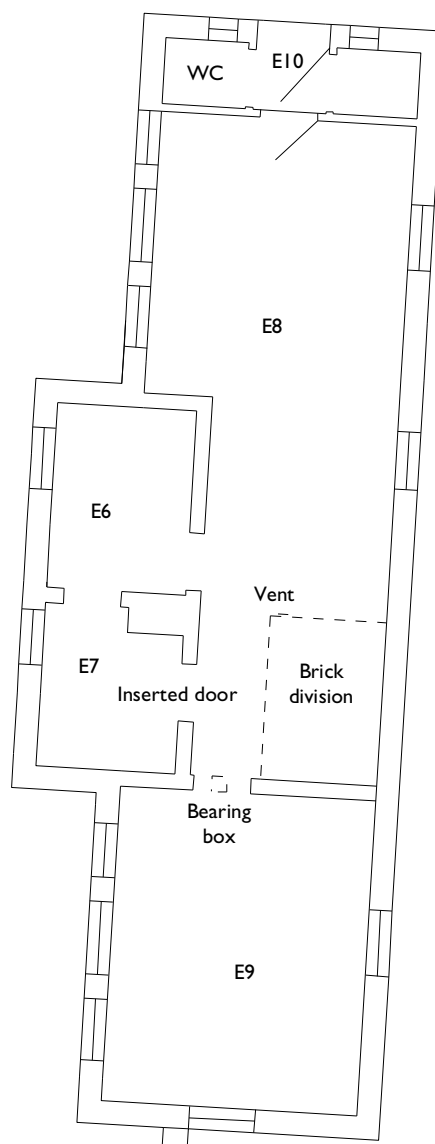
FIGURE 9 // Laundry Block Plans

4.5.14. The laundry block can be divided into three distinct areas on the ground floor and two areas on the first floor (FIGURE 9).
