CEFN SIDAN WRECK RECORDING PROJECT

PROJECT No. ~~32088~~ 56958

Report prepared  
by  
**Nigel Page**

Cadw: Welsh Historic Monuments

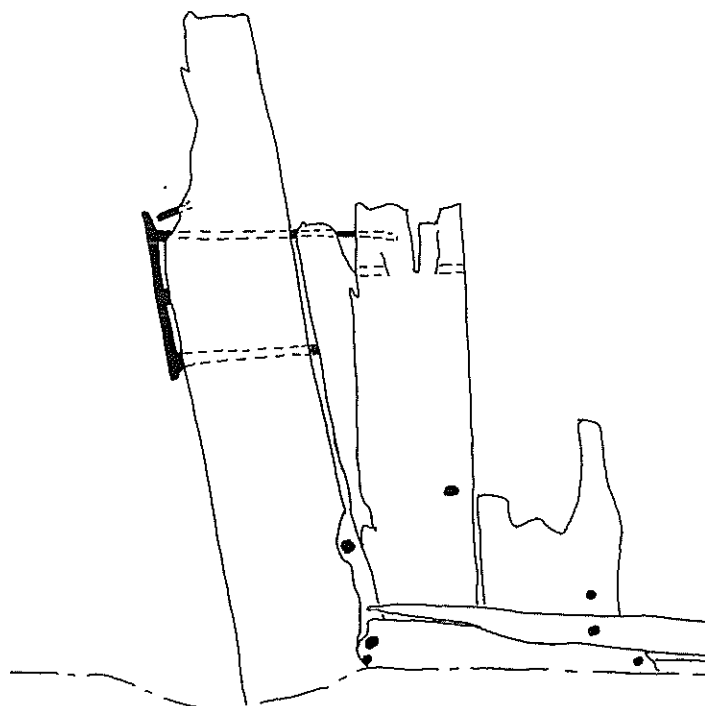
The six timbers of the stern, the planking and stern post, were the most well defined part of the visible structure, a metal plate survives on the stern post. (Fig 3; plate 1).

Stern Post Arrangement looking Northwest

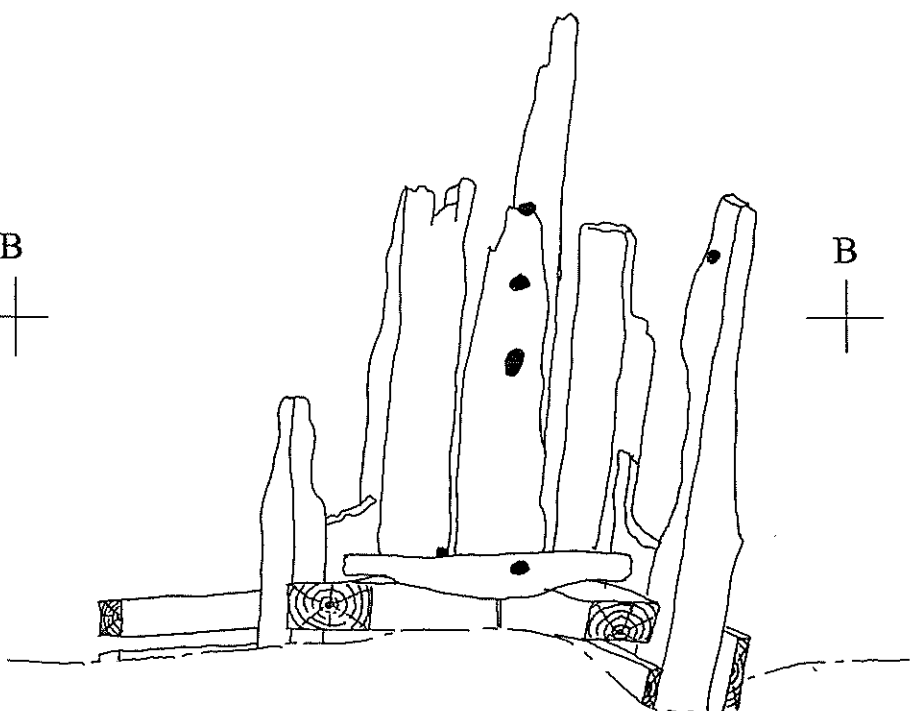
Stern Post Arrangement looking Southwest
