Historic Environment Feature Management Report:

Black Rocks, Quarry and Kilns

UID: 305,295

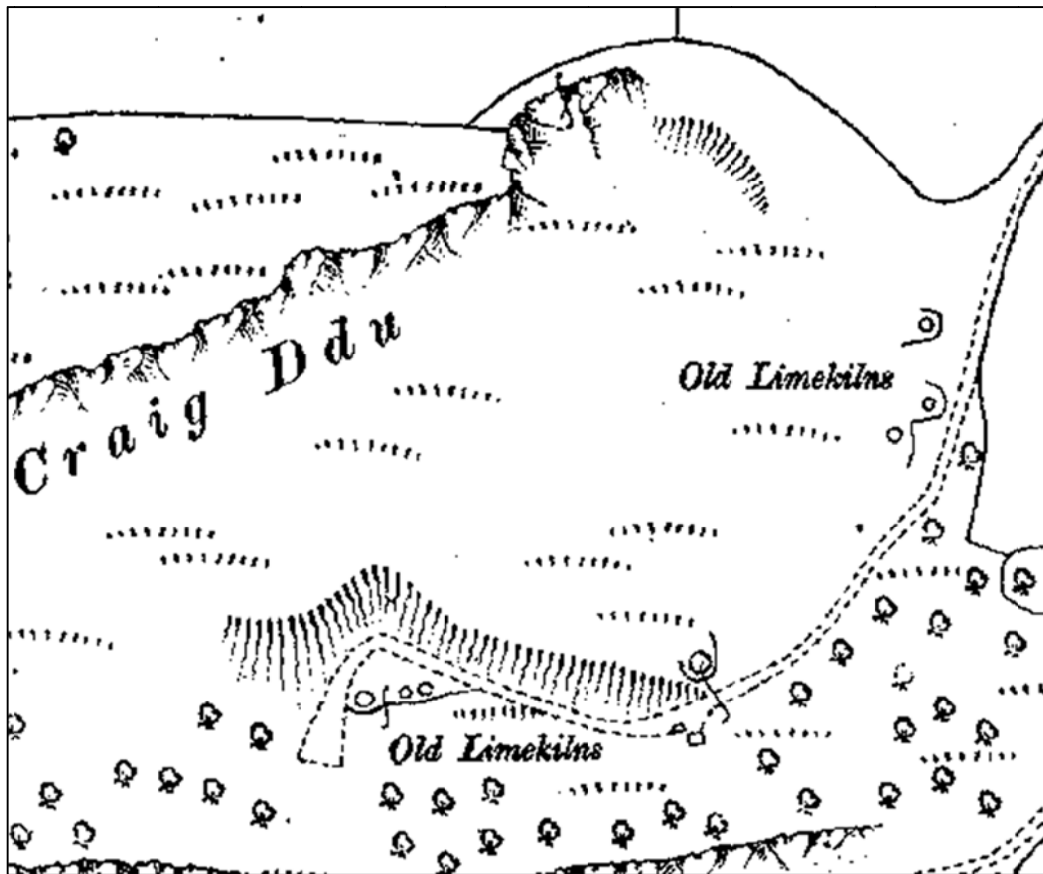
Detail from the Ordnance Survey 2nd edition map (1907) © and database right Crown copyright and Landmark Information Group Ltd (All rights reserved 08/05/2012)

The second edition map of 1907 describes all the kilns as Old Limekilns, indicating abandonment by this date. The depiction of the size and form of the quarry is unchanged suggesting that this ceased to be worked soon after the survey for the 1889 map and the whole complex became redundant.

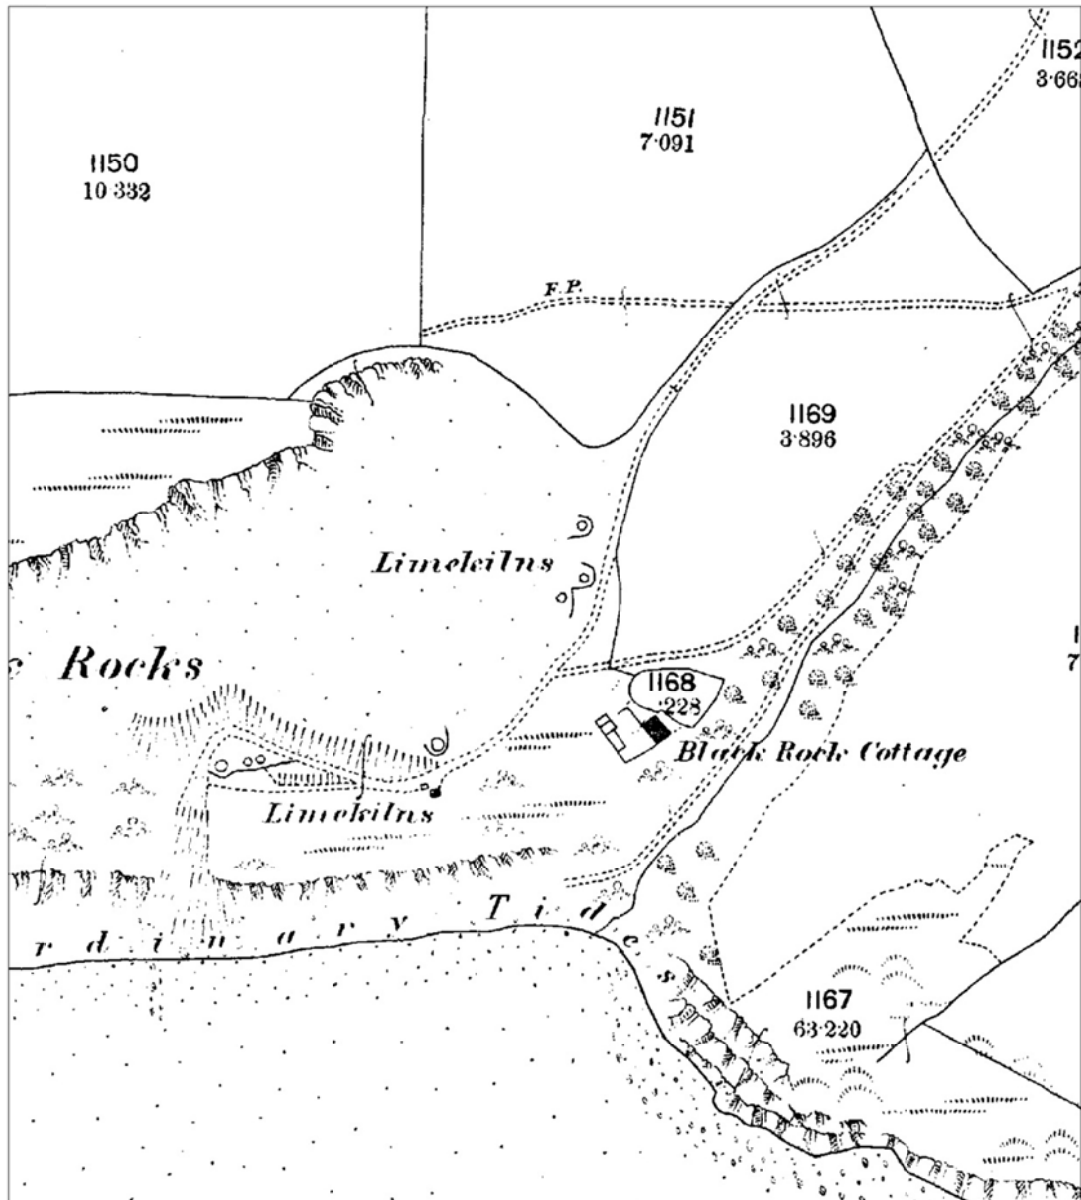
1st Edition Ordnance Survey Map

Detail from the Ordnance Survey 1st edition map (1889) © and database right Crown copyright and Landmark Information Group Ltd (All rights reserved 08/05/2012)

An irregular shaped quarry containing seven lime kilns shown on the 1st edition Ordnance Survey map. The kilns are separated into two PRNs: a bank of three with an isolated kiln (PRN 29988) and a second group of three (PRN 29989) which is Listed Grade II.

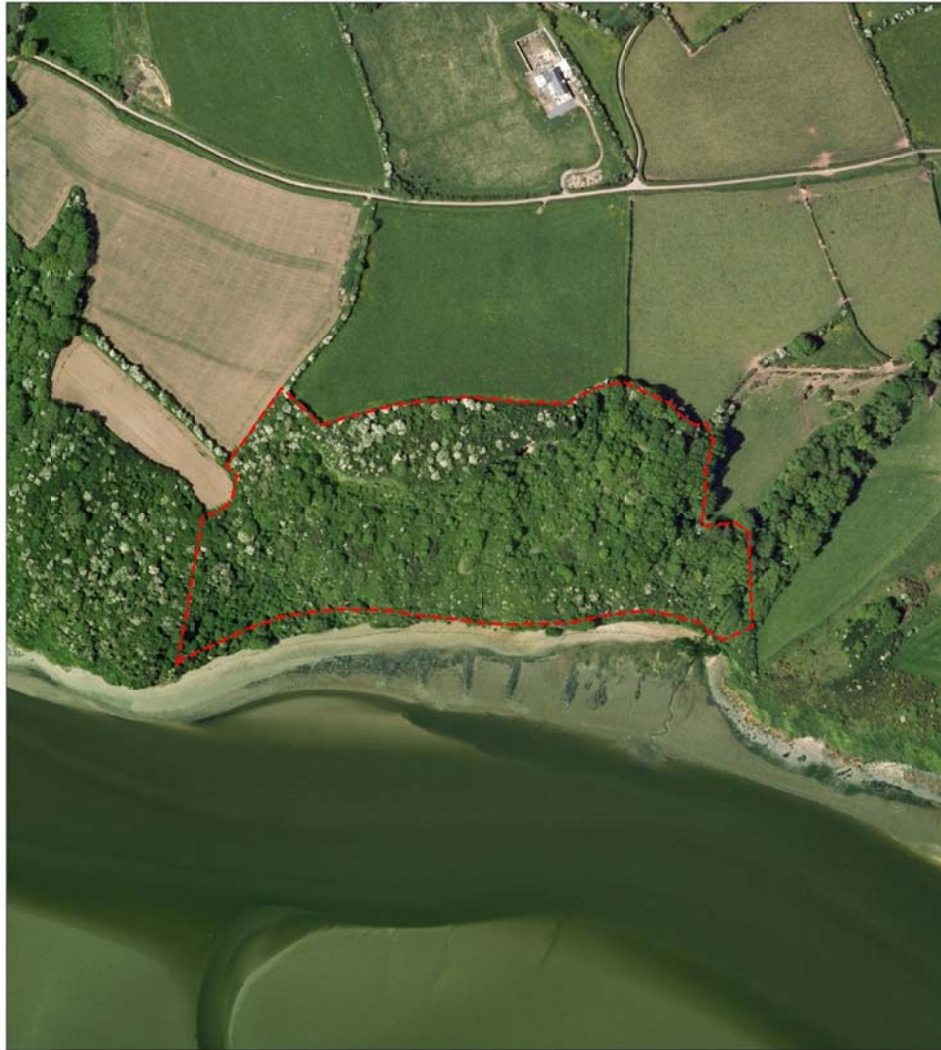
Aerial Photograph

© Next Perspectives. Welsh Assembly Government 2009

The quarry and kilns are shown on the most recent Ordnance Survey mapping (Mastermap 2011). The most recent aerial photographs (Next Perspectives, 2009) show the area to be covered with thick woodland so the current condition of the structures is unclear.
