Historic Environment Feature Management Report:

Limestone Hill, Ruined Lime Kiln

UID: 305,997

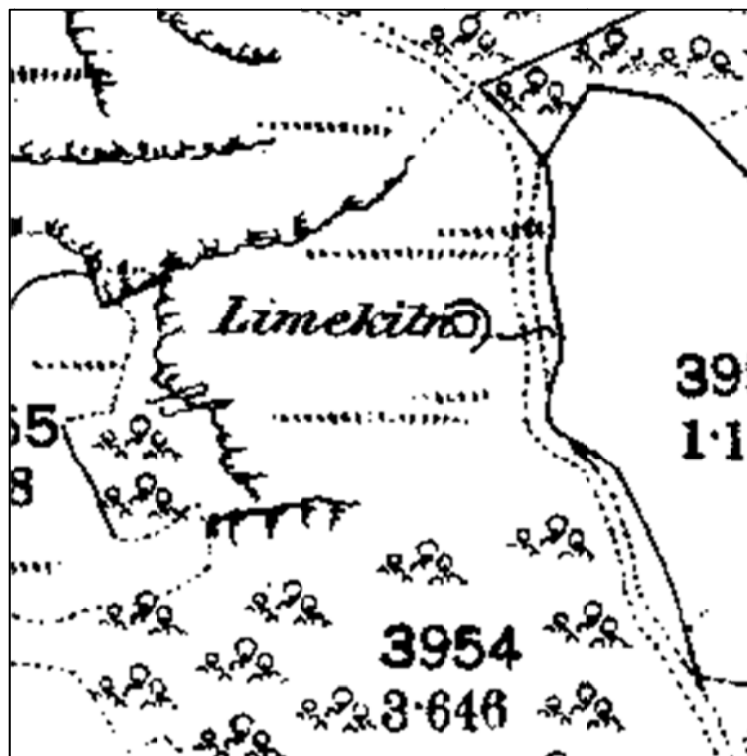
Detail from the Ordnance Survey 1st edition map (1891) © and database right Crown copyright and Landmark Information Group Ltd (All rights reserved 08/05/2012)

Lime kiln shown on the 1st edition Ordnance Survey map of 1891. By the second edition of 1907 it was marked as Old Limekiln indicating abandonment. Stone built it has a rounded front wall housing an unusual bottle shaped draw hole opening facing north-east. There are two kiln eyes in a single aperture. The roof of the draw hole passage is crudely corbelled and capped by large flat limestone slabs. The kiln is 7.0m long x 4.6m high. The pot diameter is 4.2m. (P.Sambrook 1994). Its feeder quarry was located 60m to the west to the immediate North east. It lies in an extensive landscape of old lime workings including quarry pits and faces, ruined kilns and trackways. The kiln appears on the most recent mapping (Mastermap, 2011). Recent aerial photographs (Next perspectives,2009) show the area to be heavily wooded so its current state is unclear unclear (H Pritchard,2013).
