Historic Environment Feature Management Report:

Post medieval Farm and Neuadd Llwyd/Brynderi, Lead mine and works

Customer Reference Number: A0027988

UID: 301,806: 301,807

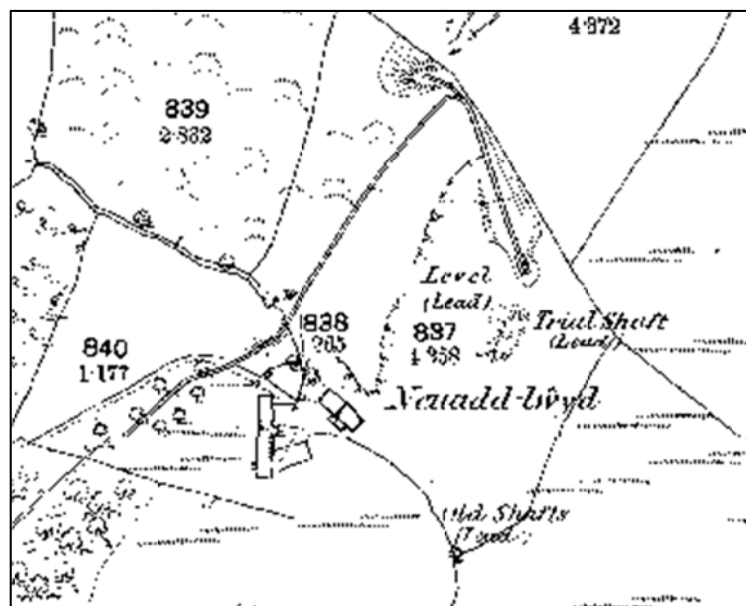
Detail from the Ordnance Survey 1st edition map (1890) © and database right Crown copyright and Landmark Information Group Ltd (All rights reserved 08/05/2012)

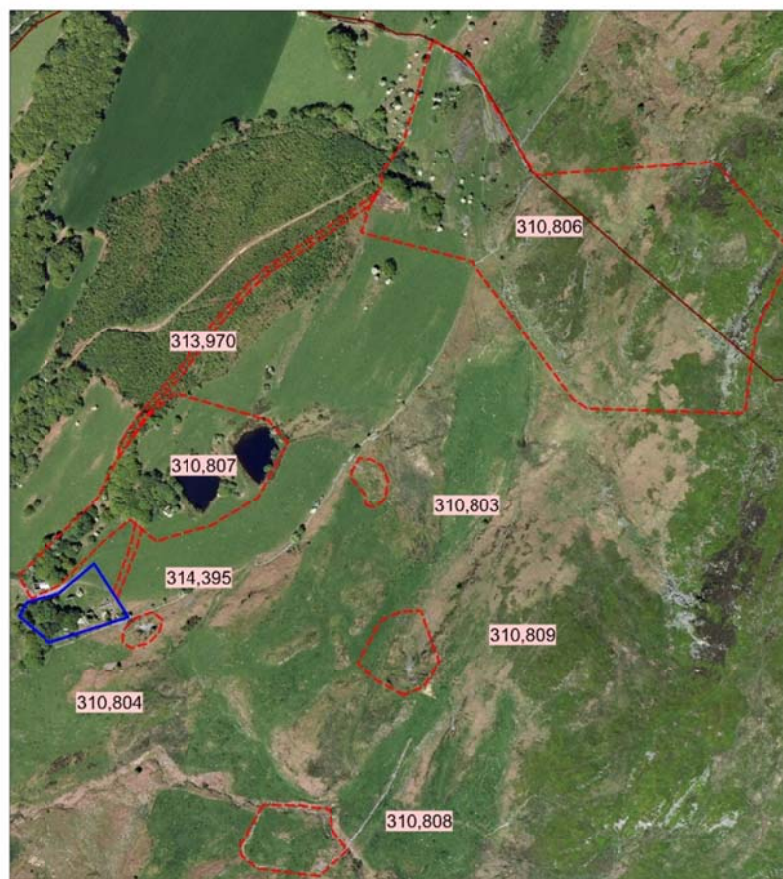
Aerial photograph showing extent of HEF UIDs

Note only UIDs 310,806; 313,807 & 313,970 are included in the report

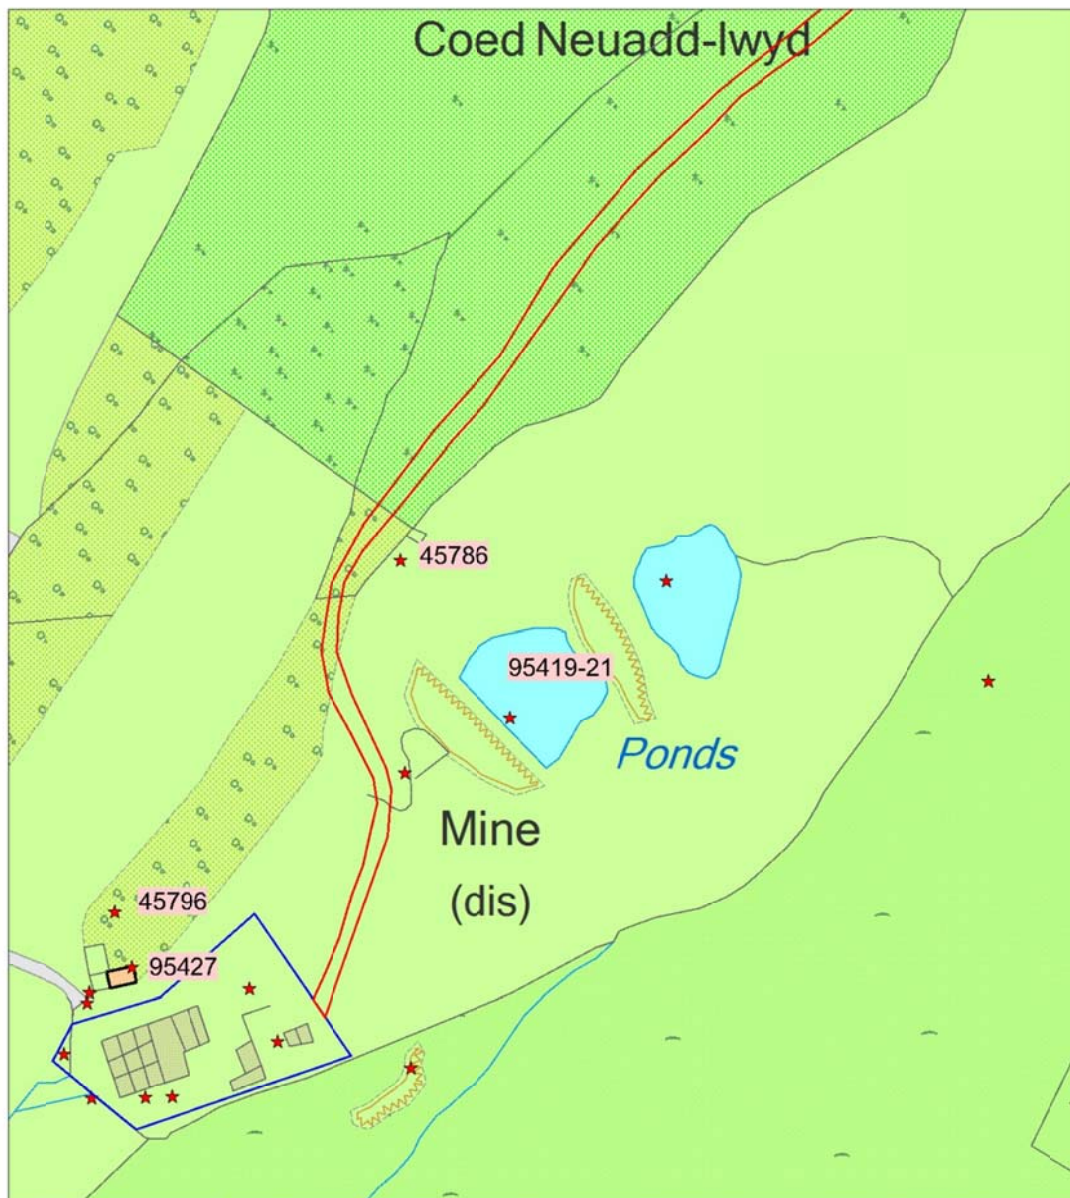
Location of HEFs described in report Southern section
