ST DAVID'S CHURCH, HENLLAN AMGOED, CARMARTHENSHIRE: ARCHAEOLOGICAL EXCAVATION 2013/14

RHIF YR ADRODDIAD / REPORT NO. 2013/75
RHIF Y DIGWYDDIAD / EVENT RECORD NO. 105881

**ST DAVID'S CHURCH, HENLLAN AMGOED,
CARMARTHENSHIRE:
ARCHAEOLOGICAL EXCAVATION 2013/2014**

Fran Murphy
with Hubert Wilson and James Meek

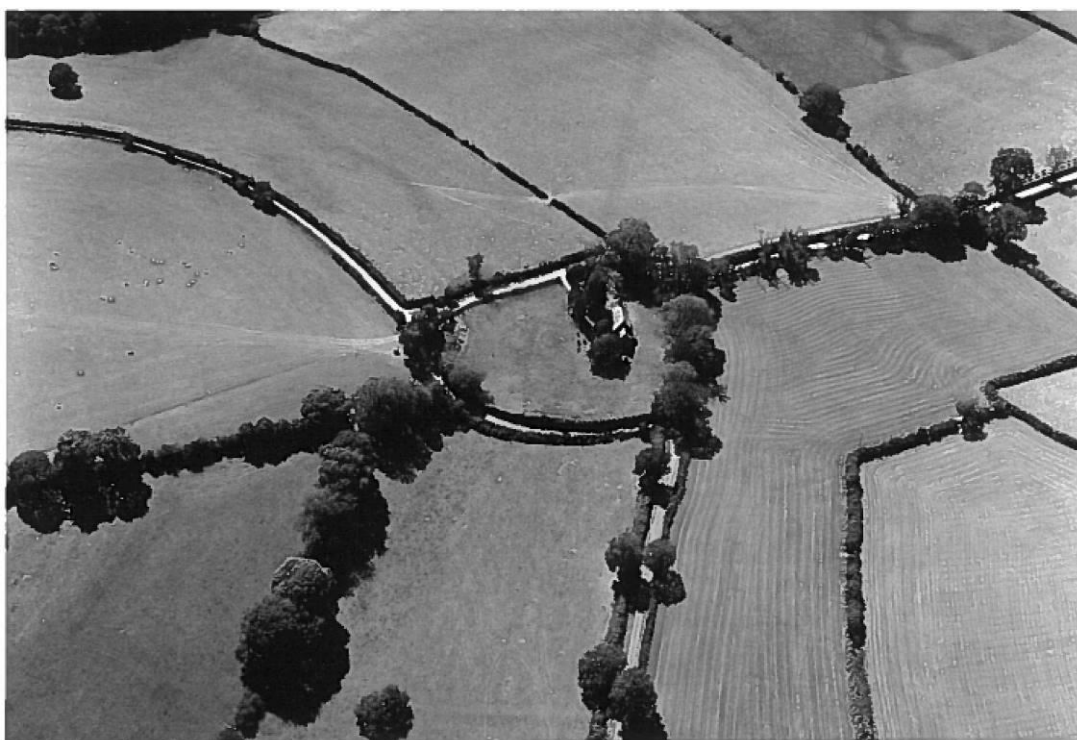
Photo 1: Aerial photograph taken in 1984 before the construction of The Beeches bungalow to the south (© DAT).

- 2.1.1 St David's Church is situated within a D-shaped churchyard with an unclassified road defining its east and south boundaries (NGR SN 1852 2072, Figures 1 & 2, Photo 1). Its west boundary is demarcated by a track leading to Henllan Farm, some 250m to the north. The whole grave yard is surrounded by a roughly continuous boundary bank.
- 2.1.2 The proposed driveway, parking, turning area and garage for the residential conversion of the church were located within the northeast corner of the church yard (Figure 3).
- 2.1.3 A modern bungalow, Beeches, lies to the north of the proposed (Figure 3).
- 2.1.4 Topographically the site is located on a moderately sloping south-facing hill side. The underlying geology comprises Llanvirn and Arenig Ordovician sedimentary bedrock (shales).

- 2.2.1 The D-shape of the churchyard of St David's (Photo 1) suggests it could have been established in the early medieval period (PRN 11789), although no archaeological evidence has as yet been recorded to confirm this. In alternative theory is that it is the reuse of an earlier circular Iron Age enclosure. Examples of the reuse of prehistoric defended enclosures for Early Medieval cemeteries have been recorded as at Caer, Bayvil in Pembrokeshire (James 1987) and it has been argued that enclosed early cemeteries could well be the predecessors of the medieval parish church and churchyard (Thomas 1971). Examples of Iron Age enclosures survive as cropmarks in close vicinity to St David's Church at Henllan Farm; 500m to the north (PRNs 11790, 11791 & 11792).

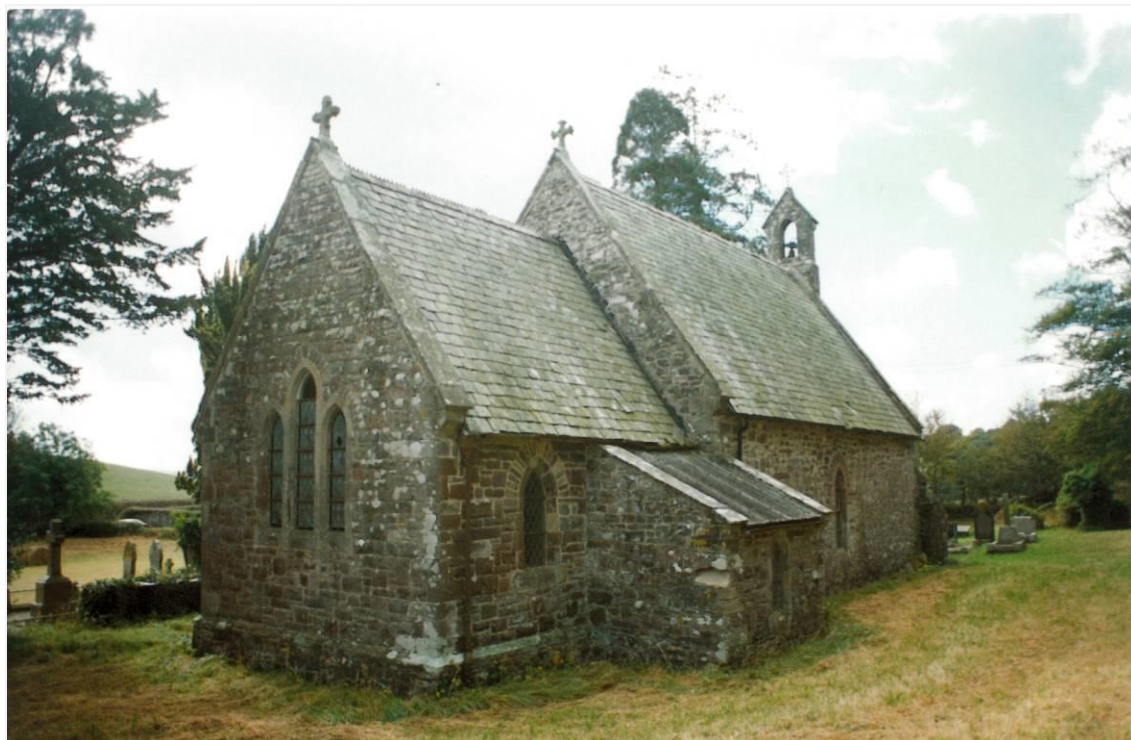
Photo 2: View looking southeast of St Davids Church, Henllan Amgoed, as it appeared during a site visit in 1996 (© DAT). Note the upstanding gravestones to the west and south but not to the north or east.

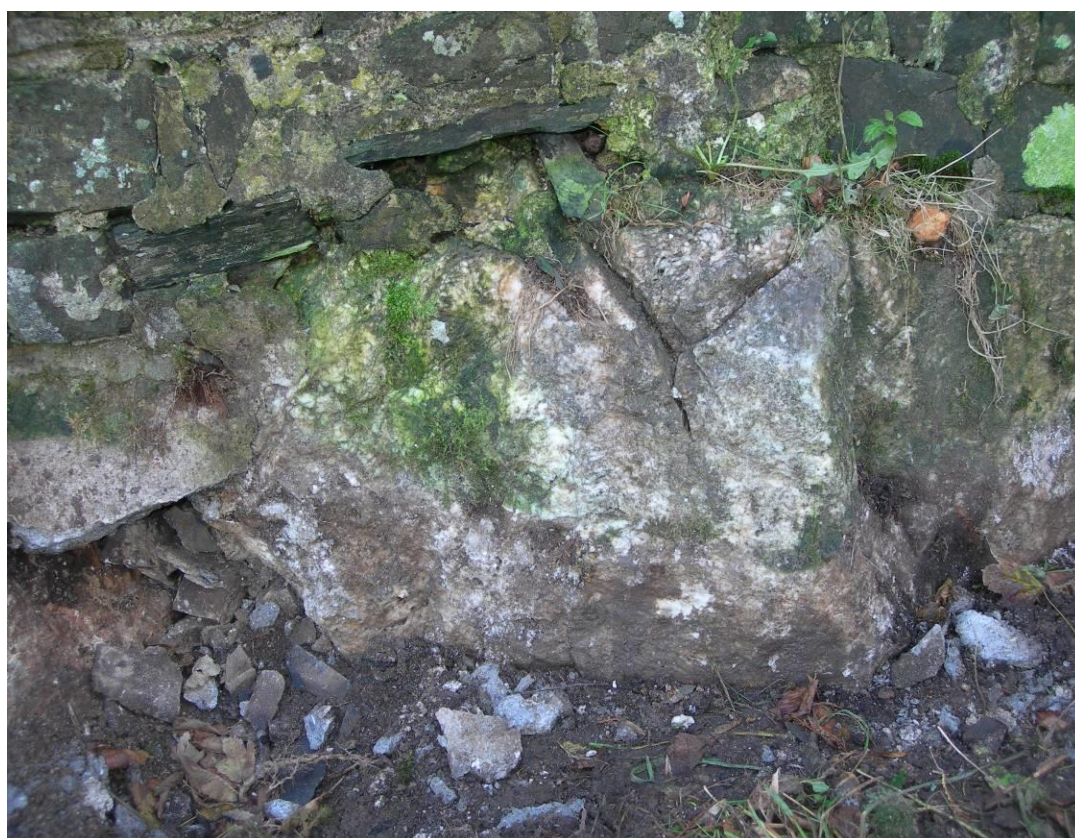
Photo 3: View of quartz blocks within later wall structure of nave.

- 2.2.5 Meek (2012) noted that substantial amounts of probably medieval fabric could be identified within the structure of the nave. Large stones visible within the walls stand out incongruously against the regular stones of the 19th century re-building and indicate re-use of earlier building materials. On the northern wall of the nave, for example, at its western end a group of quartz blocks are used in the lower plinth of the church wall (Photo 3). These are very different to the neatly cut stone blocks used throughout the remainder of the plinth.

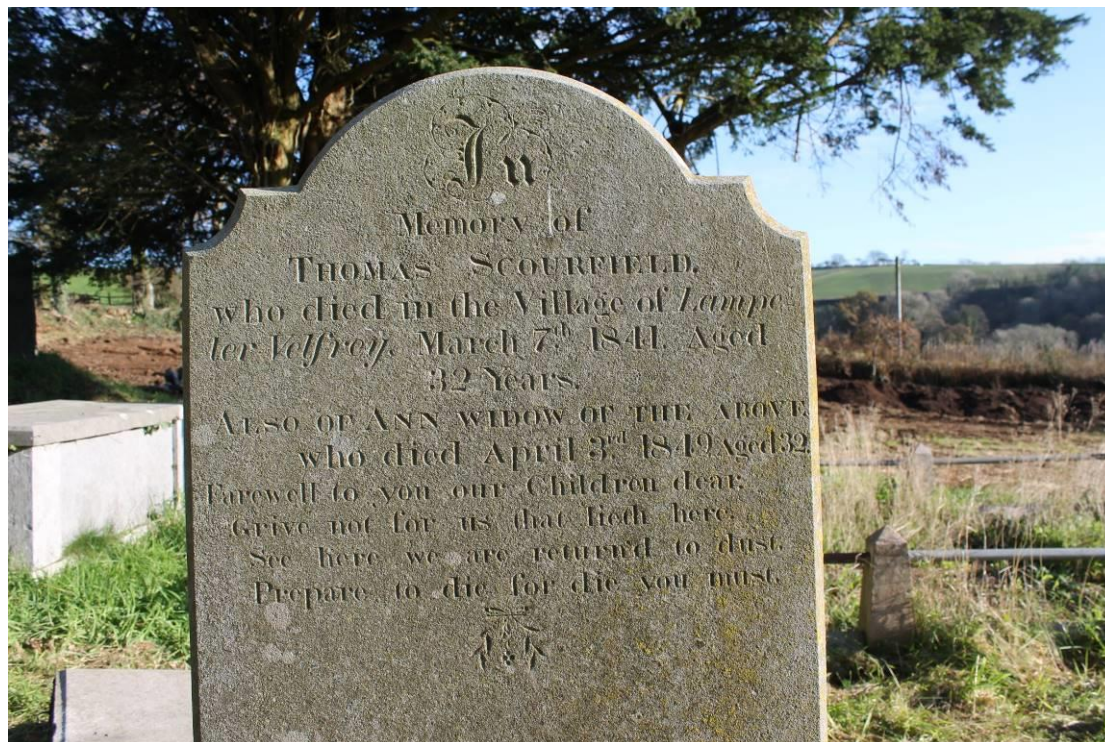
Photo 4: An example of one of the 19th century gravestones located to the south of the church.

- 2.2.6 The church closed in the late 1900s but the church yard continued to be used into the 21st century with burials evident on the western side of the church, as are a number of 20th and 19th century graves. A few 19th century graves are present close to the south of the church and an 18th century grave stone dedicated to a former priest stands on its own approximately 5m from the eastern end of the church.

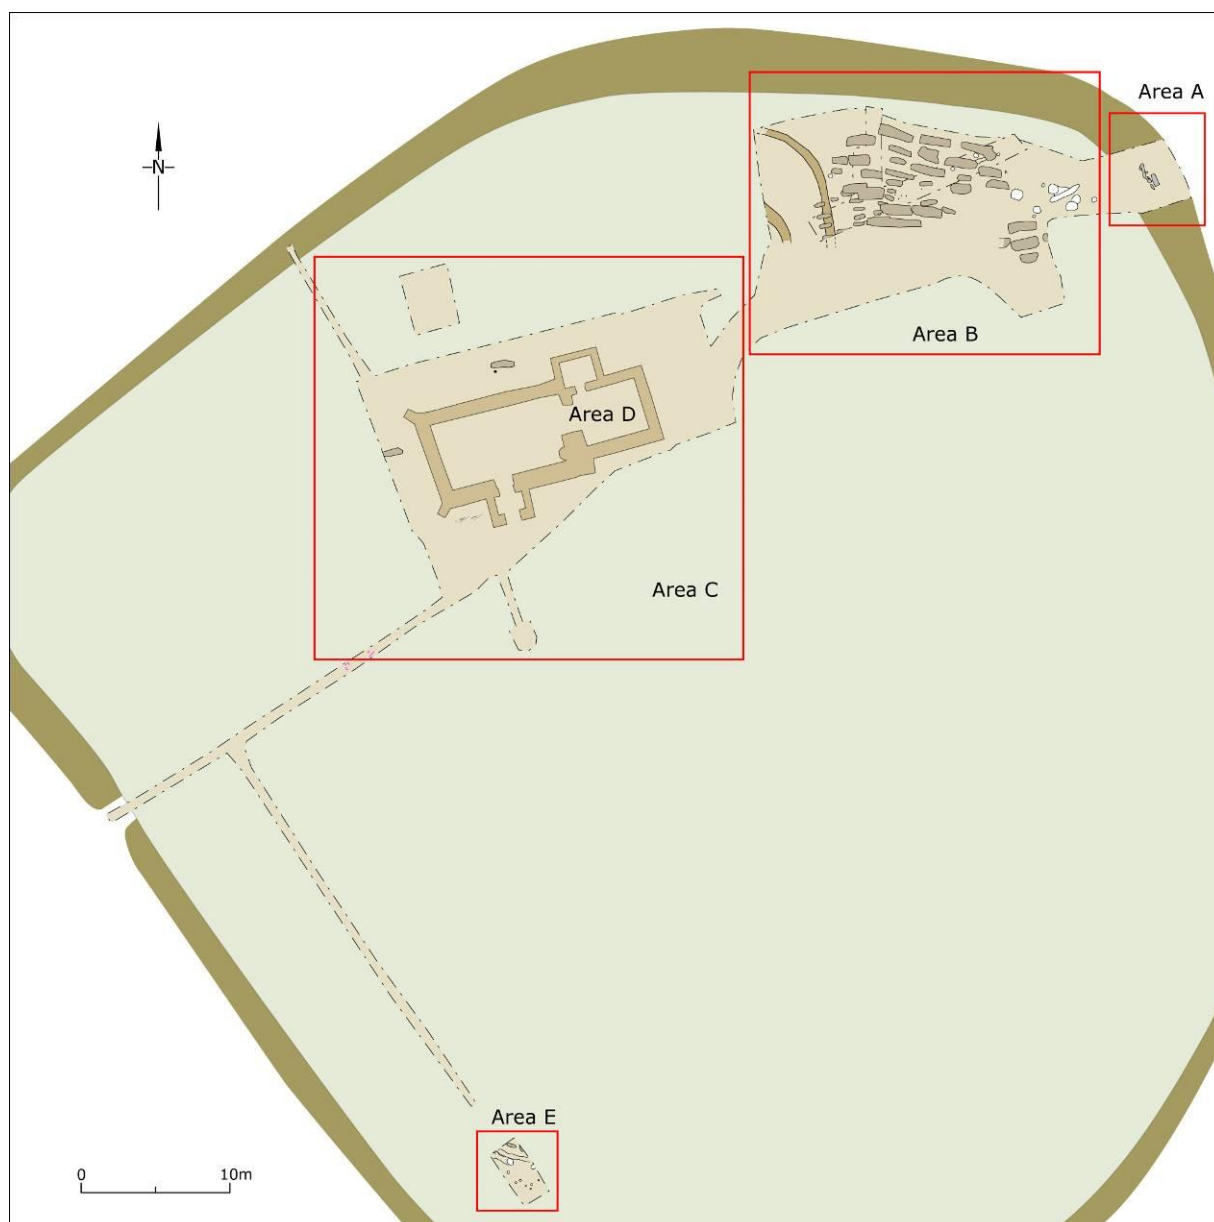
Figure 5: Overall site plan showing the five areas of archaeological investigation.

- 3.1 The methodology for archaeological mitigation to be implemented at St David's Church, Henllan Amgoed, during its conversion to a residential property was defined in a written scheme of investigation (WSI). This methodology was informed by the archaeological evaluation of the area of undertaken in 2012 (Meek 2012) prior to the determination of the development planning decision.
- 3.2 This written scheme of investigation was approved by Carmarthenshire County Council prior to the works commencing.
- 3.3 The proposed works were divided into the following tasks across five separate areas (Figure 5) with the relevant methodologies summarised below:

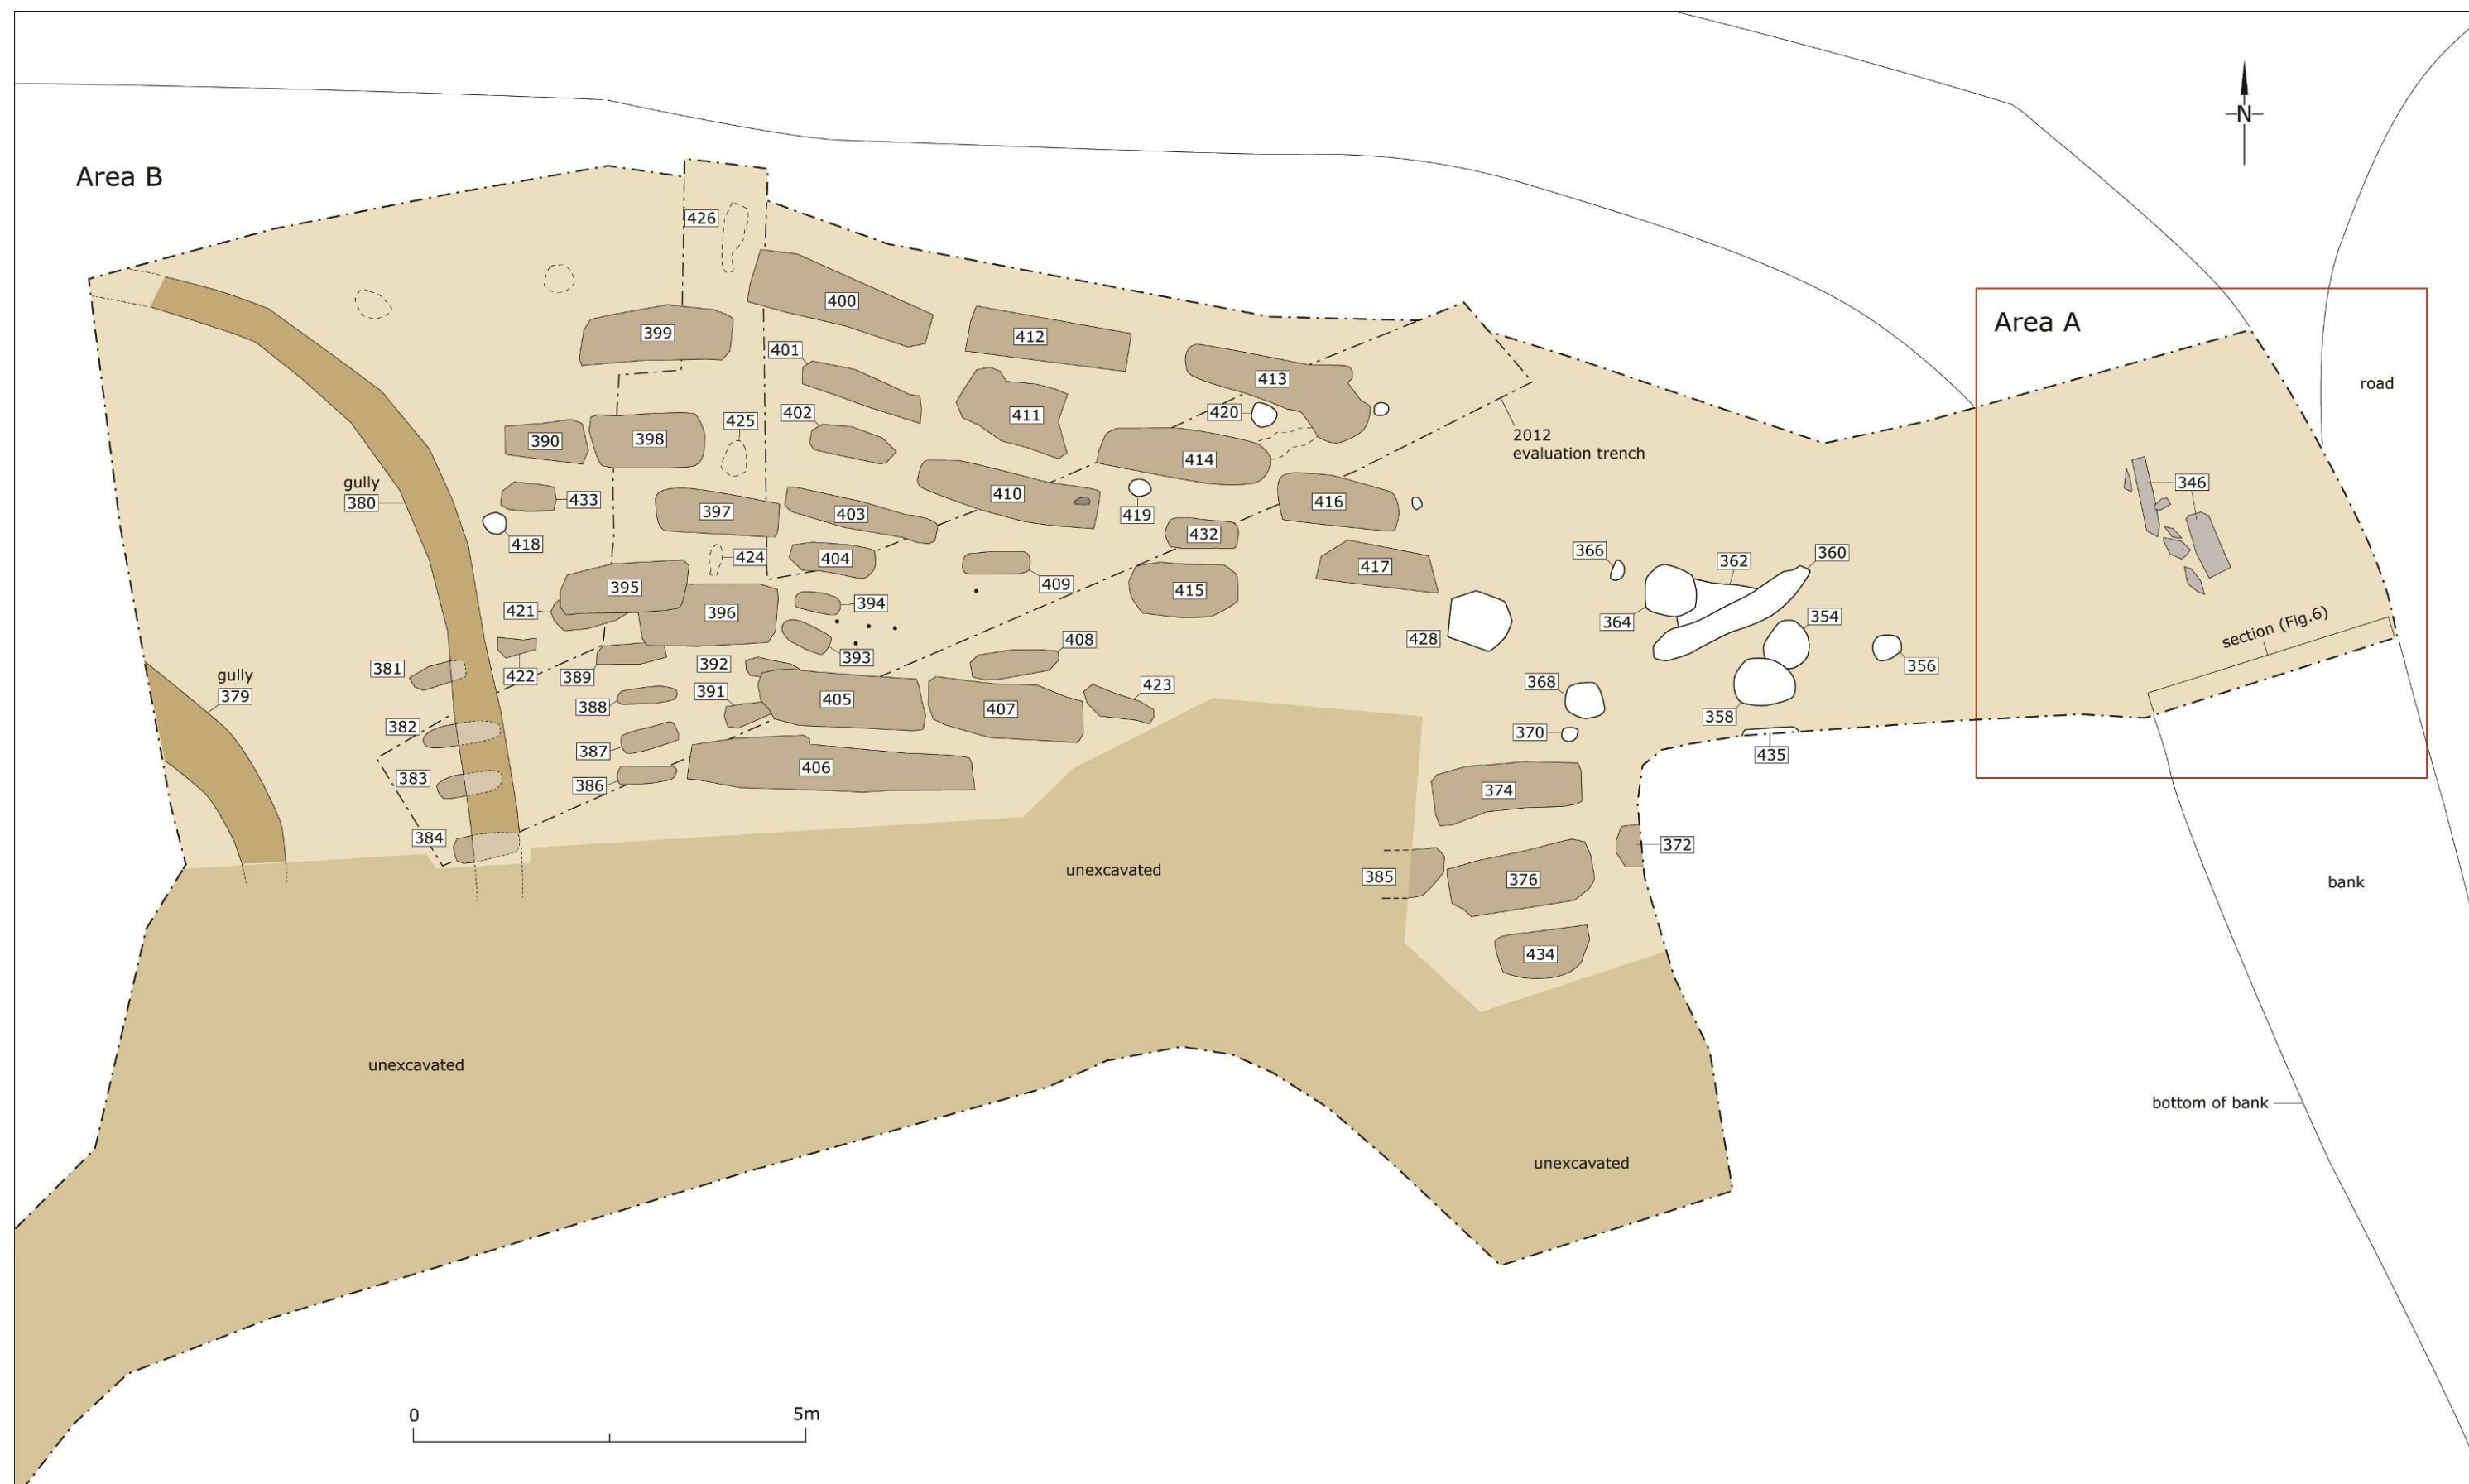
Figure 6: Areas A and B - Plan of recorded archaeological features.

- 4.2.3 To the south of the garage area it was only necessary to remove 0.10m of topsoil for the construction of the footpath to the church. In this area a remnant of topsoil remained and no archaeological features were revealed. This is the area shown as unexcavated in Figure 6. No further recording was undertaken once it was ascertained that no archaeological features were exposed at this depth in this area. As there was no requirement to lower the ground level any further the archaeology would remain undisturbed and not require recording.
- 4.2.4 The remaining extent of Area B was hand cleaned and recorded in plan. At least forty-five graves were revealed cutting into the bedrock (Table 2). The fills of the graves were noticeably darker than the surrounding shale

4.2.12 Two curvilinear gullies [379, 380] were recorded at the western end of Area B (Figure 6). Gully [380] survived as no more than a very shallow curving depression. The gully appeared to be cut by infant/child graves [381], [382], [383] & [384] indicating it is an earlier feature than the graves (Photo 15).

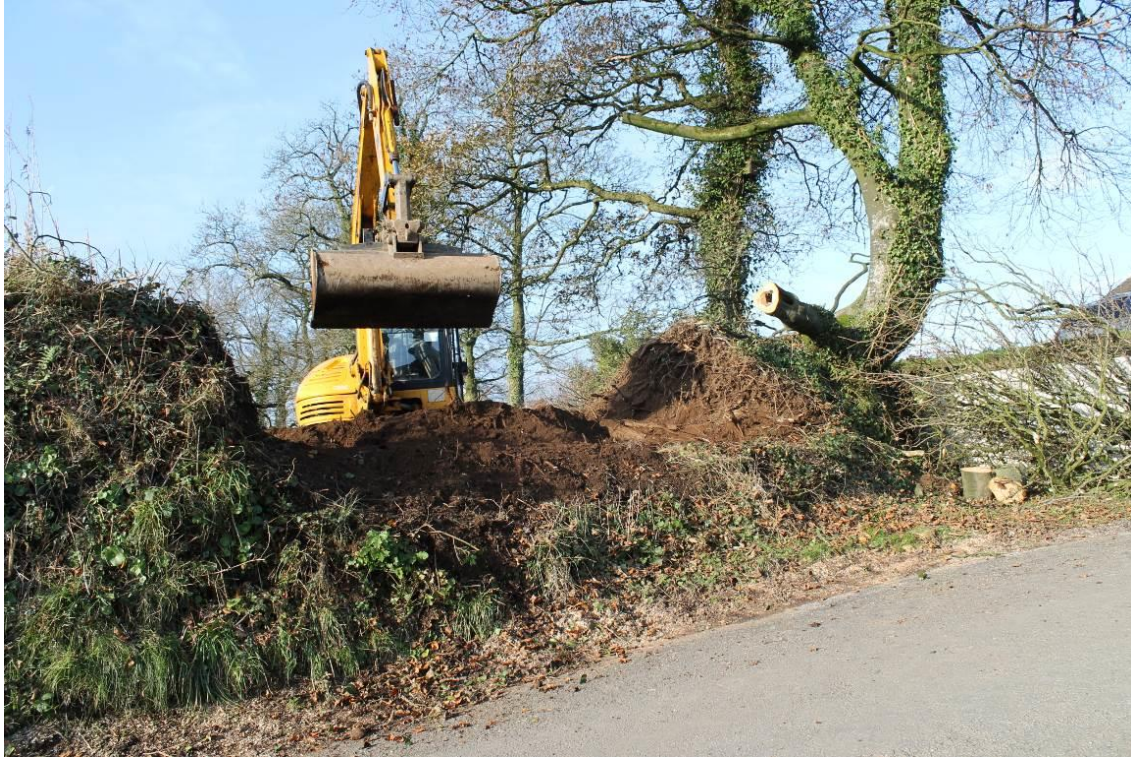
Photo 5: Removing the boundary bank to provide access into the site.
Facing west

- 4.1.2 A 4m wide length of bank was removed by a 360° mechanical excavator with a grading bucket under archaeological supervision; to provide future vehicular access into the site (Photo 5).

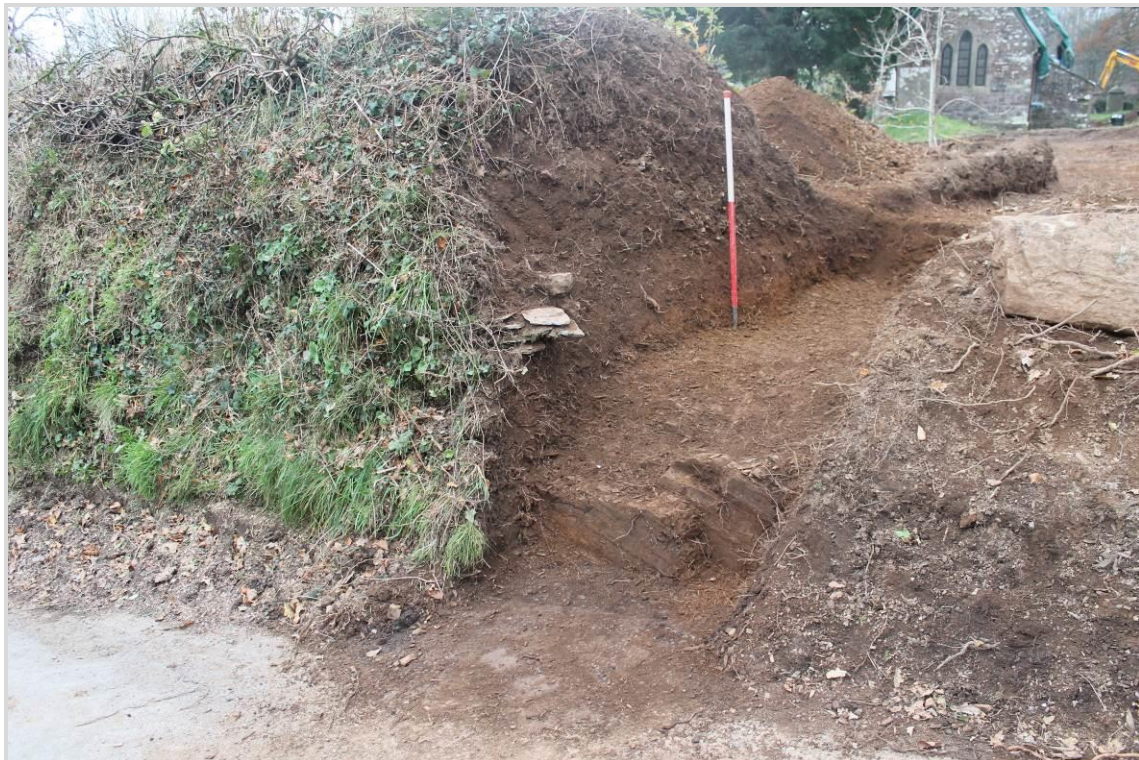
Photo 6: Looking southwest at the north facing section through the boundary bank – showing the natural bedrock protruding along the bottom outside eastern edge. 1m scale

- 4.1.3 The bank was roughly removed to the level of the churchyard that was some 0.75m higher than the level of the public road (Photo 6).
- 4.1.4 The excavations revealed a sequence of deposits forming several different phases of bank. As recorded in the north facing section (Figure 7) lying above the natural shale bedrock was evidence of a buried ground surface (350) and buried subsoil (351) beneath. On this buried surface a bank had been built from clay and broken shale (348 & 349). Above this a later bank had been built (345, 347 & 352) that had a stone revetment on its east side (346). Finally the bank was capped by a looser clayey silt (344) deposit populated by hedgerow plants. No artefacts or any dating evidence were recovered from any of the deposits within this area.

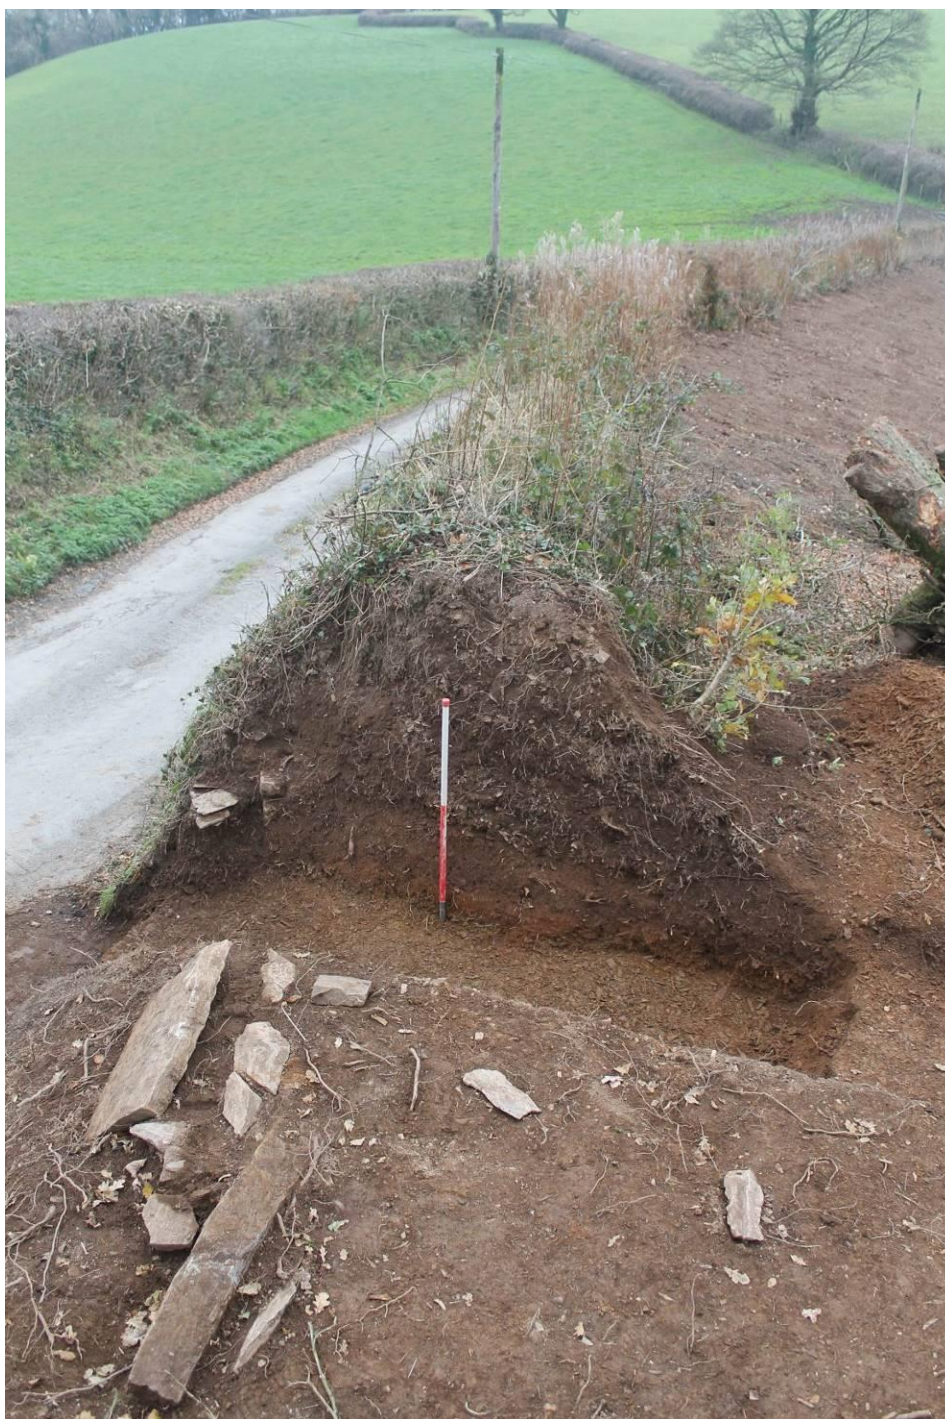
Photo 7: The north facing section through the boundary bank – showing the stones used to revet the east side of the bank. 1m scale

- 4.1.5 Towards the west edge of the bank the soils became increasingly disturbed. The bank deposits had protected the buried soil (350 & 351) but this buried soil appeared to peter out where the soils became more mixed at the western edge of the bank and merged with the layer of topsoil within the area of the churchyard (Photo 7).

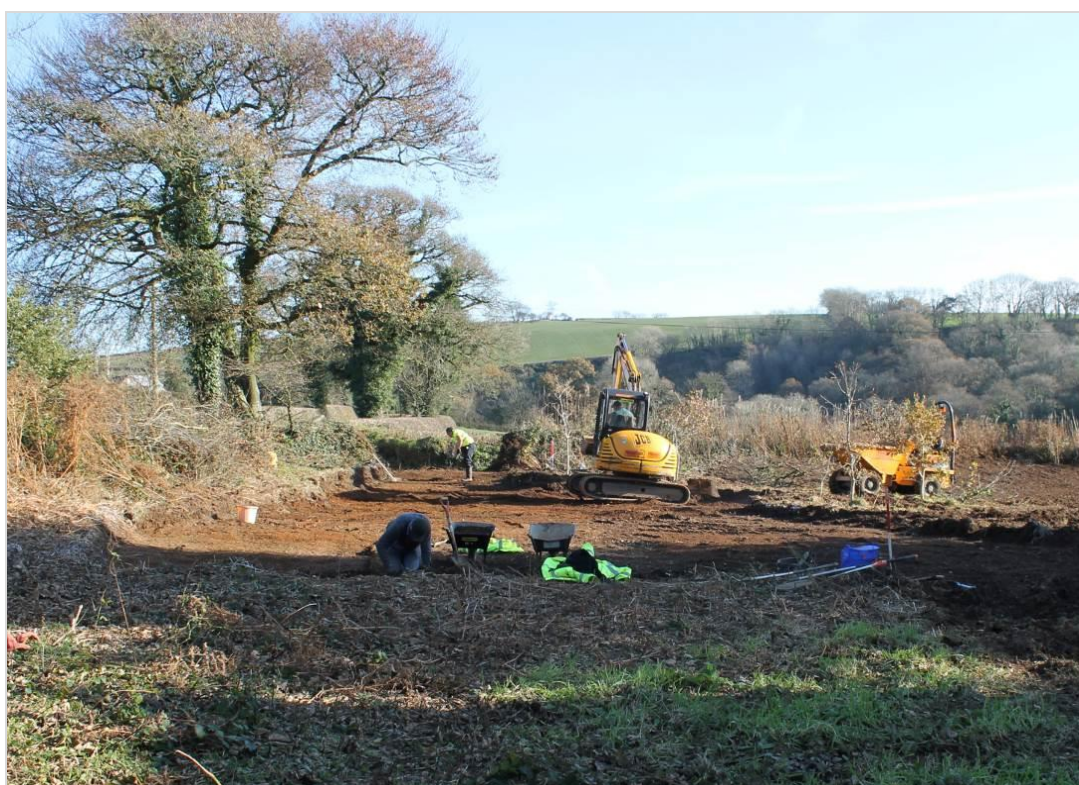
Photo 8: Looking east across the area of the driveway and garage stripped of topsoil. In the background can be seen the gap in the boundary bank after its removal.

- 4.2.1 The topsoil strip of Area B, including the area for the driveway, garage and footpath to church was undertaken under archaeological supervision (Photos 8 & 9). The ground levels necessary for the development required the removal of between 0.20-0.25m of topsoil by mechanical excavator within the area of the driveway and garage; to the top of the underlying bedrock.
- 4.2.2 The irregular shape of Area B measured a maximum of 27.0m east-west from the western edge of the excavation area to the east edge of the boundary bank, and a maximum of 8.0m north-south. The excavated area was slightly terraced into the gentle south facing slope; being slightly deeper towards the north. The depth of topsoil removed varied from c. 0.40m at the NE corner to 0.20m at the SE corner of the trench.

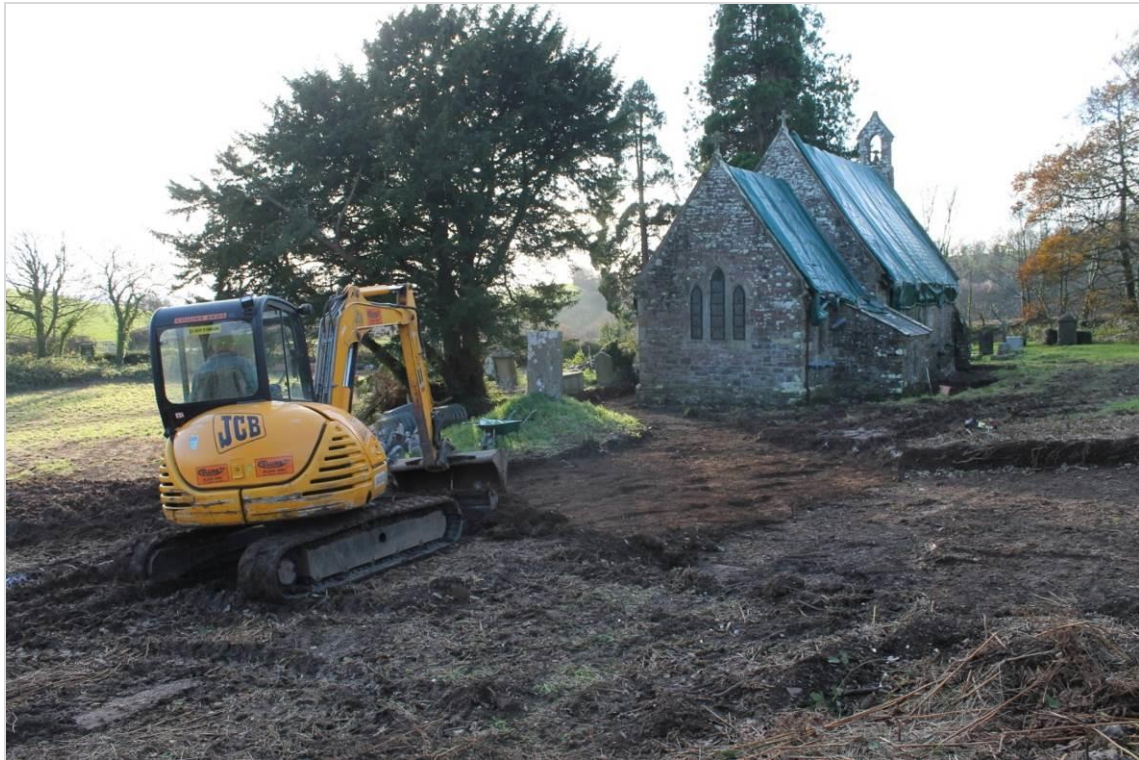
Photo 9: Looking WSW during the machine removal of the topsoil.

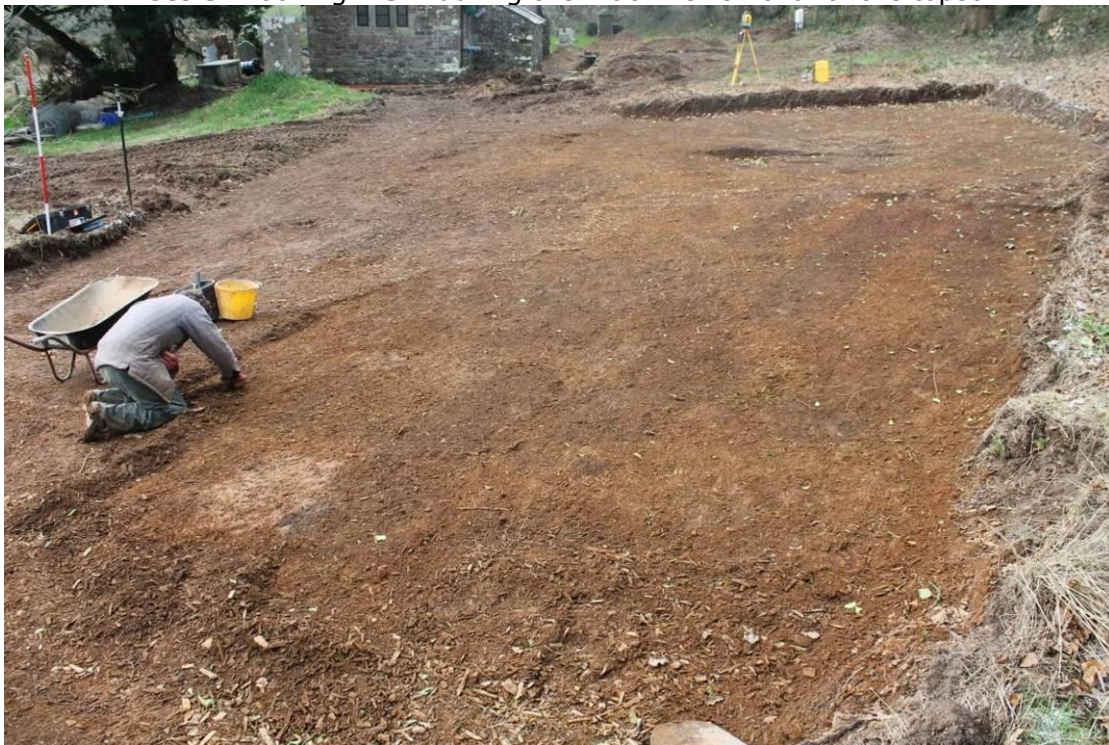
Photo 10: Looking west across Area B after machine removal of topsoil; showing the darker fills of the graves being revealed during cleaning of the area by hand. Note the shallow depth of topsoil removed.

bedrock (Photo 10) and were sealed by topsoil (300). All the graves were orientated approximately west-east.

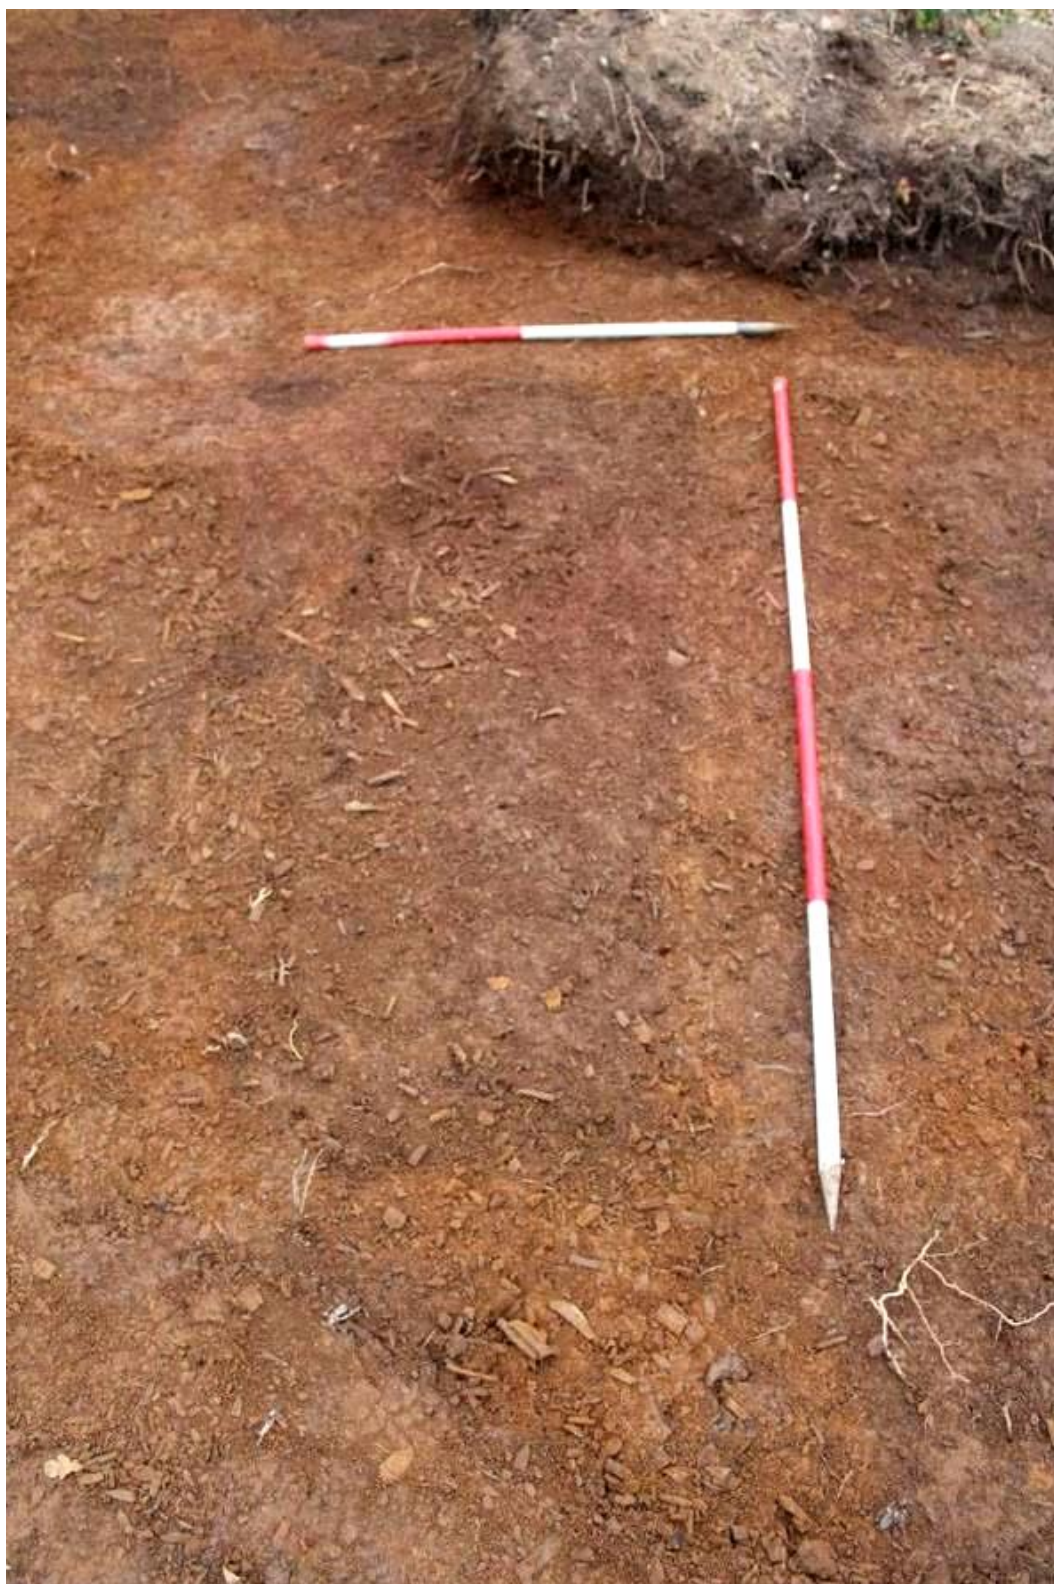
Photo 11: Looking east at typical example of an unexcavated grave [374]. 2m and 1m scales

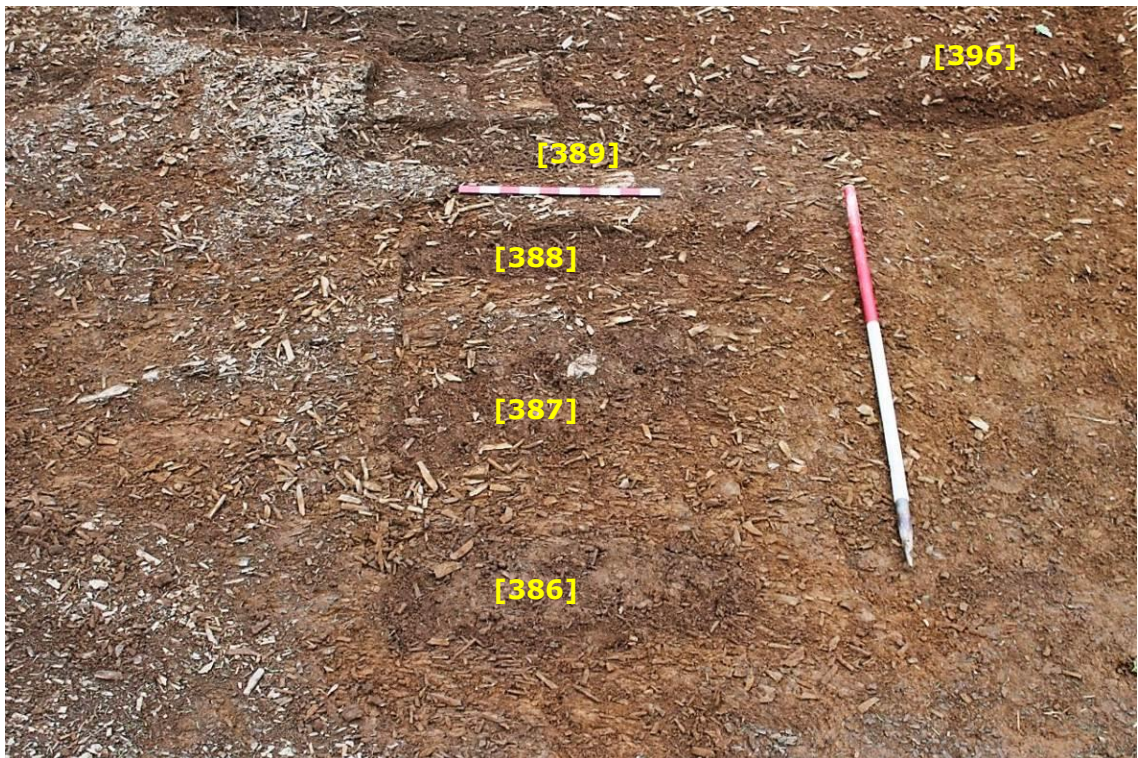
Photo 14: Looking north at a row of 4 unexcavated child graves. The most northerly grave [389] was just cut by adult grave [396]. 0.5m & 1m scales

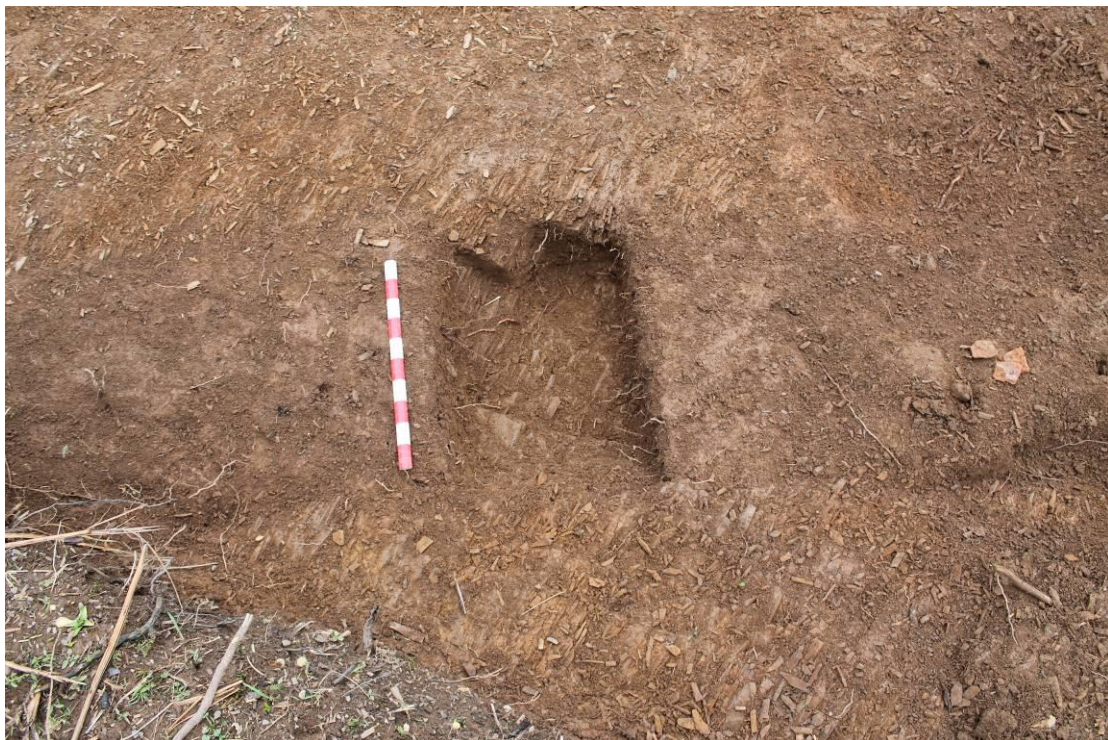
Photo 16: Looking roughly east at the section excavated through gully [379].
0.5m scale

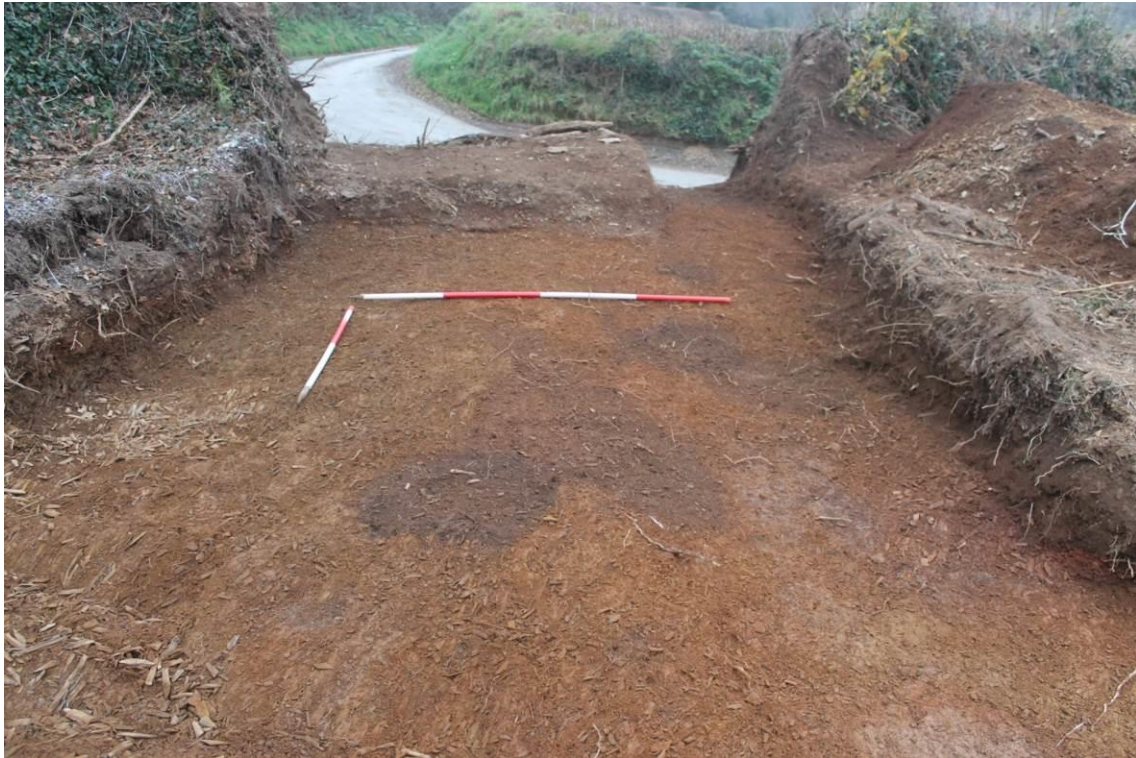
Photo 17: Looking east at the group of unexcavated features to the west of the boundary bank. 2m and 1m scales

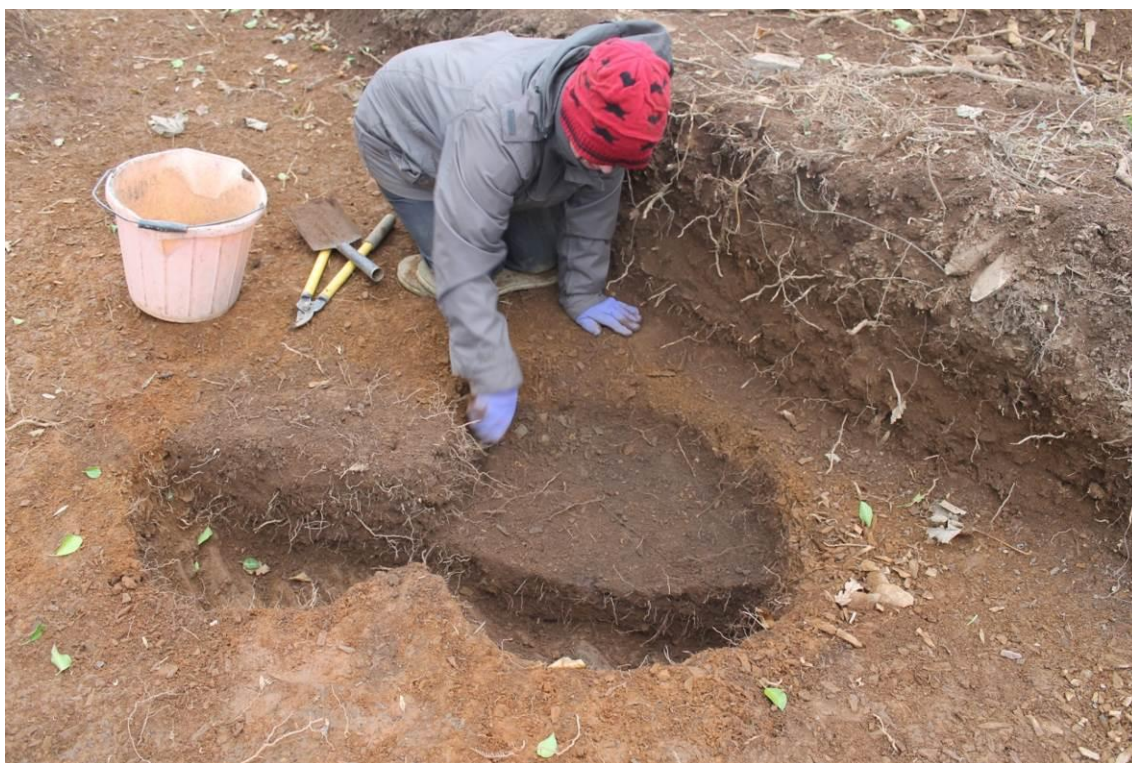
Photo 19: Removing the remaining fill from pit [358].

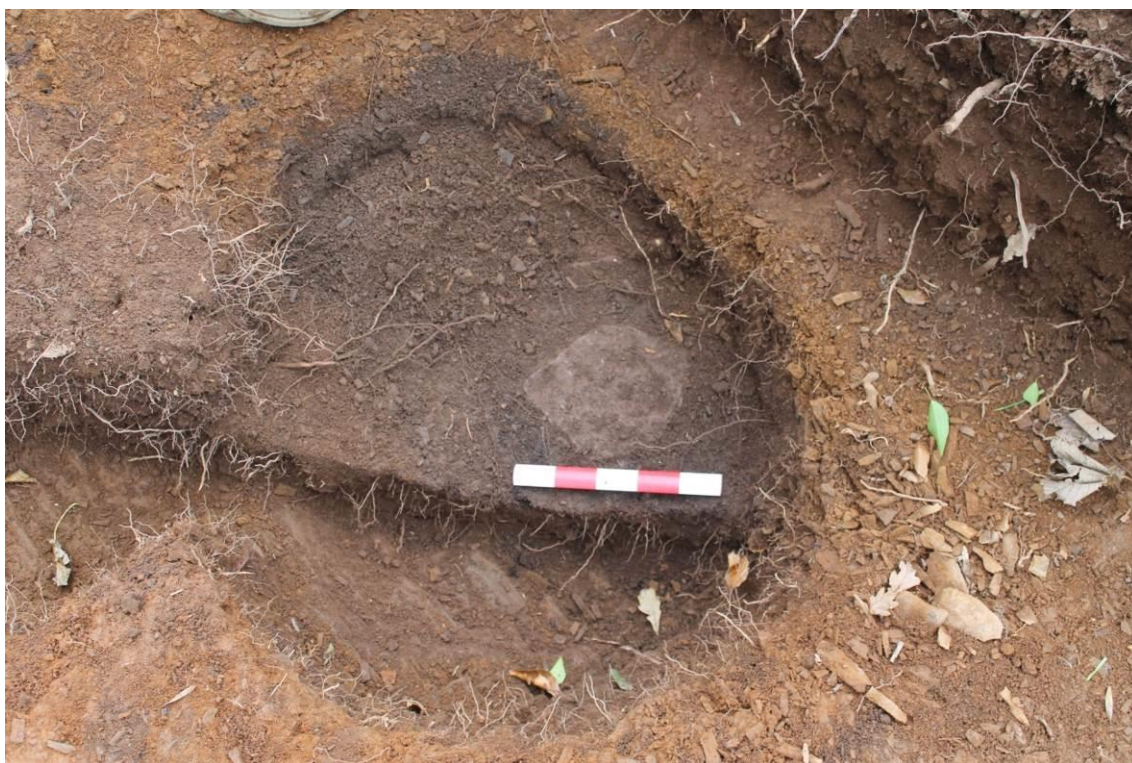
Photo 20: The flat stone lying towards the bottom of the fill of pit [358].
0.25m scale

- 4.2.19 Towards the base of pit [358] a flat stone had been placed level with the base of the pit (Photo 20) and beneath this stone and surrounding it was an area of denser charcoal and small fragments of burnt bone.
