ST DAVID'S CHURCH, HENLLAN AMGOED, CARMARTHENSHIRE: ARCHAEOLOGICAL EXCAVATION 2013/14

RHIF YR ADRODDIAD / REPORT NO. 2013/75
RHIF Y DIGWYDDIAD / EVENT RECORD NO. 105881

**ST DAVID'S CHURCH, HENLLAN AMGOED,
CARMARTHENSHIRE:
ARCHAEOLOGICAL EXCAVATION 2013/2014**

Fran Murphy
with Hubert Wilson and James Meek

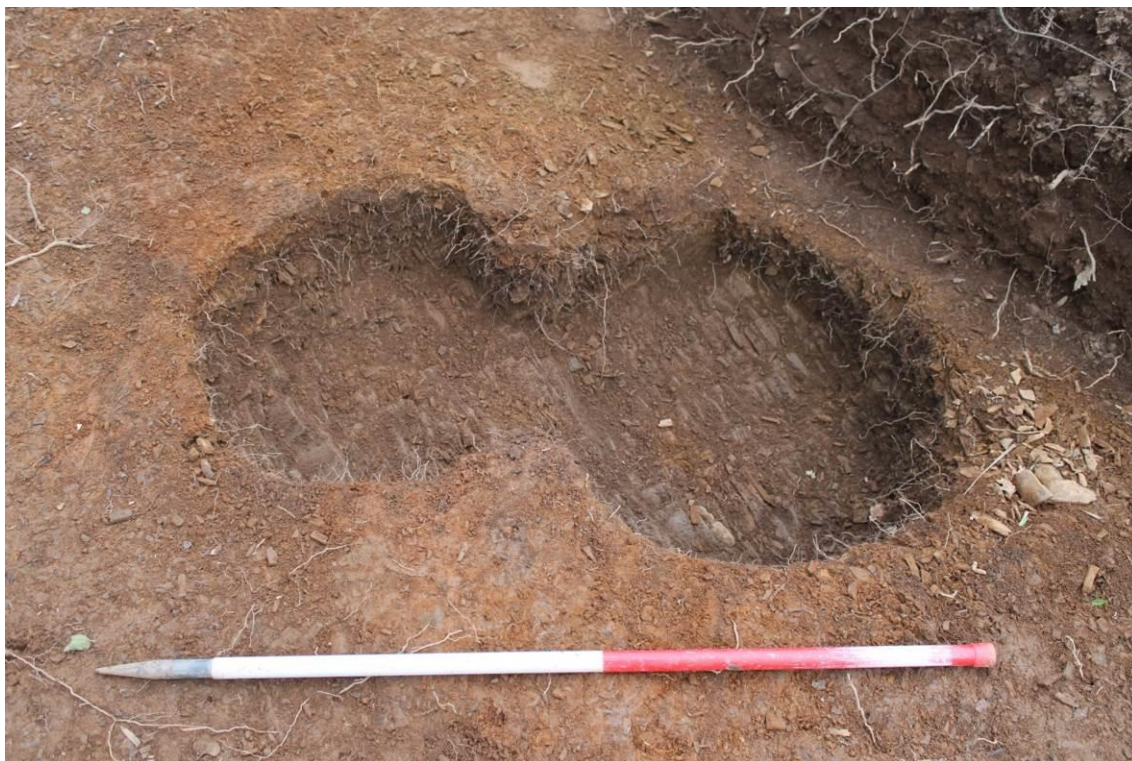
Photo 21: Looking southeast at fully excavated pits [354] and [358]. 1m scale

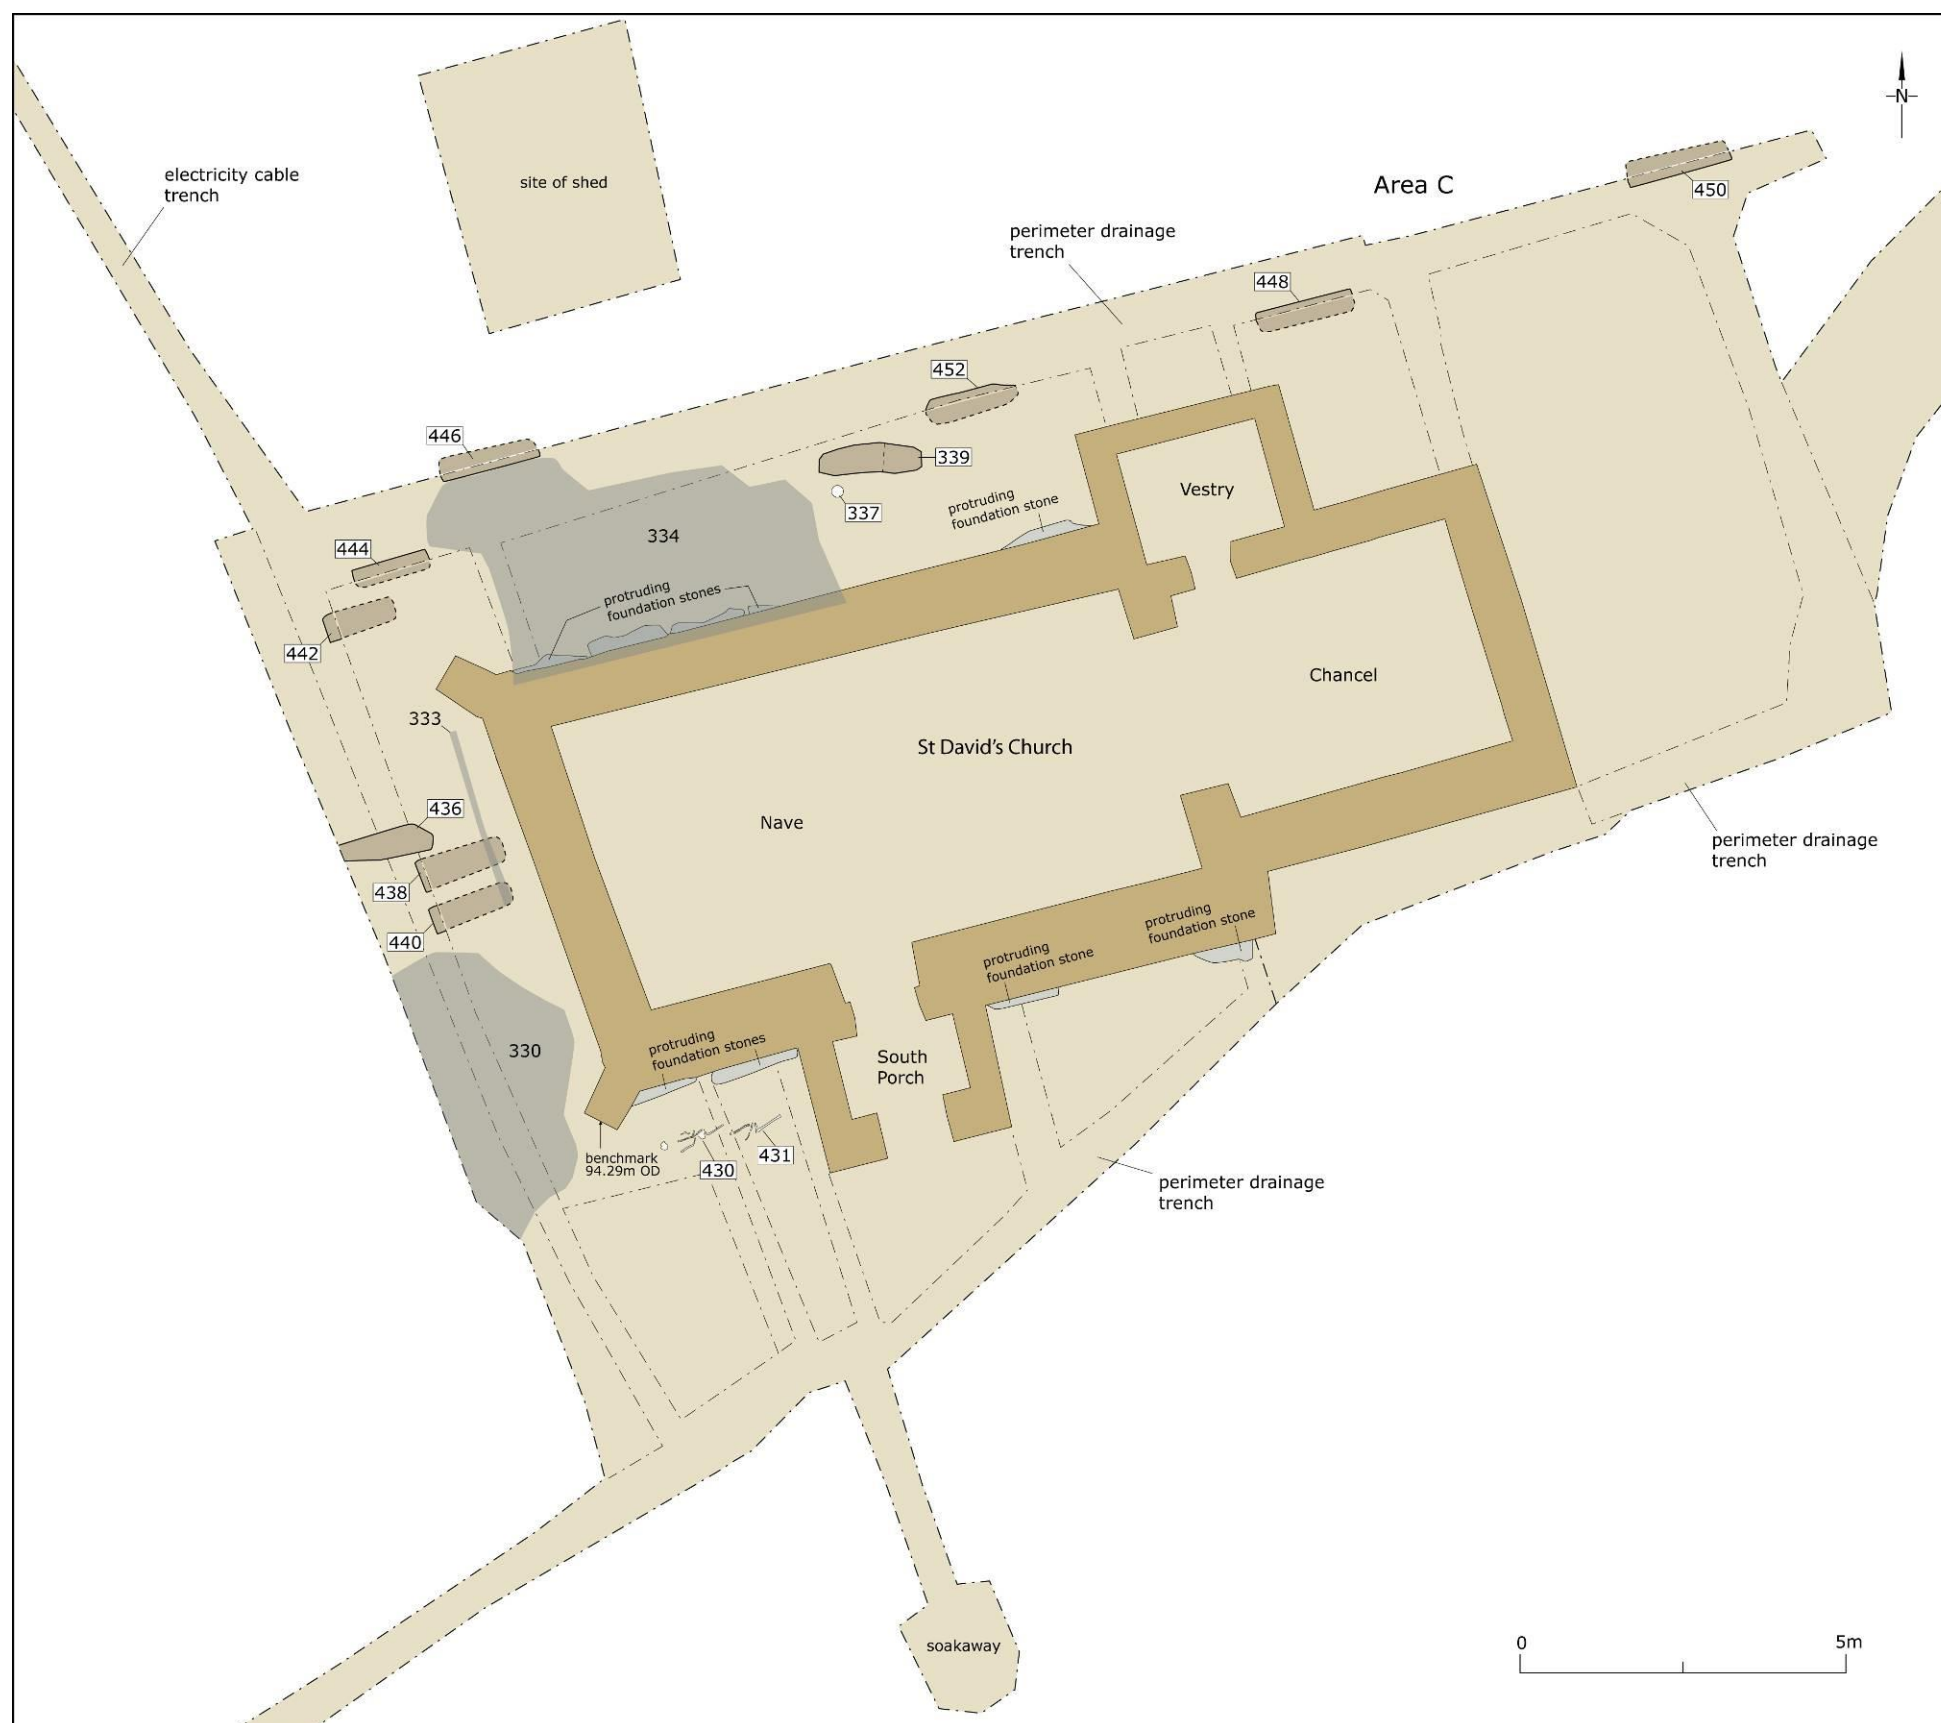
Figure 8: Area C – Area subjected to ground reduction works around perimeter of church building; also showing location of perimeter drainage trench.

- 4.3.6 Just under the turf to the west of the south porch the partial remains of two human skeletons [430] and [431] were discovered (Figure 8, Photo 25). No grave cuts for either skeleton were visible. Both skeletons were aligned west-east with their heads to the west and their small size indicates they are probably juvenile burials. Renovations in the 19th century including the insertion of a drain running parallel with the south wall are the likely cause of the obvious damage to the skeletons. The skull of [431] did not survive (Photo 26) nor had the left arm, leg and foot of either skeleton. The surviving right arms of both were laid over their navels (Photo 27). Skeleton [430] measured 0.97m from top of skull to bottom of the right femur. Interestingly in both skeletons the base of their spines appeared distorted.

- 4.3.8 The ground reduction works around the external perimeter of the church exposed a number of large foundation stones protruding from beneath the base of the walls (Figure 8, Photo 28).

- 4.3.11 A perimeter drain was installed around the church, some of which replaced an existing concrete drain. The trenches for this drain were on average 0.50m wide and 0.40m deep (Figure 8, Photos 29 & 30).

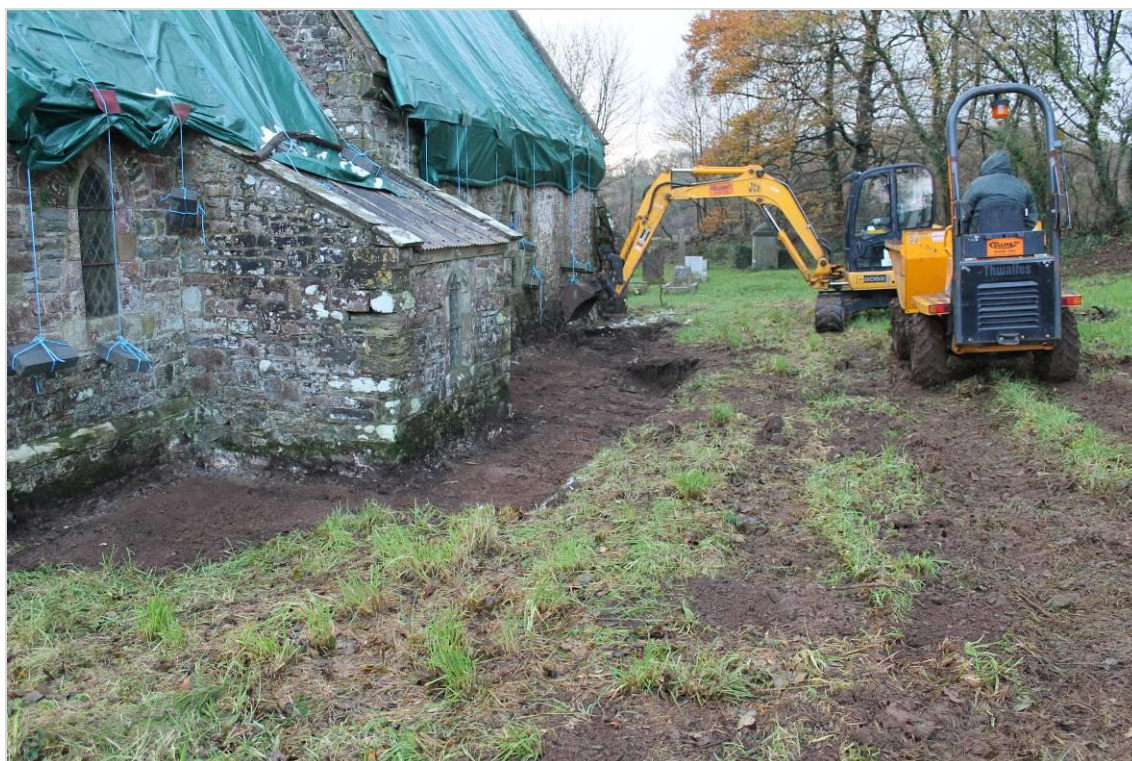
Photo 22: Ground reduction works around the perimeter of the north side of the church building. Facing roughly southwest

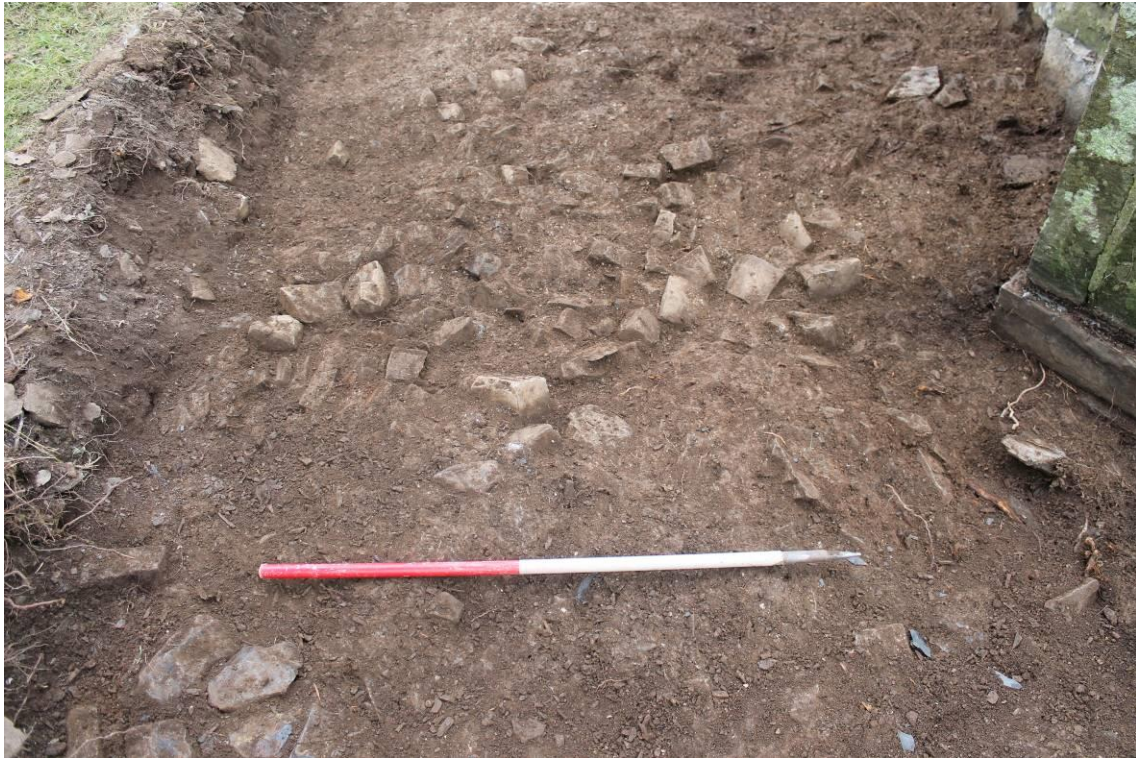
Photo 23: Rubble spread (330) outside the western end of the church building. Facing roughly north. 1m scale

- 4.3.4 At the opposite western end rubble and mortar spreads (330), (333) and (334) were recorded (Photo 23); a likely consequence church of renovations in the 19th century.

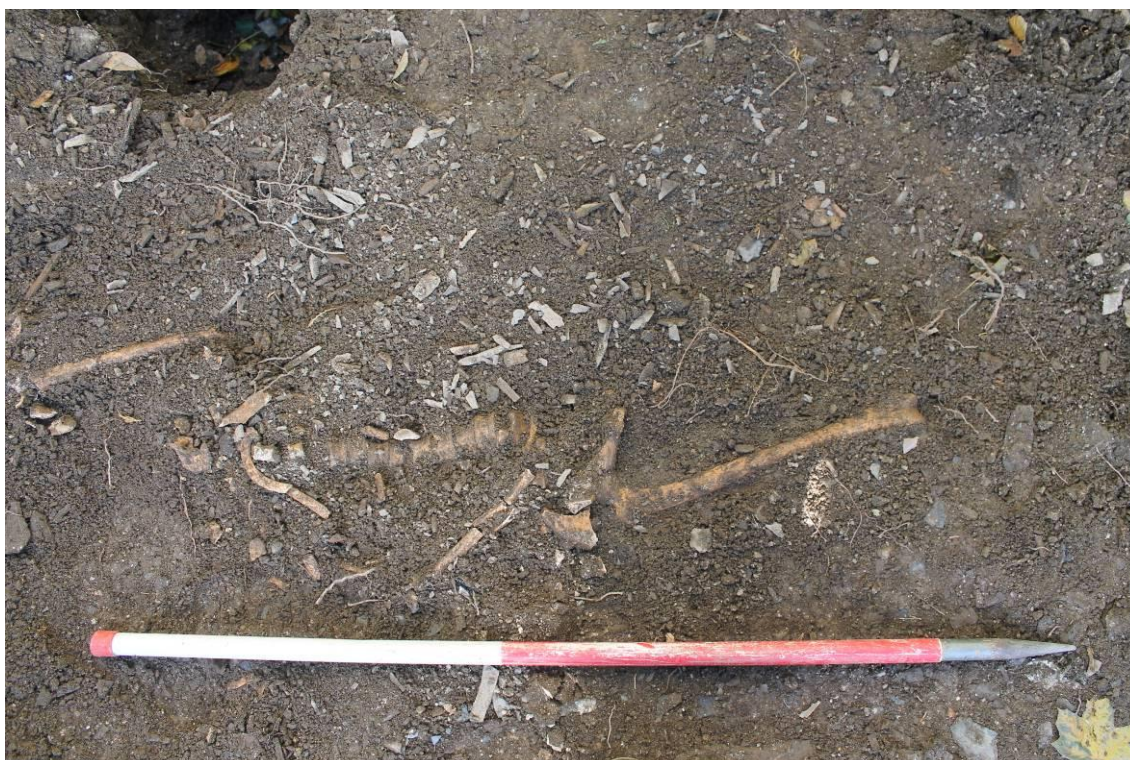
Photo 26: The partial remains of skeleton [431] discovered after turf removal to the west of the south porch. Facing north. 1m scale

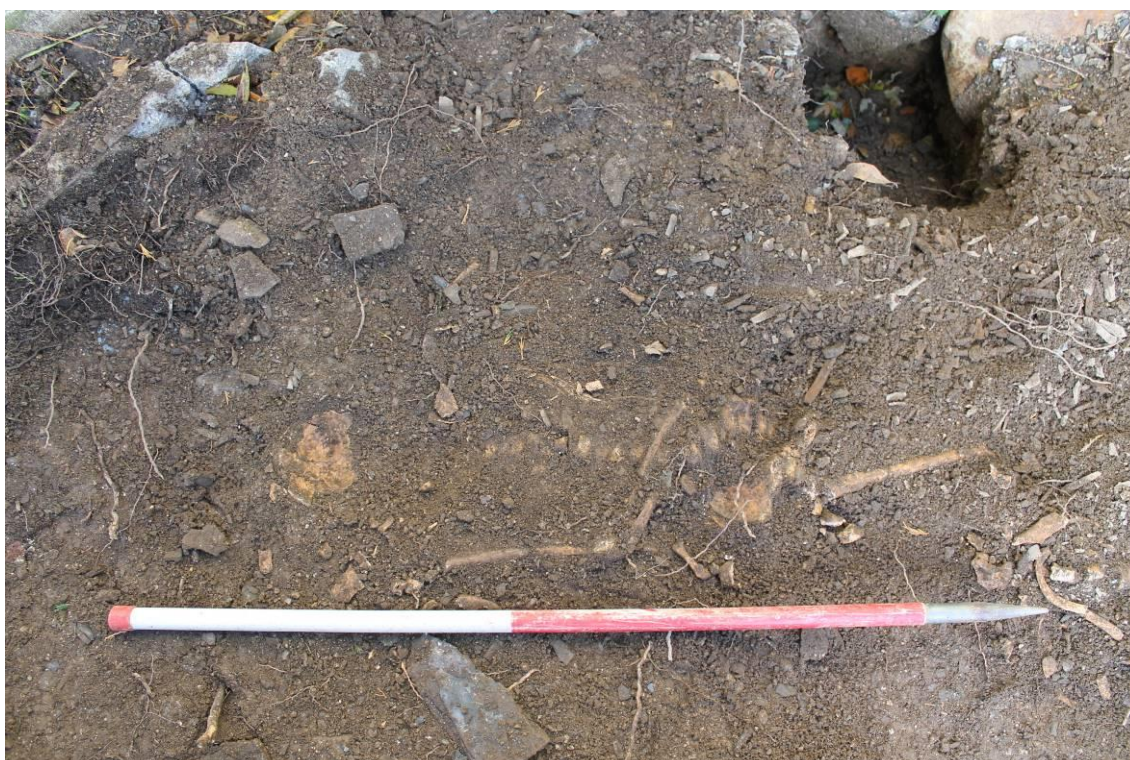
Photo 27: The partial remains of skeleton [430] discovered after turf removal to the west of the south porch. Facing north. 1m scale

- 5.22 Just under the turf to the west of the south porch the partial remains of two skeletons [430] and [431] were discovered. No grave cuts for either skeleton were visible. Both skeletons were aligned west-east with their heads to the west and their small size indicates they are probably juvenile burials. The 19th century renovations including a drain running parallel with the south wall are the likely cause of the obvious damage to the skeletons. The skull of [431] did not survive (Photo 26) nor had the left arm, leg and foot of either skeleton. The surviving right arms of both were laid over their navels (Photo 27). Skeleton [430] measured 0.97m

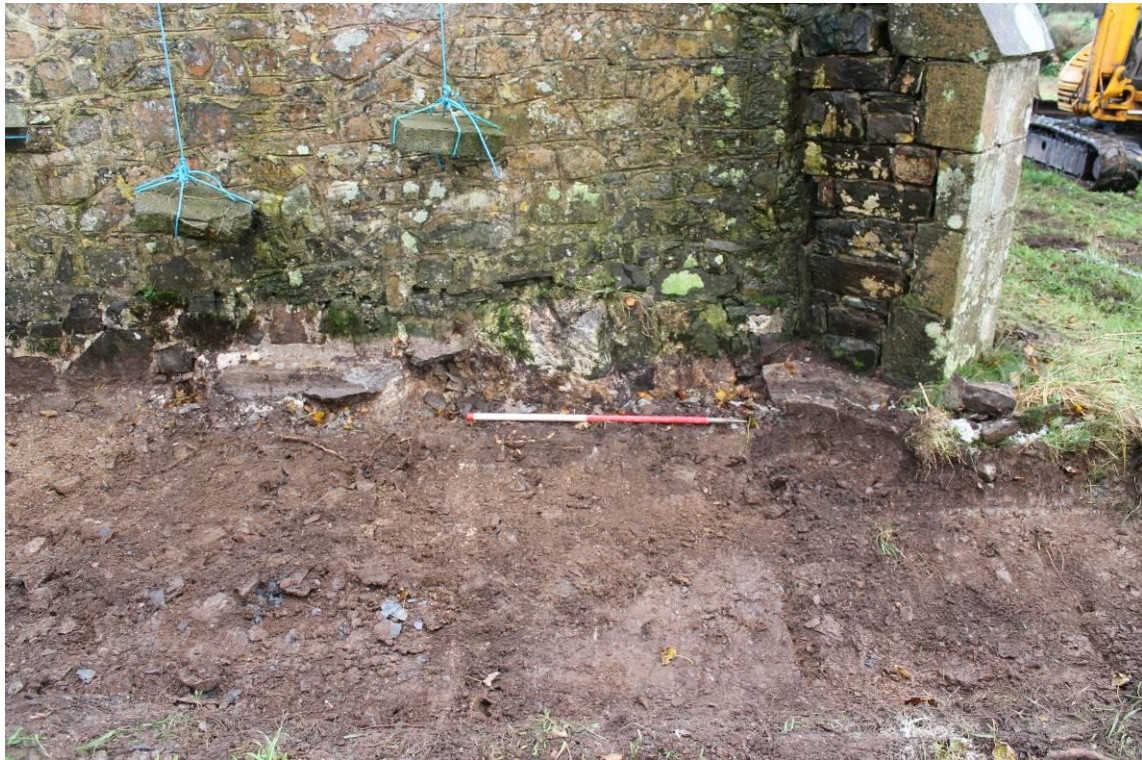
Photo 28: The large foundation stones protruding from beneath the north wall of the church building. Facing south. 1m scale

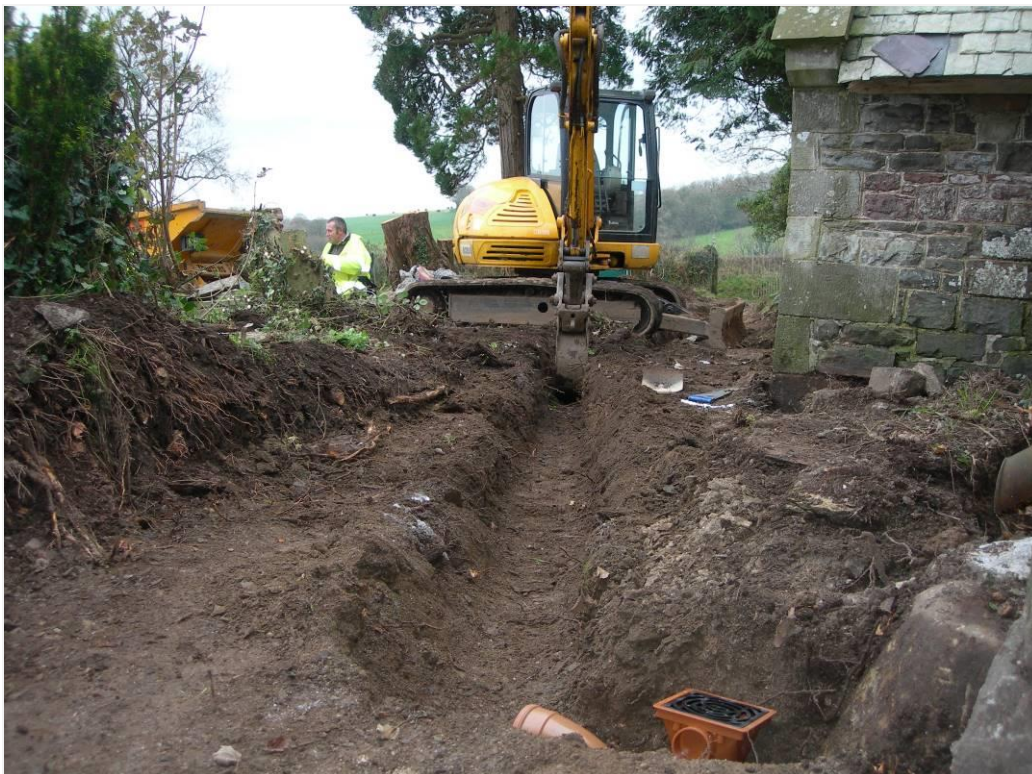
Photo 29: The machine excavation of the perimeter drainage trench south of the church. Facing east

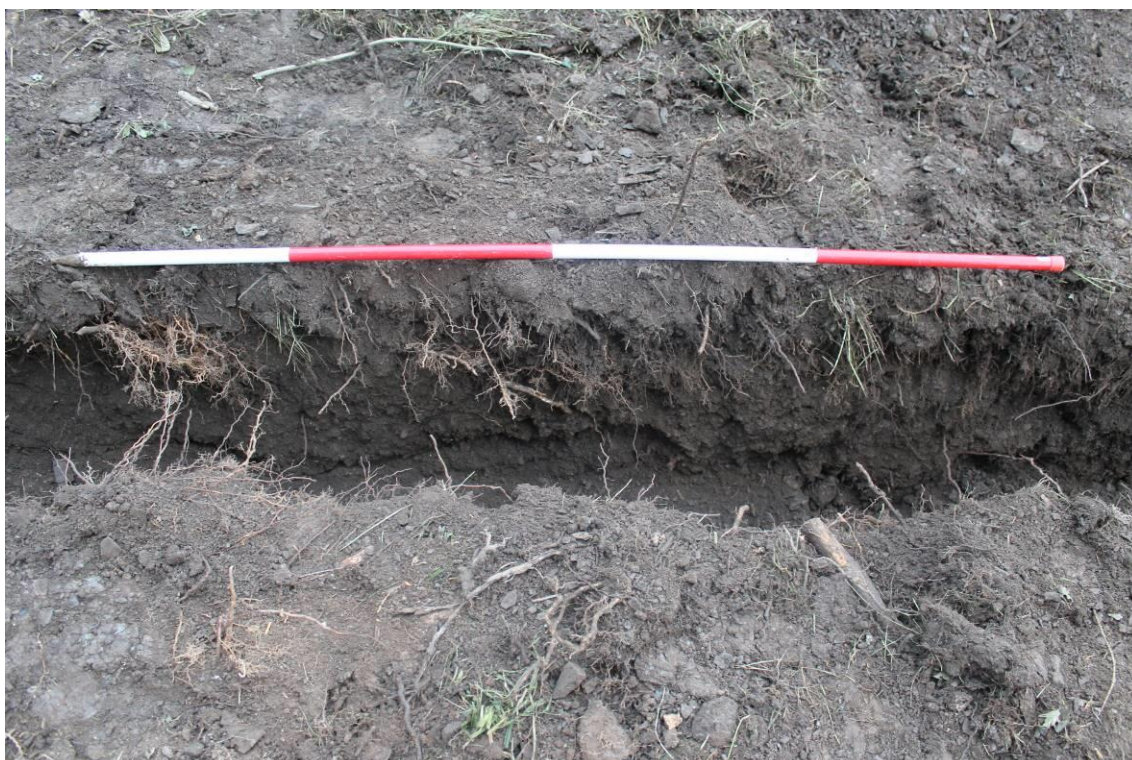
Photo 30: Typical view of the perimeter drainage trench on the south side of the church. Looking north. 2m scale

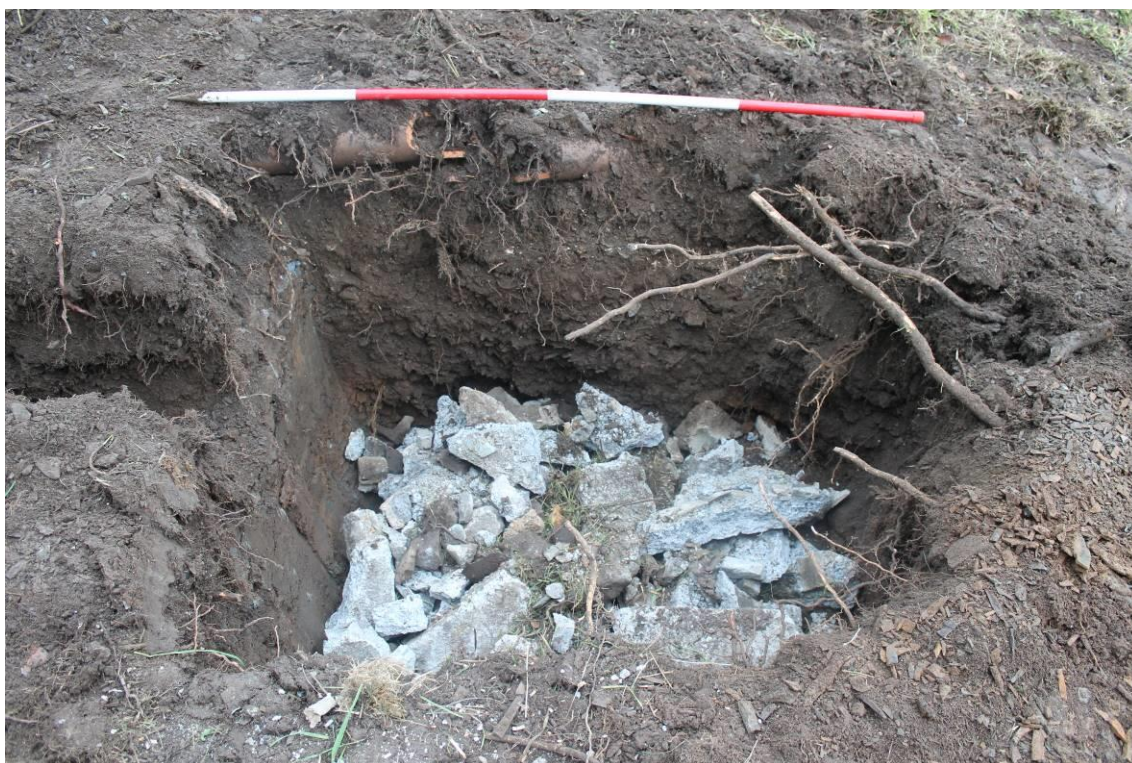
Photo 31: The soak-away trench. Facing south. 1m scale

- 4.3.13 A further trench was excavated from the south western end of the church for an approximate length of 3.5m (Figure 8, Photo 32). This replaced an existing 19th century ceramic drain. At the end of the drain a small soak-away was excavated measuring approximately 1.8m x 1.5m and 0.8m in depth (Photo 31). A watching brief monitored the excavation of both the trench and soak-away but no archaeological features or deposits were recorded during these works.
- 4.3.14 To the north of the church a small rectangular trench for a proposed shed measuring approximately 3m by 4m was excavated to a depth of 0.30m under archaeological supervision. The trench was trowelled by hand (Photos 33 & 34) but no archaeological features or deposits were identified in this area.

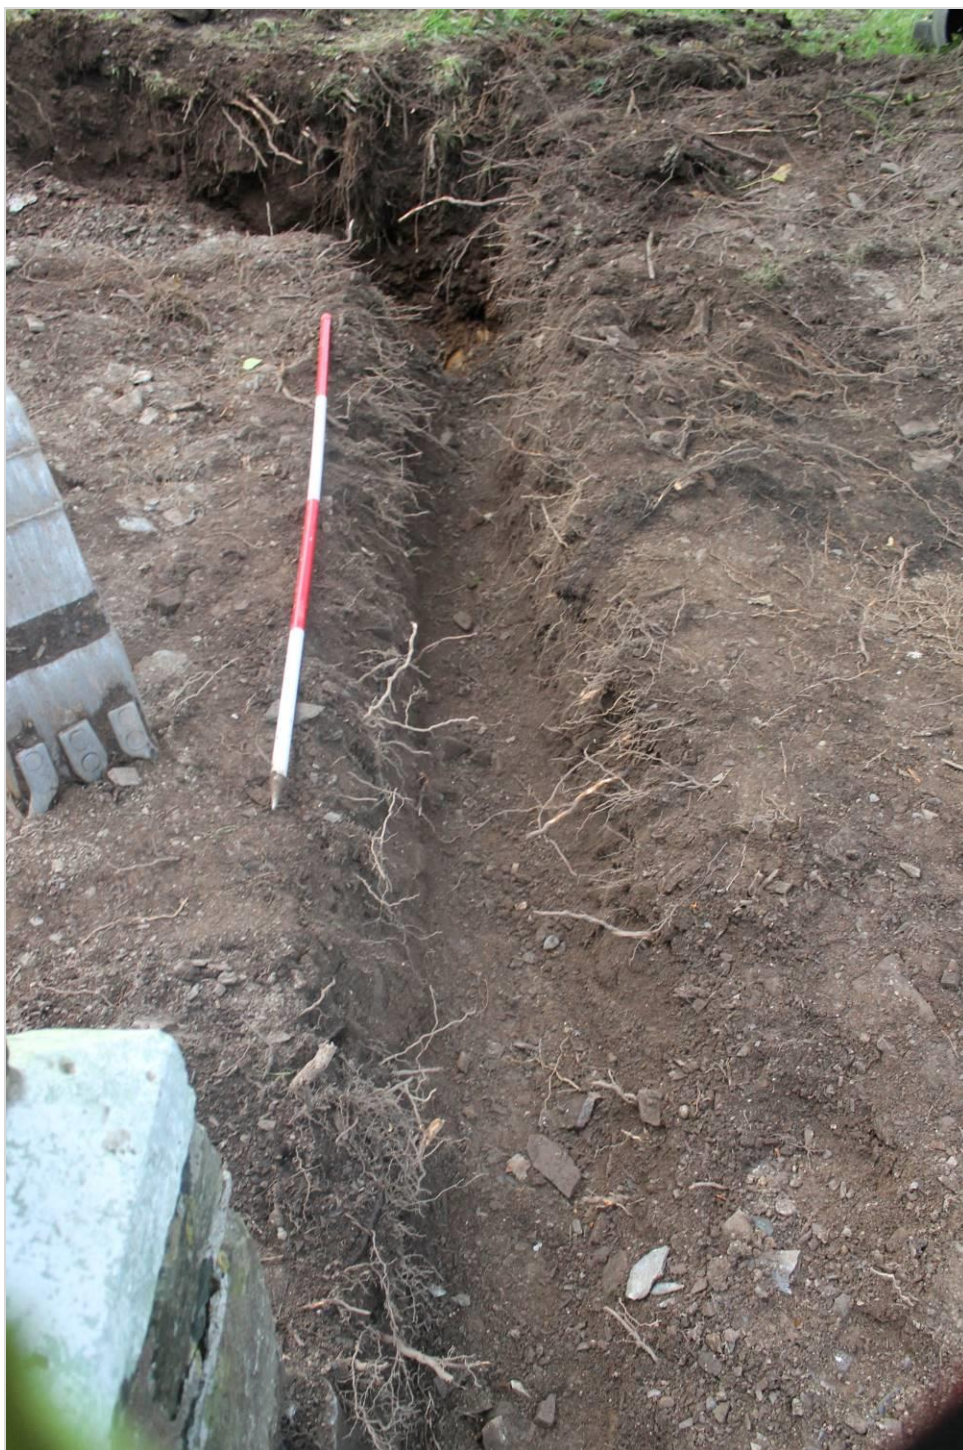
Photo 32: The machine excavated trench that ran from the church to the soak-away. Facing south. 2m scale

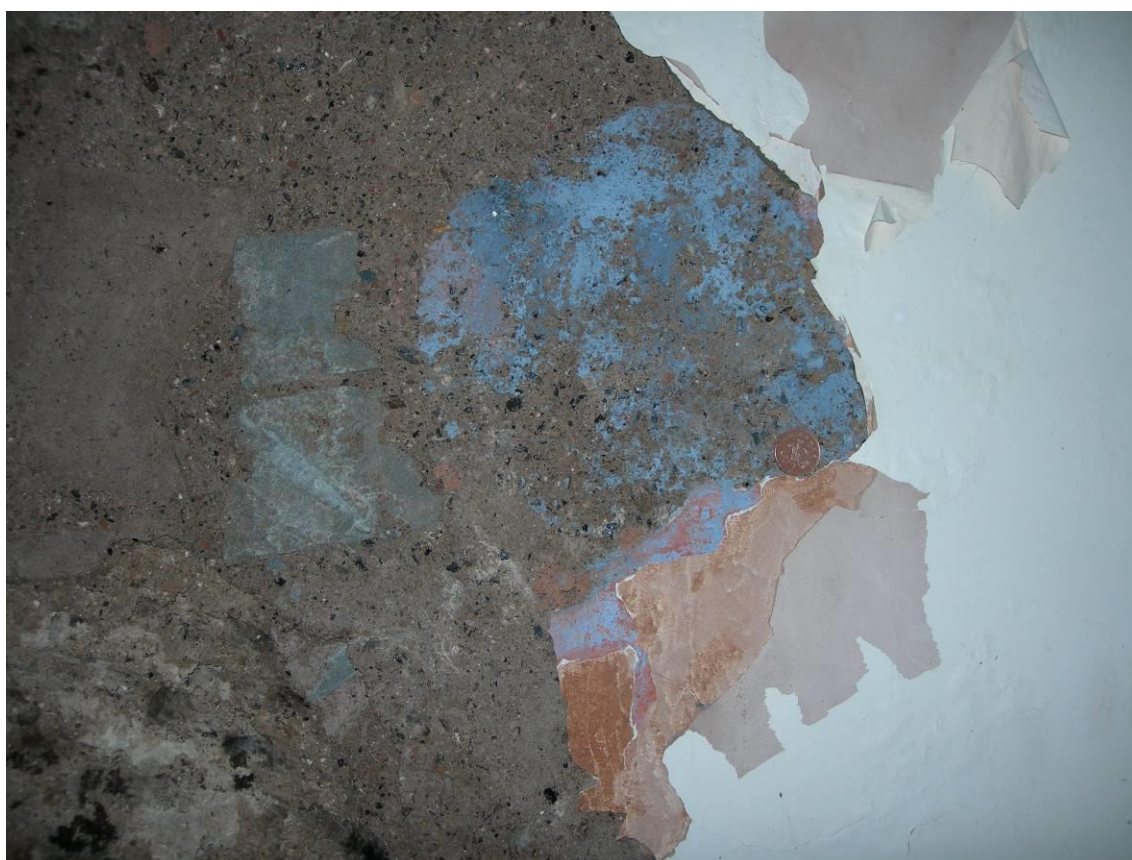
Photo 39: A typical photograph of an interior church wall during the removal of the 19th century paint and wall plaster, showing the layers beneath.

- 4.4.1 The photographs below show the interior of the church before works started (Photos 35-38).
- 4.4.2 The 19th century wall plaster was almost entirely removed from within the church. It was carefully removed and observed in case any underlying wall decoration had survived (Photos 39-40). No evidence of any earlier wall decoration or wall paintings was seen during this work.

- 4.4.3 Three layers of wall plaster were identified during this removal and the owner suggested they could be associated with three periods of restoration during the 19th century; namely 1866, 1820 and pre 1820. The evidence from the plasterwork suggested that earlier 19th century base coat plaster had been spread across the majority of the underlying stonework prior to finishing coats being applied (Ian Hartshorn pers. comm.). This would suggest that any earlier plasterwork had been removed during the extensive 19th century renovations, or that the upper parts of the walls had been substantially rebuilt. The depth of plaster was not consistent across the entire church walls, perhaps indicating differences in rebuilding, repairs or replastering. No medieval plasterwork or paint survived.

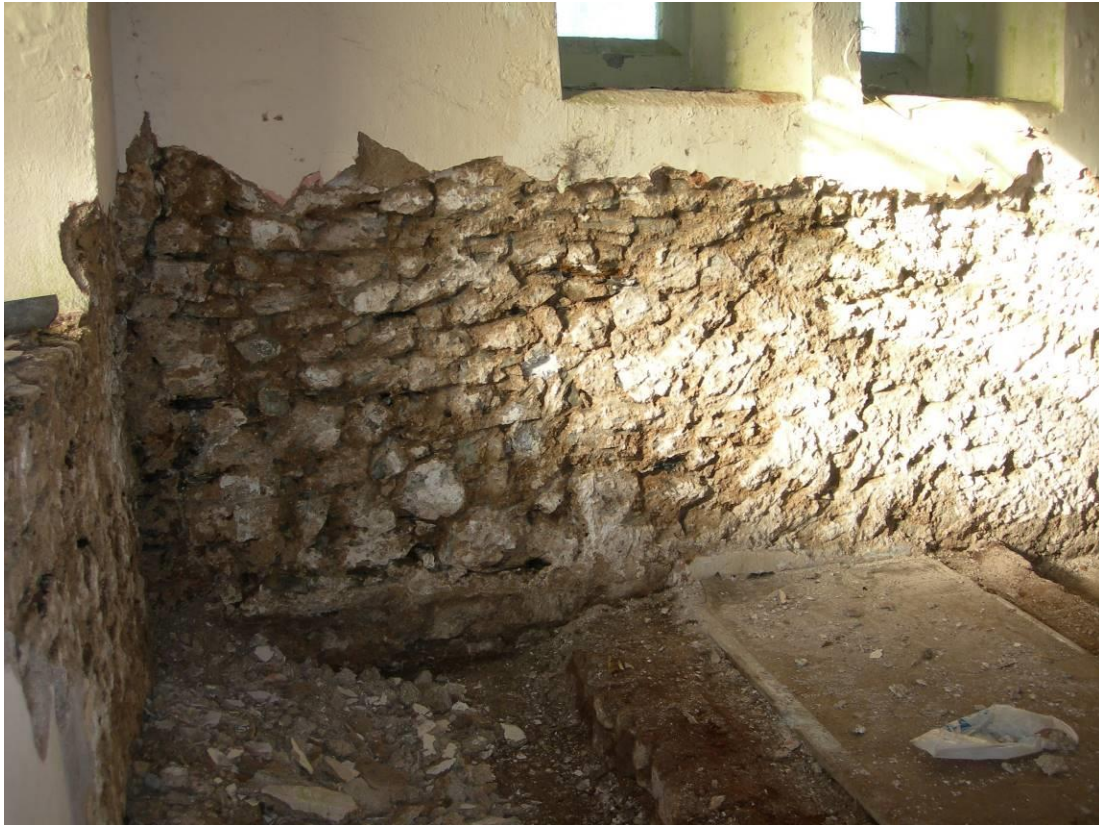
Photo 40: The west end of the church after removal of the wall plaster showing the rough stone wall construction underneath.

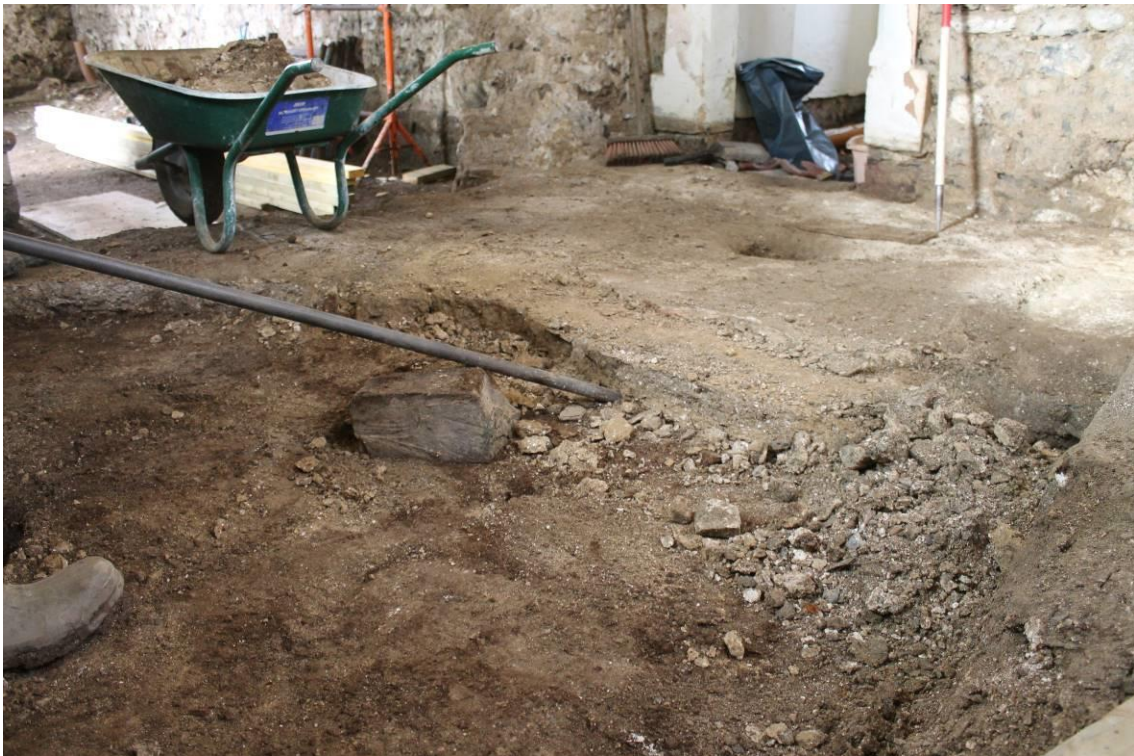
Photo 41: Removing 19th century mortar floor layer (454) within the area of the chancel, viewing northwest towards vestry doorway.

- 4.4.7 The area of the chancel was also lowered as part of the approved development plans. For the western part of the chancel this was removed and it was apparent that it comprised a sequence of potentially three mortar floor layers, indicating episodes of re-flooring or repairs (Photo 41). It was suggested by the owner, based on the similarities of the mortar compositions that they may have been similar to the three episodes of replastering of the walls. The step up between the nave and chancel enabled a visible section through the floor deposits to be seen (Photo 42).

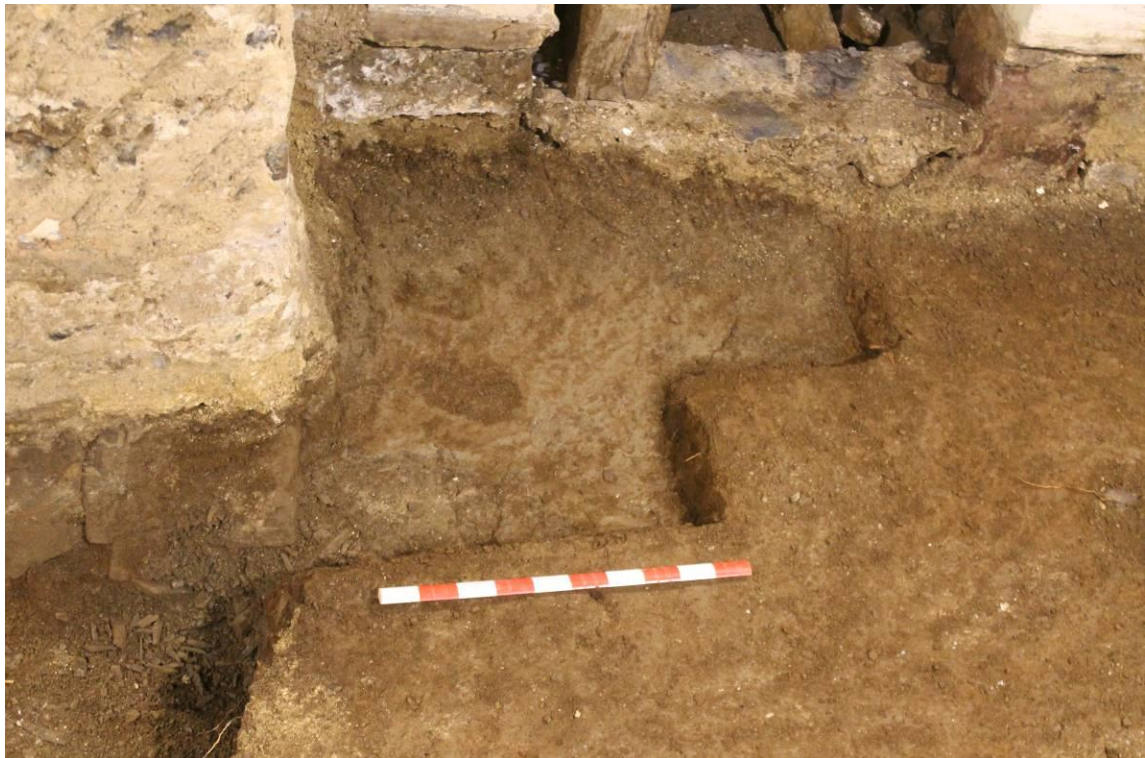
Photo 44: View of grey silty clay (461) exposed beneath brown beaten earth floor, in the northwestern corner of the chancel, with door to former vestry visible at top of photo. 0.50m scale

- 4.4.14 Small sections of floor layer (458) were removed close to the bottom of the chancel arch walls on both sides of the church. In these areas below the beaten earth floor (458) compact clean grey clay (461) was revealed (Photo 44). It was possible that this clay could have filled a foundation trench for the chancel arch walls but this possibility was not investigated further as the ground level did not need to be further reduced. This clay was very different to the broken shale found elsewhere under layer (458).

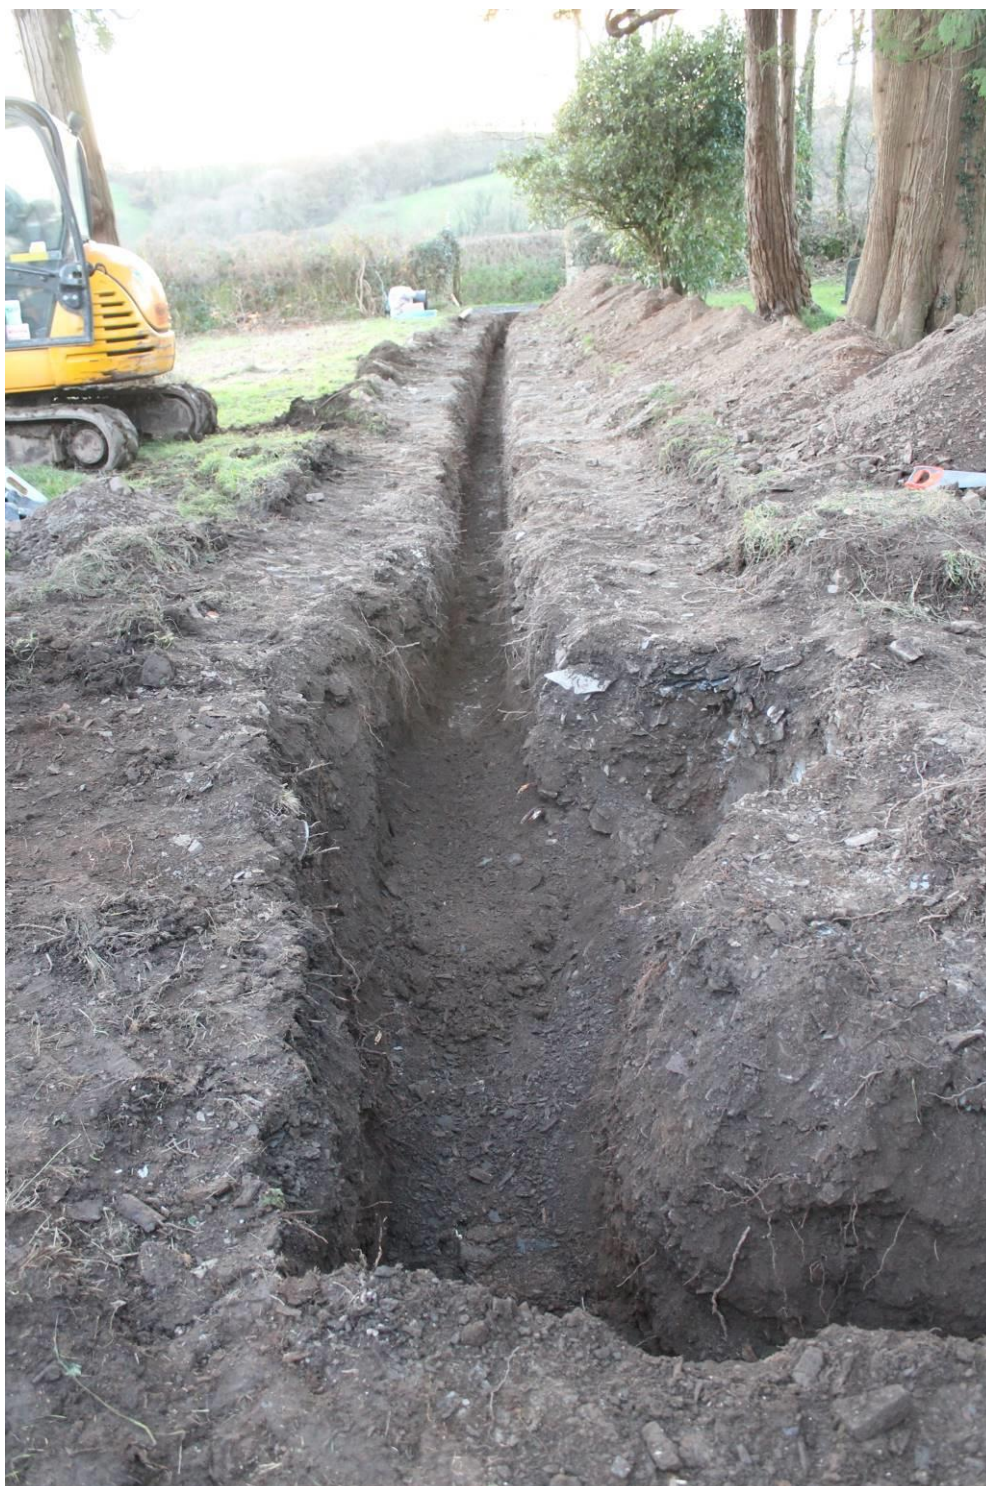
Photo 45: The machine excavated drainage trench that ran from the church to the west gate. Facing west

- 4.5.1 A narrow trench for a foul drain was excavated along the existing path for approximately 27m from the western end of the church to the west gate (Figure 5, Photo 45). From this a connecting trench for the drain ran for roughly 28m southwards to a trench excavated for the proposed location of a septic tank. The foul drain trenches were on average 0.50m wide and 0.40m deep.

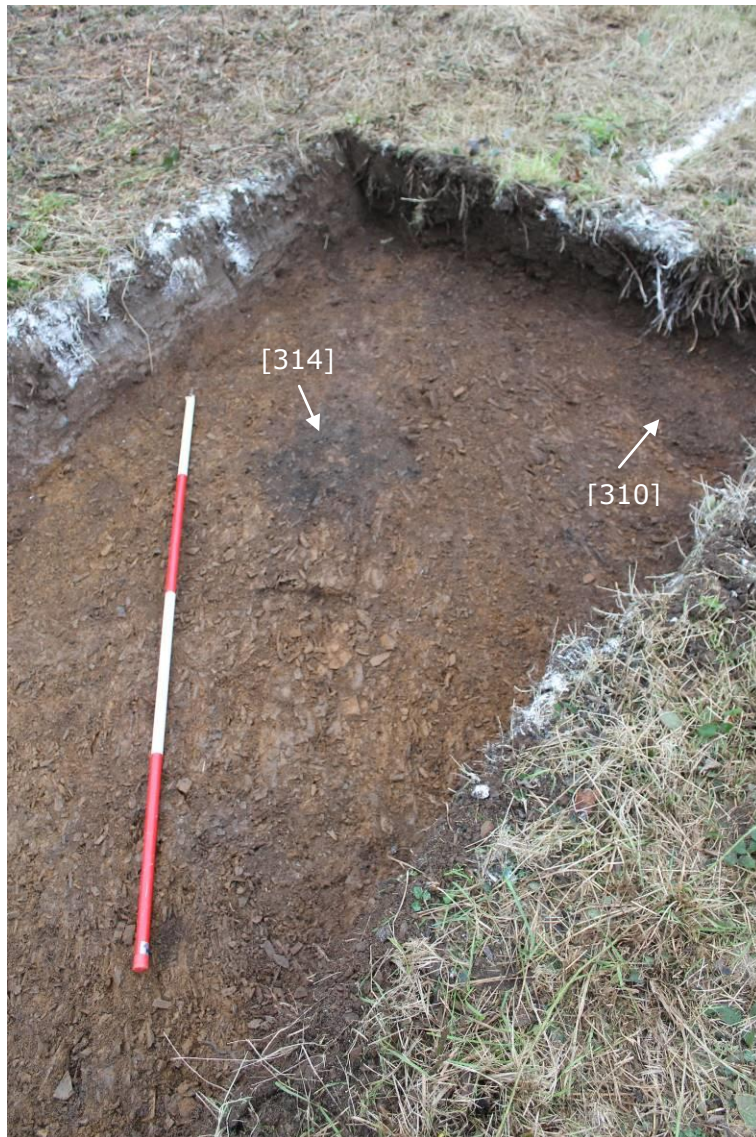
Photo 48 (left):
Photograph of north end of Area E trench before excavation of archaeological features. Looking approx. W. 2m scale

- 4.5.4 The trench was hand cleaned revealing a number of archaeological features cut into the bedrock (Photos 46 & 47). No features had been evident within the topsoil. The features were clearly visible as areas of darker soil and broken shale against the lighter undisturbed shale bedrock (Photo 48).

- 4.5.8 South of both graves was evidence of a possible curving gully [320] (Photos 48 & 49). This feature was partially excavated and measured 0.22m wide and 0.15-0.20m deep, with roughly vertical sides and an irregular base. It was filled with a sandy silt matrix surrounding much broken and crushed shale. No finds were recovered from the excavated fill.

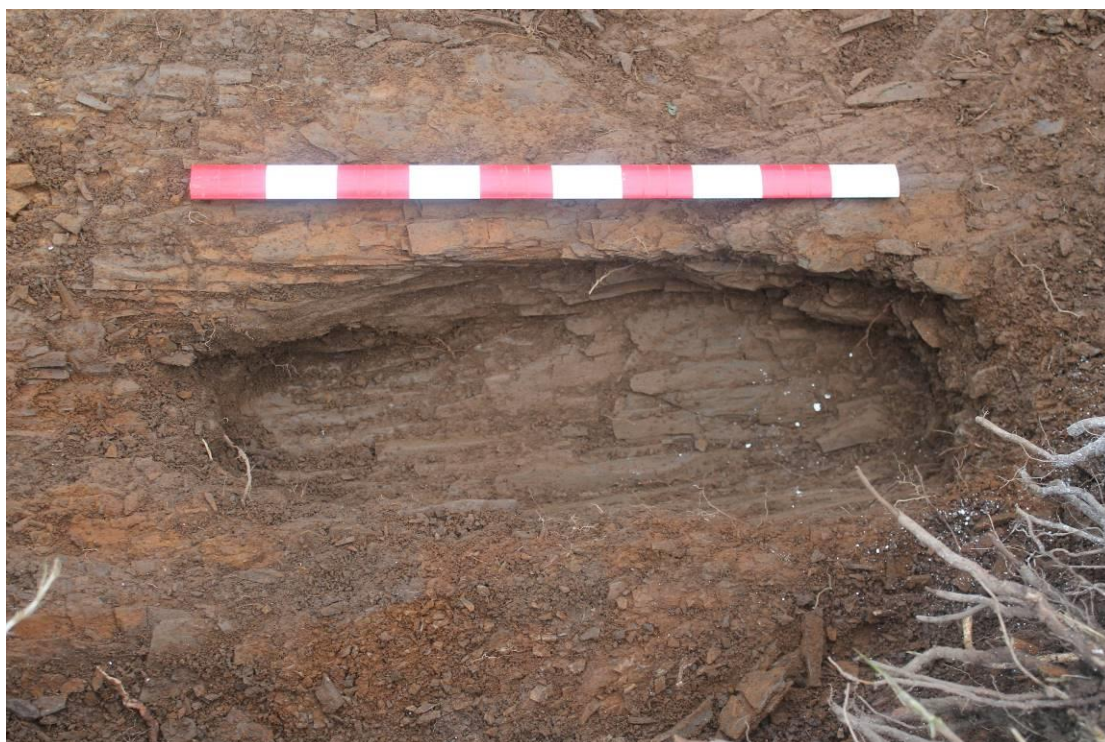
Photo 50: Looking roughly south at excavated child grave [310]. 0.5m scale

- 4.5.5 The majority of the identified archaeological features were fully excavated and are shown in plan and section in Figures 10 and 11.
- 4.5.6 Evidence of two possible graves were recorded within the trench. Grave cut [310] appeared to be a child grave (Photos 49 & 50). It was aligned approximately west-east and measured 0.62m in length, 0.20m wide and 0.18m deep. The sides were nearly vertical and the cut had a flat base. It was filled with re-deposited broken shale within a sandy silt matrix. No bone survived and no finds or any other dating material were recovered from the grave cut.
