ST DAVID'S CHURCH, HENLLAN AMGOED, CARMARTHENSHIRE: ARCHAEOLOGICAL EXCAVATION 2013/14

RHIF YR ADRODDIAD / REPORT NO. 2013/75
RHIF Y DIGWYDDIAD / EVENT RECORD NO. 105881

**ST DAVID'S CHURCH, HENLLAN AMGOED,
CARMARTHENSHIRE:
ARCHAEOLOGICAL EXCAVATION 2013/2014**

Fran Murphy
with Hubert Wilson and James Meek

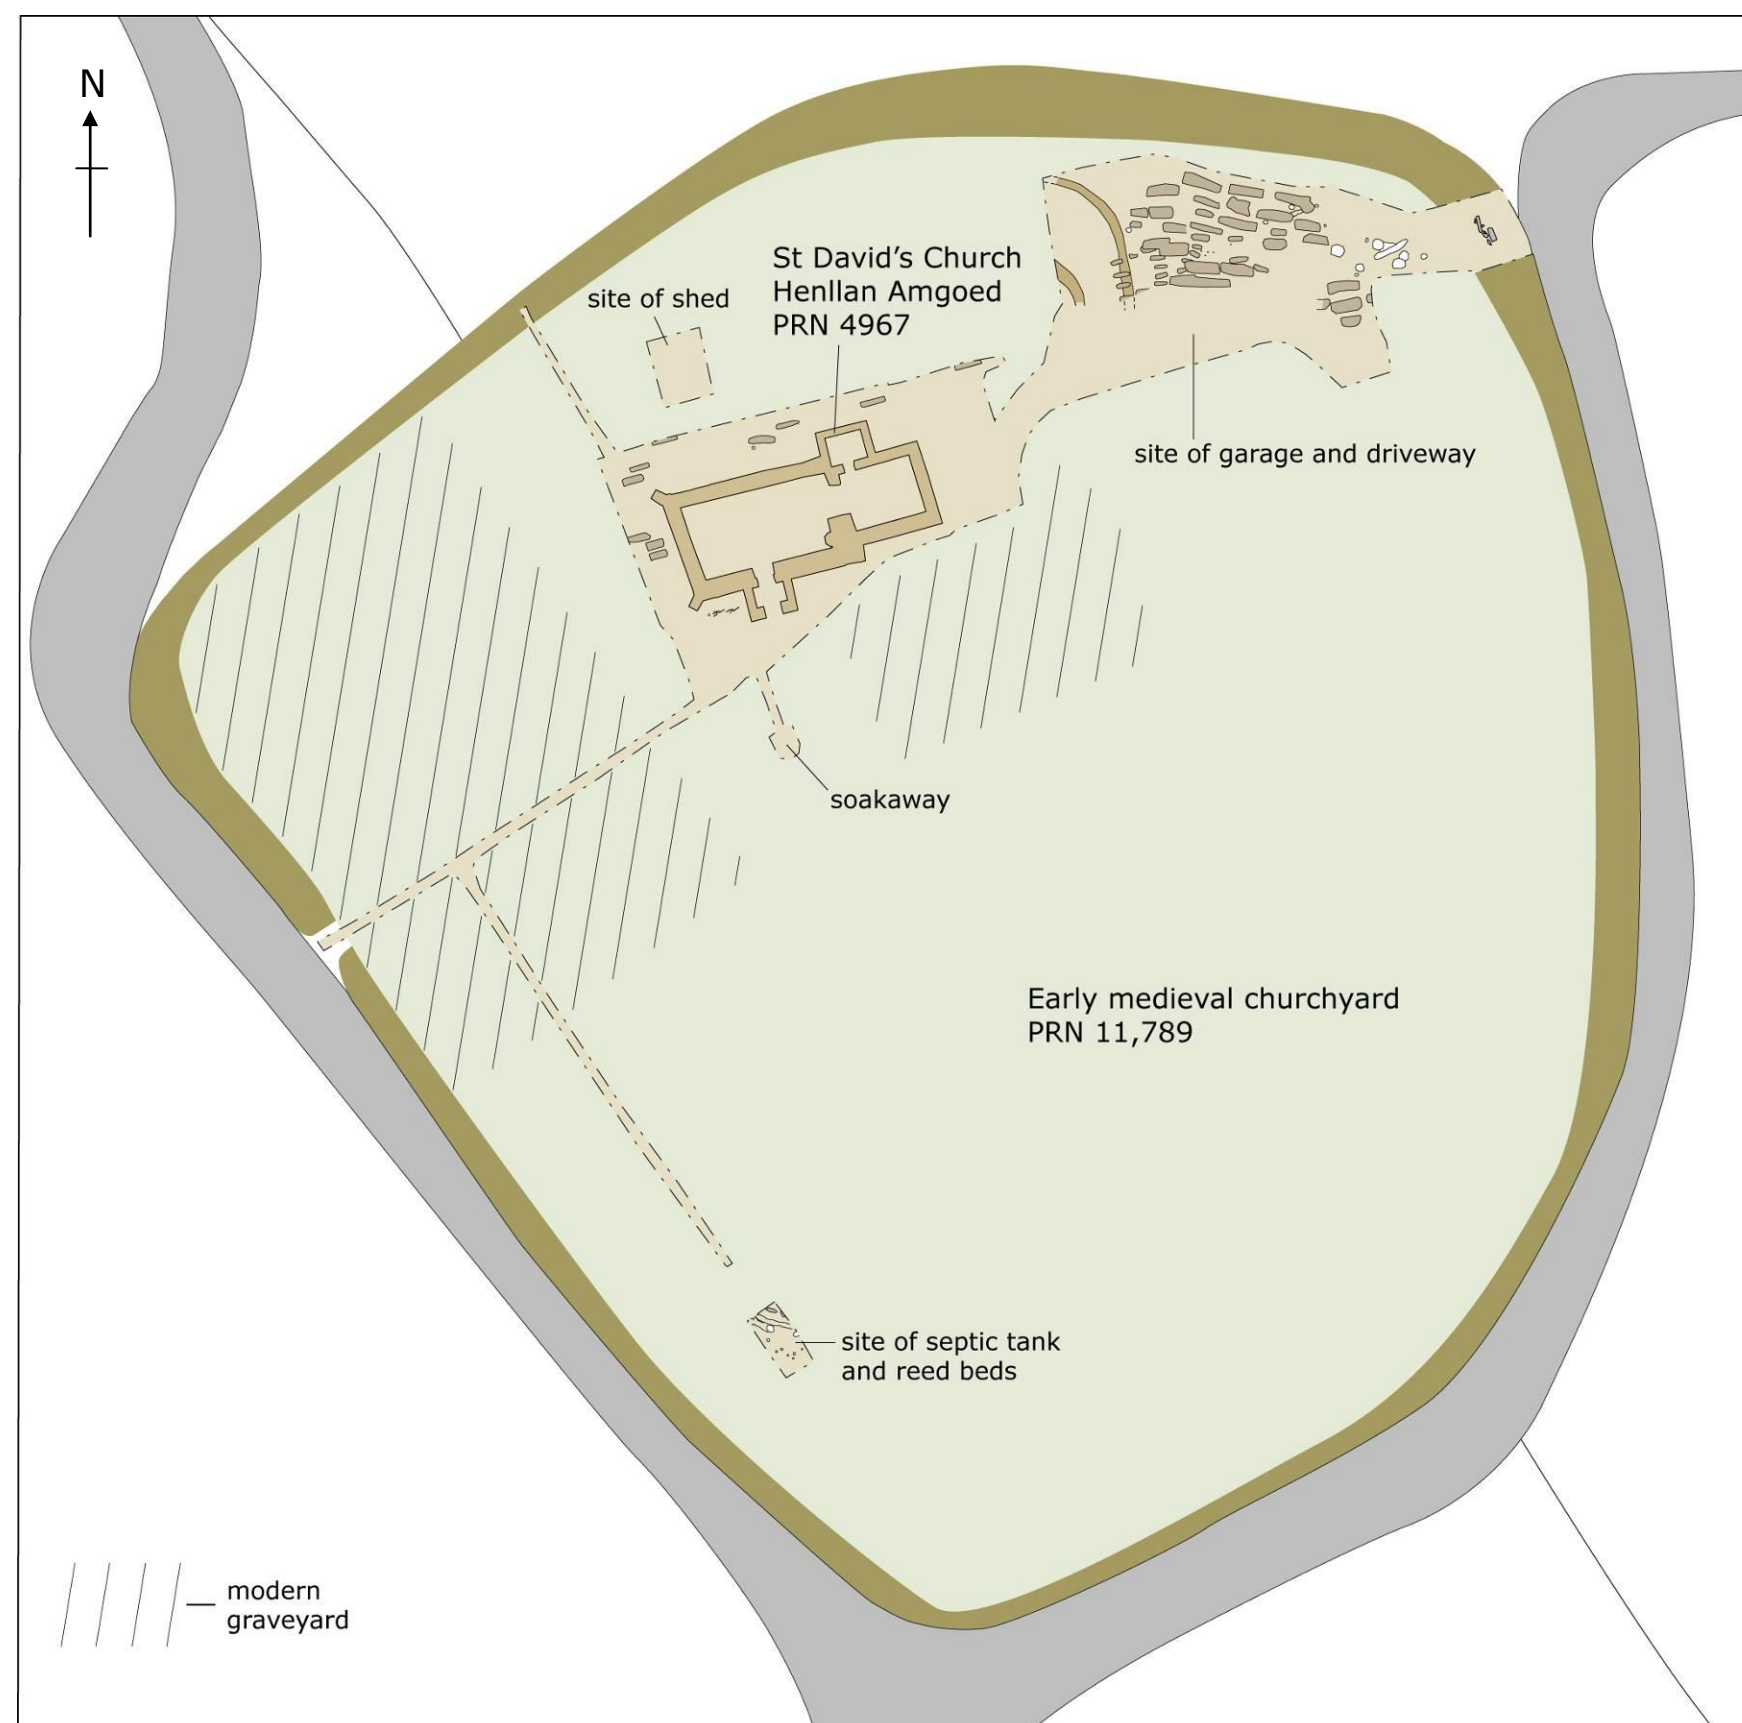
Figure 12: Overall site plan showing St Davids Church, the excavation areas and recorded archaeological features.

Archaeological remains (Figure 12)

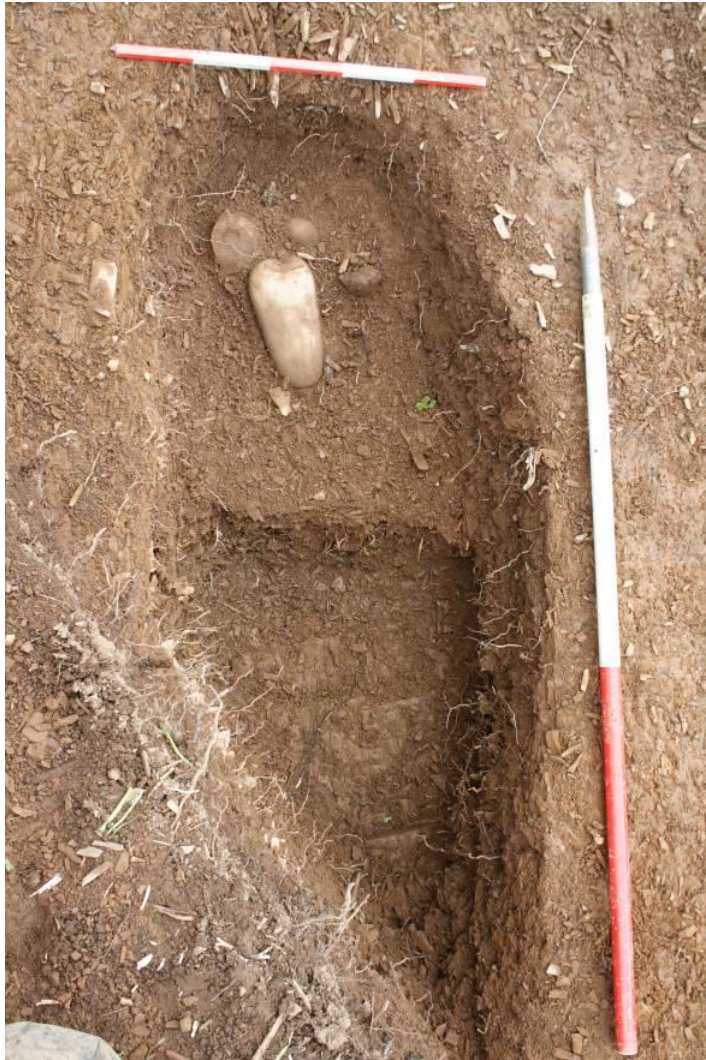
Photo 52: (left) Post-excavation shot of grave cut [410] and posthole [419]. 0.5m & 1m scales.
East facing photographs taken during 2012 evaluation

- 5.11 Evidence for a medieval date is also indicated by the stones placed in one of graves excavated during the 2012 evaluation, a burial feature thought to date from the period 11th to 13th centuries (Daniell, 1998, 158-159) (Photo 52). This was recorded in a recent excavation of a sample of two graves within an undated cemetery at Meusydd, Powys (Jones & Hankinson, 2011), where within both graves groups of rounded stones had been placed within the graves; one group towards the eastern end of one grave. The authors of this report suggested the position of the stones reflected the position of the burial; where again no traces of any human remains survived.

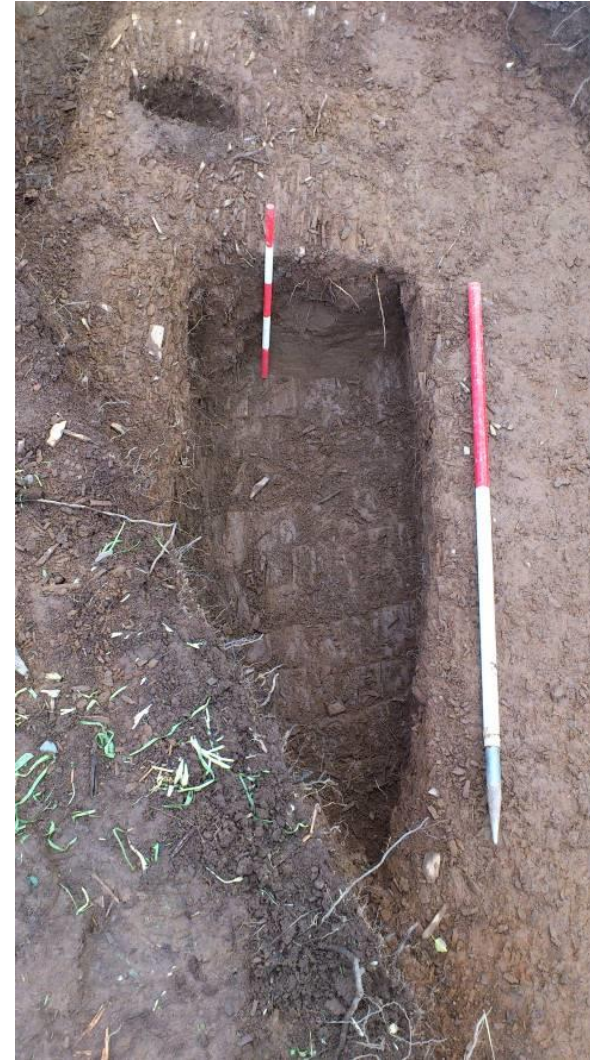
Photo 53: (right) Partial excavation of grave cut [410], showing stones at eastern end. 0.5m & 1m scales.
East facing photographs taken during 2012 evaluation
