CAREW CASTLE WALLED GARDEN, PEMBROKESHIRE: ARCHAEOLOGICAL EVALUATION 2019

RHIF YR ADRODDIAD / REPORT NO. 2019-07 RHIF Y PROSIECT / EVENT RECORD NO. 117004

Gan / By Charles Enright and James Meek

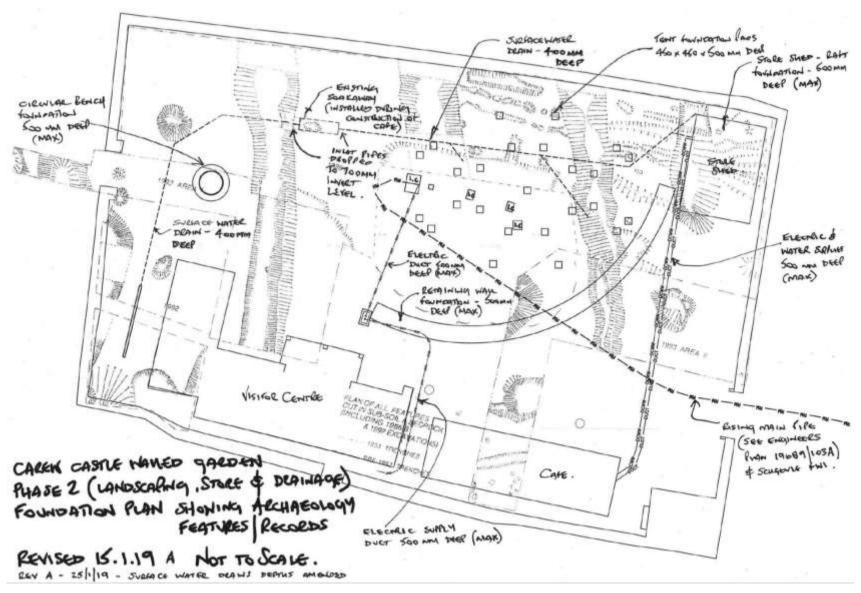
Figure 3: Proposed works for new storage shed, retaining wall, seating, drainage and rising main (plan provided by PCNPA)

- 1.1.1 DAT Archaeological Services were commissioned by Pembrokeshire Coast National Park Authority (PCNPA) to undertake an archaeological evaluation in Carew Castle Walled Garden (NGR SN 06575 03775; Figures 1 and 2), ahead of proposed works for a new storage shed, improvements to the foul drainage at the site and other landscaping works (Figures 3 5). Carew Castle is a Scheduled Monument (Reference PE001).

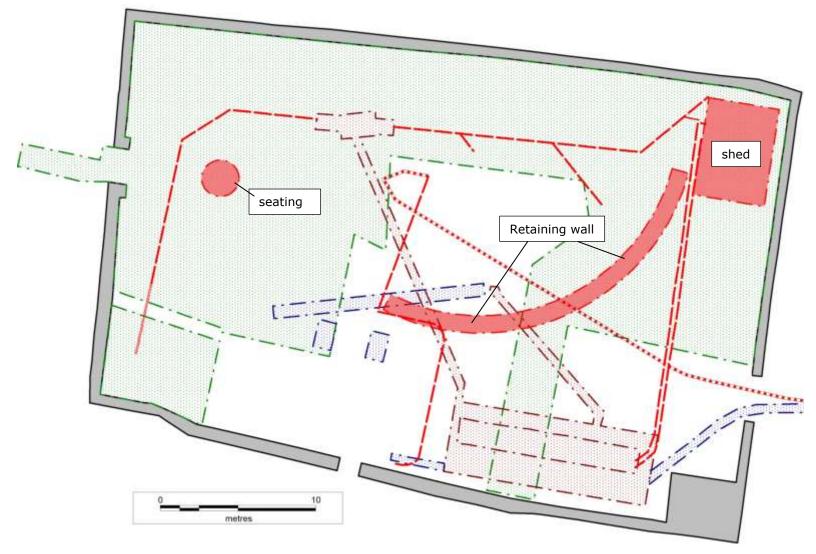
Figure 4: Former areas of archaeological investigation within the walled garden including (1986-1988 and 1992 - 3 green; 2013 watching brief approximate areas in blue; and the evaluation and watching brief 2018 brown) with the proposed areas of shed, retaining wall, seating, drainage and rising main superimposed in red

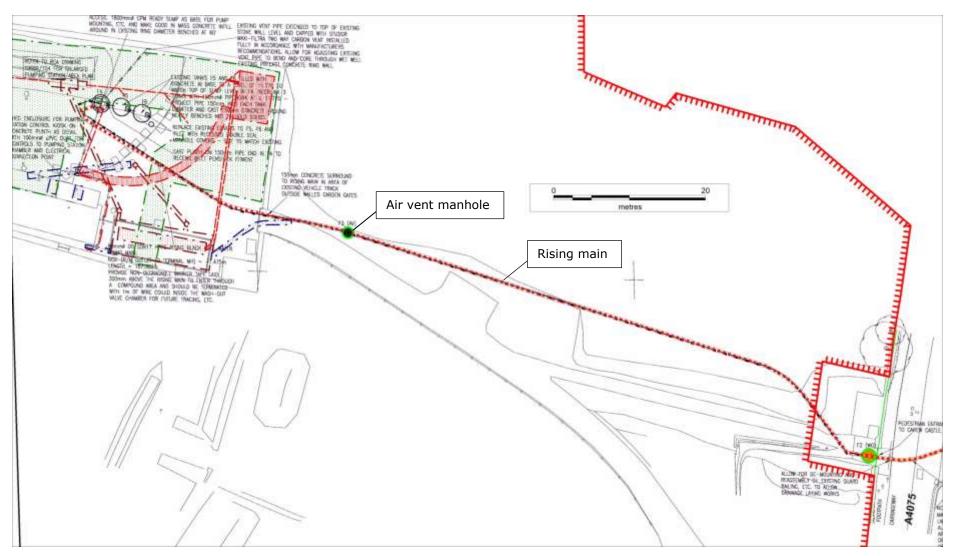
Figure 5: Proposed route of rising main route from walled garden

- 2.2.3 It is known that the previously excavated areas as shown in Figures 4 & 5 were taken down to the underlying geological bedrock and thus all deposits have been removed.

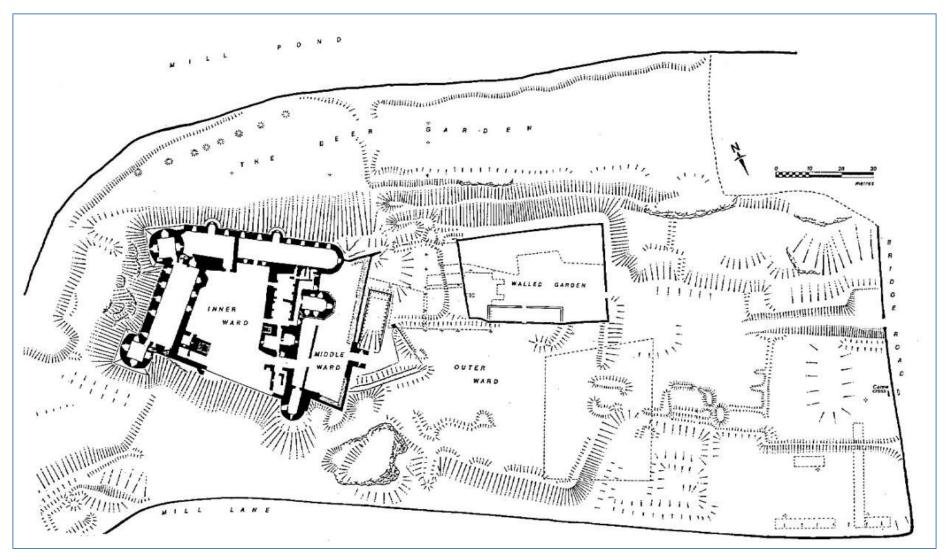
Figure 6: Survey of the castle and earthworks prior to the archaeological works begun in 1988 (D. Austin and Dyfed Archaeological Trust – used in the 1992, 1993 and 1994 interim reports and Austin 2015)

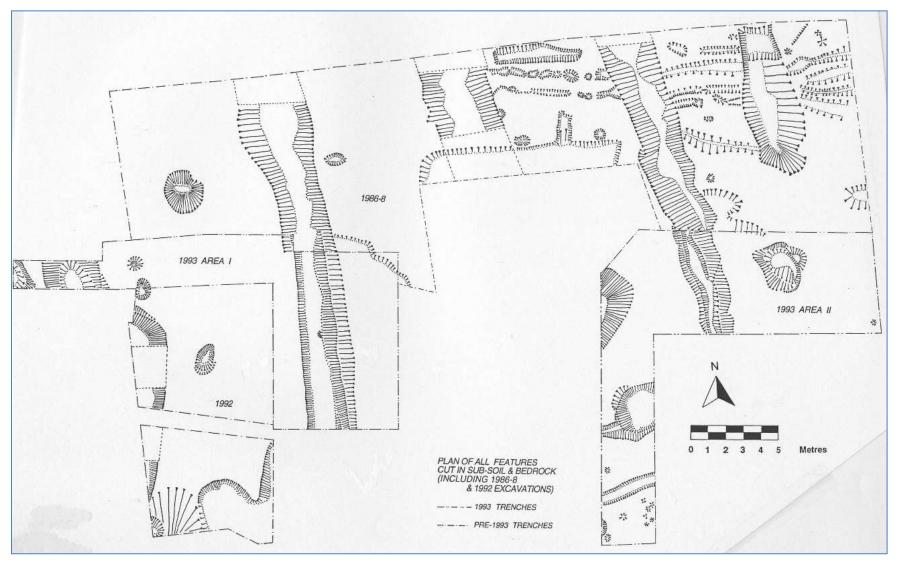
Figure 7: Plans of all features cut in sub-soil and bedrock (including 1986-1988 and 1992 - 3 Excavations) Taken from Carew Castle Interim reports for 1993 and 1994 (Austin 1994, 1995 & 2015)

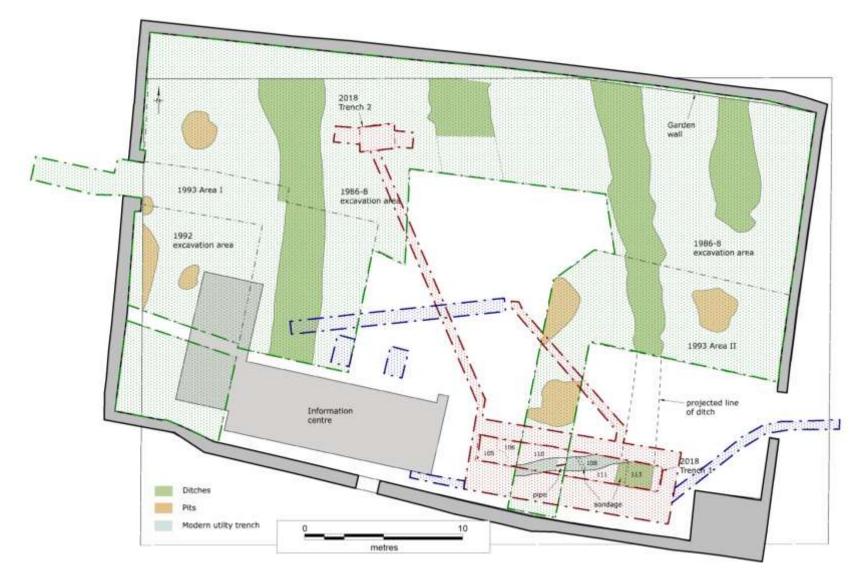
Figure 8: Plans of all investigated areas within the walled garden including 1986-1988 and 1992 - 3 Excavations (green), the 2013 watching brief (approximate areas in blue) and the evaluation and watching brief from 2018 (brown)

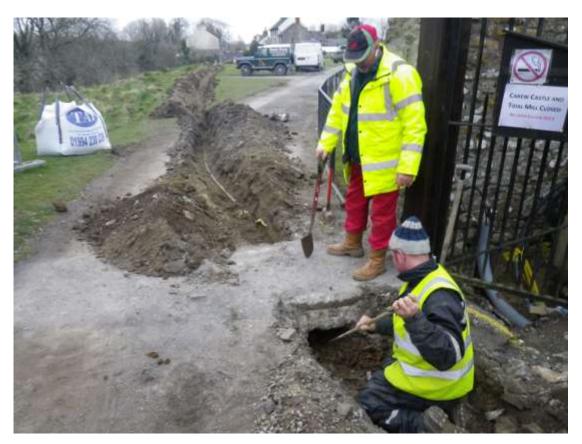
Photo 1: View east from entranceway into Walled Garden showing excavation of service trench (for water and electric) (PCNPA 2013)

- 2.2.12 As noted above, a previous archaeological watching brief was undertaken by the PCNP archaeologist during the construction of the new visitor centre. This included works inside the walled garden and also the excavation of a trench for an electricity and water cable leading from the walled garden to the east, adjacent to the main path to the castle. It is intended that the proposed rising main will try and follow this service trench to minimise the possibility of disturbing underlying archaeological remains. A series of photographs from this watching brief have been made available by PCNP which show that the drainage trench was around 0.40m to 0.50m deep in the area immediately east of the walled garden (Photos 1 and 2). As it ran downslope towards the Carew Inn, the trench was probably around 0.30m deep at most (Photos 3 and 4). Although the bucket used to excavate the service trench was 0.40m wide, it can be seen that the final width of the trench was probably around 0.60m.

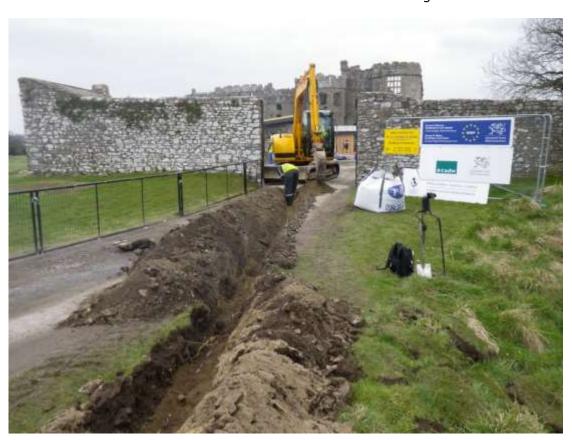
Photo 2: View west towards entranceway into Walled Garden showing excavation of service trench (for water and electric) (PCNPA 2013)

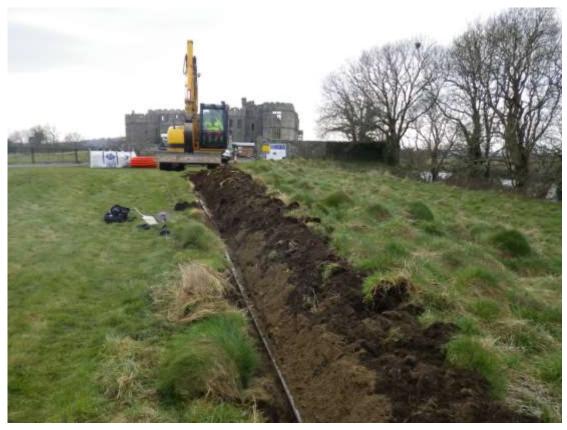
Photo 3: View west towards Walled Garden showing excavation of service trench (for water and electric) across grassed area on brow of slope (PCNPA 2013)

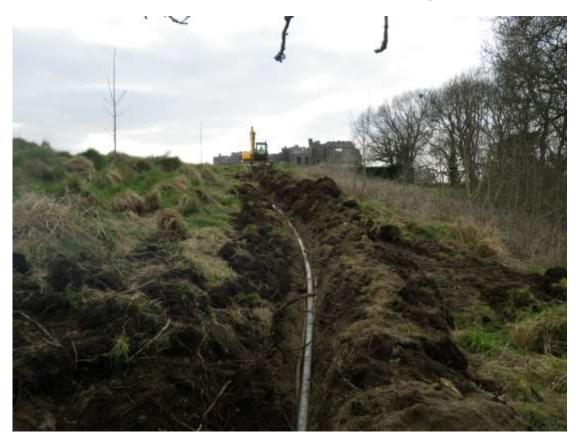
Photo 4: View west towards Walled Garden showing excavation of service trench (for water and electric) on the downslope area leading towards Carew Inn (PCNPA 2013)

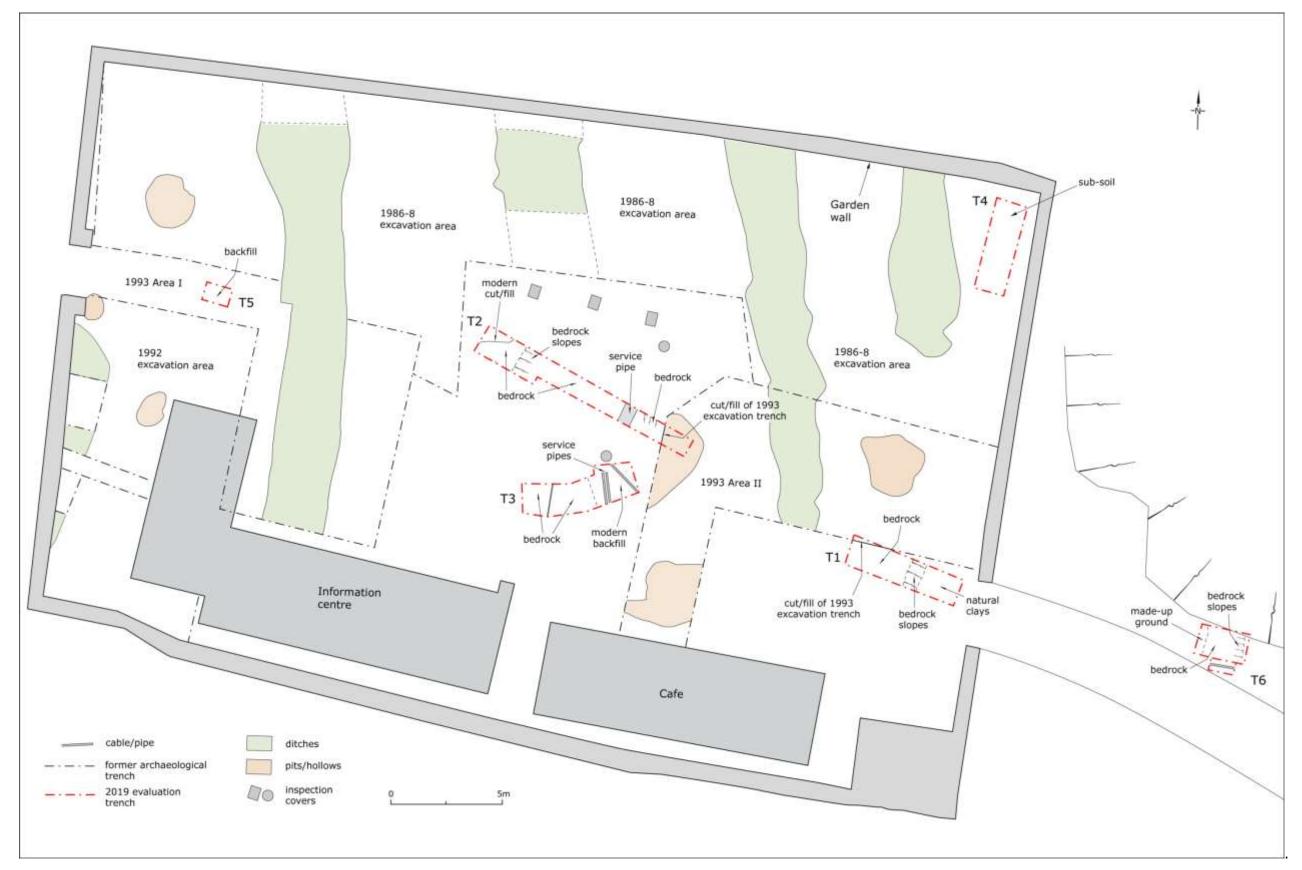
Figure 9: Trench Location Plan (T1 – T6) superimposed on plan of Walled Garden, showing former excavation areas, Information Centre and new Café building

4.1.1 During the evaluation six trenches were excavated (Figure 9). Five trenches were opened within the Walled Garden and one to the east of the entrance. Each trench in the Walled Garden (Trenches 1 to 5; T1 – T5) was overlain by the modern stone crushed surface made of fine gravels, sands and building waste which covers the majority of the interior. Trench 6 (T6) was located immediately north of the extant footpath on the causeway leading towards the main entrance to the castle through the Walled Garden. This trench was overlain by grass and topsoil.

- 4.3.3 At approximately 2.35m from the eastern end of the trench, the top of a concrete capped modern sewer pipe was exposed (Photo 9). This presumably connects to the two manhole covers seen to the north and south of the trench (Figure 9), associated with the existing septic tank system in use in the Walled Garden.

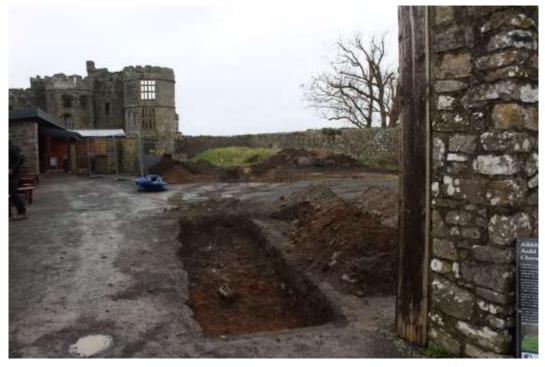
Photo 5: View northwest from entrance of Walled Garden along Trench 1, with Carew Castle behind

- 4.2.1 Trench 1 measured 5m x 1.20m and was orientated roughly east west within the eastern entrance of the Walled Garden (Photo 5). The trench was located to target the line of the proposed rising main as it enters the Walled Garden. Groundworks in this area require excavation of up to 0.50m depth.
- 4.2.2 To the west of the trench, the crushed stone surface was directly overlying the limestone bedrock geology, which was present at just 0.35m below ground level.
- 4.2.3 At the eastern edge of the trench the bedrock sloped down into a hollow, with similar characteristics to a small rock cut ditch, although no coinciding linear feature had been recorded in the previous archaeological work immediately north of the trench. It was considered most likely to represent a natural undulation in the bedrock.

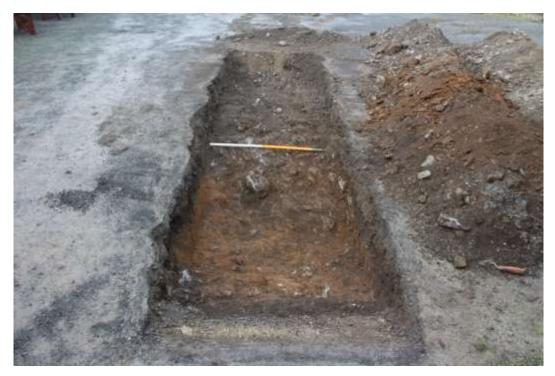
Photo 6: View west along Trench 1, with possible natural hollow visible in the foreground. At the far end of the trench the natural bedrock is exposed 0.35m below ground level, directly below the stone crushed surface.

4.2.4 The hollow was approximately 0.23m deep and filled with clean, brown silty clay (Photos 6 and 7). Overlying this was a band of loose dark silt, possibly a remnant of a former garden soil.

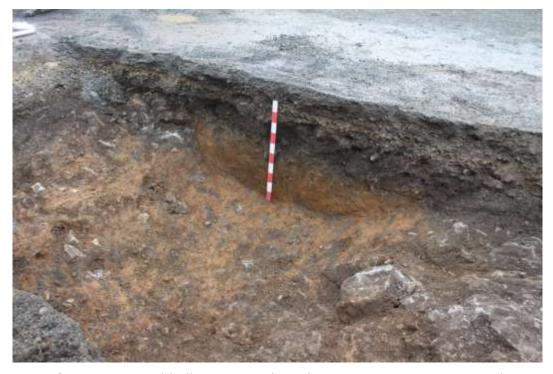
Photo 7: Natural hollow in Trench 1 after excavation, viewing south

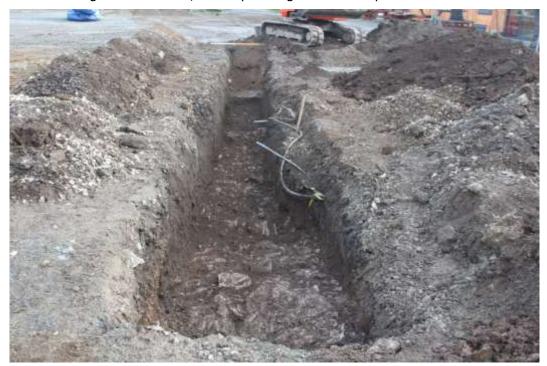
Photo 8: View southeast along Trench 2, with bedrock in foreground and electricity cable on trench edge

- 4.3.1 Trench 2 measured 10m in length and was orientated roughly northwest southeast (Photo 8). It was located to target the course of the proposed rising main part of which had an estimated required depth of up to 1.20m below ground surface. The trench mostly lay in an area not previously subject to excavation in the 1990s.
- 4.3.2 The northwestern end of the trench was initially excavated to a width of 1.20m wide but was reduced to 0.75m because of an exposed electricity cable (Photo 8). The trench was excavated to an average depth of 0.70m below ground surface, corresponding with the depth of bedrock.

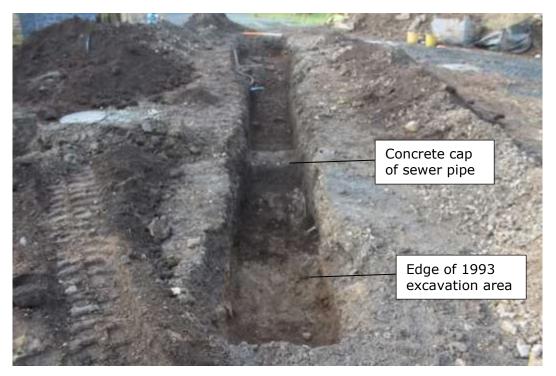
Photo 9: View northwest along Trench 2. The concrete capping of the sewer pipe can be seen towards the foreground.

- 4.3.6 To the east of the sewage pipe the bedrock dipped again. It is possible that the dip at this end was associated with a pit or hollow recorded during the 1993 excavations (Figure 9; Photos 9 and 10).

4.3.7 At the eastern end of the trench the cut for the 1993 excavation was observed (Photo 9). This contained a gritty, sandy backfill with inclusions of mortar fragments and modern debris.

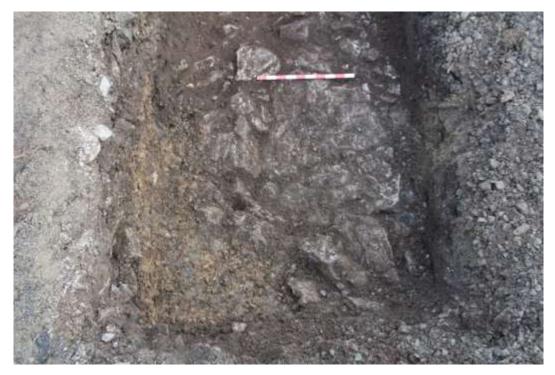
Photo 10: Cut for modern services at western end of Trench 2 filled with light brown silty clay.

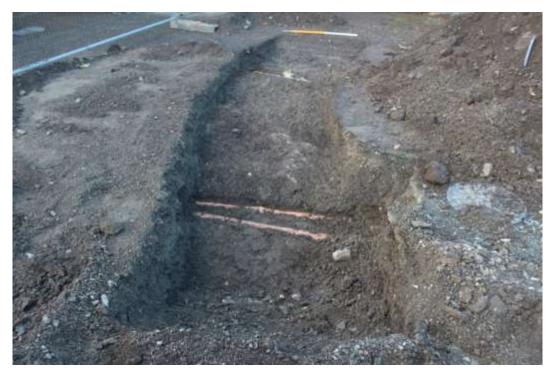
Photo 11: View west along Trench 3. Modern service pipes have heavily disturbed the eastern end of the trench. The remainder of the trench shows exposed bedrock directly below the crushed stone surface.

- 4.3.8 At the western end of Trench 2 a service trench was visible cutting into the bedrock (Photo 11). The service trench was filled with a light brown silty clay soil with frequent inclusions of small angular stones.
- 4.3.9 No significant archaeological remains were identified within the trench excluding the possible rock cut edge of the pit or hollow recorded in the 1993 excavations. No sign of the north to south aligned ditch recorded during previous excavations was identified within Trench 2.

- 4.4.1 Trench 3 was located to target the foundations for a proposed curving revetment wall. The trench was also curved and measured approximately 5.40m in length and 1.20m in width. The foundations for the proposed retaining wall will require an excavation depth of up to 0.5m.
- 4.4.2 Bedrock was exposed at the base of much of the trench at a depth of only around 0.35m below ground level.
- 4.4.3 The eastern end of the trench was significantly disturbed by modern service pipes (Photo 10), one of which was inserted in 2018. Two ran roughly north to south and the third (2018) was aligned northwest to southeast, running from the eastern end of the café to the adjacent manhole.
- 4.4.4 A water pipe and electricity cable ran across the western end of the trench aligned roughly north to south (Photo 11).
- 4.4.5 No archaeological remains were identified within the trench.

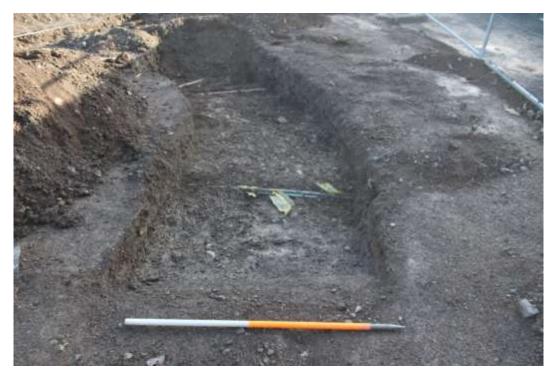
Photo 12: View east along Trench 3 with electricity cabling visible in the foreground

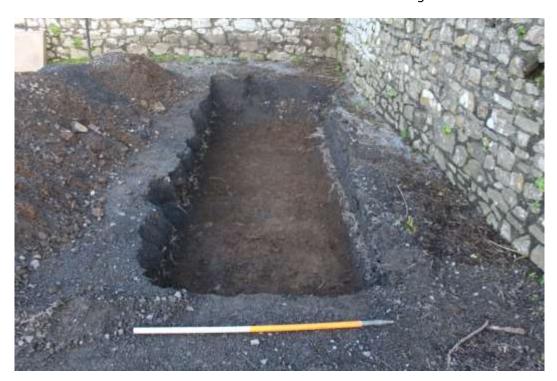
Photo 13: View north of Trench 4.

- 4.5.1 Trench 4 was located in the in the north east corner of the walled garden in the area of the proposed storage shed. The proposals will require groundworks up to 0.50m in depth for its foundations. The trench was orientated roughly north-south and measured 4.20m x 1.20m (Photo 13). It was excavated to a depth of 0.50m.

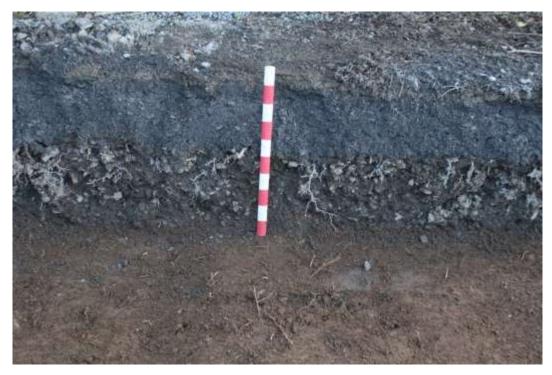
Photo 14: West facing section of Trench 4 showing the crushed stone surface, a possible former surface and the underlying subsoil.

- 4.5.2 Below the existing crushed stone surface was a depth of grey stone grits, presumably make-up layers for the extant surface (Photo 14).
- 4.5.3 A further layer of dark grey clay and abundant crushed stone lay beneath this. It is likely that this material was imported following the earlier excavations to level the ground surface (Photo 14).

- 4.5.4 A light brown silty clay subsoil was exposed in the base of the trench at 0.50m depth (Photo 14). It is presumed that this also represents initial backfill from the previous archaeological excavations undertaken in the Walled Garden.

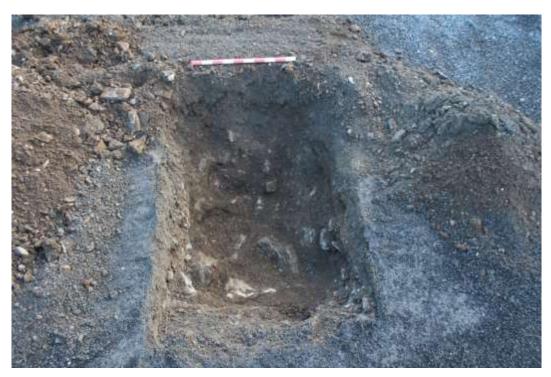
Photo 15: Trench 5. Excavation revealed bedrock lying directly below the crushed stone surface.

- 4.6.1 Trench 5 was located near the western entrance into the Walled Garden, in the area of a proposed circular bench. The proposed bench will require foundations of a maximum of 0.50m depth.
- 4.6.2 Trench 5 measured 1.15m x 0.80m and was orientated roughly east west. It was excavated to a depth of approximately 0.45m where the natural bedrock was revealed directly beneath the crushed stone surface (Photo 15).

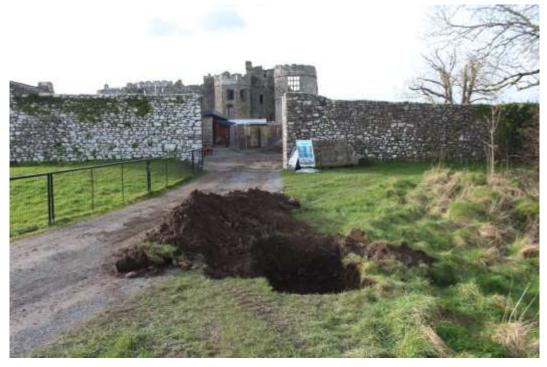
Photo 16: Trench 6 viewing west towards the entrance to the Walled Garden with Carew Castle behind

- 4.7.1 Trench 6 was located to the east of the Walled Garden at the site of the proposed inspection chamber / air vent. The required depth of excavations in this area will need to be a maximum of 0.70m depth to accommodate the proposed chamber. The trench was located directly to the north of the existing footpath that runs along the causeway to the eastern entrance of the Walled Garden in an area that was under grass, immediately adjacent to a fall in ground level to the north down towards the Carew River (Photo 16).

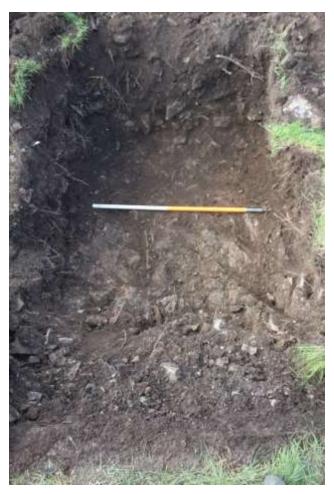
Photo 17: Trench 6 viewing west with the flat area of bedrock exposed in the base of the trench

- 4.7.4 The loose nature of the fill was such that it was not considered to be of any great age and it was removed by machine onto the limestone bedrock. The bedrock was very flat on the western side and in the centre of the trench but sloped up on the eastern edge. The flat area of bedrock lay 0.80m below ground level (slightly deeper than the required excavations).

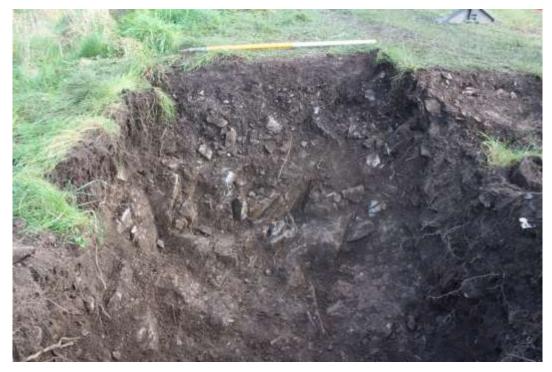
Photo 18: Trench 6 viewing east, with bedrock rising up and with extension on the southern side (right) where the trench exposed the extant service runs

- 4.7.2 The trench measured approximately 2m x 1.2m wide, aligned roughly east to west. The southern edge of the trench was partly extended to uncover the line of existing services (water and electricity) installed when the new visitor centre was constructed in 2013 and previously observed by the PCNPA archaeologist. The line of the services was confirmed (Figure 9) and it was noted that they were exposed at a shallow depth (roughly 0.20m below ground surface), although the actual service trench was deeper.
