**FORMER ABERAERON HOSPITAL,
CEREDIGION**

HISTORIC BUILDING RECORDING

REPORT NO. 2021-60
EVENT RECORD No. 126367

**FORMER ABERAERON HOSPITAL CEREDIGION:
(NGR SN 46119 62980)
HISTORIC BUILDING RECORDING**

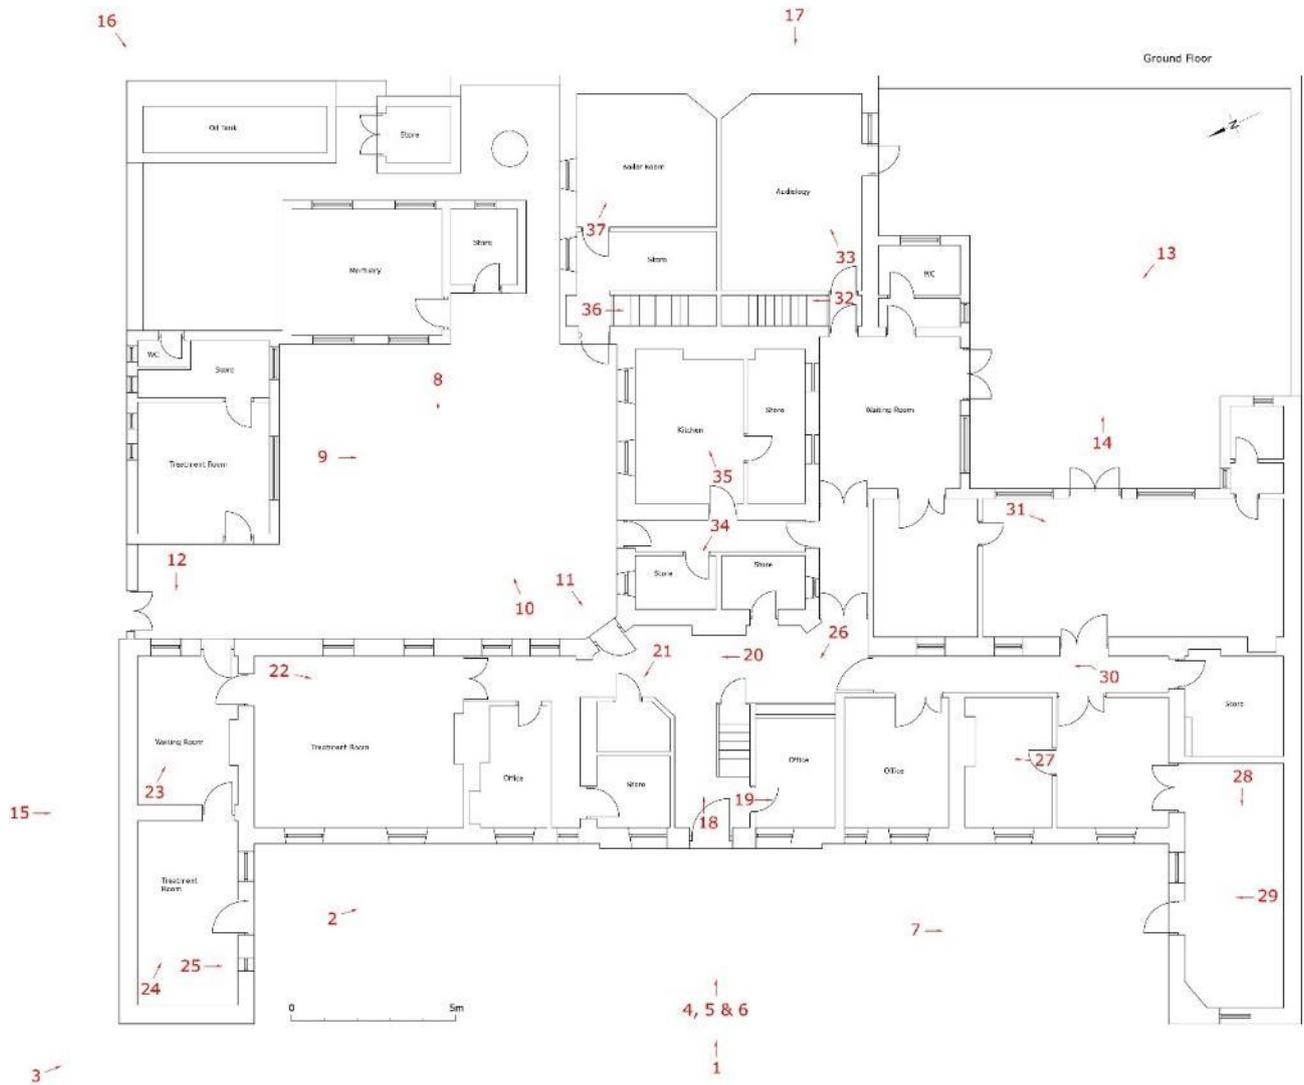
Figure 9: Location and direction of exterior and ground floor photographs.

4.1 Exterior (Figures 9 & 10)

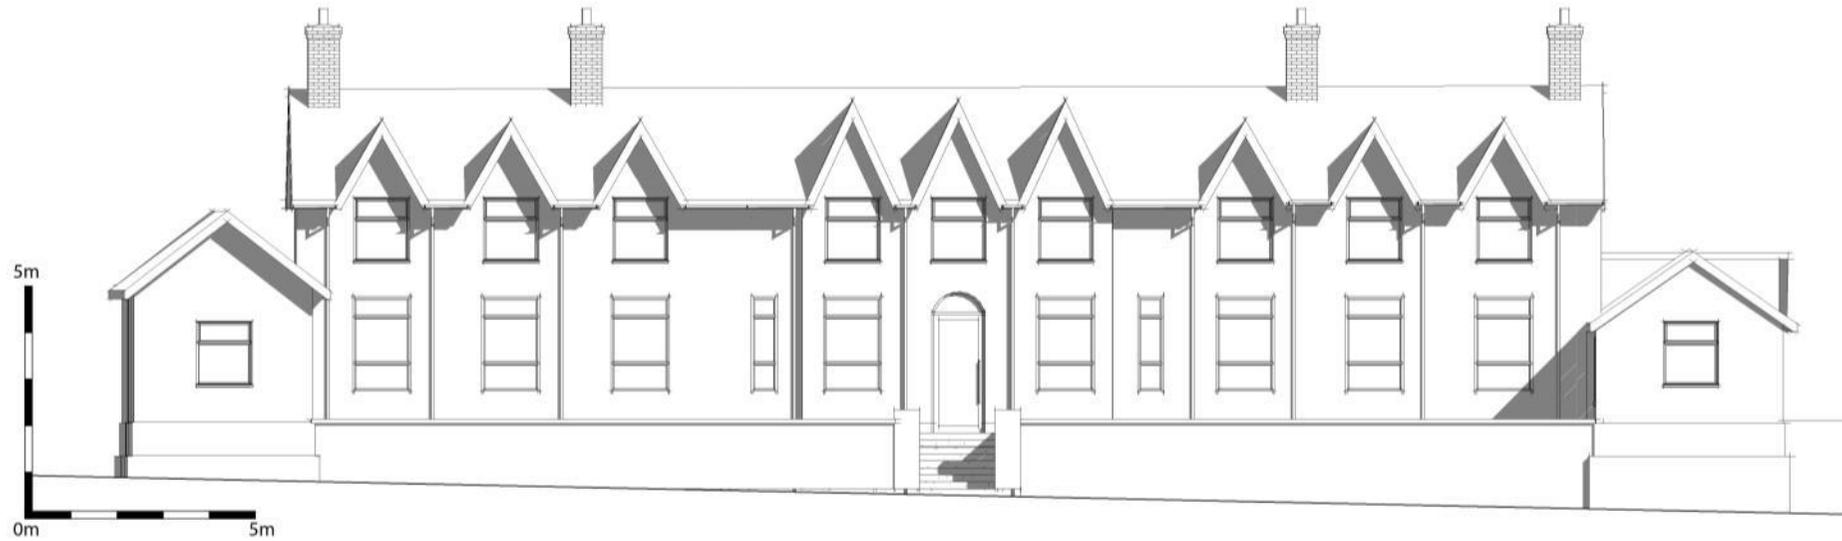
Figure 10: Existing front elevation of the former Aberaeron Hospital. Drawing produced by Chaberlain Moss King Architecture (Drawing No.A015, date 25.11.2019). Not reproduced to original scale, but additional scalebar added.

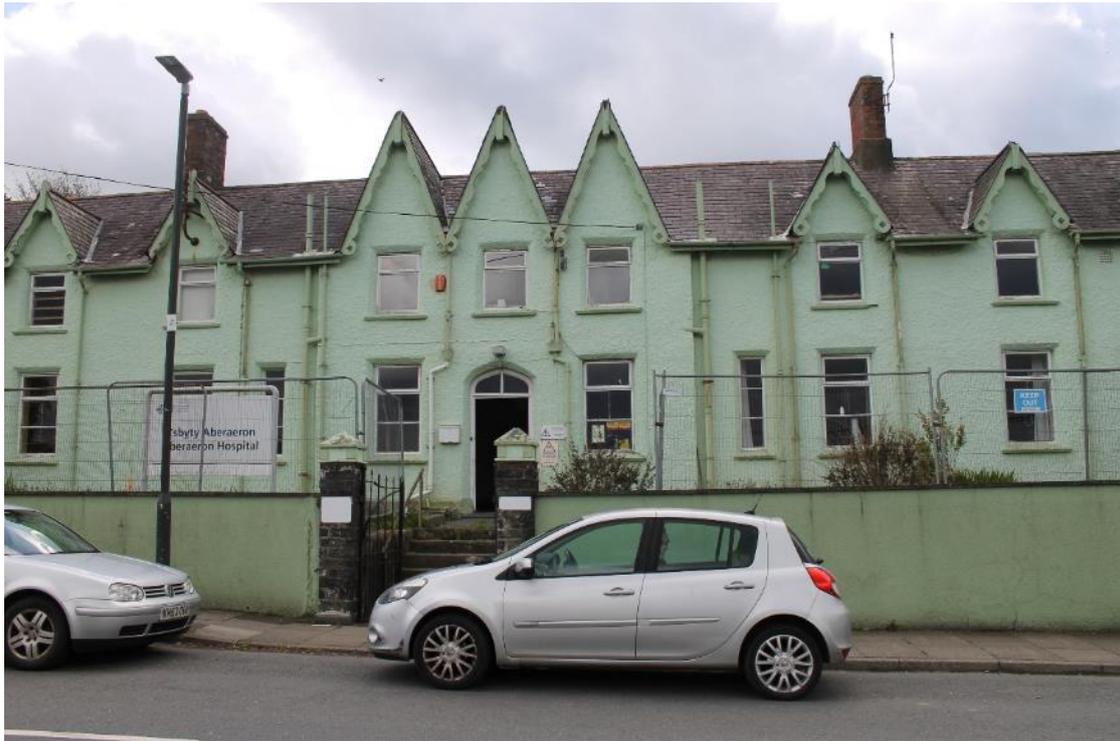
Photo 1: West (front) elevation of hospital

- 4.1.1 The building is T-shape in plan, consisting of two, two-storey ranges with one-storey, projecting wings on either side. It stands above the road and is set back 6.35m. The west walls of the wings border the pavement and a retaining wall between the wings encloses the front. Behind this wall are two small lawns and paths leading to the wings. The walls are rubble-stone with a roughcast finish (Photos 1 - 3).

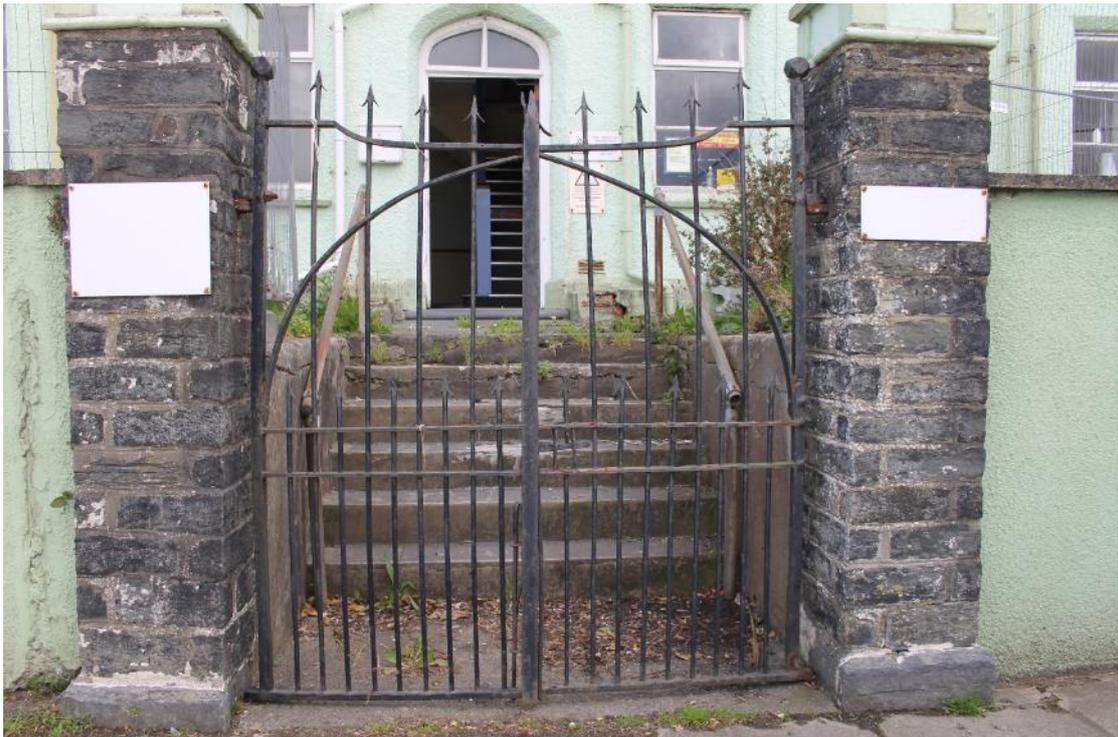
Photo 4: Iron gates and steps leading to main entrance.

- 4.1.2 The front door is approached via a pair of wrought iron gates, supported by stone piers with pyramidal tops, and concrete and slate steps (Photo 4). The door opening is a four-centred (Tudor) arch with chamfered reveals but the door is of modern design. All the window openings in the front elevation also have chamfered reveals. The front elevation, excluding the projecting wings, is approximately 27.8m long and consists of nine gabled bays grouped into threes, each gable has decorative bargeboards but the finials have been lost. The gables for the middle three bays are especially steep. A cement skirt 0.32m high and projecting 0.05m from the wall, runs the whole length of the front (Photos 4 - 6).

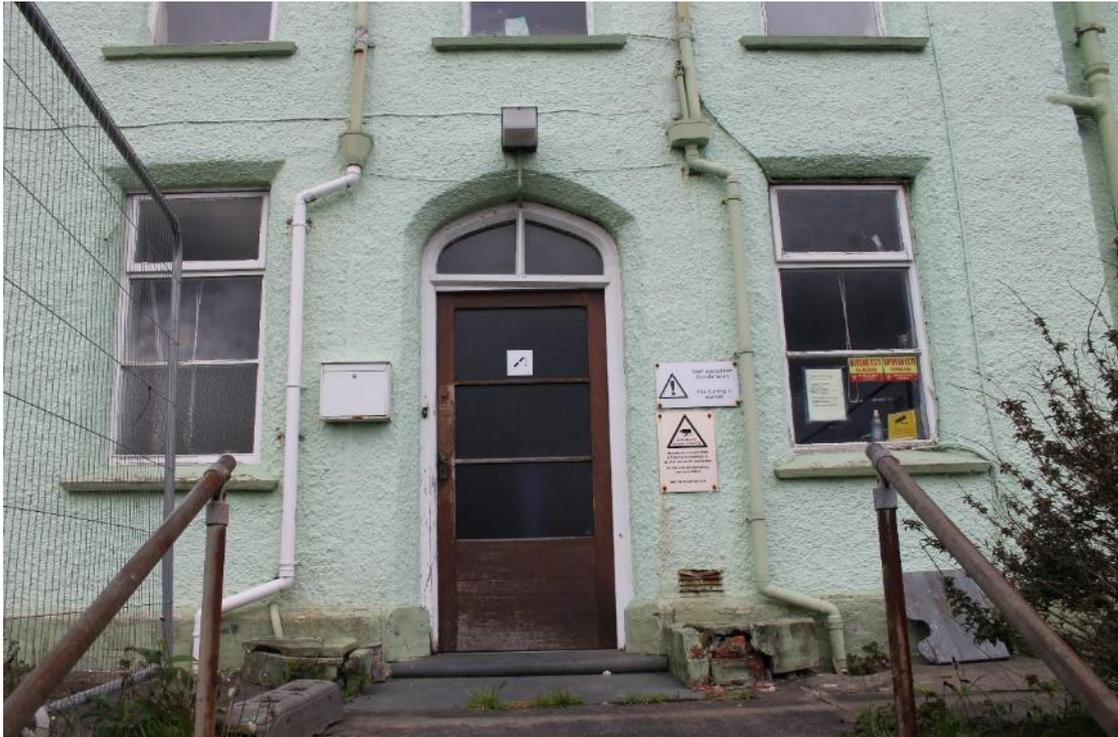
Photo 5: Main entrance with four-centered arch; door and window reveals are chamfered.

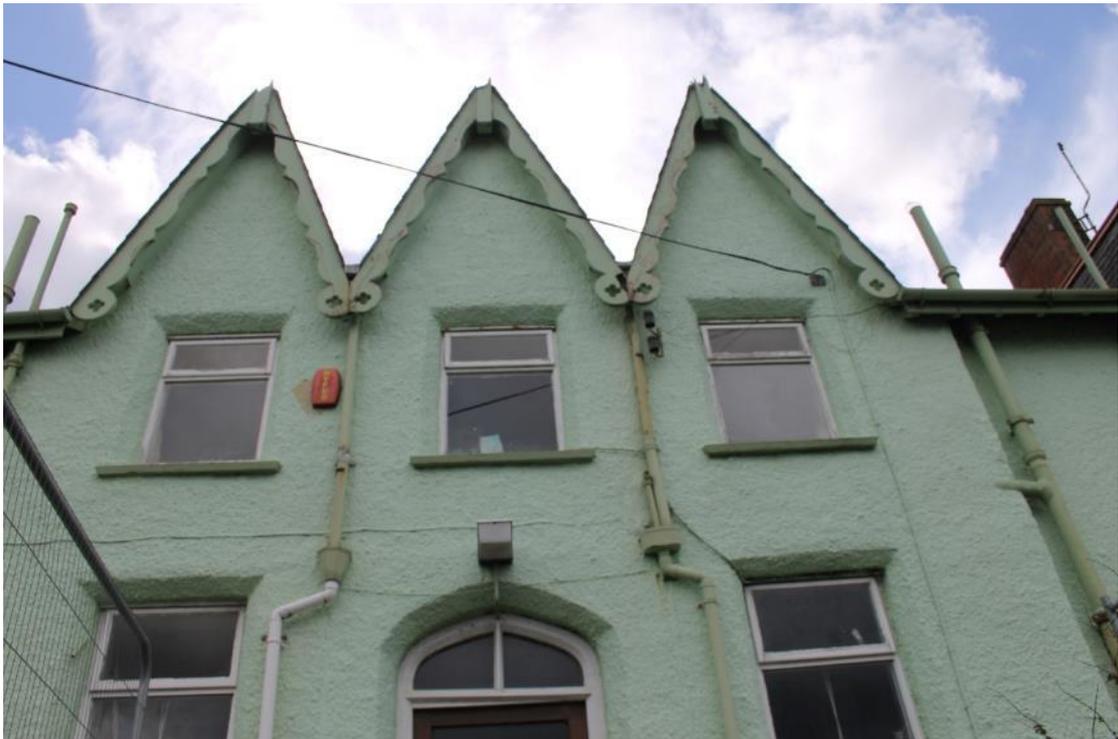
Photo 6: Central gabled bays with decorative bargeboards and missing finials

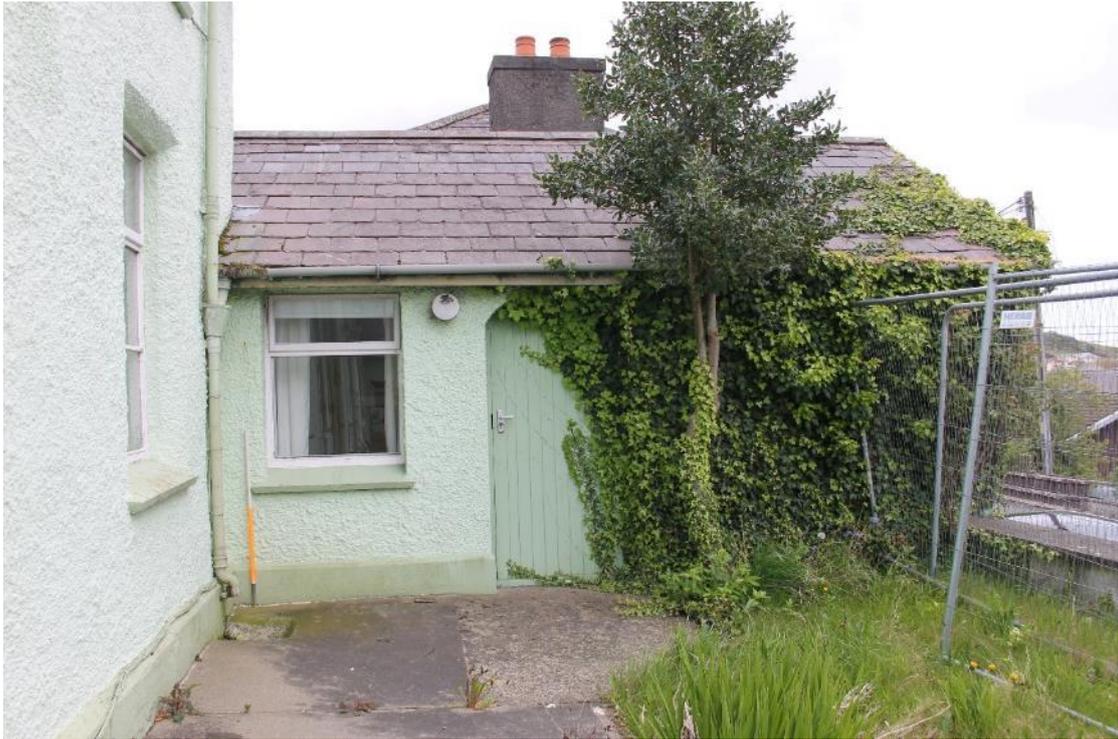
Photo 7: Southern projecting wing (1m scale)

- 4.1.3 The wings on either side of the frontage project out approximately 6.35m and are 7.05m wide. Each has a four-centred arch door opening (Photo 7).

- 4.1.7 A number of external doors that probably originated during the 1914 conversion still survive. These include arched boarded doors in the projecting wings (Photos 7 and 29) and the door with the three-paned overlight set in a splayed corner in the north yard (Photo 11).

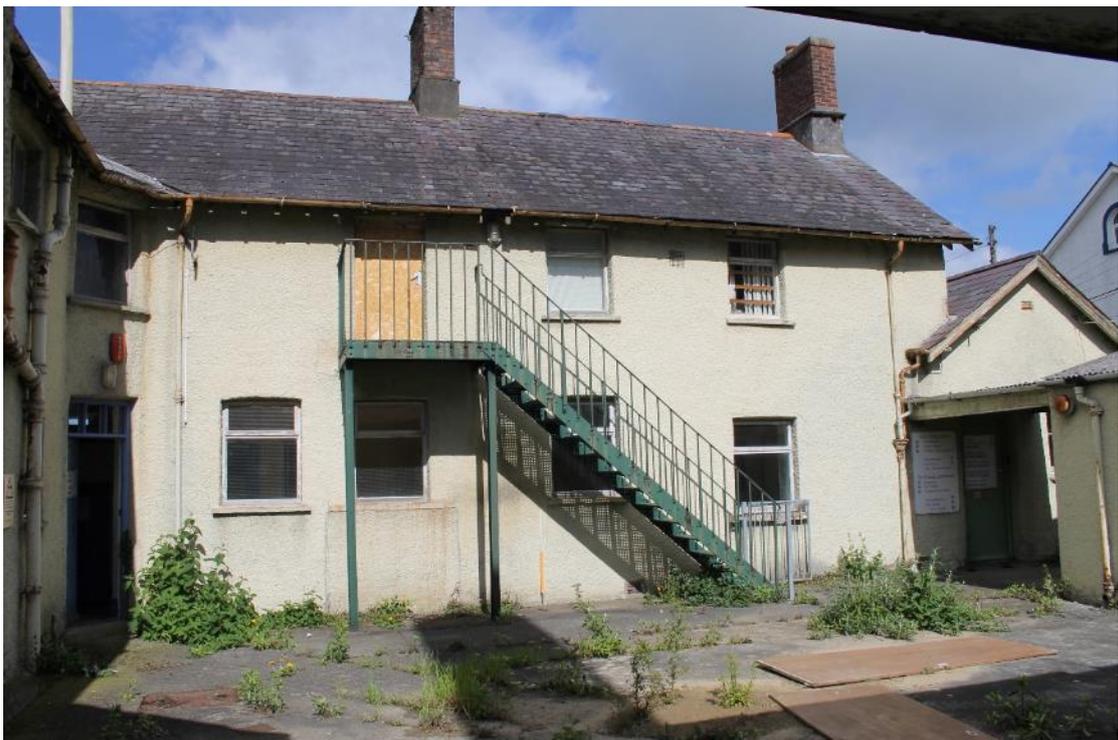
Photo 8: East facing (rear) elevation in north yard and fire escape

- 4.1.4 At the rear are two yards separated by the E-W range (Photos 8 - 14); the 1st and 2nd edition OS show that both yards were once divided in two. The roof of the E-W range is composed of welsh slate and the four, brick-chimney stacks present have all probably been rebuilt.

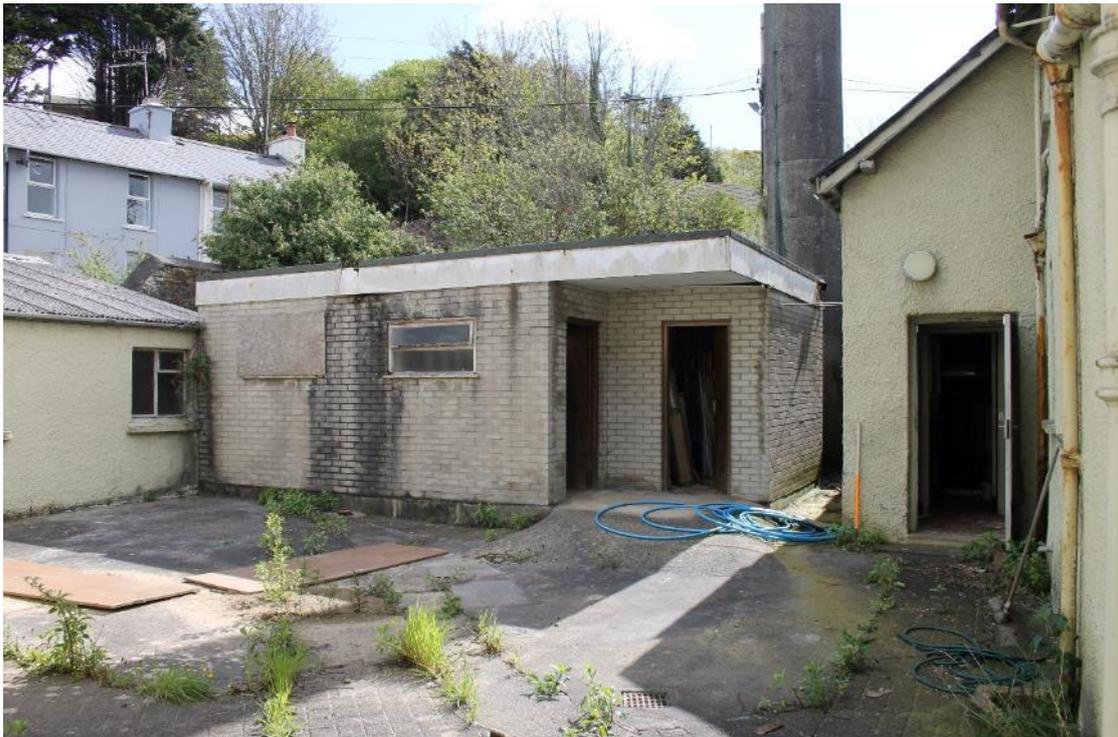
Photo 10: East facing shot of mortuary and entrance into boiler room/attic in north yard

of the yard is the modern brick-built mortuary and also, in the E-W range, the entrance into the boiler room (Photo 10).

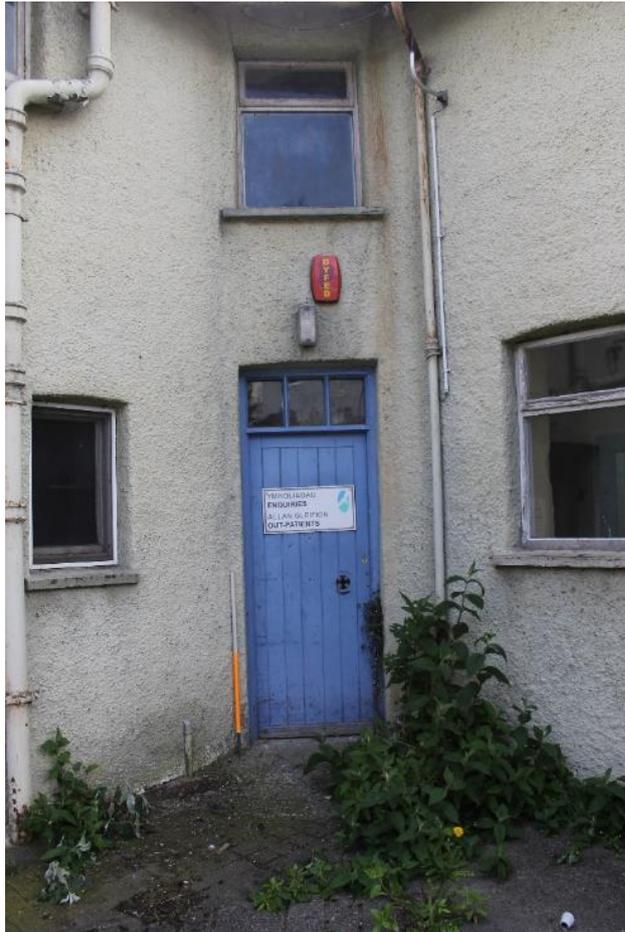
Photo 11: Splayed corner at junction of ranges in north yard.

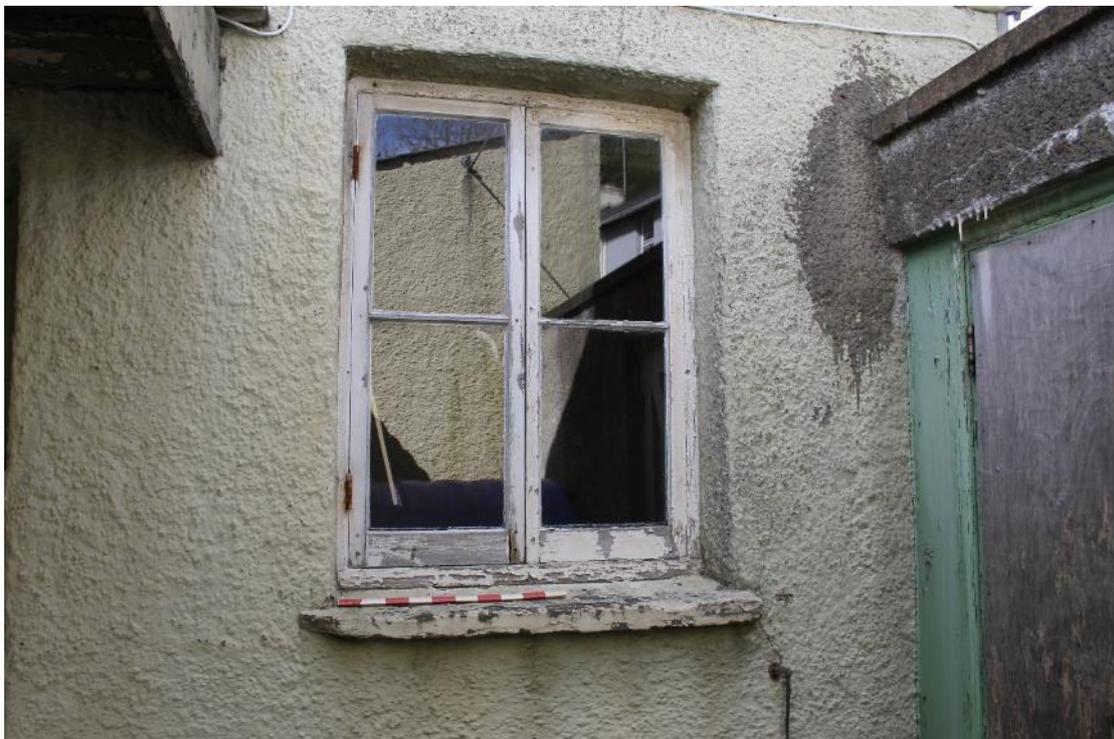
Photo 12: Window (in north yard) probably associated with conversion to hospital in 1914.

- 4.1.6 The window casements have in the main been replaced by modern metal frames but the few timber, side-hung casements present were probably inserted during the 1914 conversion into a hospital. An example can be seen in the north yard (Photo 12).

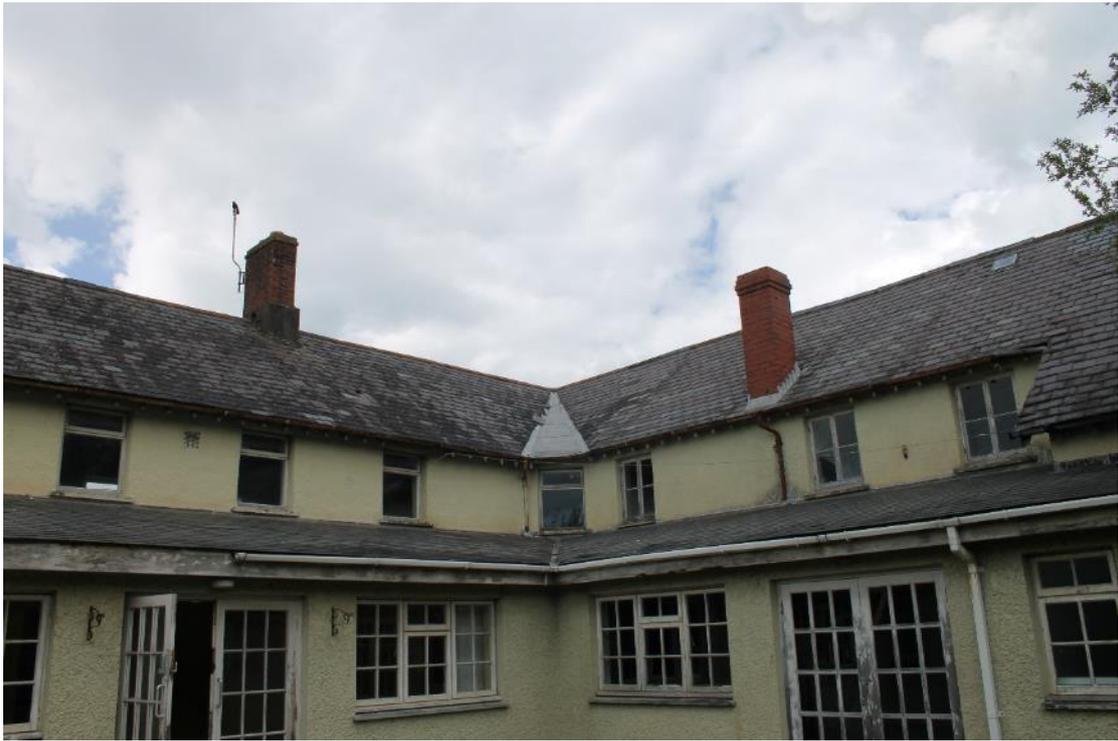
Photo 13: View of modern extension (bottom) and original range (top) from south yard.

- 4.1.8 The elevations seen from the southern yard consist of a single storey modern extension built in front of the N-S and E-W ranges (Photo 13). The wooden casement windows are probably associated with the conversion into a hospital in 1914. The southern yard, which has been terraced into the hillside, consists of a paved area and lawn with the original workhouse stone wall enclosing its southern and eastern sides (Photo 14).

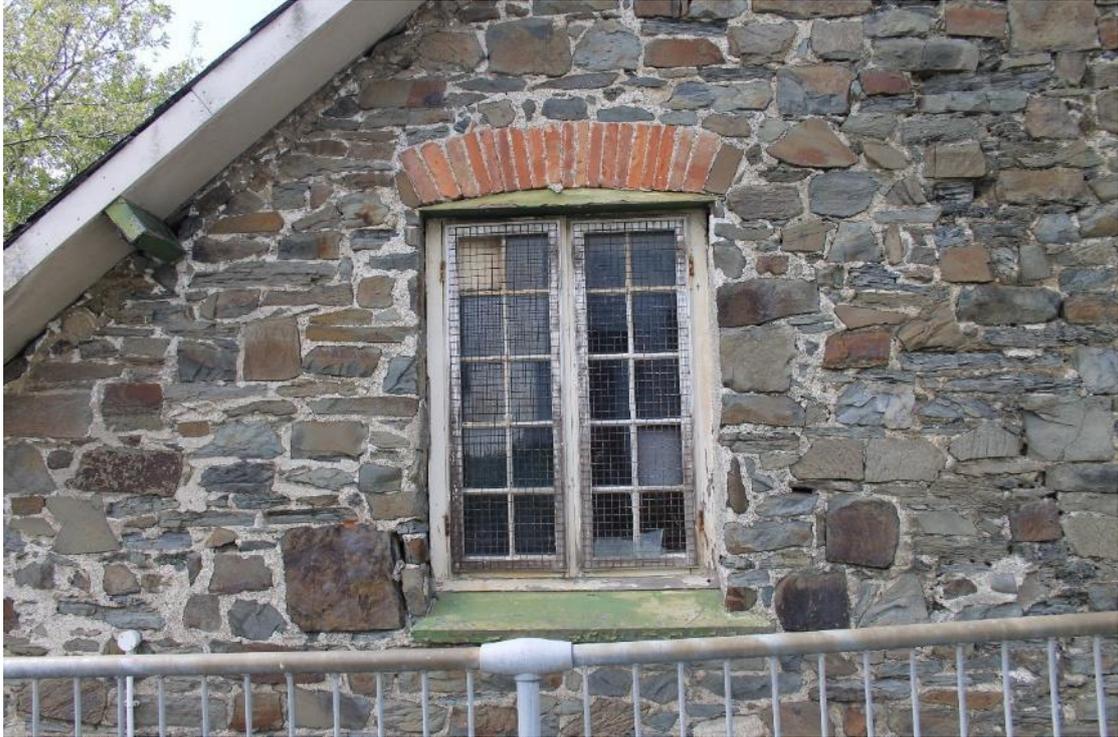
Photo 17: East facing elevation of rubble stone wall and window possibly associated with workhouse.

- 4.1.9 The east gable of the E-W range is the only wall that does not have a roughcast finish and shows the rubble stone wall of the workhouse. Within this wall is possibly the only remaining feature associated with the workhouse, a twenty-paned, casement window with brick voussoirs (Photo 17).

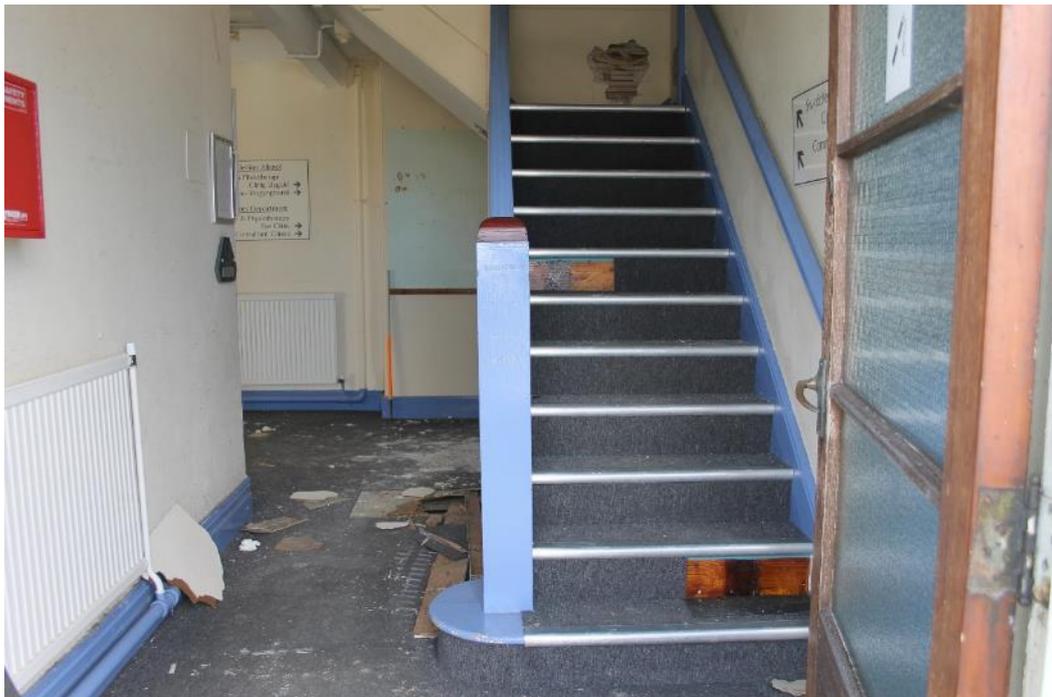
Photo 18: View of stairs and passageway from front entrance

- 4.2.1 The main entrance of the hospital opens to the stairs that lead to the upper floor (Photo 18). To the right of the entrance is the Enquiry Room containing a four-panneled cupboard door (Photo 19) whilst to the left of the stairs the passageway leads to the ground floors of the N-S and E-W ranges and the yards to the rear.

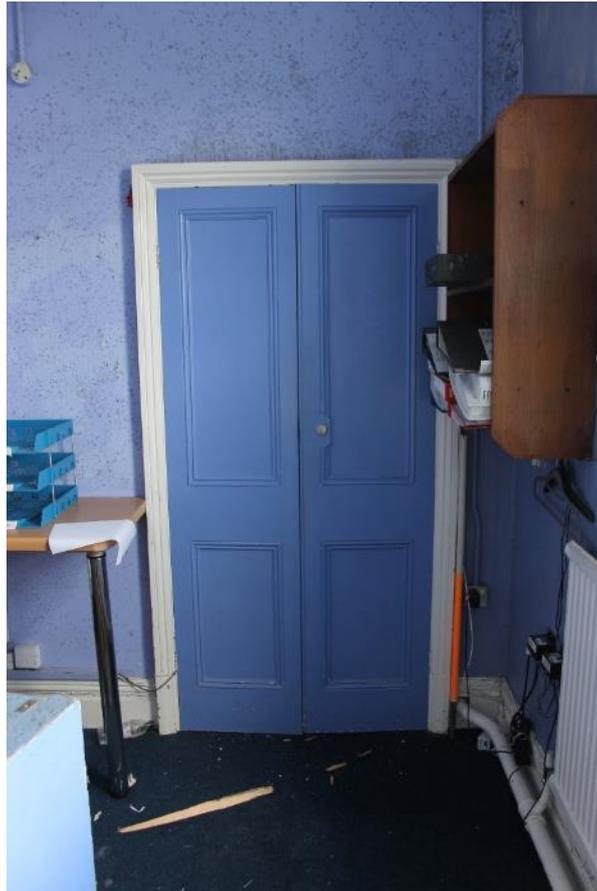
Photo 19: Four-panelled cupboard door in Enquiry Room

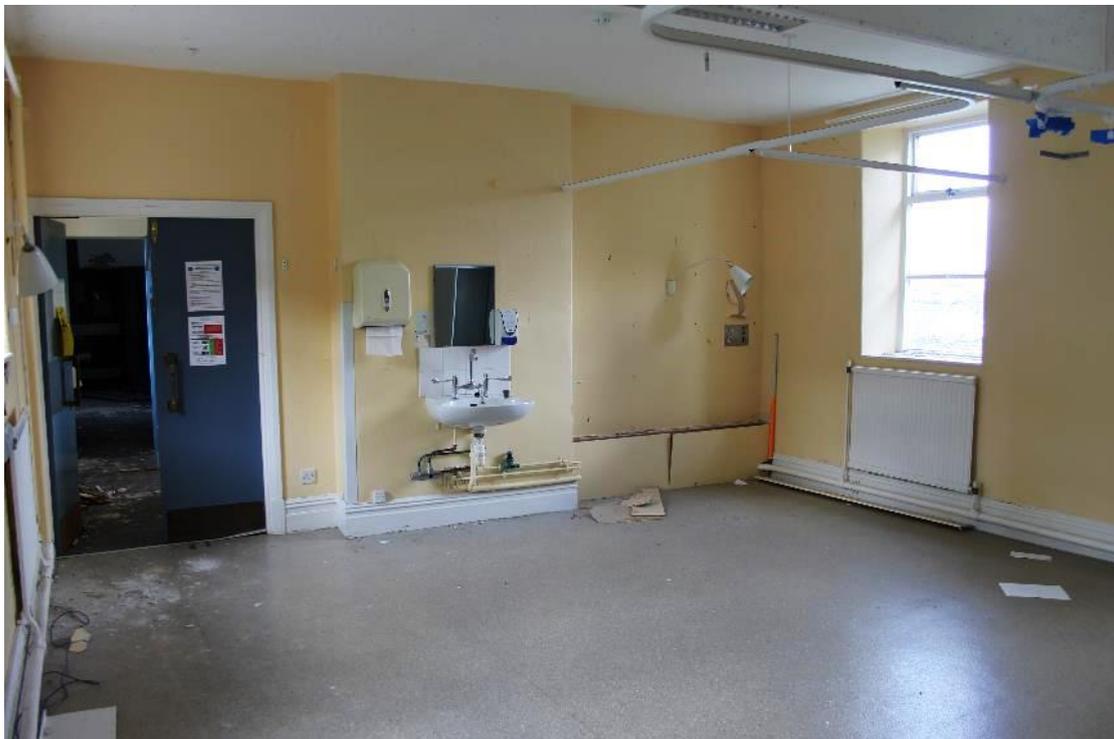
Photo 22: View of probable fireplace in south wall of Physiotherapy and Lymphoedema Dept.

- 4.2.4 The Physiotherapy and Lymphoedema Dept. measured 6.35m by 5.25m. All the windows had modern aluminium casements on the west side and modern wooden casements on the east side. The northern window on the east side might once have been a doorway. A chimney breast and probable fireplace stood on the south wall which now supported a wash basin (Photo 22). The ceiling was plain and the floor vinyl-tiled. All the walls were painted plaster with decorated skirting board (torus?). In the north wall a modern door opened to the waiting room which measured 4.55m by 2.00m. The east wall contained a window and boarded door from the former 1914 hospital (Photo 23) and the south wall a chimney breast and probable blocked fireplace.

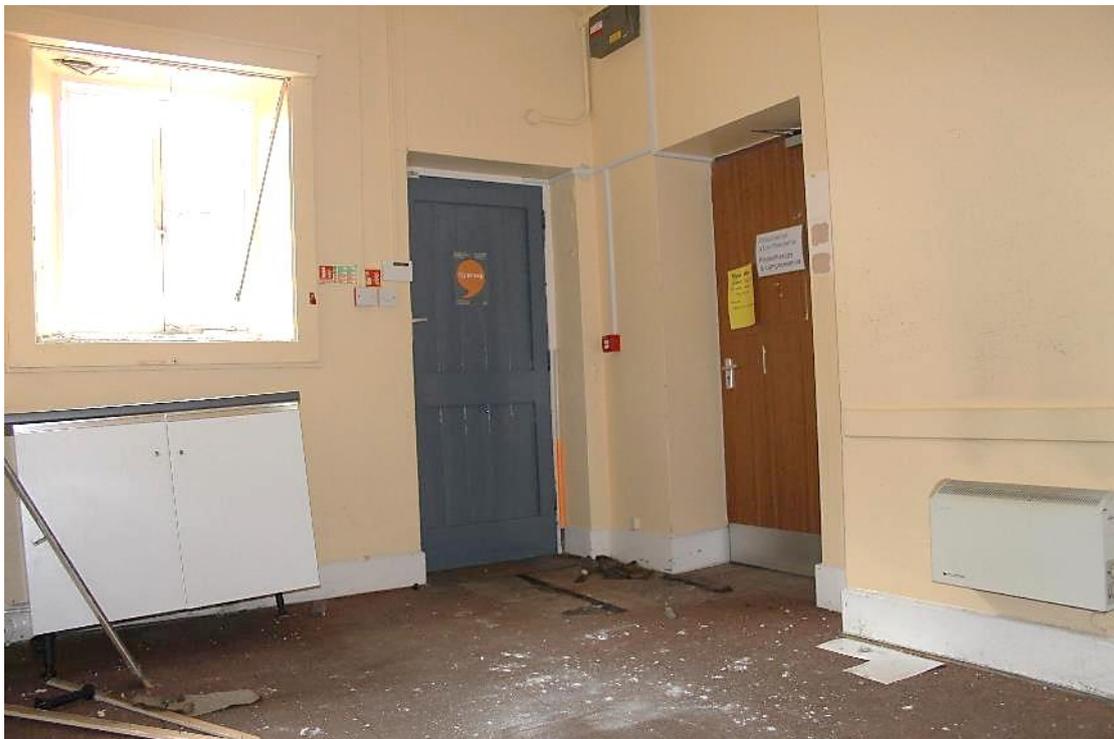
Photo 23: SE corner of waiting room with original hospital door and window on the left.

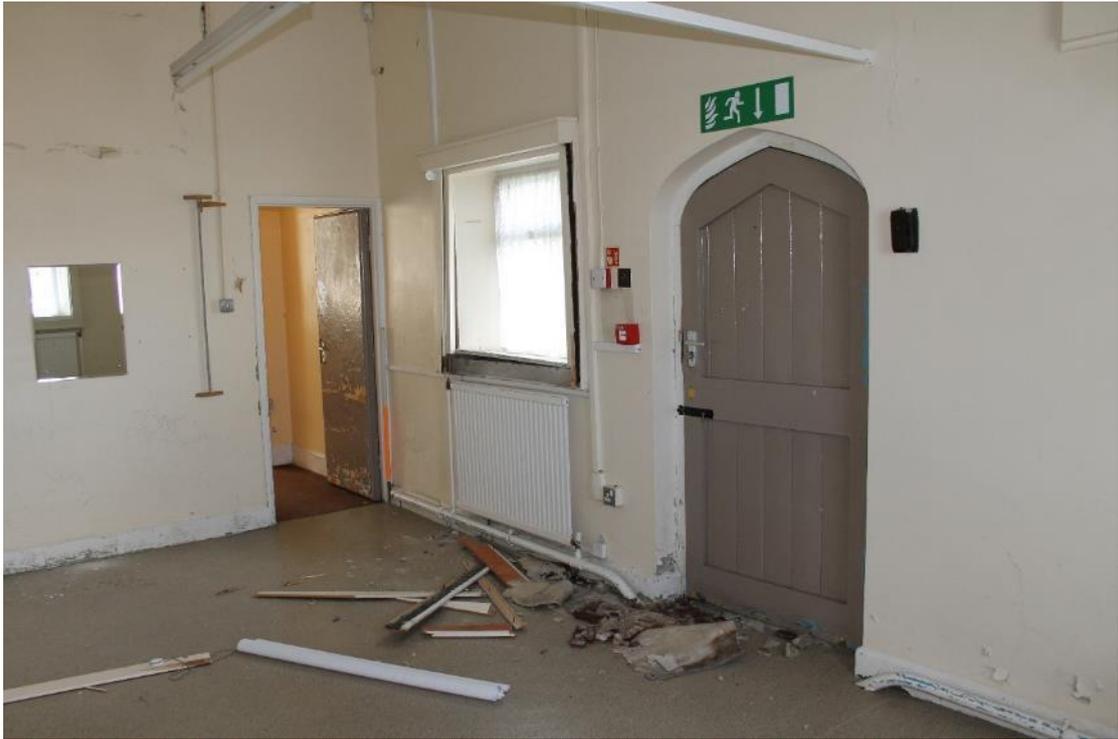
Photo 24: South wall of north wing with original arched door

- 4.2.5 A door in the west wall of the Waiting Room led to the north wing which measured 5.70m by 3.05m. The south wall featured a four-pointed arch doorway and boarded door and a small, high window complete with the original blind (Photos 24 and 25).

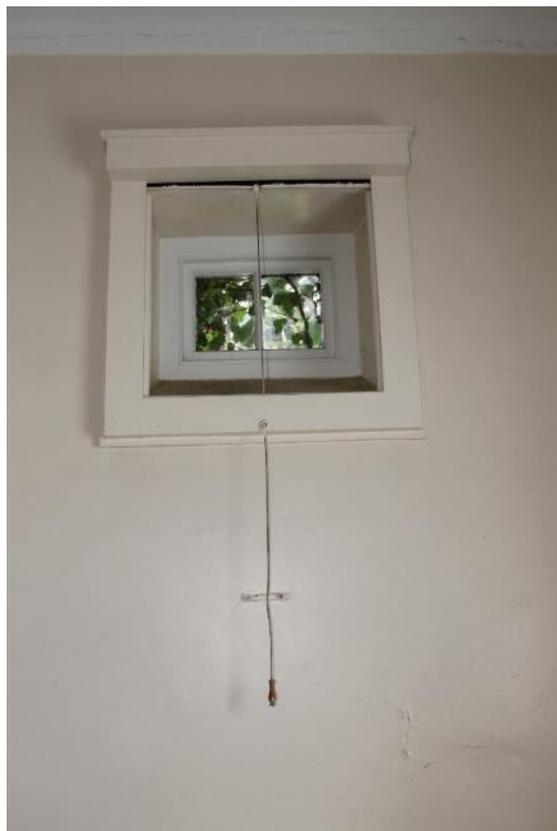
Photo 25: Original hospital window complete with blind and sash

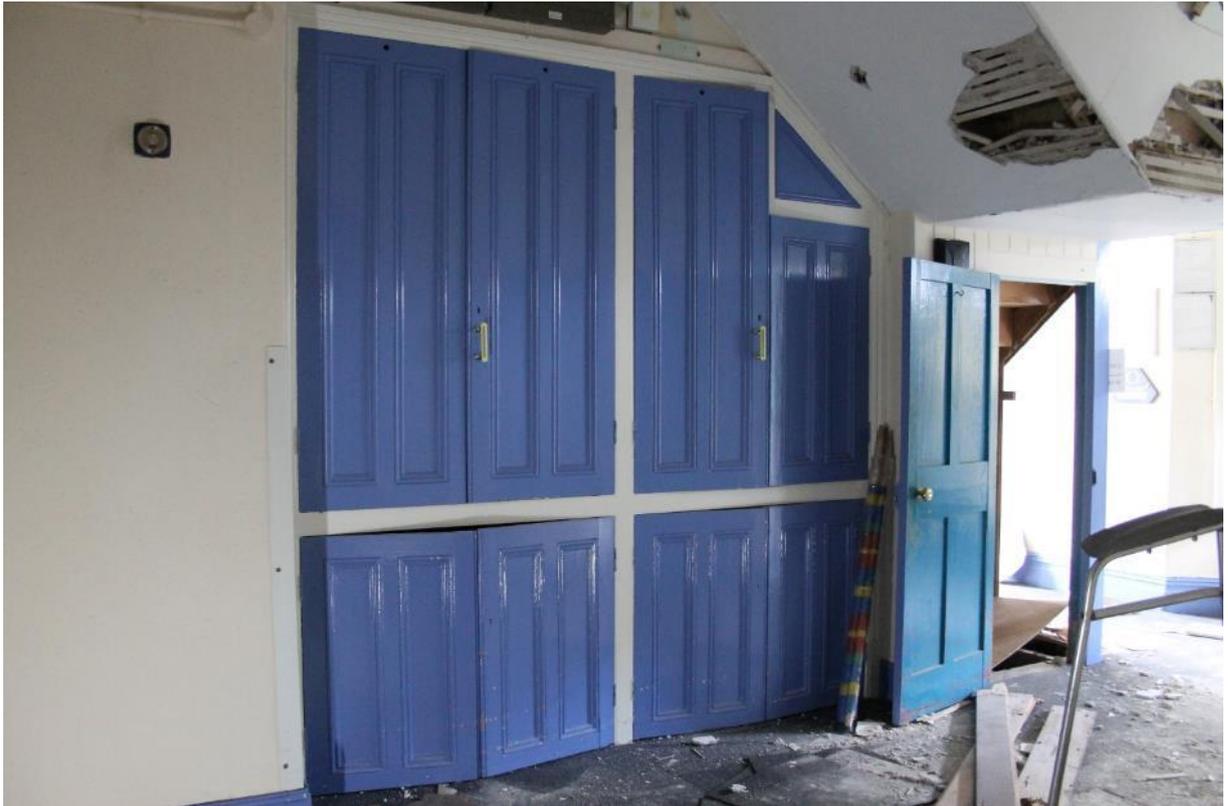
Photo 26: *Panelled cupboard doors on ground floor to the left of the staircase probably associated with the former hospital.*

- 4.2.6 At the rear of the stairs was a small four-panelled door for a 'below stairs' cupboard, to the left of which stood a shelved recess with panelled doors. These are more than likely associated with the former 1914 hospital (Photo 26).
- 4.2.7 At the southern end of the N-S corridor a chimney breast and probable blocked fireplace could be seen in the north wall of one of the small rooms (Photo 27). This is the 'twin' of the chimney breast seen in the Physiotherapy Dept.

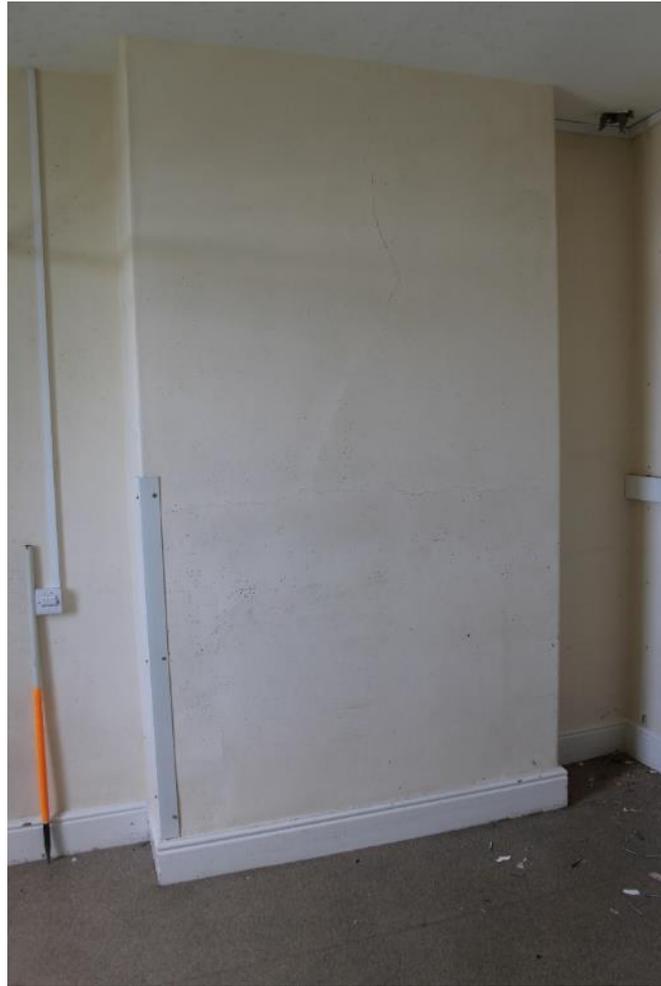
Photo 27: Chimney breast and probable blocked fireplace in a room at the southern end of the N-S corridor (1m scale)

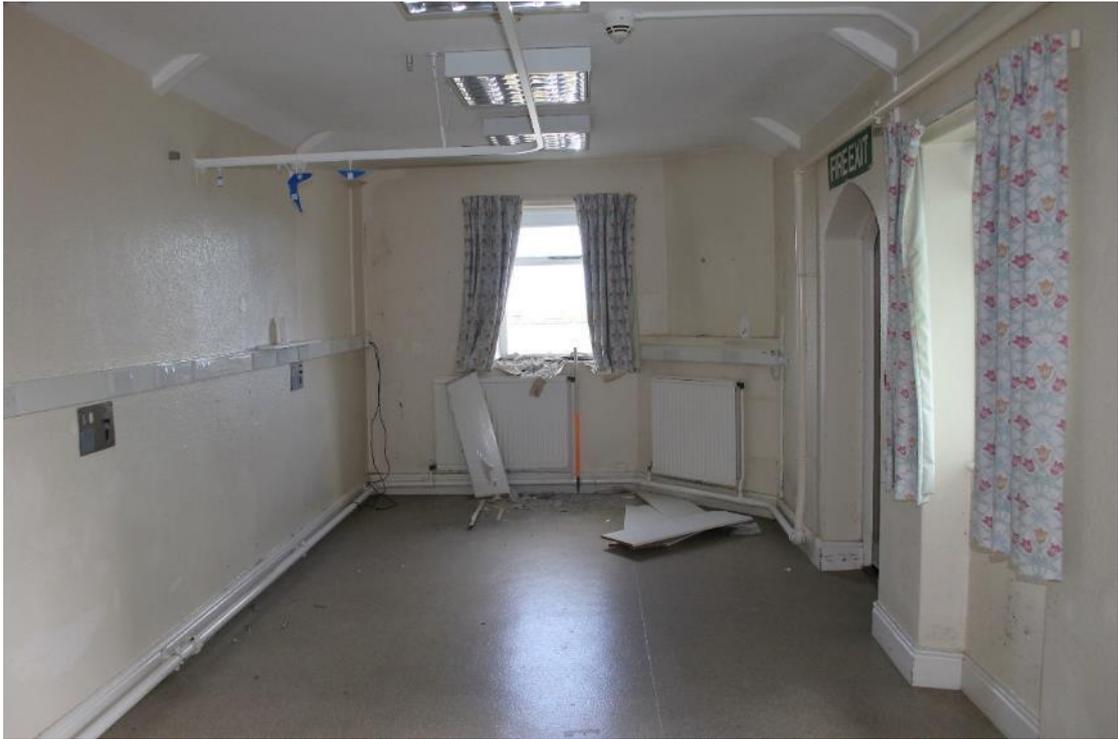
Photo 28: Looking towards west wall of southern wing (1m scale)

- 4.2.8 The southern wing measured 7.50m by 2.95m. The east wall contained a wash basin and the west wall a window opening with a modern casement and a splayed northwest corner (Photo 28). The north wall had a four-pointed arch doorway with an arched boarded door and a window to the right. The reveal for the window goes down to the floor suggesting a former doorway but considering the arched door is to the left this cannot be the case (Photo 29). The floor is vinyl-tiled and the long sides of the ceiling edges angle down in line with the roof trusses, the bottoms of which are visible between the ceiling and the wall-plate.

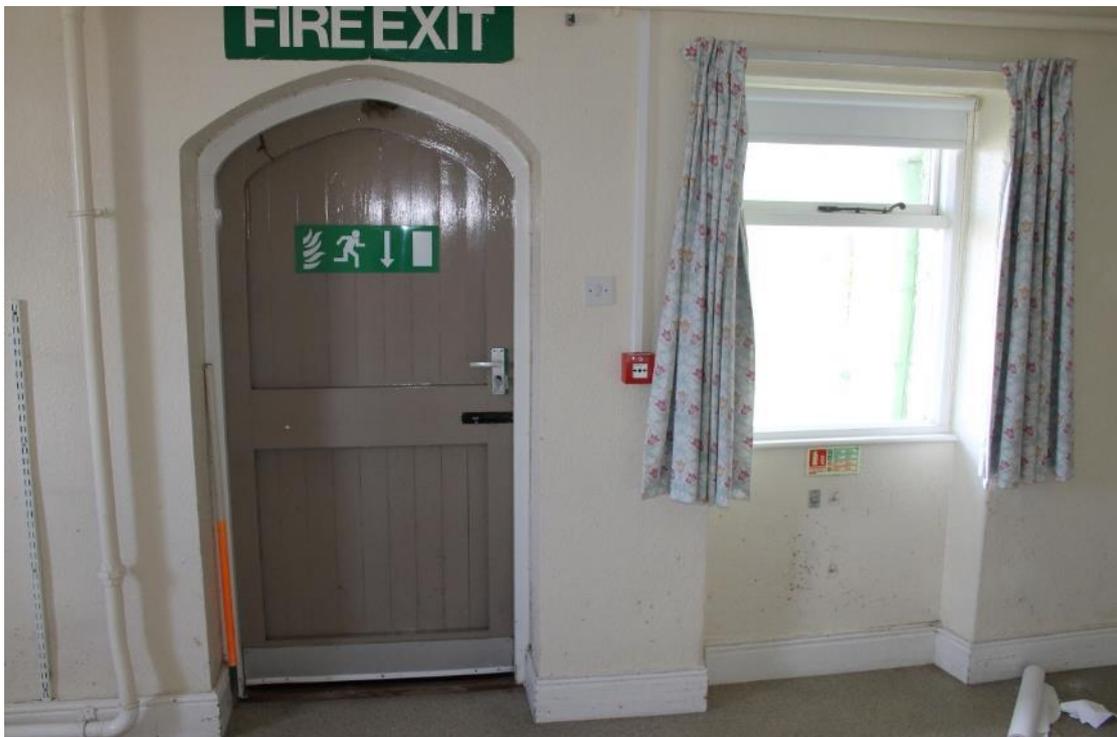
Photo 29: Arched doorway and window in north wall of southern wing (1m scale)

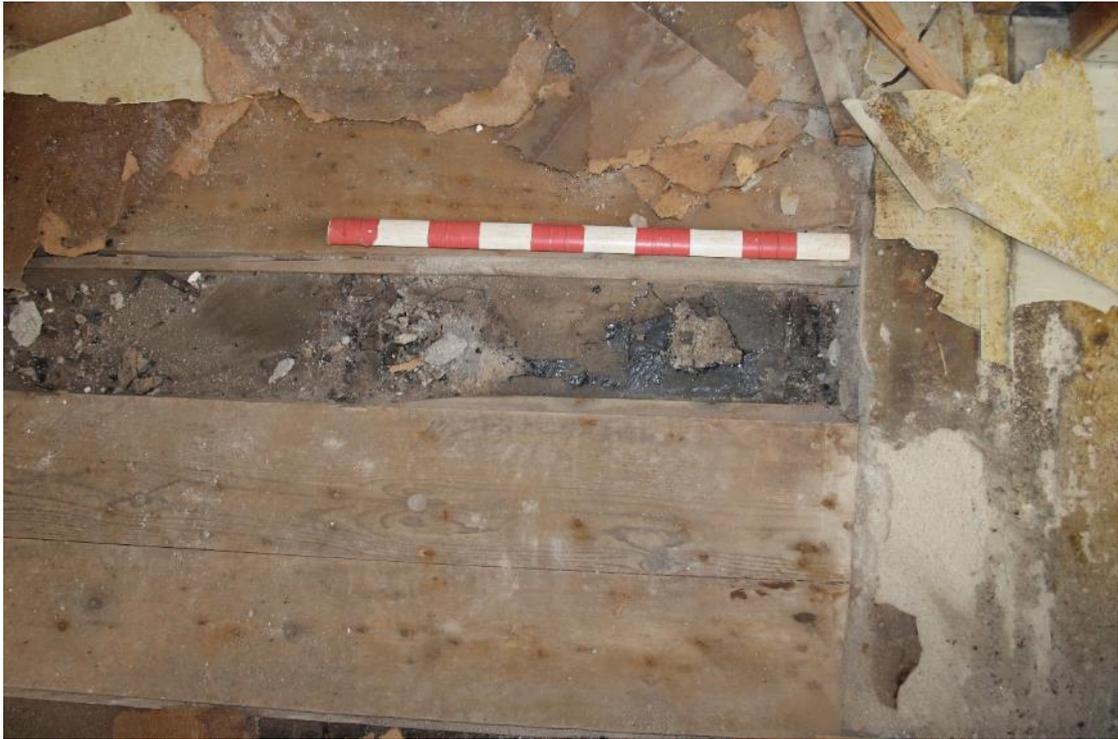
Photo 30: *Lifted floorboard showing thin layer of bitumen beneath (0.5m scale).*

4.2.9 A lifted floorboard situated in the corridor near the entrance to the modern extension showed it was adhered to the mortared base with a thin layer of bitumen (Photo 30).

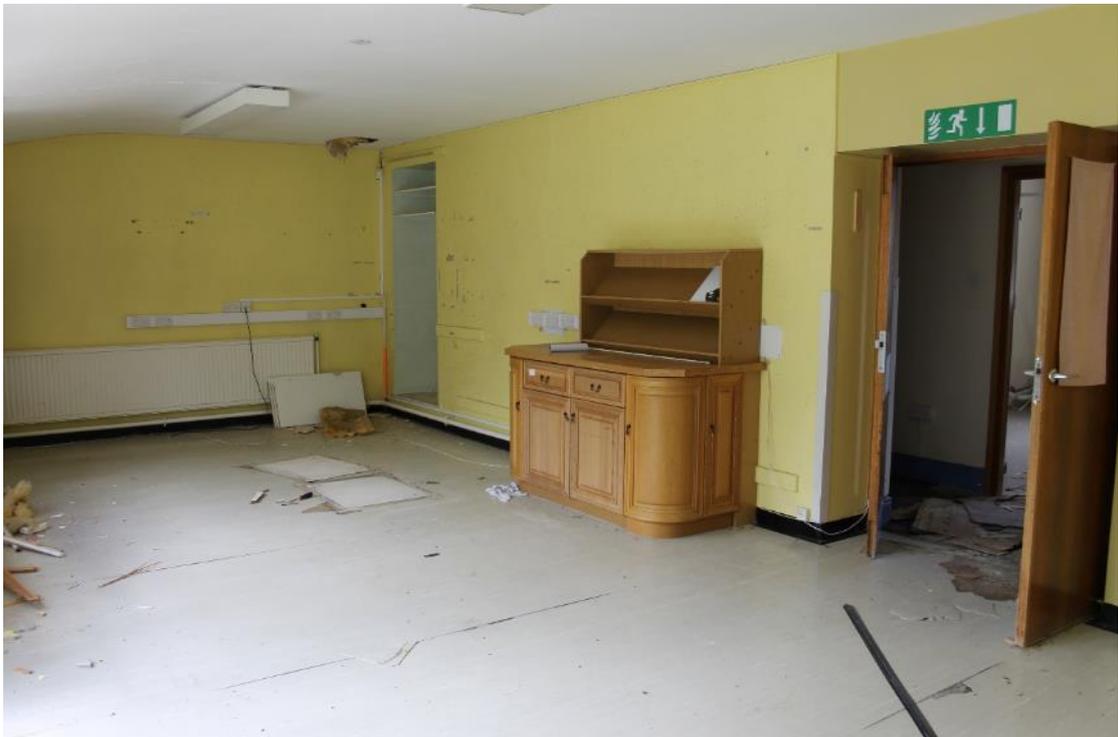
Photo 31: *Looking towards SW corner of modern extension showing blocked doorway - converted to a shelved recess (1m scale)*

4.2.10 The west wall of the modern extension at the southern end of the hospital was formerly the outside wall of the N-S range. A modern entrance has been inserted in the wall, connecting the extension with the N-S corridor. At the south end of the wall a blocked doorway (converted to a shelved recess) is visible (Photo 31).
