**FORMER ABERAERON HOSPITAL,
CEREDIGION**

HISTORIC BUILDING RECORDING

REPORT NO. 2021-60
EVENT RECORD No. 126367

**FORMER ABERAERON HOSPITAL CEREDIGION:
(NGR SN 46119 62980)
HISTORIC BUILDING RECORDING**

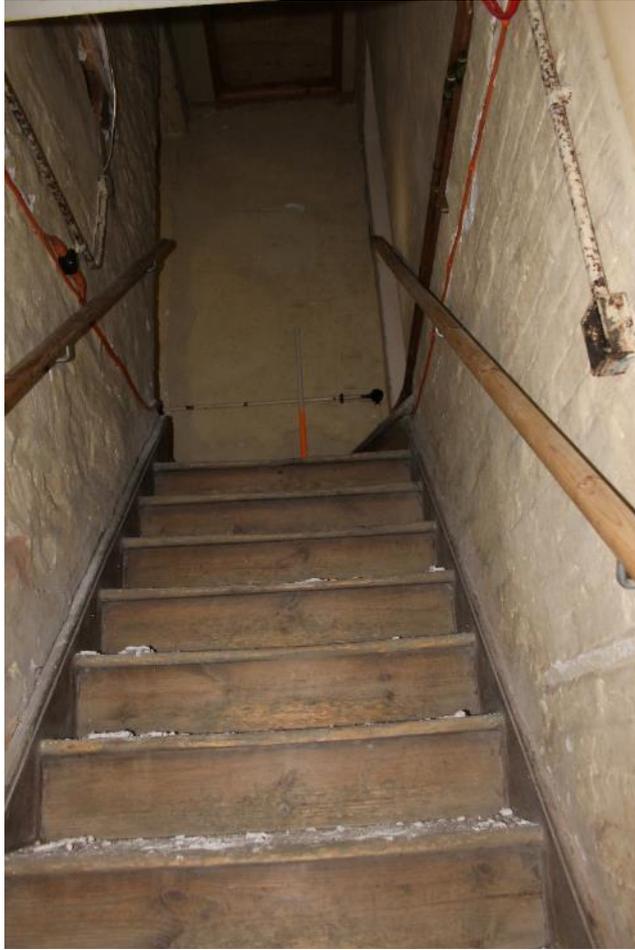
Photo 32: *Wooden stair case leading to room above Audiology Dept (1m scale)*

- 4.2.11 Immediately to the west of the entrance to the Audiology Dept. a wooden staircase leads to the room above. The lower half of the side walls are stone built and the upper half lathe and plaster. The staircase is probably associated with the workhouse (Photo 32).

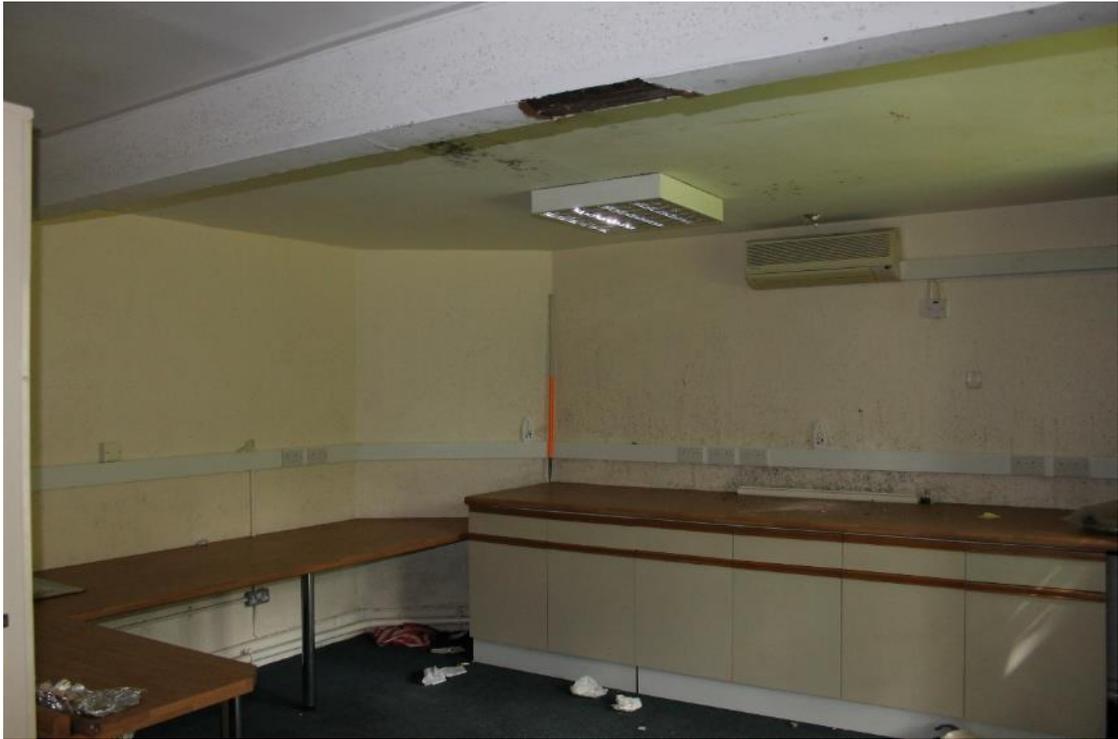
Photo 33: NE corner of Audiology Dept. (1m scale)

- 4.2.12 The Audiology Dept. situated at the east end of the hospital measures approximately 6.05m by 4.35m. The plain ceiling contains a painted timber beam aligned N-S. The NE corner is splayed (Photo 33) and the south wall contains a modern window and doorway. The floor is carpet-tiled.

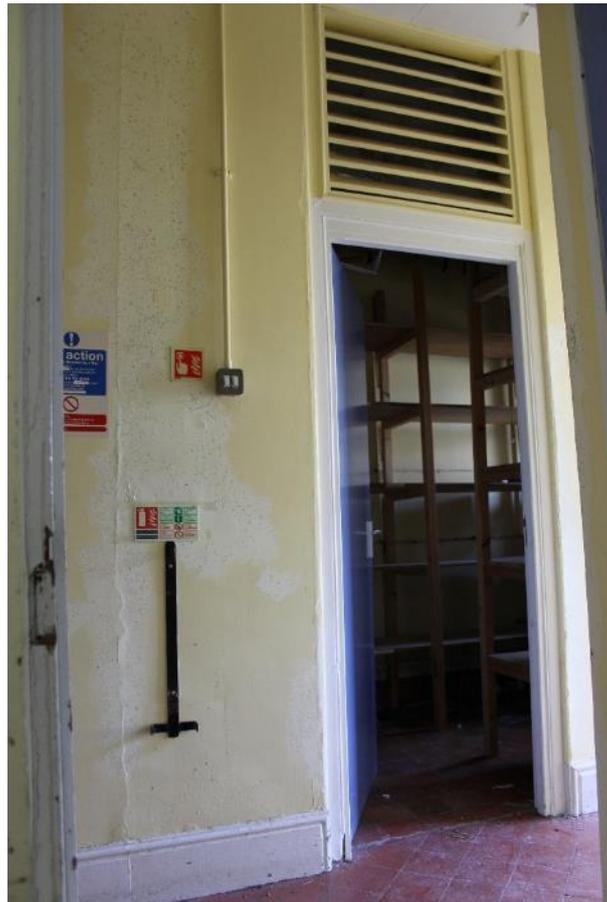
Photo 34: Modern door, louvered opening and storeroom beyond

- 4.2.13 In the E-W range a quarry-tiled cross-passage leads to a storeroom with a louvred opening above its door (Photo 33). Opposite is the entrance to the hospital kitchen, measuring 4.70m by 3.25m. It contains a quarry tiled floor and two splayed windows with modern casements in the north wall. A chimney breast and blocked fireplace are situated on the east wall (Photo 34). The south wall is modern behind which is a storeroom with blocked windows in the south wall associated with the former hospital.

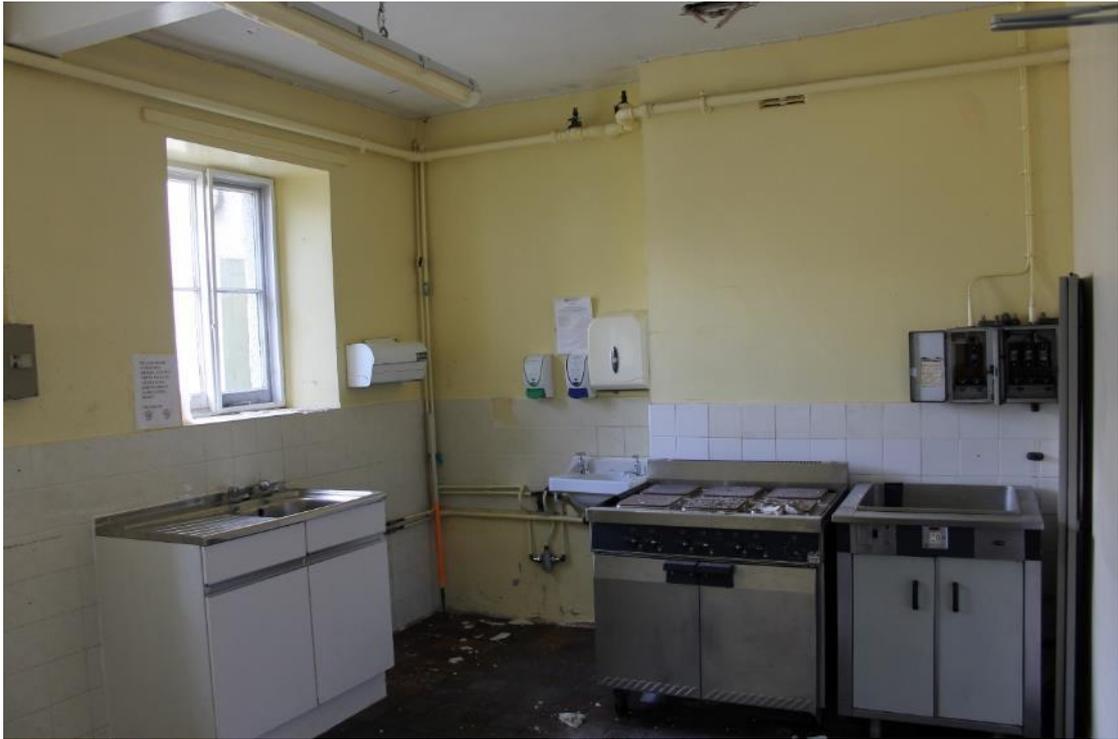
Photo 35: East wall of kitchen with chimney breast/blocked fireplace (1m scale)

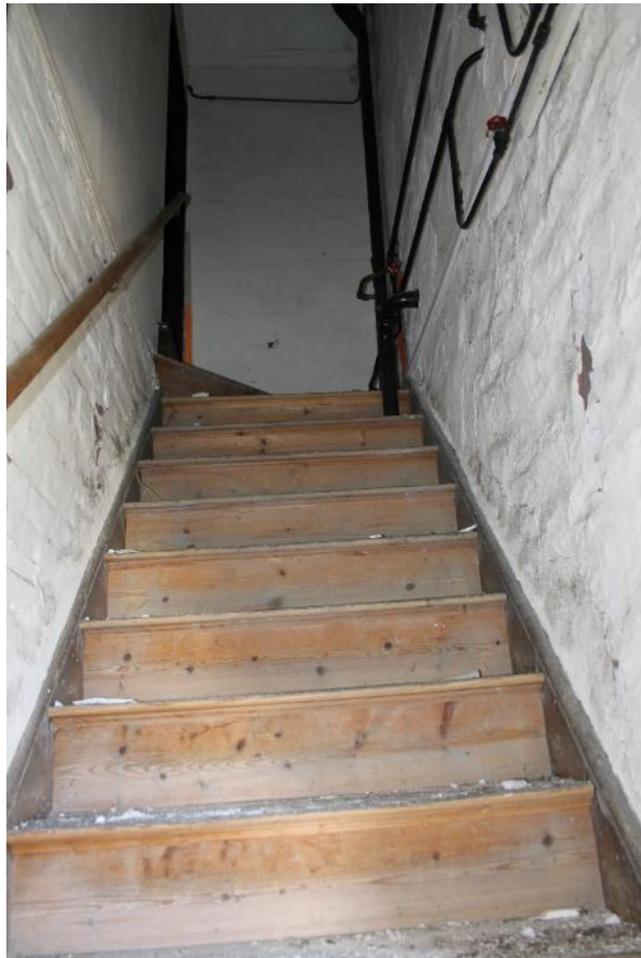
Photo 36: Wooden staircase, probably associated with the workhouse, leading to attic above Boiler Room (1m scale)

- 4.2.14 The Boiler Room and an adjacent staircase is accessed via a doorway in the north yard. The lower half of the side walls of the staircase are stone built and the upper half lathe and plaster (Photo 35). The Boiler Room contains two oil-fired boilers (Photo 36) its west wall is a later addition separating the Boiler Room from the emergency generator.

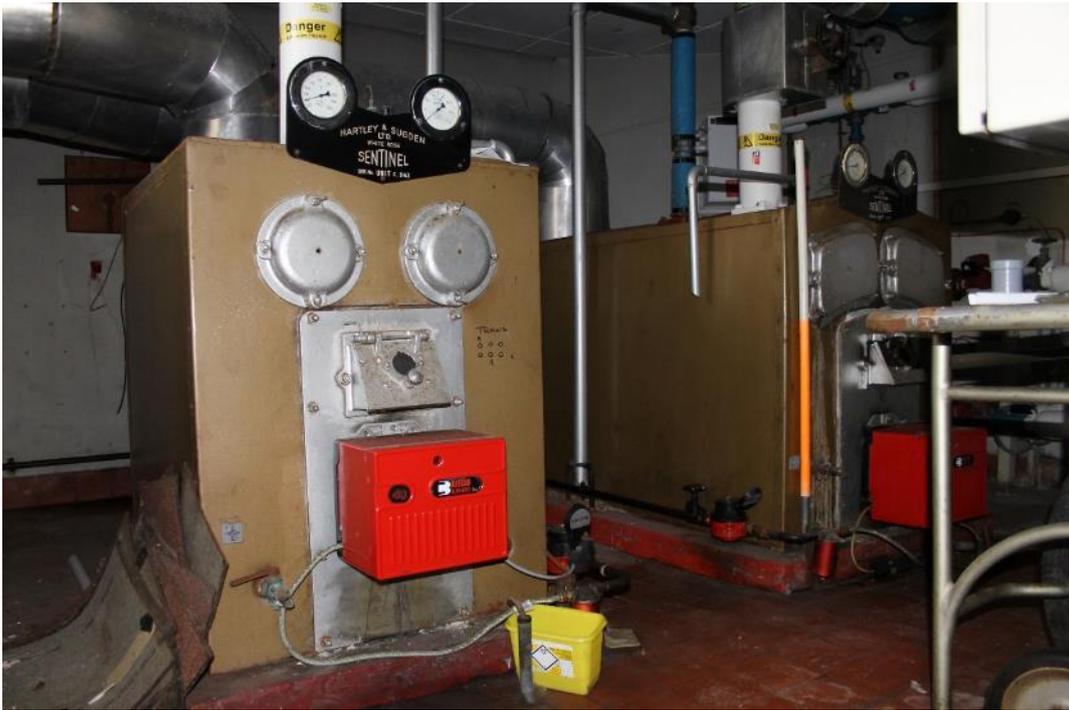
Photo 37: East facing shot of Boiler Room

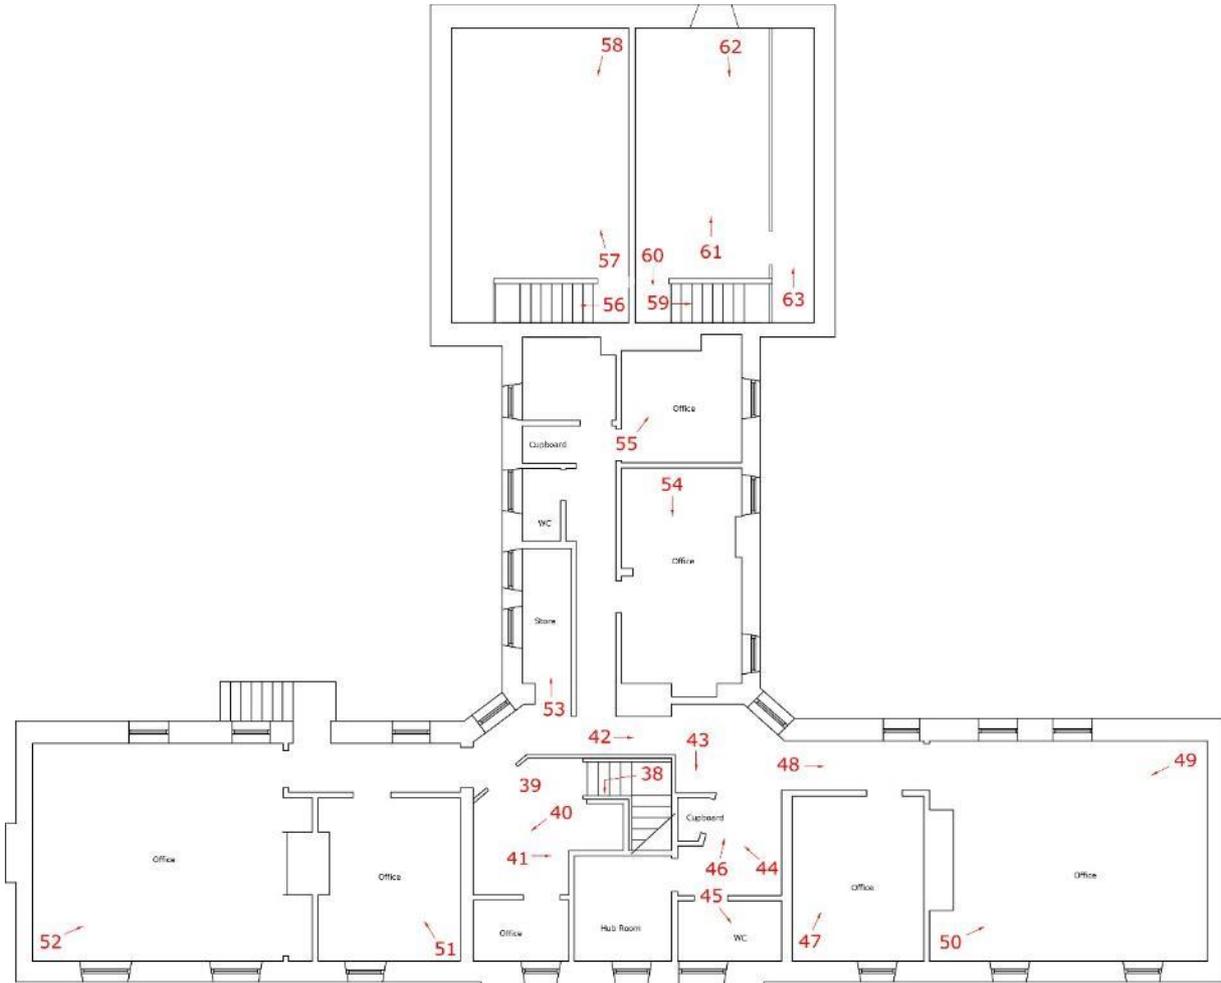
Figure 11: Location and direction of first floor photographs

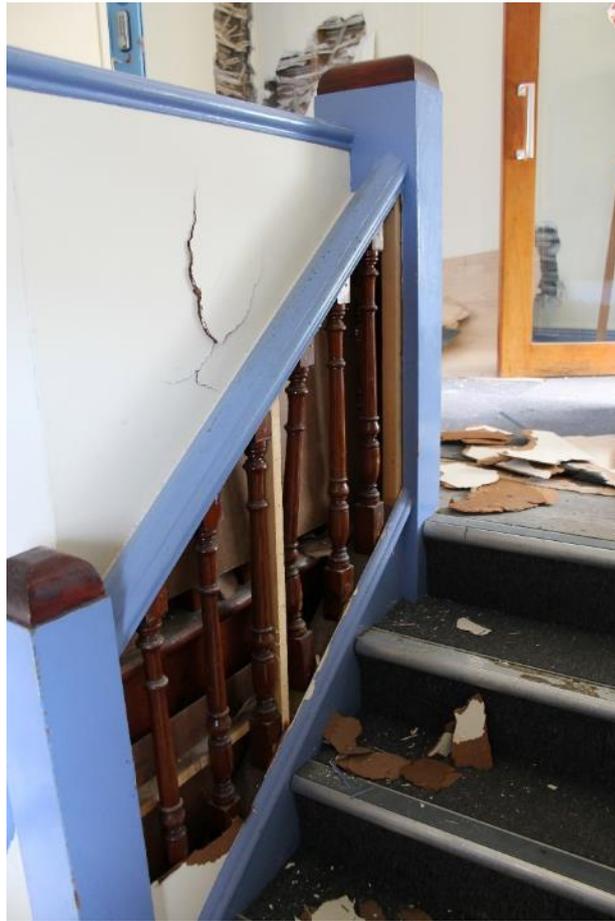
Photo 38: Original (1914 conversion) balustrade

- 4.3.1 Aside from the attics at the east end of the building, the first floor is accessed via the stairs situated directly in front of the main entrance, comprising plain, square newel posts with bullnose tops, a moulded handrail and, concealed behind painted hardboard, turned spindles (Photo 38). At mid-landing the stairs turn left; the right turn having been blocked (Photo 39); a small flight of steps can be seen in the adjoining corridor where the floorboards have been lifted (Photo 43).

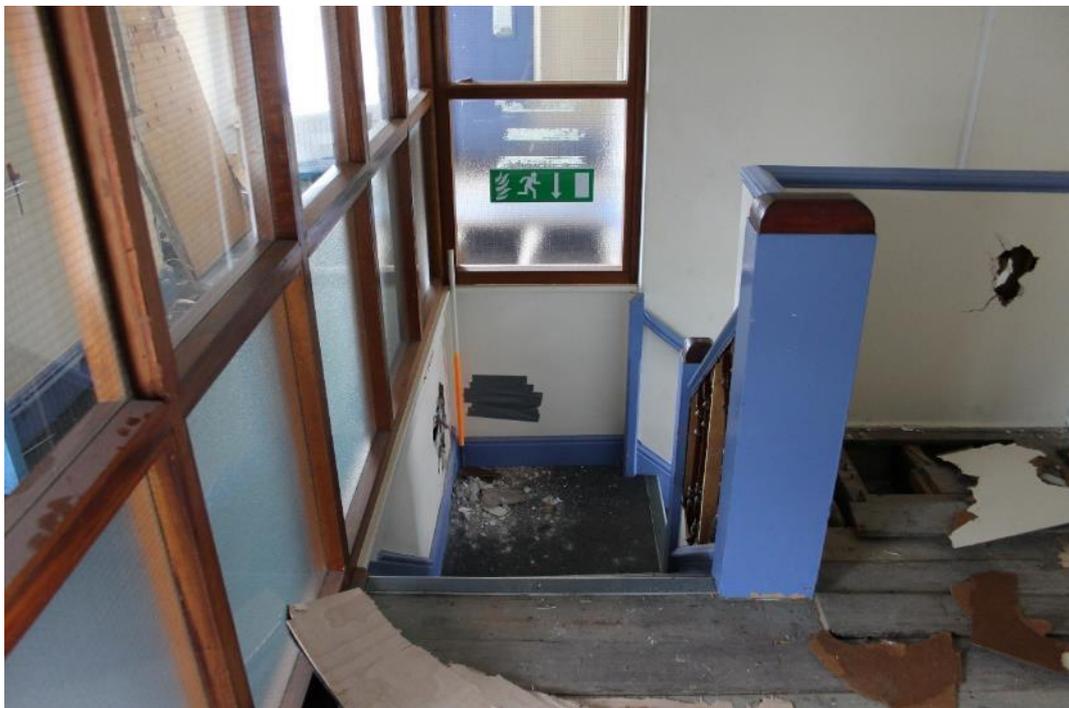
Photo 39: Reinforced glass and timber framed wall beside landing (blocked stairway right of 1m scale)

- 4.3.2 Separating the landing and the corridor is a reinforced glass and timber frame partition (Photo 39). The landing, on the north and west side, is enclosed in lathe and plaster walls (Photo 40) and the skirting board (seen almost throughout the building and, when different, is indicative of later work) has a torus moulding (Photo 41).

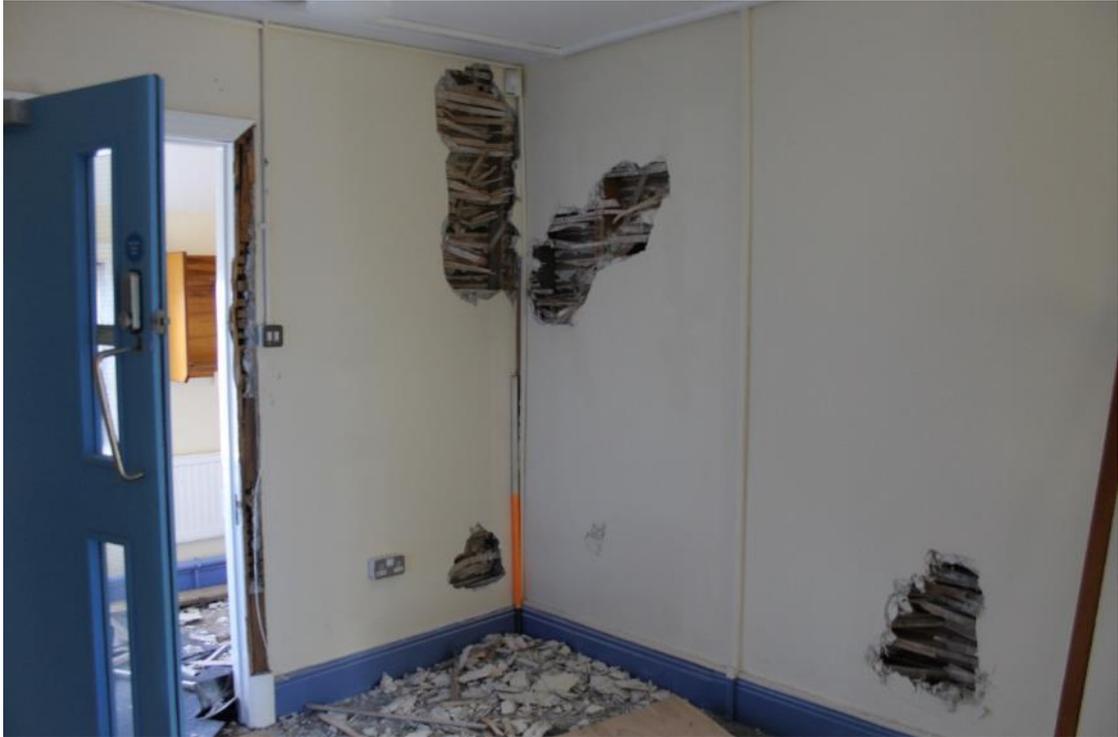
Photo 40: Lathe and plaster walls in landing (1m scale)

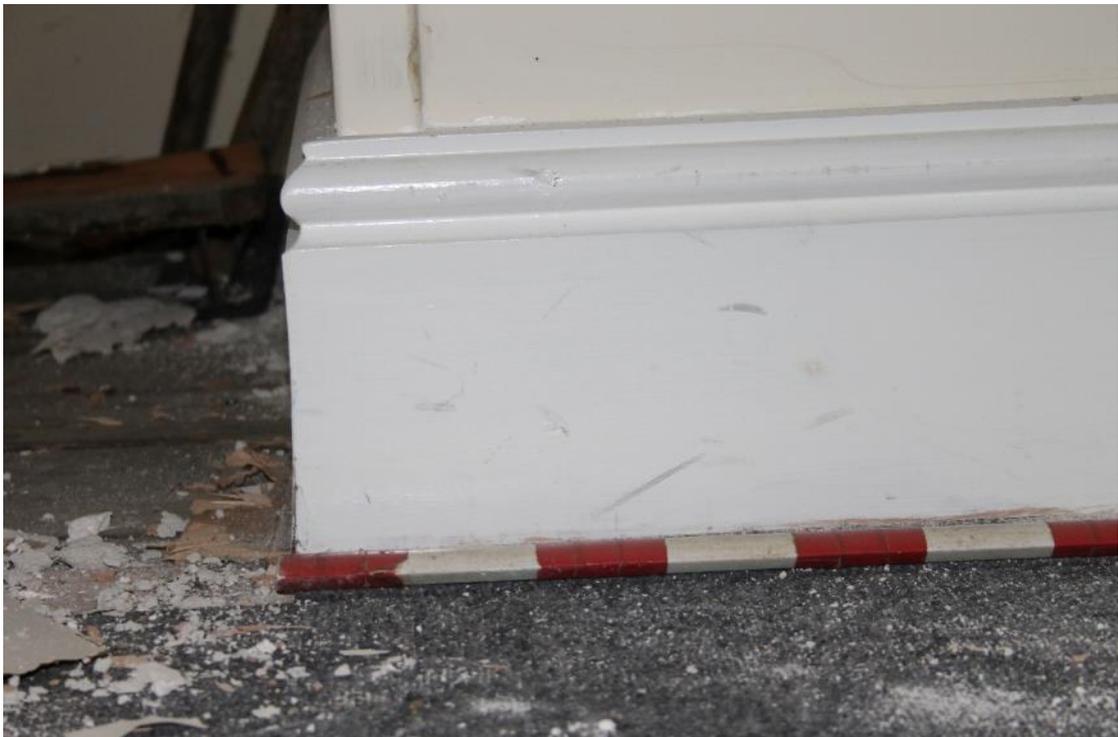
Photo 41: Typical (original) skirting board profile seen throughout building (0.5 scale)

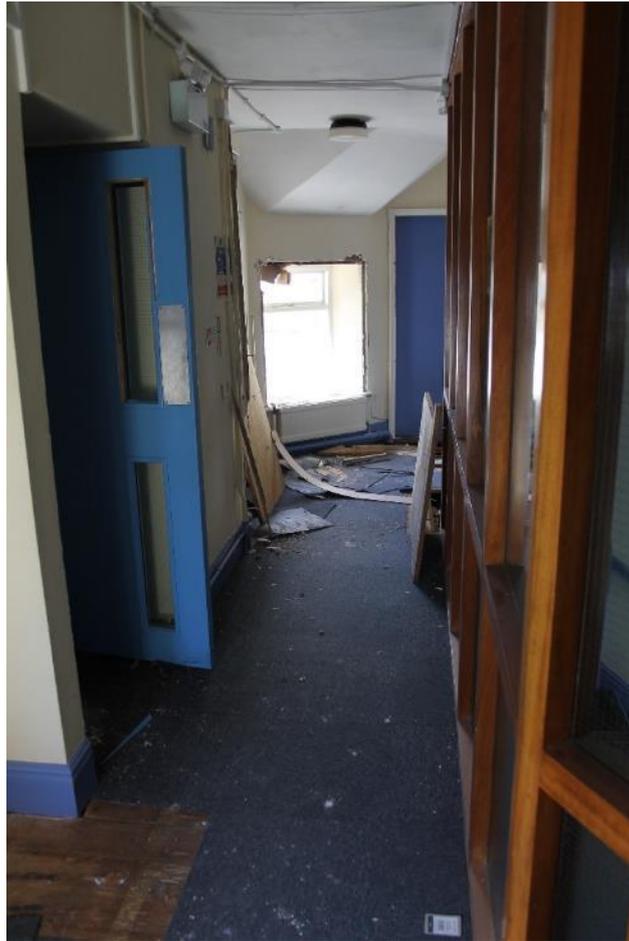
Photo 42: South facing shot along corridor adjacent to landing towards chamfered corner with window overlooking south yard.

- 4.3.3 Both ends of the corridor adjacent to the landing have chamfered corners with window openings where the two ranges meet. This would have enabled the workhouse staff to monitor the yards below (Photos 42 and 46)

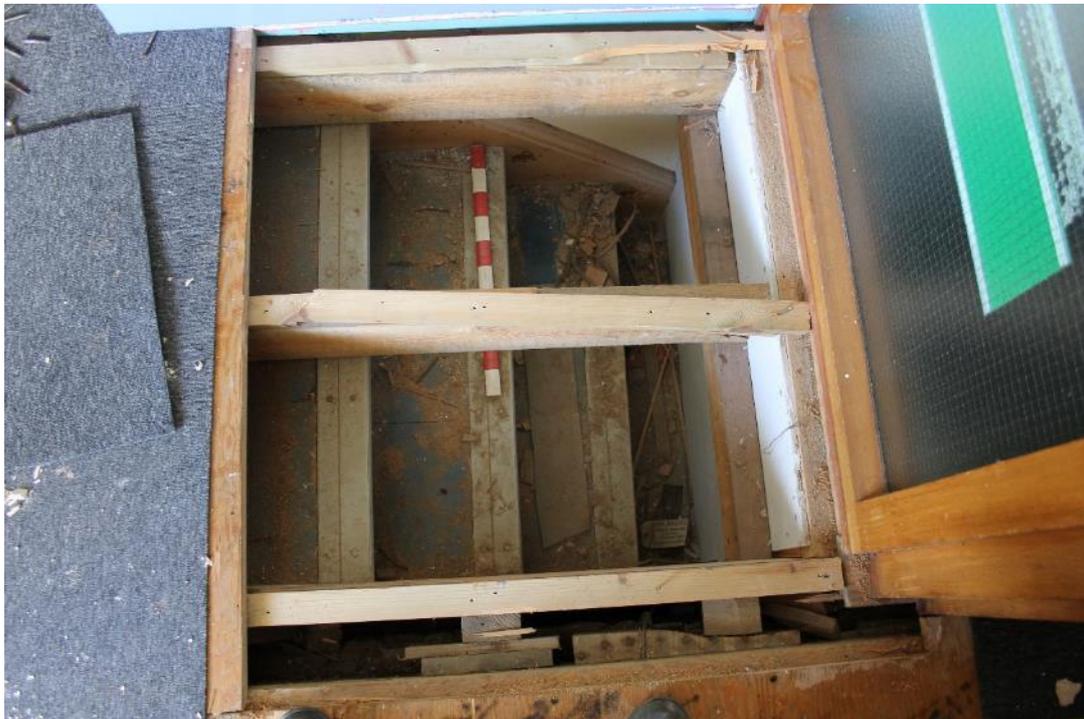
Photo 43: Lifted floorboards reveal blocked stairs leading to mid-landing (see photo 39)

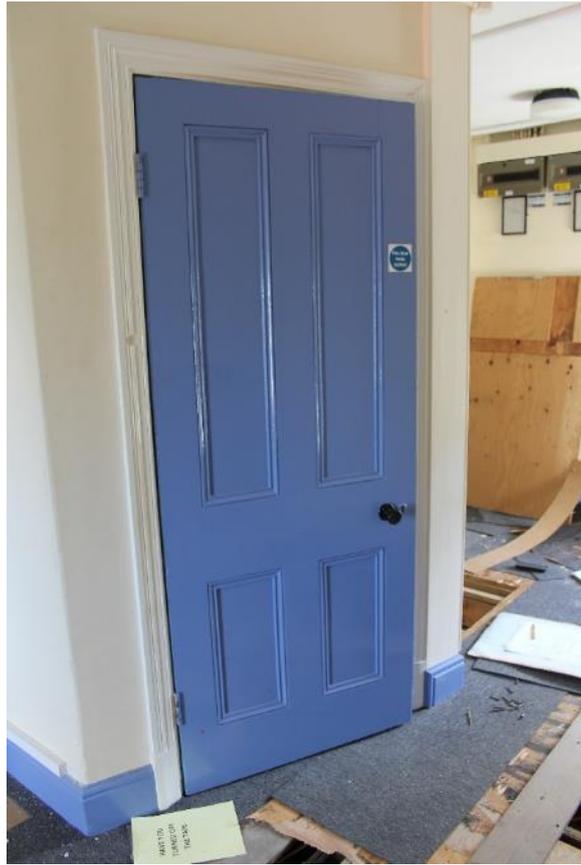
Photo 44: Four-panelled cupboard door in south corridor

- 4.3.4 A small cupboard with a four-panelled door is situated in the corridor on the south side of the stairwell. This is possibly a feature of the original hospital (Photo 44).

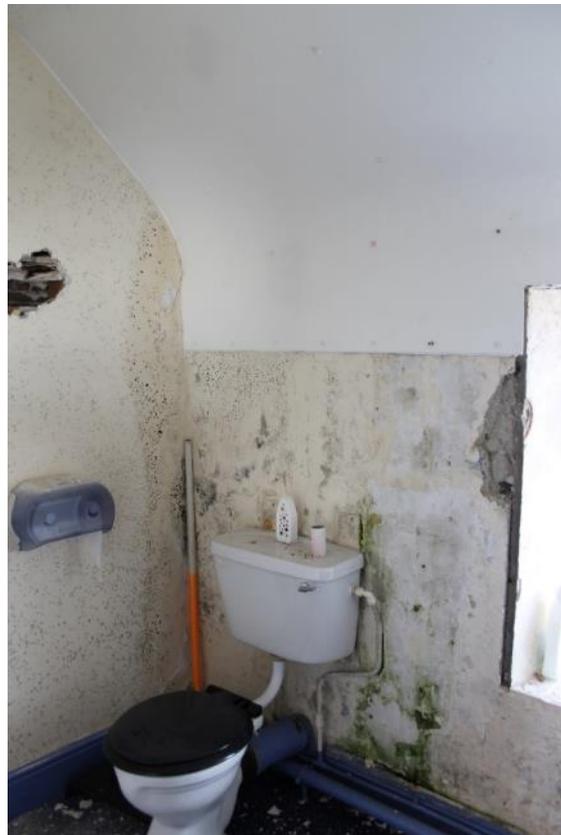
Photo 45: SW corner of WC showing angled ceiling (1m scale)

- 4.3.5 A WC measuring approximately 2.50m by 1.40m is situated in the centre of the N-S range, its sloping ceiling reflecting the roof angle (Photo 45).

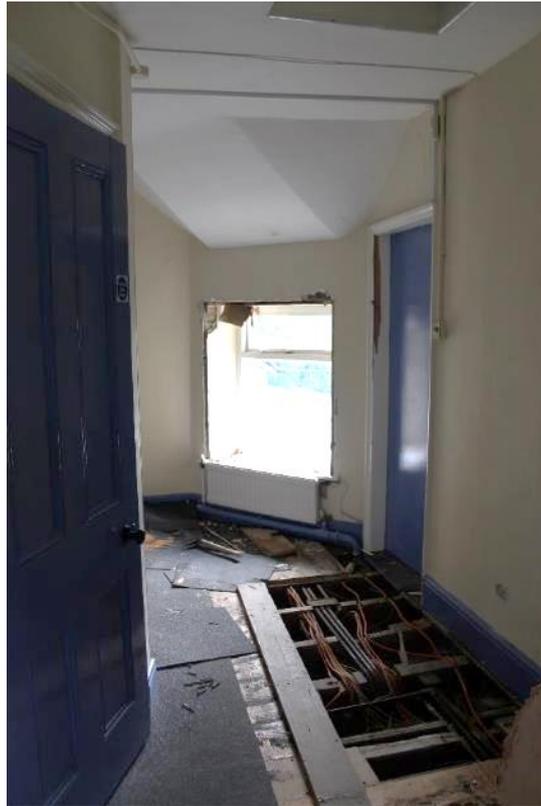
Photo 46: Looking east at splayed corner in southern corridor with window overlooking south yard

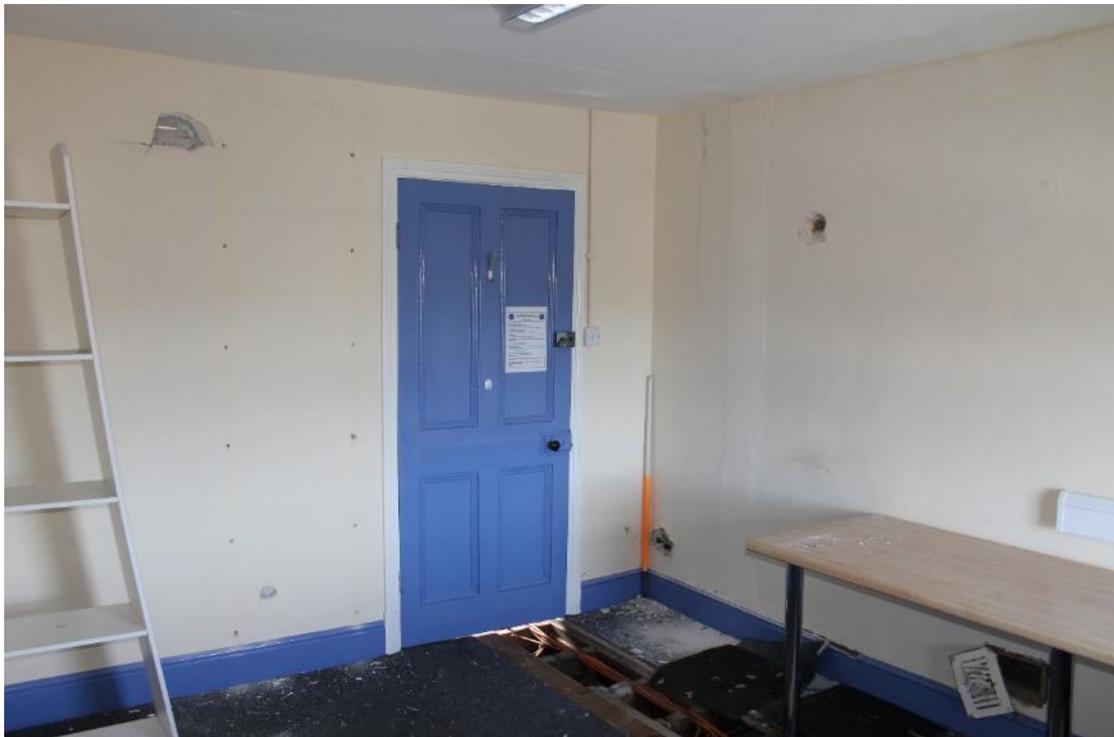
Photo 47: Four panelled door in office at south end of building

- 4.3.6 To the south of the WC is an office measuring 4m by 3.35m containing a blocked fireplace, a four panelled door and a splayed window opening with a modern casement. All the interior walls are lathe and plaster and the ceiling on the west side of the room slopes in line with the roof showing the bases of exposed roof timbers (Photo 47).

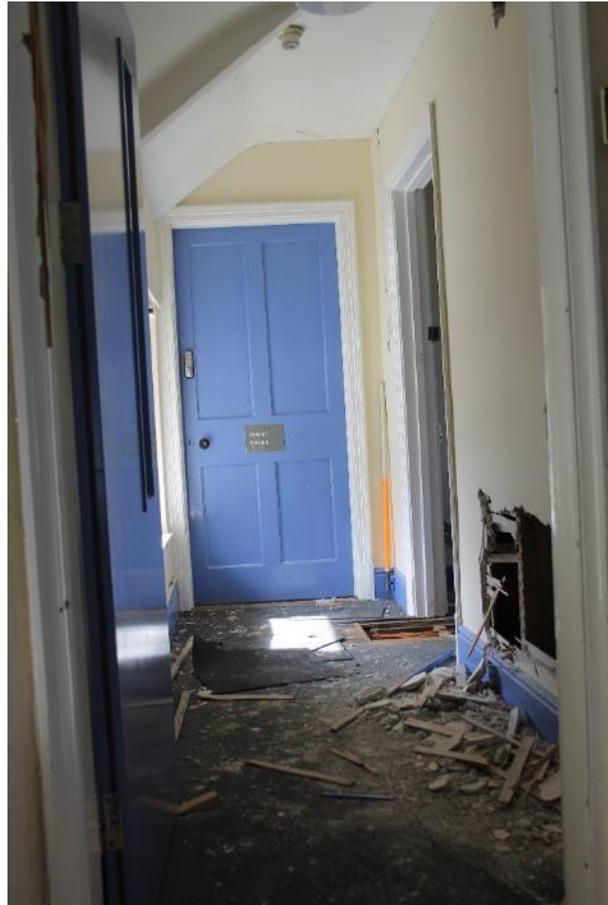
Photo 48 Four pannelled door leading to large office at south end of building

- 4.3.7 A small corridor (Photo 48) leads to a large office (6.65m x 5.25m) at the southern end of the N-S range. A four panelled door and chimney breast with probable blocked fireplace is situated in the north wall which is of lathe and plaster construction (Photo 49). The east and west walls contain two windows each, with metal casements in the west and timber casements in the east. Exposed roof timbers are visible in the ceiling and the ceiling slopes in line with the timbers. The beams have been clad in tongue and groove (Photo 50).

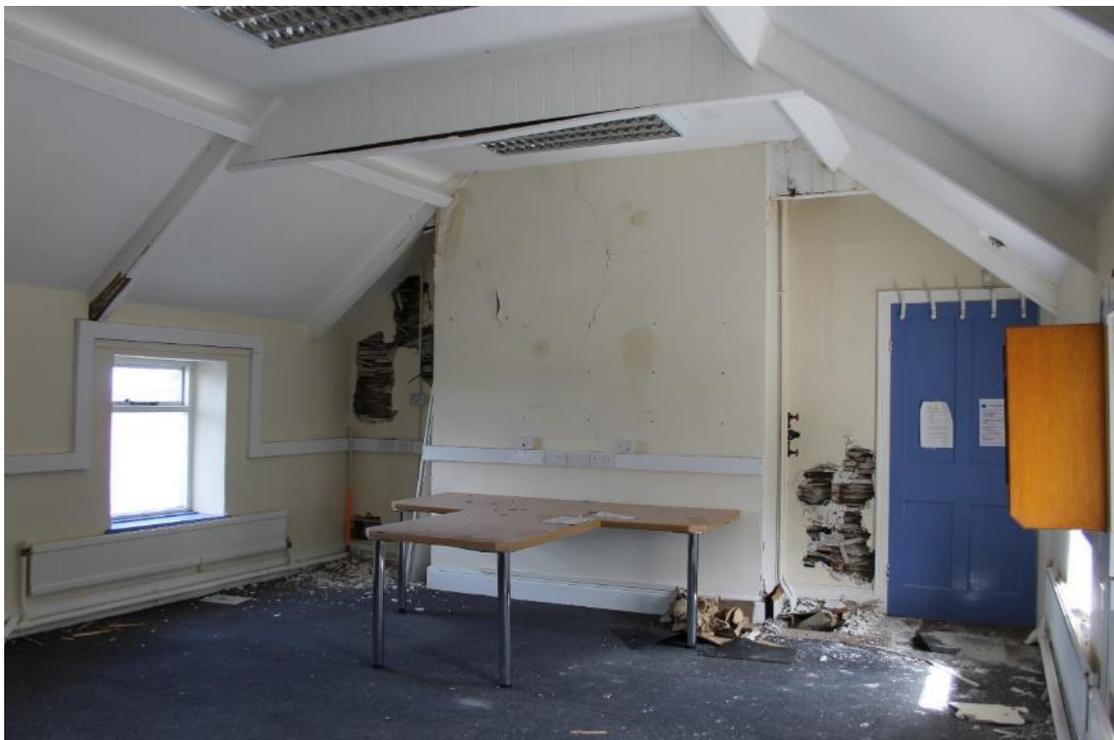
Photo 49: Chimney breast and blocked fireplace in large office at south end of building (1m scale)

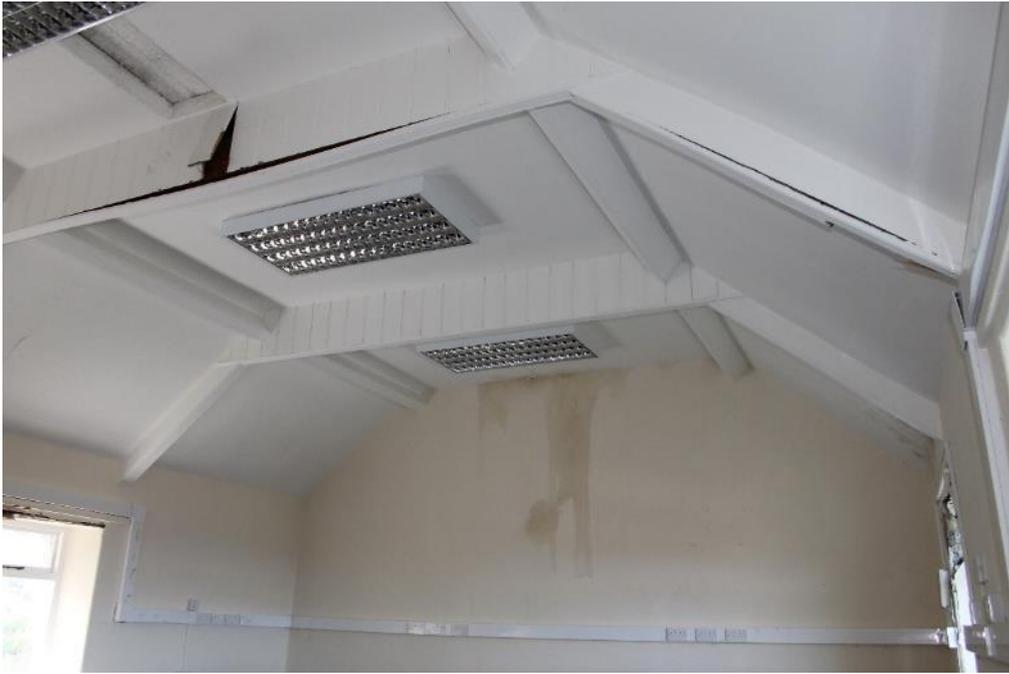
Photo 50: Ceiling and roof timbers in large office at south end of building.

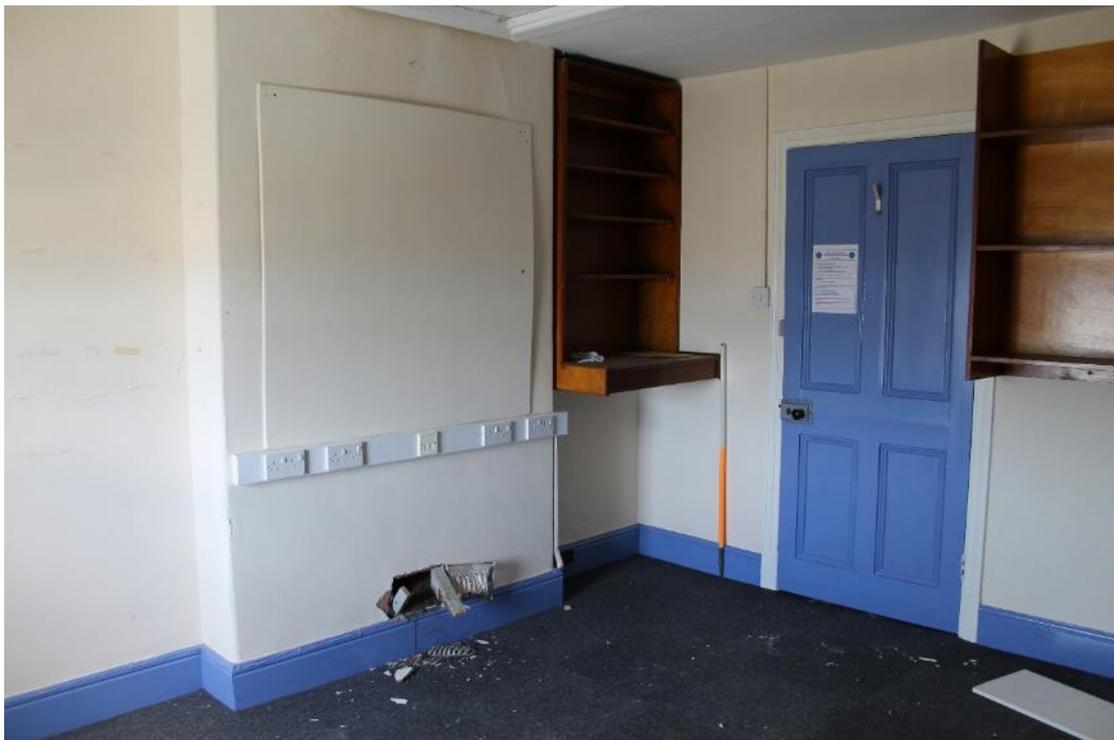
Photo 51: Blocked fireplace and four panelled door in office at north end of building (1m scale).

- 4.3.8 At the northern end of the N-S range are two offices and a small corridor. The corridor contains a small door that opens to the fire escape; the door is probably an enlarged former window. The smaller of the two offices (4m by 3.40m) contains a four panelled door and a blocked fireplace. All the interior walls are lathe and plaster. The west side of the ceiling slopes, reflecting the roof angle and there is a single splayed window with a modern casement (Photo 51). The larger office measures 6.70m by 5.25m and contains a blocked fireplace in the south wall. East and west walls contain two splayed window openings apiece with modern casements. The ceiling slopes, reflecting the angle of the exposed roof timbers which are clad in tongue and groove. The floor, like all the offices in the building, is carpet tiled (Photo 52).

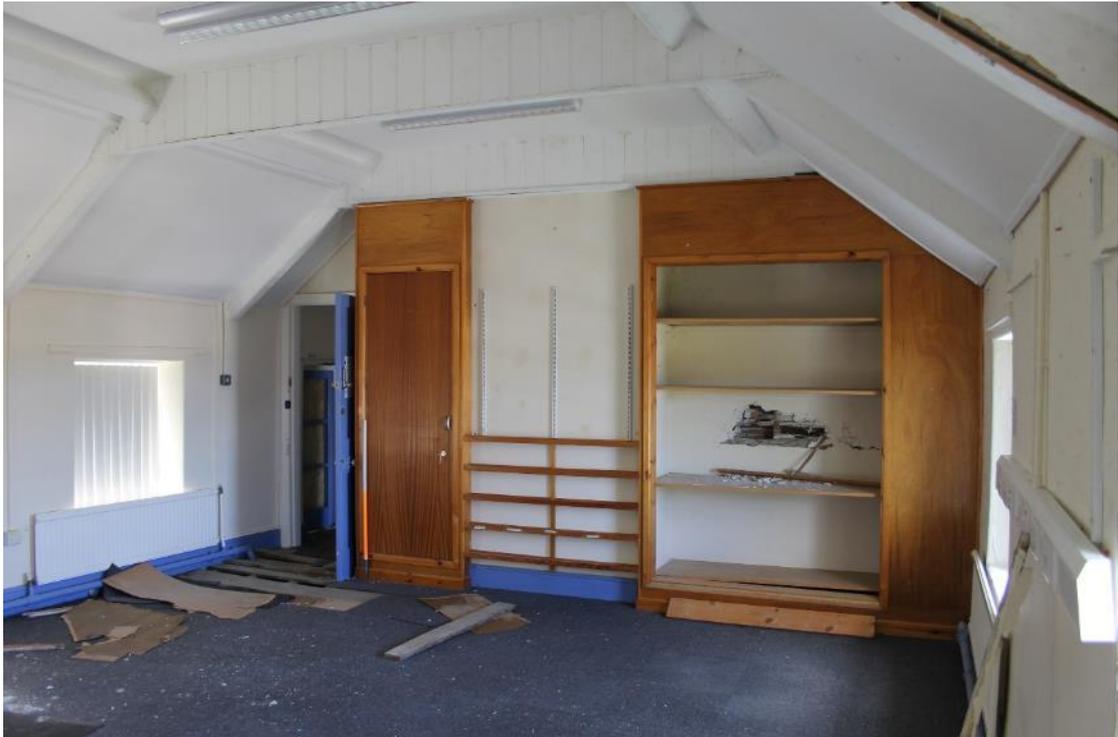
Photo 52: View south; blocked fireplace and exposed roof timbers in room in north end of building (1m scale)

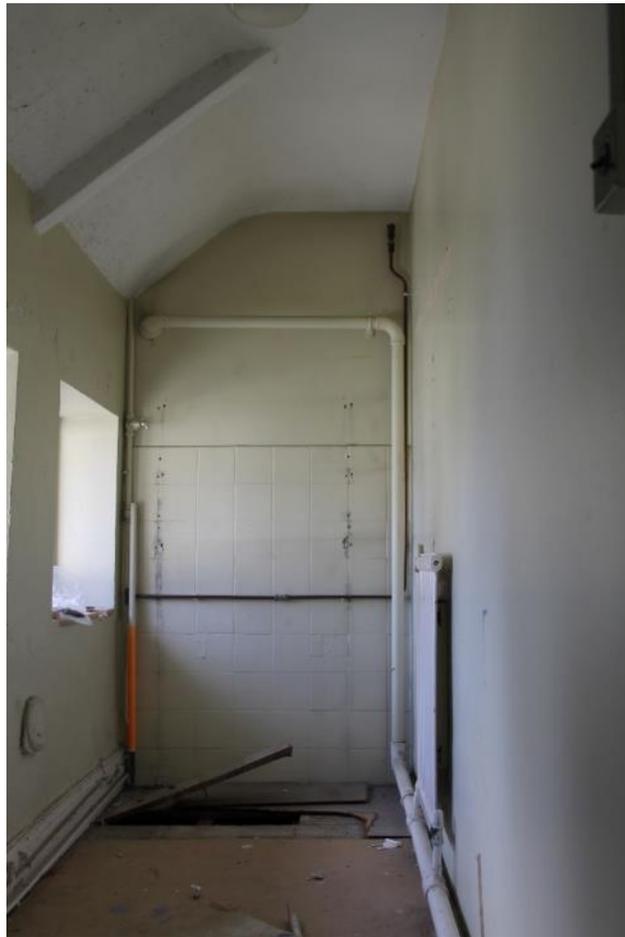
Photo 53: View east; narrow room in E-W range associated with first hospital (1m scale)

- 4.3.9 At the west end of the E-W range, is a narrow room measuring 3.70m by 1.20m. It contains two splayed windows with timber casements and tiled sill and a tiled east wall. This room is more than likely associated with the original hospital conversion (Photo 53).

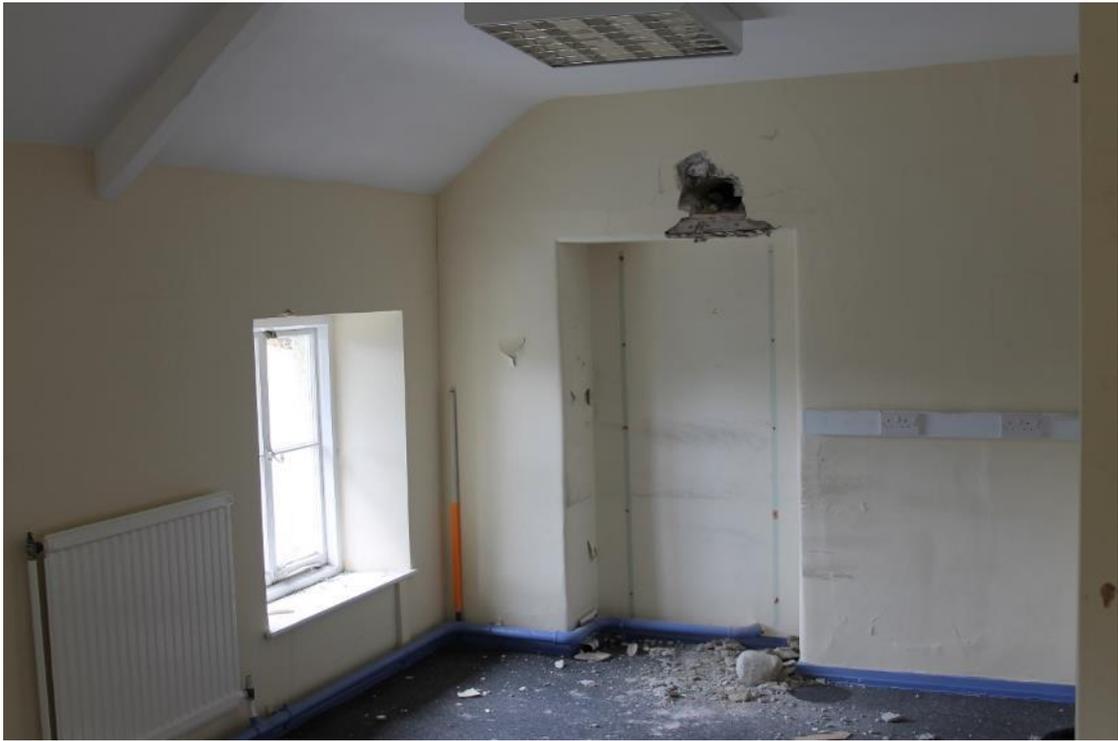
Photo 54: Office in E-W range – recess possible blocked doorway (1m scale)

- 4.3.10 Across the corridor from the room above is an office measuring 5.15m by 2.90m. Two splayed windows with timber casements with old fittings probably date from the hospital conversion. A recess in the west wall could be a blocked doorway, albeit a small one. The skirting board is small and plain. And the north wall is modern (stud and plasterboard) (Photo 54)

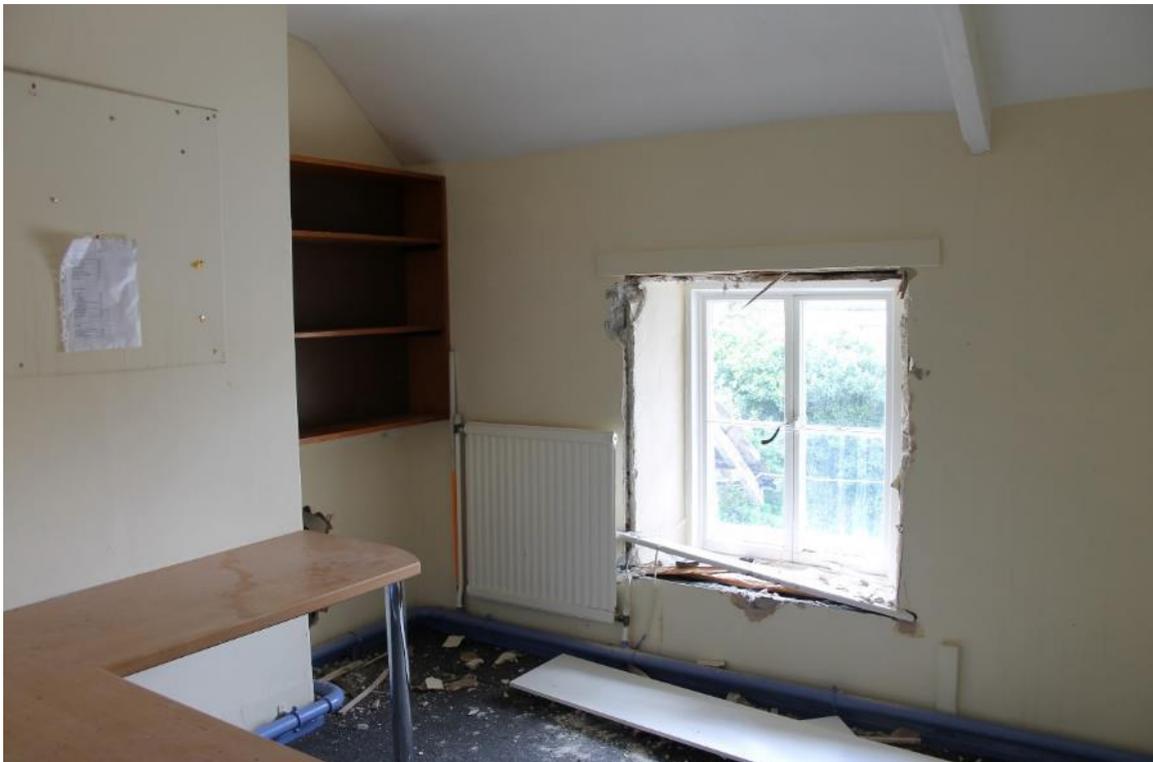
Photo 55: Small office in E-W range – wall projection on left is blocked staircase (1m scale)

- 4.3.11 To the east of the above is a smaller office measuring 2.90m by 2.70m (Photo 55). A projection at the NW corner of the room conceals a small flight of steps which connected with the stairs leading to the southernmost room in the E-W range (see Photo 60). The window in the south wall has a timber casement and probably originates from the hospital conversion. The east wall to the right of the projection is lathe and plaster but the north and west walls are stud and plasterboard demonstrating that this office and the one above are of modern origin.

- 4.3.14 Opposite the top of the stairs leading to the south room are some wooden steps leading to a blocked entrance (Photos 59 and 60). This would have led to the west side of the E-W range. The other side of the blocked entrance is seen in Photo 55.
- 4.3.15 The southern room at the east end of the E-W range measures approximately 7.35 by 4.34, similar to the northern room opposite. A 20-paned, splayed, casement window sits in the east (gable) wall (Photo 61). This window, more than likely, was part of the original workhouse; a better view can be seen in Photo 17. The ceiling is painted hardboard and the floor carpet-tiled. The west side of the room contains a built-in tongue and groove cupboard and a boarded door leading to the stairs (Photo 62). The south side of the room has been turned into a narrow store room by partitioning with tongue and groove boards (Photo 63).

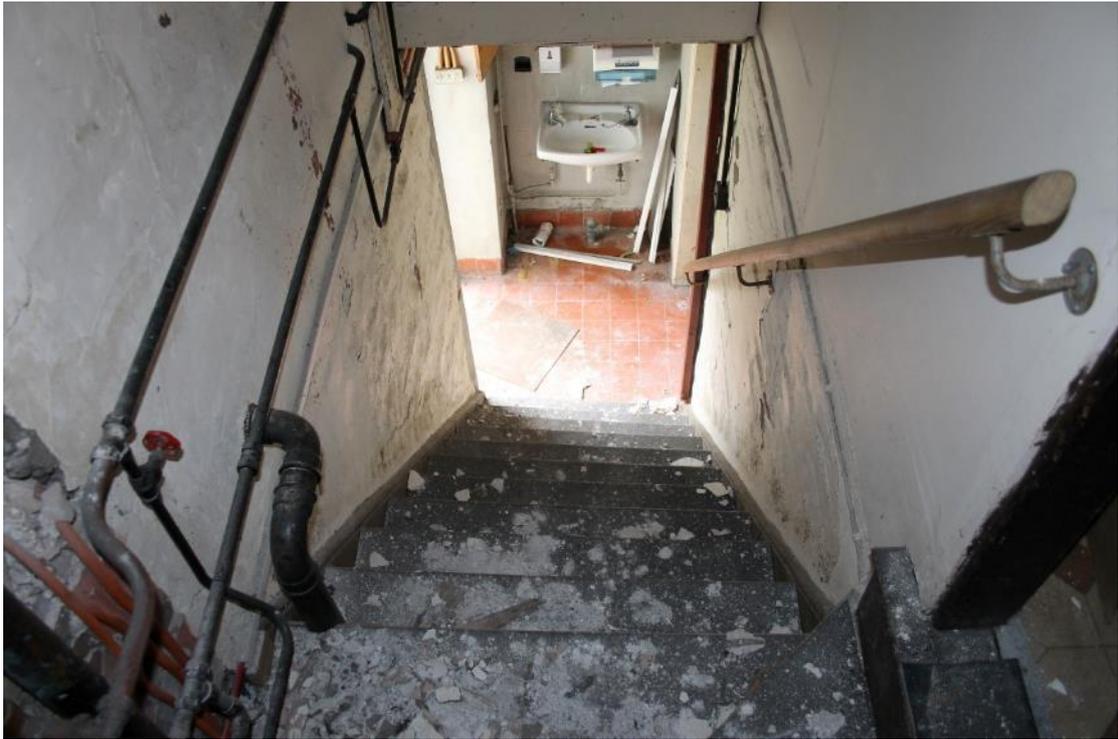
Photo 56: Looking down from staircase leading to 'Men's Bedroom' (attic)

- 4.3.12 Access to the two easternmost rooms is via symmetrically opposed wooden staircases (Photos 56 and 59). The northern staircase is only accessed through the yard and the southern staircase would have been the same except it is now inside the modern extension. Before the conversion to a hospital in 1914 access to the southern room was also possible via an entrance (now blocked) at the top of the stairs leading to the south room (Photo 60).

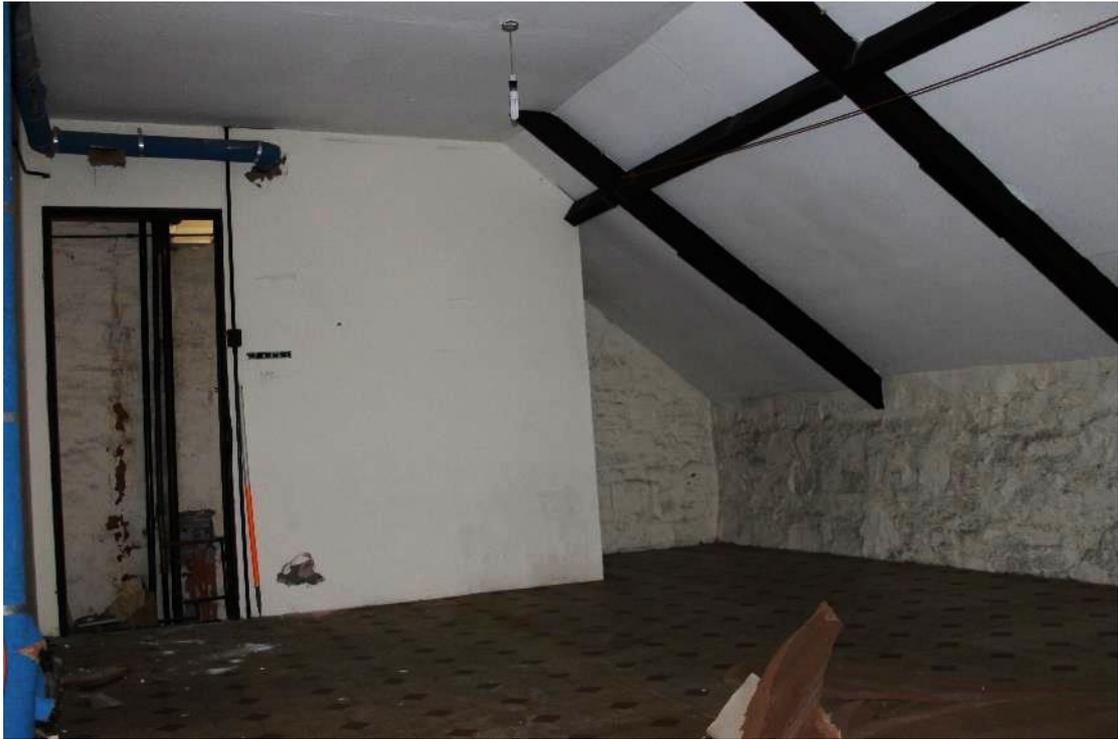
Photo 58: View west of north attic in E-W range (1m scale)

2020), which contains a photograph of a boarded door and the words 'Men's Bedroom' in Victorian script across the top. By the time of the present photographic survey the door had been removed (for preservation). The room measures approximately 7.35m by 4.35m. North and east walls are painted stone; the east (gable) wall contains a linear projection between 0.4 – 0.6m wide, protruding c. 0.15m out and spanning the height of the wall, with breeze block infilling to the east. This could be the possible remains of a chimney breast although there is no evidence of a chimney in the roof above. The floor is linoleum with timber floorboards and the ceiling is painted hardboard with exposed roof timbers (Photos 57 and 58). It is odd that this room does not contain a window like its twin on the other side of the south wall.
