**FORMER ABERAERON HOSPITAL,
CEREDIGION**

HISTORIC BUILDING RECORDING

REPORT NO. 2021-60
EVENT RECORD No. 126367

**FORMER ABERAERON HOSPITAL CEREDIGION:
(NGR SN 46119 62980)
HISTORIC BUILDING RECORDING**

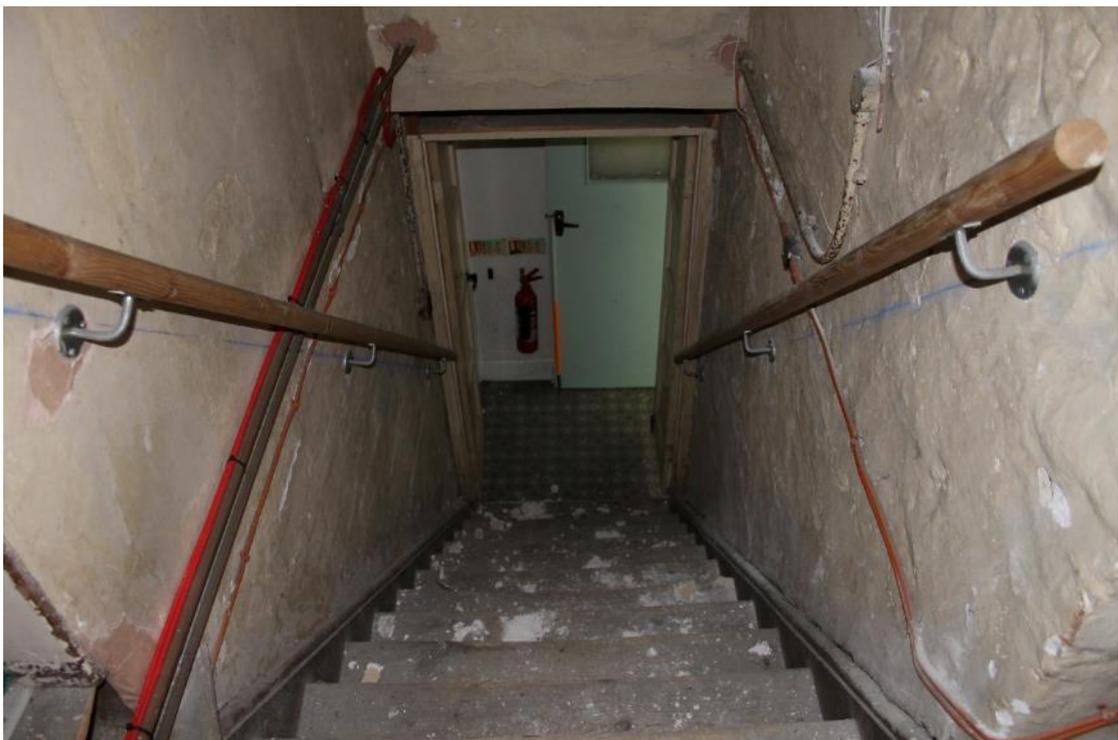
Photo 59: Looking down from top of stairs leading to south attic in E-W-range (1m scale)

- 4.3.12 Access to the two easternmost rooms is via symmetrically opposed wooden staircases (Photos 56 and 59). The northern staircase is only accessed through the yard and the southern staircase would have been the same except it is now inside the modern extension. Before the conversion to a hospital in 1914 access to the southern room was also possible via an entrance (now blocked) at the top of the stairs leading to the south room (Photo 60).

- 4.3.14 Opposite the top of the stairs leading to the south room are some wooden steps leading to a blocked entrance (Photos 59 and 60). This would have led to the west side of the E-W range. The other side of the blocked entrance is seen in Photo 55.
- 4.3.15 The southern room at the east end of the E-W range measures approximately 7.35 by 4.34, similar to the northern room opposite. A 20-paned, splayed, casement window sits in the east (gable) wall (Photo 61). This window, more than likely, was part of the original workhouse; a better view can be seen in Photo 17. The ceiling is painted hardboard and the floor carpet-tiled. The west side of the room contains a built-in tongue and groove cupboard and a boarded door leading to the stairs (Photo 62). The south side of the room has been turned into a narrow store room by partitioning with tongue and groove boards (Photo 63).

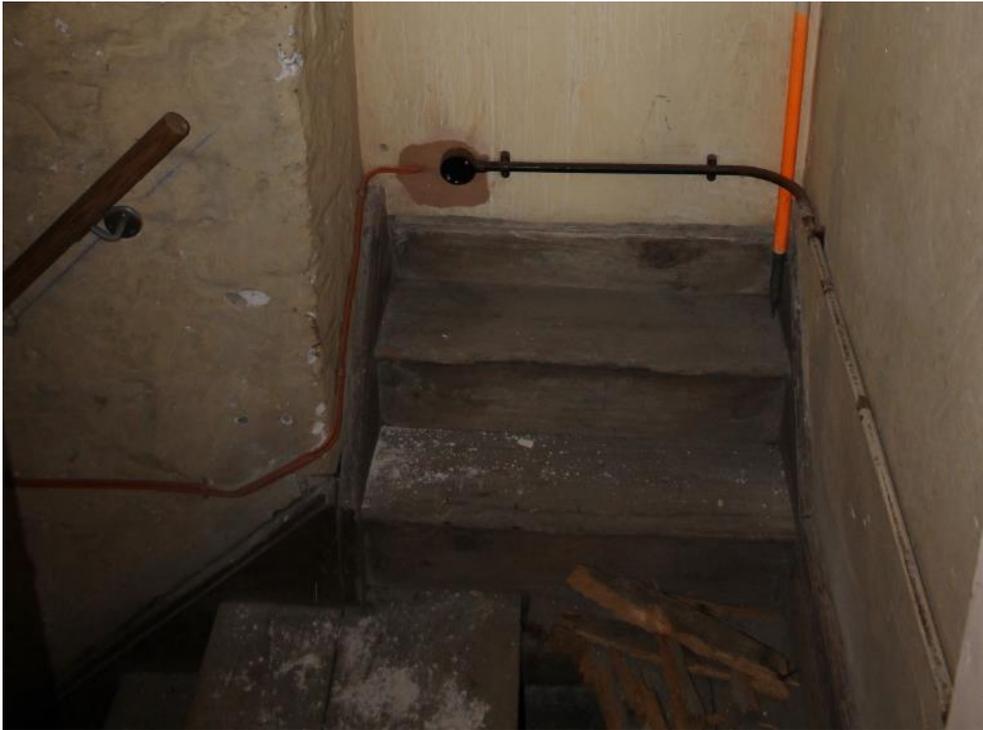
Photo 60: *Wooden steps leading to blocked entrance; opposite entrance to south attic in E-W range (1m scale)*

- 4.3.11 To the east of the above is a smaller office measuring 2.90m by 2.70m (Photo 55). A projection at the NW corner of the room conceals a small flight of steps which connected with the stairs leading to the southernmost room in the E-W range (see Photo 60). The window in the south wall has a timber casement and probably originates from the hospital conversion. The east wall to the right of the projection is lathe and plaster but the north and west walls are stud and plasterboard demonstrating that this office and the one above are of modern origin.

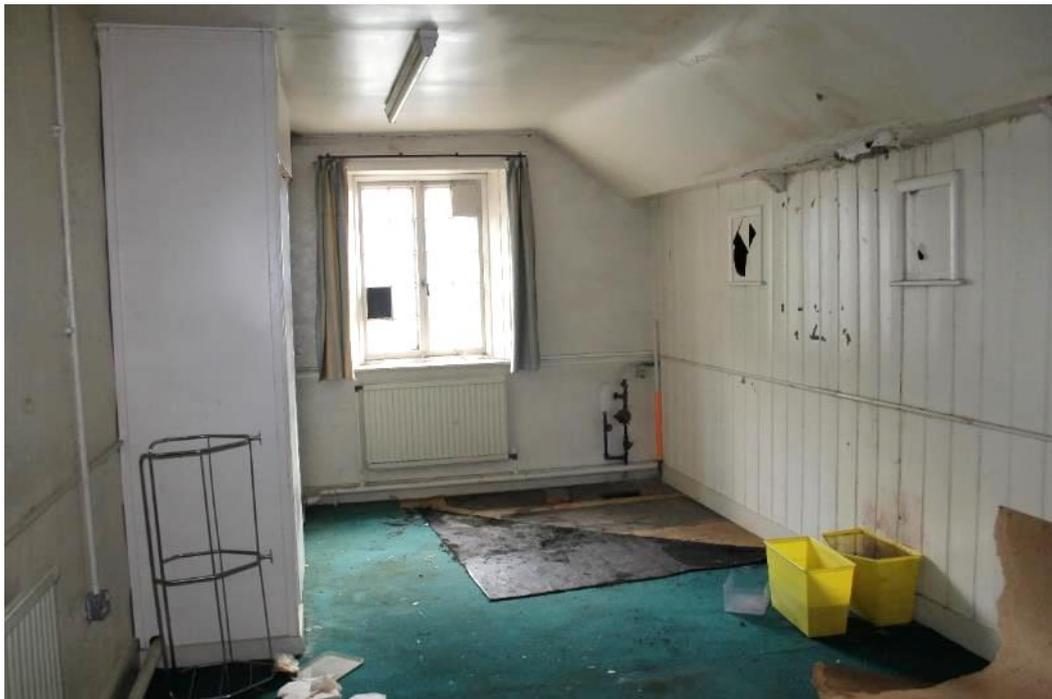
Photo 61: *View east of south attic in E-W range*

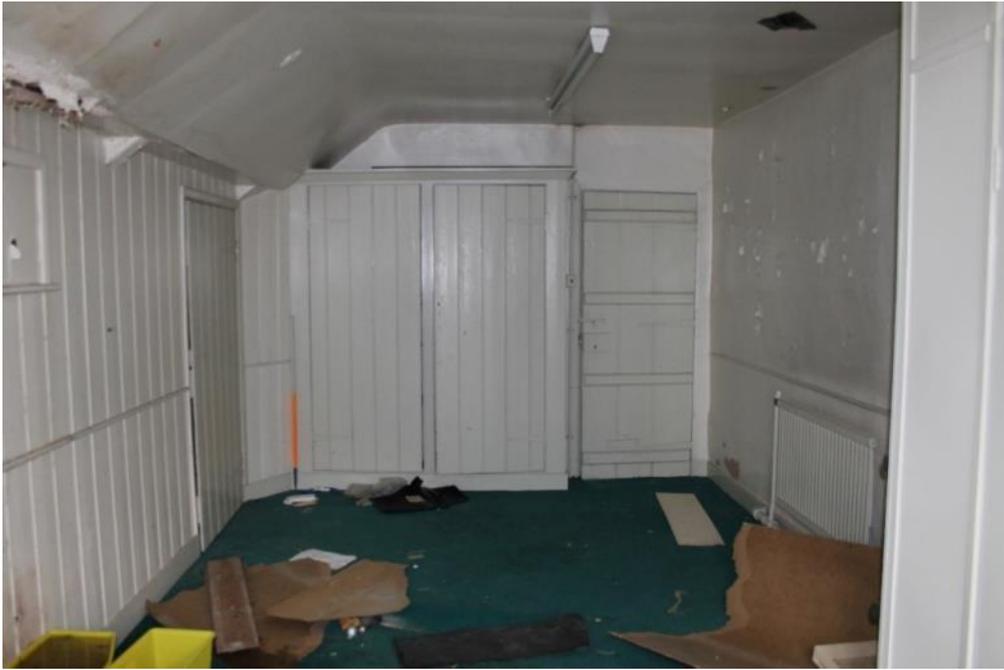
Photo 62: View west of south attic in E-W range - door on right leads to top of stairs (1m scale)

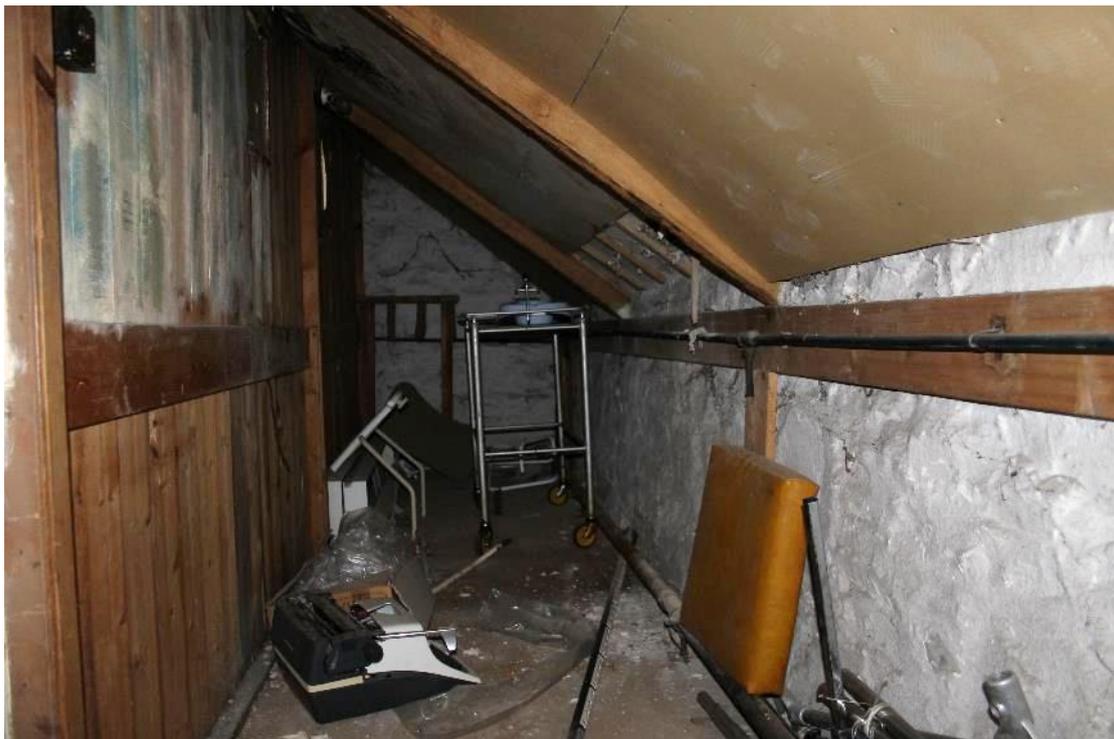
Photo 63: View east along narrow storeroom in south attic.
