1 AND 2 GREEN VILLAS, CARDIGAN

ARCHAEOLOGICAL INVESTIGATION 2003

Report No. 2003/99

REPORT NO. 2003/99 PROJECT RECORD NO. 49166

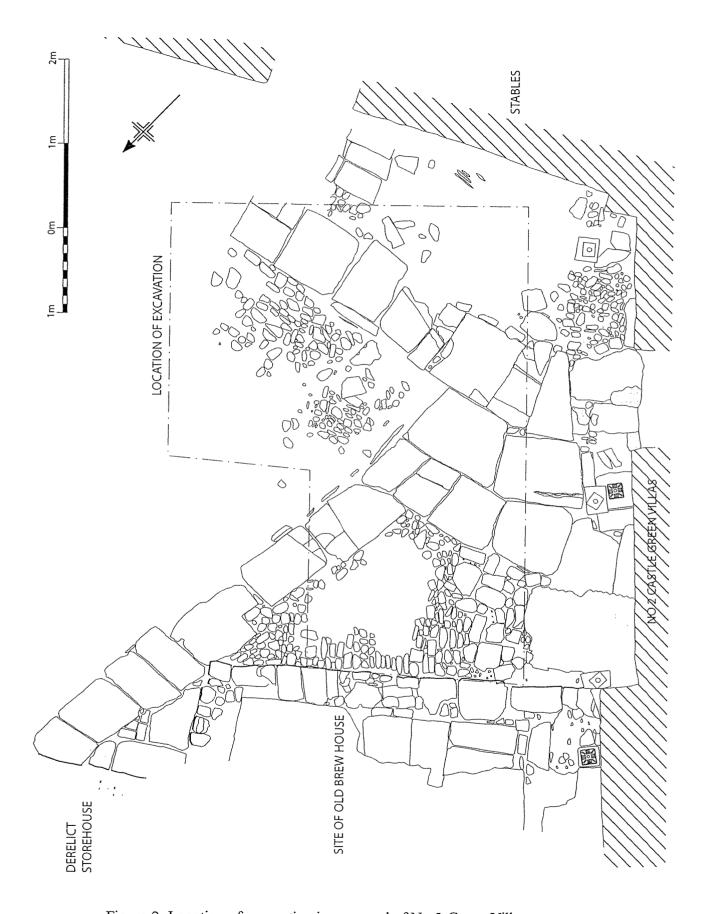
Figure 2: Location of excavation in rear yard of No.2 Green Villas

building that was demolished a few years ago. Consequently, the excavation trench was positioned in an area of discontinuous cobbles and slate slab paths behind number 2 Green Villas (Fig 2).

The cottage yard (Fig. 2; Plate 5)

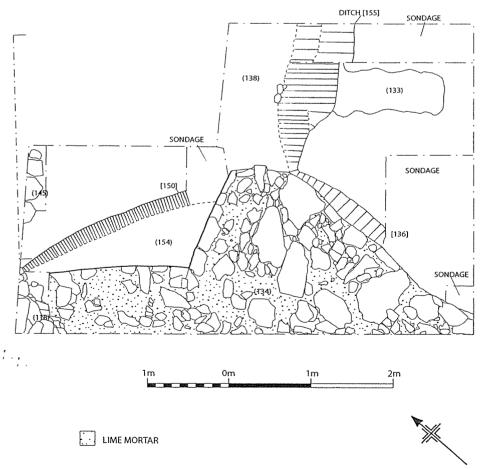
Figure 3: Plan of exposed medieval wall (134) and inner edge of defensive ditch (155)

The excavation was dominated by the remains of a well-built and massive mortared stone wall (134). In plan the exposed section of wall had a flared appearance and it extended beyond the east, south and west limits of the excavation. The faced portion of wall consists of a slightly curved east-west section, which ran for 2m before it turned at c.80 degrees north for 1.3m. From this point the wall was unfaced and curved to the southeast for a short distance, before taking on a more easterly, but still slightly curving course. The wall had been heavily robbed and the exposed upper surface sloped consistently towards the south and southeast, possibly indicating the direction from which the stones were removed from the wall.

Wall 134 (Figs. 3 and 4; Plate 1)

Defensive ditch 155 (Fig. 3; Plate 2)

Foundation trench 150 cut through the gravel subsoil on what appeared to be the inner edge of the defensive ditch (155), which extended north from wall 134. As excavated, the upper edge of the ditch sloped down to the west at an angle of c.20 degrees, before dropping to a steeper angle of c.60 degrees to a relatively flat step, which extended west beyond the excavated area. A sherd of medieval pottery of a type very similar to that recovered from within the foundation trench (see above) was recovered from what appeared to be a thin layer of primary silting (138) on the surface of the step. Layer 138 was c.2-3cm thick and consisted of silt and gravel washed out from the upper side of the ditch onto the step.

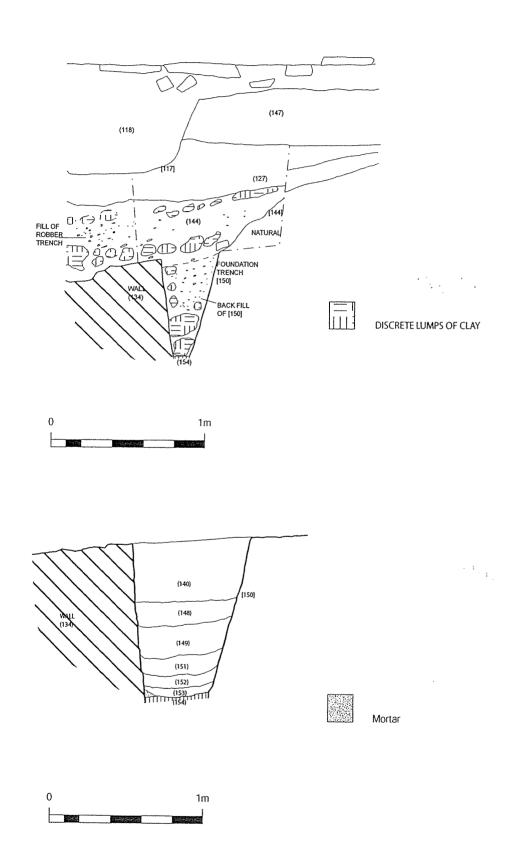
Figure 4: Sections through foundation trench 150

Wall (134) sat within a foundation trench (150) cut through the underlying gravel substrata. In the base of the western part of 150 was a flat layer of mortared stones mostly slate and shale (154) that extended under the wall and probably provided a firm level base for the wall's construction. The wall itself was for the most part constructed from poorly sorted flatish green shale slabs with some large sandstone blocks, which were more common in the lower courses. The whole structure was bonded together with a moderately hard pale grey-yellow lime mortar, which had flecks of charcoal and ash used as bulking agents. It was discovered on physical inspection that this material bore similarities to mid-17th century domestic mortar types⁶.

Where the wall was set back from the foundation trench edge the resulting void was backfilled with alternating bands of clay and gravel layers (140, 148, 149, 151, 152 and 153), which presumably had been redeposited in the trench following construction of the wall. These layers contained a reasonable assemblage of diagnostic pottery sherds and those recovered from layers (149, 151 and 152) dated from the 13th - 15th century, but the upper fill (140) contained pottery roughly dated to the 15th century. Therefore, the upper portion of trench 150 appears to have been finally backfilled during or after the 15th century.

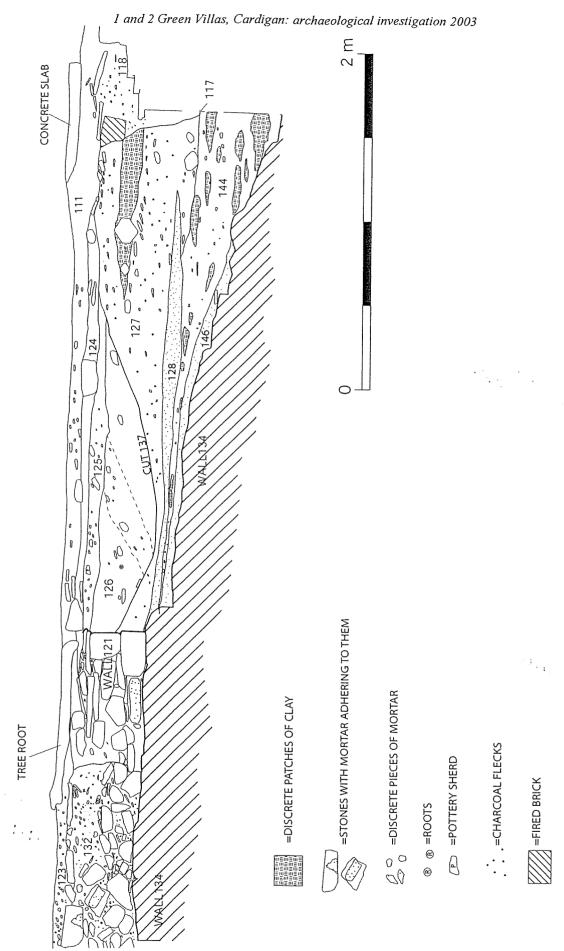
Figure 5: North-facing section showing results of wall robbing and later features

Wall 134 appears to have been robbed of its stone during at least two separate incidents, although they may have occurred over a very short time period. The earliest phase of robbing is evident as a layer of mortar rich gravel (146) that directly overlay the wall. The gravel contained sherds of locally produced medieval cooking pots of the same type and date as those recovered from the foundation trench. The mortar rich nature of (146) suggests that it was deposited during the robbing of wall (134), with the pottery resulting from the disturbance of deposits within trench (150). This appears to have occurred when the wall was robbed out to such a depth that it was lower than the adjacent foundation trench backfill, which then collapsed and spread across the robbed wall. Above 146 and sealing trench 150 was a mixed layer of redeposited clay and gravel (144), which was similar to the material that filled the foundation trench (150).

A second phase of robbing of wall 134, which seems to have been confined to the eastern part of the wall (the section under post-medieval wall 121 – see below) was represented by a cut (136 – not illustrated), which extended over the eastern half of the wall and also by a much thicker band of degraded mortar (128), which overlay the redeposited layer 144. This band of mortar was centred on the widest part of the wall and extended over an area $3.40 \,\mathrm{m} \times 1.75 \,\mathrm{m}$ and was up to $0.08 \,\mathrm{m}$ deep. A large sherd of North Devon Sgraffitto ware dating to c.1625 or later along with the other pottery sherds recovered from this layer indicates a mid 17^{th} century or later date.

Wall robbing (Fig. 5)

The spread of degraded mortar $(128 - \sec \text{ Fig 5})$ appeared to butt up against wall (121) where it meets the southern section of the excavation trench suggesting that it was deposited later than, or at the same time as the wall was built. However, it is

At some point after the area to the west of the medieval ditch (155) and wall (121) had been levelled by the deposition of 127, their line was reinstated by the cutting of a linear ditch (137) which followed the same line and presumably re-exposed wall 121 and redefined the upper edge of ditch 155 (see Fig.5). Ditch 137 was 1.75m wide, 0.35m in depth, and it extended beyond the north and south limits of the excavation. There was no real evidence of any silting in the base of this feature which indicated that it was not left open for long before presumably being deliberately backfilled. This backfilling appears to have taken place as a single event using a dirty mottled brown clay and grey silt (126), which had clearly visible tiplines. This fill was fairly rich in domestic debris which all dates to the 17^{th} century or later. In the area where this backfill butts up to wall 121 it had been covered with a rough stone layer (125), which seemed to have been used simply to cap (126) rather than to create a metalled surface as such. This layer clearly sourced some of its material from either the wall (121) or

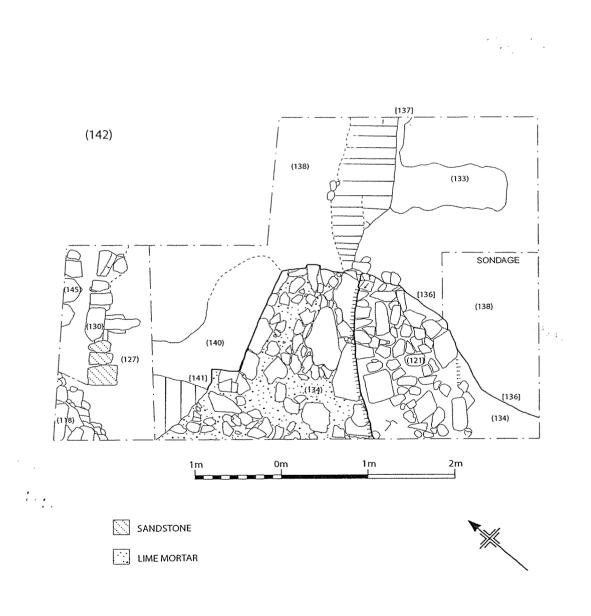
Figure 6: Plan of post-medieval wall 121

It may also have been at this stage that the next phase of construction took place with an earth bonded wall (121) built running north south across the robbed out medieval wall (134) and contained within the medieval foundation cut (150). Wall 121 was fairly substantial, 1.20m wide x 0.40m high x at least 2m long, although as it extended south beyond the limit of the excavation and may have continued under the cottage to the south, its length was not determined. This wall survived up to four courses high and was reasonably well-faced on its west side using fairly regular sandstone blocks and capped with flat green shale slabs. The core of the wall was constructed from unsorted rubble and earth. The west face of the wall roughly continued the line of the inner edge of the medieval ditch 155.

Within cut 136 in the southeast corner of the trench was a rubble layer consisting of a poorly sorted mix of slate, sandstone, cobbles and discrete pieces of mortar (132 – fig 6). This rubble is presumably made up of the stones not considered worth salvaging during the robbing out process.

Wall 121 (Fig. 6; Plates 3 and 4)

A low wall (130) and crude floor (145) were constructed at some point during the levelling process (see Fig. 6). Wall (130) was a very simple low linear structure consisting of sandstone and slate stones loosely stacked without any visible means of bonding. The stones had been roughly sorted for size with the sandstone blocks being $c.0.30 \,\mathrm{m} \times 0.30 \,\mathrm{m} \times 0.08 \,\mathrm{m}$ and the slate being up to $0.50 \,\mathrm{m} \times 0.30 \,\mathrm{m} \times 0.05 \,\mathrm{m}$. The floor, which was only just visible within the trench, appeared to be a very simple surface of slates laid on the levelled ground surface. Neither the flooring or the wall had any real structural integrity and both appeared to be firmly within the matrix of (127) although the fill above the flooring was given a separate context number (129) in case it should prove to be significant. Given the limited area of this structure revealed within the trench – it extended beyond the north and west edges of the excavation and presumably under the foundations and surviving floor of the demolished small brewhouse behind No.1 Green street – it is not possible to interpret its purpose.

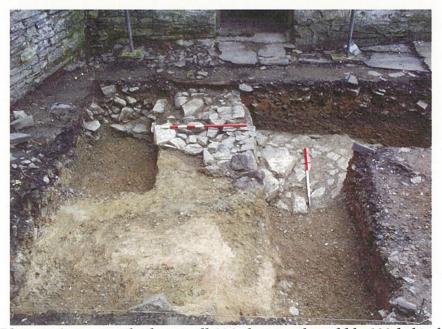
Plate 4: A view south along wall 121 showing the rubble 132 behind.

The rear face of this wall was not faced in any way and it appeared to butt up to the rubble layer (132) behind, although the irregular nature of the rear face made it difficult to be certain. It is possible that the material for the construction of wall (121) came from the rubble. Although two sherds of medieval pottery were recovered from a band of clay (143) at the base of this wall, it appears that the clay was almost certainly part of the original backfill of (150) which had slumped in after the original wall was robbed out.

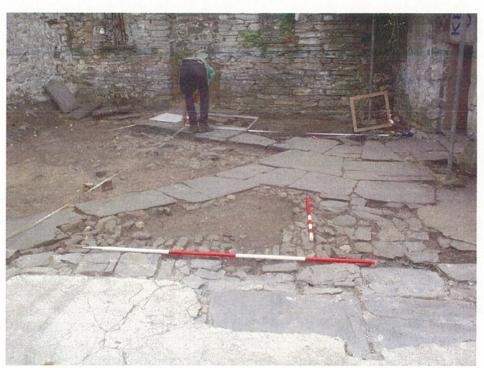
Plate 5: a general view east of the rear yard area prior to excavation. The former stable block of No.2 Green Villas is visible in the background and the floor and east wall foundation of the brewhouse of No.1 are visible in the foreground.

The whole of the surface of the excavated area was covered with a mixed sandy silty material, which contained frequent inclusions of coal ash and slate fragments. This material was put down in a rather patchy manner and the variations were sufficient for them to be allocated different context numbers (109, 112, 115 and 119), even though were parts of the same process. These layers appear to have been laid to create a good base in which to lay a cobbled surface made up of sub-rounded cobbles, which were well sorted for size and firmly laid (106).

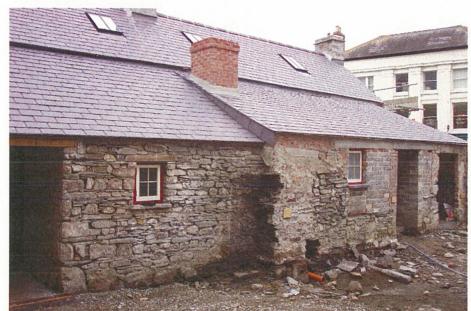
Plate 6: a view of the rear extensions on Nos. 1 and 2 Green Villas during renovation works.

The Green Villa cottages comprised of two inline, two bay, one and a half storey, central entry through passage buildings (Plate 6). Originally built as single storey (possibly lofted) two bay buildings with a central through passage plan possibly at the beginning of the 19th century. Towards the end of the 19th century the cottage walls were raised to give extra space within the loft area and create in effect an extra half storey. Outshoots were also added at this stage along the rear wall of the cottages, and other internal alterations and improvements were also carried out, such as alterations to the windows and fireplaces.

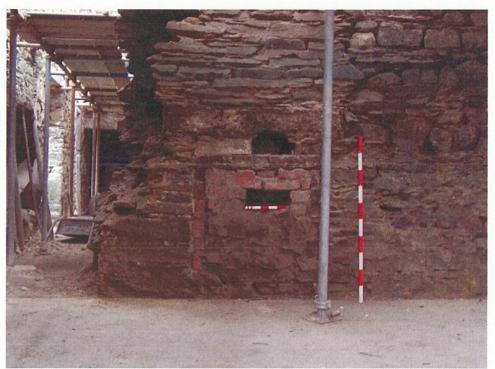
Plate 7: Fireplace inserted in to the party wall of No.1. Note how the fireplace was subsequently reduced in height by the insertion of a second mantel.

Once the interior plaster was removed it did not appear that the central party wall was bonded to the external walls, which suggests that it may have been a later insertion, although this seems somewhat unlikely. A fireplace had been inserted into party wall, which was subsequently altered to lower the mantel height (Plate 7). The only other feature of note was a skew wall in the outshoot (Plate 8), which may be from an

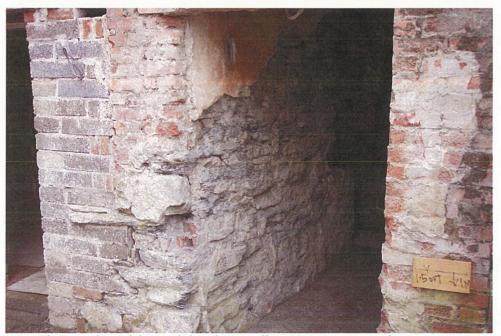
Plate 8: The weathered face of the skew wall in No.1 suggests that it may originally have been an external wall.

earlier structure and which appeared to lead to a now blocked opening in the original north wall (Plate 9). The stonework of the skew wall was far more weathered in appearance than any of the other walls is either cottage, suggesting that at some point it had been an external wall. The blocked opening in the north wall, which from the north side extended to the floor, was from the south side a small hooded niche that did not extend to ground level, but had a stepped base approximately 50cm high (Plate 10). The hood was constructed from stepped brick courses.

It also seems likely that certain elements of the cottages were part of, or at least aligned with reference to, earlier buildings or structures. The skewed east wall of cottage No.2 appears to incorporate, or be built against an existing structure, possibly the garden wall of Castle Green House, in which case a 19th century date for the cottages would appear reasonable. Likewise the skew wall in the outshoot addition to the rear of cottage No.1 appears to be on roughly the same alignment as the east wall of No.2 and when it was stripped of plaster the stones appeared to be weathered as if it had been an external wall at some time in the past (Plate 8).

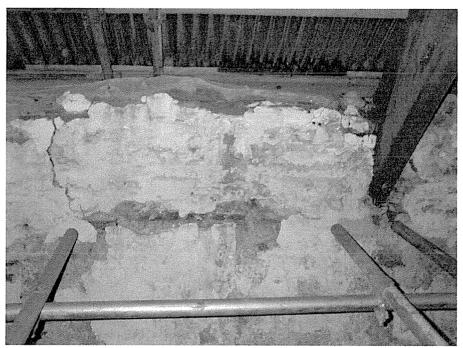
Plate 11: The height of the walls was raised when the outshhots were added to the rear of the cottages.

The major change to the form and layout of both cottages probably occurred towards the end of the 19th century when the walls were heightened and outshoots added to the rear (Plate 11). The entry passage between the outshoots was unroofed. The internal wall faces of No.2 reveal a distinctive horizontal break in the plaster finish around the line of the first floor (1) as well as a break in the bonding of the south and east and south and west walls at around 3.1m from ground level (2). Despite intrusive woody growth within the southeast corner of the cottage, it is apparent that the south and east walls are well bonded up to this level and therefore must be of one structural build phase. However, above this point the south wall abuts the east wall and is therefore of a later structural phase. This division can also be seen in the junction of the south and west walls (10) and a ledge in the west end of the north wall (12) represents the original early 19th century wall top. To light the new upper floor, two over two pane sashes were introduced to the first floor (7) & (3), and the same form of windows were also added to the ground floor (19). There was presumably a further window opening to the left of the front door, though this would have been lost through the later insertion of a larger garage door (8). To access the first floor a stair was located

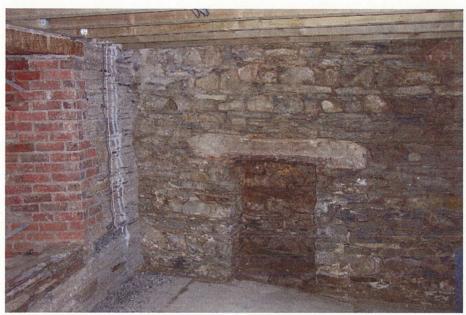
Plate 12: Fireplace inserted into the party wall in No.2.

Presumably, at the same time as the walls were heightened a fireplace was also added to the western (party) wall to provide heating to the new first floor accommodation (11). A further fireplace also appears to have been added at ground floor level of this wall (21 – Plate 12). The presence of fireplaces within this wall does however indicate a shift in emphasis within the cottage, the room to the right remained the kitchen and day-to-day room, but the now heated room to the left was now the principal room for important activities. It is also likely that the current range (18) was introduced at this time, replacing a much simpler form of heating and cooking within the inglenook fireplace (plate 13).

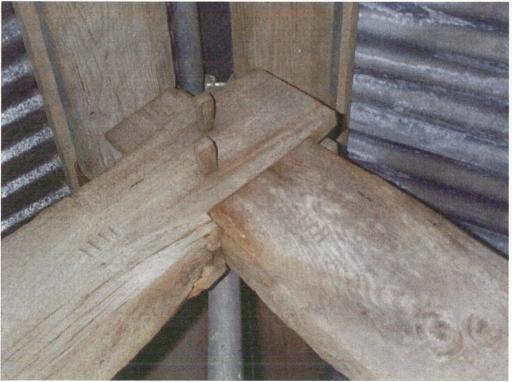
Plate 14: The central truss in No. I showing the carpenters' marks (IIII).

It is also worth noting the truss details in both No.1 and No.2. There are three trusses forming the roof structure in each cottage; they consist of two principal rafters bridle jointed at the apex and a tying collar beam forming an 'A' frame. There is a varying range of collars and purlins, some trenched into the principal rafters and some not. There are four sets of trusses which have carpenters marks, the eastern (mark is V), the central (IIII), and western (III) truss in No.1, and the eastern truss in No.2 (II). Given the inconsistencies in purlins and collars, and that there is a total of six trusses only four of which are marked with carpenters marks in an incoherent fashion, it is save to assume that these roof timbers are reused (plate 14).
