HERITAGE IMPACT STATEMENT

FORMER PROVISIONS MARKET, CARMARTHEN
STREET, LLANDEILO

PEMBROKE DESIGN LTD

JULY 2019

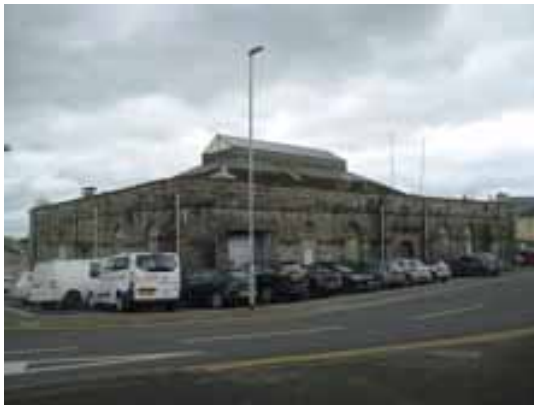
Market exterior: Asphalt flat roof with solar reflective coating over concrete slabs and steel beams. The roof is punctured by glazed metal lanterns with fibre cement cladding, a variety of flues and two red clay chimney pots. The central area has a hipped pitched roof with corrugated and flat fibre cement sheets and glass panels within metal framework. Lead lined outlets fall into cast iron hoppers draining into UPVC downpipes. UPVC soil and vent pipes and waste hoppers are located on the north east elevation only. Walls are built of exposed coursed squared stonework laid to banded diminishing courses with recessed panels, stone string and impost courses. The north east elevation is less formal with odd traces of limewash amongst the random rubble stonework with flush concrete bands mimicking the string course with red sandstone quoins at the corners and around openings. There are several different types of pointing but the majority has been undertaken in cement raised ribbon style. The main entrance along the south west elevation has a red sandstone moulded door surround with keystone arch and depressed spandrels. Above is a recessed niche with stone carved letter block. The side entrance to the north west elevation has lugged stone surround with flat arched head. Arched openings are finished with stone voussoir with concrete lintels to large flat heads and concrete window cills throughout. The parapet is finished with concrete copings. A built up opening to the north west elevation has a brick arch. Painted metal fixed and opening casement windows and fitted with plain and textured single glazing, some with arched heads. External doors are all painted timber with the large ones folding into leaf's with framed ledged and braced boarded panels. Timber doors along the north east elevation of similar construction are smaller. Doors to the south west and north west elevations are flat panels decorated with raised timber beading with arch and narrow panels. There is a painted iron gate to the south west elevation lined with plywood internally. A Victorian post box is built into the south west elevation.

Figure 7 above: Market viewed from north west

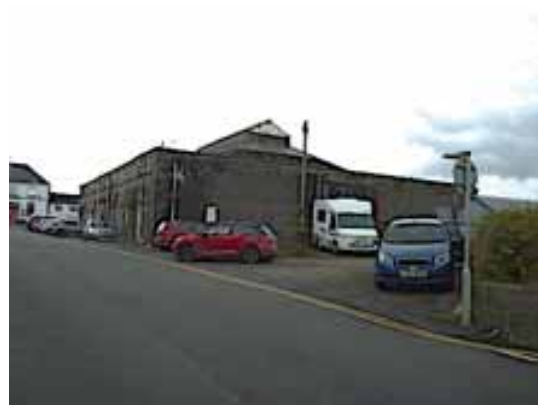
Figure 8 above: Market viewed from south west

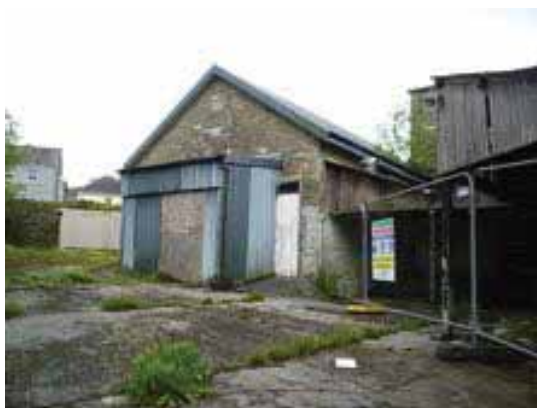
Slaughter house exterior: Powder coated metal sheet pitched roof covering with angled ridges and verge overcloak's. Painted timber fascia and UVC rainwater goods. Partly modified timber roof structure with king posts, timber purlins and steel beams added for hoists. Exposed random rubble stonework and painted render walls. Stone voussoir to round arched heads and stone cills to windows. Traces of limewash and paint over stone. Carved stone date plaque. Powder coated corrugated steel store room. Painted timber windows with plastic panes, mesh and iron bars. Painted timber framed, ledged and braced doors.

Figure 9 above: Slaughter house viewed from north east

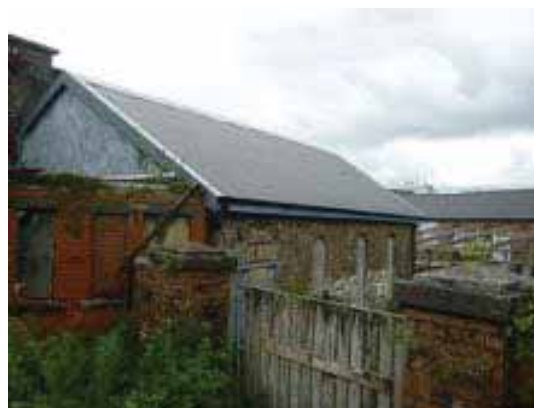
Figure 10 above: Slaughter house viewed from south west

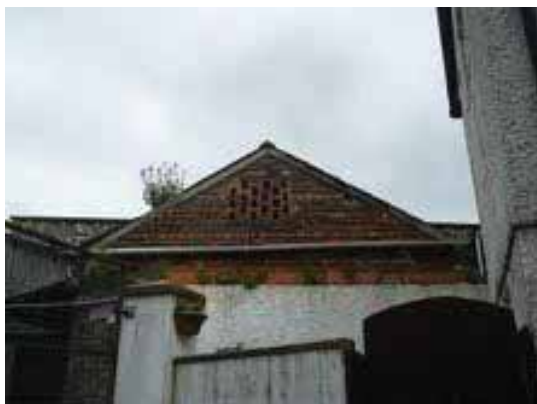
Figure 11 above: Store shed viewed from north east

Store shed exterior: Pitched roof covered with natural Welsh slate and artificial slate. Mix of interlocking through coloured blue/back clay tiles and glazed terracotta butt jointed ridge tiles. Rendered barge, painted timber fascia with UPVC and painted cast iron rainwater goods. Partly modified timber roof structure with king posts and steel beams added for hoists. Exposed random rubble stonework to walls with painted and fair faced brickwork, painted render. Missing bricks for ventilation to gables with concrete lintels above openings. Painted timber framed, ledged and braced doors.

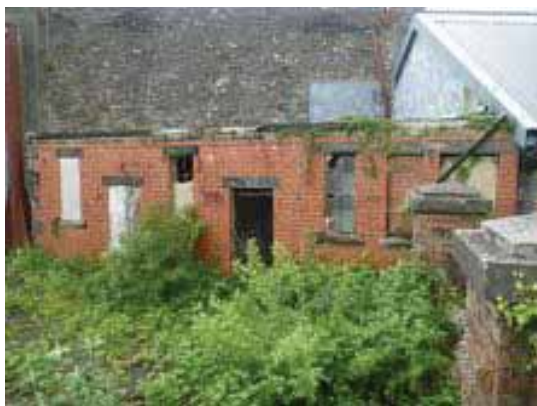
Figure 12 above: Toilet block viewed from south east

Toilet block exterior: Felted flat roof covered with bitumen and solar reflective coverings with UPVC rainwater goods. Facing brickwork walls with concrete lintels and cills. Concrete quoins and plinth course. Boarded up windows and doors. Interior not accessible.

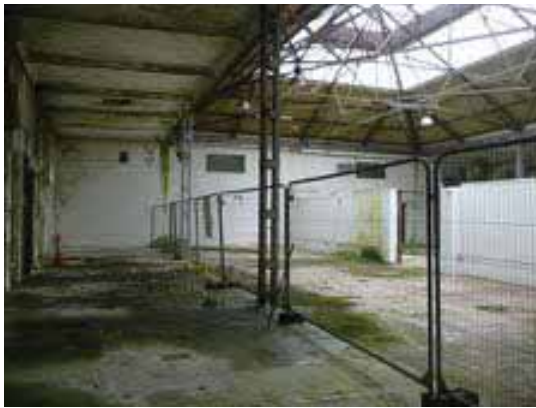
Market interior at upper ground and mezzanine levels: Largely modernised with painted and unpainted plastered walls, some drylined with plasterboard and plywood. Traces of limewash under some finishes. Painted steel columns and posts with unfinished iron fink type trusses. Plywood, timber board and painted concrete ceilings with exposed steel beams. Exposed underside of corrugated fibre cement roof sheeting. Exposed concrete floors and timber board mezzanine timber floors served by timber stairs. Partitions are a mix of solid painted, plastered brick and concrete block, timber stud with hardboard linings. Tiled fireplaces to north wall. Early C20th painted panelled and boarded timber doors with textured glass panels. Textured glass fanlights within metal frames. Large boiler with stainless steel flue to east corner. Disused glazed lanterns infilled with timber boarding. Roller shutter galvanized door behind gate to south west elevation.

Figure 13 above: Market interior main space viewed towards north west corner

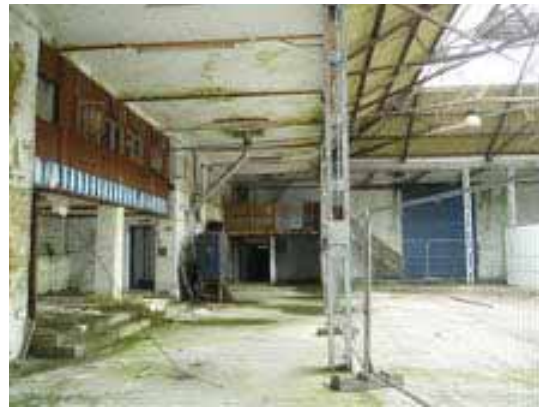
Figure 14 above: Market interior main space viewed towards south east corner

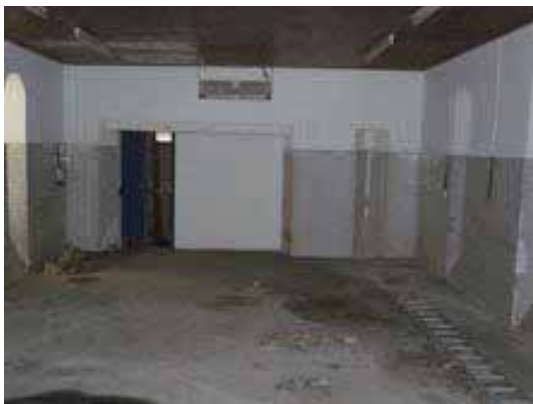
Slaughter house interior: Varnished plywood ceiling and exposed underside to corrugated metal roof covering. Painted plaster walls and white ceramic tiles to mid wall height including window reveals. Exposed concrete floor with ramps.

Figure 19 above: Slaughter house interior east end

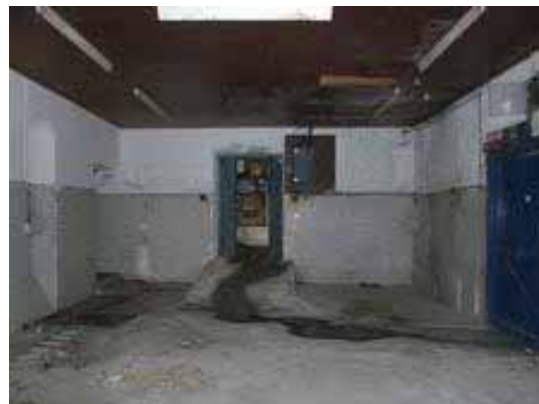
Figure 20 above: Slaughter house interior west end

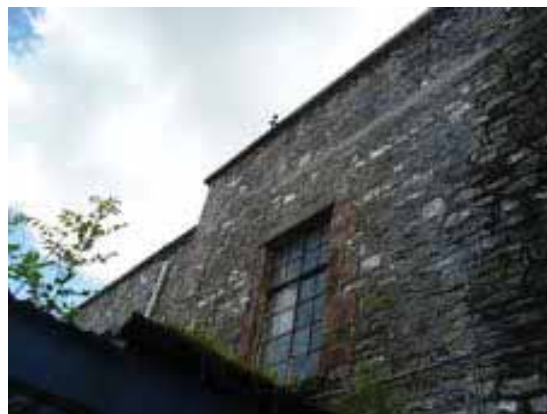
Stonework to the rear north east elevation of the market is much poorer than the rest of the building with random rubble and string course continued in concrete, suggesting this area was perhaps raised in the C20th. Isolated sections of red sandstone have been incorporated along upper level, supplemented with red sandstone quoins lining window reveals which are clearly later C20th origin with concrete cills and lintels. Many of the stones at upper level appear to have been recycled too with traces of lime wash. Red sandstone was used to pick out the entrance door to the south east elevation with moulded stone architrave with keystone arch and depressed spandrels and suspect this is a later addition too.

Figure 26 above: Stonework to north east elevation

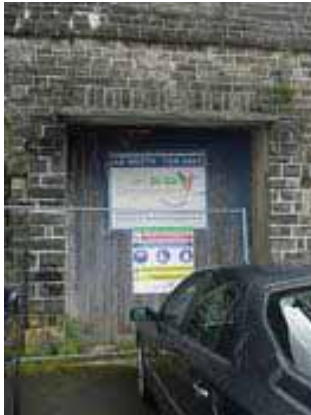
The design to the main façade along New Road and Carmarthen Road is markedly different with squared rubble laid to diminishing courses set with impost band connecting half round stone arches to blind recesses. The parapet also has a projecting stone string course with sunken rectangular panels. This has probably not changed much since the original construction. C20th work appears to be the addition of a raised parapet with opening up of some of the blind panels with small arched windows and perhaps later, the creation of large rectangular openings given the concrete lintels above.

Figure 27 opposite: door to south west elevation

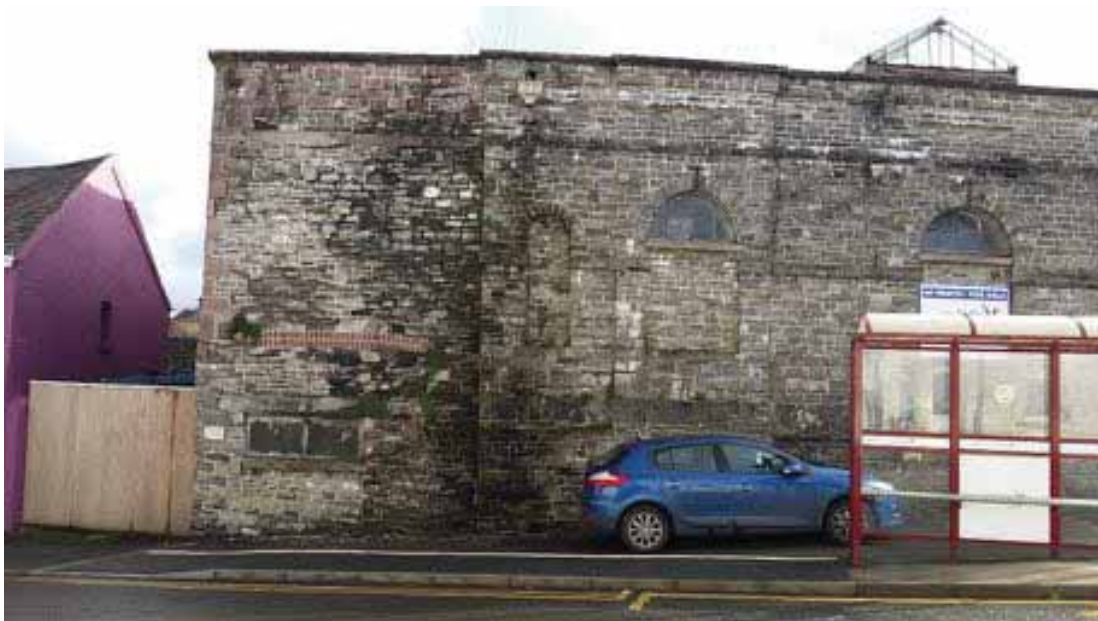
Figure 28 above: Contrasting market stonework along north west elevation highlighting different periods of construction and style

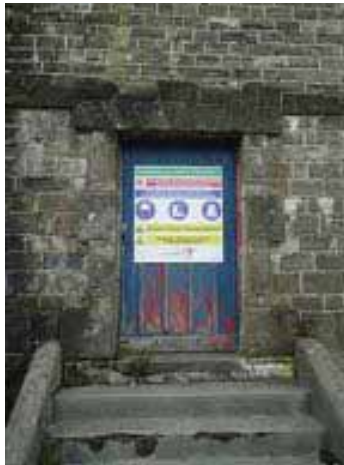
Most of the external doors date from the late C20th but there are a couple on the market which are likely to be earlier. Although the door to the south west elevation boarded over now, they share the same design and detailing as the exposed door on the north west elevation. Planted beads create long panels with an arched head and internally the door is lined with diagonal boarding. The south west door no longer serves the market due to the additional of a small room in the southern corner which is only accessible from the external door. The Victorian post box in the south west elevation appears to be a later insertion rather than part of the original design.

Figure 31 above: Door to north west elevation of market

Fragments of the southern door to the market south west elevation may remain behind the boarding which will allow a like for like replacement. The door detail has been recorded in earlier photographs however and a matching door on the north west elevation will allow for a faithful replacement.

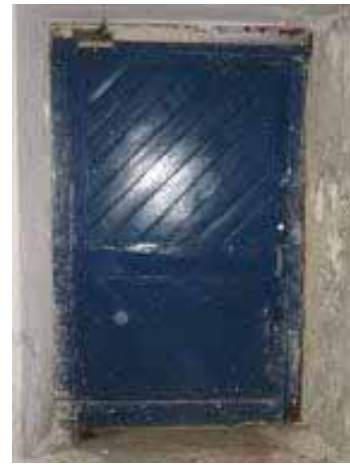
Figure 32 above: Door to north west elevation of market viewed internally with diagonal boarding

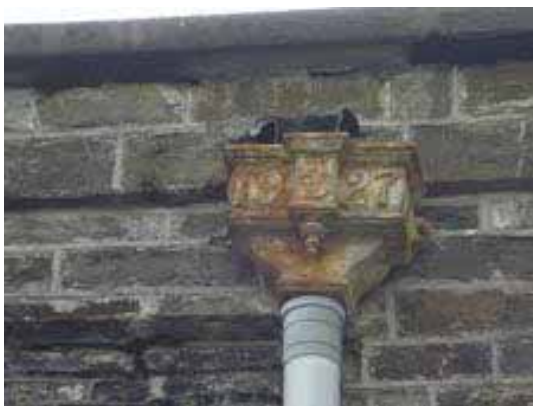
All wall tops throughout appear to have been rebuilt with C20th concrete copings laid onto damp proof course. The flat roof is likely to have been introduced in the early C20th and some of the cast iron hopper heads are dated 1927. The different types of hopper does suggest slightly different periods of construction however. There does not appear to be any evidence of former downpipe fixings other than the 1927 ones. This supports the idea that the earlier roofs were perhaps a shallow lean-to draining into the courtyards.

Figure 34 above: Hopper to market north west elevation

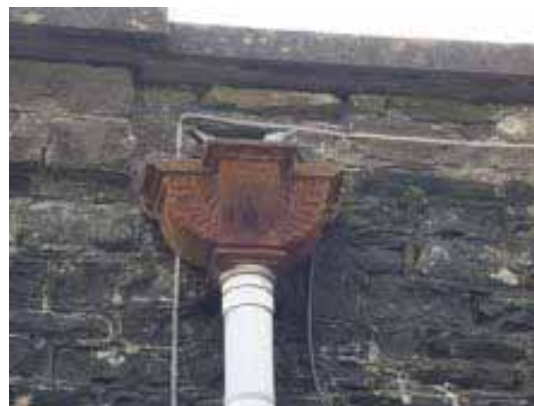
Figure 35 above: Hopper to market south east elevation

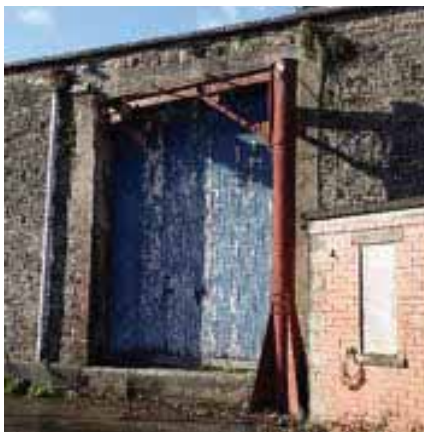
Figure 37 above: Hoist from iron foundry - - source Pembroke Design Ltd

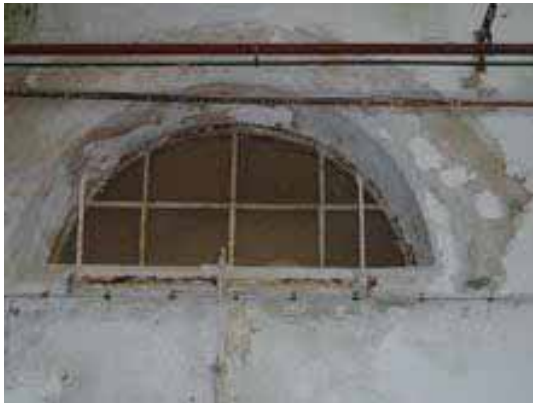
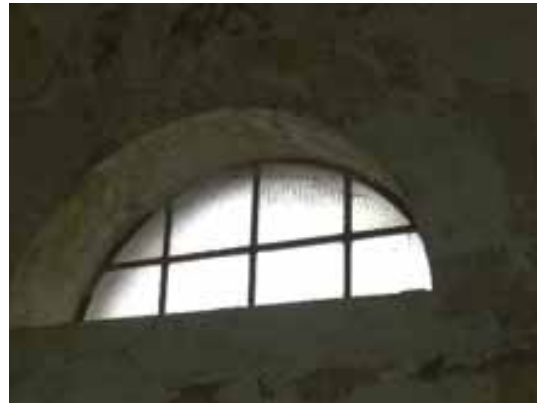
Large door openings to the south east and north west elevations were inserted later. A brick arch inserted in the north west elevation has been partially infilled and fitted with modern timber window. Whilst the current arched metal windows are clearly C20th, there is speculation as whether the blind arch recesses were fully glazed originally. There is evidence of alteration around the current windows with making good. Fully blind recesses would have worked better with the original layout as shallow structures laid out around the two courtyards did not need the natural light from Carmarthen Street or New Road. The stone used in the recesses is consistent with the building too, although could have come from demolition of the early central wing. The south west and parts of the north west elevation are laid out in diminishing courses but masonry below the windows is laid to equal coursing. This may have been part of the original design however and internally, there is no suggestion of infill. The making good around the windows with strips of render and exposed brick to the arched reveals would probably not have been necessary if simply removing infill too.

Figure 39 (left) and Figure 40 (right) above: typical arched metal window inserted into north west and south west elevations

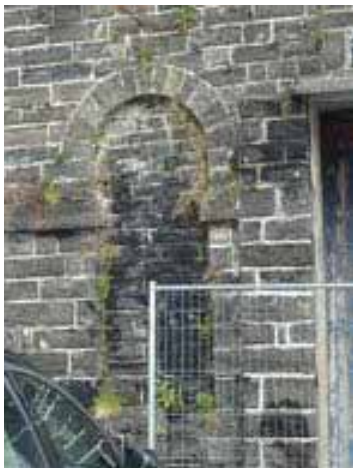
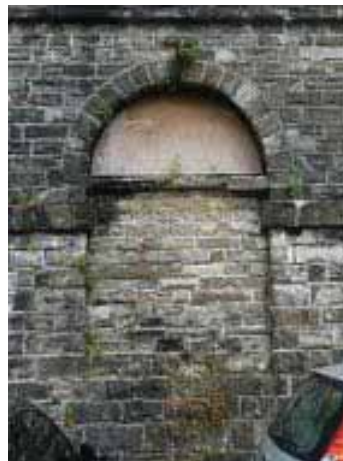
Figure 41 (left) and Figure 42 (right) above: Example of retained smaller blind panels and larger panels with windows inserted

Consented drawings show the opening up of the smaller blind opening for the louvre but it is proposed that this opening be fully glazed instead with the louvre located in adjacent existing rectangular opening. The consented main market space is being reduced in size but is still intended for use as a market or event space as well as office break out space. New partitions subdivide the rest of the main market space into offices, meeting rooms and stores. The consented ramp is relocated slightly with no change in floor levels. As with the rooftop extension, the proposed hoist to the north east corner is omitted but the adjacent proposed staircase remains. A new door opening is created in the stone wall providing ramped access between the different upper ground floor levels. Proposed accommodation along the north east wall also becomes office space with minimal alteration except for a new fire escape staircase in the south east corner to provide sufficient means of evacuation for the additional office accommodation created on this level. This proposed new staircase descends into the lower ground floor of the market below linking office accommodation on both levels. An adjacent existing door opening with steps is to be built up but this could be reversed in the future. The floor between these levels is already planned for replacement in the current consent but it is thought to be a later addition too with modern upper floor finishes.

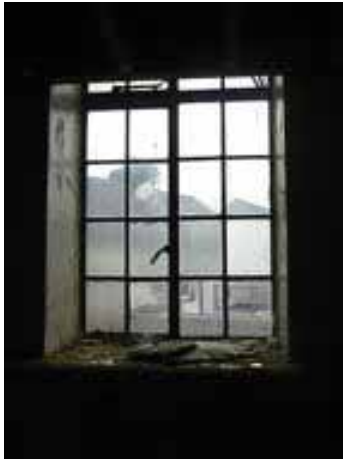
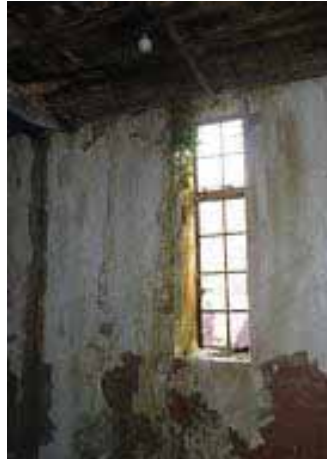
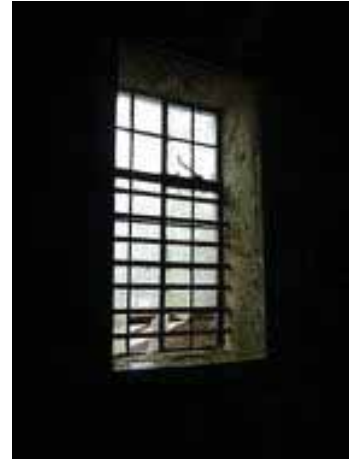
Figure 43, (left) Figure 44 (centre) and Figure 45 (right) above: typical rectangular metal windows inserted into the upper ground floor level of the north east elevation

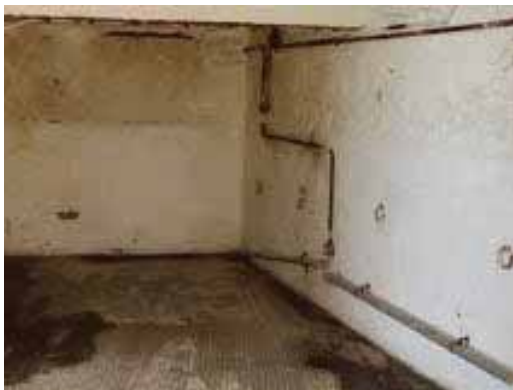
Within the eastern store room, there are also old tethering rings built into the wall which would have been used to tie up animals. The buildings at low level also exhibit larger areas of lime wash which was important for cleanliness.

Figure 46 left: Above tethering rings – source Pembroke Design Ltd

Figure 76 above: Area of proposed new staircase to south east corner in market upper ground floor level with door opening to be built up. See also Figure 46 showing area on lower ground floor

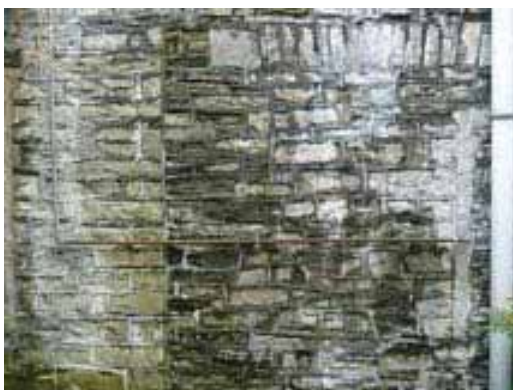
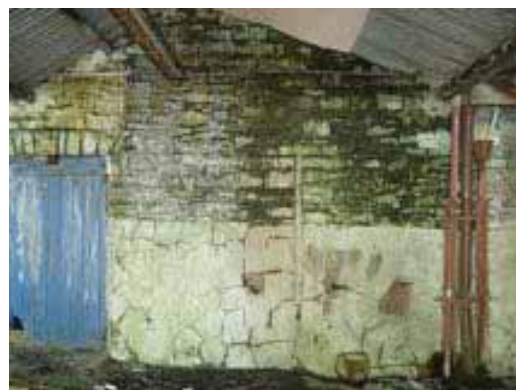
The lower ground levels of the market north east elevation have number of splayed vents, window and door openings that have been fully been built up. These suggest that the area was used to house livestock, possible prior to slaughter.

Figure 47 (left) and Figure 48 (right) above: old openings to north east wall at lower ground level – source Pembroke Design Ltd

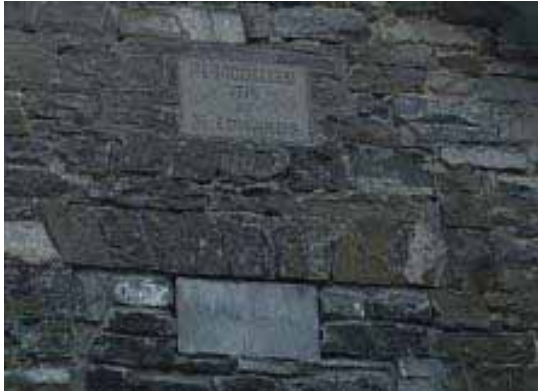
The former slaughterhouse was also modified in the C20th with stone block dated 1914 located on the gable. A window opening was modified to create the east doorway but both west and north doorways are later additions with steel lintels and brick heads. A small window to the eastern gable of the former slaughterhouse has been built up and there is a blank stone which may have been intended for scribing. Traces of window joinery remain behind the slaughter house boarding with iron bars within timber frame. The interior has been partially tiled and again is thought to hail from the early C20th. The roof structure has been altered with king post trusses cut and modern treated timbers and steel beams inserted.

Figure 49 above: Stone plaques to former slaughter house – source Pembroke Design Ltd

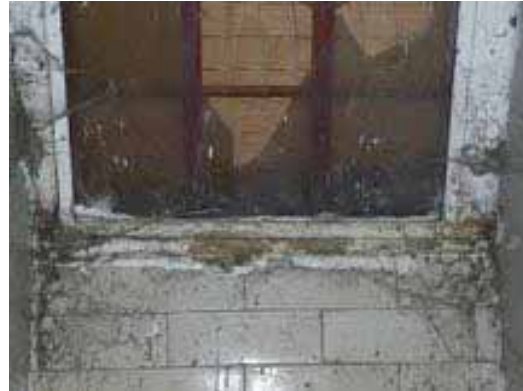
Figure 50 above: Window/tiling remains to former slaughterhouse – source Pembroke Design Ltd

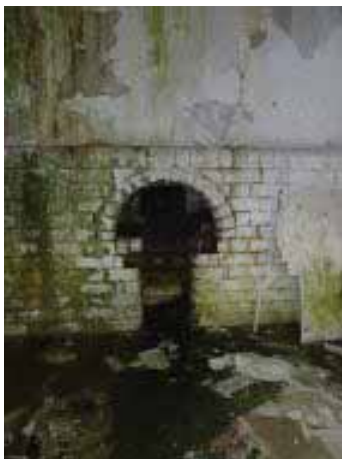
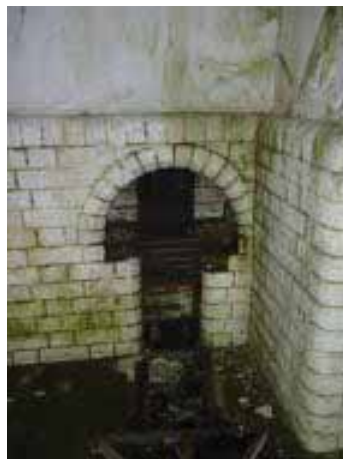
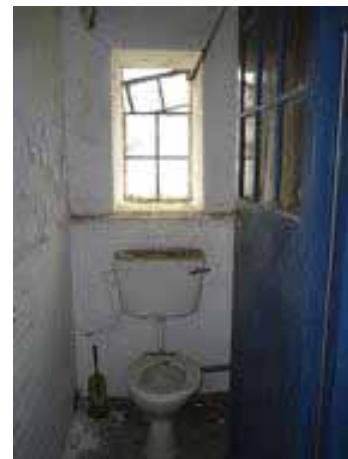
Internally, all buildings have been altered and modernised. Early C20th glazed bricks exists to a couple of fireplaces within the market together with bullnose course within a couple of toilets. A few doors from this period but otherwise, only the basic fabric provides any early evidential information.

Figure 51 (left), Figure 52 (center) and Figure 53 (right) above: Market glazed bricks found in the central area of the north east wall only

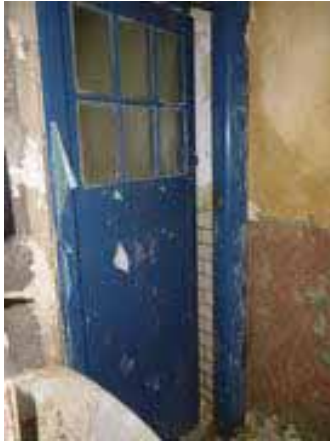
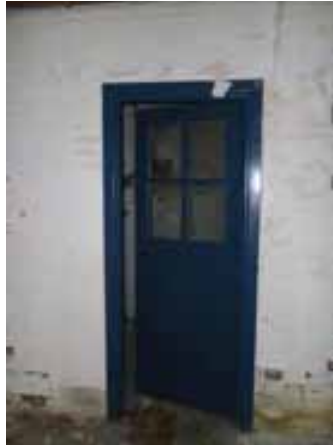
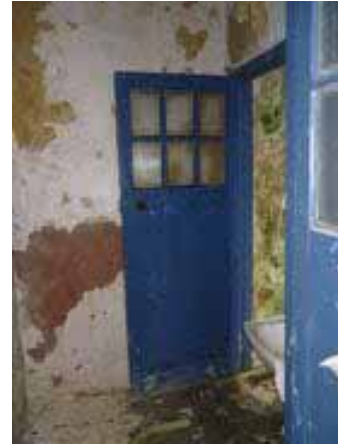
Figure 54 (left), Figure 55 (center) and Figure 56 (right) above: Market internal doors from 1920- 1950's

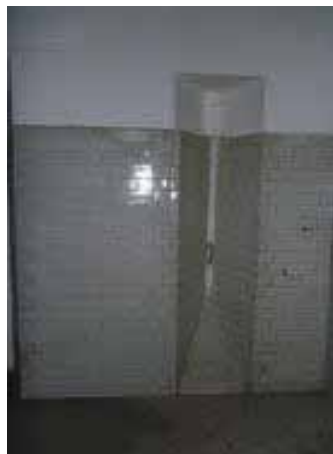
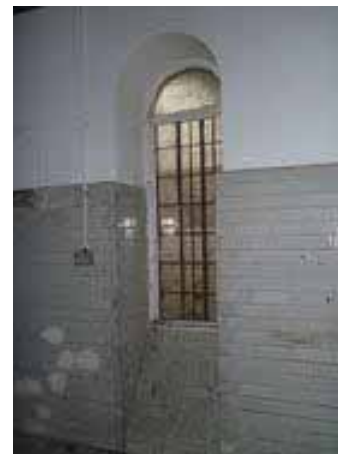
Figure 57 (left) and Figure 58 (right) opposite: Slaughter house tiling from the early C20th

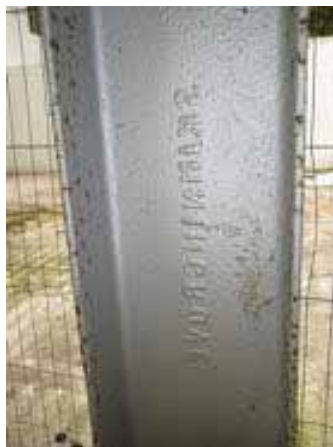
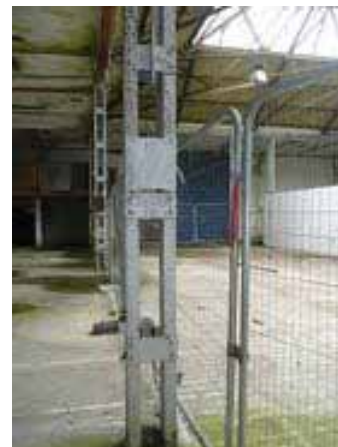
Steel columns supporting the market glazed roof are fabricated in sections with the foundry mark of 'Skinningrove' and are likely to be pre-1950's. The same mark was found on other steelwork in the former slaughter house from a later date however. This steelworks was formed in 1880 in North Yorkshire initially producing pig iron then steel and specialised in long products. The flat roof has been punctured by various vents and flues with some openings built up and other lanterns appearing to be from different dates.

Figure 59 (left) and Figure 60 (right) opposite: columns supporting market roof

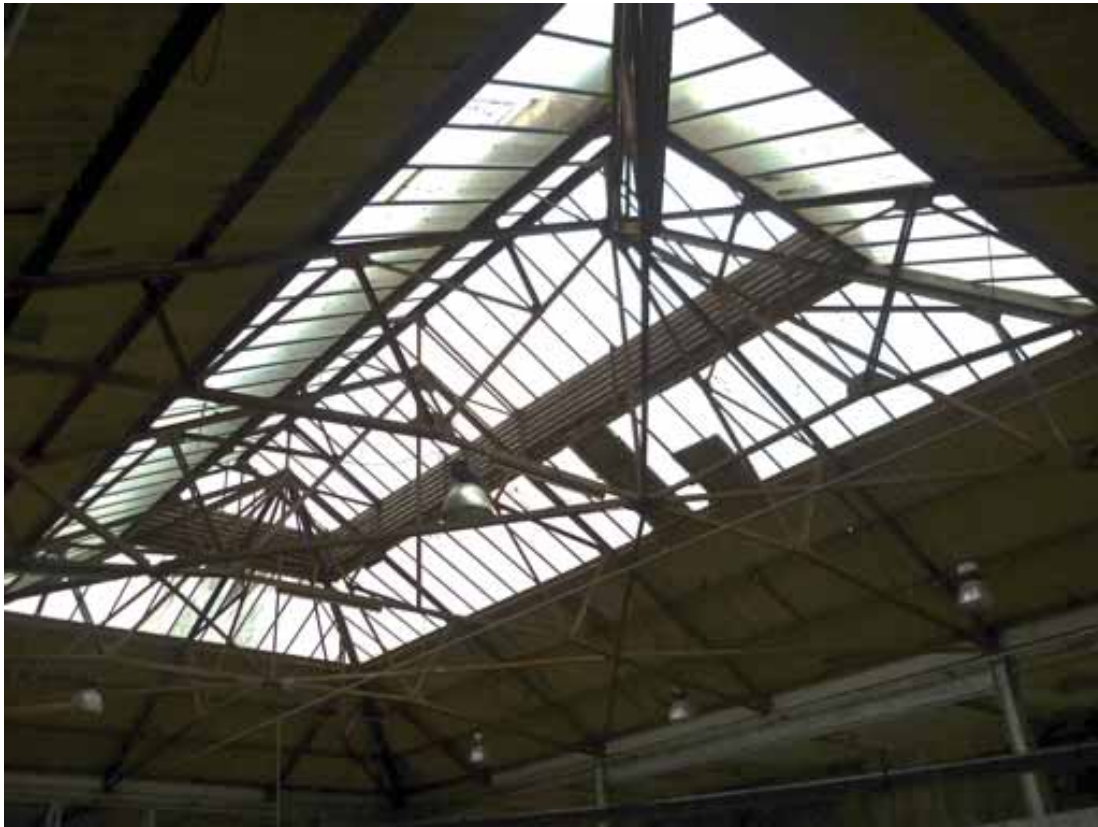
Figure 61 above: Glazed roof above market with early C20 steel trusses and uneven thickness glass panes

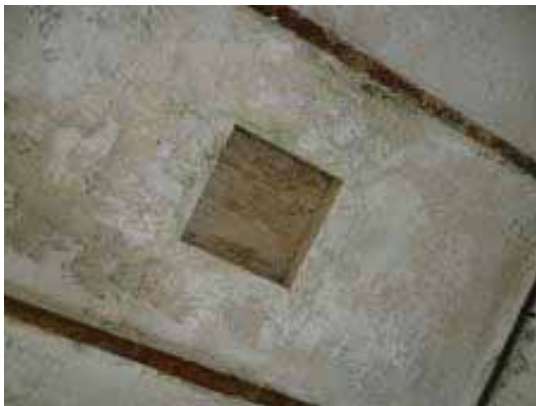
Figure 62 above: Boarded aperture to market flat roof

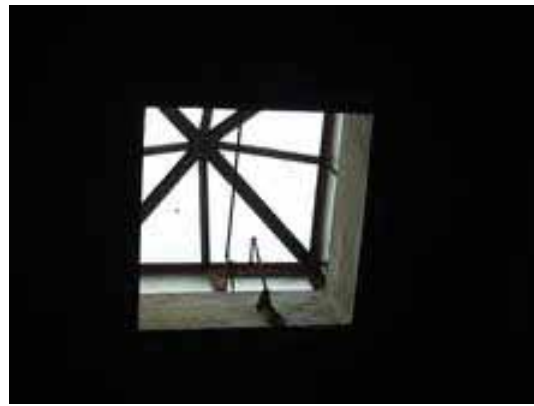
Figure 63 above: Glazed lantern mid C20th to market flat roof

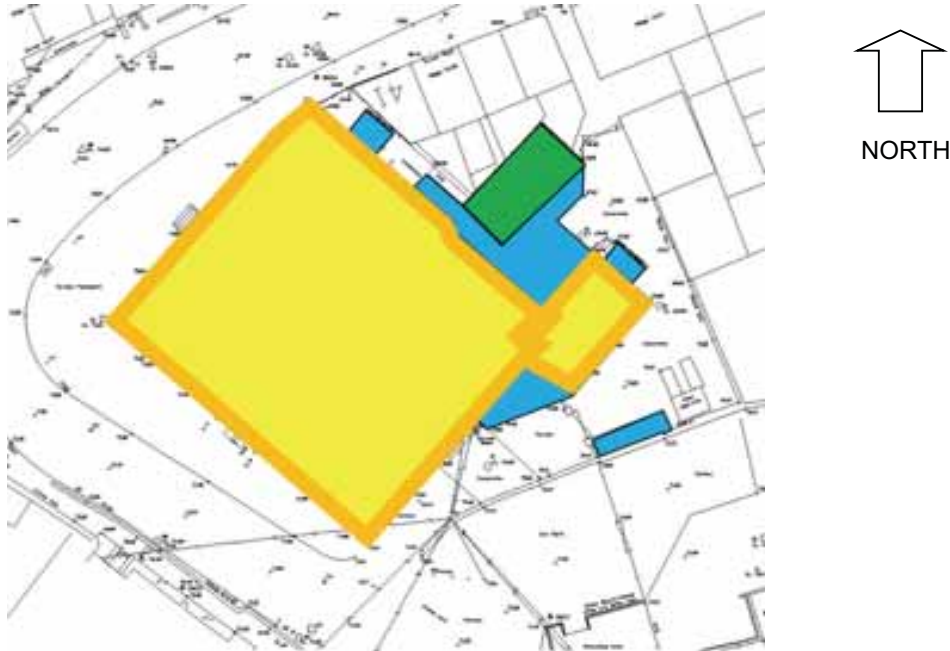
Figure 64 below: Taking into account alterations, the significance of the building can be illustrated as follows

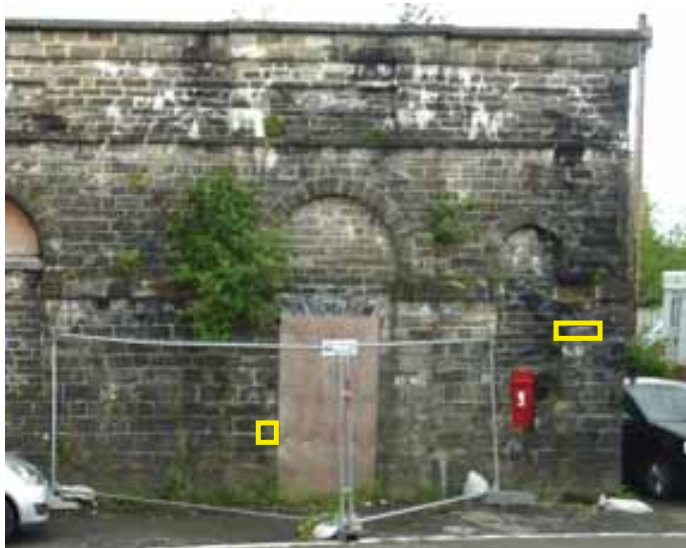
Stone repairs to the southern end of the south west elevation have been identified in the condition report but essentially entail the replacement of 2no. missing stones. This work can be undertaken on a like for like basis and is necessary to prevent further loss of masonry and minimise risk of further deterioration such as vegetation growth, risk of frost and salt contamination from saturation of exposed core masonry. Work is confined to a local area and will be undertaken using traditional materials such as lime mortar with stone salvaged and reused from the works. Works comply with Cadw Conservation Principles due to understanding the impact of the repair, minimal intervention, sustaining heritage values and use of tried and tested materials.

Figure 73 above: Missing stones highlighted in yellow and boarded up door to be replaced on southern end of market south west elevation

The proposed stone repairs are confined to a small local area. Matching stone will become available from the opening up of the blind windows so the repair work will be discreet. The repair will prevent further loss of stone and deterioration and help conserve the striking masonry to this building. Using lime mortar, the repair will be undertaken like for like with traditional materials with proven durability. As the stones have already been lost, there will be little disturbance to fabric other than raking out mortar locally with negligible impact upon evidential values. The work will have beneficial impact upon significance by reinstating lost detail.

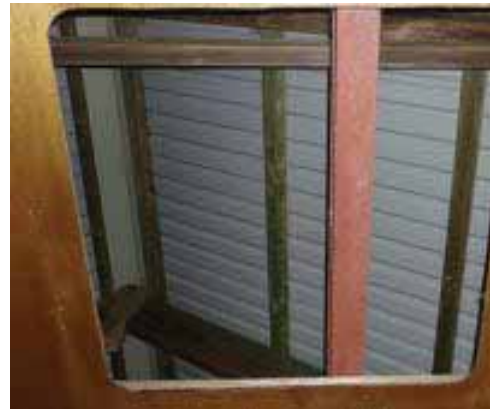
The corrugated metal roof is a later replacement and its prominence in the conservation area is particularly evident due to eye level position opposite the open space of car park. New steel beams and timber purlins have also been inserted but the C19th trusses remain. The top of the king post was notched for a ridge board with the roof most likely slated originally given the surrounding building finishes. Reinstatement of this traditional finish is therefore considered appropriate. The work complies with Cadw Conservation Principles in that it will enhance the setting without any further loss of historical detail with the current roof clearly a modern replacement.

Figure 74 above: View to underside of former slaughter house roof.

Although no old photographs of the former slaughter house have been found, the current corrugated metal roof is clearly a modern replacement with alterations to the roof structure. Given the singular use of slate in nearby roofs of similar period, we can be fairly confident that the former slaughter house roof was slated. The reinstatement of a slate finish will encourage the use of traditional building skills with more durability. It is also a more sympathetic material to the Conservation Area, particularly the visible prominence of the roof in the streetscape. The corrugated metal roof was raised above the C19th king post trusses on new purlins and therefore new purlins and rafters can be fitted slightly lower in their original position.

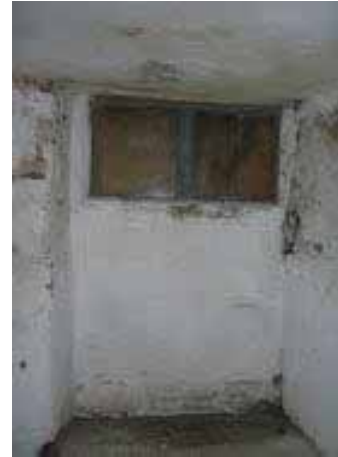
Figure 85 above: Window to be replaced in lieu of re-opening door – source Pembroke Design Ltd

Consented office accommodation on the lower ground floor level of the market is retained but the small kitchenette and toilet is relocated to allow for the new staircase in the southern end. There is no longer a need for an external door at the southern end of the north east elevation and therefore the existing window opening can be retained with widow replaced. Consented changing room spaces at the northern end of the market lower ground level are being changed to a plant room with no new partitions required so the single space reverts back to its current layout. Minor alterations are made to partitions around small kitchenette and toilet in the central area with vision panel added to the external door but the adjacent refuse area and new staircase remains as consented. No changes are proposed to store shed or former slaughter house which remain in office as use as consented. The vision panel is being inserted into a new replacement door with no further loss of original fabric. Whilst the vision panel improves connectivity between internal and external spaces it will only be local with other solid doors being retained to match original character.

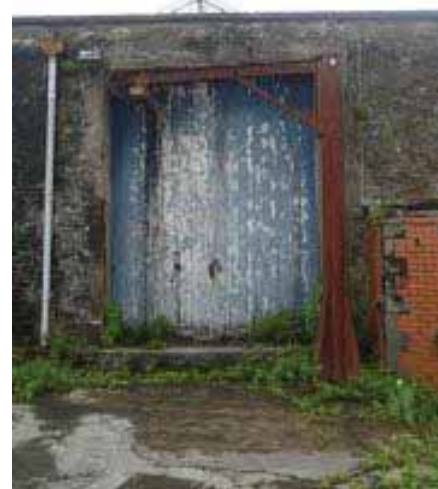
Figure 96 above: Solid door to be replaced with glazed door on market south east elevation with hoist retained

The proposed further subdivision of the main market space limits direct access to the central area and calls for a new entrance to create additional flexibility to allow this part of the building to be used independent of the offices. The large opening along the market south east elevation is probably a late C20th inserted for foundry use with external hoist located at the opening. Consented plans show the door to this opening being replaced like for like with a solid timber folding/sliding door but this does not particularly highlight it as another principle entrance. A glazed door would make it more attractive and create a visual connection for people approaching the building. It would also serve to make the interior space more welcoming with external aspect. The industrial feeling can be recreated by the use of glazing bars with horizontal emphasis and large glass panes. Retention of the external hoist and original proportions of the opening also helps minimise impact upon heritage values.

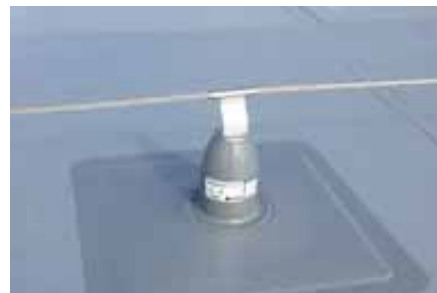
Figure 100 above: example of anchor point and cable within single ply roof finish

Cherry picker access is limited particularly due to neighbouring buildings, height and topography. The fitting of walkways and guard rails would be visible apparent with handrails 900mm above the roof and a roof and a fall arrest system is therefore being proposed as the least invasive solution. This will entail new anchor points incorporated in the new roof over the market hall connected with heavy duty cable. The anchors and cable will be located close to the roof surface and be in a similar colour to the roof covering. Fittings are also small scale and will also be set back from the edge of the roof to minimise visual impact. See Figure 104.
