St. David's Church, Blaenporth, Cardigan, Ceredigion Cardigan SA43 2AP

Archaeological Watching Brief

HRSWales
Report No: 245

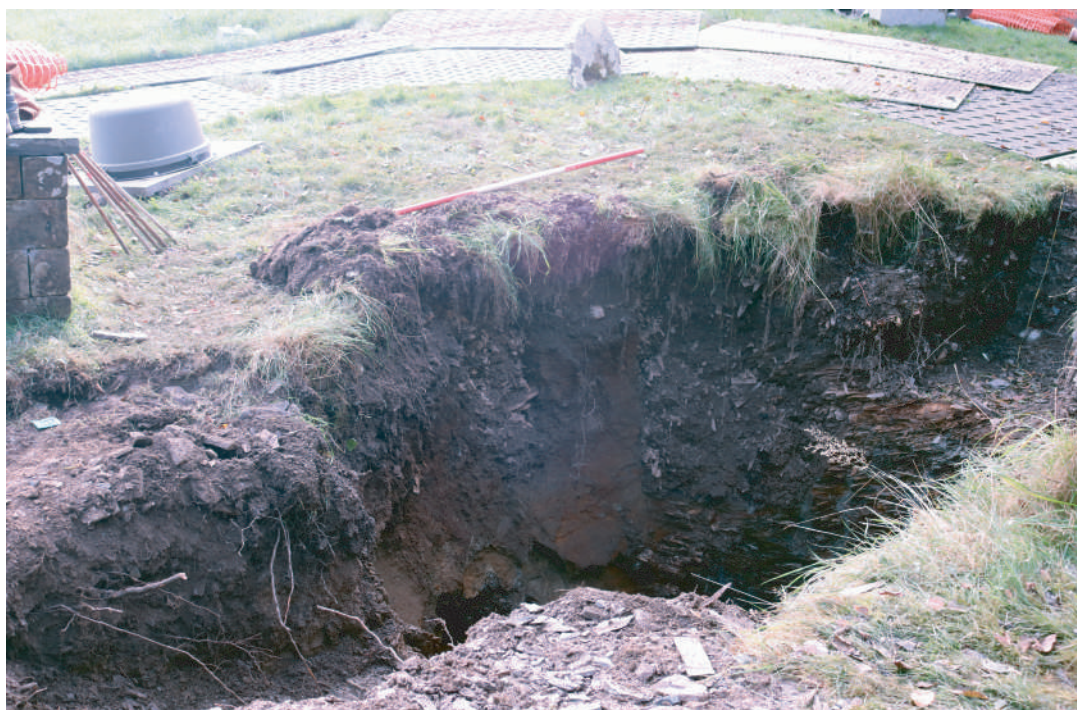
Plate 09. St. David's Church, Blaenporth - West facing section of pit for septic tank. Looking SE..

- 5.3 The excavation for the sewage treatment plant was undertaken within the footprint of the earlier evaluation trench undertaken in 2019. Once the turf (100) and top soil (101), which averaged only approximately 0.30m in depth only had been removed, the west end of a grave (102) became exposed (Grave 1). This was evidenced by a cut (103) and a fill (104) of loose shale on the east side of the trench, part of which had already been exposed in the earlier evaluation trench. The cut (105) and loose shale fill (106) of a further grave (Grave 2) (107) also became exposed immediately north of Grave 1. As with Grave 1, only the extreme west end of this grave became exposed and given that the trench was circular in form, only a small part of the second grave became exposed. Both graves had been cut into the natural shale mudstone (108) that appears at only approximately 0.30m – 0.40m from the surface. Both these graves remain undamaged and no dis-articulated remains from either grave were encountered. Further excavation of this trench revealed no further grave cuts or any other features. The natural shale mudstone appeared at approximately 0.40m.

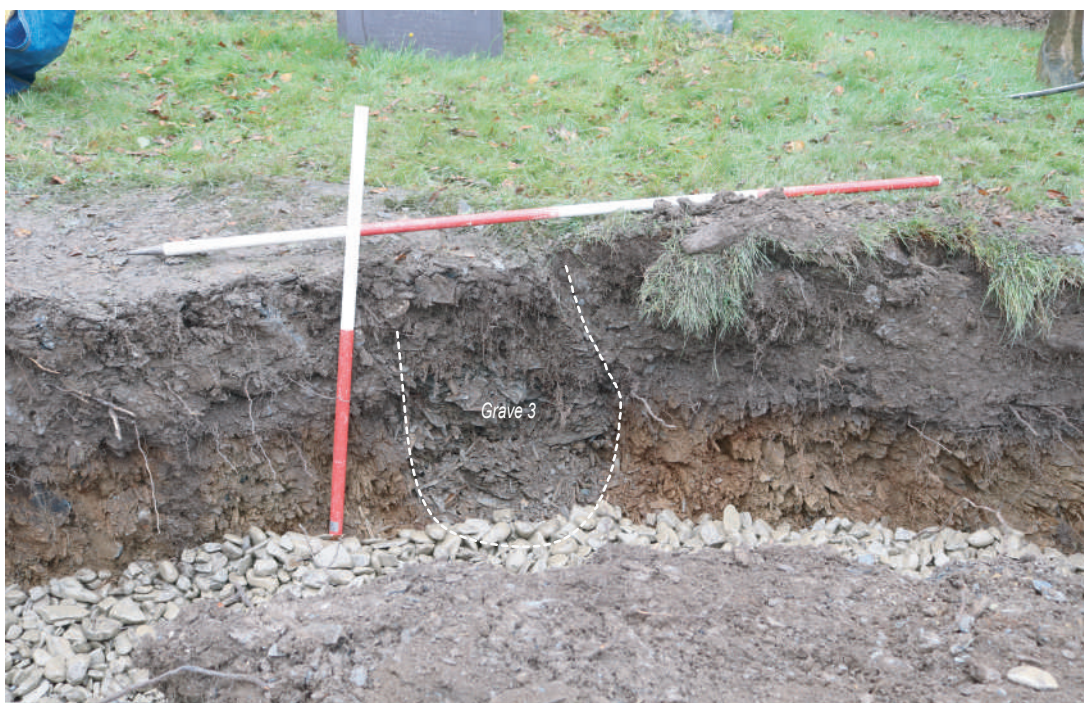
Plate 13. St. David's Church, Blaenporth - View of early grave cut in east facing section of drainage cut. Looking west.

- 5.4 Once the depth of the trench for the sewage treatment plant had been reached, which entailed considerable machine pecking through slate bedrock to the required depth of 4 meters, groundwork continued northwards for the creation of the new drain field. This entailed the removal of turf (100) and top soil (102) and the further removal of natural shale grit (108) to a depth of 0.50m only. This groundwork only exposed the eastern edge of one grave (Grave 3) on the western side of the trench, marked by a cut (109) and loose shale fill (110) as with Graves 1 and 2. Only two disarticulated remains were recovered from this groundwork and each was reinterred once the trench was back-filled. No further features or finds were recovered during this groundwork.

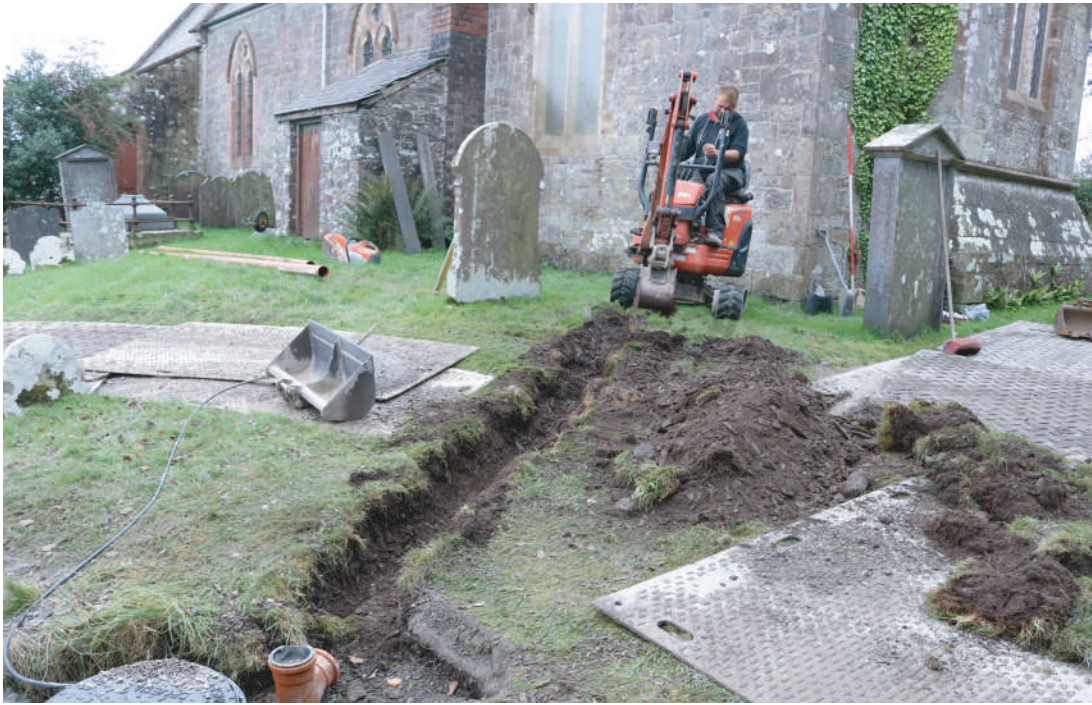
Plate 14. St. David's Church, Blaenporth - View of cut drainage trench from septic tank toward west end of church. Looking SE.

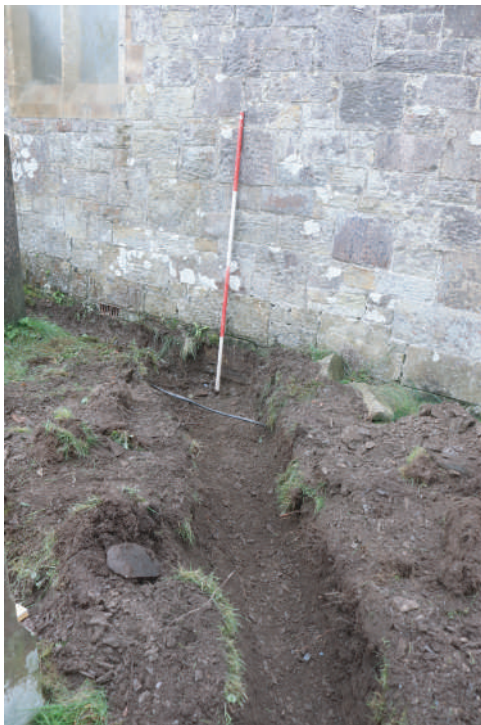
Plate 15. St. David's Church, Blaenporth - View of cut drainage trench alongside west end of church. Looking SE.

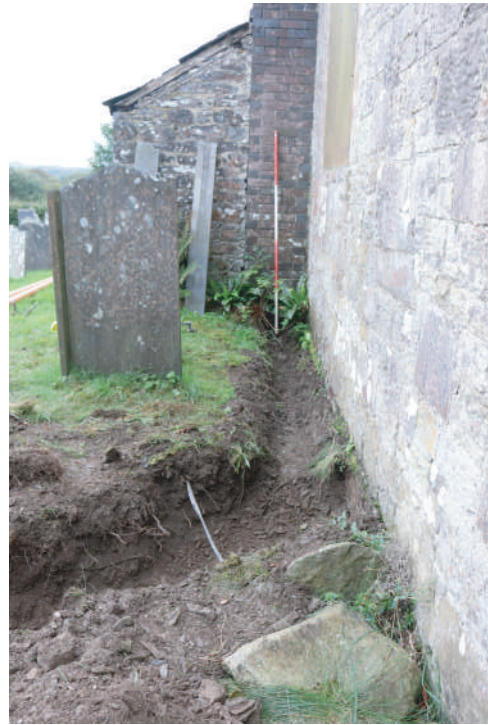
Plate 16. St. David's Church, Blaenporth - View of cut drainage trench alongside west end of church. Looking E.

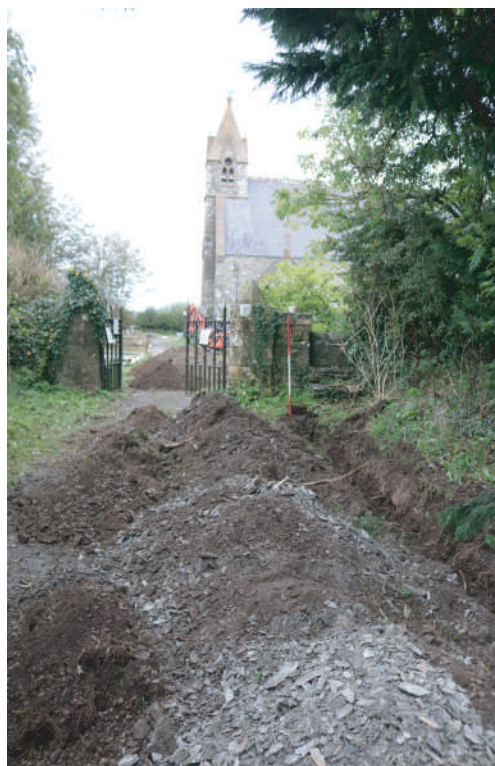
Plate 21. St. David's Church, Blaenporth - View of cut trench for proposed water pipe outside of cemetery entrance. Looking N.

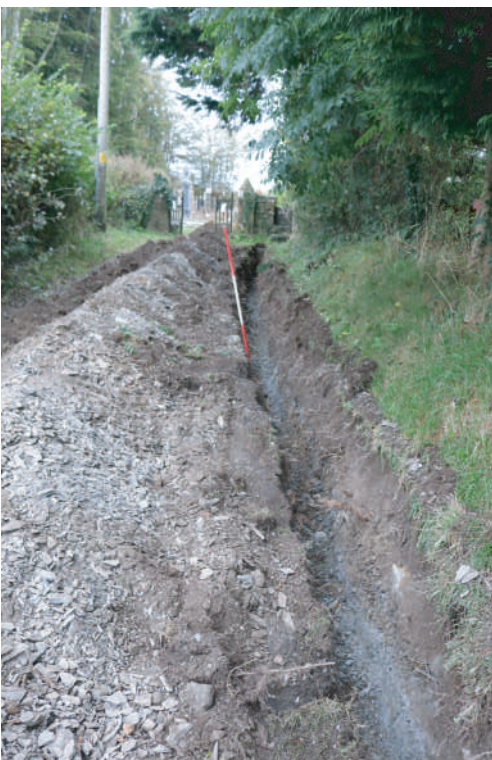
Plate 22. St. David's Church, Blaenporth - View of completed cut trench for proposed water pipe outside of cemetery entrance. Looking N.

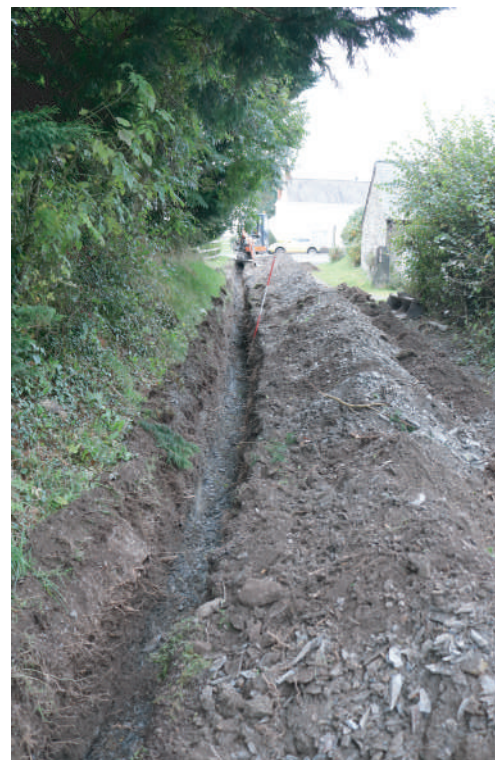
Plate 23. St. David's Church, Blaenporth - View of completed cut trench for proposed water pipe outside of cemetery entrance. Looking S.

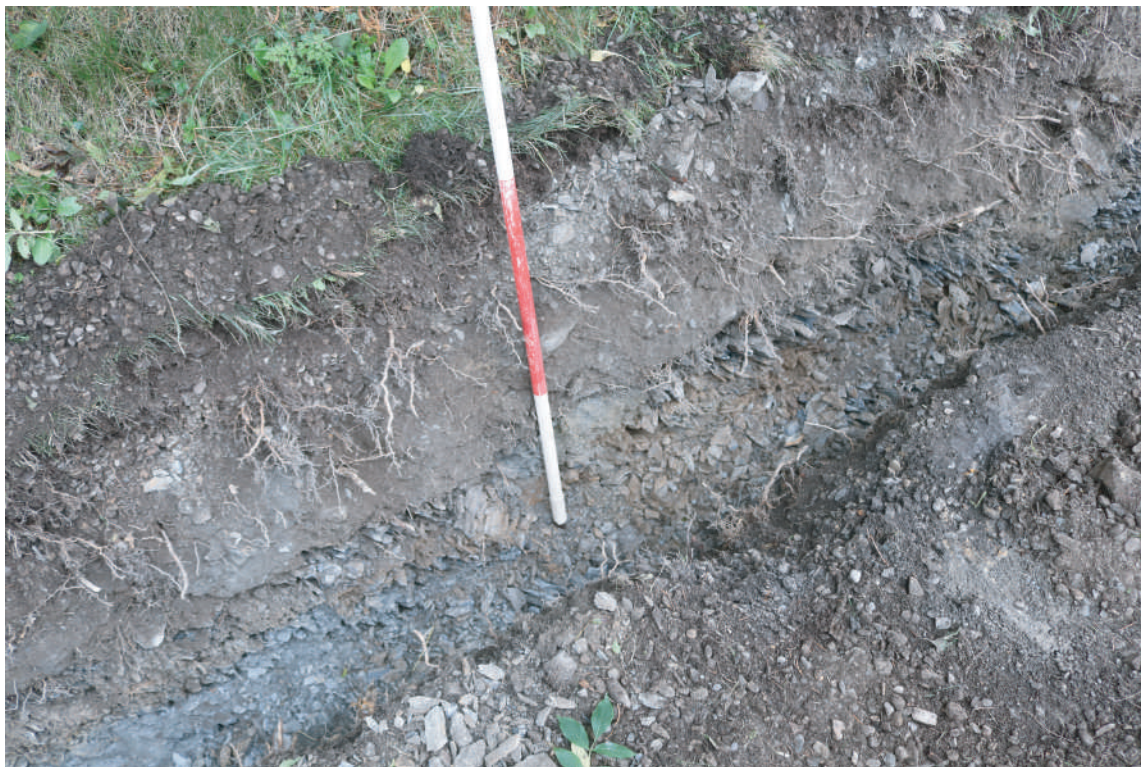
Plate 24. St. David's Church, Blaenporth - Typical stratigraphy in proposed water pipe trench outside of cemetery entrance. Looking SE.

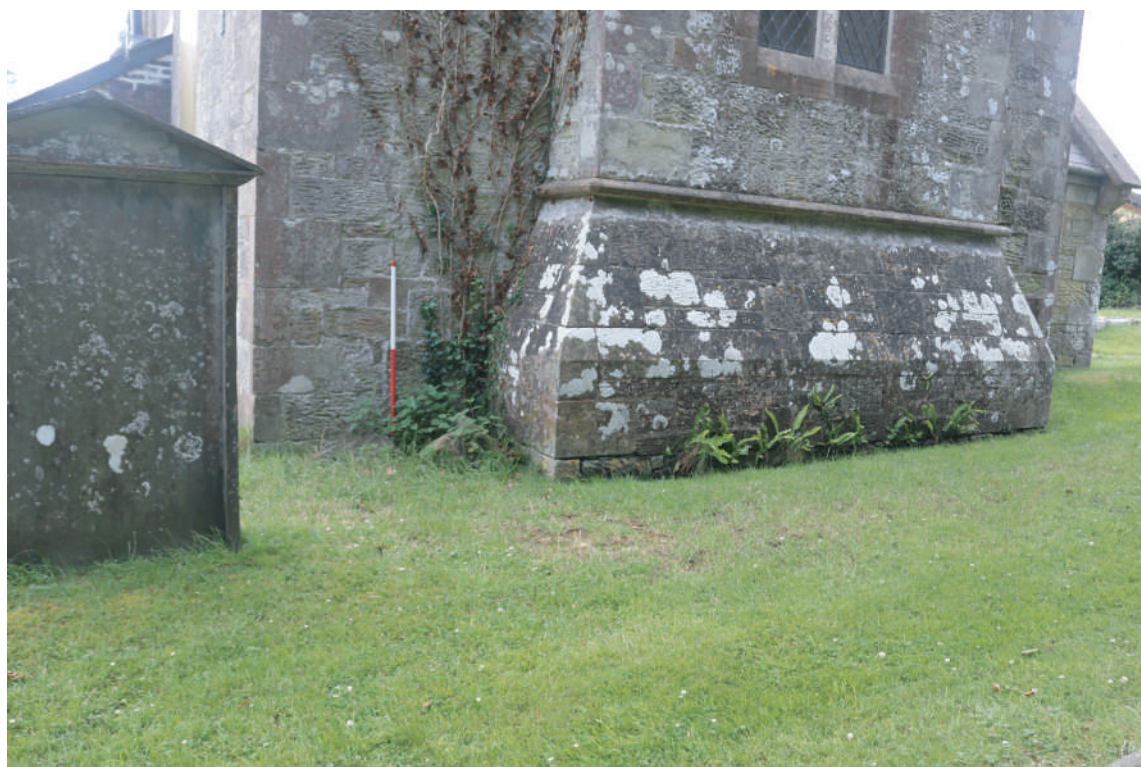
Plate 25. St. David's Church, Blaenporth - Position of proposed Lightning Conductor Plate 1. Looking E.

5.10 3) *Lightning Conductor Plates (see Photo Plates 25 - 34)*

5.12 *i)* The trench for Lightning Conductor Plate 1 (L1) was positioned at the far northwest corner of the church. Deposits encountered were the turf (100), top soil (101) and loose shale (102). No significant finds, features or deposits were encountered in this trench, other than the existing copper cable and rod for the pre-existing lightning conductor.

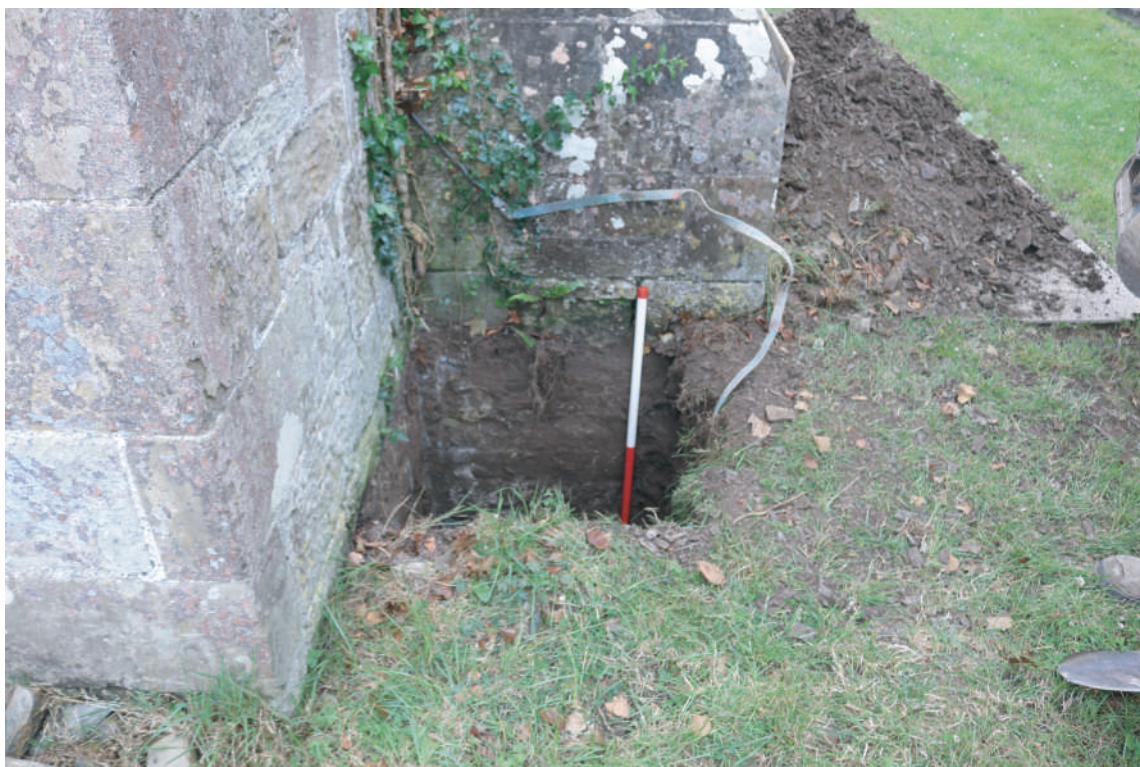
Plate 26. St. David's Church, Blaenporth - Completed Trench for Lightning Conductor Plate 1. Looking S.

- 100. Deposit – Turf
- 101. Deposit – Top soil deposit. Mid brown clayey deposit.
- 102. Deposit – Loose shale.

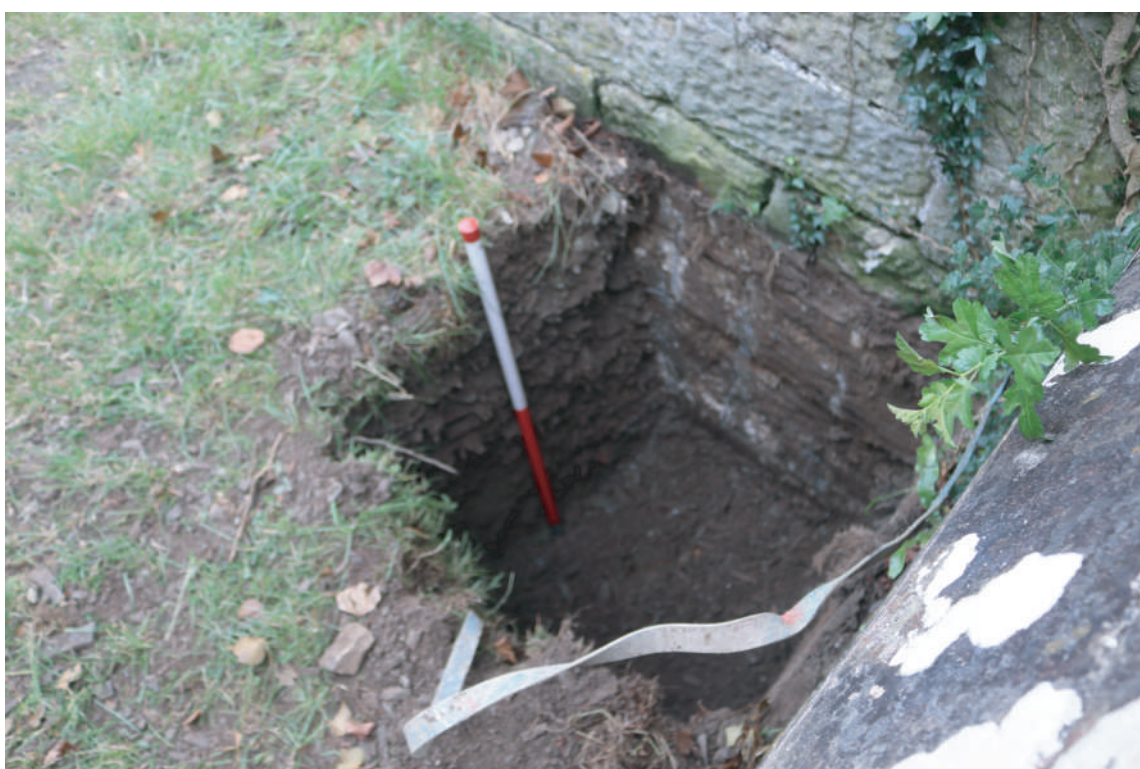
Plate 27. St. David's Church, Blaenporth - Completed Trench for Lightning Conductor Plate 1. Looking S.

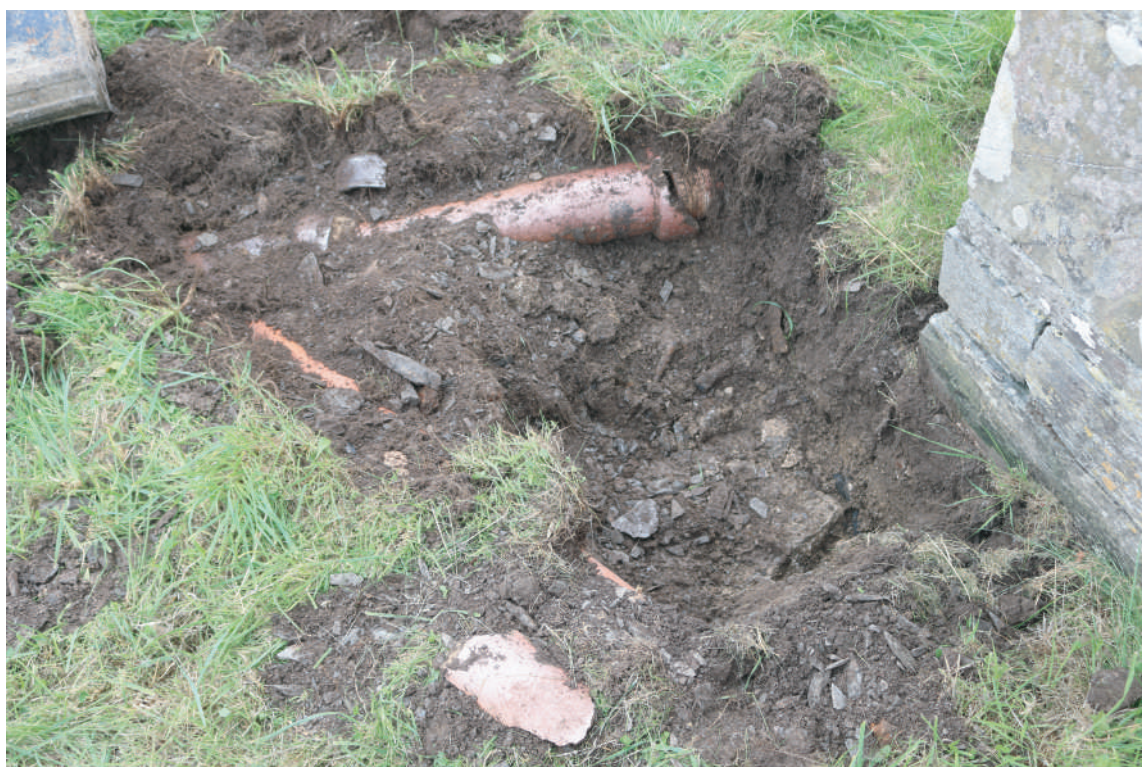
Plate 29. St. David's Church, Blaenporth - Working shot during cutting for Lightning Conductor Plate 2. Note 1930s/50s stone drainage pipe. Looking E.

5.13 *ii)* The trench for Lightning Conductor Plate 2 (L2) was positioned at the far northeast corner of the church. Following the initial removal of the turf (100), an active plastic storm drain (101) became exposed running in a NE direction. Excavation around this modern drain, further exposed a 1940s/50s ceramic storm drain pipe (102) running in a N-S direction, running alongside the southern end of the church. A further clay section of a 19th Century drain (103) also became exposed directly below the 1940s/50s drain (102). This section of storm drain pipe was now obsolete and had been superseded by the 1940s/50s drain pipe. Excavation continued in the same location between these modern drain pipes, leaving just enough room to accommodate the new lightning conductor plate. Below these drains a mid brown soil deposit mixed with shale became exposed (104). This deposit continued to the base of the trench at 1m. No significant finds, features or deposits were encountered in this trench, other than the existing copper cable and rod for the pre-existing lightning conductor.

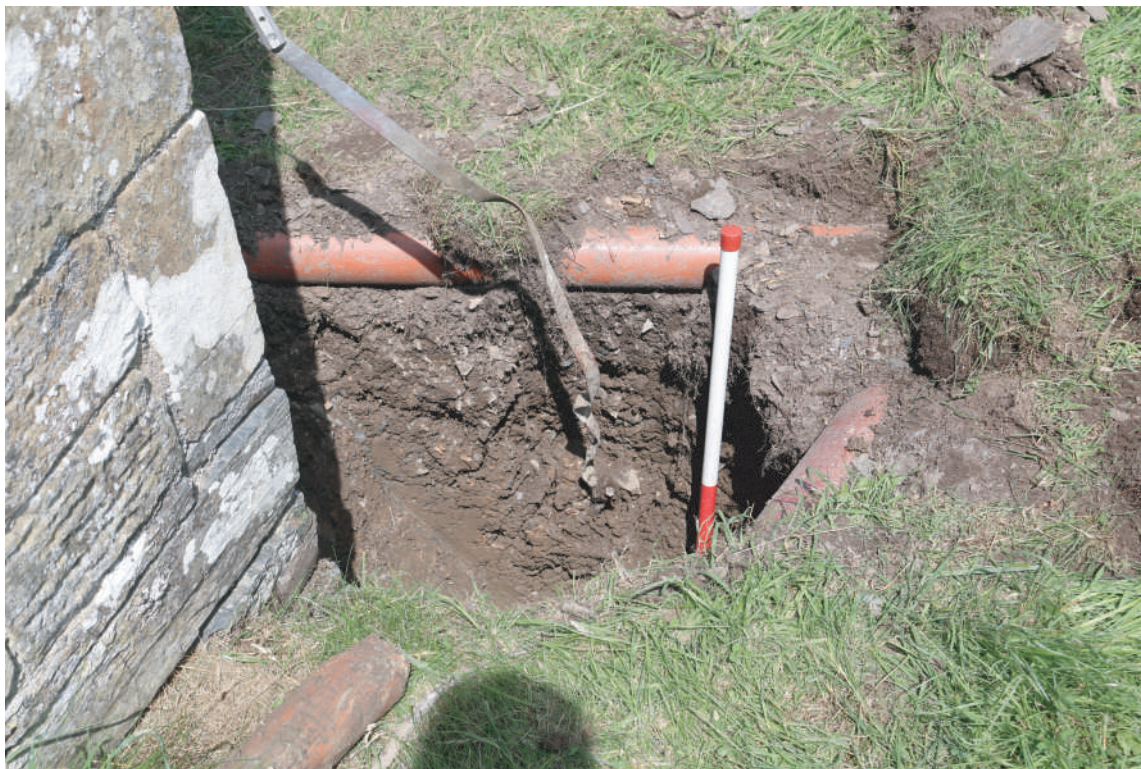
Plate 30. St. David's Church, Blaenporth - Completed Trench for Lightning Conductor Plate 2 at eastern corner of church. Looking N.

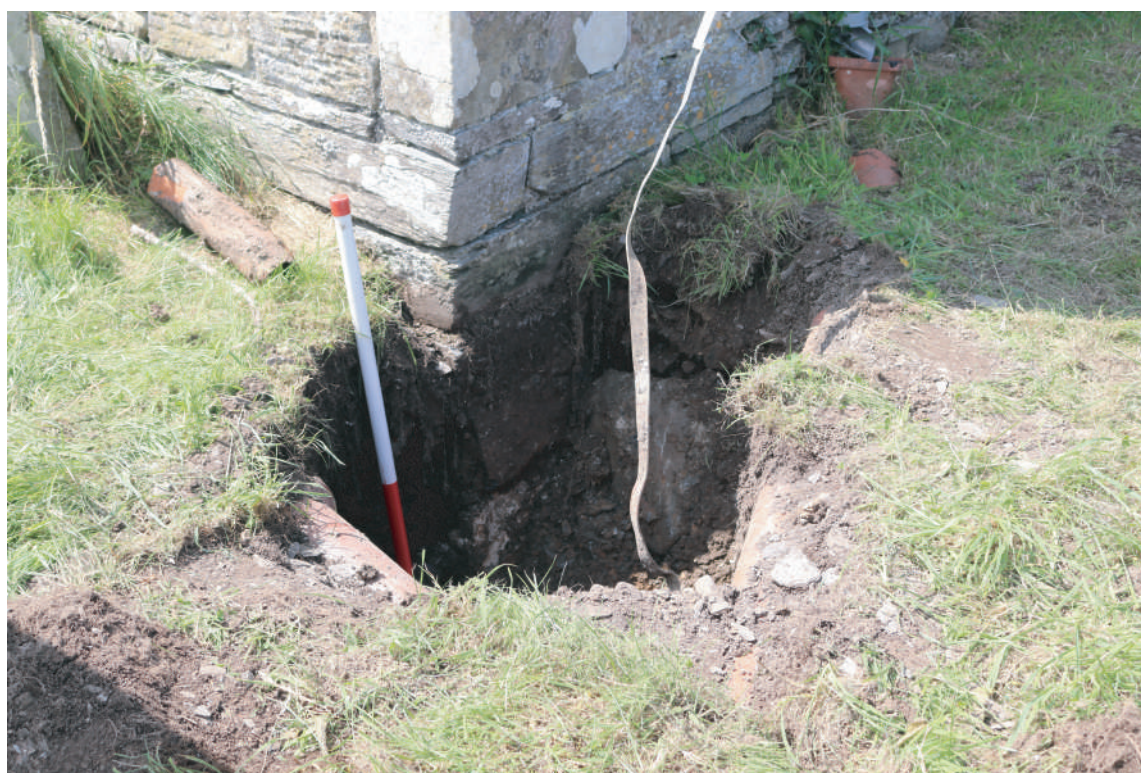
Plate 31. St. David's Church, Blaenporth - Completed Trench for Lightning Conductor Plate 2 at eastern corner of church. Looking SW.

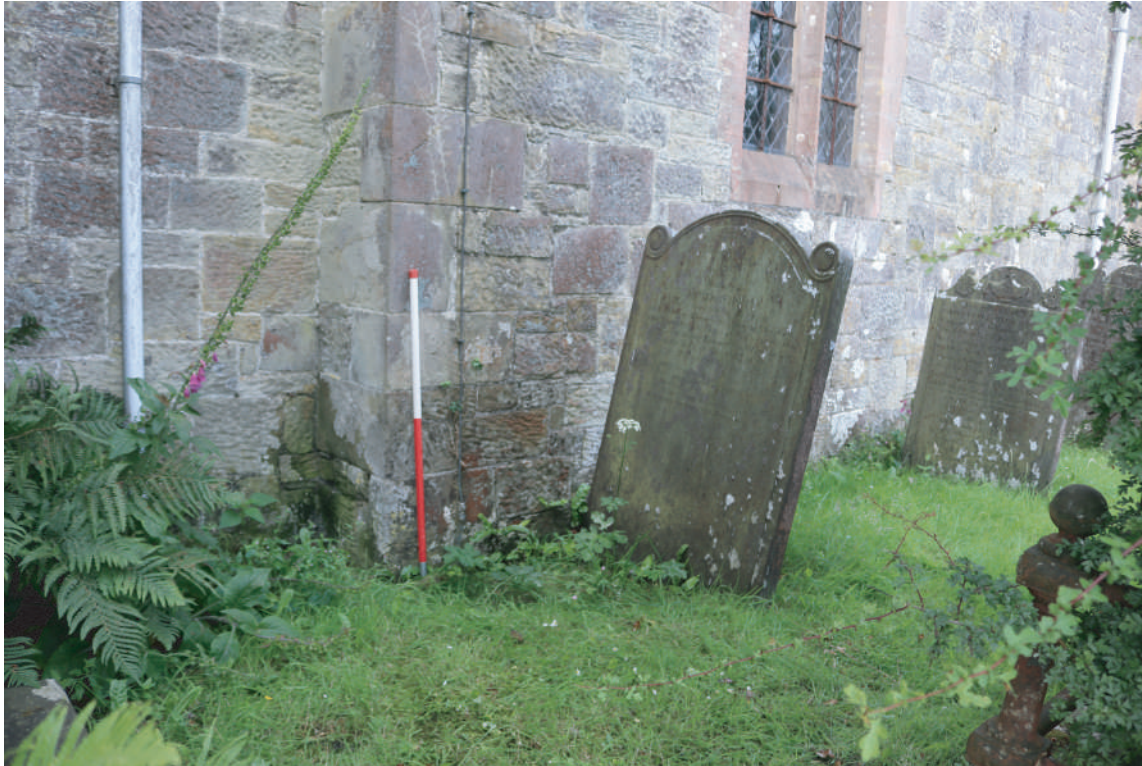
Plate 32. St. David's Church, Blaenporth - Location of Trench for Lightning Conductor Plate 3 on west side of Vestry. Looking SW..

5.14 *iii)* The trench for Lightning Conductor Plate 3 (L3) was positioned between the Vestry and the Boiler house, on the eastern side of a tall Victorian gravestone to one James Thomas. In order to avoid potential damage to the grave beneath the gravestone as well as the groundwork possibly compromising the gravestone, the trench was moved, approximately 0.50m further east. Following the removal of the turf (100) and top soil (101) a loose mid brown soil deposit intermixed with shale and

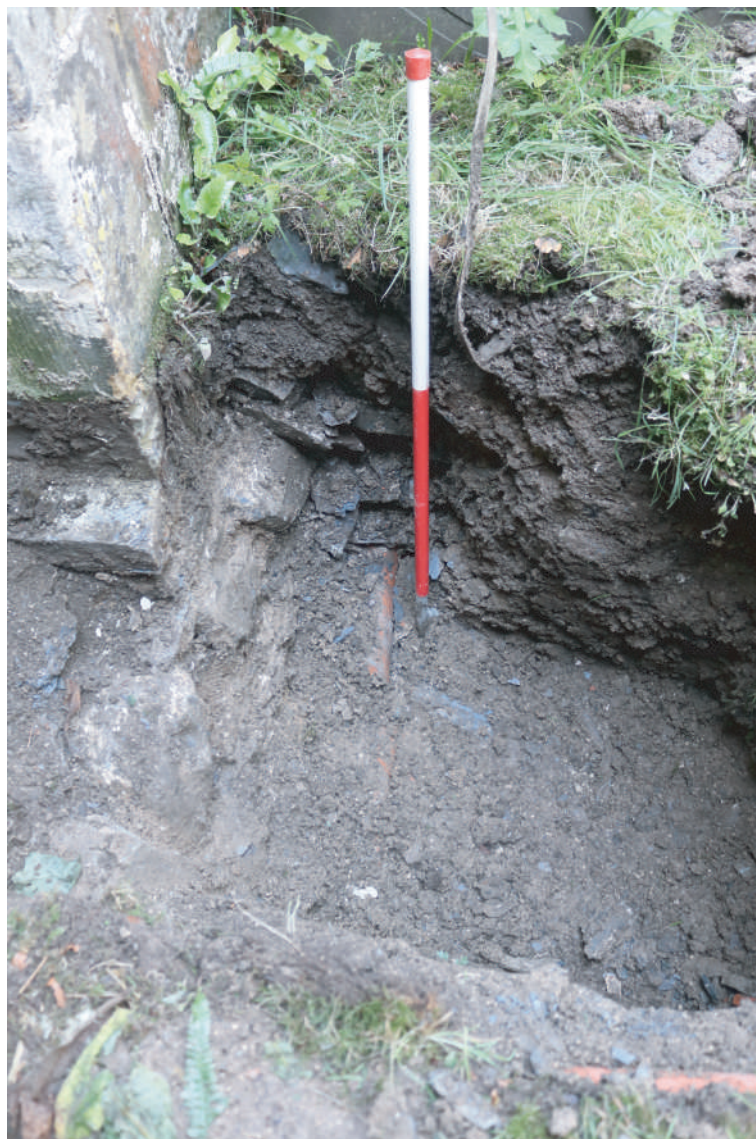
Plate 34. St. David's Church, Blaenporth - East facing section of completed Trench for Lightning Conductor Plate 3 on west side of Vestry. Looking W.

- 100. Deposit – Top soil.
- 101. Deposit – Mid brown clayey deposit.
- 102. Deposit – Loose mid brown soil deposit intermixed with shale and lime mortar flecks.
- 103. Deposit - Former slate roofing slates
- 104. Fill – Fill of cut 105. Contains roofing slates and 19th Century terracotta drain pipe section.
- 105. Cut – Cut for 19th Century drain pipe.
- 106. Structure – Section of remains of earlier medieval church foundation.
