### PRIORY STREET, CARMARTHEN

## ARCHAEOLOGICAL WATCHING BRIEF IN THE CAR PARK, JUNE 2018

## REPORT BY NEIL LUDLOW FOR WESTERN POWER DISTRIBUTION

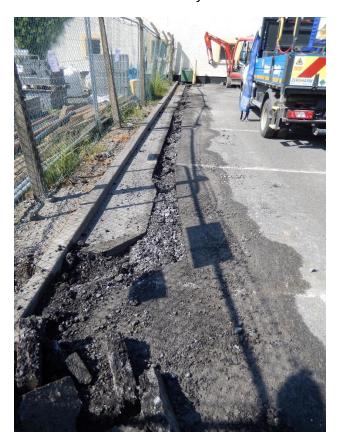
Photo 1 – Cable trench (Trench A), looking southwest towards the football club pavilion at commencement of excavation

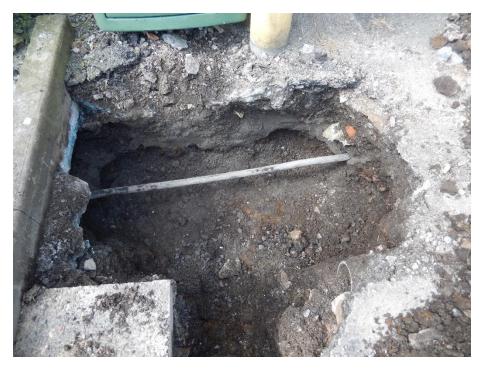
Photo 2 – The southwest end of the cable trench (Trench A), looking southwest at completion of excavation

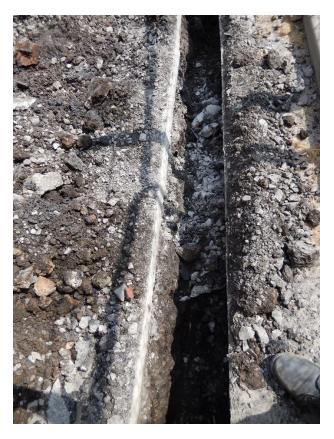
Photo 3 – The western concrete feature, from southwest

Two areas of concrete were present, both running beneath both sides of the trench section, and neither removed to its base (Fig. 11). To the southwest, a concrete surface appeared at a depth of 0.40m and ran for 1.50m through the trench. To the northeast, a narrower 'band' of concrete appeared 0.20m beneath the surface; it was 0.30m wide.

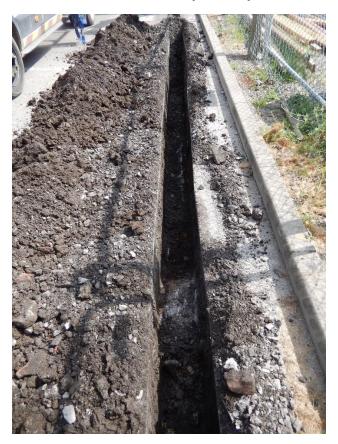
Photo 4 – The eastern concrete feature, from southwest

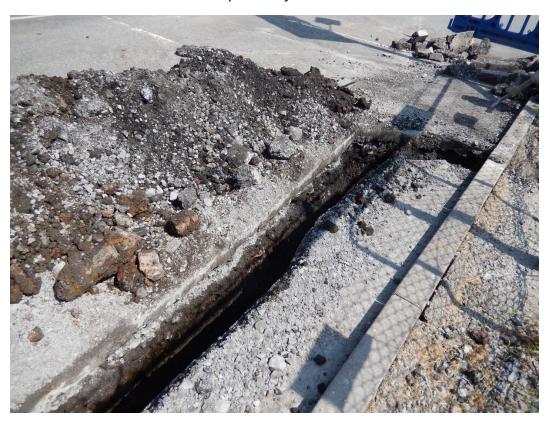
Photo 6 – The northeast end of the cable trench (Trench A), looking north at completion of excavation
