# MYNYDD LLANDEGAI TO BETHESDA LINK MAIN

# ARCHAEOLOGICAL MONITORING, TRIAL WORK AND RECORDING (G1169)

prepared for Dwr Cymru/Welsh Water

Gwynedd Archaeological Report No. 125

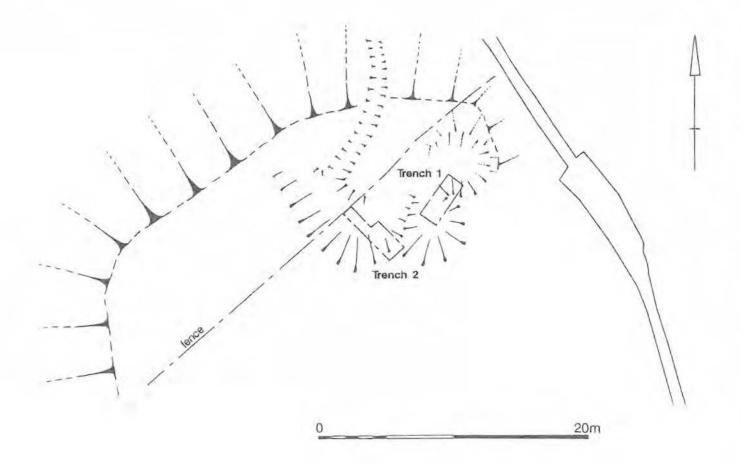
Fig. 2 Bod-Feurig farm - area of depressions and banks

Trench one was excavated across one of the most prominent of the shallow banks which appear to define some of the edges of the depressions. It was thought that some evidence of structure, for example large embedded foundations stones, might have survived the clearance of the huts. The trench was oriented so that its SW end also sampled the deepest part of one of the circular depressions (see Fig.2).

Trench two (Fig.2) was excavated oriented NW to SE so as to investigate the edge of another of the depressions, again in the hope of picking up structural remains. It also extended down into one of the depressions to sample the interior of the depression where the tops of a random pattern of moderate sized stones could be seen protruding through the turf. The final dimensions of the trench measured 5m long by 1.5m wide and 0.4m deep. However, initially the trench was excavated to a length of 3m. Removal of the topsoil revealed an orange brown silt (005) containing moderate slate fragments. This layer was excavated down on to 006, a reddish brown sandy silt which contained frequent sub-rounded and sub-angular stones from 0.1m to 0.4m in size. The stones appeared to form a distinct layer with many voids between them and with the matrix almost as a sealing layer. There appeared to be no pattern to their arrangement. The trench was then extended towards the NW to investigate the extent of the stone layer. The layer's general character remained unchanged and it extended right across the trench. The layer below the stones at a depth of 0.4m, consisted of a light orange/brown sandy silt (007), and was similar in character to 003 in trench one but with far fewer slate fragments.

In addition, the NE field wall immediately adjacent to this area was of unusual form exhibiting a pronounced widening from its usual 1.0m to 2.5m near the visible earthworks (Fig.2). Surviving ancient stone structures would, as a matter of course, have been robbed of their stonework for modern field enclosure, and recent work by the Trust at Bush Farm near Port Dinorwic has confirmed that it is also reasonably common for parts of these features to be retained as elements of field boundaries where convenient (GAT report: Bush Farm Excavations 1992, Port Dinorwic Bypass, forthcoming).

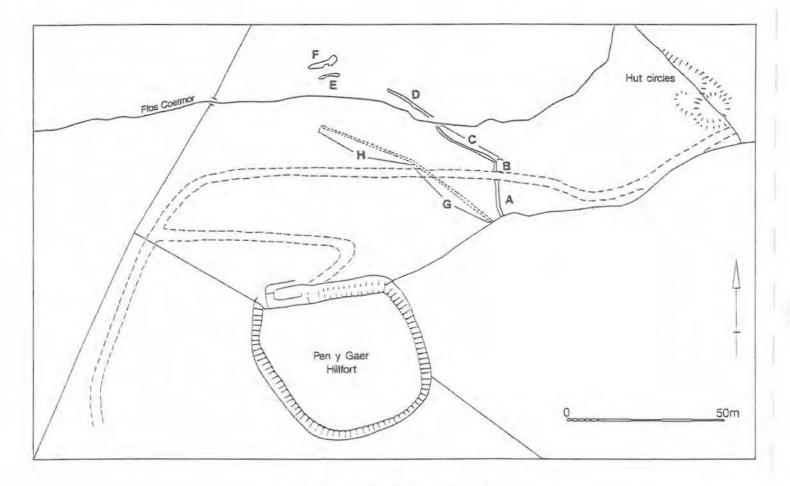
Fig. 3 Cilfoden Farm - linear features.

The walls and bank were seen to comprise several elements (a-h Fig.3):

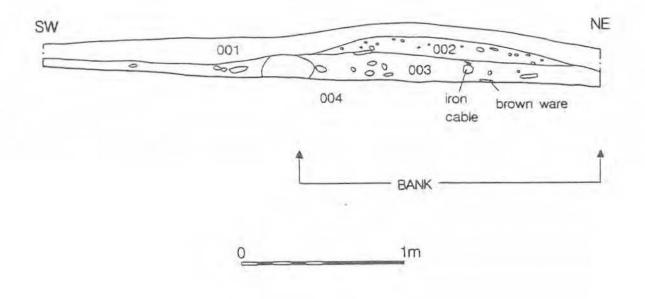
Fig. 4 Ty'n y Clwt Isa - Section through linear bank.

The excavation consisted of a hand dug trench measuring 3m by 1m positioned across the bank feature. The trench was excavated to a depth of 0.36m (see Fig.4) and revealed the natural geology here to be a light brownish yellow silty clay (004). Above this was a light yellowish brown silty clay, stony, with a 50mm diameter iron cable running through it at right angles, this layer also contained post-medieval pottery. Above this in turn was a wedge of material which appeared to form the core of the bank proper: a greyish brown silty clay with small stones and slate fragments (002), varying in height from 0.08-0.12m. The uppermost context was a grey clayey silt topsoil (001).
