# Llanddwyn Church Newborough, Anglesey

Archaeological report to aid  
digital reconstruction and interpretation

## St Dwywnwen's church, Llanddwyn

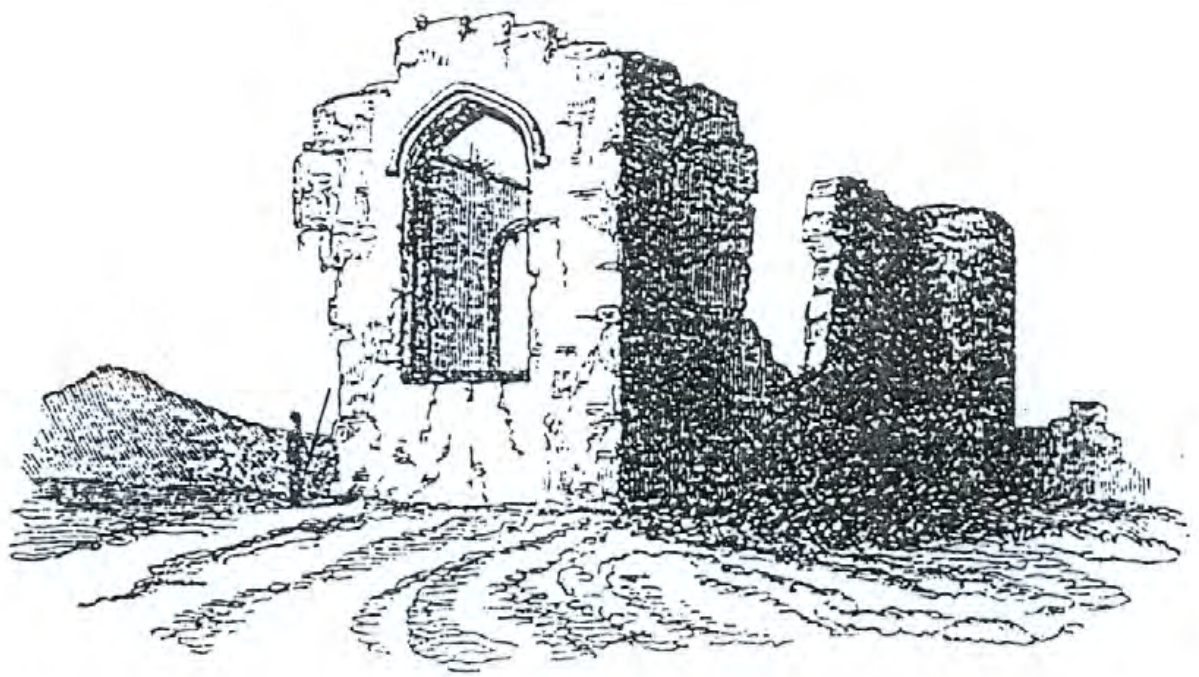
Fig 4. View of church in 1844 from north-east (*Archaeologia Cambrensis* 1846, 126). The north chancel window dressings have been removed. The four-centred hood mould is clearly represented over the east window.

A view of the church drawn in 1844, and reproduced in *Archaeologia Cambrensis* 1846, is from the north-east. The north window of the chancel has fallen, and the top of the chancel wall has partly fallen. The west end and the transepts

appear to be ruinous. The east window of the chancel is drawn with a hood mould with upturned ends.

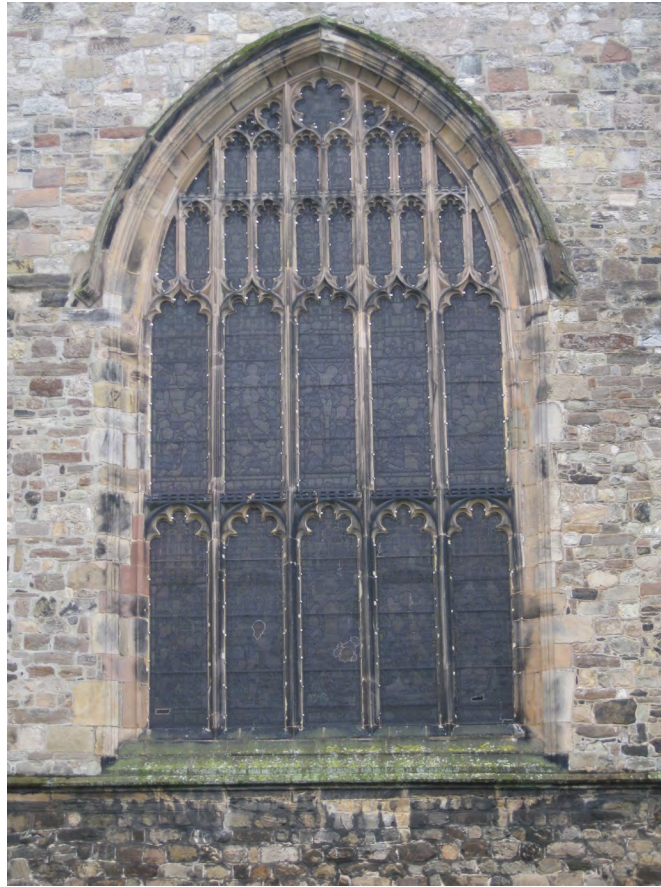
Fig 8. Bangor Cathedral east window with cusped tracery under two-centred arch with hood-mould

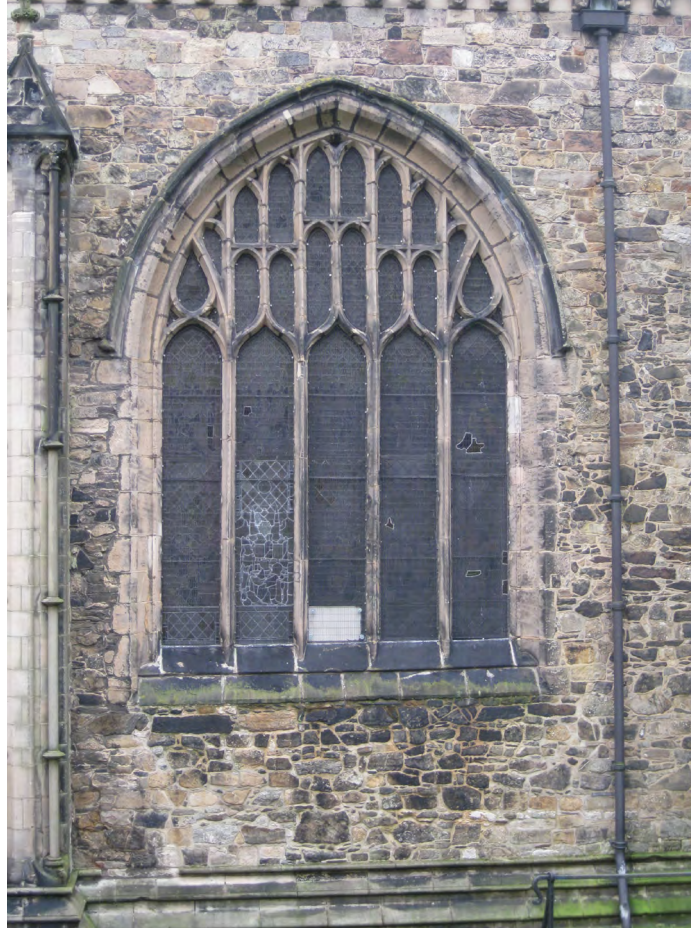
Fig 9. Bangor Cathedral south chancel window with uncusped tracery under two-centred arch with hood-mould

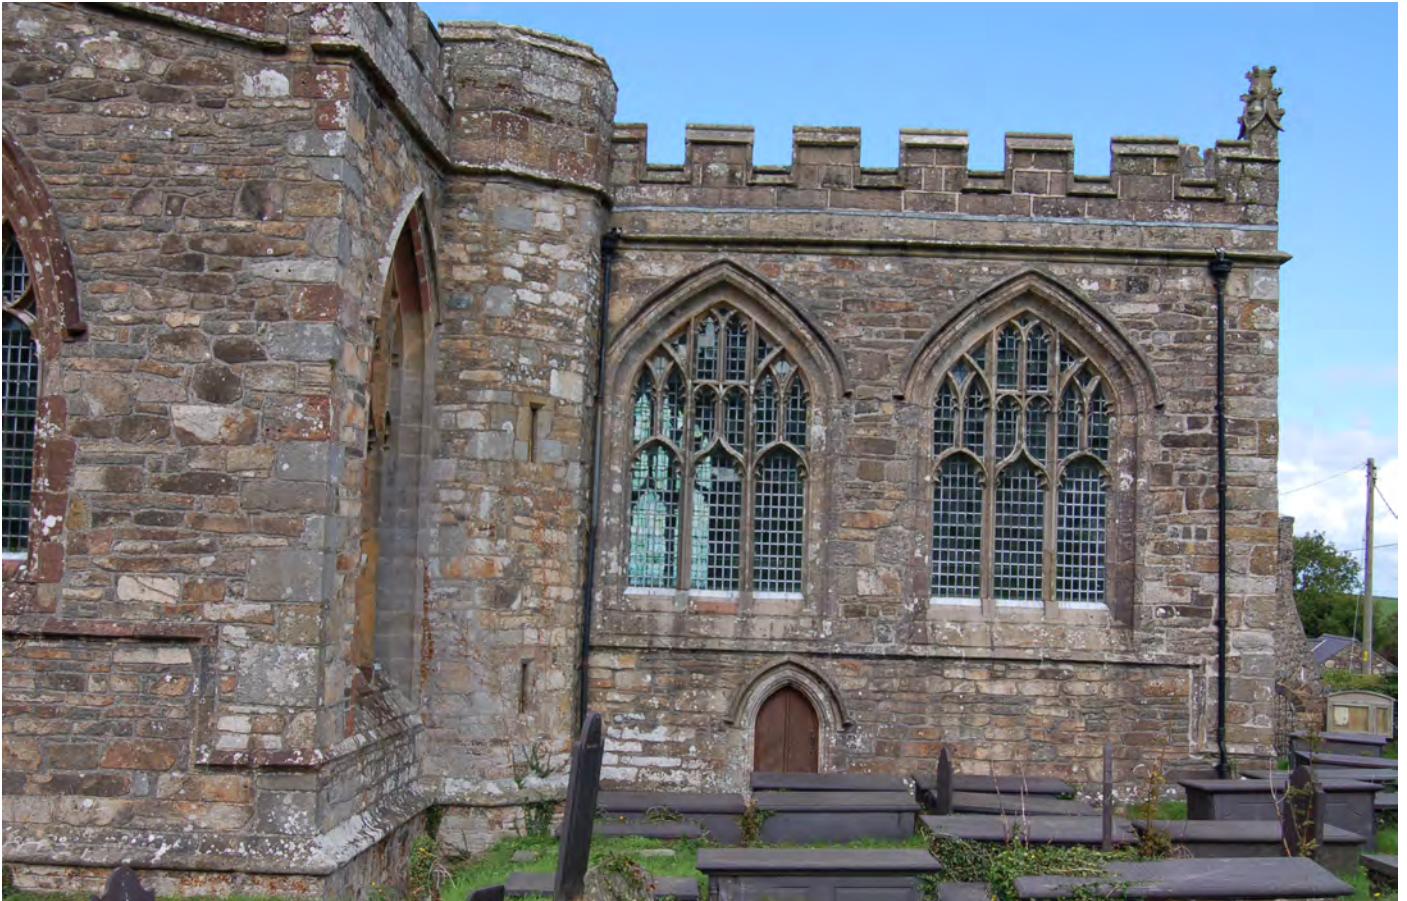
Fig 10. Clynnog church showing chancel from north. Cusped tracery in four-centred arch with crenelated parapet and stair tower in angle with south transept.

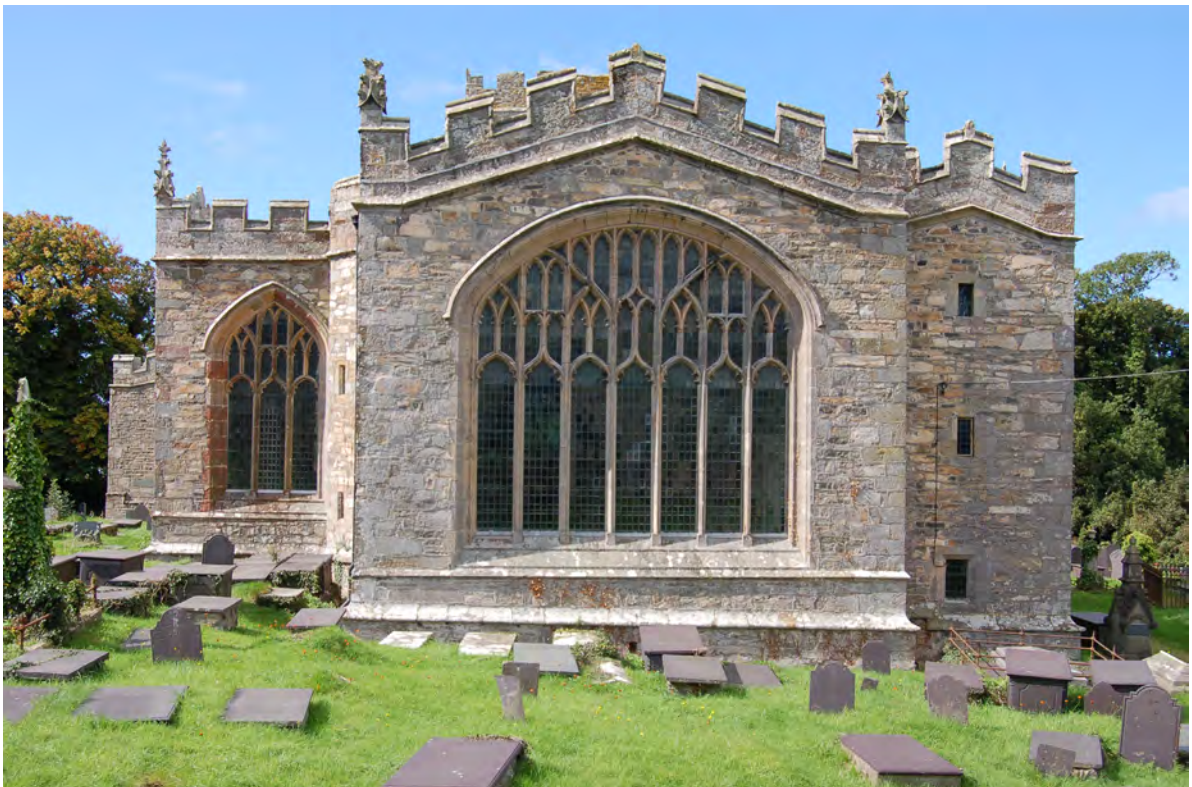
Fig 11. Clynnog church from east. Large cusped east window with casement moulding and crenelated parapet above.
