23-25 Bridge Street, Caernarfon

Archaeological Excavation and Watching Brief

GAT Project No. 1955

Report No. 716

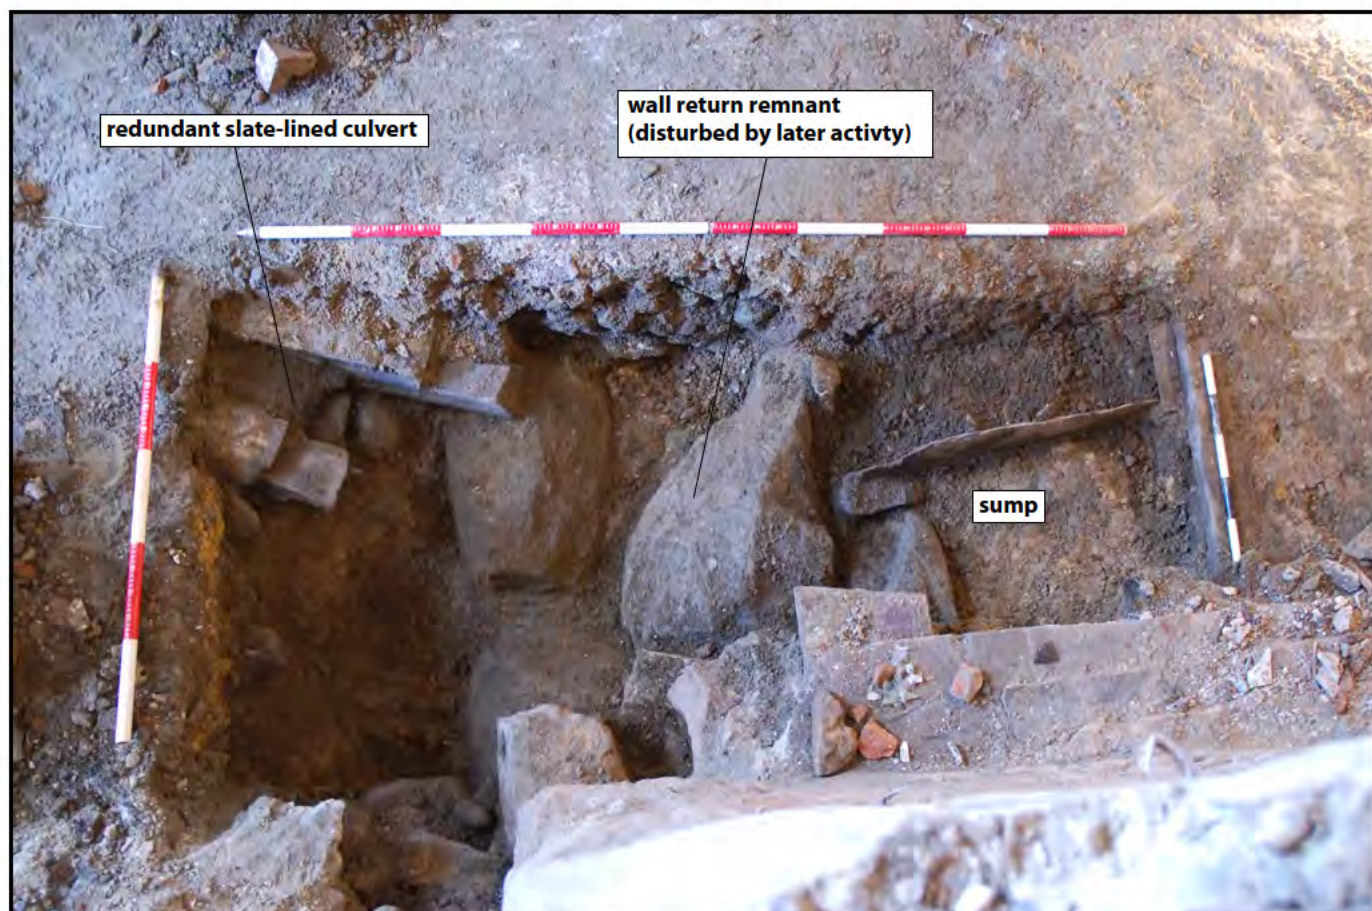
Plate 03: Overhead image of Trench 02, detailing redundant slate-lined culvert, associated sump and wall return remnant

Trench 02 was located within the same room as Trench 01 (Figure 04), 0.40m to the south, along the north facing elevation of the cross-wall (301) (see Plate 03). It was positioned to investigate the remains of an apparent return wall (context 202) visible in the elevation both as a redundant stub and in plan as a truncated foundation course (Figure 05).

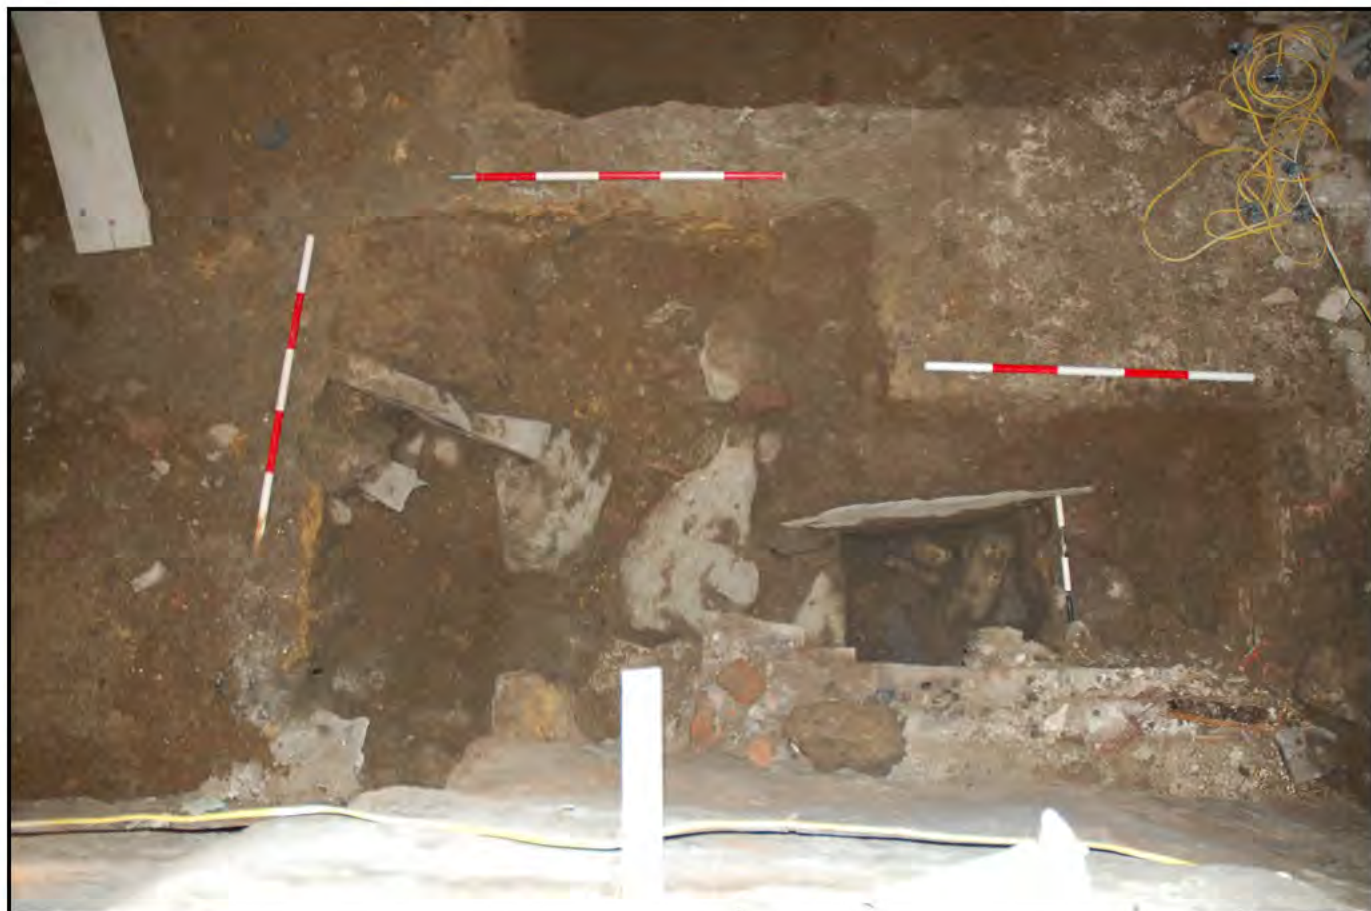
Plate 04: Second overhead image of Trench 02 after excavation completed. Attempt was made to identify full extent of wall return, but no other activity was forthcoming, suggesting it was truncated by later activity. The yellow sand within image relates to a modern phase of levelling

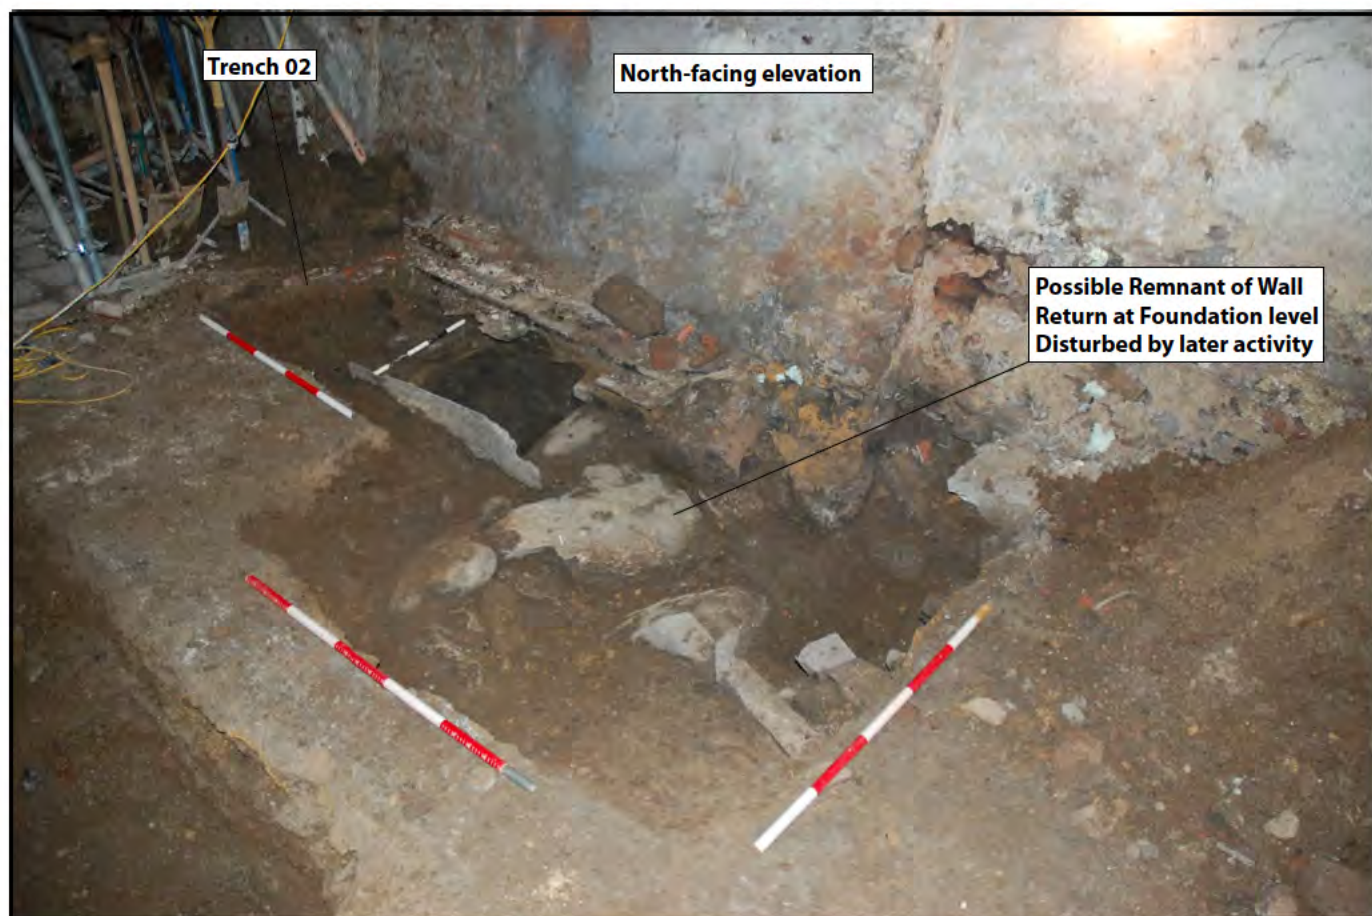
Plate 05: View from northwest of Trench 02 and North-facing elevation. Cf. Plate 04 for overhead shot

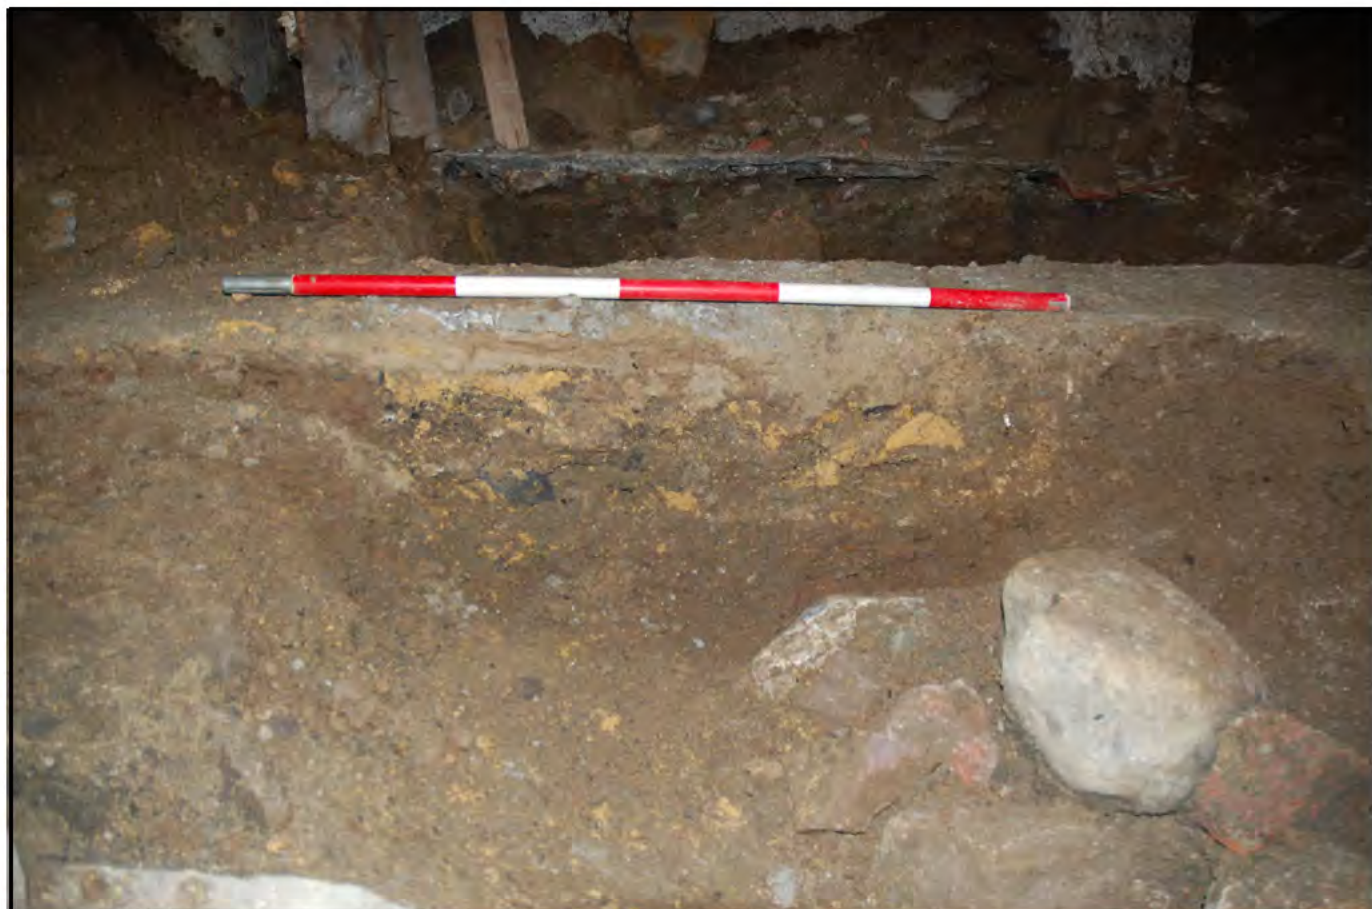
Plate 06: Close-up of former location of wall return, backfilled with post-medieval levelling material, including modern sand, slate and brick fragments

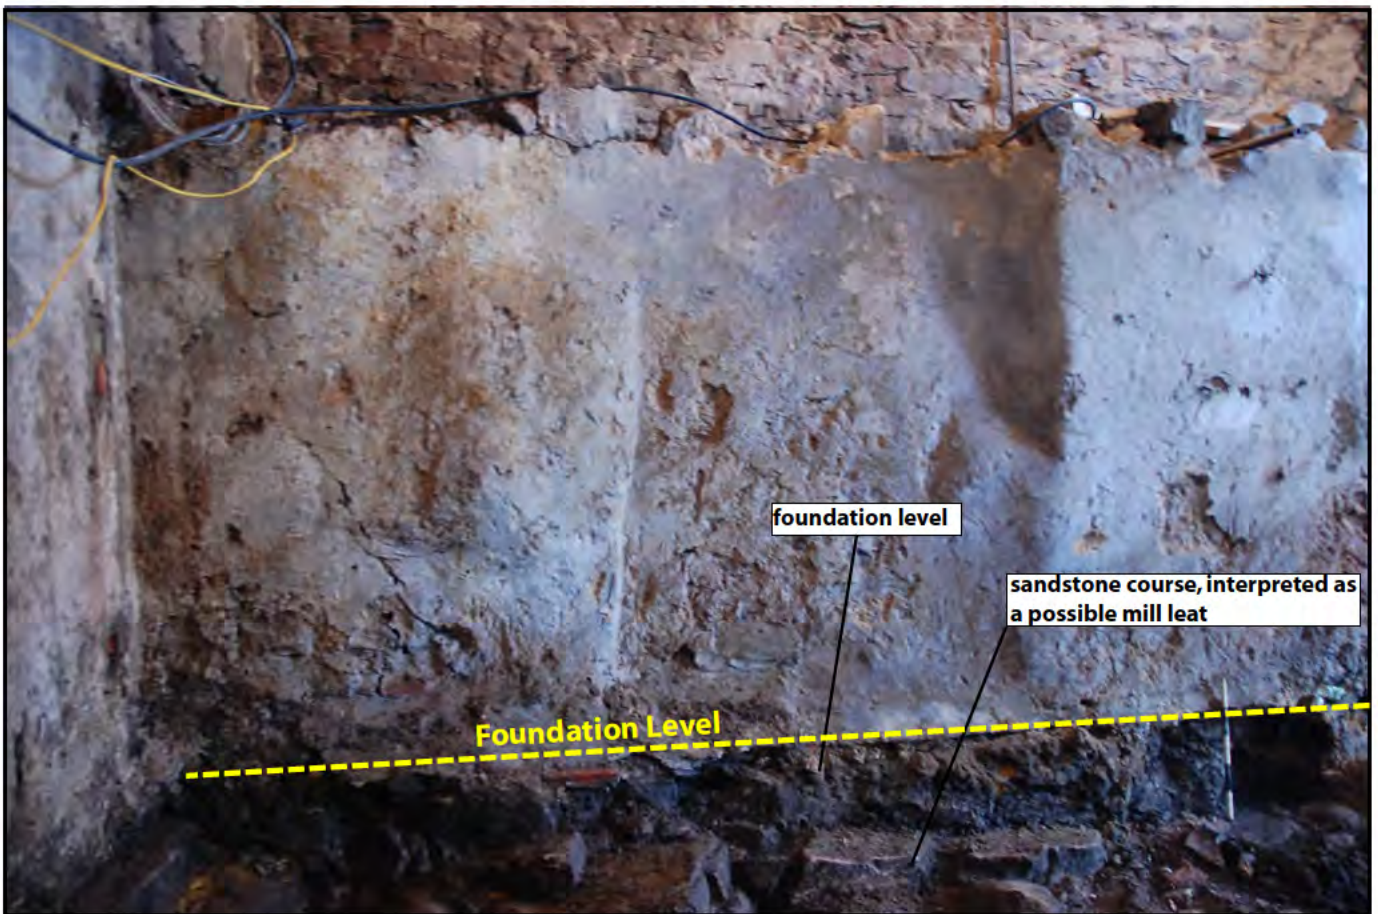
Plate 07: North-facing elevation/east end at Lower Basement Level, detailing construction/foundation level (including a separate sandstone course).

- The lower part of the north facing elevation of the south gable wall was hidden by the 2.5m high parallel wall that ran in front of it (feature 301 on fig 5; plates 7-10). The void between the two walls contained a brick built culvert, and was also backfilled with rubble and earth. The drain measured 0.70m in width and ran the length of the room, from the direction of Bridge Street, into the courtyard at the rear of the building (Figure 04). The elevation of this wall had been rendered in the same style as the south facing elevation. Due to the extent of rendering (which was not going to be removed during the renovation work), it was not possible to discern any patterns of structural phasing, though at the west end there was an indentation that might represent a blocked doorway. At approximately the centre of the wall, 3.5m from the east end, was an indent that was thought to mark the location of a return wall running north (plate 09). Excavation revealed the fragmentary remains of a wall here (feature 202 on fig 05) but it had been badly truncated, and could not be traced for much more than a metre. The west part of the upstanding wall (201) had been faced with a modern brick wall, which was removed during the current works, exposing the wall face which comprised irregular sub-rounded and sub-angular igneous stone.

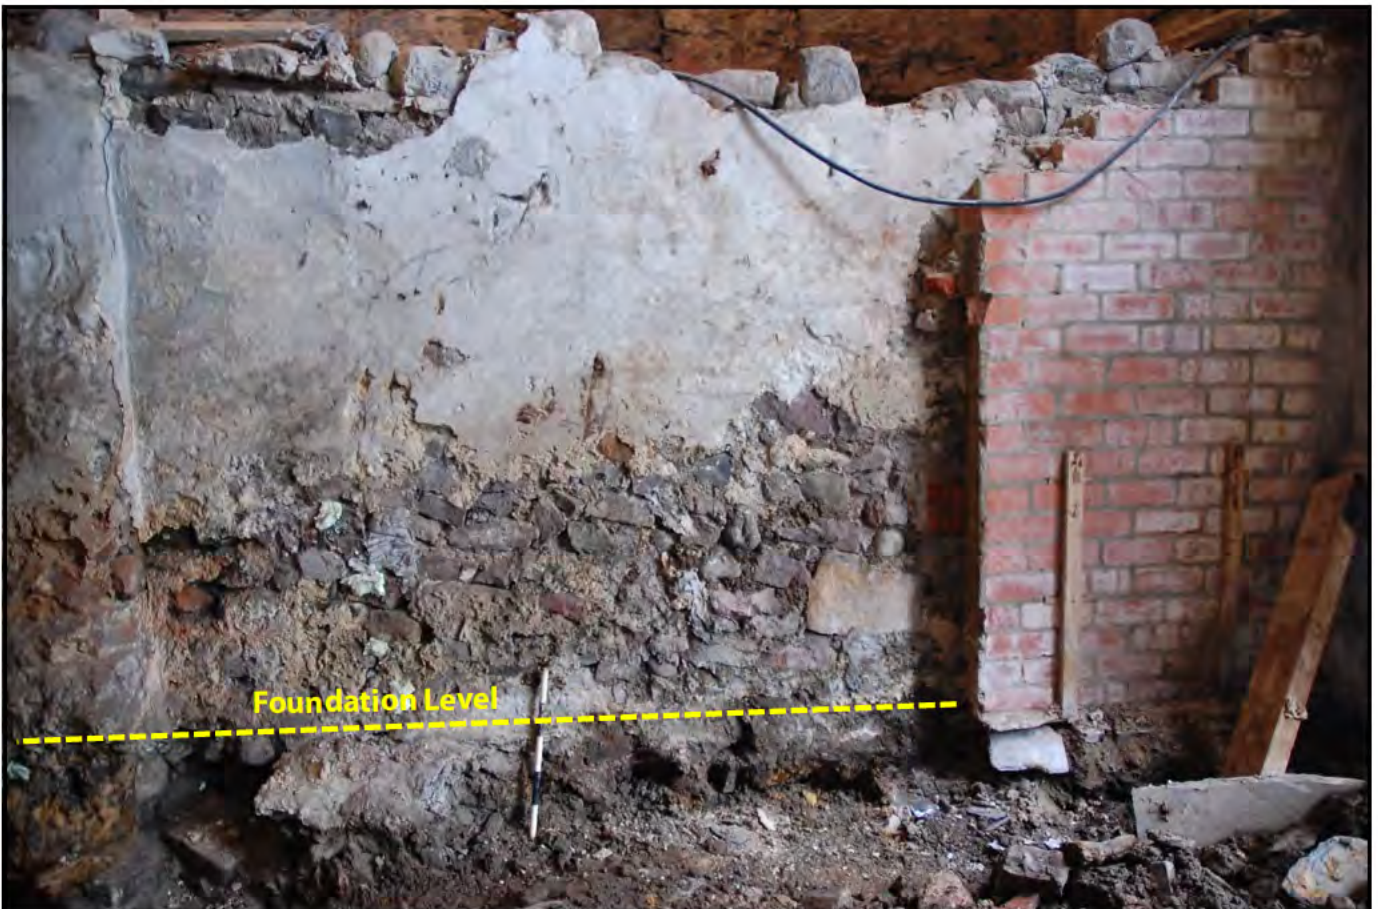
Plate 08: South-facing elevation/west end at Lower Basement Level, detailing construction/foundation level at final excavation level required by groundworks team. Note modern brick wall and original build material where render has been removed. A quarry tile can be seen at bottom left of screen, which could suggest this section of wall was built or repaired during nineteenth/ twentieth century

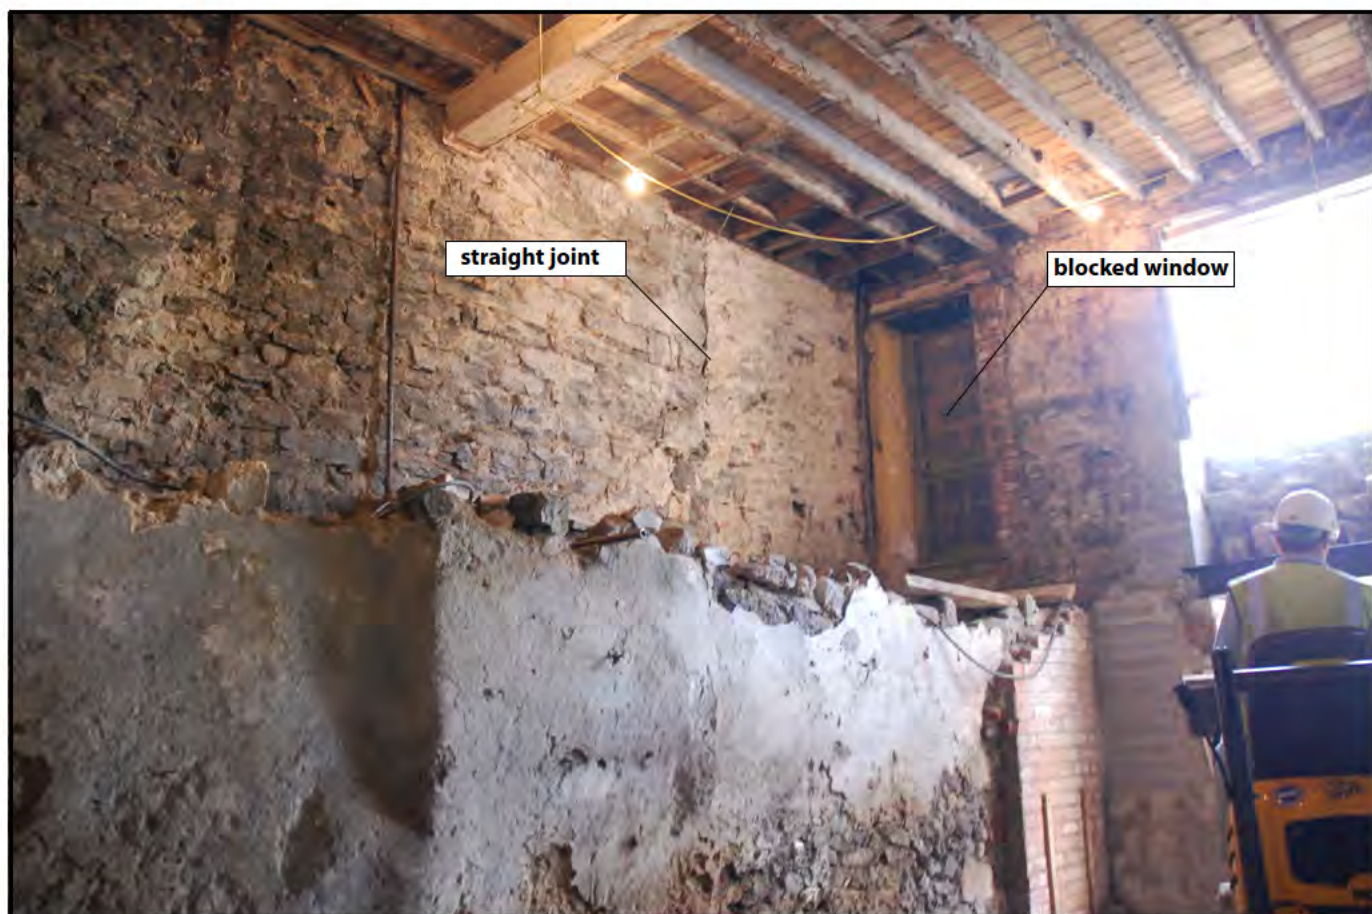
Plate 09: North-facing elevation at Lower Basement Level & Basement level. Note blocked window on basement level and vertical joint in masonry (straight joint)

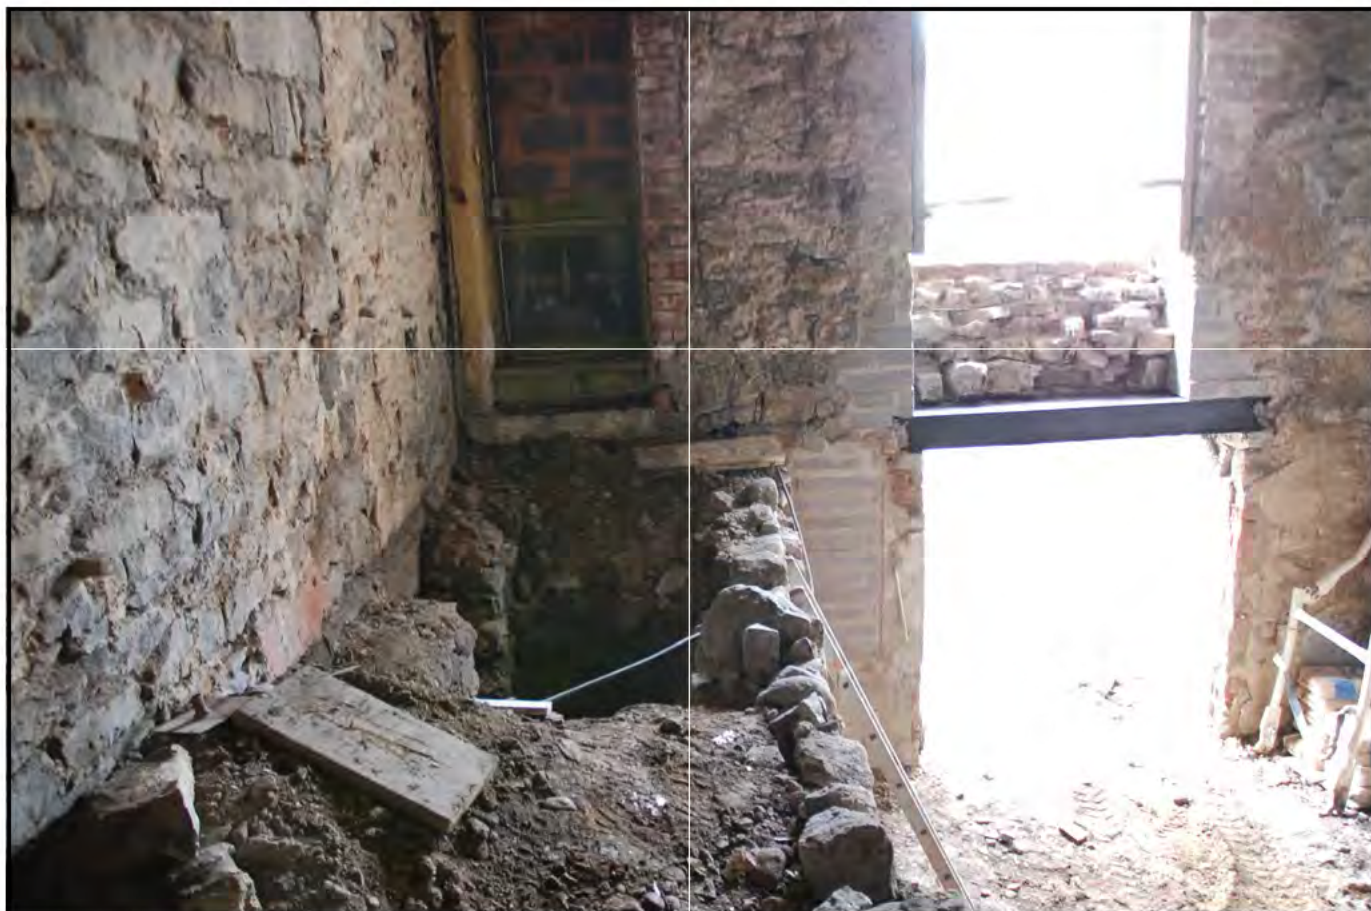
Plate 10: Basement level, detailing east-facing elevation and "void" separating north-facing elevations for lower basement level and basement level respectively. A brick-built culvert was located within the void

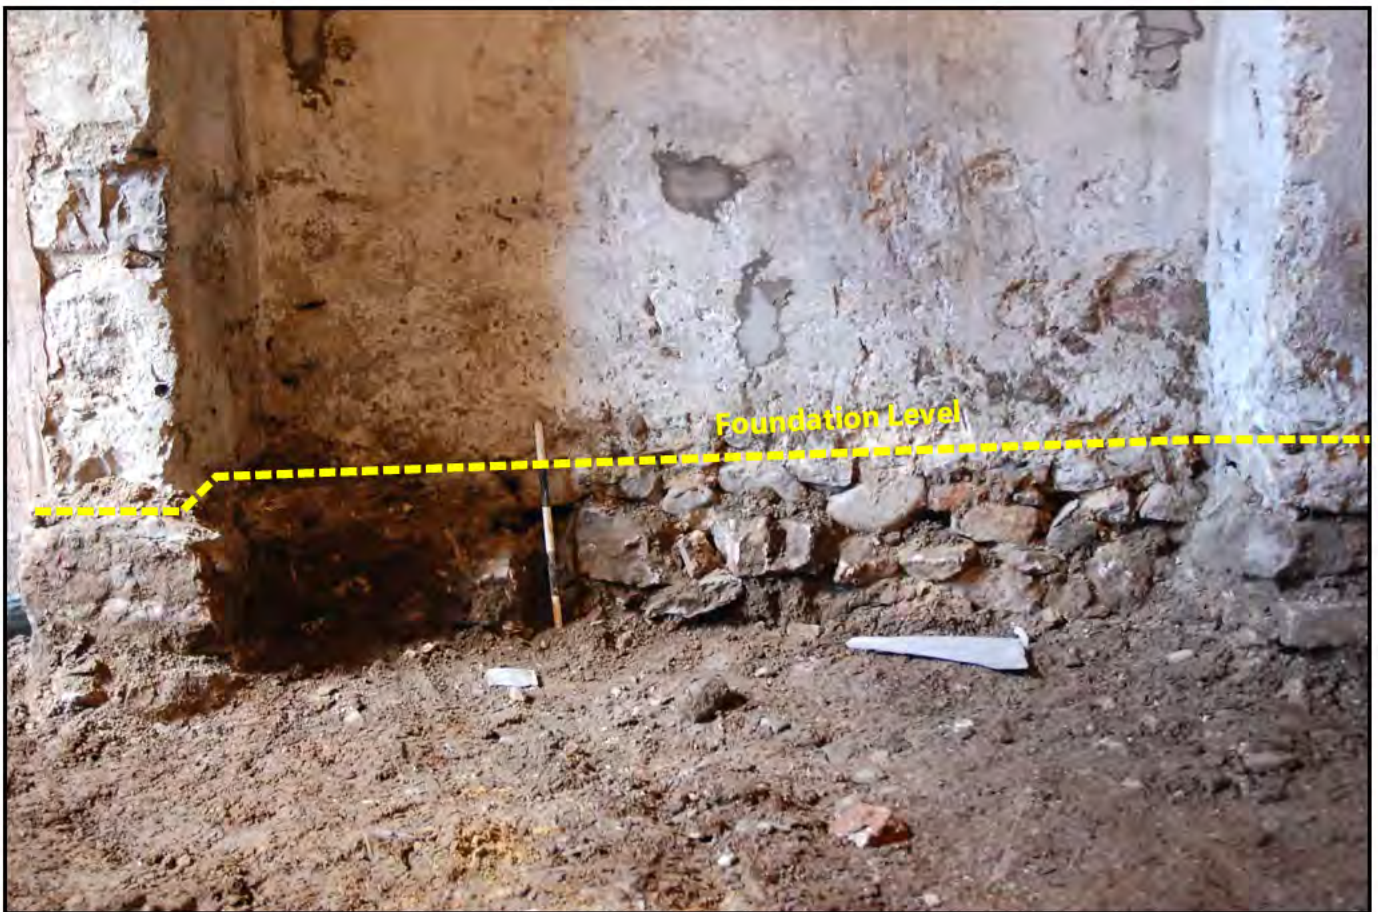
Plate 11: South facing elevation at Lower Basement Level. Final excavation level for groundworks team detailing building technology used. Note use of sandstone blocks at foundation to support buttresses. Similar stones identified along north-facing elevation. In this instance, they appear to have been reused

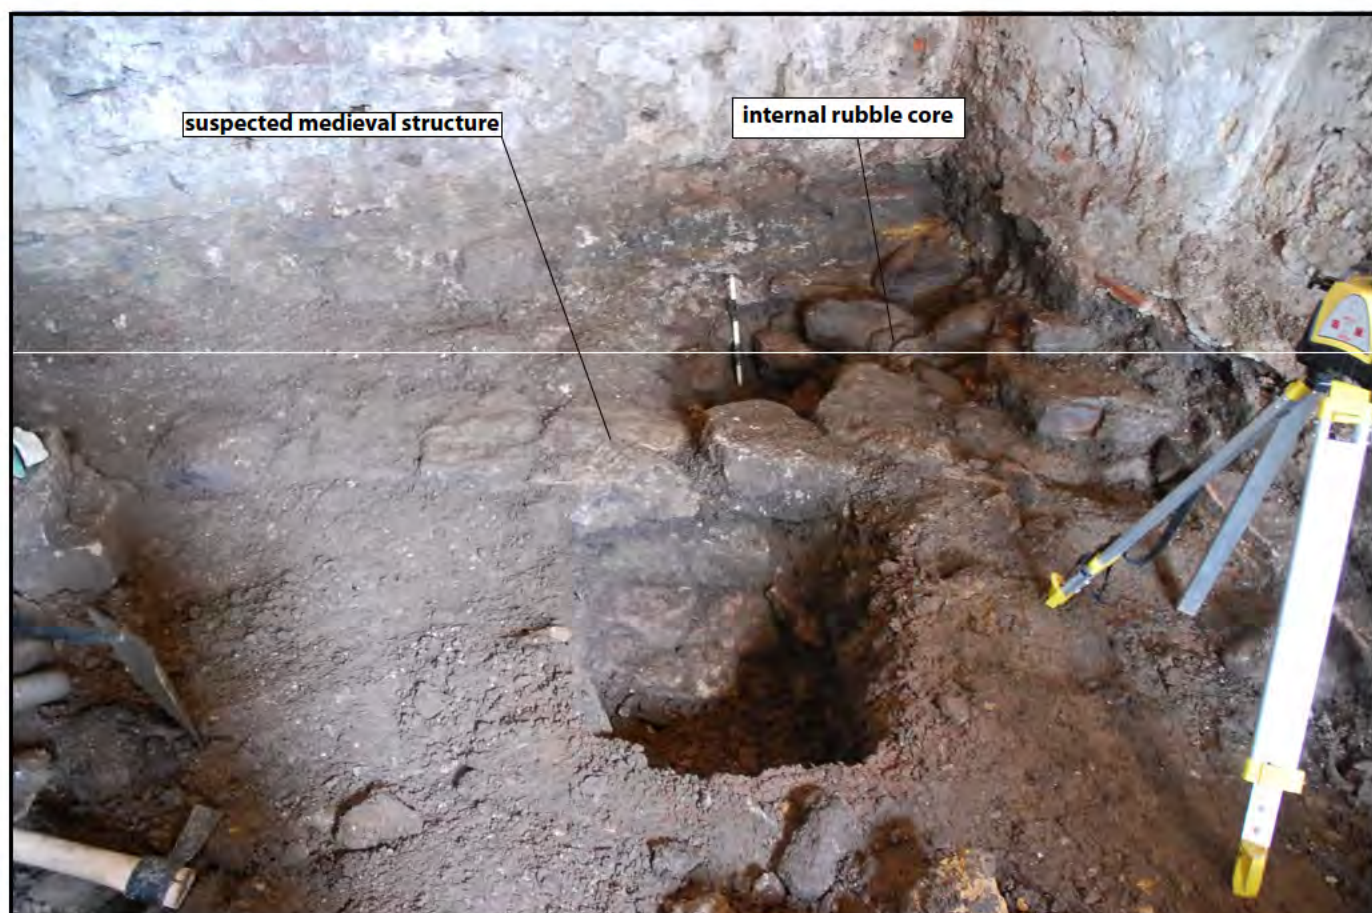
Plate 13: Detail of suspected medieval structure, identified at foundation level and sealed by post-medieval levelling material. Note the blockwork is dressed, with an internal rubble core. A slot was dug to investigate this feature further

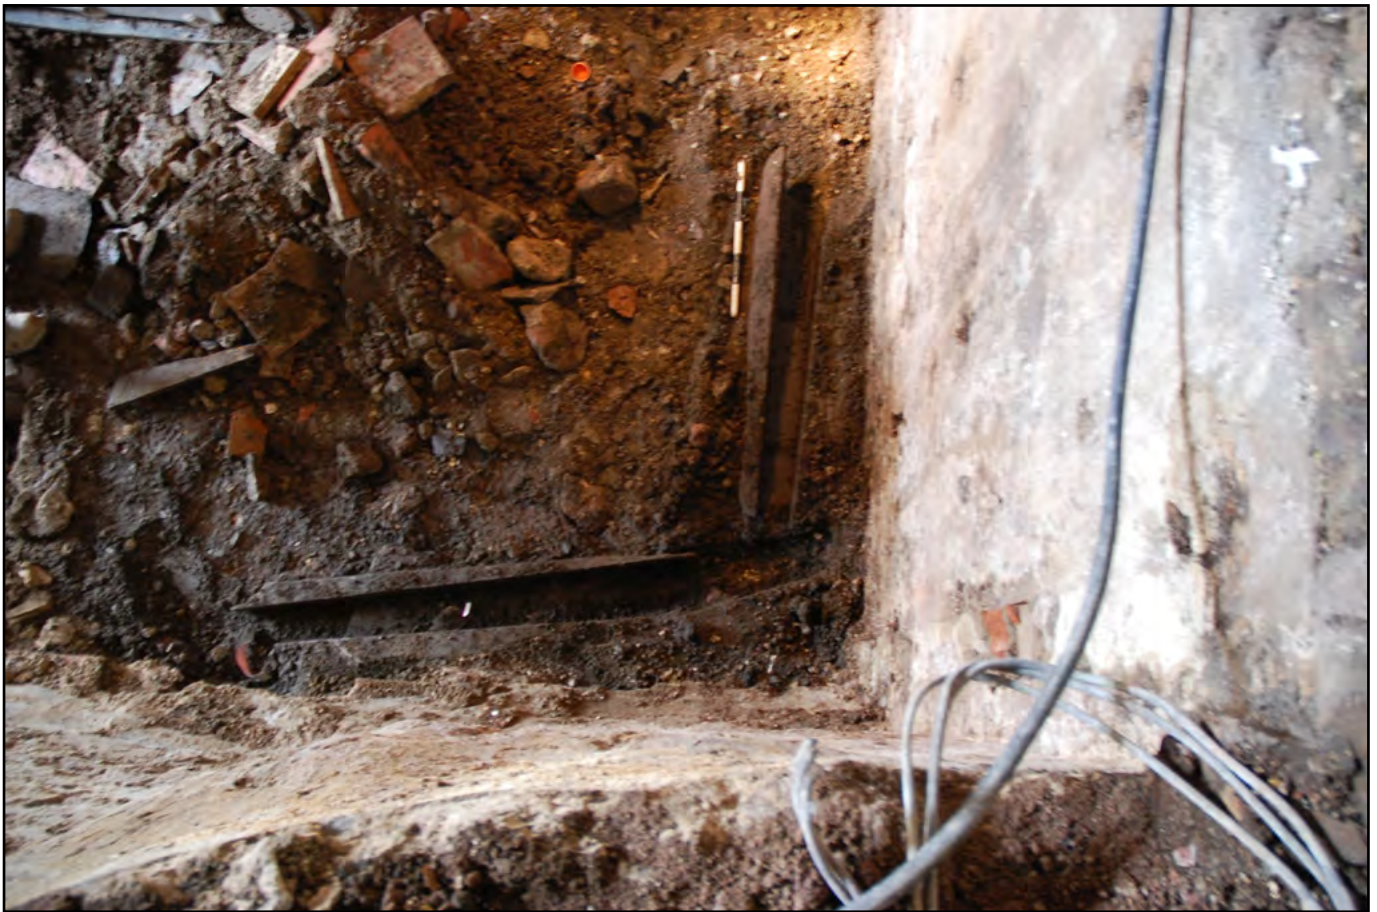
Plate 15: Watching Brief Phase: Slate-lined culvert. The culvert fed into the sump identified in Trench 02 (cf. Plates 02 to 04). The culvert was removed during groundworks, exposing post-medieval levelling material, below which was the suspected medieval structure (Plates 13 and 14; Figures 04 and 05)

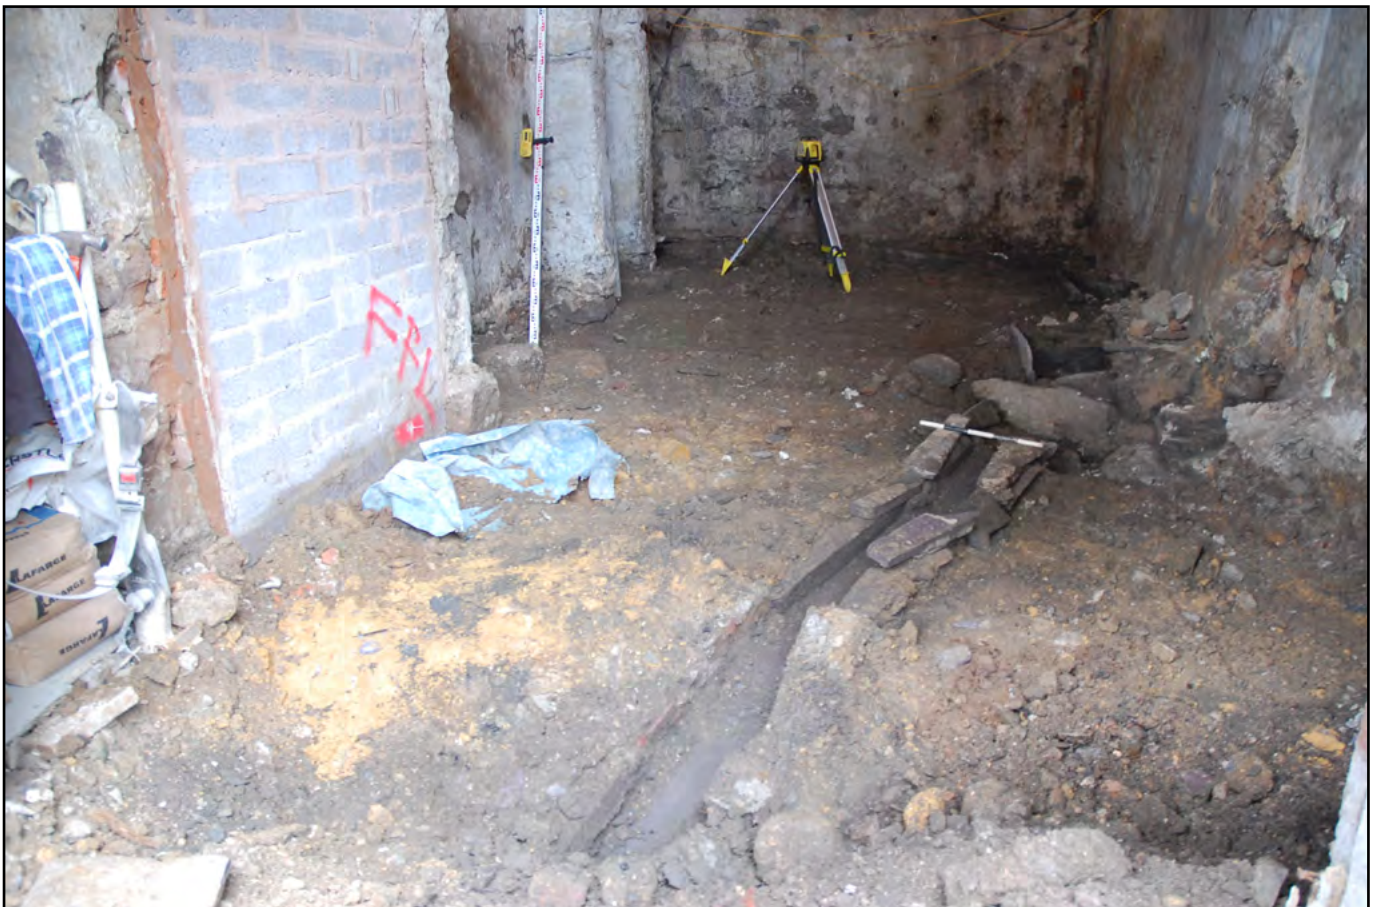
Plate 16: Watching Brief Phase: Slate-lined culvert, which fed from the sump identified in Trench 02 (cf. Plates 02 to 04). The culvert was removed during groundworks. The yellow sand was part of the levelling material for the modern floor surface (removed)

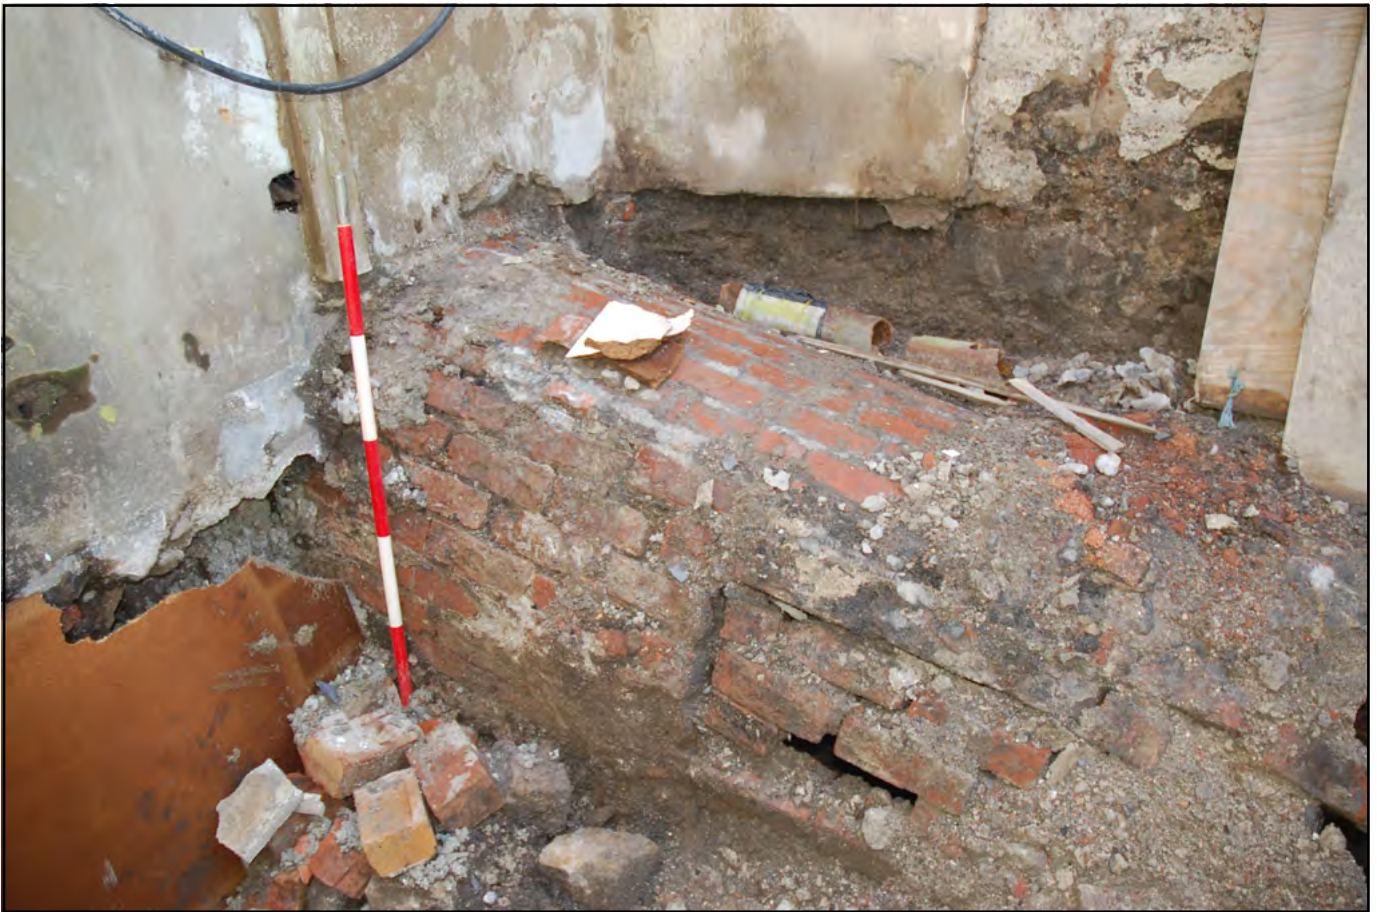
Plate 17: Brick-Built culvert, exposed during work in the rear "courtyard".

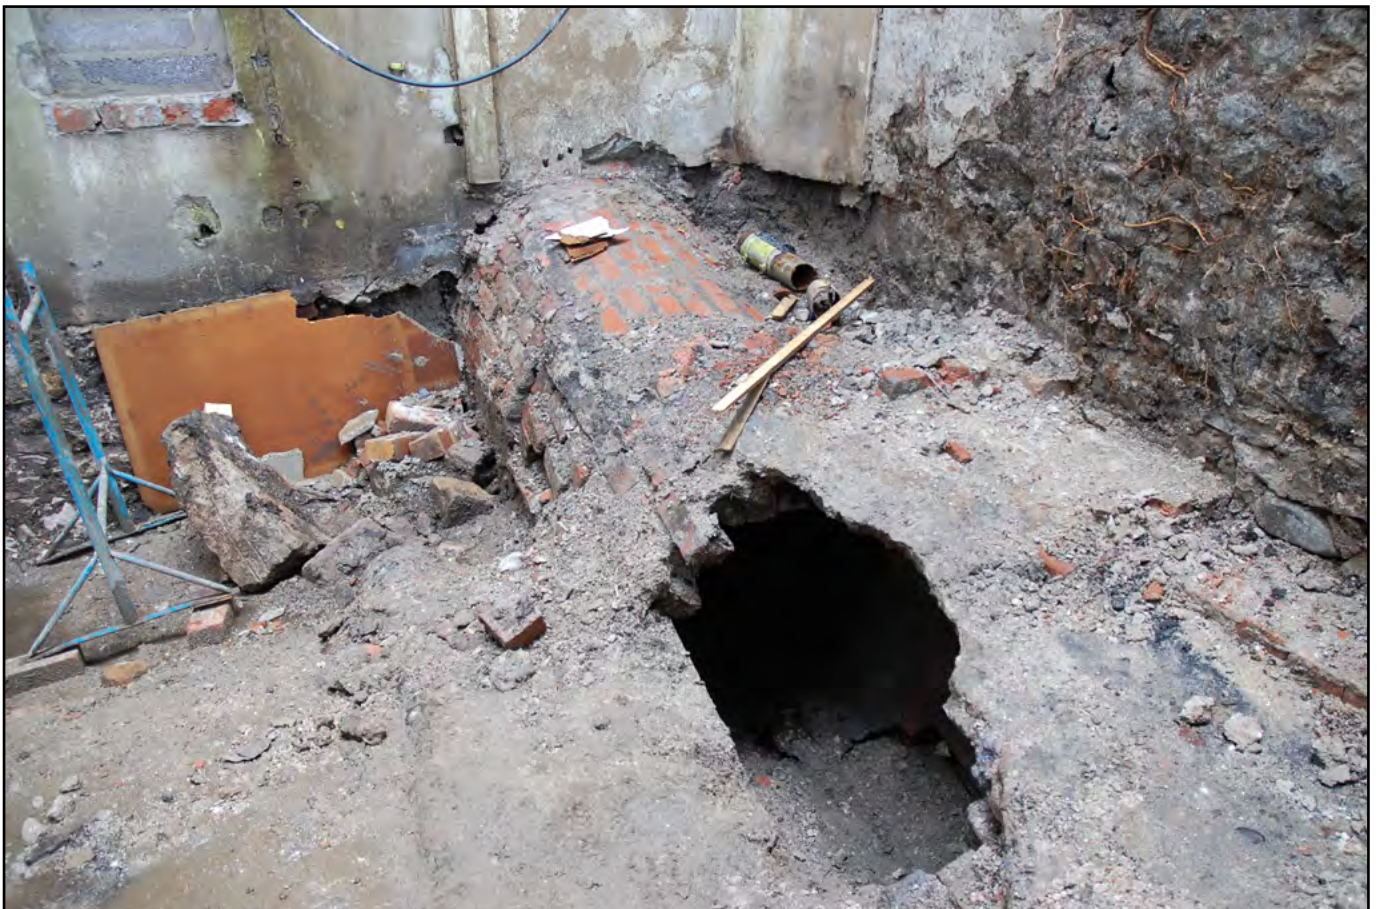
Plate 18: Brick-Built culvert, exposed during work in the rear "courtyard" during subsequent breach
