Saint Dwynwen's Church, Ynys Llanddwyn

Introduction

Removal of turf, fallen stone and sand from Saint Dwynwen's Church and its churchyard was undertaken by Grosvenor Construction in August and September 2012. The arch and hood-mould of the east window of the chancel, which had fallen in the mid-1950s, was reassembled from the fallen stones with the replacement of those stones either missing or damaged in the fall. In addition, parts of the adjoining stonework and south east corner were rebuilt using stones recovered from the clearance of the church in order to provide structural stability. The final part of the programme consisted of repointing and recapping of the tops of the walls, and the installation of geotextile membrane and cockle shells within the church. The focus of this report is on the excavations and on certain features unearthed by the process of removing turf, modern debris and wind-blown sand, and was partially dependant on trial excavations in the chancel and north transept carried out by SLR Global Environmental Solutions in January 2012. Previous work had been completed in 1995 and consisted of partial rebuilding of the east wall of the chancel and north wall o

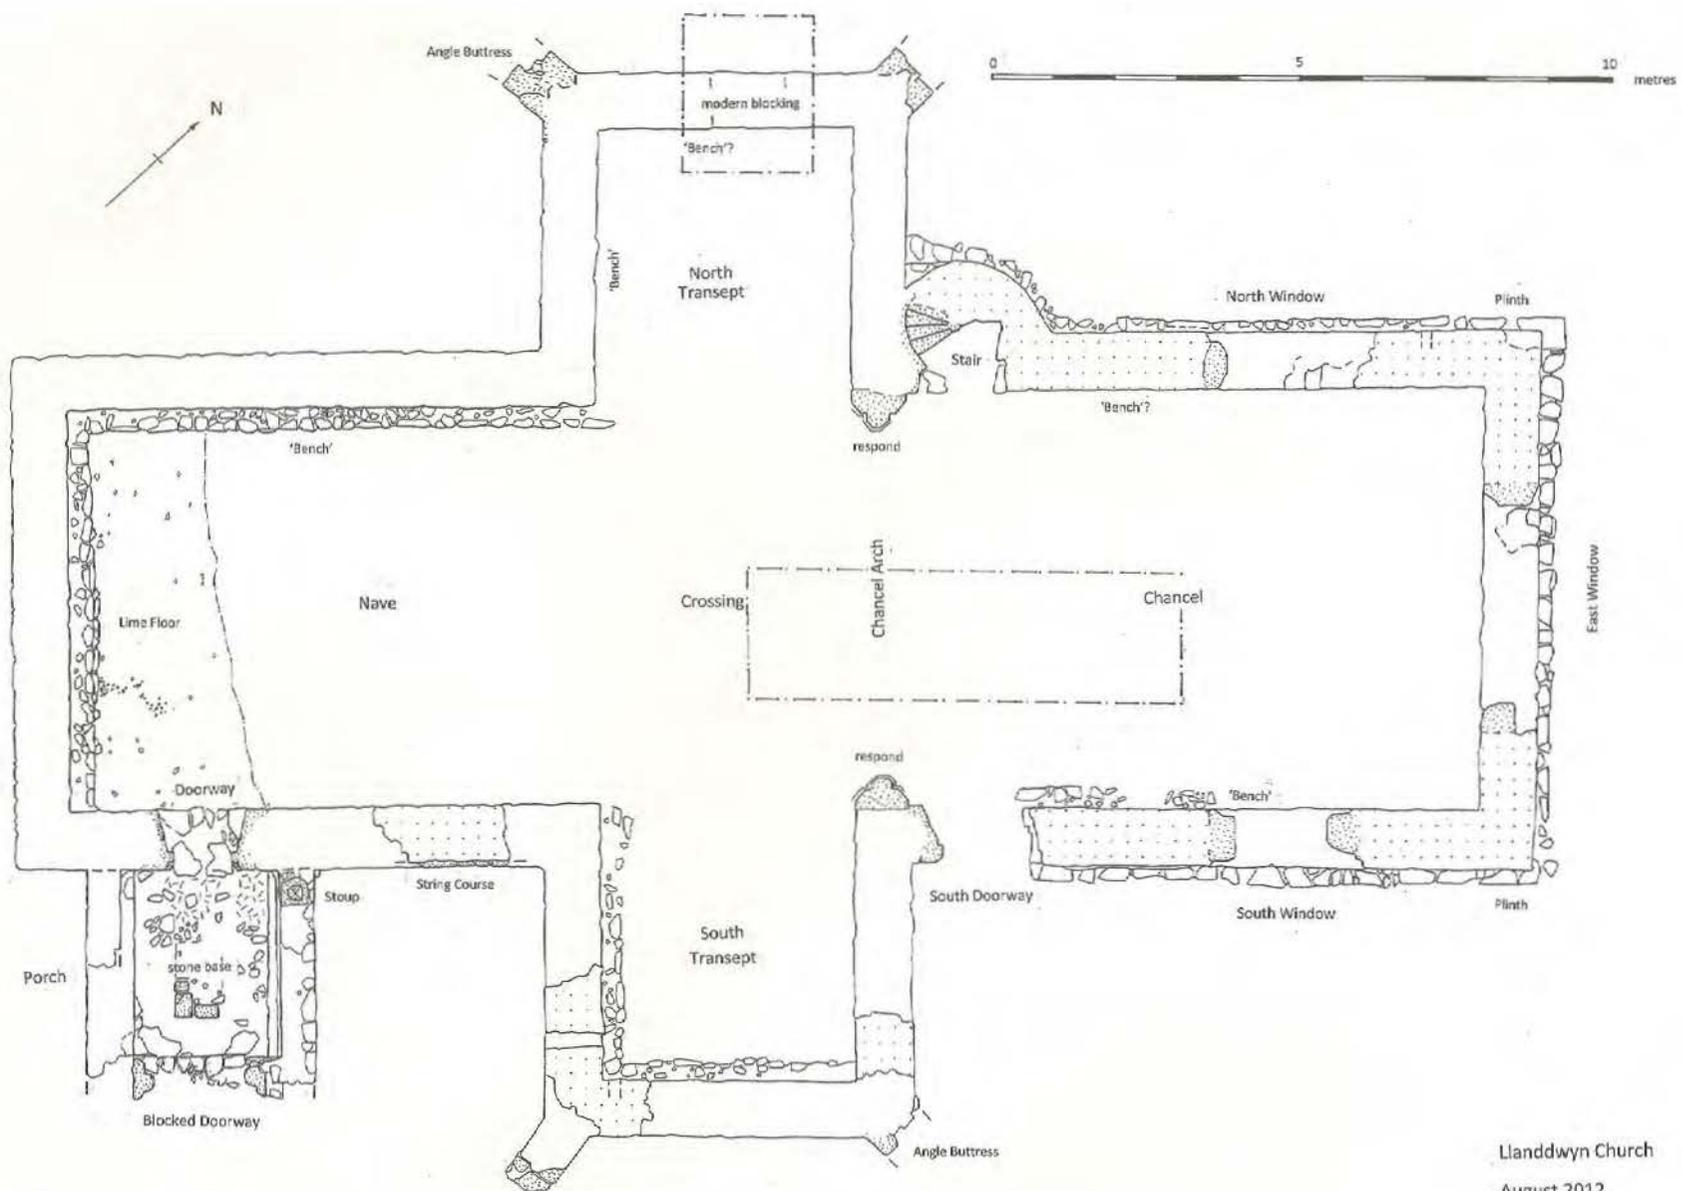
Fig.2: Plan of Church

Llanddwyn Church
August 2012

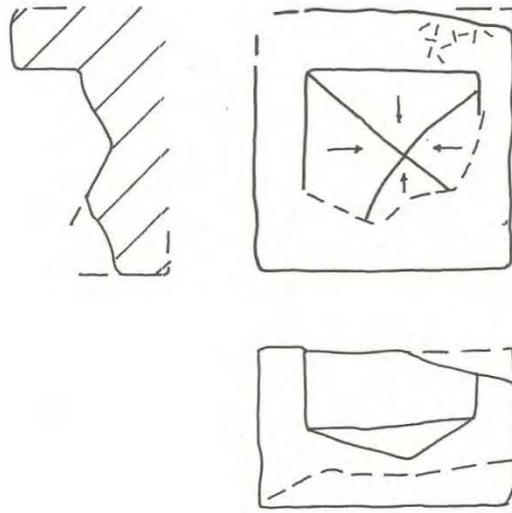
Fig.6: Porch Stoup and Ex Situ Jambs

In Situ Porch Stoup

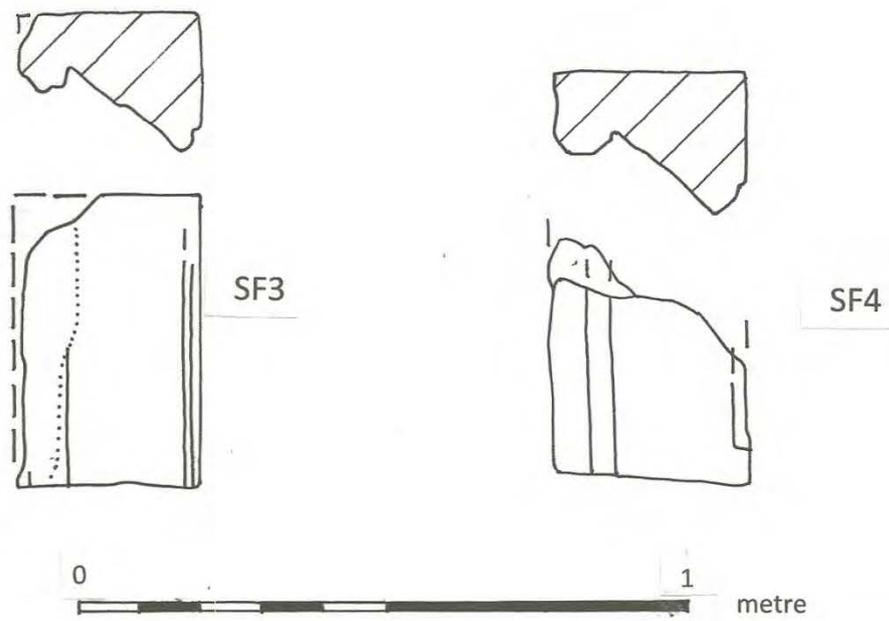
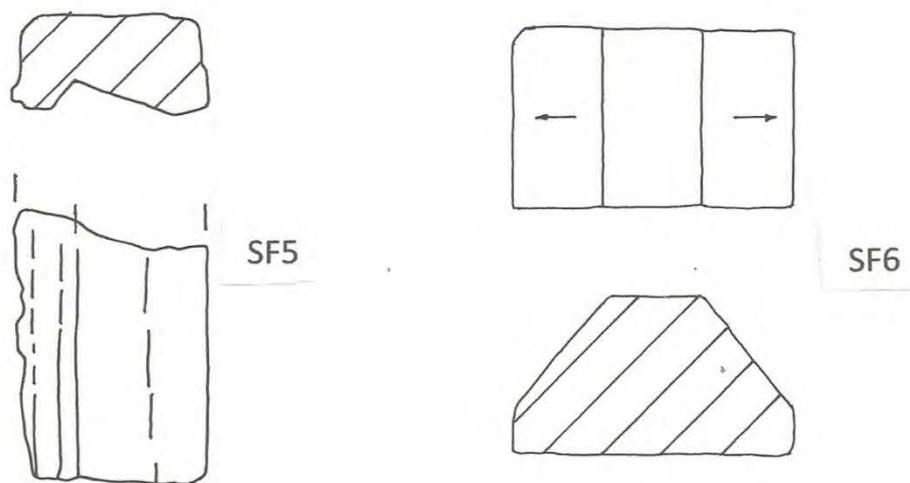
Fig.7: Ex Situ Stone

Ex Situ Stones

The volume of dressed sandstone was expanded considerably by the clearance of debris from the stair, south doorway and transepts, revealing the sandstone bases of the responds for the chancel arch, and four of the lower steps and newel of the stair, although both the threshold and the frame of the doorway are lost. The west jamb of the south doorway was also revealed, the position of the east jamb being marked only by lime mortar attached to the bedrock. The lowest stones of angle buttresses to the transepts were uncovered by stripping of turf and clearance of topsoil, all four being tied into their respective walls, but the surprise was quite how much dressed stone had survived the fall – or demolition – of the porch. Both the lower jambs of the doorways were intact, even if the side walls, which abutted the south wall of the nave, had been reduced to no more than a metre above the interior, as well as part of a holy water stoup (Fig.6) in the east wall close to the inner doorway. The stoup is faceted, but there is no drain-hole and both its face and the lower part have broken off. The outer doorway had been blocked with red sandstone, which predominates in the east half of the church, and at the centre of the porch red sandstone had again been reused to create a mortared altar or base 1.0m. long, north to south, and 0.7m. wide, but of which only three blocks and pieces of slate remained. This feature accords with the Post-Medieval use of the porch noted above. Three fragments of finely carved mudstone, two of which appear to include the folds of a robe, were recovered from the porch and spoil-heap.
