**GLAMORGAN-GWENT ARCHAEOLOGICAL TRUST**

**PRELIMINARY EXCAVATIONS AT THE  
BEDFORD IRONWORKS  
CEFN CRIBWR**

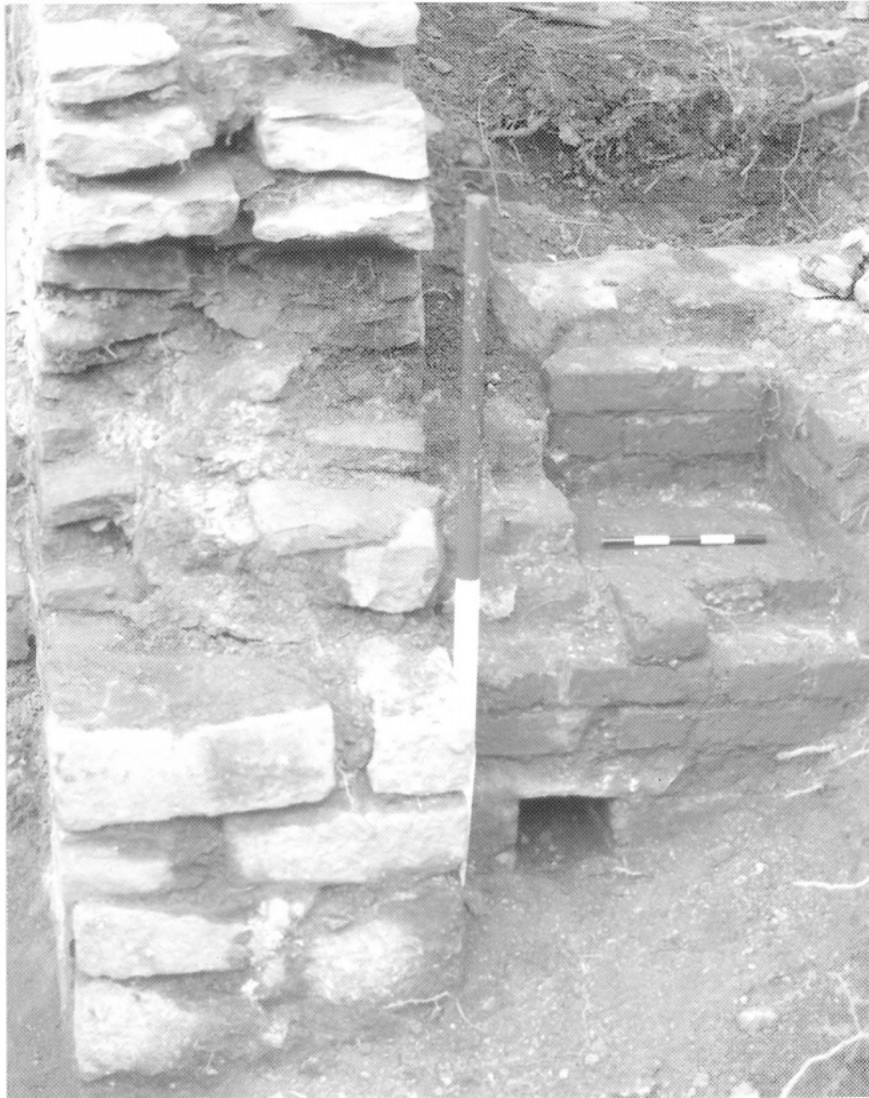
**Plate 1:** Wall abutting east wall of casting house, from the south

In order to allow the sides of the opening to be consolidated, the excavation extended a little way outside the opening in the eastern wall. This revealed the end of a wall abutting the eastern wall of the casting house between the opening and the building's north-eastern corner, (Figure 2, and Plates 1 and 2). Its inner face was some 0.2 metre to the north of the opening. It was 0.8 metre thick and 0.7 metre of its height was uncovered. It was constructed mostly of brick but had a stone face on its northern side. The wall contained the base of an alcove in its southern side which measured 360mm wide by 430mm deep. The southern face of the wall was pierced by a small opening measuring 250mm wide and more than 250mm high, at the base of the part of the wall which was uncovered. The base of the wall was not found.

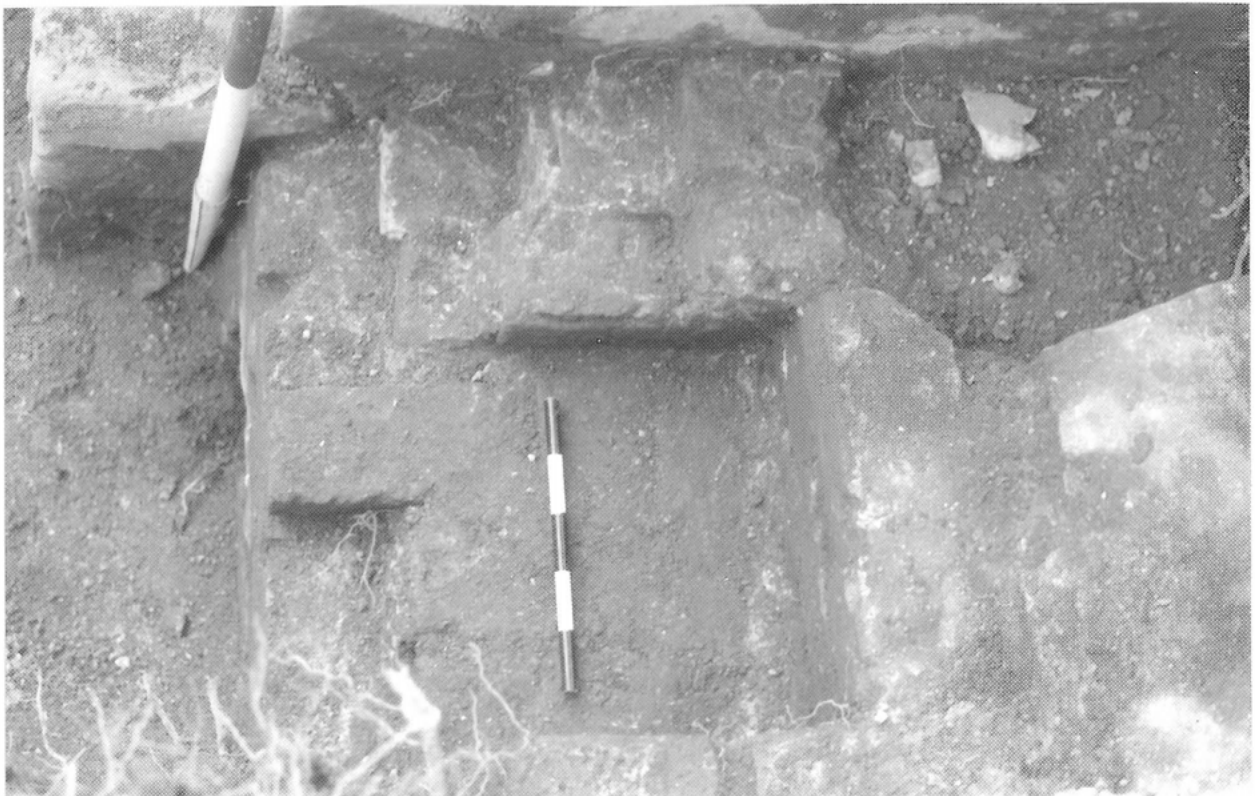
**Plate 2:** Detail of wall abutting east wall of casting house

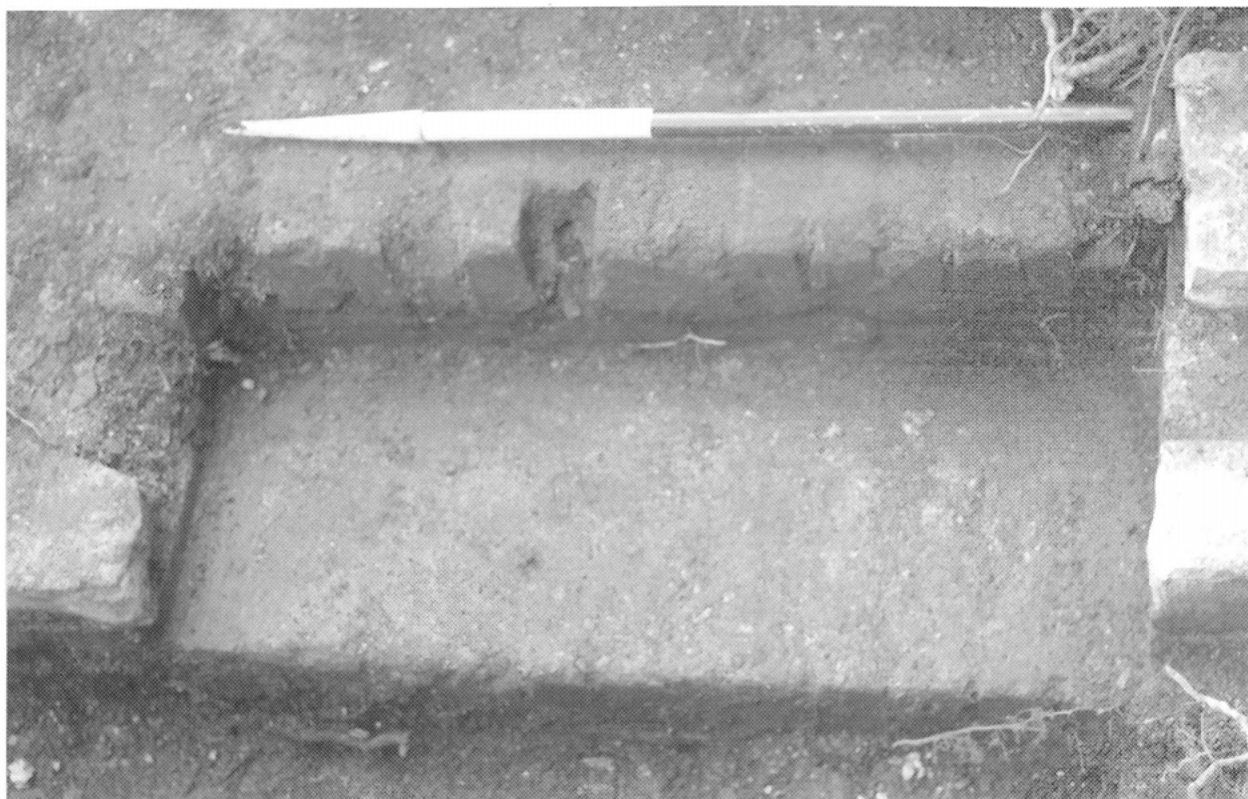
**Plate 3:** Detail of brick steps in opening in west wall of casting house

The opening in the western wall was 0.9 metres from the north-west inside corner of the building, and was 2.56 metres wide. This opening had clearly had a slightly more complex history than that in the eastern wall. It was found to have been partially blocked with masonry to form a narrower opening at its northern end, some 1.02 metres wide. In the base of this opening two brick steps had been built, (Plate 3). This would suggest that at the time the steps were built, the ground level outside the building was higher than the floor level inside. This narrower opening had then, in turn, been blocked with stone rubble, apparently deliberately.

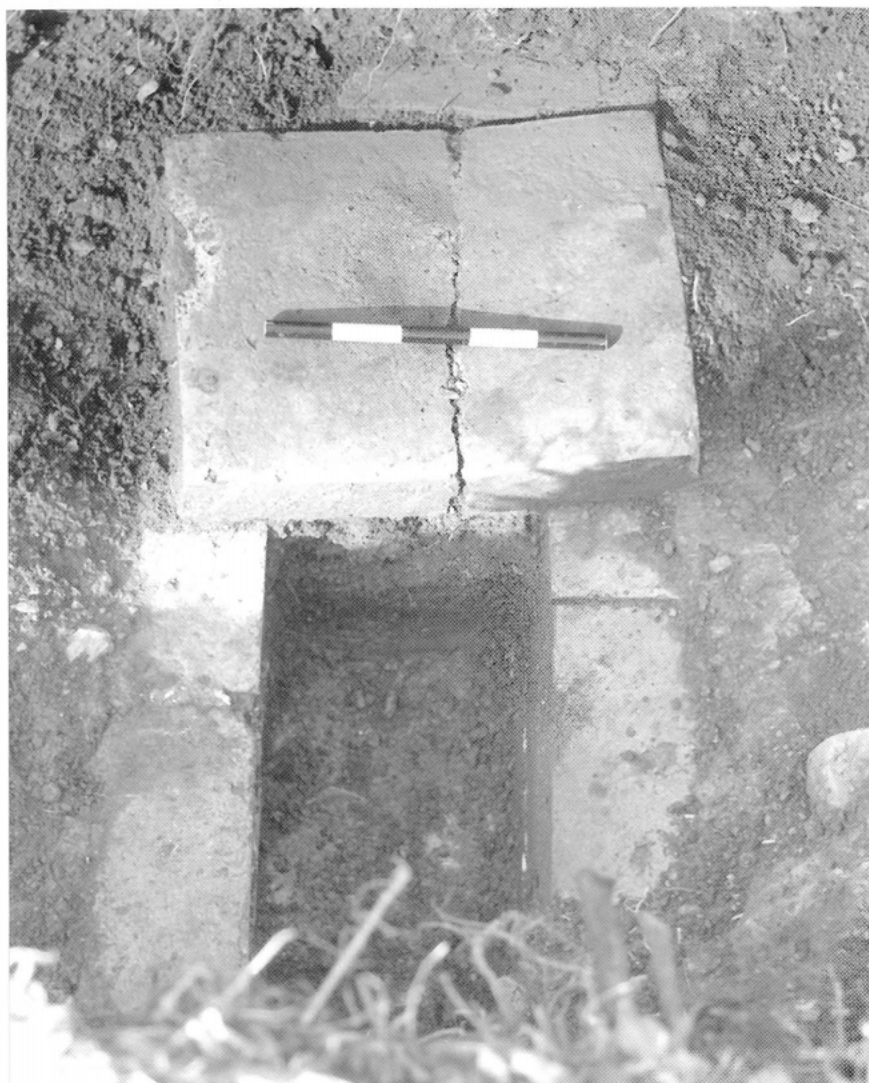
**Plate 4:** Brick-lined gully to south of calcining kilns, (Scale: 0.25m)

Throughout most of the length of the trench the material through which it cut consisted of clay and fragments of shale mixed with coal ash and slag. To the south and south-west of the calcining kilns there were large quantities of coal, coal dust, ash, and cinder. To the south of the calcining kilns a brick-lined gully was found, (Plate 4). It was cut into the underlying clay and its sides were lined with three courses of bricks forming a gully 0.22 metre wide and 0.2 metre deep. It was capped with brick slabs. The gully was filled with loose humic soil and its base was unlined. It is most likely that this gully was intended to carry water, perhaps as a drain.
