BULFORD ROAD IMPROVEMENTS, JOHNSTON TO TIERS CROSS, PEMBROKESHIRE: ARCHAEOLOGICAL WATCHING BRIEF AND CONTROLLED STRIP FINAL REPORT

(NGR SM 9292 1006 to SM 9062 1071)

RHIF YR ADRODDIAD / REPORT NO. 2015/46 RHIF Y PROSIECT / PROJECT RECORD NO. 107301

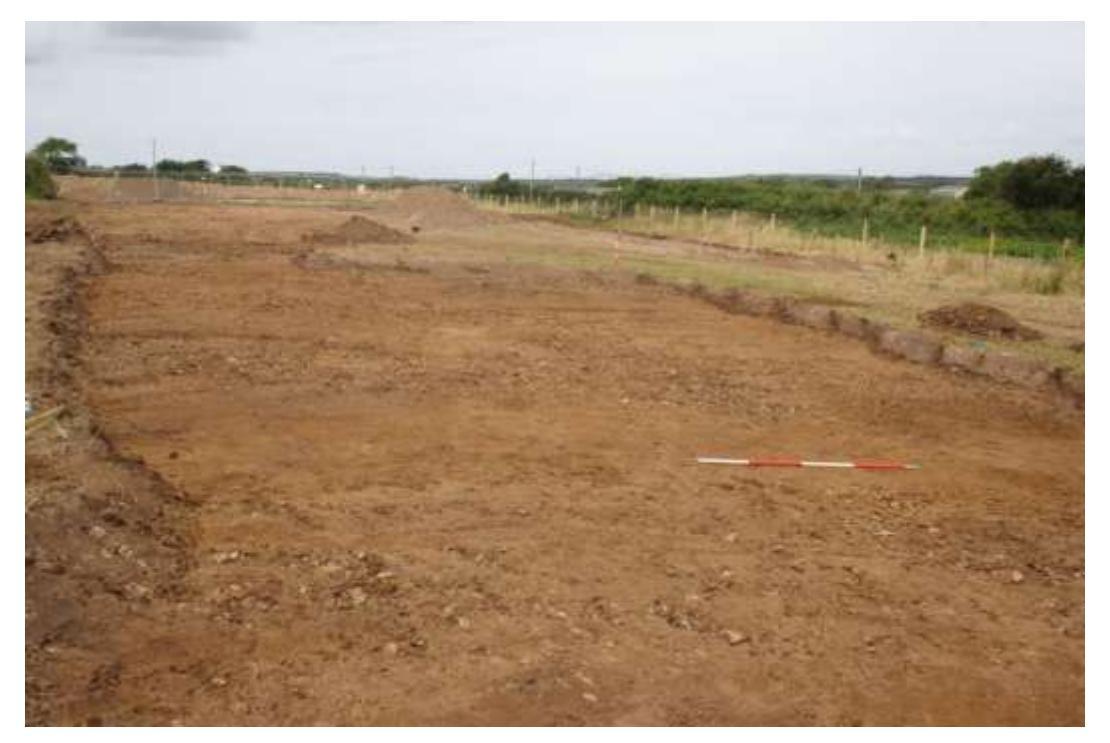
Photo 1: Area 1 of enhanced archaeological potential. Representation of exposed ridge and furrow aligned northeast to southwest.

- 4.2.2 A controlled strip and cleaning of the adjacent area to the east of GSNo.1 revealed evidence of ploughing in the form of ridge and furrow on a northeast to southwest alignment (Photo 1). The ridges consisted of sandy clay with frequent stone inclusions and were approximately 3m wide. The furrows contain clay silt and are approximately 2m wide. These features are presumed to correspond with geophysical anomalies GSNo.4 and GSNo.3. Anomaly GSNo.2 probably represents a former field boundary.

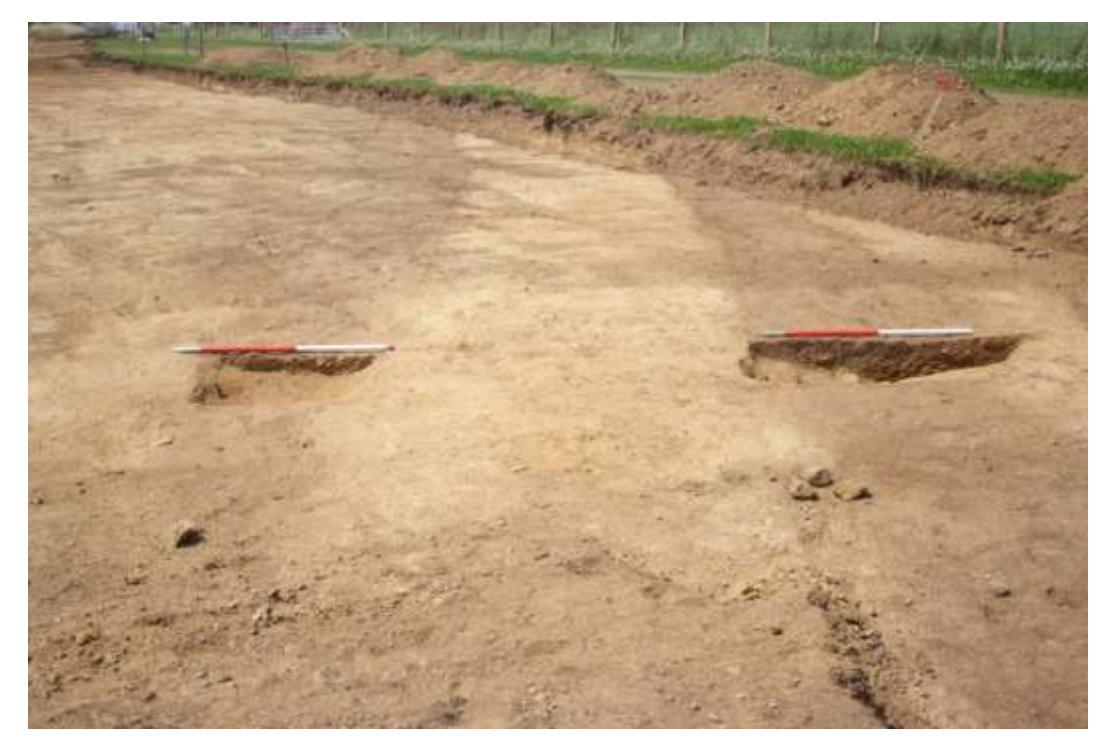
- **Photo 2:** Former hedgebank and flanking ditches exposed in Area 2 (GSNo. 14), viewing northwest along northwest to southeast aligned double ditches, showing excavated sections. (Left: [207], Right [209]/[211]).
- 4.4.4 The roughly northwest-southeast oriented ditches (anomaly GSNo.14) clearly correspond with field boundaries shown on the 1847 Steynton Tithe Map (Figures 9a & 9b) and the first edition Ordnance Survey maps (Figures 10a & 10b). The anomaly on the southeastern side of the area (anomaly GSNo.15) corresponds with a modern field entranceway, which runs over another former field boundary. The north to south aligned stretch forming the western side of the possible enclosure (anomaly GSNo.13) is not shown on the early OS maps nor is it shown on the 1847 Tithe map of the area.

- 4.4.5 Fragments of post-medieval pottery and clay pipe from the fills of these ditches suggest they are boundaries created in the post-medieval period and are unlikely to have had earlier origins.

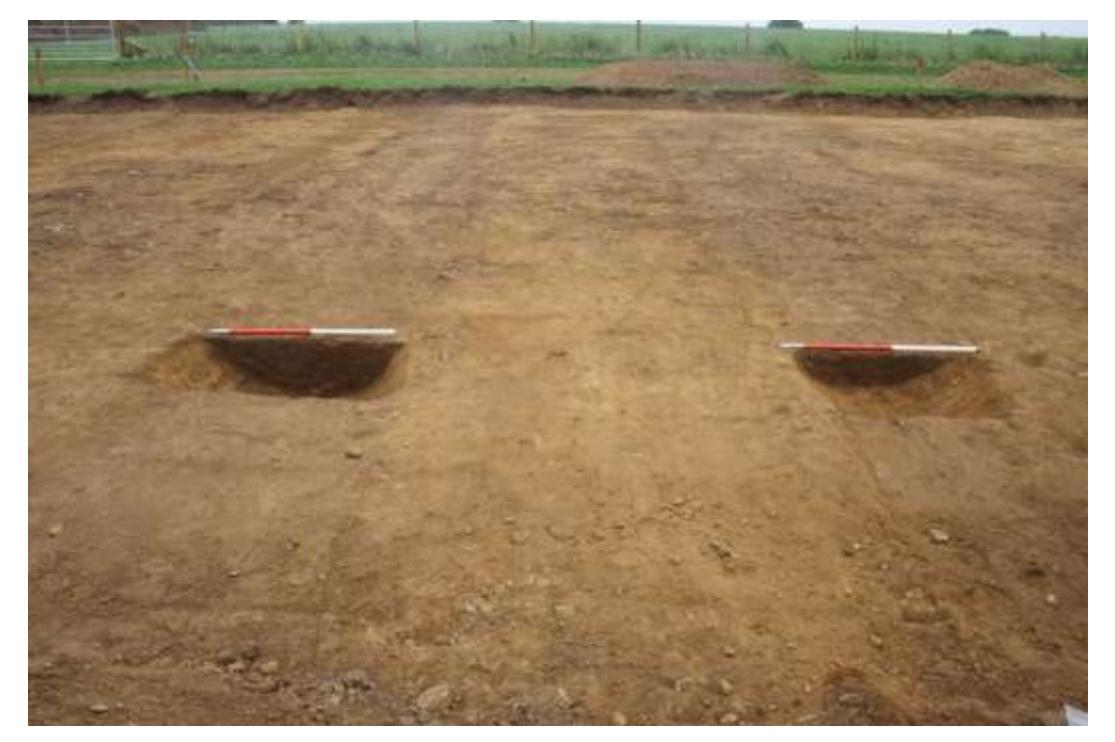
- **Photo 3:** Former hedgebank and flanking ditches exposed in Area 2 (GSNo.13), viewing north along north to south aligned double ditches, showing excavated sections. (Left: [201], Right: [203]).

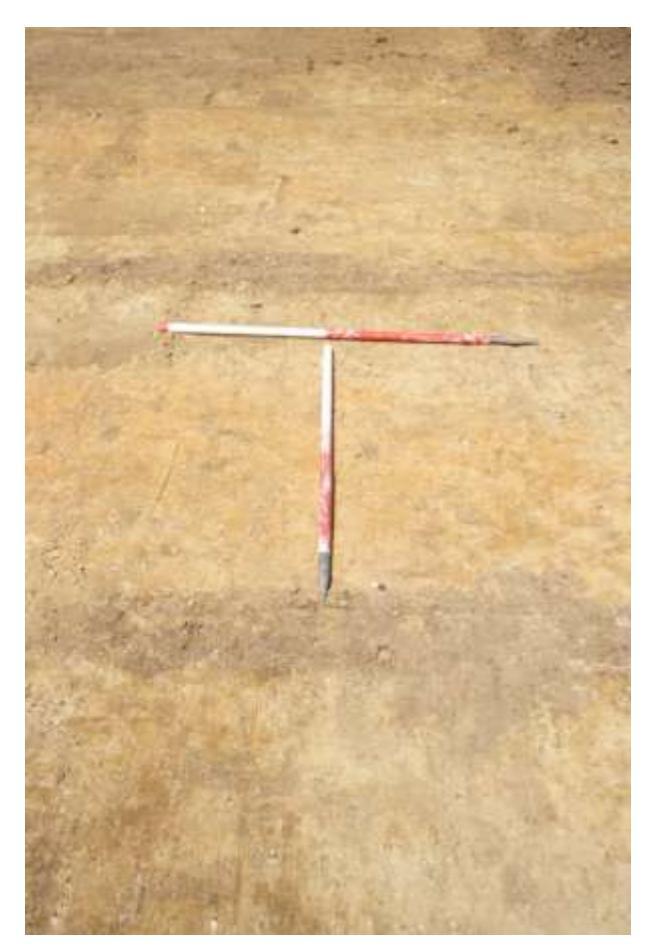
Photo 4: Plough marks within Area 2 (205).

- 4.4.6 A large number of similar linear features (205) running parallel with the north-south aligned ditches and spaced 1.70m apart were visible to the east (Photo 4). On investigation it was apparent that these were cultivation marks, possibly the result of steam ploughing in the early 19th century. The cultivation marks are visible in the upper fills of the north-south aligned field boundary ditches (202) and (204), indicating this boundary was removed, prior to the survey for the tithe and OS maps, but before the fields were ploughed. It is possible that the field boundary was removed to create a larger field that was suitable for steam ploughing.

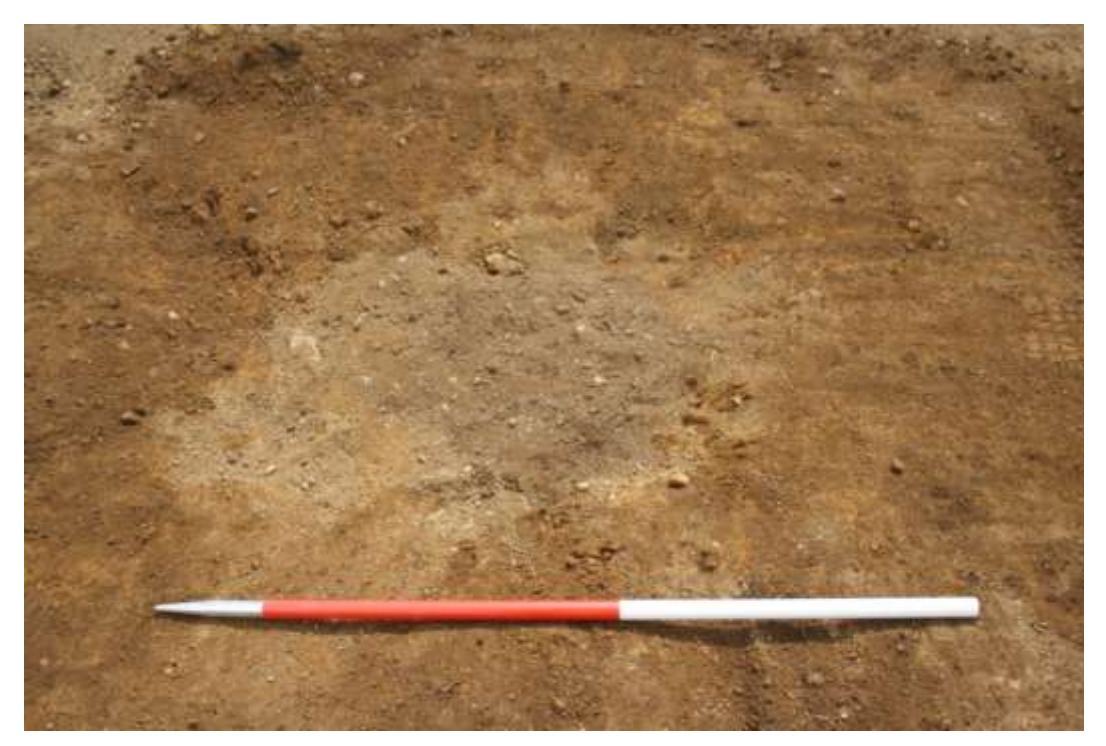
Photo 5: Possible posthole located in Area 2.

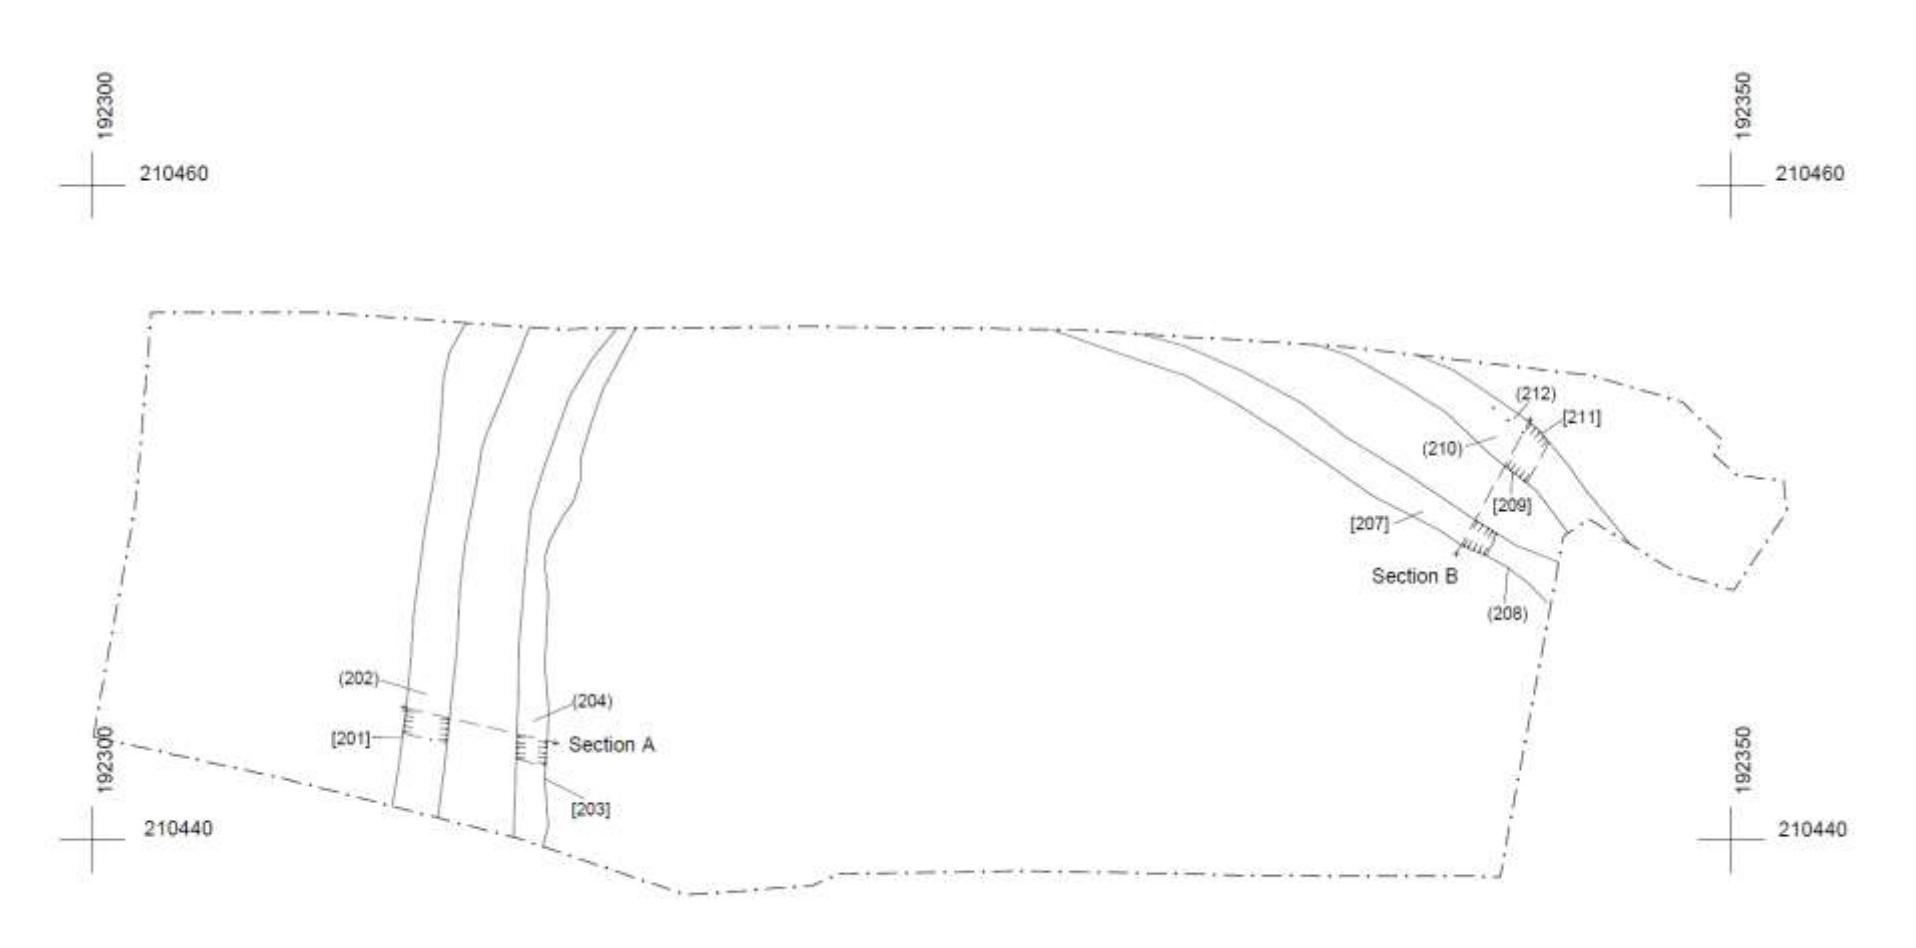
Figure 7: Area 2 detail showing machine stripped area and excavated sections through ditches

Ditches [207] & [209]/[211] correspond with field boundaries shown on the 1847 Tithe map and the first edition Ordnance Survey map; ditches [201] and [203] had been infilled and removed by 1847

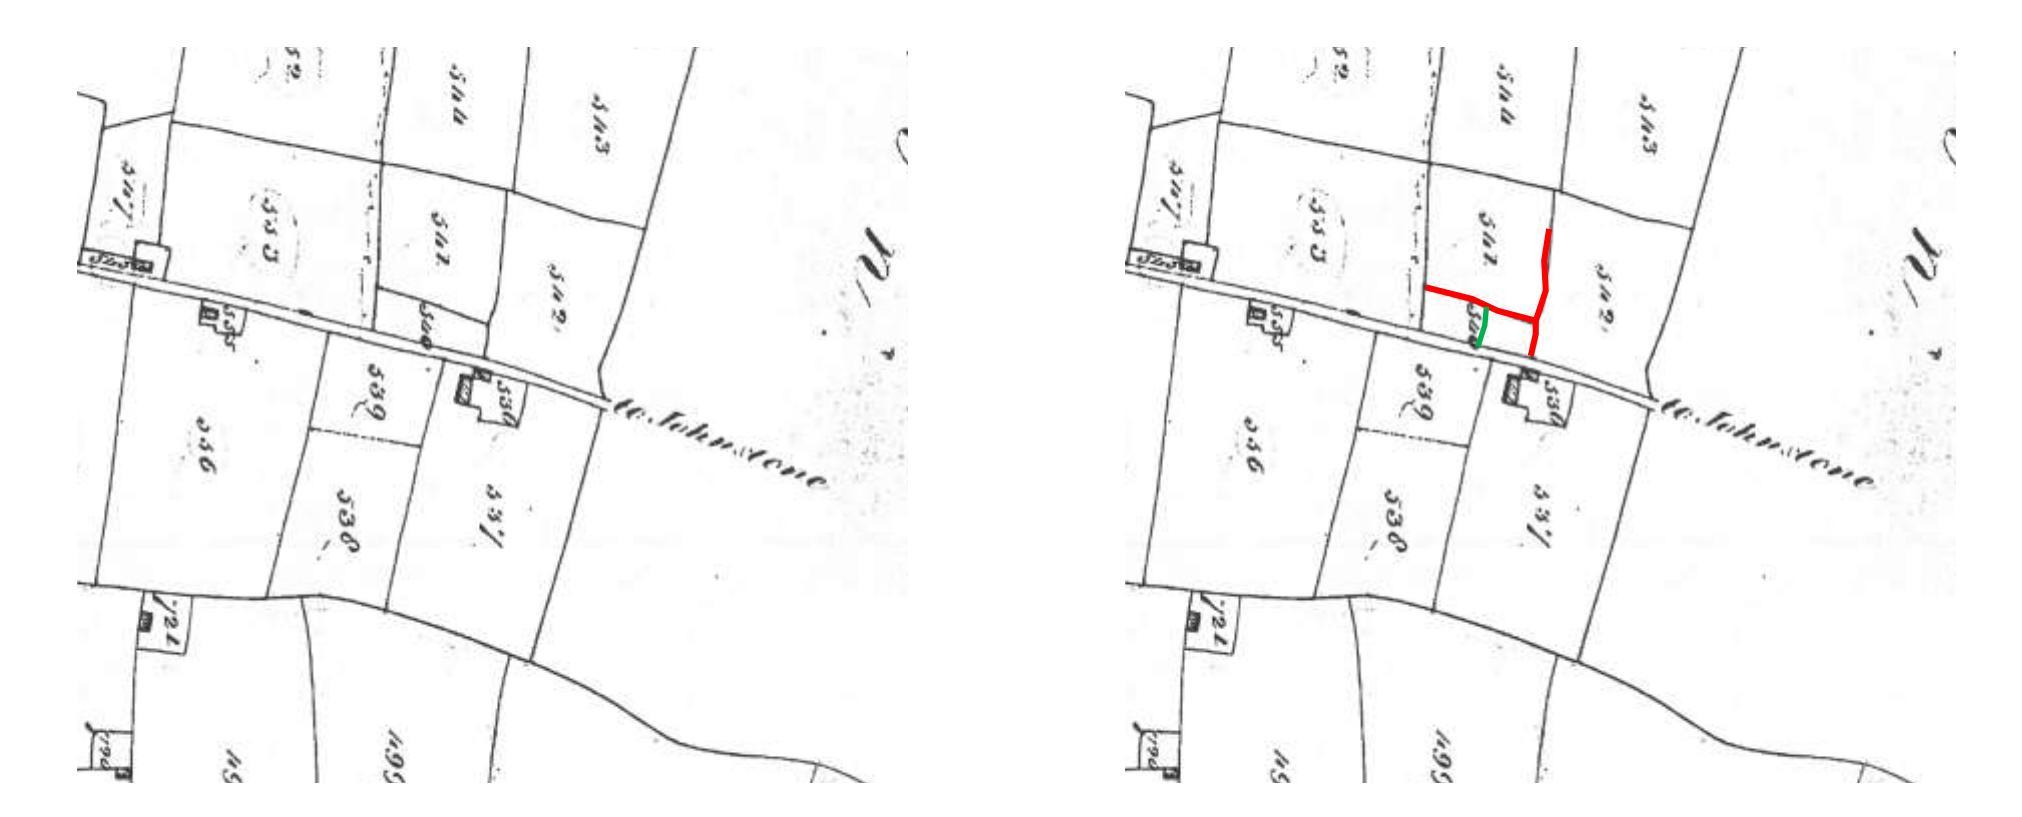
Figures 9a and 9b: Extract of 1847 Tithe Map of Steynton showing field boundaries north of Bulford Farm, and approximate position of former field boundary line (green)

Field 540 is called Little Meadow and used as a meadow at the time of the Tithe Apportionment

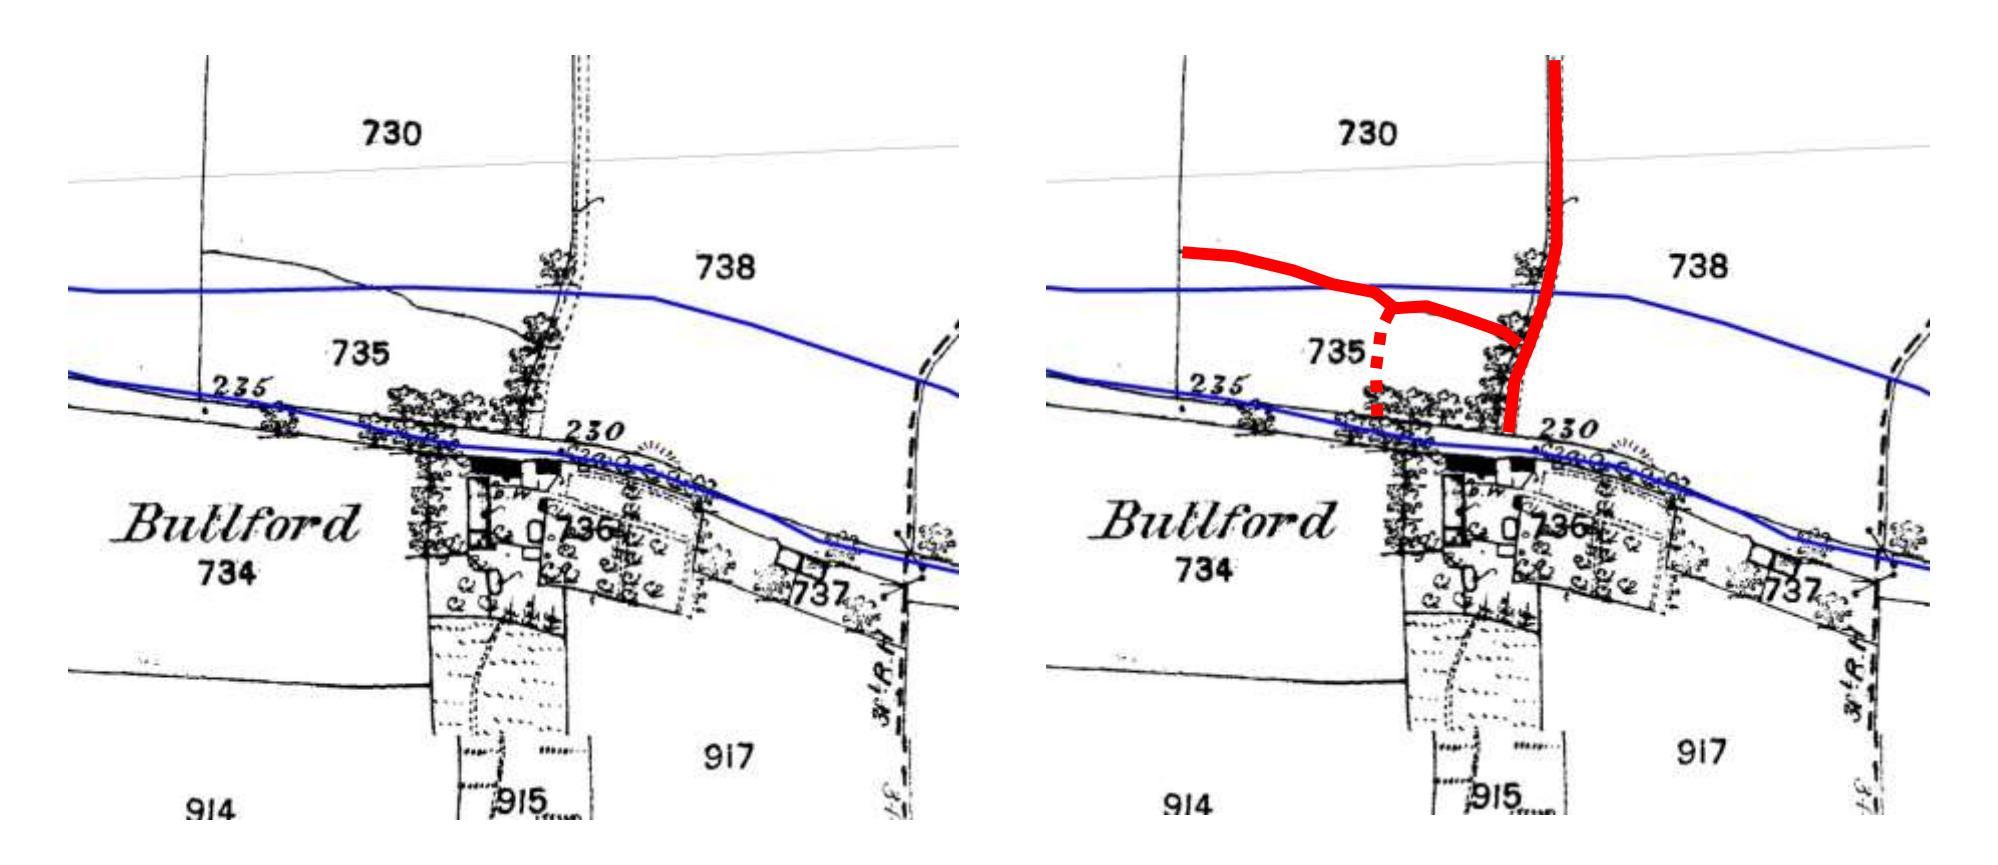
Figures 10a and 10b: First edition Ordnance Survey map showing field boundaries north of Bulford Farm, including former field boundary line (dotted red)

A small kink in the northern field boundary corresponds with the line of the north to south boundary (dotted red) which had been removed by 1847

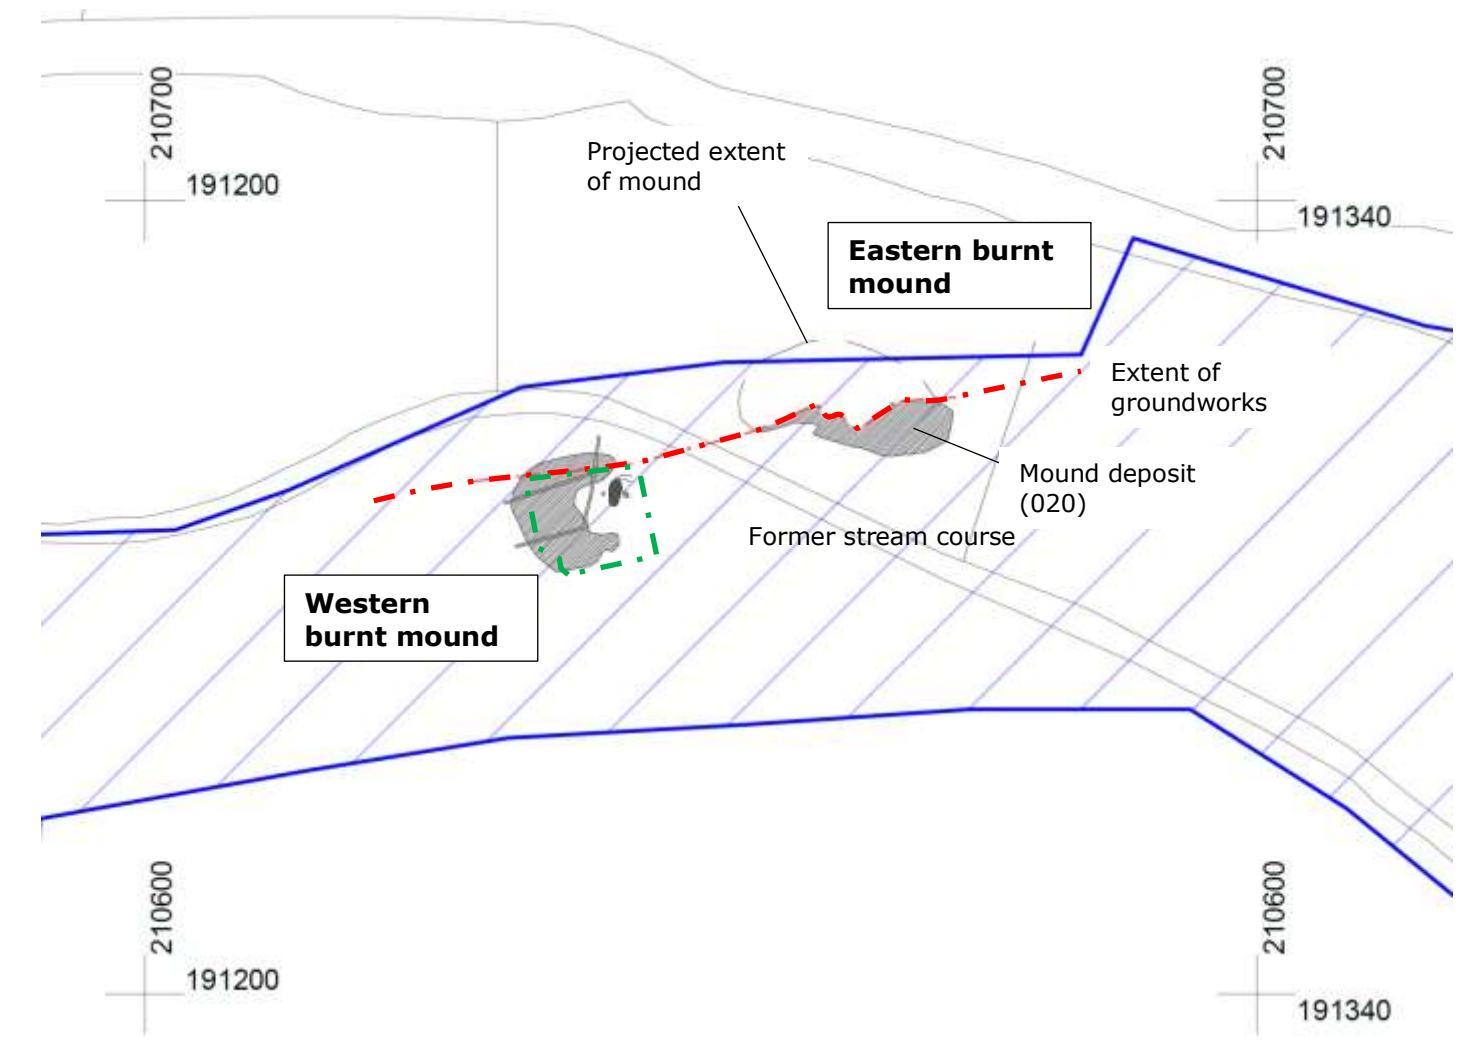
Figure 11 Area 4 showing former stream course and the two burnt mounds identified within the road line The plan also shows the extent of groundworks for the road (red line) and excavation area cleared around the Western burnt mound (green)

- 4.5.6 The area of burnt material 002 had a well-defined, roughly horse-shoe shape, with an east facing opening (Photo 6; Figures 11 & 12). The feature occupied an area of approximately 181 sq m. The burnt mound material (002) survived to a maximum depth of approximately 0.06m, suggesting that the mound had been heavily eroded by ploughing.

of the burnt mound earthwork, beyond the edges of the machine stripped area, are shown on Figures 11 and 15. It is possible that the height of the ground in this area was exacerbated by the presence of a former hedgebank field boundary.

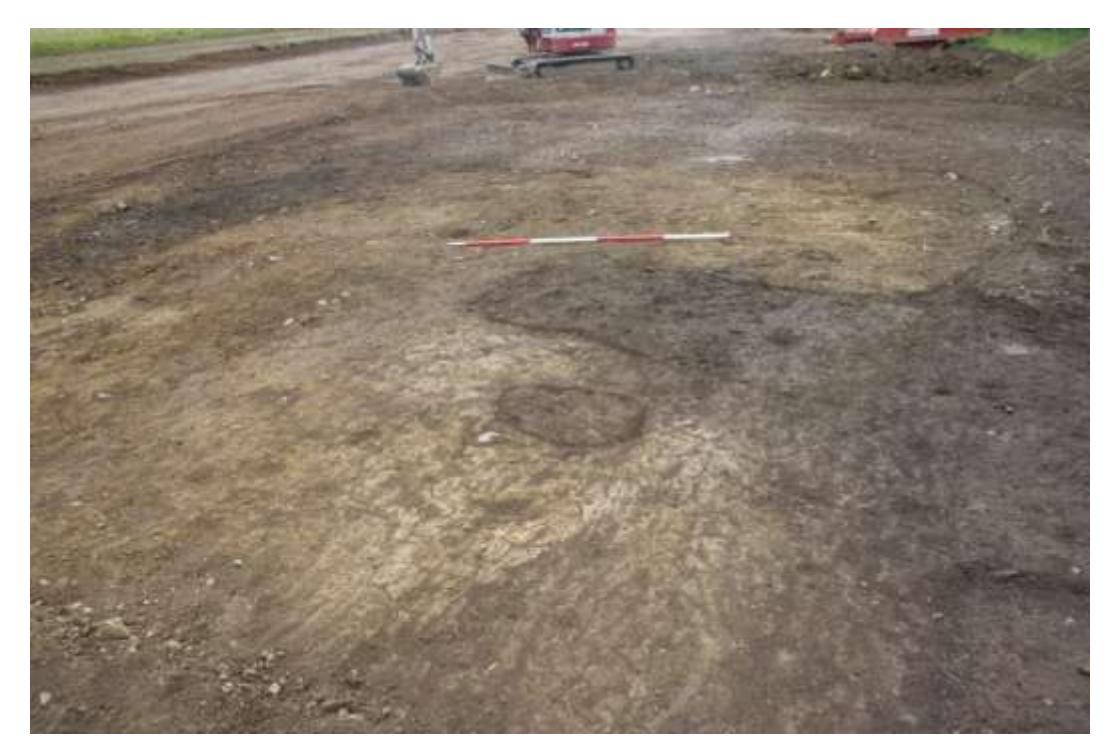
Photo 6: Western Burnt mound after cleaning with features marked. The horseshoe shape mound is visible in the background, the probable trough in the centre of the picture and a possible pit in the foreground (2m scale).

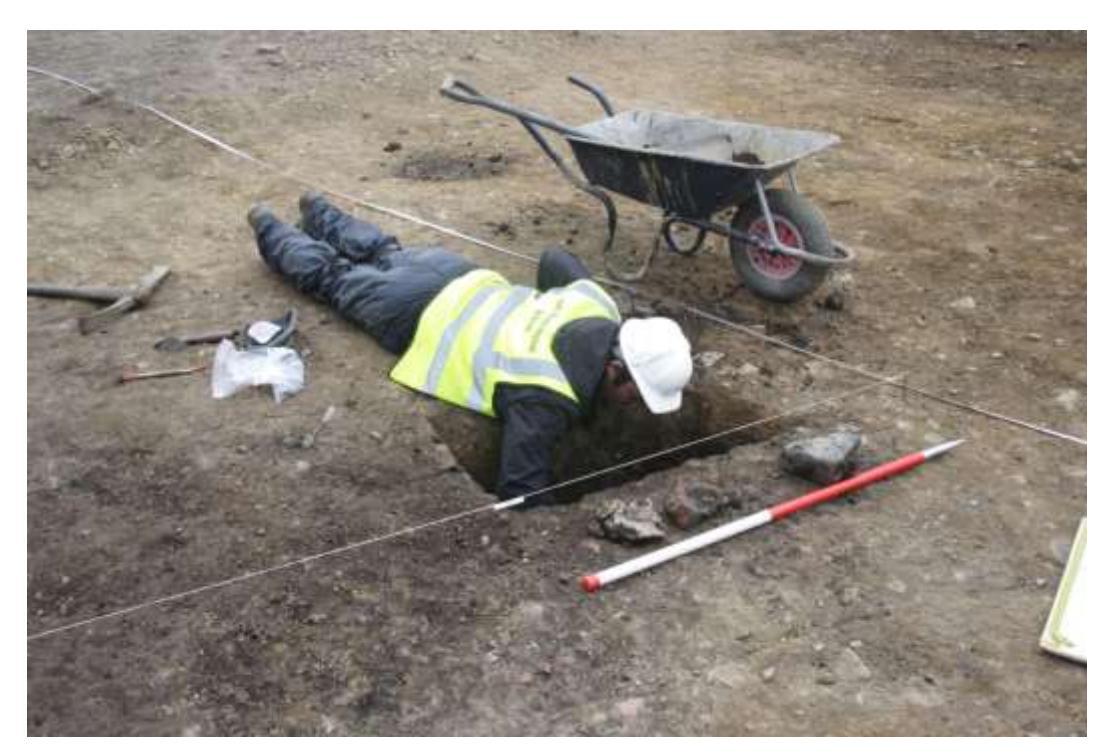
Photo 7: Excavation of the southern end of the trough feature

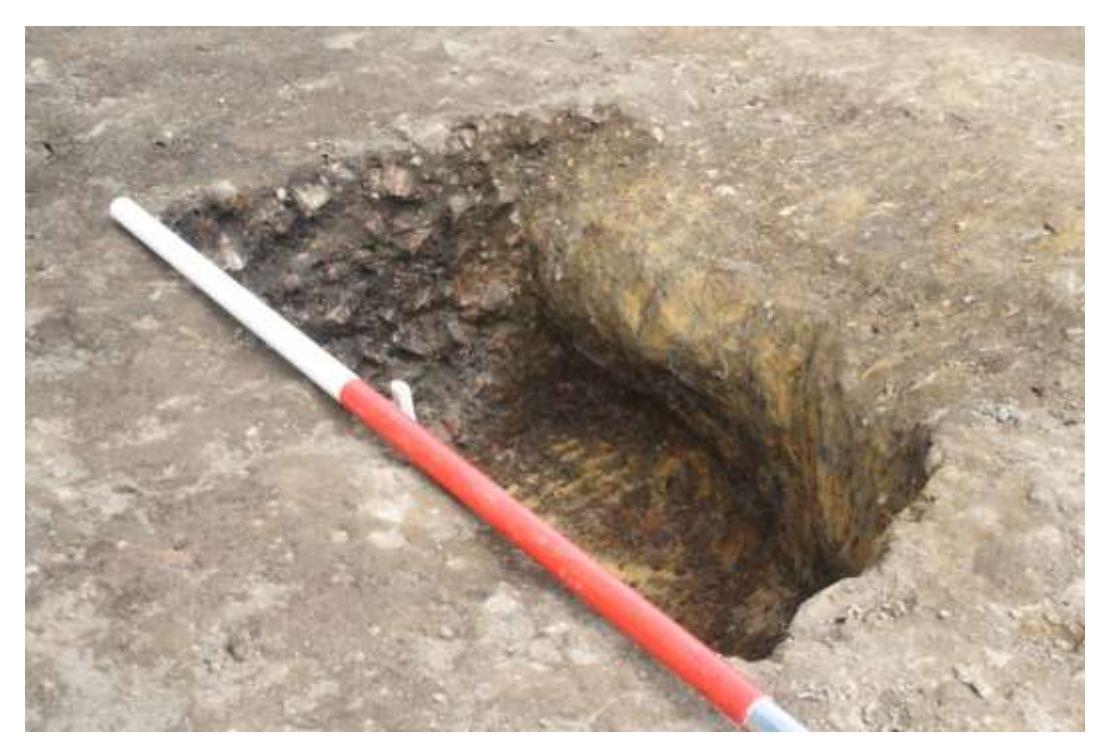
Photo 8: Southeastern section through trough showing slight undercutting on eastern side.

- 4.5.8 The trough [009] was located on the eastern side of the burnt material (002), adjacent to its east facing opening. The roughly oval shaped northsouth aligned trough had rounded ends and measured approximately 3.30m in length and approximately 1.40m at its widest point. It was 0.50m deep, with steeply sloping or undercutting sides, with a flat, smooth base. The trough was cut into natural clay which may have been sufficient to ensure it could hold water. It was excavated in three sections along its length. The eastern side had been undercut by approximately 0.10m and the western side was nearly vertical (Photos 7 & 8). At the north end of the trough a number of charred wood fragments were discovered. These are likely to be the charred remains of a wooden lining to the trough.

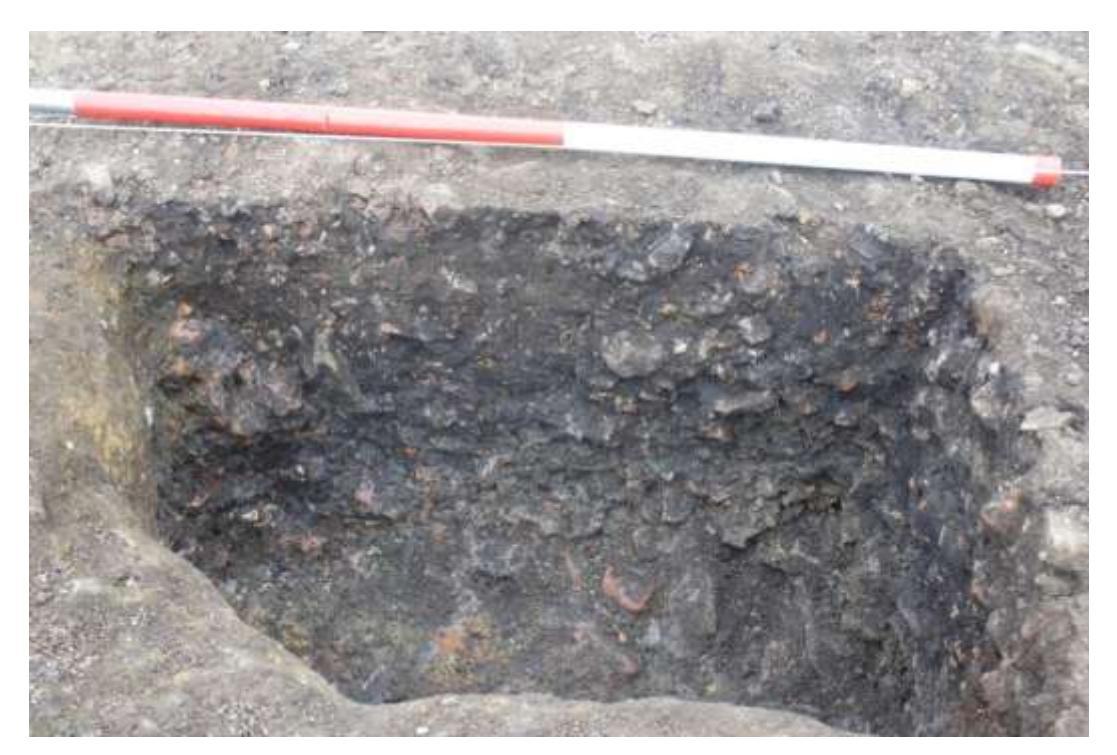
Photo 9: South eastern quadrant of probable trough after excavation showing high level of burnt material (south end of Section 1, Figure 14)

- 4.5.9 The trough [009] contained three fills (Figure 14, Sections 1 & 2). The lowest (012) was a compact clay/silt that contained a high percentage of burnt material that included heat affected stones and charcoal, this layer is probably the by-product of the last use of the trough. The middle layer (011) consisted of almost entirely burnt material and was rich in charcoal and is probably deliberate backfilling of the trough using burnt material from the surrounding mound. The upper layer (010) comprised burnt material with a black/grey silt with frequent stone inclusions (Photo 9).

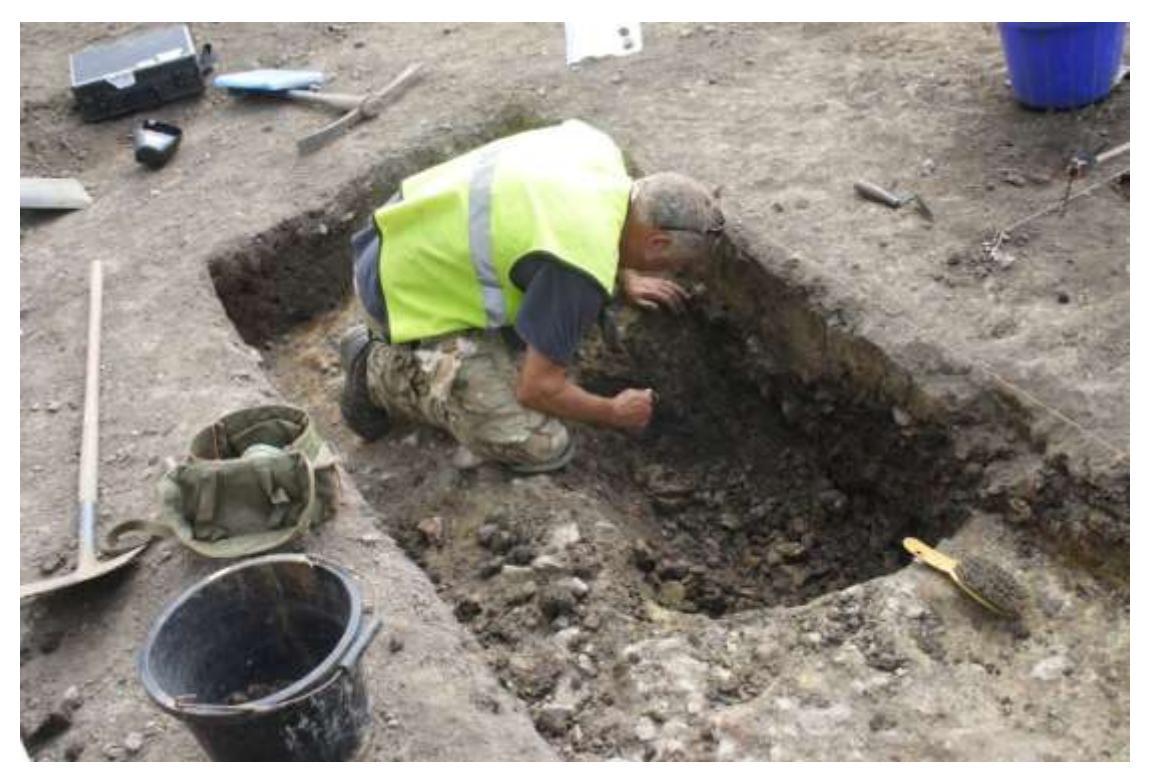
Photo 10: Excavation of northern section through trough, viewing southeast

- 4.5.10 At the northern end of the trough (nearest the current location of the stream) (Photos 10 & 11), excavation revealed an east-west oriented linear feature (024). The dimensions of this feature are uncertain but it is thought to have been contemporary with the trough, and was interpreted by the excavators as a 'gulley-like' channel (Photo 11; Figure 13). The channel is thought to have diverted fresh water from the stream to the northern end of the trough, and then continued eastwards to re-join the stream, forming a leat.

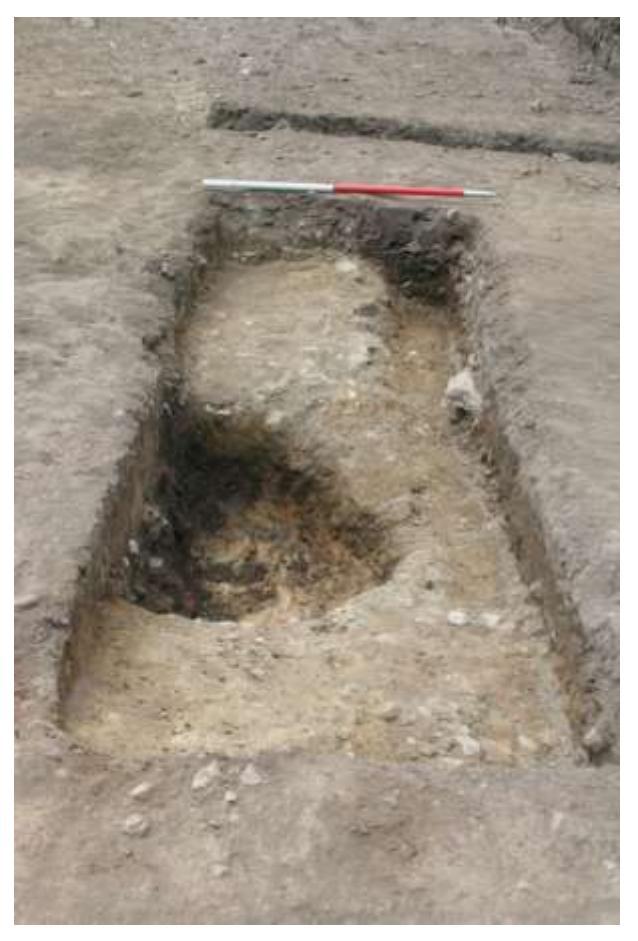
Photo 11: Northern section through trough with part of a possible water channel [024] visible on the right hand side

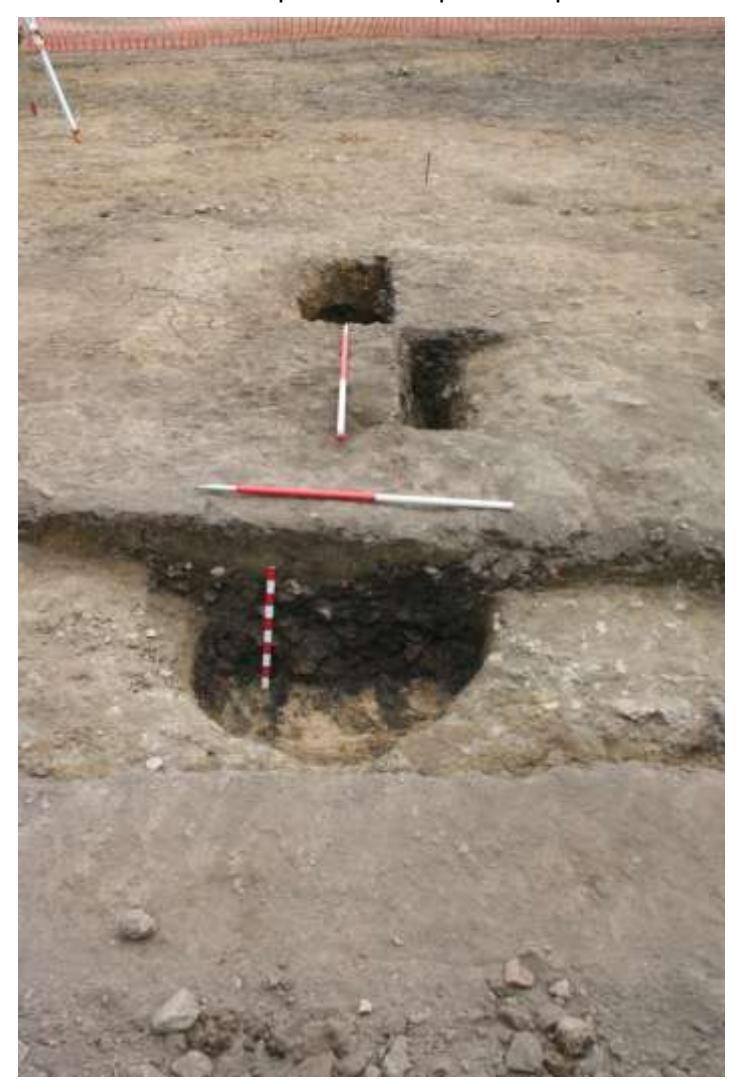
Photo 12: View south along trough following excavation of sections

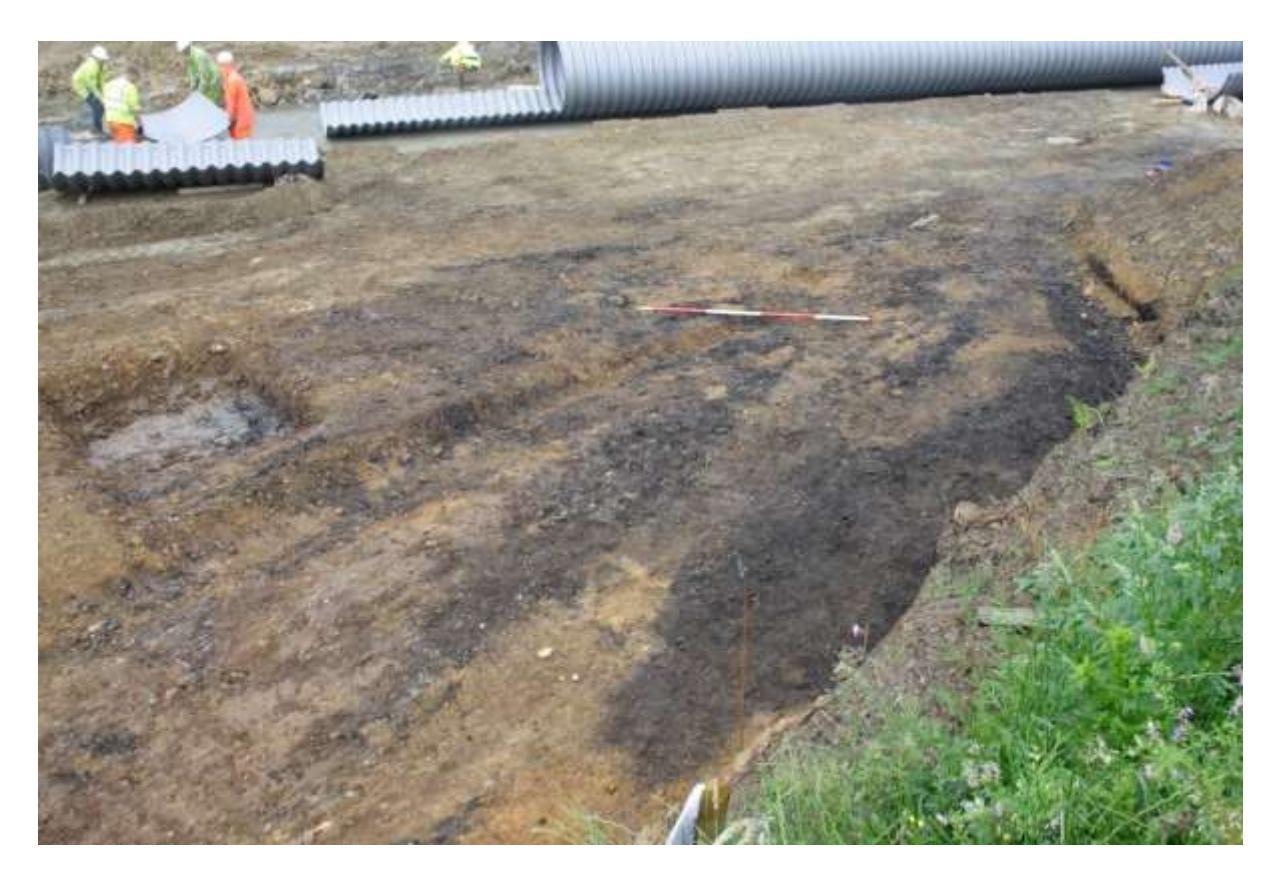
Photo 13: Eastern burnt mound which appeared to have been heavily disturbed

- 4.6.3 This burnt mound was located in an area of waterlogged ground either as a result of its proximity to the former stream course, or perhaps as a result of a channel cut to divert water from the stream to the location of the burnt mound (as appears to be the case for the Western Burnt Mound).

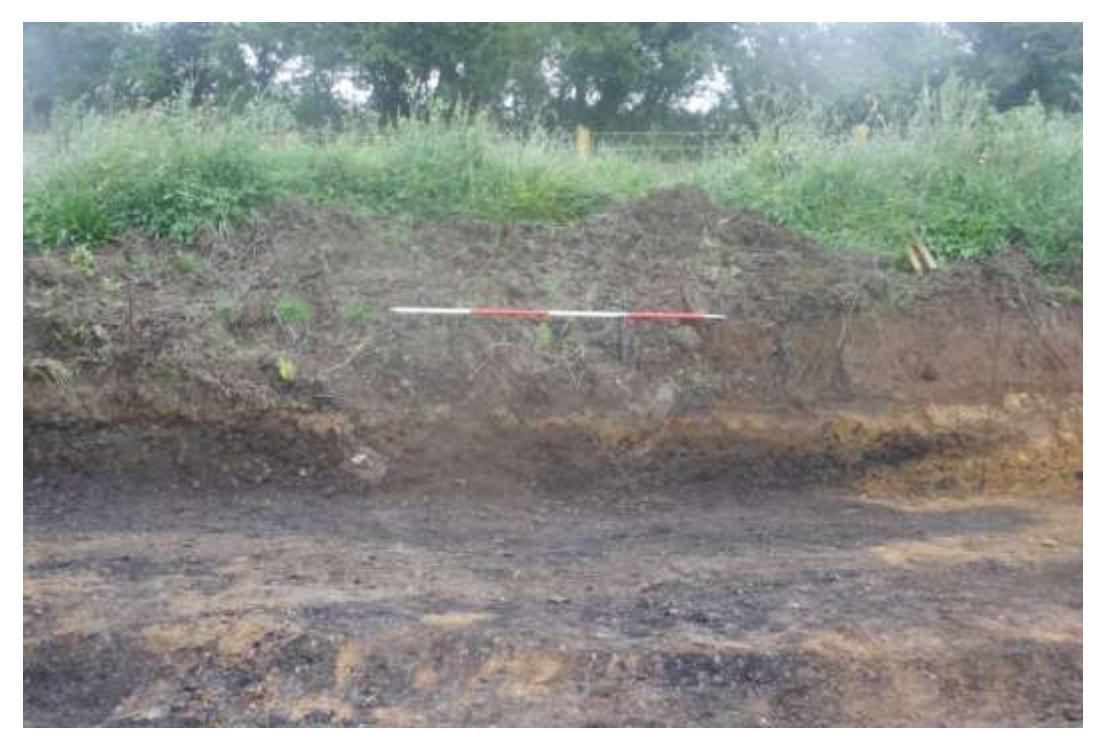
Photo 14: South facing section along edge of machine stripped area for road line, showing the burnt mound material at the base of the section and

4.6.4 The northern edge of the machine stripped area for the road line was cleaned up and it was evident that the burnt mound material survived for as much as 0.55m above the stripped surface (Photo 14; Figure 16, Sections A & B). The depth of material could be seen to survive as a visible mound in the field to the north beyond the extent of the groundworks for the Bulford Road improvements. The approximate outline

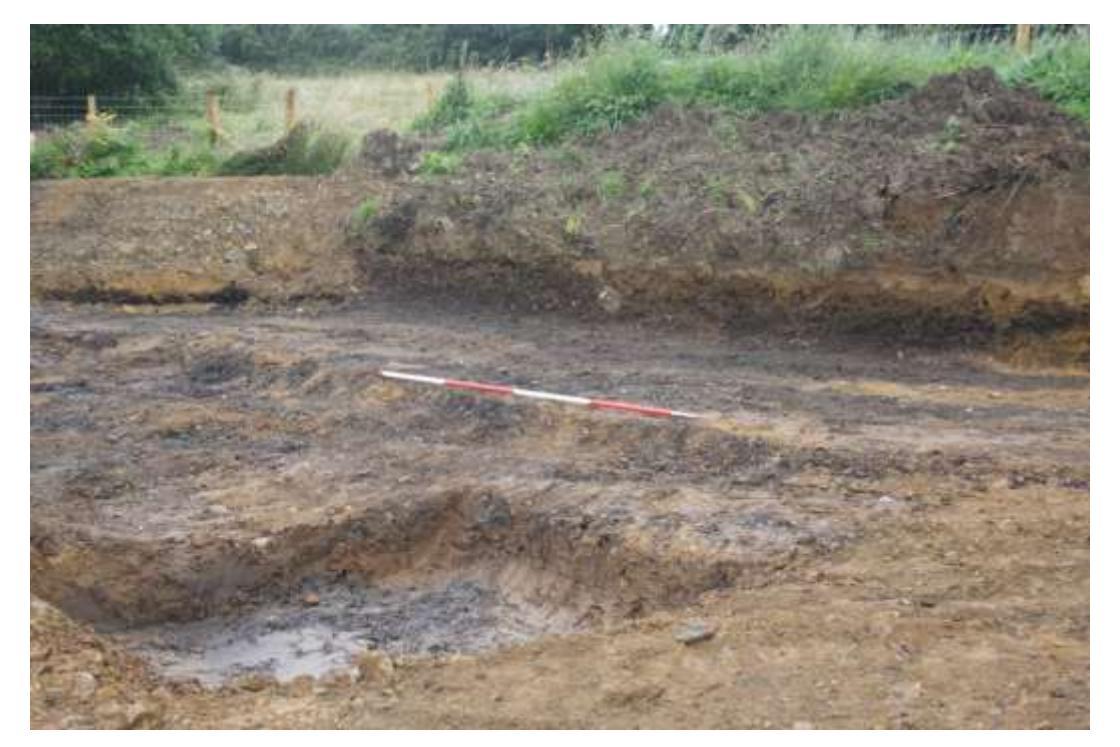
Photo 15: View north across excavated sondage with section along edge of excavated area visible to rear

- 4.6.5 An exploratory sondage was excavated through the burnt material (020) which demonstrated that it was still present at a depth of approximately 0.30m below the stripped ground surface. This suggests that not only does a significant depth of burnt material survive on the eastern side of the stream course, but that it also has probably been subject to less disturbance from agricultural activity than that to the west. The fact it survived below the depth of the machine stripped area would indicate that an accumulation of soils (colluvium / hill wash) had built up around the base of the mound, or even that a terrace had been cut into the hillslope for the burnt mound.
