BULFORD ROAD IMPROVEMENTS, JOHNSTON TO TIERS CROSS, PEMBROKESHIRE: ARCHAEOLOGICAL WATCHING BRIEF AND CONTROLLED STRIP FINAL REPORT

(NGR SM 9292 1006 to SM 9062 1071)

RHIF YR ADRODDIAD / REPORT NO. 2015/46 RHIF Y PROSIECT / PROJECT RECORD NO. 107301

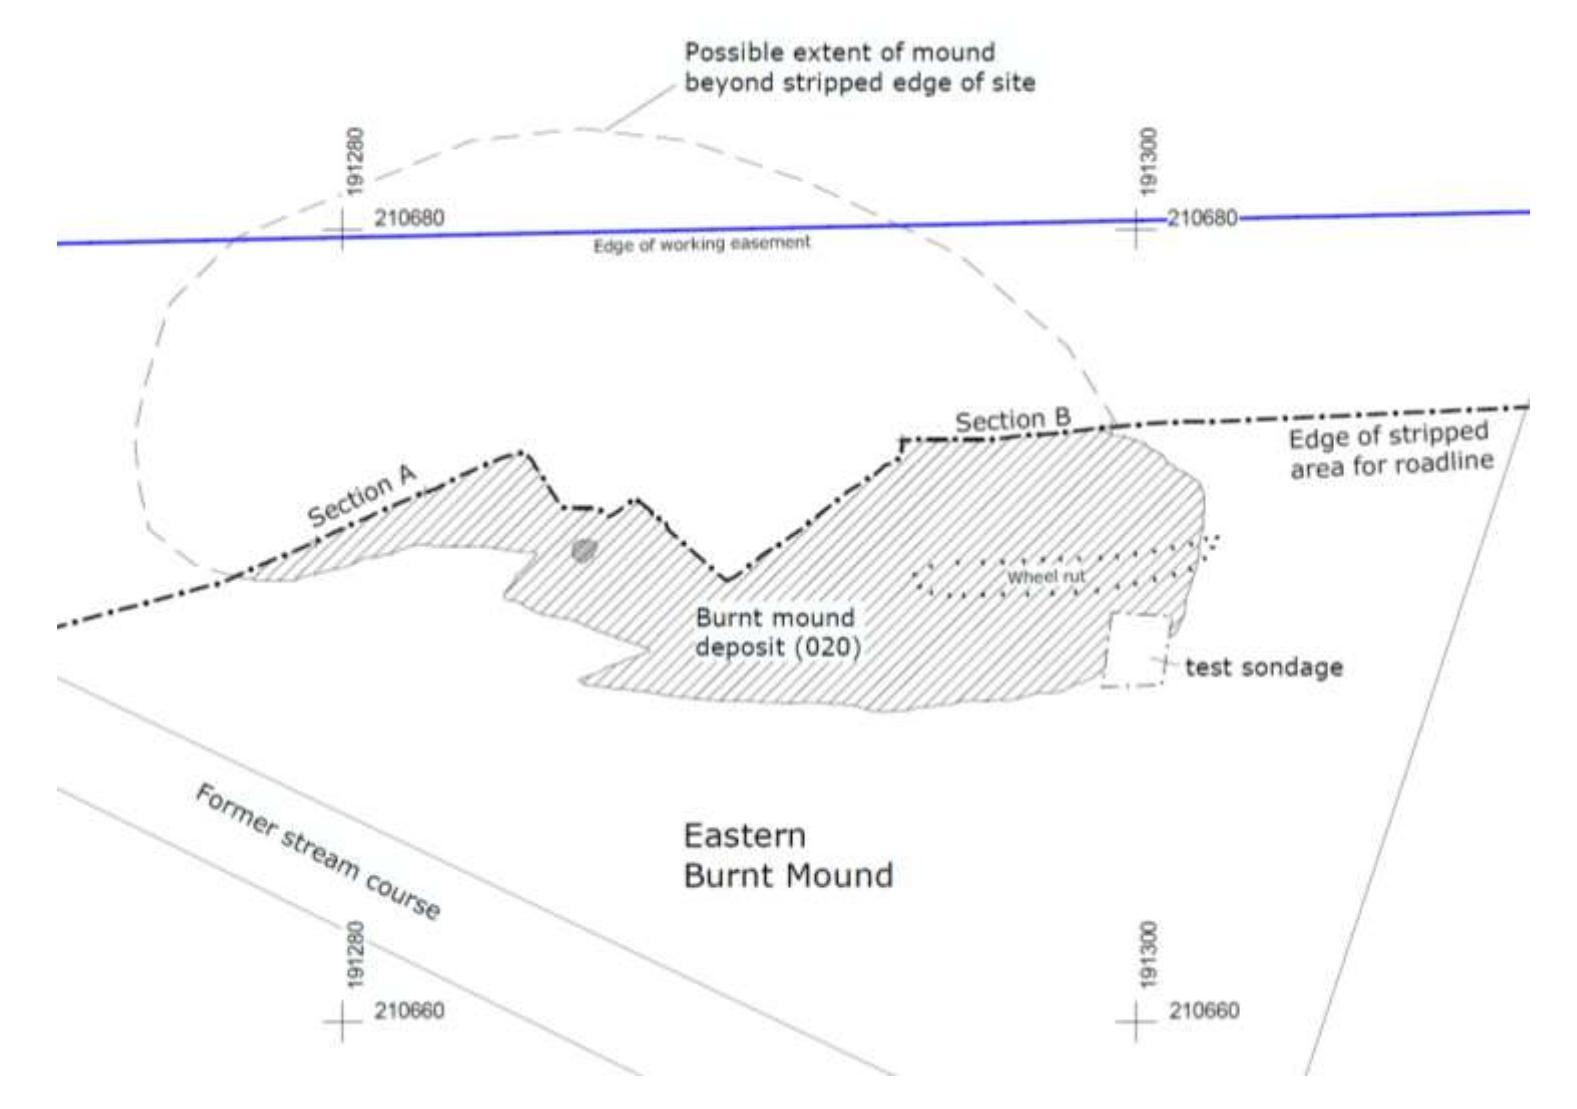
Figure 15: The Eastern Burnt Mound showing its extent within the topsoil stripped area of the road line (hatched area) and an approximation of a mound within the adjacent non-stripped area which could represent the extent of the burnt mound.

of the burnt mound earthwork, beyond the edges of the machine stripped area, are shown on Figures 11 and 15. It is possible that the height of the ground in this area was exacerbated by the presence of a former hedgebank field boundary.
