Threat-Related Assessment of Twentieth Century Military Sites:

FIRST WORLD WAR - Industry and Manufacturing

Interim Report Year 2

Llanelly National Shell Factory PRN 107898 (Llanelli Reference Library)

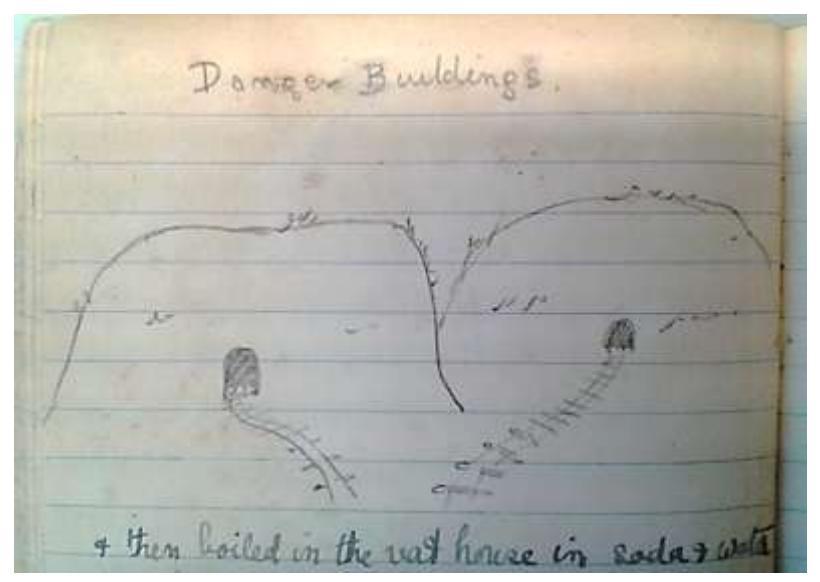
Figure 8: A drawing from the diary of Gabrielle West showing the danger buildings at Pembrey.

To make cordite guncotton had to be dried in **guncotton drying stoves** and then weighed in a **weighing house** before being combined with nitroglycerine.

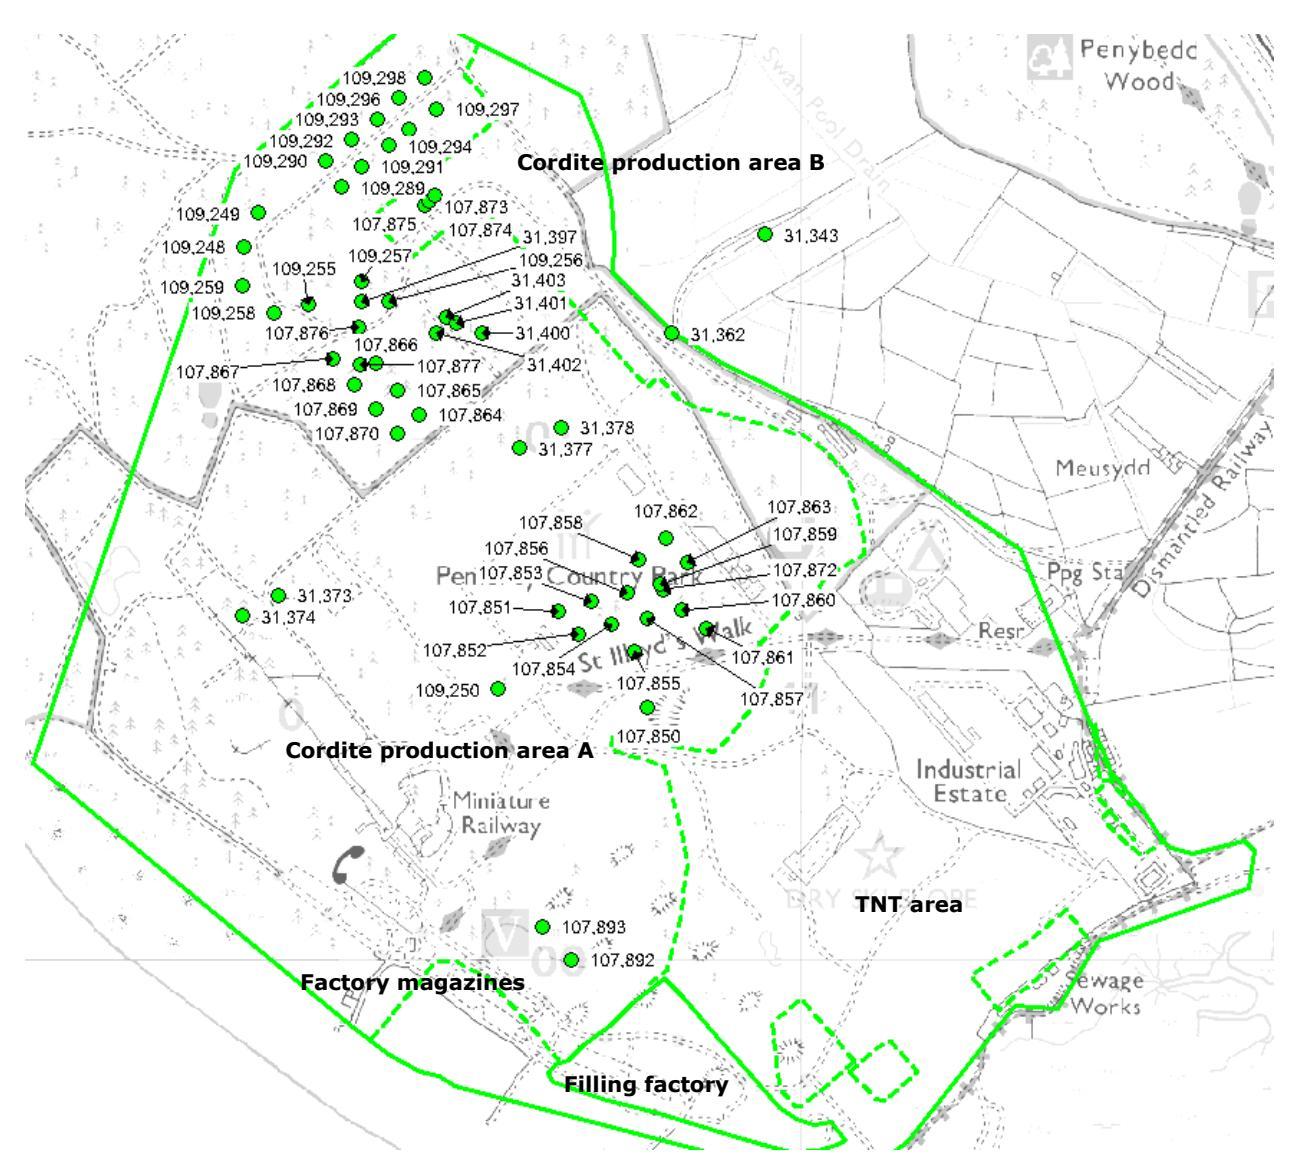
The cordite producing areas lie over the western half of the factory site where large areas survive as earthwork remains. Two distinct areas of cordite production have been identified, one in the central area of the site, Cordite Production Area A and a second which lies to the north-western extent of the site, Cordite Production Area B (see Fig. 9).

Figure 9: First World War sites recorded as surviving within Pembrey Country park.

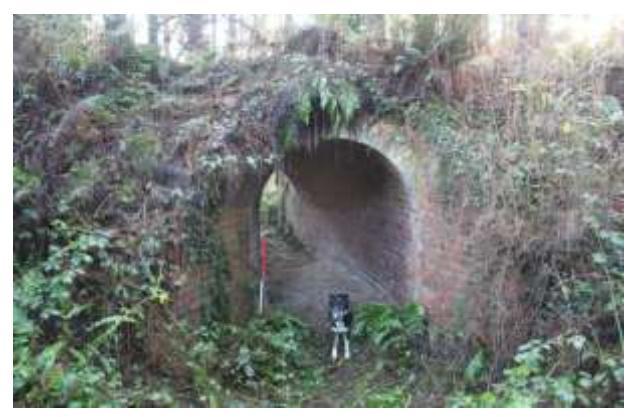
The tunnels curve in whichever direction required to enable a tram to exit the structure and join a connecting tramway. The tunnels are well constructed with round arched roofs over which the bank continues above. In some tunnels there are traces of concrete or cement floors. In the sides of the brick tunnel walls, at approximately 4 brick courses high, are the remains of bronze or copper pegs or nails.

Figure 10: The entrance tunnel of enclosure PRN 107854.

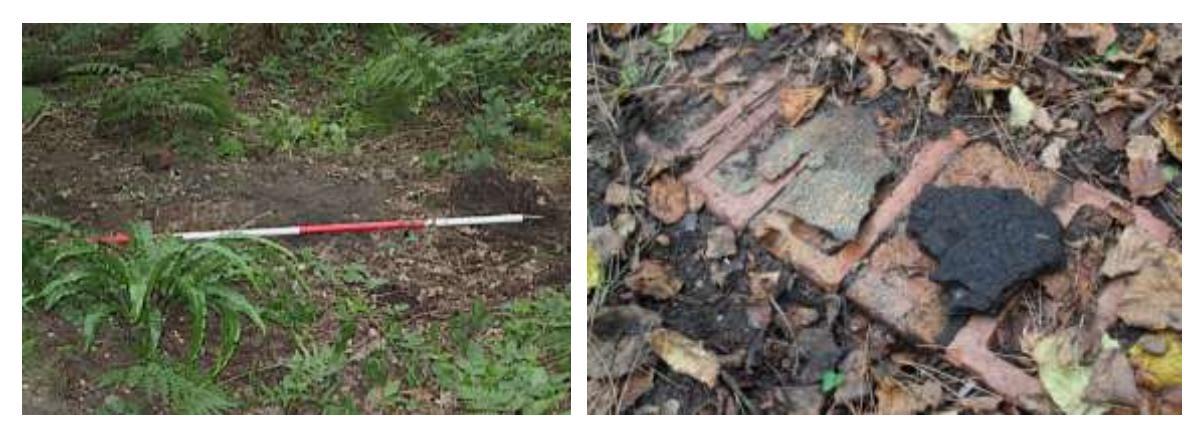
No buildings survive within these structures, but within one enclosure the traces of structures where identified. PRN 107683 is particularly interesting as within the enclosure a structure is identifiable by a brick foundation course running NW-SE, and three iron bolts project from the brick foundation which would presumably have fixed a wooden superstructure (Fig. 11). Artefacts lying within the enclosure include fragments of a rubberized material or lino and a Trimsaran brick. A 'Coedely' brick lies on the exterior of the enclosure.

Figure 11: PRN 107863 showing brick foundation course.

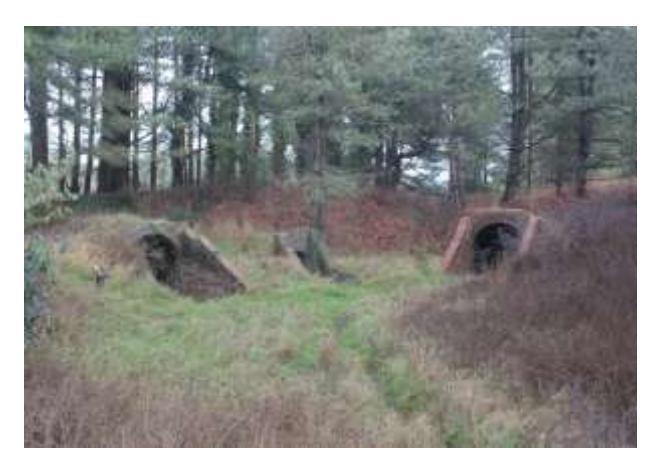
the site in the second world war. It is located on a high ridge above the other cordite mixing areas in order to allow gravity to run off nitroglycerine which was too dangerous to pump or carry.

Figure 12: The remains of the nitrator separator house PRN 107850.

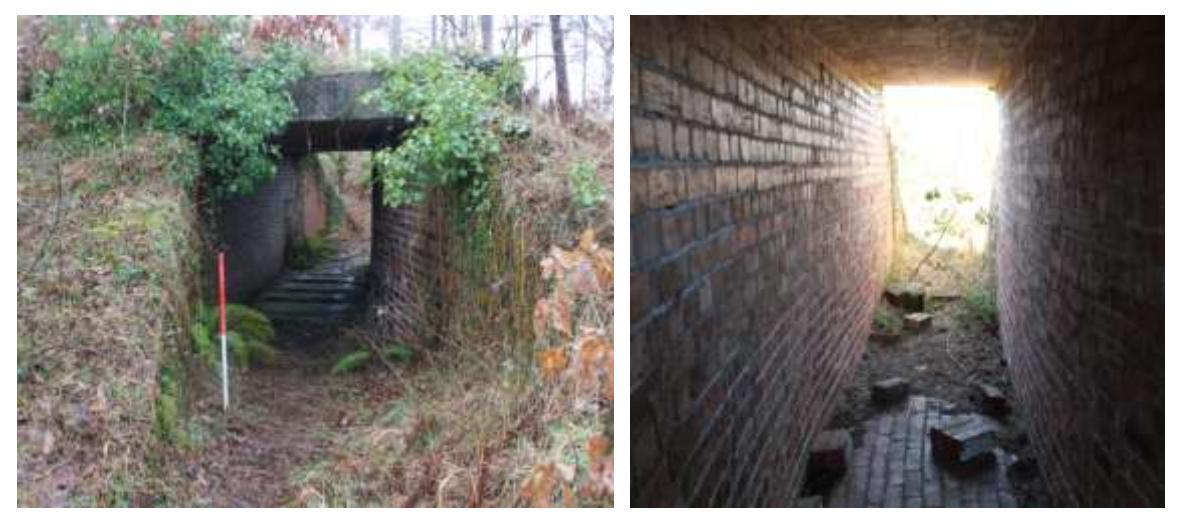
All these structures are very overgrown and access was severely limited, however where limited access for recording was gained the structures differ from those seen in Cordite Production Area A. The brick lined tunnels are not as clearly curved in plan and do not have brick arched roofs. Here they are constructed with concrete slabs and a number of them have concrete floors with the impression of wooden sleepers surviving. In addition there is a second access tunnel on the opposite side of the enclosure. This tunnel is commonly narrower and suggests a pedestrian access tunnel with a brick floor.

Figure 13: Access tunnels into the danger buildings.

A number of the access tunnels have been blocked with breeze blocks in order to create bat roosts.

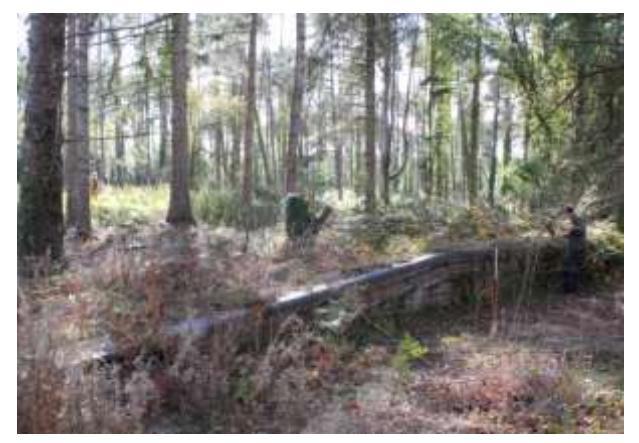
Also within this dense area of woodland are the remains of a railway platform shown on the c.1917 plan as a railway terminus, and other structures were recorded (PRNs 107873 – 107877).

Figure 14: the remains of a railway terminus in Pembrey forest.

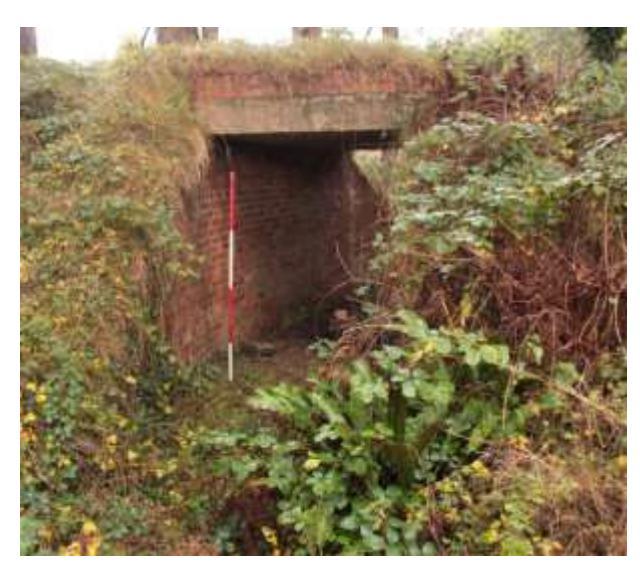
Figure 15: The entrance to a factory magazine

These structures follow the same pattern of circular earthwork banks accessed by a curving brick tunnel and a concrete slab roof.

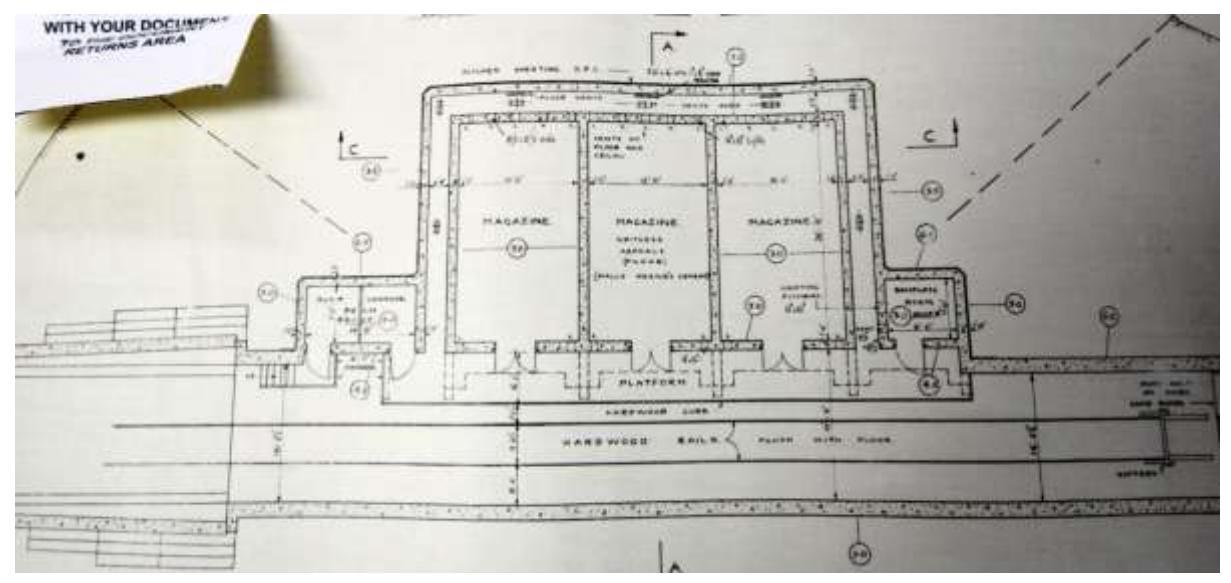
Plans for the specification of the magazines also survive within The National Archives (WORK13/139) along with photographs of their construction (WORK 26/21).

Figure 20: Plans for the construction of the Magazines (WORK 13/139).

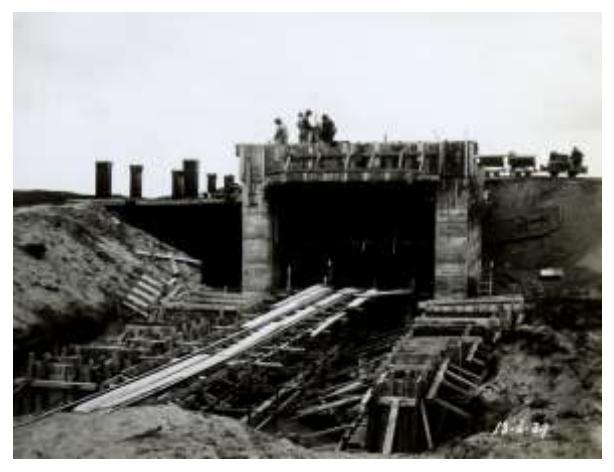
Figure 21: Photograph of magazine no 8 under construction, dated 13/6/1939 (WORK 26/21).

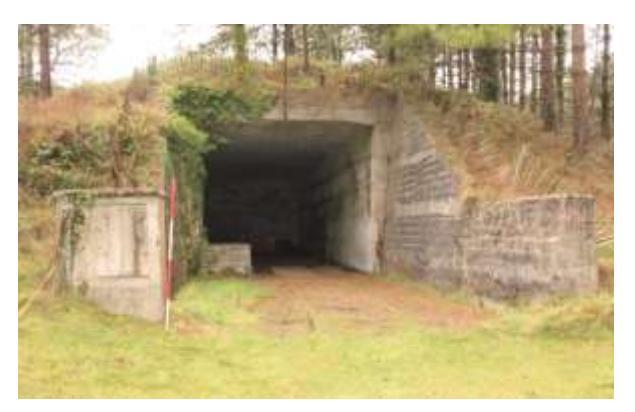
Figure 22: Photograph of Magazine no 8, PRN 107847 in November 2015.

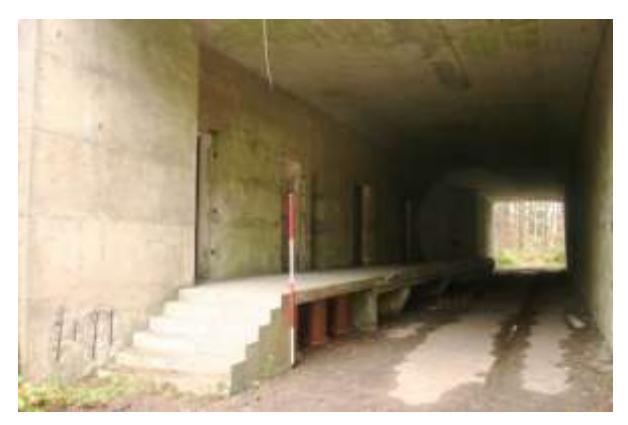
Figure 23: Interior showing platform and rail access, magazine no 7 PRN 107846.

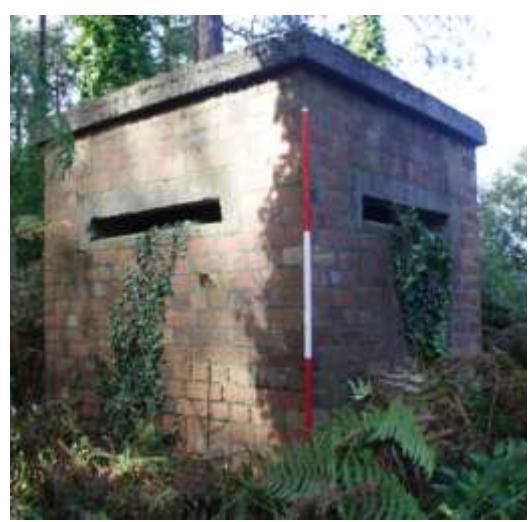
Figure 24: PRN 107871 lookout post.

Brick-built rectangular building with flat concrete roof. Protected entrance, though part of the blast wall has been lost. A characteristic lookout found on ROF factory sites. A Pyper 2014 Blast protection wall over entrance. NP 1995

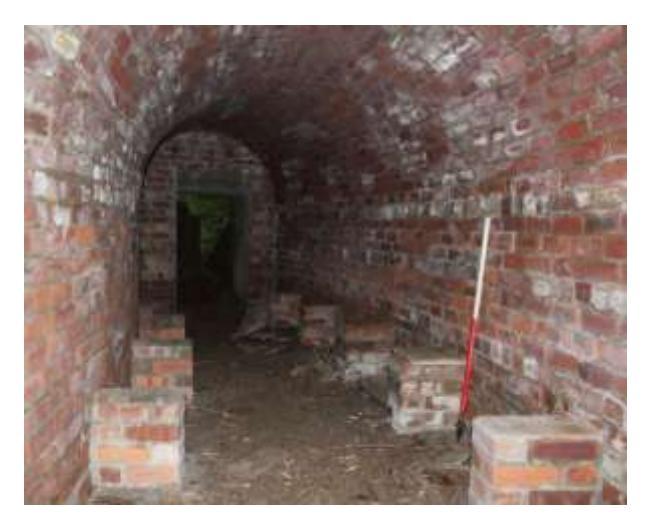
It is also of interest as the tunnel entrance has been converted into an Air Raid Shelter (PRN 109254), with partially blocked entrances at either end. Above the low entranceways are ventilation holes left open in the brick-work. The splayed tunnel entrances also have a blast wall protecting the entrances. Within the tunnel low brick piers are arranged along either wall which would have supported bench seating (Fig. 25).

Figure 25: PRN 109254 Air Raid Shelter constructed within one of the earlier entrance tunnels to a cordite paste mixing house PRN 107863.
