# CAREW CASTLE WALLED GARDEN, PEMBROKESHIRE: ARCHAEOLOGICAL EVALUATION 2018

RHIF YR ADRODDIAD / REPORT NO. 2018-25 RHIF Y PROSIECT / EVENT RECORD NO. 112145

# CAREW CASTLE WALLED GARDEN, PEMBROKESHIRE:

# **ARCHAEOLOGICAL EVALUATION 2018**

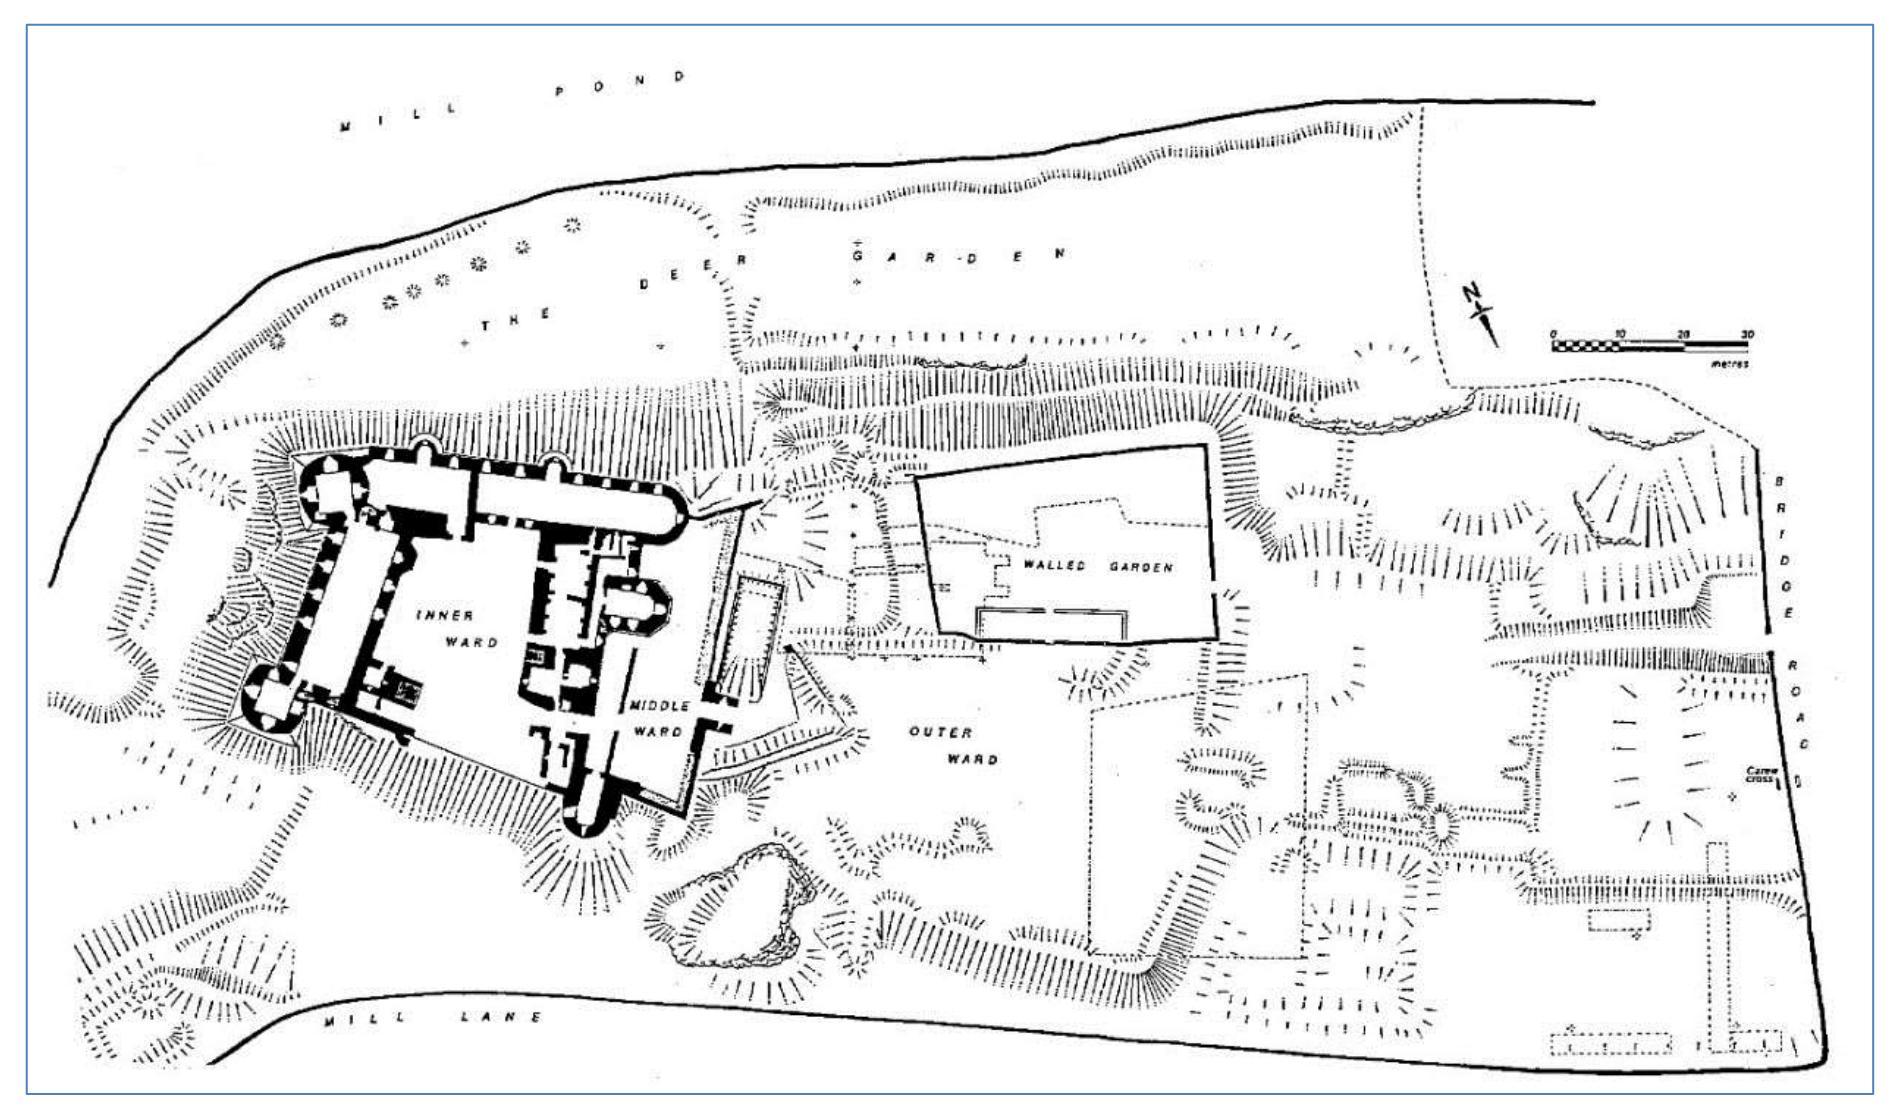
**Figure 3:** Survey of the castle and earthworks prior to the archaeological works begun in 1988 (D. Austin and Dyfed Archaeological Trust – used in the 1992, 1993 and 1994 interim reports and Austin 2015)

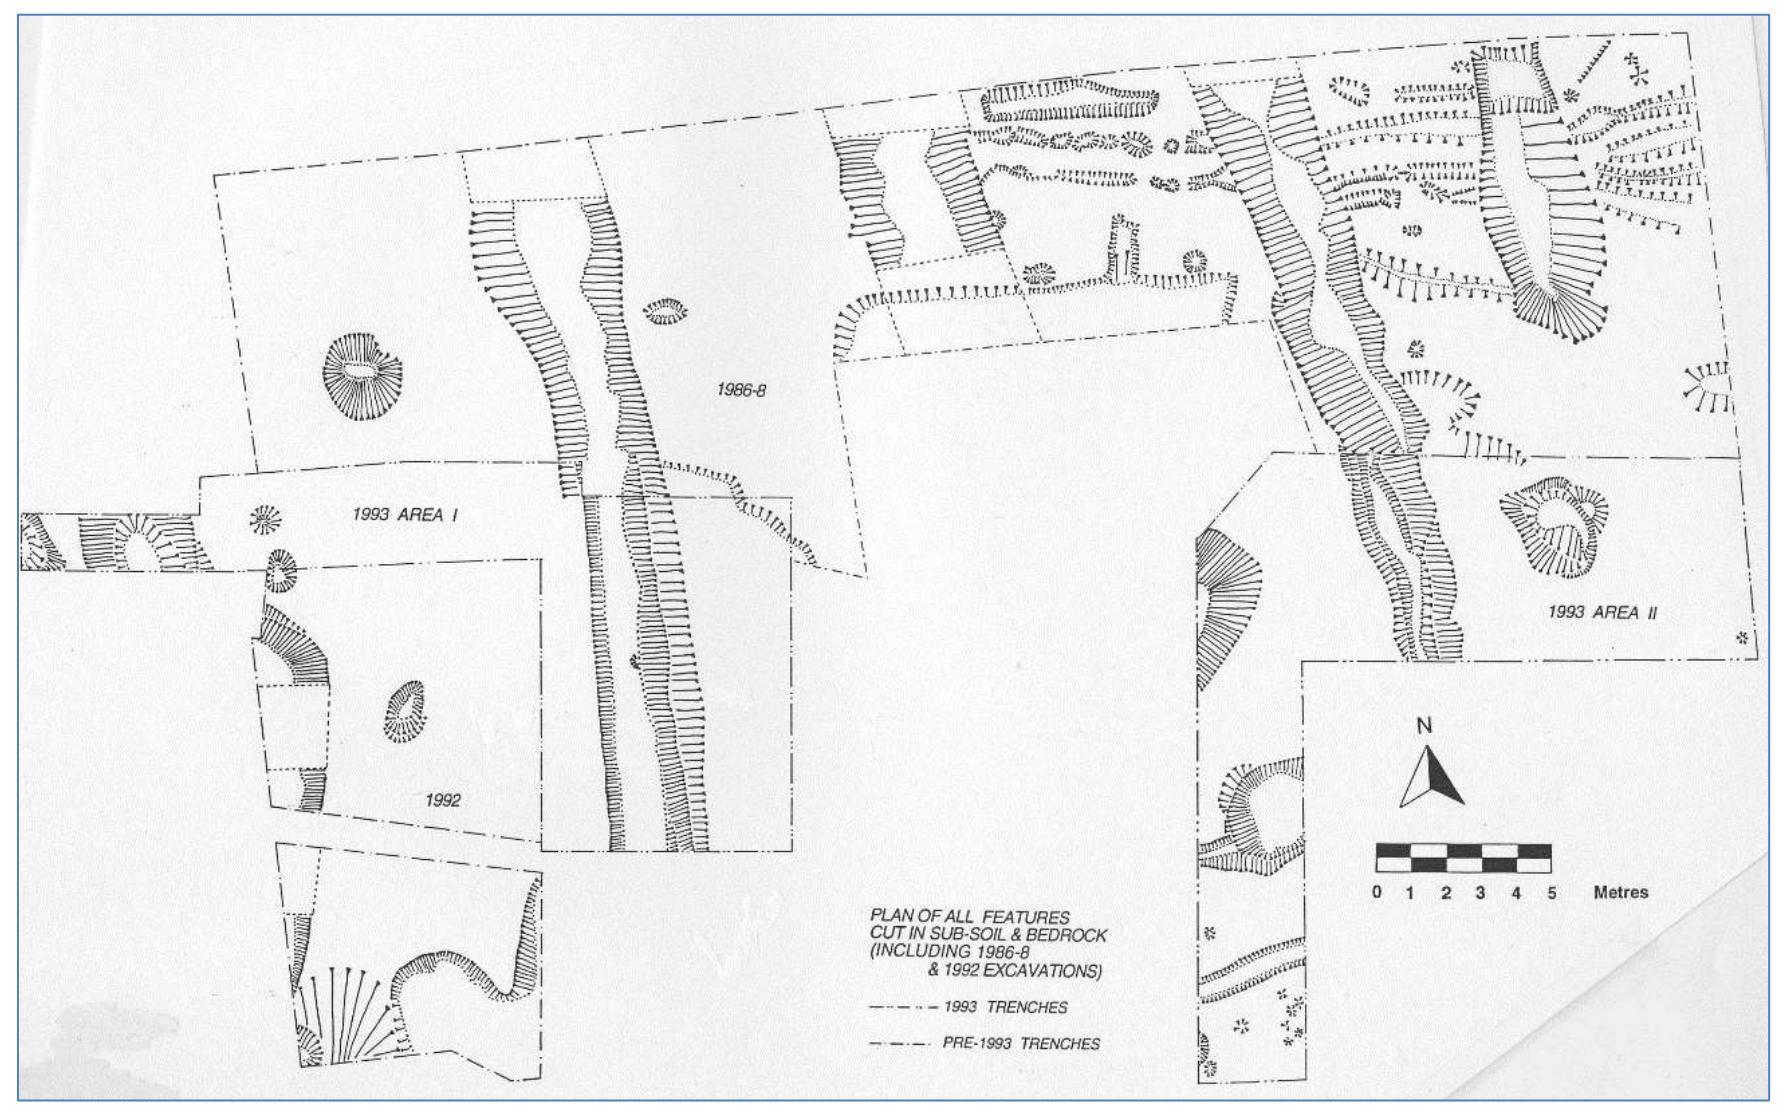
- 2.2.3 It is known that the previously excavated areas as shown in Figures 4 & 5 were taken down to the underlying geological bedrock and thus all deposits have been removed.

**Figure 4:** Plans of all features cut in sub-soil and bedrock (including 1986-1988 and 1992 - 3 Excavations) Taken from Carew Castle Interim reports for 1993 and 1994 (Austin 1994, 1995 & 2015)

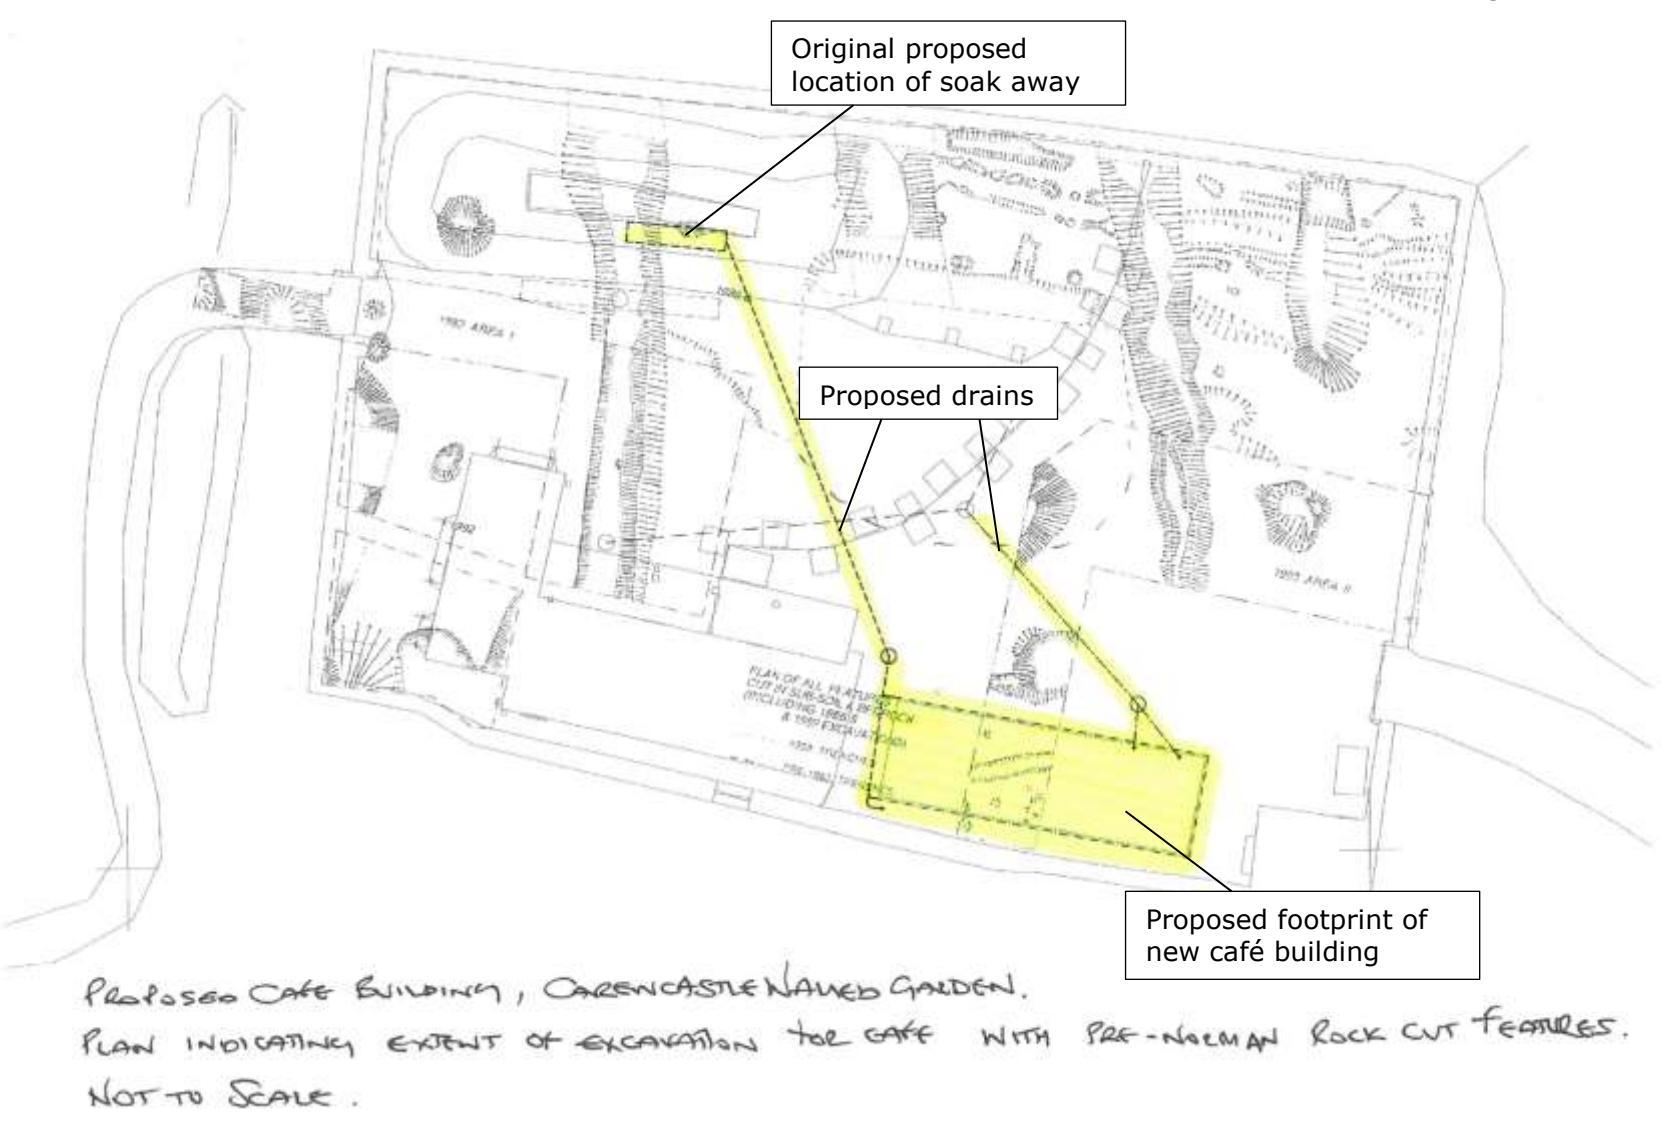
**Figure 5:** Plans of all features cut in sub-soil and bedrock (including 1986-1988 and 1992 - 3 Excavations) with the present development proposals superimposed. Taken from Carew Castle Interim reports for 1993 and 1994 (Austin 1994, 1995 & 2015) Plan prepared and supplied by Andrew Muskett of PCNPA, with provisional location of soakaway shown (North to top).

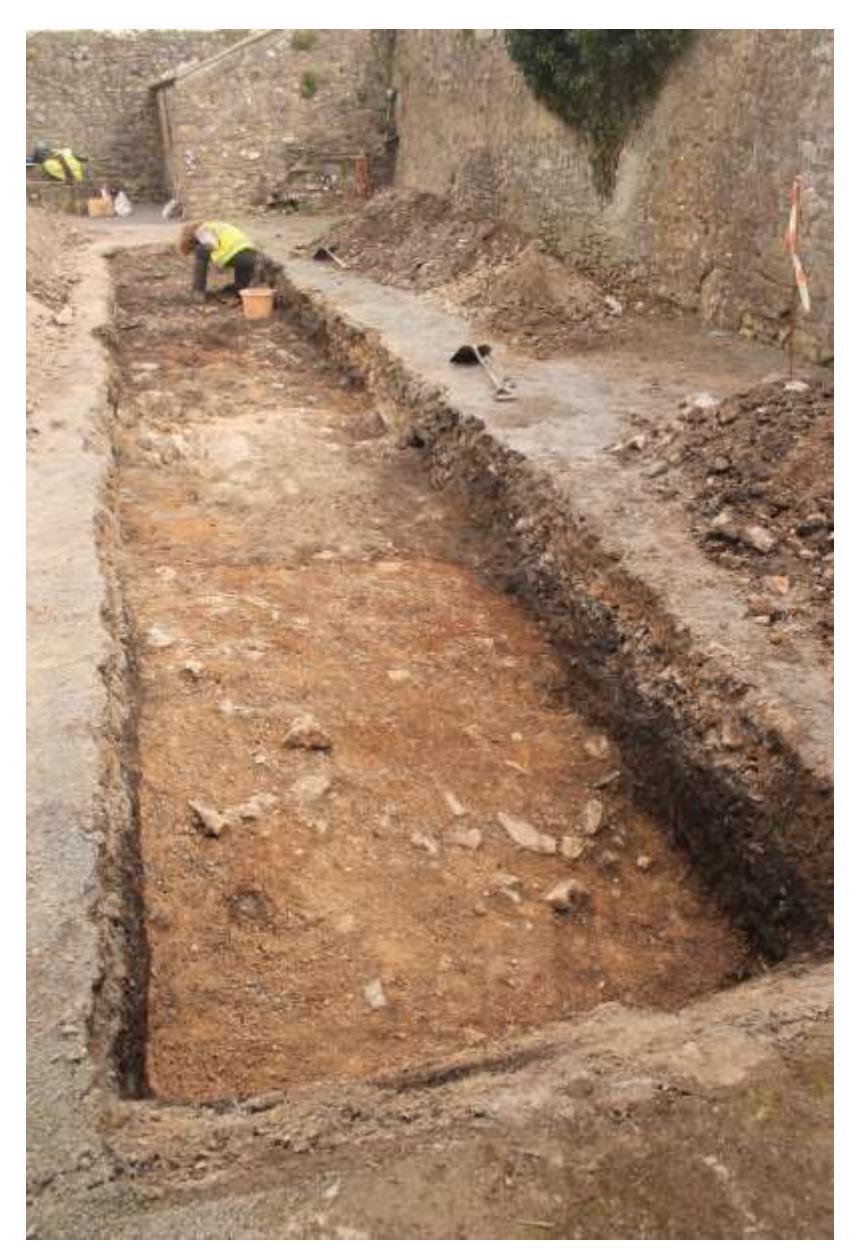
4.2 Trench 1 measured 1.6m by 12.5m and was orientated roughly east west along the length of the proposed new café building (Photo 1). The upper layers comprised the modern crushed stone surfaces across the Walled Garden made of fine gravels, sand and builders waste (101), (102) and (103) (Photos 2 and 3). These had a maximum combined depth of 0.33m.

Photo 1: View east across Trench 1 during cleaning showing wall of walled garden

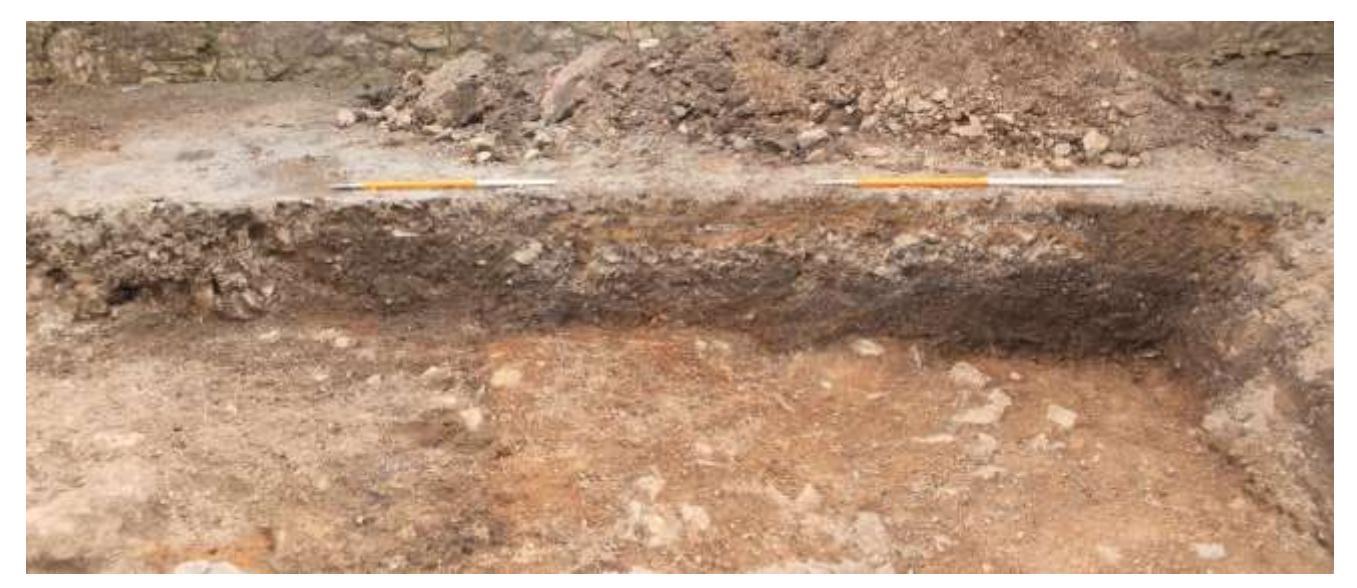
**Photo 2:** Western end of trench, viewing south, showing crushed stone surface layers and underlying band of dark humic soil (former topsoil?)

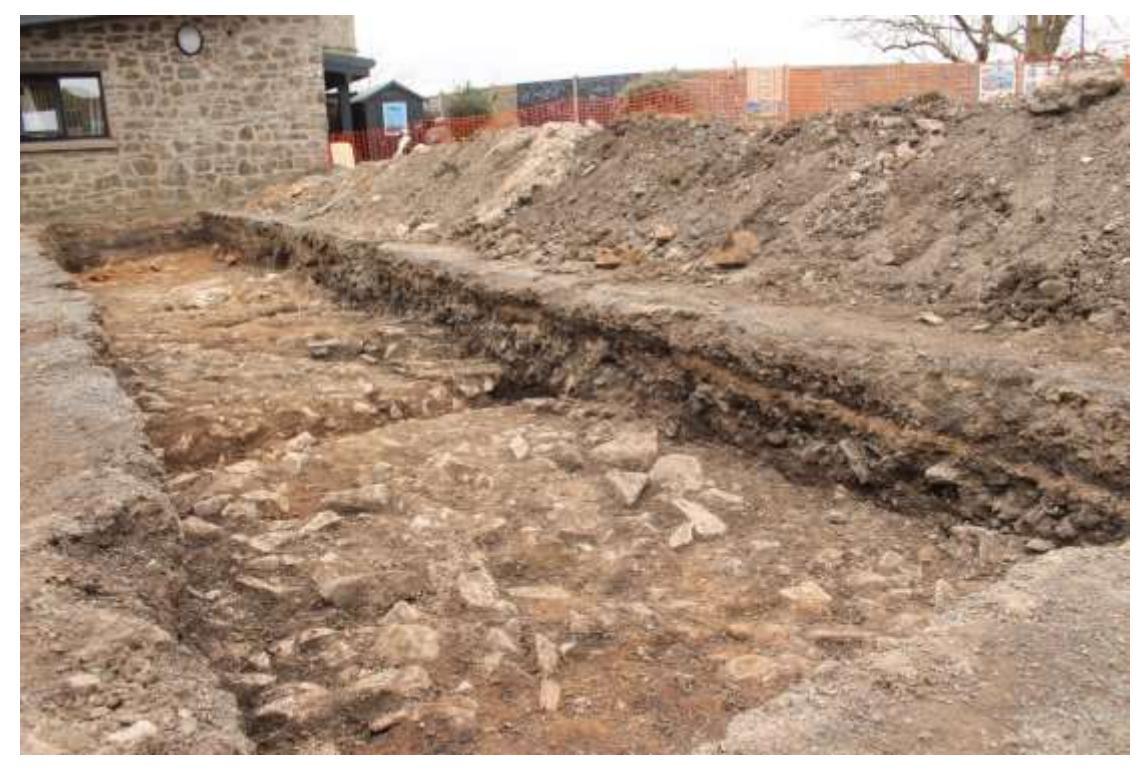
**Photo 3:** View northwest across south facing section of trench, with make-up crushed stone layers visible at eastern end of trench

- 4.3 Beneath the modern surface of the Walled Garden was a dark brown humic soil (104) which could potentially be derived from the use of the Walled Garden (Photos 2 and 3), although only modern finds were recovered from the layer (ceramics and modern detritus which was noted and discarded). This possible garden soil layer was a maximum of 0.22 m depth, being thickest at the western end of the trench.
- 4.4 Towards the western end of Trench 1 the former archaeological trench excavated by Professor David Austin in 1993 was revealed, cut [109] (Photo 4). This trench appears to have been backfilled with demolition rubble, general builders waste, cement and other detritus. The 1993 excavations revealed a modern sewer trench containing a plastic pipe

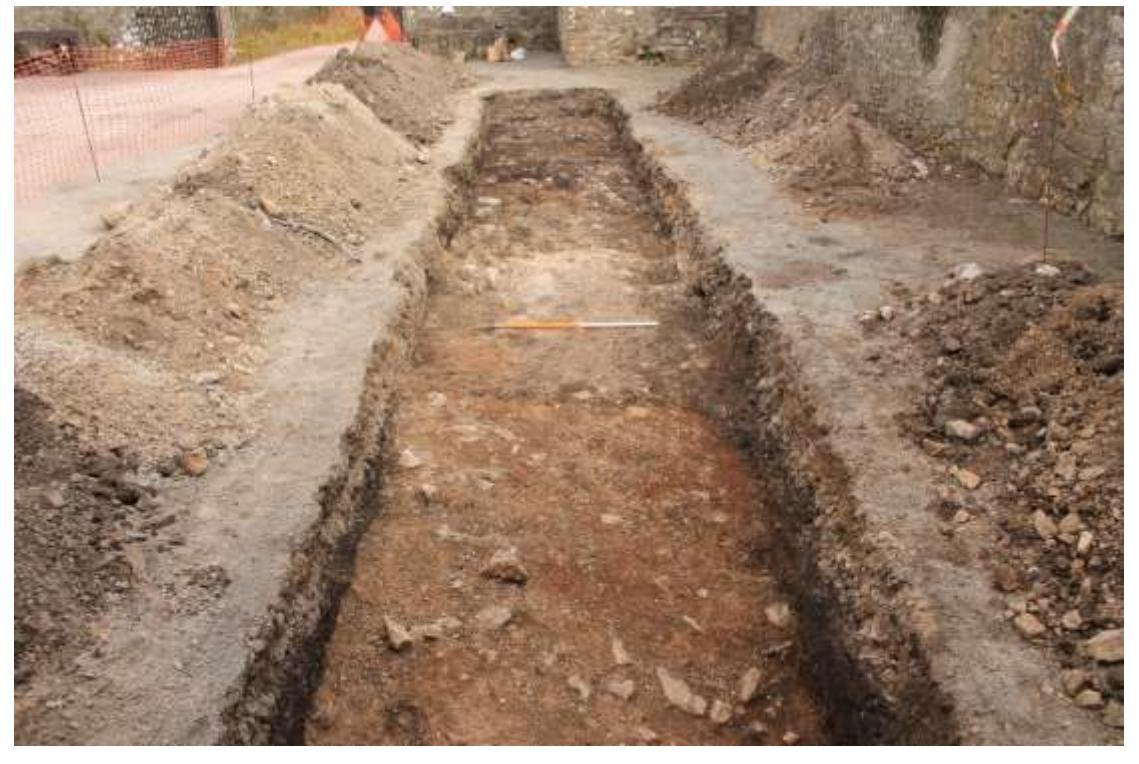
**Photo 4:** View of western end of Trench 1 after cleaning, viewing east, with scale bar located on area of backfilled excavation trench from 1993

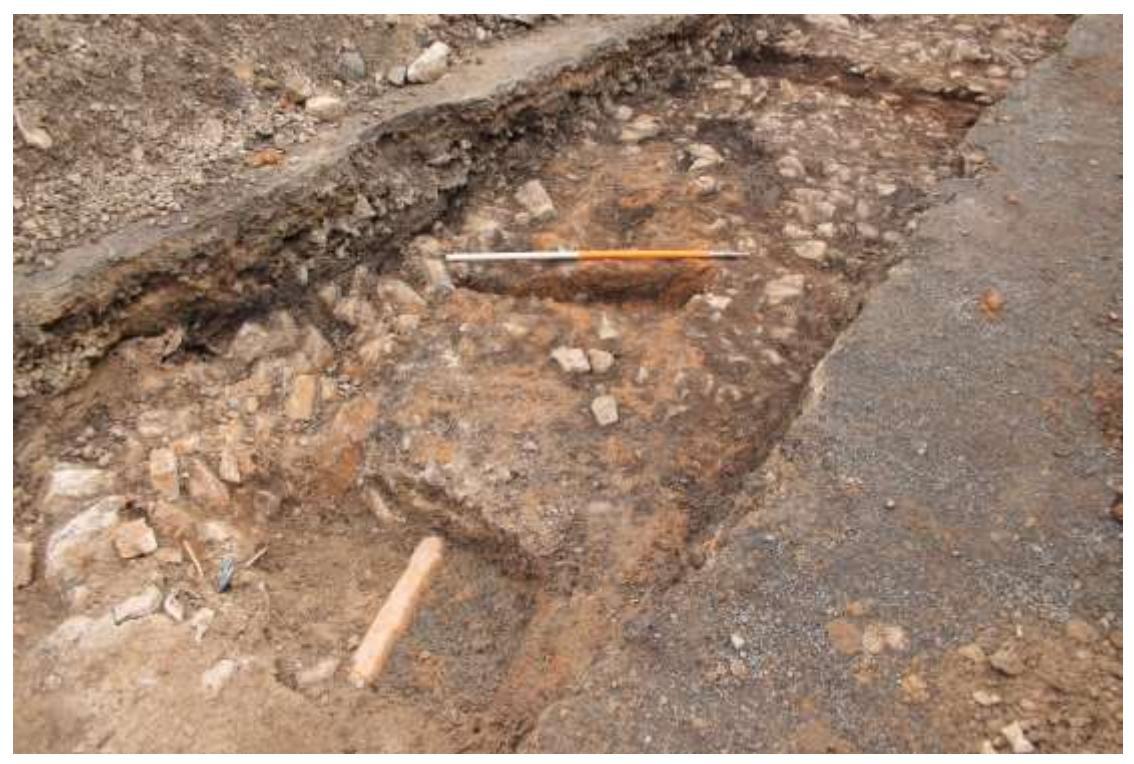
which ran approximately north-east by south-west. This sewer trench continues through Trench 1 consisting of a cut with vertical edges filled with orange clay and garden soil, with large angular stone inclusions (108) and central plastic pipe (Photo 5, Figure 7).

**Photo 5:** Line of sewer trench running through Trench 1 with excavated pipe located within backfilled excavation trench from 1993, viewing east-northeast

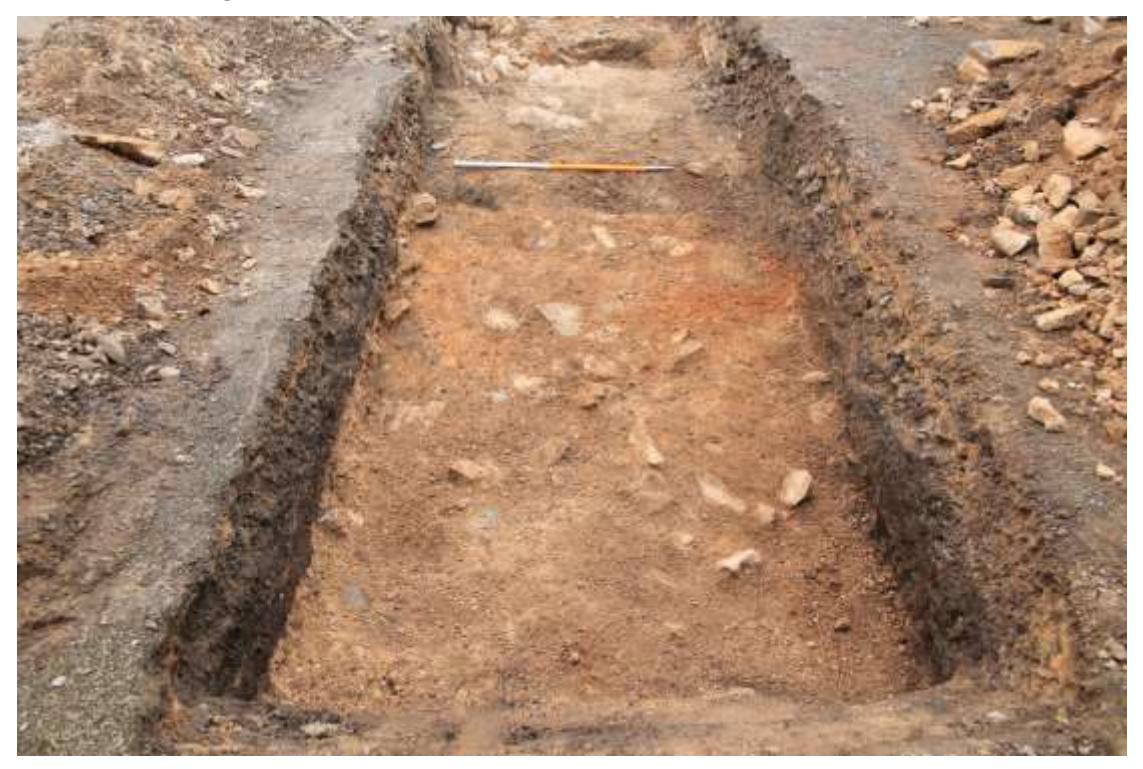
4.5 At the western end of the trench was a mortar dump (105) which measured at its thickest 0.21m deep (Photo 6). This layer was made up almost entirely of crushed mortar with occasional, much larger fragments. Its eastern extent was truncated by the 1993 excavation trench but it did not appear to continue in the eastern half of the trench. Beneath this layer lay demolition rubble (106) consisting of compact orange clay with large amounts of slate roof tile inclusions (Photo 6). This layer was not excavated as it lay beneath 0.50m but like layer (105) it did not appear to continue on the eastern side of the 1993 trench. It is likely that both these layers (105, 106) are from the same phase of demolition, although their origin and date is not clear.

**Photo 6:** Mortar dump (105) and demolition rubble (106) at western end of Trench 1, viewing east

- 5.6 On the western side of the trench, beyond the former excavation area, was a layer of crushed mortar overlying a demolition layer comprising broken limestone. The upper material was encountered at the 0.50m depth limit of the trench (although dug into slightly below this level). The layers were not dated and their origin is uncertain. Austin (2015) notes that the Walled Garden was previously used by '*PCNP as a yard for the masons restoring the castle*, although as these deposits were sealed by the disturbed topsoil layer they are probably earlier. They could thus be related with 'a deposit of destruction material probably to be associated with the 16th century when the Outer Ward buildings were removed for the construction of the Renaissance gardens (Austin 2015).

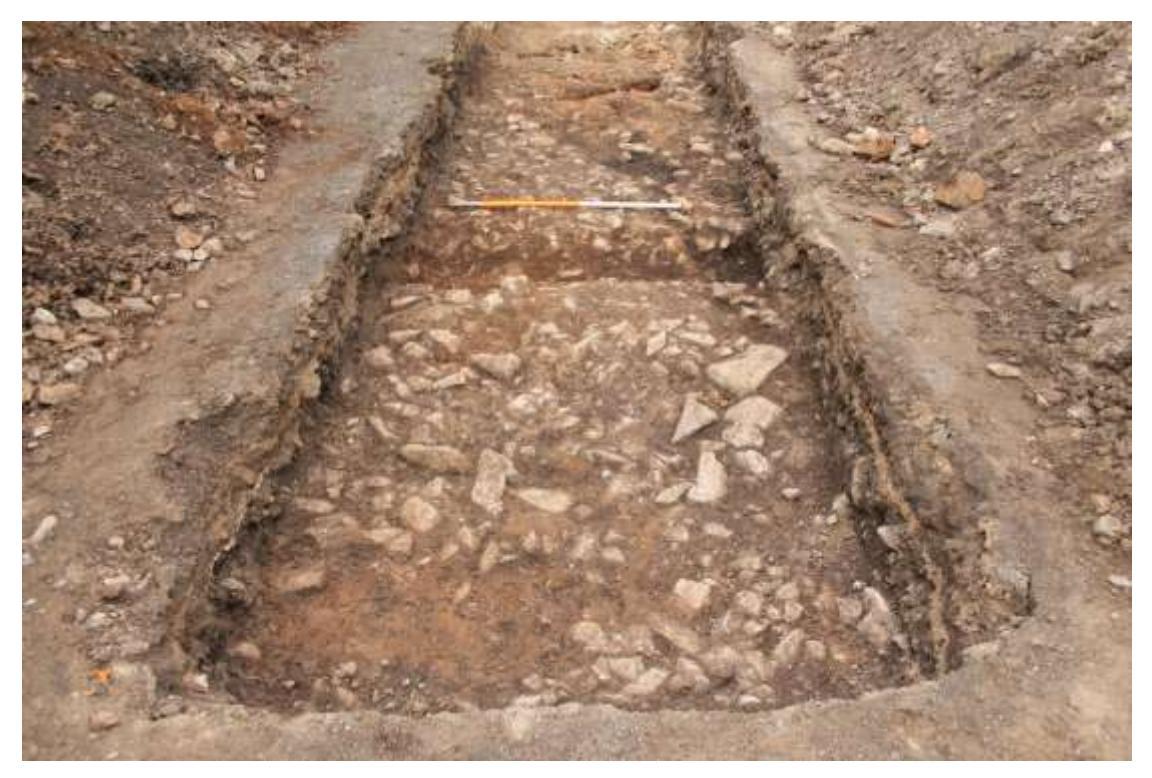
4.6 At the eastern end of the trench an approximately 2.25m wide linear feature, running north to south, crossed the trench. It consisted of light brown silt containing a very high concentration of fractured limestone (113), cut [112] (Photo 7). This was initially thought to be bedrock but subsequent investigations suggested it is more than likely to be a continuation of one of the ditches uncovered in the 1993 excavation. Both had similar fills and there is a good alignment between the two features, even though a 0.10m deep sondage, excavated along its western edge proved to be inconclusive. These ditches were thought to be part of the original castle defences, of early medieval date. Stratigraphically it seems to predate all other features in this trench.

**Photo 7:** Fractured limestone layer (113) at eastern end of Trench 1, possibly a continuation of early medieval ditch identified in 1990s excavations

1990s excavations that crossed through the walled garden. It was noted in the interim reports prepared by Austin (1993, 1994 and 1995) that the ditches were partially filled with stone which suggests each ditch had a stone faced earthen bank. The top of the visible feature lay at around 0.48m below the existing ground surface. It would be exposed by the proposed groundworks associated with the new café building, with a thin skim potentially removed. It is suggested that as the area was so compact (associated with vibro-compaction of the site at some point – possibly when the existing crushed stone surface was built) that there would be no need to dig into it further and adequately recorded through a watching brief when the footprint was reduced to ground level.

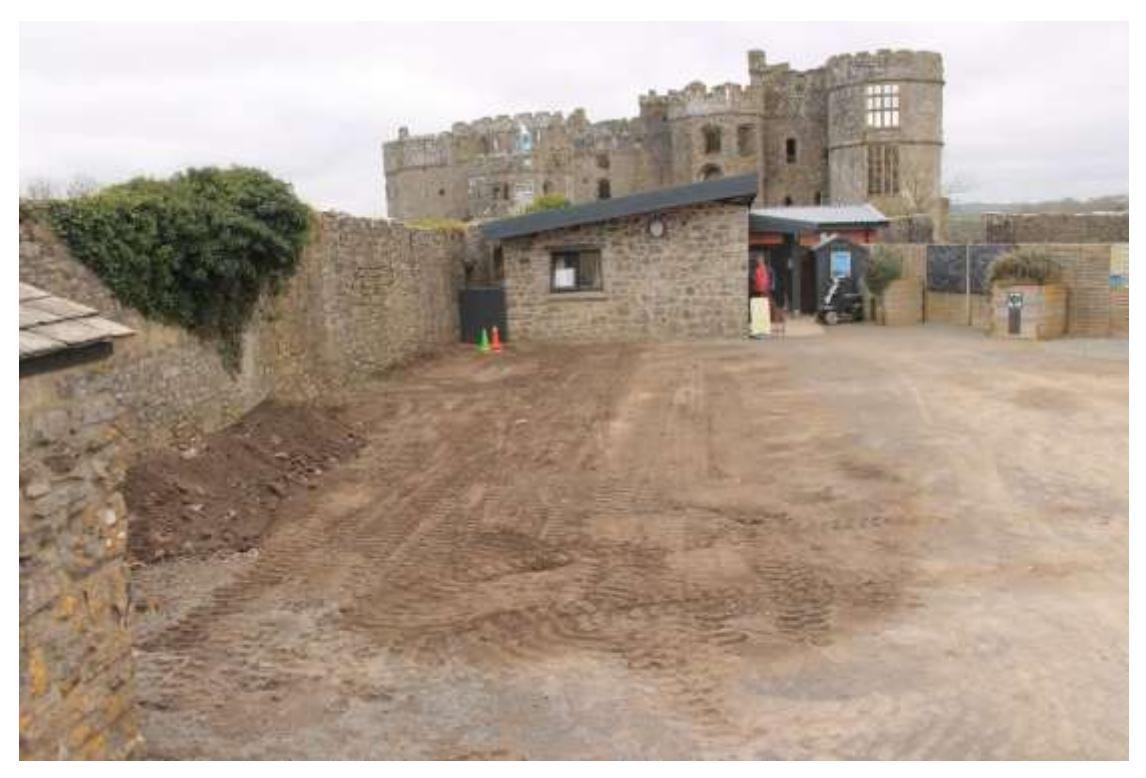
- 4.10 The trench was backfilled and levelled at the end of the works (Photo 8).

**Photo 8:** Trench 1 following backfilling and levelling at the end of the works with Carew Castle behind

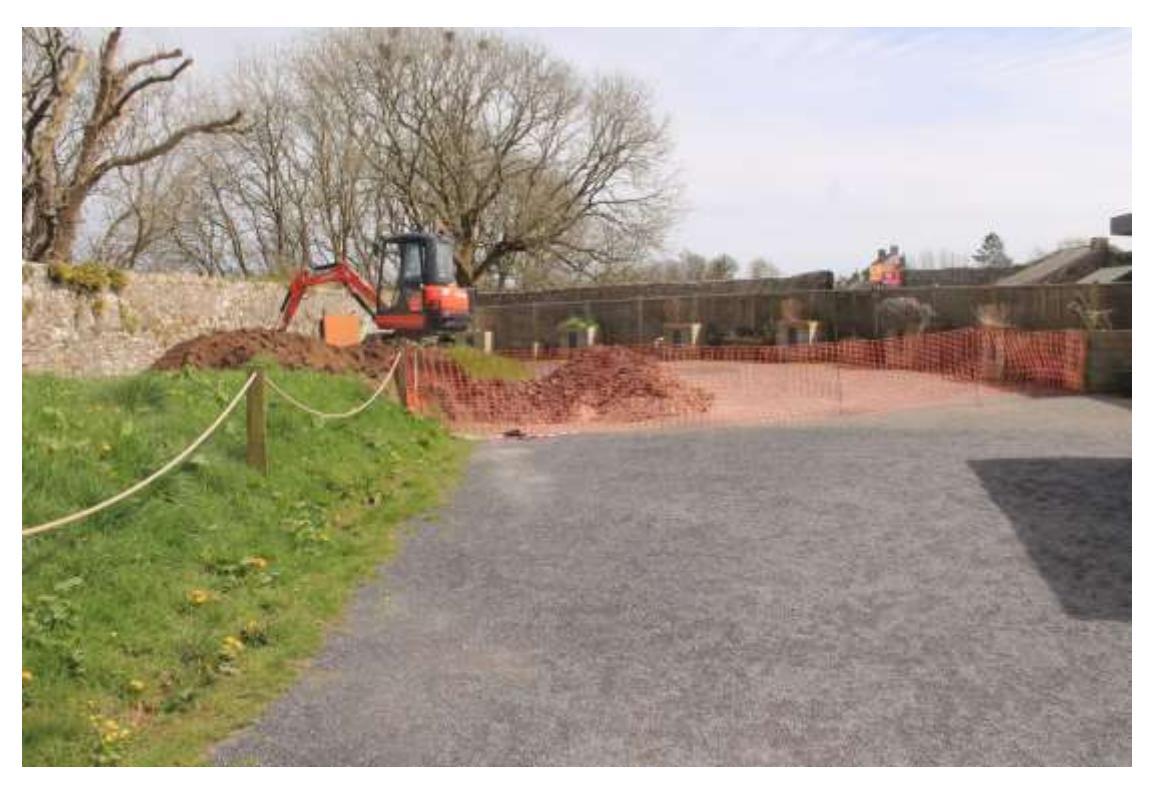
- 4.11 Trench 2 was excavated within the area of the proposed soakaway for the new café (Figure 6; Photo 8) to the north of the existing entrance and visitor centre building. The trench was designed to confirm that this area had already been fully excavated during the excavations in 1993 and that there were no remaining archaeological remains likely to be affected by the proposed works, and to confirm the depth of the natural bedrock.
- 4.12 Trench 2 measured 1.55m x 2.2m and was orientated roughly east-west. The trench was excavated down to bedrock using a 1.60m grading bucket on a 360 degree excavator. The trench was initially excavated through a pile of topsoil which had been stored in this part of the site. The topsoil appeared to have been laid directly upon the crushed stone surface that had been laid across the interior of the Walled Garden in recent years.

**Photo 9:** General view of the area of Trench 2 showing stockpile of topsoil, viewing east towards eastern wall and entrance into Walled Garden

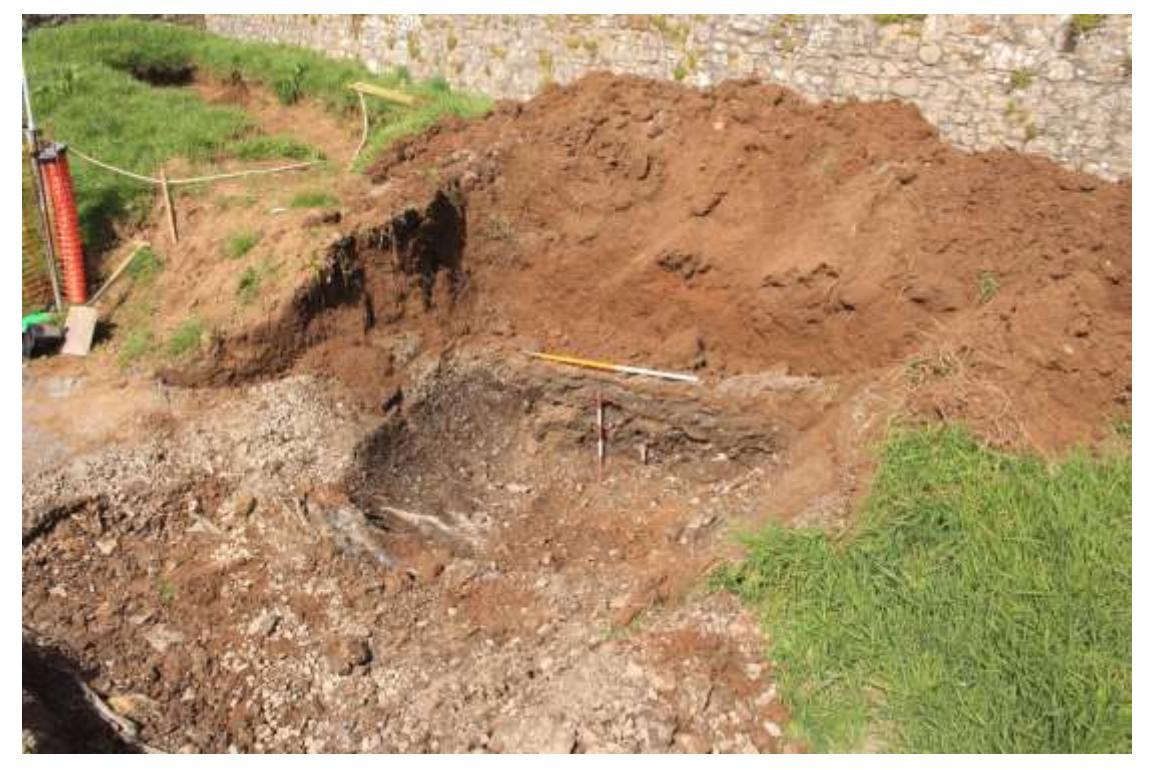
4.13 Following removal of the piled topsoil, the deposits detected comprised different layers of modern gravels similar to layers (101), (102), and (103) in Trench 1. However in Trench 2 the gravels were laid directly onto bedrock which was likely stripped in the 1993 excavations and were much thicker with an average combined depth of 0.52m (Photos 10 and 11).

Photo 10: View northwest across excavated area of Trench 2, showing piled topsoil over gravel layers

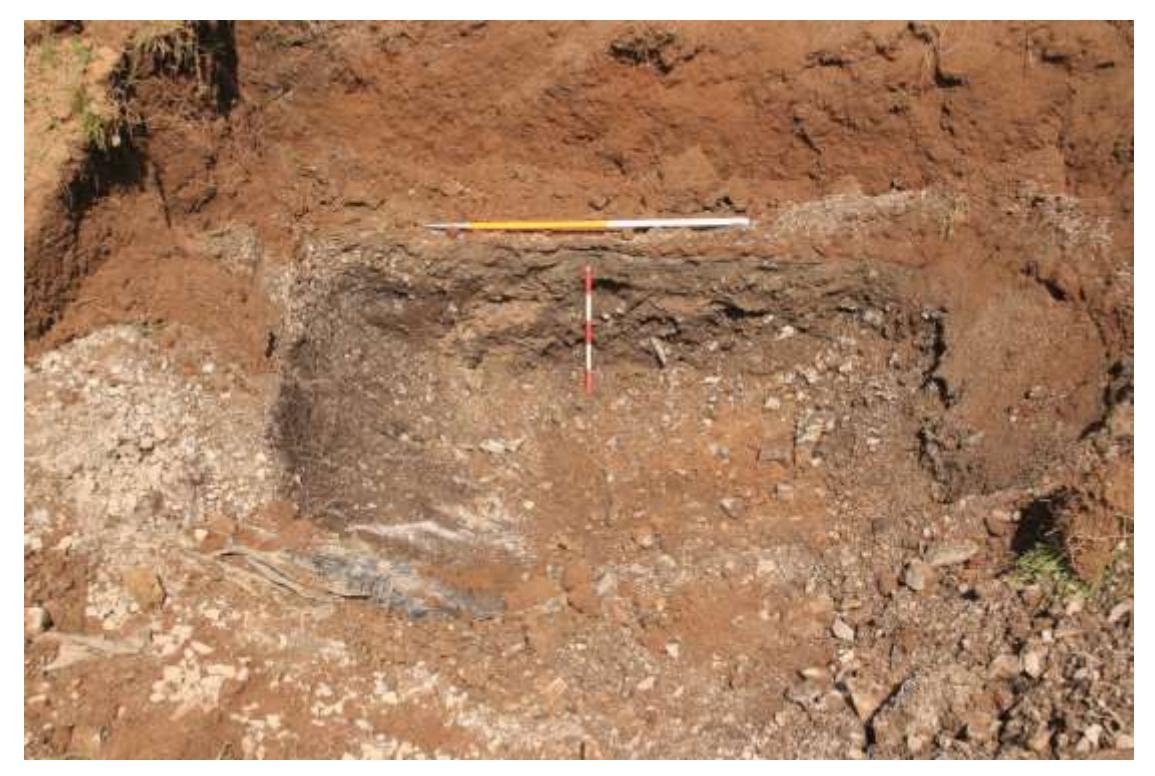
**Photo 11:** View north of south facing section of Trench 2 showing gravel layers sitting directly upon bedrock

- 4.14 It was clearly evident to the on-site archaeologists that the area had been previously excavated to bedrock and backfilled with layers of crushed stone. No archaeological remains were detected during the excavation of this trench. The upper crushed stone layers may have been associated with the recent Walled Garden ground surface.

- 4.15 Natural bedrock was identified at a depth of between 0.52m and 0.60m from present ground surface. The top of the crushed stone surfaces below the topsoil pile was not cleanly identified and varied in recorded height between 13.35m aOD and 13.00m aOD (an average of 13.19m aOD). It is assumed that the upper level (13.35m aOD) would be more likely to represent the true ground level in this area, and the lower levels possibly caused by disturbance during removal of the topsoil pile. The base of the trench and bedrock was reached at levels of between 12.70m aOD and 12.85m aOD (an average of 12.79m aOD).

- 5.9 Trench 2 aimed to determine the depth of the underlying bedrock within the area formerly excavated in 1993, where it was intended to install a soakaway and drainage for the new café building. The trench confirmed bedrock at between 0.52m and 0.60m below ground level (not including the topsoil pile on top). All remains had been previously removed and the excavation area backfilled with crushed stone. The proposed soakaway and associated drainage will cause no impacts to archaeological remains. The location of the soakaway has been amended from that shown in Figure 5 by PCNPA in order to avoid the lines of the early medieval ditches excavated in 1993 in order that the rock cut remains will remain undisturbed by the excavation of the soakaway.

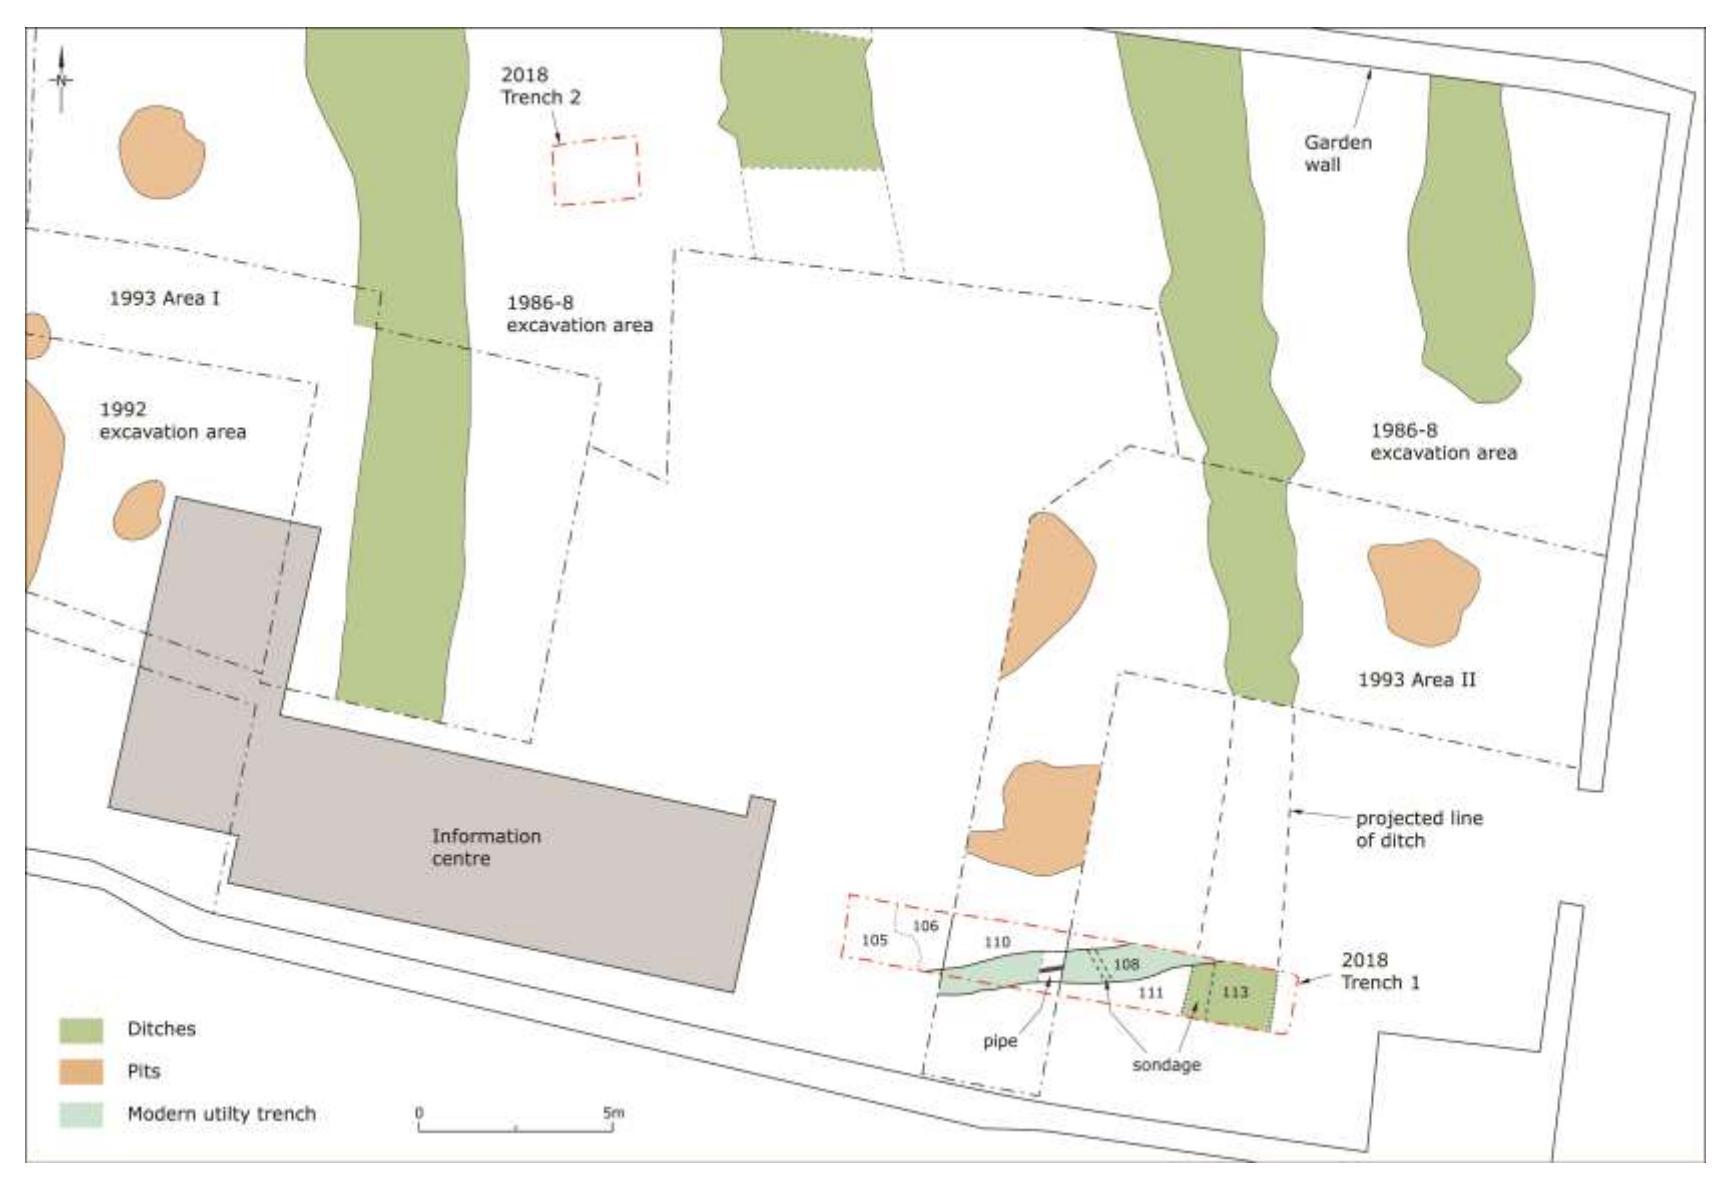
- 3.2 To ascertain the depth, significance and state of preservation of the potential archaeology within the footprint of the proposed new café building, a trench (Trench 1) measuring approximately 1.6m in width and which ran for the full length of the proposed building *c*.12m was excavated (Figure 6).

- 3.5 A similar excavation methodology was employed for the area of the soakaway and adjacent drain, Trench 2 (Figure 6). The proposed location of the soakaway was within an area that has been previously excavated and backfilled and ascertaining the depth of the natural bedrock was the main aim of the excavation within this area. Trench 2 measured 1.55m by 2.20m, also aligned roughly east to west.

Figure 6: Trench location plan in relation to Walled Garden and previous archaeological investigations
