NATIONAL BOTANIC GARDEN OF WALES, WALLED GARDEN BIOMASS BOILER: ARCHAEOLOGICAL WATCHING BRIEF SN 51948 18136

RHIF YR ADRODDIAD / REPORT NO. 2018/32 RHIF Y DIGWYDDIAD/ EVENT RECORD NO. 112380

NATIONAL BOTANIC GARDEN OF WALES, WALLED GARDEN BIOMASS BOILER:

ARCHAEOLOGICAL WATCHING BRIEF

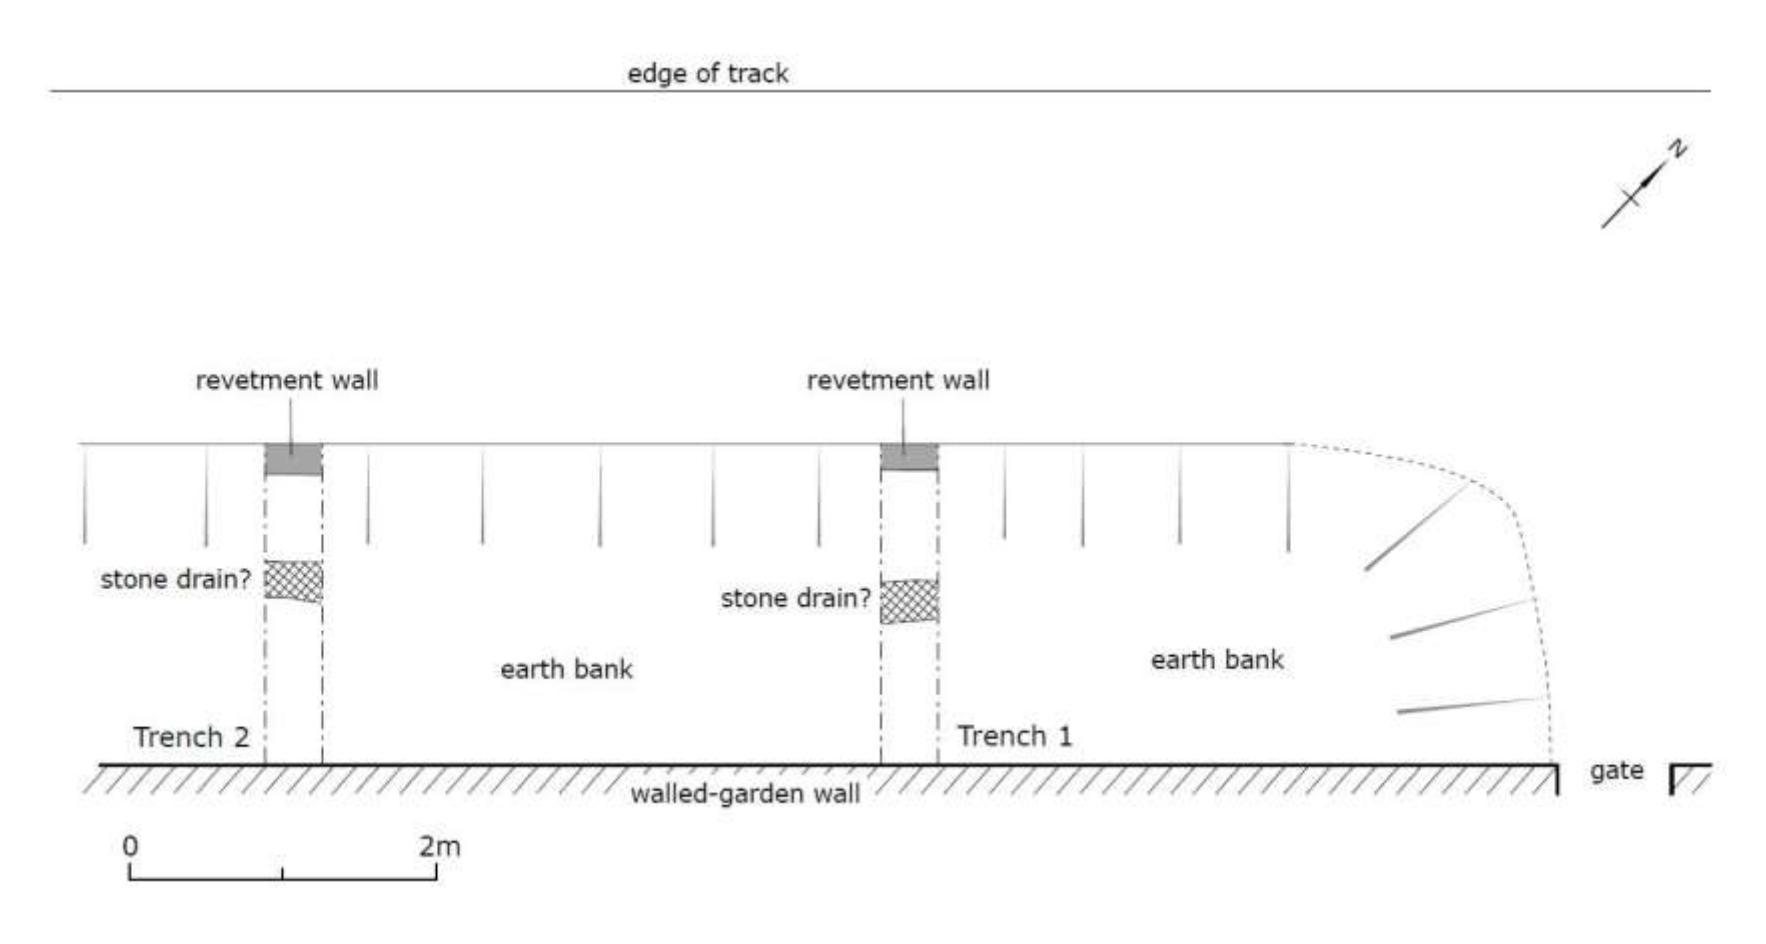
Figure 4: Plan of excavated areas (area indicated on Figure 3 in red box)

- 4.3 Trench 1 refers to the northeastern trench and Trench 2 that to the southwest (Figure 4). The archaeological horizons detected in both trenches revealed a near identical sequence of deposits and build up and are discussed together (Figures 5 & 6). Context numbers of layers within Trench 1 run from 100 to 108, those in Trench 2 from 200 to 207. Layers contexts are shown in round brackets and cuts for features in square brackets.

- 4.4 Trench 1 measured 3.95m long and *c*.0.70m wide and was aligned roughly northwest southeast with a maximum depth of 1.60m (Figures 4 and 5). Trench 2 measured 3.90m x *c*.0.70m and was also aligned northwest southeast with a maximum depth of 1.50m (Figures 4 and 6).

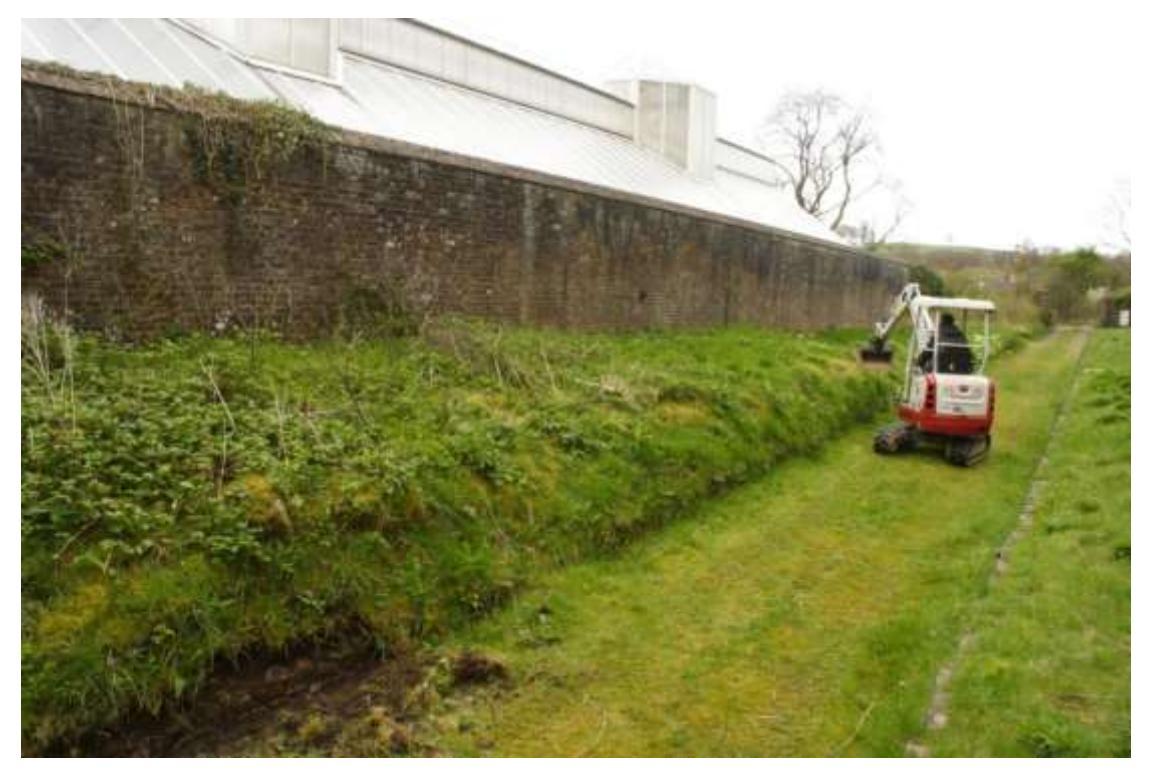
Photo 1: View southwest with showing the proposed location of the biomass boiler prior to works commencing

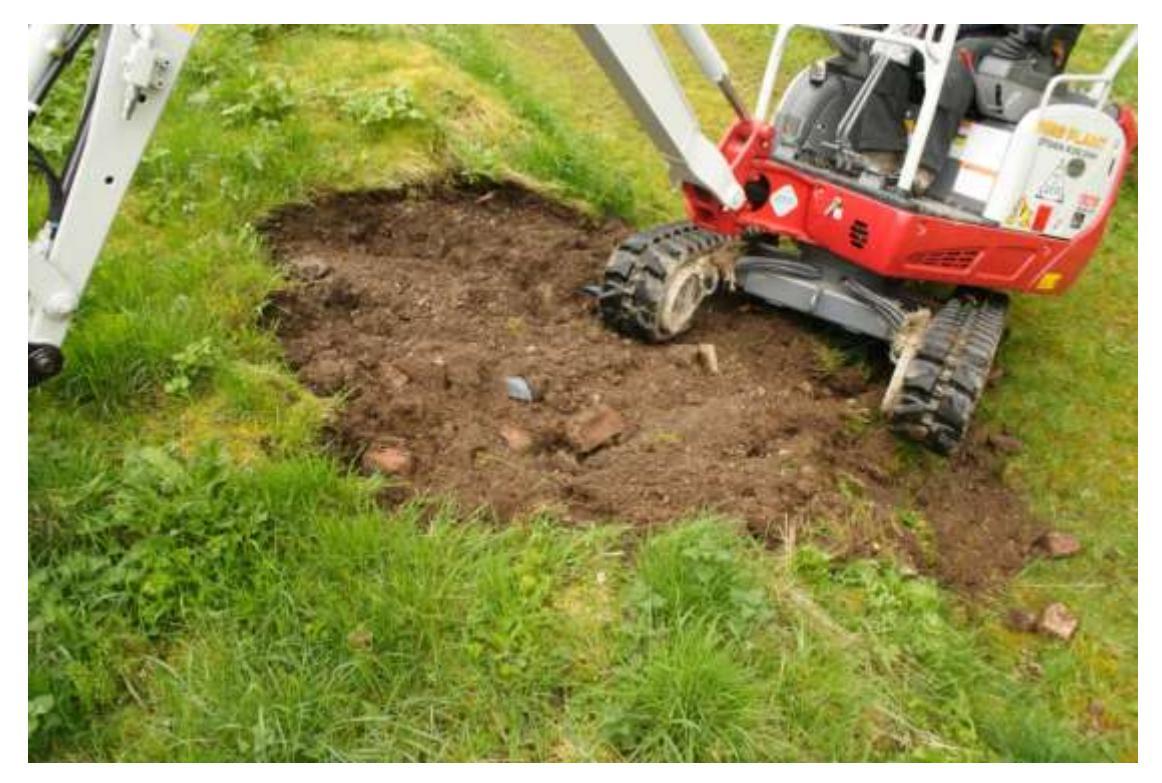
Photo 2: Initial excavation of Trench 2 showing start of removal of layer of modern rubble overlaying plastic sheeting.

- 4.5 The upper layer seen in across the tops of both trenches consisted of a turf and vegetation layer (100) and (200), only a few centimetres thick (not shown on Figures 5 and 6). This overlay a dump of rubble and modern detritus laid on top of blue plastic sheeting, which was present along the northwestern edge of the banked material, directly below the turf and vegetation horizon (101) and (201). This layer had a maximum depth of 0.21m in Trench 1 and 0.19m in Trench 2. In both trenches this layer was thickest at the edge closest to the path exaggerating the steepness of the slope of the existing bank.

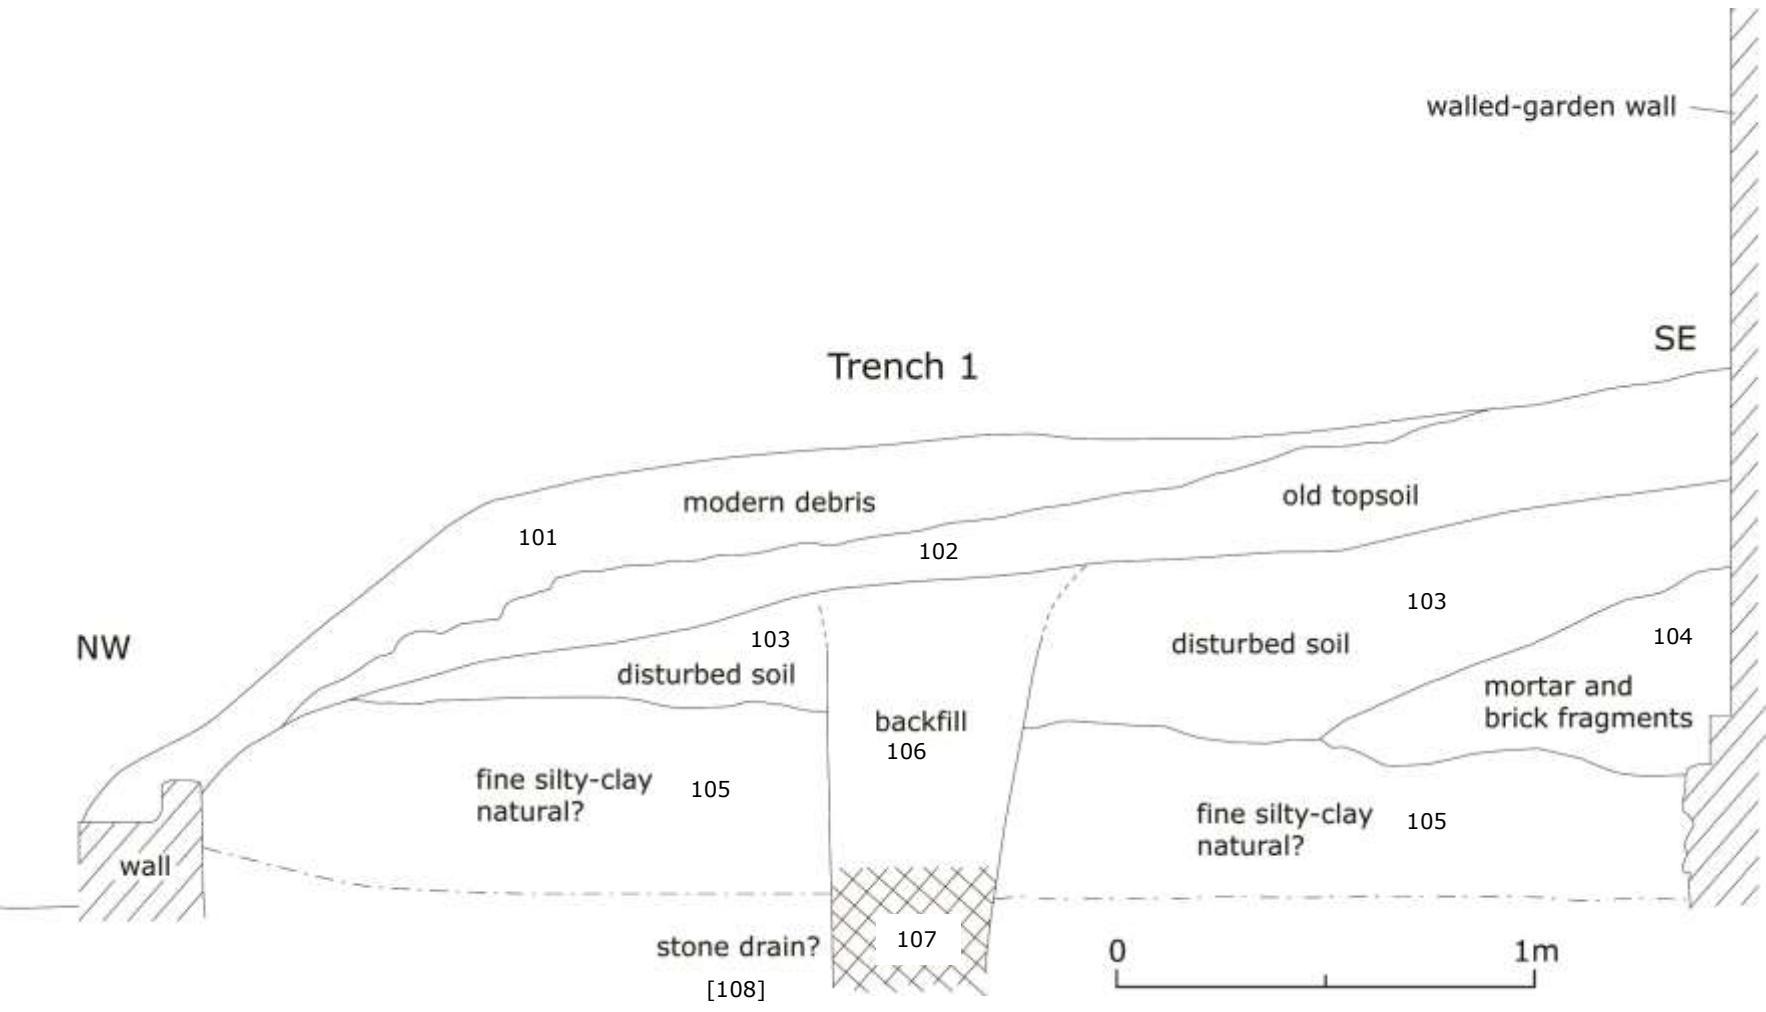
- 4.7 In Trench 1 beneath the buried topsoil layer there was a disturbed reddish soil which was deepest nearest the walled garden wall to the southeast (102). This overlay a deposit of brick fragments and mortar which was piled against the wall (Figure 5). Trench 2 contained a similar deposit made up of dark brown silty-clay with inclusions of mortar and brick fragments (203) (Figure 6).

- 4.8 The deepest layer detected in both trenches was a fine silty-clay soil revealed at the base of the section and forming the base of the trench (105) (204). It is likely this represents the natural geological sub-strata. Both the walled garden wall to the southeast and the small retaining wall to the northeast appeared to have been cut into this layer (Figures 5 and 6).

Figure 5: Drawing of southwest facing section of Trench 1

4.11 At the southeastern ends of both trenches the walled garden wall was exposed below ground level continuing to the base of both trenches (Photos 7, 8 & 9). The wall footings continued below the excavated level. No clear foundation cut for the wall could be discerned. Neat faced brickwork was visible for some 8 courses below the top of the trench. A layer of roughly finished brick and stone with slate levelling pieces lay beneath the neat brickwork, which projected slightly wider than the wall above. These in turn lay upon rough stone footings which projected even further out from the wall (Figures 5 & 6).

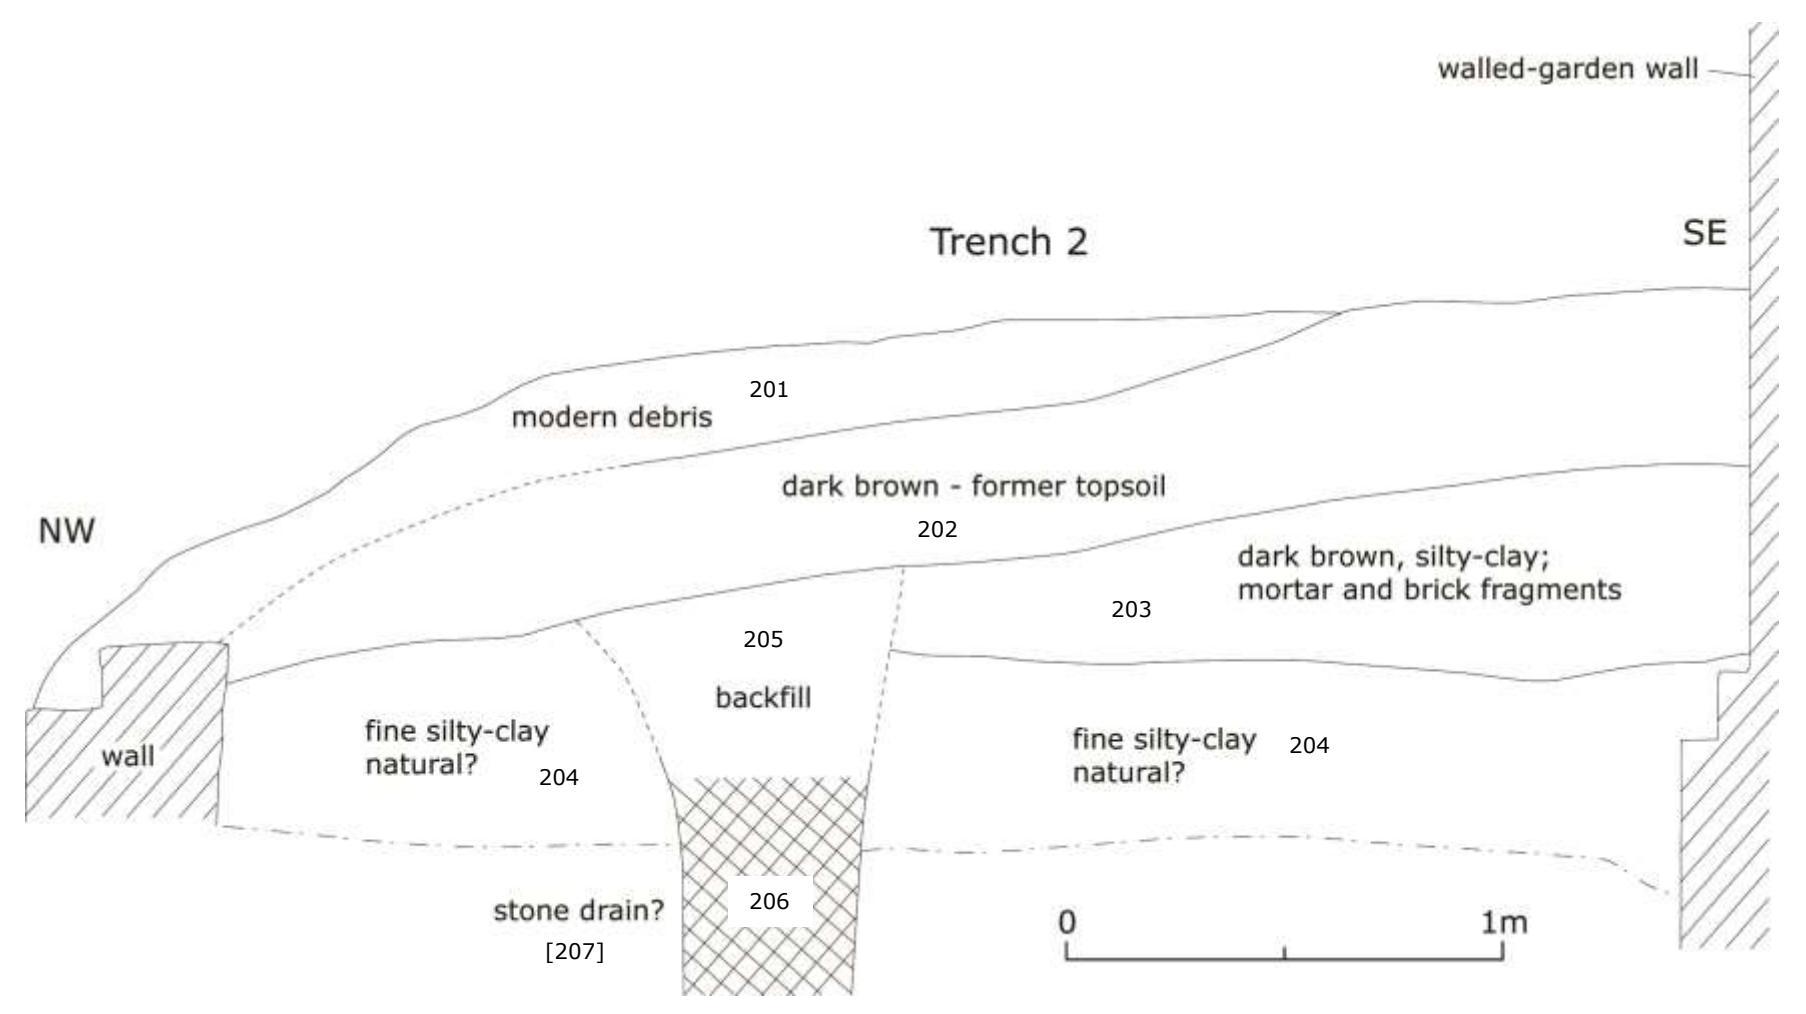
Figure 6: Drawing of southwest facing section of Trench 2.

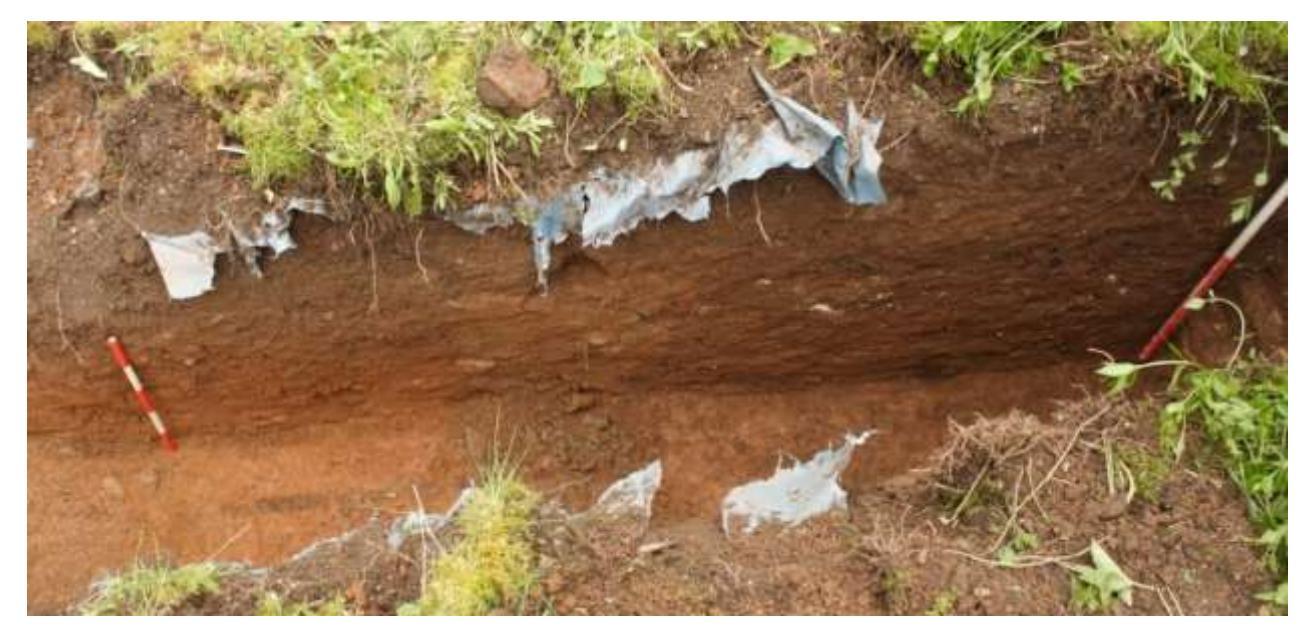
Photo 3: Southwest facing section of Trench 1

- 4.9 Directly below layers (102) and (202) the cut for a steep sided feature could be seen, cuts [108] and [207]. This was also visible crossing the base of both trenches and evidently formed part of the same linear feature(Figures 4, 5, and 6, Photos 3, 4, 5 & 6). Close to the base of both trenches the feature was clearly filled with loose small to medium sized angular stones. It was of around 0.40m width.
- 4.10 To the northwest of both trenches the small retaining wall was visible. It was cleaned up and photographed for its entire length within the proposed development area. It was made of rough coursed stonework with very fragmentary mortar within it. The outer face was quite neatly faced where it survived, but the inner face was very rough and appeared to be pushed into the soil behind (Photos 3 and 4).

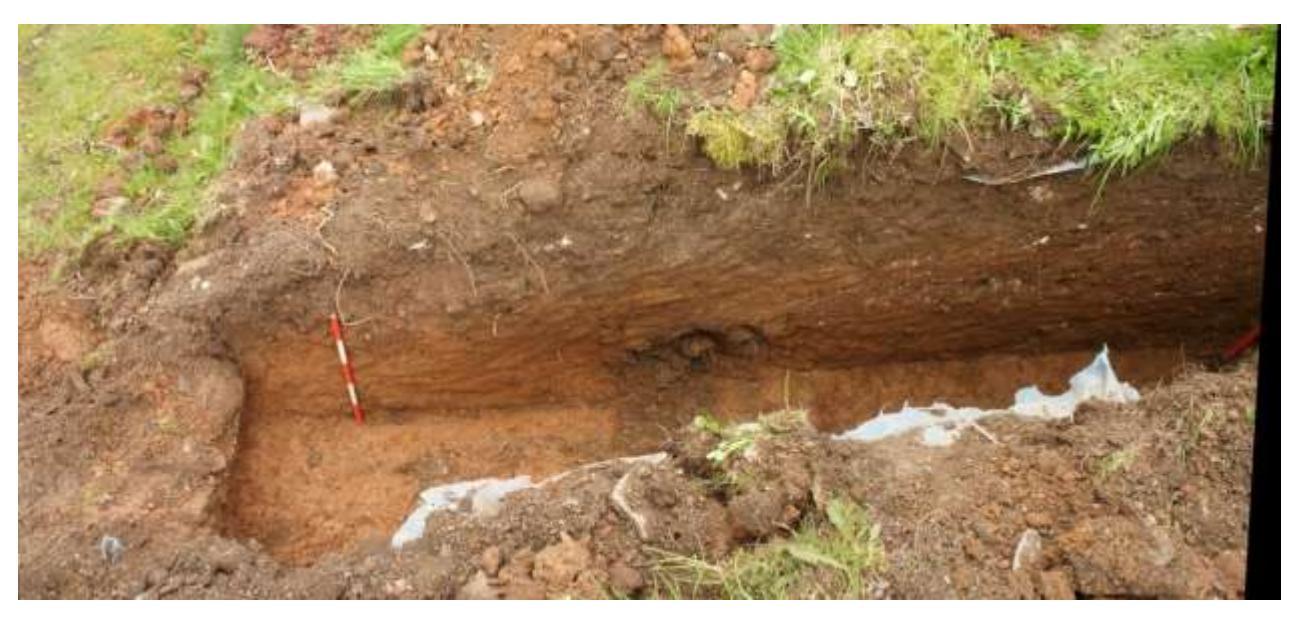
Photo 4: Southwest facing section of Trench 2.

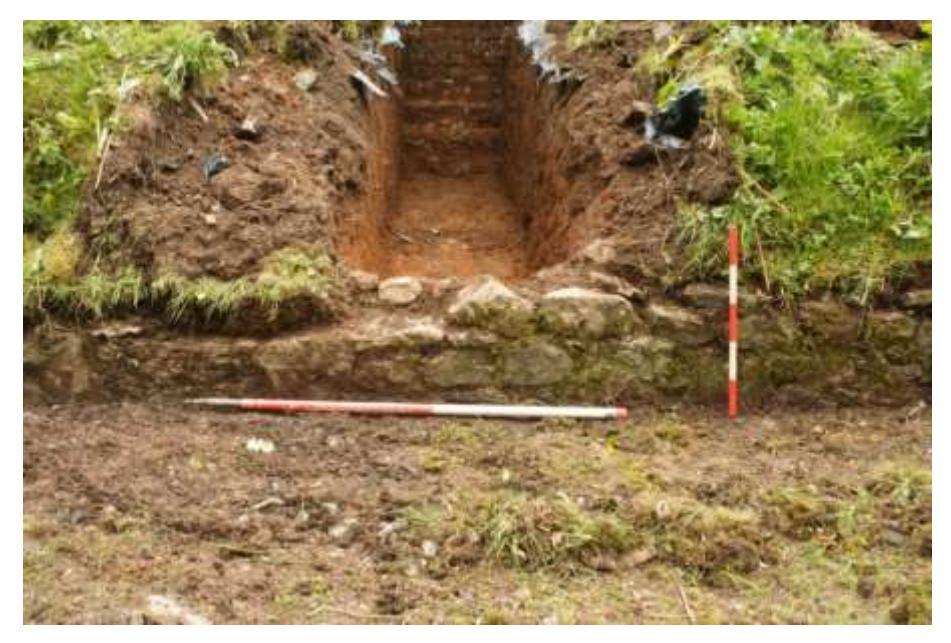
Photo 5: View southeast across retaining wall, with Trench 1 behind and walled garden wall in background

- 5.3 The small retaining wall, which will either be retained or rebuilt following the installation of the boiler house was cleaned and recorded through detailed photographic record. This demonstrated that the wall was in a relatively poor state of repair and only survived to its original full height of around 0.3m in a few places within the recorded area.
- 5.4 The wall was constructed of roughly coursed local shale stone with poorly surviving mortar visible in only a few places. The northwestern side was neatly faced, but the southeastern side was roughly finished, suggesting that it was built up against a slight terrace in the ground level. This indicates that the original ground level was slightly cut into to form the trackway on the northwestern side of the wall.

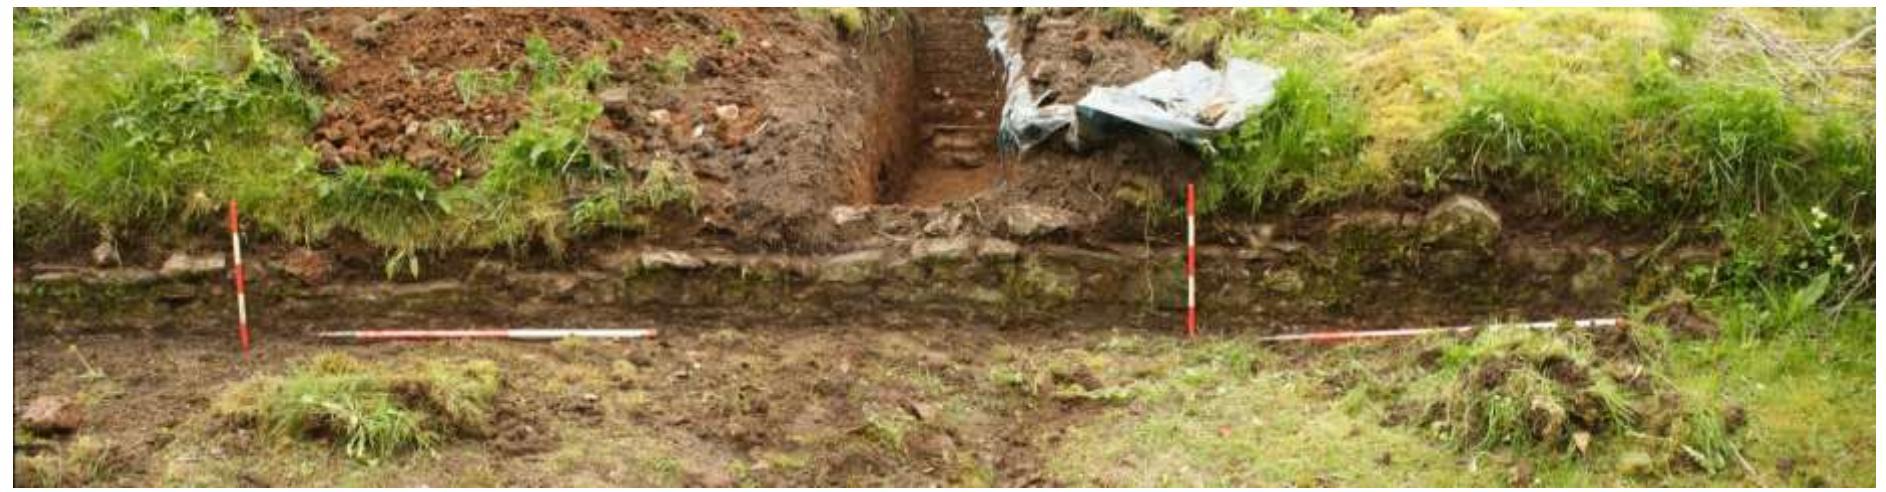
Photo 6: View southeast across retaining wall around Trench 2 to the end of area (panorama created with several photographs)

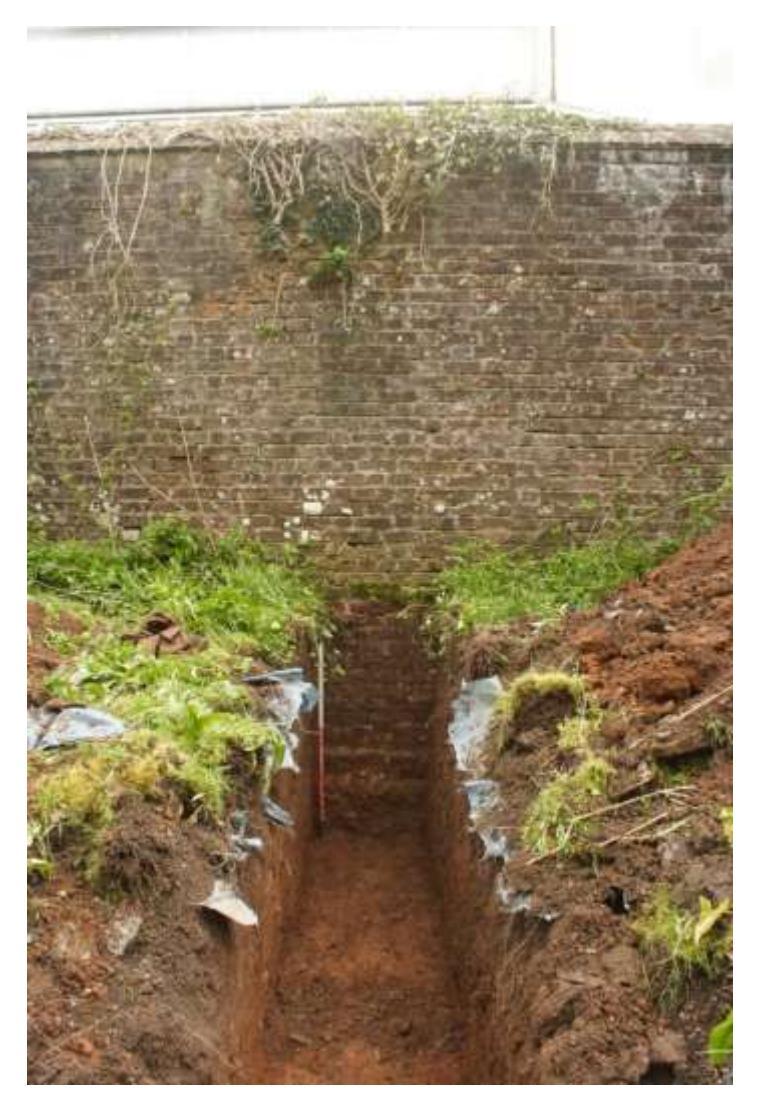
Photo 7: View southeast across Trench 1 showing full height of walled garden wall, with part of Tropical House visible behind

- 5.5 The walled garden wall formed the southeastern boundary of the development area. It is constructed of brick resting on a lower, offset rough stone (limestone? and shale) footing. The full depth of the footing was not exposed and would appear to have been deeper than the 0.40m maximum height exposed in Trench 2.

- 5.6 Above the stone footing was a slightly offset roughly finished brick plinth of around 0.18m height, and two brick courses. This also contained a few flat slate pieces, presumably to create a level plinth above the rubble stone base footing.

- 5.7 Above this level were eight courses of brick that were covered by the mounded soil, although the bricks had been neatly pointed as though meant to be visible or at least were originally above ground level in order for them to be pointed on both sides.

- 5.8 In total the brick wall was approximately 3.30m in height from the offset brick plinth to the underside of the capping for the wall. The bricks used were a dark reddish brown colour.

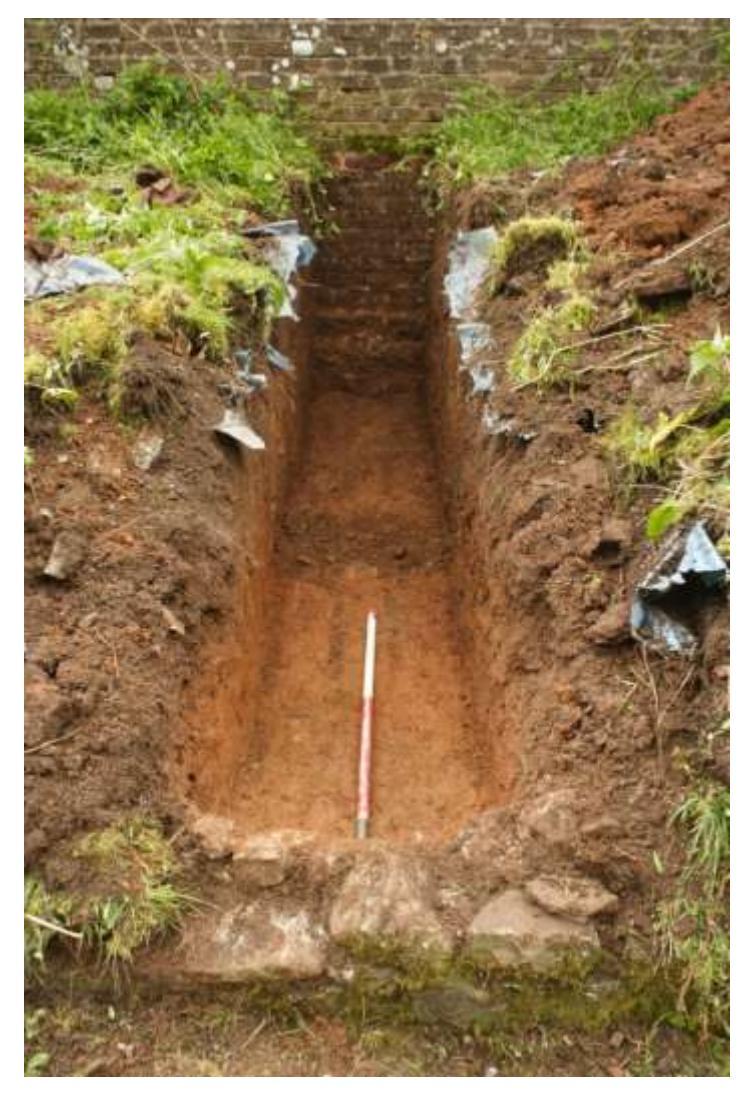
Photo 8: Overview of Trench 1 facing southeast with walled garden wall to rear

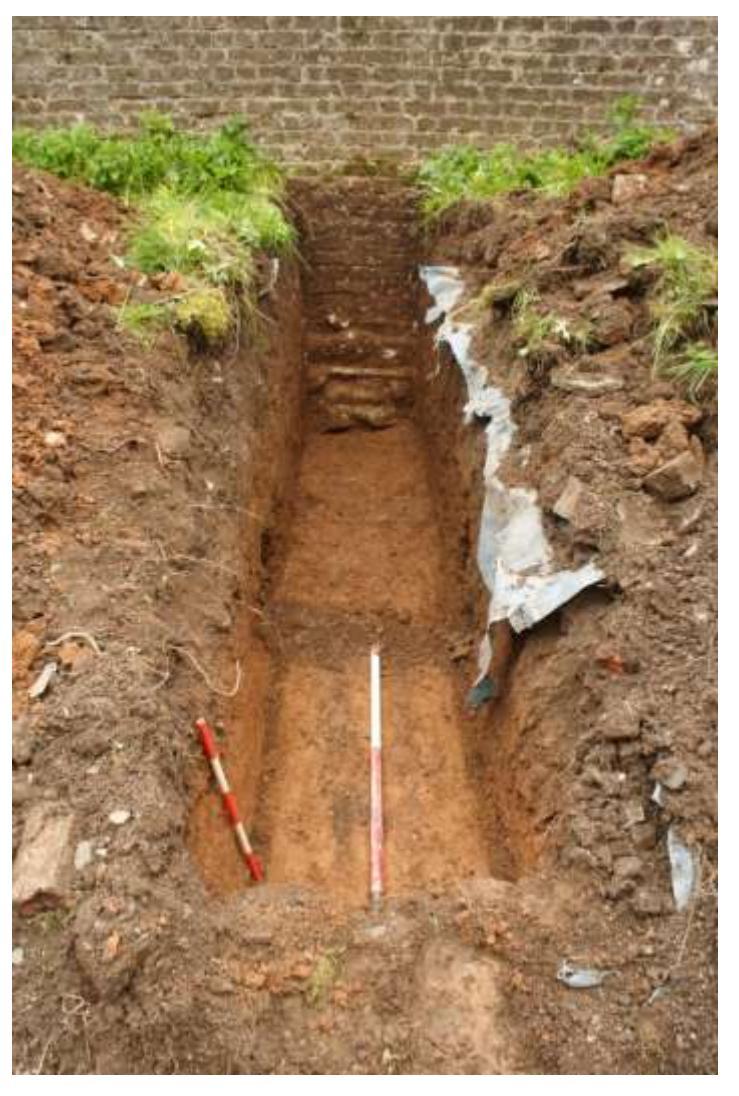
Photo 9: Overview of Trench 2 facing southeast with walled garden wall to rear

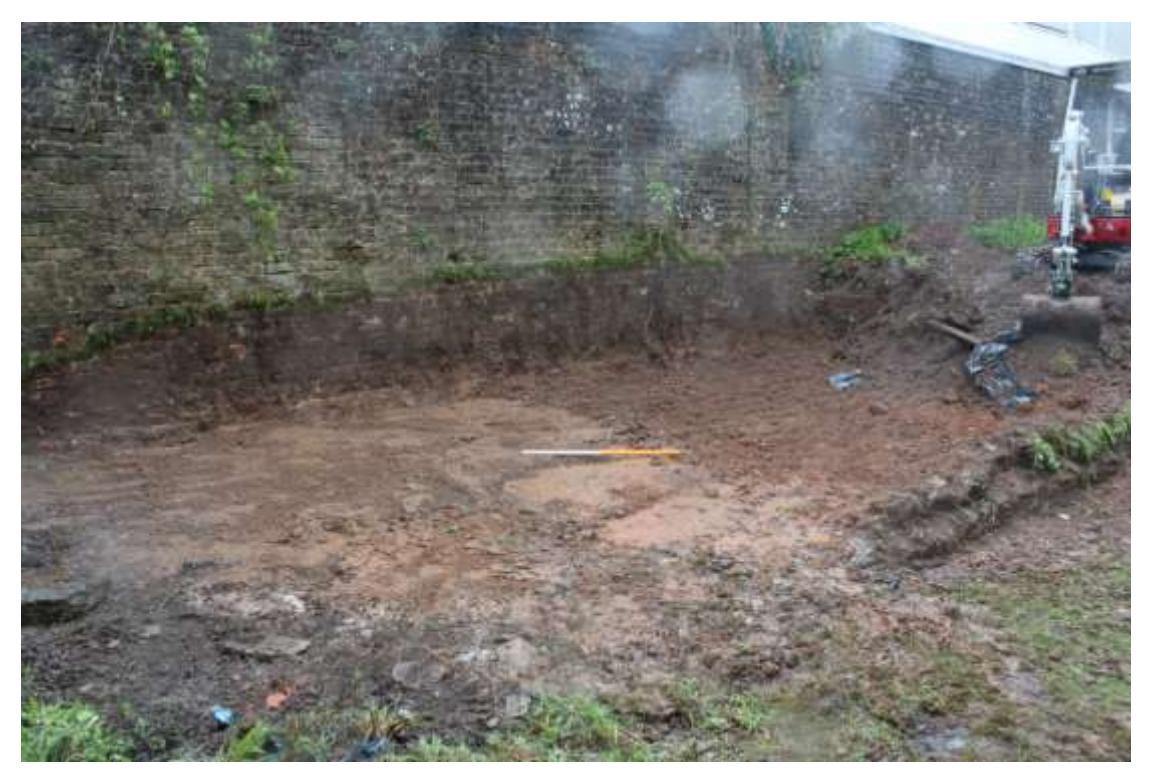
- 4.12 Following the results of the watching brief undertaken on 23rd April it was agreed that the site area could be reduced to the formation level required for the new boiler house with intermittent observation by an archaeologist. On the 24th of April the site area was observed nearing the completion of the ground reduction to formation level to confirm that the observations recorded within the two test trenches were the same across the entire site area (Photo 10).
- 4.13 No new archaeological features were noted during this second visit confirming the observations noted on the previous day. No further visits to the site area were necessary.

Photo 10: Showing stripped area surrounding Trenches 1 and 2.

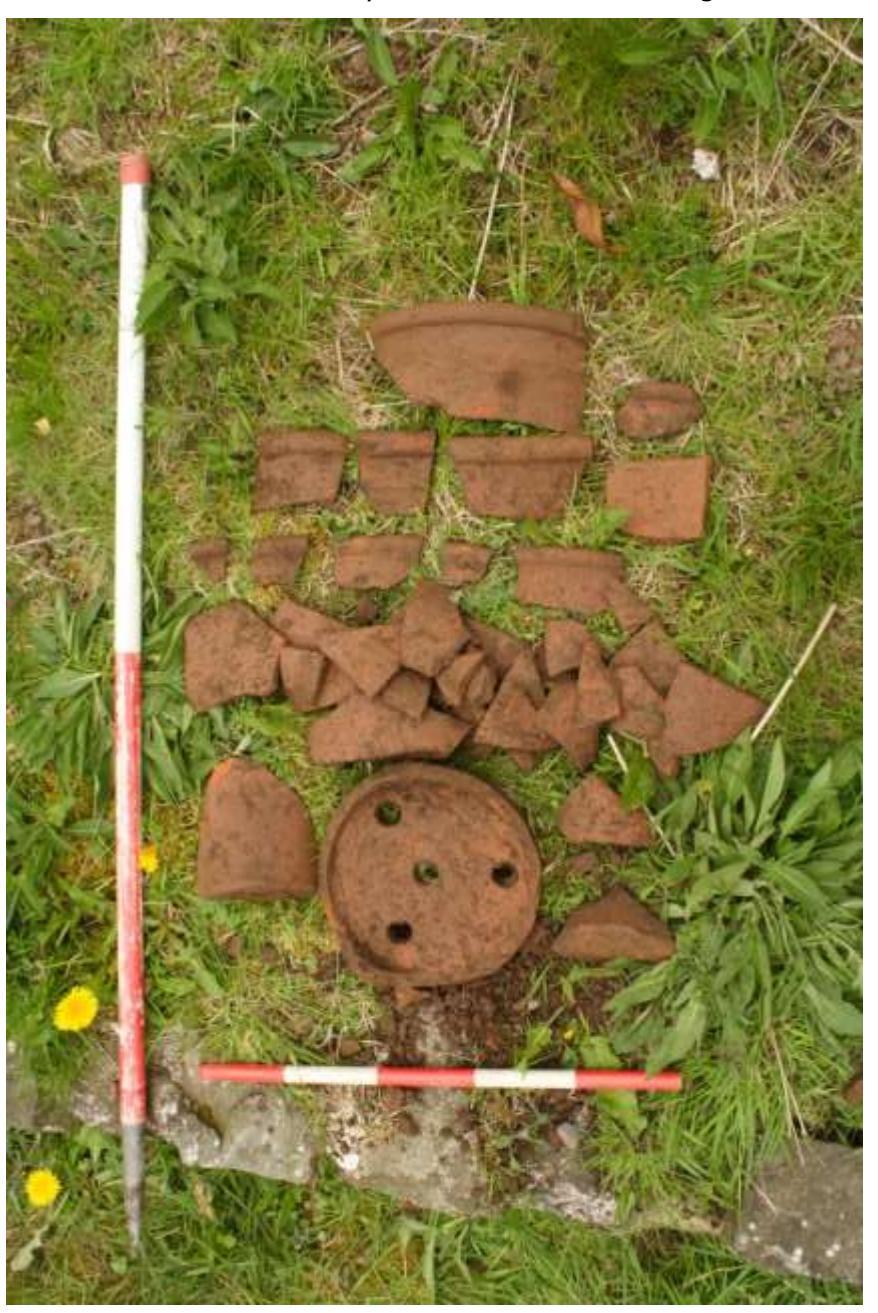
- 5.17 The only activity revealed later beyond the original construction was a large rubble dump which was likely associated with the ground works for the propane tanks for the current greenhouse heating system.
- 5.18 In the topsoil layer behind the small retaining wall in Trench 2, a dump of broken flower pots was revealed (Photo 11). These were of different sizes and bore no manufacturing marks or emblems associated with estate. The material has been retained by NBGW for their handling collection.

Photo 11: Collection of broken flower pots recovered from topsoil (202) within Trench 2
