# NANTYMWYN LEAD MINE HISTORIC ENVIRONMENT DESK BASED ASSESSMENT

Prepared by DAT Archaeological Services for The Coal Authority

REPORT NO 2021-06 EVENT RECORD NO: 125658 February 2021

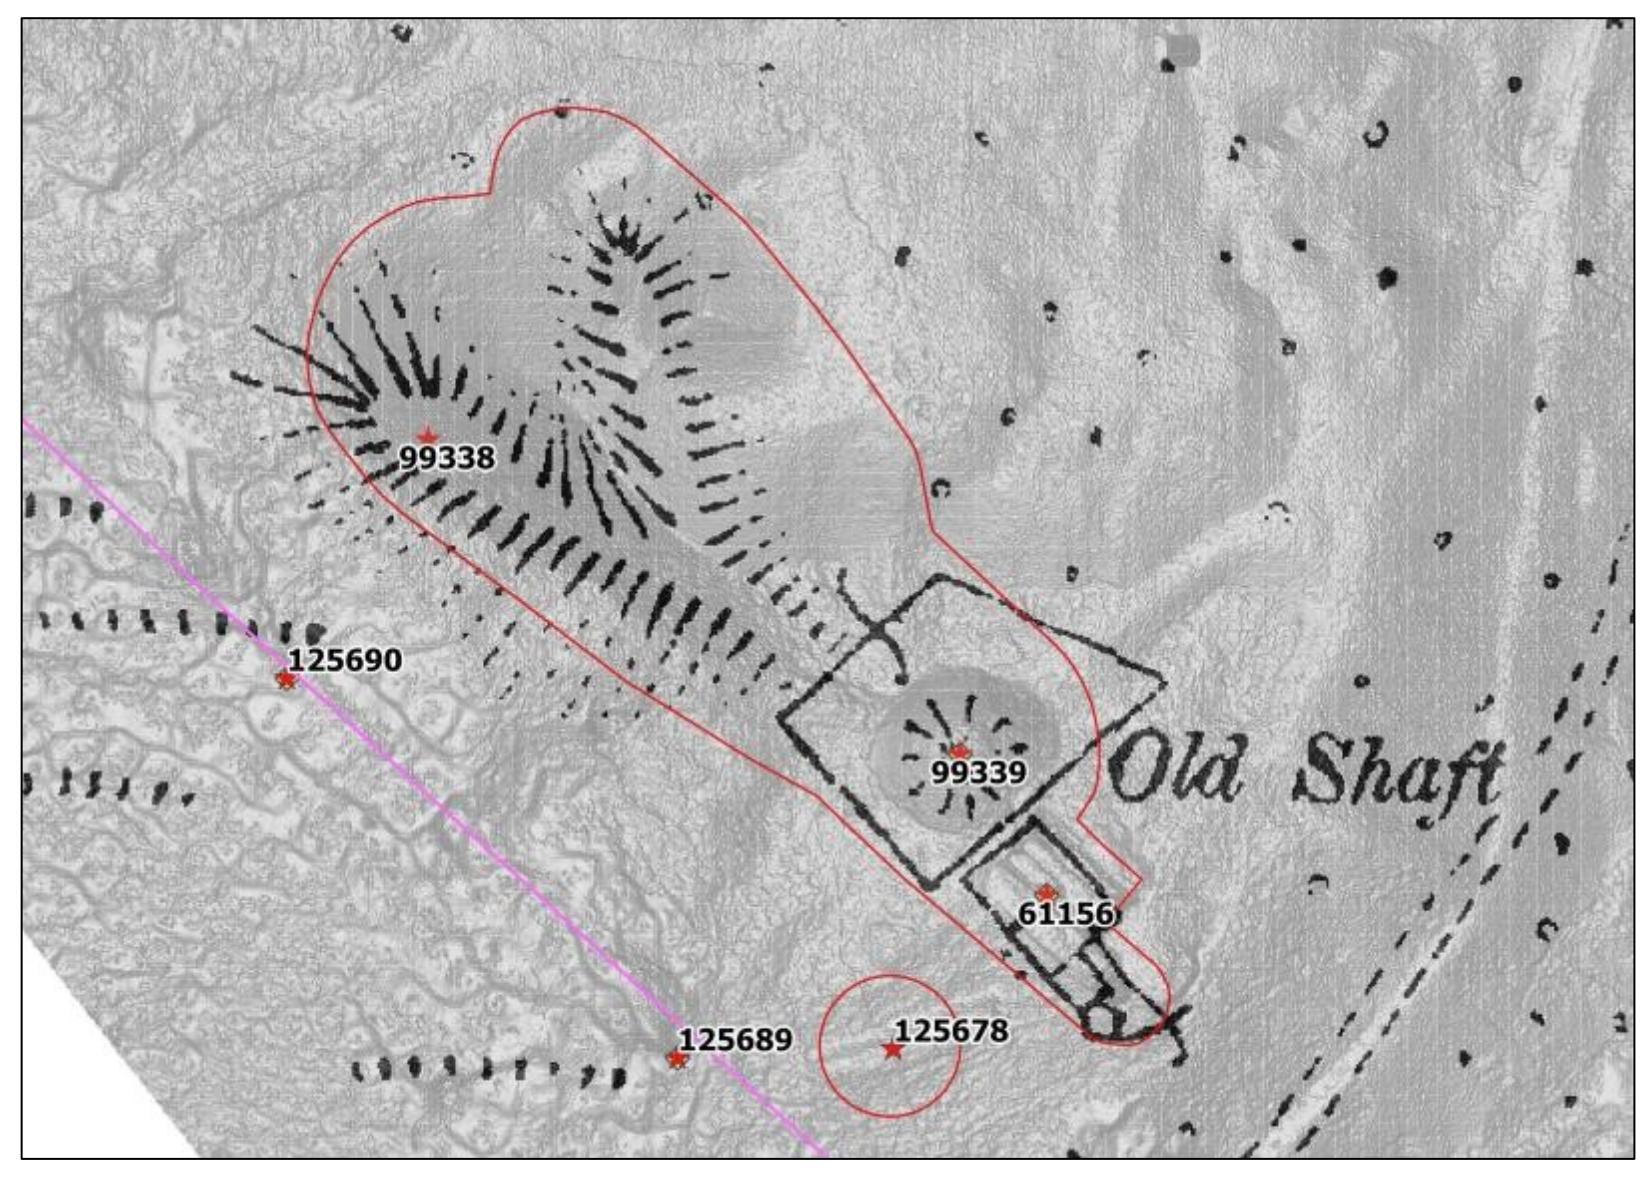
- 6.5.3 The site walkover began at the scheduled Angred Shaft and Engine House (CM215; PRNs 99339 and 61556) at the south-eastern extent of the study area (Figure 13). The engine house is located at an elevated position on the contours of Pen Cerrig Mwyn and overlooks the vast expanse of the mine workings in this area. It is flanked by forestry to the southwest and north east (Photos 1 & 2). The masonry remains of the engine house is in generally poor condition. A roofless shell for some time, its considerably ruinous given its relative age and material construction although its gables survive almost to full height. A tree has taken hold of the wheel pit and there are significant structural cracks visible on the external elevations (Photo 3). Indeed, the southwest facing elevation appears to be leaning outwards, tearing quietly away from the rest of the building fabric. Little remains of the adjoining boiler house save some plinths of wall, and a pitch line is visible in the cement rendered, eastern gable (Photo 4). Here a void in the concrete floor exceeds 1m in depth. The chimney is in a similar condition and the red brick section at the top of the stack area looking quite perilous.

**Figure 13:** 1905 2<sup>nd</sup> edition 1:2500 OS map overlying the 25cm LiDAR data showing the recorded archaeological assets (red stars) around the scheduled areas (red polygons) of the Angred Shaft and Engine House. (25cm LiDAR ©Coal Authority 2020)

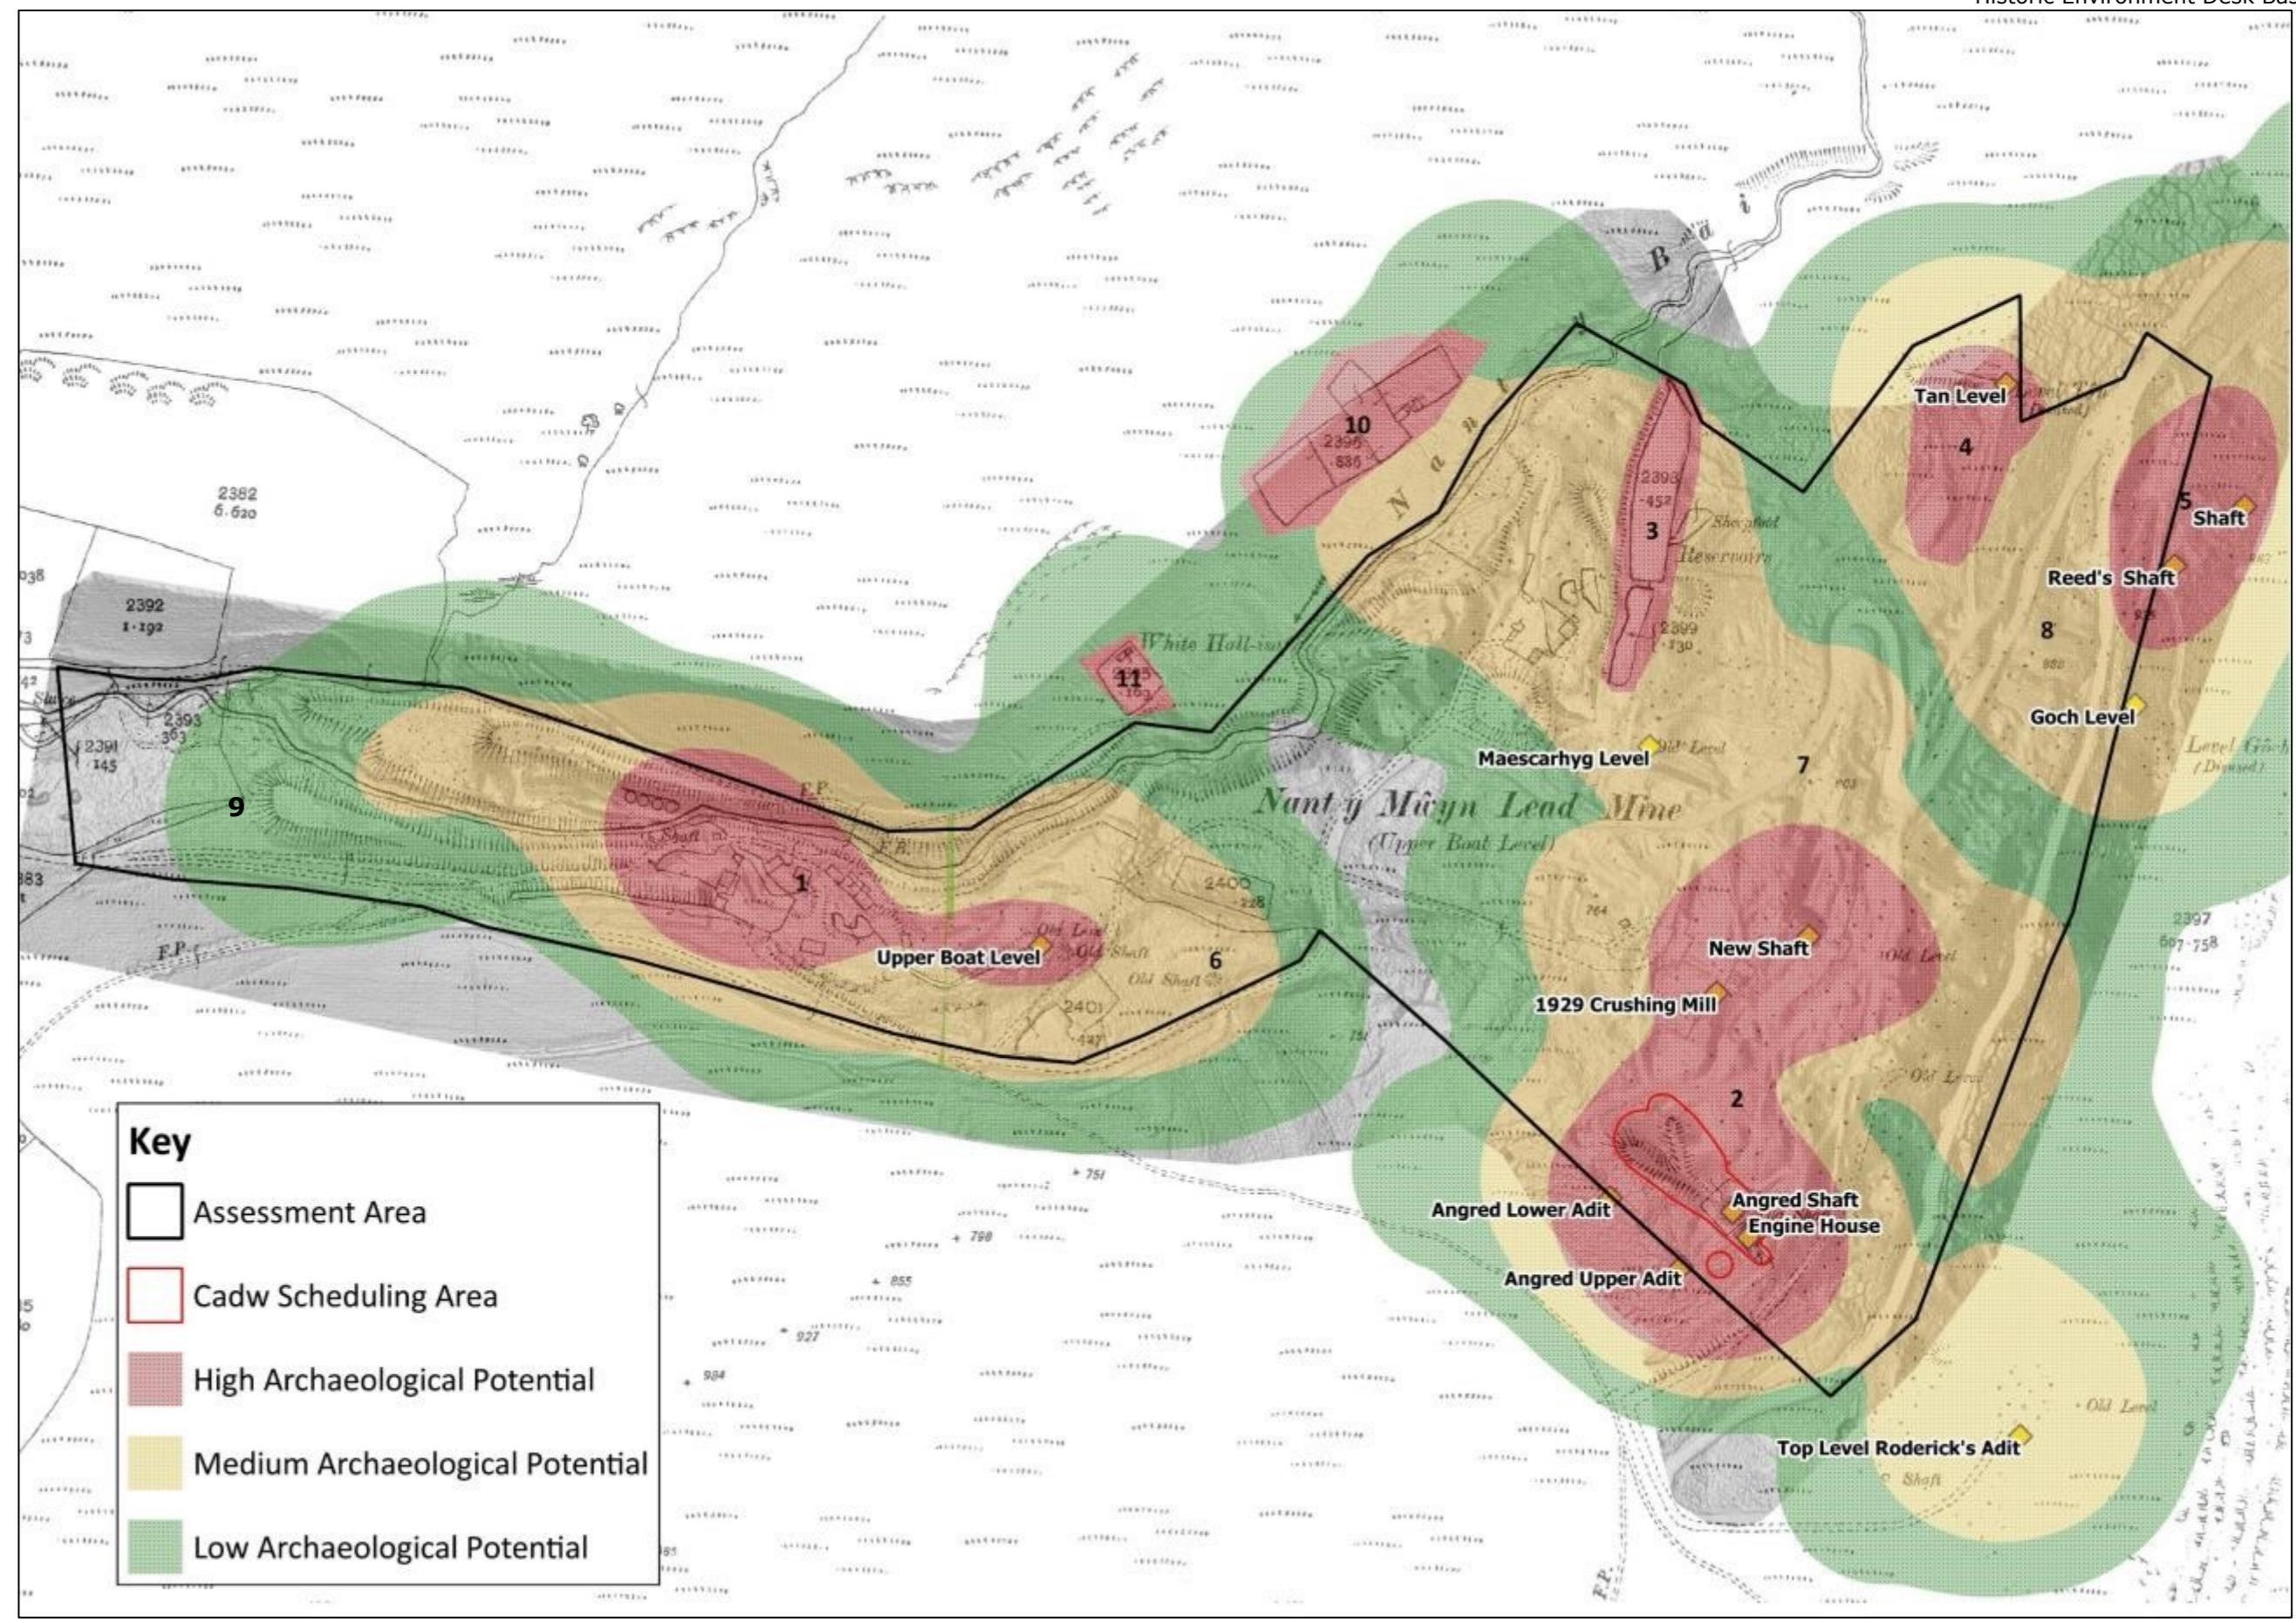
Figure 19: Areas of archaeological potential within the Nantymwyn study area. The 25cm LiDAR DTM data is overlaid with the 1905, 2<sup>nd</sup> edition 1:2500 Ordnance Survey map. (25cm LiDAR ©Coal Authority 2020)

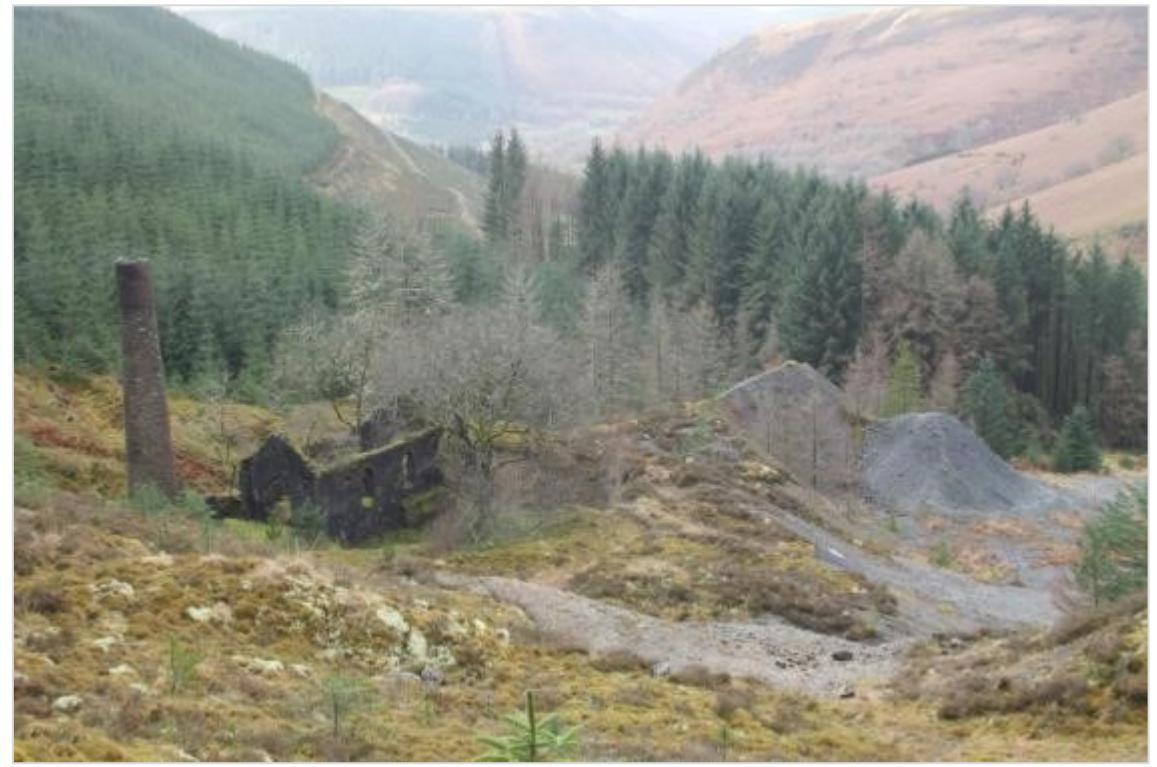
Photo 1: Overview of Scheduled Area CM215 (including Engine House, Angred Shaft, Chimney and development tip). DAT photo#2559

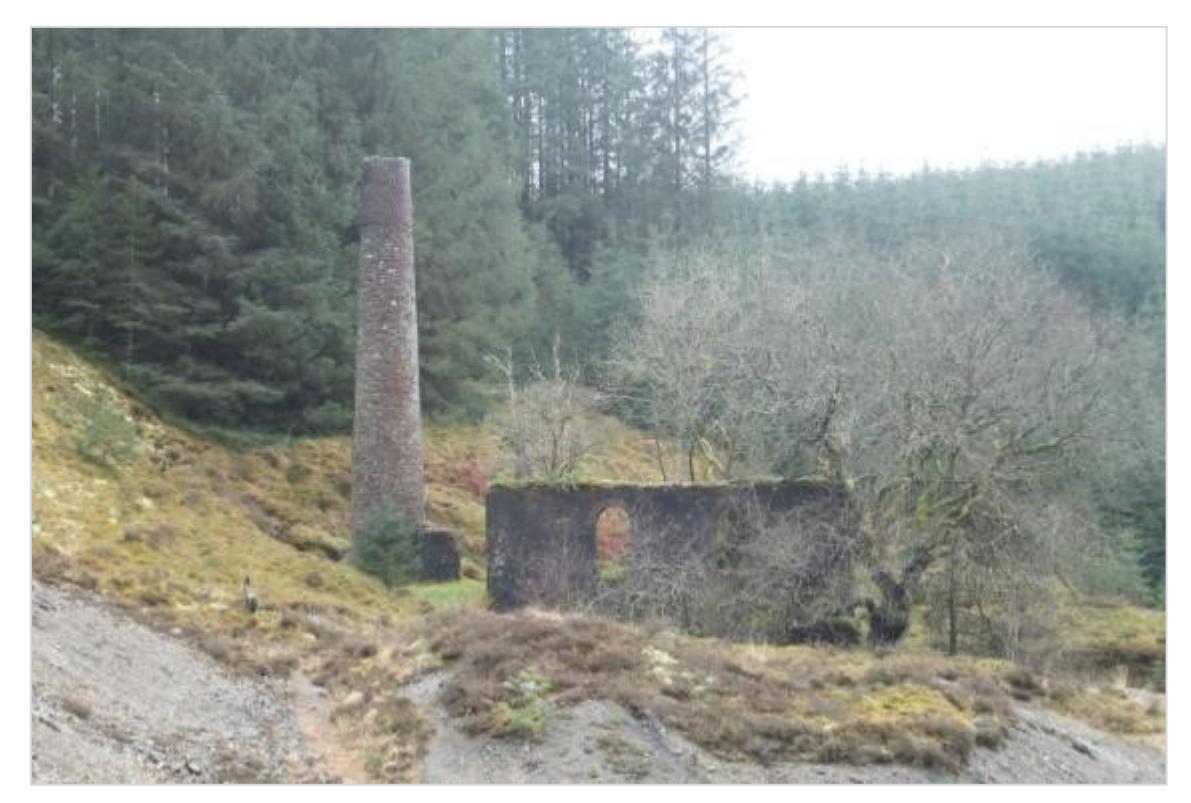
Photo 2: Overview of scheduled monument CM215 - Angred Engine House & Chimney. DAT Photo#2540

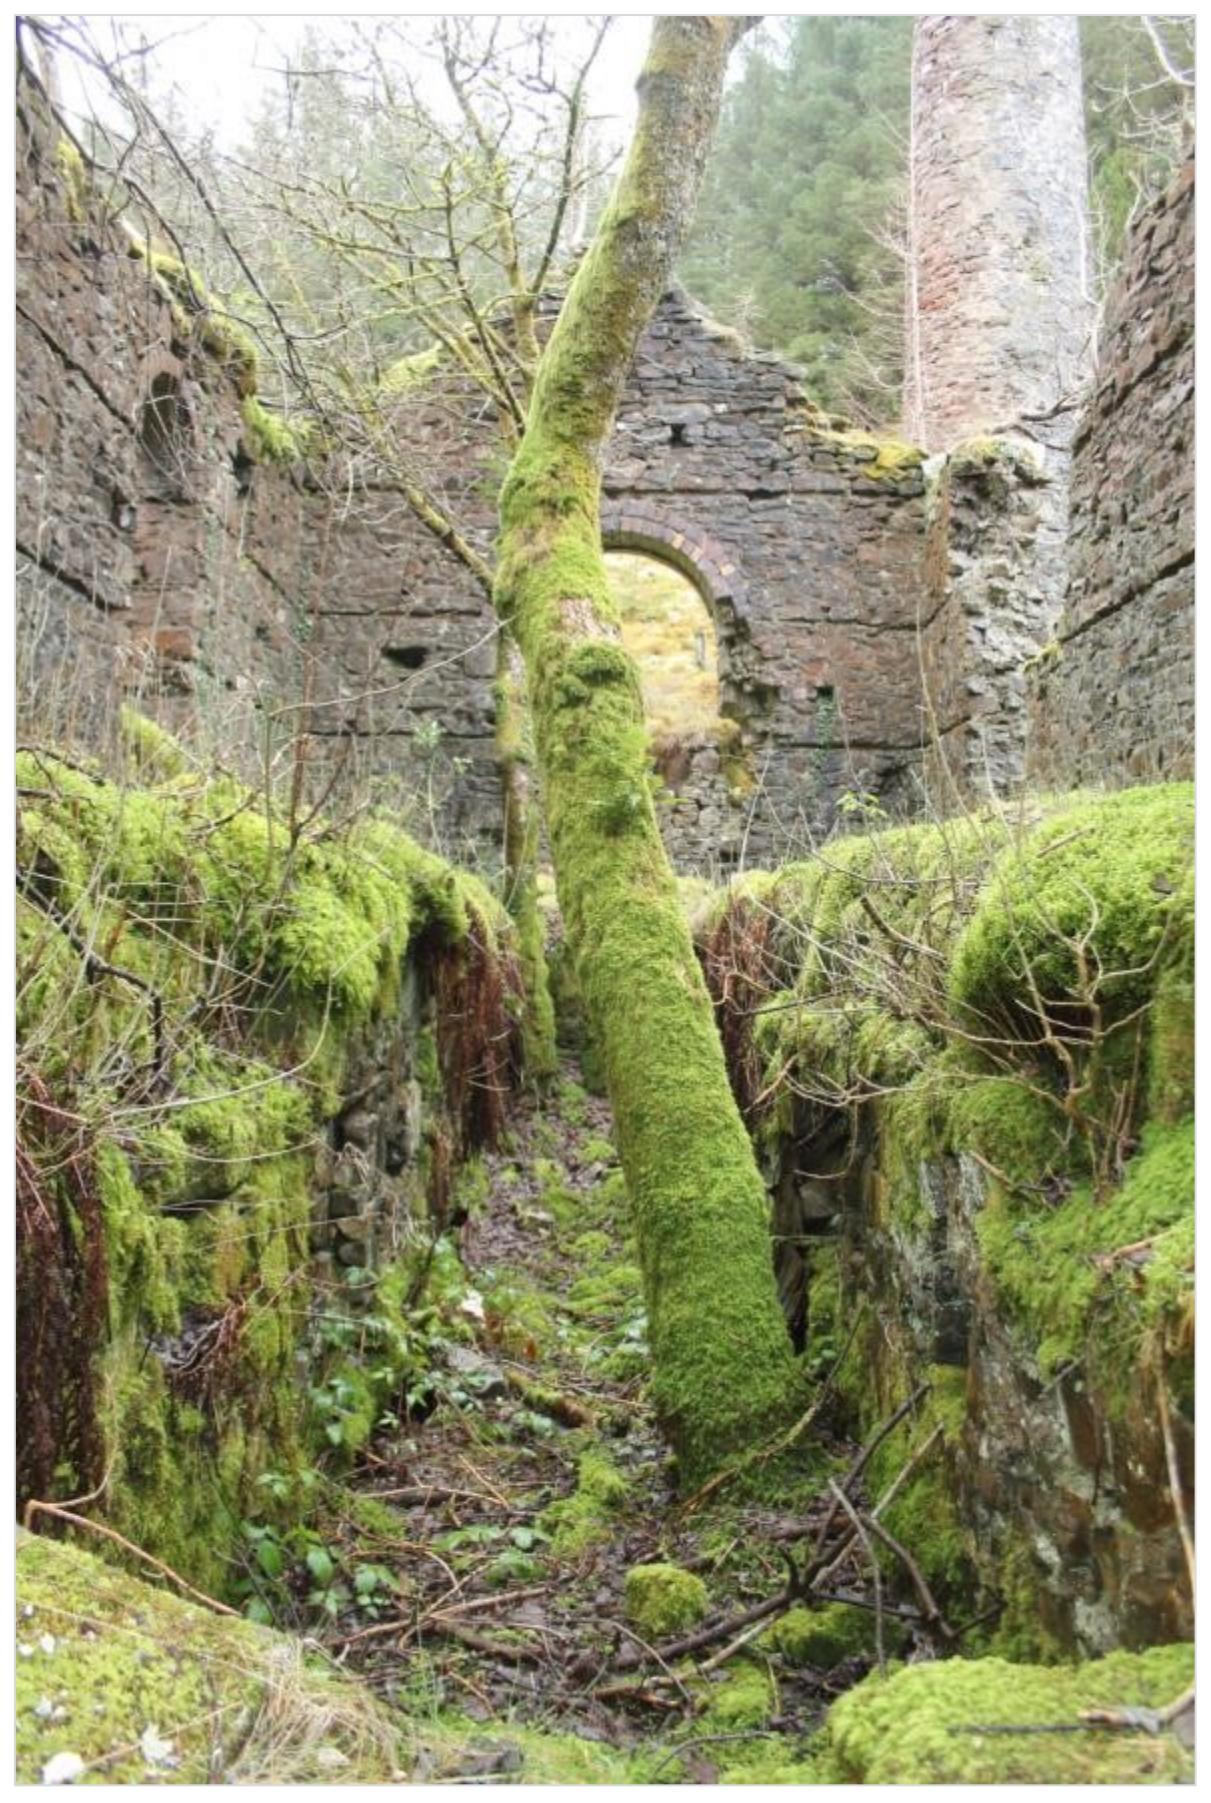
**Photo 3**: The tree growing from the wheel pit of the Angred Engine House. DAT Photo #2545

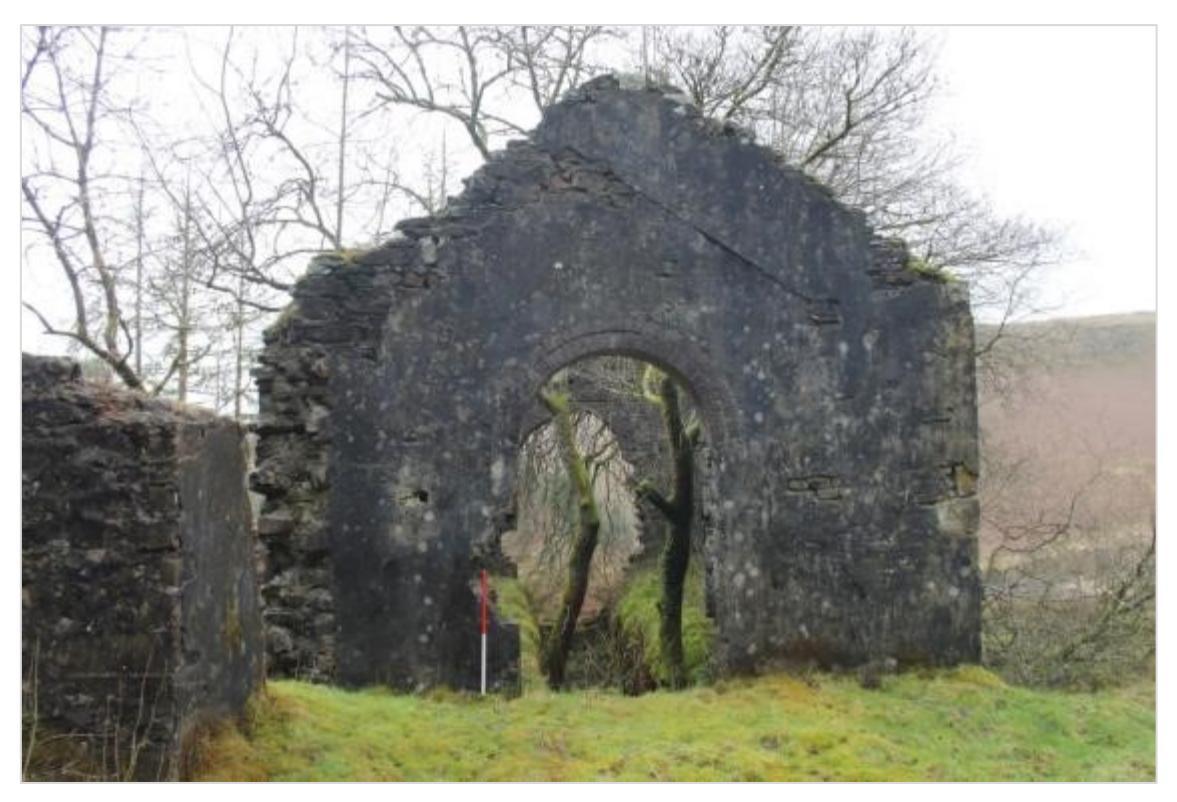
Photo 4: The southern gable of the Angred Engine house showing roof pitch line. 1m scale. DAT Photo#2548

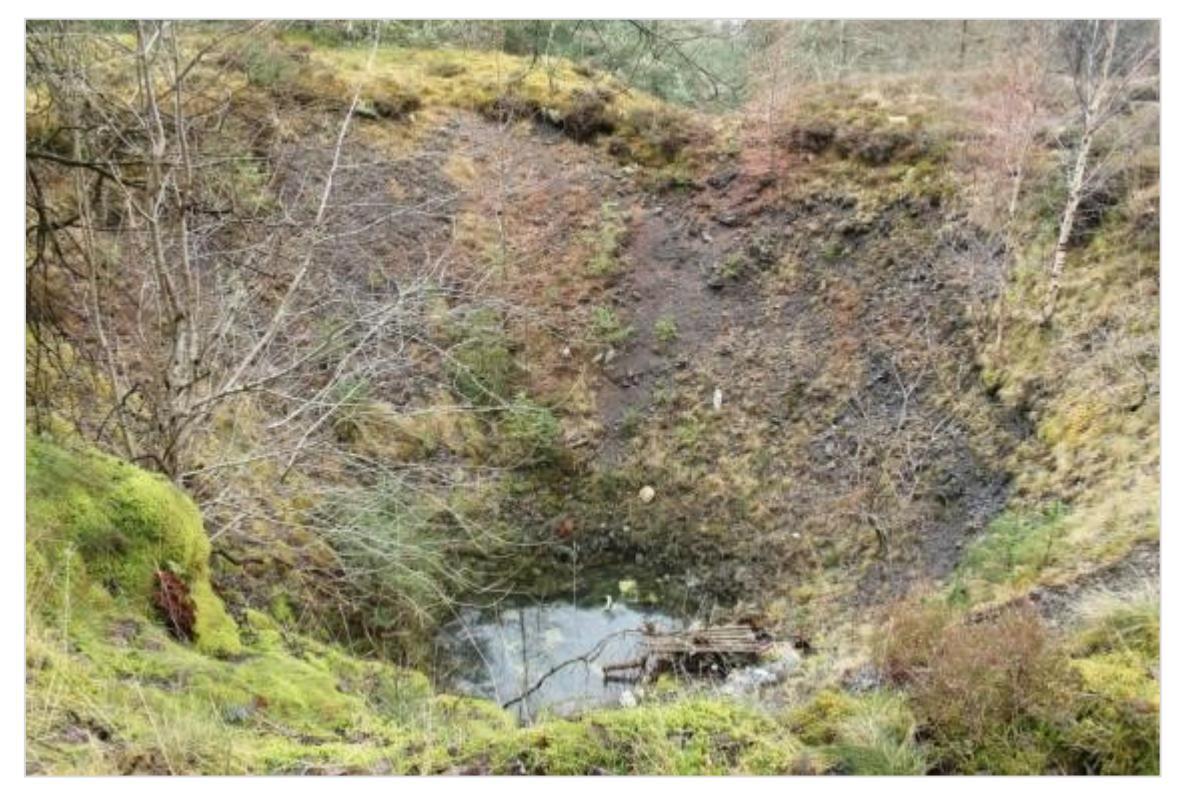
Photo 5: Subsidence cone of the Angred Shaft (PRN 99339). DAT Photo#2543

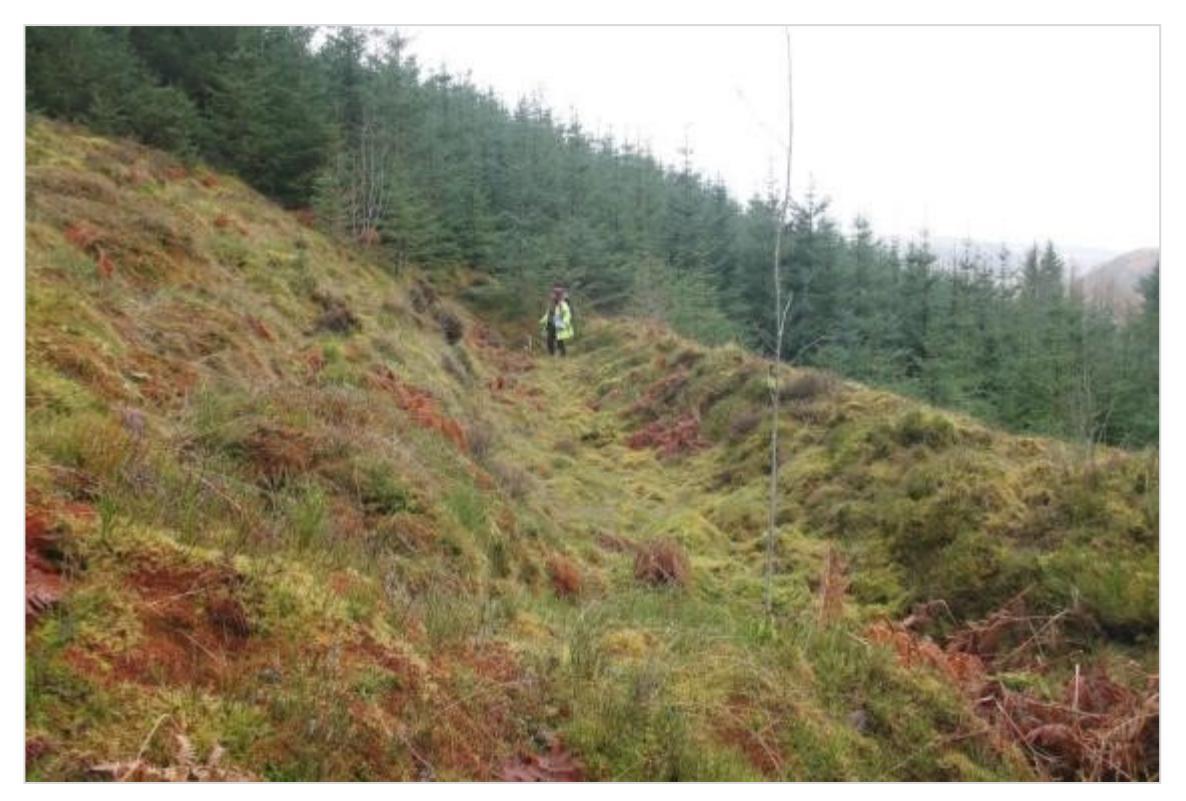
Photo 6: Overview of the boiler feeder reservoir to the Angred Engine House (PRN125678). DAT Photo#2553

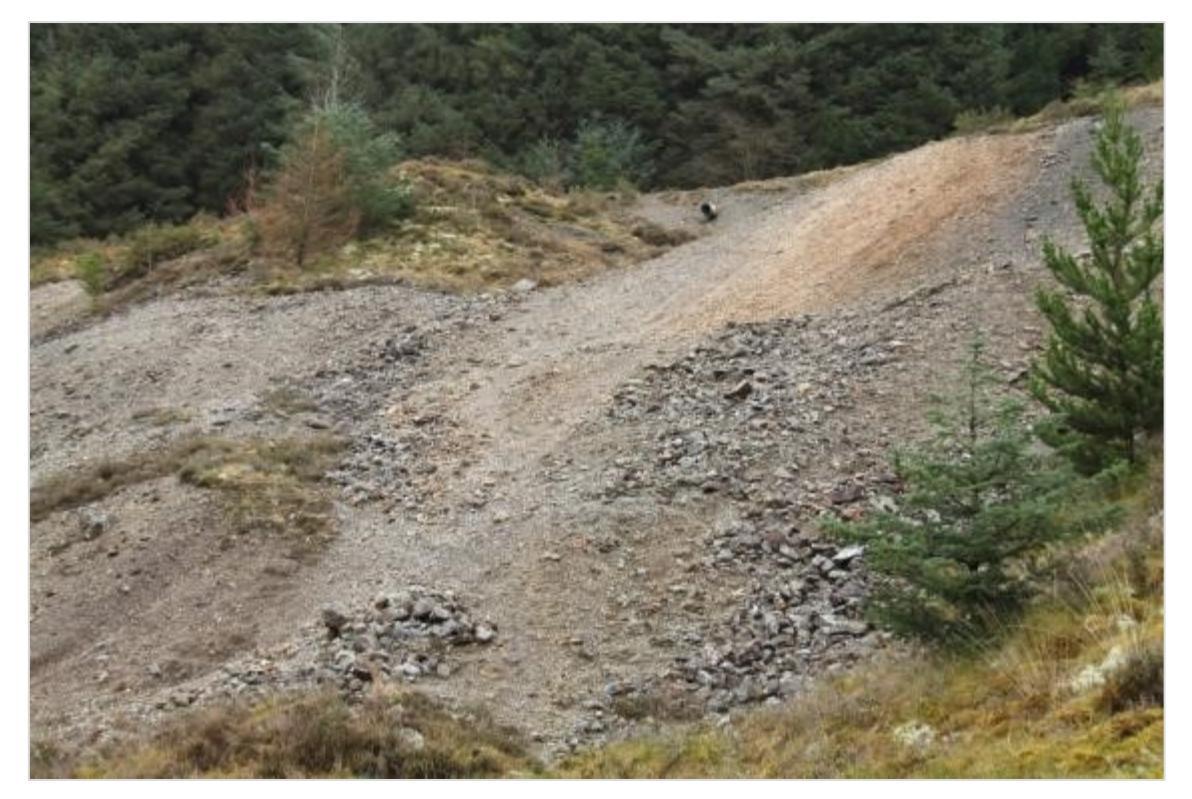
**Photo 7:** The modern culvert and eroded tips above the Angred Engine House. DAT Photo#2549

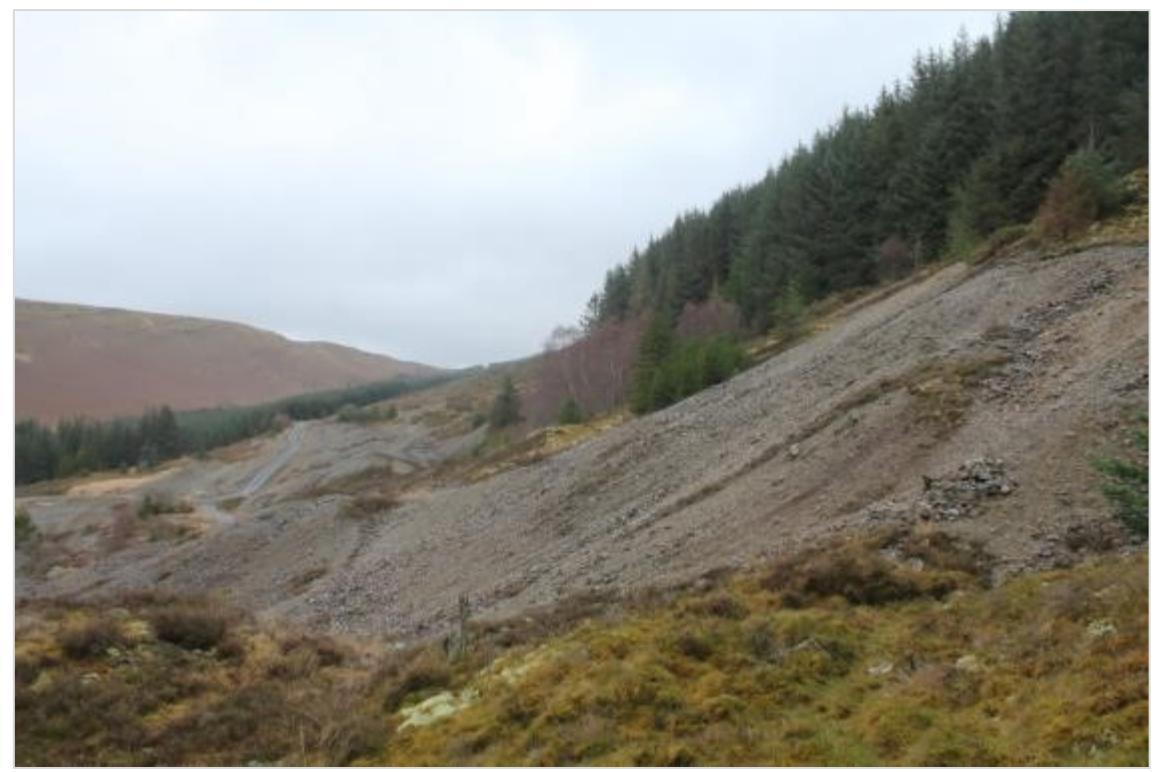
**Photo 8:** Overview of the eroding tips above and to the northeast of the Angred Engine House. DAT Photo#2550

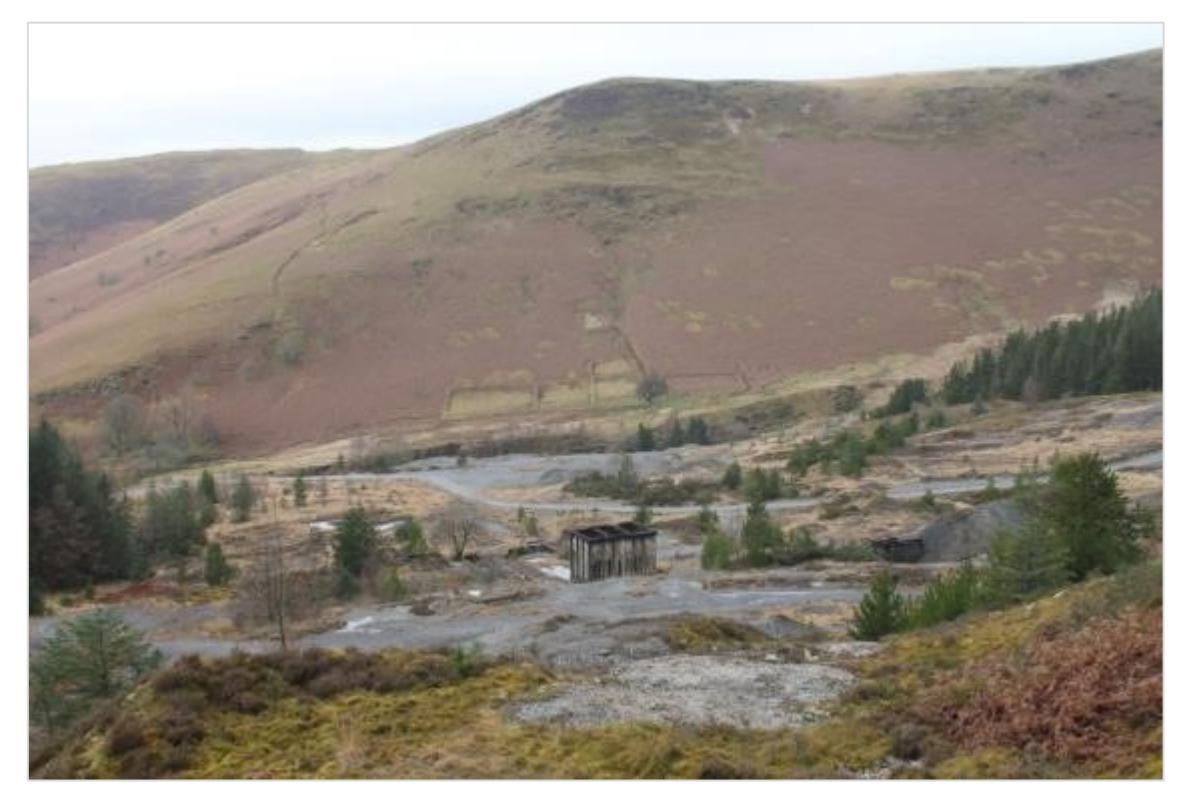
Photo 9: Overview of the mine workings at the eastern extent of the study area. The ore bin (PRN 99335) of the modern crushing mill is visible in the foreground whilst the enclosures of White Hall Uchaf are visible on the northern slopes of the Nant y Bai. DAT Photo#2556

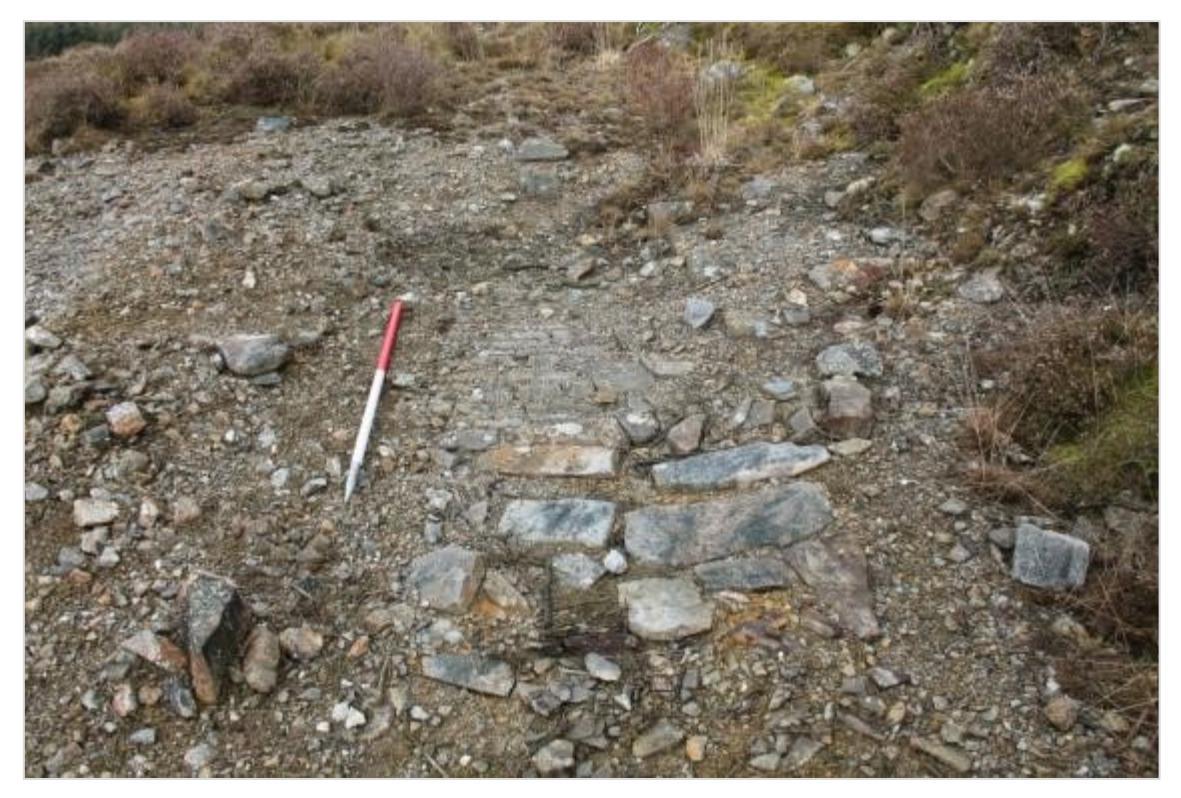
**Photo 10:** The pitched stone surface of the inclined track (PRN 99325). 1m scale. DAT Photo#2567

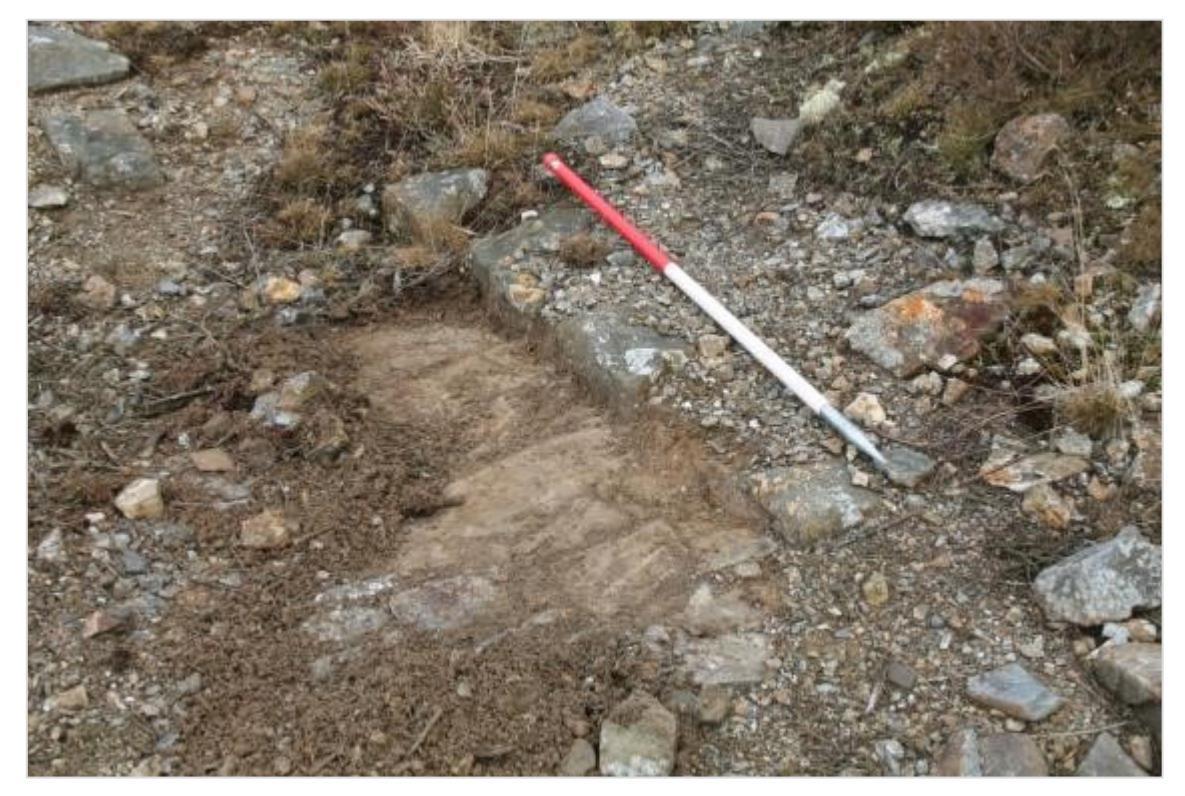
Photo 11: The lightly trowelled surface of the metalled track (PRN 99325) revealing it's eastern kerb. 1m scale. DAT Photo#2569

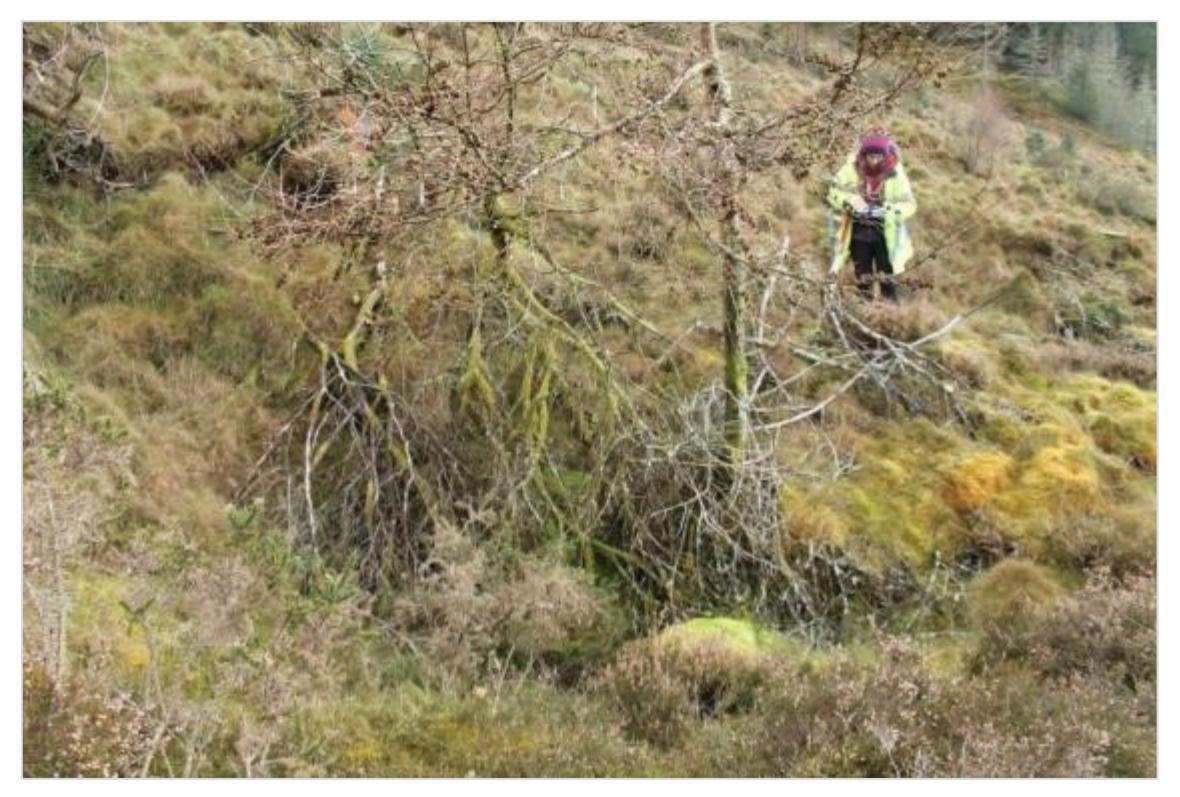
Photo 12: A small circular shaft (PRN125679). DAT Photo#2568

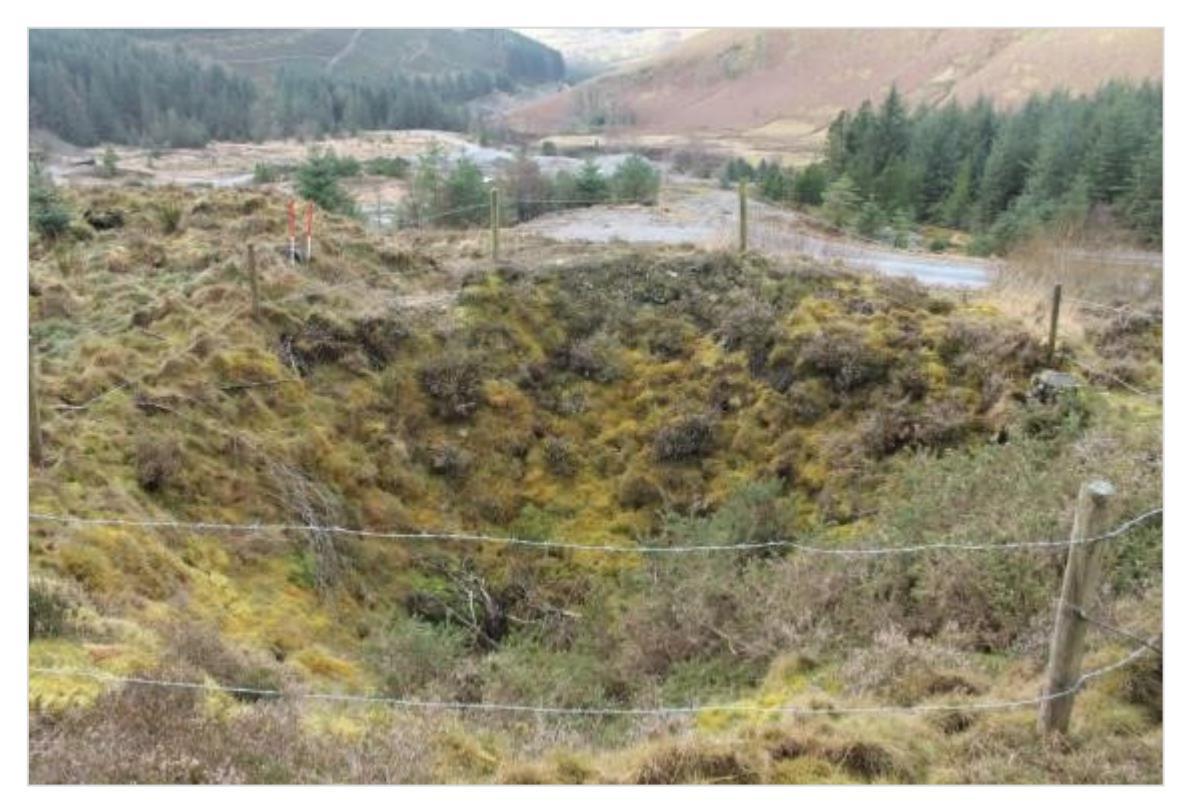
Photo 13: Subsidence cone (PRN 99324) of the possibly erroneously named "Reed's" shaft. DAT Photo#2564

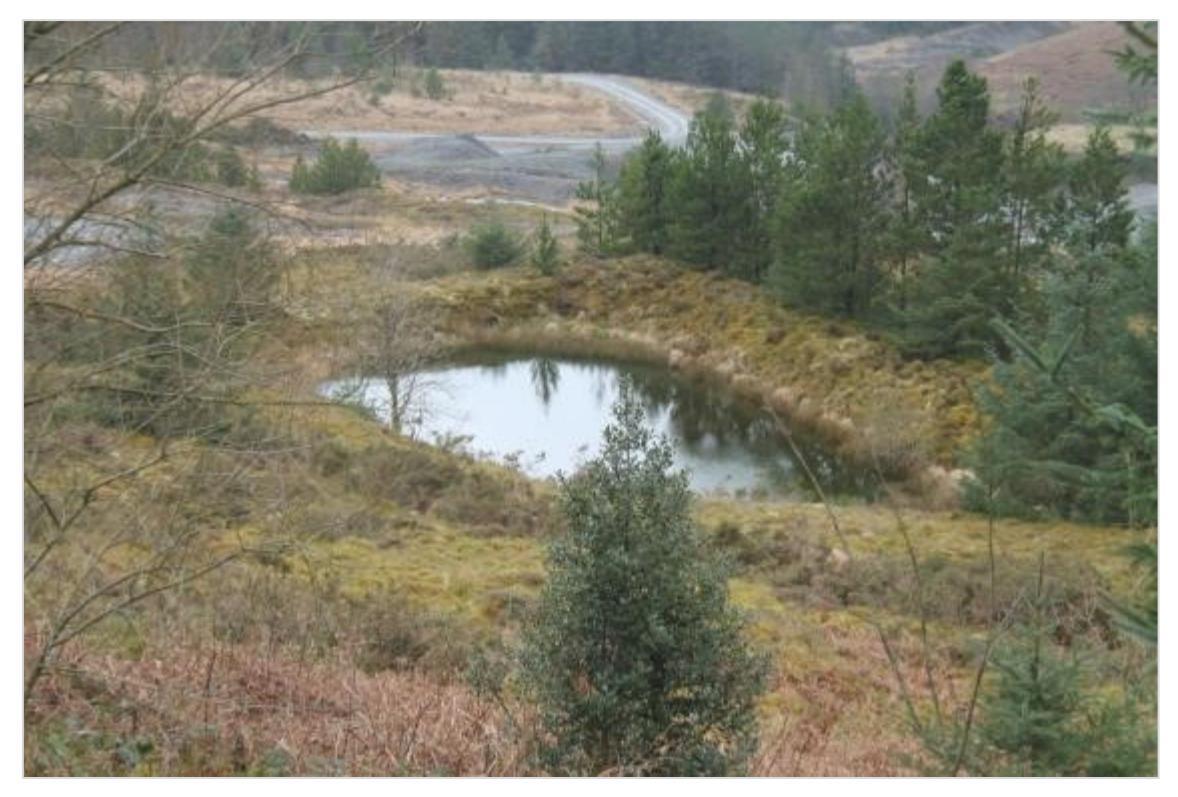
Photo 14: Overview of the small reservoir (PRN 99315), south of Level Tan with the linear earthwork visible in centre of the image. DAT Photo#2570

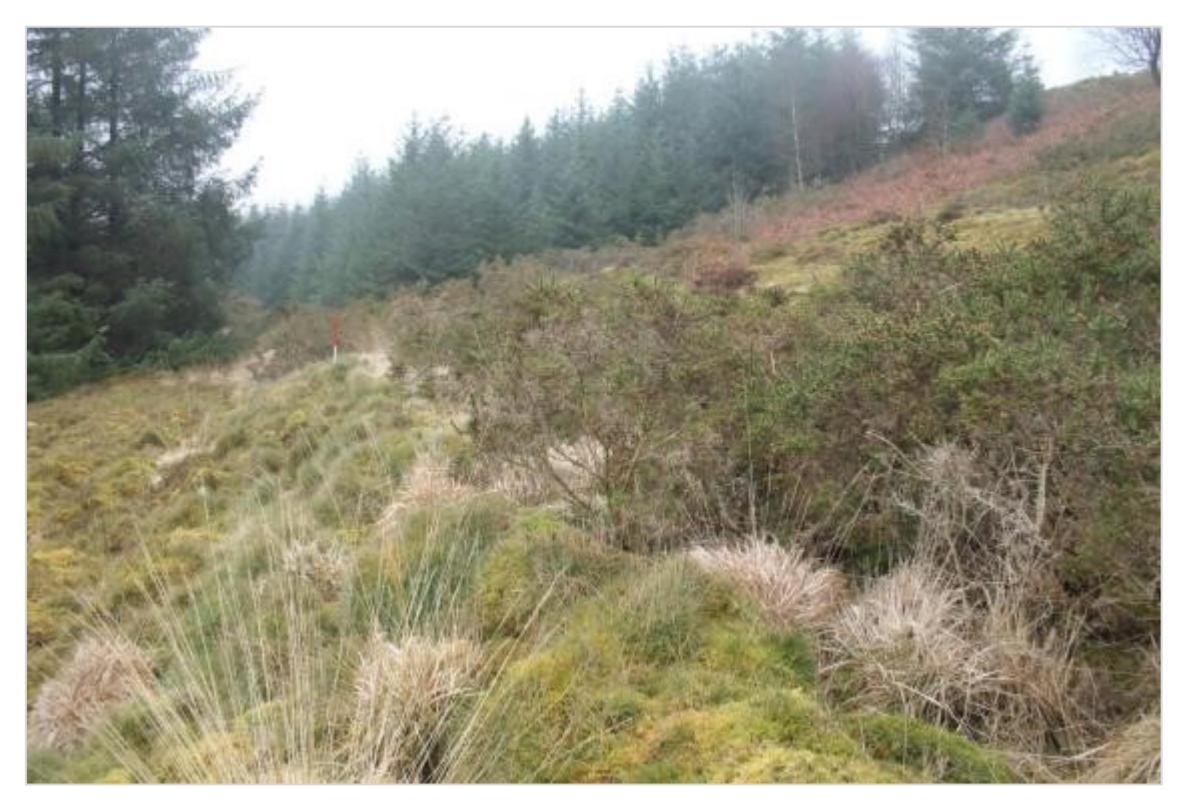
Photo 15: General view of the linear earthwork (PRN 125688) south of Level Tan and densely covered by gorse. DAT Photo#2575

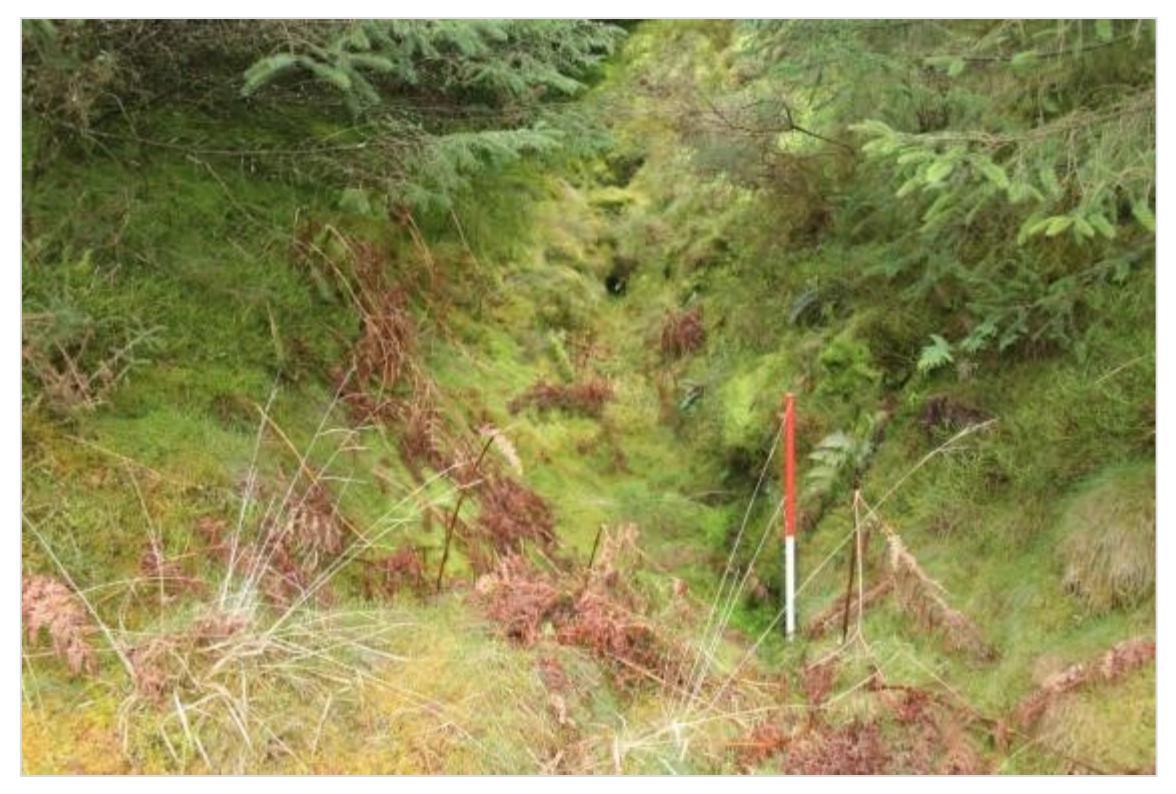
Photo 16: The slumped portal of Level Tan (PRN 99317). 1m scale. DAT Photo#2572
