# NANTYMWYN LEAD MINE HISTORIC ENVIRONMENT DESK BASED ASSESSMENT

Prepared by DAT Archaeological Services for The Coal Authority

REPORT NO 2021-06 EVENT RECORD NO: 125658 February 2021

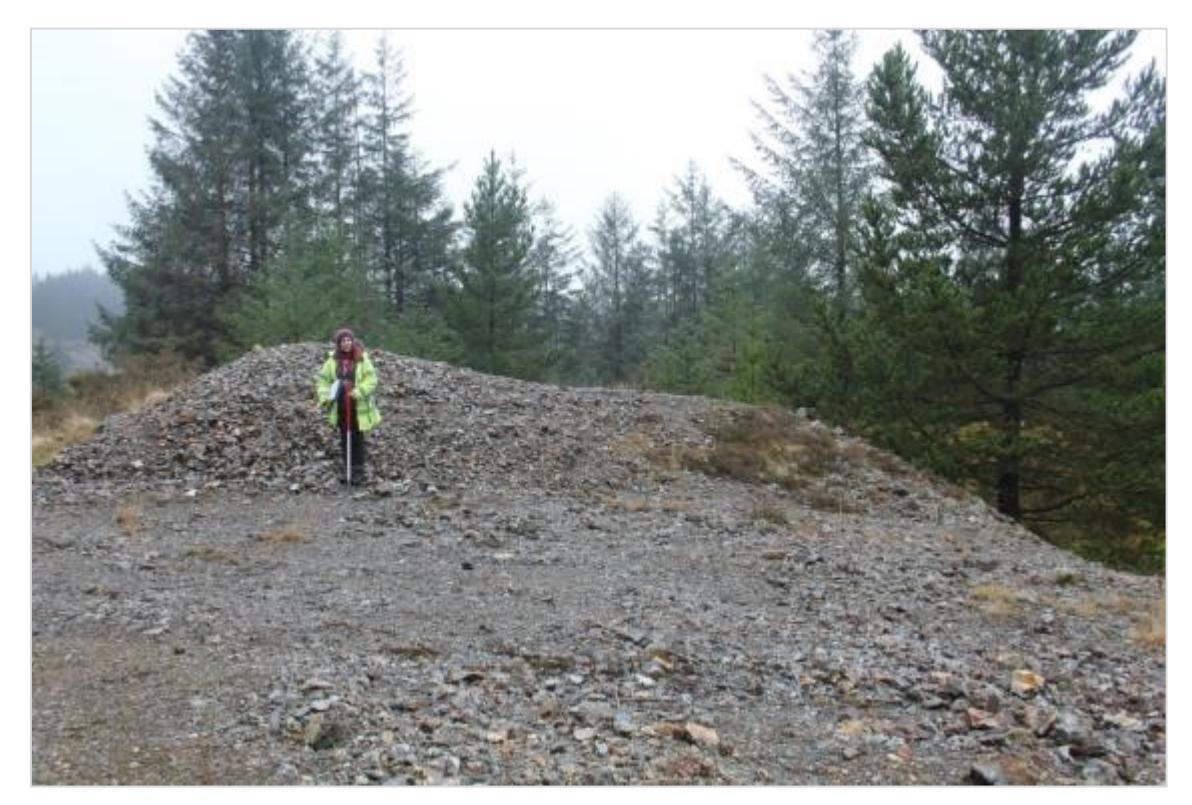
Photo 17: The start of the development tip (PRN 99316) of Level Tan. DAT Photo#2573

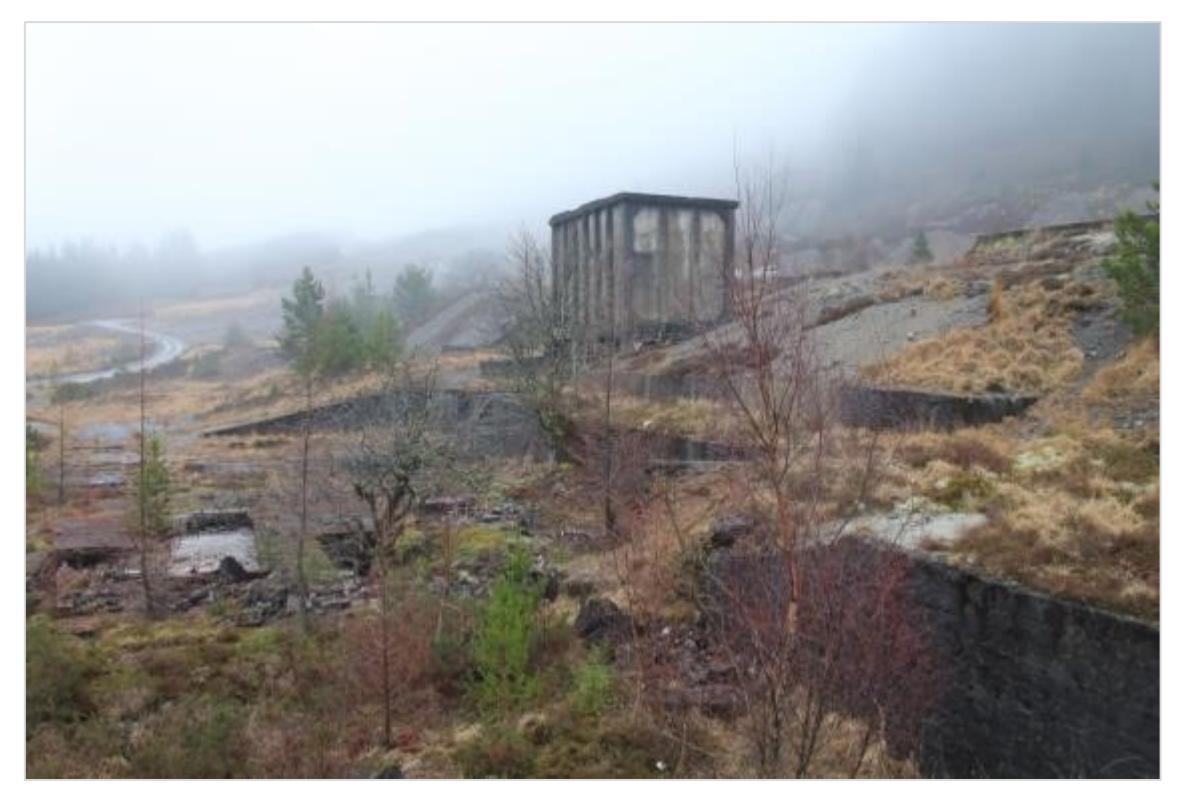
**Photo 18:** Overview of the ore bin and footprint of the 20<sup>th</sup> crushing mill (PRN 99335). DAT Photo#2576

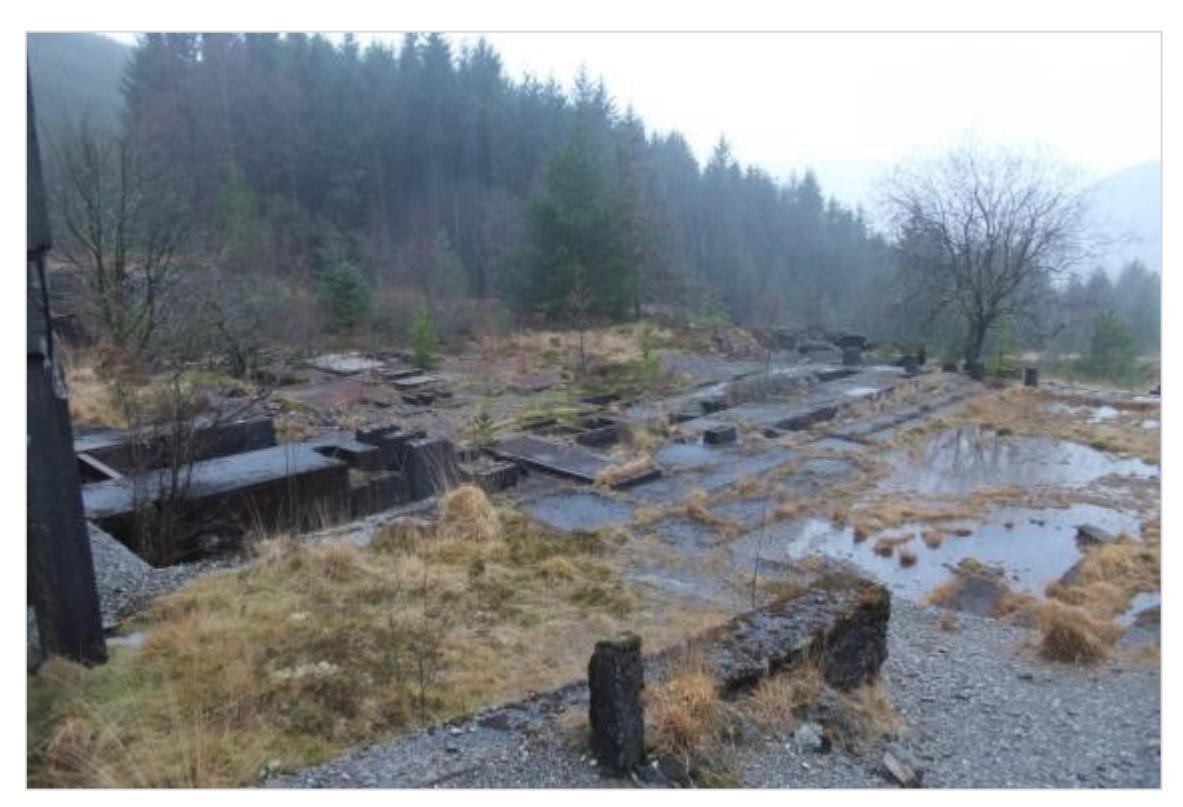
**Photo 19:** The shuttered concrete platform of the 20<sup>th</sup> century crushing mill (PRN 99335). DAT Photo#2588

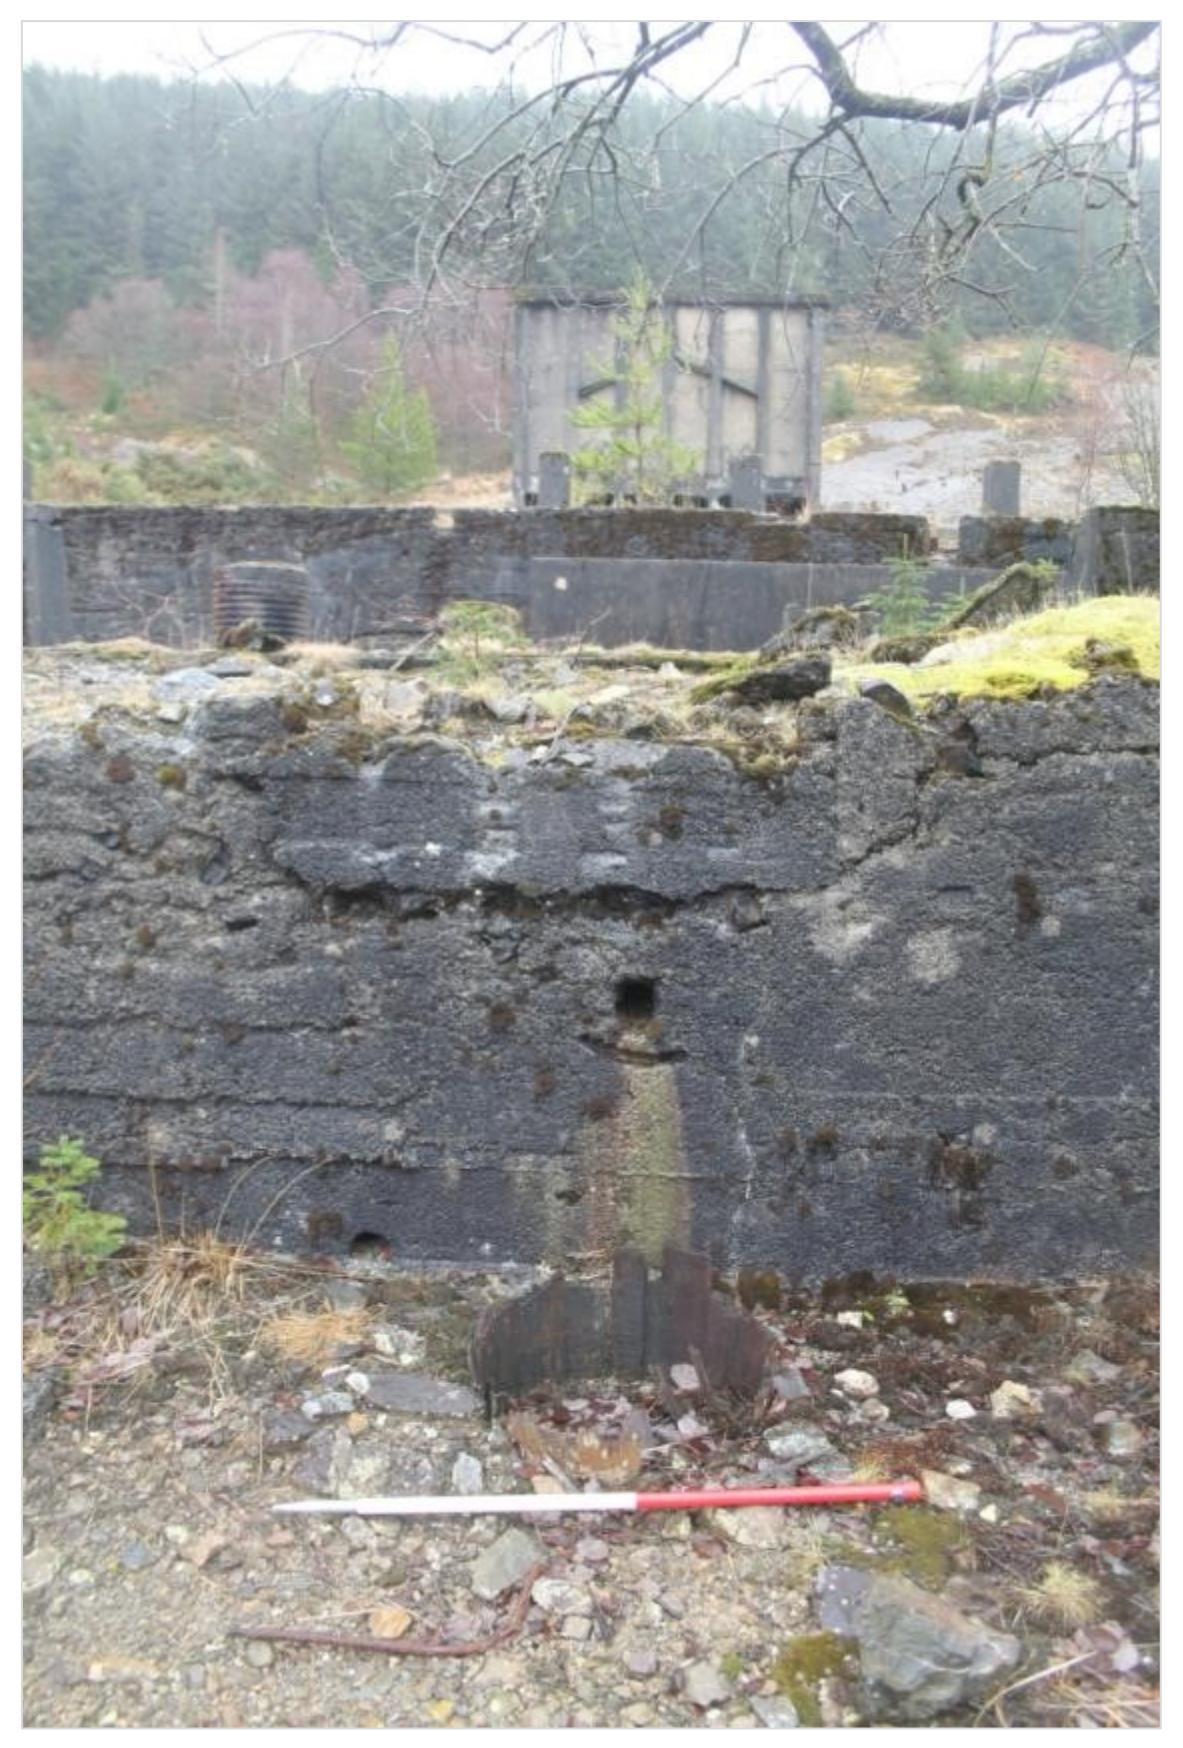
**Photo 20:** The remaining staves of a wooden bucket at the base of the 20<sup>th</sup> crushing mill (PRN 99335). 1m scale. DAT Photo#2581

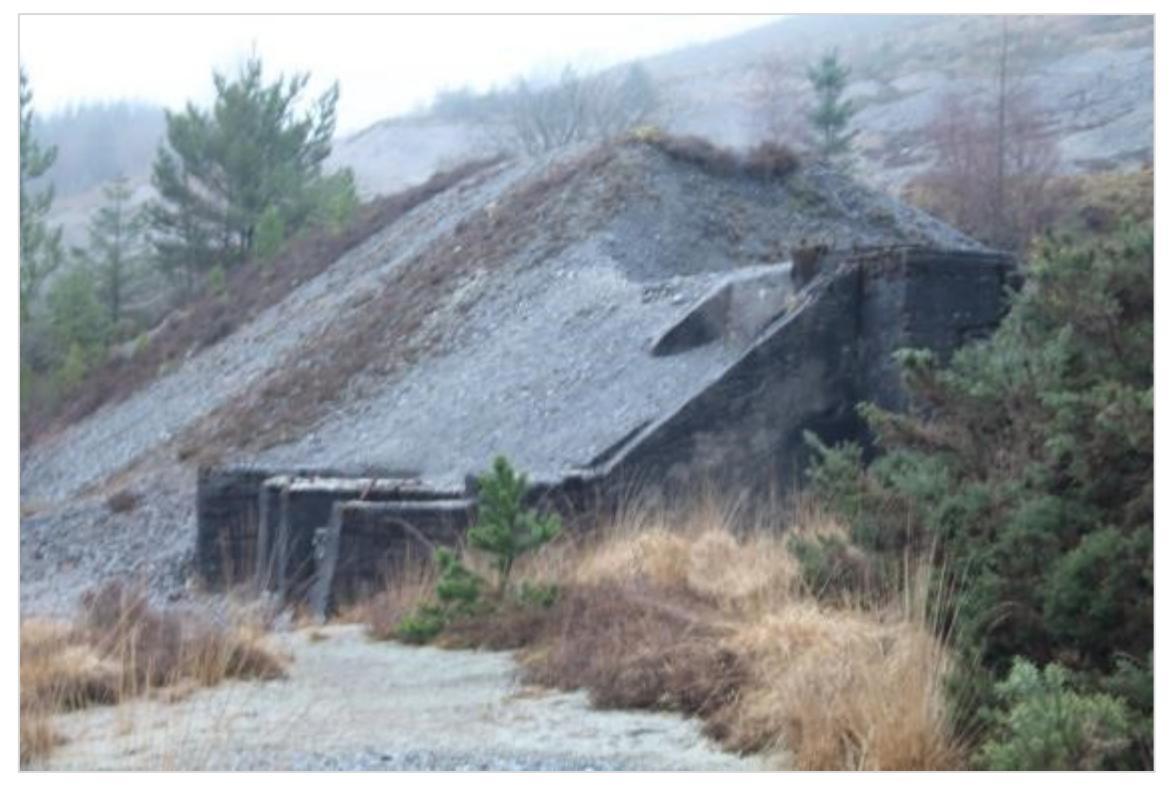
Photo 21: Concrete buttress for the former steer of the headframe of New Shaft. DAT Photo#2587

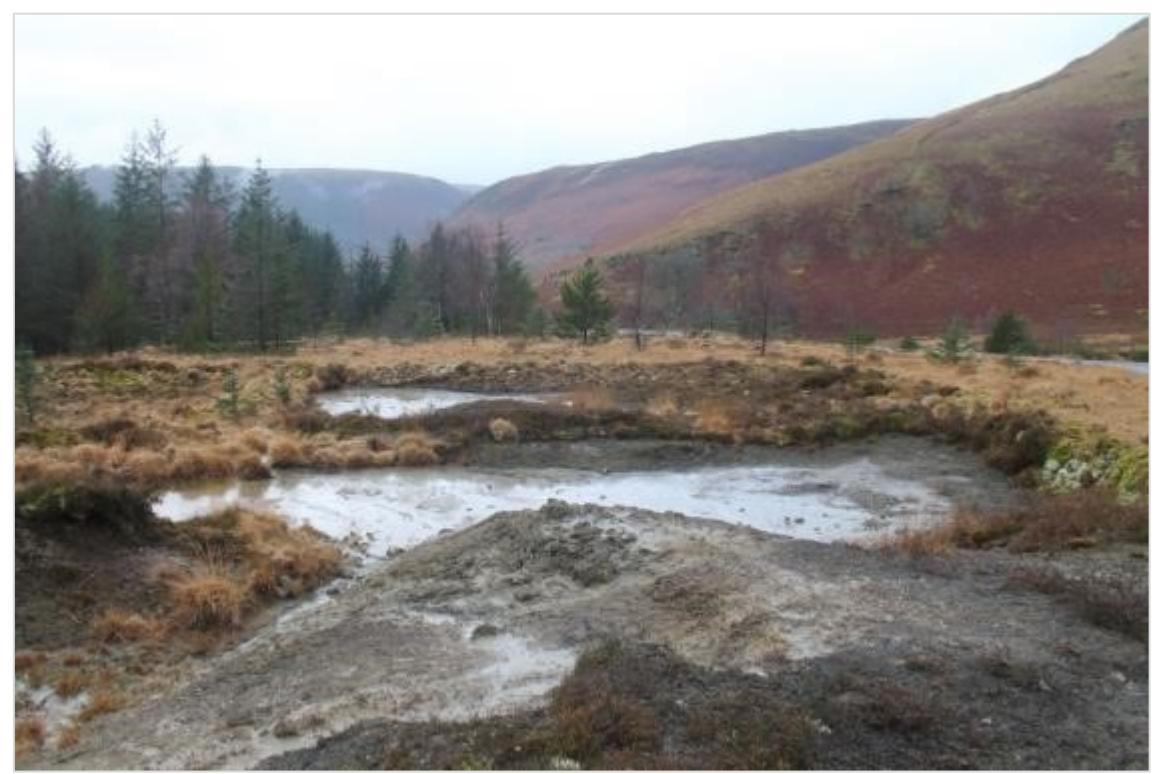
**Photo 22:** The terraced slime pits (PRN 99307) at the northwest of the 20<sup>th</sup> mills. DAT Photo#2583

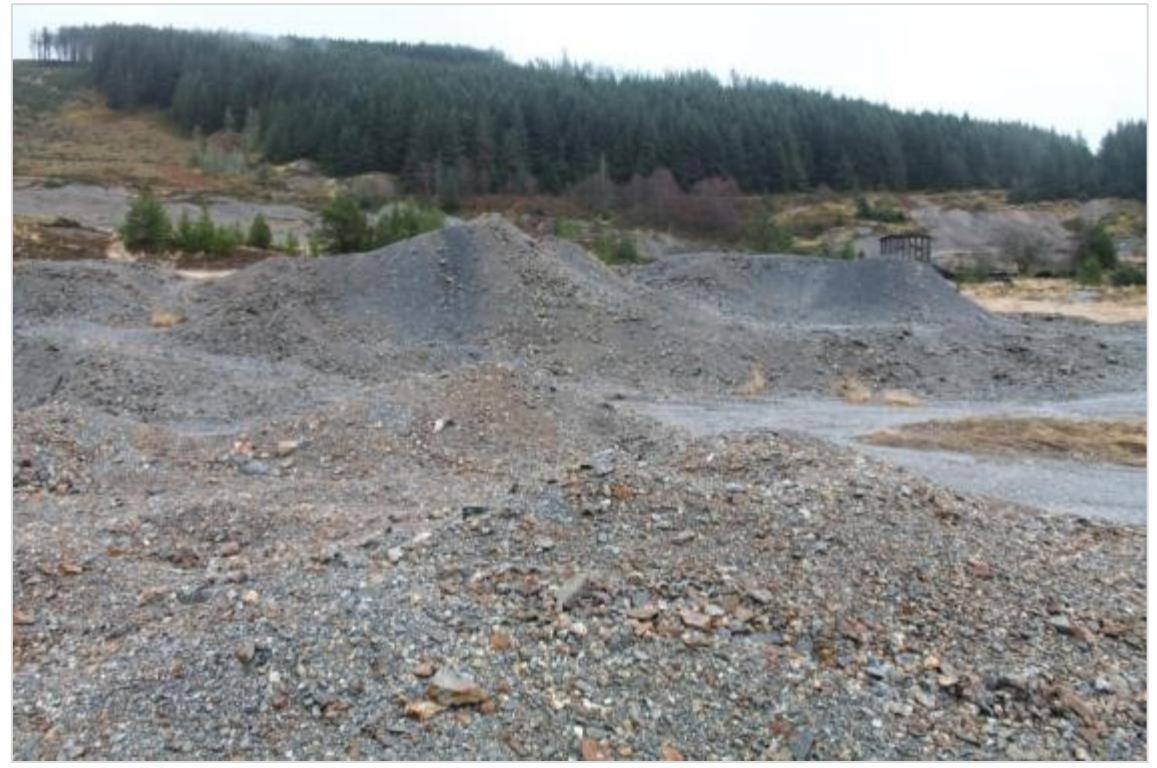
Photo 23: Resampled tailings at the southern end of the Maescarhyg Level (PRN 99313) former dressing floor. DAT Photo#2585

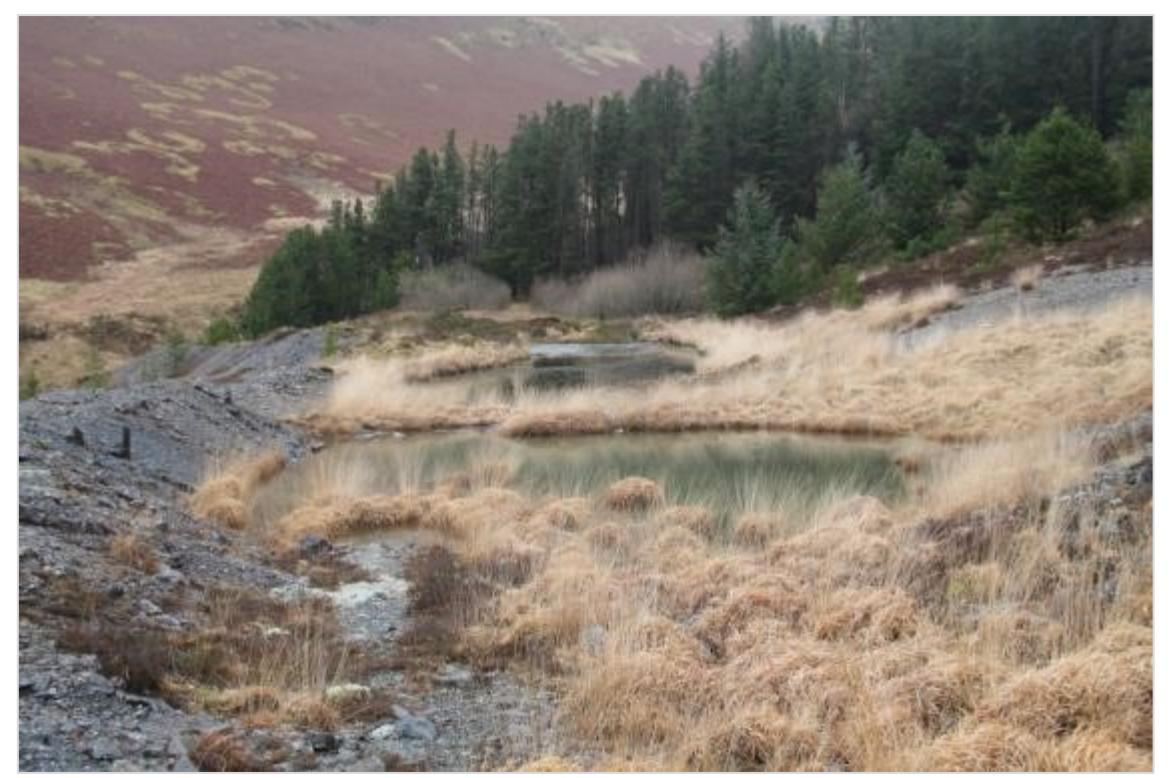
**Photo 24:** The reservoirs east of the former dressing floor of the Maescarhyg level (PRN 99313). DAT Photo#2586

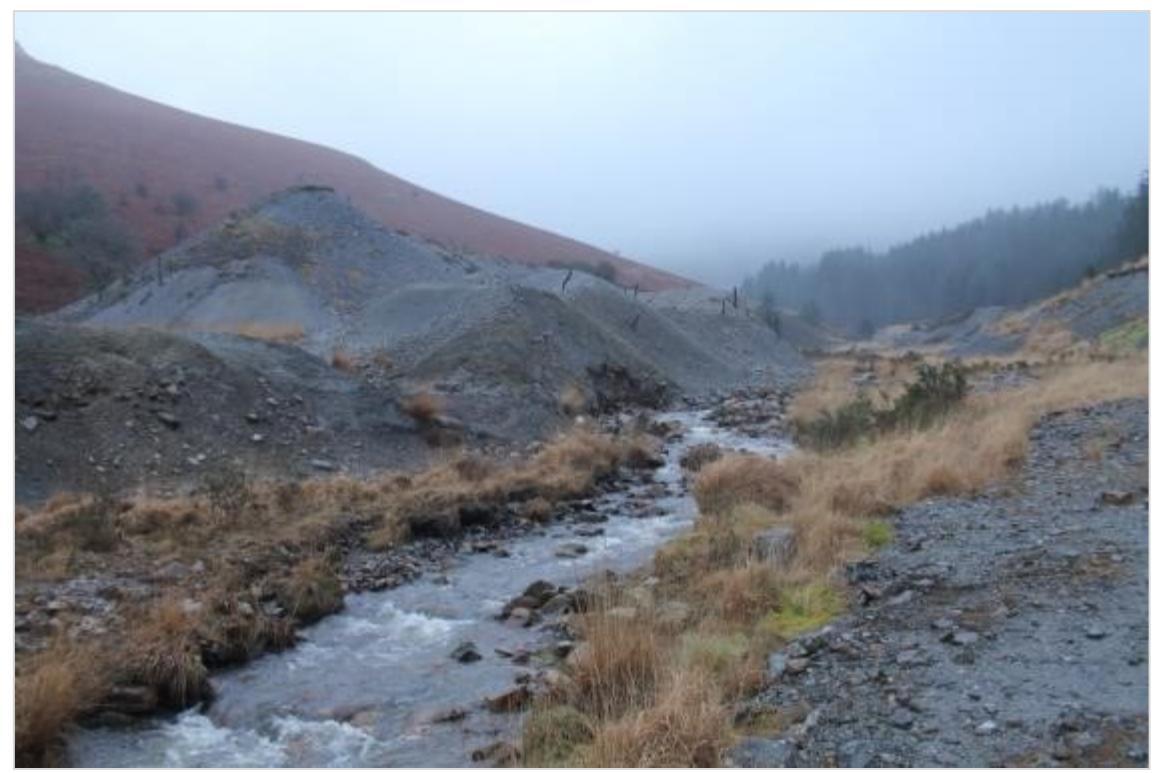
**Photo 25:** Overview of the dumps at the western end of the Upper Boat Level dressing floor. The Nant y Bai runs down the centre of the area. DAT Photo#2591

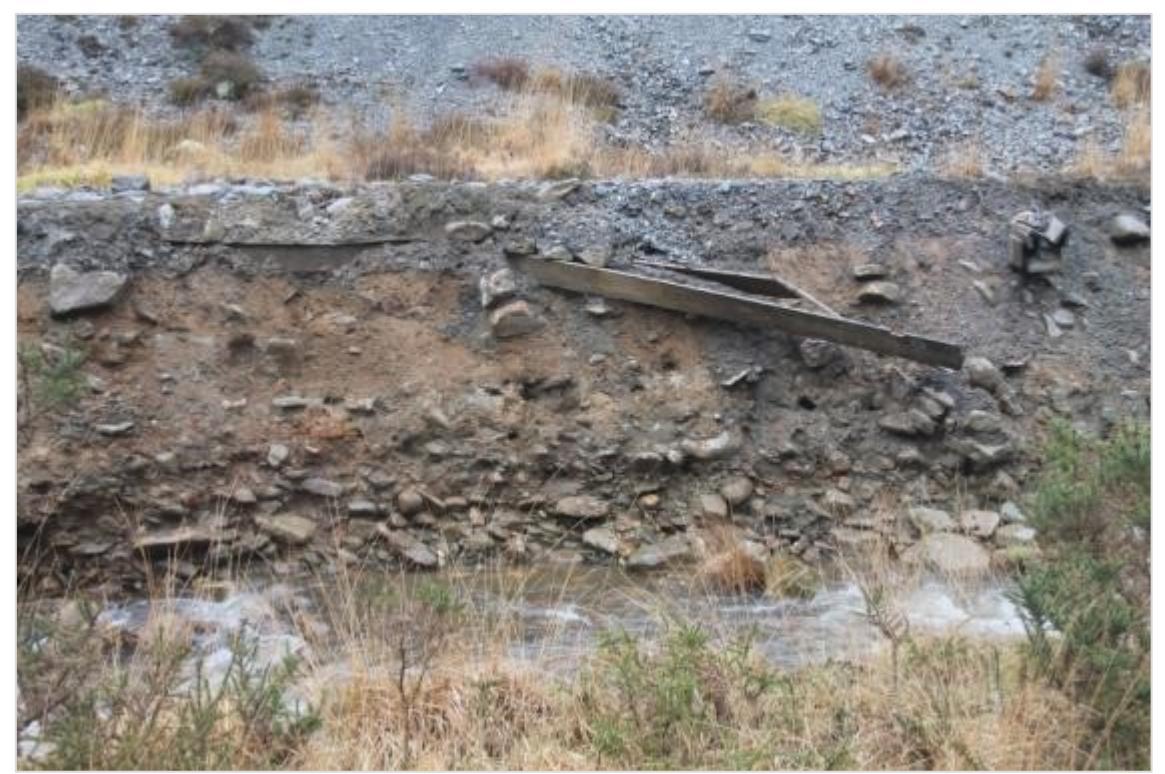
**Photo 26:** Wooden launders (PRN 125680) eroding below the tailings on the northern bank of the Nant y Bai and the Upper Boat Level Dressing floor. DAT Photo#2592

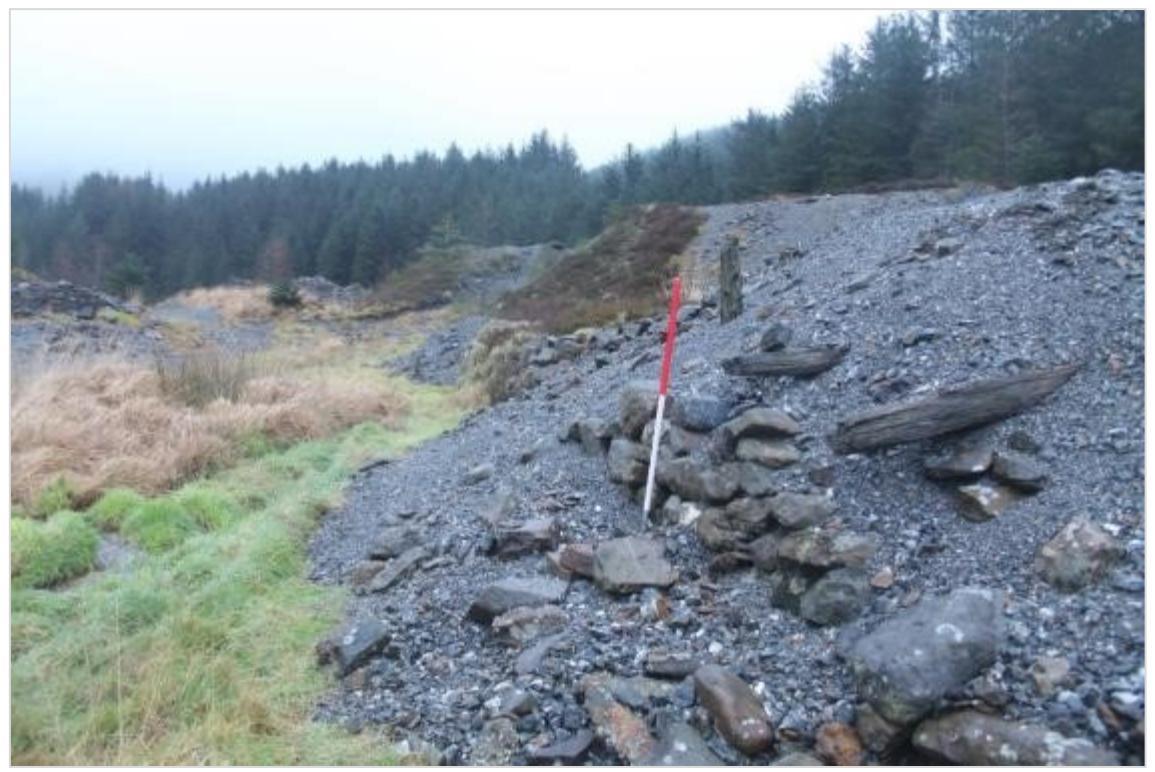
- 6.5.17 Upstream from here, the remains of a substantial, linear stone platform with protruding timbers (PRN 125681) were found (Photos 27 & 28). This does not easily correlate to any features shown on historic mapping and nor is it well defined on LiDAR data. There was no trace of waterwheel (PRN 99292) depicted on historic mapping.

Photo 27: The western end of a linear stone platform (PRN 125681), with protruding timbers at the Upper Boat Level dressing floor. 1m scale. DAT Photo #2593

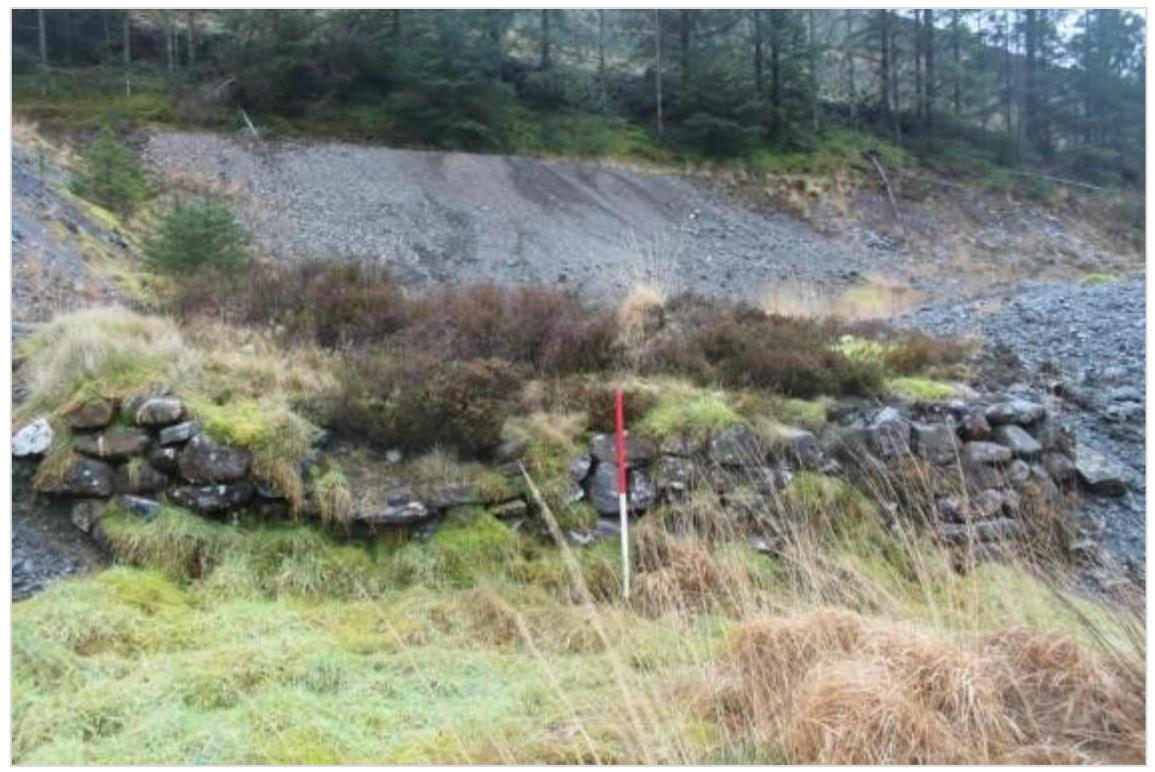
**Photo 28:** A section of dry stone walling on the northern side of the stone linear platform (PRN 125681) at the Upper Boat Level dressing floor. 1m scale. DAT Photo 2594

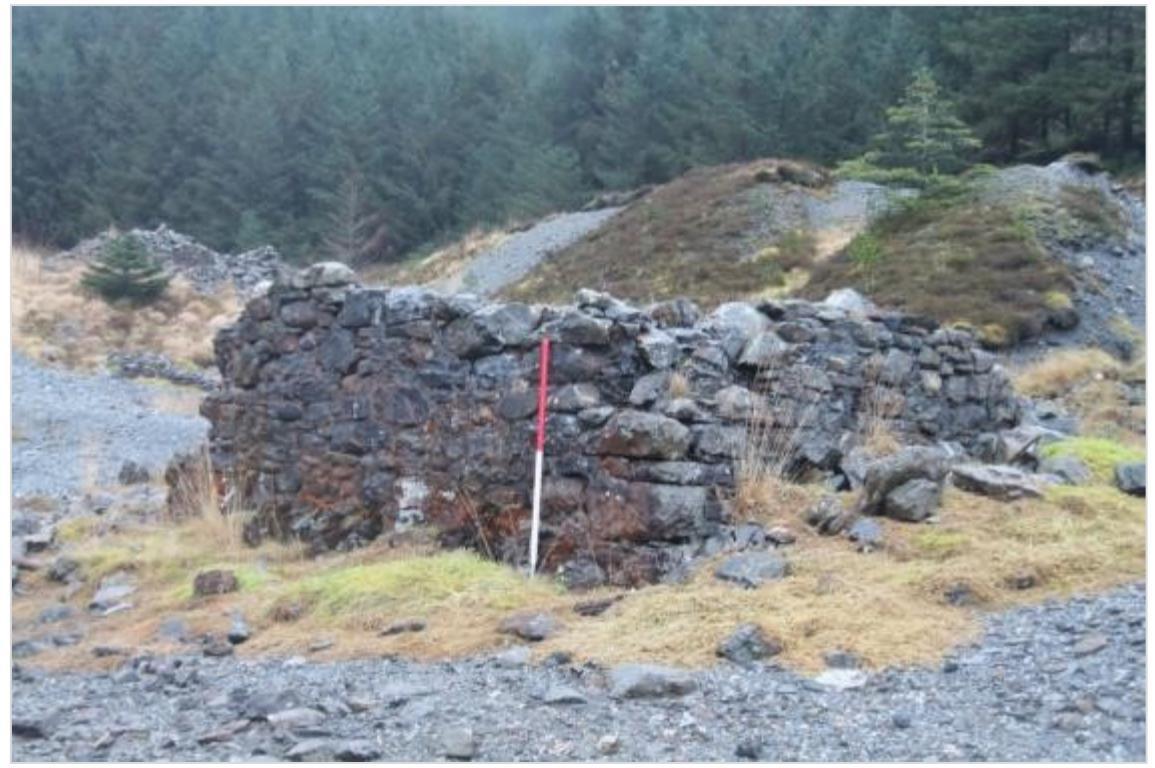
**Photo 29:** The remains of the small, square building (PRN 99294) shown north of the historic crushing mill, and visible on the 1946 aerial photograph. 1m scale. DAT Photo #2595

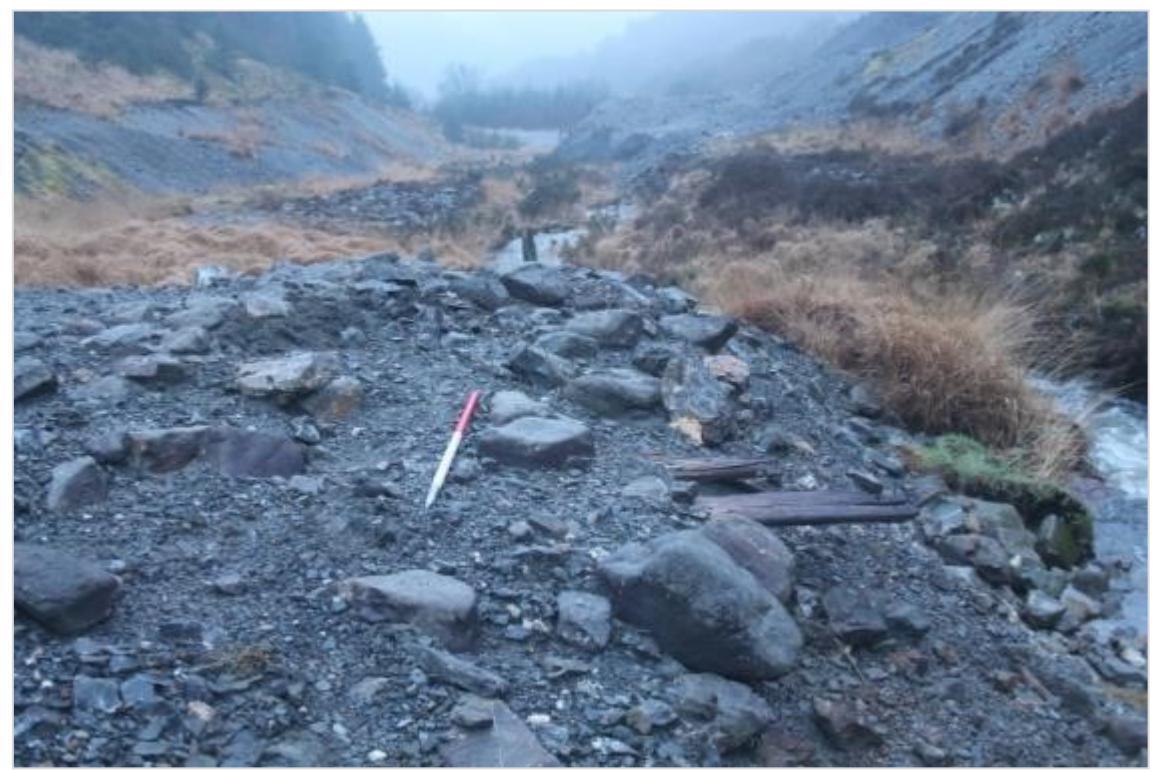
**Photo 30:** The linear stone platform (PRN 125686), with eroding horizontal planks at the Upper Boat Level dressing floor. 1m scale. DAT Photo #2610

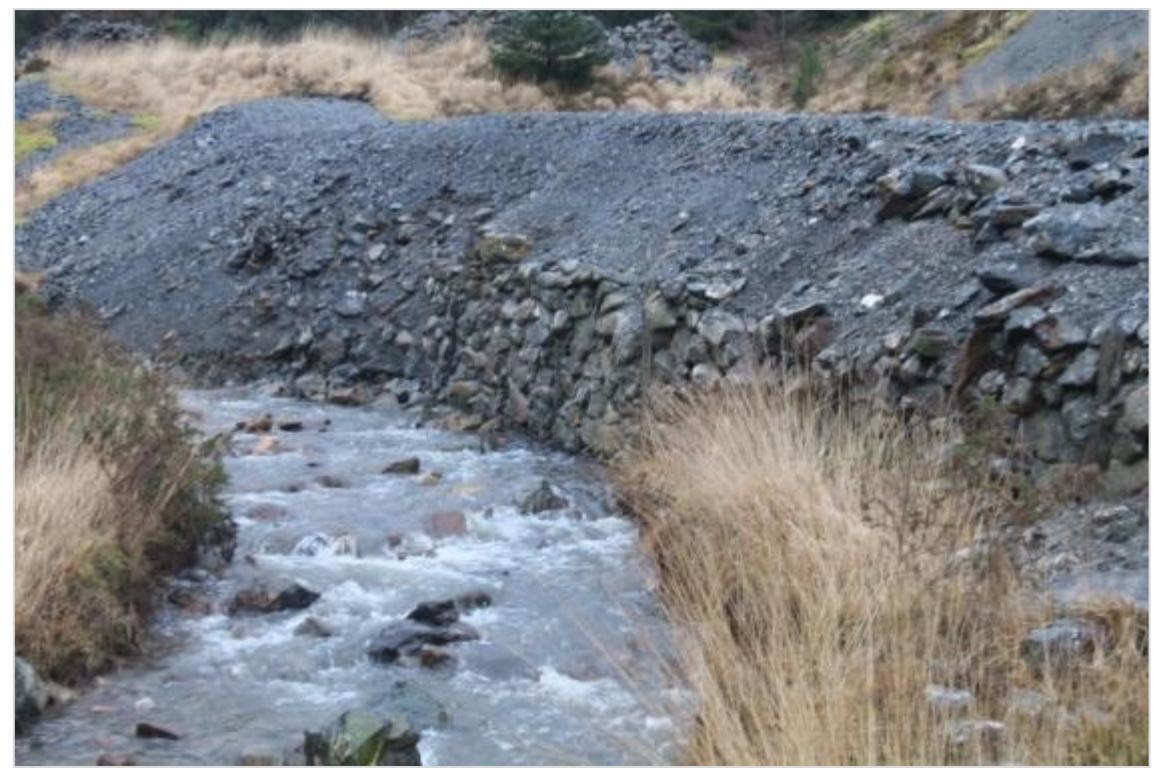
Photo 31: Revetted stone walling (PRN 125683) on the southern side of the Nant y Bai on the dressing floor at Upper Boat Level. DAT Photo 2596

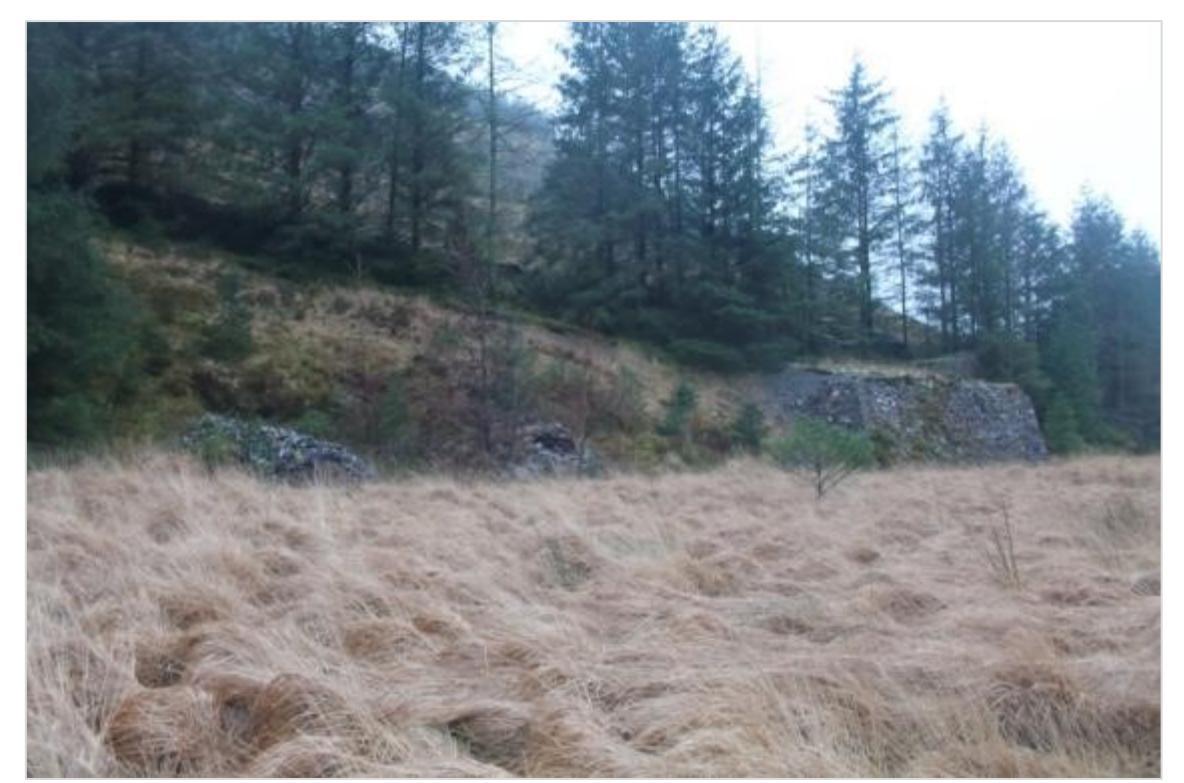
**Photo 32:** The remains of a pair of buildings (PRNs 99295 and 99296) and embankment shown on historic mapping south of the crushing mill on the Upper Boat Level dressing floor. DAT Photo # 2606

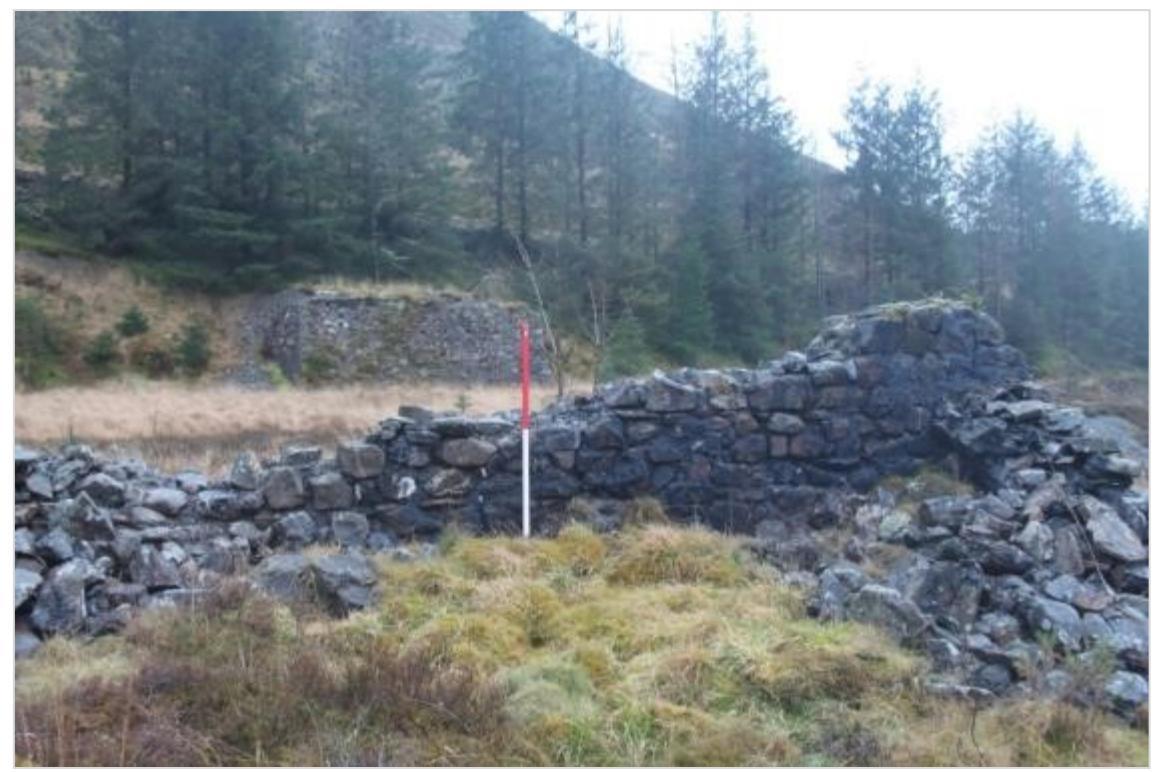
Photo 33: The remains of the smithy building (PRN 99298) marked on historic mapping and visible on 1946 aerial photography. 1m scale. DAT photo #2598

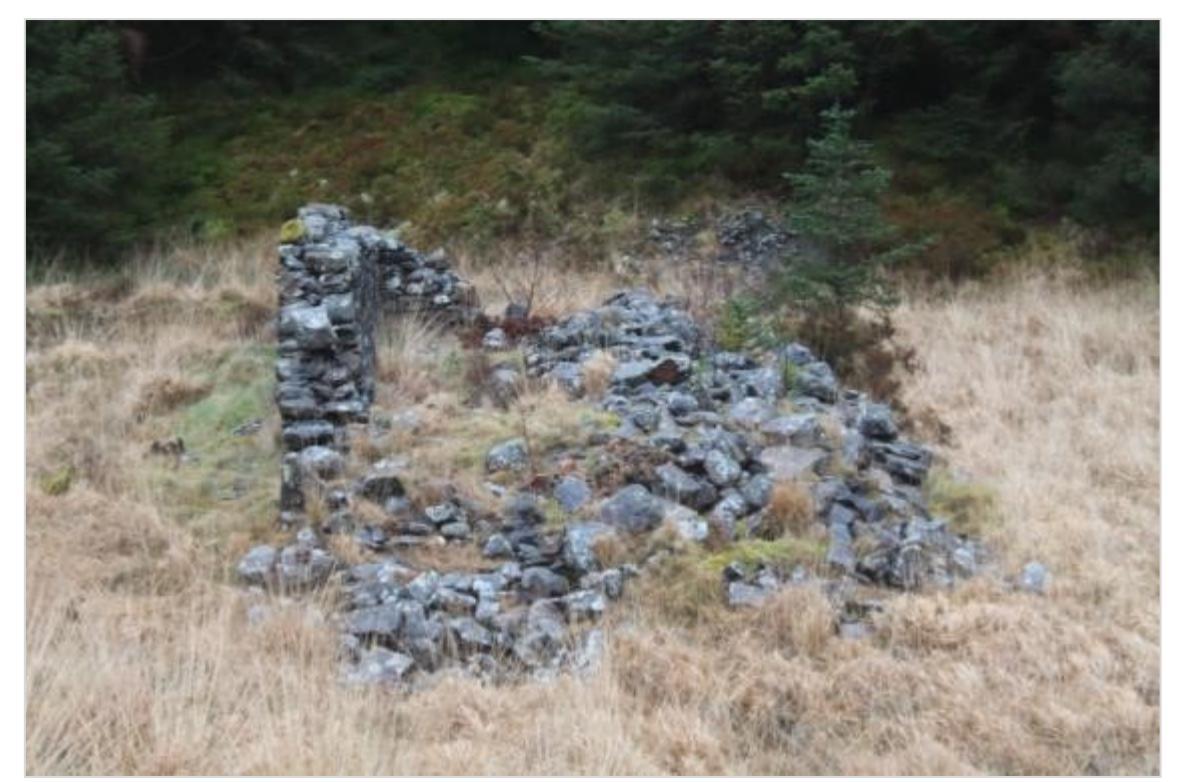
Photo 34: The remains of a small, rectangular building (PRN 99299), at the eastern end of the former Upper Boat Level dressing floor. DAT Photo #2599

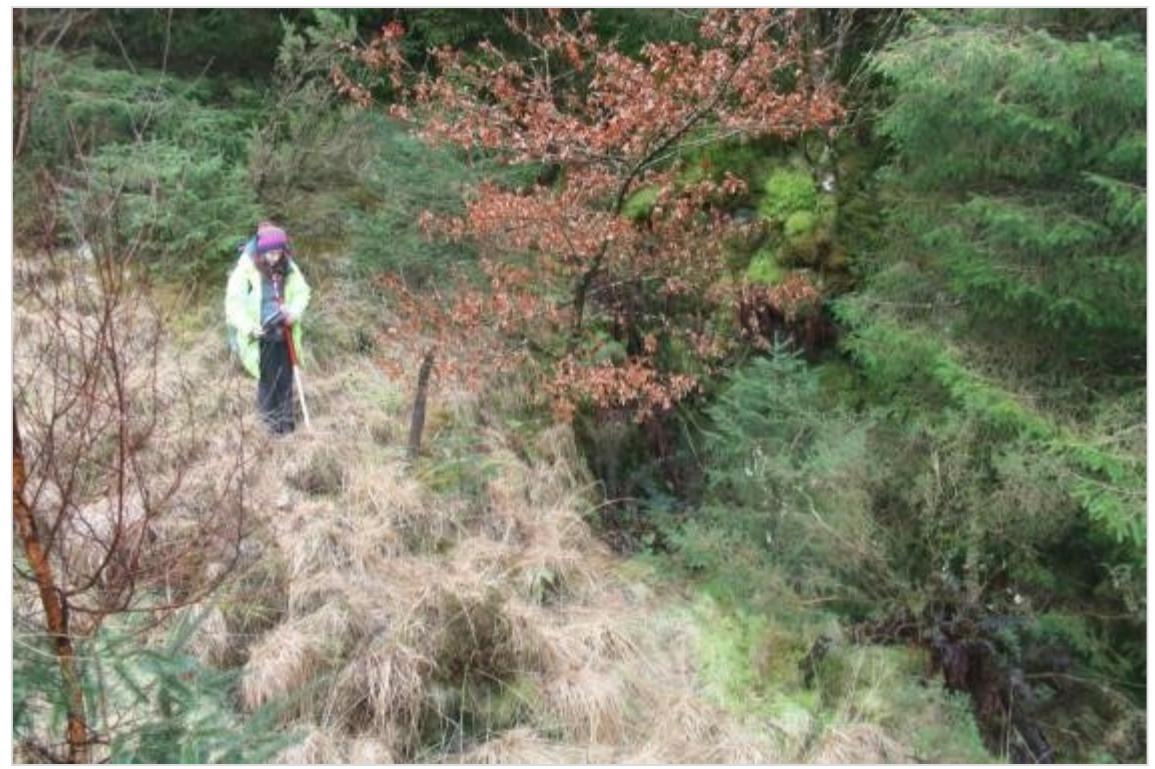
- 6.5.21 The portal for Upper Boat Level (PRN 99300) has collapsed and no formal structure survives. However, an ochreous stream discharges from a heavily vegetated crevice (Photo 35). The airshaft crown hole (PRN 99301) located a short distance up slop was not visited.
- 6.5.22 The final explorations upstream in this area revealed the remains of a low wall at the toe of a spoil heap (PRN 99302) (Photo 36) and a second (PRN 125685), in the location of the small reservoir shown in the first edition Ordnance Survey map, replaced by a single wall on the 2<sup>nd</sup> edition (Photo 37). The survey did not progress beyond this point.

Photo 35: The collapsed and heavily vegetated portal of the Upper Boat Level (PRN 99300). DAT Photo #2604

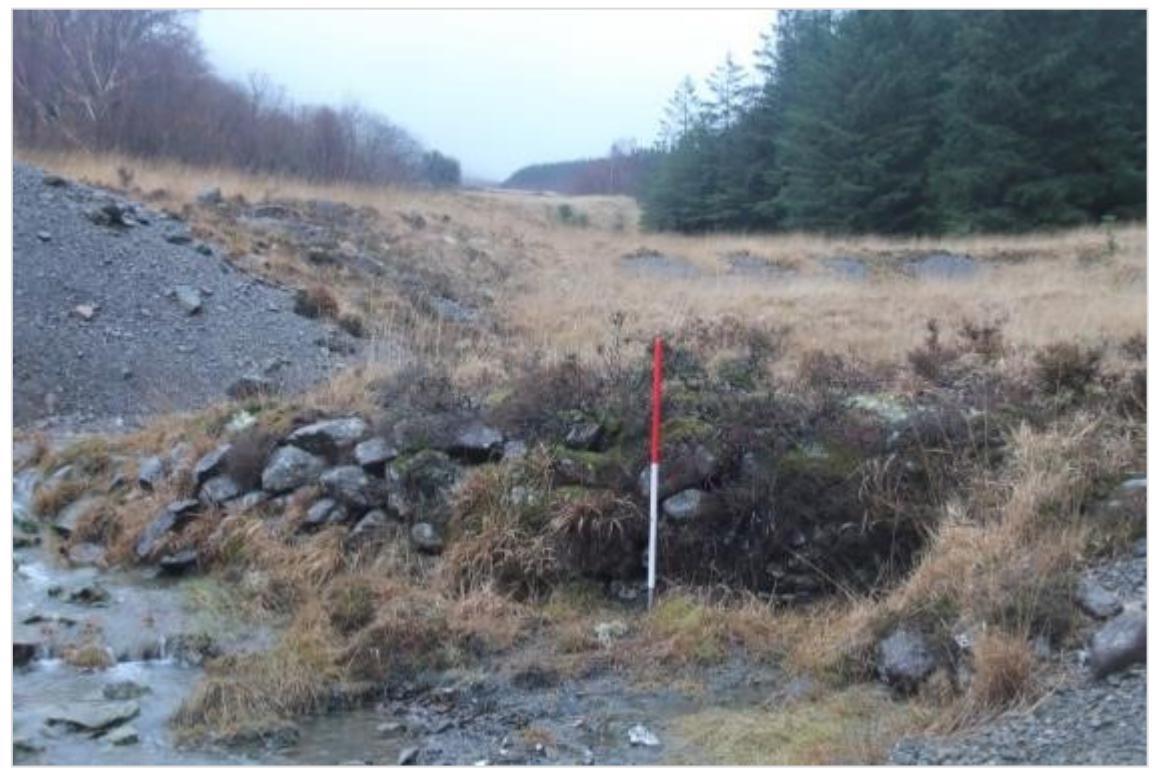
Photo 36: The remains of a low wall (PRN 99302) at the eastern end of the Upper Boat Level dressing floor. 1m scale. DAT Photo #2601

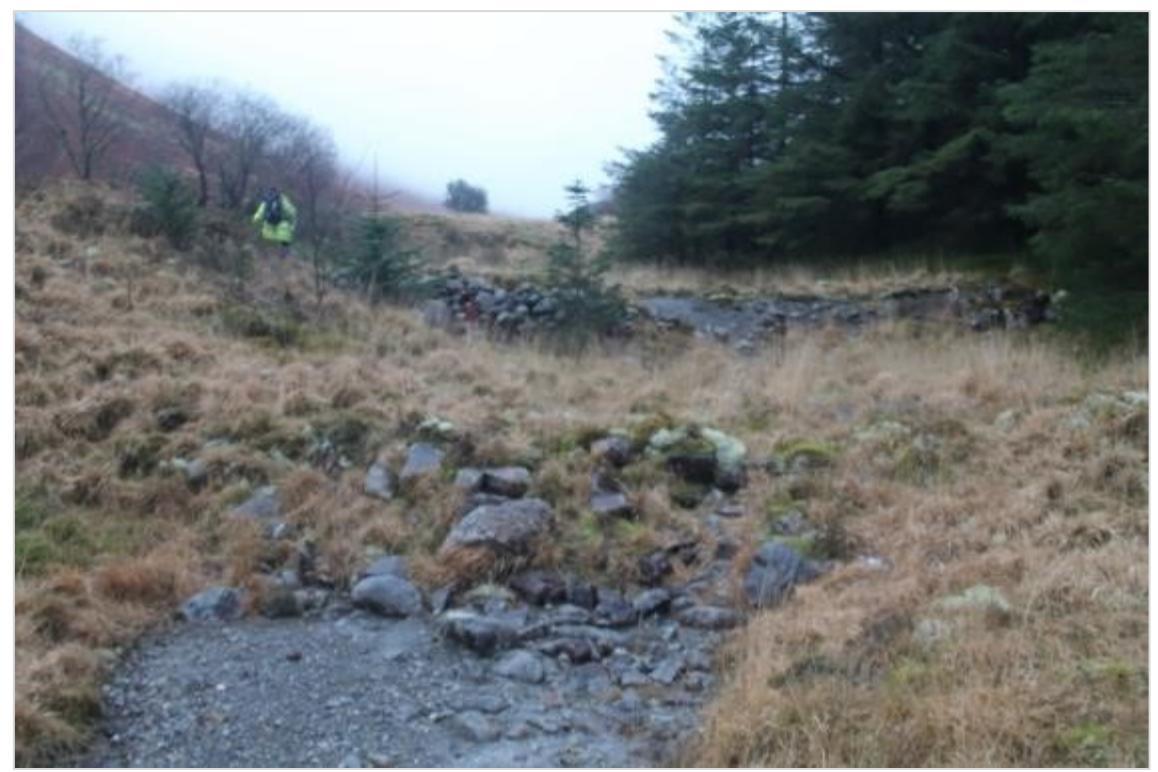
Photo 37: The remains of a low wall (PRN 125685) shown on the 2<sup>nd</sup> edition Ordnance Survey map at the very eastern end of the Upper Boat Level dressing floor. DAT Photo #2605
