# ABBEY CONSOLS MINE WATER CAPTURE PROJECT- PHASE I:

# ARCHAEOLOGICAL WATCHING BRIEF 2021

REPORT NO. 2021-56 EVENT RECORD NO. 126363

DAT Archaeological Services were commissioned to undertake an archaeological watching brief during ground works associated with the construction of a mine water capture system at Abbey Consols Metal Mine, Ceredigion (NGR SN7432 6610).

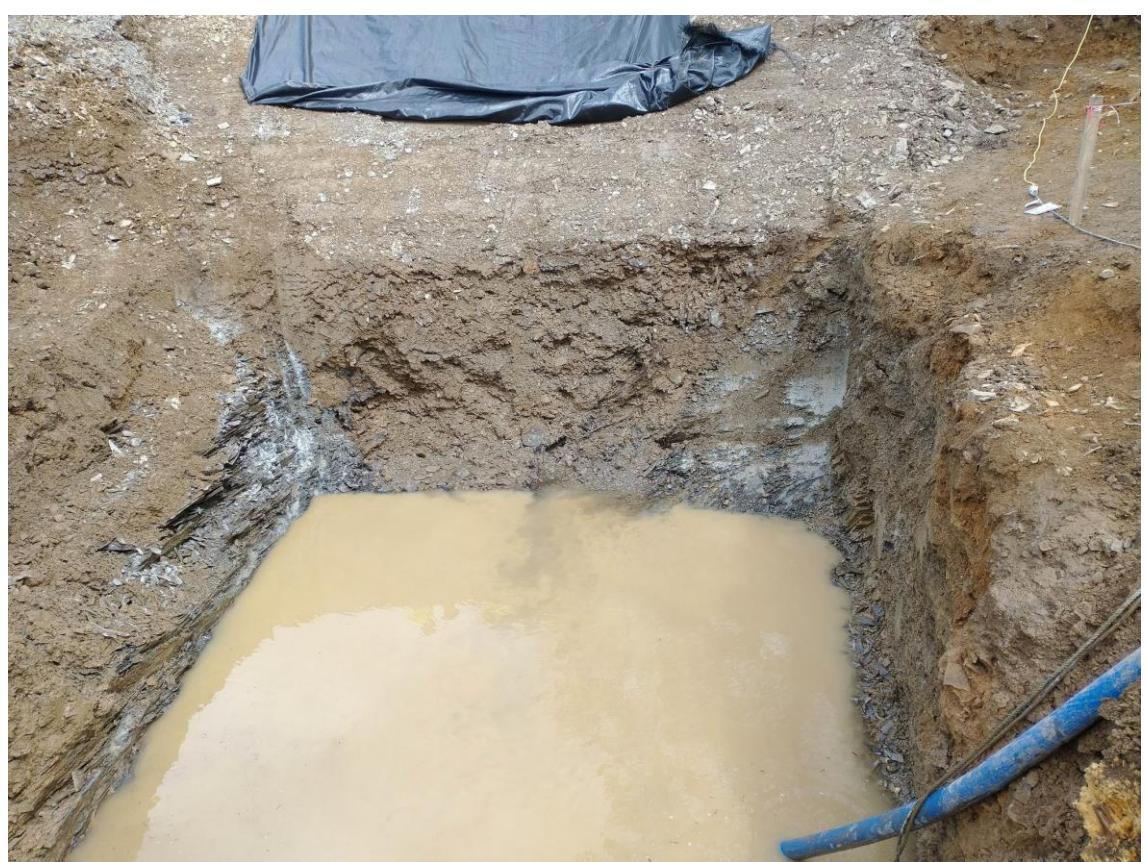
View northeast of the excavated trench section showing the steep cut through bedrock for the tramway cutting.

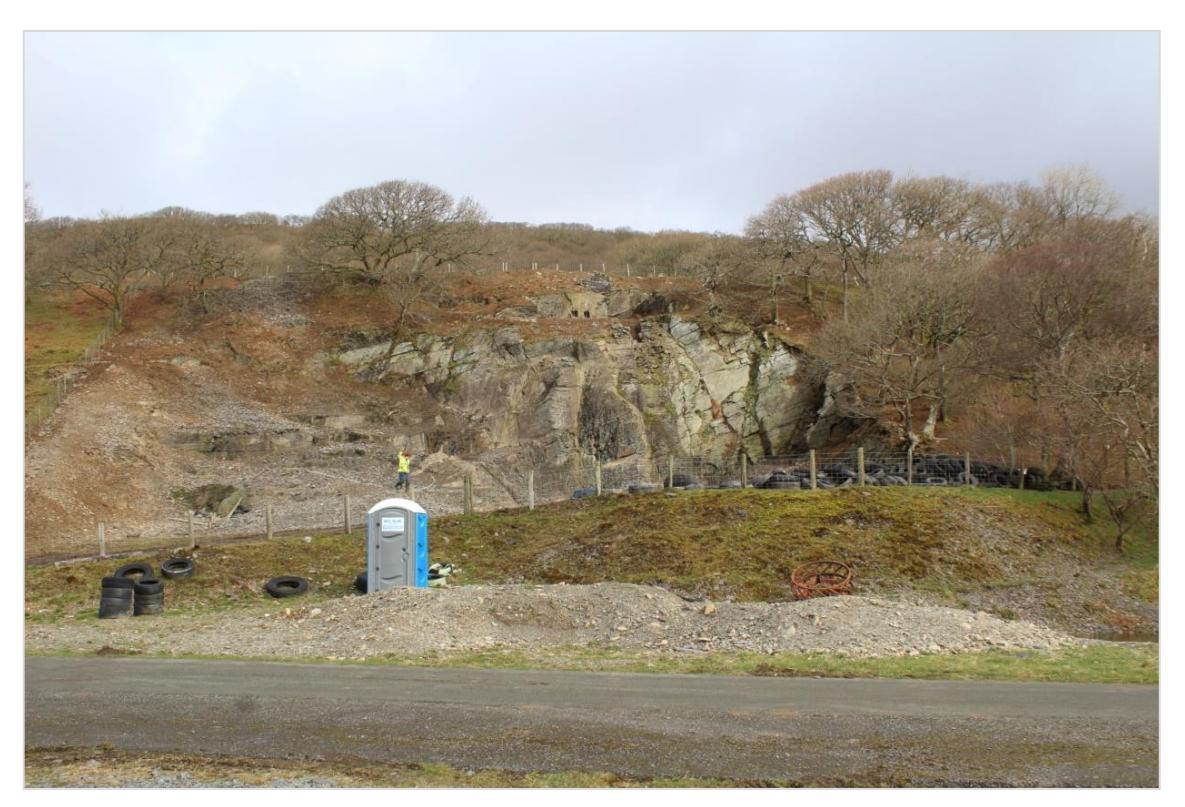
**Photograph 1:** View north from the dressing floors of the mine towards the location of the wheel pit and position of deep adit entrance in hillside. Photograph taken before start of development groundworks.

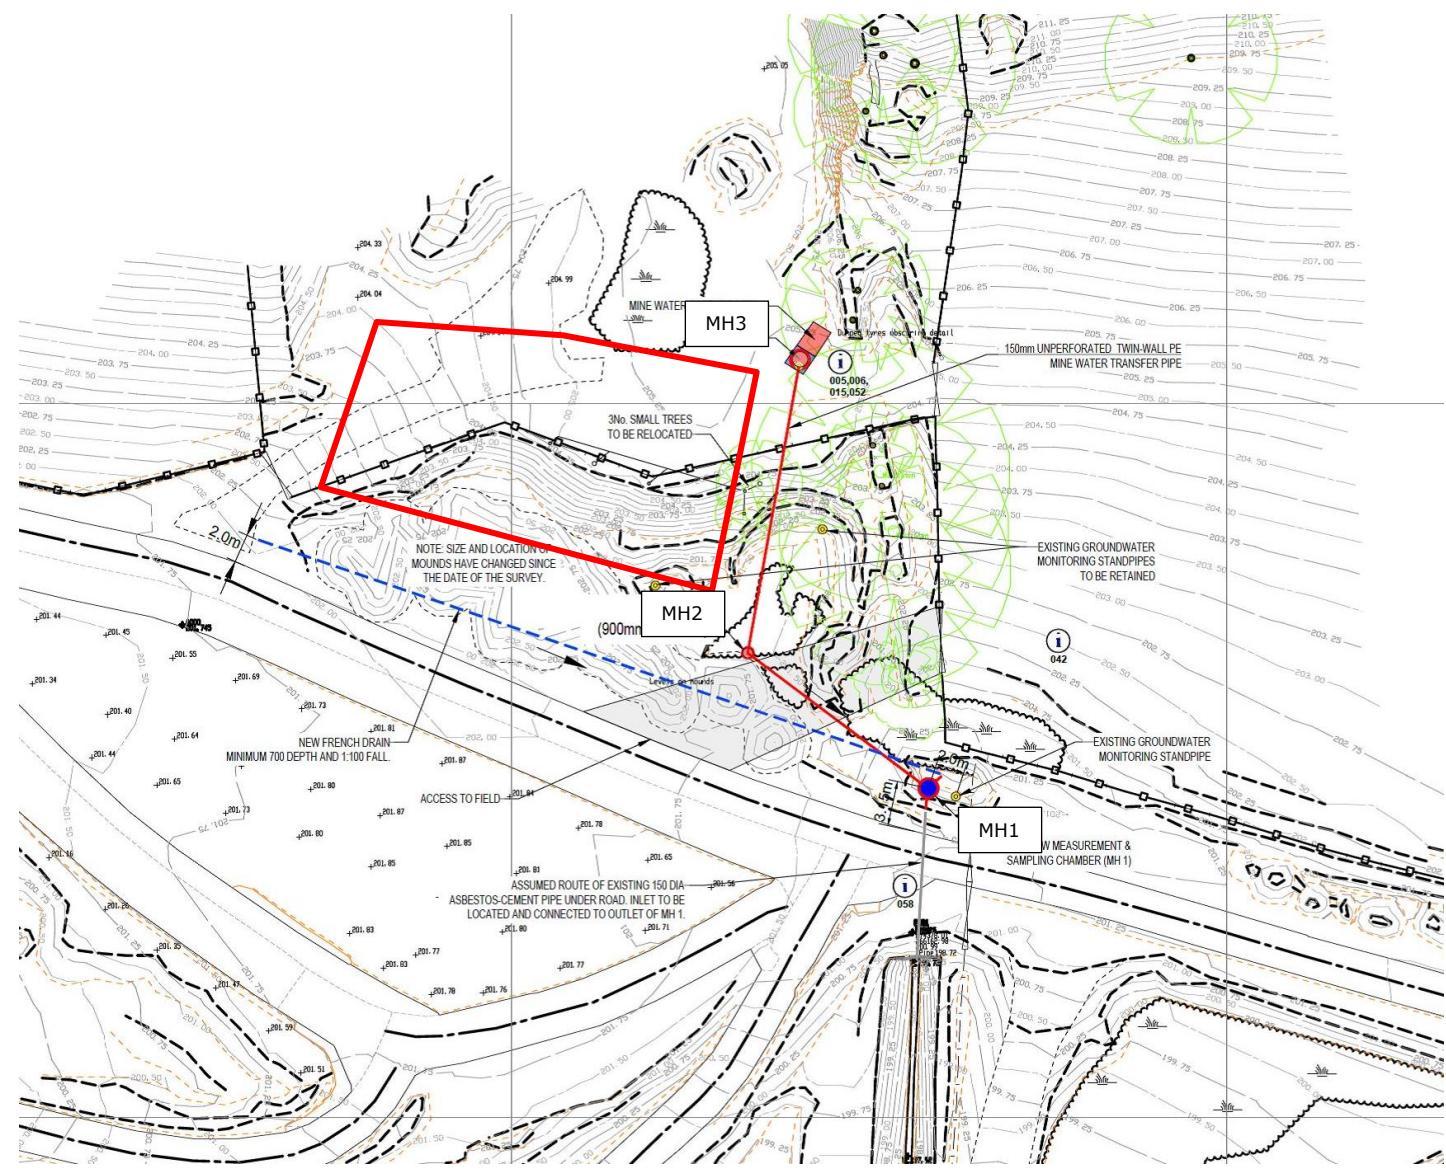
- 1.1.4 The main elements of the mine water capture construction (Figure 2) are:
  - Excavation in the vicinity of the buried adit entrance to install a mine water capture structure (MH3 chamber with gravel & perforated pipe water inlet).

- Installation of a chamber (MH1) near to the road for flow measurement and sampling.
  - Trenching and installation of a carrier pipe from the mine water capture chamber to MH1, including an intermediate chamber (MH2).

- Replacement of existing land drain along north side of the road, also feeding into MH1; and
  - Temporary pipe connection between MH1 and the existing discharge pipe under the road.

Figure 2: The mine water capture arrangement plan- supplied by client. Not to original scale.

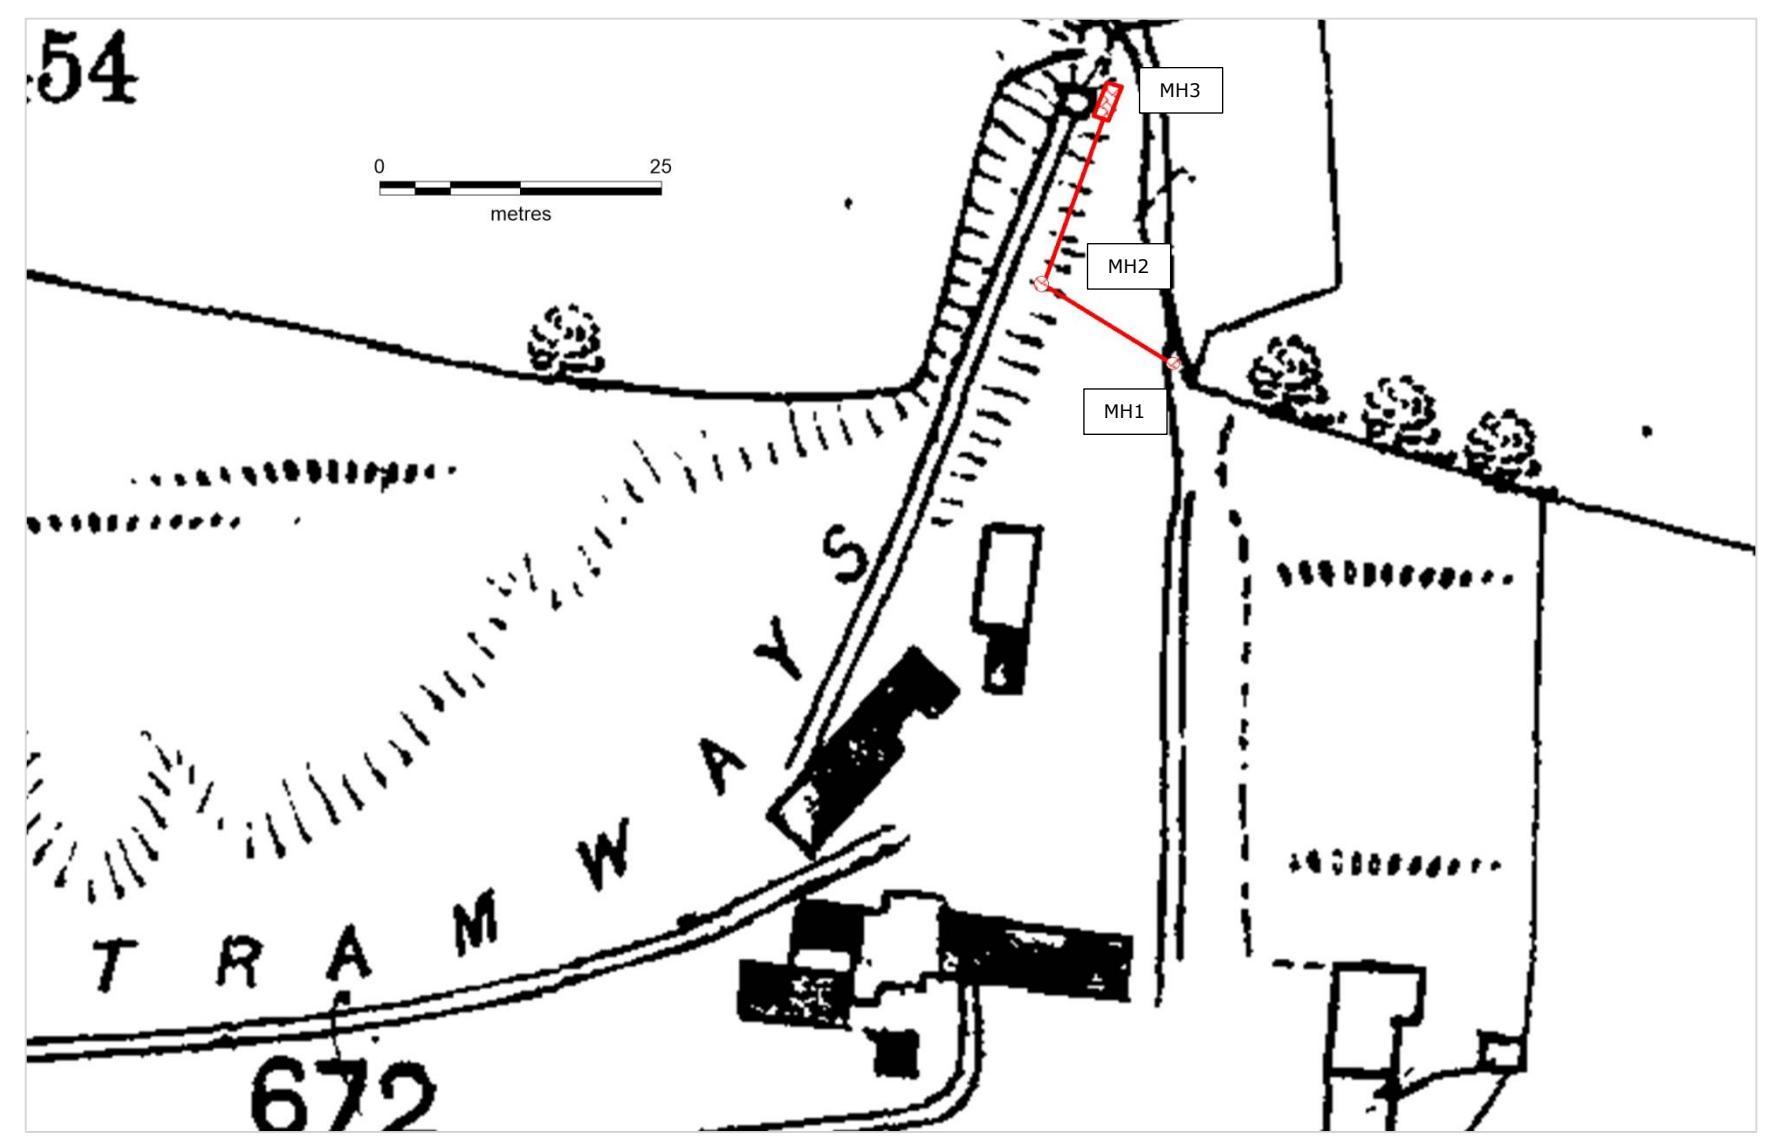
**Figure 3:** The mine water capture arrangement plan (outlined in red) overlying an extract of the Ordnance Survey 1<sup>st</sup> edition 25" map published in 1889

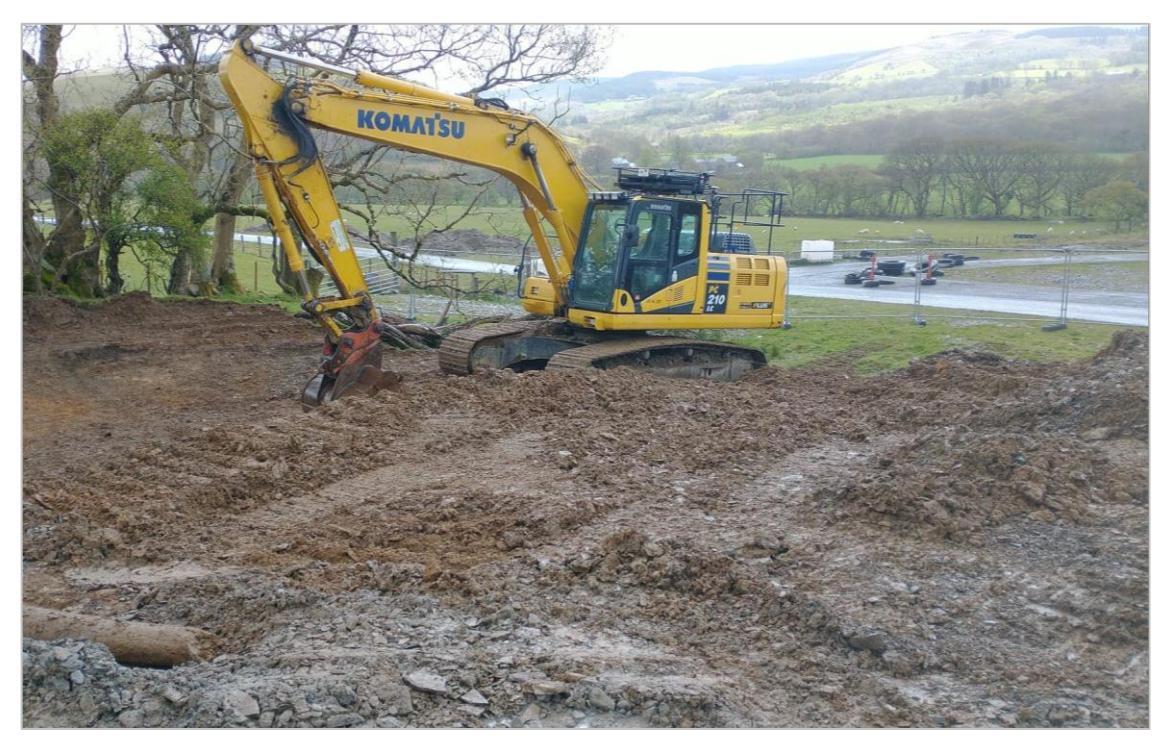
- 4.1.3 Excavation started on the 7<sup>th</sup> of May 2021 using a 20 tonne Komatsu 360° bucket excavator (Photograph 3). During the watching brief it was generally only possible to monitor the works from the edge of the excavated trench due to the depth of the excavations and water ingress rendering the trench unstable and unsafe to enter. Therefore, all measurements of archaeological deposits and features could only be estimated.

- 4.1.4 The excavation trench measured approximately 15m north/south by 18m east/west. The reason for opening such a large trench despite the relatively small footprint of the mine water collection system was due to the required deep depth of excavation necessitating the trench edges to be stepped and battered.

**Photograph 3:** Excavation area. Looking southeast.

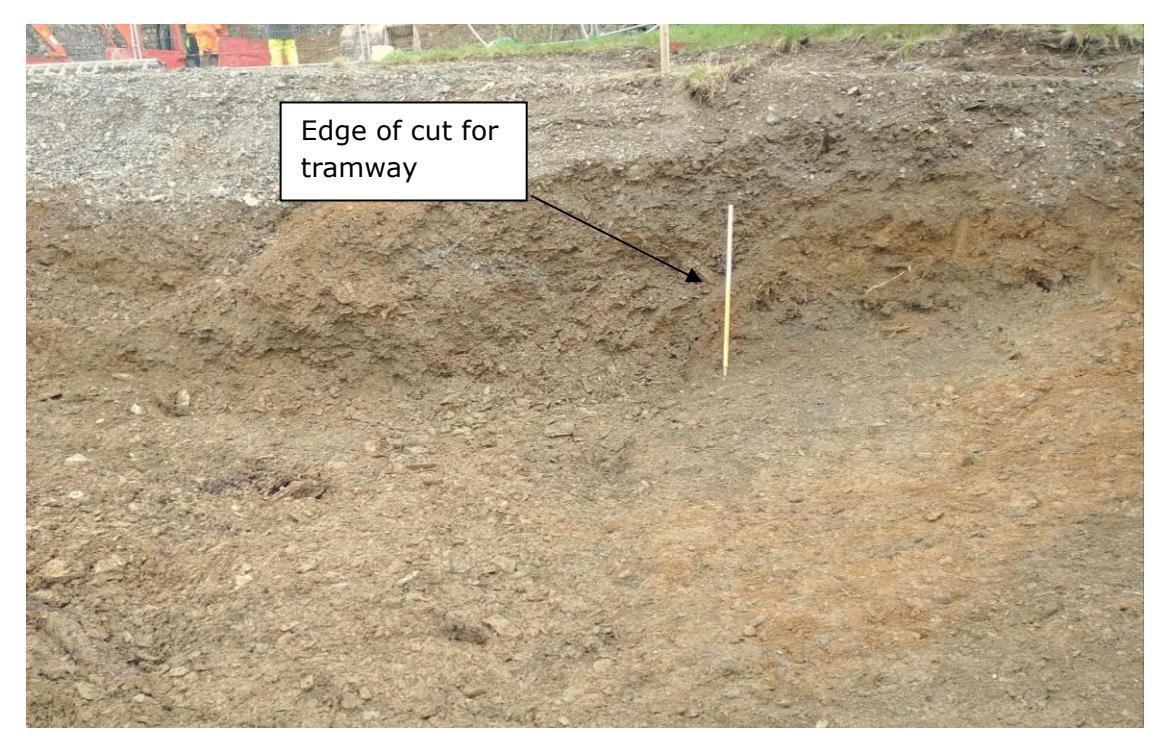
- 4.1.5 Upon removal of substantial amounts of quarry waste at the eastern edge of the excavation area, natural undisturbed ground was recorded comprising orange silty clay. A linear feature cutting the undisturbed silty clay was recorded (Photograph 4), which appeared to indicate the line of the former tramway cutting heading towards the mine adit entrance.

**Photograph 4:** Showing the cut for the tramway beginning to appear after removal of modern quarry waste. Looking northeast, 1m scale.

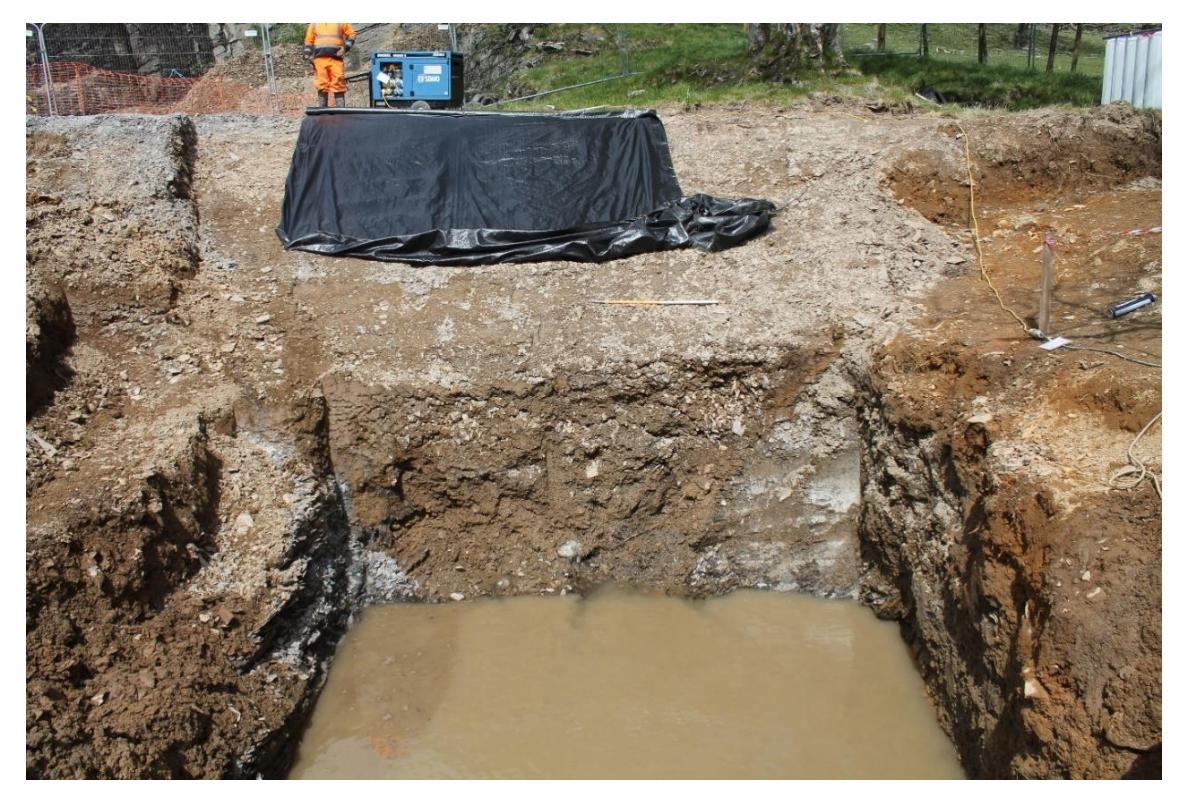
- 4.1.8 From observations during excavation of the trench the tramway cut measured circa 6.0m deep and 5.0m wide and was orientated north-north-east by south-south-west (Photographs 5 & 6). The sloping edges had a gradual break of slope at the top which became almost vertical where bedrock was encountered at lower depth. It is thought that it had a slightly convex base, although water ingress obscured this. No remains of a tramway itself were recorded.

**Photograph 5:** View of the excavated trench section showing the steep cut through bedrock for the tramway. Looking northeast, 1m scale.

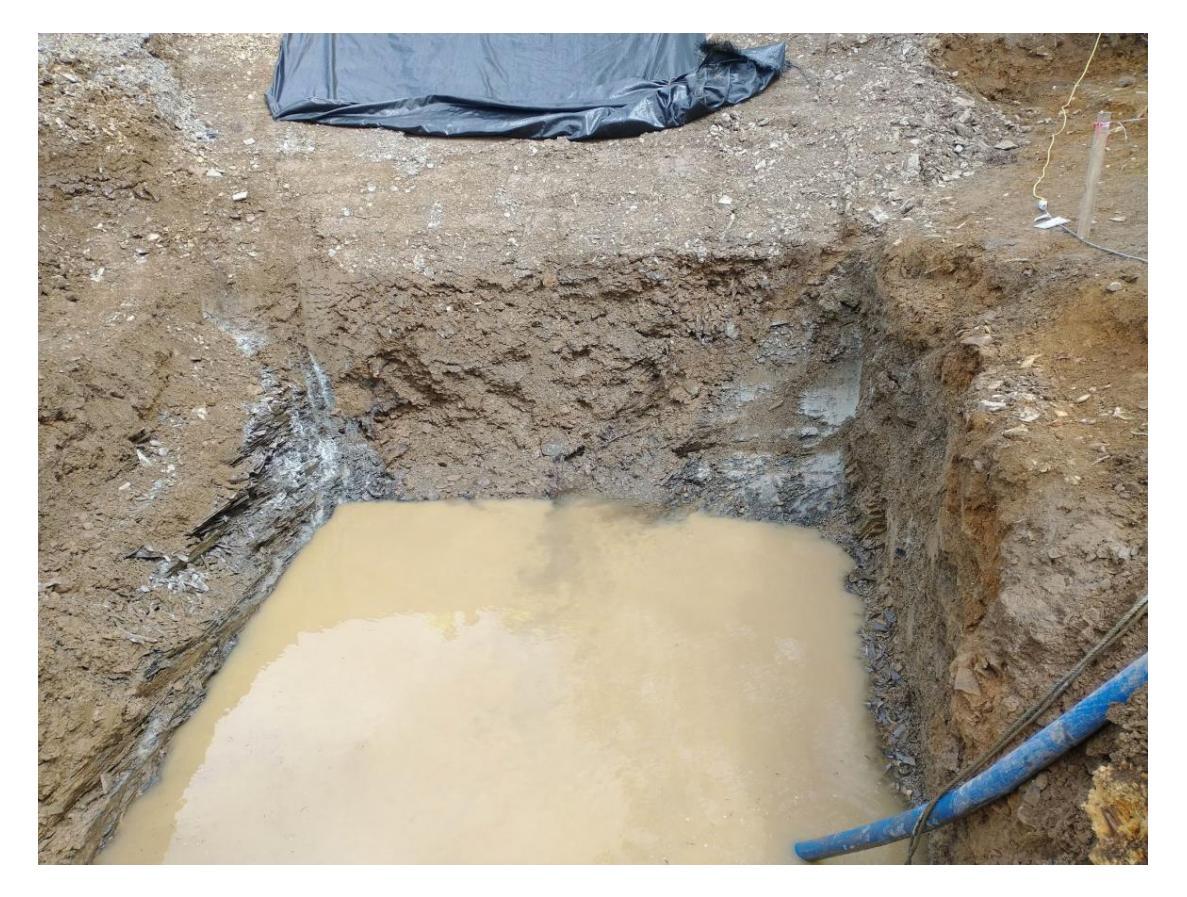
**Photograph 6:** Closer view of the excavated trench section showing the steep cut through bedrock for the tramway. Looking northeast.

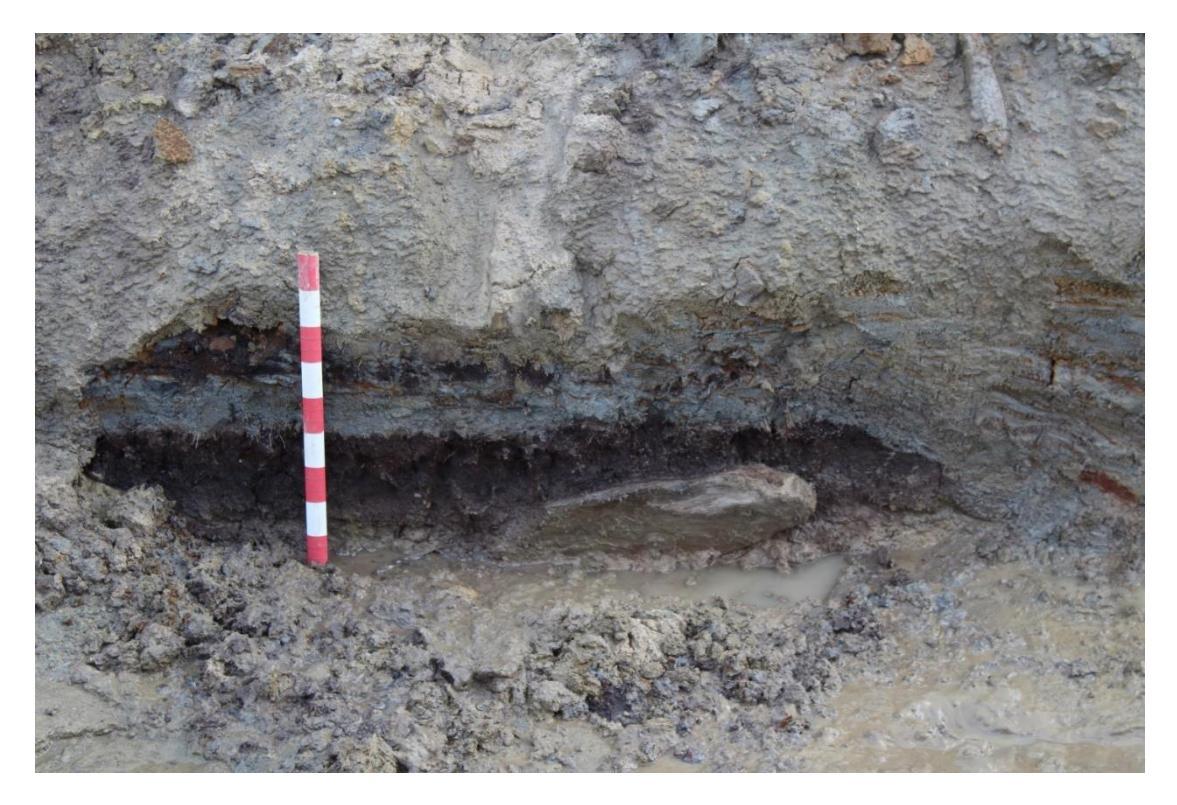
- 4.1.9 It was possible at one point during the excavations to view the bottom of the tramway cutting where a deposit of dark grey mixed mine waste that likely dated to the 'use' period of the mine (Photograph 7) was seen. This

deposit appeared to comprise mine tailings (processed mine waste), mixed stone and organic matter. The deposit measured approximately 0.35m in depth and covered the whole of the base of the tramway cutting. Further inspection of this deposit was not possible due to safety concerns.

**Photograph 7:** View of probable mine waste covering the base of tramway cutting. Looking west, 0.5m scale.

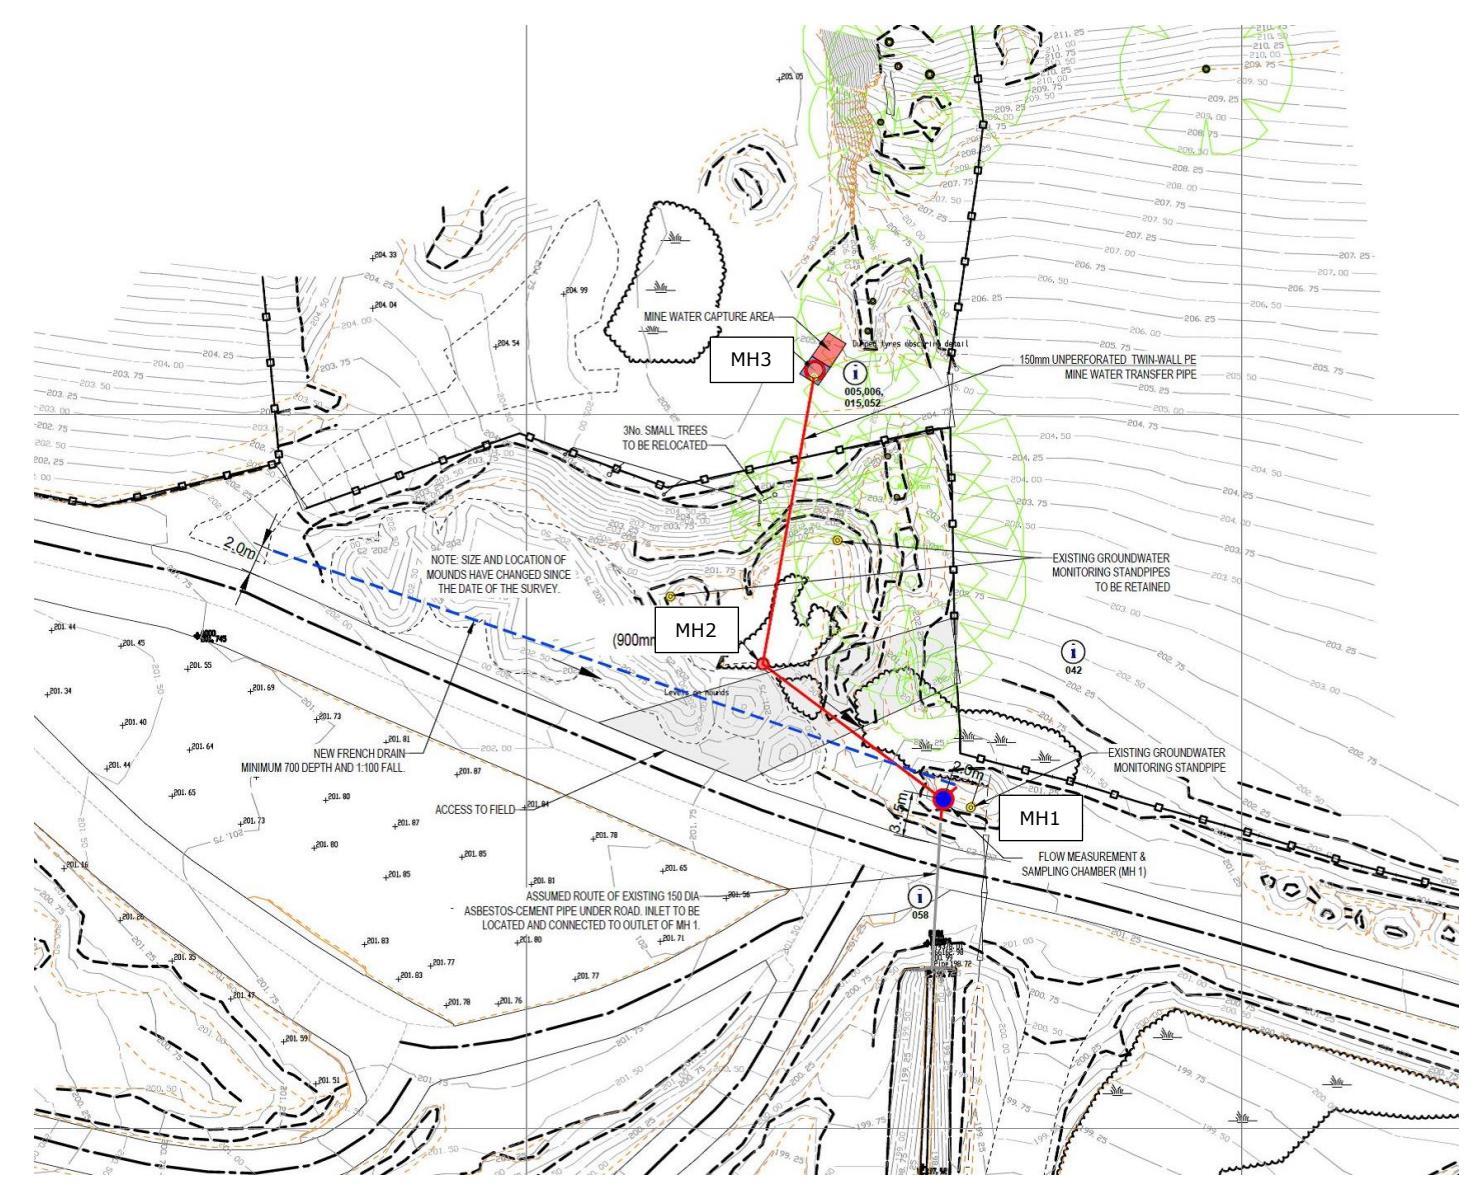
**Figure 2:** The mine water capture arrangement plan- supplied by client.

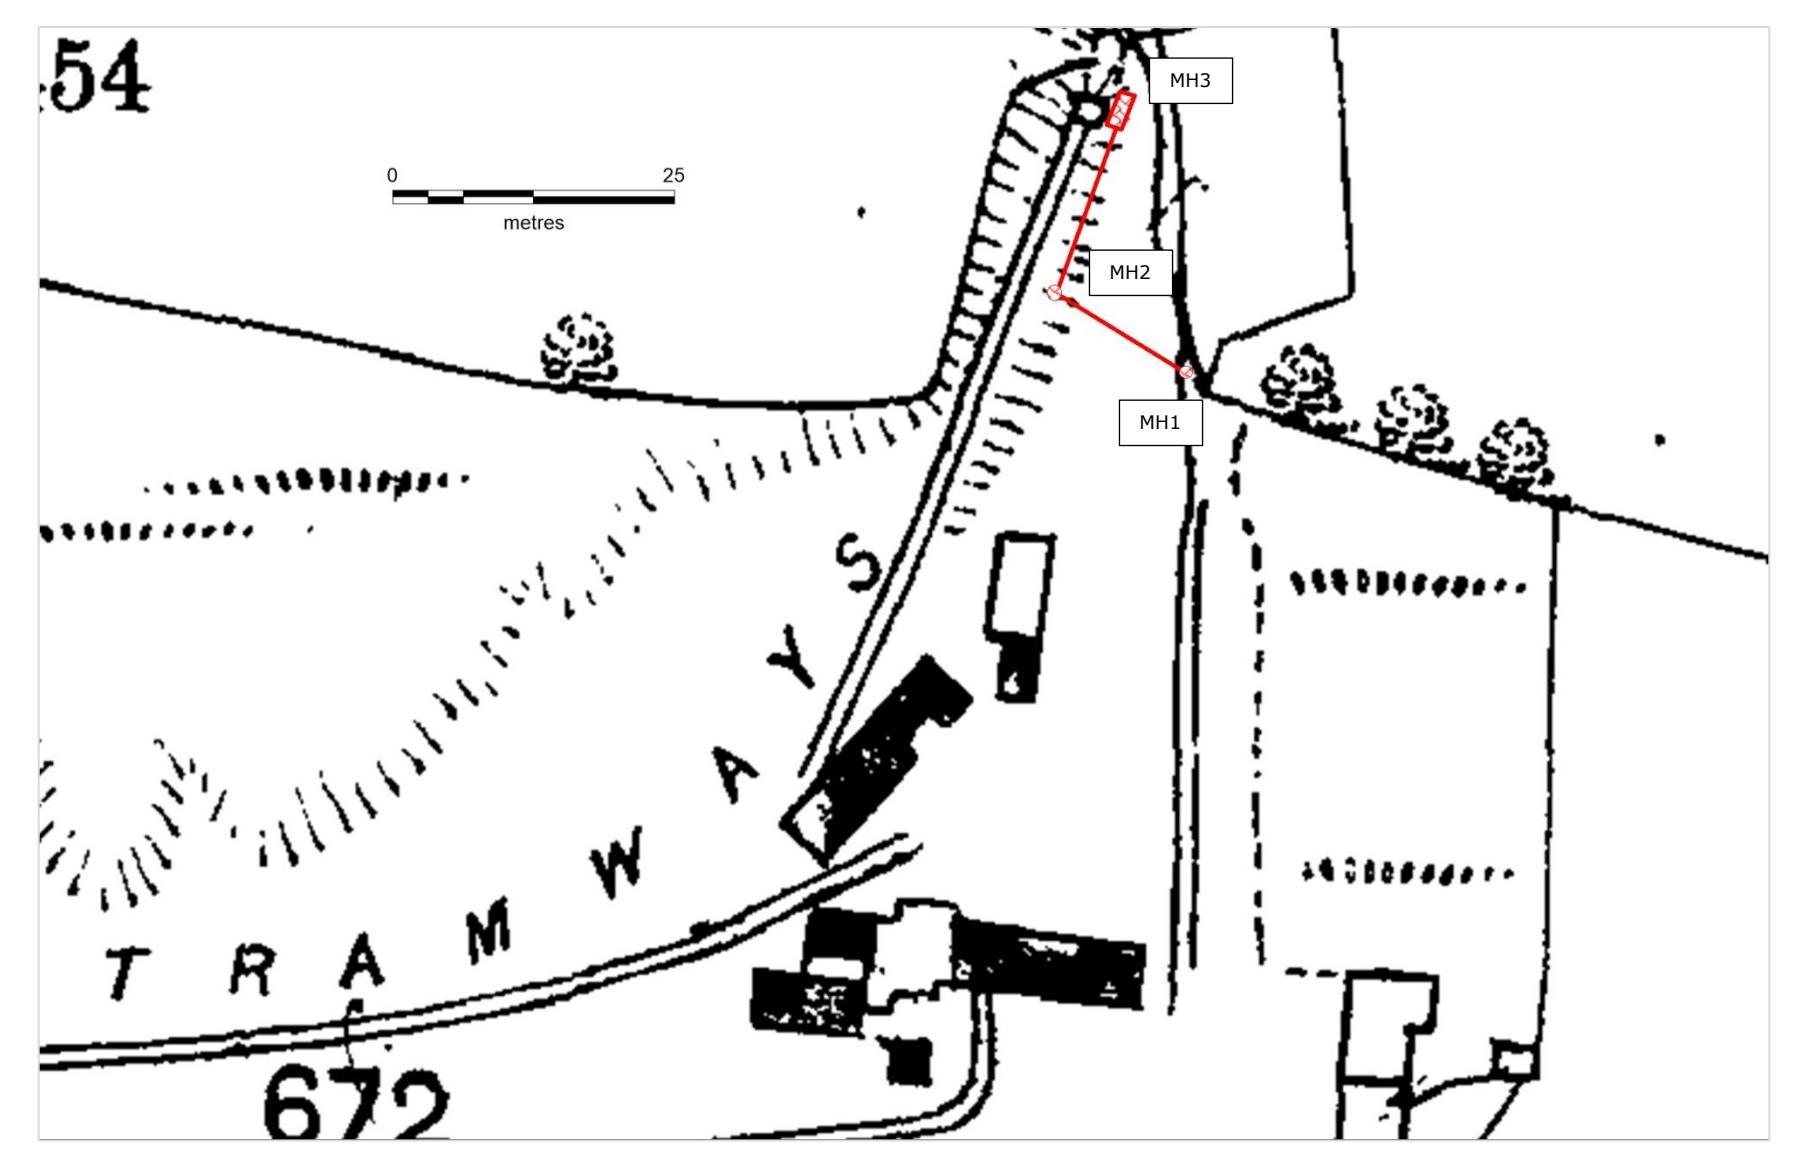
**Figure 3:** The mine water capture arrangement plan (outlined in red) overlying an extract of the Ordnance Survey 1<sup>st</sup> edition25" map published in 1889

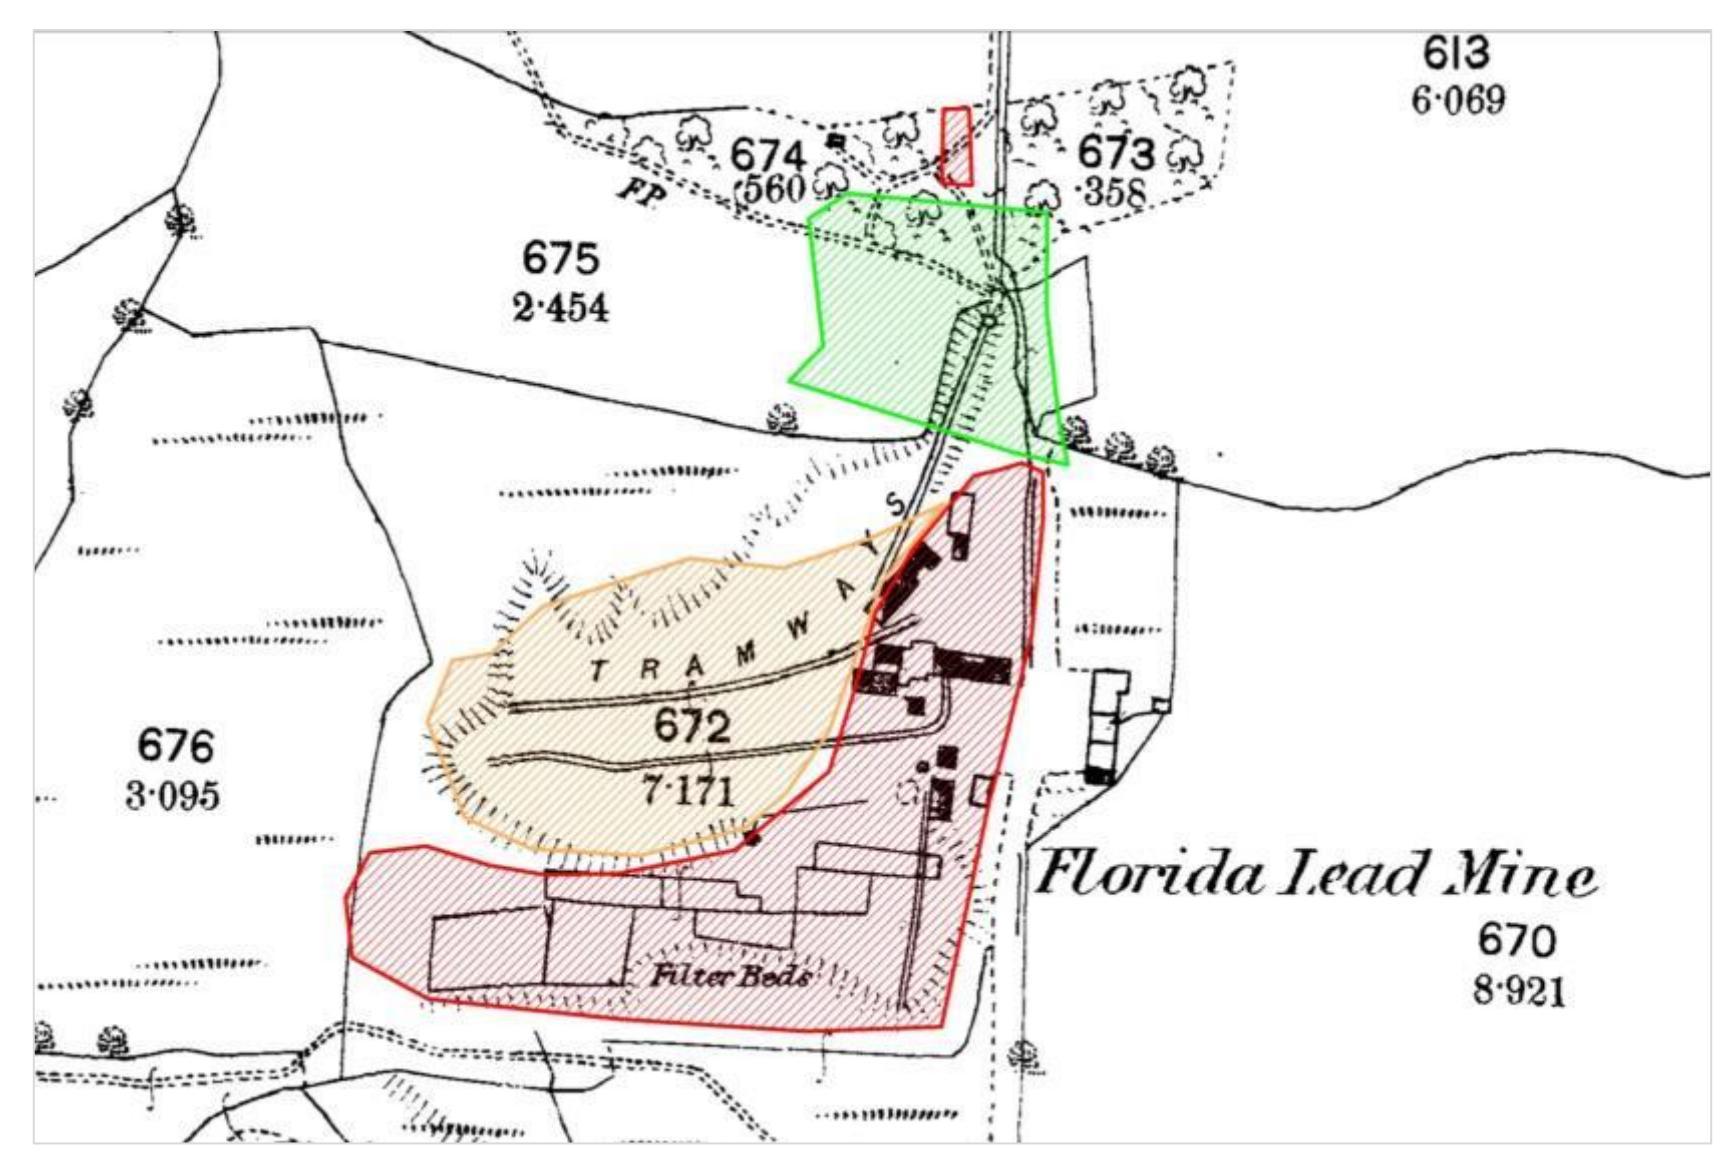
**Figure 4:** Areas of low (green), medium (orange) and high (red) archaeological potential (Bell et all 2016) overlying an extract of the Ordnance Survey 1<sup>st</sup> edition25" map published in 1889.
