# FAN FOEL ROUND BARROW, MYNYDD DU

# AN ARCHAEOLOGICAL ASSESSMENT, OCTOBER 2002-MARCH 2003

REPORT NO. 2003/84 PROJECT RECORD NO. 48596

**JUNE 2003**

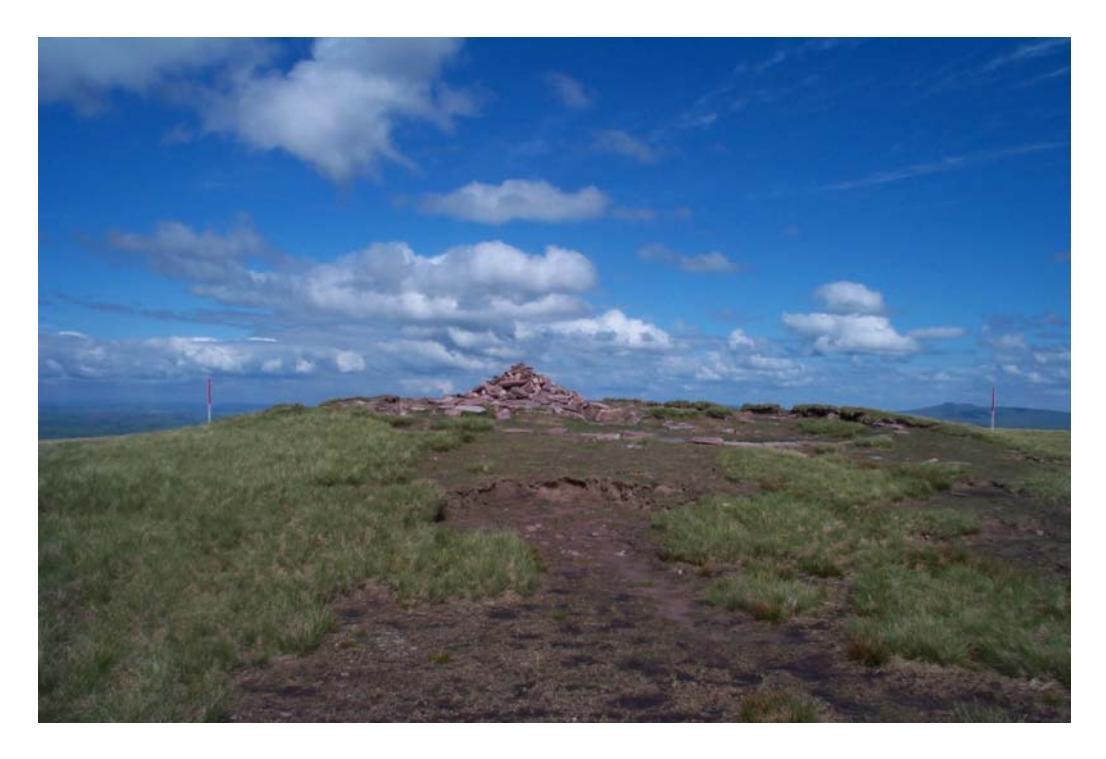
Plate 1 – The barrow at Fan Foel looking northeast. Erosion scars are visible in the foreground

The cairn is situated on a summit at 781m AOD. The most recent OS 1:25,000 map indicates that the modern county boundary runs through the centre of the monument. The recent erosion has exposed a continuous arc of stones on the western side of the site (Plates 1 and 2). This stone 'kerb' appears to continue under a thin protective cover of turf and dark soil on the southern side of the monument and appears to be visible as an intermittent arc of stones set into turf on the eastern and northern sides, forming a feature 11m in diameter. The modern walkers' cairn is located in the northeastern sector and measures approximately 4m x 2.5m in plan and 1m high. A number of other, smaller stones are set into the surface of the eroding interior of the cairn. There is a reference to finds of flint flakes and a 'string of clay beads' from a cairn on Fan Foel, although the provenance is uncertain (Grimes 1933). This suggests that the cairn may have been partly 'excavated' in the past. There are no obvious surface traces of such an earlier disturbance although an area of stone free soil in the southwest sector of the cairn requires closer inspection.

There can be no doubt that the barrow continues to be under considerable threat. Ongoing erosion, both from weathering and from visitors, is continuing to cause damage to the surviving fabric of the barrow and the ring kerb. In fact it was observed that several of the kerbstones on the north side of the barrow had been removed during the course of the assessment. These were recorded during the initial survey in August 2002 and were missing by the time of the assessment undertaken in March 2003 (Fig. 2). It has since been reported that further stones have been moved (reported by Duncan Schlee in May 2003). A similar threat was the impetus for the full excavation of the cairns on Pen-y-fan and Corn-du in the early 1990s. At these sites two options were initially considered. The first option involved covering both surviving mounds with Terram matting or pea gravel and then consolidating the mounds with loose, local stone. However, this option was rejected on the basis that it would be logistically difficult to achieve, it would mask the archaeology creating 'false' monuments and could not be regarded as a final solution but rather as the first stage in an on-going process of expensive consolidation. The preferred option was to totally excavate both sites allowing the preservation by record of the surviving data. Both these options are currently available for consideration for the barrow at Fan Foel.

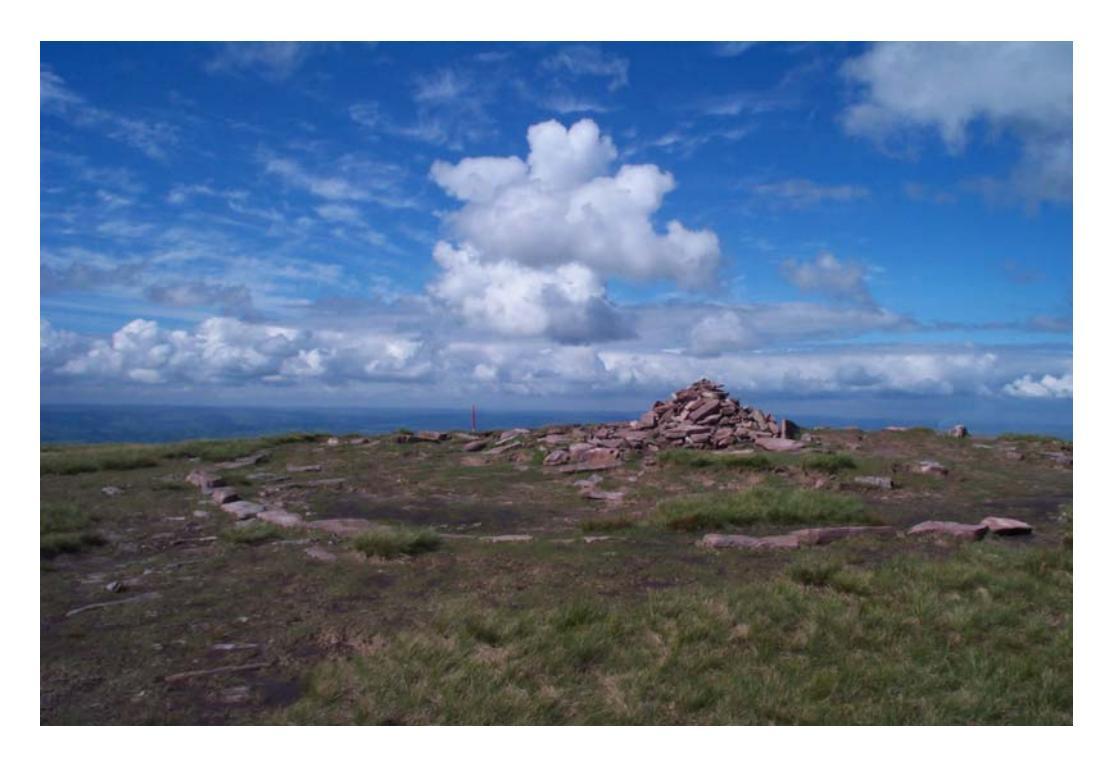
Plate 2 – The barrow at Fan Foel looking north showing detail of the stone 'kerb'

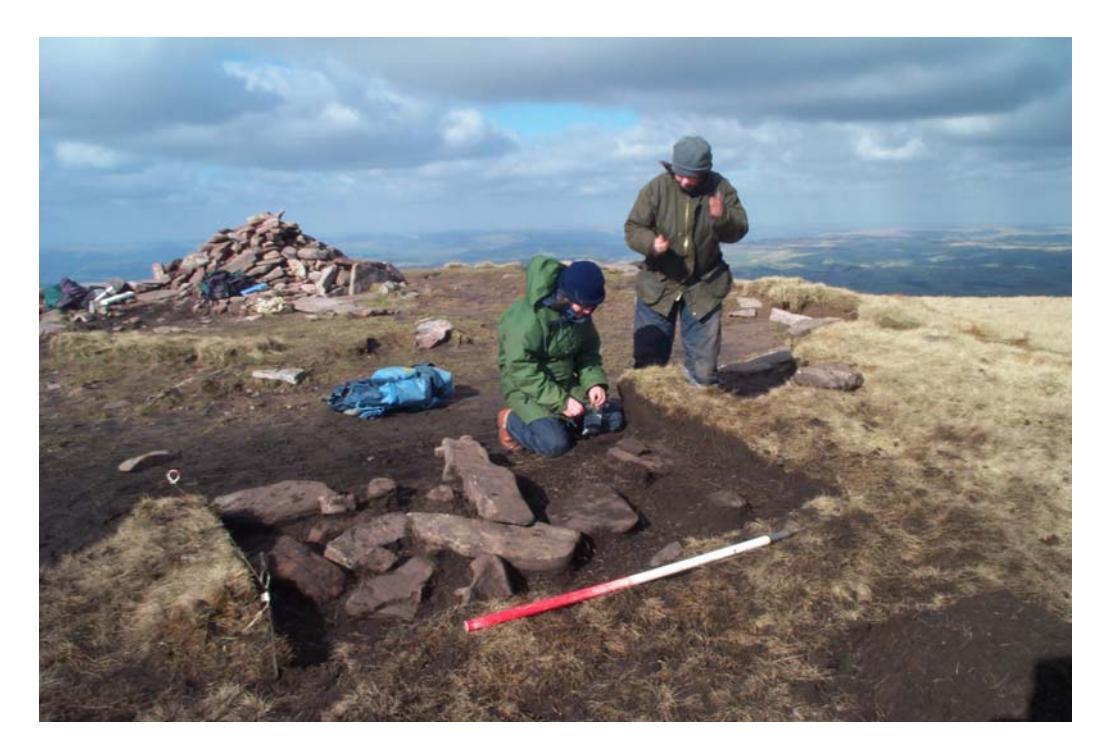
Plate 3 – Palaeoenvironmental sampling of Trench 1

**Trench 1** – The turf and topsoil comprised a black, humic peaty loam (001). At the northern end of the trench the topsoil was 0.35m thick and at the southern end it was 0.12m thick. This overlay elements of the stone cairn or kerb (002) that comprised medium to large sandstone blocks. This in turn overlay a relatively stone-free, dark brown, silty loam (003). Test probing with a cane suggested that this deposit was up to 0.43m thick. Pollen samples were taken from this deposit where it was sealed by cairn stones. Further samples were taken from a small sondage that was excavated in the northeastern sector of the trench (Plate 3). A preliminary examination of the pollen samples by Astrid Caseldine (University of Lampeter) indicates the presence of grass and heather pollen in all the samples along with hazel pollen (20% total land pollen or more). The evidence suggests an open environment in the immediate area of the pollen deposition sites/cairn but with some hazel woodland in the region (the proximity of this is unclear at present). The presence of Plantago lanceolata and Potentilla pollen suggests grazing activity. The results appear to be broadly in keeping with those from Waun-Fignen-Felen (Smith and Cloutman 1988).

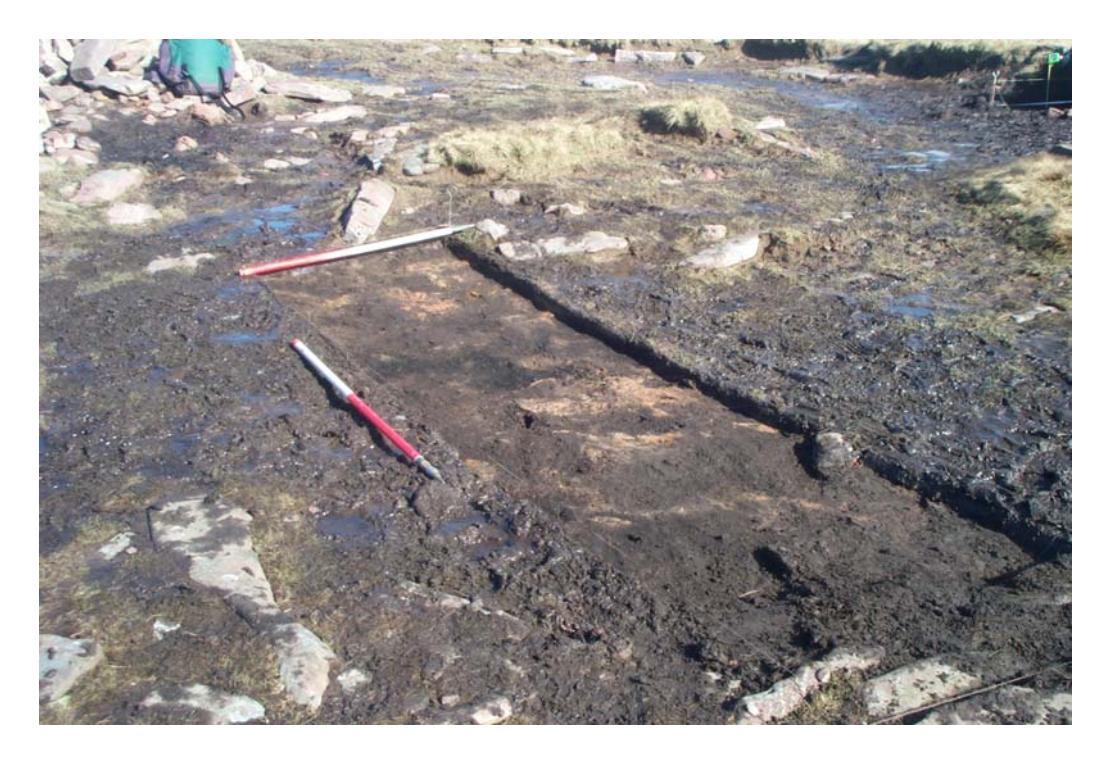
Plate 4 – Trench 2

**Trench 2** – The overlying topsoil and turf was no more than 0.1m thick. This overlay a dark-brown to black silty loam and peat (004) with lenses of yellow-brown silty clay giving a mottled or mixed appearance (Plate 4). This deposit was relatively stone-free, although a few cairn stones were exposed in the southwestern end of the trench in the area near to the ring kerb. Probing this deposit with a cane suggested that it was approximately 0.45m thick.

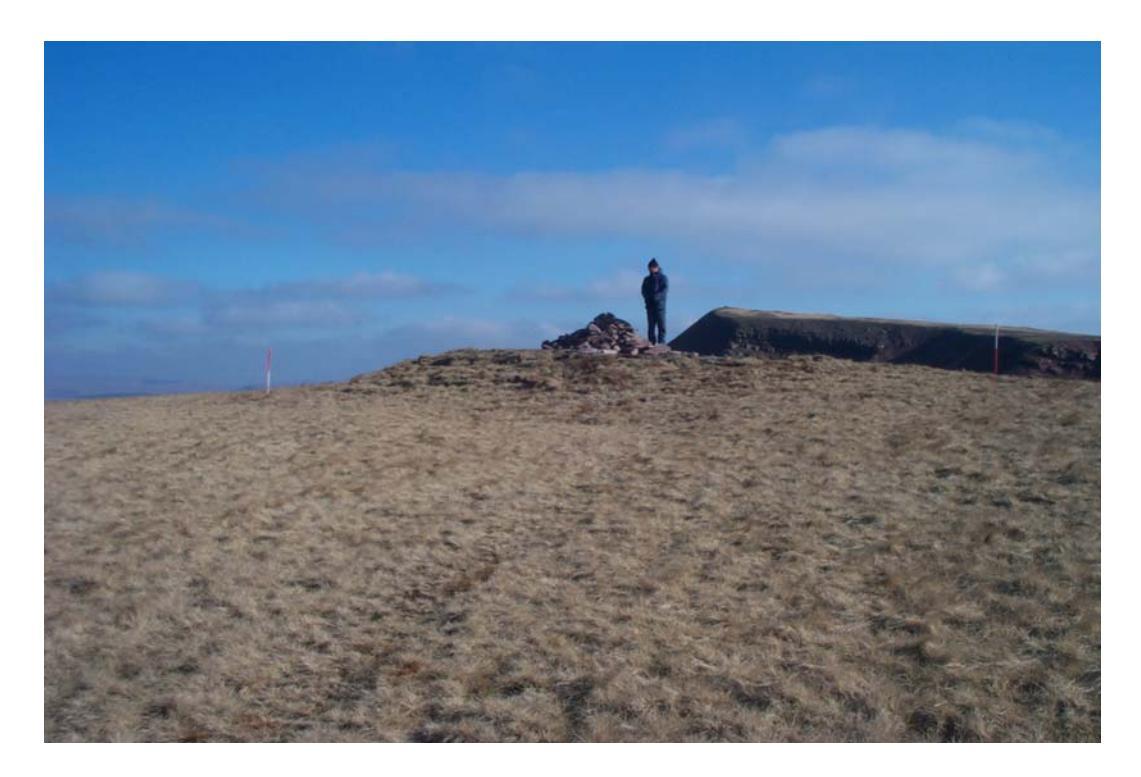
Plate 5 - View of the barrow from the west

The peaty loam appears to have been deliberately deposited (perhaps in the form of turf) to create a level platform. This material appeared to be up to 0.45m deep on the south side of the barrow. However, the general profile of the barrow when viewed from the west (Plate 5) suggests that the depth of this material might be rather deeper on the north side, perhaps up to 1m. The ring kerb and associated cairn material appears to been placed onto this barrow platform effectively forming a capping. Comparable barrows
