REPAIRS AT ST PATRICK'S CHAPEL, WHITESANDS BAY, SAM Pe012

September 2006

Repairs at St Patricks Chapel, Whitesands Bay, SAM Pe012

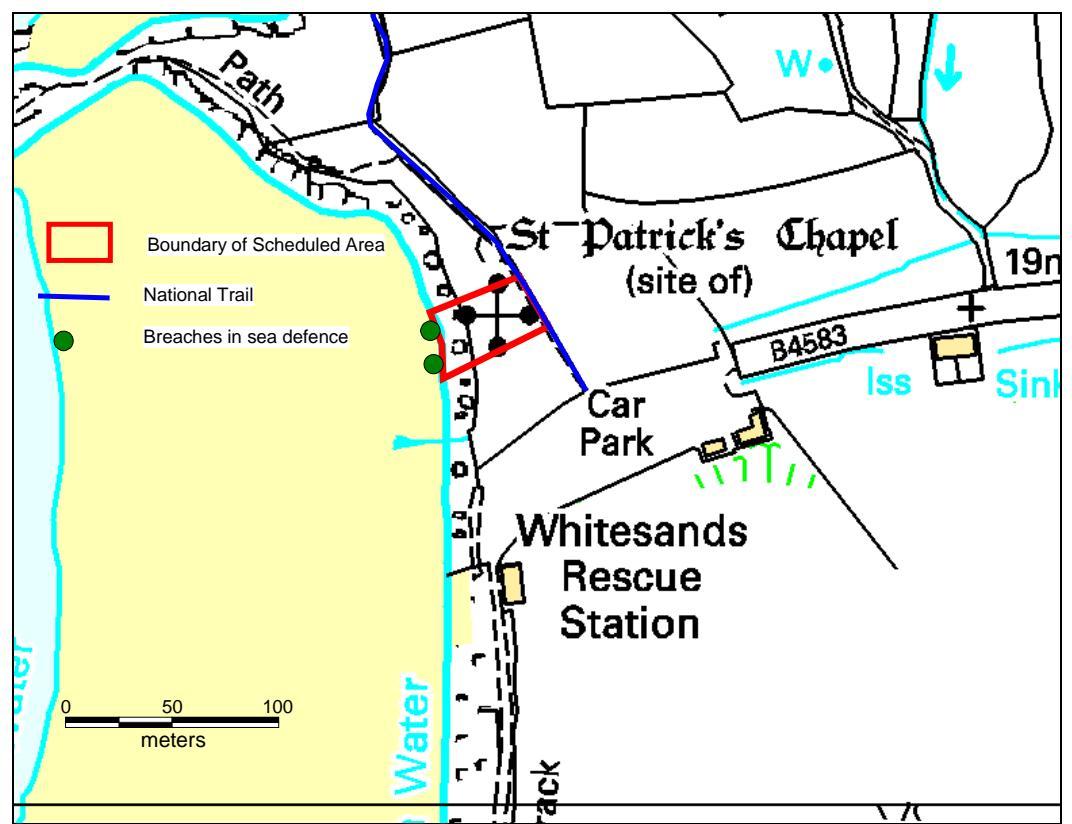
Figure 2: location of the Scheduled Area, the National Trail and breaches in the sea defences.

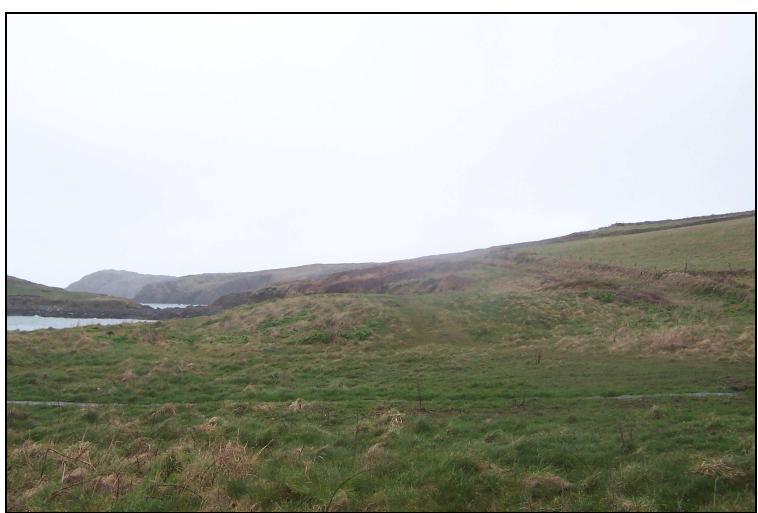
Picture 1: Parc y Capel, viewed from the car park at Whitesands Bay. The gentle mound in the foreground is the chapel mound – most visitors to the site are unaware of its existence.

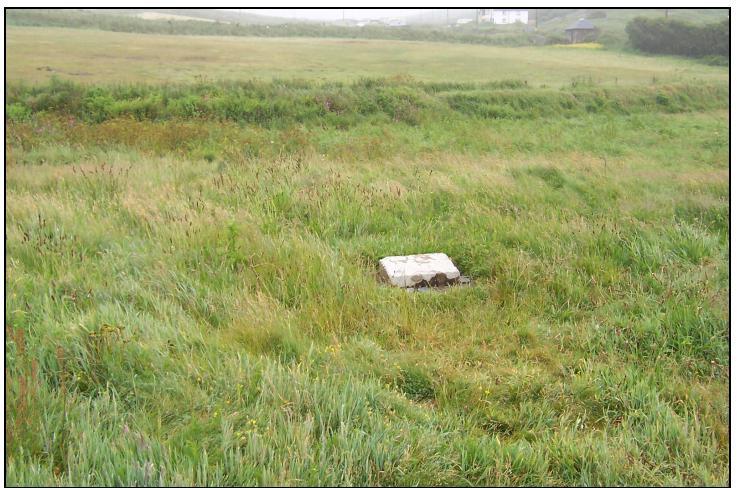
Picture 2: The low stone plinth marking the site of the altar, as discovered in the early twentieth century excavations.

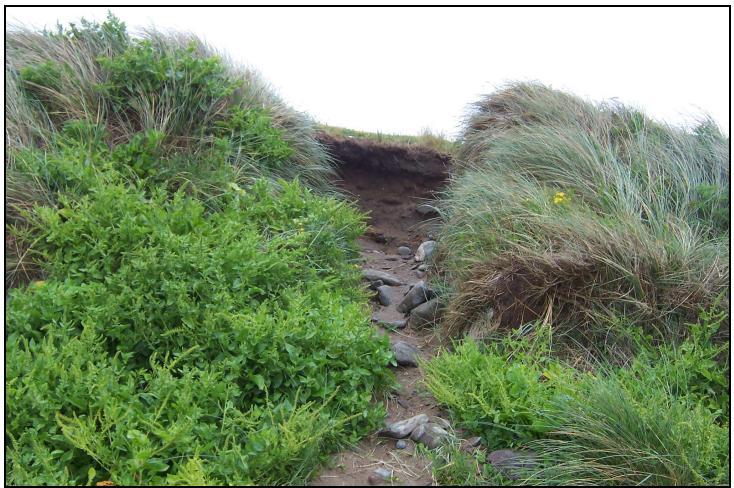
St Patricks is set in a field behind the beach and above the reach of a normal high tide. However, in bad weather or exceptional tides, the waves break against the edge of the sand mound which covers the site. In an attempt to alleviate this problem, the National Park Authority placed large boulders along the edge of the mound to act as a breakwater and try and prevent sand being washed out. However, the sea has breached this defence in two places resulting in two erosion scars 'eating into' the Scheduled area. The most westerly of these two was a serious cause for concern, visibly expanding with each passing season. The exposed section revealed layers of sand and soil with occasional fragments of roof slate included.

Picture 3: The western breach through the sea defences.

The work was carried out on a dry day in February 2006, and was monitored by the Pembrokeshire Coast National Park Archaeologist. A sheet of the geo-textile 'Terram' was pinned over the surface of the erosion to act as a marker for future monitoring. The digger driver first of all replaced the boulders into the breach, and then filled in behind them with sand and soil imported from a nearby farm.

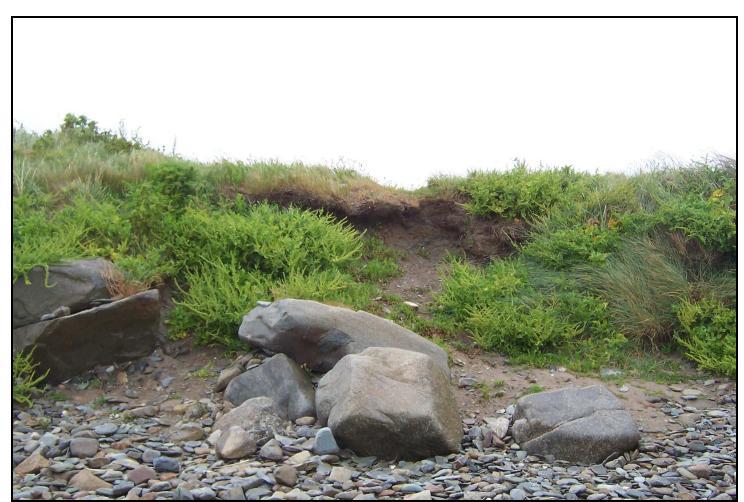
Picture 4: The smaller, but developing, eastern breach in the sea defences.

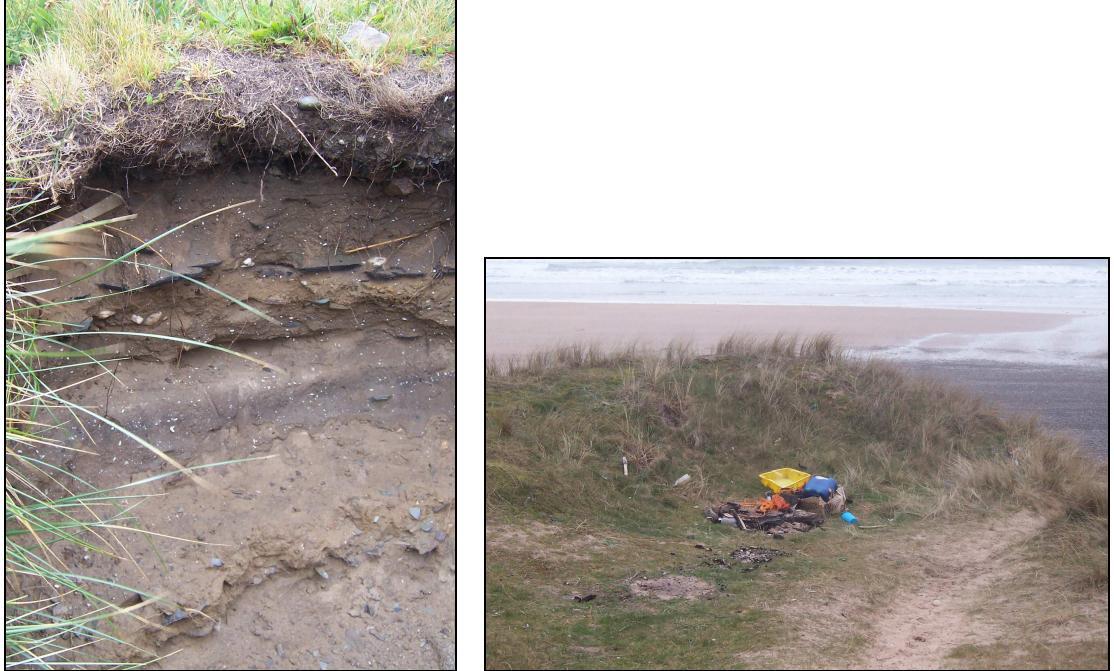
Picture 5 (above left): the exposed section within the erosion scar. Layers of sand and soil were revealed, along with fragments of roofing slate and beach pebbles. Picture 6 (above right): after days when the beach has been busy there is frequently litter left in Parc y Capel.

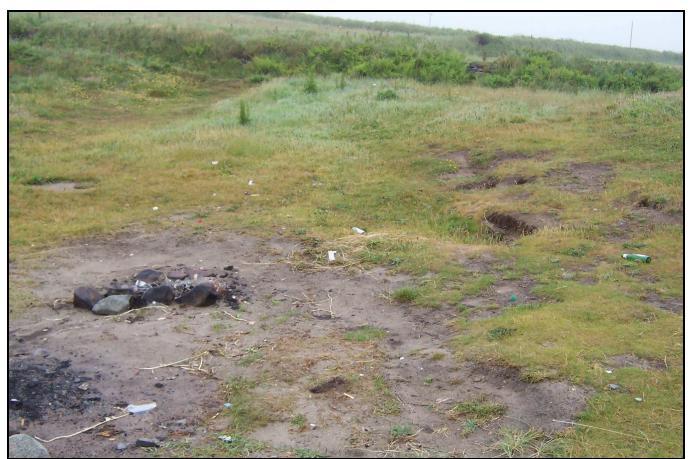
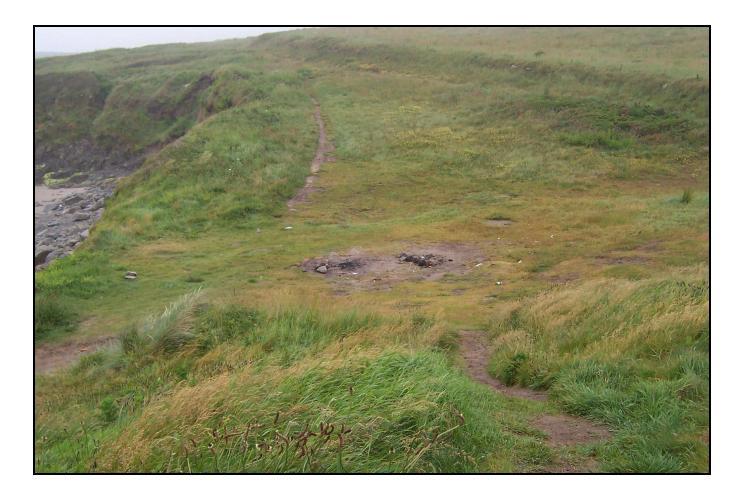
Since there are no fences or barriers, Parc y Capel is also used almost as an extension of Whitesands Beach with people picnicking and sunbathing in the field and, frequently, on the chapel mound. In themselves these activities do not appear to be any cause for concern, however, more damaging is the fact that the mound is often used as a campsite, and on numerous visits during 2004 – 5 there were new fire-pits and barbecues dug into the mound and the surrounding area. The area is also often left covered with litter.

Pictures 7 and 8 (above and below): some of the damage caused by unofficial campsites and barbecues on the chapel mound itself.

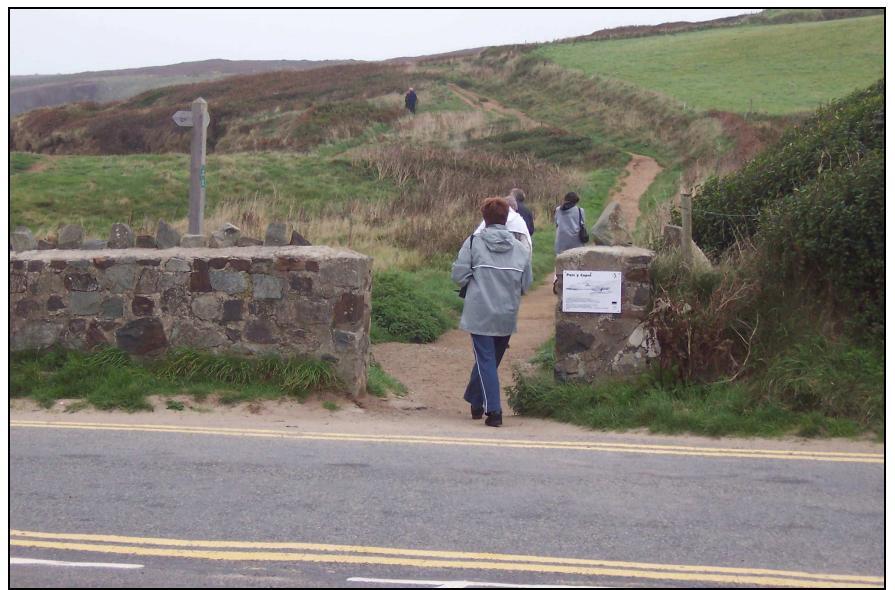
Picture 15. The sign which has been put up on the entrance way to the field. It is hoped that by giving people some information about the significance of the site, some of the unintentional damage will be reduced. The reconstruction drawing is designed to make it easier for people to view the field as a significant place.

A reconstruction drawing of the chapel was commissioned to go on the sign (see photograph below). Planning and budgetary constraints meant that a full interpretation panel was not possible at this site, nor would it necessarily have been desirable. The sign was fabricated in aluminium and placed onto the fence adjacent to the entrance to Parc y Capel. The effectiveness of this approach will be monitored over 2-3 seasons, and if there is a notable decrease in the amount of damage caused by visitors and campers then the sign will be replaced in a more robust (and expensive!) material.
