TENBY CASTLE 2007 ARCHAEOLOGICAL EVALUATION OF UNSTABLE BANKS

Prepared by Cambria Archaeology For Pembrokeshire County Council

REPORT NO. 2007/90 PROJECT RECORD NO. 63304

December 2007

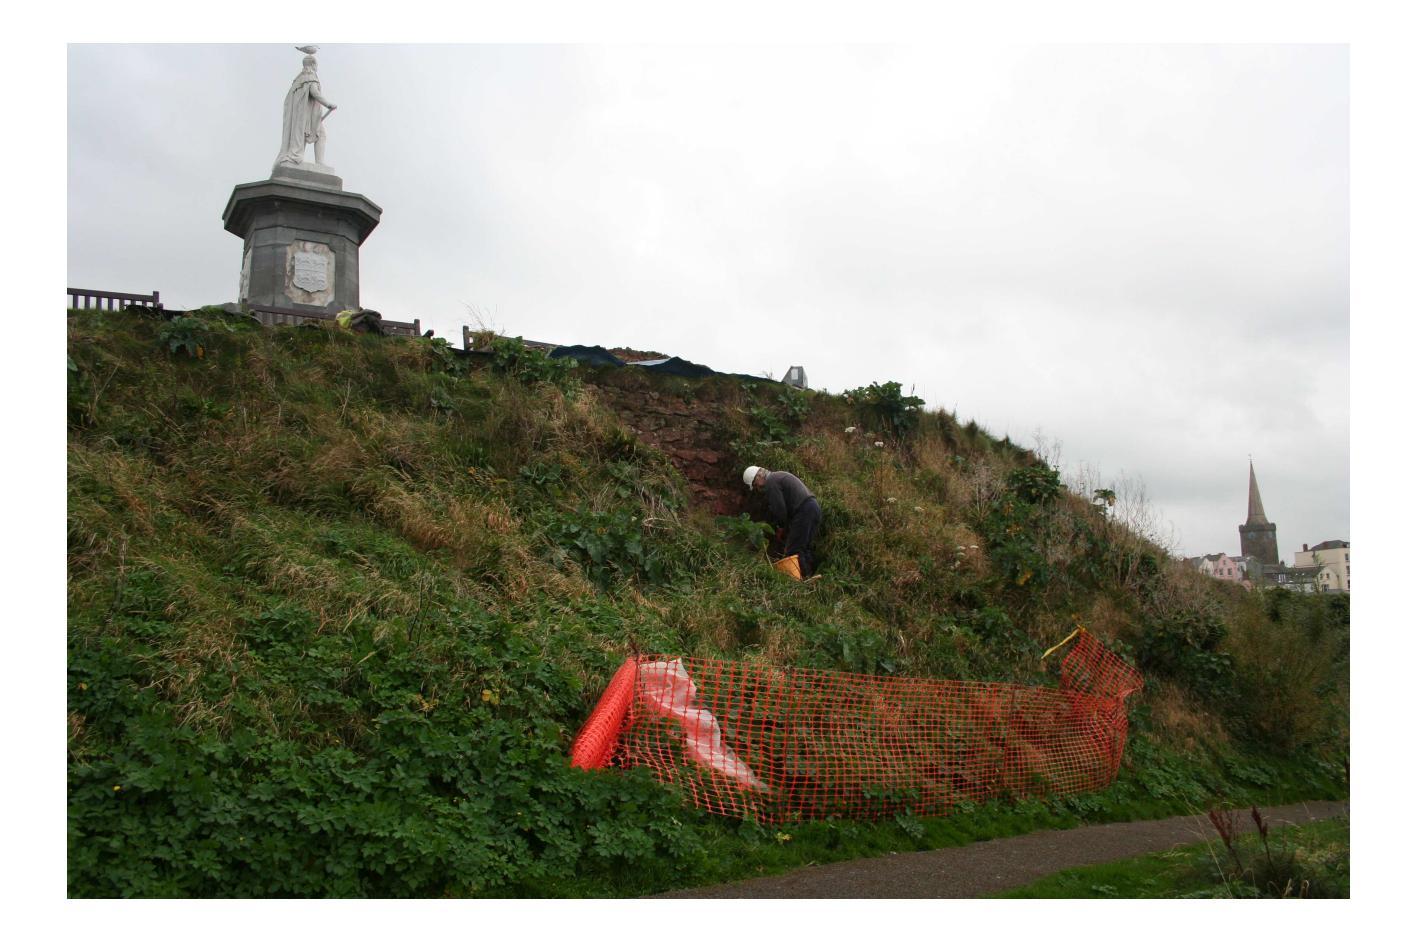
Cover Plate: Trench 1 under excavation. View SW

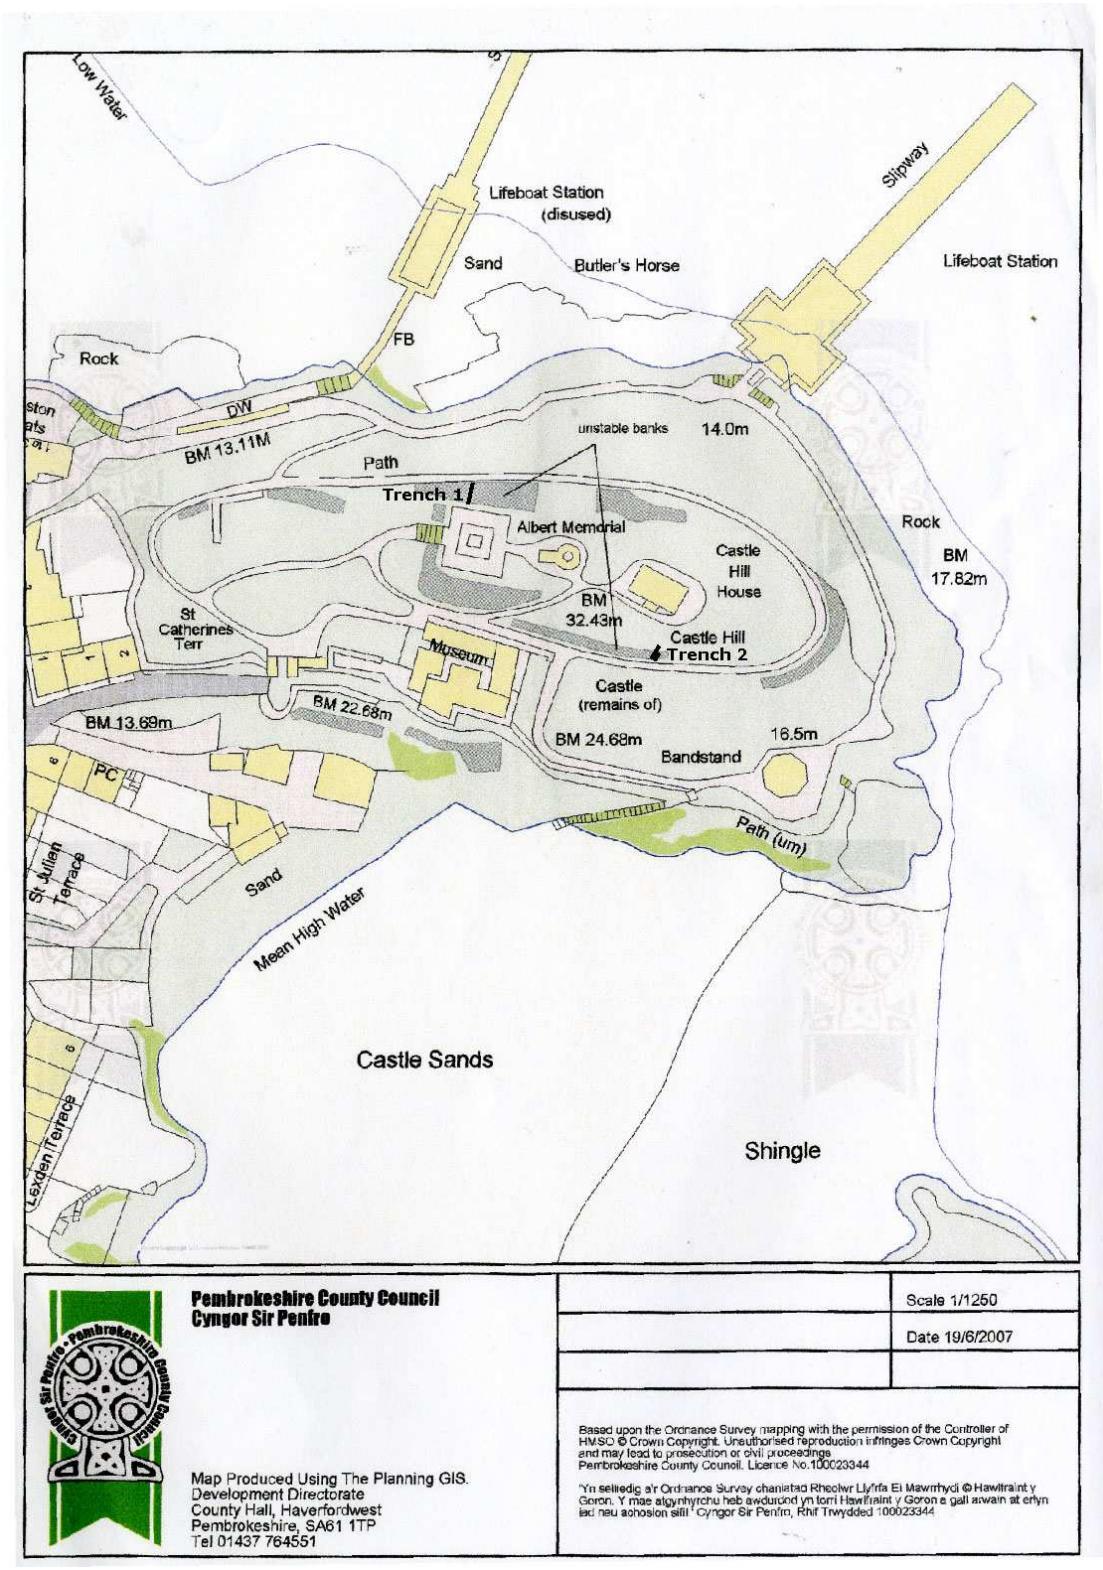
Figure 1: Location, Castle Hill and Trenches 1 and 2

This project was undertaken to look at two areas on the north and south sides of Castle Hill that had apparent unstable banks which had been showing slippage recently (Fig. 1). It was proposed therefore that two evaluation trenches be dug to investigate what was happening at these locations and the potential implications for any archaeological remains should consolidation of these banks be necessary. Tenby Castle (NGR SN 13700053) is a Scheduled Ancient Monument (SAM Pemb No 163) and a Site of Special Scientific Interest (SSSI). Pembrokeshire County Council obtained consents from both Cadw in respect of the SAM, and the Countryside Council for Wales regarding the SSSI before this work commenced.

Trench 1 (Fig. 1 and cover photo) was located on the north side of the castle, running from the top of the slope below the summit platform to 1.5m short of the path. This slope was very steep, being just under 45°. At the top of the slope the trench was 1.5m wide to enable safe footing when starting the trench, while lower down the slope the trench was narrowed to 1m wide, and in the lowest part a 0.5m slot was excavated down to bedrock, in order to reduce backfilling and any subsequent settling of the backfilled material. The trench was 4.3m long with a maximum depth of 1m and had a fall of 5m (Fig. 2). The west side of the trench was in line with the lowest step on the west side of the Prince Albert Memorial.

Trench 2 (Fig. 1) was positioned 1m to 2m east of the line of the east end of Coast Guard House and 7m to 10m to the south, placed at the western end of an apparent ground subsidence. Initially the trench was 3m long and 1m wide but this was extended to 2m wide on part of its western side.

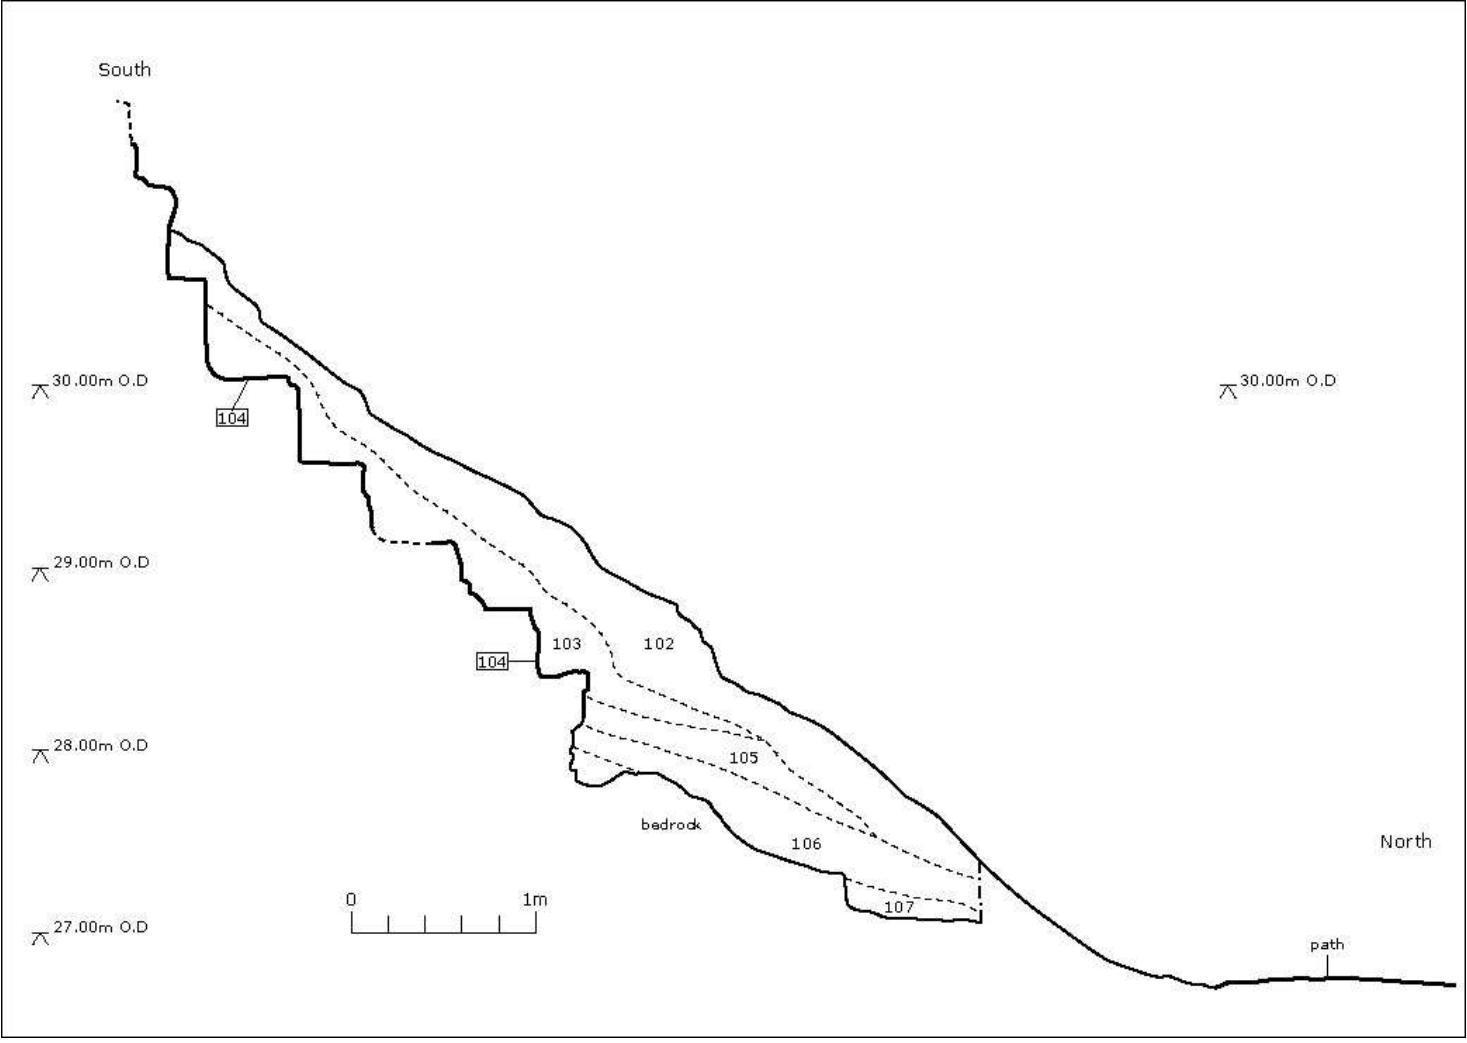
Figure 2: Trench 1 main section

Results Trench 1 (Fig. 2)

Bedrock was only encountered in the northern end of the trench, with the rest of the trench only excavated to expose a stepped retaining wall (104). The surface of the bedrock was uneven (Plate 1) and appeared to be limestone. Above this was a layer (107) of reddish brown silty clay with rare slate fragments and mortar flecks. Overlying 107 was a gritty deposit (106) containing a large amount of grey roof slate fragments particularly towards its northern end. Above 106 was a layer (105) of slightly reddish grey brown silty loam that appeared to be a buried soil horizon. This appeared to have been cut by the construction of the stepped retaining wall (104) (Plates 2 to 4); although there was no visible separate foundation cut for the wall it is possible that the lower 'facing' stones were laid against the edge of the construction trench.

This stepped retaining wall (104) was built of local stone and bonded with a hard, off-white-grey mortar. This walling was roughly faced and coursed with mortar protruding from some of the joints, and the steps of the wall were different in height and depth. Above the retaining wall there was a sloped layer (103) of slightly reddish grey brown sandy silt loam containing a reasonable amount of angular stones, some of which were quite large. Overlying 103 was a thick layer (102) of fine sandy silt loam topsoil with few stones capped by rough turf and sea kale. This upper layer and, to some extent, the layer below (103) were disturbed by animal burrows and roots.

It is uncertain if the surface of the bedrock had been artificially altered and a much larger area would probably need to be uncovered than the 0.5m slot excavated, to ascertain if this was the case. The layer (107) above could certainly be natural but disturbed by roots and animal burrows.

The gritty layer with a lot of roof slate fragments (106) would appear to be the remains of a demolition layer, given the number of slate fragments. After this deposit, there would appear to be a time of stability when turf accumulated (105).

The stepped retaining wall, although of solid construction, was so uneven and poorly pointed it would suggest that none of it was ever intended to be seen. It would appear that this retaining wall was an essential support for the construction of the platform on which the Prince Albert Monument, dedicated in 1865, stands. The material above the stepped retaining wall, consisting of soil with large stones (103), was probably deposited soon after the wall's construction and may have been covered in soil (102) and turfed. There was considerable evidence of rat burrows in this topsoil (102) that extended occasionally into the layer below. These upper two layers above the retaining wall appeared to have be settling rather than slipping to any extent.

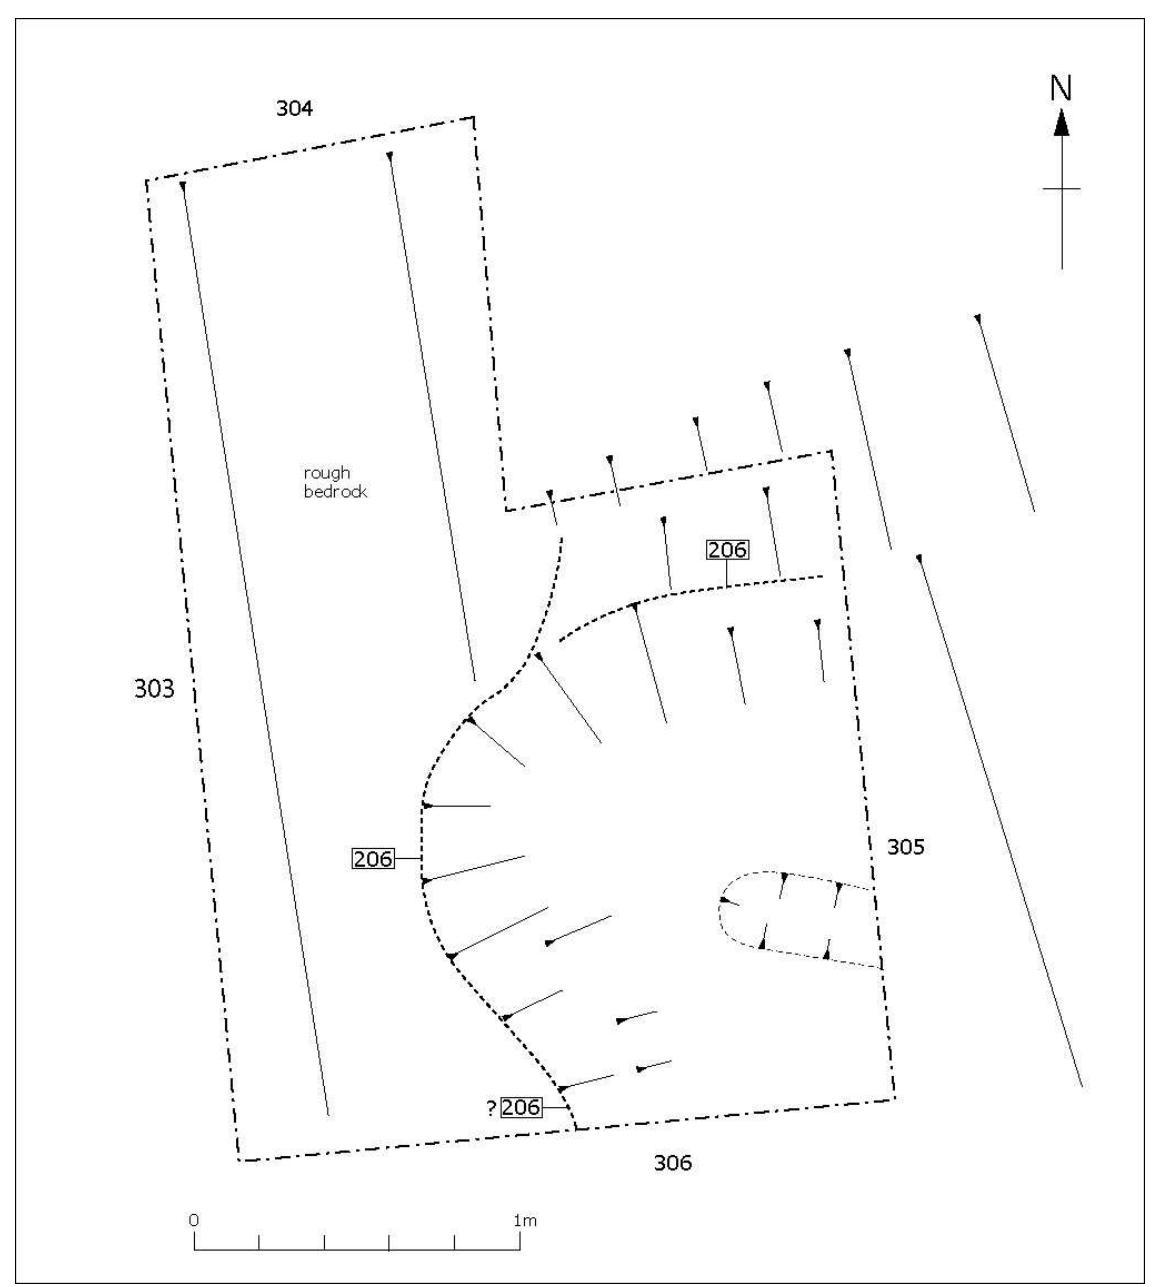
Figure 3: Trench 2 plan (simplified bedrock)

The whole of the trench was excavated down to the uneven bedrock (Plate 5). The bedrock appeared to be cut by a feature (206) that seemed to have been dug utilising the natural joints in the rock. There may have been a small channel in the base of this feature (Fig.3 and Fig. 4). There were no signs of any tool marks in the sides or base of 206. The northern portion of the base of 206 was covered by a primary fill (205) of reddish brown sandy silt containing a reasonable amount of grit and small angular stones, similar to the bedrock. Above 205 was a small deposit (204) of grey brown silt with a lot of medium angular stones and a smaller amount of grit. Overlying both 204 and 205 was a layer of grey brown silt with a lot of small to medium sized angular stones and grit (202); this fill also

The cut (206) does not appear to be a natural feature and its function could not be ascertained; much of it probably lies outside the trench and is possibly partly destroyed where a seating area has been terraced back into the slope. Its primary fill (205) appeared to have been re-deposited natural. The lack of topsoil in primary fill 205 suggests that this feature predates the Victorian landscaping in the castle and could even pre-date the castle. The small deposit (204) would appear to be a spill of stones weathered from the exposed bedrock on the side of 206. However, the main fill or layer (202) in the feature would appear to be Victorian. The topsoil contained modern material but also a few fragments of medieval pottery.

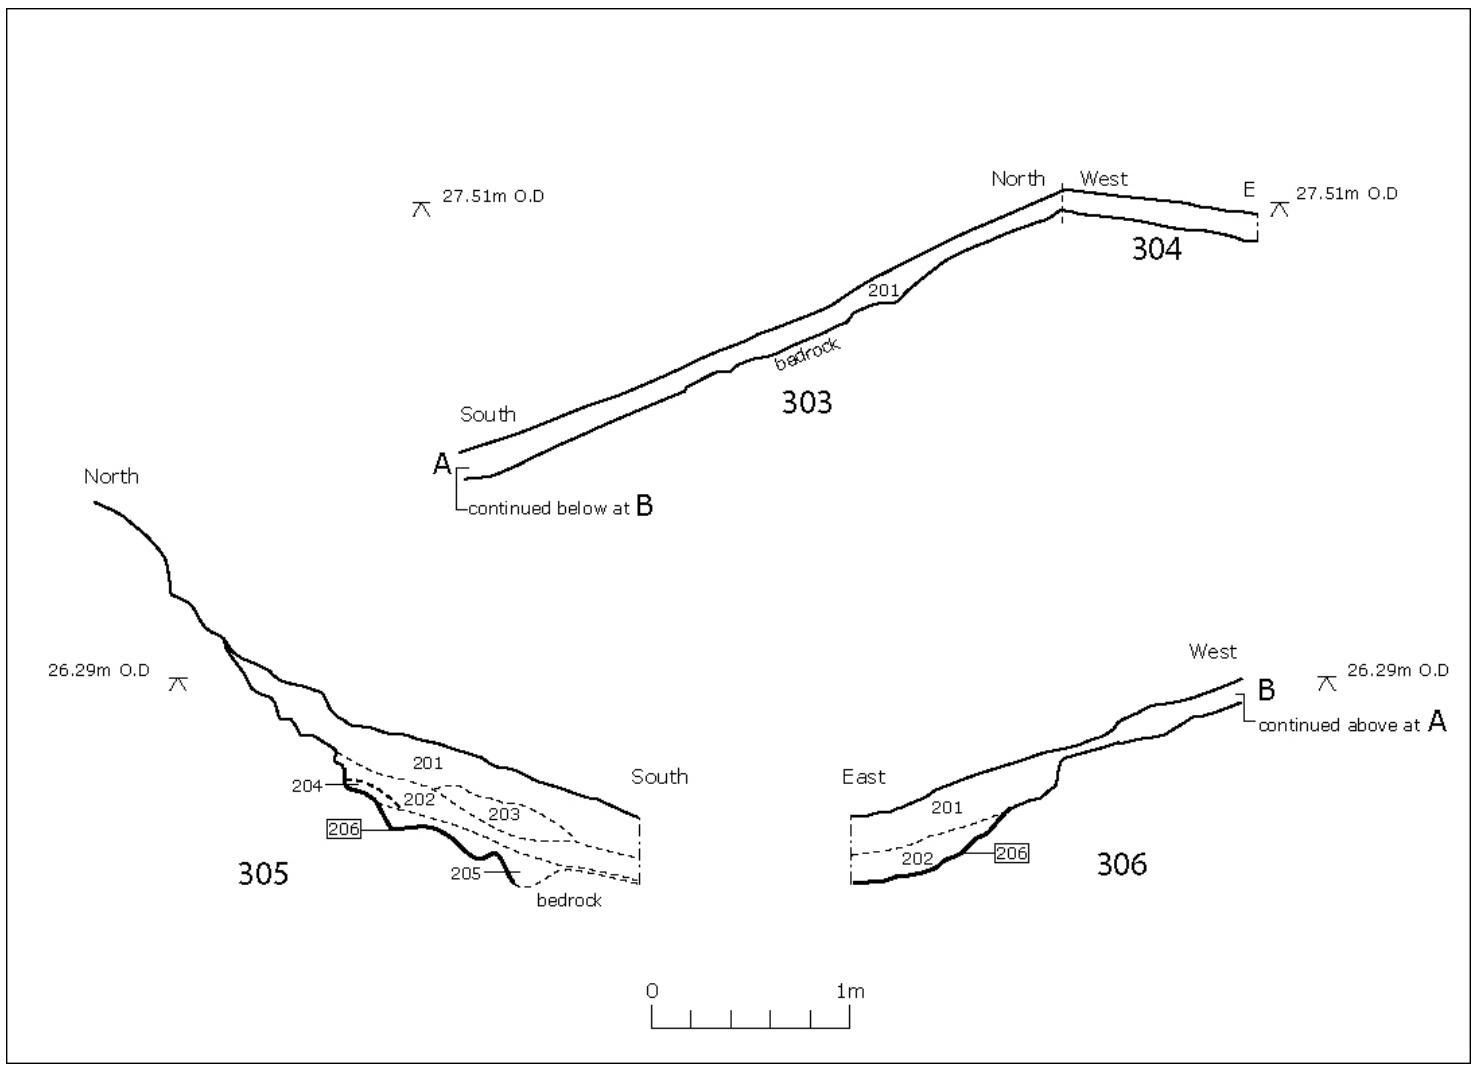
Figure 4: Trench 2 sections

contained a clay pipe stem and an iron nail or rivet. Above 202 was a small deposit (203, Fig. 4, 305) similar to 202 although with fewer but larger stones. Overlying this fill and the bedrock outside of possible feature 206 was a layer (201) of topsoil containing some post-medieval and recent china fragments, which was covered by a reasonable depth of turf.

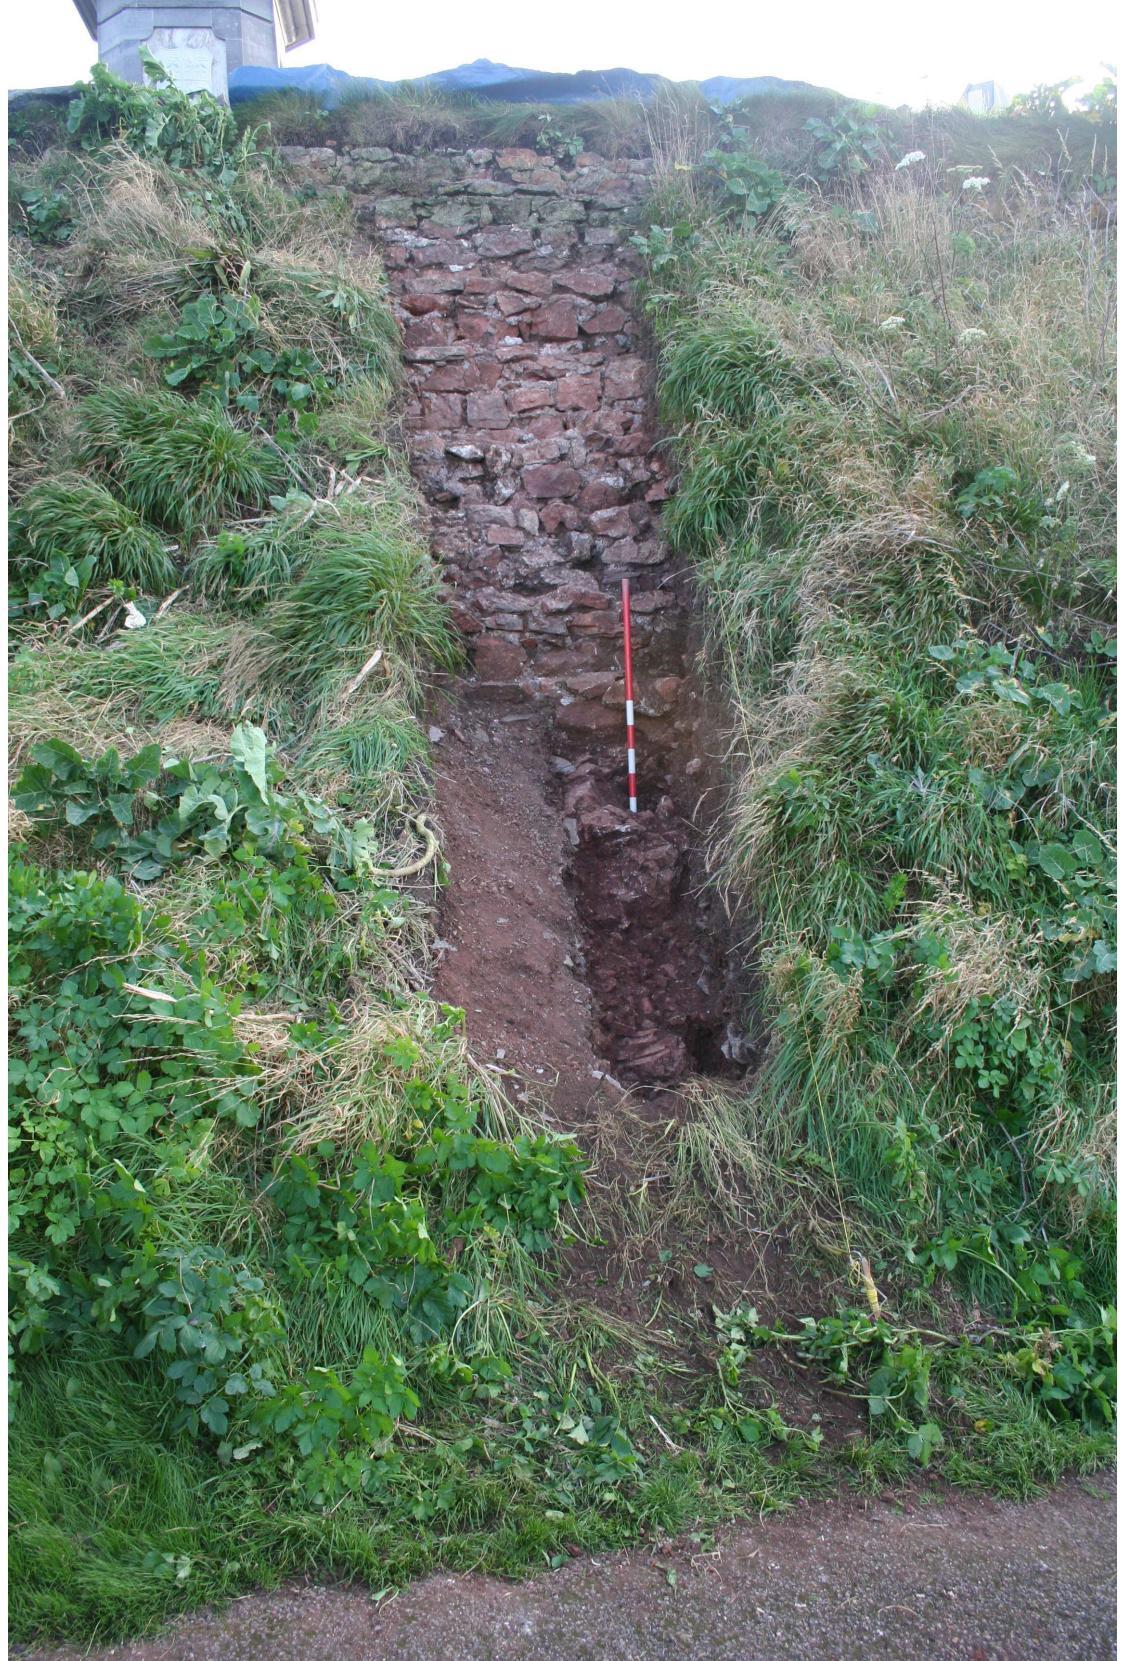
Plate 1: Trench 1, bedrock below scale. View S. Scale 1m

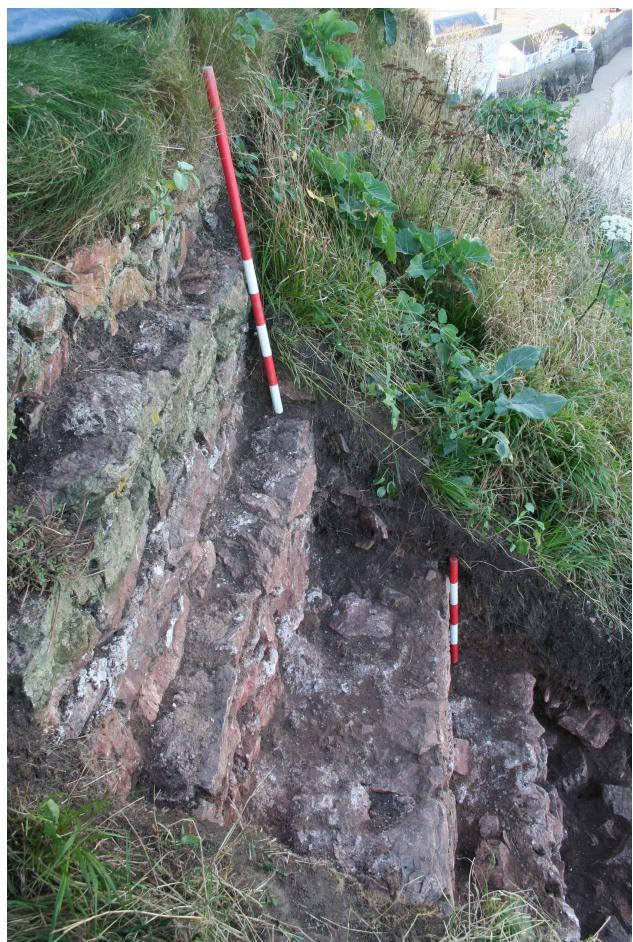
Plate 2: Trench 1, upper (south) part of retaining wall 104. View W, Scales 0.5 and 1m

In both trenches it appears that the soil had settled rather than slumped. The retaining wall in Trench 1 is in good condition, but where the upper section has been revealed it may need attention if left exposed for any length of time. It may be worth considering building up the soil where the top of the retaining wall is exposed (although this may affect the SSSI) or monitoring any erosion of this area and re-pointing the exposed retaining wall as necessary.

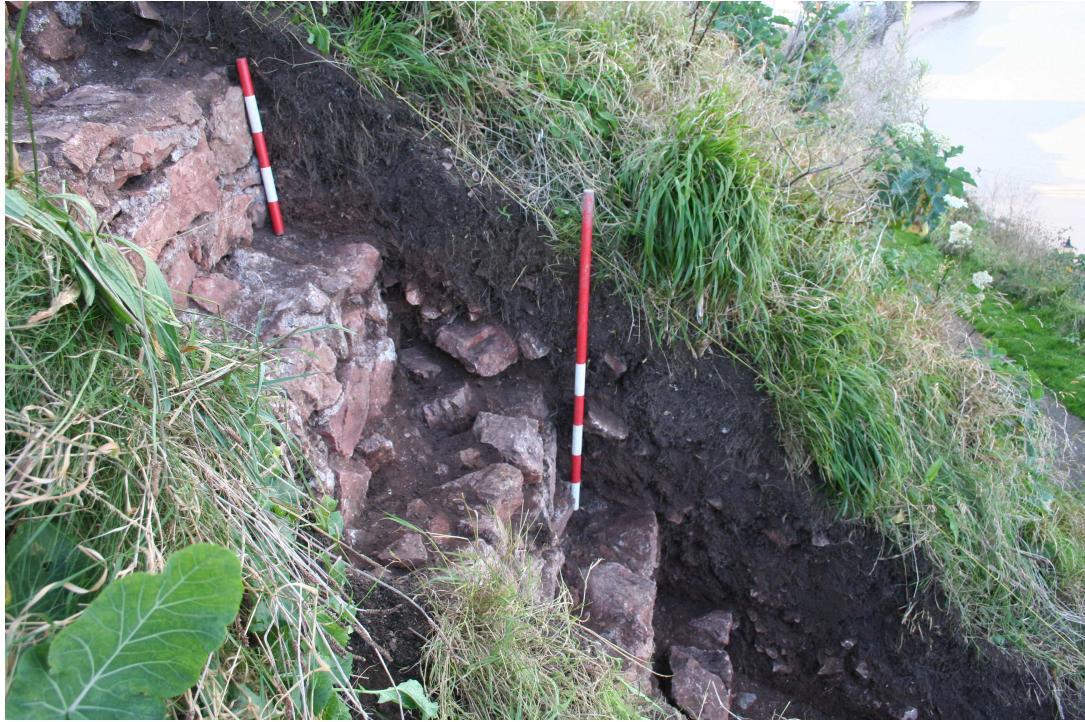
Plate 3: Trench 1. Middle part of retaining wall 104. View W. Scales 0.5 and 1m

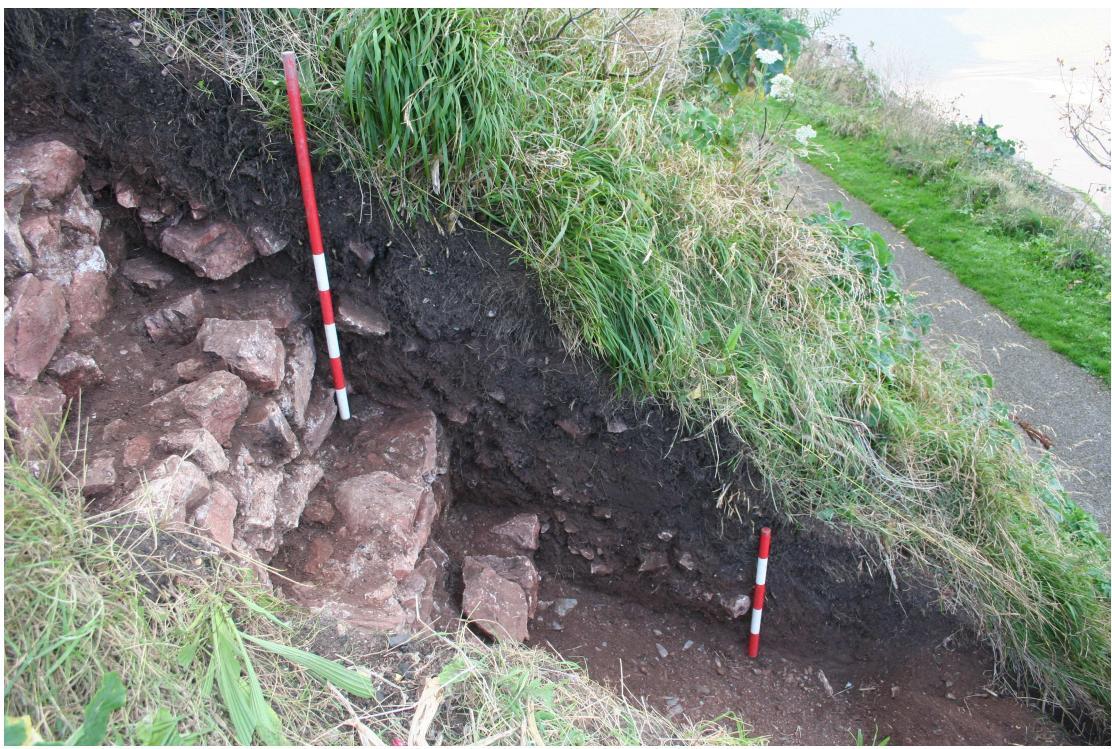
Plate 4: Trench 1, lower (northern) part of retaining wall 104. View W. Scales 0.5m and 1m

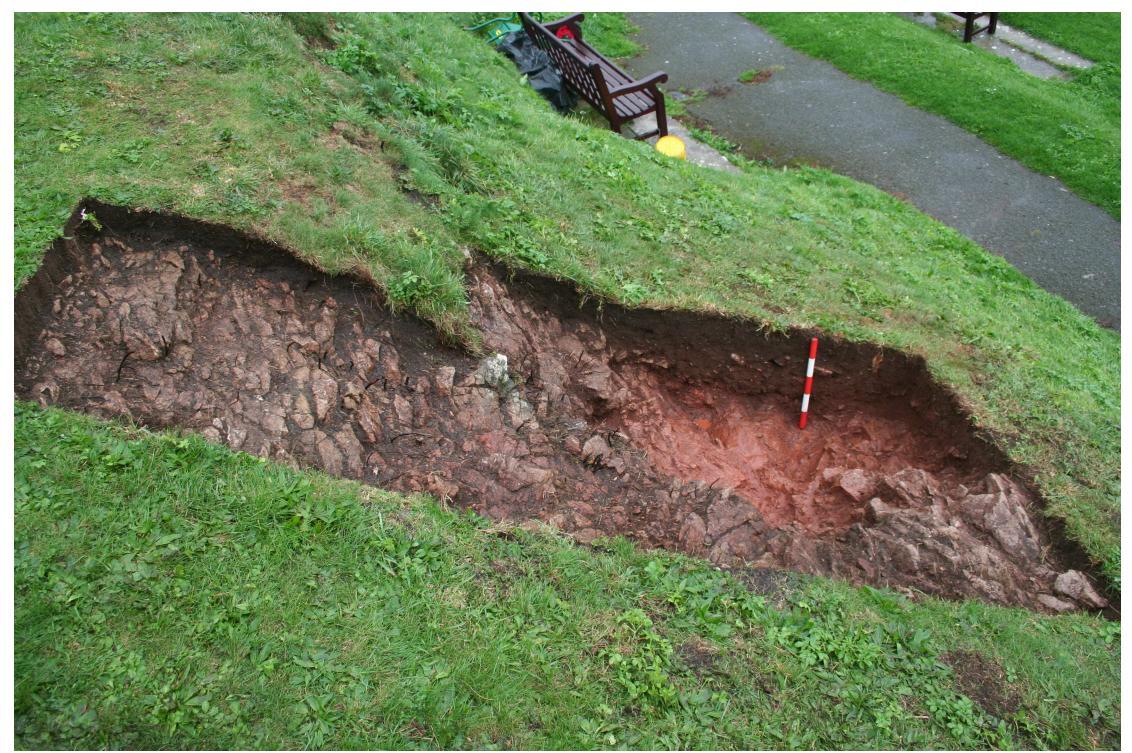
Plate 5: Trench 2, as excavated. View W. Scale 0.5m
