INVESTIGATION OF TWO POSSIBLE ROMAN ROADS COMING INTO PORTH MAWR (WHITESANDS) ST DAVID'S

CARRIED OUT END OF MARCH AND EARLY APRIL 2021

A 'VIA JULIA'

B POSSIBLE TERMINATION OF THE FLEMISH WAY ON THE WHITESANDS GOLF COURSE

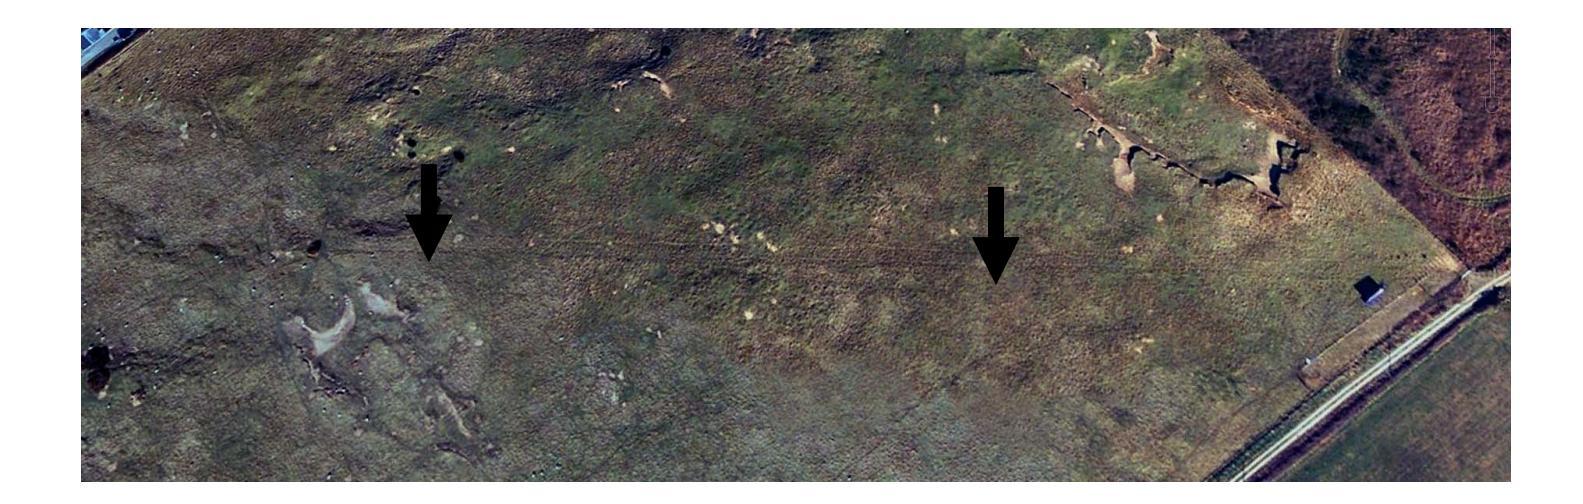
Whilst tracing the course of the so-called 'Via julia', a line was spotted heading W towards the cliff-top at Whitesands. The large field in particular showed a very strong 5m wide line on Google Earth 2005. See below

The official view is that a Roman road being visible in this location is impossible, due to a large depth of windblown sand spread over this area by freak storm events in the Middle Ages. Searches were sent to Dwr Cymru, and it can be confirmed that this line does not co-incide with any sewers or water mains. The most likely explanation for the crop marks, particularly judging by the width, was therefore a road, and it seemed likely, due to their visibility, a road had been built on sand and subsequently covered by sand.

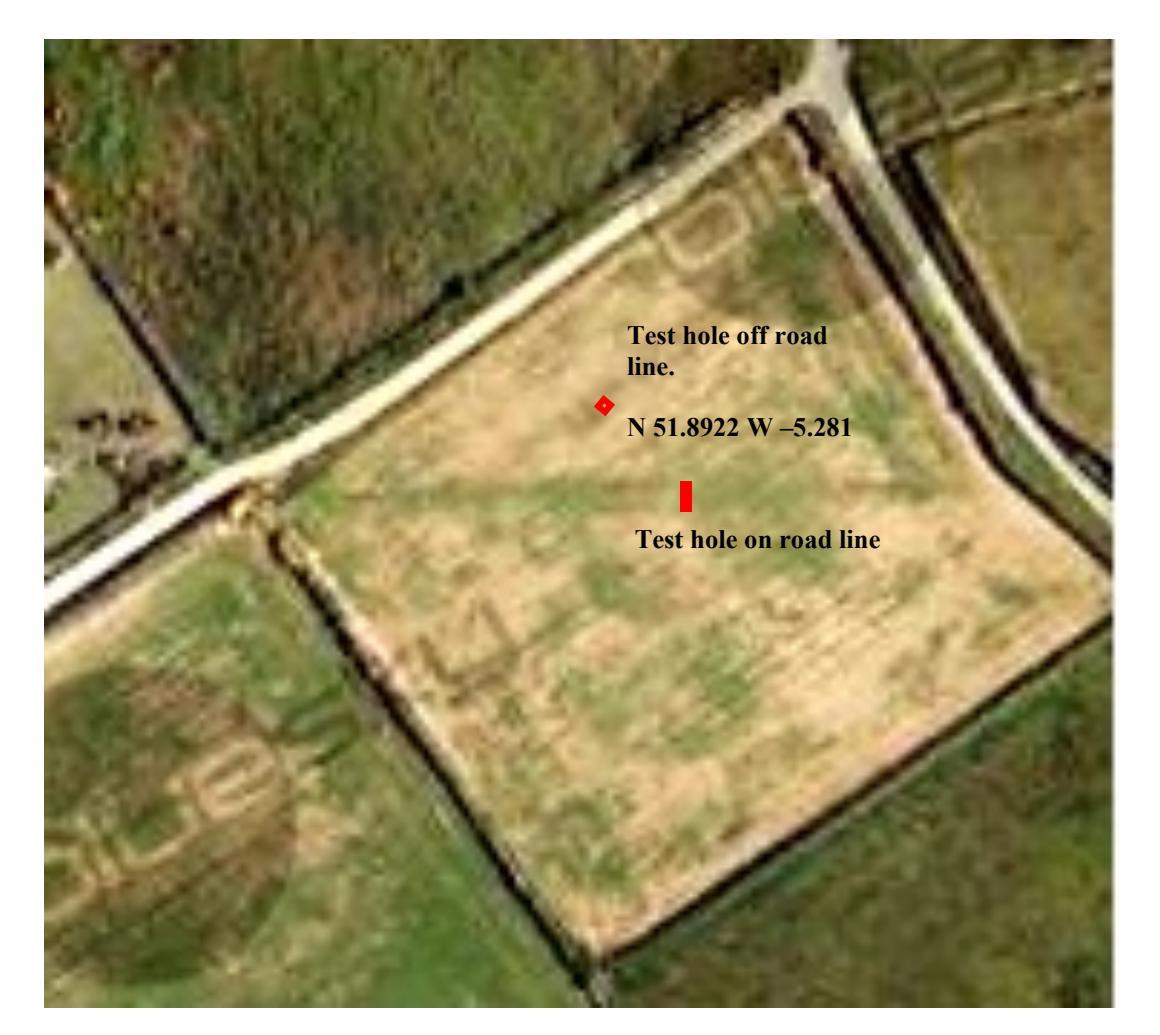
Unfortunately, permission could not be obtained for investigation on the large field, but Robin Elliot of Porthllisky farm very kindly gave permission to probe the smaller square field (below) for evidence of a road.

Intially, this was done by repeatedly pushing a rod down into the sand and feeling for resistance. This was a bit hit and miss, because there were loose stones below the surface, but eventually, a test hole was dug in the most promising location. This revealed a hard surface with stones 270mm below the surface. A 'control experiment' was then carried out well off the line of the road to confirm that a similar surface was not encountered everywhere in the field. This revealed two different coloured layers of sand with a sharp dividing line between. The top layer of dark sand was 190mm down from the surface. Below this a more orange-yellowy sand continued down for an unknown depth. There was no hard surface and a road along the line was thus more likely.

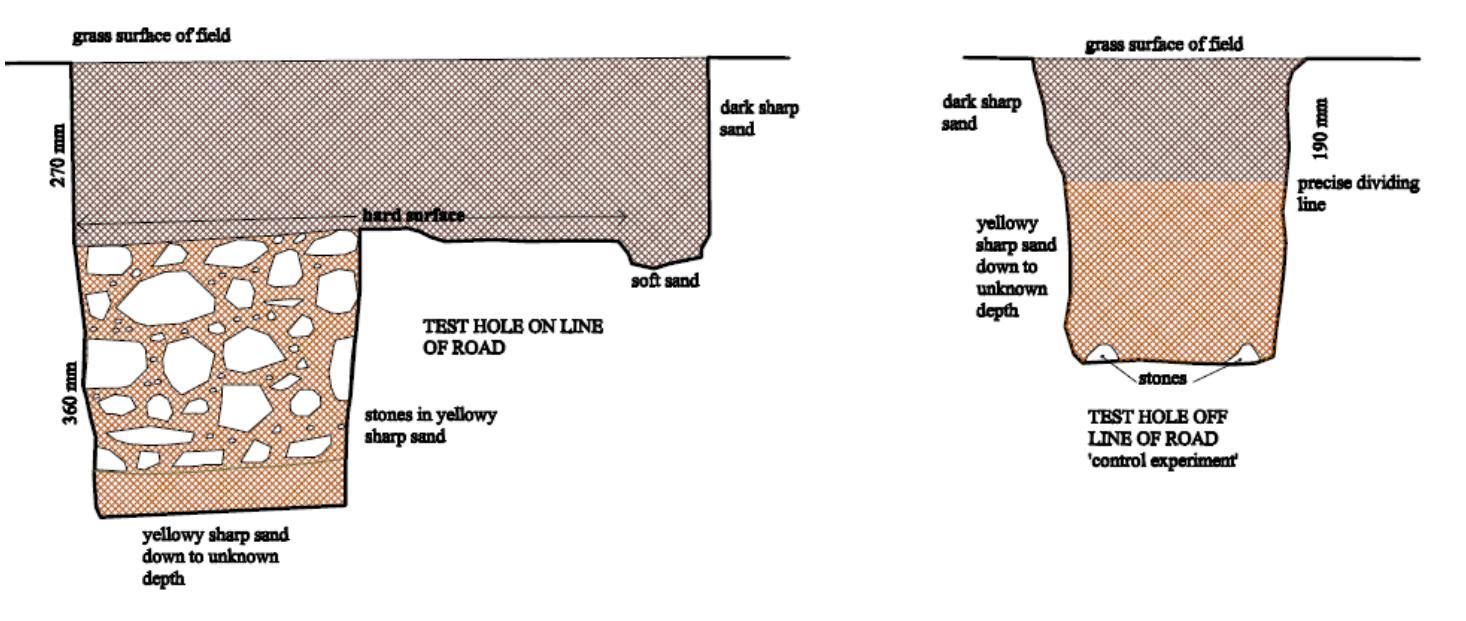
A construction hole was then dug through the initial hole in the road line, which revealed a 360mm thickness of stone and yellowy sand, perhaps 50-50 in proportion. Below this, clean sand of the same colour continued on down for an unknown depth.

The road test hole proved that a stone layer consistent with a road existed along the line of the crop mark. I suspect that it was patchy in terms of survival. It was built on the orange-yellow sand.

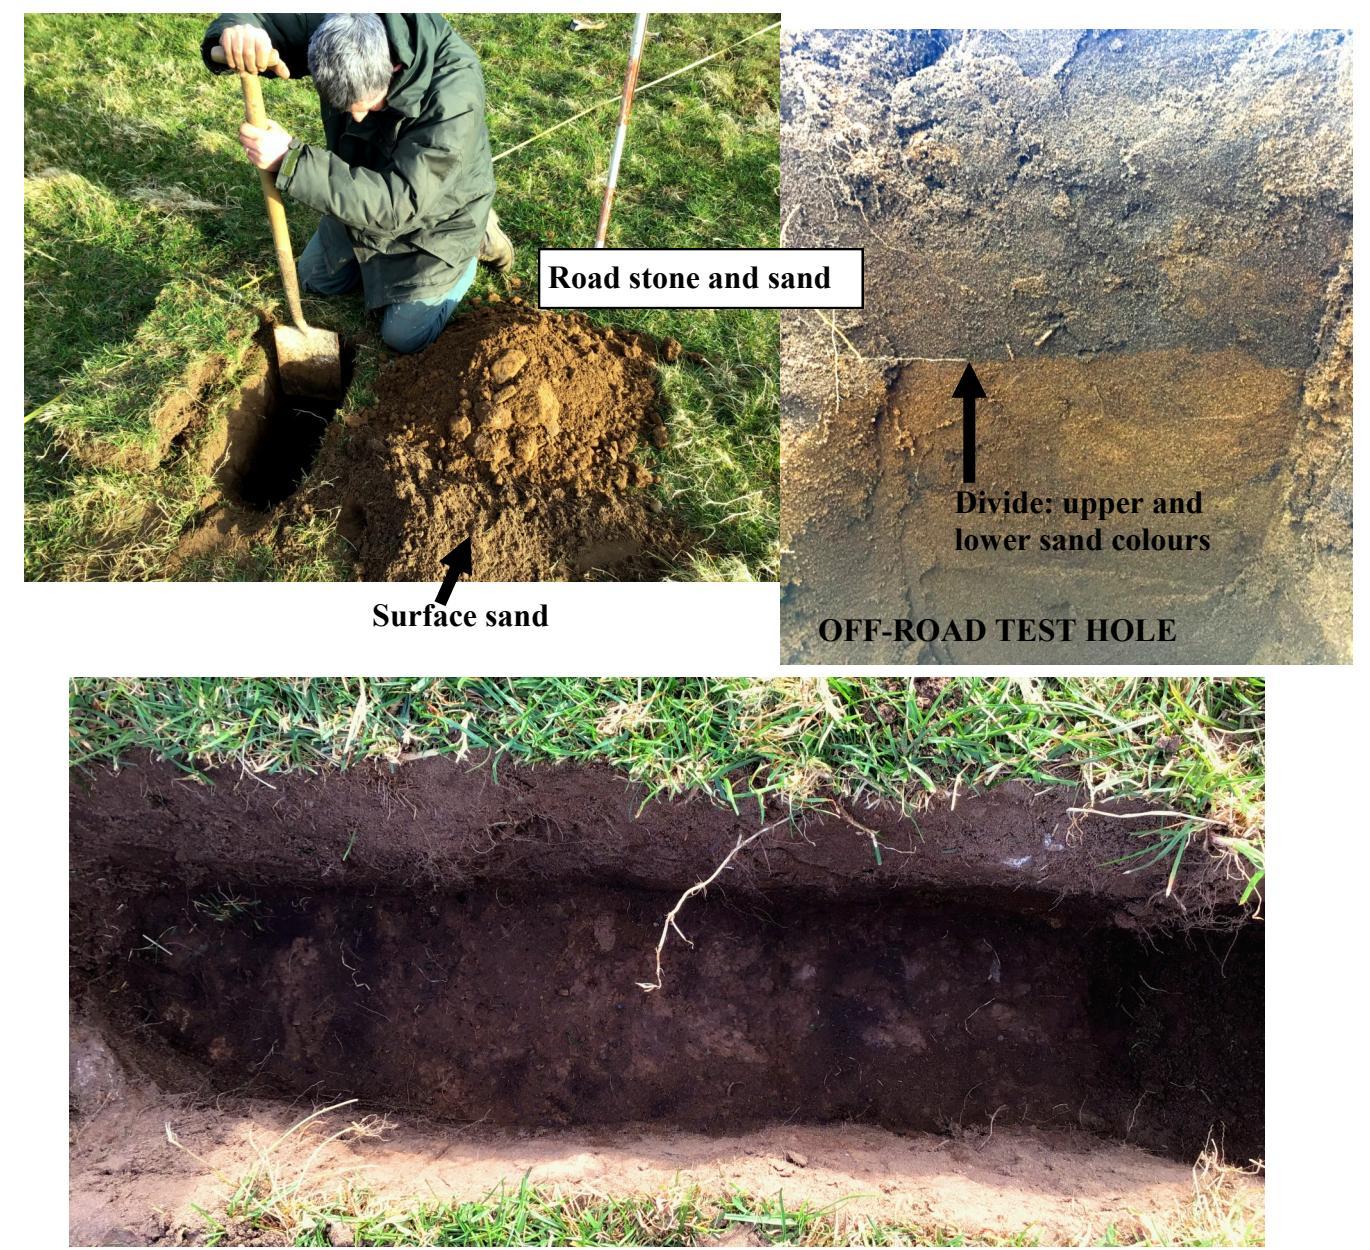
ROAD SURFACE

An attempt was now made to establish the width of the road by prodding the soil with the steel rod. This was not successful, possibly because the rod was striking stones below the surface.

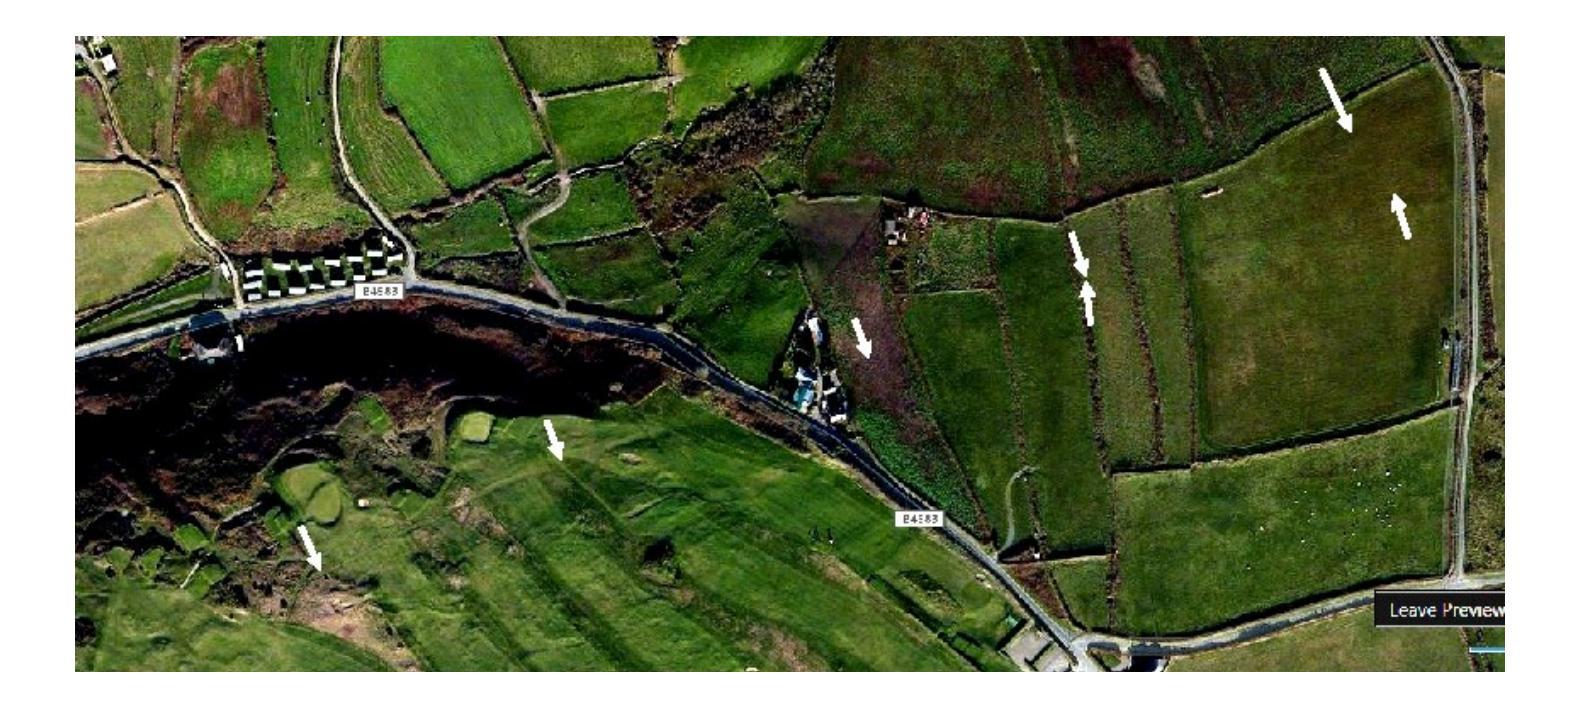
SM 736 270

This line was spotted 5 years ago and was thought potentially to be the termination of Flemish Way at Porth Mawr (Whitesands). East of the golf course, it crosses the present road, goes straight through Ffynnon Faiddog and then splits into a fork as it heads east, with one branch headed towards Fishguard and another towards the Preselis. The investigation of the possible road was carried out on the rough of the golf course at the westernmost arrow in the aerial view above.

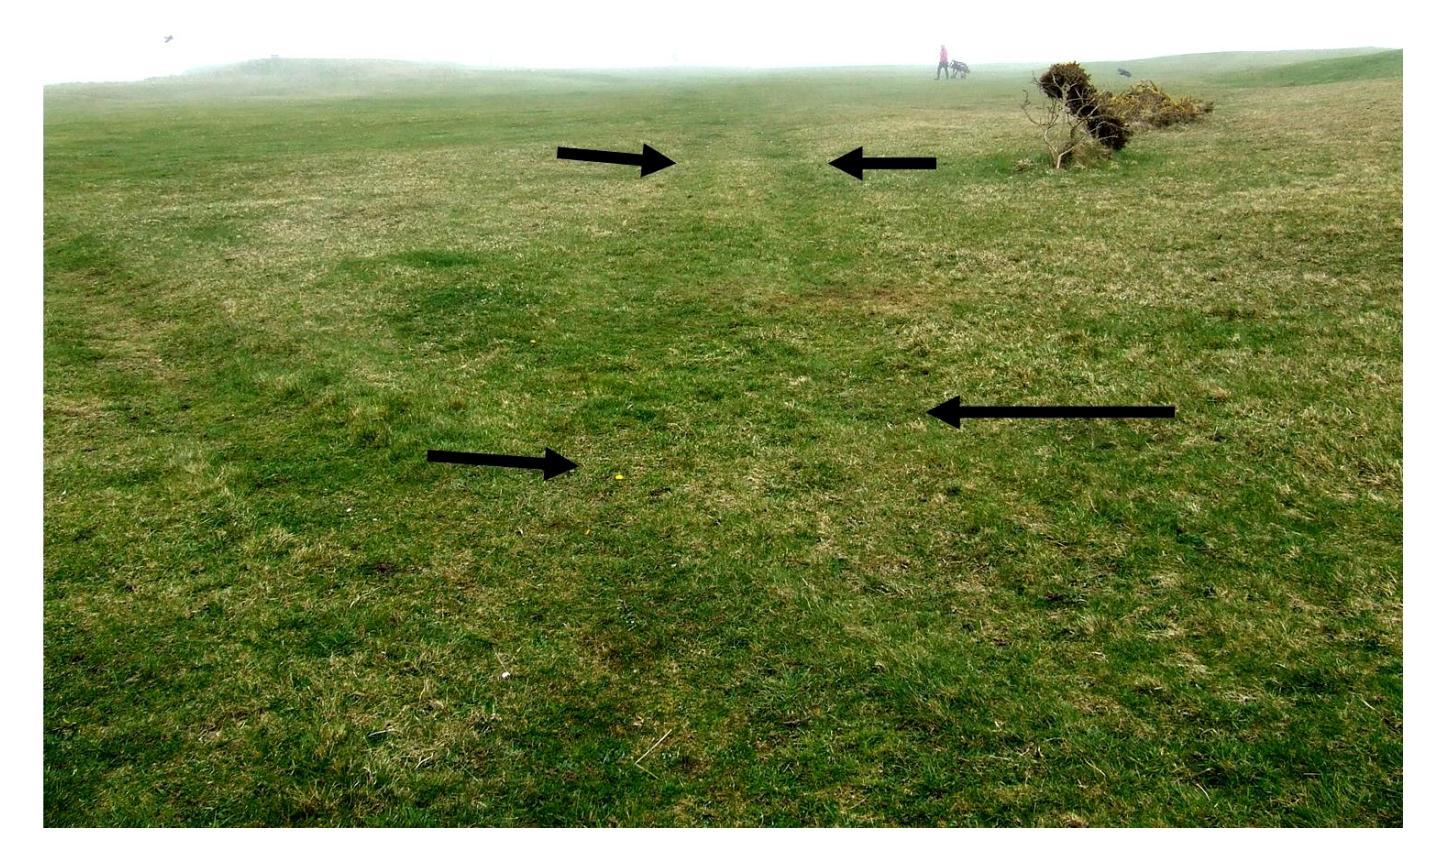
Once we reached the location at 51 deg 53' 47", 5 deg 17' 34", it became immediately apparent that this was indeed a road or track running through the golf course and the photo below shows it

looking east from the trial hole site, which was off the fairway on the rough. Phil the groundsman assured us that he never went along it on his mower.

The initial road hole went down through 280mm of sand to a hard layer of gritty clay. We expected on digging further to reach a road construction of stones, but this did not happen. Instead, the initial layer very soon (perhaps in 25mm) gave way to clay-shale, and ultimately shale until we reached a depth of 730mm and went no further. We then made a test hole, the 'control experiment', off the line of the road, and found a similar hard surface with shale below, 170mm down.

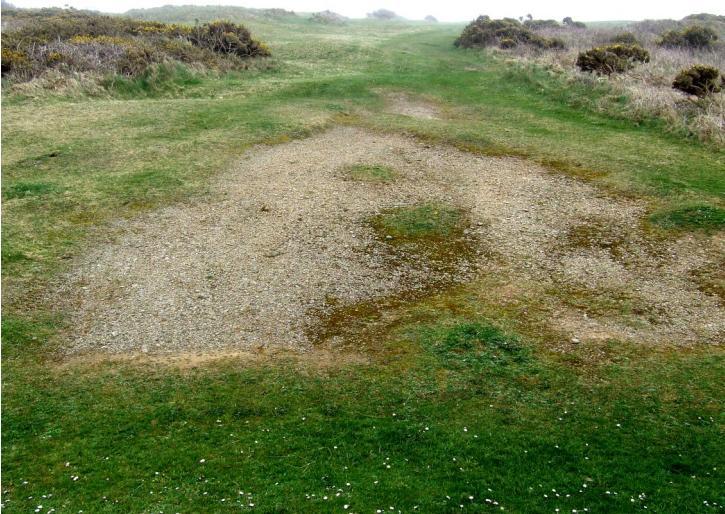
Further probing and test holes in the quarry area, about 180 metres SW of the road hole, and off the golf course, revealed in the low ground between dunes exactly the same hard layer 8-10" down from the surface. The dunes themselves reached a considerable height, and were of the same grey sand; but almost certainly, a hard plane with a gritty surface and deep shale below it was passing below everything. In other words, yes there was wind-blown sand, but it was only deep where the dunes were. In between them, and on the golf course, it was shallow. In the photo below, the hard

plane can be seen appearing at the surface. Also prevalent off the golf course were boulders apparently sitting on the hard layer and embedded in the grey sand.

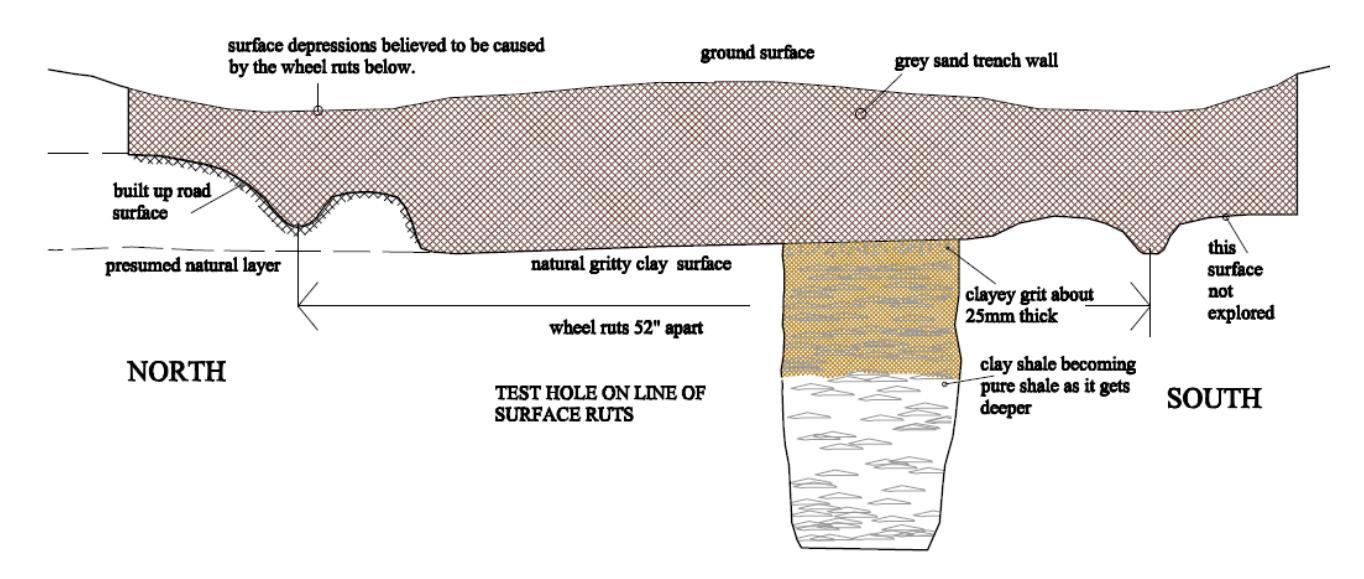
The road was therefore something of a mystery, because it was quite obviously a road or track, but there was no construction layer, only the natural hard surface. Could it be that it was considered unnecessary to build a road because everywhere was a natural road? The only way to gain any more insight was to do a wider test hole below the shallow surface ruts. This revealed quite a surprise. The uncovered surface was imprinted with precise cart ruts to a narrow gauge of 52".

On the north side was a built-up stony surface which trowelled as a road, came very close to the ground surface and was maybe 6" above the hard natural grit plane which ran through the site. It seems that the rest of the section had been worn down to the hard natural layer by the hooves of a draught animal. The initial deep test hole has been shown here for clarity, but it was actually made a couple of feet west of the wider hole in the same line. It seems to show all natural material, and if we had dug deeper, I believe we would have hit rock. Had we not widened the hole width, we would not have found evidence of a road construction.

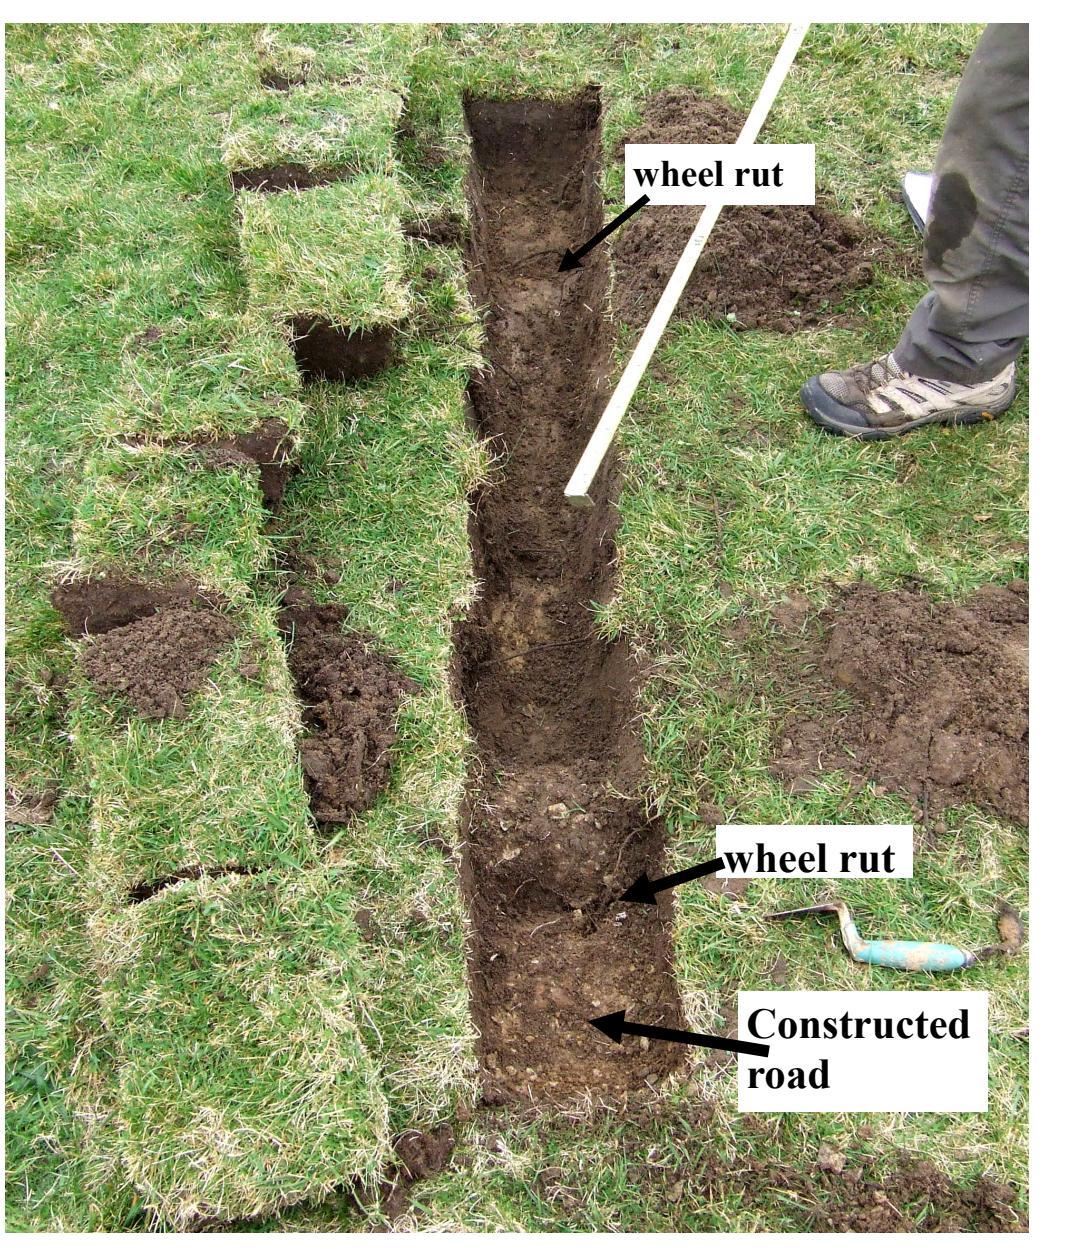
RUTTED ROAD SURFACE BEING UNCOVERED

Looking south

The strongest argument for this being an ancient road, for me, is that it lines up with the line on the fields E of Ffynnon Faiddog. The wheel ruts, being under the sand, appear to have existed before the wind-blown sand events, and I am not persuaded, though I keep an open mind, by the WW2 scenario. If this is a built-up metalled ancient road, as I believe it is, its last use would appear to have been by a single property overlooking the beach with one cart who used it for a long time until the extreme storm events. The surface ruts may indicate its continued use afterwards, but for this to be the case, the road would have to have had boundaries, because otherwise it would have been lost in a sea of sand.
