### Glasffrwd, Strata Florida, Ceredigion

Archaeological Survey

Report No. 1232

#### June 2014

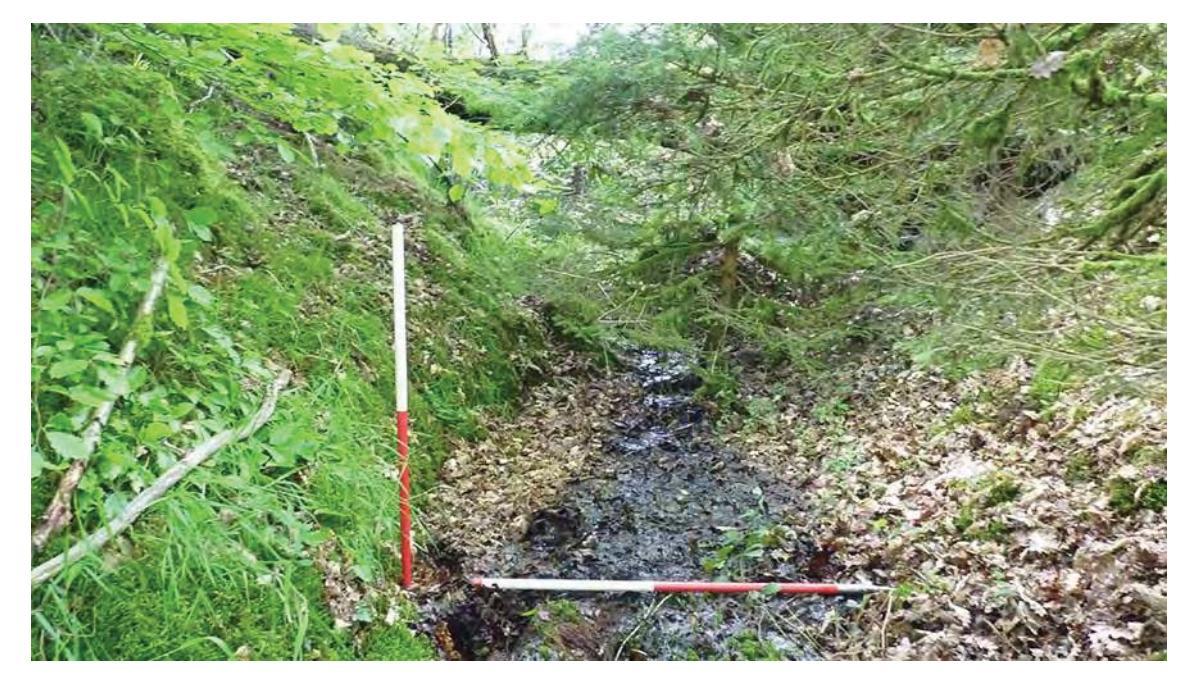
- 5.1.2 **No.1** consisted of a 2.3m wide, slightly concave, linear ditch or hollow running in a roughly N S to NE SW direction. The feature is faintly visible *c*. 6m from the south bank of the Glasffrwd. As the ground begins to rise *c*. 10m further to the south, the ditch or hollow becomes more pronounced. From this point the western side is formed by a vertical cut into the rising ground, 1m deep. The eastern side is formed by a shallower slope, cutting 1.1m into the rising ground. Large stones are visible in the rising ground on this eastern side, although it is uncertain if they are naturally occurring river boulders or deliberately piled stones. This feature was traced a total of 24m to the south, before the route became too choked with undergrowth to continue surveying. However, the route is visible on Lidar imagery (Figure 7).

- 5.1.7 No.1 appears to represent a trackway that crosses the Glasffrwd via a ford, which is marked on the 1889 Ordnance Survey map, and continues northwards to meet the current road along the north side of the Glasffrwd. This route can be traced on Lidar imagery (Figure 7) extending in a south-westerly direction for some distance. On the north side of the Glasffrwd, the track appears to run along the front of the medieval Abbey precinct wall, and may therefore have been established by the Abbey to provide access to its extensive estates.

Photo 1: View south down a possible medieval trackway (No.1) at the NW end of the pipeline route. 1m scales.

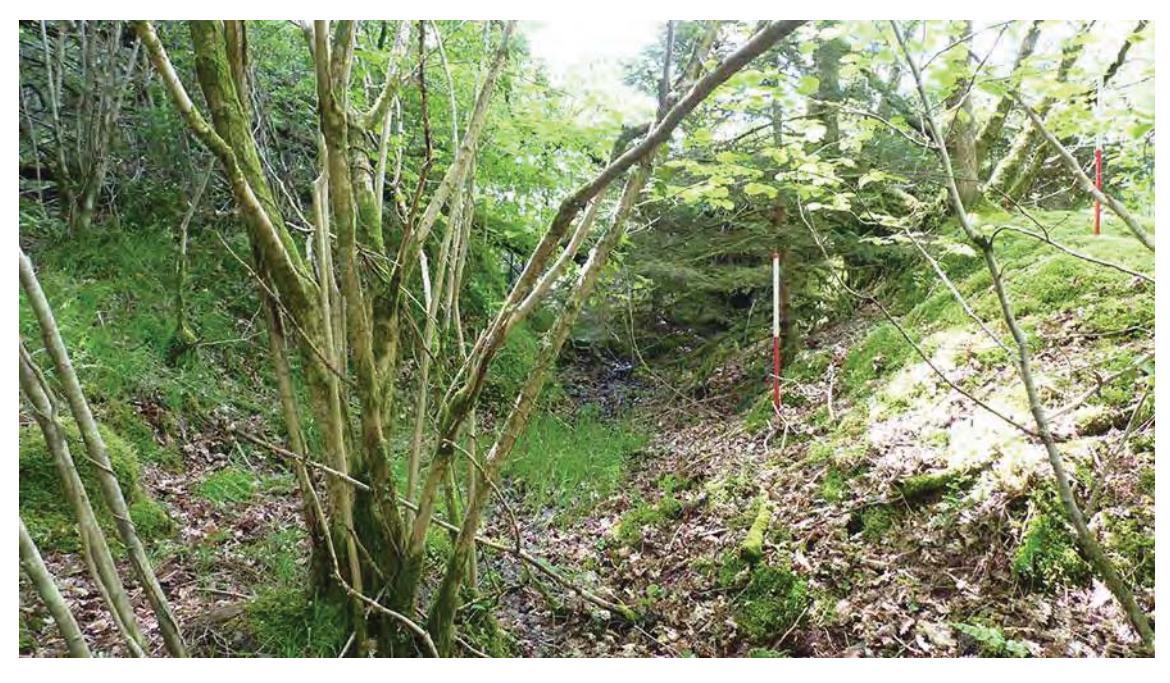
- 5.1.4 **No.3** lay 3.5m to the east of No.2, the two separated by a 1.6m to *c*.2m high bank, which has a vertical drop to No.2 on its western side, and a gentler slope down to No.3 on its east. The bank is vegetation covered, but appears to be a stone and earth bank rather than the remains of a collapsed wall. No.3 itself comprises a 2m wide ditch or hollow running in a north south direction in a relatively straight line, with a high bank on its western side and rising ground to the east. This ditch/hollow is first visible *c*.19.5m from the south bank of the Glasffrwd, its line lost on the low ground edging the river. As the ground begins to rise the ditch/hollow can be traced for *c*.28m, with slight kinks in the line, possibly due to bank collapse or fallen trees. Beyond this point, the ditch/hollow becomes shallower and begins to fade into the thick undergrowth, although the route is visible on Lidar imagery (Figure 7).

- 5.1.8 Similarly, given its comparative width, No.3 also appears to represent a trackway. It appears to be flanked by a bank, with a well-constructed drainage ditch cut along its western side (No.2). It is also visible on the 1<sup>st</sup> edition Ordnance Survey map and the Lidar image. The Lidar image shows the feature continuing for some distance to the south (Figure 7). The Ordnance Survey map, however, does not mark a trackway, instead it depicts a field boundary following the same route. Clearly this feature was used as a boundary during the later post-medieval period, although the possibility remains that it was used as both a trackway and a boundary during the medieval period. Its location, and the considerable resources clearly expended in creating it (which would be unusual for a simple post-medieval field boundary), gives a strong indication that it was monastic and origin and formed part of the Abbey's extensive estates.

Photo 2: View south down remains of one of the trackways (No.3) at the NW end of the pipeline route. 1m scales.

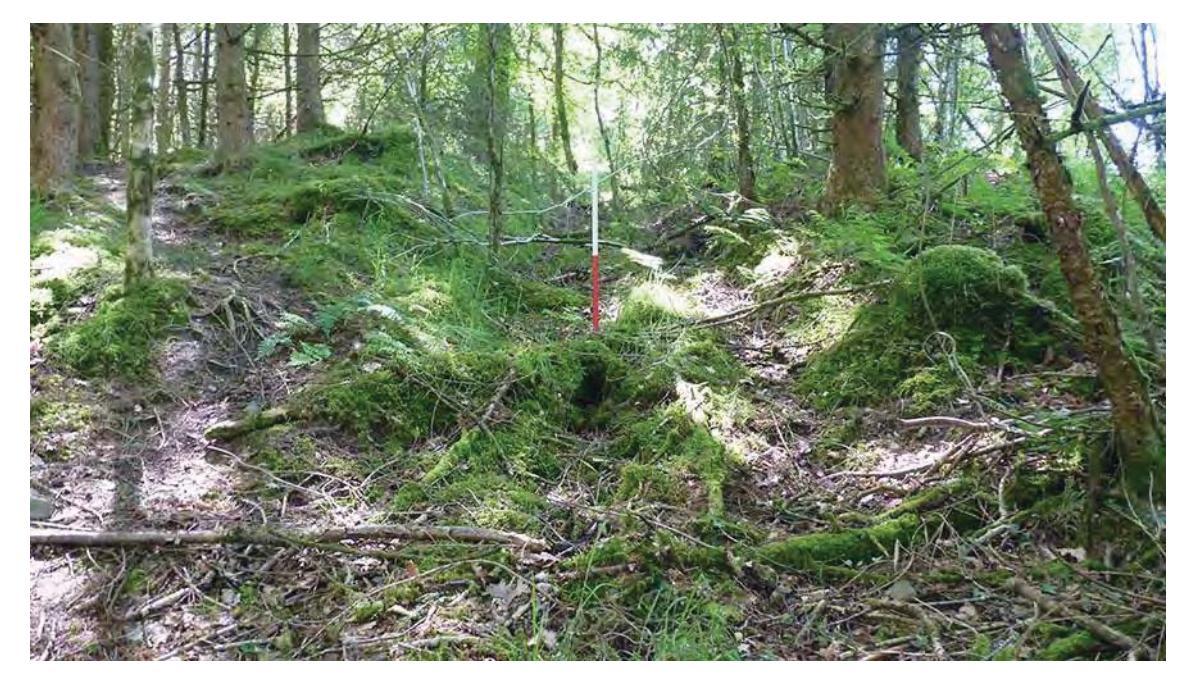
- 5.1.6 **No.5** meets No.4 at the point where the two become visible in the natural rising ground. It runs in a slightly more SSE direction than No.4 and extends further before fading out on higher ground where there is a pine plantation. This ditch/hollow is formed by a flat-bottomed ditch, 1.7m wide, with relatively steep, slightly convex, edges.

- 5.1.9 Although slightly smaller and more indistinct Nos.4 & 5 may also be remnants of trackways leading onto the higher ground on the eastern side of the main trackway / boundary represented by No.3. The Lidar image appears to pick up the line of No.5 running for a short distance into the woodland. The woodland comprises a 20<sup>th</sup> century pine plantation, and modern ridges and drainage channels associated with it are clearly visible on the ground in the area. This raises the possibility that these smaller trackways may be associated with later woodland management activity.

Photo 3: View south down a trackway (No.5) at the NW end of the pipeline route. 1m scale.

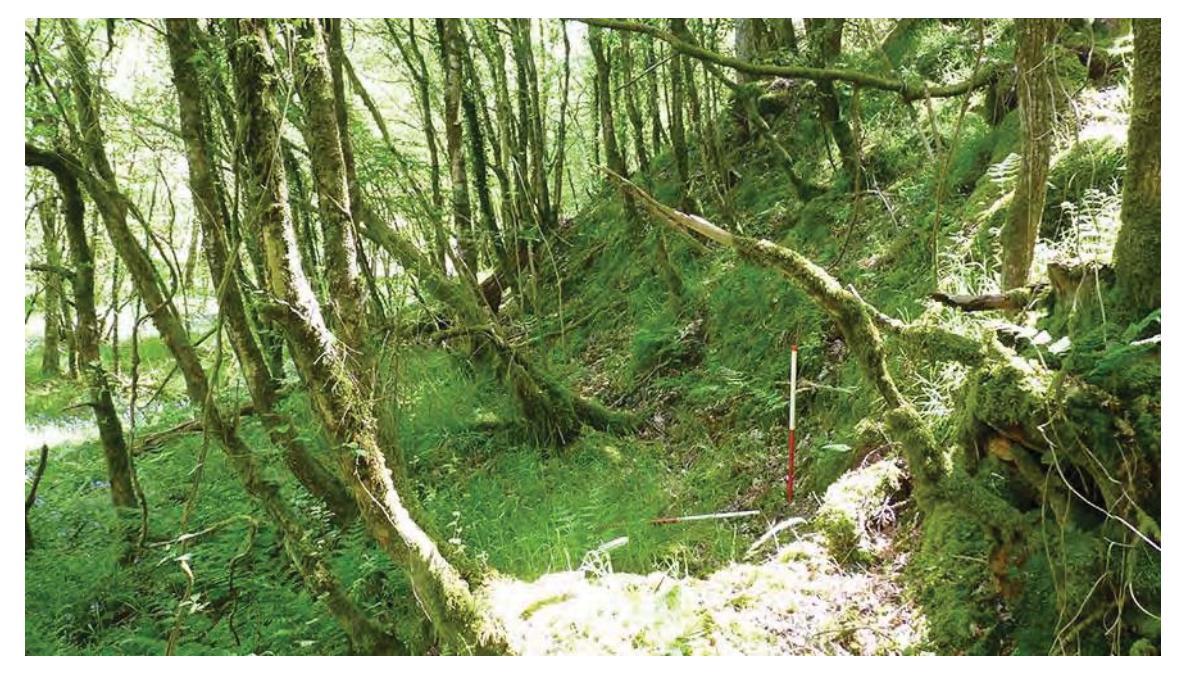
- 5.2.1 A short distance to the southeast, as the ground rises sharply *c*.30m to the south of the Glasffrwd, a leat is visible cutting into the contours of the rising ground. The leat itself is *c*.2m wide and visible as a slightly concave, near level, depression cut into the hillslope, which is now covered in vegetation. The line of the leat is traceable to the point where it is fed by the Glasffrwd to the southeast, up to an area close to the earthworks described above. At this point the line of the leat was lost amongst the various drainage features associated with the pine plantation, however a recent survey undertaken by the RCAHMW, commissioned by the Strata Florida Research Project, was able to identify and trace the line of this leat continuing in a westerly direction, its line taking it further away from the banks of the Glasffrwd.

5.2.3 Although the leat is not marked on late 19<sup>th</sup> or 20<sup>th</sup> century mapping for the area, on consideration, it is most likely to have been built in association with 19<sup>th</sup> century mining activity.

Photo 4: View SE along the post-medieval leat towards the NW end of the pipeline route. 1m scales.

6.7 The line of the pipeline will, at some point, cross the line of the leat at the NW end of the route. This will only disturb a small section of the overall leat, while the best preserved remains, at its intake from the Glasffrwd, will remain undisturbed by the proposed works.

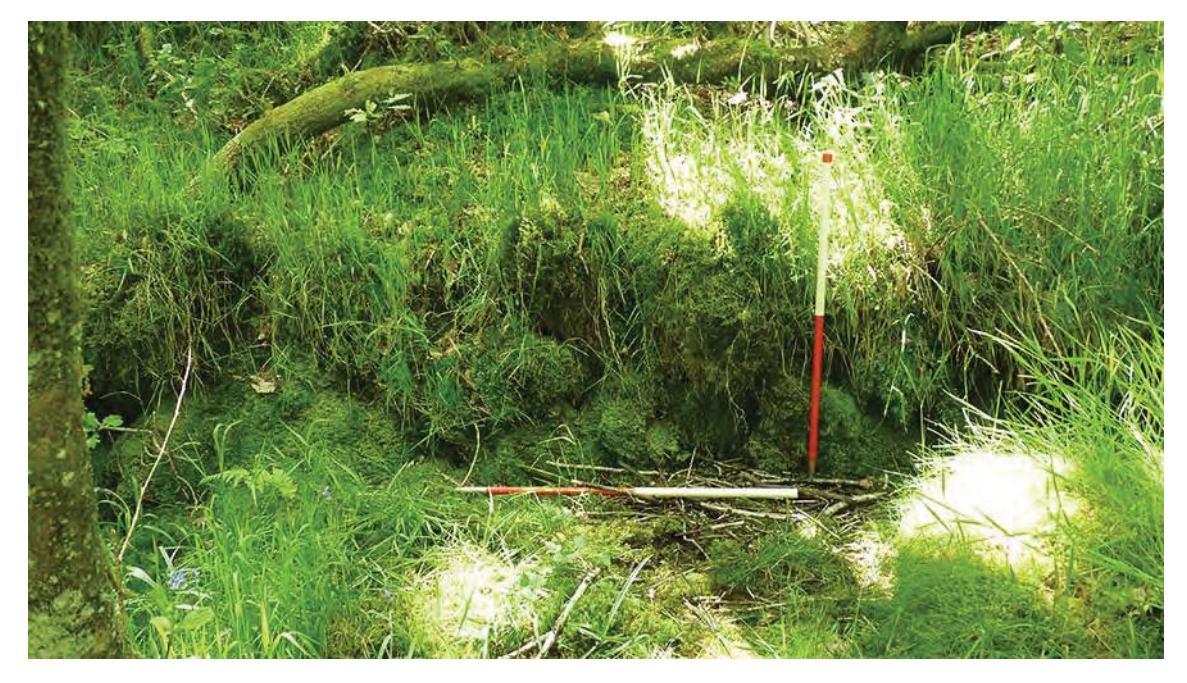
- 5.2.2 At the point where it is fed by the Glasffrwd, the leat is visible as a squared, rock-cut, feature with straight vertical edges and a flat base, 0.9m wide. It is flanked on its northern side by a 2.4m wide bank fronted by a dry-stone built wall that faces the river, 0.7m high. This wall runs along the edge of a rectangular bay cut into the south-western bank of the Glasffrwd, measuring 4m long, and 2.8m wide, cutting back into

Photo 5: View SW at the post-medieval leat, at the point its intake point from the Glasffrwd. 1m scales.

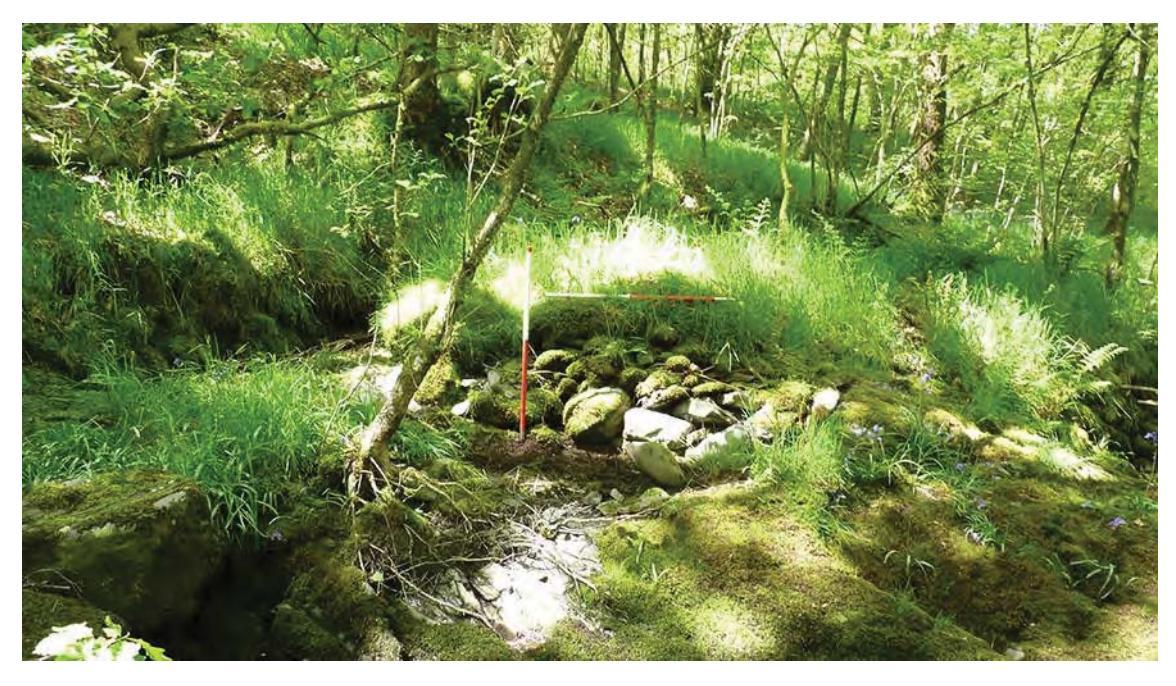
Photo 6: View NW showing the leat intake on the left, with the scales lying on the dry-stone wall revetted bank between the leat and the Glasffrwd.

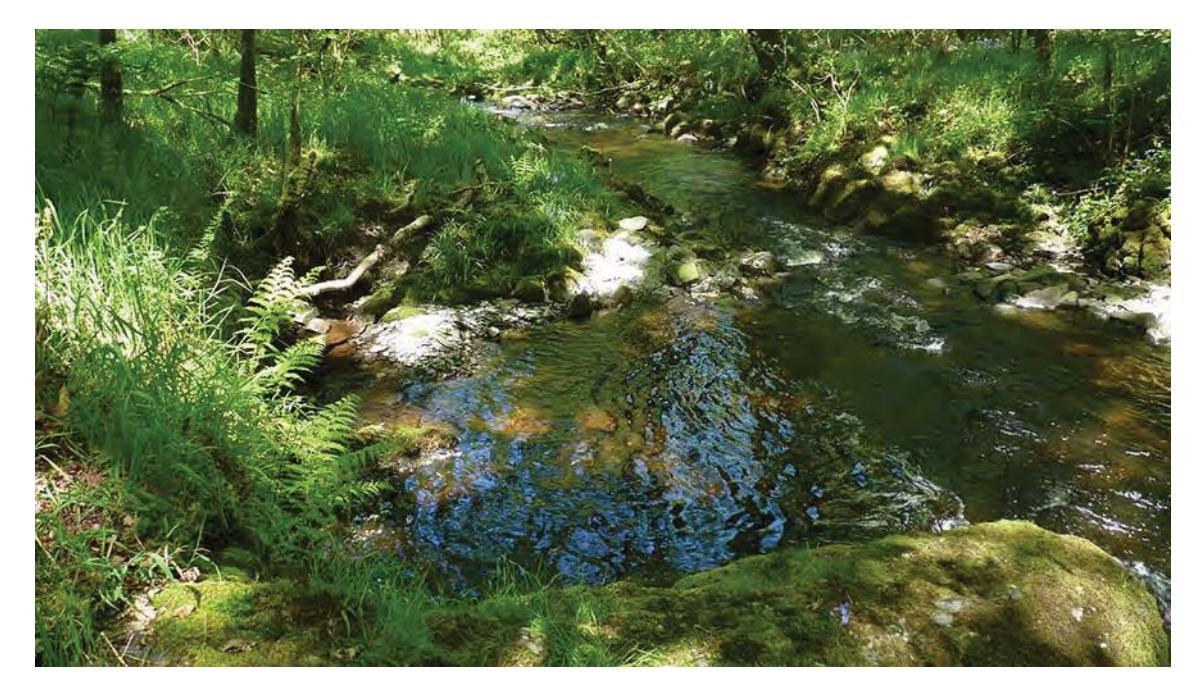
the south-western bank. The water pools in this bay, opposite which, on the northeastern side of the river, a channel is cut into the rising ground, end in what appears to be a partially in-filled mine adit. Immediately to the southeast of this point the banks of the valley close in and the Glasffrwd cuts through a rocky gorge.

Photo 7: View NW across the square bay cut into the western bank of the Glasffrwd next to the postmedieval leat intake.

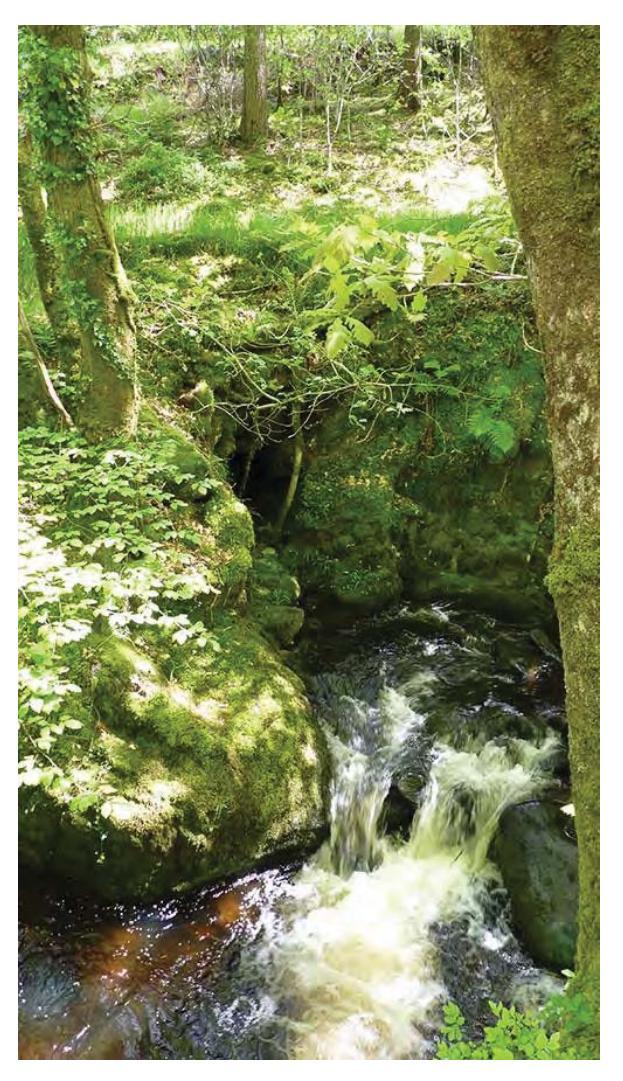
- 5.3.1 Roughly halfway along the route of pipeline, the Glasffrwd can be crossed via a bridge giving trackway access to Crofftau. At this point the Glasffrwd cuts relatively deeply into the bedrock, forming a small gorge in places. Roughly 60m to the south of the bridge, two opposing former mine adits are cut into the bedrock, close to the base of the gorge. These adits are recorded on the HER (PRNs 26622 & 36720), described as a minor post-medieval metal mine, comprising a level, with both entrances now infilled with stone. Due to their location at the base of the gorge it was not possible to record these adits in any detail, however, on the east bank of the Glasffrwd, above the area of the adits, a series of stone walls and trackway is visible.

Photo 8: View west of the mine adit (PRN 36720) in the eastern bank of the Glasffrwd.

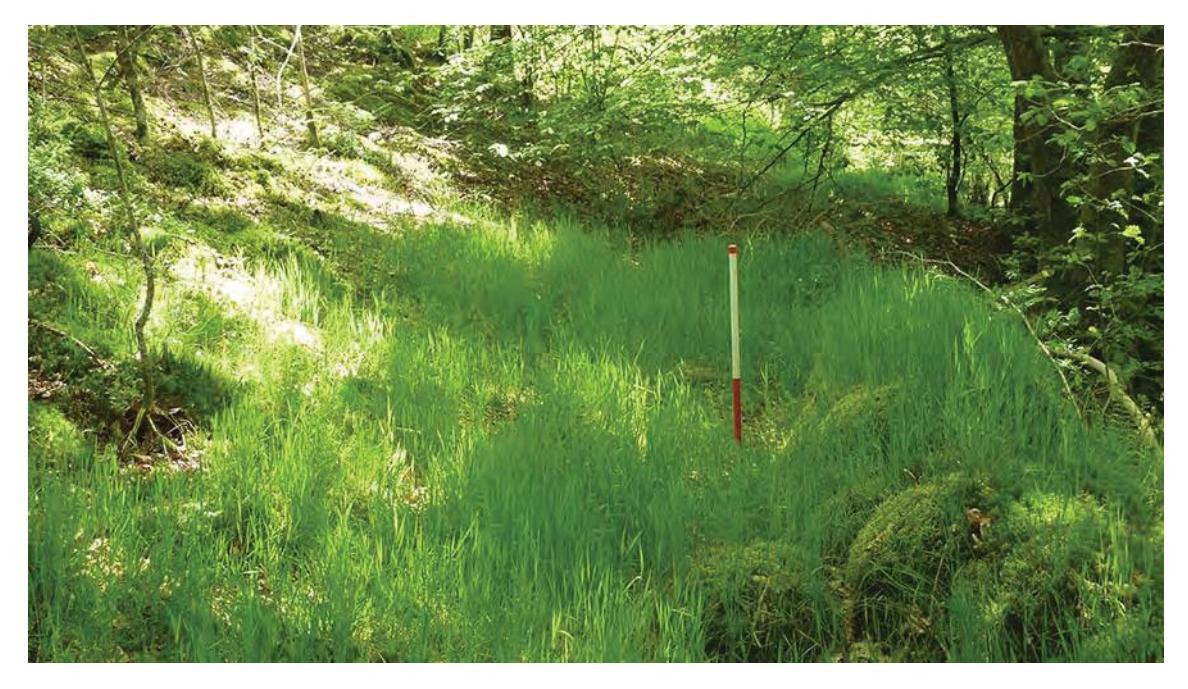
- 5.3.2 Running along the top of the eastern bank, behind the eastern mine adit is a trackway *c*.2m wide, cut into the rising ground. The track is now vegetation covered but a stretch *c*.15m long is clearly visible behind the mine adit. It appears to continue in sections along the banks of the Glasffrwd for a greater distance. It is flanked on its western, river, side by a stone wall, 0.9m high, built of unworked local stone bedded in clay and soil, partly tumbled in places.

5.3.5 Due to its location adjacent to the visible mine adits, the trackway, with its associated boundary wall, appears to be related to the use of the mine. It is difficult to say whether such remains represent a simple access route, or are part of a more extensive processing operation that would have been located above the mine. The 1889 Ordnance Survey map marks a footbridge at the point of the northern mine adits. Although neither the adits themselves nor the trackway is marked, the presence of the footbridge indicates that the trackway was still in use at that time. The trackway and adits, therefore, are likely to be later post-medieval in date, although a precise date is unknown.

Photo 9: View south along the trackway associated with the mining remains. 1m scale.

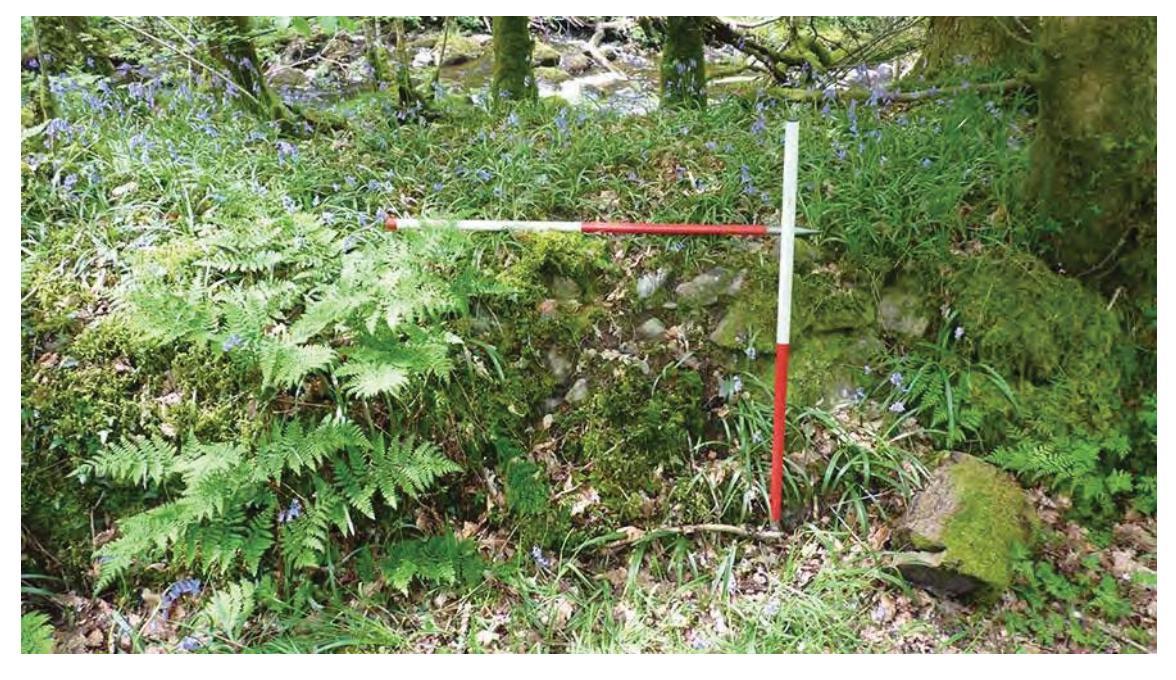
Photo 10: View west of a section of the wall between the trackway and the Glasffrwd. 1m scales.

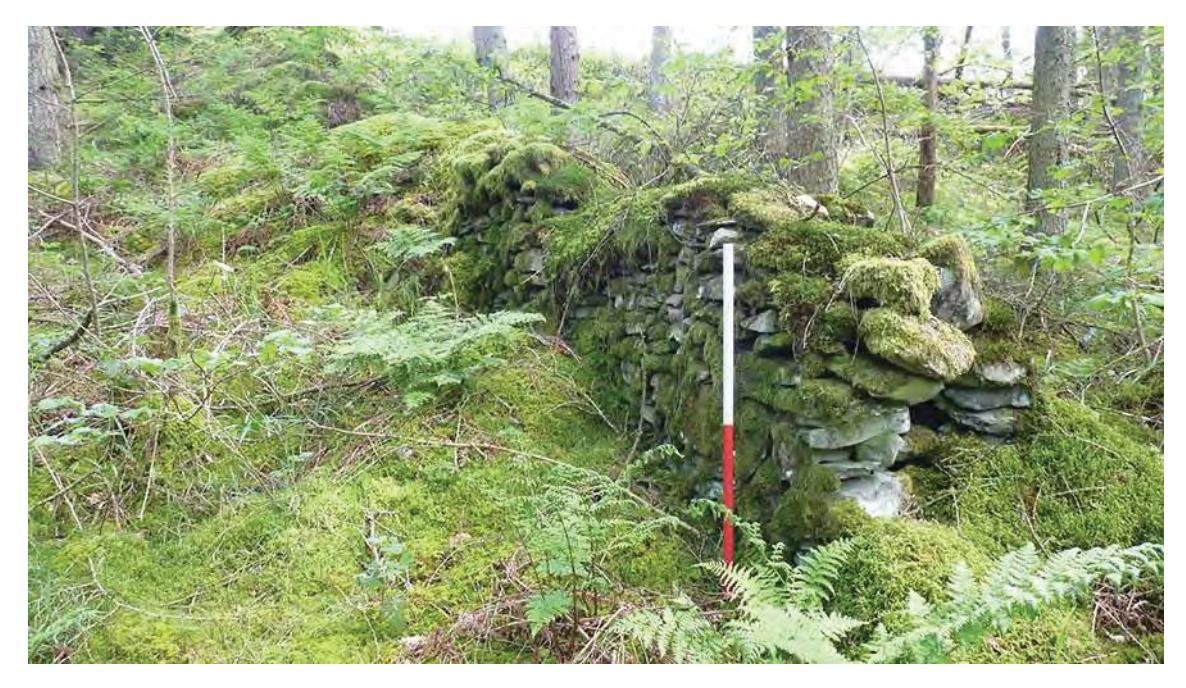
- 5.3.4 Another 20m beyond this point, a dry-stone built wall is visible, running east to west from the current road to the edge of the Glasffrwd. This wall is 1.1m high, 0.5m wide, and built of large blocks of unworked local stone. It continues the line of the field boundary visible on the opposite side of the road to the east.

5.3.6 The dry-stone wall to the south appears to be remnants of a post-medieval field boundary, and is shown on the tithe map of the 1840s and the 1889 Ordnance Survey map.

Photo 11: View SE of the field boundary wall to the south of the mining remains. 1m scale.

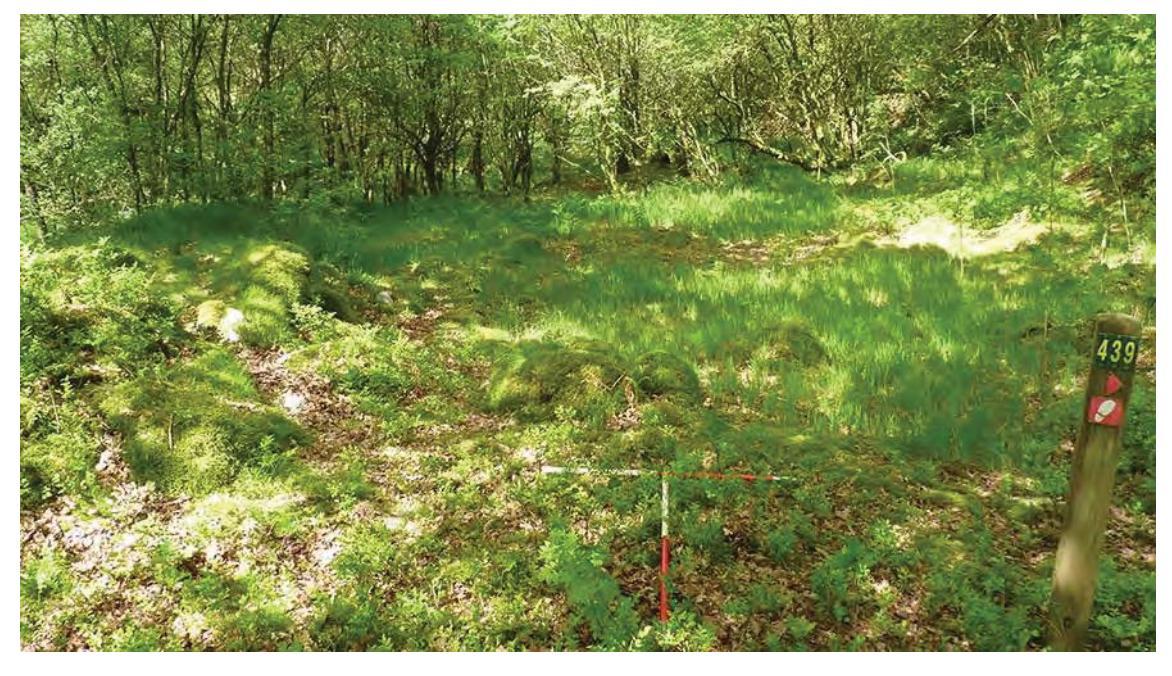
- 5.4.2 The site of the enclosure consists of an area of raised ground occupying the southern end of a low-lying river bank set within a curve in the steep eastern valley side of the Glasffrwd. This raised ground measures roughly 12m SE – NW by 17m SW – NE with an occasional large boulder visible on the ground amongst a covering of low vegetation. The north-western end of the area is defined by a 0.4m to 0.6m high bank of riverwashed stone. The height of the bank is measured from the lower lying ground to the northwest; the ground to the southeast is roughly level. The bank follows a curvilinear route. As it curves round to the southwest, close to the current banks of the Glasffrwd, a pile of large river-washed boulders is visible along its line. This pile measured 4.5m long, 3.4m wide, and is 1.1m high on its southwest (river-side) edge and 0.4m high on its northeast edge.

- 5.4.4 Although identified as a walled enclosure, its location within an area where the valleyside has been scoured out, taken in consideration with the presence of river-washed boulders along the curvilinear line of the bank, particularly along its north-western edge, gives the impression that this is a naturally occurring landform created by highenergy fluvial activity. There is little indication from any of the exposed stones of regularity or deliberate construction, although given its location adjacent to the river, and incidentally a short distance downstream from a confluence of the Glasffrwd with another large stream, any structural remains in this area are likely to have been badly affected by fluvial activity.

Photo 12: View NNW across the interior of the possible enclosure at the SE end of the pipeline route. 1m scales.

- 6.3 At the SE end, a possible enclosure may be disturbed by the positioning of the intake weir and pipeline. The route of the pipeline was marked out with stakes along the north-western edge of this possible enclosure. There is, therefore, a potential for any works associated with the laying and positioning of the pipe to affect this bank. Similarly, the weir intake will lie close to the edge of the possible enclosure, although it is unlikely to be located directly on top of features associated with it. What is unknown, at present, is the extent of the area that may be affected by ground disturbance associated with the construction of the weir intake. Any ground-breaking activity that results from associated work, such as site compounds and the movement and storage of materials and machinery, also has the potential to disturb archaeological features in this area. It should be noted, however, that it is not clear if the possible enclosure is of archaeological origin; the surveyors, for example, considered it a natural feature.

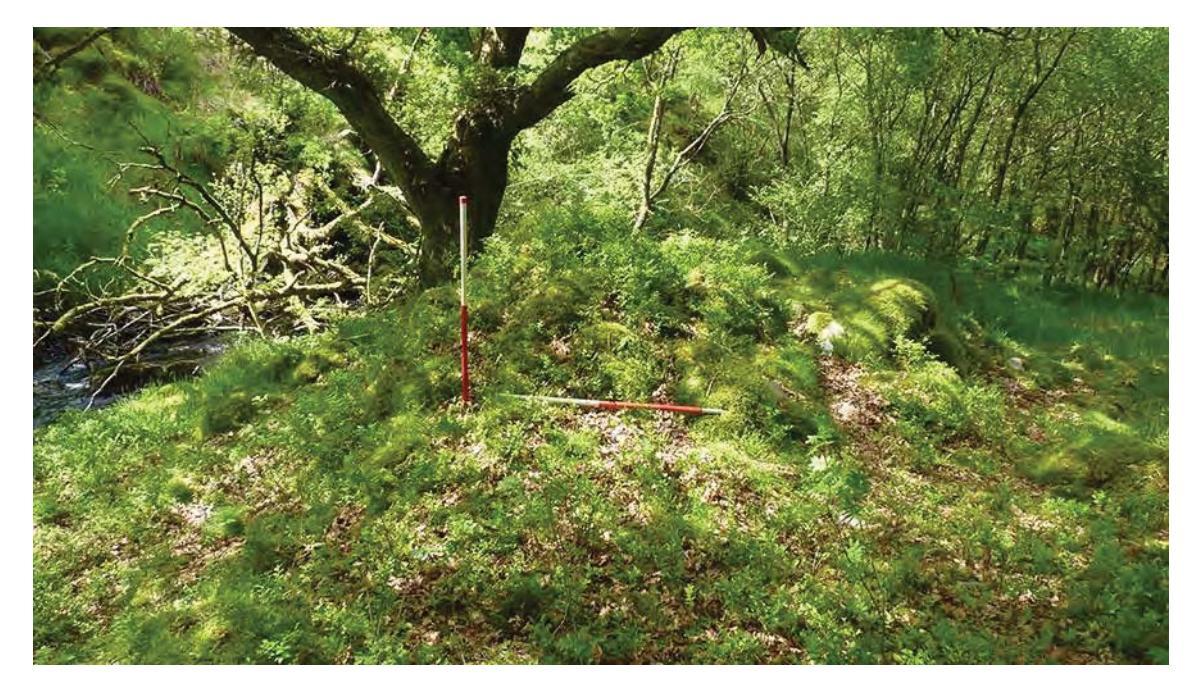
Photo 13: View NW across the pile of larger stones on the line of the possible enclosure boundary at the SE end of the pipeline route. 1m scales.

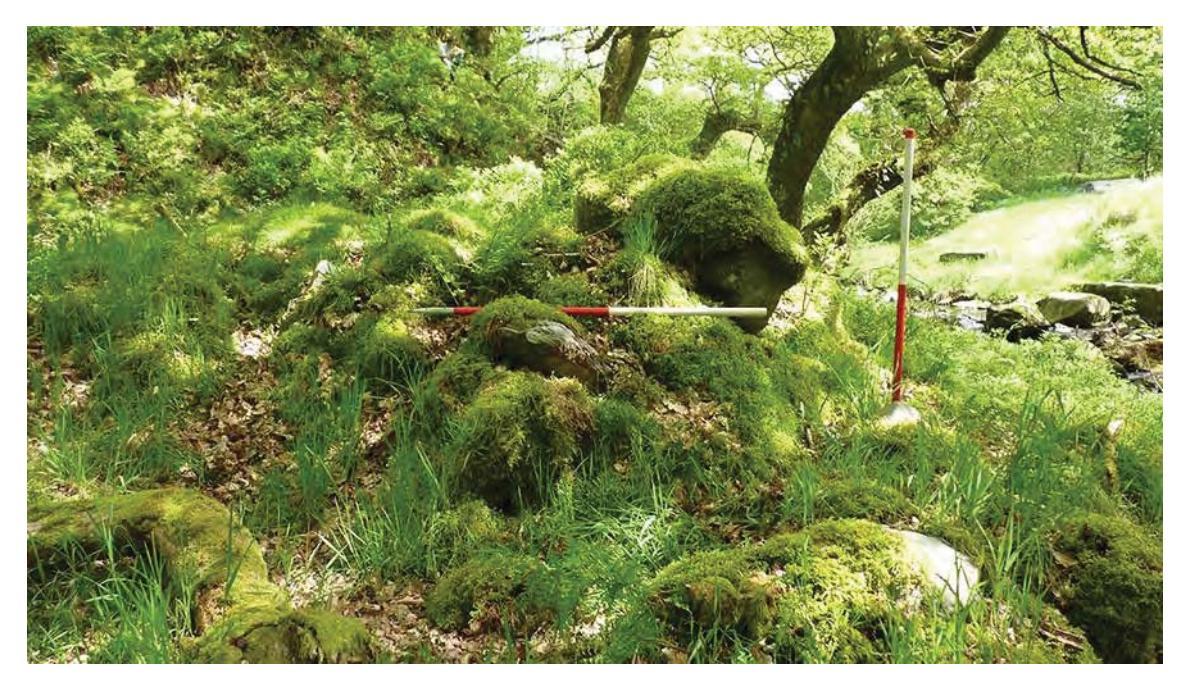
Photo 14: As above, taken in the opposite direction. 1m scales.

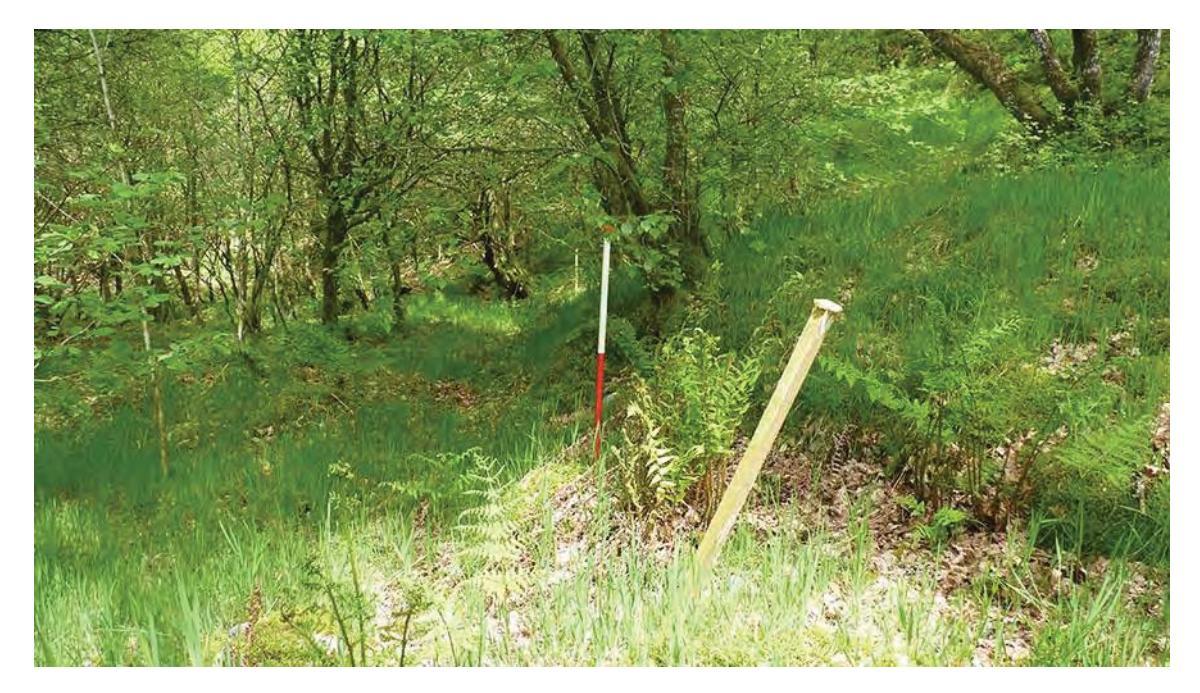
Photo 15: View NE along the NW edge of the possible enclosure, represented by the raised ground on the right. The wooden stakes mark the line of the pipeline. 1m scale.

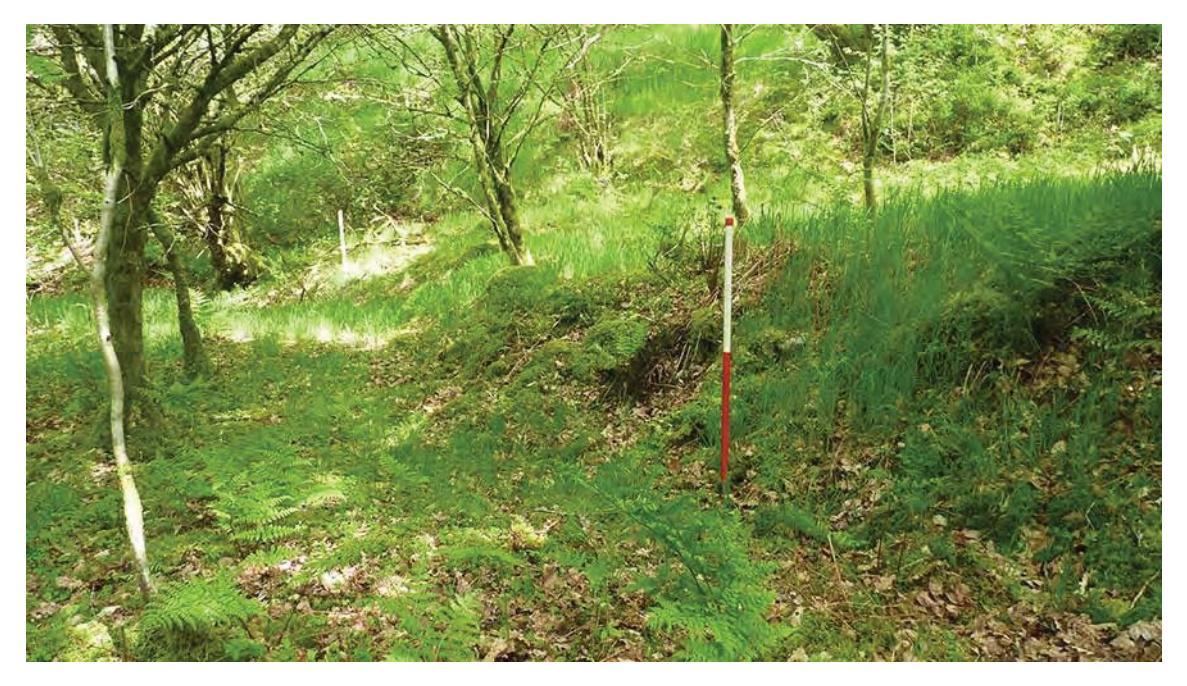
Photo 16: As above, looking east. 1m scale.

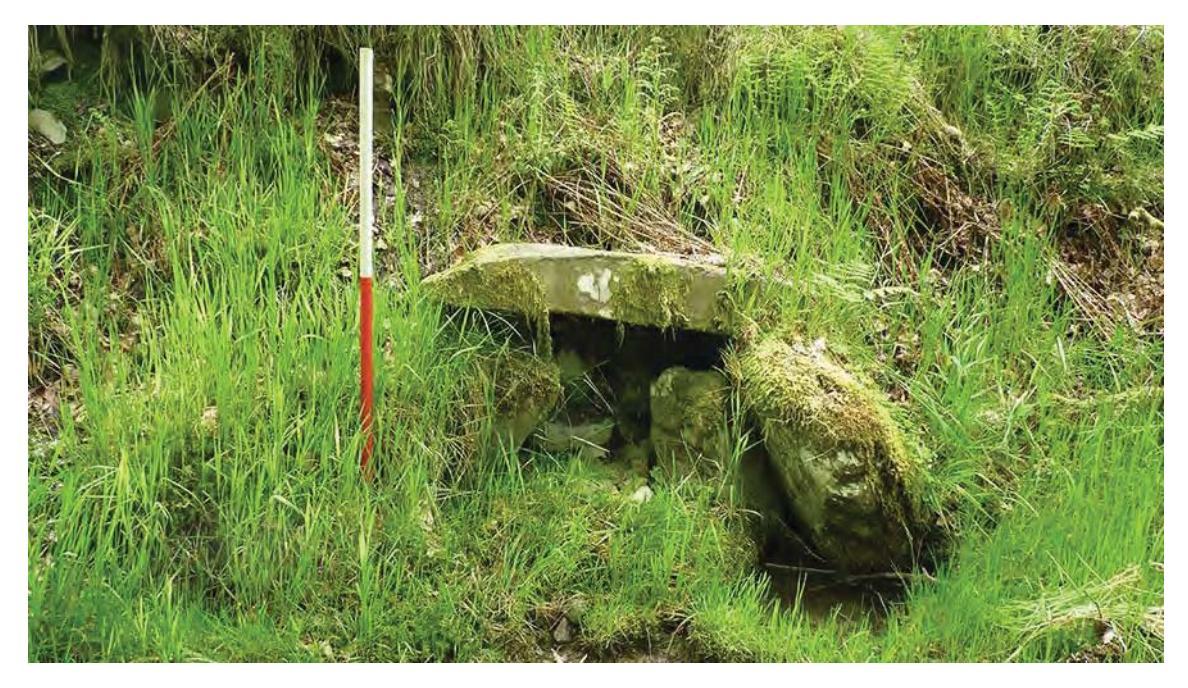
- 5.4.3 On the opposite banks of the Glasffrwd, at this point, are the remains of an apparent stone-lined culvert. The culvert consist of two very large, relatively flat, stones laid vertically, with a similarly sized capstone, enclosing an area *c*.0.5m square just above the current waterline. The culvert runs back into the riverbank, but the interior is blocked with collapsed stone.

- 5.4.5 The conduit is more obvious as a deliberately built structure, although the date of its construction and information on how it would have functioned in this location is unclear. Stepping stones across the Glasffrwd *c*.15m to the south demonstrate a degree of investment in a footpath through the area, but it is difficult to see the conduit being associated with this. It is of note that a medieval well (PRN 36494), renowned and visited for its medicinal qualities, which lies on higher ground *c*.170m to the west, is fed along a slate cistern and may therefore drain through a stone-lined culvert.

Photo 17: View SW at the stone-lined culvert close to the SE end of the pipeline route. 1m scale.

- 6.4 The stone culvert lies on the opposite side of the Glasffrwd and therefore should not be directly affected by the proposed works, although this will depend on the extent of the area to be disturbed during the construction of the weir intake.

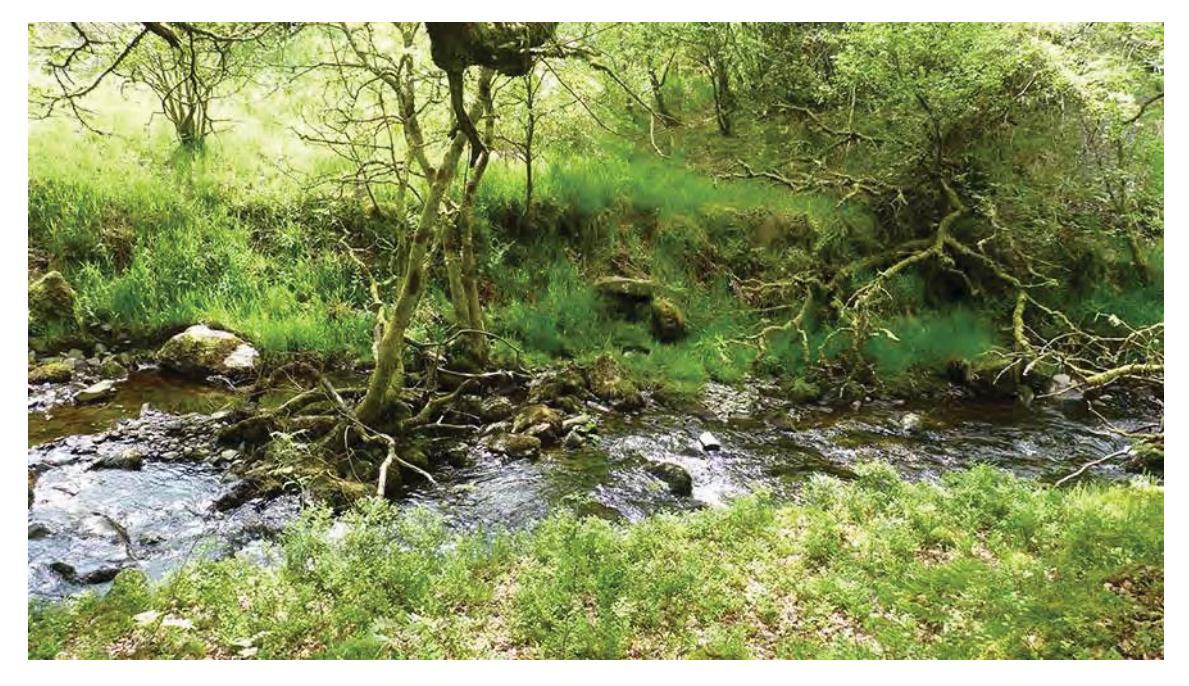
Photo 18: As above, showing the culvert in its setting.
