Cwm Rheidol Lead Mine, Ystumtuen - Adit 9 and Lagoon Works (Phase 1)

Archaeological Watching Brief

HRS Wales Report No: 242

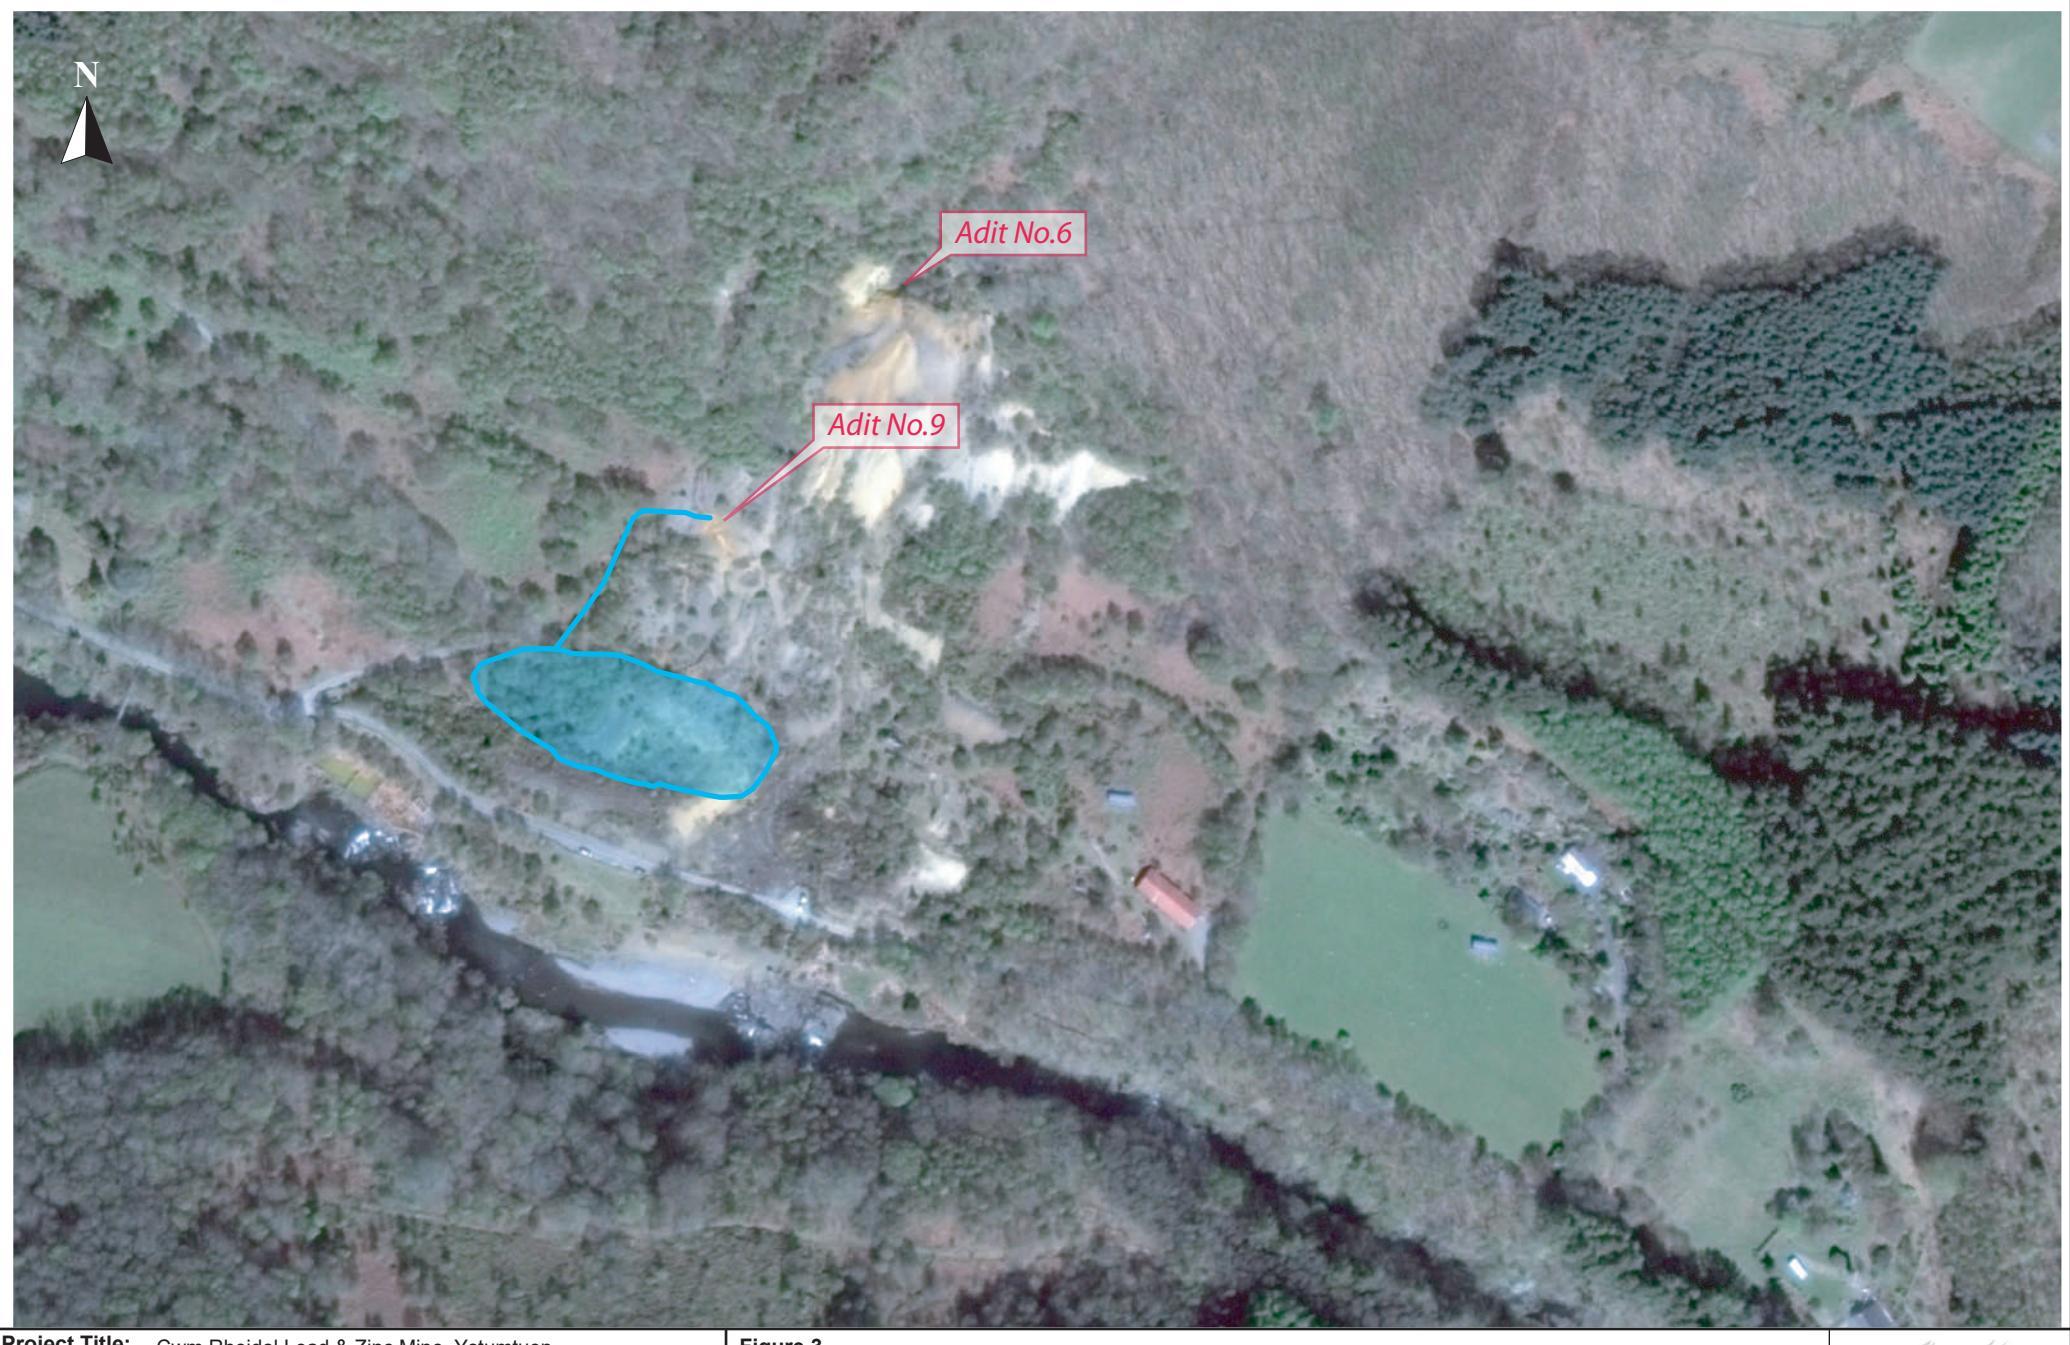
Project Title:
 Cwm Rheidol Lead & Zinc Mine, Ystumtuen.
 Figure 3.

Date:
 Approx. Scale (@ A4):
 OS Aerial photo (2014) within Cwm Rheidol Lead Mine showing Adits 6 and 9 and area of proposed extended lagoon and outflow pipeline.

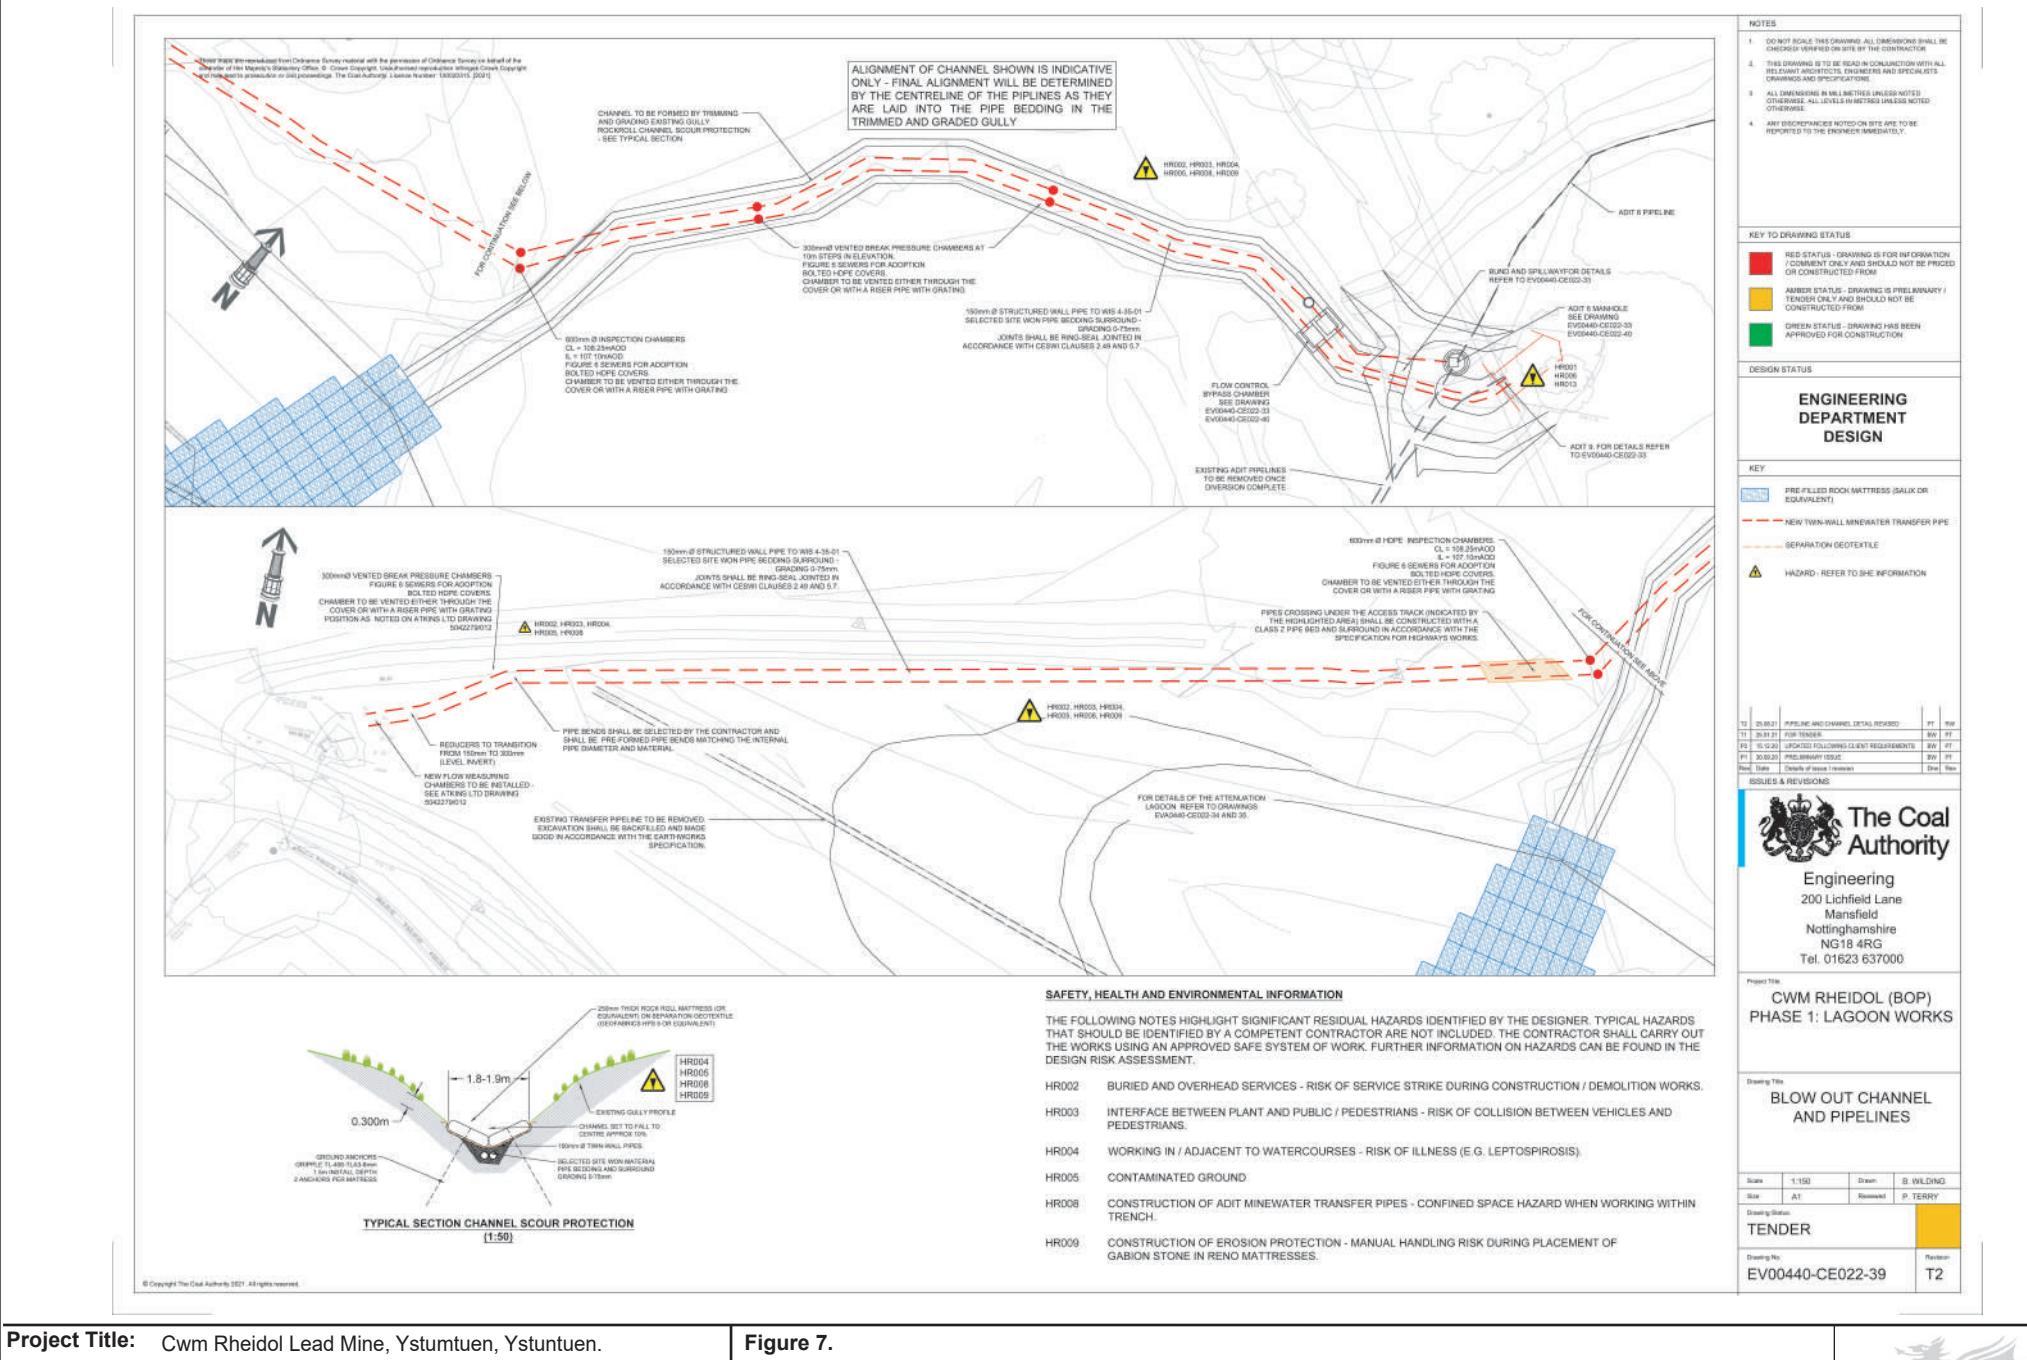
Proposed Adit 9 Blow-out Channel and pipelines

- *ii)* Adit 9 Portal Blow-out Protection Once the existing Adit 9 pipeline has been removed from the adit portal, a bund will be formed on either side of the portal from site won material and laid in 200mm compacted layers. The crest of the bund 1m wide and level to be 110.00mAOD. Once the bund has been formed, its internal sides will be lined with a concrete canvas which will be lapped under the Gabion mattress that lines the spillway and blow-out channel base. The newly formed bund and spillway will be enclosed with a realigned timber post and mesh fence that will help secure the adit portal.

- *Mine-water Transfer pipeline* Initially the existing Adit 6 pipeline will be diverted just above Adit 9 and reconnected to the new transfer pipeline. A manhole and a flow control chamber will be positioned just southwest of Adit 9. From here the pipeline will follow the route of an existing gulley/spillway positioned southwest of Adit 9, which will eventually run down-slope toward the proposed extension lagoon. The proposed transfer pipeline will be constructed from two 150mm HDPE twin-wall with ring seal joints at 6m spacing. The pipes will be bedded using site won material and will follow the topographical low point of the existing gulley. Across the channel/gulley invert will be placed rock-roll mattress for erosion/scour protection and laid down the full length of the blow-out channel. A series of vented break pressure chambers will be positioned in 10m steps along the pipeline. Where the pipes cross under the access track a class Z pipe bed will be used.
