Parc y Wern, Tufton, Pembrokeshire Watching Brief

Report by: Trysor

January 2013

Trysor Project No. 2012/257

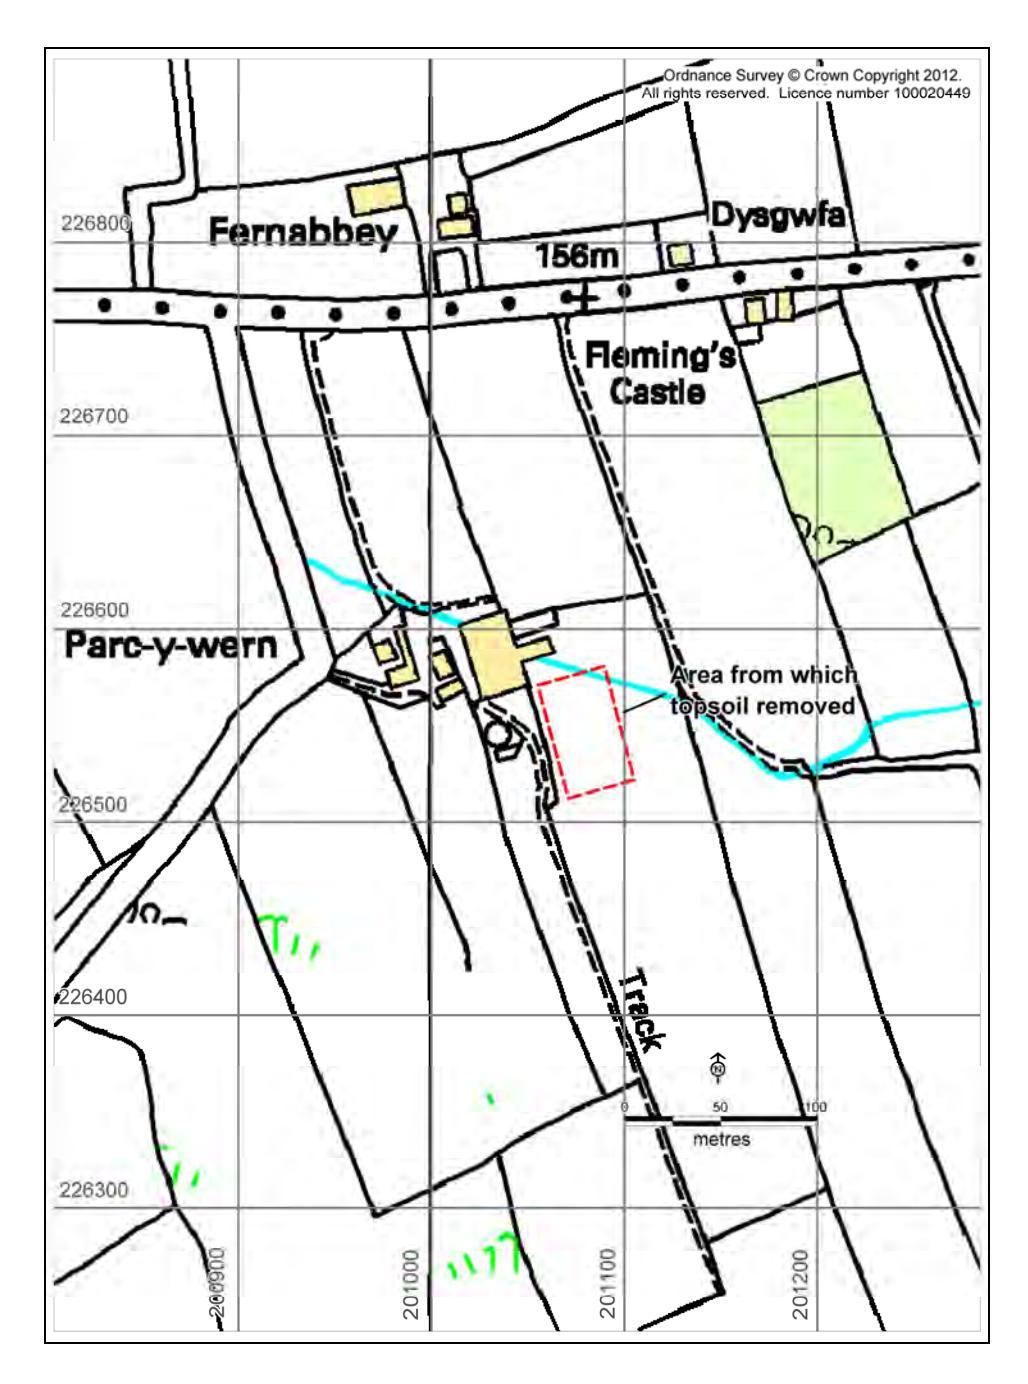
Figure 3: The area from which topsoil was removed for the slurry pit.

On Thursday 5^{th} July 2012, an area of 60 metres x 35 metres foundation trench was stripped of topsoil down to subsoil using a mechanical excavator and a grading bucket. This process was observed by Trysor.

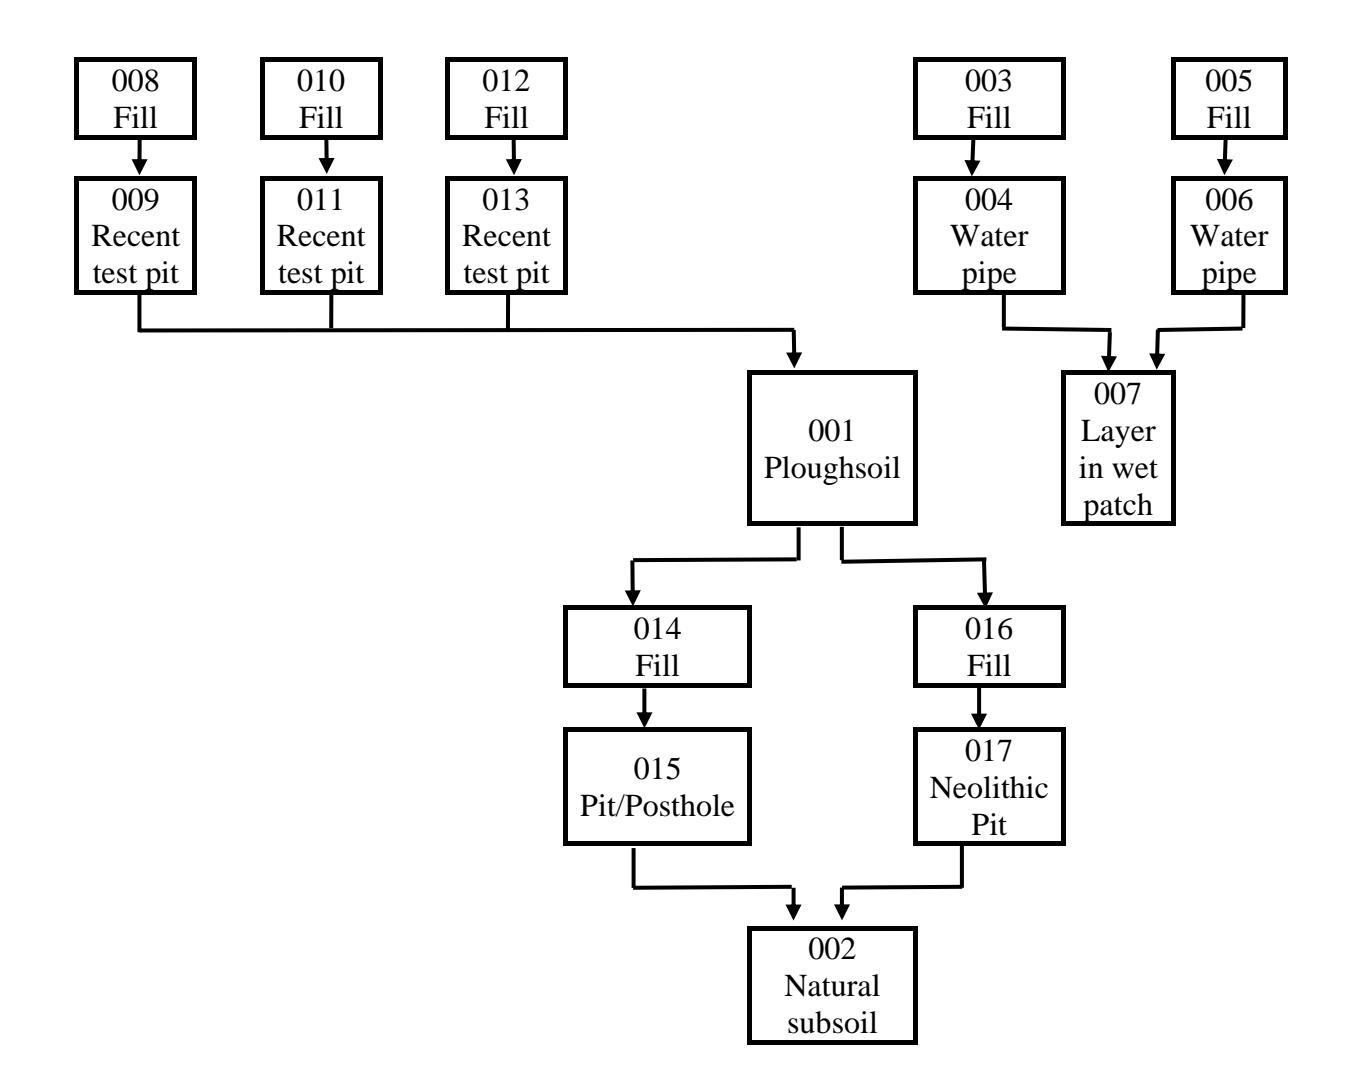
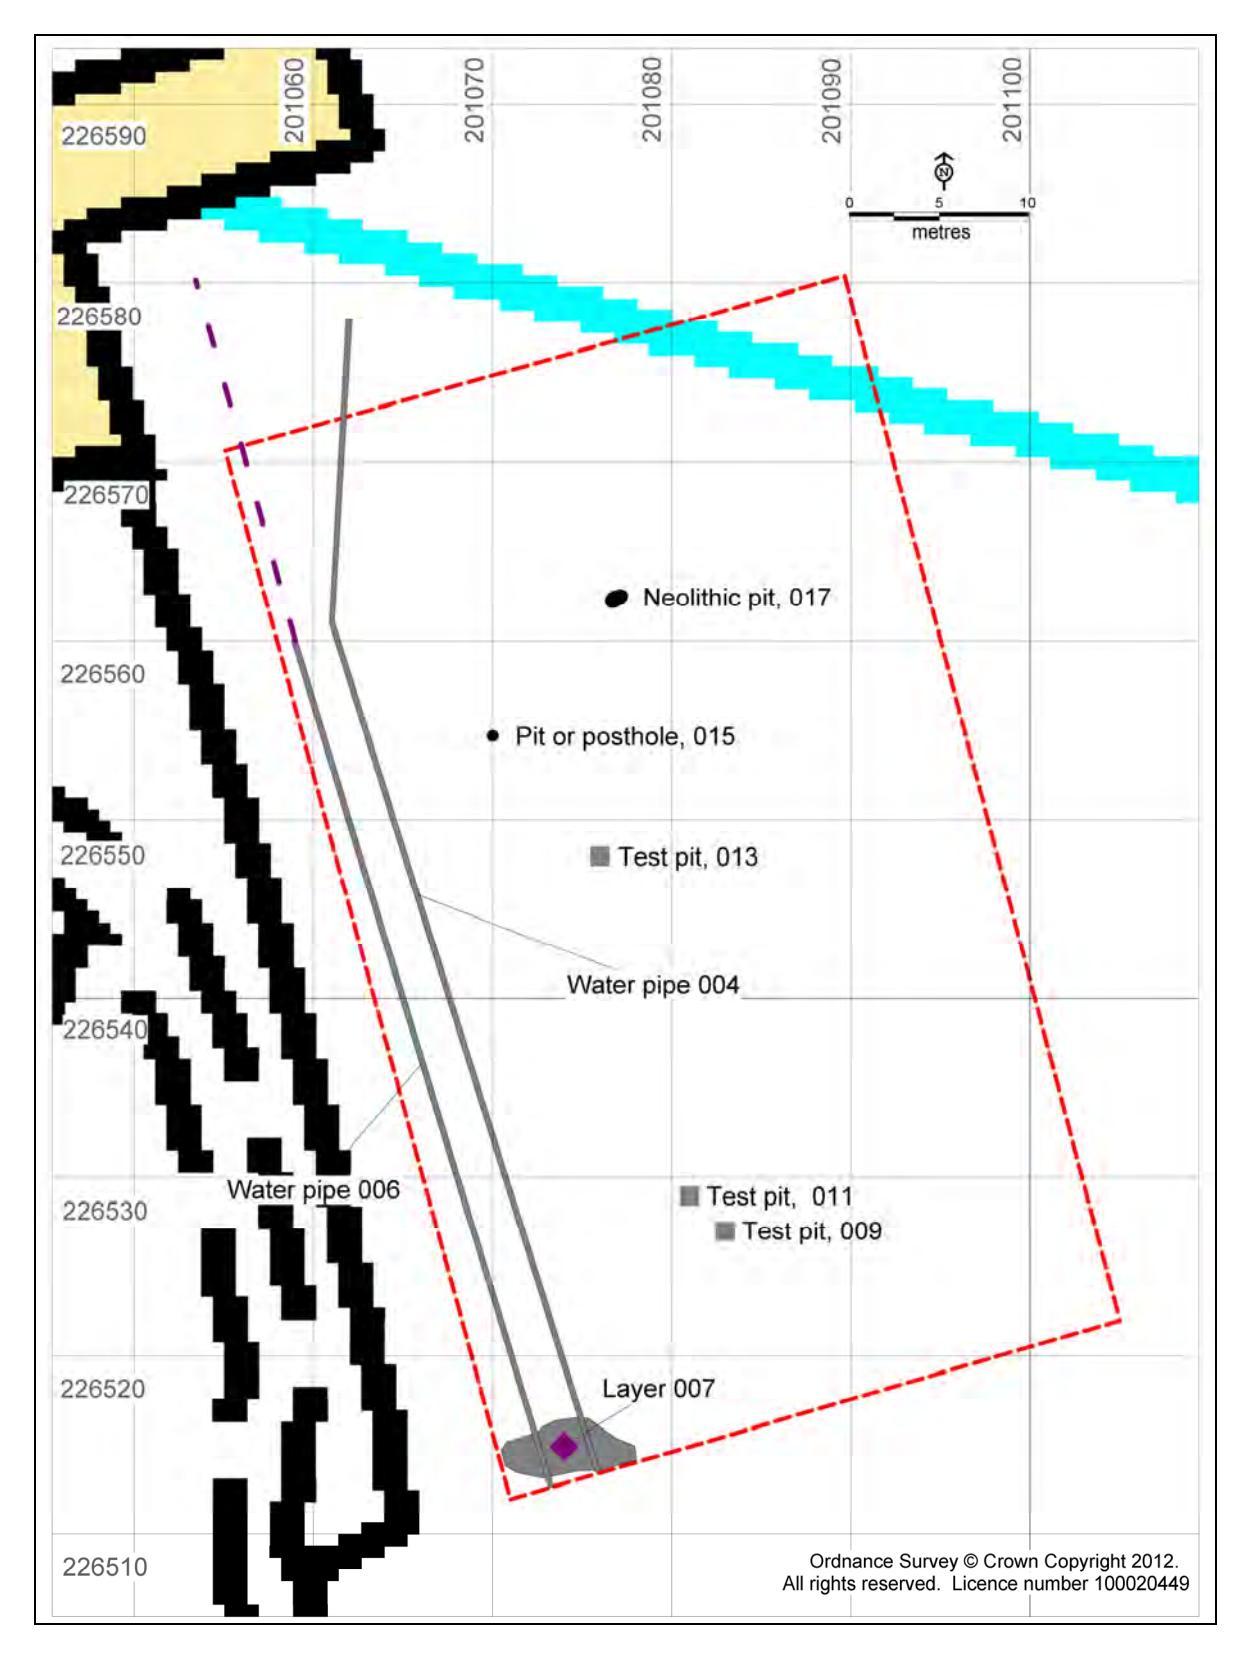
Figure 4: Location of features recorded after removal of topsoil.

Context Number	Depth	Description	Interpretation
001	0.30m-	7.5YR4/3, loam with very	Ploughsoil
	0.35m	occasional small stones	-
002		7.5YR 4/4	Natural subsoil

-	Silty clay with occasional clay	
003		Fill of 004	Fill of a modern
			water/drainage trench
004		A linear feature cutting through	Modern
		subsoil but cut from higher up.	water/drainage trench
		Confirmed by farmer as being a	
		modern feature and not excavated.	
005		Fill of 005	Fill of a modern
			water/drainage trench
006		A linear feature cutting through	Modern
		subsoil but cut from higher up.	water/drainage trench
		Confirmed by farmer as being a	
		modern feature and not excavated.	
007	0.10m-		Material dumped in a

0.20m		wet corner of the field
008		Fill of 009	Fill of test pit 009
009			Modern test pit, part of
			the pre-application
			work for the slurry pit
010		Fill of 011	Fill of test pit 011
011			Modern test pit, part of
			the pre-application
			work for the slurry pit
012		Fill of 013	Fill of test pit 013
013			Modern test pit, part of
			the pre-application
			work for the slurry pit
014		Fill of pit 015.	
015		A roughly circular feature seen	A small pit, or
		cutting the subsoil when the	possibly posthole,
		ploughsoil was mechanically	although no postpipe
		removed. The feature was	was visible. Undated
		approximately 0.75 metres in	and purpose unknown.

-		diameter and 0.10 metres deep	
016		Fill of pit 017. A friable gritty loam	
		containing many fragmented quartz	
		blocks (up to 50% of total) and	
		charcoal. Charcoal was sampled, a	
		radiocarbon date obtained by Beta-	
		Analytic and sample analysed. The	
		radiocarbon date was given as CAL

BC 3640 to 3520 (4780+-30 BP conventional radiocarbon age), see Appendix C. Analysis of the sample showed it to be hazel with a few fragments of hazel nut (CJ Griffiths, 2012, see Appendix D)	
017	An irregular, oval pit, 1.3 metres by 0.90 metres and 0.25 metres deep from the ploughsoil/subsoil interface.	Neolithic pit containing burnt hazel and quartz blocks.

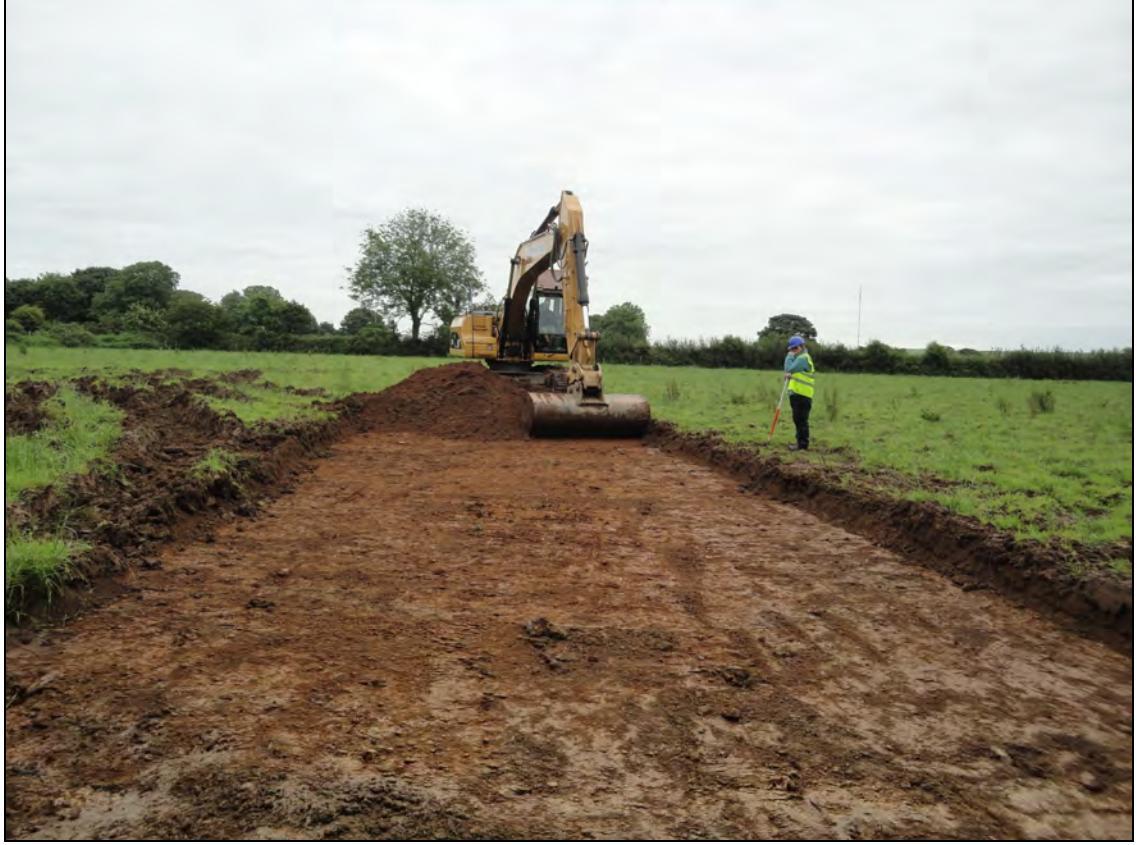
Plate 1: PYW2012_100, Stripping of the southern end of the trench, looking east.

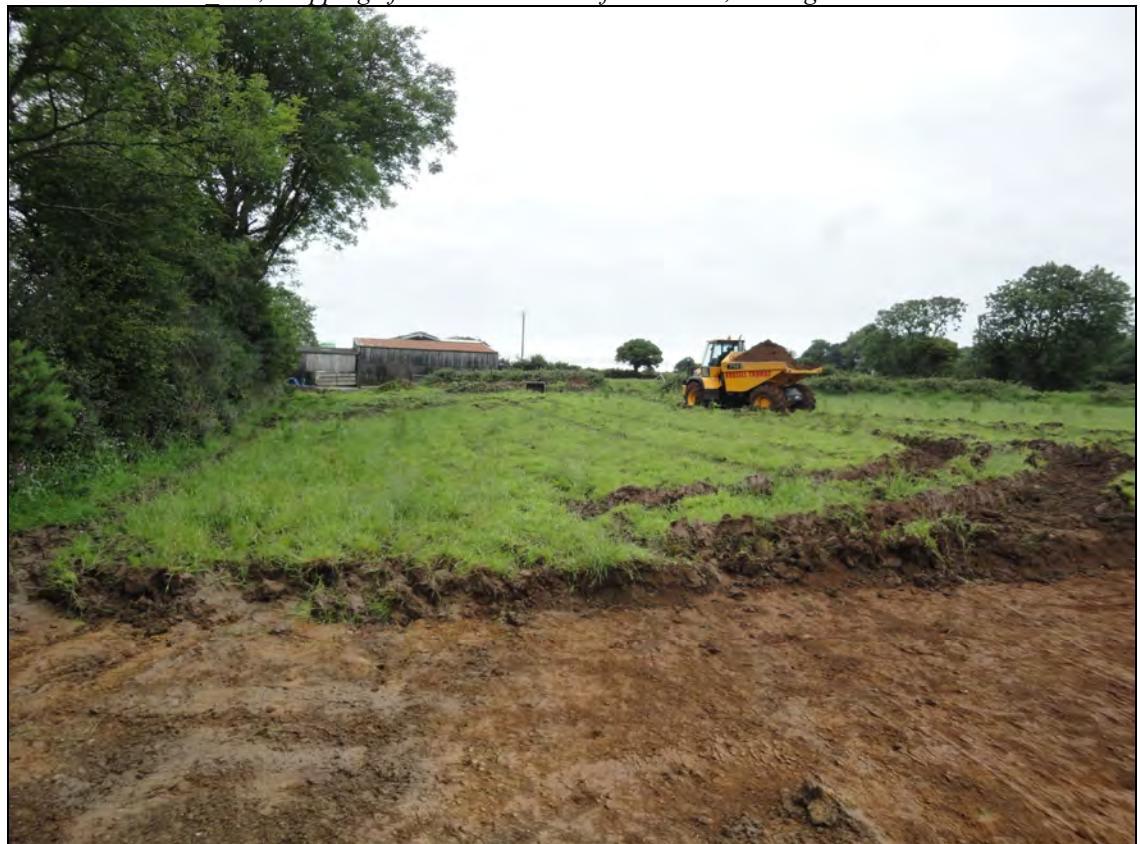
Plate 2: PYW2012_101, The southern end of the trench, with layer 007 in the foreground, looking north northwest, across the area still to be stripped.

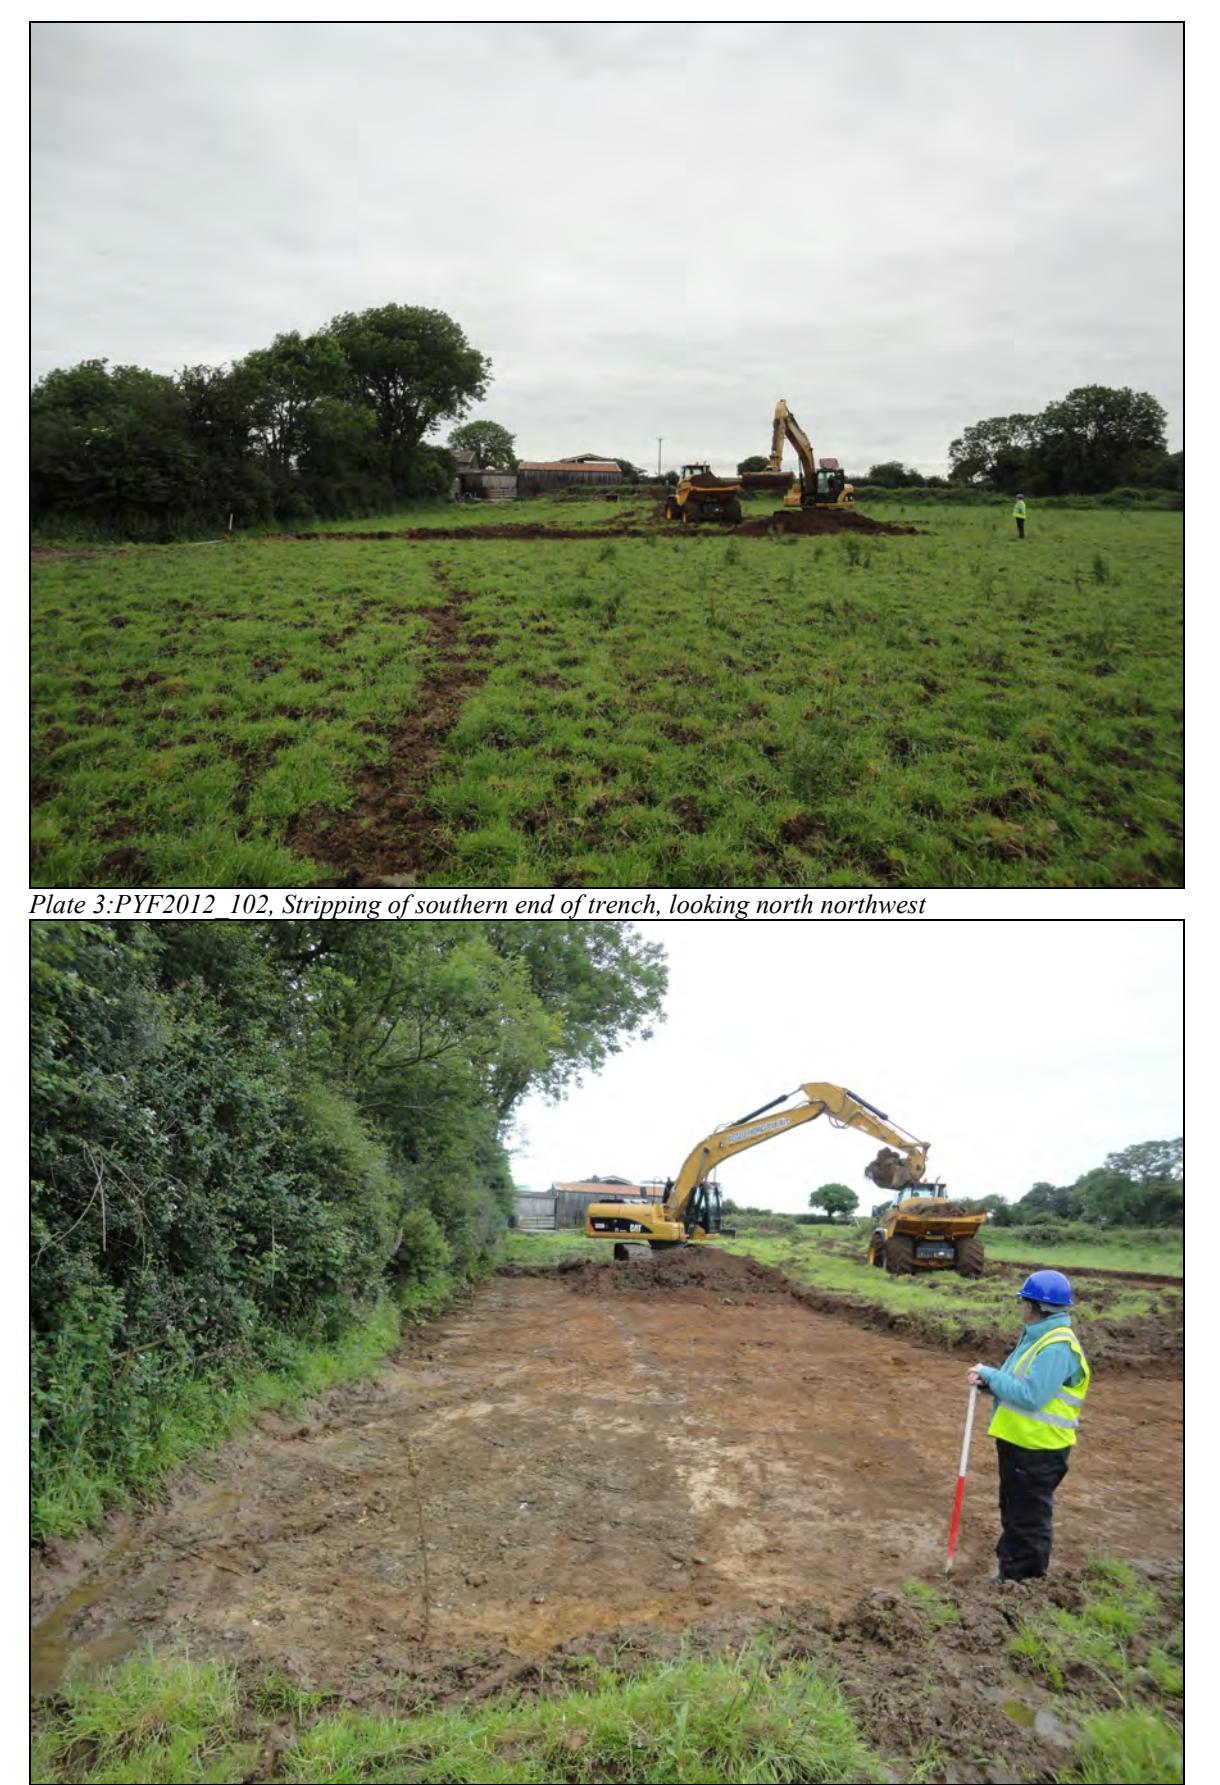
Plate 4: PYW2012_103, The southwestern corner of the trench, showing waterpipe trenches 004 and 006 cutting layer 007, looking north northwest.

Most features were of a recent date: two water pipe trenches, 004 and 006, three test pits connected with pre testing for the slurry pit 009, 011, 013. A stone layer in the southwest corner of the trench was cut by the two water pipe trenches but was in a wet part of the field and appeared to be material deposited to patch up the damp area.

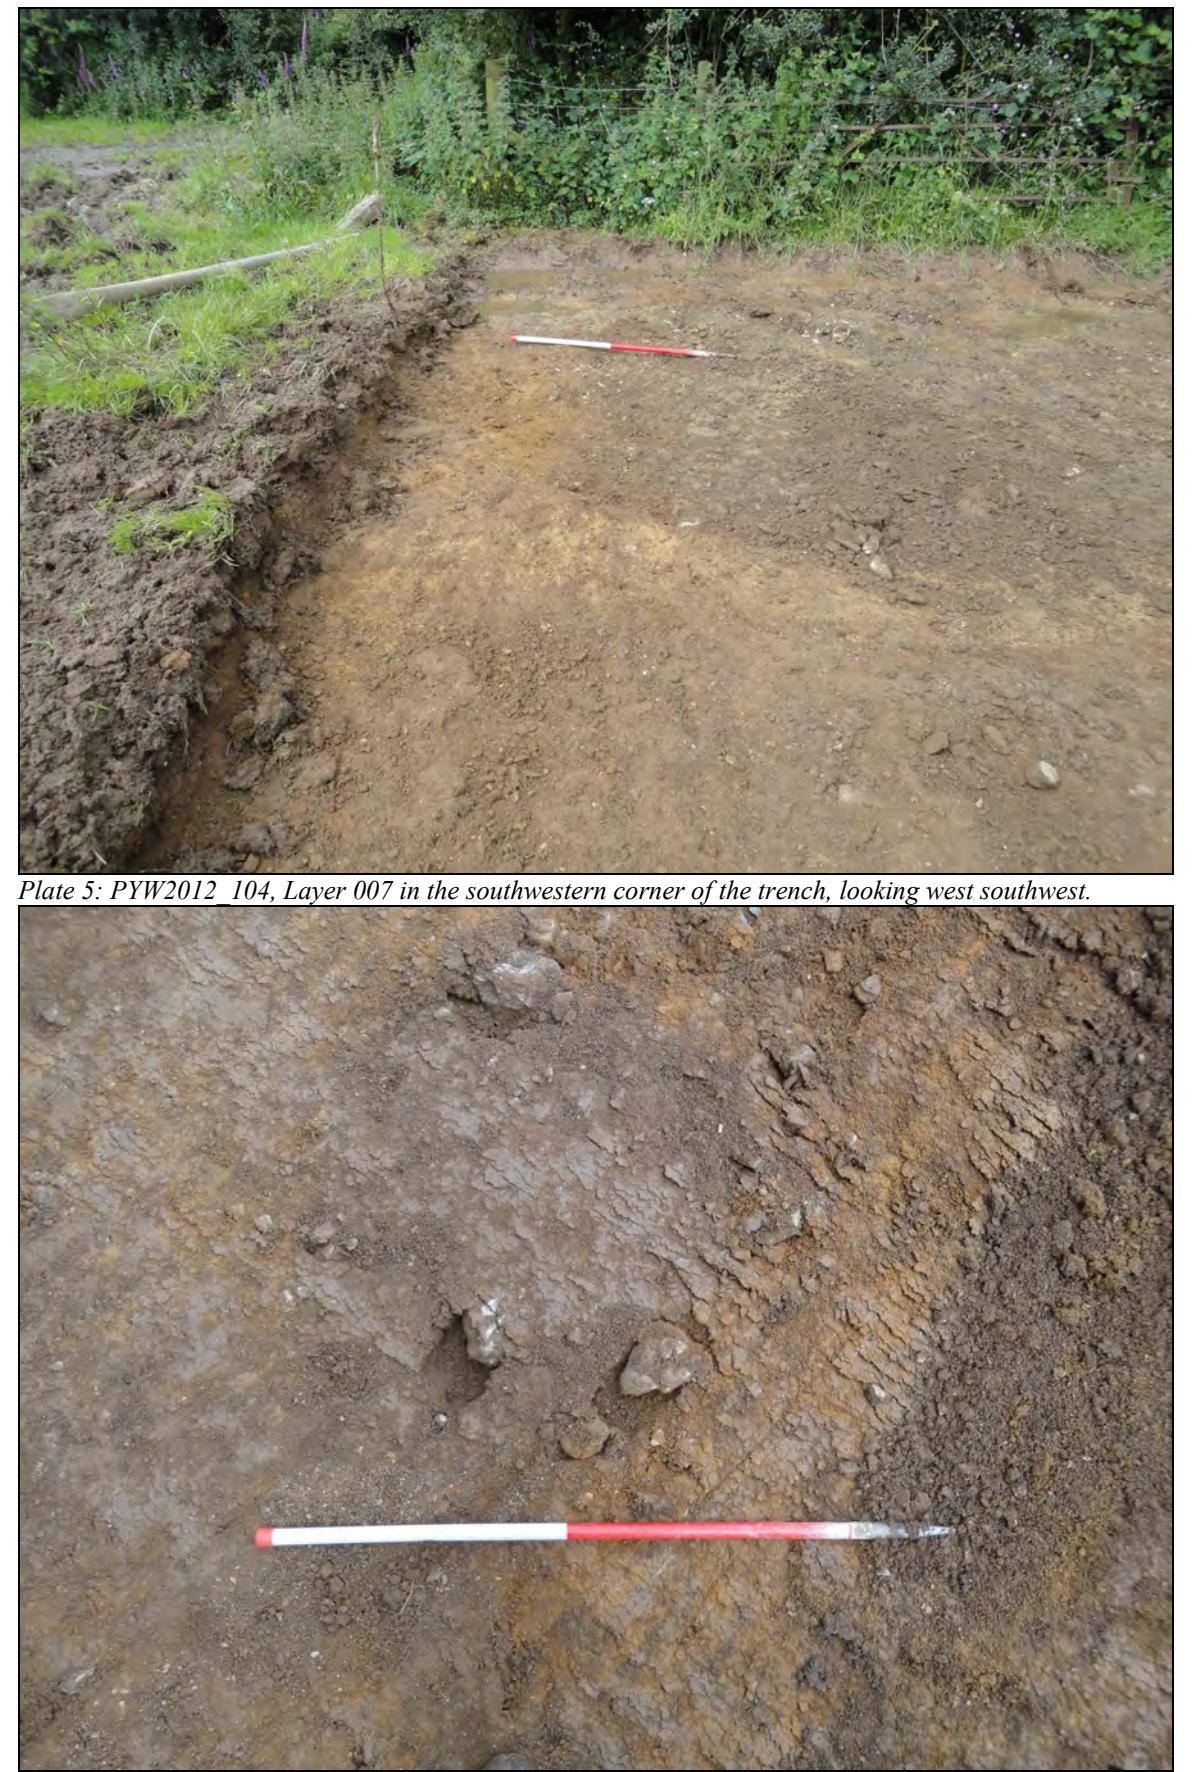
Plate 6:PYW2012_105, Posthole or pit 015, looking north.

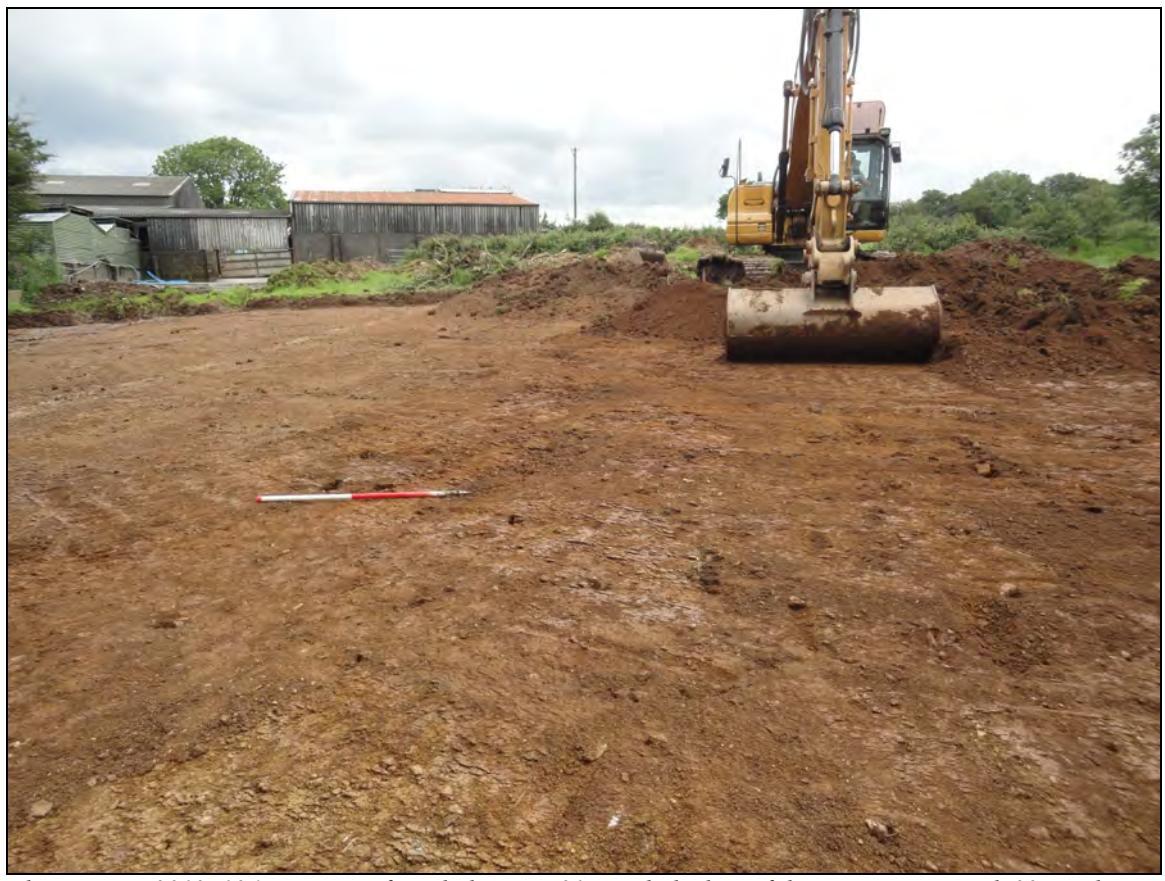
Plate 7: PYW2012_106, Position of posthole or pit 015, with the line of the water pipe trench 004 in the background to the left, looking north.

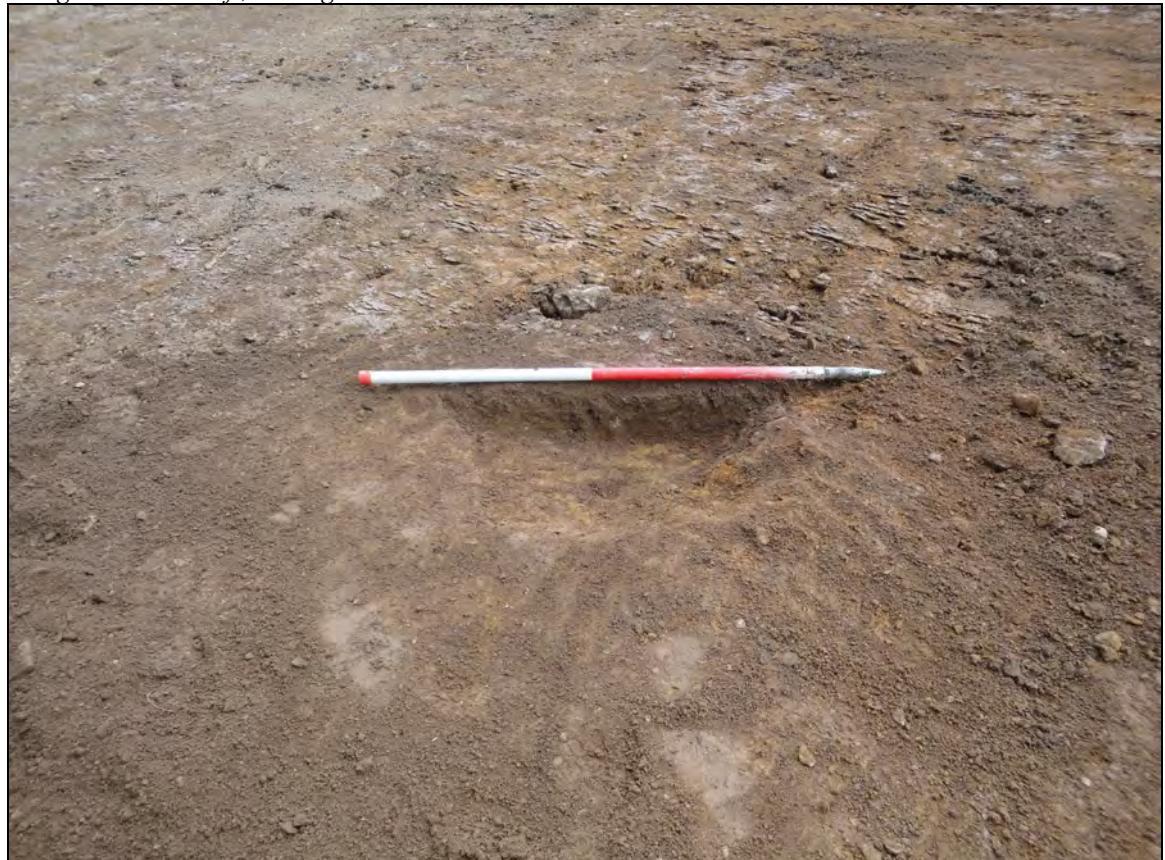
Plate 8:PYW2012_107, posthole or pit 015 after half-sectioning, looking north.

Two features of archaeological interest were recorded. A posthole or small pit was fully excavated but provided no dating evidence or purpose. A second pit was fully excavated and contained a large quantity of burnt, cracked quartz blocks and charcoal. A sample of the charcoal, which was hazel, with a few hazelnut shell fragments, gave a calendar age of CAL BC 3640 to 3520.

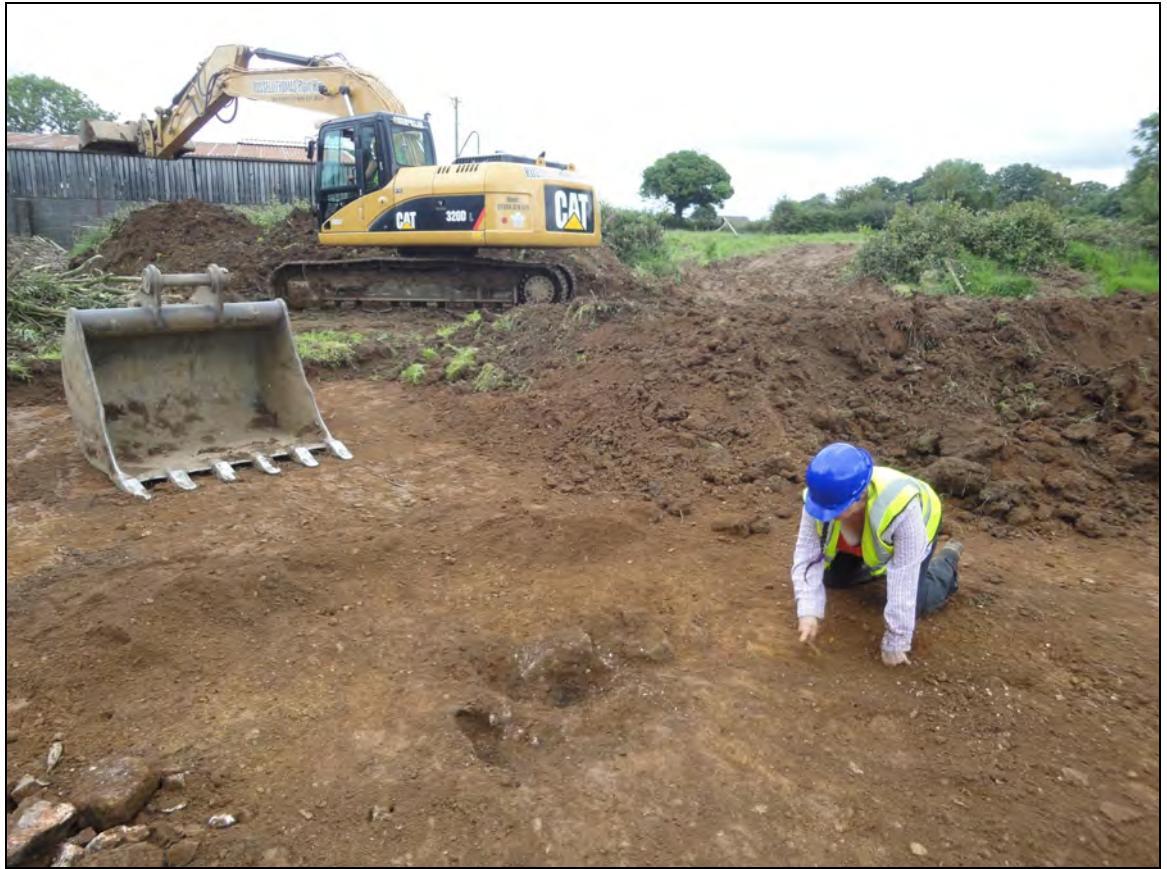
Plate 9: PYW2012_108, Trowelling around pit 017, prior to excavation, looking north.

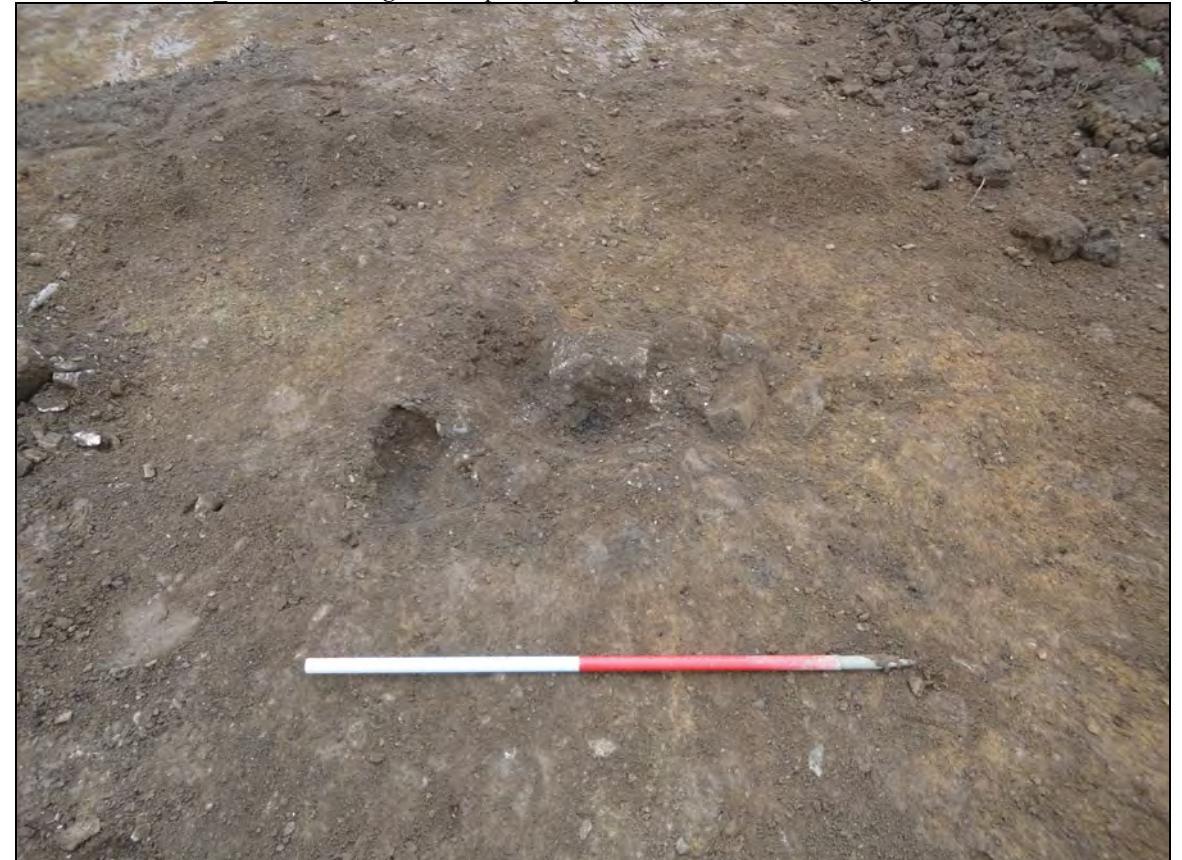
Plate 10: PYW2012_109, pit 017 before excavation, looking northwest.

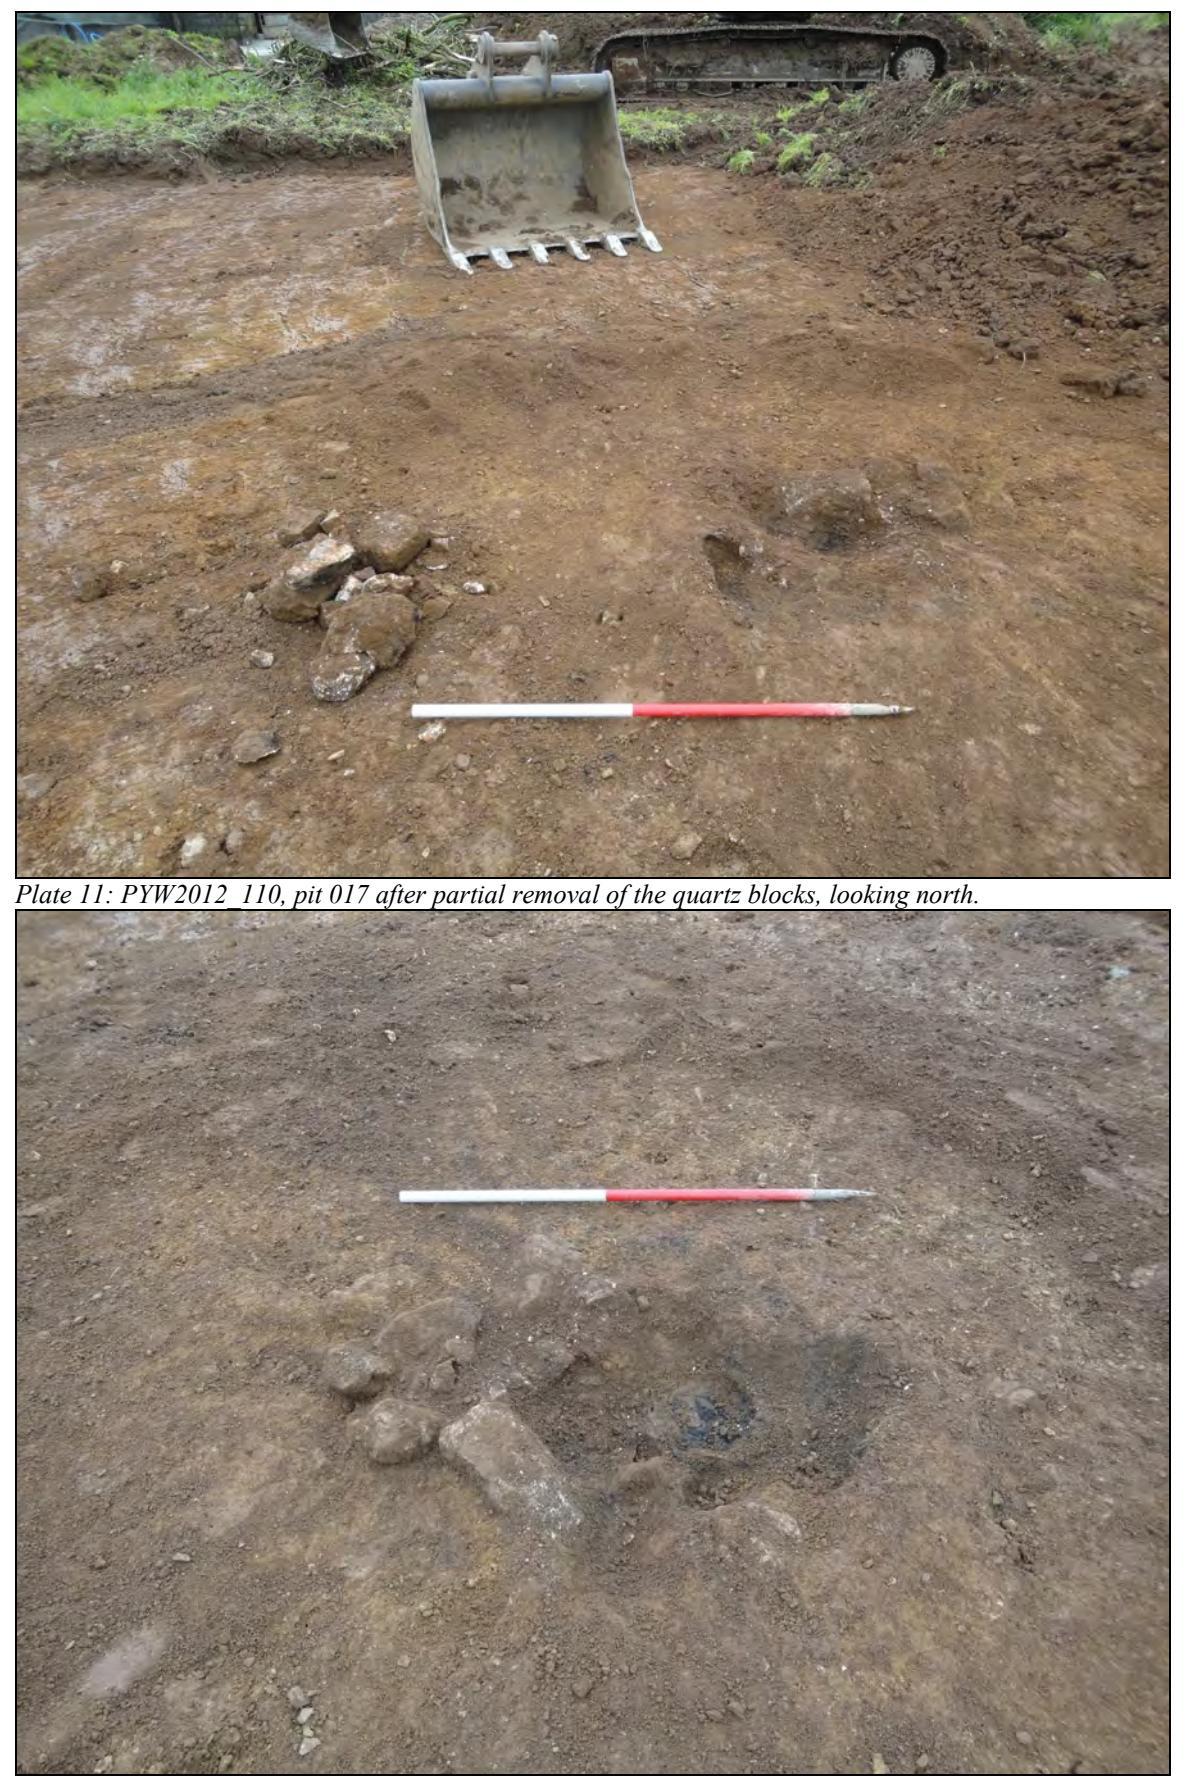
Plate 12: PYW2012_111, pit 017 after partial excavation, showing charcoal with some of the quartz still in situ, looking southeast.

The quartz-filled pit uncovered at Parc y Wern, context 017, was 1.30 metres long by 0.90 metres wide and 0.25 metres as excavated. It contained hazel charcoal and burnt quartz blocks and was dated to the Early Neolithic period, CAL BC 3640 to 3520. This date is comparable to that of the earliest phase of activity at Banc Du and the discovery of the pit points to a Neolithic presence across the wider area.

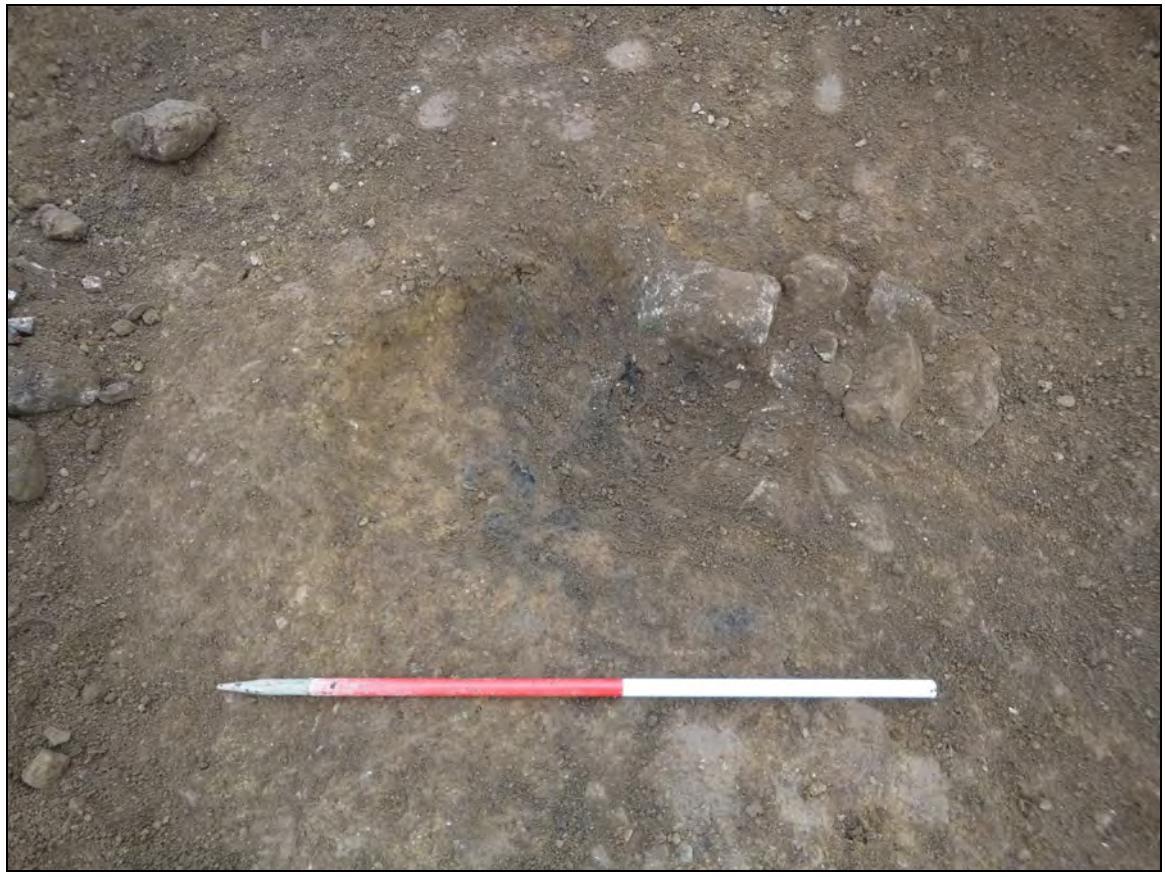
Plate 13: PYW2012_112, pit 017 after further excavation showing continuation of charcoal, looking northwest.

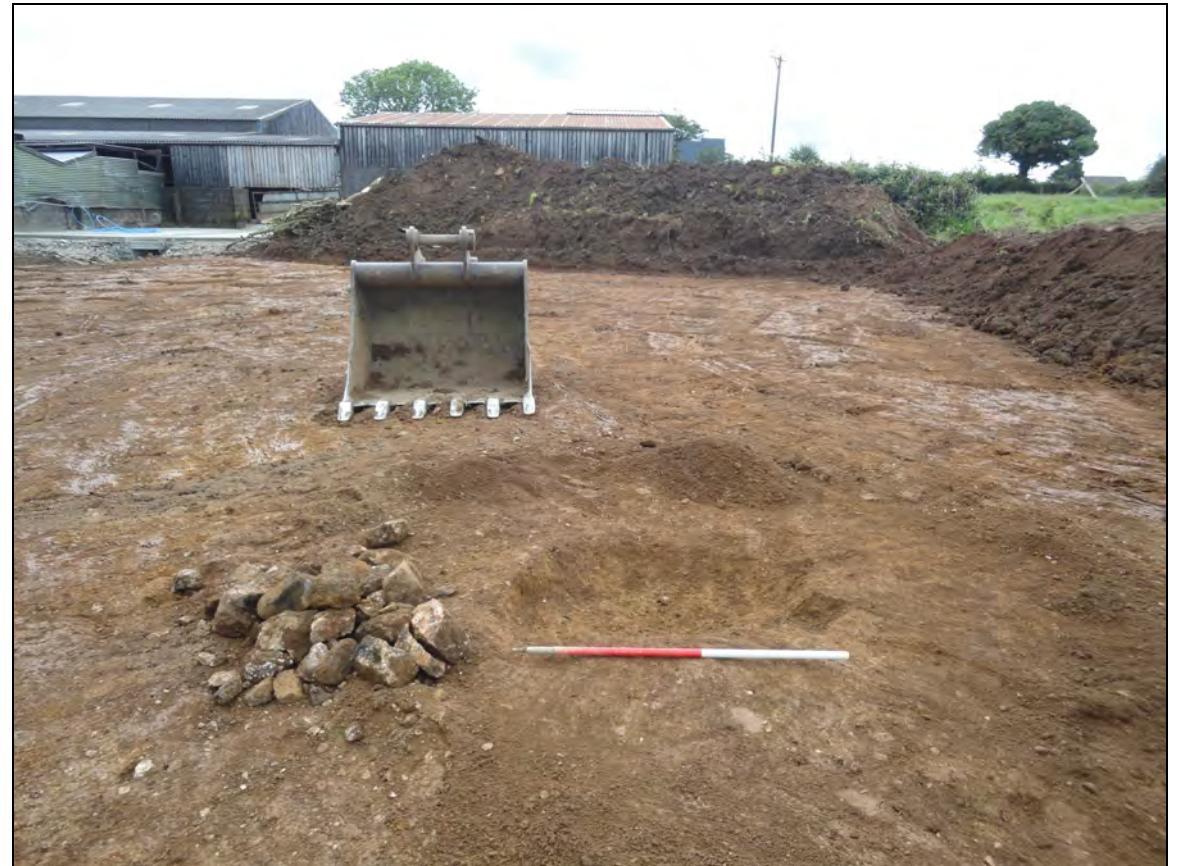
Plate 14: PYW2012_113, pit 017 after total excavation with the quartz removed piled alongside, looking north northwest.

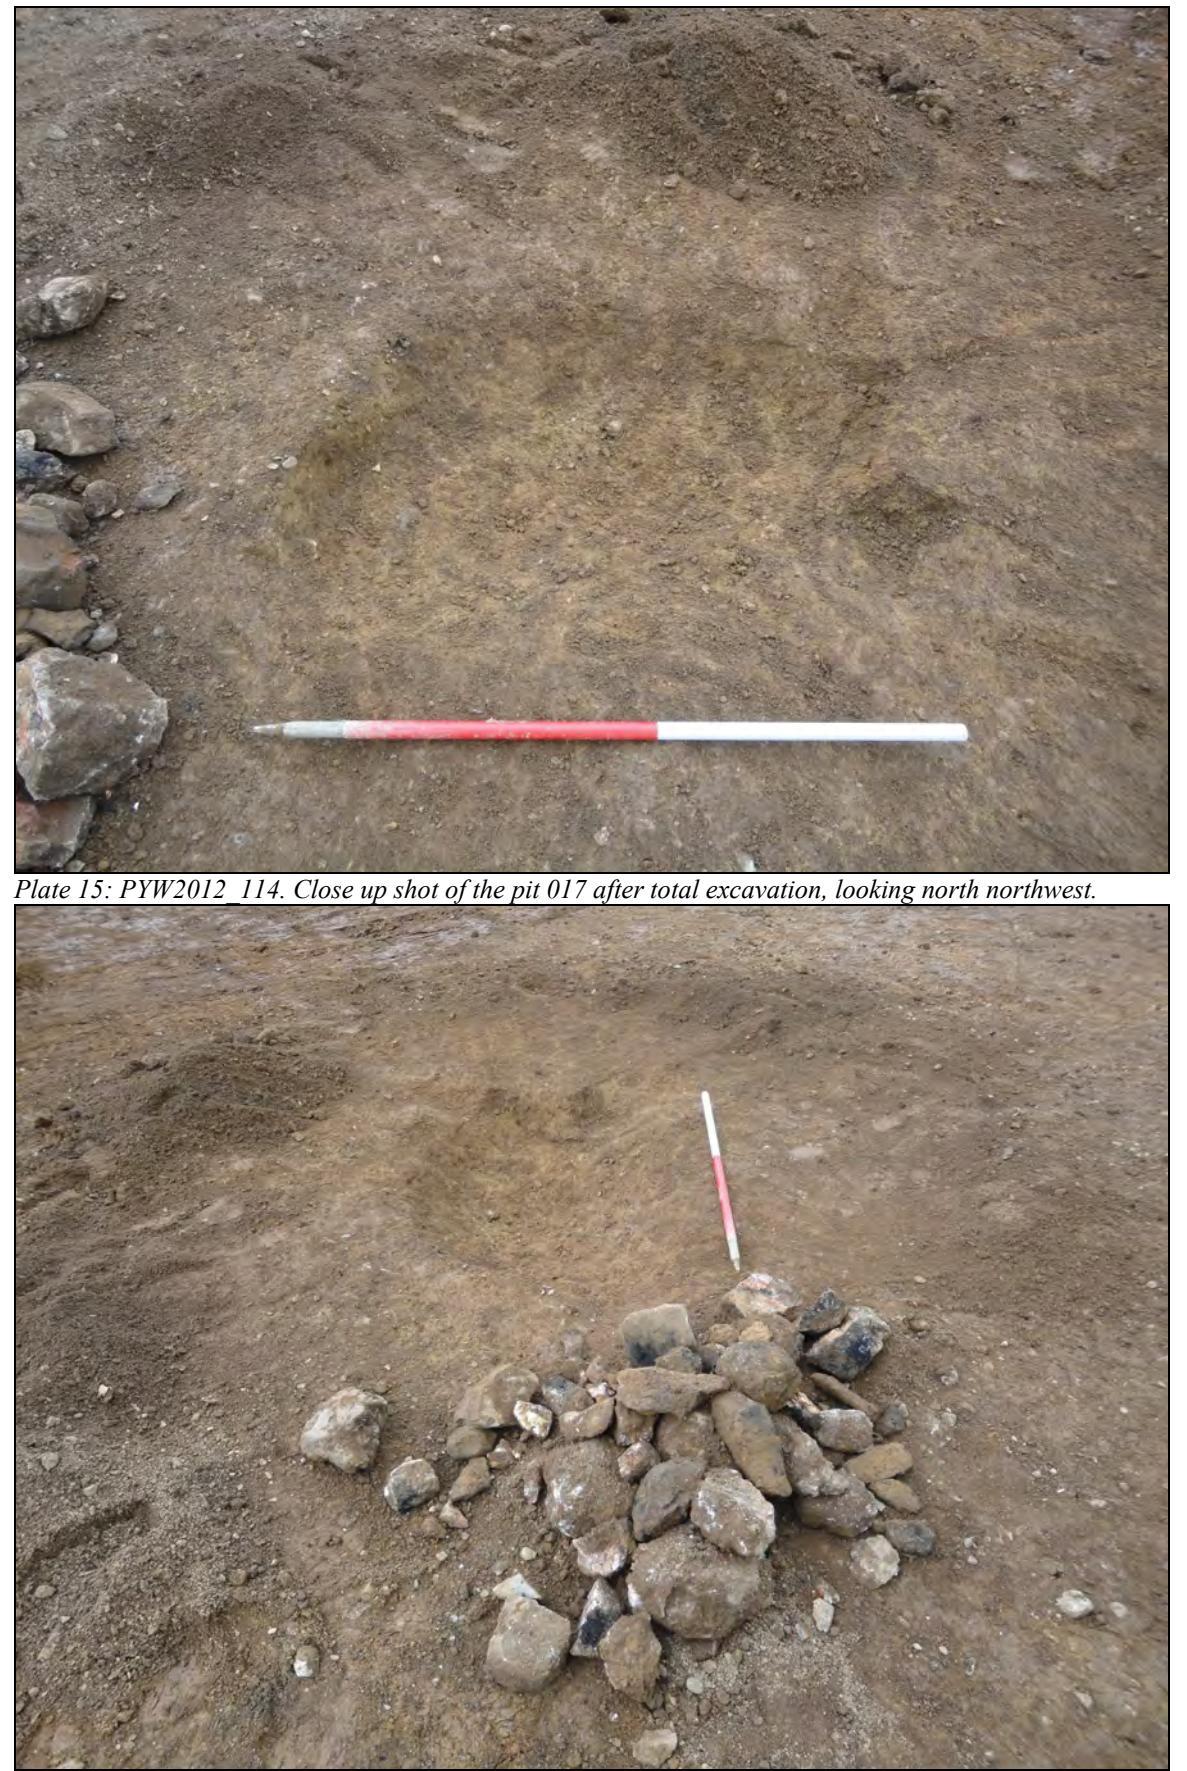
Plate 16:PYW2012_115, Pit 017 after total excavation with the quartz removed from the pit, looking northeast.
