Parc y Wern, Tufton, Pembrokeshire Watching Brief

Report by: Trysor

January 2013

Trysor Project No. 2012/257

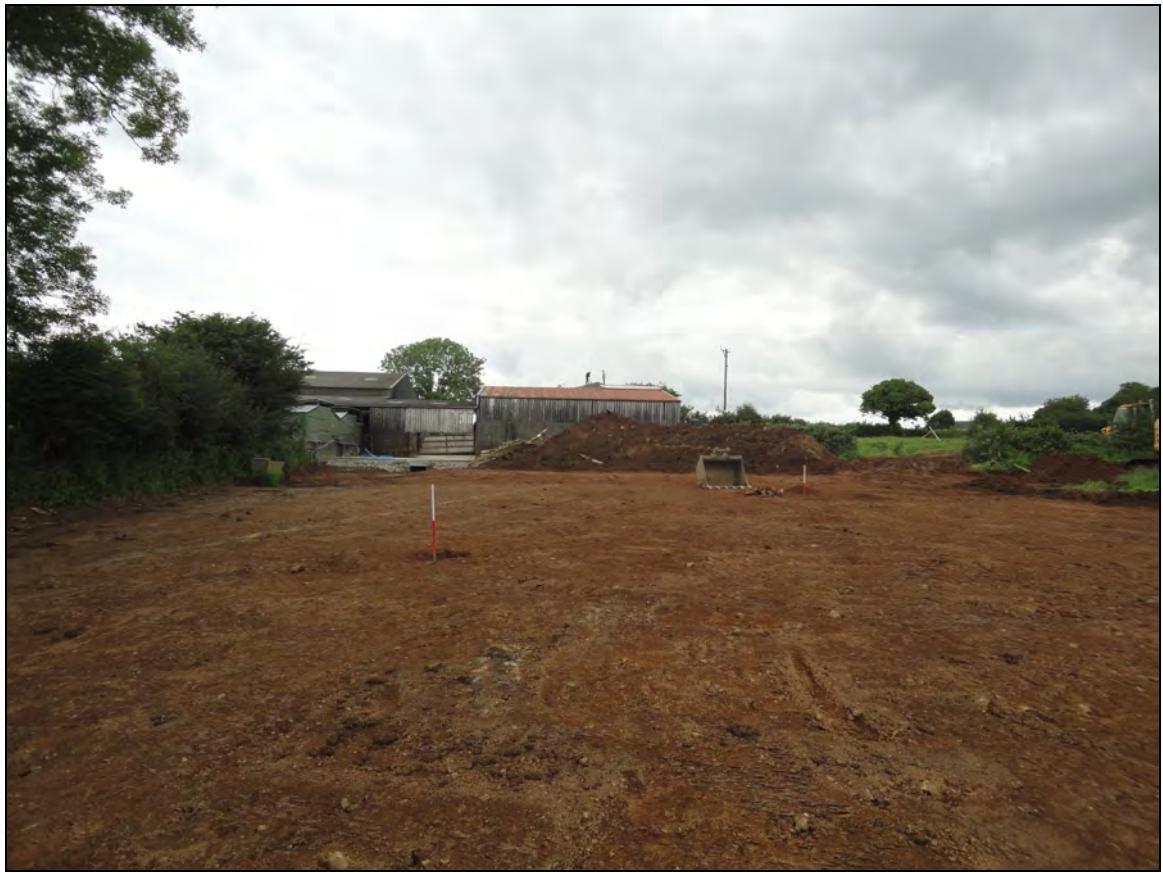
Plate 17: PYW2012_116, Ranging rods showing the location of posthole/pit 015 (to the left) and pit 017 (further back to the right), looking north northwest

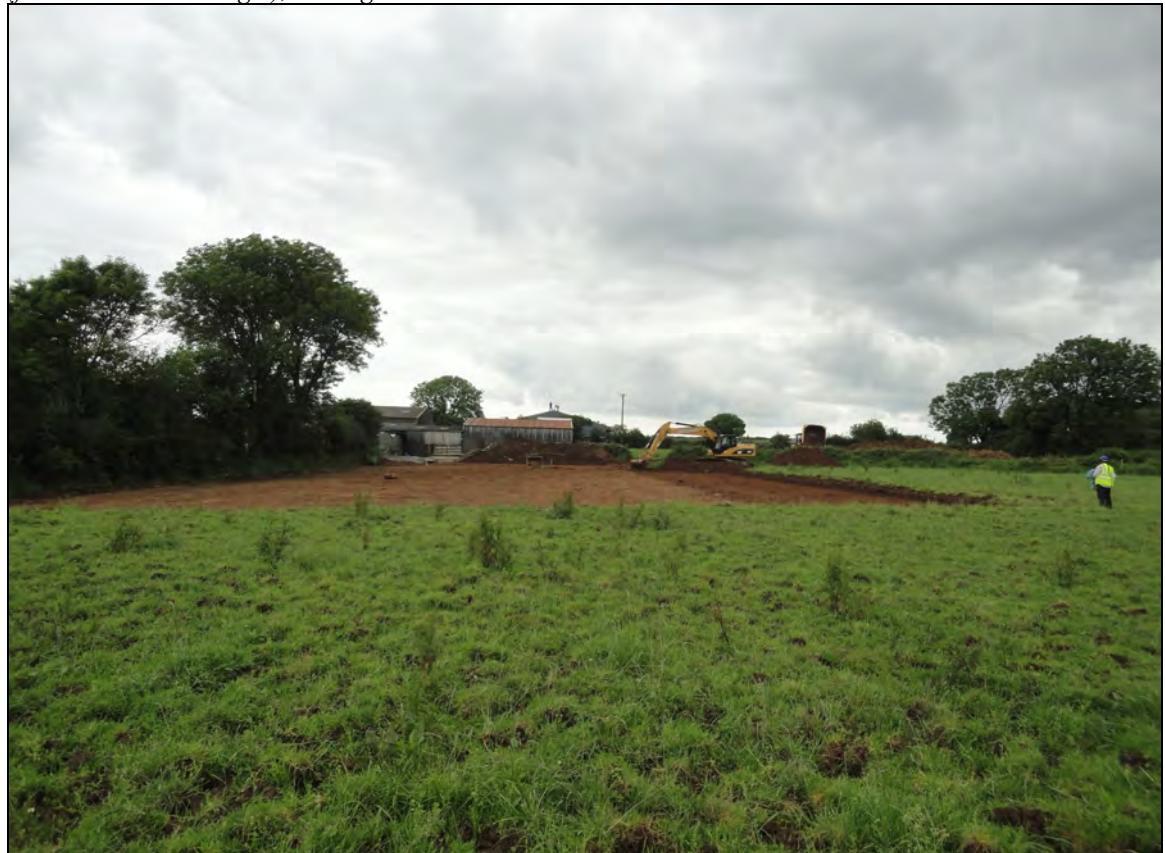
Plate18: PYW2012_117, The whole trench after stripping of the topsoil, looking north northwest.

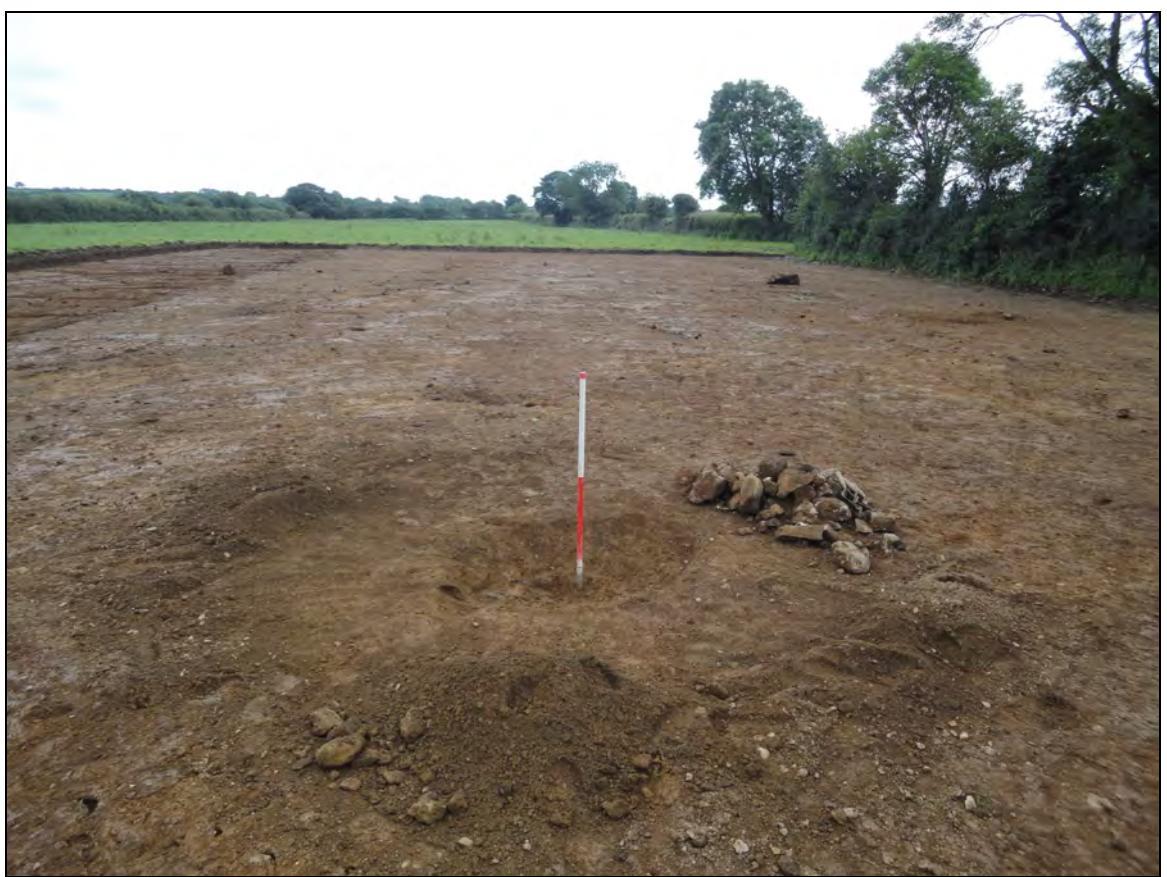
Plate 19: PYW2012_118, Pit 017 in the foreground, showing the rest of the trench, looking south.

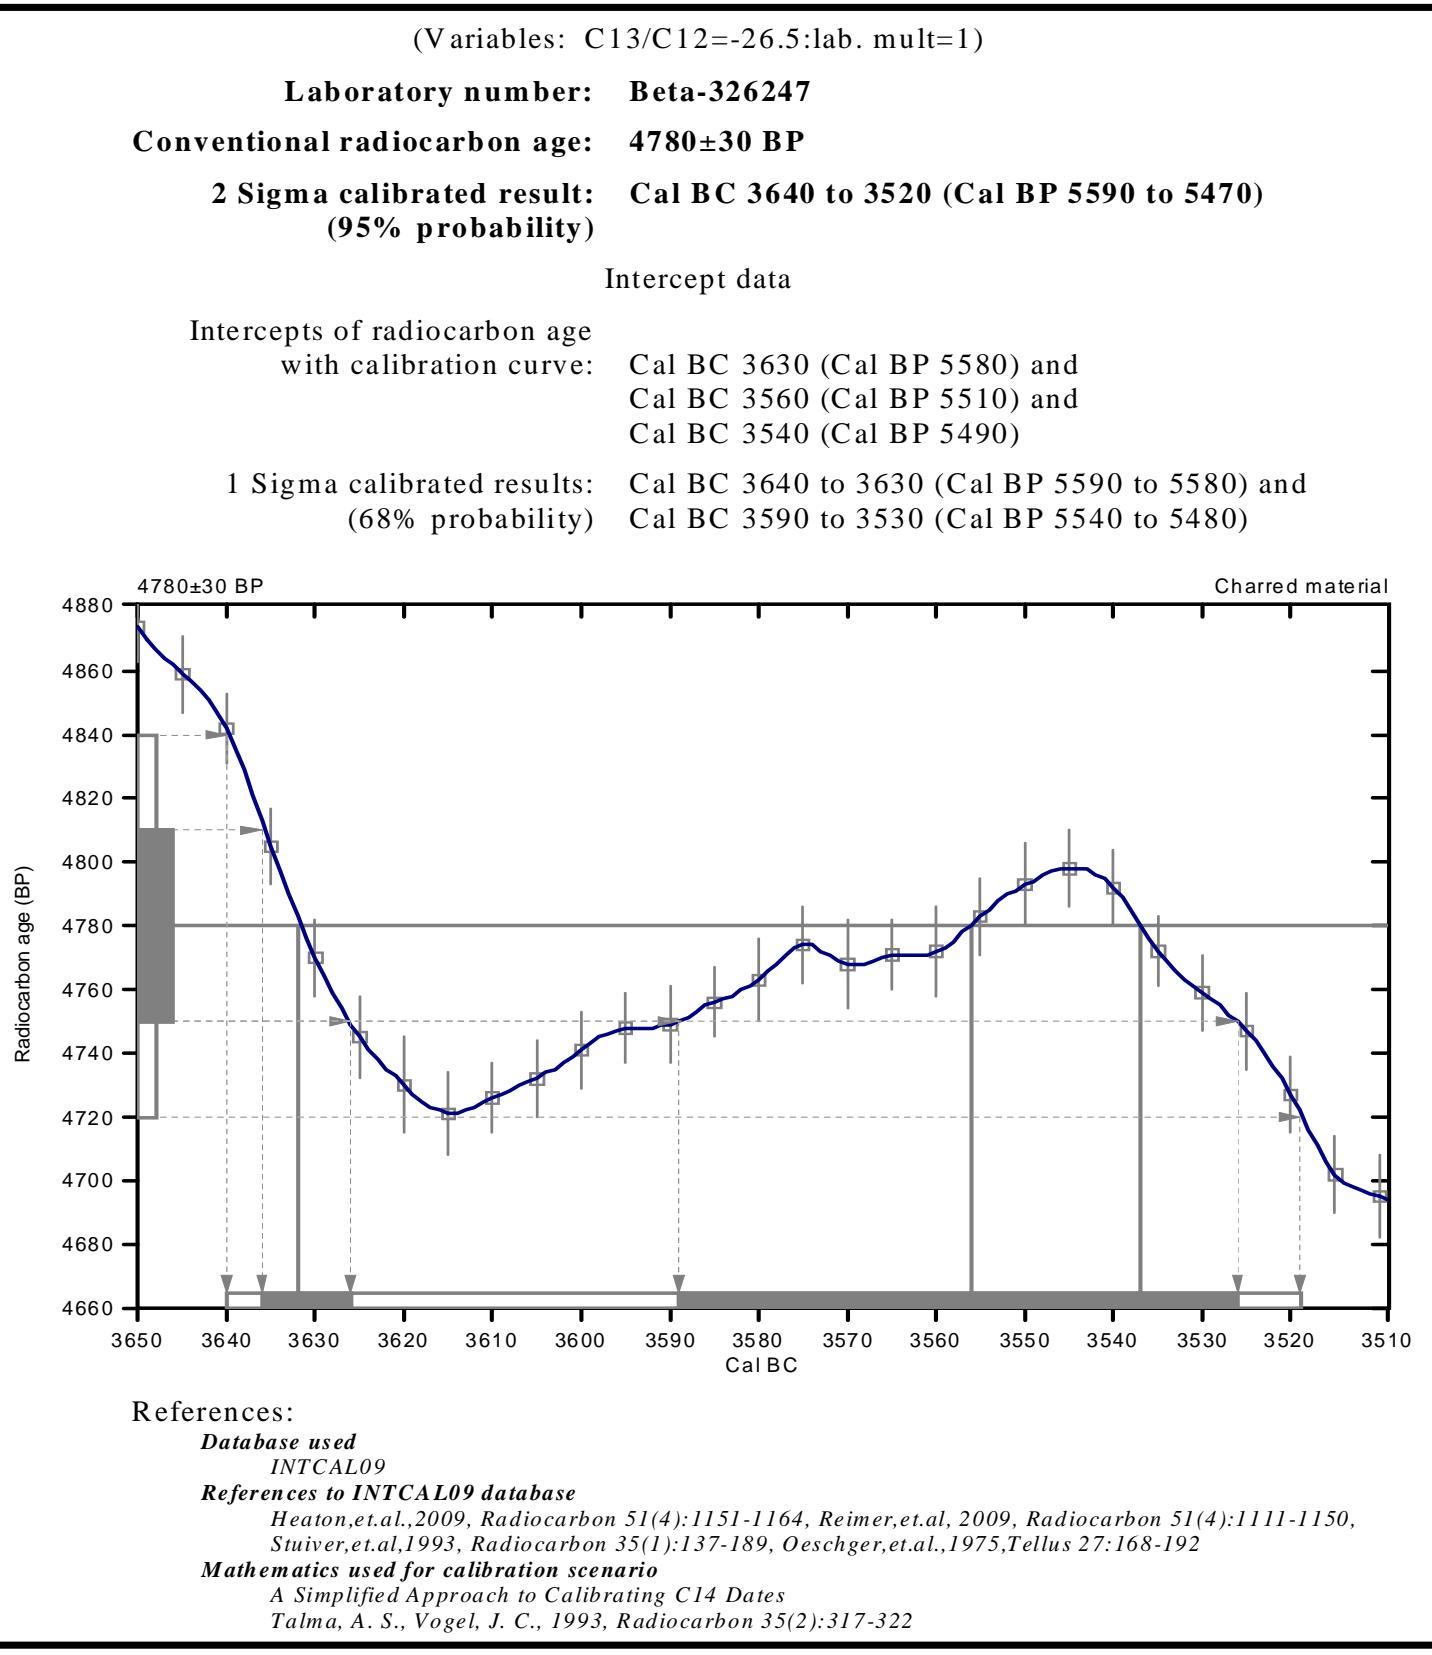
CALIBRATION OF RADIOCARBON AGE TO CALENDAR YEARS

The Conventional Radiocarbon Age represents the Measured Radiocarbon Age corrected for isotopic fractionation, calculated using the delta 13C. On rare occasion where the Conventional Radiocarbon Age was calculated using an assumed delta 13C, the ratio and the Conventional Radiocarbon Age will be followed by "". The Conventional Radiocarbon Age is not calendar calibrated. When available, the Calendar Calibrated result is calculated from the Conventional Radiocarbon Age and is listed as the "Two Sigma Calibrated Result" for each sample.
