# Evaluation of Earthwork Feature, Rhydygwydd, Taliaris, Carmarthenshire

For: Seren Energy

May 2014

Trysor Project No. 2014/370

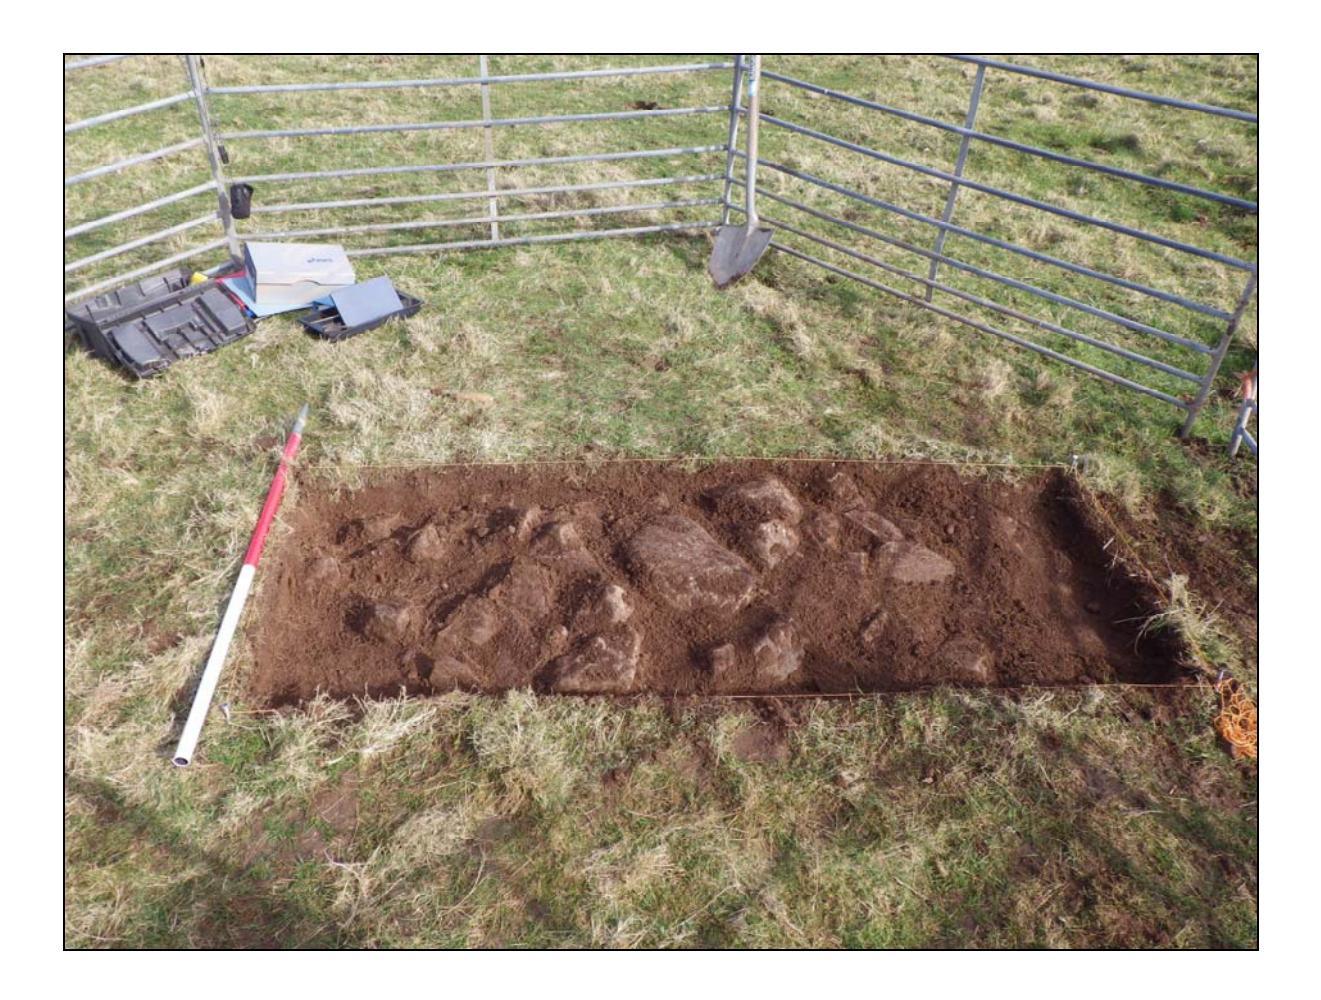
Cover photograph: The evaluation trench showing the stones of the cairn, looking east

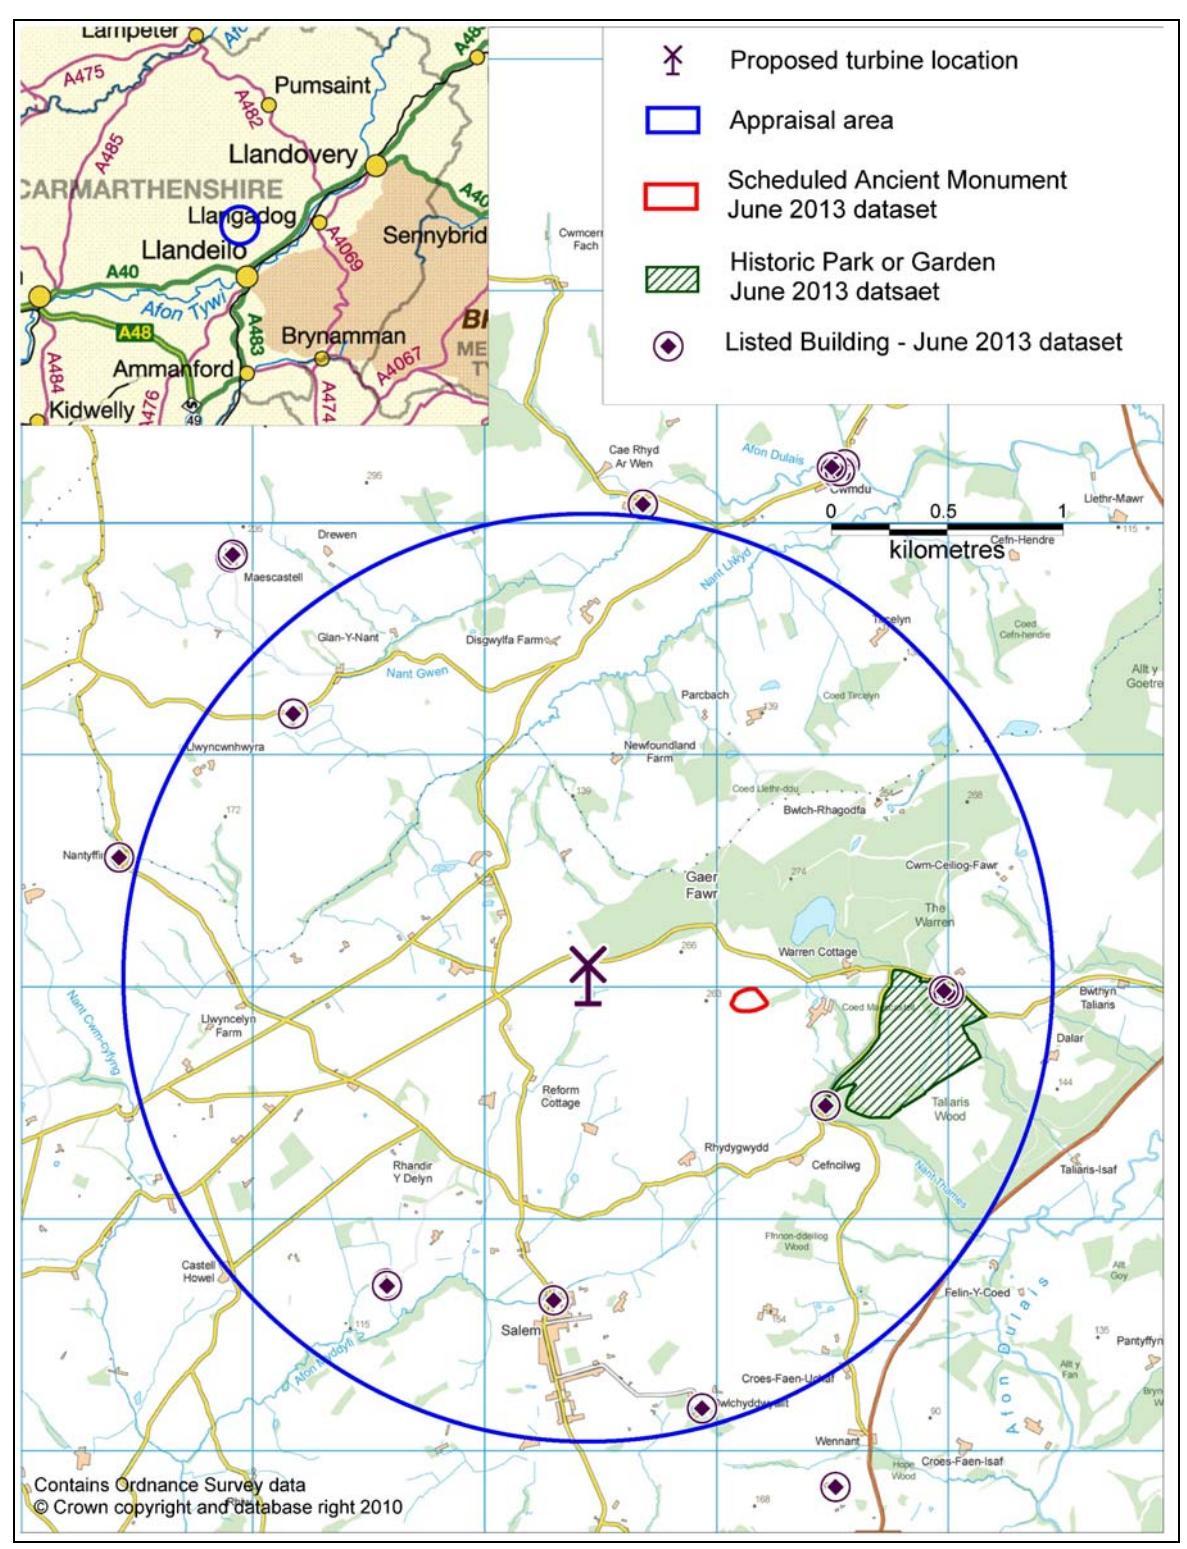
Figure 1: Location of Rhydygwydd and the proposed turbine. The mound lies approximately 30 metres to the northeast of the proposed turbine.

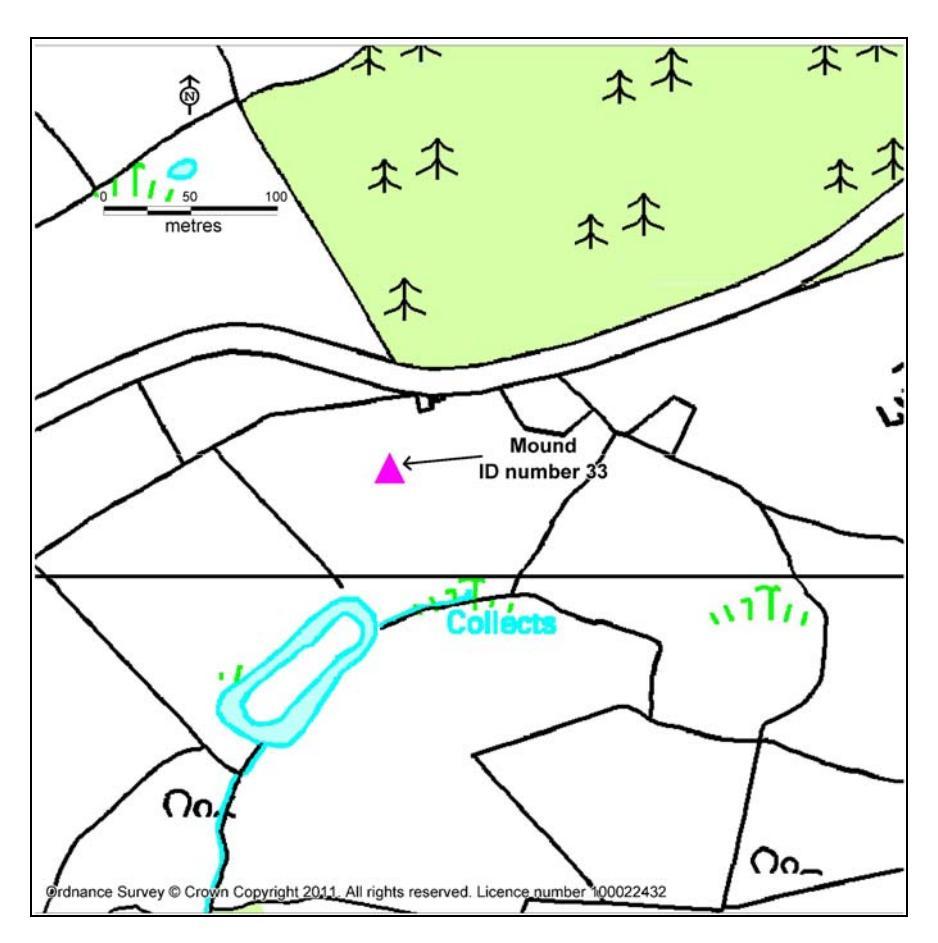
Figure 2: Location of Rhydygwydd and the proposed turbine. The mound lies approximately 30 metres to the northeast of the proposed turbine.

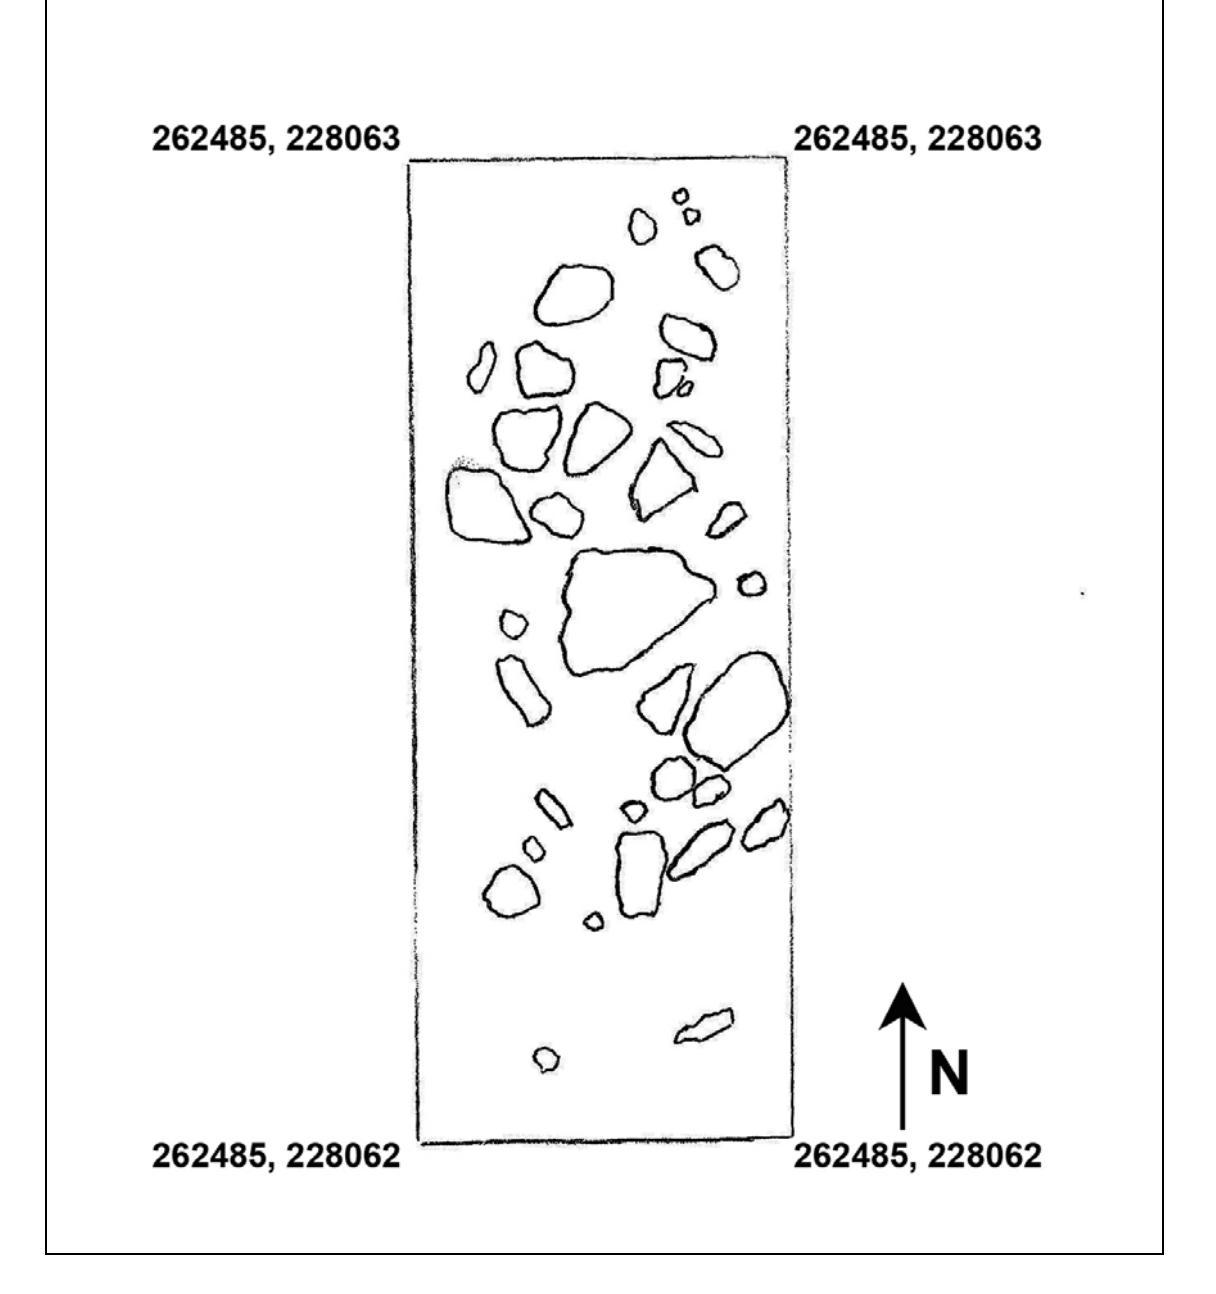
7.2 Three contexts were recorded. The topsoil, context 001, was a dark brown (10YR 3/3) silt clay loam, with coarse component of small quartz rounded pebbles. It was very shallow, less than 0.10 metres deep. Underneath this lay two contexts, 002, a dark yellowish brown (10YR3/6) soil, and 003, a layer of stones from 0.10 metres to 0.36 metres in size.

7.3 As contexts 002 and 003 were not excavated, the relationship between the two was not established, 002 could lie under the stone layer 003 or over it.

7.5 Context 003 was planned at a scale of 1:20. the trench was plotted using a handheld GPS, readings to the nearest metre, see Figure 3.

*Figure 3: Plan of context 003, the stone layer. Scale 1:20. GPS readings at the corner of the trench are to nearest metre.*

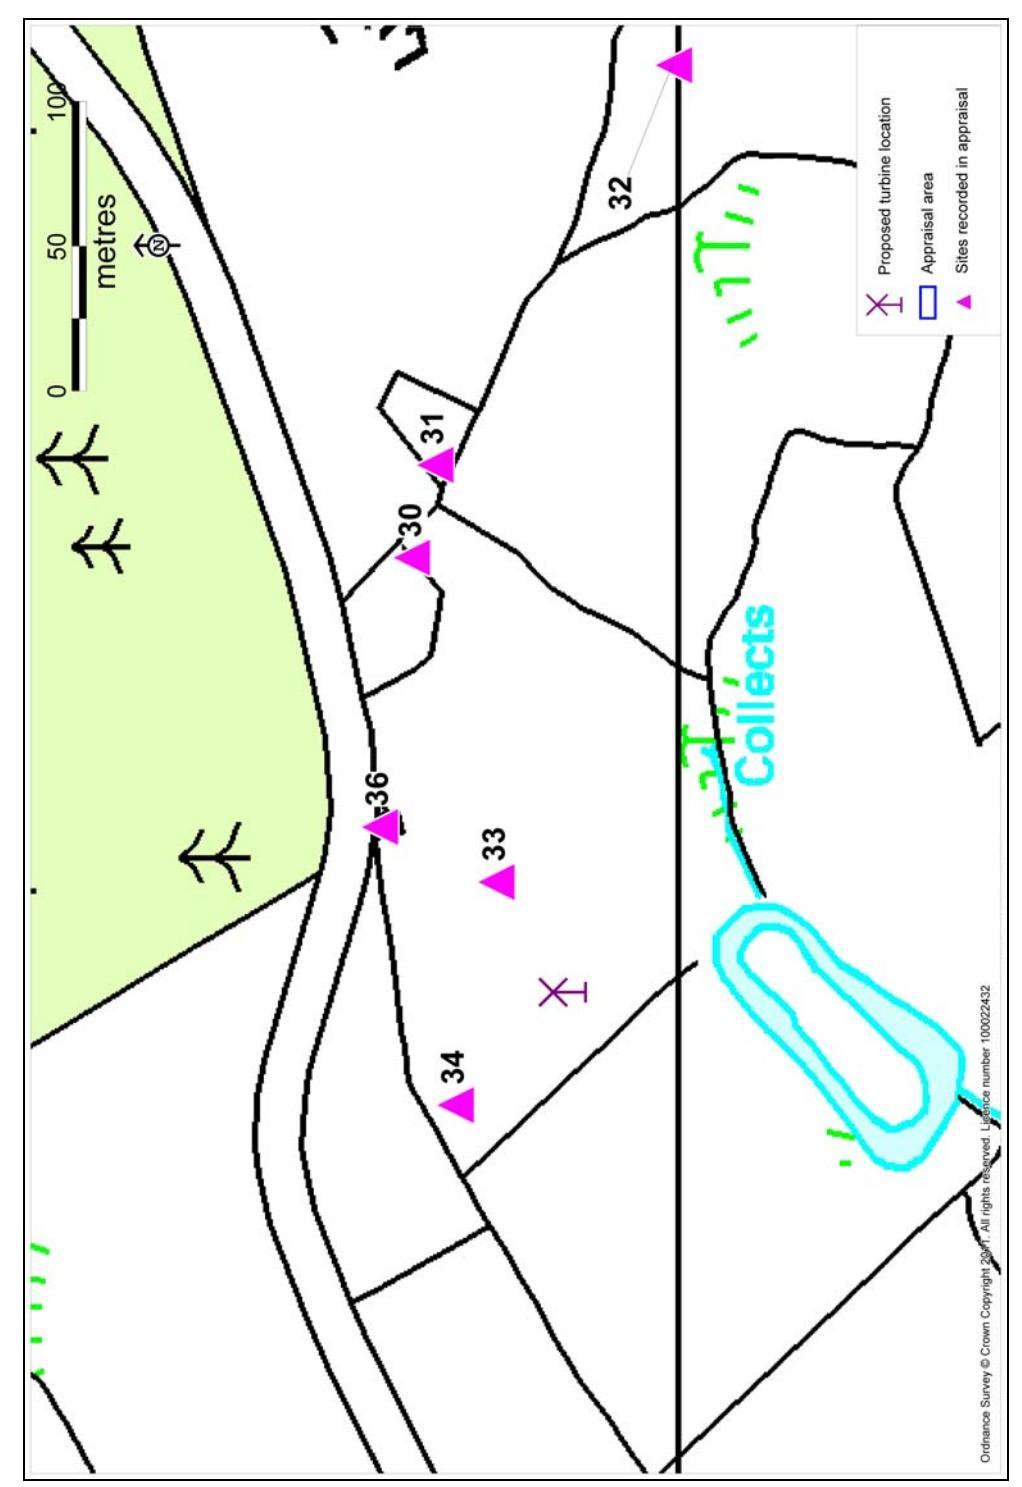
2.1 One historic asset (ID number 33) was determined to experience a High direct impact if the development went ahead. This feature was identified during a rapid walkover survey for the appraisal. It is a low earth mound, with occasional stone protruding through the grass cover. It measures 3 metres in diameter. It is most notable on its south and southwest sides, where it is up to 0.5 metres high. Its origins are not clear and could be a natural outcrop, clearance cairn or burial cairn.

Figure 2: Proposed turbine and the sites around it recorded during the appraisal.

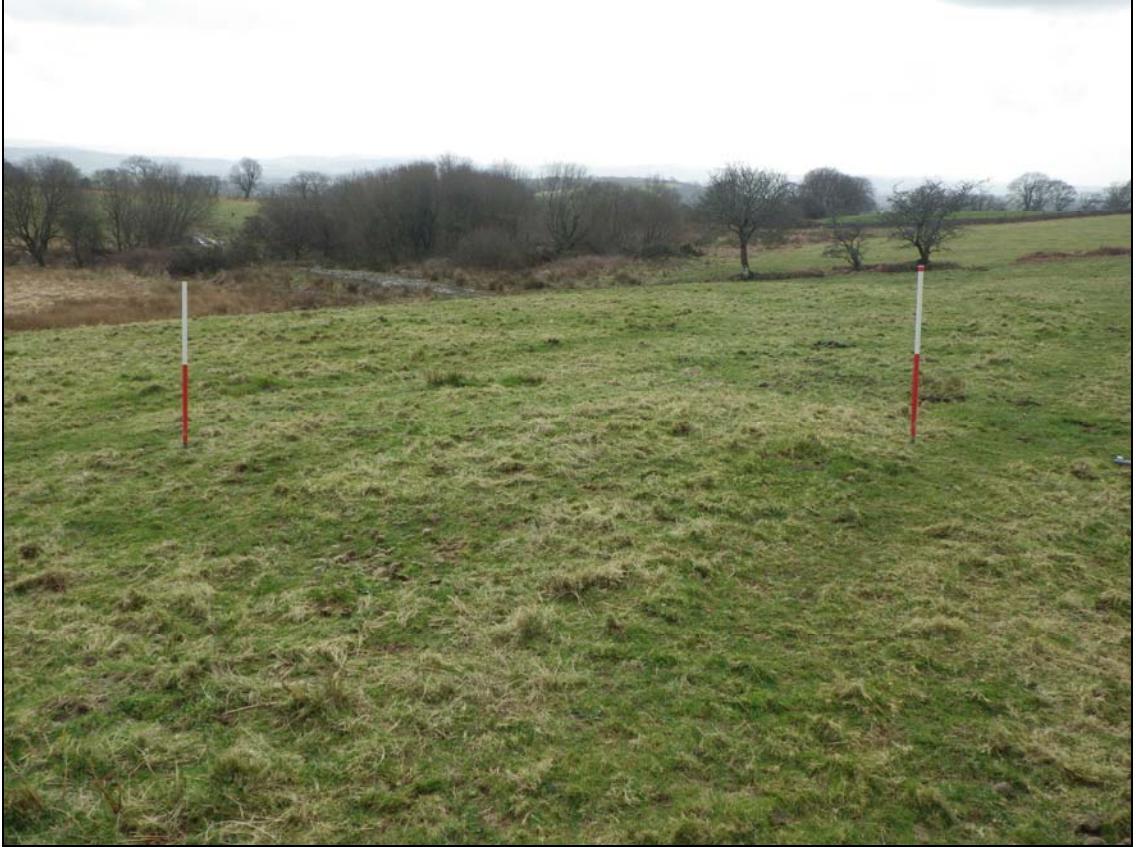
5.2 It is a low earth mound, with occasional stone protruding through the grass cover. It measures 3 metres in diameter. It is most notable on its south and southwest sides, where it

Plate 1: RYG2014\_101, The mound, in a pasture field, before evaluation trench excavated, looking south

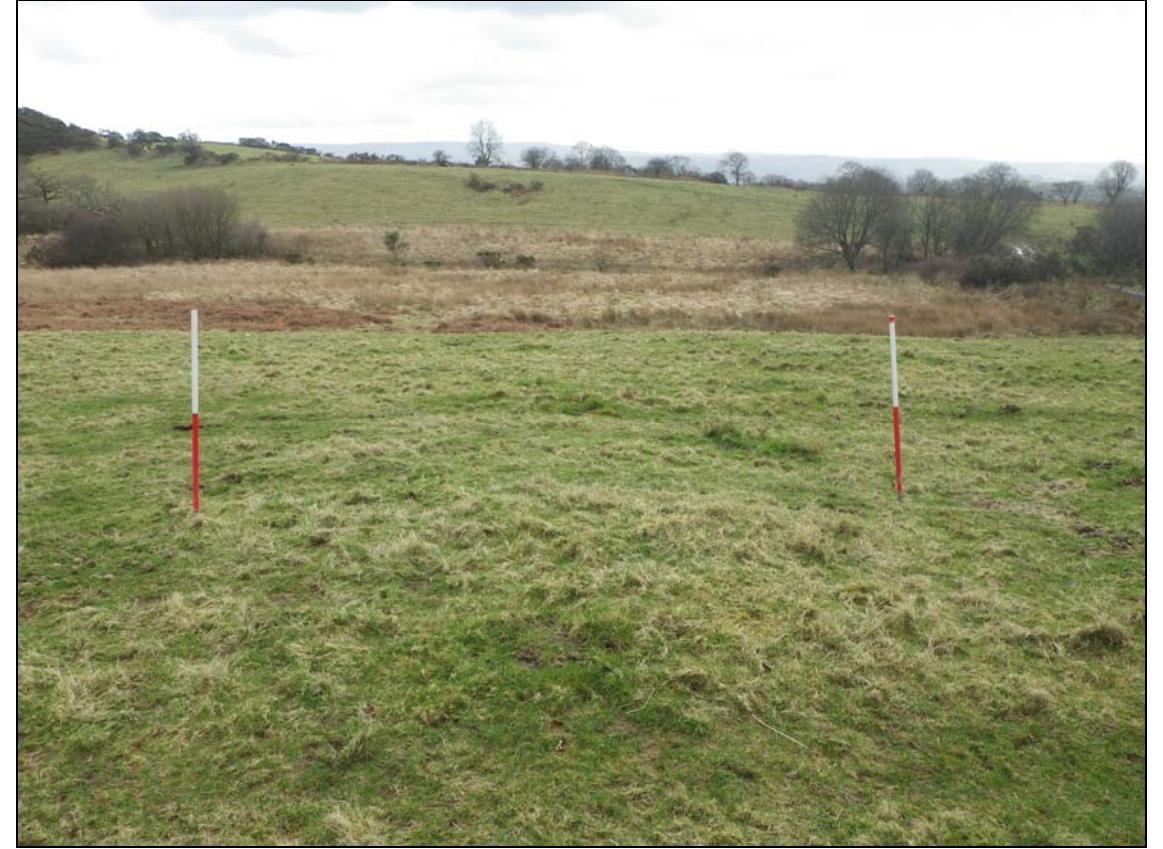
Plate 2: RYG2014\_102, the mound, in a pasture field, before evaluation trench excavated, looking southeast.

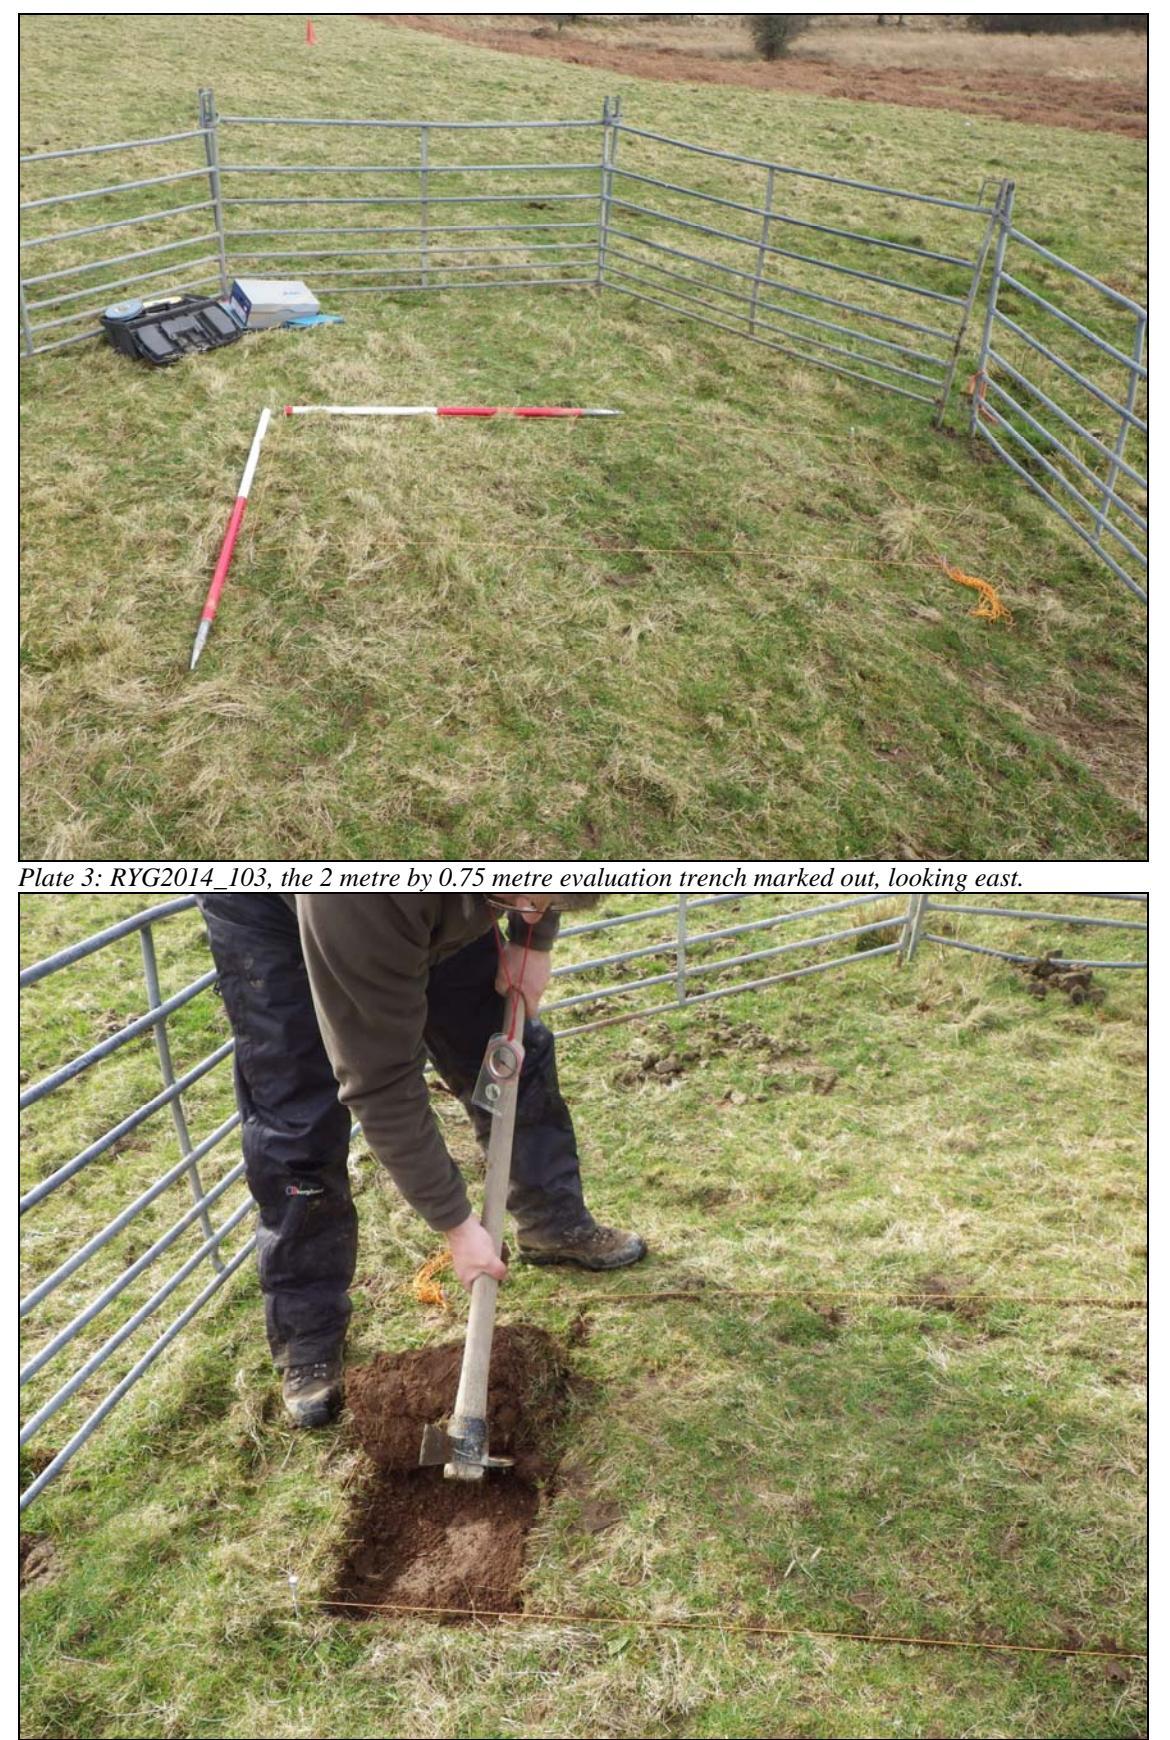
Plate 4: RYG2014\_104, beginning removal of the turf at the southern end of the trench, looking west.

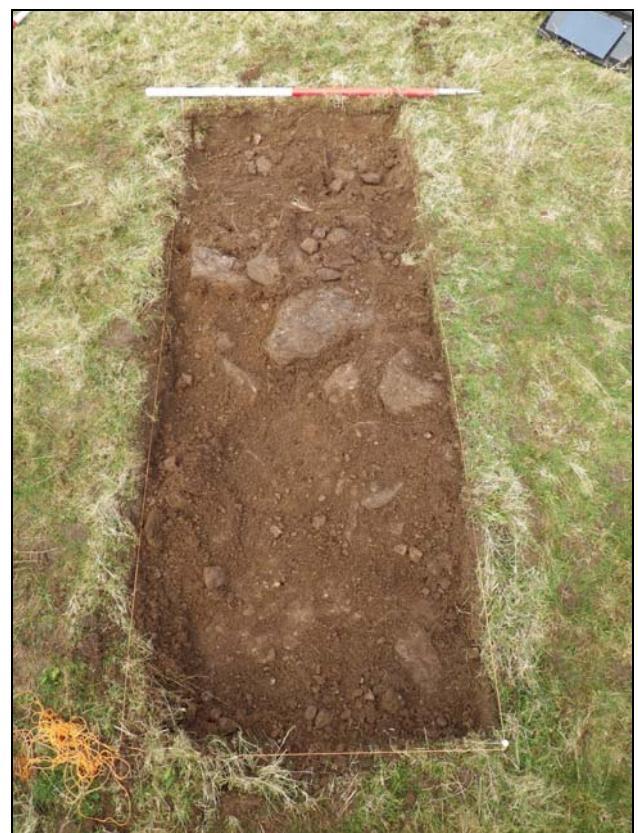
*Plate 5: RYG2014\_105, after removal of the turf, showing the remains of the topsoil, context 001, overlying partially visible stone layer, context 003, looking west.*

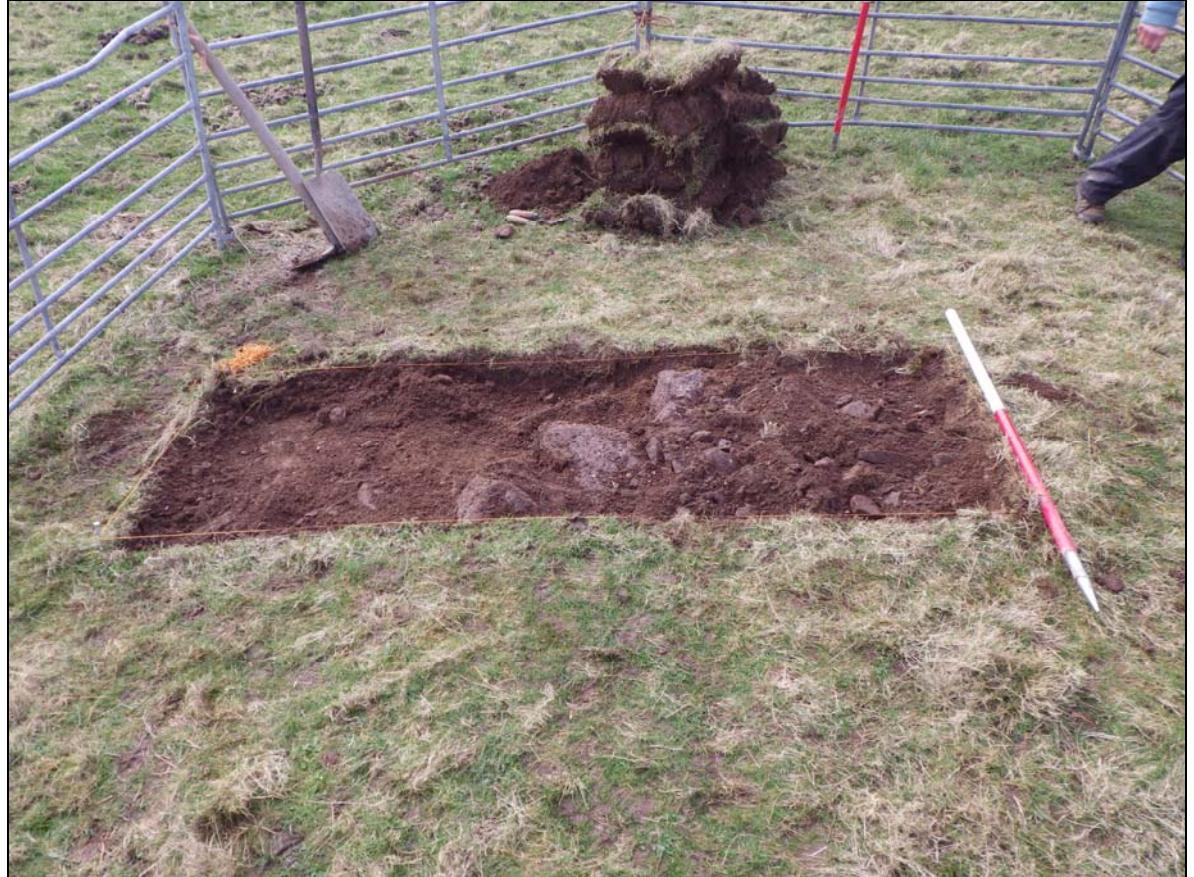
*Plate* 6:*RYG2014\_106, after removal of the turf, showing the remains of the topsoil, context* 001, overlying partially visible stone layer, context 003, looking west.

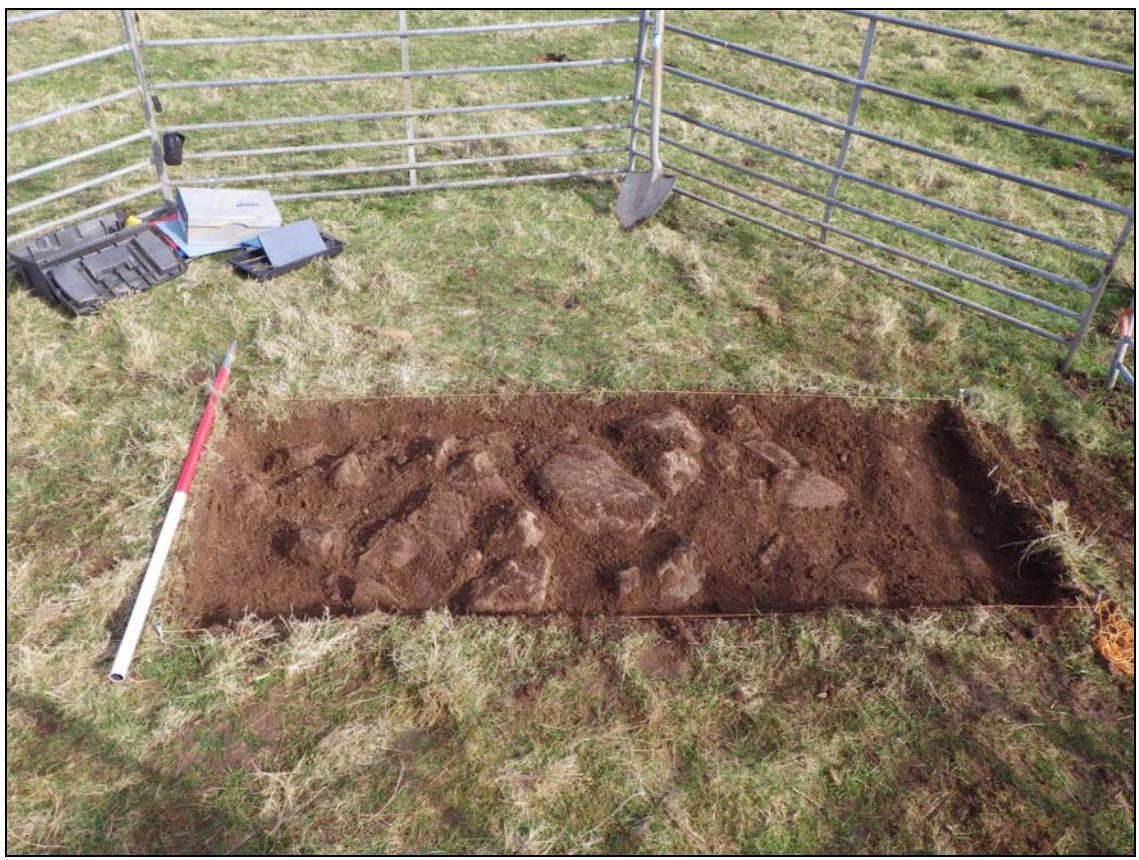
9.2 The stone layer revealed after the turf and topsoil was removed was considered to be a stone pile created by human activity. It was not established whether it was a funerary cairn or a clearance feature as for the purposes of the evaluation it established that the feature needed to be avoided by the turbine and its construction works

Plate 7: RYG2014\_107, After removal of the remains of the topsoil, context 00, looking east

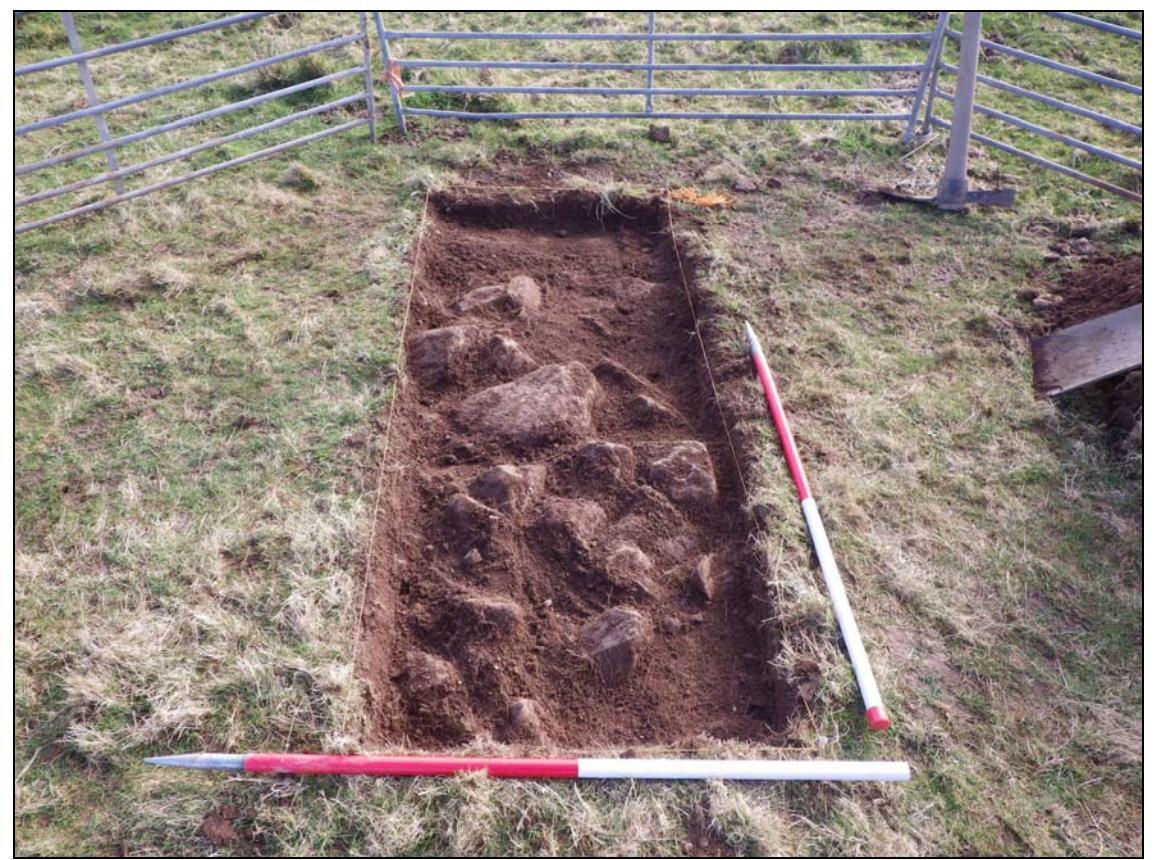
Plate 8: RYG2014\_108: After removal of the remains of the topsoil, context 00, looking south.

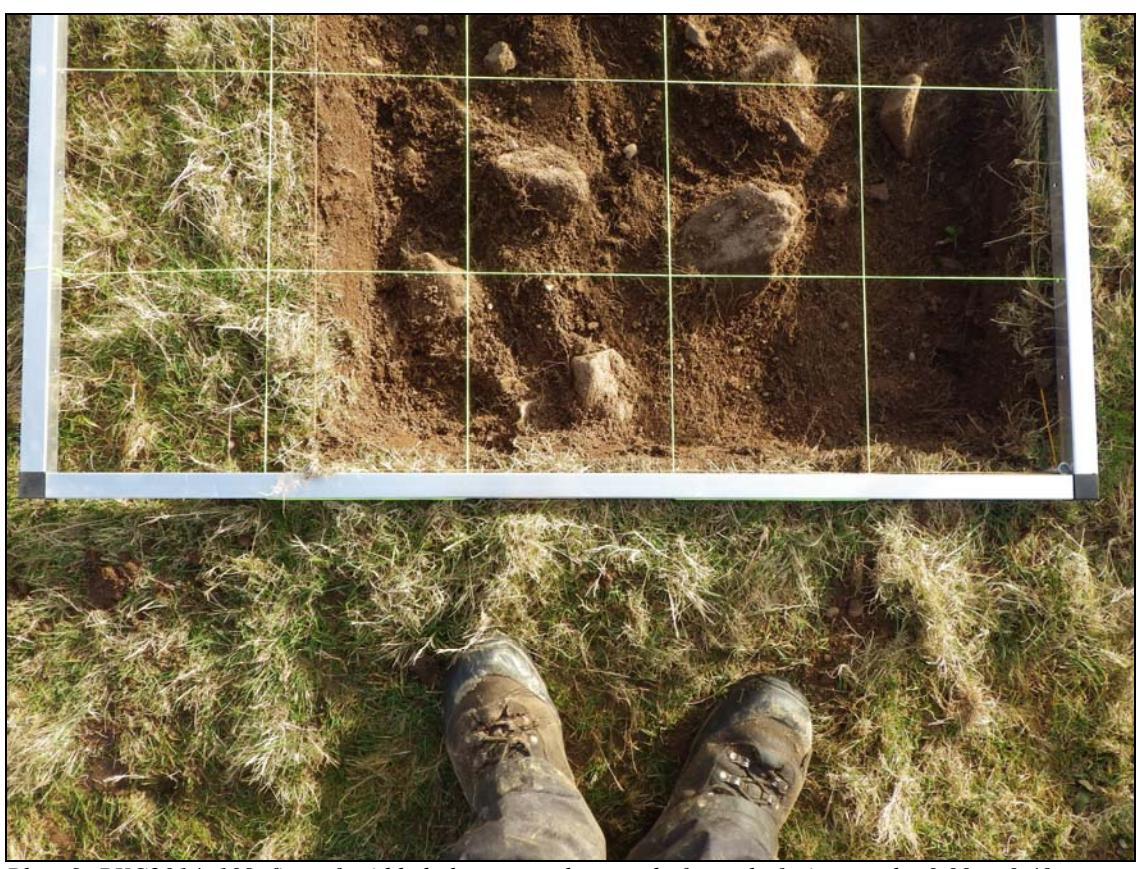
Plate 9: RYG2014\_109, first of gridded photos, northern end of trench, facing south. 0.00 to 0.40 metres, north to south.

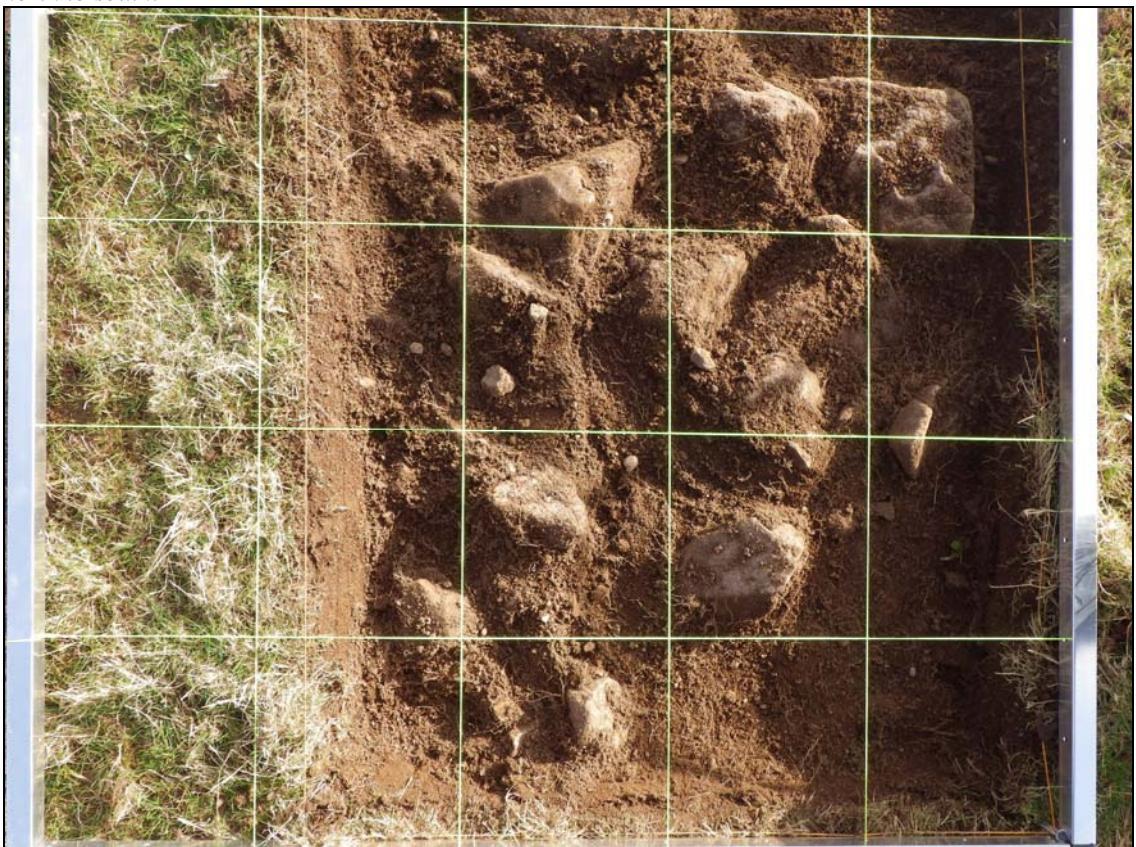
*Plate 10: RYG2014\_110: second of gridded photos, northern end of trench, facing south. 0.00 to 0.80 metres, north to south.*

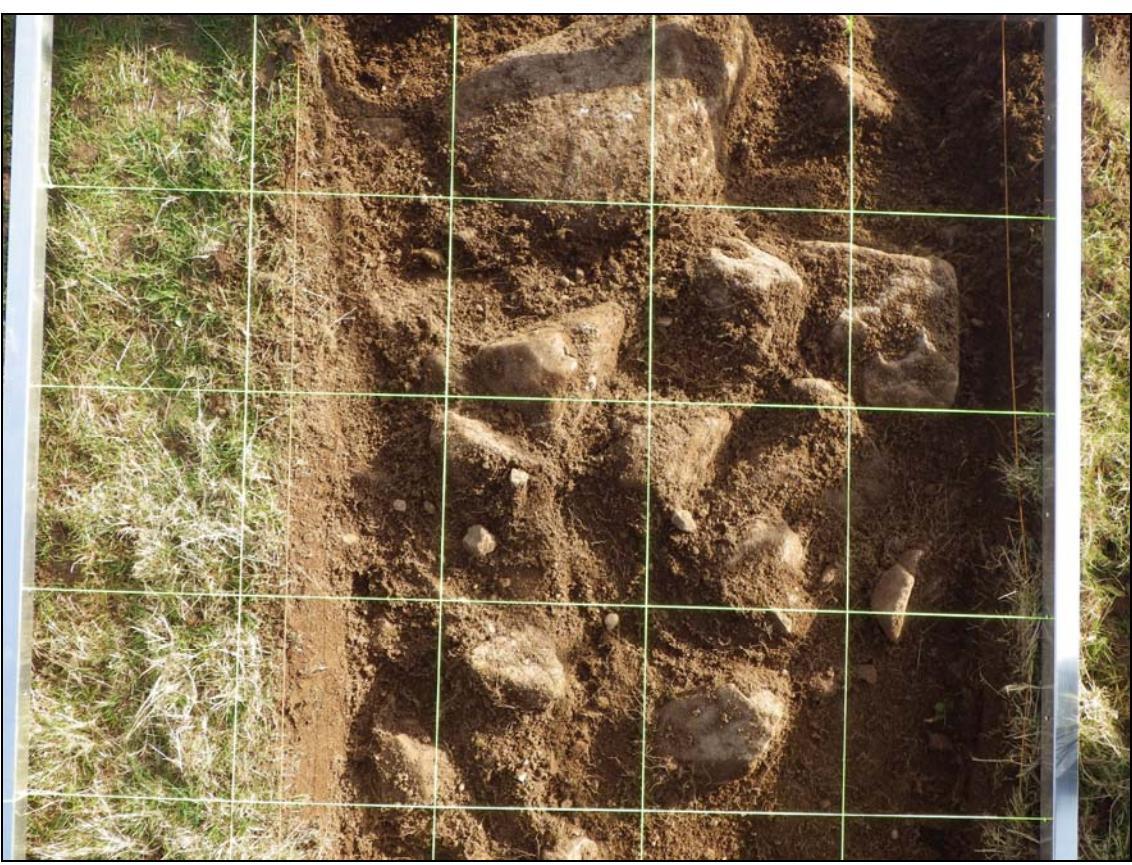
Plate 11: RYG2014\_111, third of gridded photos, northern end of trench, facing south. 0.20 to 0.80 metres, north to south.

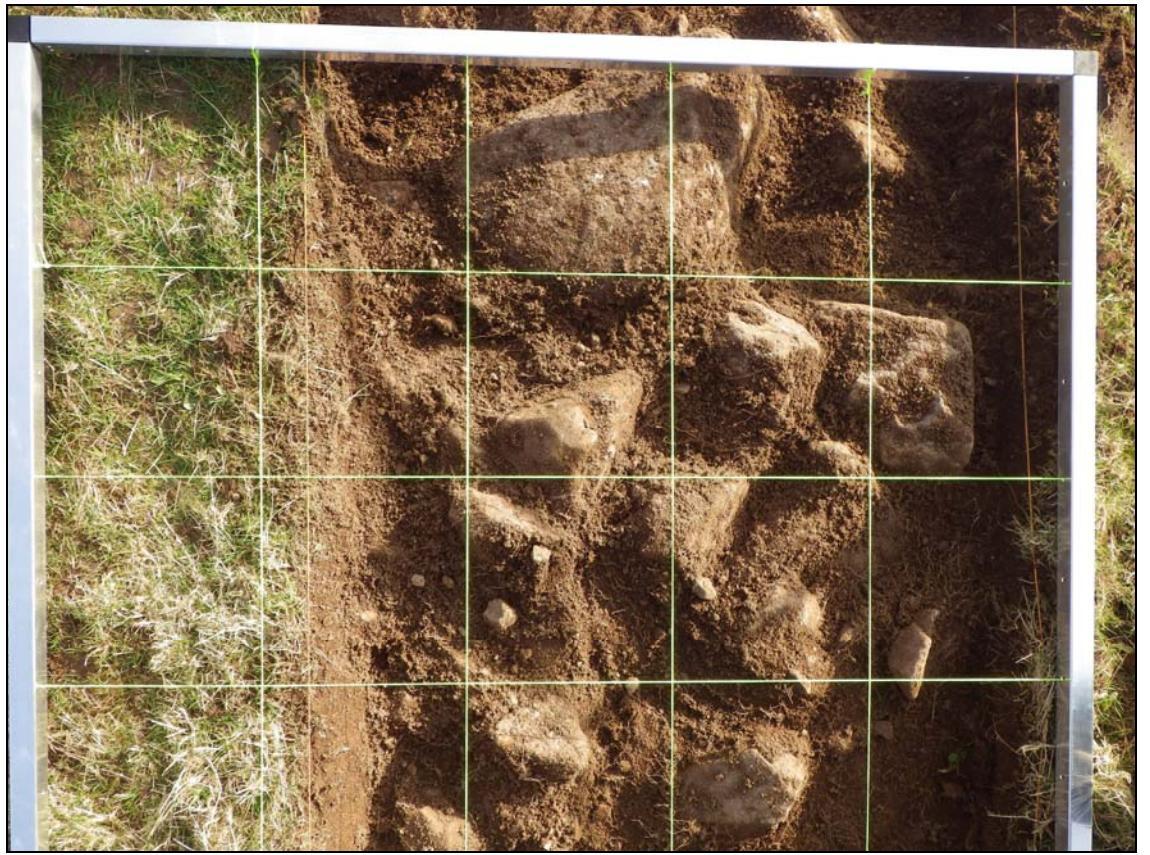
*Plate 12: RYG2014\_112: fourth of gridded photos, northern end of trench, facing south.* 0.40 to 1.00 metres, north to south.

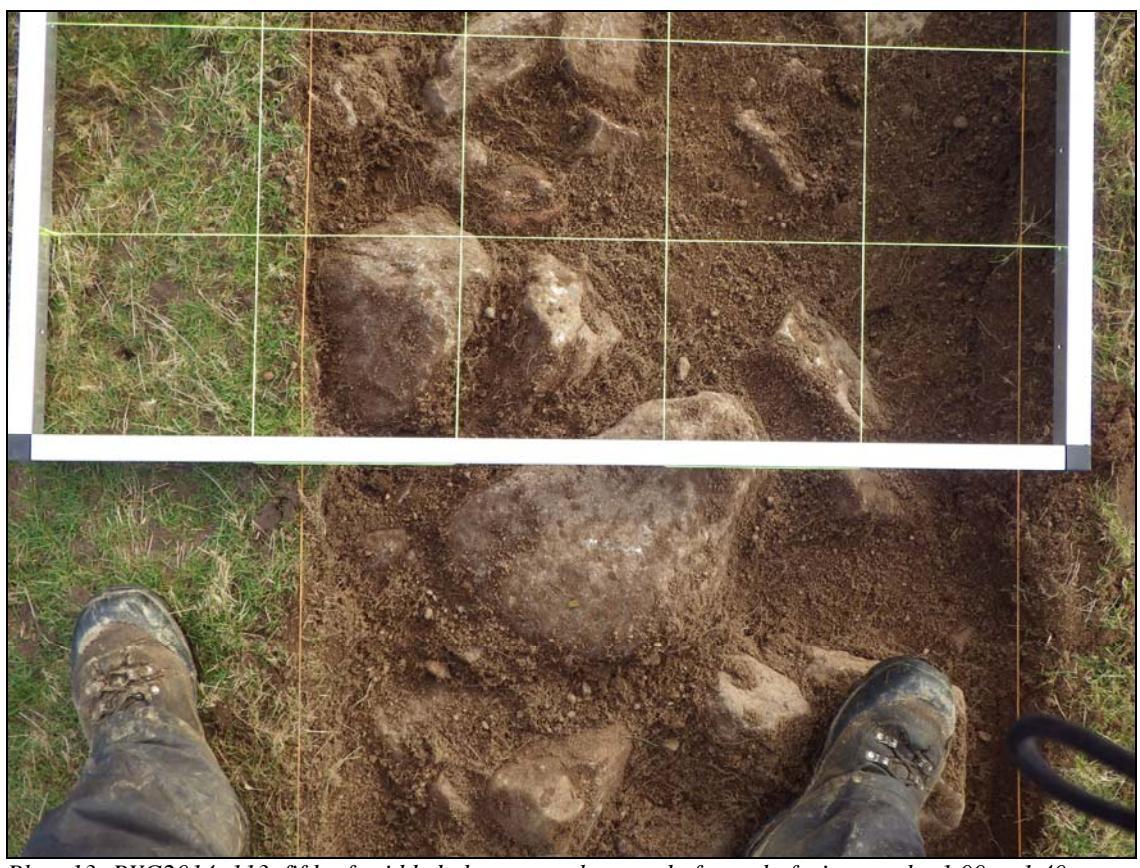
Plate 13: RYG2014\_113, fifth of gridded photos, northern end of trench, facing south. 1.00 to 1.40 metres, north to south.

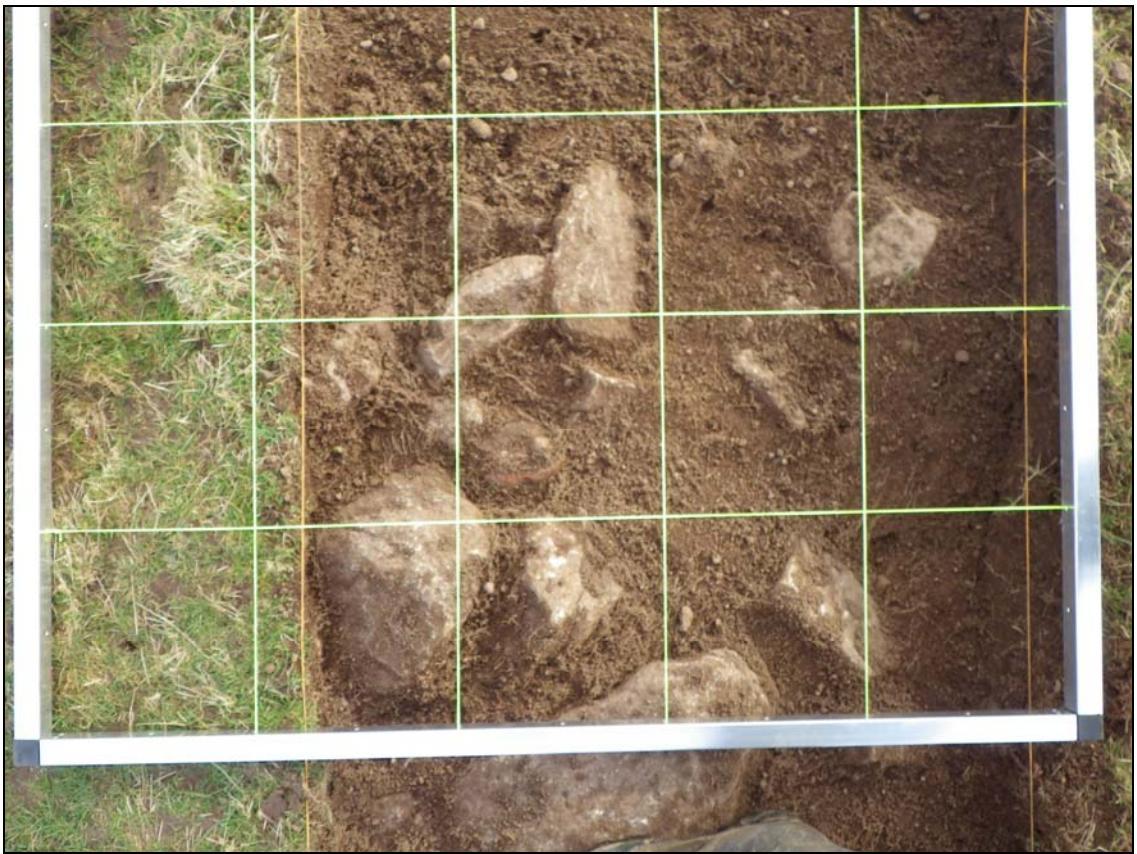
*Plate 14: RYG2014\_114: sixth of gridded photos, northern end of trench, facing south. 1.00 to 1.60 metres, north to south.*

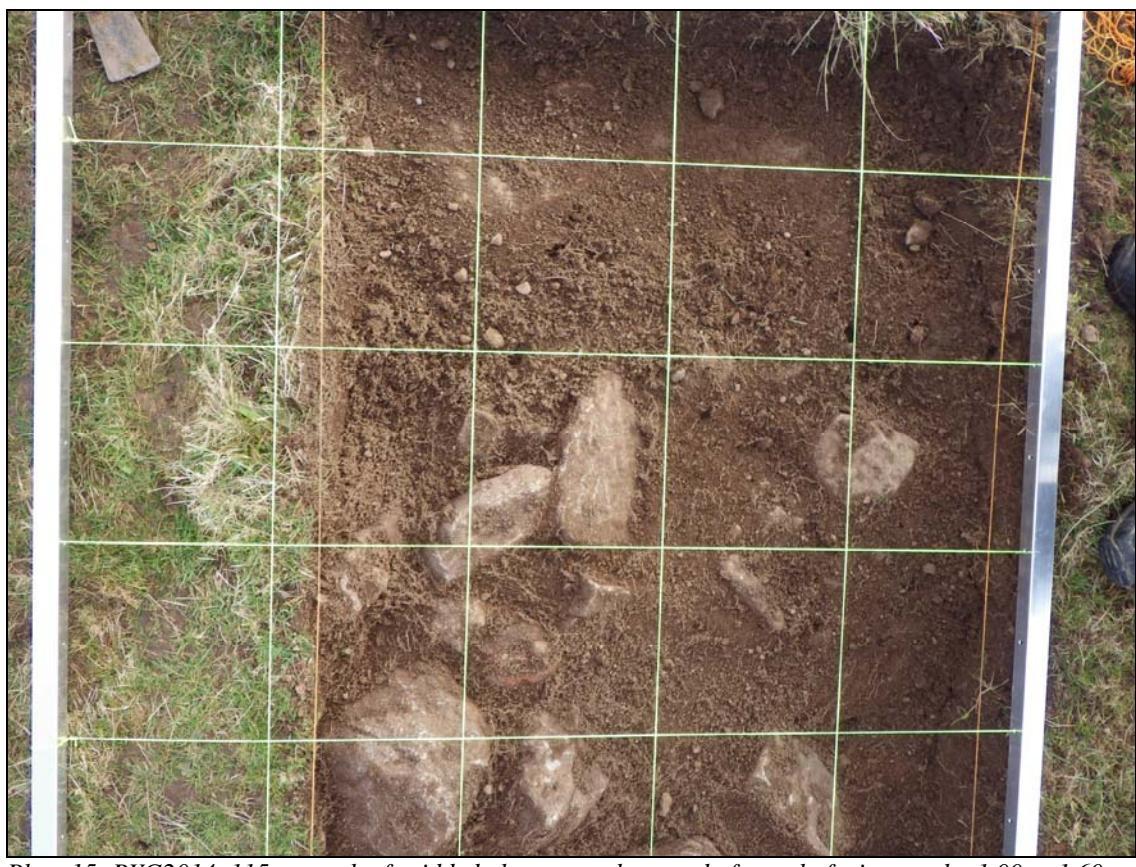
*Plate 15: RYG2014\_115, seventh of gridded photos, northern end of trench, facing south. 1.00 to 1.60 metres, north to south.*
