# Evaluation of Earthwork Feature, Rhydygwydd, Taliaris, Carmarthenshire

For: Seren Energy

May 2014

Trysor Project No. 2014/370

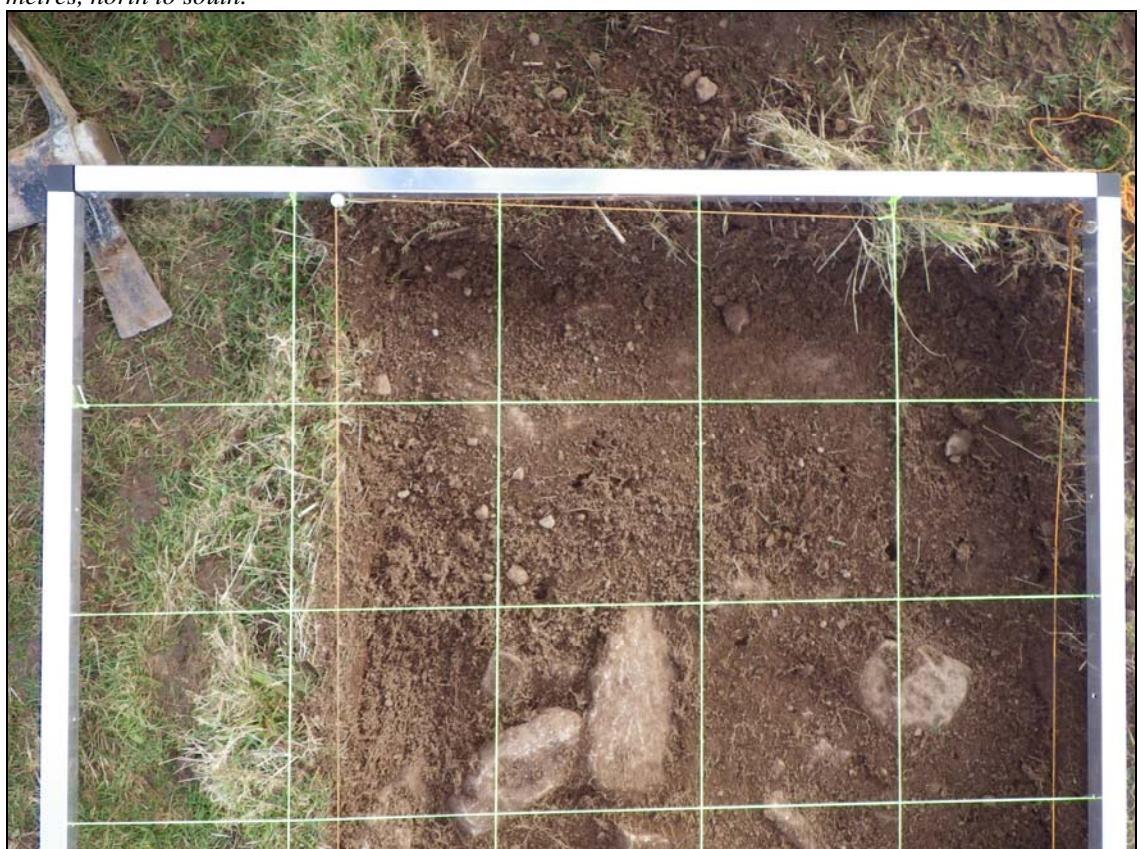
Plate 16: RYG2014\_116: eighth and final gridded photo, northern end of trench, facing south. 1.00 to 1.60 metres, north to south.

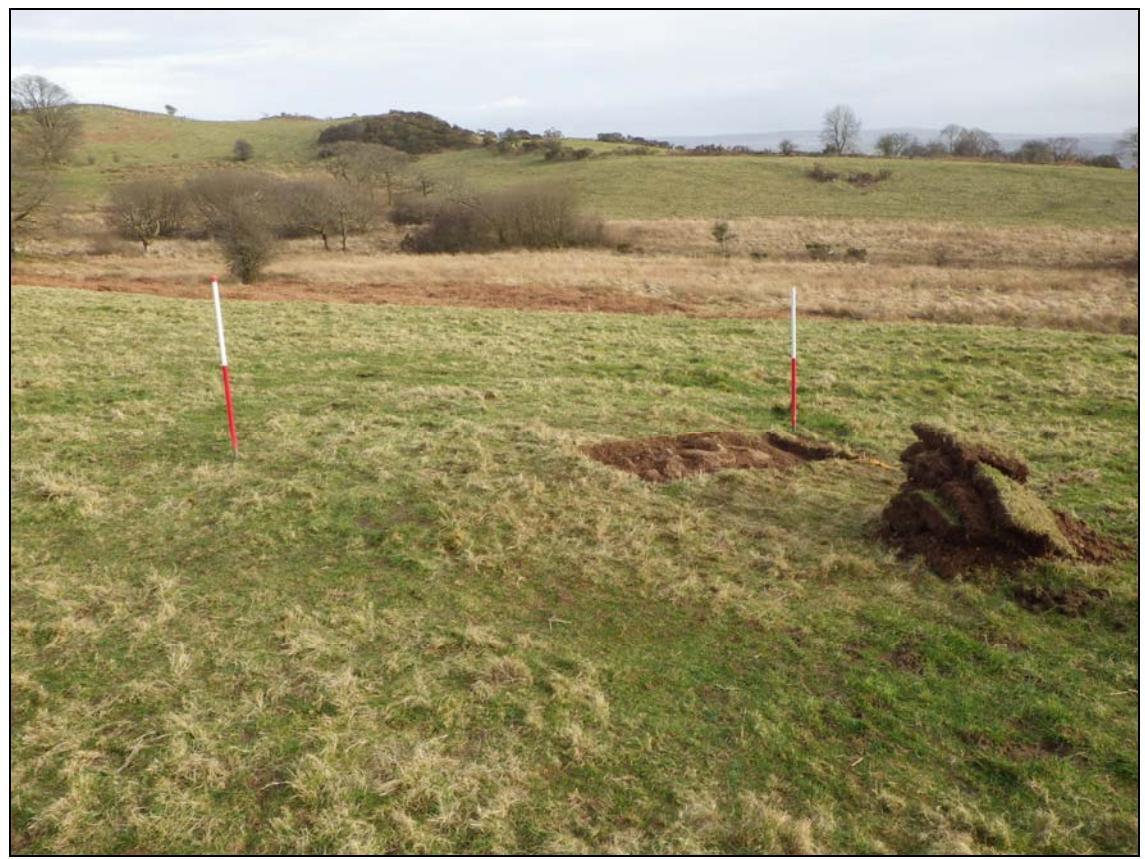
Plate 17: RYG2014\_117, showing the mound and open trench, looking southeast.

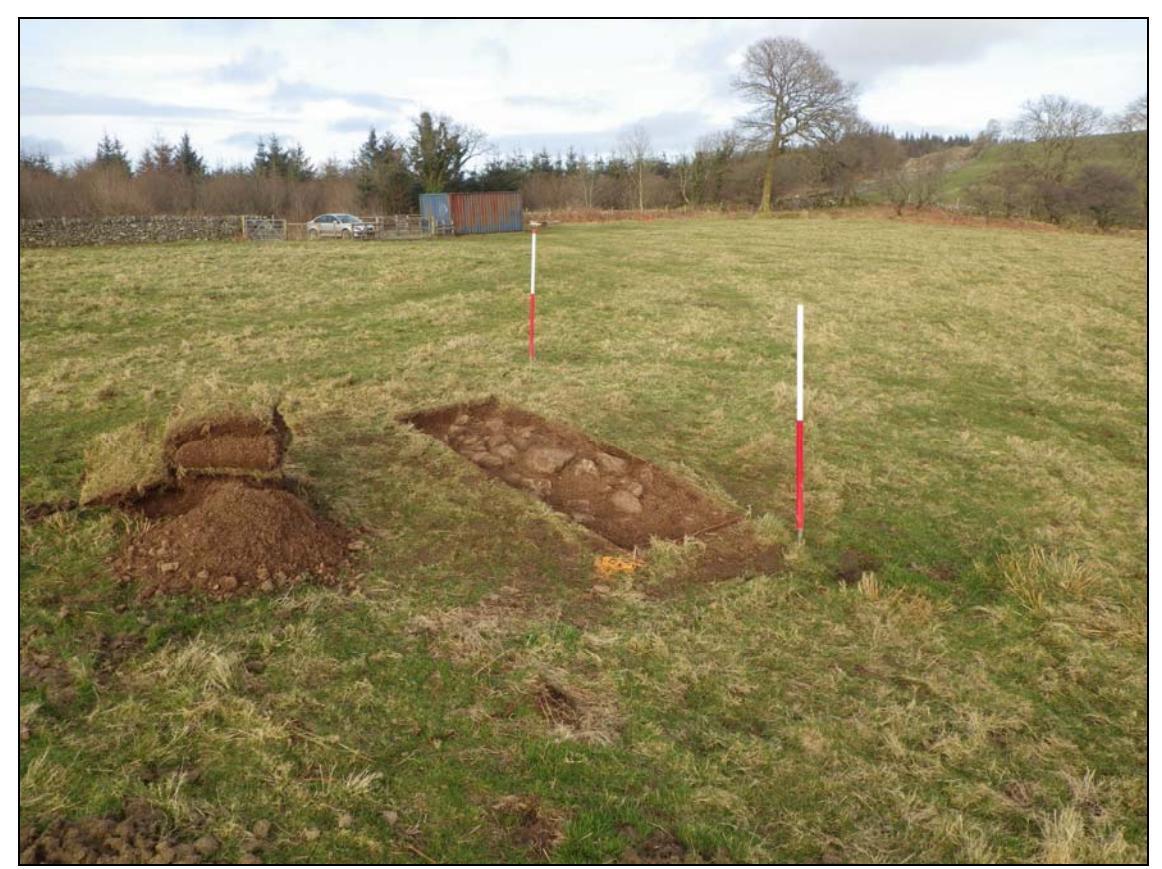
*Plate 18: RYG2014\_118: showing the mound and open trench, looking northeast.*

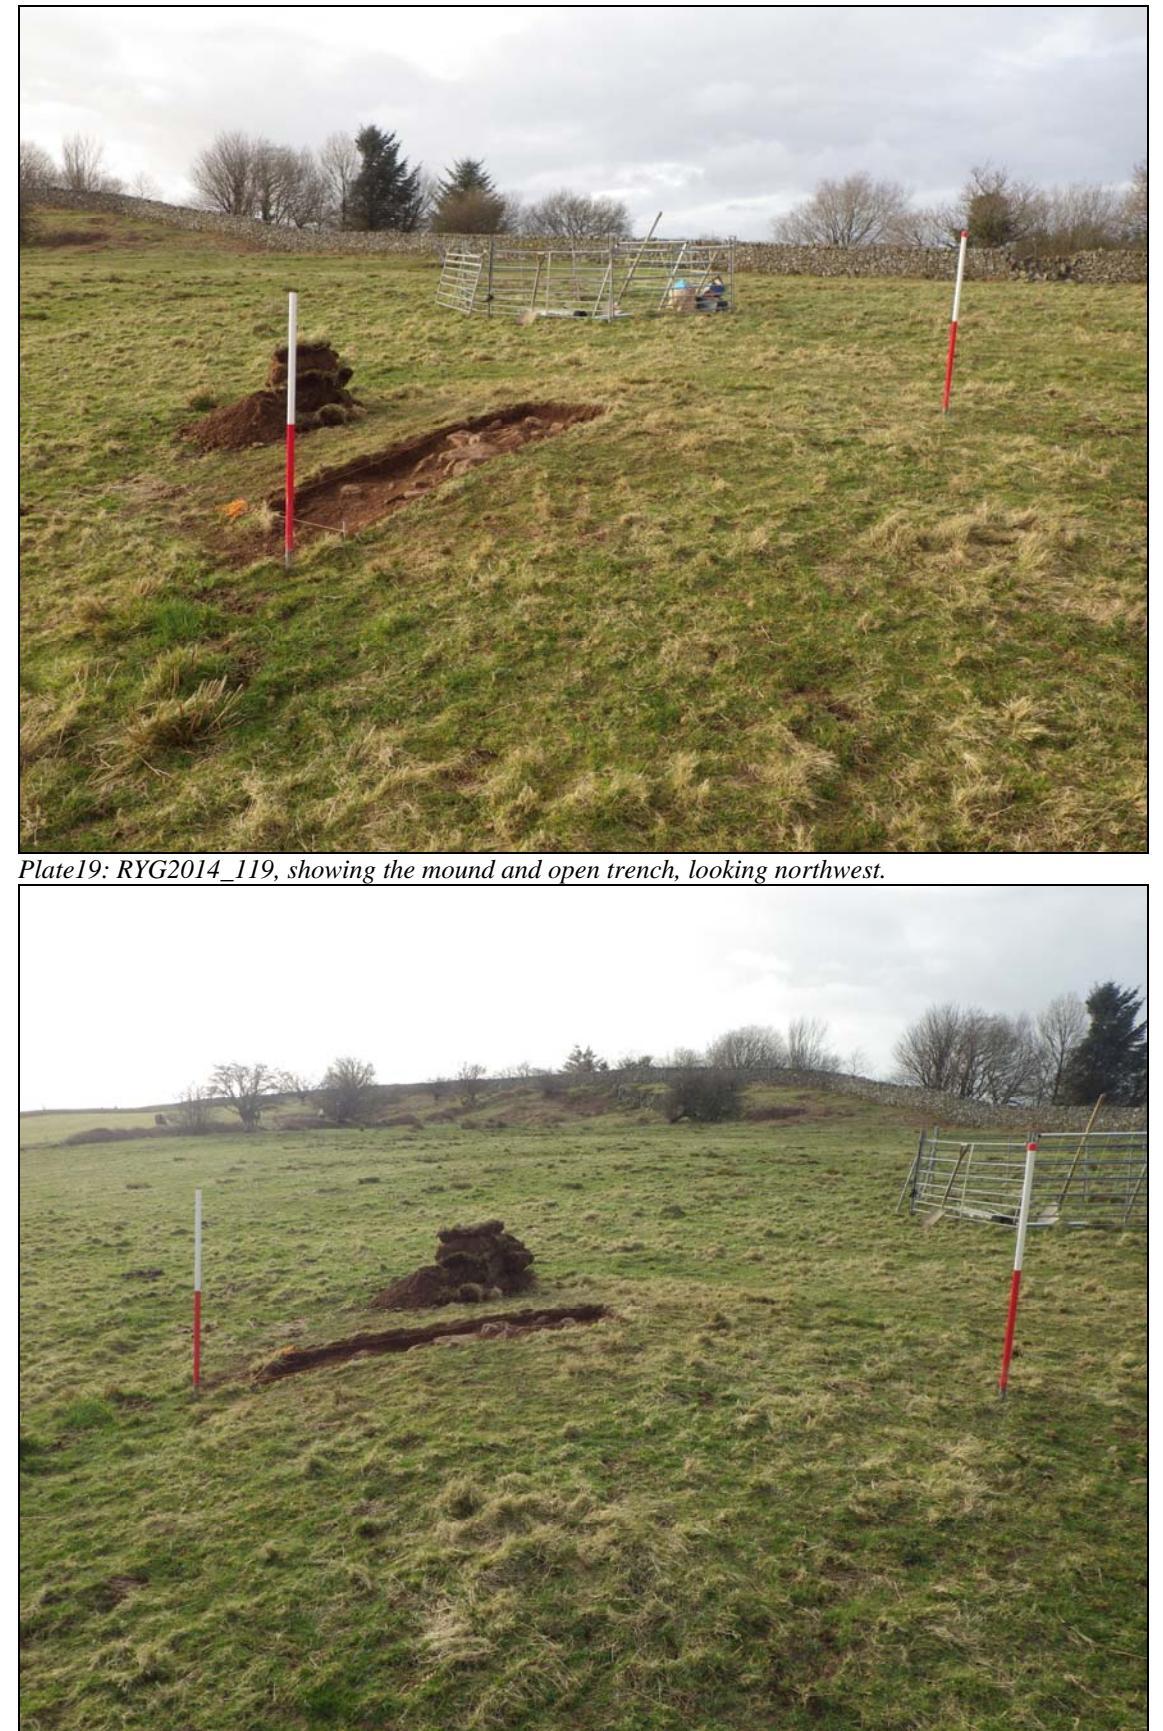
Plate 120: RYG2014\_120: showing the mound and open trench, looking west.

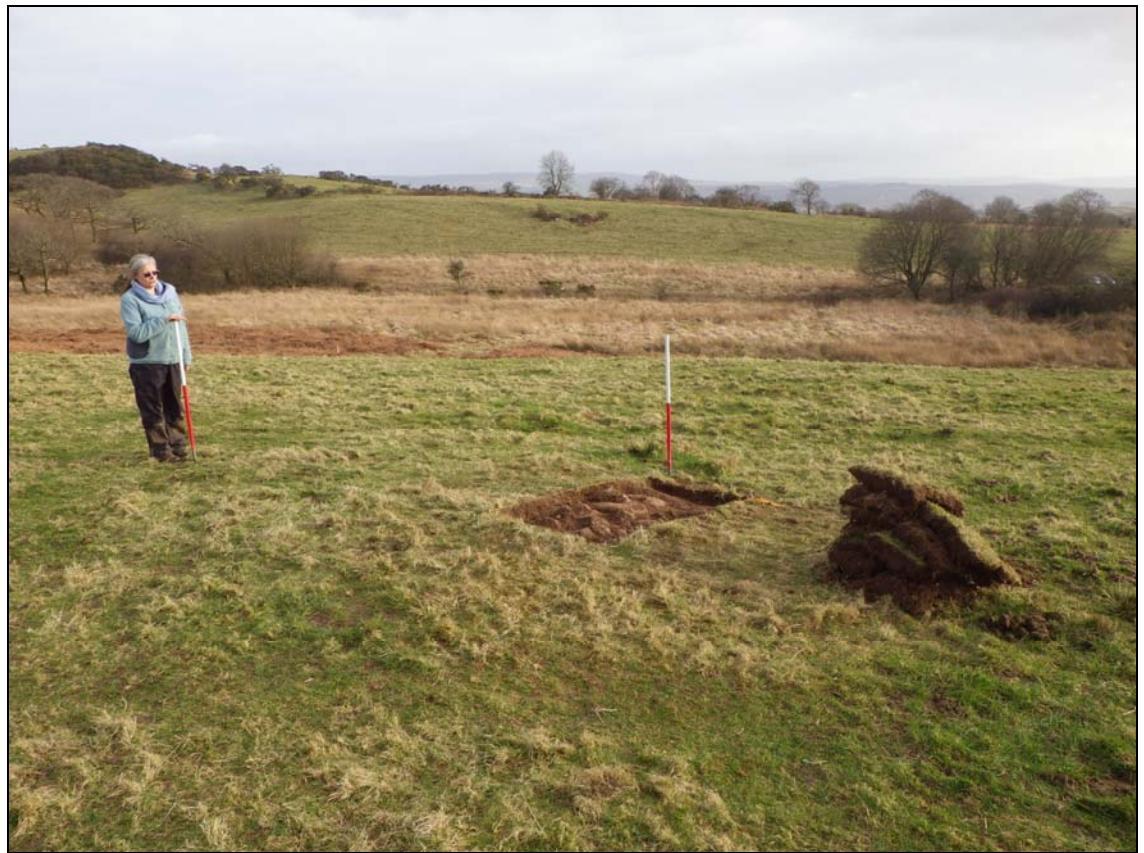
*Plate 21: RYG2014\_121, showing the mound and open trench, looking south southeast.*

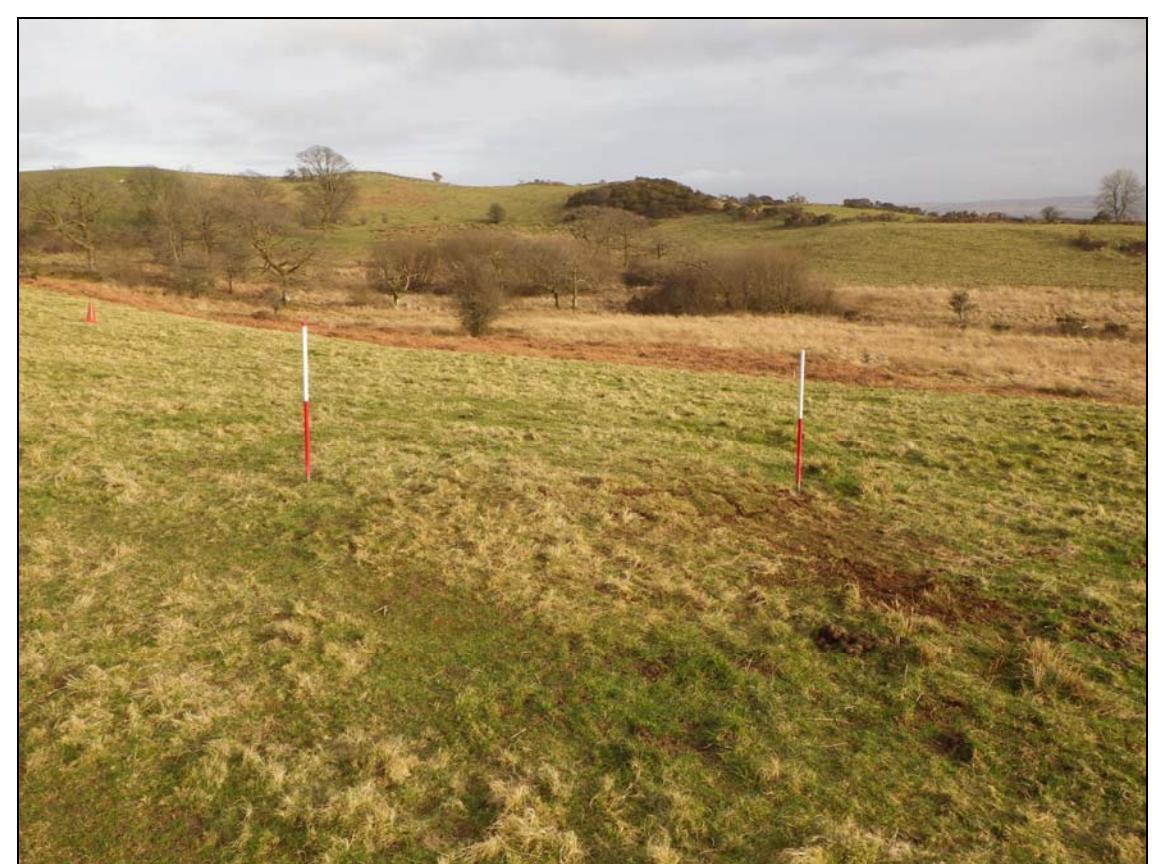
Plate 22: RYG2014\_122: Mound after reinstatement, looking east southeast.

9.3 The findings of the evaluation were passed to the client who altered the design of the hardstanding area and made arrangements for the protection of the site during construction. Trysor amended the appraisal accordingly, Hall & Sambrook, 2014a.

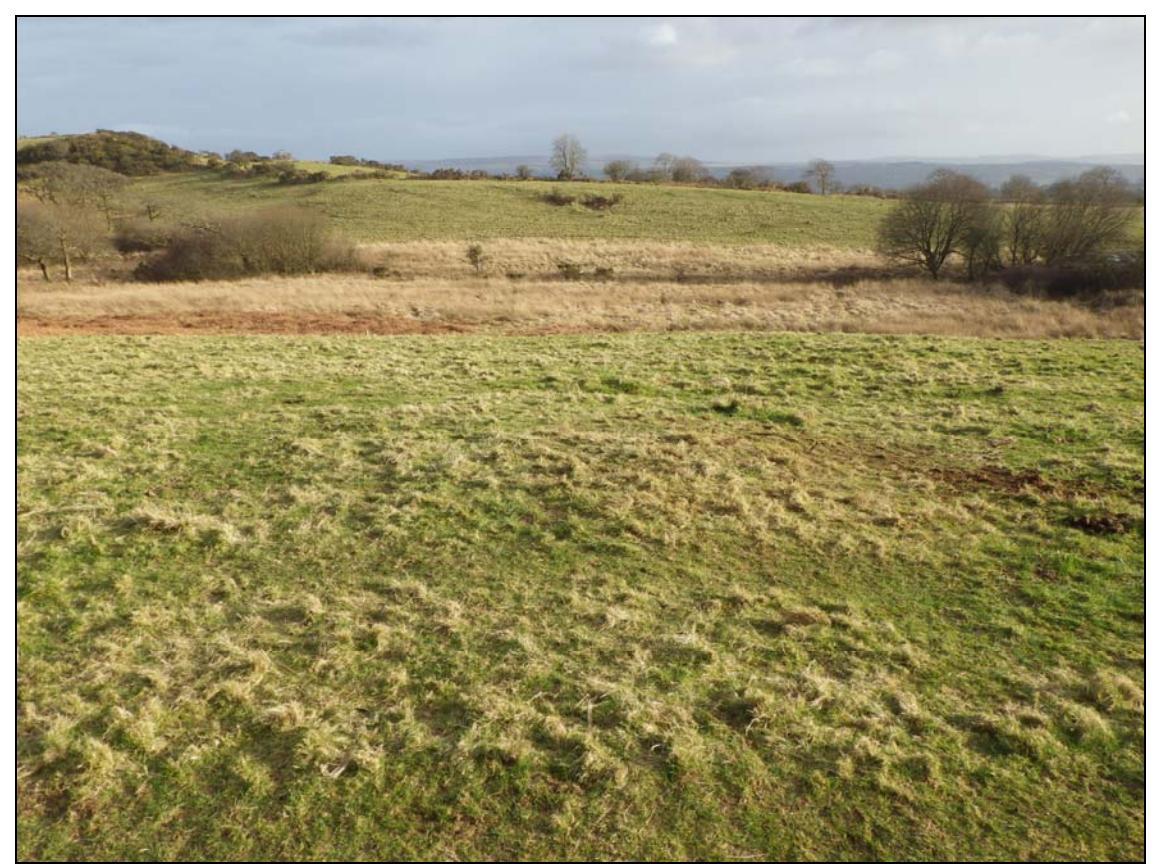
Plate 23: RYG2014\_123, mound after reinstatement, looking south southeast.
