Prehistoric Features at Llyn Morwynion, Ffestiniog

Archaeological Recording

Project No. G2437

Report No.1290

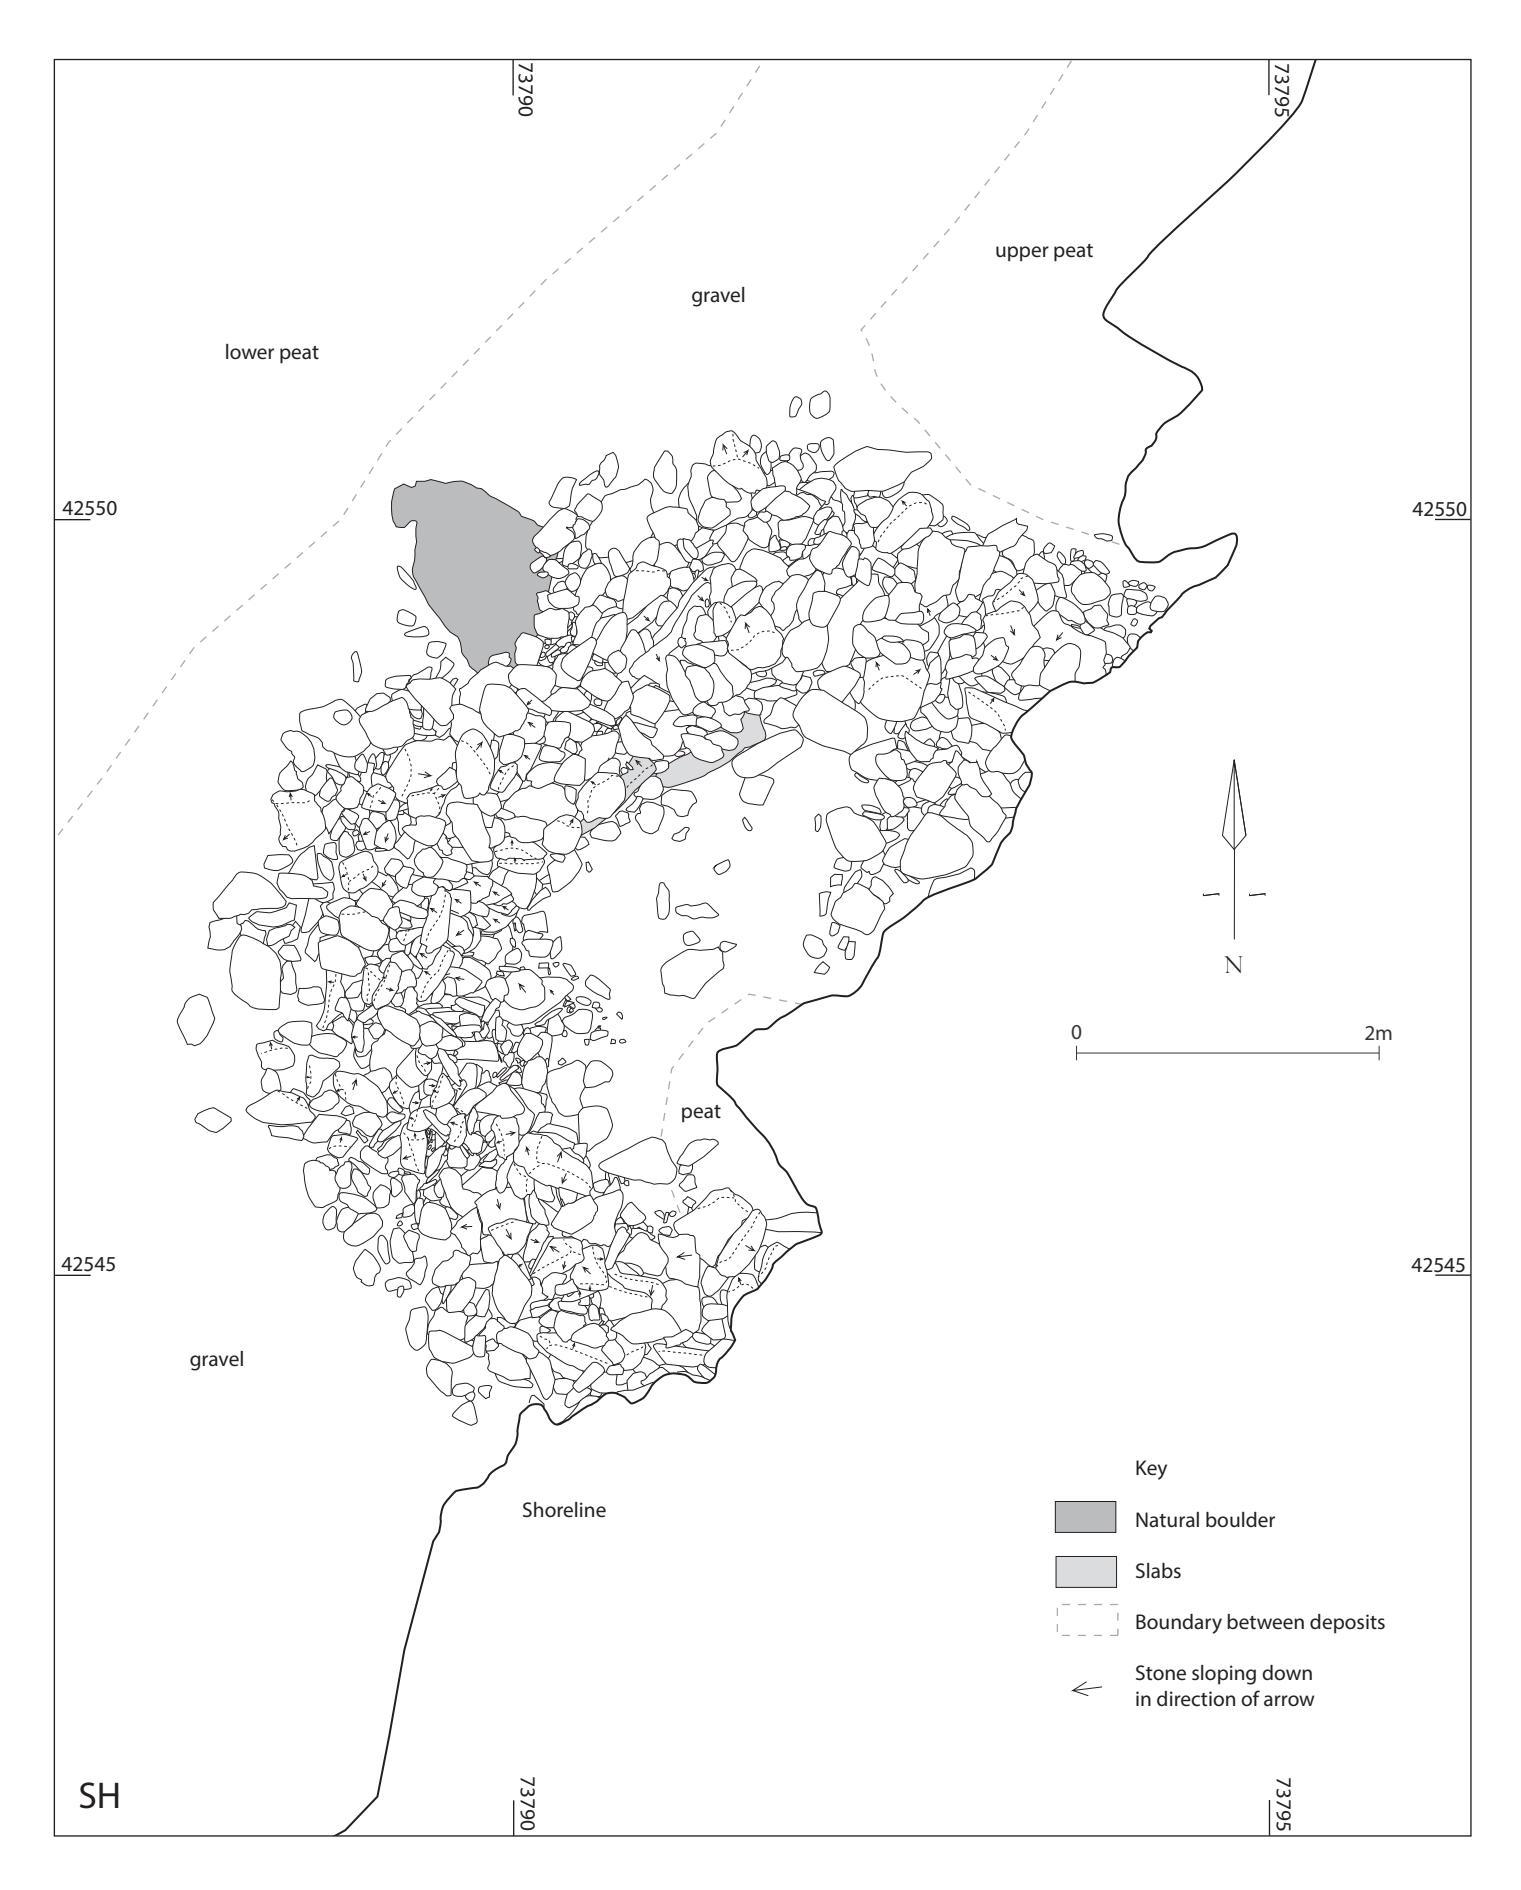
Figure 3. Plan of round-hut PRN 5144 drawn from 3D photogrammetric data

An arc of a circle of stones can be seen where peat has been eroded on the lake shore (plates 4 to 6). The arc suggests a circle c.7m in diameter externally and possibly 3.5m internally. The stones are haphazardly heaped around the arc, although there are two flat slabs visible in the base on the north-western side. The largest stones are the flat slabs which are up to 0.75m long, other stones are less than 0.5m long. Also on the northern side are a few stones that are slightly more orderly that could indicate an inner face. This can particularly be seen where the stones extend under the peat. The arc is built over a natural boulder projecting from the peat on the north-western side.

This feature is on the south-eastern side of a small bay, much of which is full of peat. The edge of the peat is very close to the structure but does not quite reach it and the structure is built on an angular shaley gravel. Up to 0.6m of peat directly overlies the eastern part of the structure. No evidence of cut features was visible inside the arc of stones but the area was not cleaned.

There is no trace of an entrance in the exposed arc. The land rises to the east and an entrance on this eastern side would be unlikely, as water running down the slope would run into it. This raises the question whether the structure originally had an entrance at all.

A detailed stone-by-stone plan (figure 3) was produced of this feature from a 3D photogrammetric model (plate 7 and PRN5144.pdf).

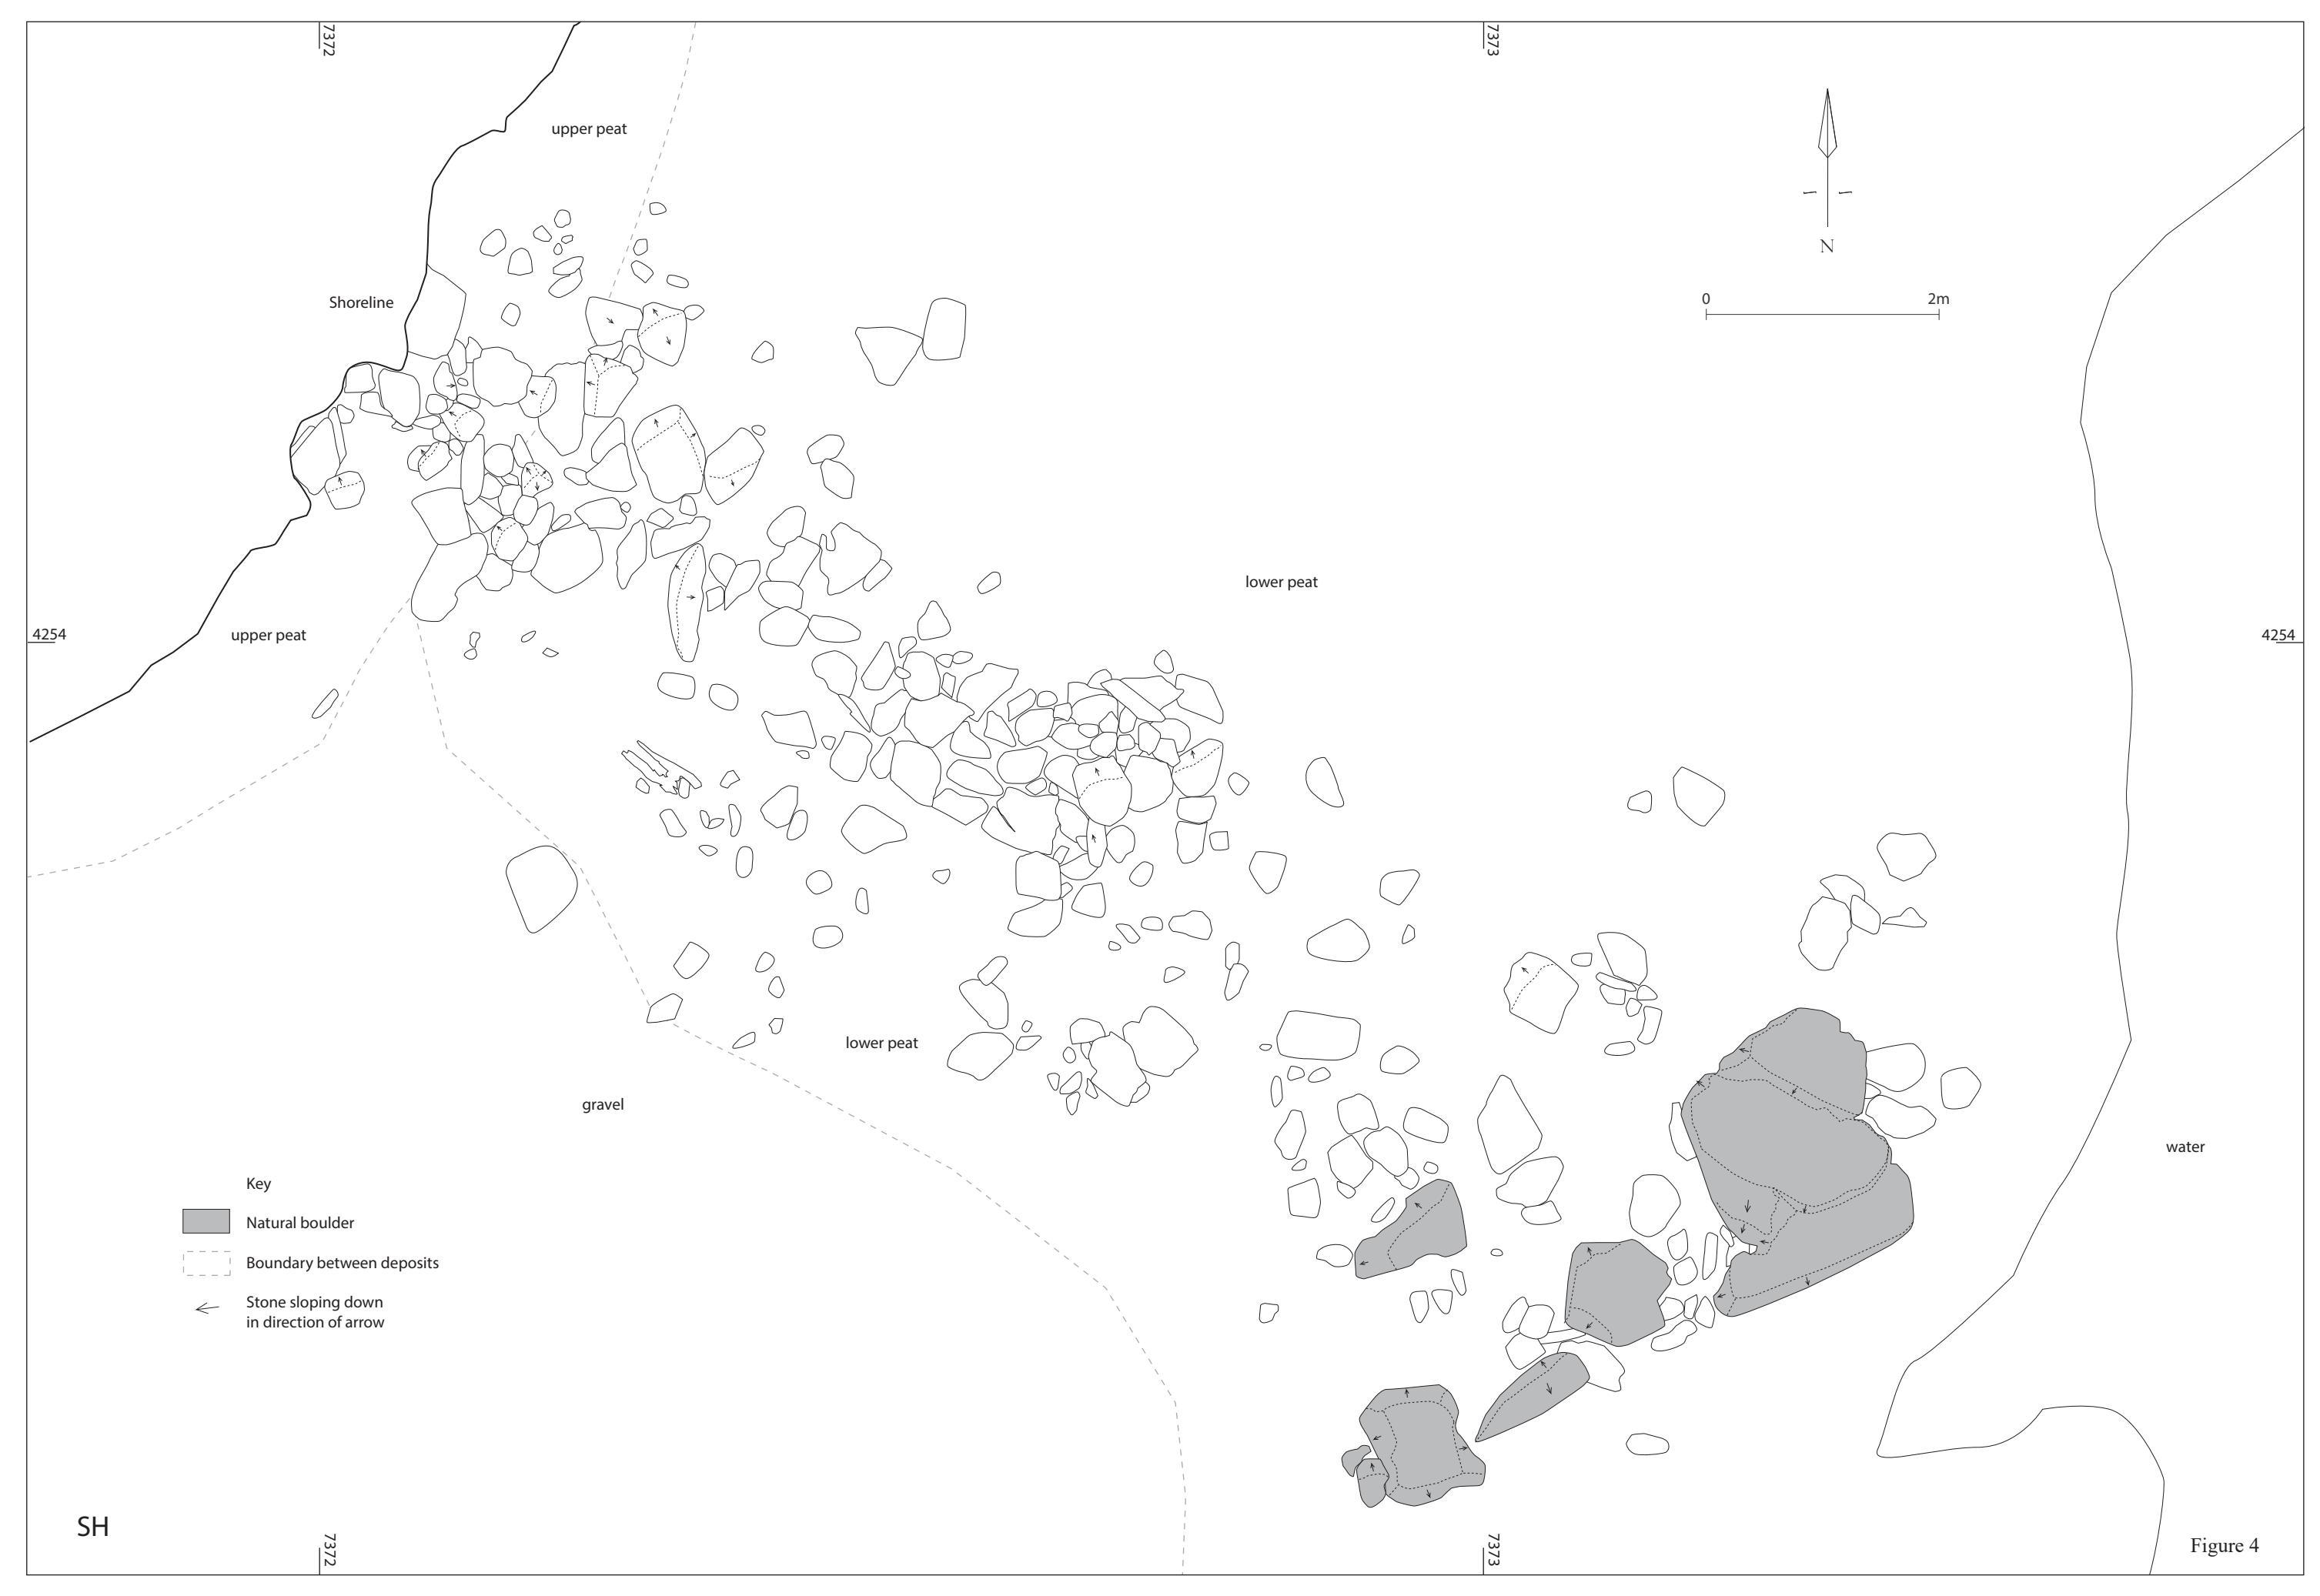
Exposed on the lake shore is a length of denuded wall (plates 11 to 13). This runs fairly straight north-west to south-east for about 8m after which there are only occasional scattered stones indicating that is originally ran to a group of natural boulders. The wall is about 2m wide where it is best preserved as it first appears from under the peat.

The largest stones are up to 1m long and are haphazardly arranged, although some are laid flat at the base of the wall, embedded in the underlying peat. Some of the overlying peat seems to have been left around some stones, but it is clear that the lower part of the peat deposit extends under the stones of the wall. The wall appears to sit on a very slight bank, which is where the peat has been protected by the stones while it has been more eroded elsewhere.

The exposed section of wall is located at SH7372042542. A detailed stone-by-stone plan (figure 4) was produced of this feature from a 3D photogrammetric model (plate 11 and PRN61248.pdf).

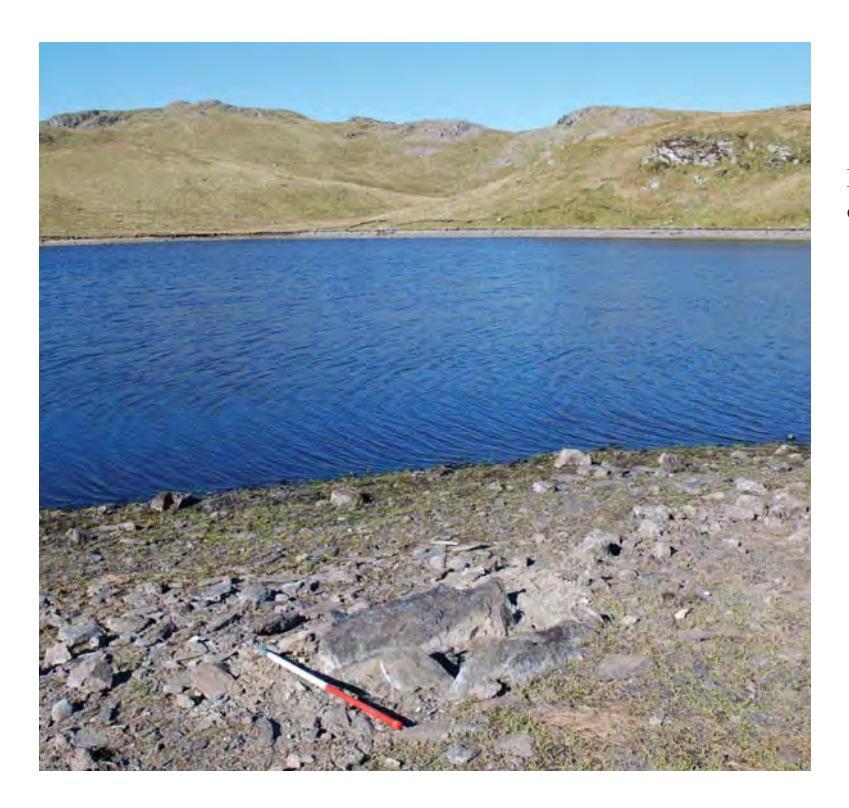
Plate 1. Location of cist-like feature (PRN 61246) on lake shore

The feature that had initially been reported is composed of several slabs of stone on edge that resemble a Bronze Age cist. The feature is located on the shore, below normal lake level at SH 73906 42321 (figure 1, plate 1). A large slab aligned c.NE-SW projects from the ground at an angle of about 60 degrees. Other roughly parallel but smaller slabs also project from the ground, lying roughly parallel to the large slab (plates 2 and 3). The large slab is 1.1m long and the whole group is about 0.9m wide. Although the layout of the stones does give the impression of a possible cist cleaning around the slabs showed that they were deeply embedded in compact, clean gravel. This gravel was the same inside and outside the area defined by the stones and appeared to be the natural glacial gravel.

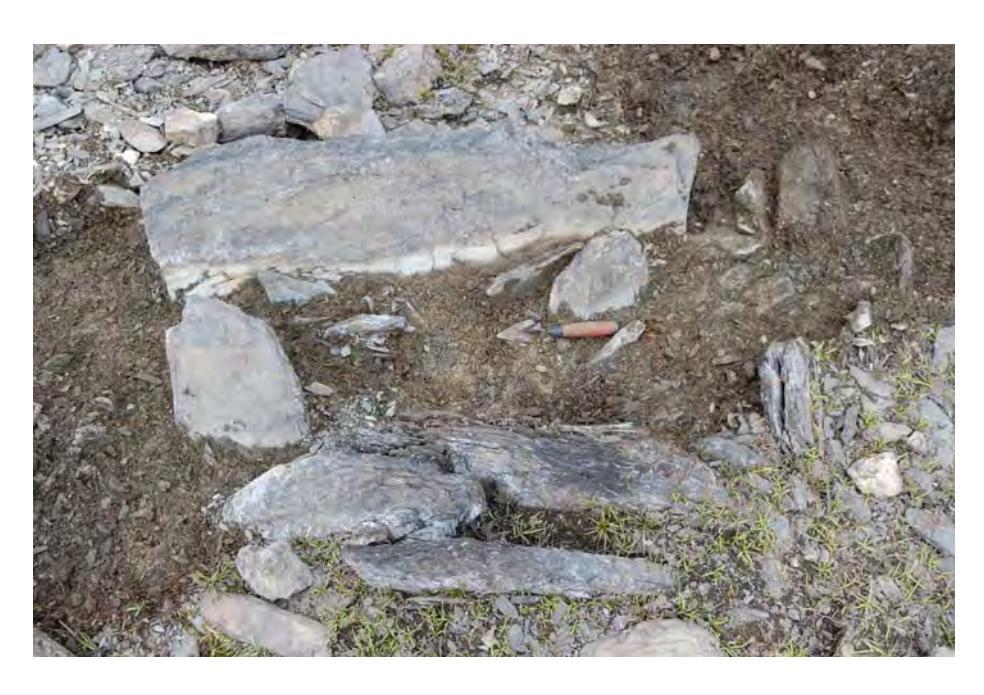
Plate 2. Cist-like feature (PRN 61246) after investigation

In many places on the lake shore slabs can be seen projecting from this gravel and also eroding out of the lake edge cliffs at a variety of angles. The bedrock along the southern part of the lake is a slabby sandstone and this seems to have been moved by glacial action and slabs mixed into glacial gravels often at steep angles. It was concluded that this feature was entirely natural in origin.

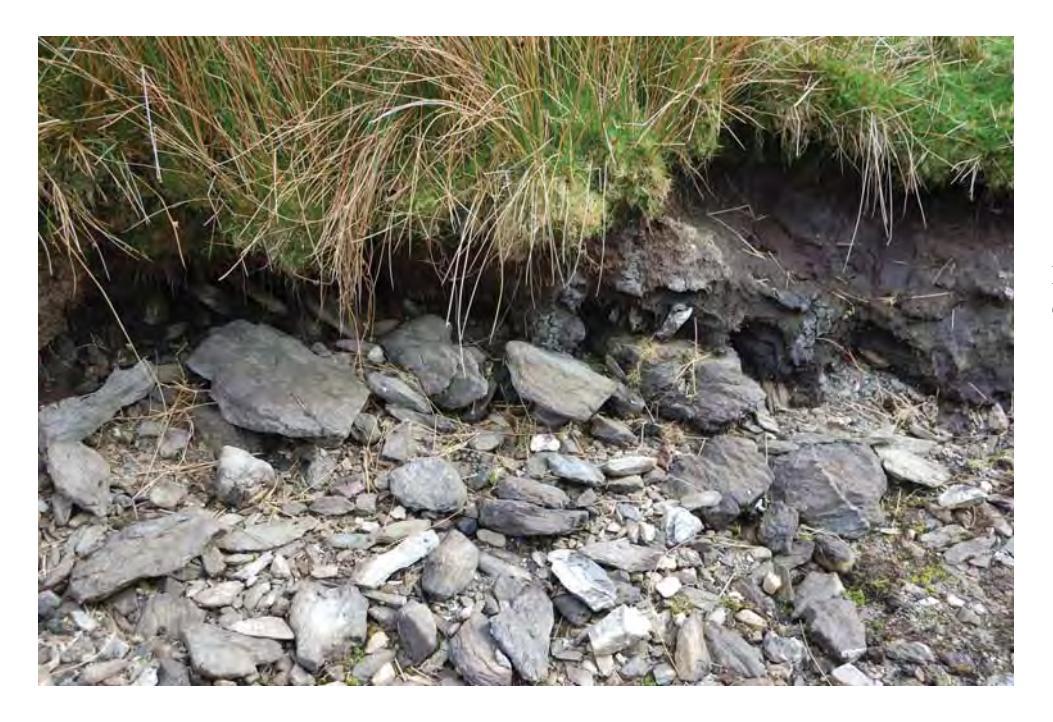
Plate 8. Possible wall remains on south side of PRN 61247

About 3.5m to the north-north-east of PRN 5144 (figure 2, SH 73796 42556) is an area of larger flatter stones than appear in the general gravel. George Smith marks a stony surface on his sketch plan in this area (Smith 1998, Fig 13). Close inspection of the eroded shore edge revealed rough piles of flat slabs at each side of this stony area (plates 8 to 10). Occasional stones suggested that these had extended further to the west but had been eroded away. The remains are very eroded and obscured but it is possible that this was the remains of another small round-hut, no more than possibly about 3m in diameter externally. Much of this feature must remain buried under the peat.

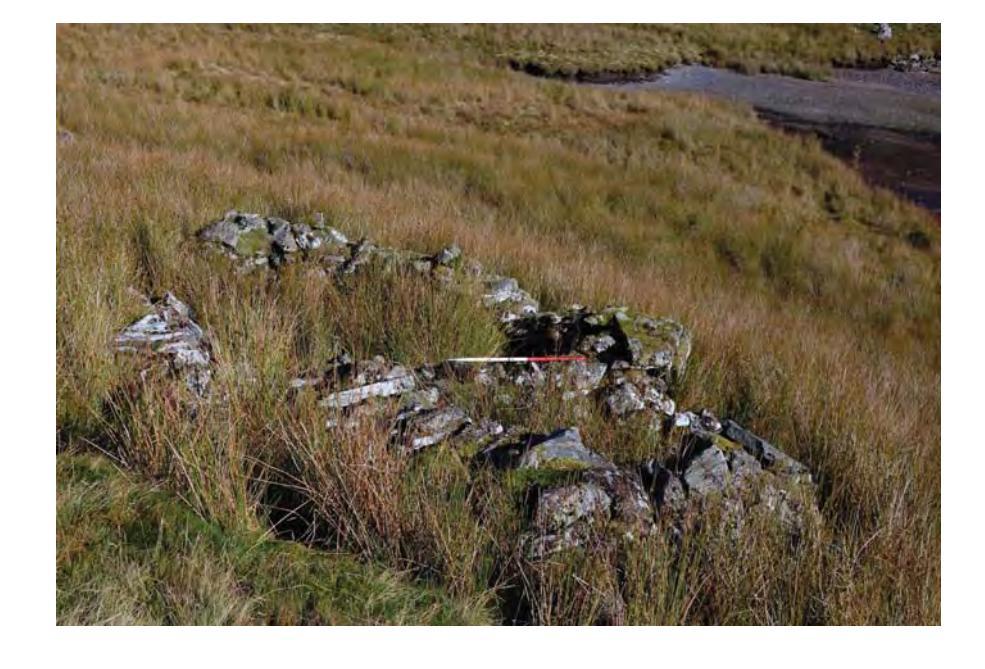
Plate 14. Sheepfold PRN 61249 from west

The current work did not record in any detail the features on the hillside on the north-western side of the lake, but these sites were briefly inspected and photographed. These two sites were surveyed by George Smith in 1998 (Smith 1998) (figure 2). The north-eastern site (PRN 61249) at SH7372042589 is a small sheepfold with two compartments and splayed walls at the north-eastern end to direct the sheep into the entrance (plate 14). It is partially collapsed but still stands to about 0.5m high. The south-western structure (PRN 61250) at SH7370842572 is more confused and while it appears to have been reused as a sheep fold or shelter it is possible that the remains of a stone round-hut are still traceable beneath the alterations (plate 15).

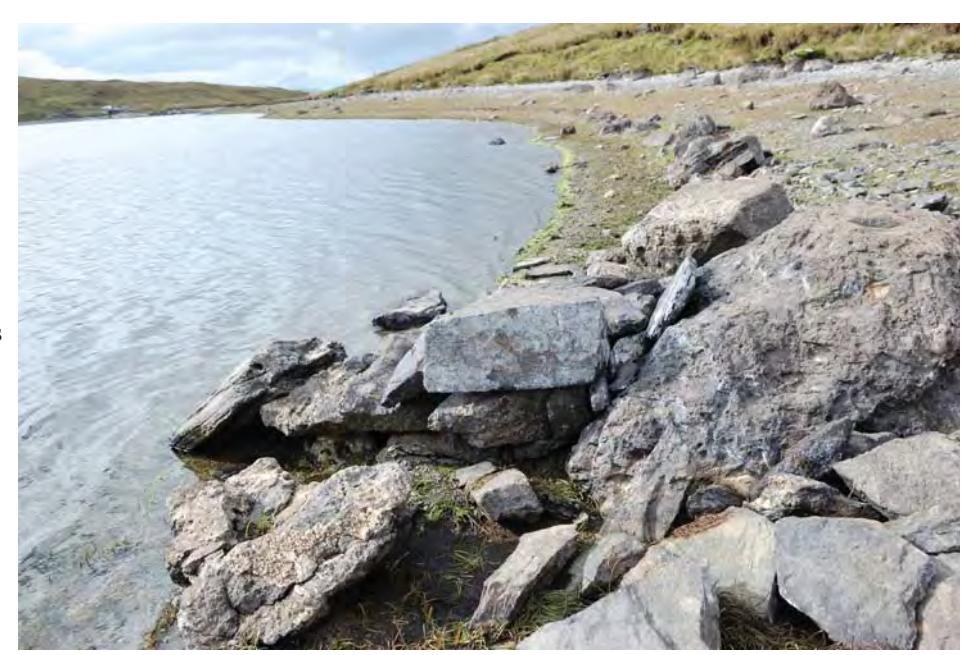
Plate 16. Recent "jetty"/fisherman's stance at north-east end of PRN 61251

To the south-west of the exposed section of wall PRN 61248 there is a line of stones that when inspected were located just above the water's edge but which are normally submerged. These start from a small rough "jetty" running 1.2m out into the water from a large boulder and constructed of stacked slabs (plate 16). This feature is similar to occasional others around the lake shore and appears to be a fairly recent structure to provide a platform for fishing from, presumably largely underwater when in use.

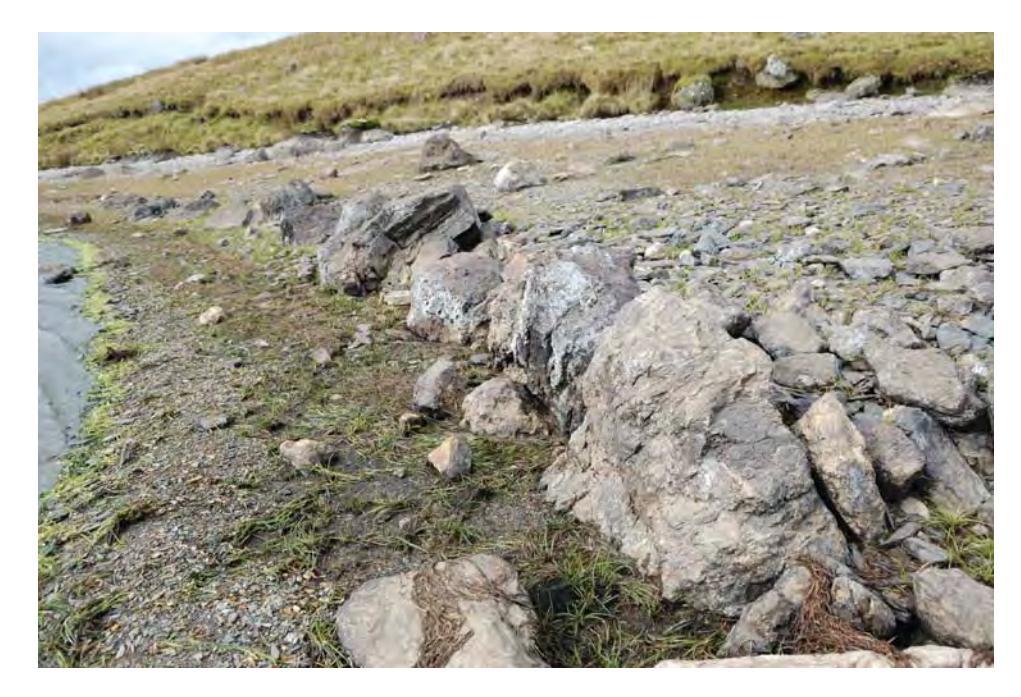
Plate 17. Water-side wall PRN 61251 from north-east

Running south-west from this are four stones, up to 0.6m long, set on edge in the gravel. The line of these stones is continued by other less deliberately placed stones to form a rough line running for about 20m (plate 17). It was noticed that there are linear concentration of larger stones at about this level around the lake shore. It seems likely that this is was the natural level of the lake before the construction of the dam and that erosion and water movement have caused stones to be exposed or deposited particularly along this contour. However this particular line of stones seemed more coherent and especially the first four stones more deliberate placed than at other points round the lake. It seems likely that this is the remains of a wall, probably related to wall PRN 61248.

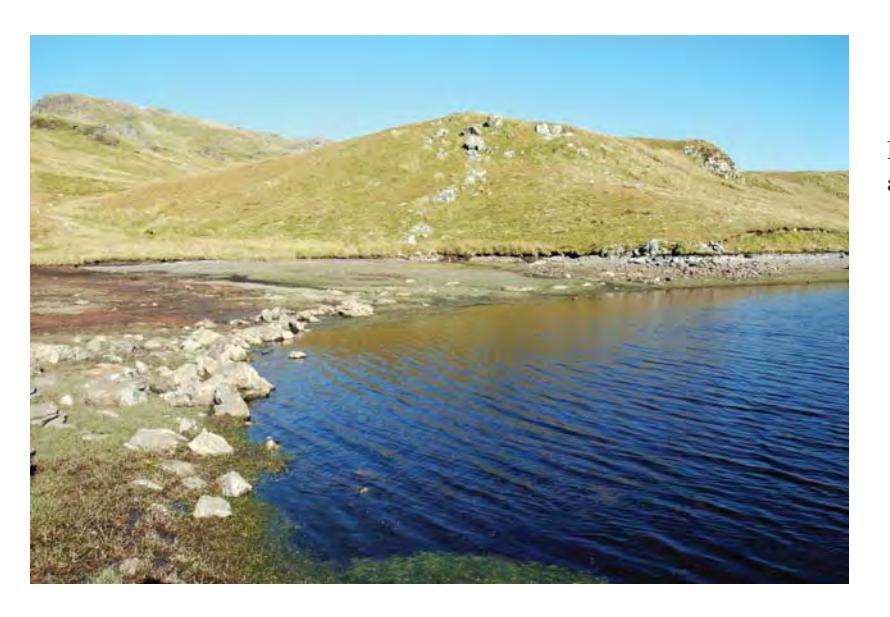
Plate 18. Natural stones running across mouth of bay at northern end of Llyn Morwynion

It initially appeared that a similar water-side wall continued across the northern bay, as there is a rough linear collection of stones running across part of the mouth of the bay. However these are more scattered and haphazard than PRN 61251. They also seem to continue a line of boulders running down the small hill to the east of the bay (plate 18). Although these form quite a straight line they appear to be entirely natural and it is assumed that a dyke or other geological feature runs through the bedrock here causing this line of surface eroded rocks.

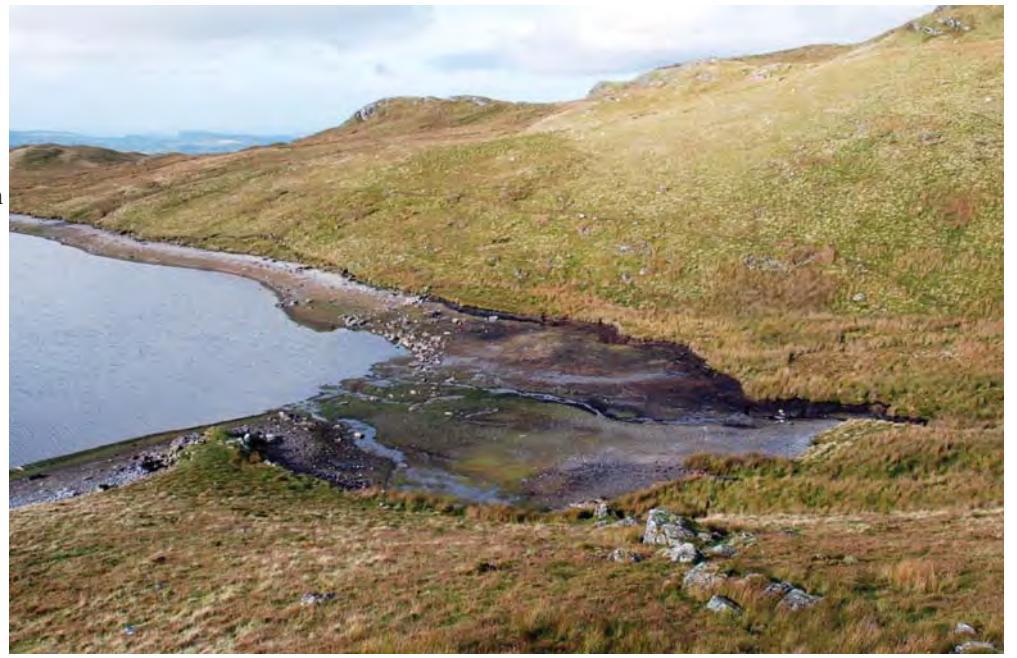
Plate 19. Peat deposits in bay at northern end of Llyn Morwynion

At the northern corner of Llyn Morwynion is a small bay created where two streams, one a very short drain from a bog, enter the lake (figure 2, plate 19). The larger stream has deposited a fan of gravel creating a bank of firmer ground through which the stream cuts. The peat within the stream channel was probed and was up to 1m deep but generally shallower.

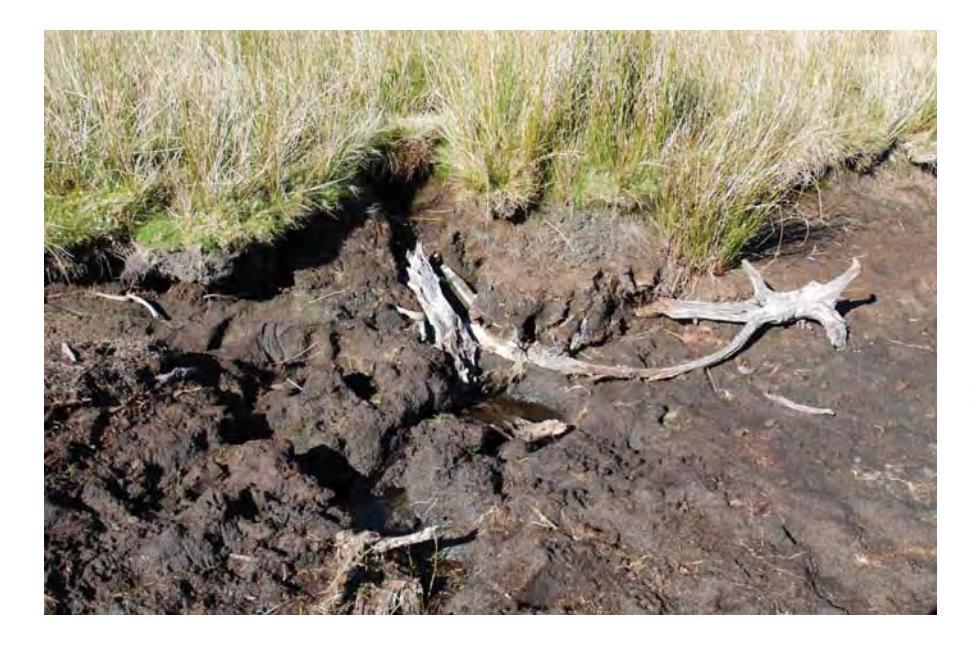
Plate 20. Tree roots in north-west side of bay at northern end of Llyn Morwynion

The north-western part of the bay appears to be essentially part of the peat bog which extends inland to the north-east. Here the small stream runs over the top of the peat and has deposited gravel over the peat in places obscuring its extent. When the peat was probed in this area it was considerably deeper than the 1.2m probe used and could be of much greater depth. The rough location of the peat is shown on figure 2 but the limits of the peat in the bay have not been surveyed and only a sketch of the peat location is provided. George Smith noted a tree stump in the peat close to the round-hut (PRN 5144) (Smith 1998, fig 13). That is no longer visible but there are other tree roots visible eroding out of the peat on the north-western shore of the bay (plate 20).
