REPORT ON THE PRE-RECLAMATION ARCHAEOLOGICAL SURVEY AND EXCAVATIONS OF THE CYFFTY MINE COMPLEX, LLANRWST.

by L.A.Dutton and P.T.Muckle for Gwynedd Archaeological Trust Ltd with historical summary by R. W. Vernon

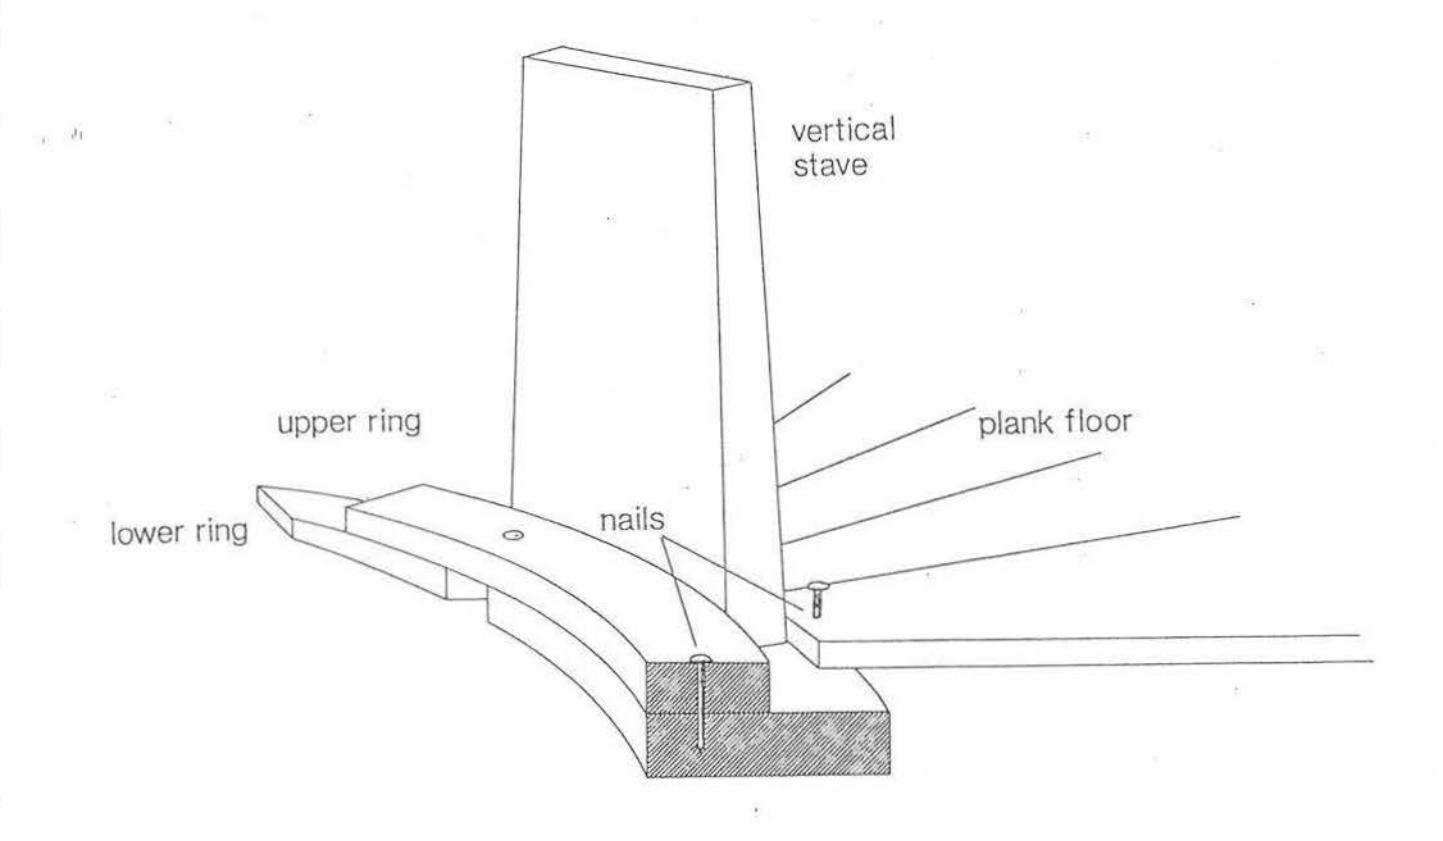
Fig. 9 Detail of construction of central hub support, staves and floor.

The vertical staves forming the uprights were attached by similar length nails to the outer face of the upper ring. Out of an estimated 55 staves, 12 survived *in situ*. The staves measured 0.145 by 0.055 m (5.75 by 2in) around and were 0.3 m (1ft 1in) long, representing the original height of the hub sides. The staves were inclined from the vertical by 5 degrees towards the centre of the hub. The top end of the staves would have originally been held fast by another timber ring frame. The position of this is indicated by a band of discolouration around the inside top of the staves resulting from the disintegration of iron nails that once secured the frame.

The floor of the buddle was supported by and attached to three concentric timber rings. The innermost of these was critical to the strength and symmetry of the buddle for as this formed the base upon which the central hub element was constructed. The inner ring is actually two rings, one above the other, each composed of six separate curving timbers of irregular length. The direction of the grain in the timbers indicated that these components had been sawn to shape rather than bent. The larger, lower ring had an external diameter of 2.5 m (7ft 6in) and the timbers measured 0.038 deep by 0.14 m wide (1.5in by 5.5in). The upper ring, which provided a fixing point for the vertical staves, had an external diameter of 2.35 m and the timbers measured 0.038 deep by 0.07 m wide (1.5in by 2.75in). The rings were held together by iron nails 0.05 m (2in) long, driven down through the upper ring.

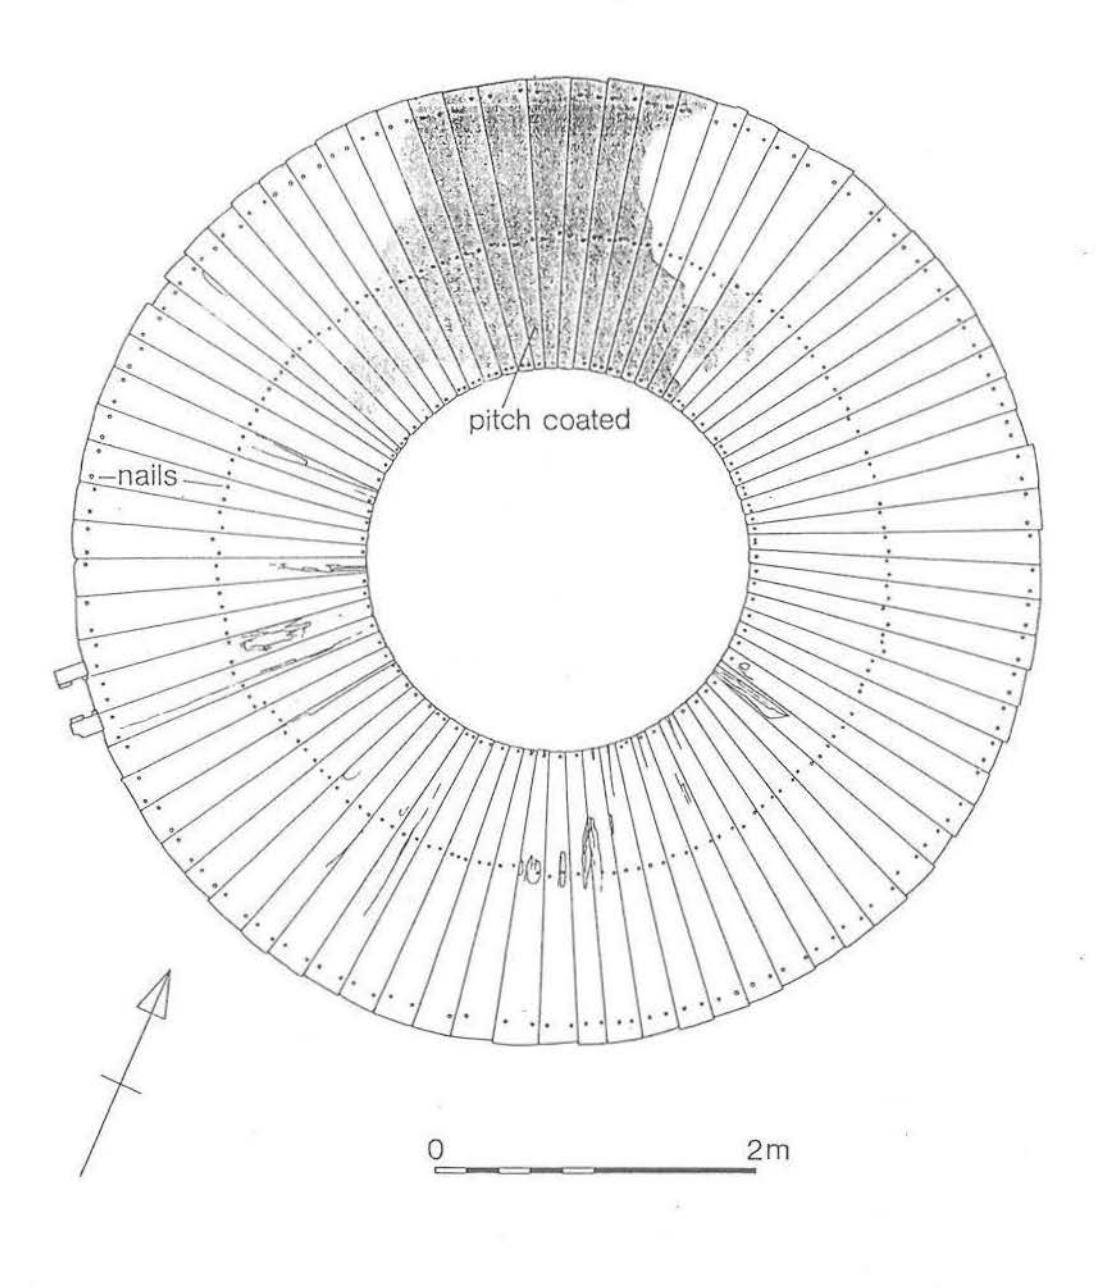
Fig. 10 Detail of wooded buddle plank floor.

The floor was built of 81 tapering planks, 1.85 m (6ft) long, radiating from the hub and with outer edges cut to fit the shape of individual stones in the wall. The planks sloped down from the hub to the wall at an angle of 4 degrees. The width of the planks ranged between 0.03 m and 0.1m (1.25in and 4in) at the hub end and between 0.2 m and 0.23 m (8in - 9in) at the wall end. The timber floor was not disturbed but one loose plank was raised to reveal two concentric rings of supporting timbers onto which the planks had been nailed. The thin end of the planks rested on the lower central ring abutting the upright staves of the hub. The middle and outer rings of timber supports had a diameter of around 4.0 m (13ft) and 5.95 m (19ft 6in) respectively. About 550 nails were used in the buddle floor. The north quadrant of the floor displayed the remains of pitch coating, which was to protect the floor and to allow the water and ore to run easily over the timber.

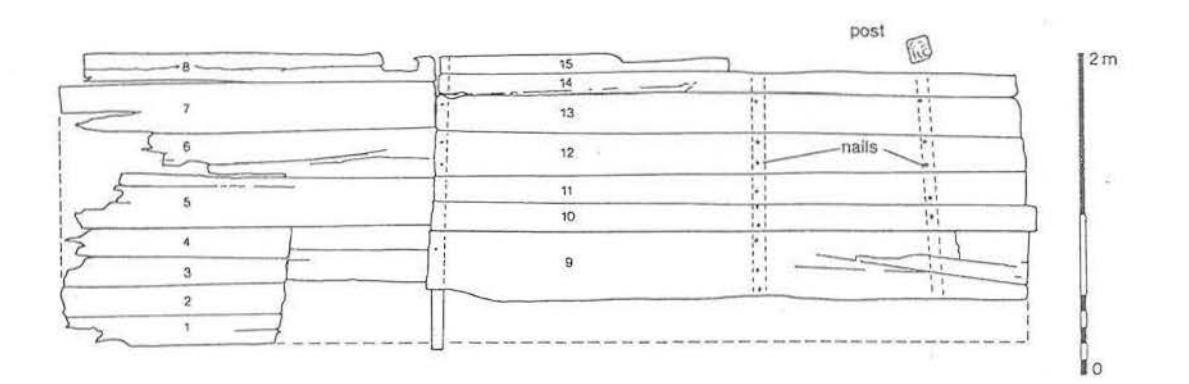
Fig. 11 Plan of surviving plank floor associated with location of Jig.

The surviving remains of the feature comprise 17 separate planks mounted onto 3 narrow crossbeams, average 0.07m (2.5in) square. About 80% of the estimated floor area has survived, with at least two planks on the south side missing. The planks do not appear to be of uniform size and there is no indication that they were coated with pitch or anything else. Planks 5 and 6 may indicate that the floor was repaired and that planks 1 to 4 were originally the same length as planks 7 to 10.

The planking that comprised this feature was buried under 0.7 m of tailings abutting the bedrock plateau west of the crusher (Fig. 6, Detail Fig. 11). It is associated and contemporary with the operation of the Crusher House and the buddle between which it is situated. Constructional details are based solely on surface observation after the timbers were revealed and cleaned.

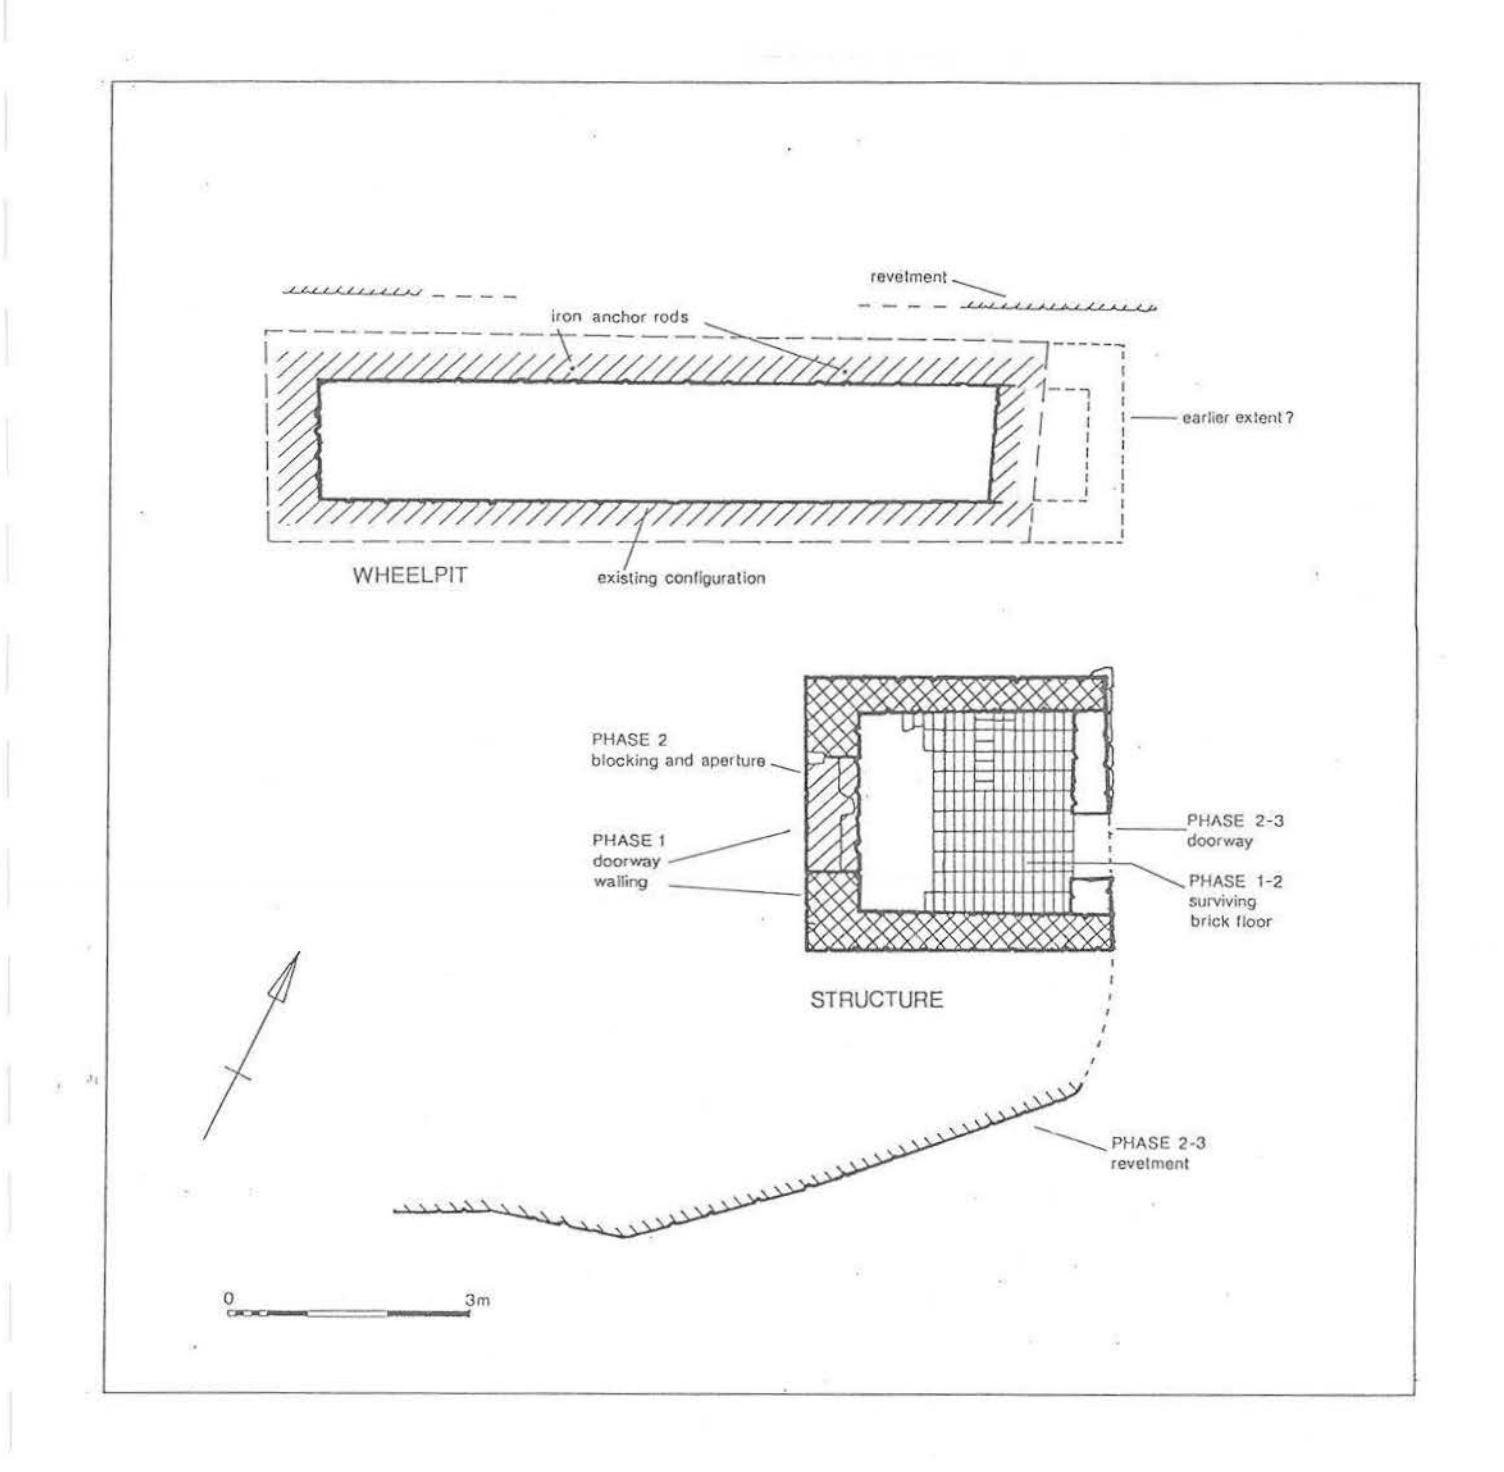
Fig. 18 Wheelpit W3 and associated structure - Plan of surviving structural features

The wheelpit is situated 1.5 m south and west of the square structure and is 8.3 m long (27ft 3in) by 1.4 m wide (4ft 8in) and 2.2 m (7ft 3in) deep. The parallel side walls are of massive, square dressed masonry construction, and have been built up to and around two square sectioned, iron beam anchors on each side, 3 m (9ft 1in) from the south-west end, 3.4 m (11ft 2in) apart and 1.9m (6ft 3in) from the northeast end. In wheel pits 1 and 2 the beam anchors are encased by wooden shutters, allowing them to be tightened or removed.

blocks and not at right-angles to the side walls, which they abutt. The character of the end walls and the fact that the machine anchors are not central to the side walls, as one might expect suggests, that originally the side walls extended 1 m - 1.2 m (3ft 7in) further at the north-east end, which would increase the size to about 9.5 m (31ft).

If the assumption is made that the diameter of the waterwheel is 3ft smaller than the length of the pit, then this would lead to the conclusion that a larger 28ft wheel was replaced by a 25ft wheel. One possibility is that the original wheel was removed to wheelpit 2 which replaced wheelpit 3. The side walls of wheel pit 3 were originally 1 - 2 m (3ft - 6ft 6in) higher than they are today based on these estimates.
