RHOS ON SEA COASTAL PROTECTION WORK ARCHAEOLOGICAL EVALUATION REPORT

RHOS ON SEA COASTAL PROTECTION WORKS - Archaeological Evaluation Report

An archaeological evaluation was carried out for Colwyn Borough Council between Nov. 30 and Dec. 16 1992 by the Gwynedd Archaeological Trust in accordance with the evaluation brief agreed with the Clwyd Archaeology Service, Clwyd County Council.

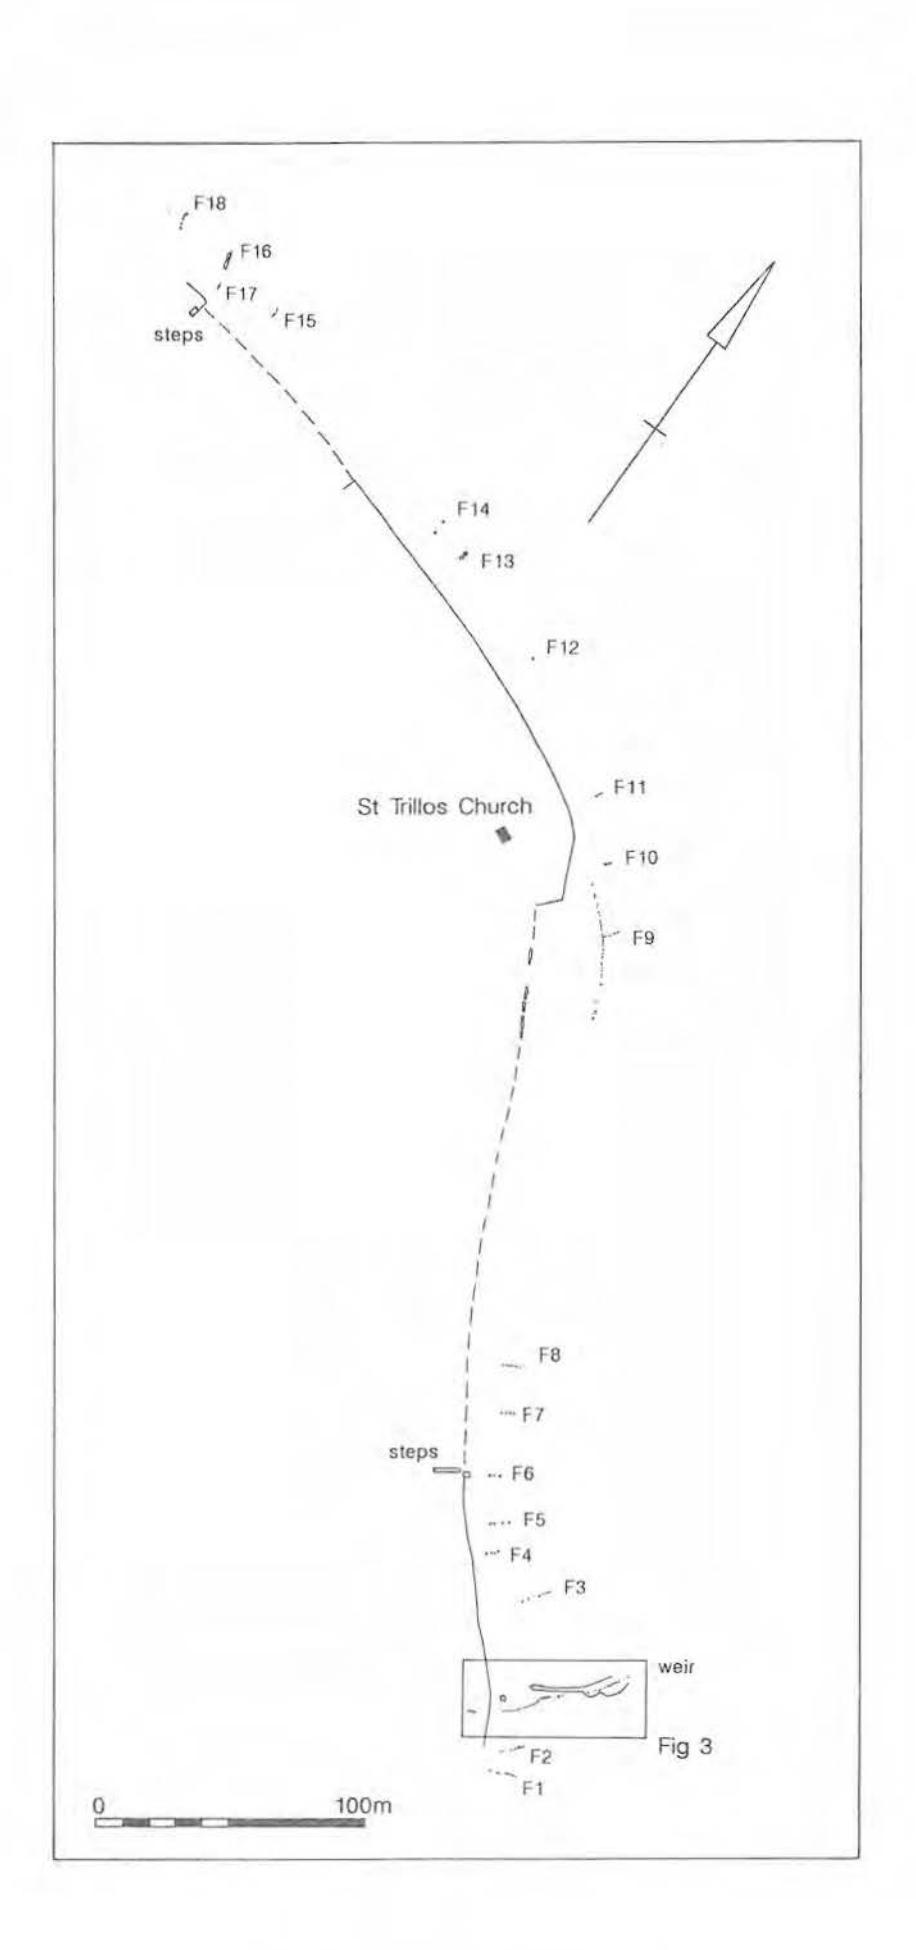
Fig 2. Coastal features identified.

The following features were identified (Fig.2): (NB: posts are numbered starting from the shore)

F1- Linear arrangement of 10 timber posts stretching from a point 3.36m from sea wall to a point 15m to ENE of the sea wall. The posts stand a maximum 0.23m tall, and though badly eroded , it is probable that they are circular in section with a maximum recorded diameter of 0.11m.

F2-23 very closely arranged timber posts forming at times a double line stretching from a point 6.16m from the sea wall to a point about 15m to NE of the sea wall. The posts stand a maximum 0.24m high and though badly eroded they appear to be circular in section. The recorded diameter was generally no more than 0.09m though one post has a diameter of 0.16m.

F3- Linear arrangement of 11 timber posts stretching from a point 16m from the sea wall to a point 28m to NE of the sea wall. They stand a maximum 0.29m tall and though badly eroded are likely to be circular in section with a maximum recorded diameter of 0.10m.

F9- 35 timber posts forming a gently curving line some 50m long very roughly parallel to the present shoreline opposite St. Trillo's Chapel. The NW end is 10m from the shore while the SW end is 26m clear. A further line of 9 timber posts runs at right angles from the main body towards the NNE. The posts are generally about 0.20m tall, round in section and up to 0.15m in diameter.

F16- A linear band 5.15m long and 0.52m wide consisting of closely packed rounded stones embedded in the sea bed. It is located 12m from the sea wall and is oriented towards the NW. There is no sign of a matrix. There are four timber posts associated with this feature, three are located within the stone band at its N end and one 1.5m to the NW of the feature. Posts 3 and 4 are semi-circular in section, ie split posts, while 1 and 2 are circular. They are some 0.16m in diameter and stand to a maximum 0.40m tall, leaning moderately towards the shore.

F19- Five short stretches of rough dry stone wall ranging from 2 to 5m long running from a point 40m to the SE of St. Trillo's Chapel along the base of the turfed bank towards the SE for a distance of 32m. They are heavily overgrown and engulfed by the bank forming the present shore. The walls comprise rounded stones 0.15-0.25m in size and measure a maximum 1.0m tall.

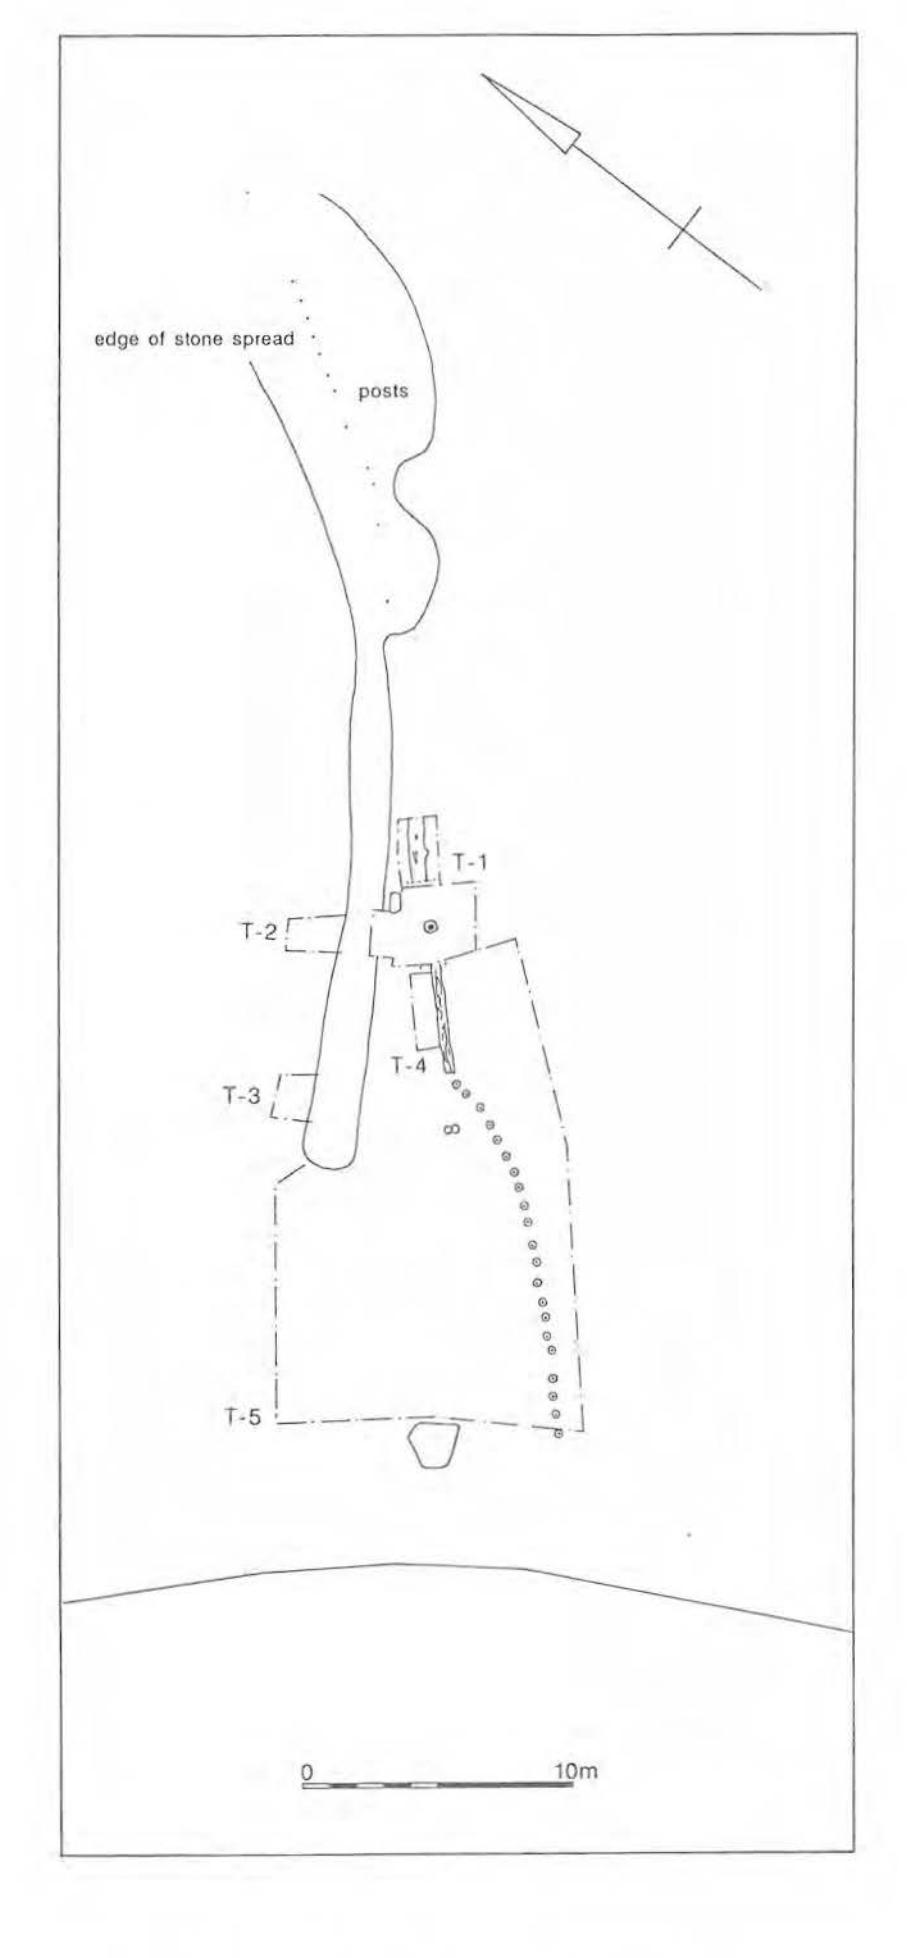
Fig 3. Location of evaluation excavation trenches.

This was achieved by the machine clearance of three small areas at the base of the narrow band of stones (Fig), trench one (T-1) and trench two (T-2) located about halfway along on the E and W sides respectively and trench 3 (T-3) located on the W near the southern end of the stones.

T-1 initially measured approximately 1.5m sq., while T-2 was 1.5 x 2.0 and T-3 was 1.25m x 1.65m. All the trenches were excavated with a toothless bucket and to a maximum depth of about 0.30m initially.

The Excavations: (Fig.3 & 4)

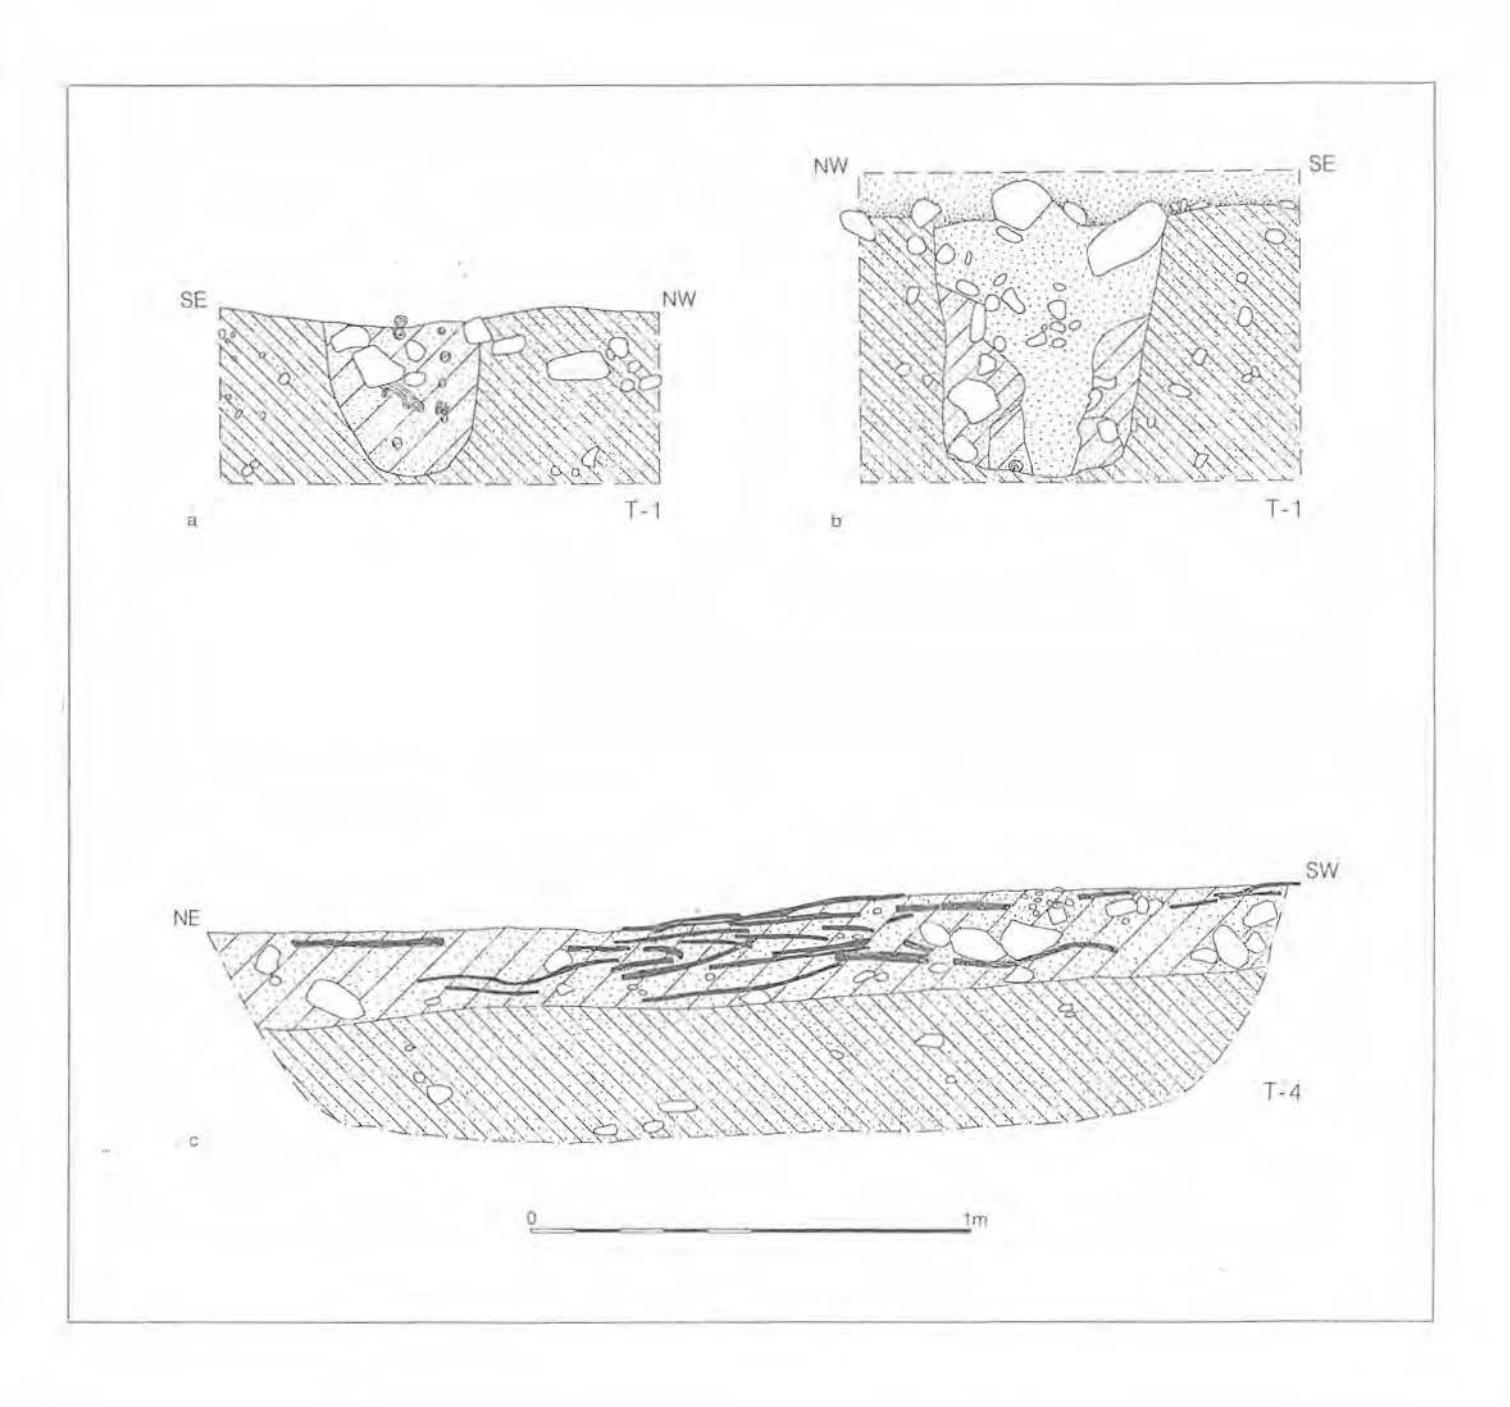
Fig 4. The linear slot - excavated trench sections

a) Trench 1 - narrow slot.

b) Trench 1 - wide slot.

c)Trench 4 - narrow slot in elevation.

To the S it consisted of a "U" shaped profile slot cut into the sea bed clay measuring 0.37m wide and 0.35m deep and some 4m long which butt ended 18m from the present shore. The feature was filled with a soft homogeneous mid grey sandy clay containing moderate rounded stones. This fill surrounded a series of horizontal wattles which in section appeared arranged one above the other in two parallel vertical lines located centrally within the fill. In plan occasional wattle strands could be seen forming long shallow 'S' shapes on the surface of the fill of the slot. In elevation the wattles could be traced running down the length of the feature.

To the N, the feature comprised a flat bottomed rectangular profile slot cut into the sea bed clays measuring 0.53m wide and 0.60m deep and was cleared to a length of 2.6m but certainly ran beyond the N limit of the T-1 extension. It contained a more complex sequence of fills, the lowest being a mid grey sandy clay similar to the fill of the S slot but containing only one wattle end in section. Above this was a soft brown clay filling the feature to three quarters of its depth. The top quarter of the feature was filled by a a dark grey very loose medium sand containing frequent shell flecks. This fill also formed a band 0.10-0.15m wide located in the centre of the feature which in section penetrated down through the lower fills to the bottom of the cut.

Excavation of the slot in the base of T-1 revealed a large sub-circular shaped posthole located in the dead centre of the trench. It had a "U"shaped profile and measured 0.36m in diameter and approximately 0.25m deep. The fill was a soft mid grey sandy clay.

It would seem most probable that the slot feature recorded during the evaluation excavation represents the remains of the weir. It is roughly in the position expected and butt ends some distance from the shore which would not be reasonable for a groyne or other breakwater structure. The effort taken to anchor the wattles in a slot cut into the extremely hard sea bed clays suggests some special purpose for which special effort had to be made. The feature is also much further from the shore than any of the other timber groynes identified and appears to line up fairly satisfactorily with the remaining visible weir remains further out to sea.

The two different characters of the sections of the slot probably indicate two phases of the weir, the larger feature cutting the earlier smaller one. The fills are certainly radically different and the lower fill in the large feature (with its single wattle) may represent redeposited material from the narrow feature.

It would seem likely that the section of the wider feature represents a post pipe within a post hole. No post was seen in this cut though posts occur immediately to the NE of the section. It may be that the particularly deep posthole excavated in T1 represents the anchor post at the S end of a fairly modern version of the weir. The two end posts (ie the anchor post and the post in the section drawing) were torn out perhaps by storm (possibly that of 1917 which also destroyed the pier jetty?) while the next post to the N has also suffered and is prostrate. No posts or post holes were identified in the narrow slot so it is perhaps not coincidental that surviving posts begin to appear at a significant change in the character of the slots.
