Penrhos Leisure Village, Holyhead, Anglesey

Report on Archaeological Evaluation Trenches

Project No. G2163

Report No. 1050

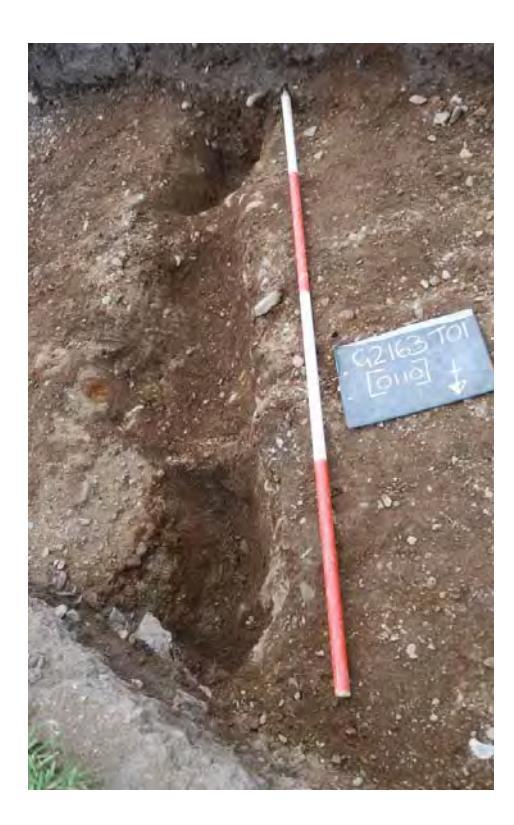
Plate 4: Foundation trench [0110] for possible roundhouse, from the north

Towards the eastern end of the trench was a linear feature [0110], 0.7m wide, running NNW to SSE and possibly curving slightly. This had steep sides and a narrow rounded base but was particularly notable for the unevenness of the base. The feature was formed of a series of elongated hollows separated by narrow ridges of gravel (plate 4). These hollows measured up to 1.26m long and the feature was up to 0.46m deep in the base of the hollows. This feature had a loose gravelly fill packed around numerous thin schist slabs mostly set on edge either vertically or at an angle (figure 7). These slabs had the appearance of packing stones. A flint flake (SF02) was recovered from the fill. About 7.7m to the west was another feature [0109] very similar in character with upright slabs in its fill. Only a short section of this survived in the trench as it was cut by ditch [0107].

A prehistoric date is suggested for feature [0110] by the presence of a flint flake in its fill, although it is possible that this was residual. More diagnostic is the distinctive character of this feature, which is very similar to the foundation trench of a round house excavated just over 1km to the east in Parc Cybi (roundhouse I) (Kenney *et al* 2011). This roundhouse was nearly perfectly circular and had an internal diameter of 9.6m and the wall was defined by a foundation trench very like feature [0110] with conjoined, elongated postholes set within a continuous slot (figure 10). The roof of the structure would have been supported by a ring of postholes. The entrance was on the north-western side with a substantial porch supported by large postholes and beam slots. Radiocarbon dates have not yet been obtained but on stratigraphic grounds it has been concluded that this building was roughly contemporary with the stone-built roundhouse settlement to the north-east and these are assumed to be Iron Age in date.

The presence of feature [0109], which is almost certainly a continuation of [0110], makes it likely that this is a circular foundation trench. A circle of about 10m diameter will fit between these two features giving a potential internal diameter very similar to the Parc Cybi example. The absence of postholes may be explained by them lying outside the trench or the use of post pads rather than postholes. Roundhouses often have entrances in the south-eastern arc but if the parallel with the Parc Cybi roundhouse I example is exact it is possible that the entrance is just outside the trench. The stones in slots [0109] and [0110] appear to have been packing stones to support uprights in the elongated holes. The shape of these holes led to the suggestion for Parc Cybi roundhouse I that they held stone slabs rather than wooden posts. Timber planks might be a possibility but they would be more likely to be set in a continuous trench. The possibility that these conjoined holes actually did hold stones is supported by the excavation of a roundhouse on Trevelgue Head in Cornwall (Catling 2012) with stone slabs set on edge forming the inner face of the wall in just the same manner as imagined for the Holyhead examples.

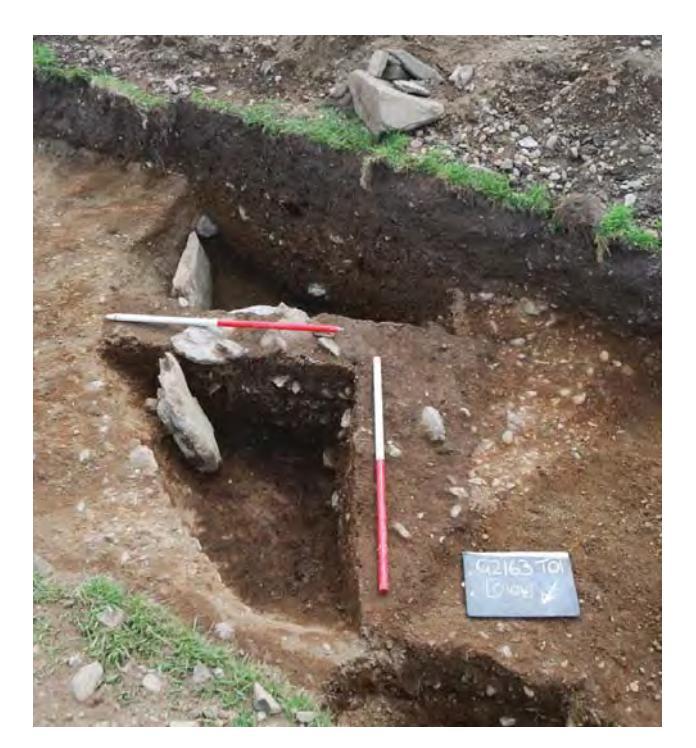
Plate 5: Probable corn drier [0104] partially excavated to show charcoal layer in base, from the NW

Towards the middle of the trench was the rounded NW end of a feature [0104] aligned NW to SE and extending out of the trench to the SE. As it appeared in the trench this feature was an elongated oval in plan, 1.7m wide and 0.55m deep. It had steeply sloping sides and a fairly flat base. It had occasional stone slabs (0124) set nearly vertically at intervals around the sides and the base was covered by a thin deposit of black silt (0117) (plate 5, figure 8). This contained lumps of burnt clay and lenses of pale grey silty clay with frequent charred cereal grains. Overlying the black deposit were several irregularly shaped slabs (0121) that seemed to form a partial lining to the feature. These were sealed by gravelly deposits (0118, 0122, 0123), that seemed to have slumped in from the sides of the feature. Over this were deposits of rounded cobbles (0119 and 0120); the latter contained sherds of prehistoric pottery (SF07) that seemed to have collected towards the base of the deposit. Built over this infill was what appeared to be a rough drystone structure (0114), comprising a slightly curving, 1m long section of walling constructed of slabs up to 0.45m long (plate 6). This structure was only one course high but the slabs were laid horizontally. The structure was sealed under a brown silt (0113) similar to the ploughsoil.

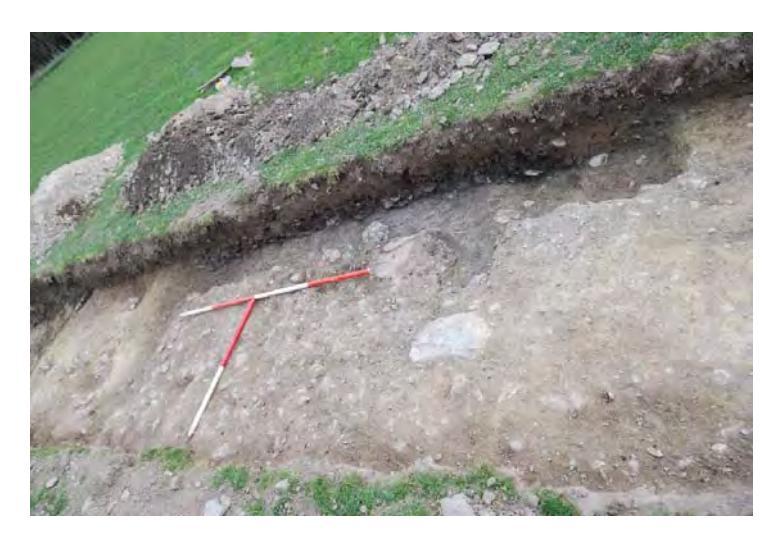
Plate 10: Burnt mound spread 1704, from the west

In T17 were two areas of burnt stone (1704 and 1705) corresponding to the two geophysical anomalies (PRN 34742, SH 26396 80160). These covered the width of the trench and were 3.7m and 6.4m in length, respectively and up to 0.2m deep (figures 21 and 22). They were composed of small angular stones, generally no larger than 0.15m in length in a matrix of grey silt (plate 10). There was generally little charcoal present except in occasional lenses. The stones were often reddish in colour due to heating. In layer (1705) there were two large flat stones (up to 0.55m in length) laid next to each other and quite level within the mound material. There was no evidence that these formed part of a structure but they seemed to have been deliberately laid.

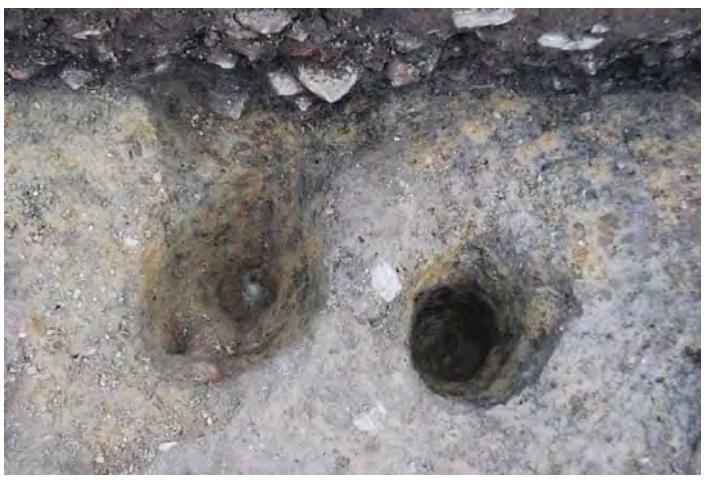
Plate 11: Postholes 1706 and 1707 fully excavated, from the north

Once recorded the burnt mound material was removed partly by hand and partly by machine. Beneath the mounds was a thin layer of grey silt (1715), which may be the remains of a buried soil. Cut through this were two probable postholes. Feature [1706] was an oval cut with steep sides and a narrow base, 0.5m by 0.35m and 0.4m deep. A projection on the southern side extended into the baulk, suggesting that it may be part of a larger feature. Feature [1707] was a near circular cut, 0.27m in diameter and 0.39m deep, with steep sides and a narrow tapering base (plate 11). Both features were filled with densely packed stones up to 0.2m long, most of which were burnt. The shape of the features strongly suggests that they were postholes although the stones they contained did not seem to be post packing stones, but were probably introduced after the posts had been removed.

Although groups of postholes and stakeholes are found on burnt mound sites the size of the posthole in T17 is also difficult to parallel and could indicate the former presence of a structure of considerable size.

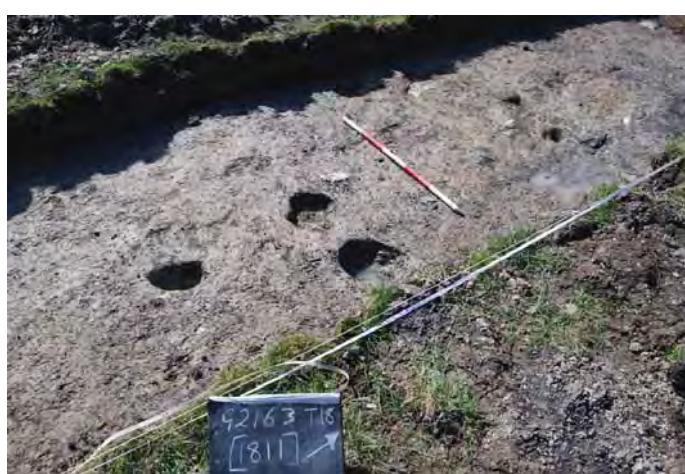
Plate 12: Posthole group 1811, from the SE

The burnt mound (1804) in T18 (PRN 34743, SH 26428 80311) was very thin, less than 0.05m thick, and seems to have largely been truncated by ploughing (figures 23 and 24). It was composed of a dark grey charcoal-rich silt with numerous burnt stones. This layer was removed by hand to reveal features beneath. There was a group of shallow features that may be postholes (1811) (plate 12). There were three larger sub-circular cuts [1806, 1820, 1822], up to 0.25m diameter and no more than 0.13m deep. More scattered were three slighter features [1824, 1826, and 1828] no more than 0.2m in diameter and 0.08m deep. All were filled with burnt mound material and if they were truncated it was presumably before the burnt mound material was deposited. They did not form a clear plan of a structure but other features outside the trench might clarify their function.

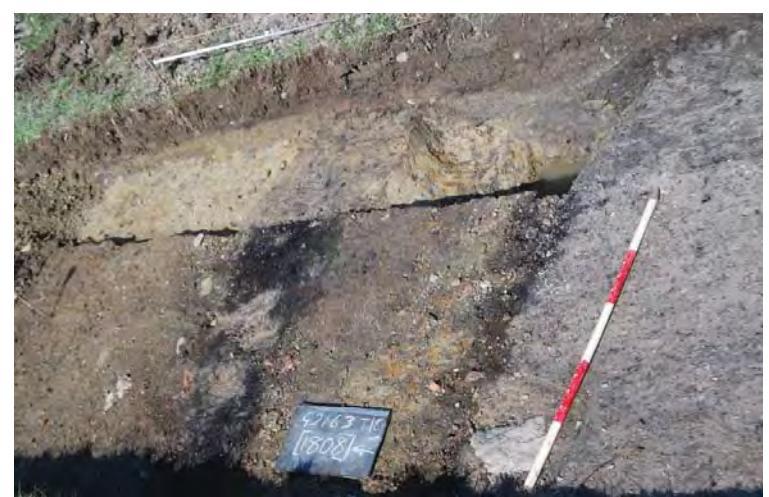
Plate 13: Ditch 1808, from the SW

Towards the NW end of the trench was a ditch [1808], 0.85m wide and 0.45m deep, with a near V-shaped profile. It had a complex sequence of fills (plate 13). The lower fill (1816) contained burnt stones and seemed to be erosion or slumping of burnt mound material from the northern side into the ditch. After some silting, burnt mound material identical to, and continuous with the main burnt mound layer (1804), slumped into the southern side of the ditch. Over this was a series of fine, often organic silt layers, representing the infilling of the remaining wet hollow. The ditch cut through a thin patch of charcoal (1818). This ditch was open when the burnt mound was being deposited so that the material could slump into the ditch, but it was also preceded by activity that created the charcoal patch. It therefore seems likely that the ditch was used as part of the burnt mound activity and was dug during the use of the site.

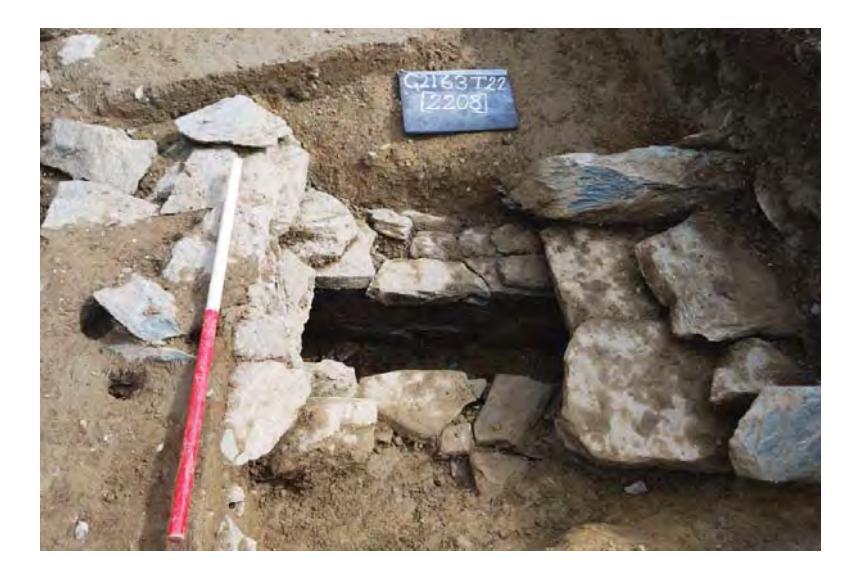
Plate 14: Area of capstones removed to show construction of culvert 2207, from the SW

A substantial culvert [2207] was found in T22 (figures 25 and 26). This was 1.3m wide and 0.4m deep and constructed with drystone side walls composed of undressed slabs (2218) capped by large flat slabs measuring up to 1m by 0.4m (plate 14). These were covered by other smaller stones (2208) up to 0.5m in length. This culvert was still functioning with water running along it.

Stone-filled land drains were seen to cut through the fill of the culvert rather than feeding into the culvert so the field drainage seems to post-date the culvert. The size and careful construction of the culvert suggests that it was part of a coherent drainage scheme implemented by the Penrhos estate. A similar culvert was found at Parc Cybi and they are almost certainly part of the same scheme. The map evidence suggested that the Parc Cybi culvert was built in the mid 19th century (Kenney *et al* 2011) and a similar date is suggested for the present feature. The former example carried a stream from an area of marsh and it is probable that this culvert provided a similar function rather than being purely for field drainage, which seems to have been added after the culvert was built and probably feeds directly into the field-side ditch rather than into the culvert.

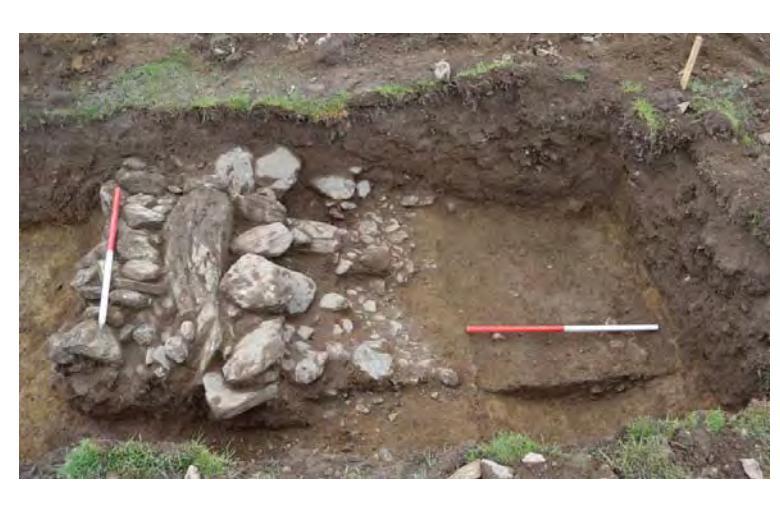
Plate 19: Wall 2404 and ditch 2405 from the NW

Most of the features shown on the geophysical survey and investigated by the trenches seemed to be field boundaries. One class of geophysical anomaly indicated by a narrow negative linear anomaly seemed generally to correspond to fragmentary remains of drystone walls found in the trenches. These were found in trenches 24, 27, 28 30 and 32, although similar signals elsewhere did not produce convincing remains of walls or banks. In T32 the feature was not noticed in plan as it was very slight and indistinct but in section a stony bank could be seen slumping down a terraced slope (figure 30). In T28 only 3 large stones indicated the line of the wall (plate 17) and in T30 and T27 a scatter of loose stones were all that survived (plate 18, figures 31 and 32). Only in T24 was the wall foundation well-preserved (plate 19, figures 35 and 36). Here the wall (2404) was constructed of cobbles and boulders up to 1m in length, the larger of which were laid flat. The natural deposits were lower on either side of the wall, probably due to the effects of ploughing and immediately to the SW was a ditch [2405], 1m wide and 0.25m deep.

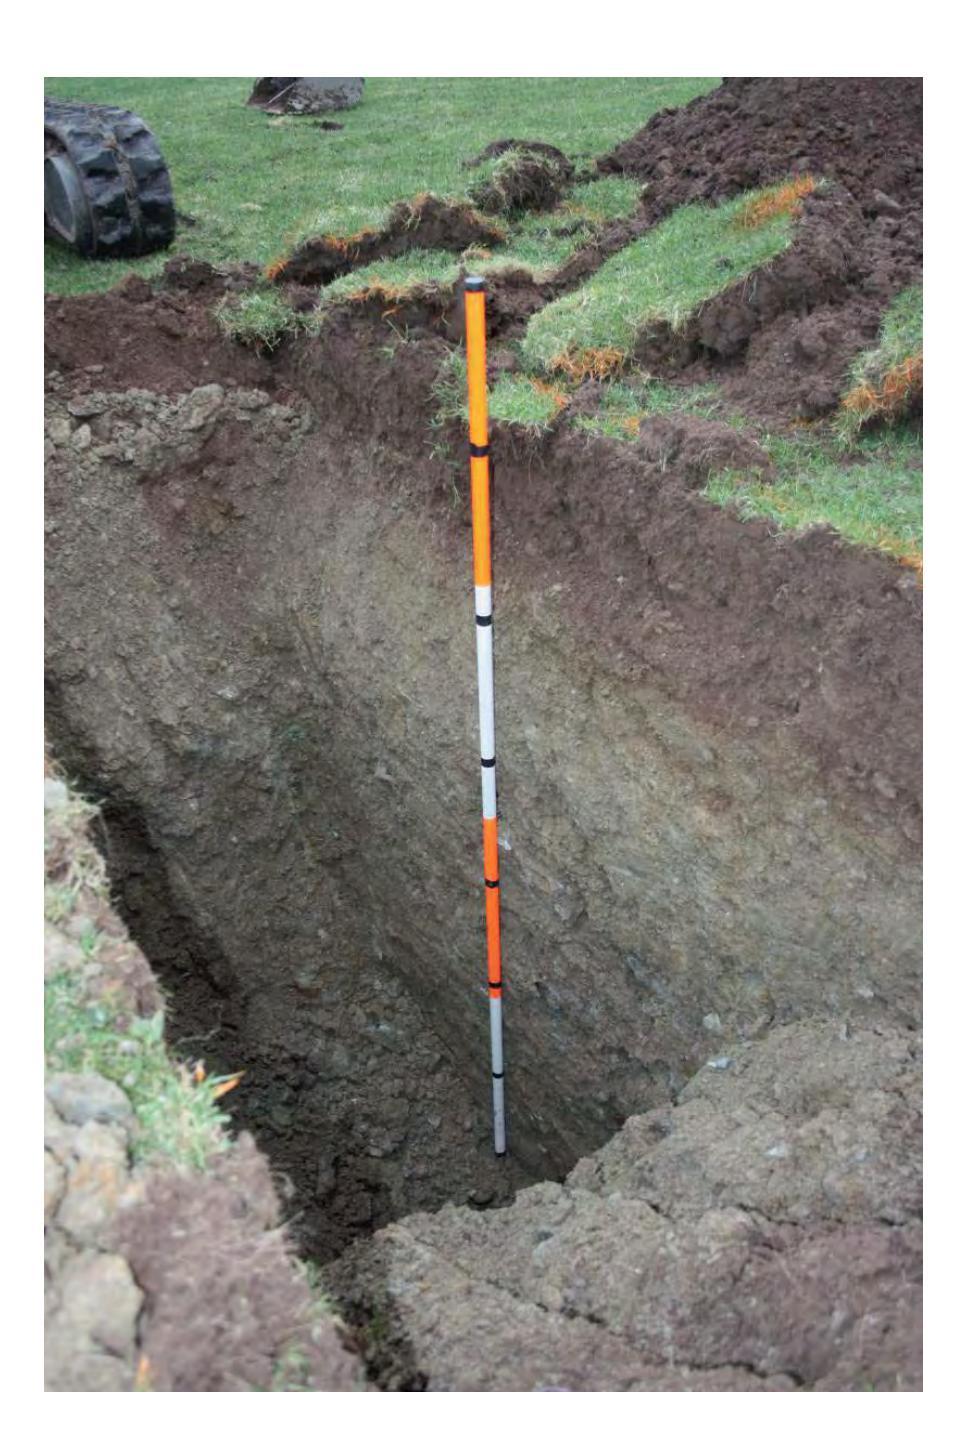
Deepest excavation 150cm

Depth (cm)	Comments
30	Topsoil
60	Change in colour. Sandy soil. Stones up to 120mm.
90	Change to clay.
120	Gray shale. Some rocks up to 300mm
150	Shale / bed rock
