## **BOSTON LODGE**

# ARCHAEOLOGICAL EVALUATION AND RECORDING REPORT

Project No. G2401

Report No. 1288

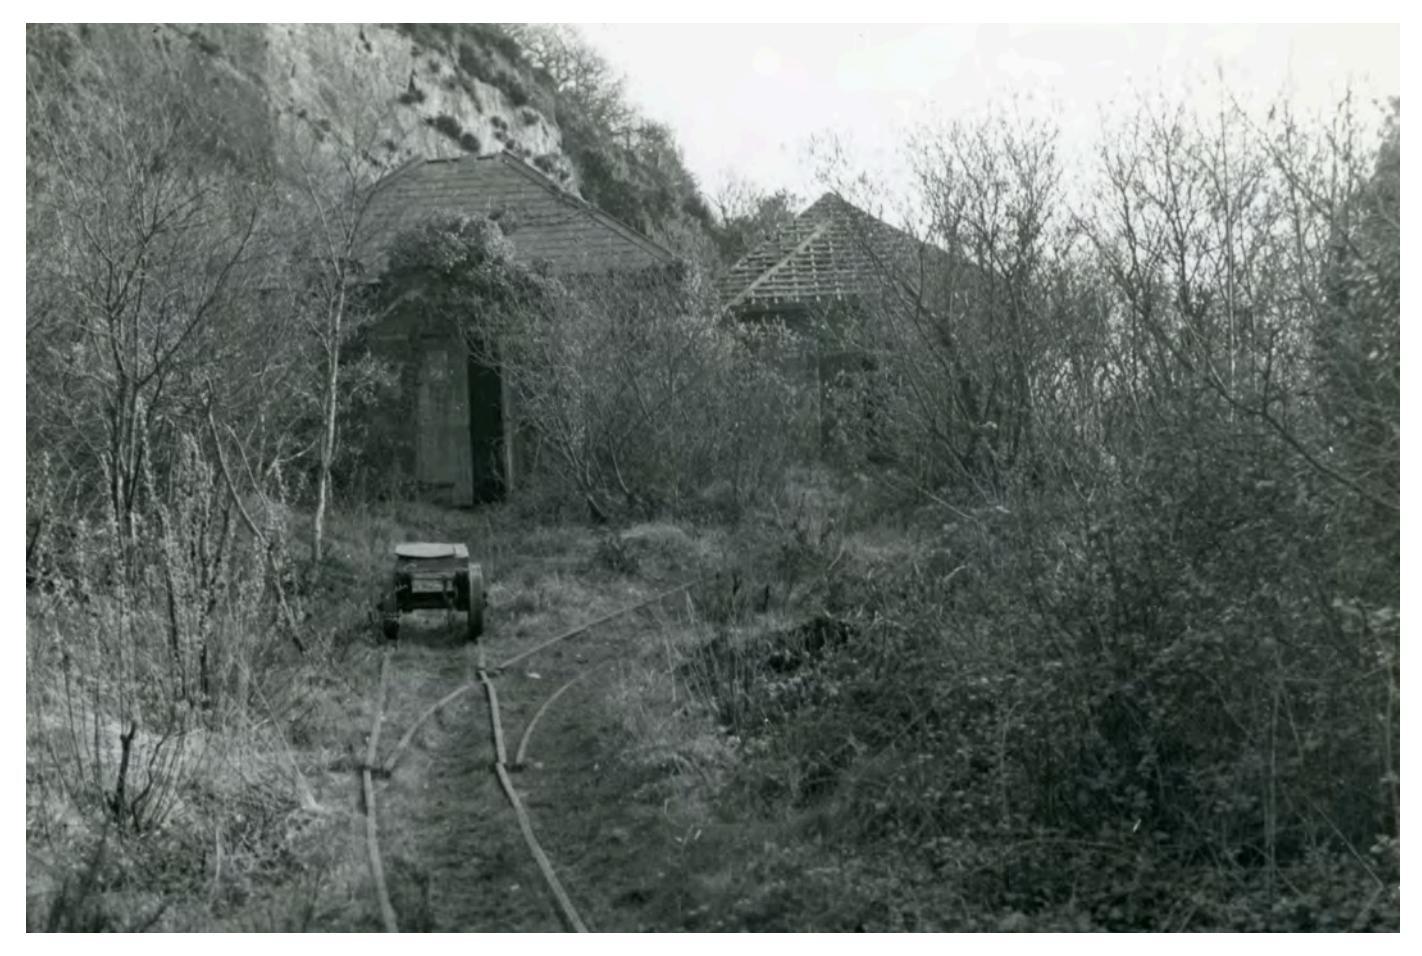
PLATE 01: GUNPOWDER SHEDS 1 AND 2 IN 1957. SOURCE JG GILLHAM FR CO COLLECTION

Boston Lodge closed in 1946 and it is likely that the gunpowder sheds at Boston Lodge fell into disrepair soon after this, if not before. A photo from 1957 shows two of the gunpowder sheds (1 and 2) heavily overgrown with vegetation, and with slates missing from the roof of gunpowder shed 2 (Plate 1). A later photograph from 1964, shows the same two gunpowder sheds with the roof of gunpowder shed 1 partially collapsed (Plate 2). The remains of gunpowder sheds 1 and 3 are still visible today,

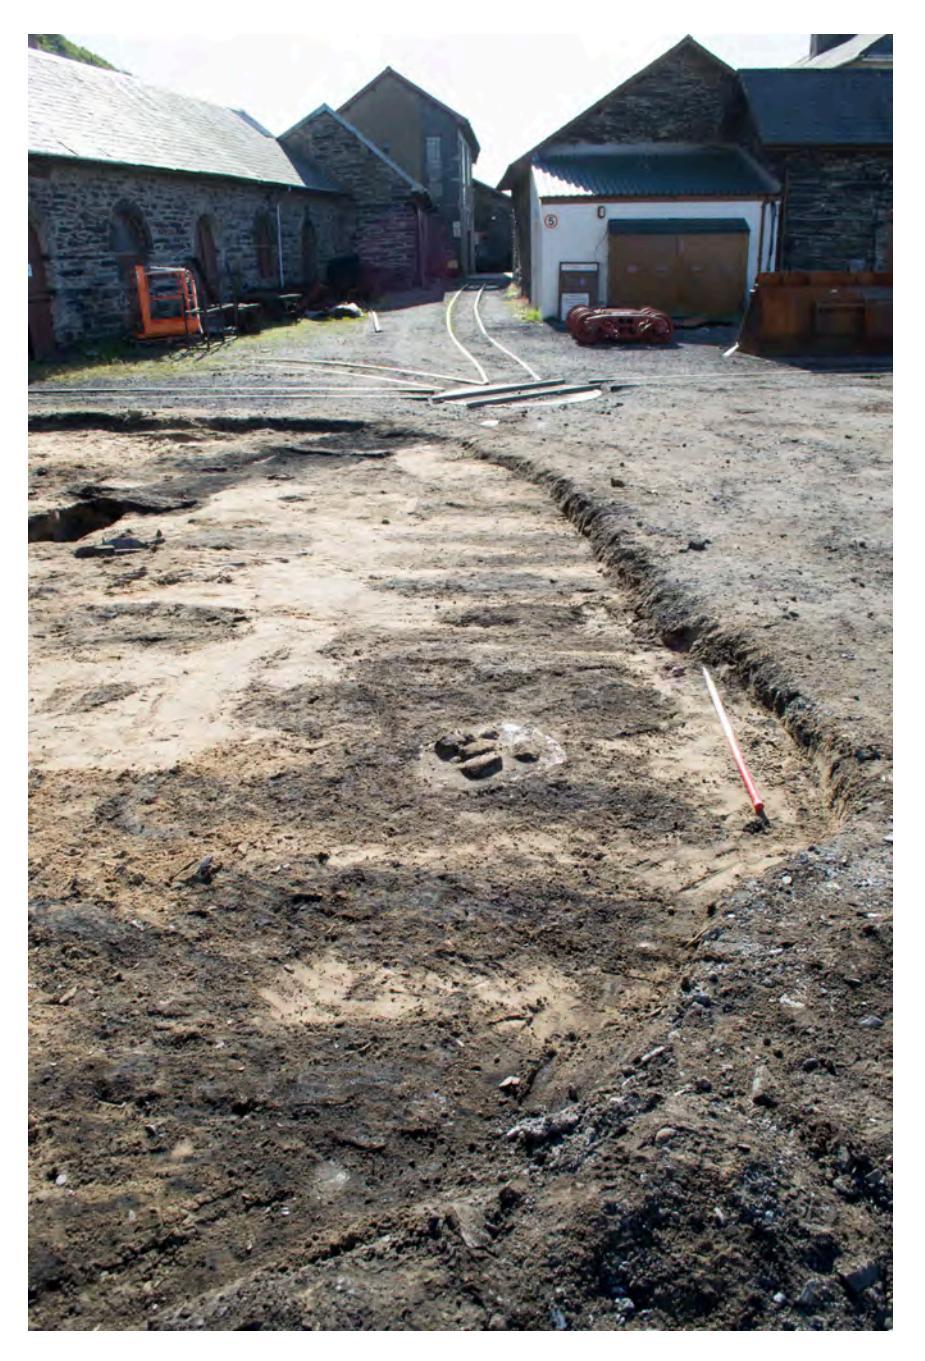
PLATE 04: RAIL TRACKWAY 114. VIEW FROM THE NORTHEAST

At some point between the smithy's initial construction and 1946 when it went out of use, the rail trackway leading into the smithy was replaced with a different trackway (**102**) on a slightly different alignment, as evidenced by the sleepers for this trackway truncated the wall foundations (**104**). This realignment of the rail trackways is also visible within the Top Yard where trackway **115** is replaced with trackways **108** (uncovered within the previous excavations (**22**)) and **114**.

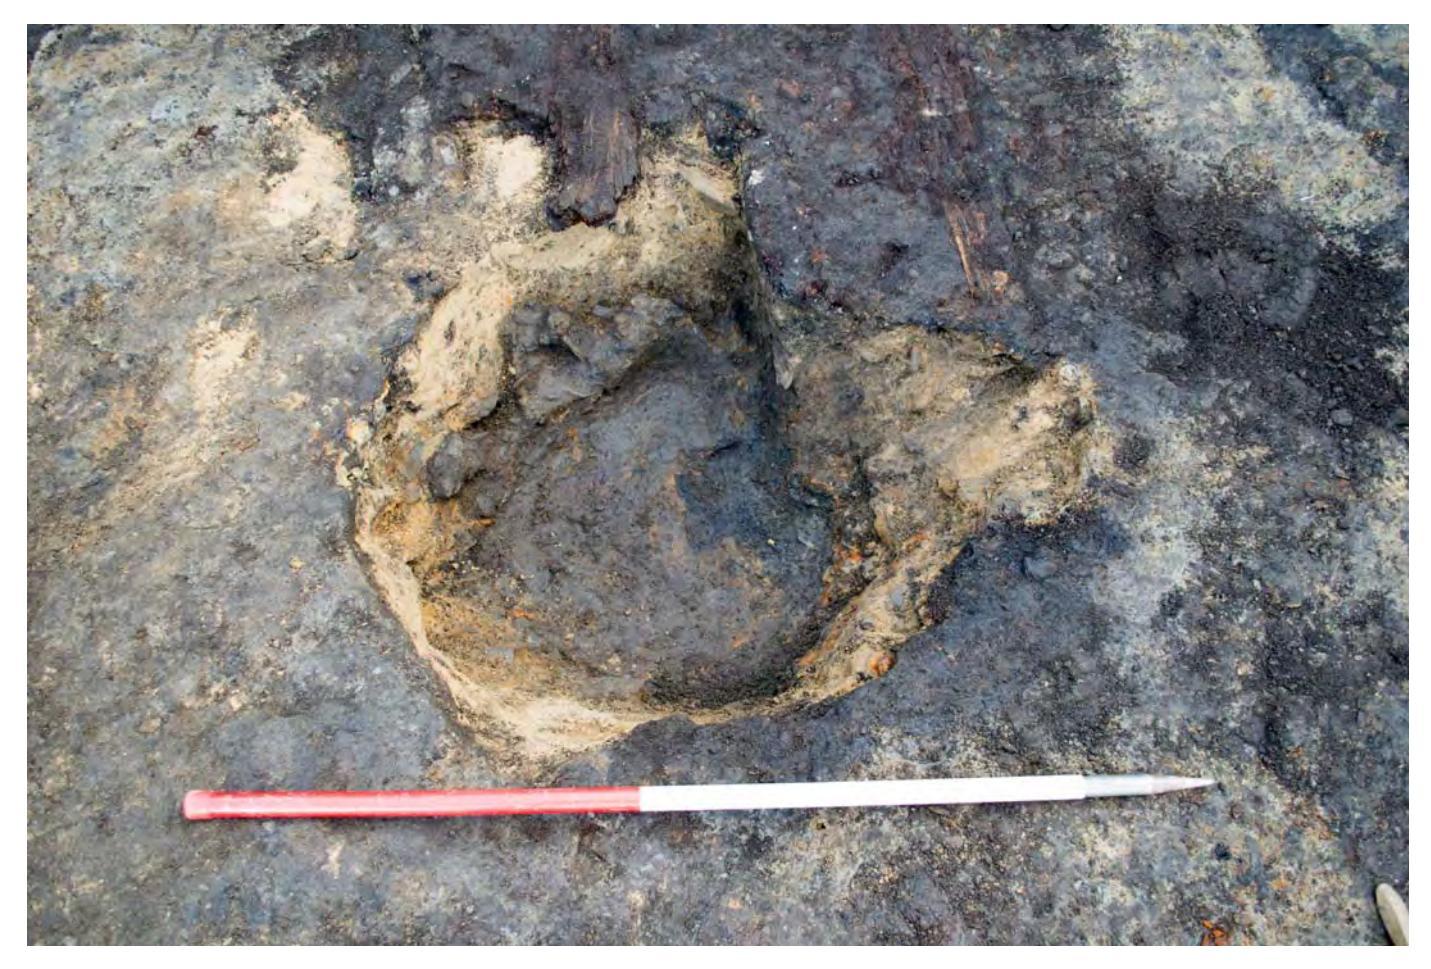
PLATE 09: PIT 143. VIEW FROM THE NORTHWEST

A large oval pit (143), measuring approximately 1.3m by 0.85m, and with a depth of 0.3m was uncovered towards the rear wall of the smithy (Figures 9 and 10, Plate 9). The base of the pit consisted of a burnt/ metalled surface (153) on top of the natural bedrock. A greyish brown silty sand deposit (147) sealed this surface and formed the main fill of the pit. A 0.05m thick layer of black silty sand (125) sealed the pit and contained two wooden beams, which would have extended over the pit, possibly sealing it. The northwestern half of the pit was filled with a loose black sandy silt (126), representing a dumped backfill. This suggests that something was removed from this half of the pit, and the presence of the burnt/ metalled surface at the base of the pit suggests it was something to do with a forge, however its exact function is unknown.

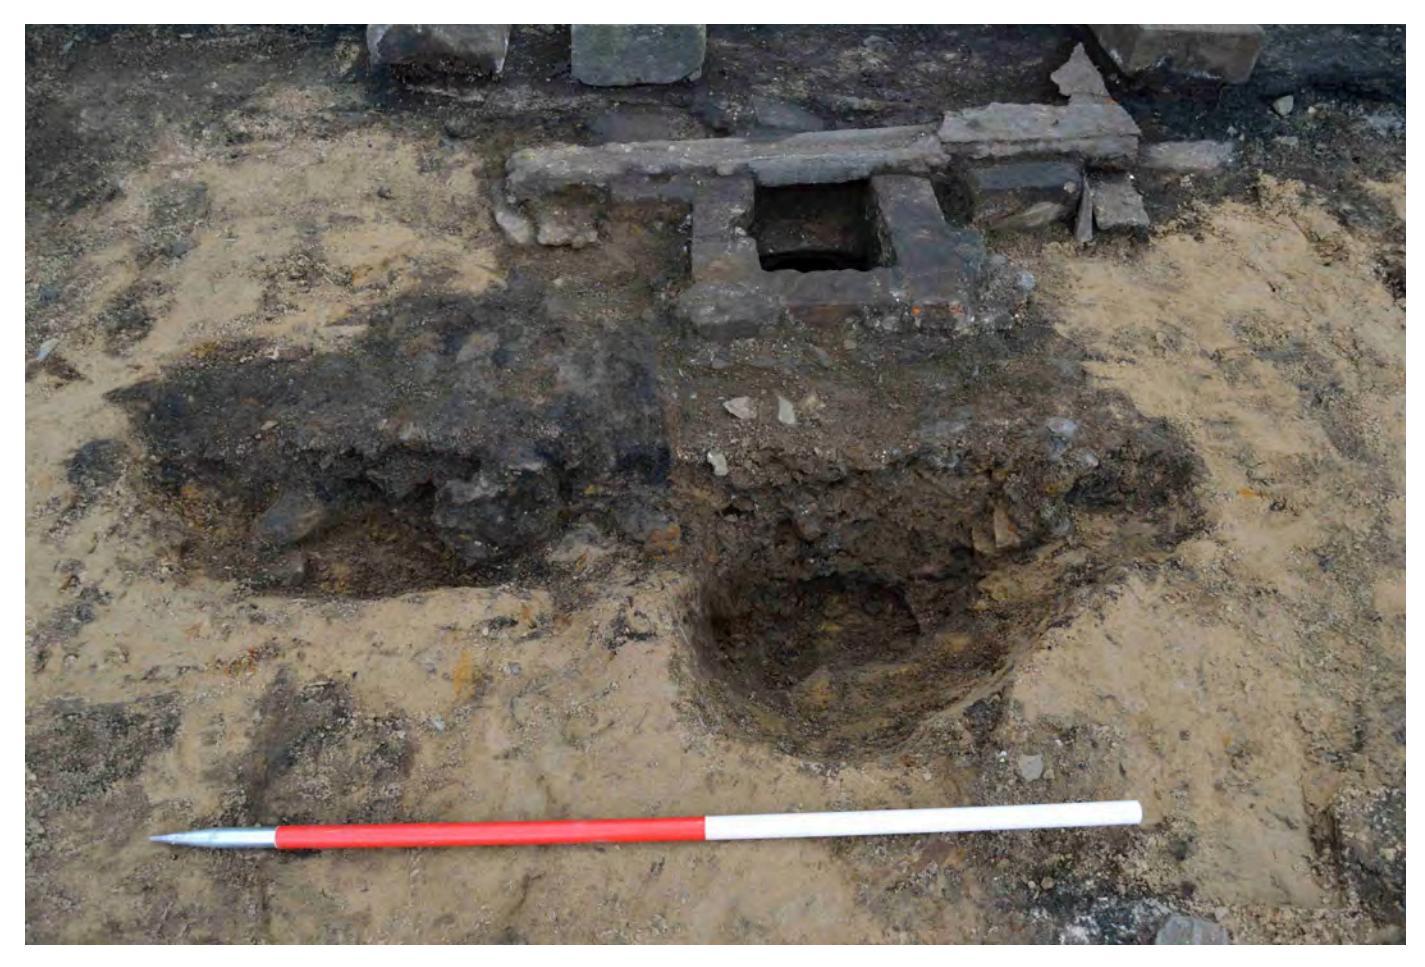
PLATE 12: PITS 185 AND 186. VIEW FROM THE NORTHWEST

Pit **185** was uncovered partially truncated by the possible forge (**127**), and in turn was visible truncating pit **186** (Figure 9, Plate 12). Both pits were sub-circular in shape and measured 0.82m by 0.82m and 0.82m by 0.62m respectively. They were filled with a similar dark grey sandy silt (**157** and **158** respectively) and contained fragments of corroded iron objects. The function of these pits is unknown.

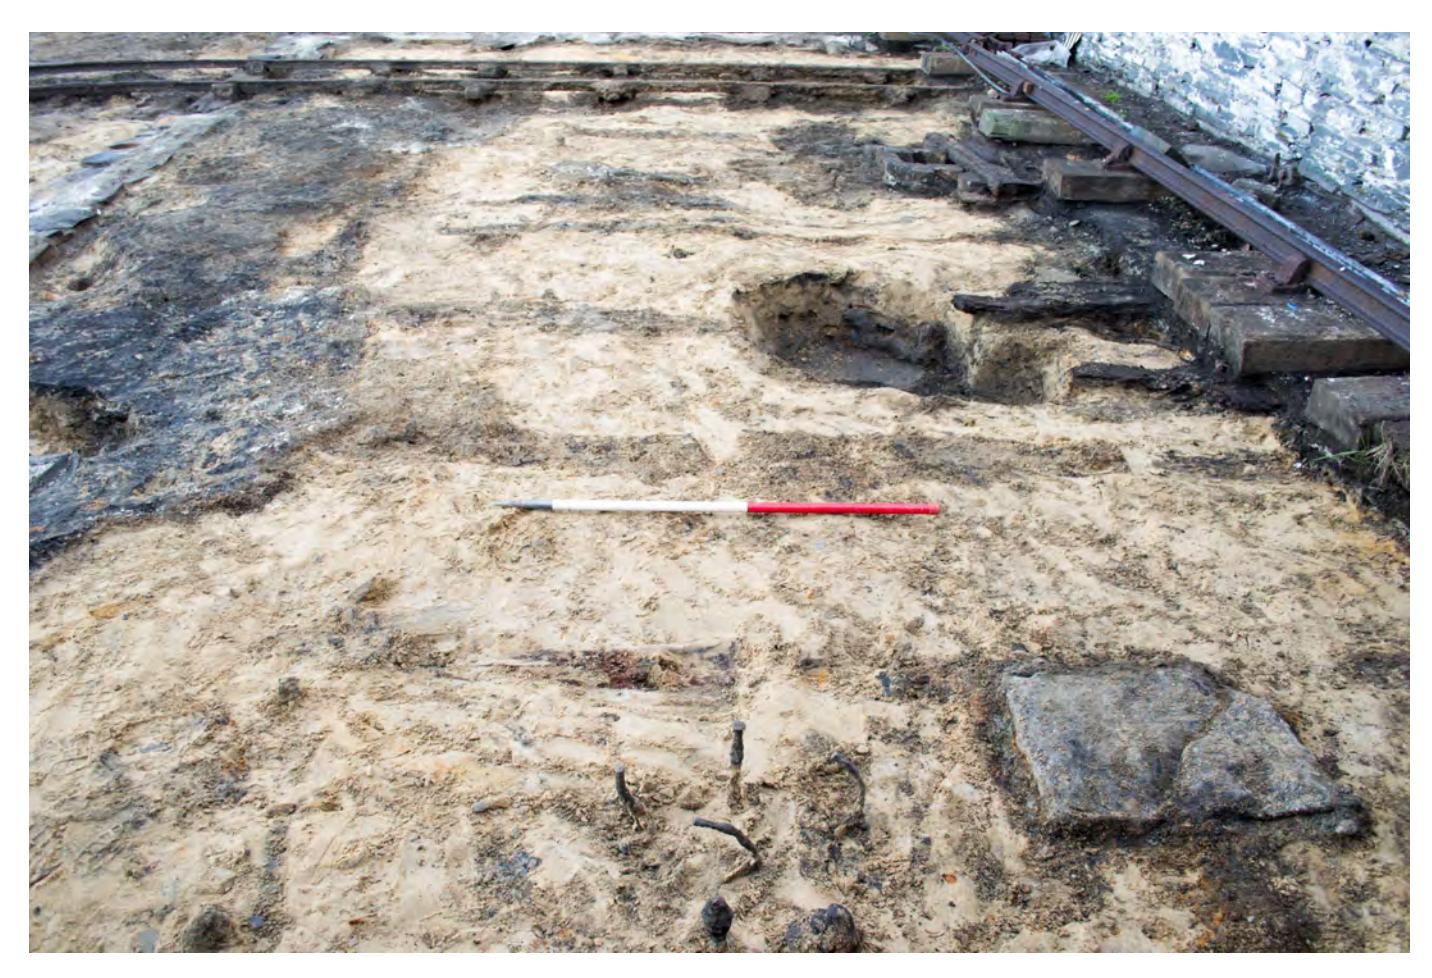
PLATE 14: SLEEPER TRENCHES 166. VIEW FROM THE SOUTHWEST

The floor layer (136) also sealed three lines of sleeper trenches (166) that ran parallel to the rectangular pits (179) and gully (173) and were also cut into the sand levelling layer 107 (Figure 8, Plate 14). These measured on average 1m in length with a width of 0.15m and the remains of wooden sleepers were visible within them. The sleepers were laid in three rows 0.7m apart, with the sleepers 0.2m apart in each row. They were visible running up to and under rail trackway 102/ 142 but did not continue on the other side, and may represent the foundations for a wooden floor rather than lines of a rail trackway, as no metal fixings/ chairs were visible within any of them.

The sleepers (**166**) uncovered to the southeast may have been used as the foundations of a floor layer (**163**) rather than for a trackway as none of the sleepers showed any evidence of rail fixings/ chairs. Only three lines of sleepers were uncovered within the excavation area. However, as no excavation was able to take place within 1m of the rear wall, and no excavation took place on the southeastern side of this wall, it is possible that as this wall is of a later date, then the original rear wall of the wagon storage shed was set further back and that a fourth line of sleepers did exist. If this is the case these sleepers may well have formed part of a rail trackway within the shed.

The line of sleepers (166) do not continue on the northeastern side of the sleepers for rail trackway 142, which would suggest that these are broadly contemporary. No evidence for a sliding turntable was uncovered in the vicinity of this rail trackway, however as it was replaced by a later rail trackway (102) it may have been removed at this time. As excavation was not possible within 1m of the later rear wall (101), it is also possible that the sliding turntable, or remains of, are located within this area.

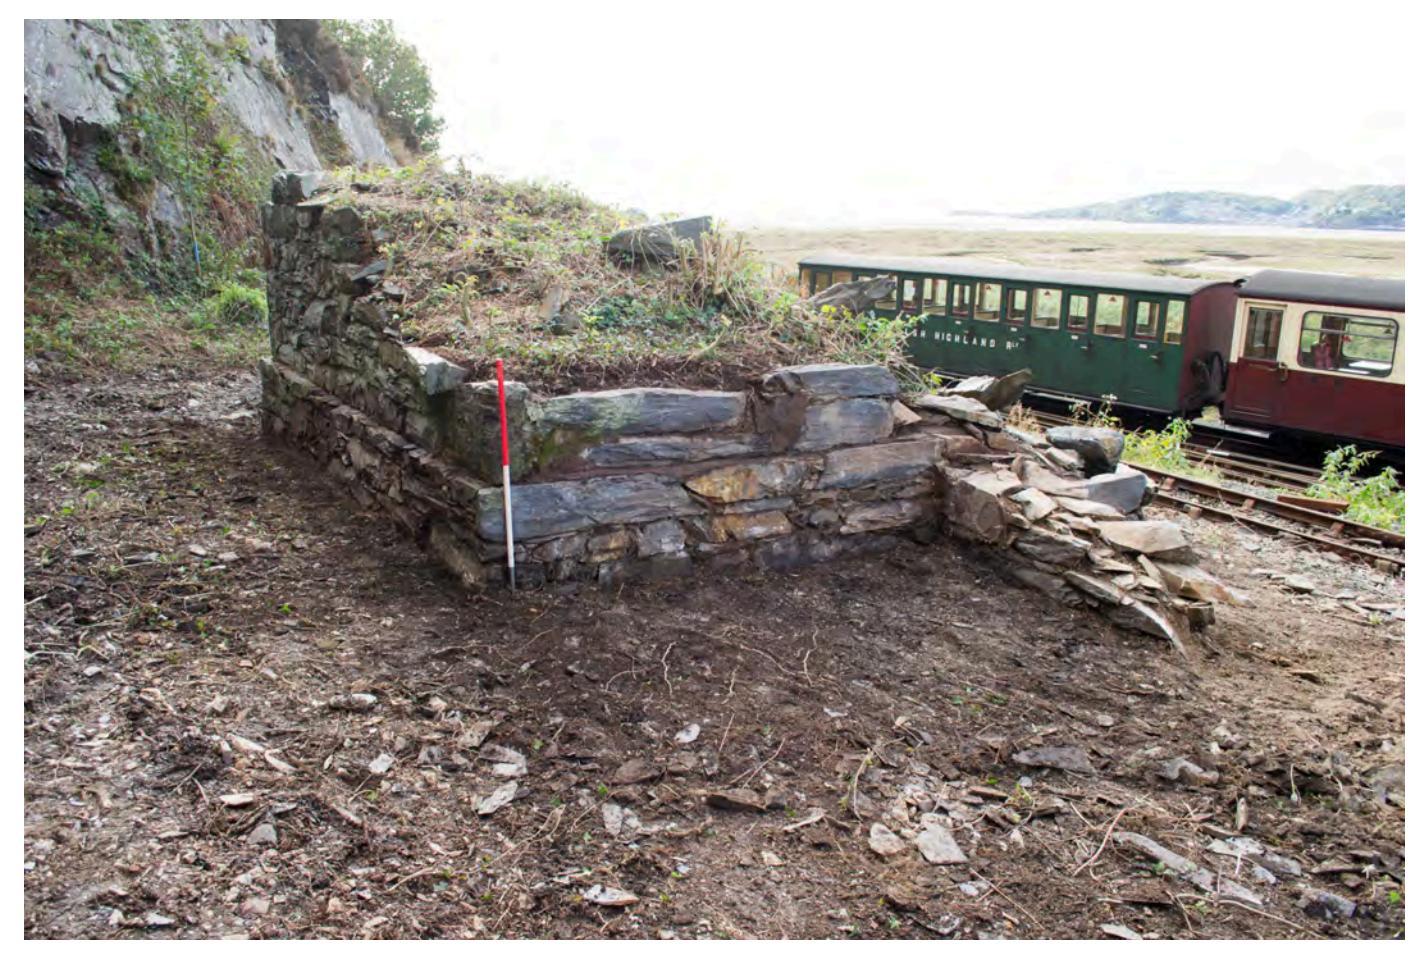
PLATE 15: GUNPOWDER SHED 1. VIEW FROM THE NORTHEAST

The two gunpowder sheds have been fully recorded and 3D models produced. No remains of the third gunpowder shed were found and it is likely that this was completely demolished at some point after 1964.

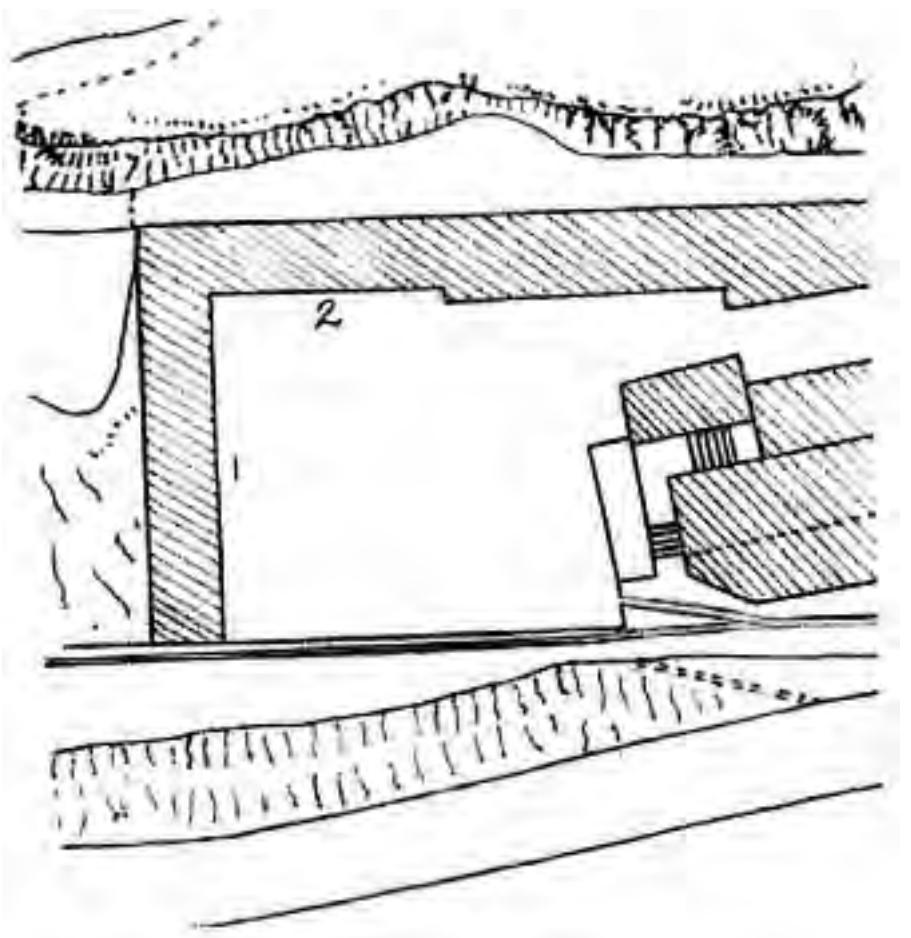
Fig. 3 Outline plan of Top Yard in 1847 (John Alexander)

The guarry for the Cob fell out of use after completion and repairs to the embankment in 1814. In 1842 two wagon storage sheds were built along the north-east and south-east sides of the yard (Fig. 3). There was an access ramp running to Penrhyn Isaf behind the southeastern shed. In 1856 the south-eastern end of the north-eastern shed was separated off as a store and the remainder was subsequently converted into the Loco Superintendent's office, the pay office and then into a residence. This is shown on a plan of 1915 (Fig. 5 provided by John Alexander). The residence now survives as a stand-alone building called Plas Smart named after a former resident Ian Smart. The shed was modified in 1920 to accommodate a siding running through the building immediately to the south-east of Plas Smart. This provided access to the sand pit to the rear (Fig. 6 shows this phase and gives a general overview of the works in 1963). A photograph from the Ffestiniog Railway archives shows the shed after this insertion, probably in the 1930s (Plate 1). The shed can be seen to have a mono-pitched roof. The south-eastern end used the former quarry face as a back wall, the north-western end a mortared stone wall. Later photographs (Ronald D 1958 Corley D J 1959 in Zeepvat B. 2011) show that the wall adjacent to the sand-pit siding access was made of wood.

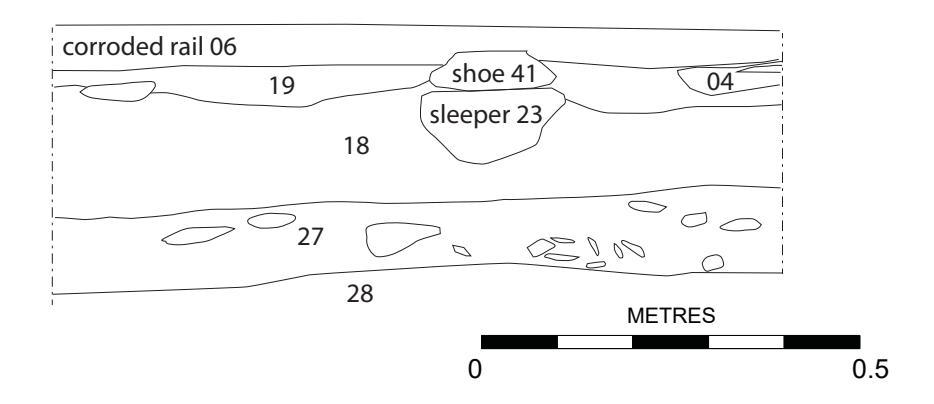
Fig 10 Trench 1: south-west facing section

The site originated as one of two quarries for the stone used in building the Cob from 1808 to 1811 and probably during repairs to a breach in 1812 to 14. The rock face forming the northwest side of the excavation marked the limit of the quarry in this direction. The level of the quarry floor was unknown but presumed to be close to or above the level of the Cob. Two small sub-trenches in the excavation (Trench 1 and Trench 2 Fig. 9) aimed to investigate the early deposits. Trench 1 identified a layer of compacted shattered stone and larger rocks (28 and Plate 5) at 7.05m OD. This was 0.35m below the level of the floor of the wagon storage sheds. This appeared to be the working level of the quarry although excavation down to bedrock was not possible in the small trench. The lowest excavated level contained fibrous organic matter, probably preserved roots and grass dating from the period between the abandonment of the quarry and the levelling of the site for Boston Lodge works. It was noted that the organic material was sealed by hard infill with no apparent root penetration suggesting that the material was not a product of the development of weeds during the 20<sup>th</sup> century abandonment; sections are shown on Figs 10 and 11.

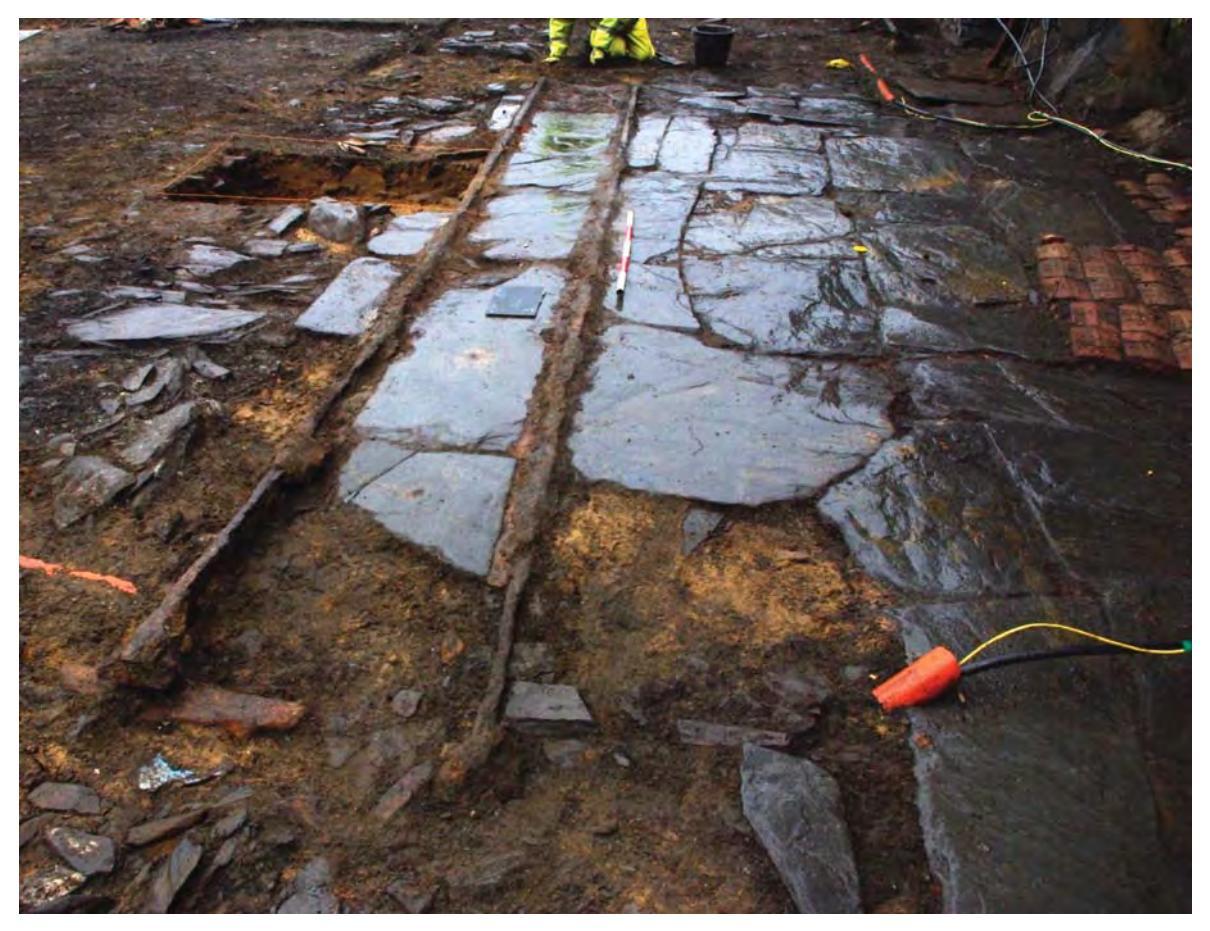
Plate 7 Rails and slate slabs after excavation from the south-east

An area of slate flooring and a length of rails were uncovered immediately beneath the modern overburden (Plate 7). The slab floor was bounded on the south-east (02) and south-west (10) by the somewhat fragmentary remains of the foundations and lower courses of a stone wall. The wall corresponds to the limits of the north-eastern wagon shed as shown on the 1889 25" OS map and 1915 plan. The south-western wall was also, having once been part of the same structure, aligned with the front of Plas Smart. The wall foundations were not investigated in detail.

The interior of the south-eastern end of the shed was better-preserved. A 7.5m x 3.25m area of slate flooring (04 and 05) and a 6.5m length of 1 ft. 11  $\frac{1}{2}$  in (597 mm) gauge rails (06) were preserved directly beneath the modern overburden (18). The south-west facing section in trench 1 (Fig. 10) demonstrates that a sleeper (23) and probably the rail and slabs were laid directly onto the sand infilling (19 appears to be modern material under the edge of the top of the rail). The rails were badly corroded and apart from their upper surface, mostly hidden beneath the slab floor. They were T-shaped in section, about 28mm wide and 61mm deep. Measurements are approximate because, the rails were both corroded and covered with concretions of rust and sand. The south eastern end had been slightly disturbed by a modern service duct (13) but the mains of chairs and a wooden sleeper could be identified. As noted above, a second wooden sleeper (23) was present in trench 1. The north western end of the length of rail (Plate 8) was resting on a stone sleeper block about 22cm deep, and again sitting on sand. A second stone sleeper (30) block was recorded 0.8m to the north-west of the end of the rails.
