Evaluation of Toilet Pits on Ynys Enlli /Bardsey Island

Project No. G2318 (additional)

Report No. 1352

Prepared for: Bardsey Island Trust

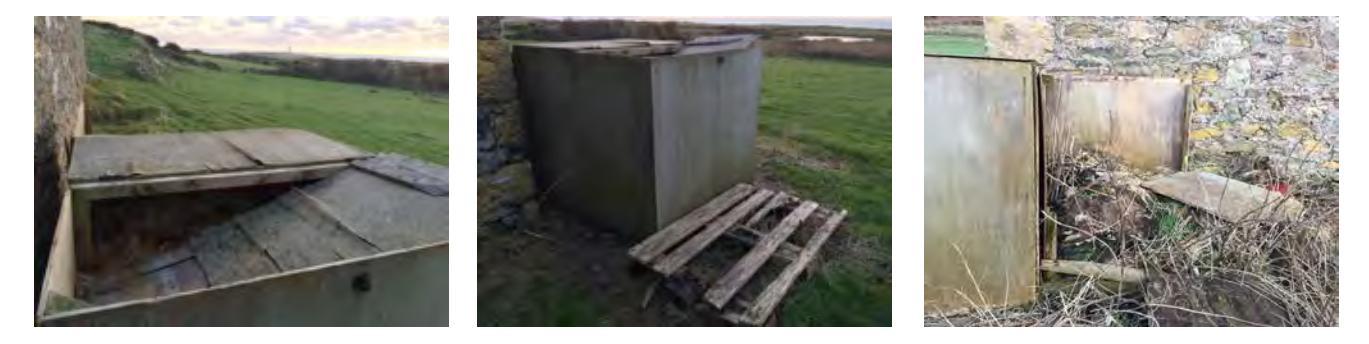
It became apparent that all of the plywood pits have the same fundamental design problems which result in them breaking and not being very user friendly. For example, many of the lids to the pits break in the same way and none of the lids have a handle for users to hold to pull the pit open. Most of the pits are too tall, resulting in inappropriate 'steps' being used and then breaking, creating a serious health and safety risk.

Above from left: Carreg North Pit, Carreg North pit and broken pallet used as steps, Carreg South pit destroyed.

As a result of these problems I have worked with Gwyn Stacey (my brother) to produce this proposal to innovate the existing model with a view to making the system work better for guests, staff and be more cost efficient for the Trust.

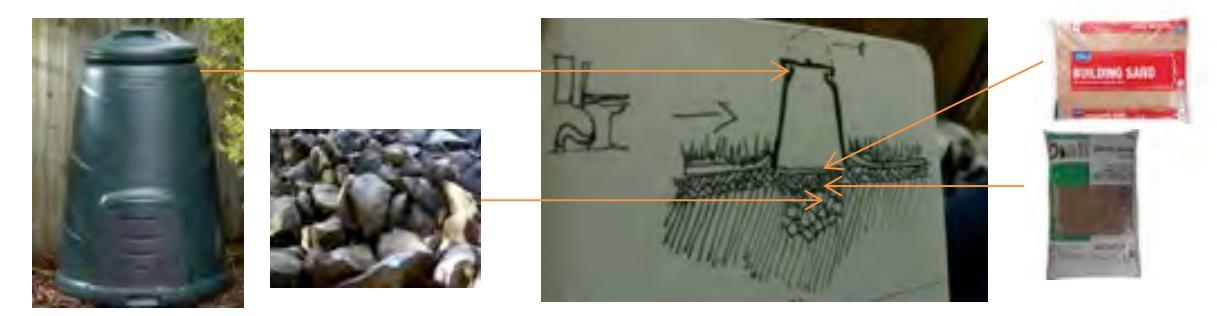
The proposed system will utilise a standard 330L compost bins made from recycled plastic. Below which will be a pit excavated to ~0.5m depth and 0.8m Diameter. This pit will be back filled with large rocks for 0.35m, gravel for 0.1m and finally a top layer of sand 0.05m thick. This will allow for liquids to slowly drain out and have partial biological filtering. Sods removed before excavation will be laid around the circumference of the compost bin to provide stability and alleviate liquids leakage.

- 1. Remove sods to diameter of compost bin, retain for reuse
- 2. Dig pit to 0.5m deep 0.8m diameter separating and retaining any large stones.
- 3. Backfill pit to 0.35m with large stones
- 4. Fill 0.1m of 20mm gravel above this
- 5. Finally level with 0.05m of sand
- 6. Place compost bin in place
- 7. Place sods around circumference of compost bin.

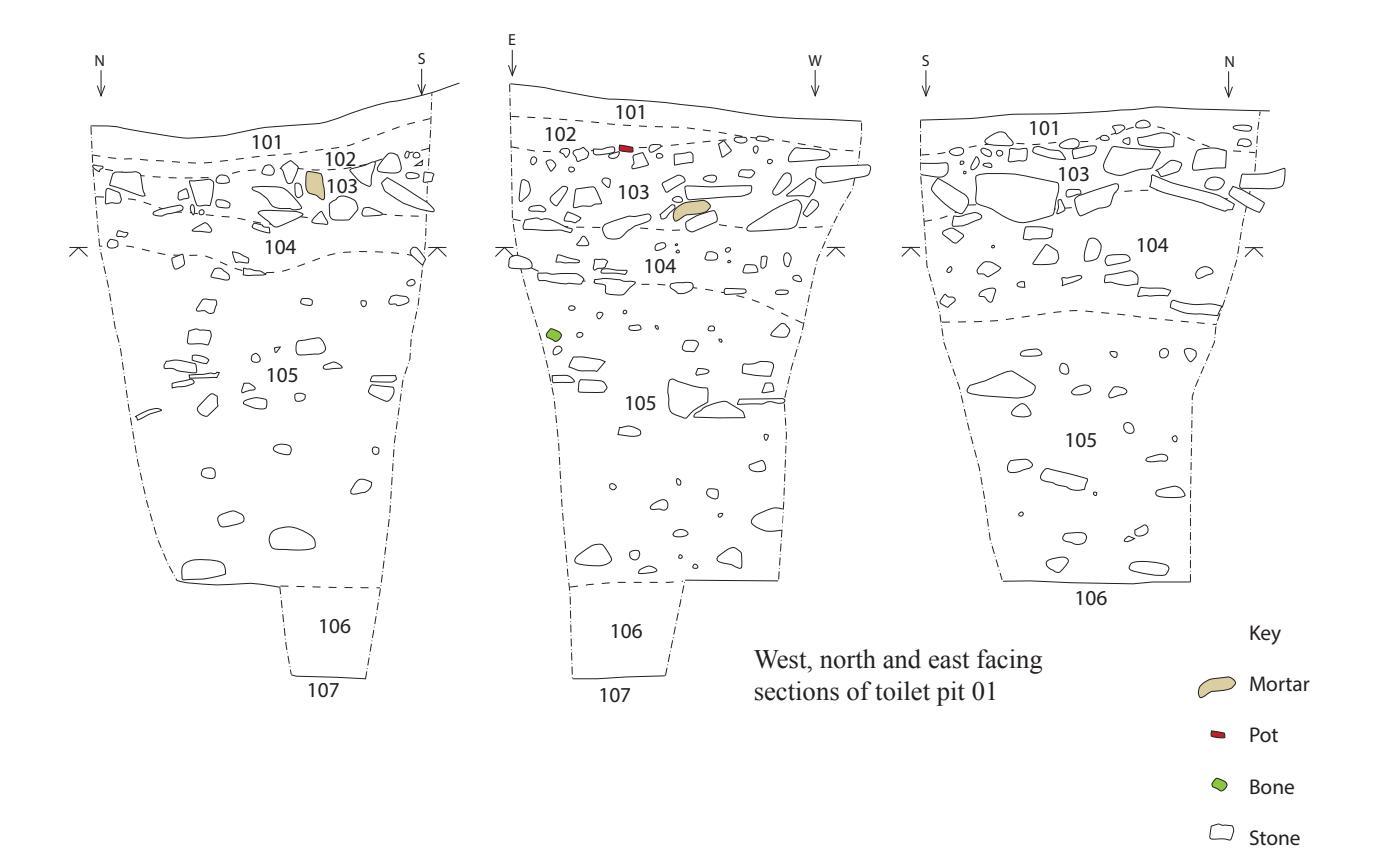
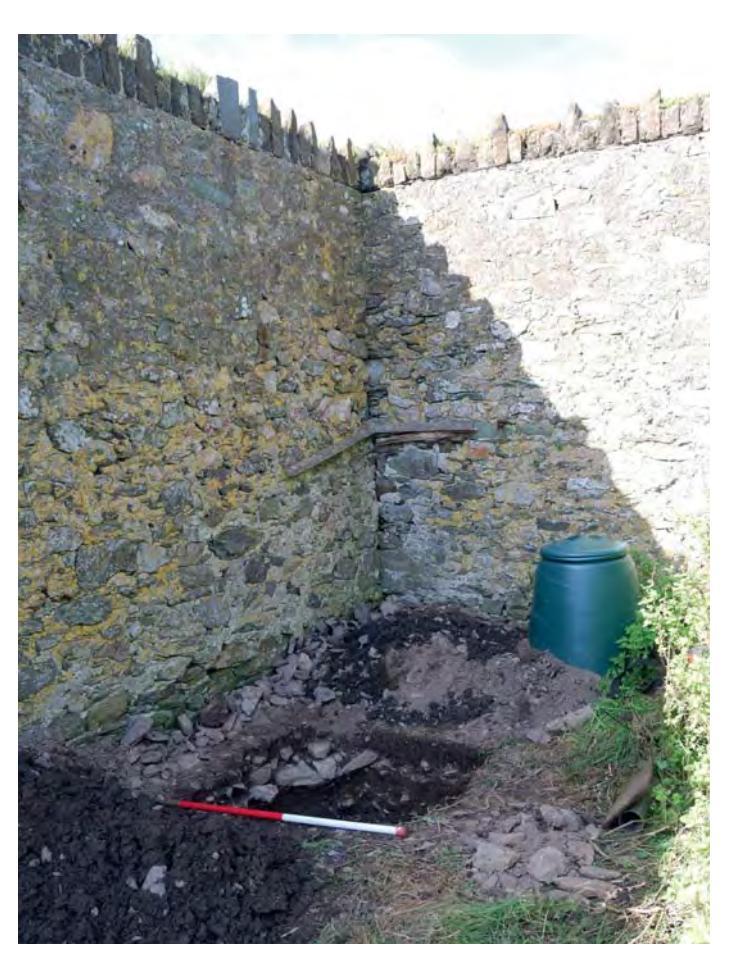
Figure 3. Section drawings and photographs of toilet pit 01

The pit was only 1m square and the natural boulder clay was 1.55m below the surface, so only a small area was exposed in the base of the pit as the sides had to be battered for stability. However this pit was very useful in understanding the make-up of the farmyard. Under 0.1m of topsoil was up to 1.2m of rubble and soil sealing a buried soil layer (106). The buried soil was about 0.25m deep and was composed of very soft dark grey sandy clay with some rounded beach pebbles. It contained no artefacts. The glacial boulder clay (107), an orange brown sandy clay, was 1.55m below the present ground surface.

The natural ground surface under the yard clearly sloped down from east to west. This can be seen by the eastern entrance to the yard being at ground level while the western door from the yard leads to a flight of steps and the ground surface inside is well over 1m above that outside the yard. The rubble layers seen in pit 01 were used to level the ground within the yard. The lowest of these layers (105) was a very dark grey sandy loam with c.20% angular stones, the stones becoming more frequent towards the base of the layer. It also contained fairly high quantities of animal bone, mainly very fragmentary and appearing to be general domestic rubbish. Above this was a layer (104) with numerous stones, lumps of brown clay, and patches of degraded mortar. The highest rubble layer was very stony (103), with sand from degraded mortar as well as lumps of mortar. While 105 appears to have been a general make-up layer with some domestic rubbish included the upper layers seem to be composed largely of building rubble, probably material either left over from building the current yard or from the demolition of earlier buildings.

Location of toilet pit 01

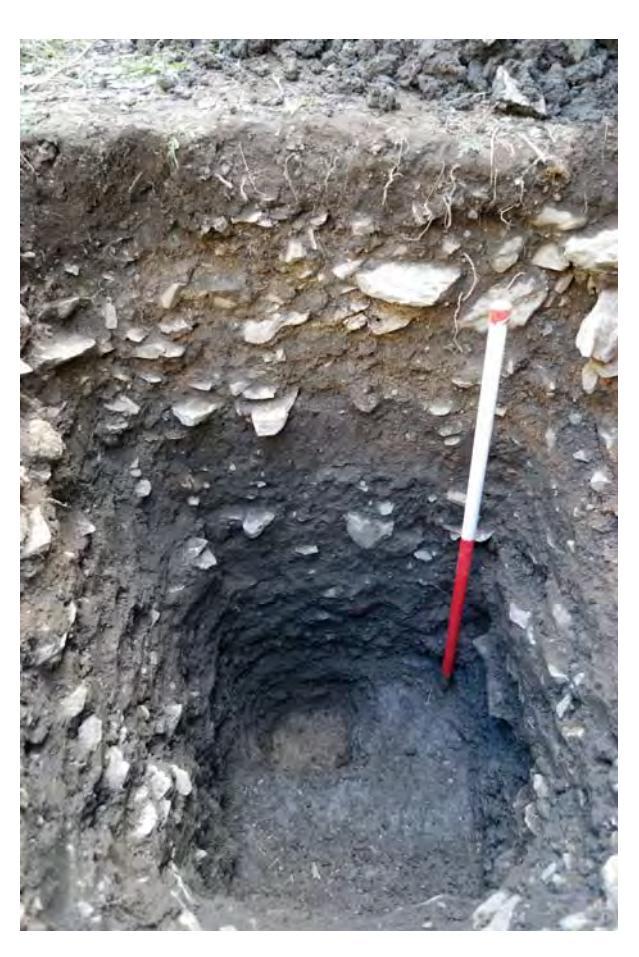
N facing section of toilet pit 01 with layer 106 exposed in base of pit

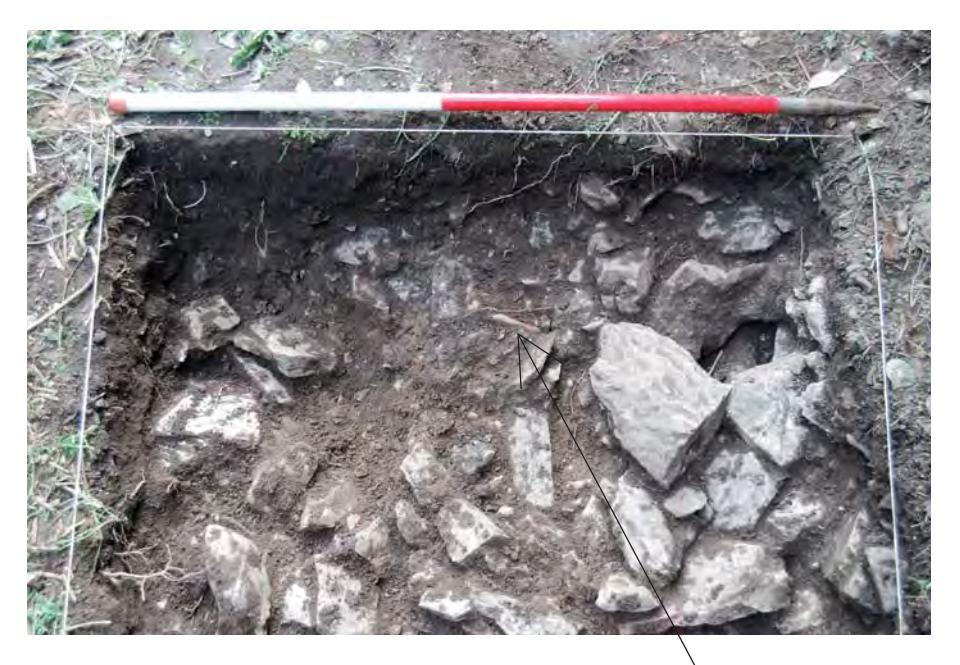
Figure 4. Human bone from toilet pit 01

The upper rubble layer (103) contained some human bones as well as those of other animals. These bones included a complete human radius (lower arm bone), part of a skull and other smaller fragments (figure 4). This layer is clearly the origin of the bones found previously in this area and it is clear that the bone is disturbed and redeposited; dumped unceremoniously in with the rubble. The human bones almost certainly came from a

Rubble layer 103 with human radius

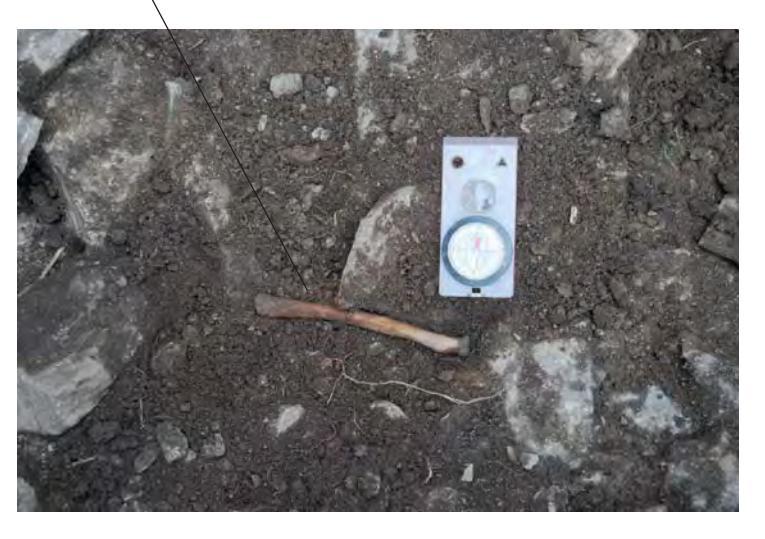
Human radius fully exposed

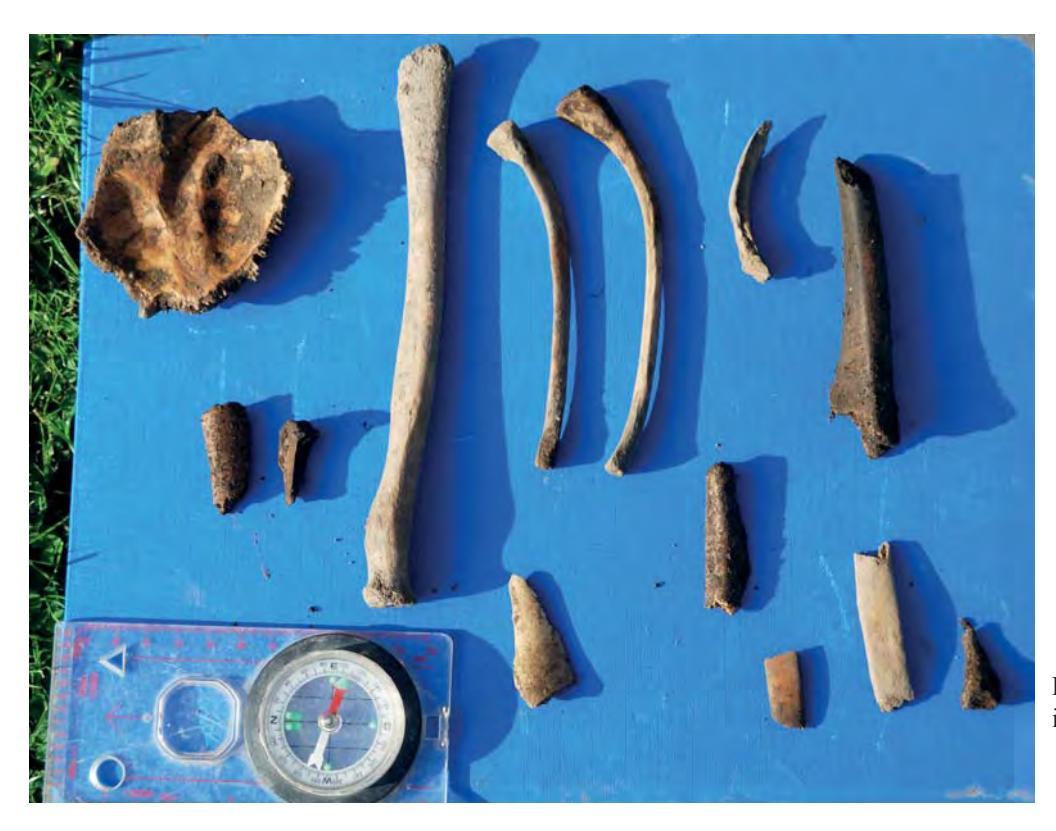
medieval grave disturbed by the building foundations within the yard. There was no sign of a grave cut within the buried soil exposed in the base of the pit and it is unlikely that burials would have been disturbed in this western end of the yard as the ground was being built up rather than dug into. The disturbed grave is more likely to have been in the eastern side of the yard.

Human bones from layer 103 in toilet pit 01

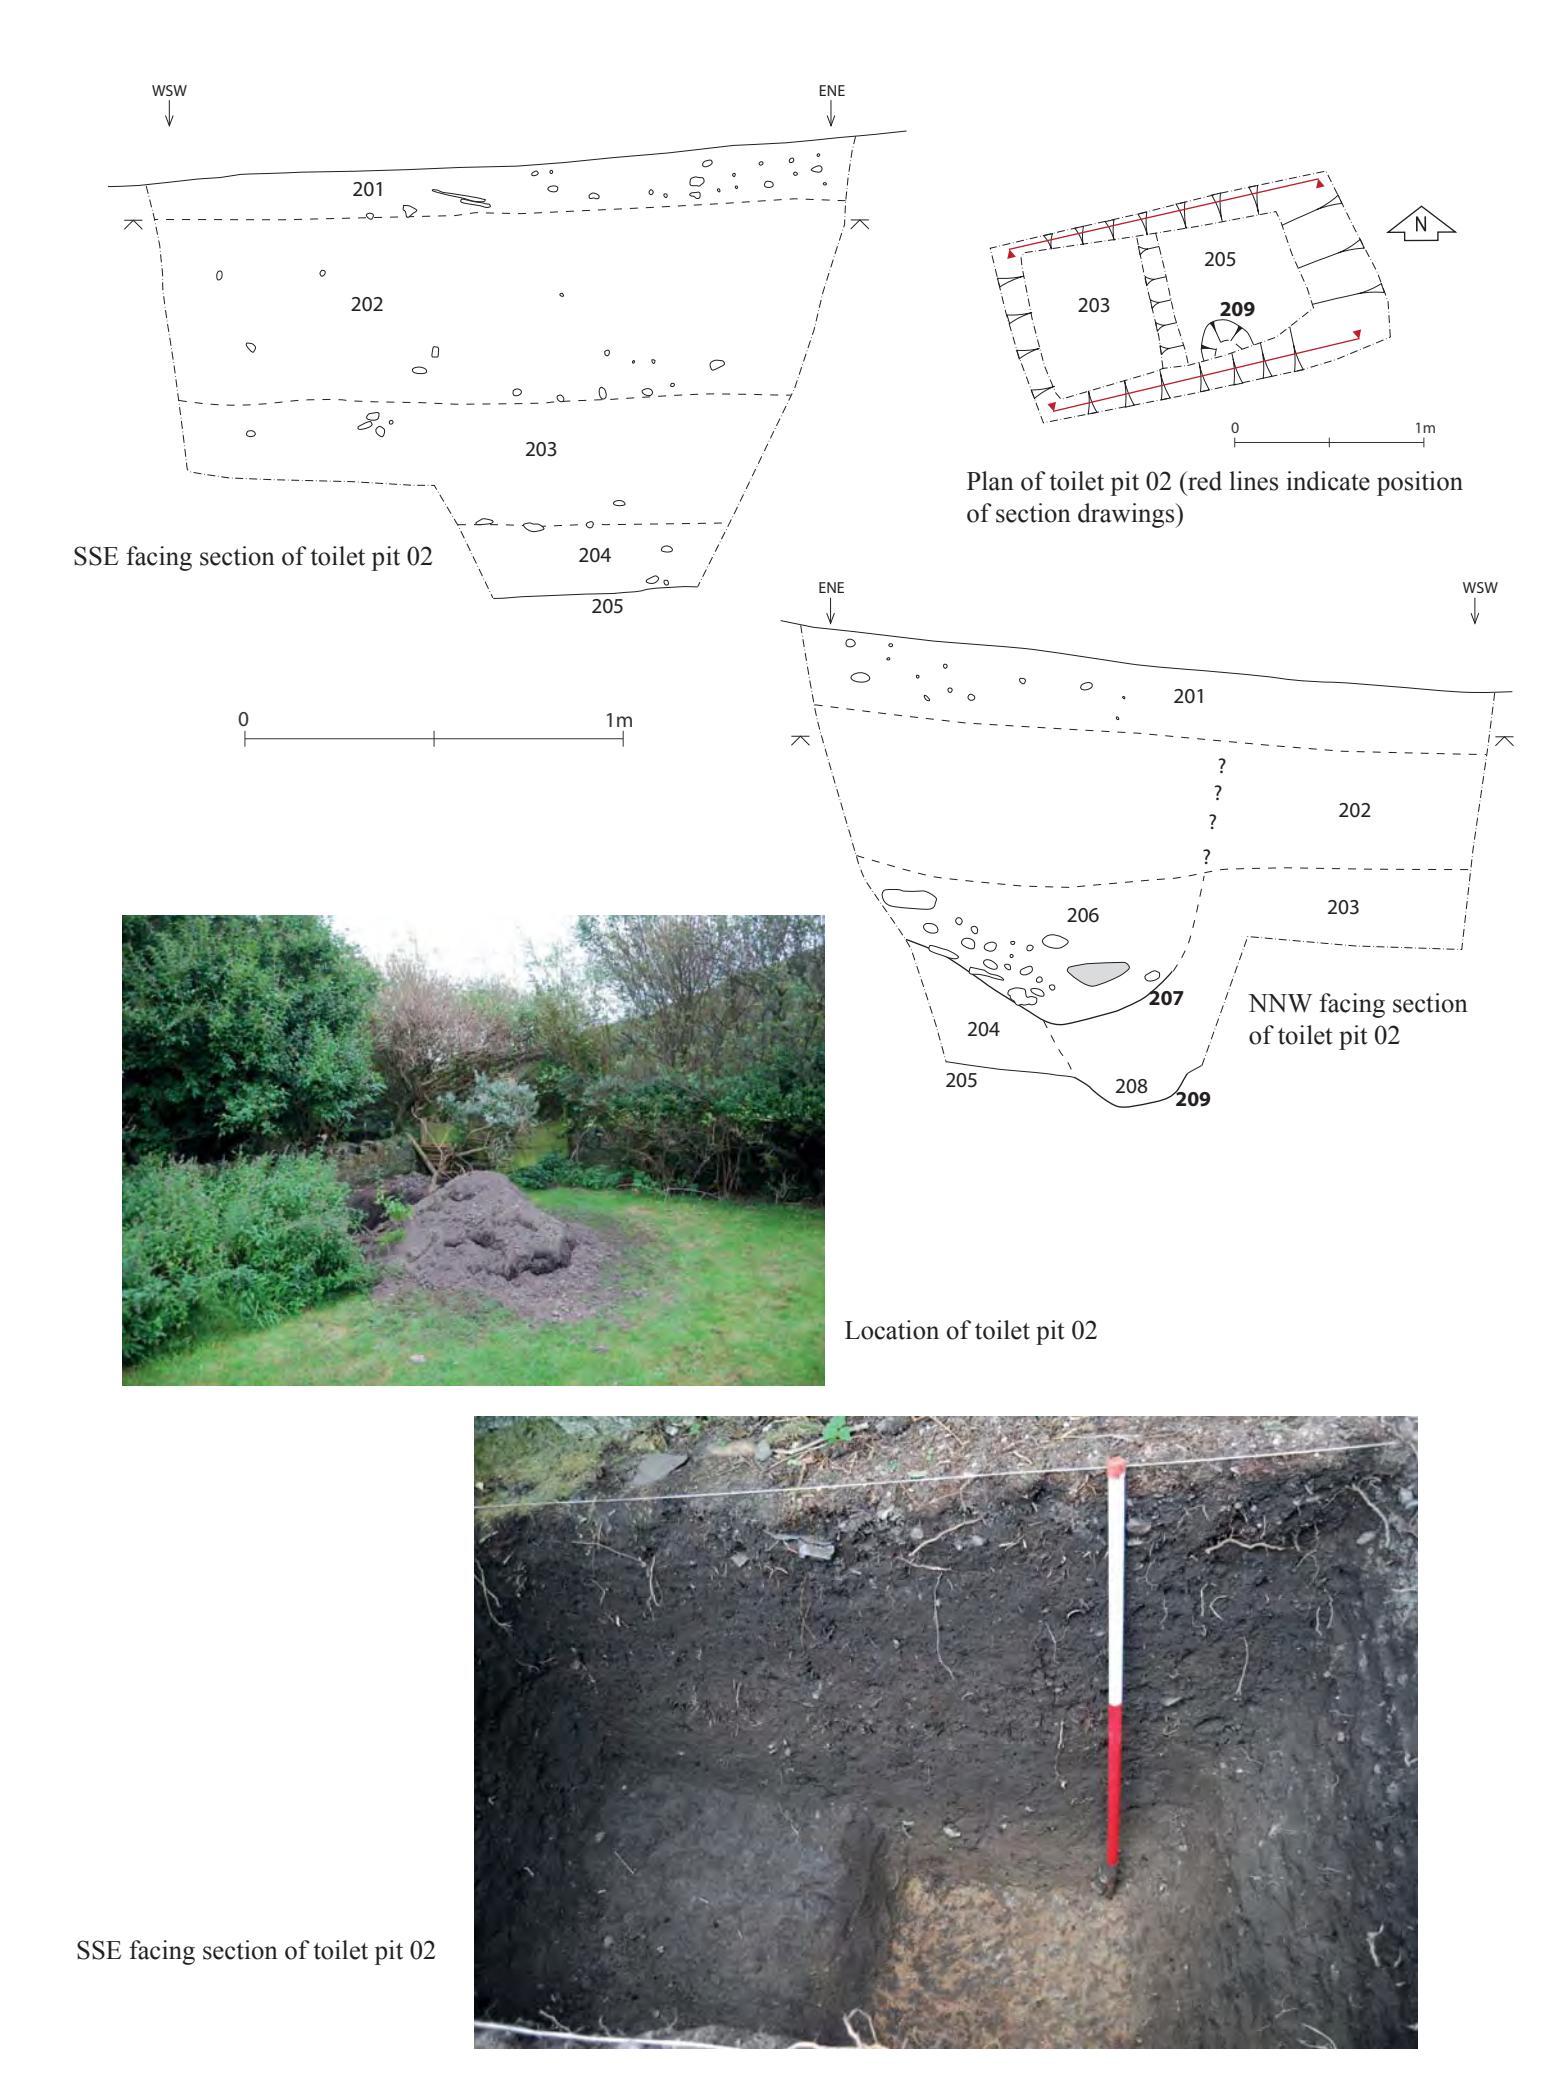
Figure 5. Plan, section drawings and photographs of toilet pit 02

This pit which measured 2m by 1m was located in the northern corner of Nant garden. The garden soil here was about 0.5m deep, as it has obviously been worked over a long period. This overlay an almost alluvial layer (203) of dark grey silty loam, 0.3m deep. Unlike the garden soil it contained no clinker, pottery or other rubbish. Below that was what appears to be a buried soil (204), a very dry and compact brownish grey clayey loam. The boulder clay was seen at 1.2m below the ground surface.

The depth of the deposits in this pit initially suggested that a ditch may run through this area but no edge to this was seen in the pit and a ditch would be expected to have cut away any buried soil. The explanation of the grey loam (203) is therefore unclear but would repay further exploration if the opportunity arose.

A possible feature was visible in the trench as a small pit or hollow [209] cut the buried soil on the SE side of the trench. The fill of the cut was indistinguishable from deposit 203. The trench also just clipped a large modern pit on its SE side. This pit [207] had numerous stones in its fill as well as plastics and other recent rubbish.

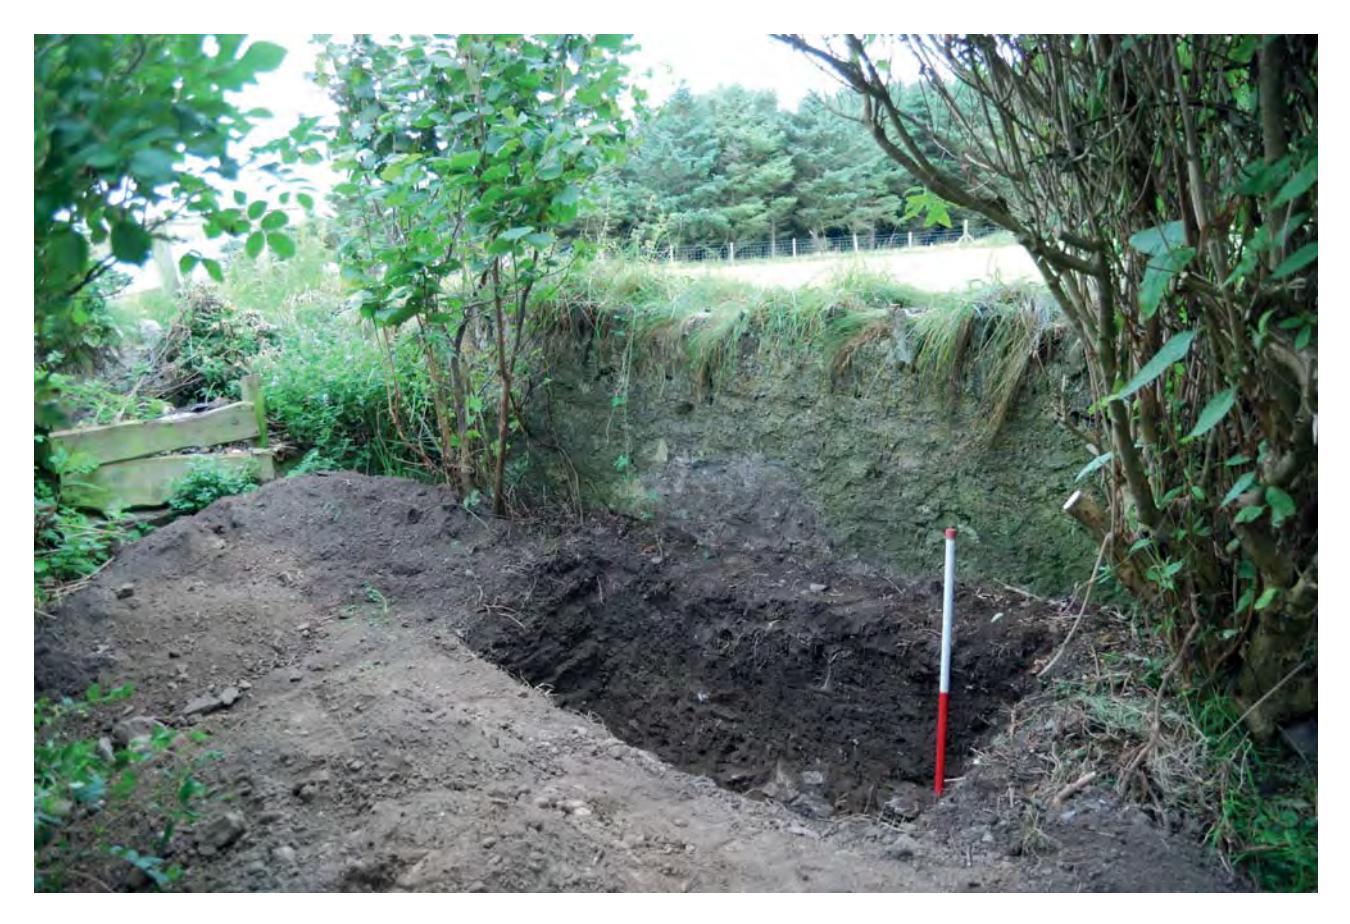
This pit was dug against the north-eastern wall of Hendy garden, just fitting into a space between shrubs and the lawn. About 0.45m of garden soil overlay a possible buried soil layer (303), which was a very firm and dry. It was 0.3m deep and composed of grey brown clayey silt with c20% angular stones and occasional flecks of charcoal. No features or unusual deposits were seen in the trench apart from a slate-lined drain (305) running across the S end of the trench.

Location of toilet pit 03

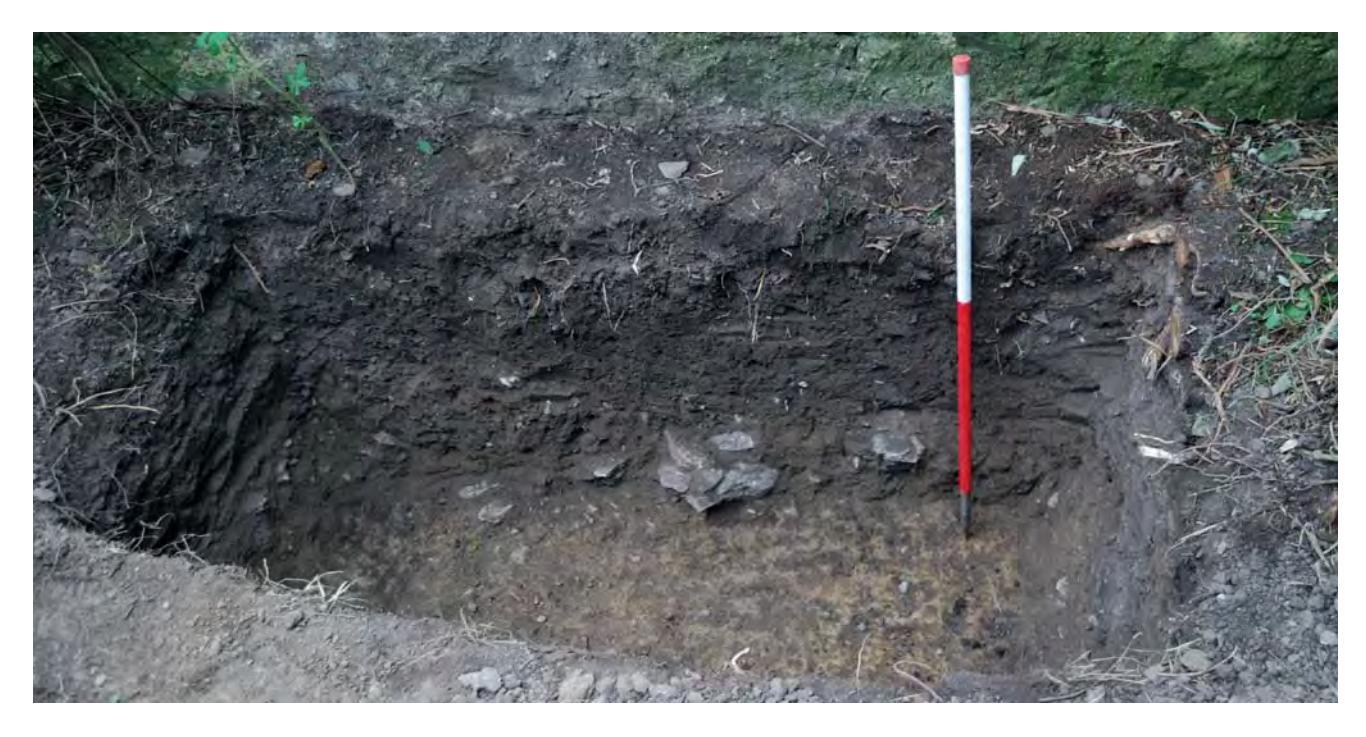
WSW facing section of toilet pit 03

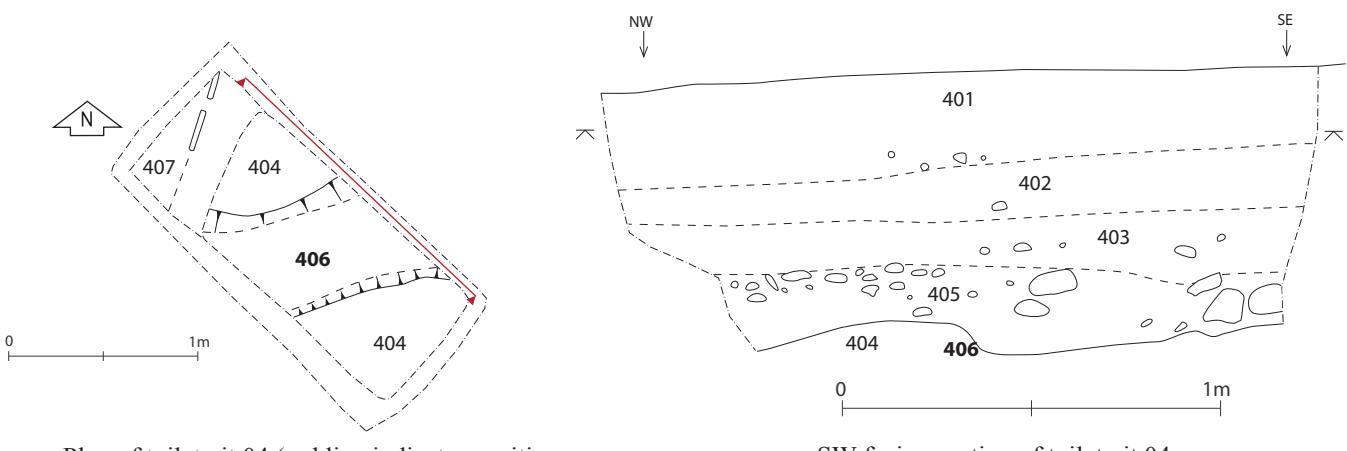
Toilet pit 4 was dug in an area overgrown by trees and shrubs at the north-eastern end of Tŷ Capel garden. The topsoil here was 0.4m deep and the area had clearly formerly been a garden plot heavily dug over. Below this was a very firm, dry layer that was hard to dig through (403). This was 0.2m deep and similar to the possible buried soils in trenches 2 and 3. It was a dark brown silty loam with few stones and overlaid a similar but much stonier layer (405) with c.30% rounded and angular stones, some up to 0.15m long. A deposit similar to 405 but with fewer stones filled a shallow gully [406]. This gully ran about east-west across the trench and was 0.1m deep. It had fairly steep, well-defined sides and flat base. While it is possible that this gully is a genuine archaeological feature its position apparently sealed under what appear to be buried soil layers (403 and 405) make it likely that it was an animal burrow dug through these layers and when it collapsed was backfilled by the same deposits.

In the base of the trench was an orange brown silty clay concreted with iron oxides which represented the surface of the natural boulder clay. A slate drain (407) ran NE-SW across the north-western corner of the trench cutting through the topsoil.

Plan of toilet pit 04 (red line indicates position of section drawing)

SW facing section of toilet pit 04

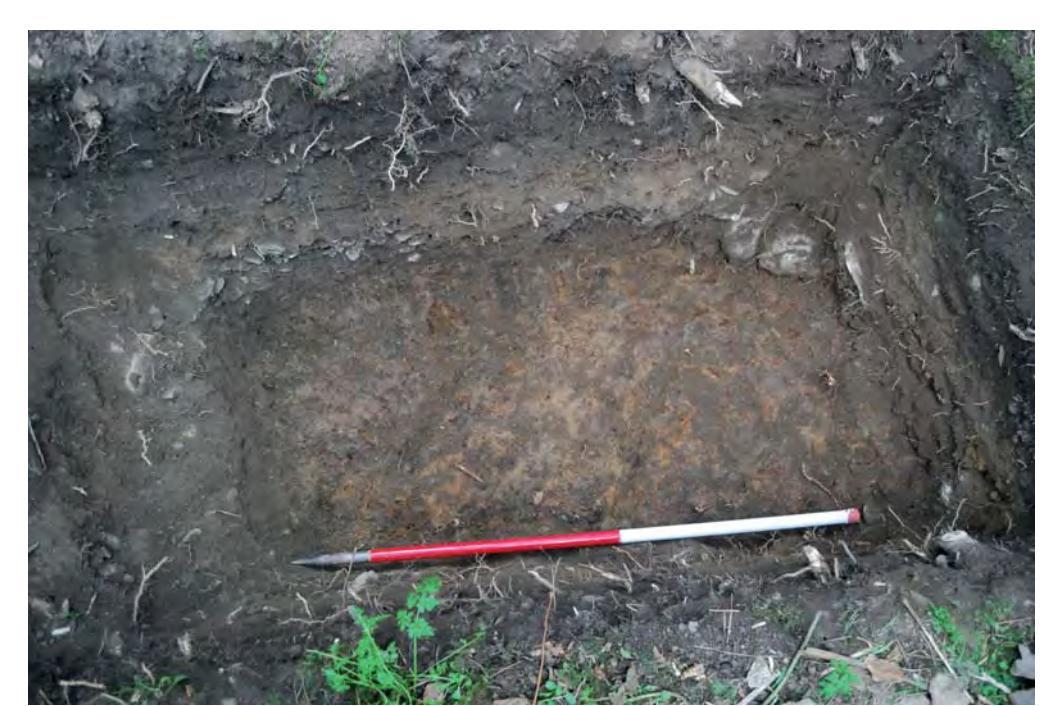
Toilet pit 04 from the south-west

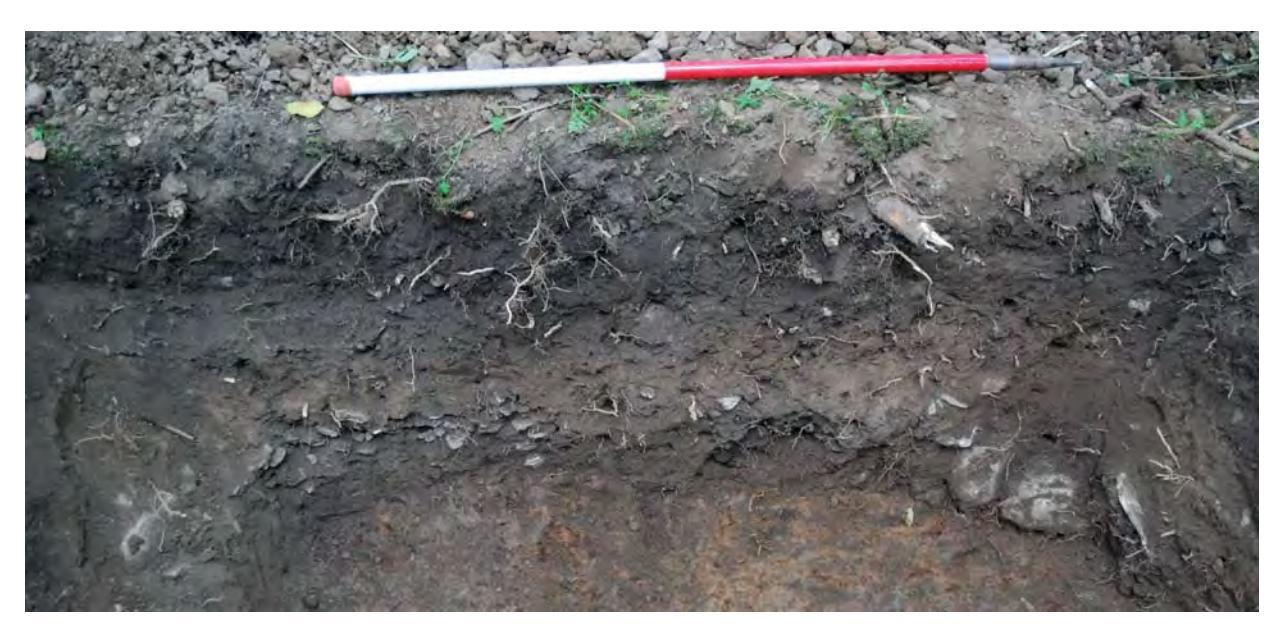
SW facing section of toilet pit 04

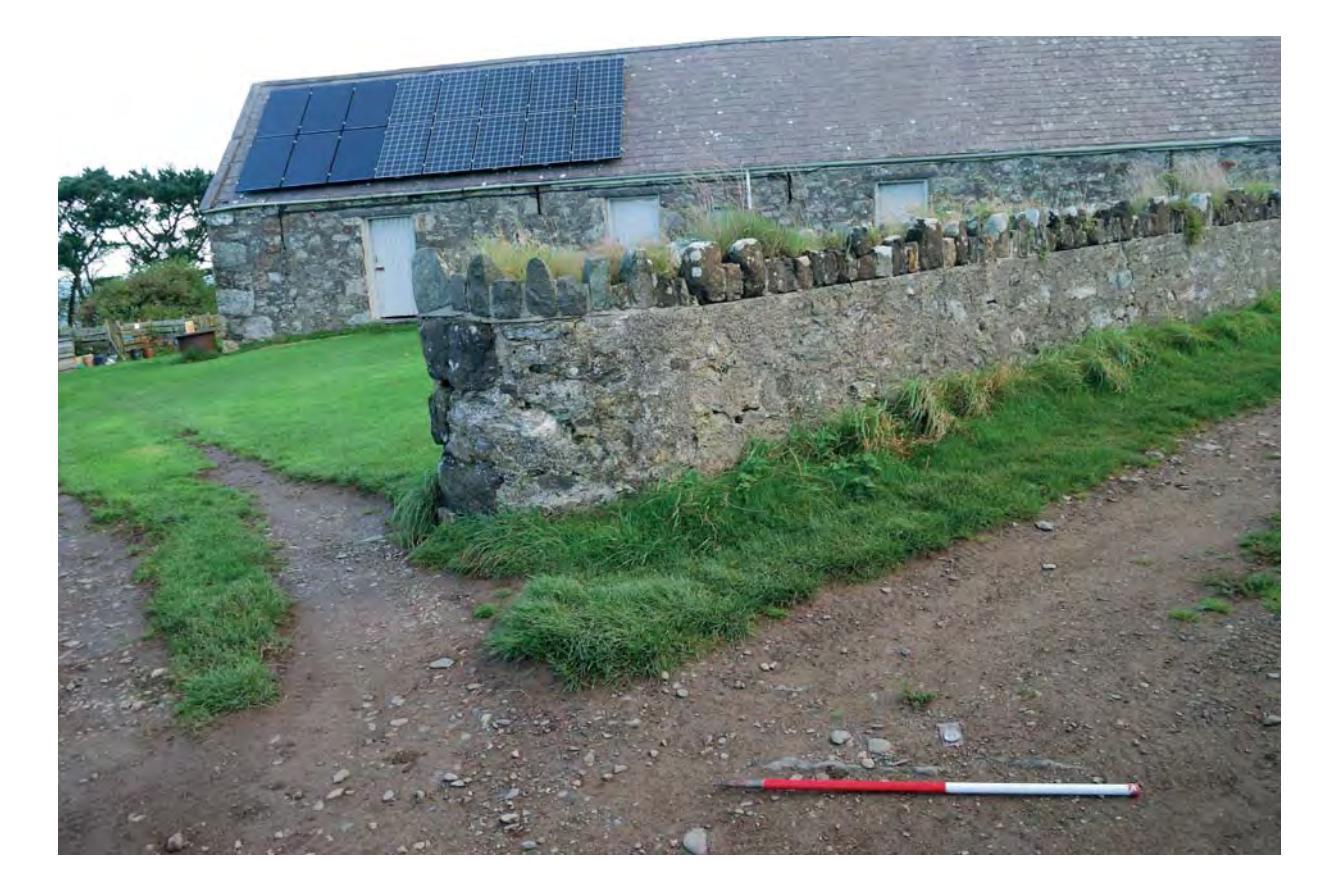
Figure 8. Photographs of cist grave PRN 62364

The cist is located at SH 11995 22125 within the trackway and very slightly to the north of the entrance into the grass area between Tŷ Bach and the barn (figure 2). The edges of two slabs can be seen aligned almost exactly east-west. Together these are about 0.9m long. About 0.5m to the north a short section of another slab can be seen aligned exactly parallel (figure 8). The edges of the slabs normally only just project above the gravel of the track or are entirely covered by gravel. The slabs are firmly supported by the gravel and deposits below and do

Location of grave, seen just behind the ranging rod

not seem to be moved in anyway by vehicles passing over them. As long as gravel is maintained in this area of the track there does not seem to be any significant erosion that will threaten the grave.

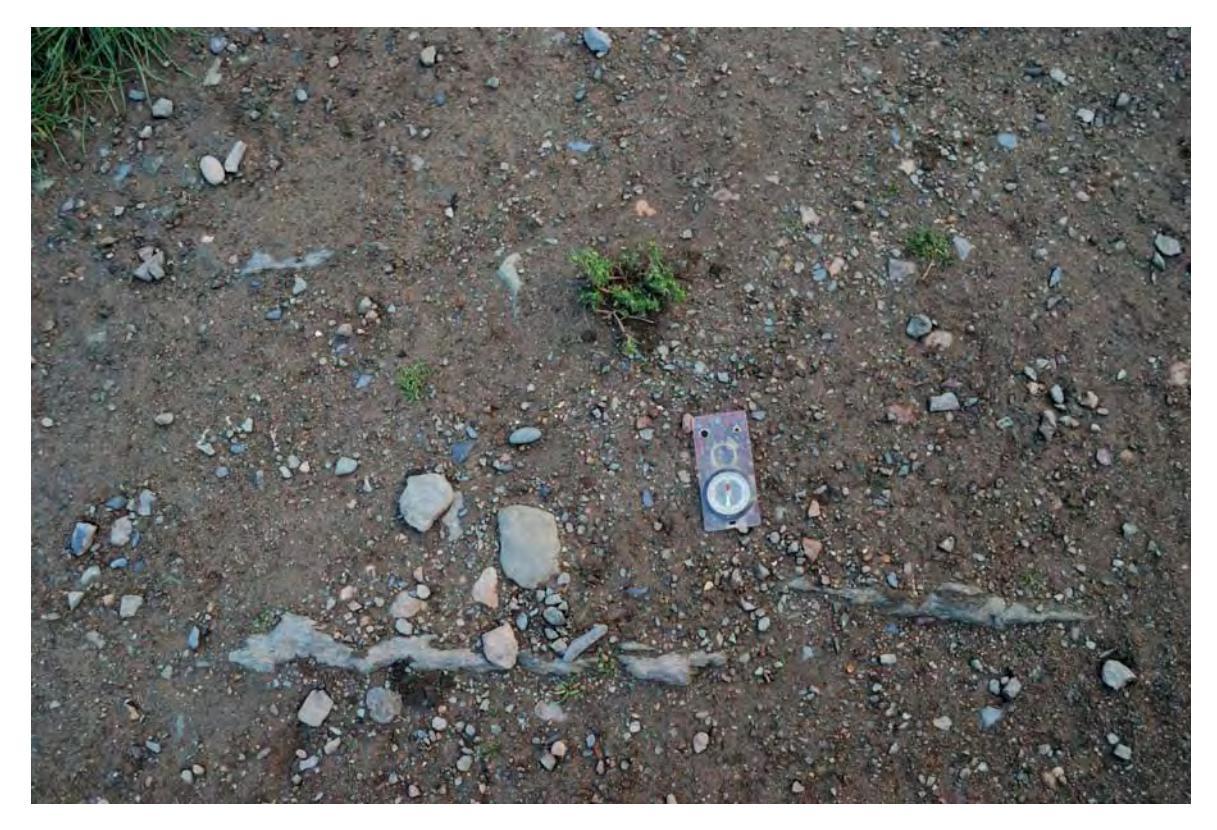
Detail of grave slabs just protruding through the gravel of the track
