FFESTINIOG POWER STATION

Archaeological Assessment

Prosiect Rhif / Project No. G2532

Adroddiad Rhif / Report No.1396

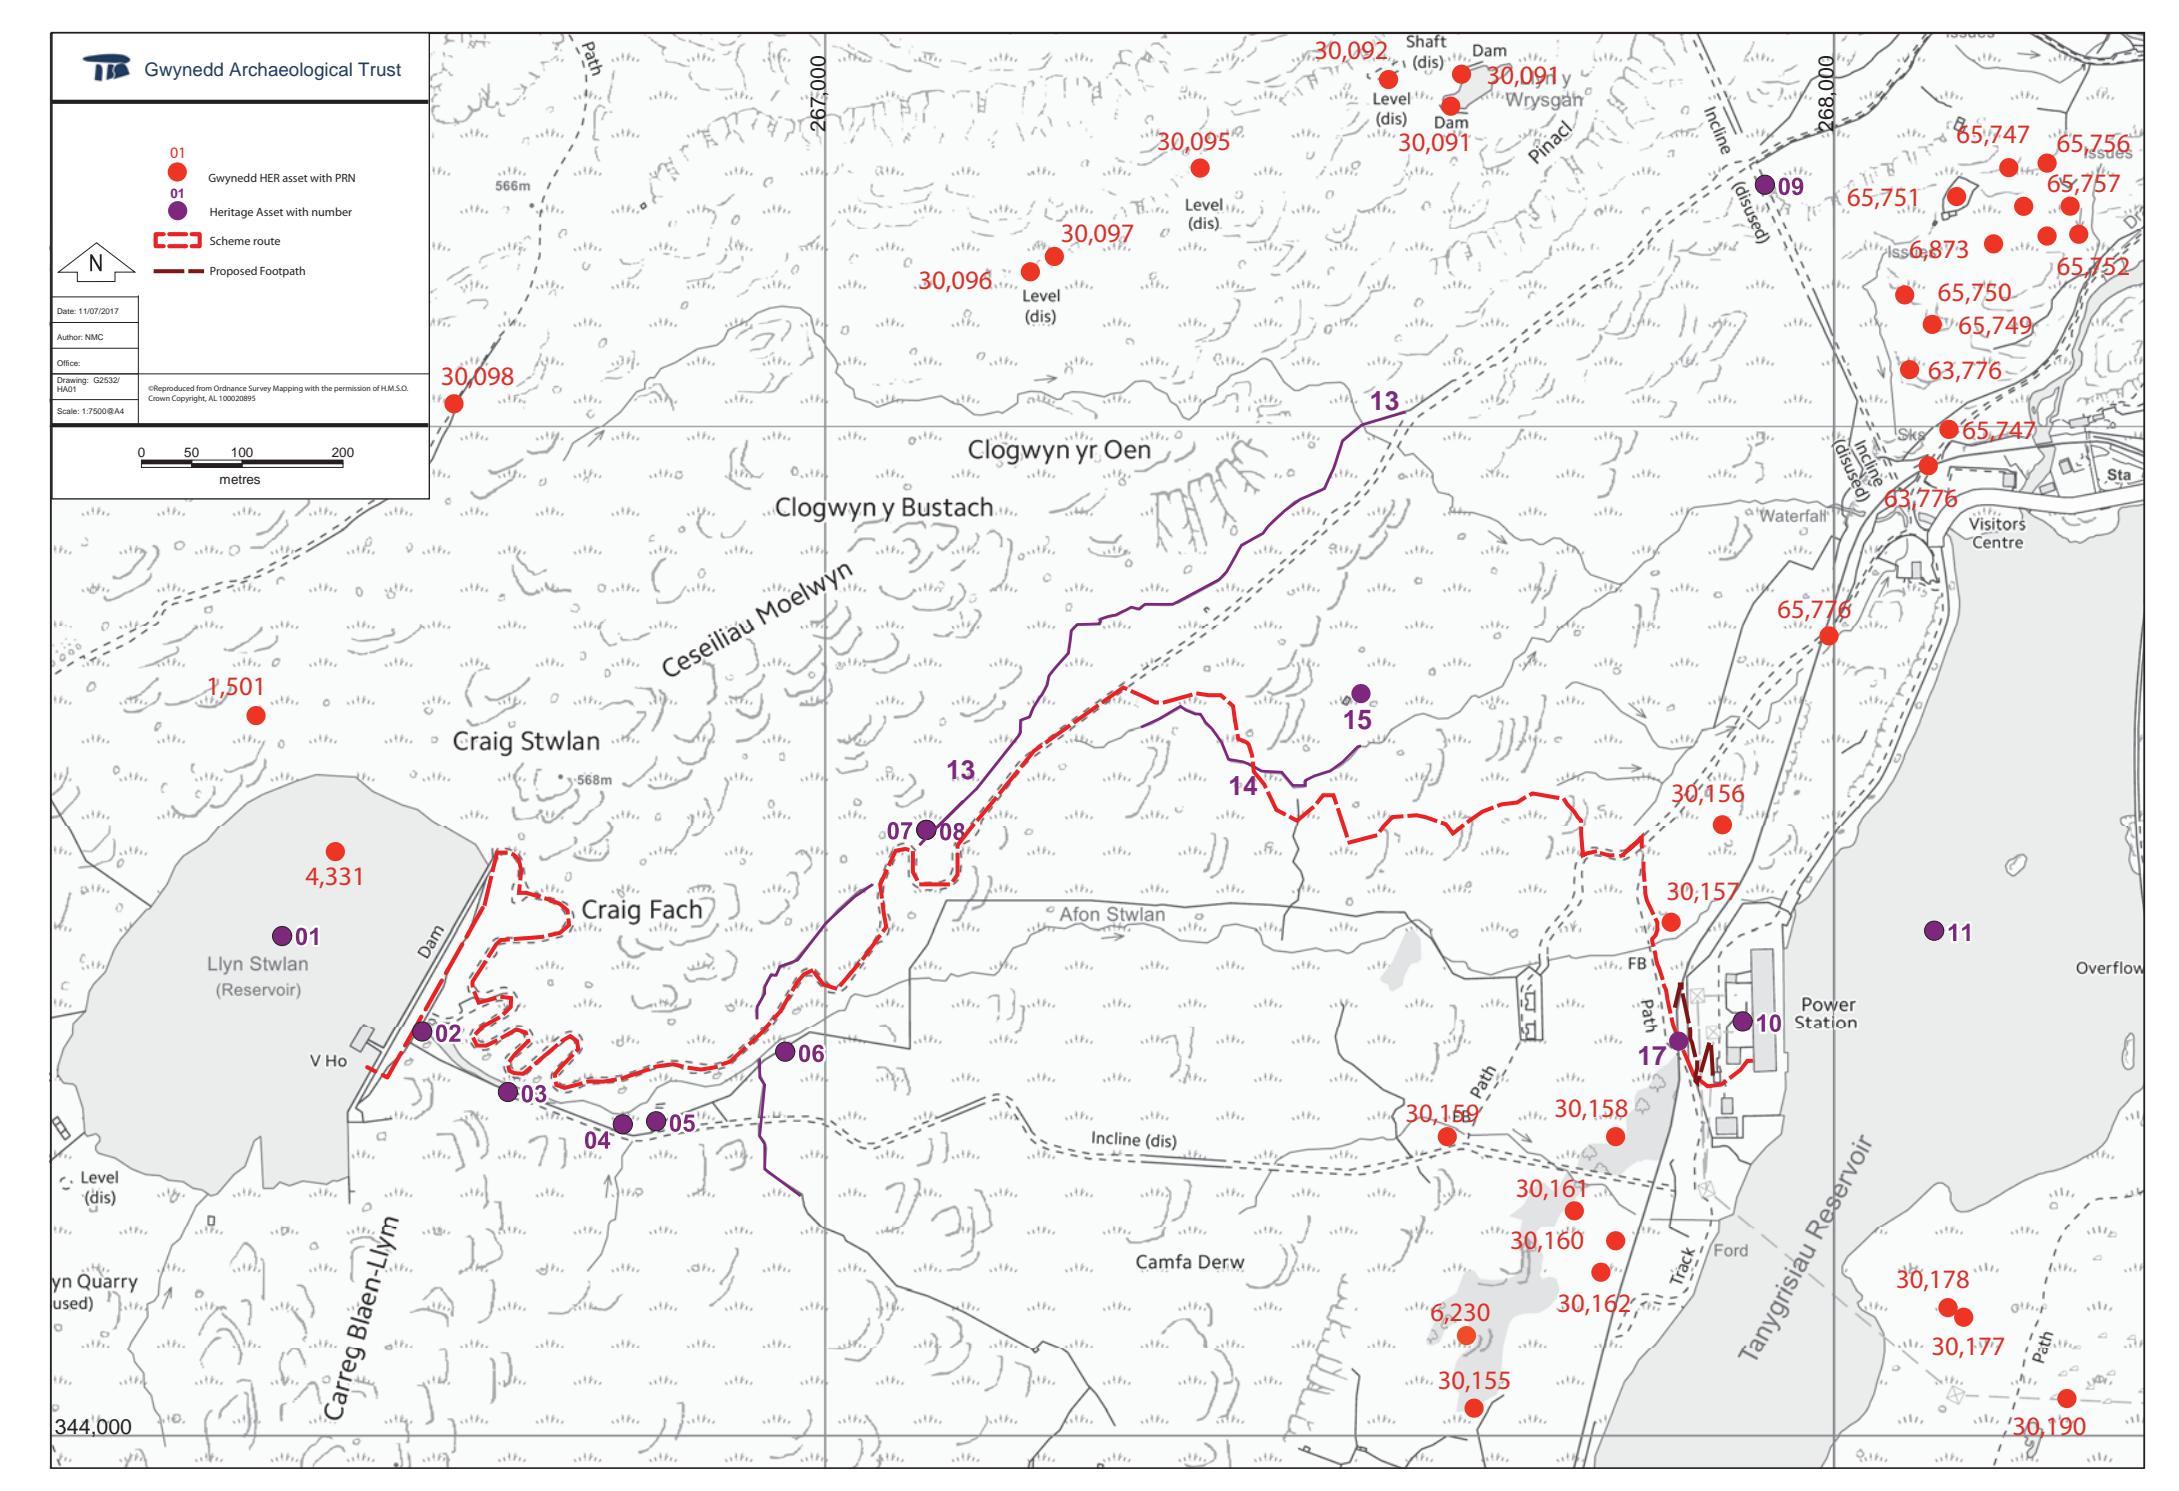
Figure 01: Location Plan and Proximity Heritage Assets. Based on Ordnance Survey 1:10 000 Series Sheet SH 64. Scale as Shown

The sites identified in the desk-top study and on the walk-over survey are listed below, and shown on Figure 01 (except Feature 12 modern drainage). <u>Any recommendations given are based on the current understanding of the scheme route and methodology. Any amendments to this may result in a requirement to amend the recommendations. A 'C' after the grid reference indicates the central point of a larger or linear feature</u>

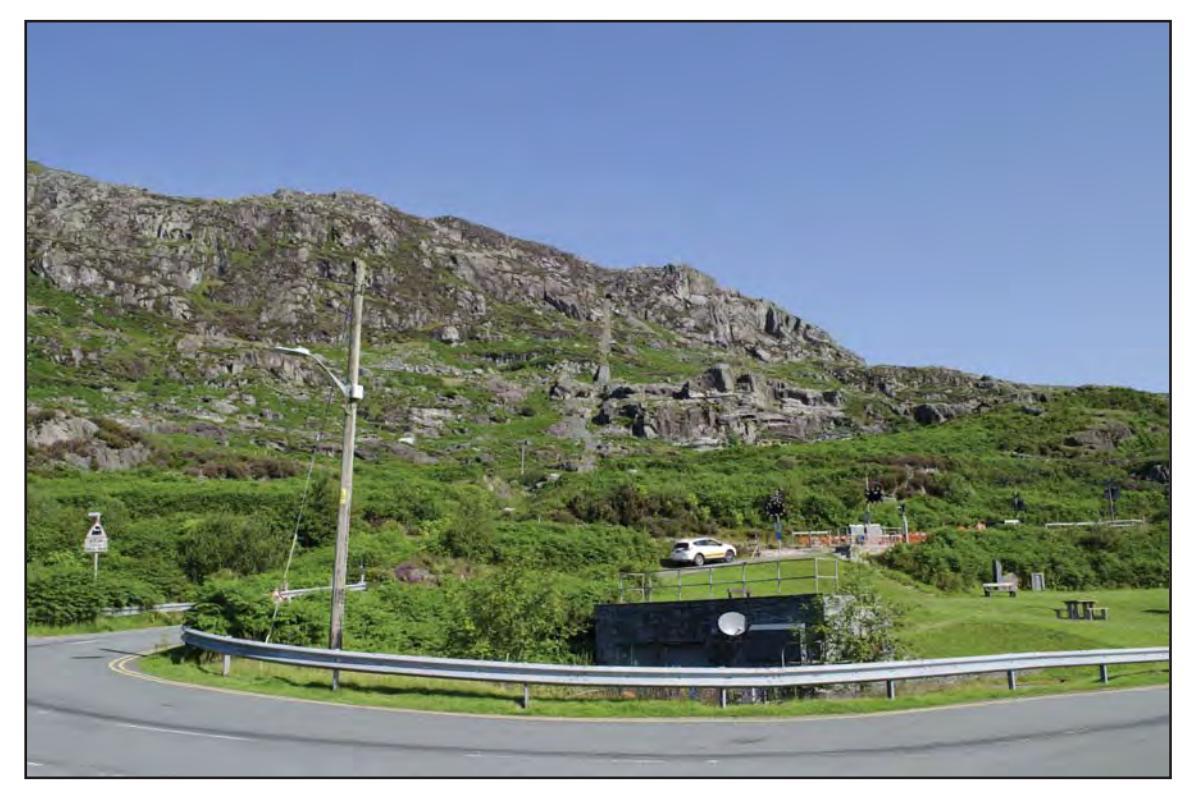
Plate 01: Feature 09 - General view of Wrysgan incline (PRN55764) from powerstation roadside (archive reference: G2532_01).

Description: The incline is a remarkable piece of 19th century engineering, the upper part of the incline being in a tunnel the approach to the head placed in a cutting $\frac{7}{6}$ of the way up the hillside (Cadw/ICOMOS 1999, 78; Roberts, 1994). It is still in good condition apart from where it has been obliterated by the access road serving the Stwlan reservoir. The original drum house associated with the incline has collapsed, however much of the drum gear remained on the site in 1994 (Roberts, 1994, 7). The structure is constructed of loose fieldstone rubble, with larger facing stones (up to 0.6m by 0.4m). Much of the associated incline infrastructure survives, including a machine spun cable and two incline waggons, along with a hook and a supporting brace. It is approximately 3.5m wide, and varies in height over uneven ground between 0.6 and 2.5m.

Recommendations for further assessment: None Recommendations for mitigatory measures: Avoidance

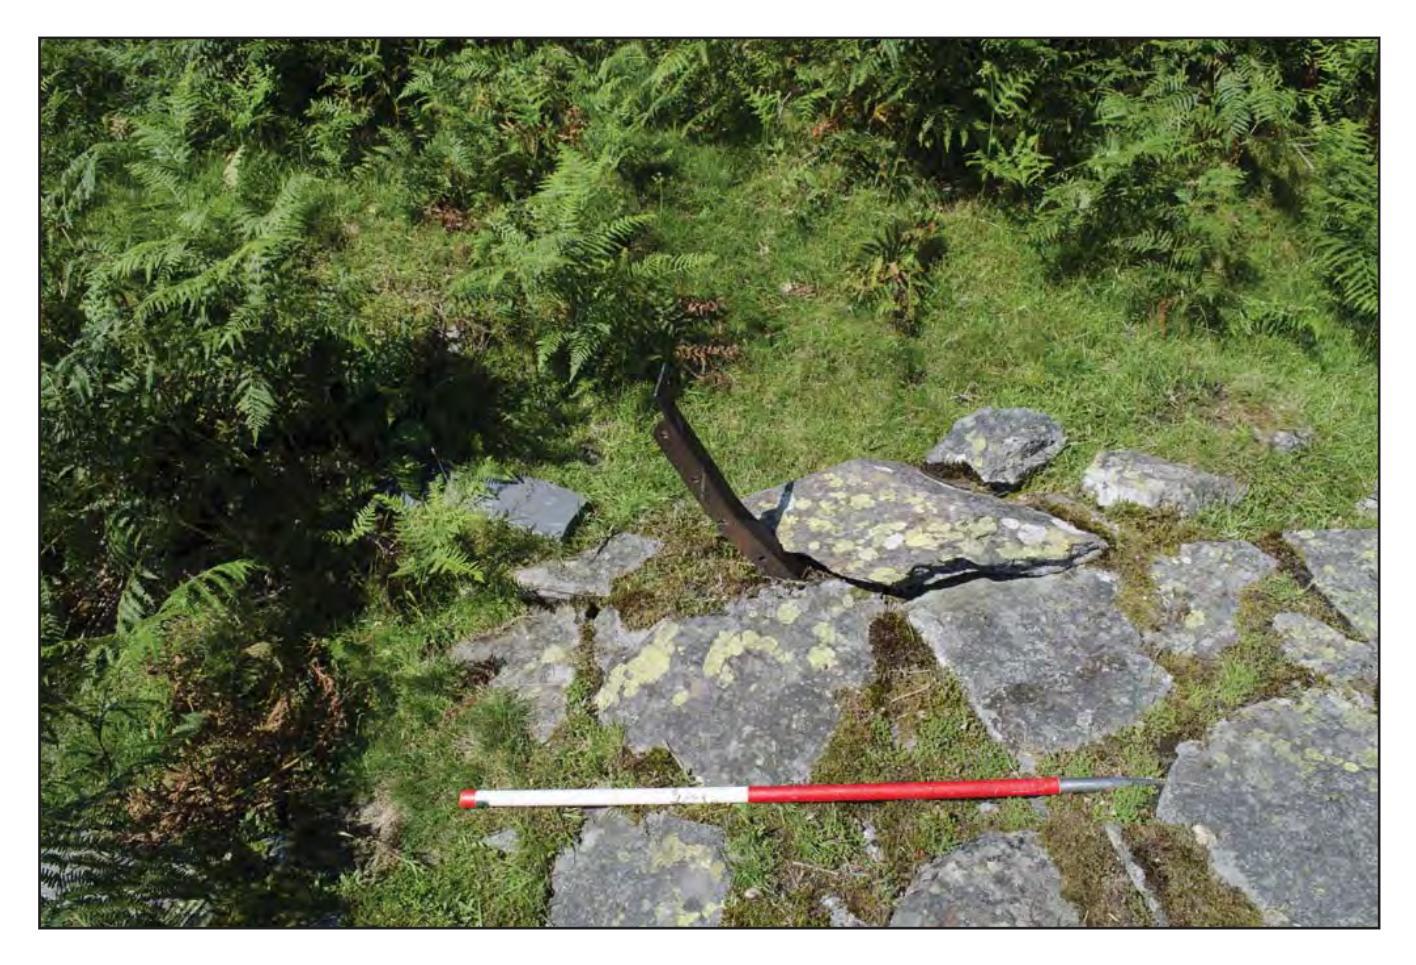
Plate 04: Feature 09 - Detailed shot of surviving metal brace surviving on incline (PRN55764); scale: 1x1m (archive reference: G2532_05).

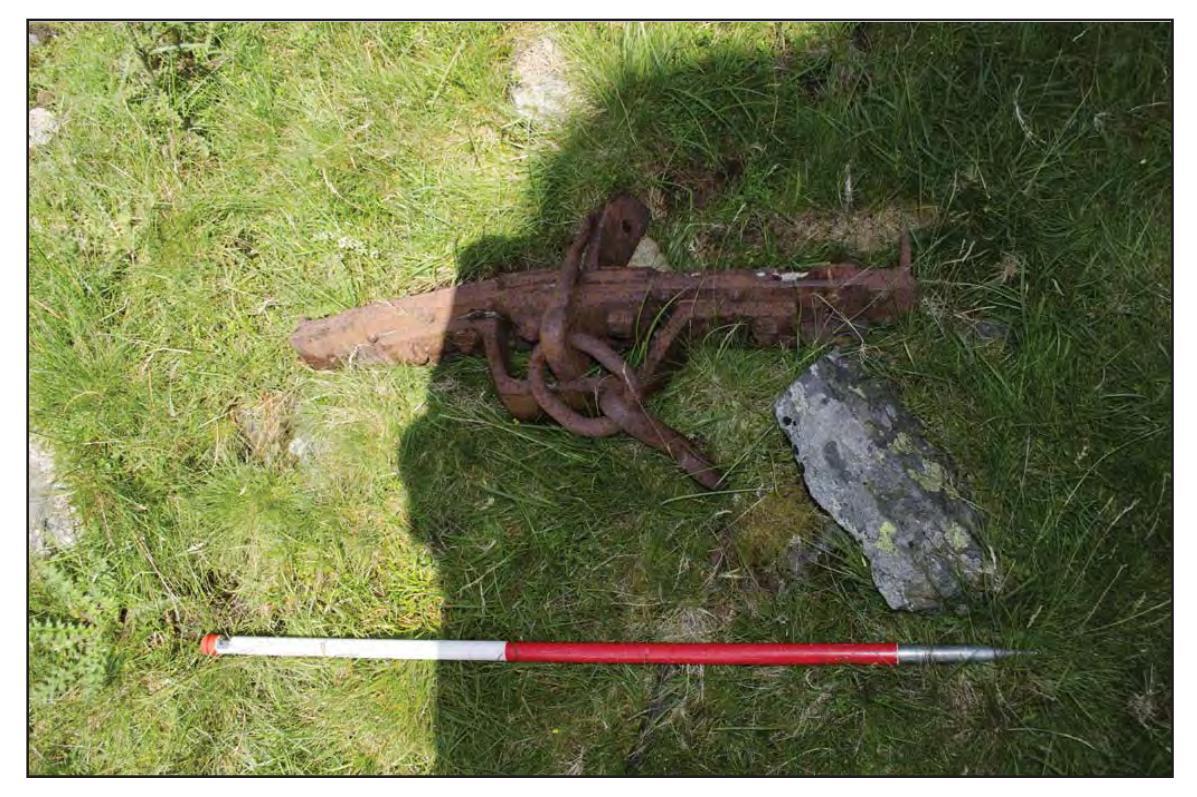
Plate 05: Feature 06 - Detailed shot of end of cable mechanism on the Wrysgan incline (PRN55764); scale: 1x1m (archive reference: G2532_06).

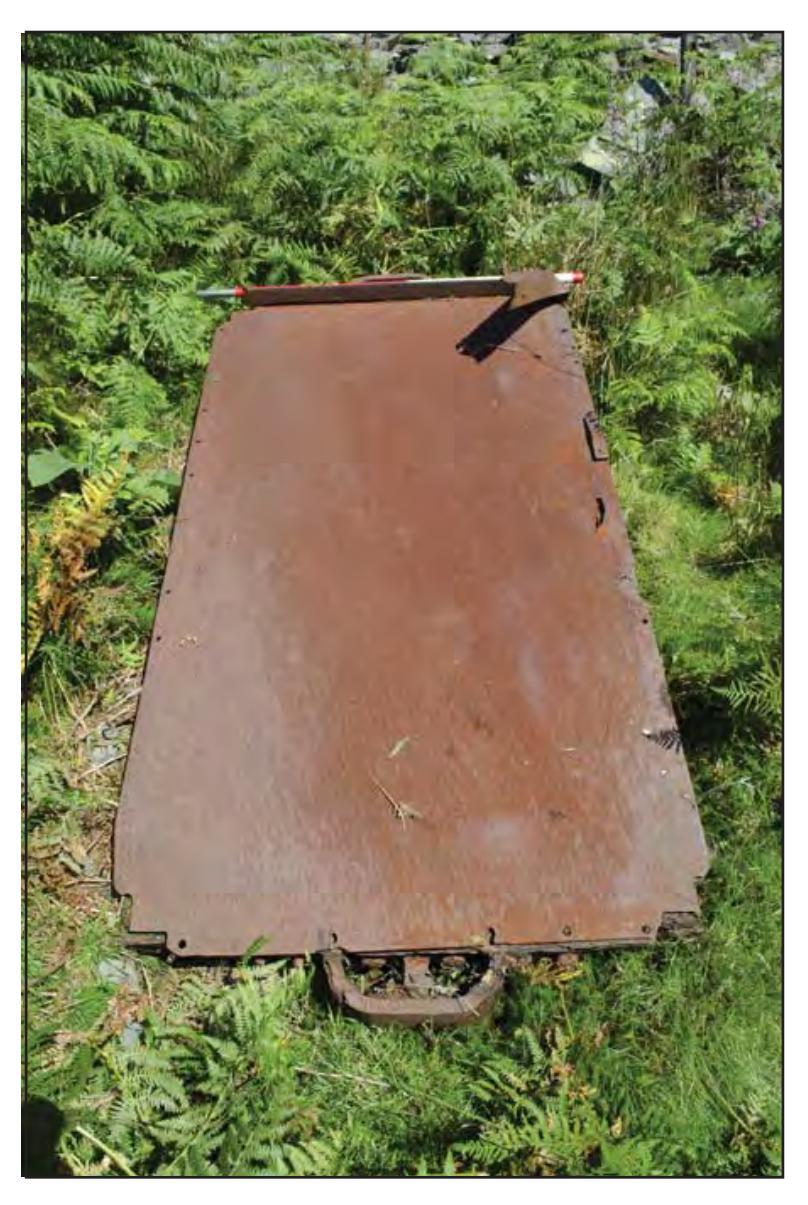
Plate 06: Feature 09 - Detailed shot of former slate wagon on incline (PRN55764); scale : 1x1m (archive reference: G2532_07).

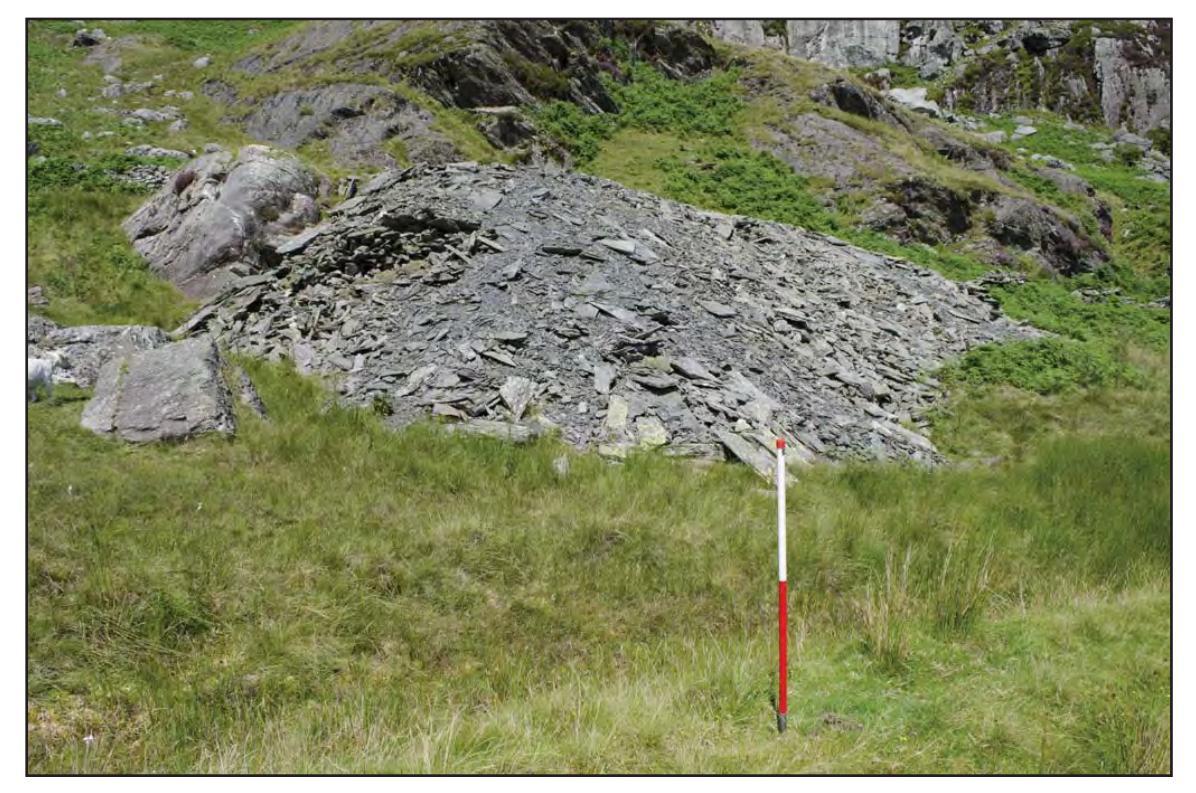
Plate 15: Feature 08 - Close-up shot of quarry tailings (PRN20288); scale: 1x1m scale (archive reference: G2532_21).

Feature 8 (PRN 20288; Plates 15-16) Site Name: Chwarel Twm Feltiwr Grid Reference: SH67104460 Period: Post-Medieval Category: C Impact: None Description: A small slate quarry. Evidence of tailings and a platform, forming remains of the quarry were identified during the walk-over survey (Plates 15-16). Recommendations for further assessment: None

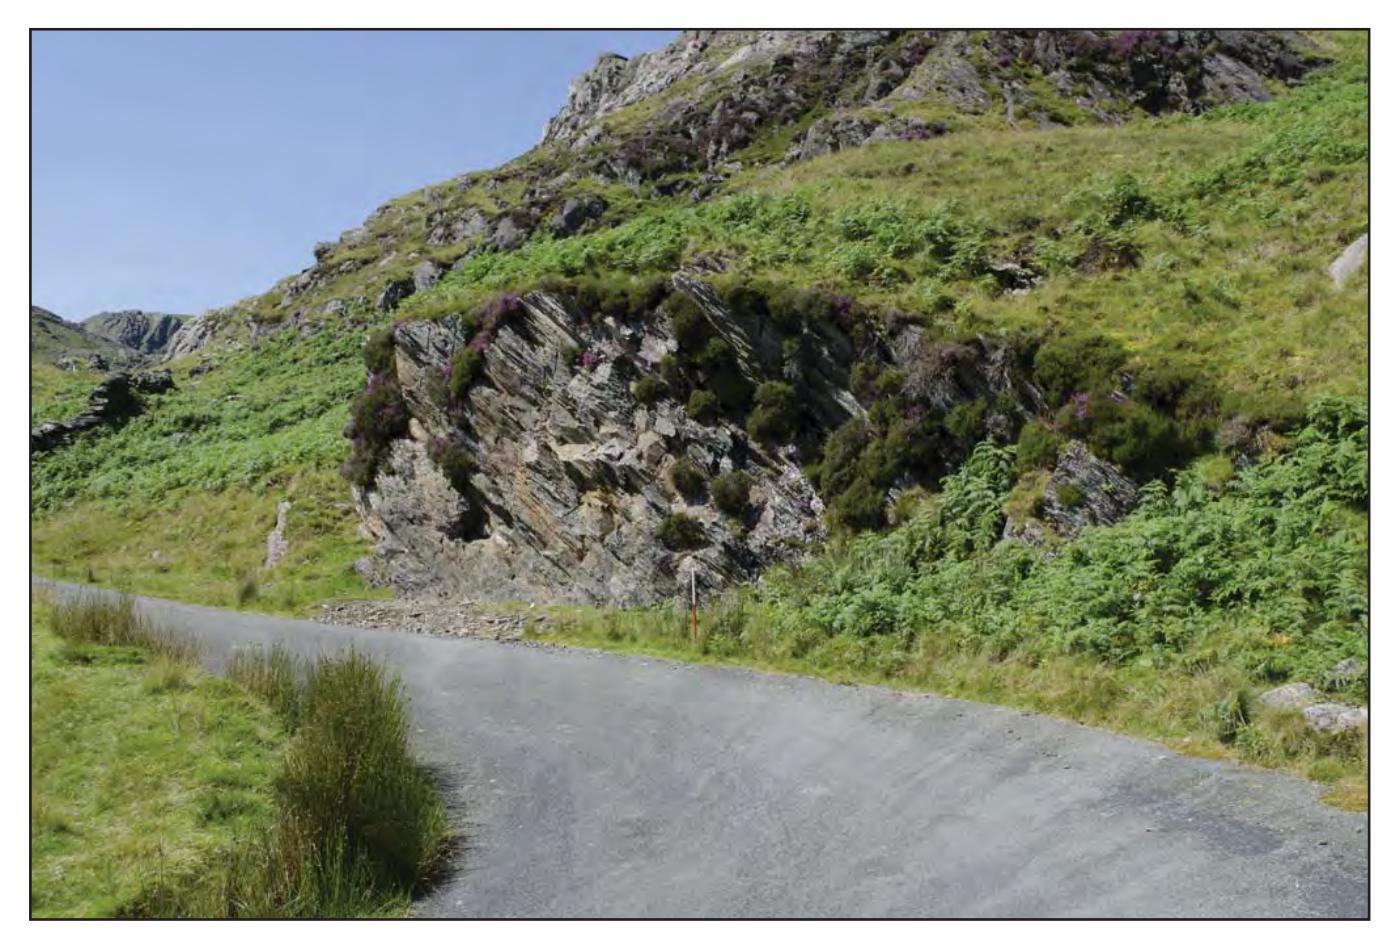
Plate 17: Feature 07 - Shot of copper mine (PRN21838) face of quarry; scale: 1x1m (archive reference: G2532_23).

Feature 7 (PRN 21838; Plate 14, 17) Site Name: Llyn Stwlan Copper Mine Grid Reference: SH67104460 Period: Post-Medieval Category: C Impact: None Description: A small mine, visible as a quarried face. It was last worked in 1919, where lead, copper and zinc were extracted (Gwyn 1998). Recommendations for further assessment: None

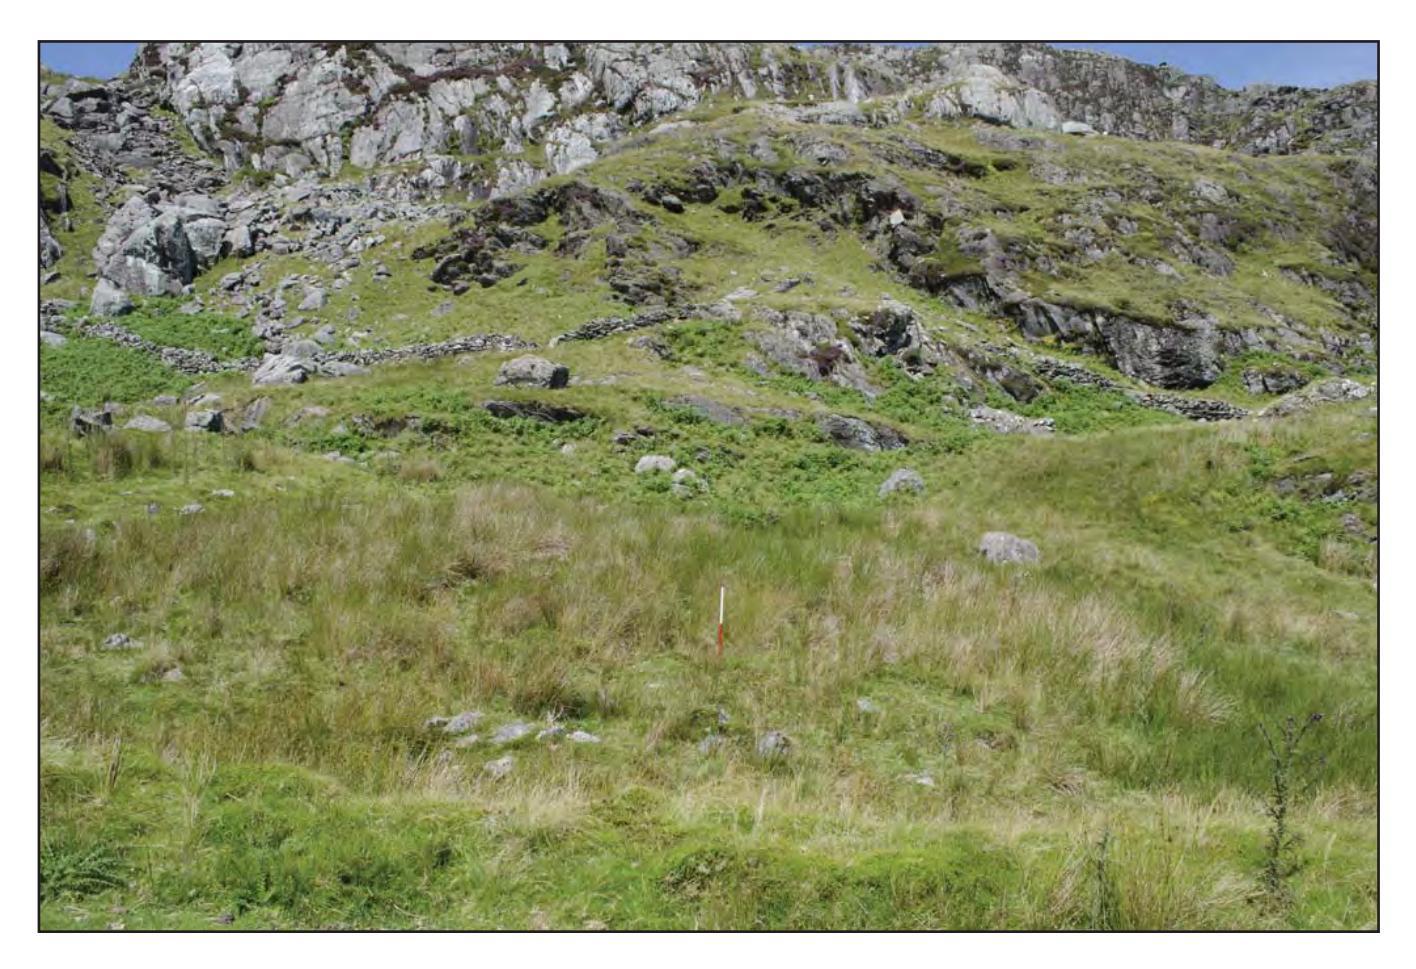
Plate 18: Feature 06 - Site of hut circle (PRN 1500) *not very clear evidence from the ground due to overgrown foliage*; scale: 1x1m (archive reference: G2532_24).

No clear evidence of prehistoric activity was noted, although the bracken ground cover did make the identification of this type of feature more difficult. As there is one known possibly prehistoric hut-circle site (Feature 6; Plate 18), it is still possible that there is more unidentified archaeology. The wider landscape would appear to be rich in medieval and earlier archaeology, but no sites were identified within the buffer zone.

Recommendations for mitigatory measures: Avoidance, with watching brief being carried out during cable trench excavation close to this site. The site should also be fenced off during ground works.

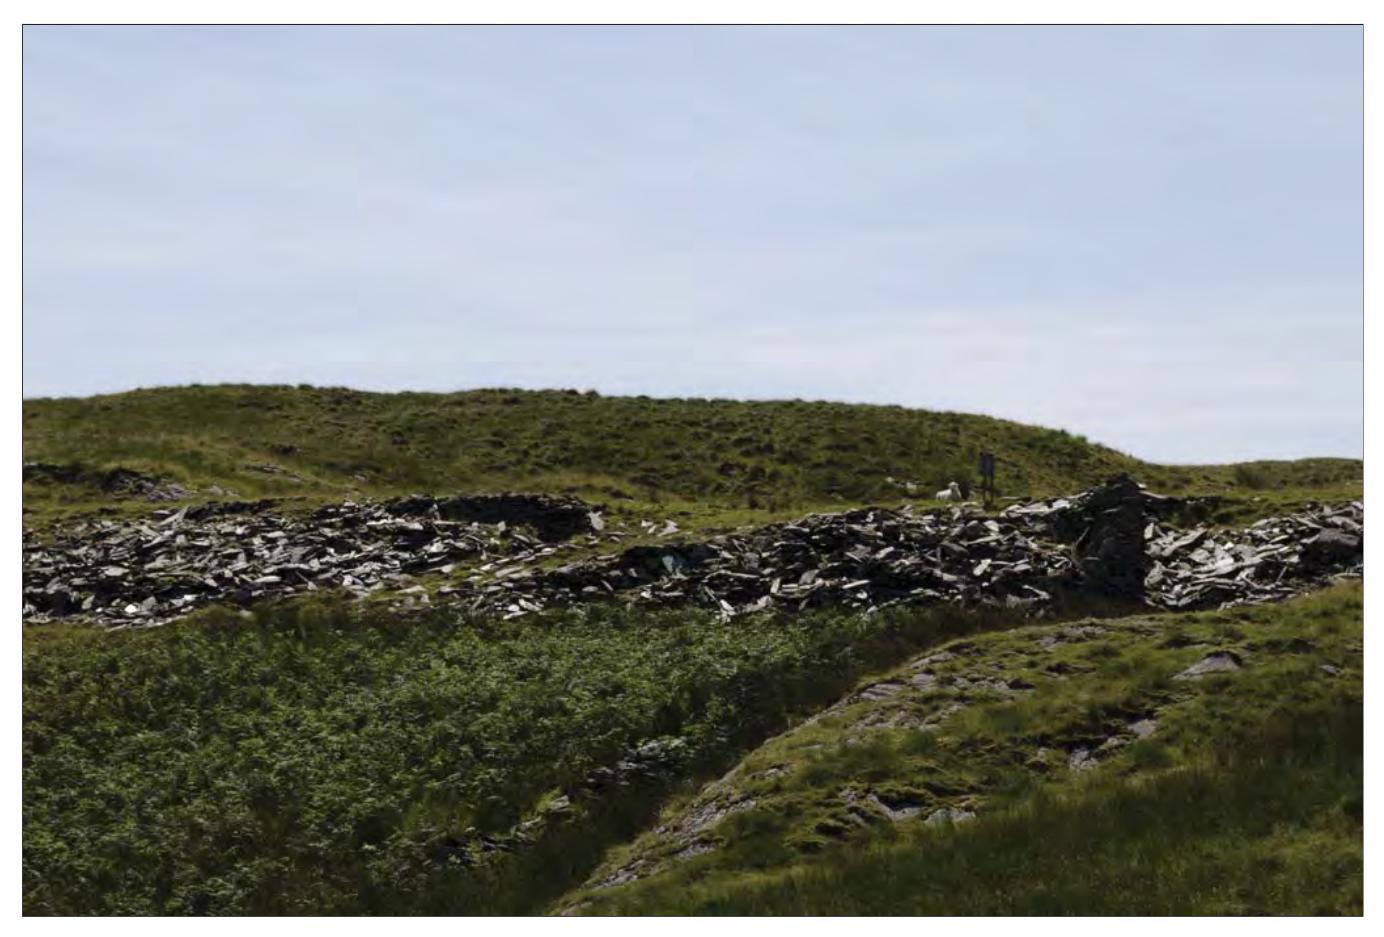
Plate 21: Feature 04 - close-up view of quarry building; only survives at foundation level (archive reference: G2532_28).

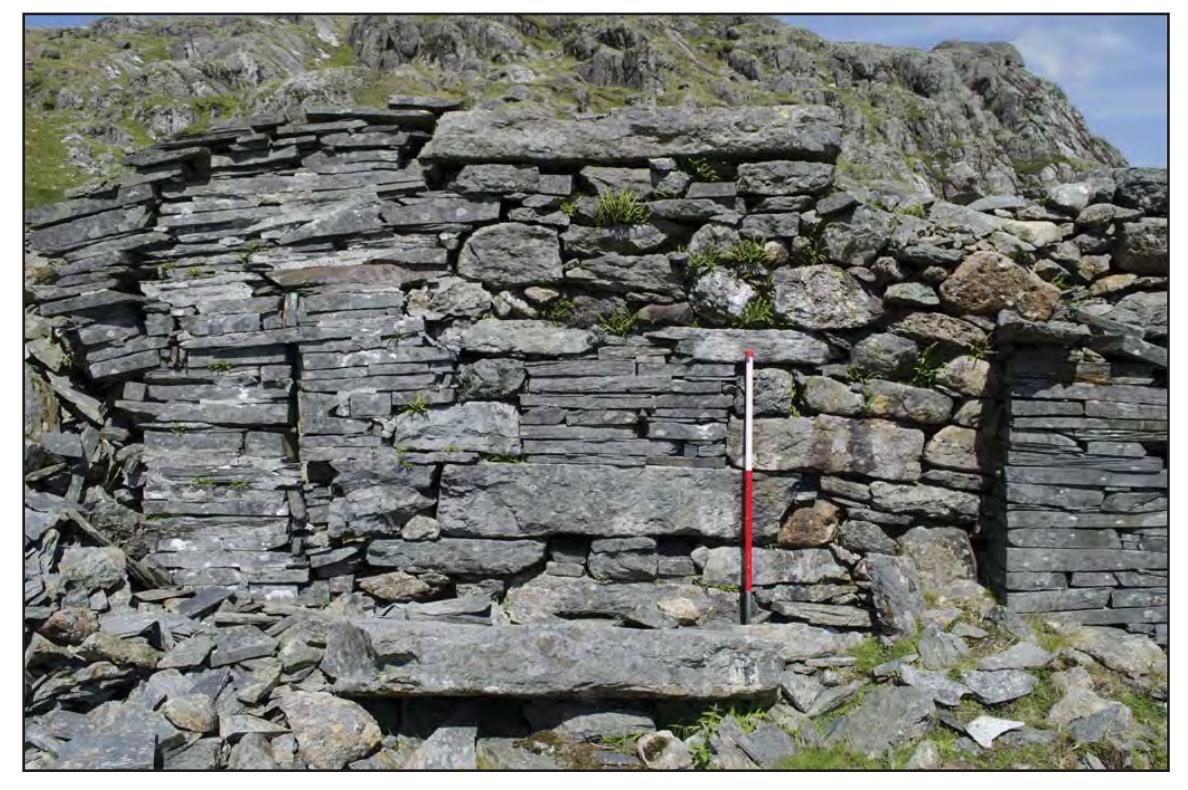
Plate 23: Features 03 and 05 - Detailed shot showing possible blocked up window (PRN419351 and PRN409280); scale: 1x1m (archive reference: G2532_33).

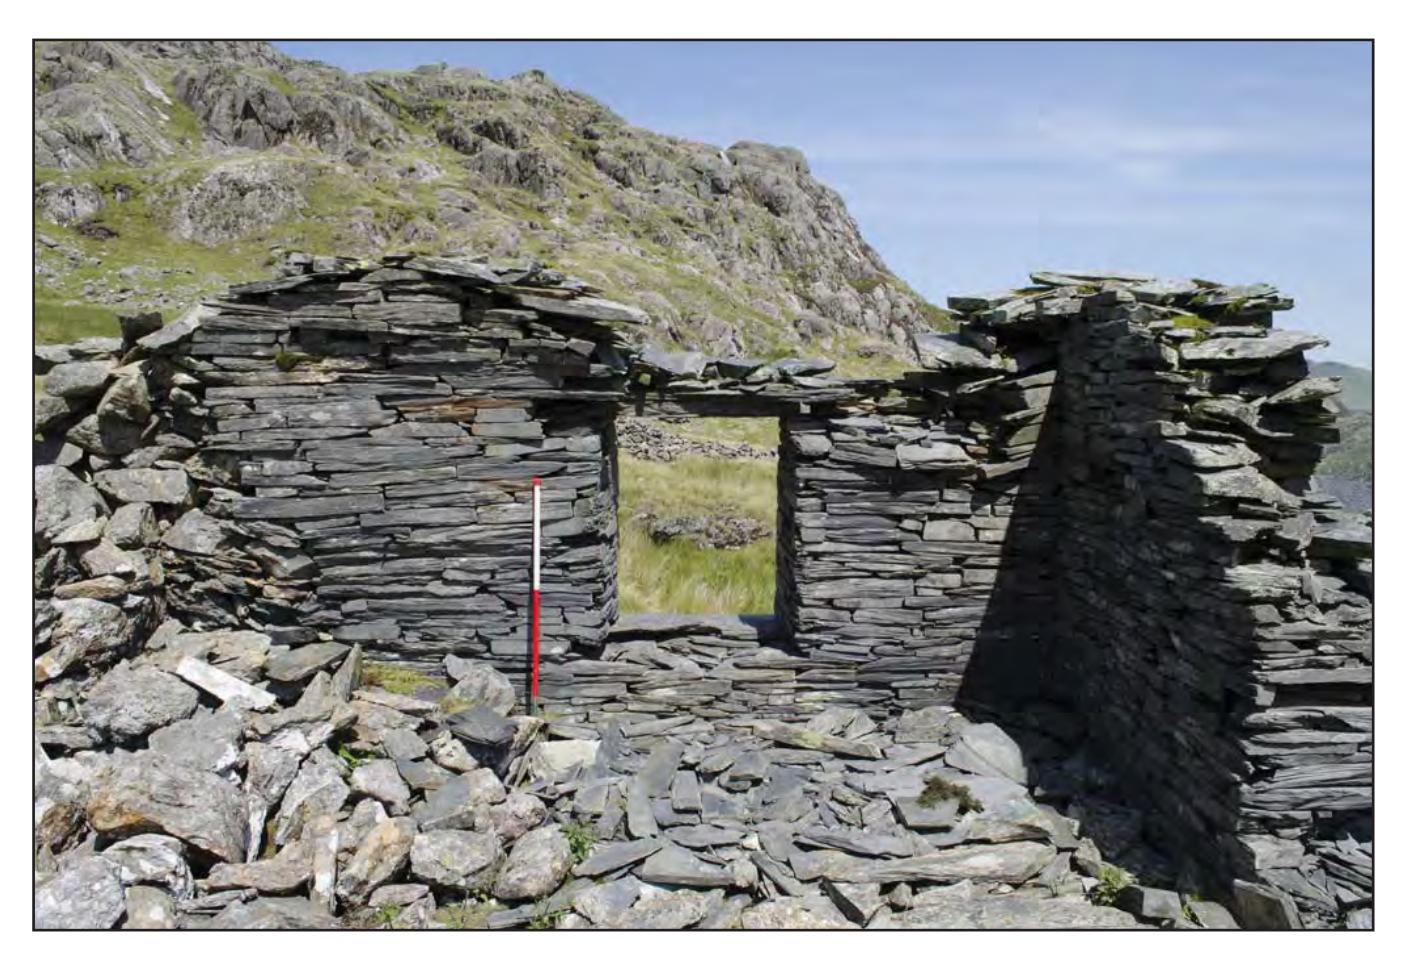
Plate 28: Features 03 and 05 - Detailed shot of slate lined window in mill building (PRN419351 and PRN409280); scale: 1x1m (archive reference: G2532_39).

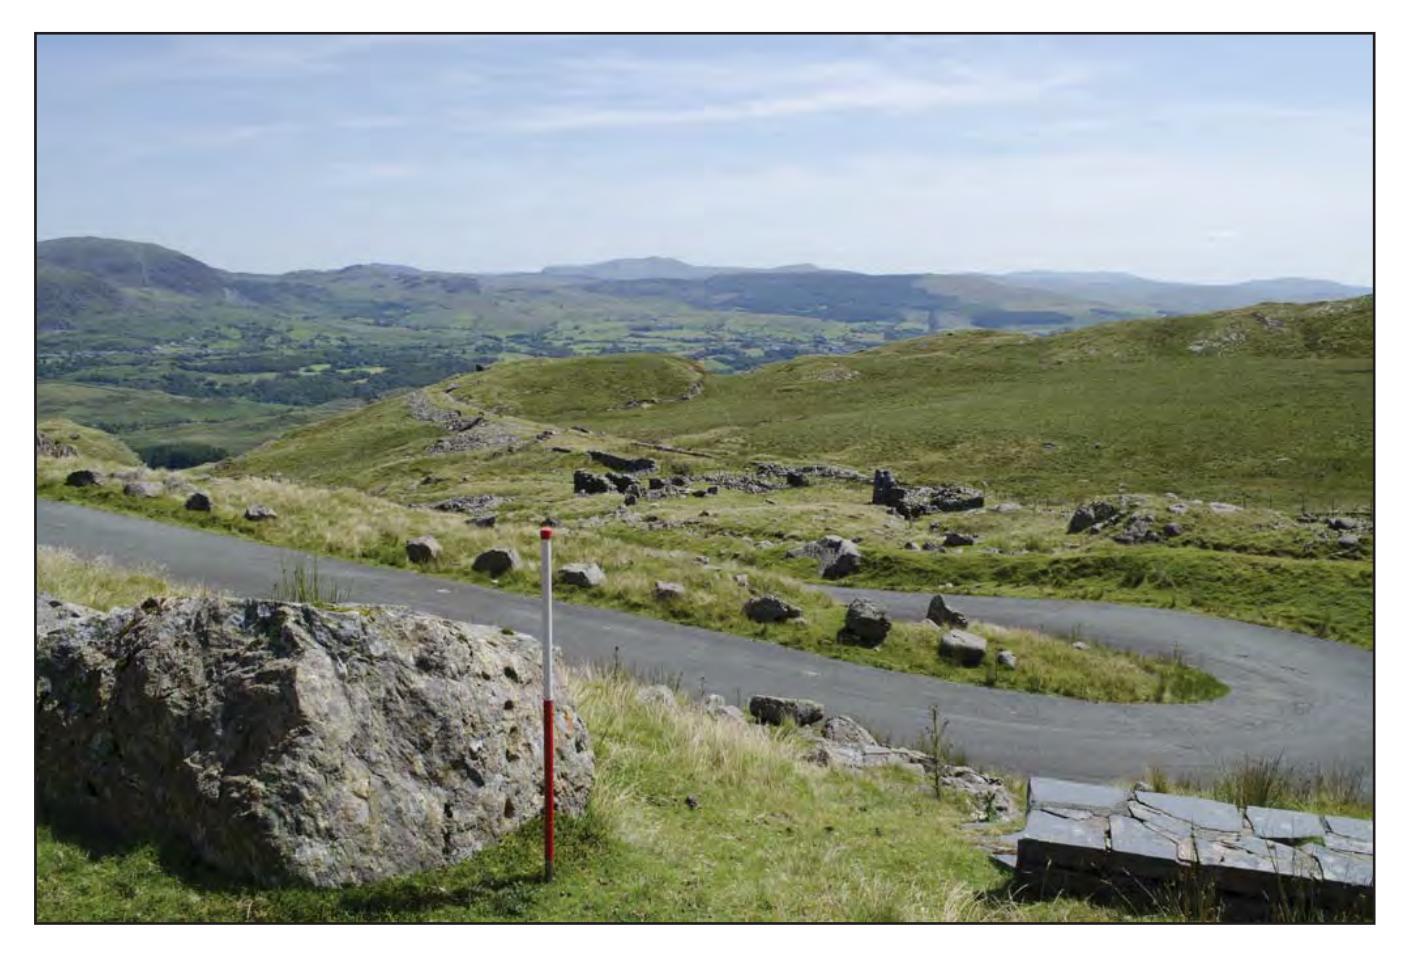
Plate 29: Features 03 and 05 - View of Moelwyn slate mill from above (PRN419351 and PRN409280); scale: 1x1m (archive reference: G2532_40).

Description: The mill was probably built in the 1860s, using local rock rubble rather than slate. It contained six saw benches and seven dressing machines, driven by a 40ft (18.9m) diameter by 4ft (1.2m) wide waterwheel in a pit on the north side. There was a small stacking area to the east by the exit tramway, and a building to the west which may have been an office and store, which are now ruined. The very small tips of trimmings noted at the site testify to very small production at this site.

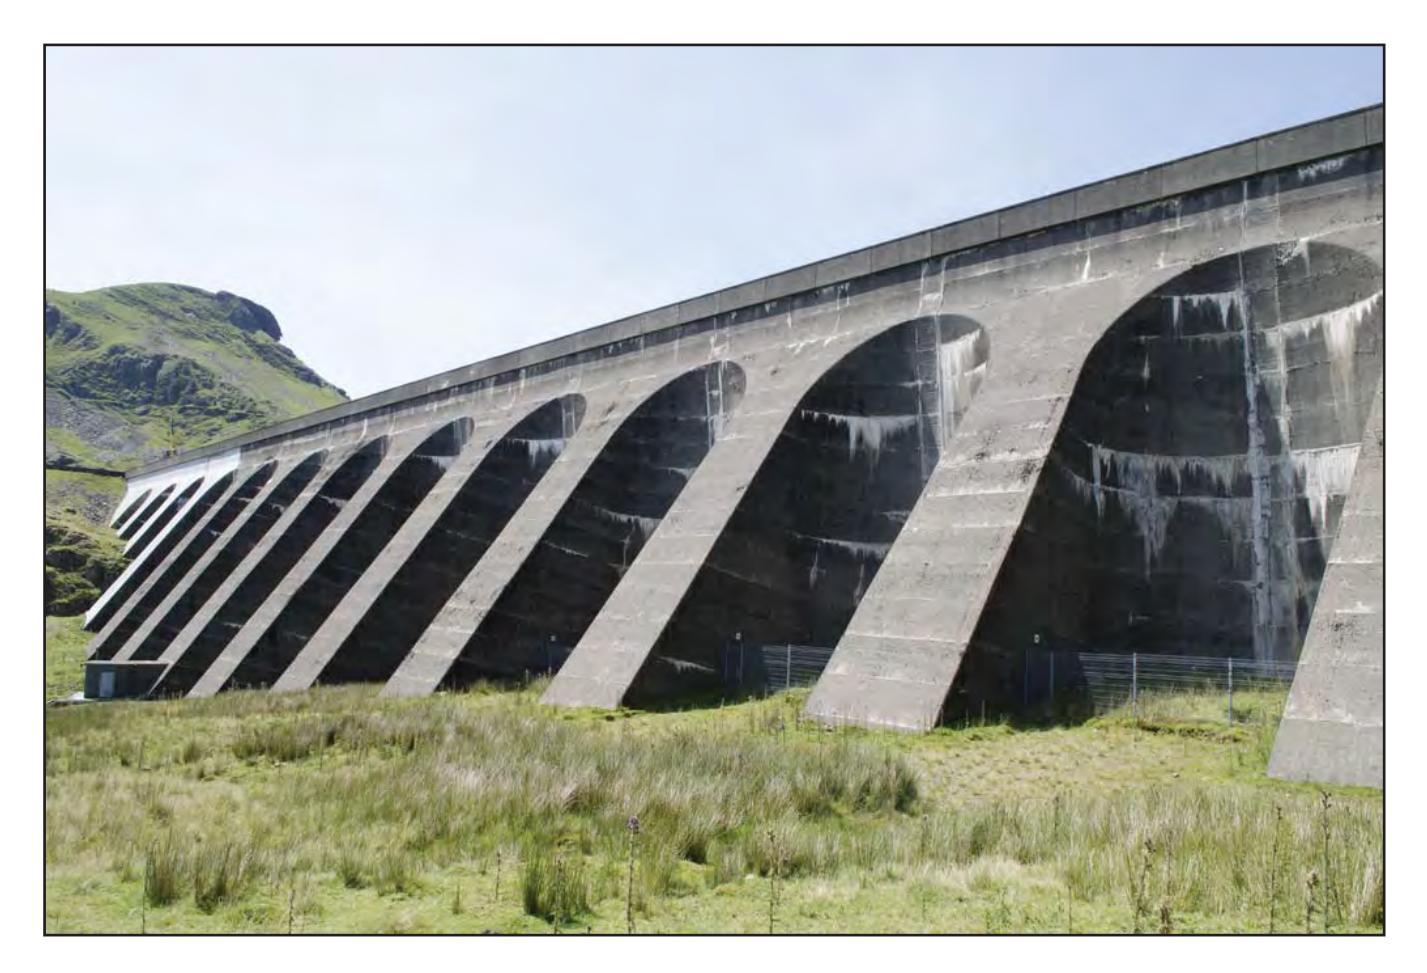
Plate 30: Feature 02 - General view of Stwlan dam (PRN5490) (archive reference: G2532_41).

Recommendations for further assessment: None Recommendations for mitigatory measures: None Feature 2 (PRN 5490; Plate 30) Site Name: Dam, Llyn Stwlan Grid Reference: SH666444 Period: Modern Category: A Impact: None Description: The upper reservoir was formed by enlarging Llyn Stwlan with a concrete dam 380m long and 34m high (Feature 02; PRN 5490; SH666444). The Stwlan dam is one of the most prominent man-made landmarks in Gwynedd (Cadw/ICOMOS 1999, 79). Recommendations for further assessment: None

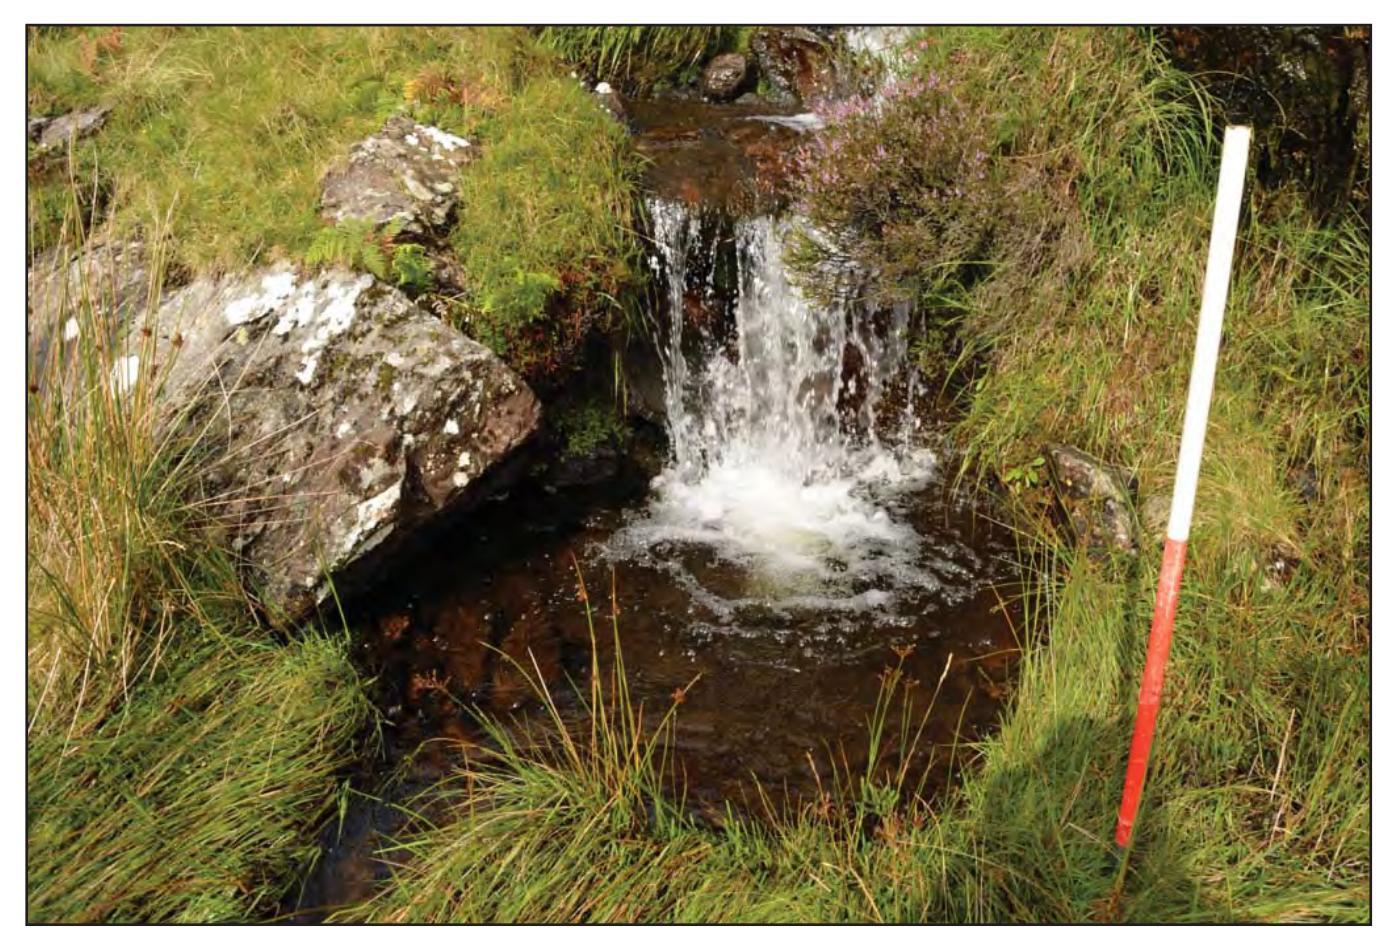
Plate 38: Feature 14 - View southwest of water management activity comprising a small dug pit at base of waterfall; scale: 1.0m (archive image ref G2532_067).

The access road to Llyn Stwlan dam appeared to have been partly constructed on one of the upper terraces. There was evidence for water management in the form of pits and channels dug for the small cataracts that debouched down the hill slopes (Feature 14; Plate 38). A rectangular building (Feature 15; Plates 40-42), which measured 9.05m long x 5.55m wide was noted 50m northeast of the proposed cable route, which may have been associated either with former quarrying or mining activity, or agriculture in the form of a sheepfold. No other activity that had not been previously noted was identified.
3.3 Gazetteer of Features

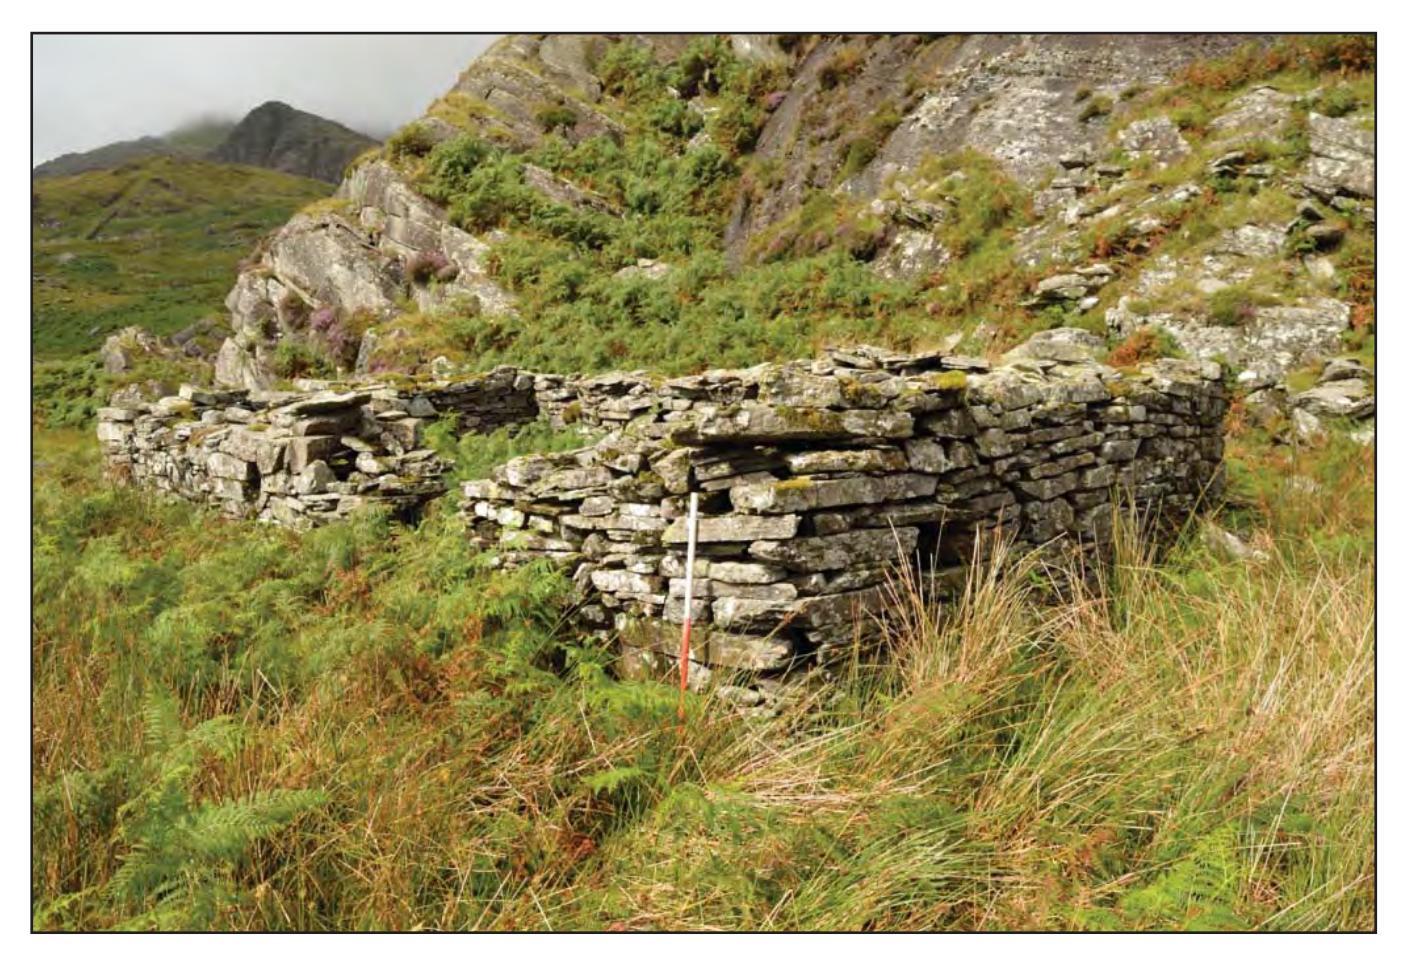
Plate 40: Feature 15 - View southwest of rectangular structure, with entrance on eastern side; scale: 1.0m (archive image ref G2532_070).
