SEION WASTE WATER TREATMENT WORKS, SEION, GWYNEDD

Archaeological Assessment

Project No. G2563

Report No. 1435

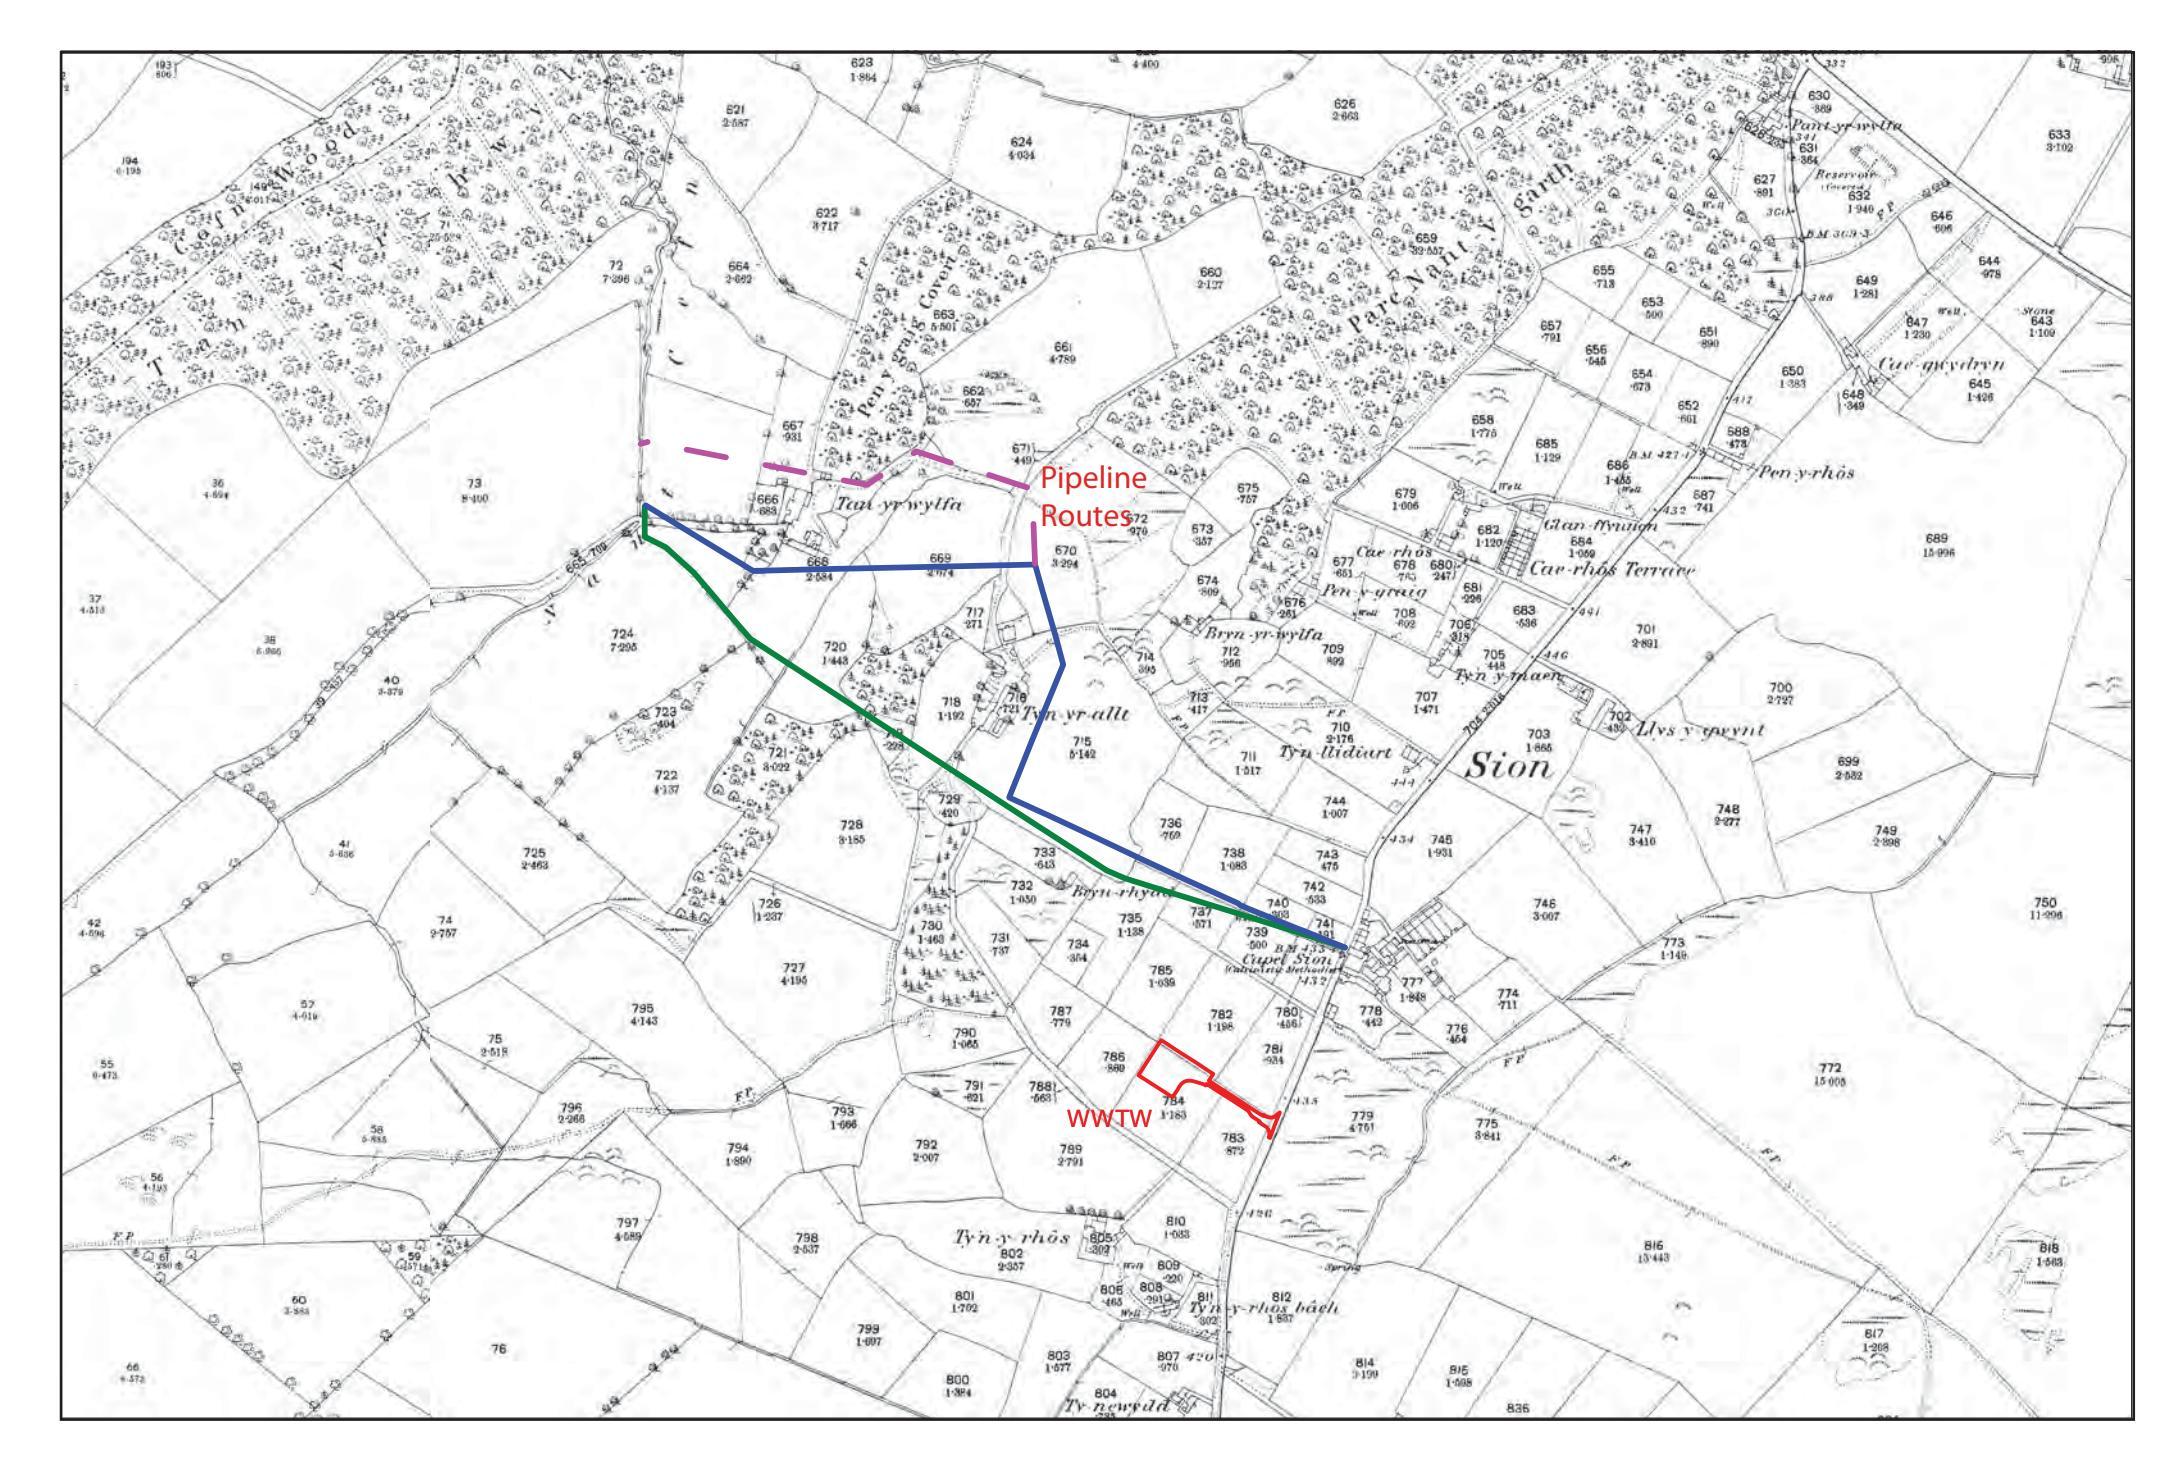
The 1st edition 25 inch Ordnance Survey map of 1889 (Figure 05) shows that the landscape of the area has changed in only a minor way from that shown in 1867. There was some amalgamation of the fields belonging to Tynrallt, although this was limited. No discernible changes were noted on the 2nd edition map of 1900 or the 3rd edition map of 1914 (Figures 06 and 07).

Figure 05: Ordnance Survey Caernarfonshire County Series 1st edition 25 inch map of 1889, sheet XI.7, with the WWTW and Pipeline Routes overlain. Scale 1:6000 @A4

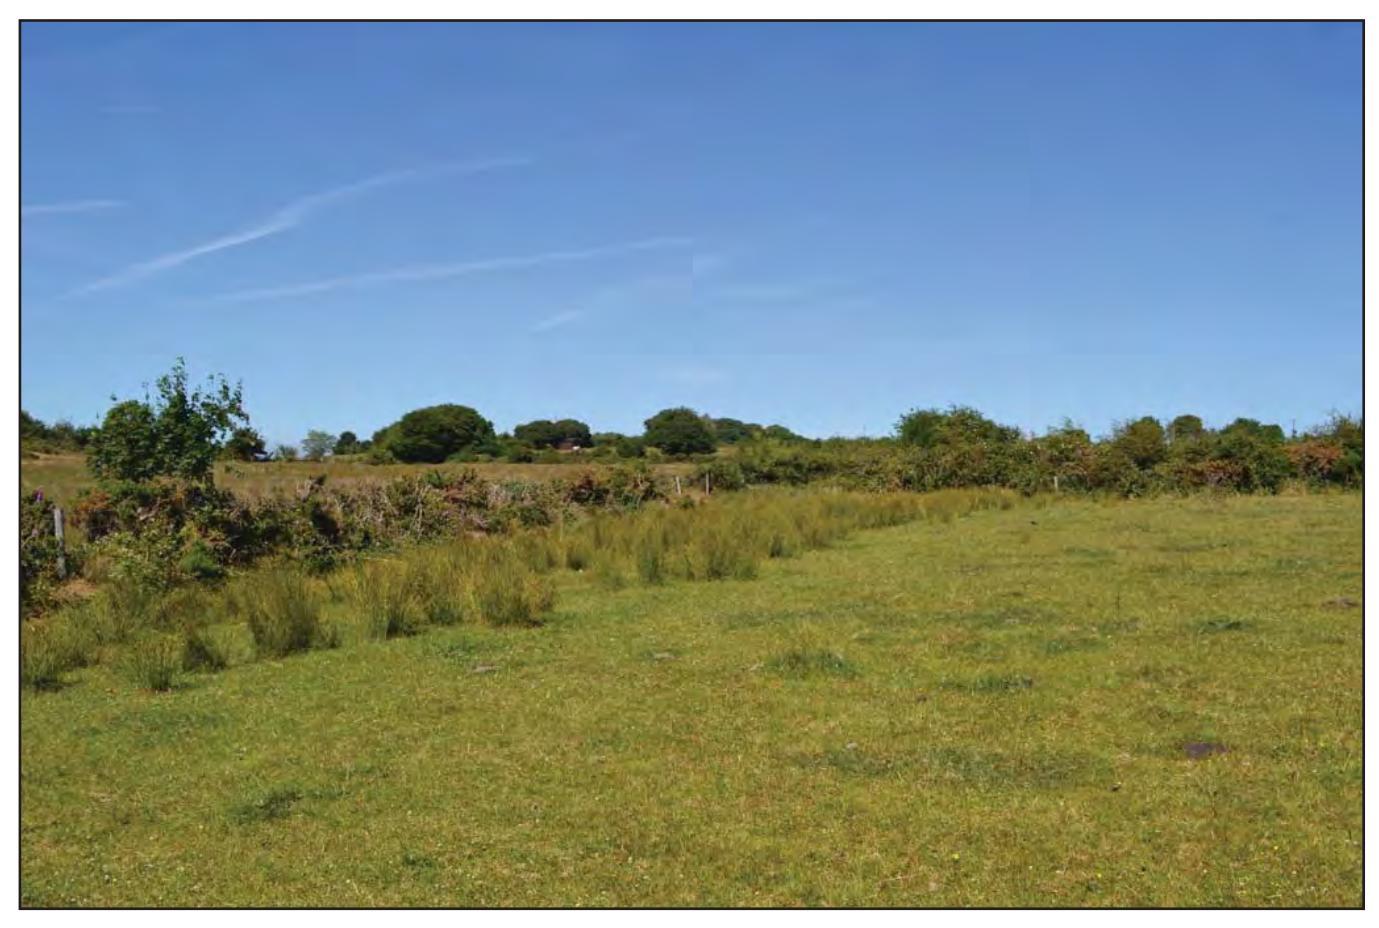
The presence of patches of rushes (juncus) (Plate 7) in both the lower northern and southern corners suggests that under typical rainfall conditions, both of these areas are normally wetter than the rest of the field. This may be particularly significant in the northern corner as this lies within the footprint of the proposed waste water treatment works and it may be that the potential for survival of peat deposits or organic material in any as yet unknown archaeological features here is increased.

Plate 7 - Wetter ground in northern corner of field (archive reference: G2563_009).

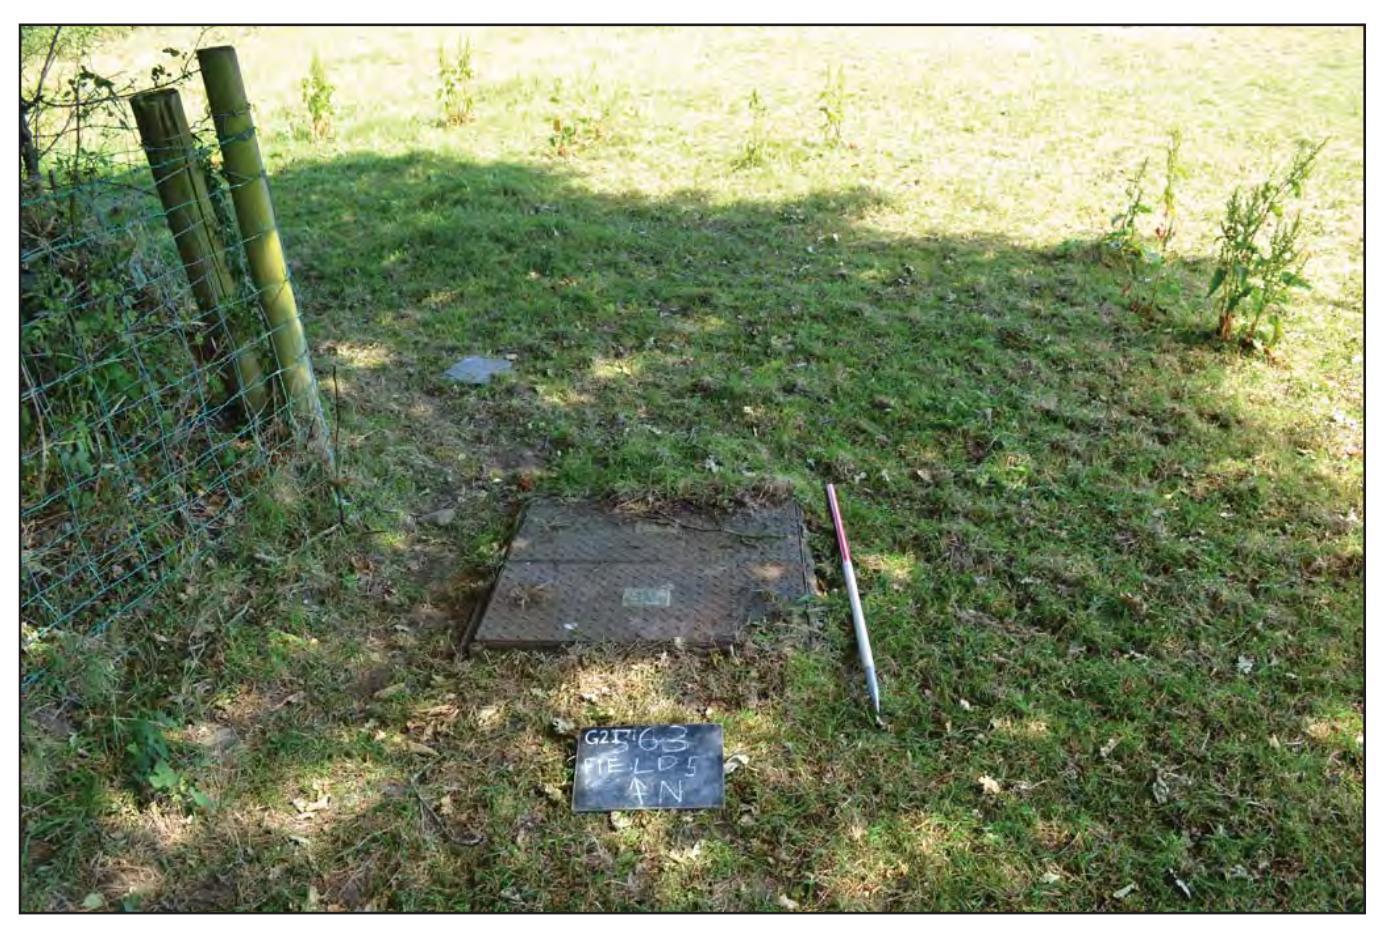
The area through which the pipe routes pass is undulating, with the local high point concentrated around the farm Ty'r-yr-allt and the house Bryn Clychau'r Gog and the ground slopes quite dramatically to the north of these properties. While the majority of the routes pass through fields of pasture, sections of *Route Three* extend along lanes that are public rights of way and the garden of Tan-yr-wylfa (Figure 09). It was noted during the walkover survey parallel with the southern field boundaries of Fields 1, 2 and 5 that there were several manhole covers (Plate 10). This would indicate the presence of an existing pipe.

Plate 10 - Manhole cover adjacent to Feature 4, Field 5; scale: 1x1m (archive reference: G2563_035).

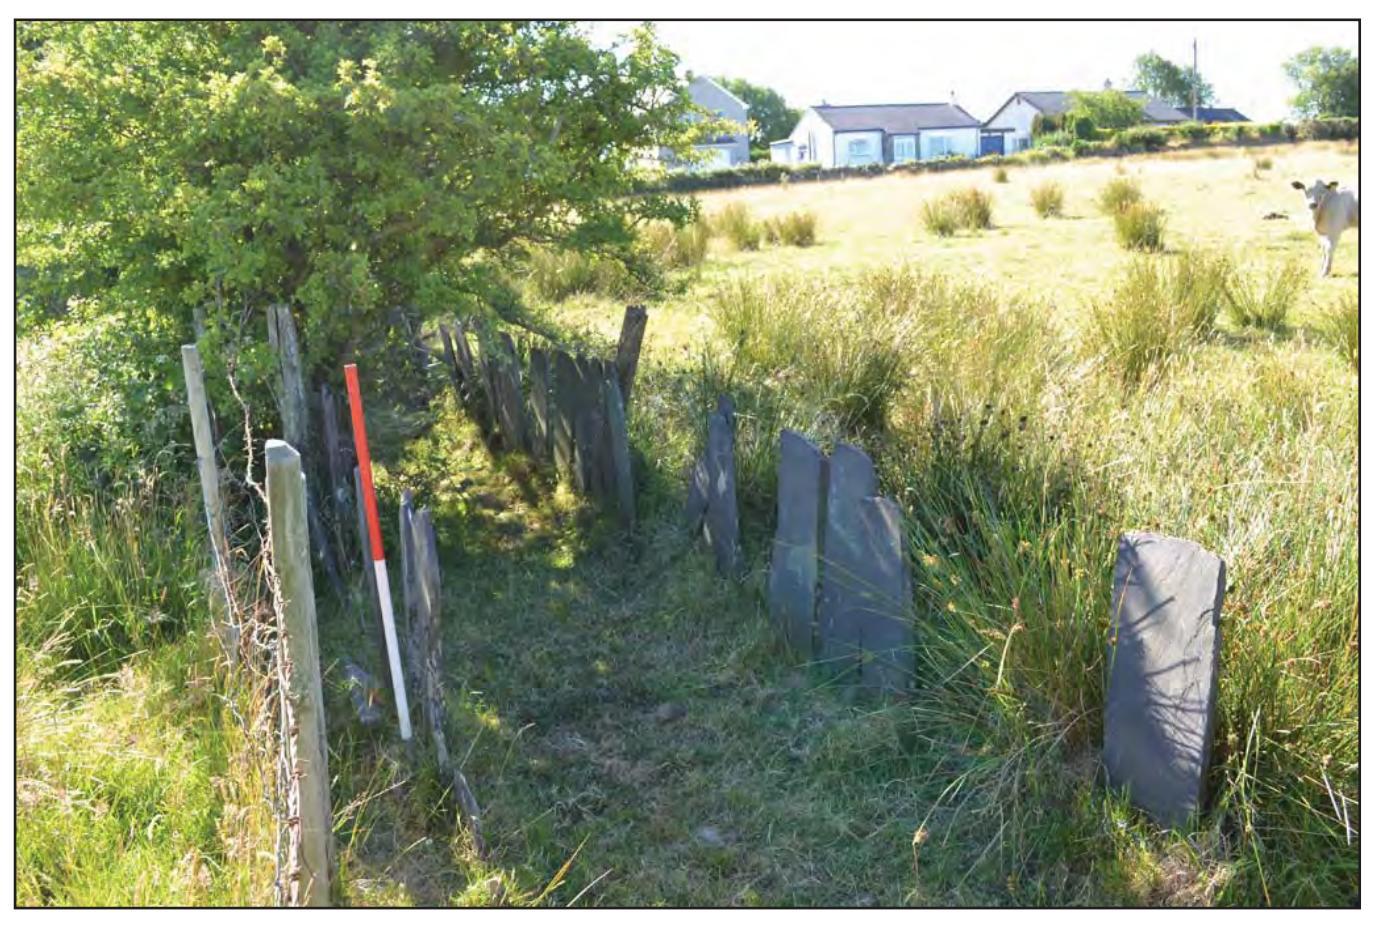
Description: This is the remnants of wire and slate fencing that appears to define a path aligned east-west. It extends along the northern boundary of Field 3. The slates are machine cut, set vertically into the ground and held in place by thick, rusted iron wire. The path enclosed by the fencing is 1.20m wide, with an average height of 0.70m for the slates. It has an approximate length of 55m, before disappearing into thick undergrowth at the east corner of Field 3 and has been truncated by a more recent wire and post fence in the southwest corner of Field 1. *Routes One* and *Two* will most likely have a negative impact on sections of this feature. Feature 01 is probably depicted on the Vaynol estate map of 1867.

Plate 12 - Primary Reference Number: 71209. Field 3 remnants of slate and wire fencing, proposed pipe routes 1 & 2; scale: 1x1m (archive reference: G2563_022).

Recommendations for mitigatory measures: Avoidance or have an archaeologist present to record the breach.

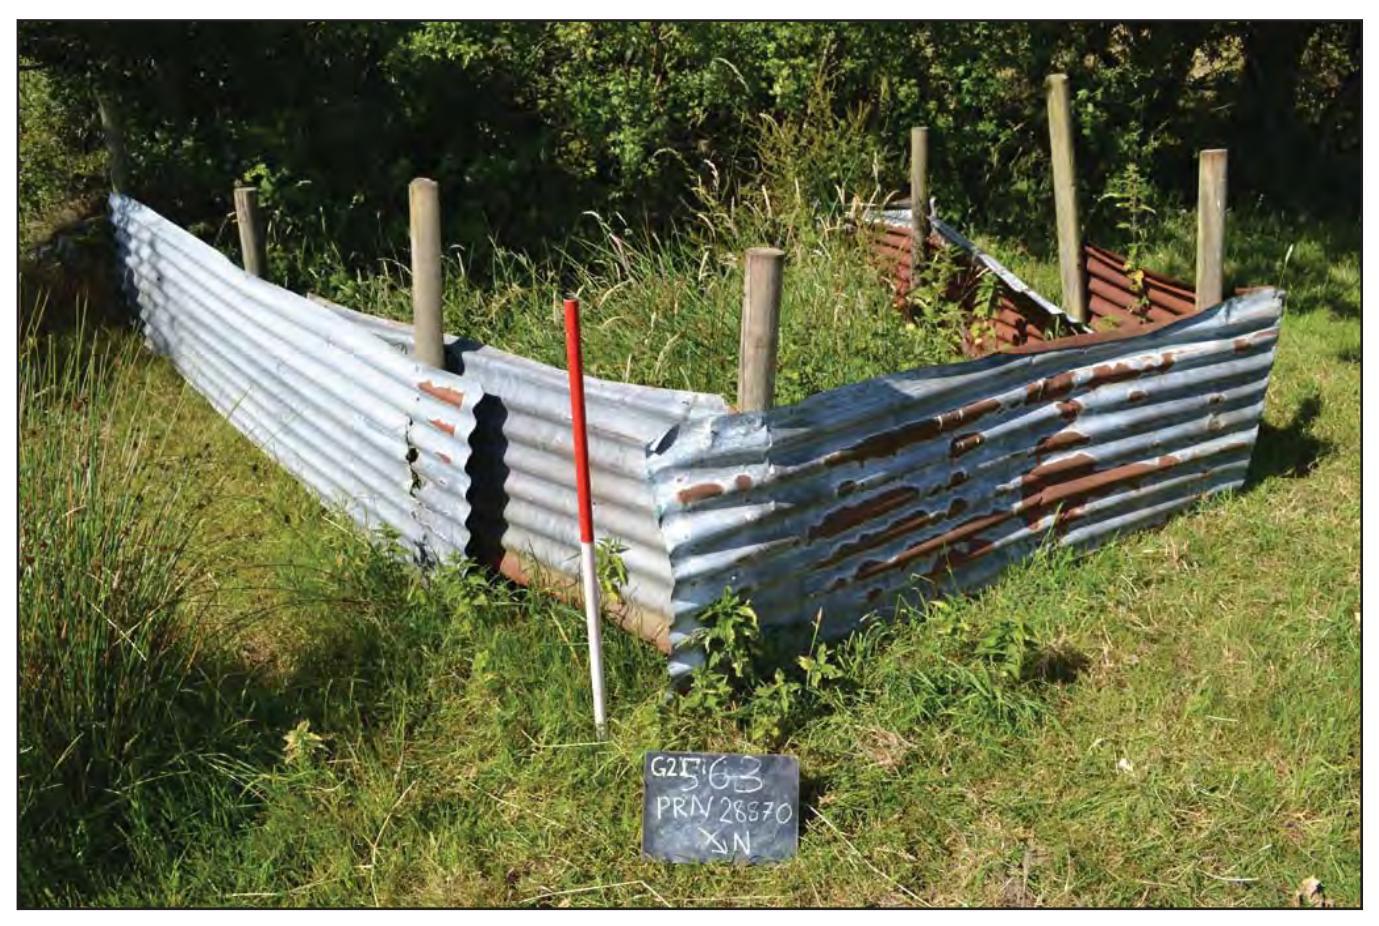
Plate 13 - Primary Reference Number: 28870. Well - Feature 2, proposed pipe route 1; scale: 1x1m (archive reference: G2563_027).

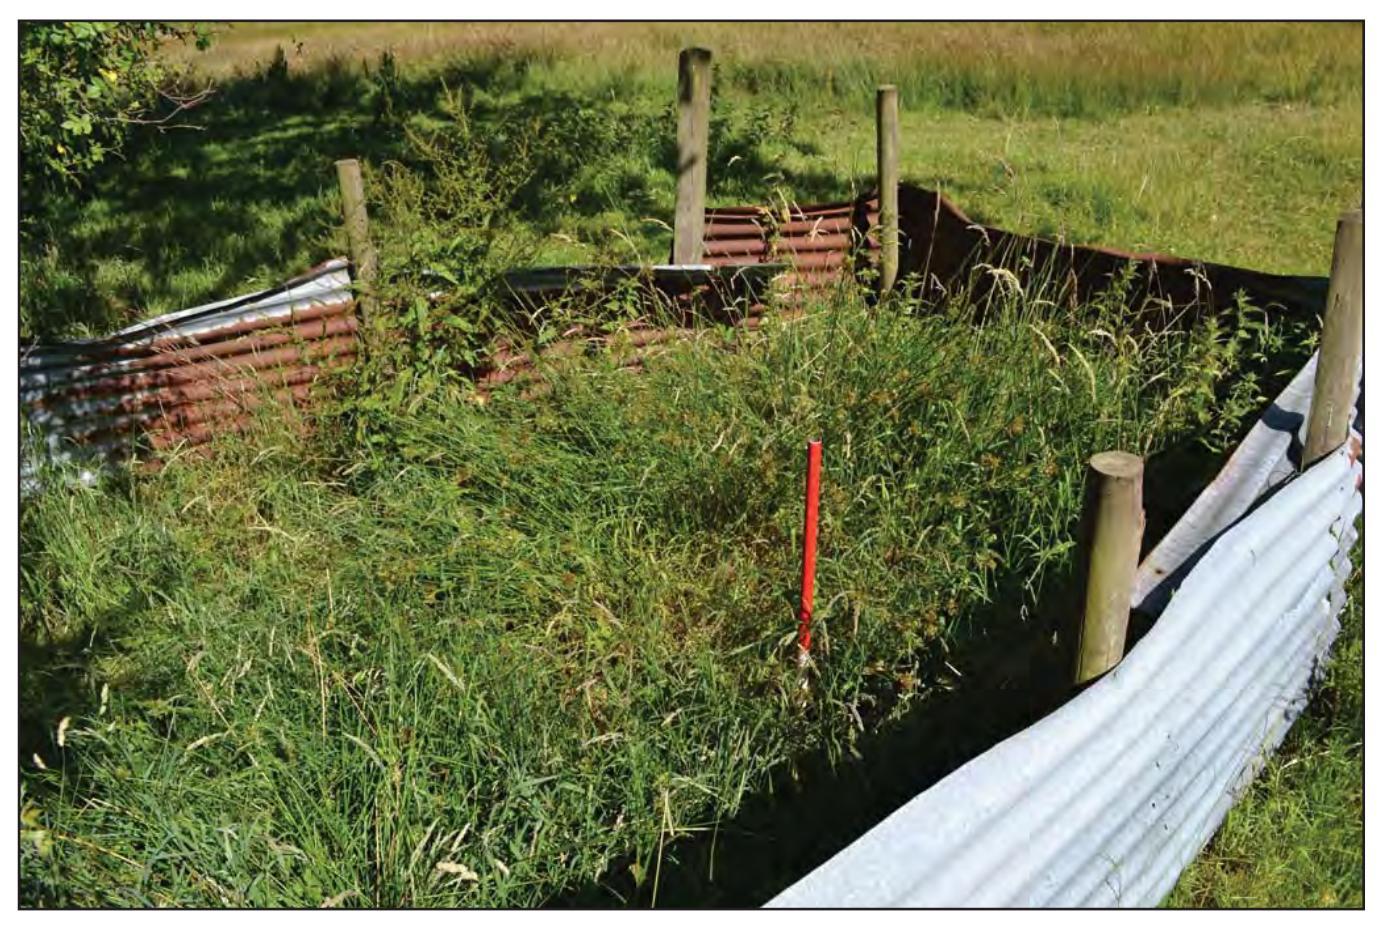
Plate 14 - Primary Reference Number: 28870. Interior of well - Feature 2, Field 2, proposed pipe route 1; scale: 1x1m (archive reference: G2563_028).

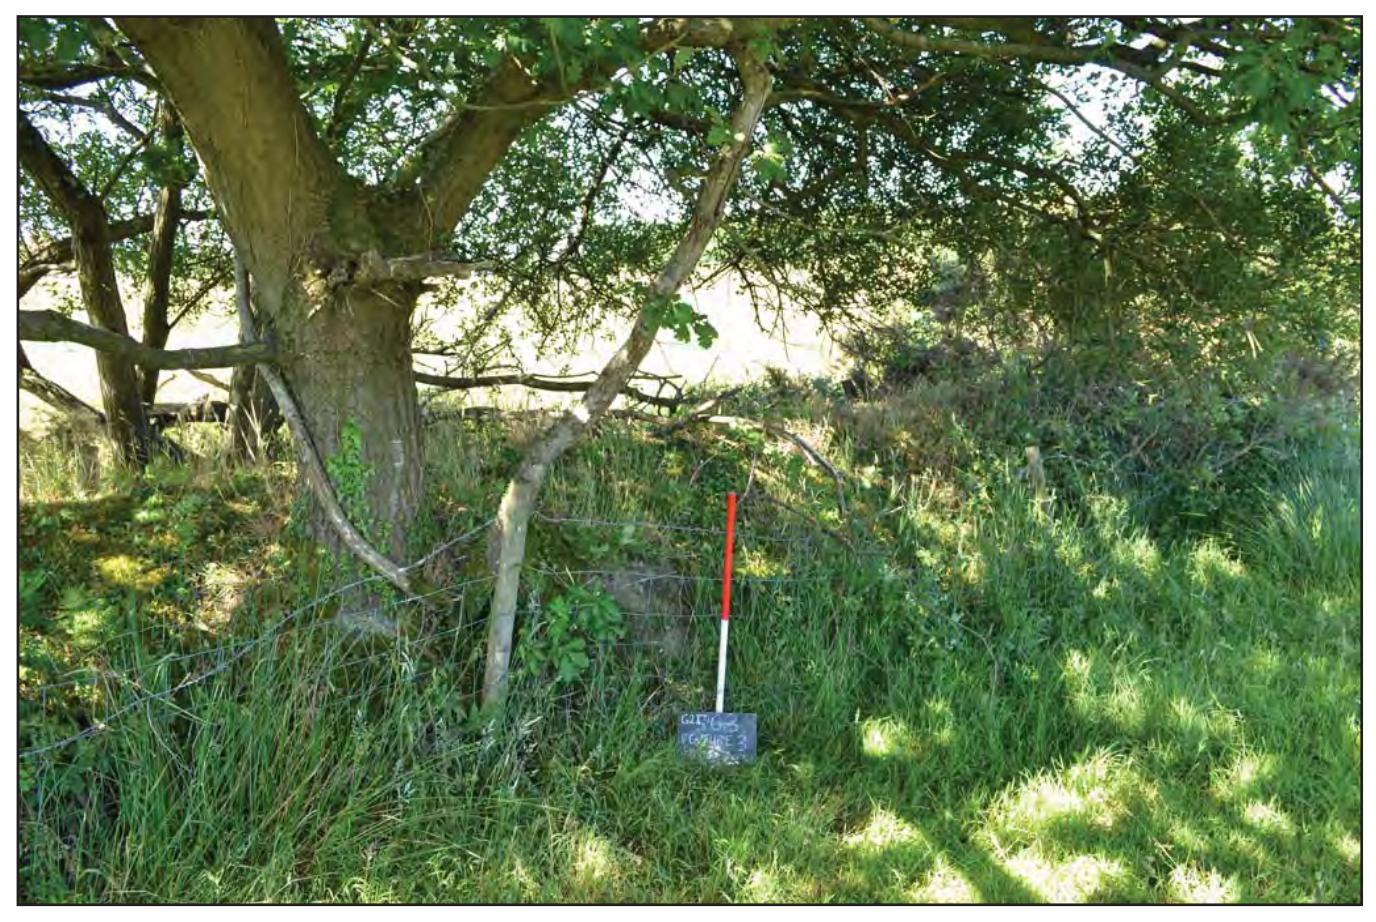
Plate 15 - Primary Reference Number: 71210. Feature 3 - clawdd - Field 2, proposed pipe route 1; scale: 1x1m (archive reference: G2563_029).

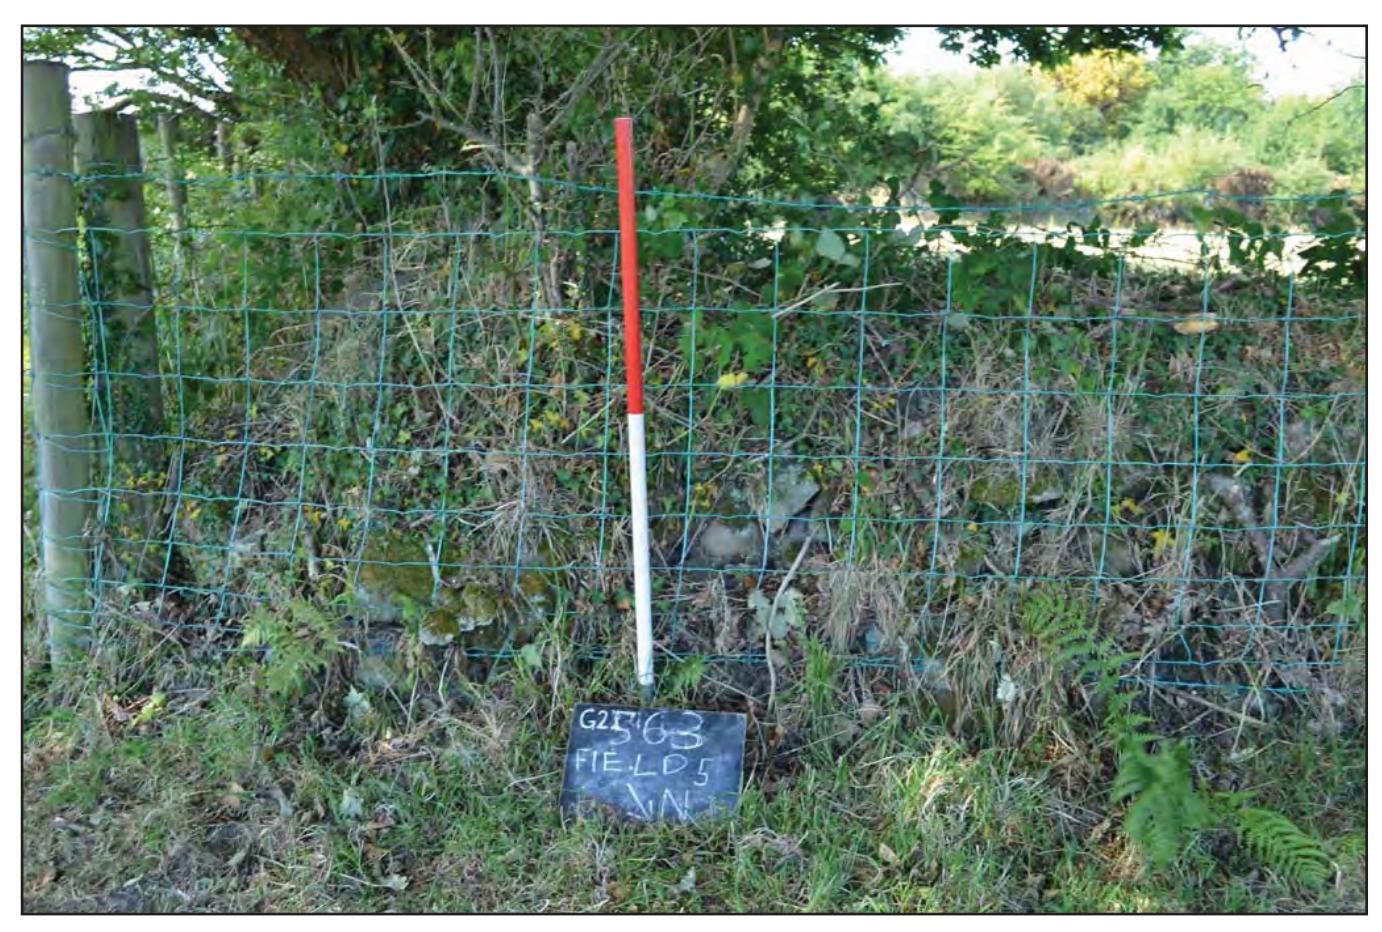
Plate 16 - Primary Reference Number: 71211. Close-up of north face of Feature 4, Field 5; scale: 1x1m (archive reference: G2563_037).

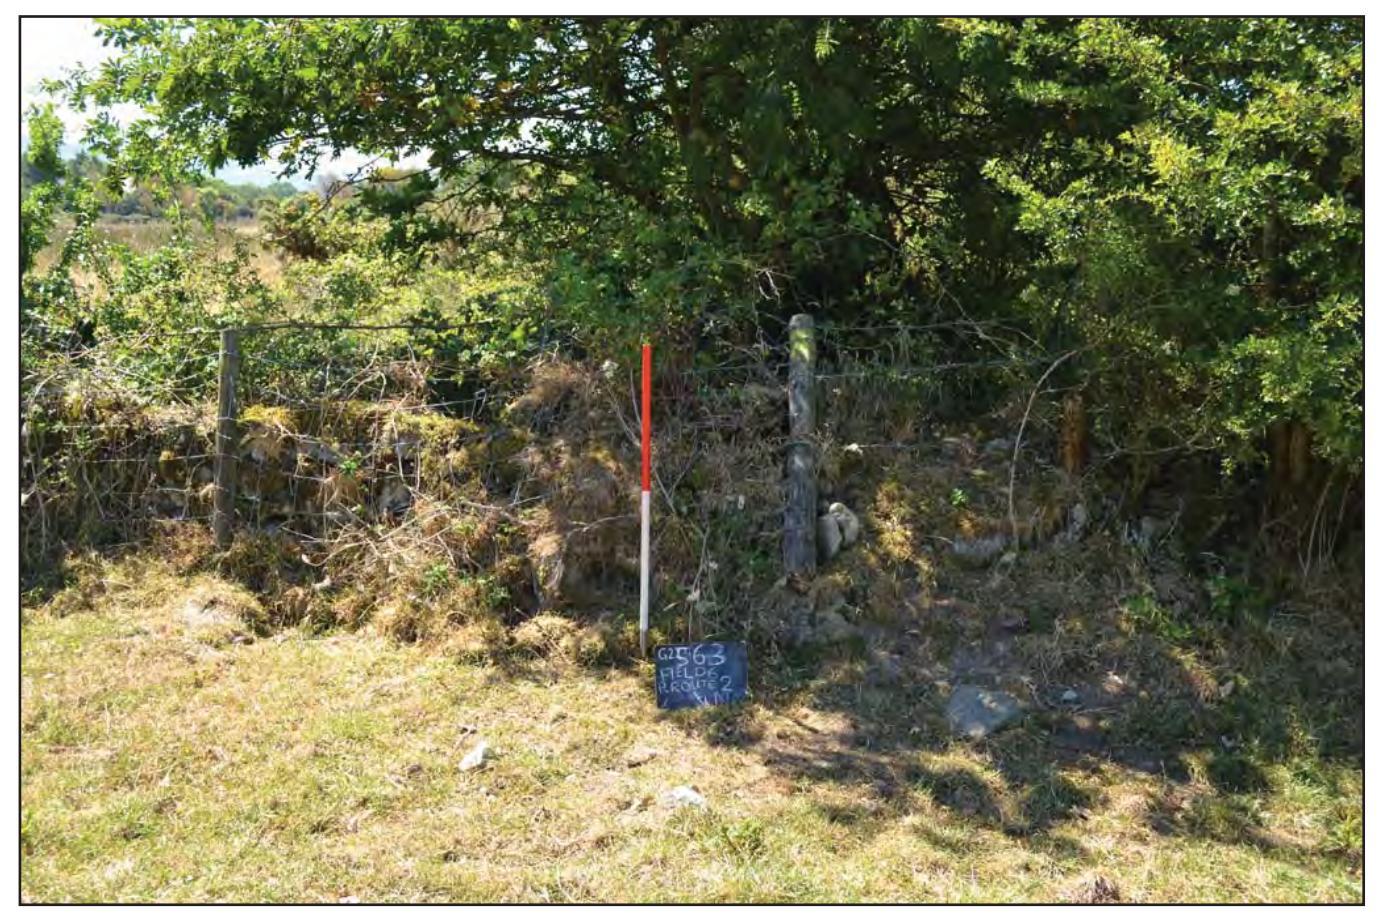
Plate 17 - Primary Reference Number: 71212. Feature 5, southern field boundary of Field 6; scale: 1x1m (archive reference: G2563_044).

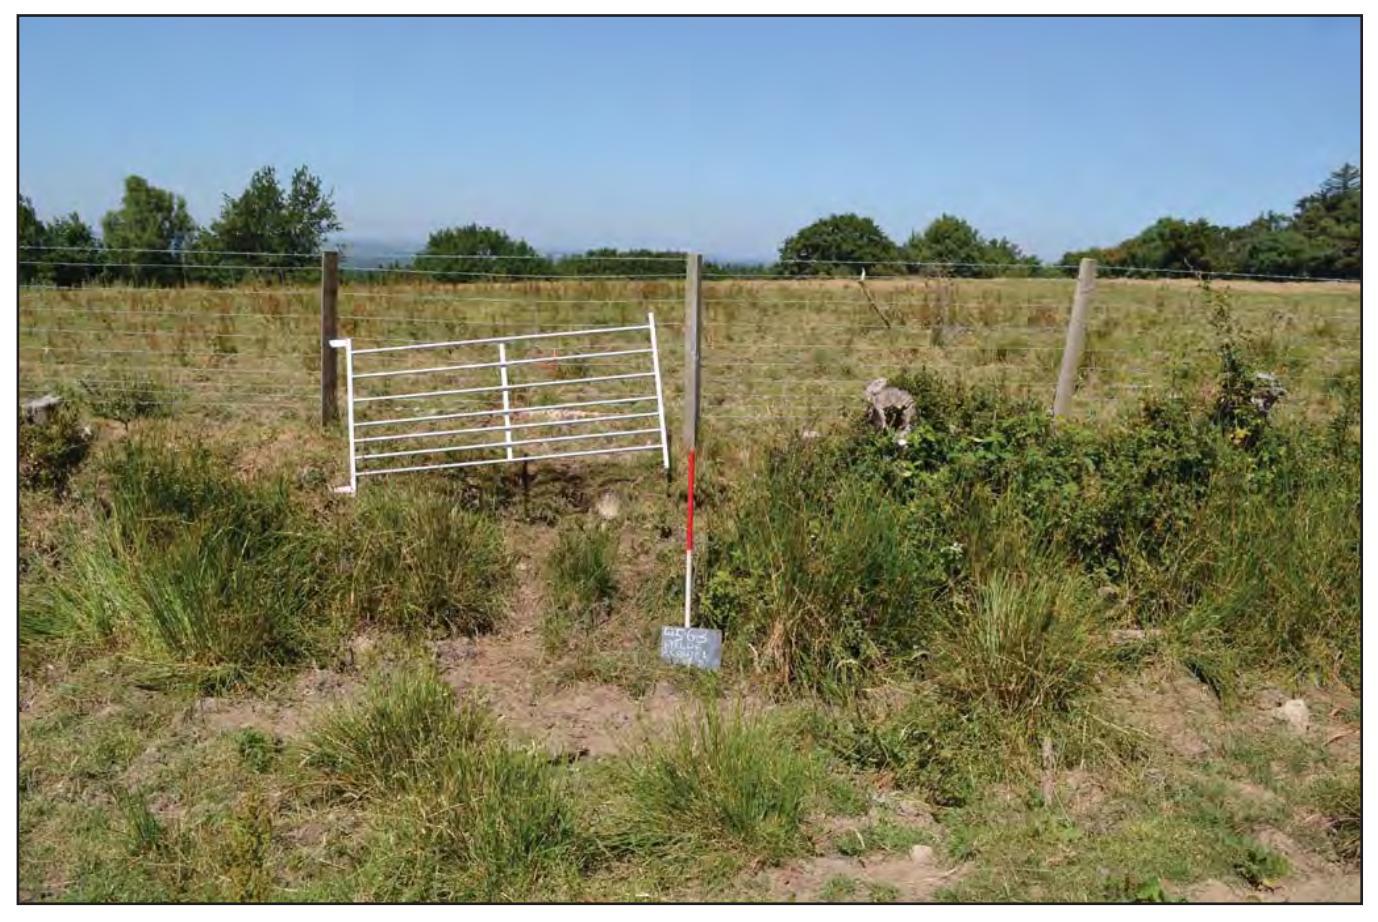
Plate 19 - Primary Reference Number: 71213. Exit point for proposed pipe route 1 through Feature 6; scale: 1x1m (archive reference: G2563_054).

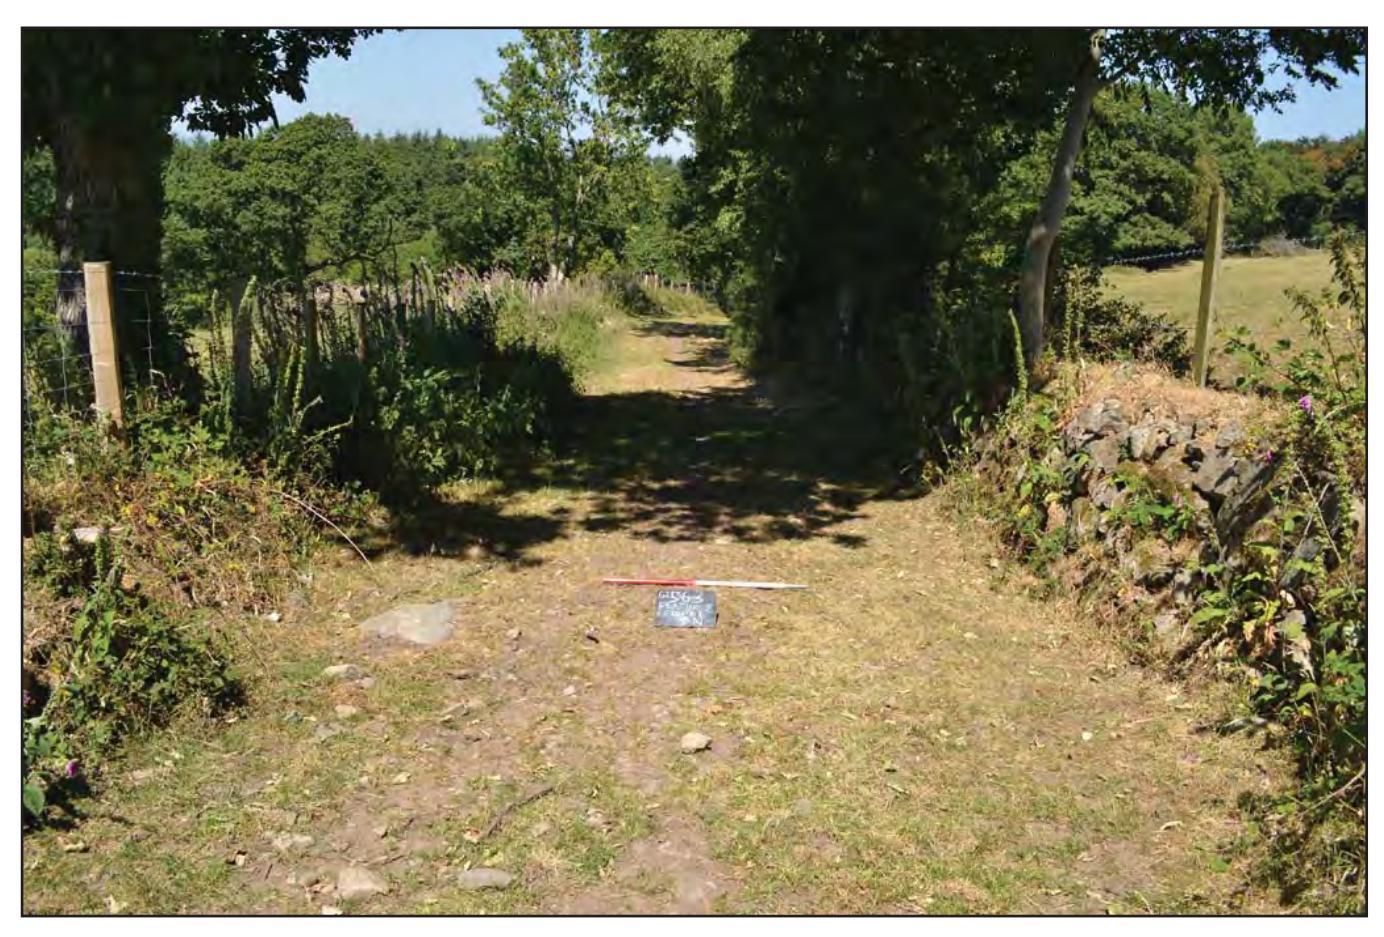
Plate 20 - Primary Reference Number: 71214. Feature 7 (lane); scale: 1x1m (archive reference: G2563_059).

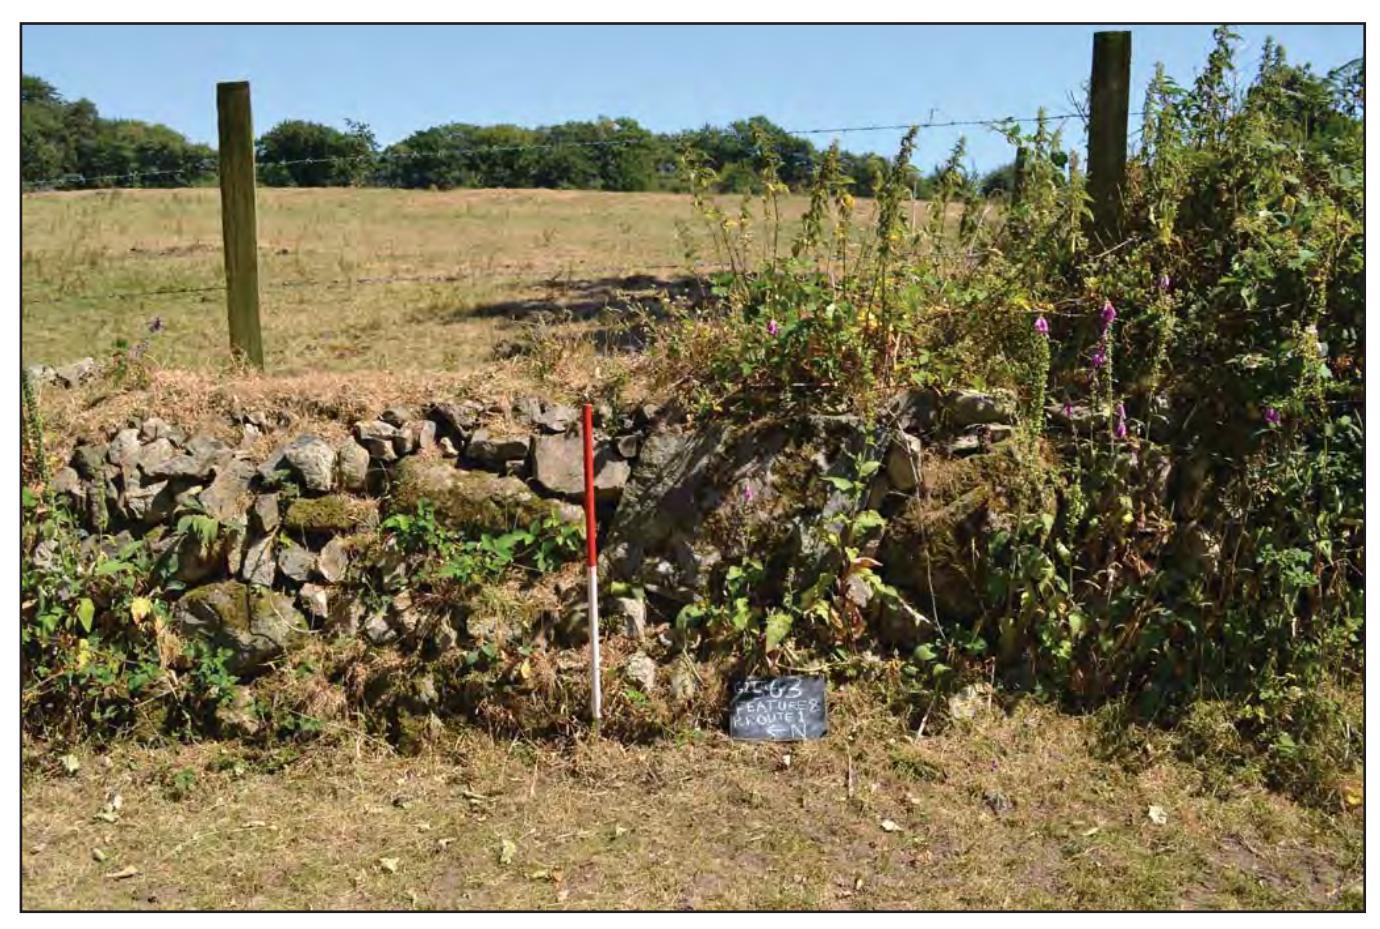
Plate 21 - Primary Reference Number: 71214. Feature 7, eastern clawdd; scale: 1x1m (archive reference: G2563_060).

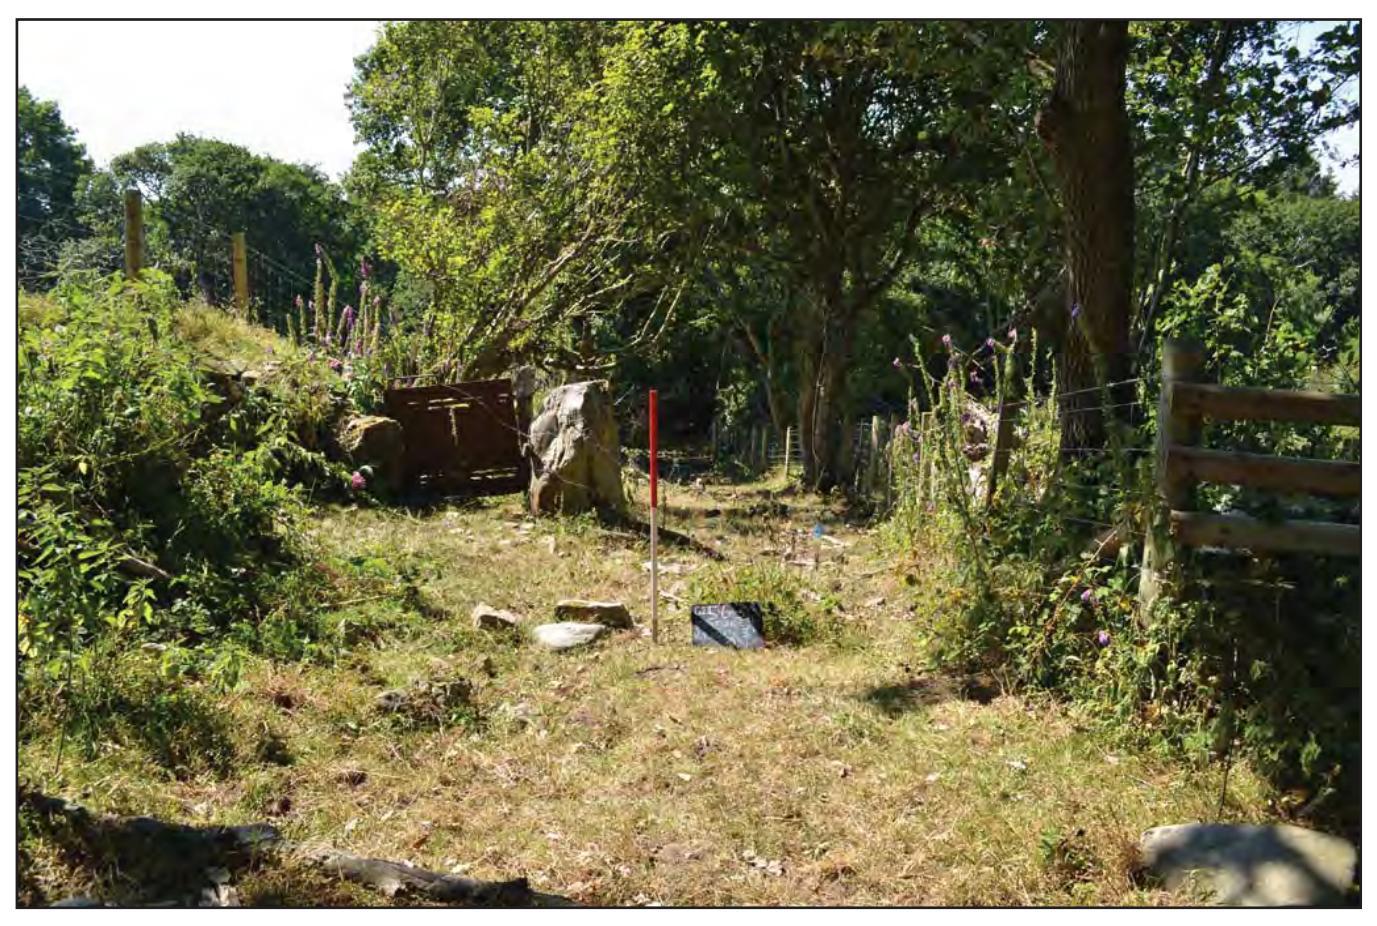
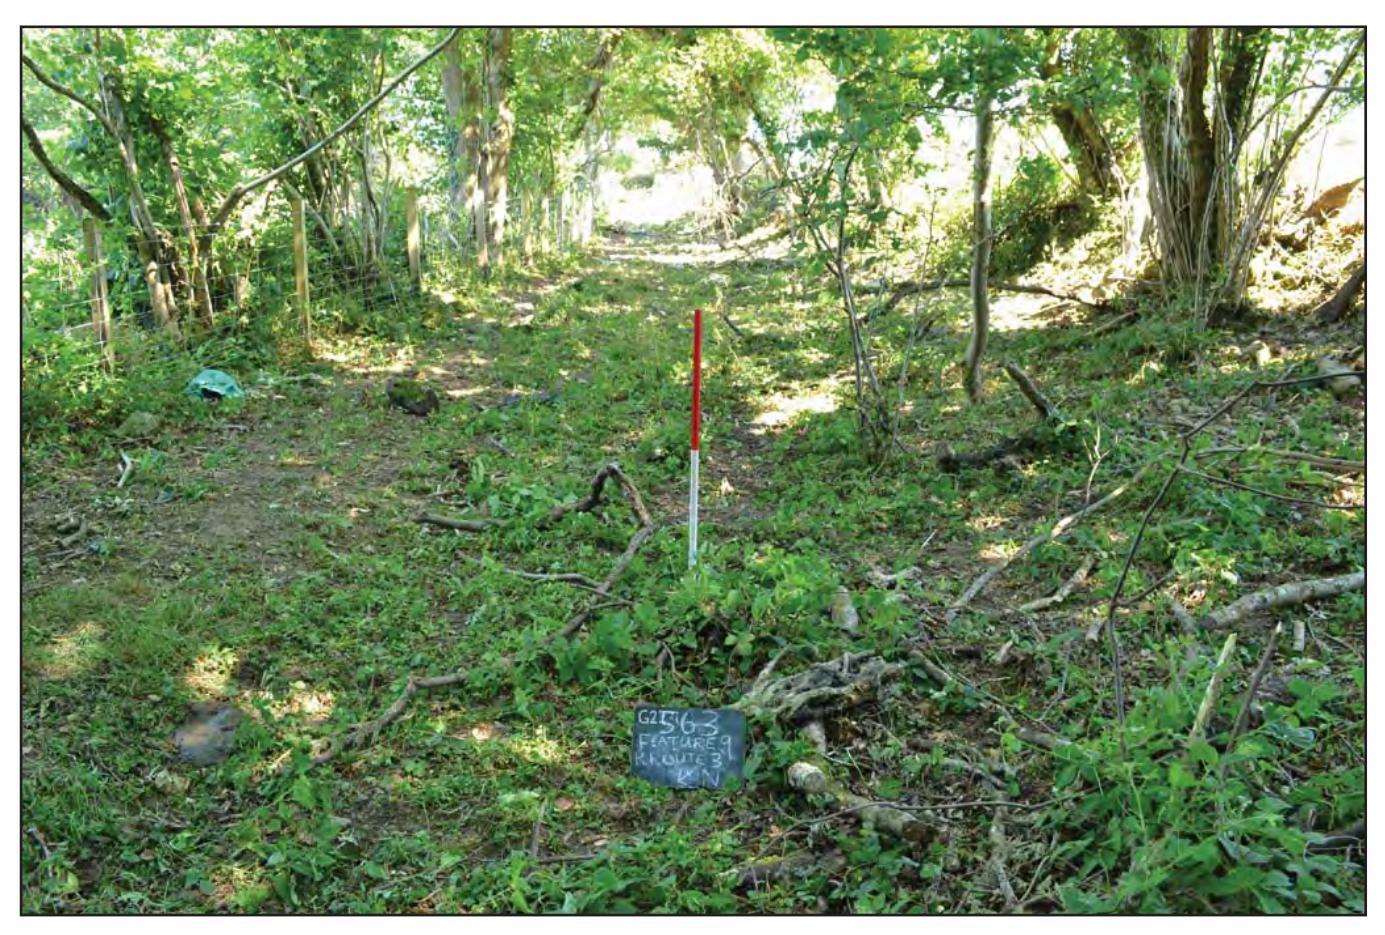
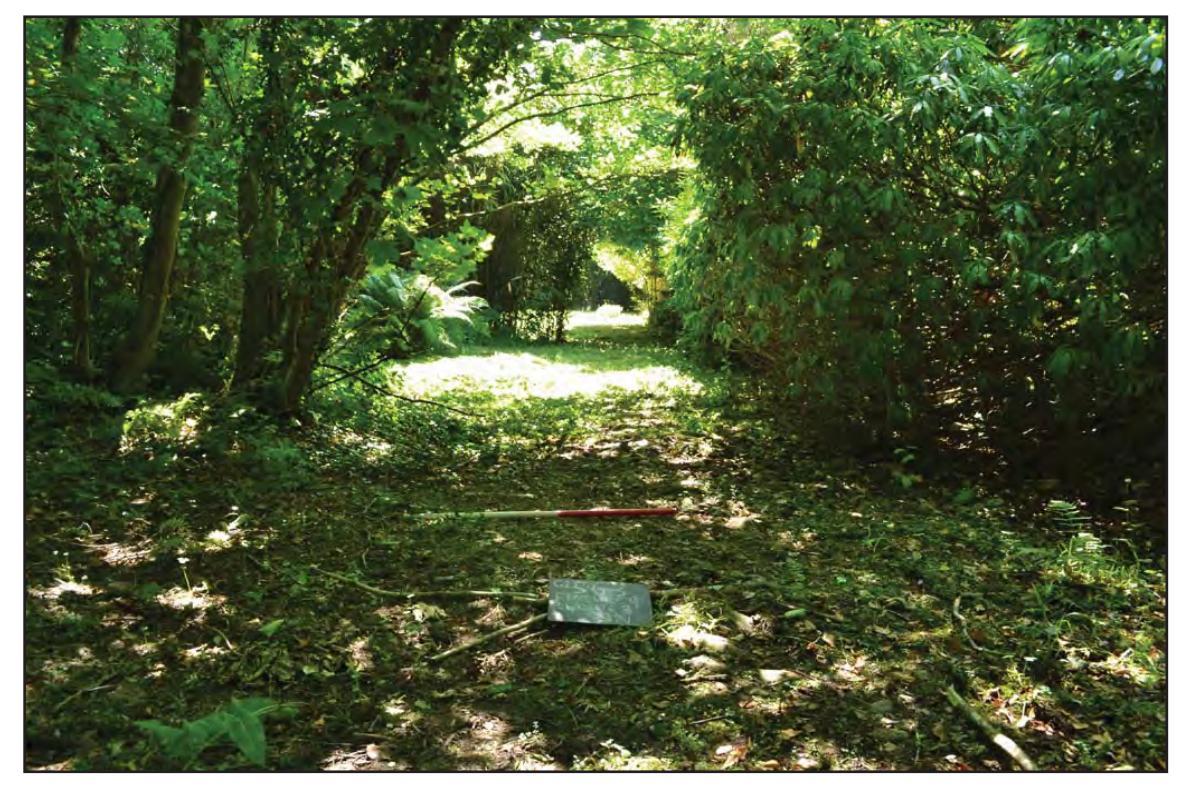
Feature 09 (PRN 71216; Plates 23, 24 & 25) Site Name: Lane Grid Reference: SH5443667311 (* Taken at interface with Feature 07) Period: Post-Medieval Category: C Impact: Likely **Description:** This is a lane and public right of way that extends west from Feature 07, along the northern edge of Field 08 and terminates within the garden of Tan-yr-wylfa. The lane has an estimated length of 170m and maximum width of 5.0m. The eastern half of the lane appears to have been widened, as noted by clearance of vegetation, a new post and wire fence along the northern boundary and the now redundant gate at the eastern terminal with Feature 07. The lane incorporates Feature 10 and bordered by Featured 11 in the western section. Pipe *Route Three* will extend along the full length of the lane. Feature 09 is shown on the Vaynol estate map of 1867.

Plate 23 - Primary Reference Number: 71216. Proposed pipe route 3 access to Feature 9; scale: 1x1m (archive reference: G2563_068).

Plate 24 - Primary Reference Number: 71216. Proposed pipe route 3 through Feature 9; scale: 1x1m (archive reference: G2563_069).

Plate 25 - Primary Reference Number: 71216. Proposed pipe route 3 through Feature 9; scale: 1x1m (archive reference: G2563_072).

Recommendations for mitigatory measures: Watching brief along lane if pipe *Route Three* is the chosen outflow route.

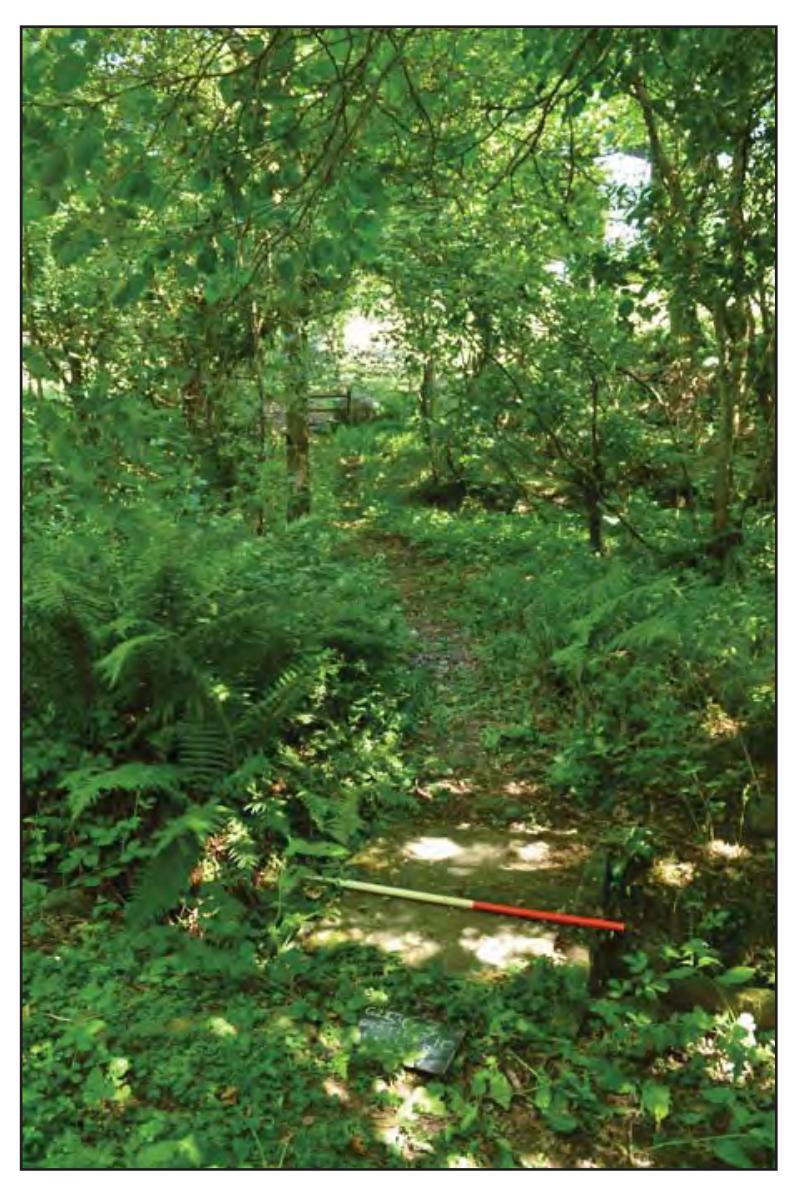
Plate 26 - Primary Reference Number: 71217. Location of Feature 10, set within Feature 9, proposed pipe route 3; scale: 1x1m (archive reference: G2563_071).
