SEION WASTE WATER TREATMENT WORKS, SEION, GWYNEDD

Archaeological Assessment

Project No. G2563

Report No. 1435

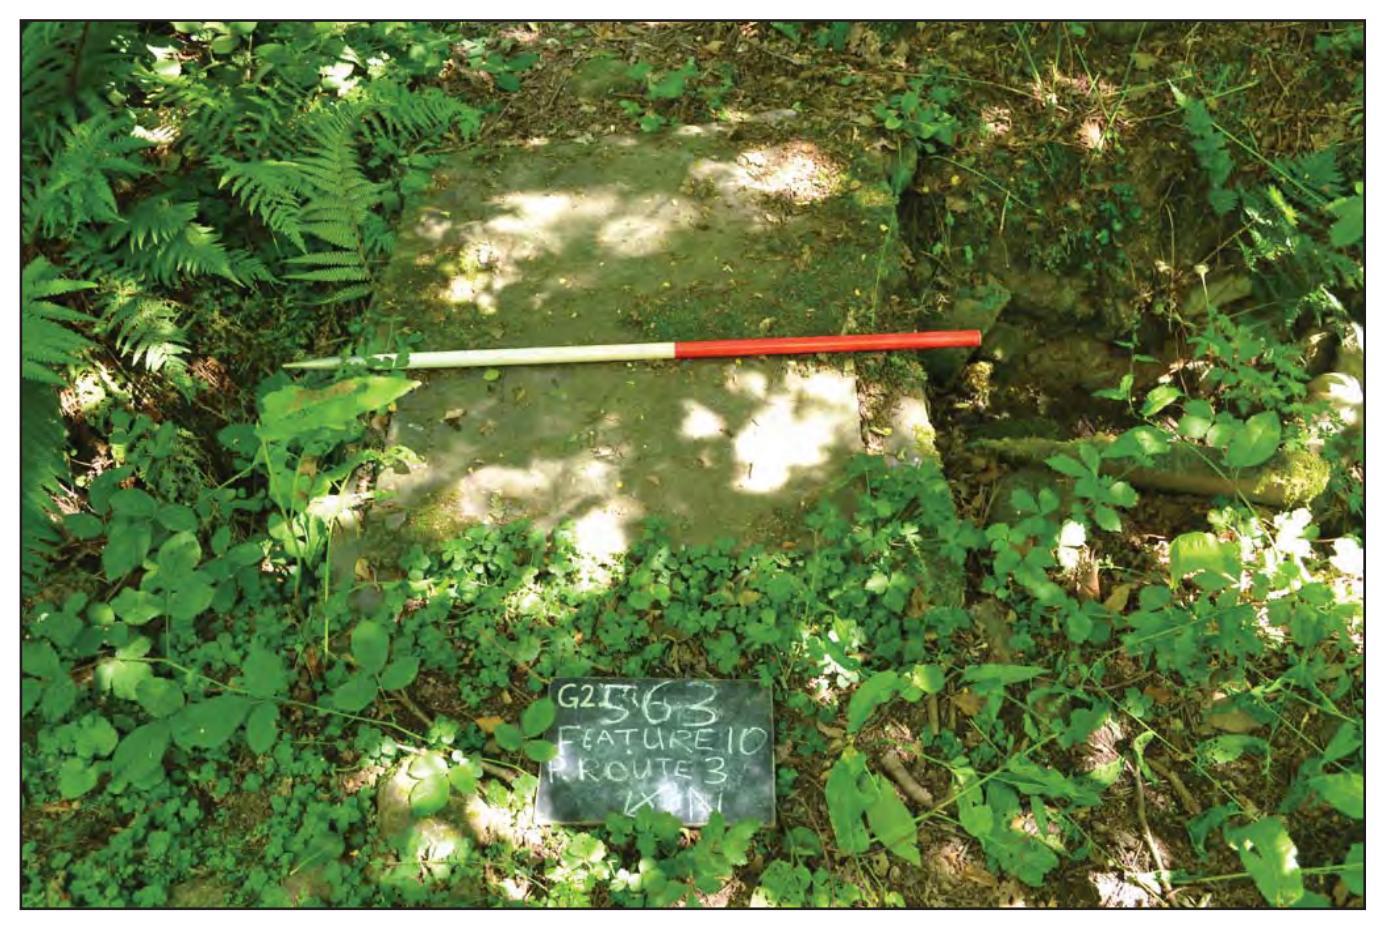
Plate 27 - Primary Reference Number: 71217. Close-up of Feature 10, proposed pipe route 3; scale: 1x1m (archive reference: G2563_070).

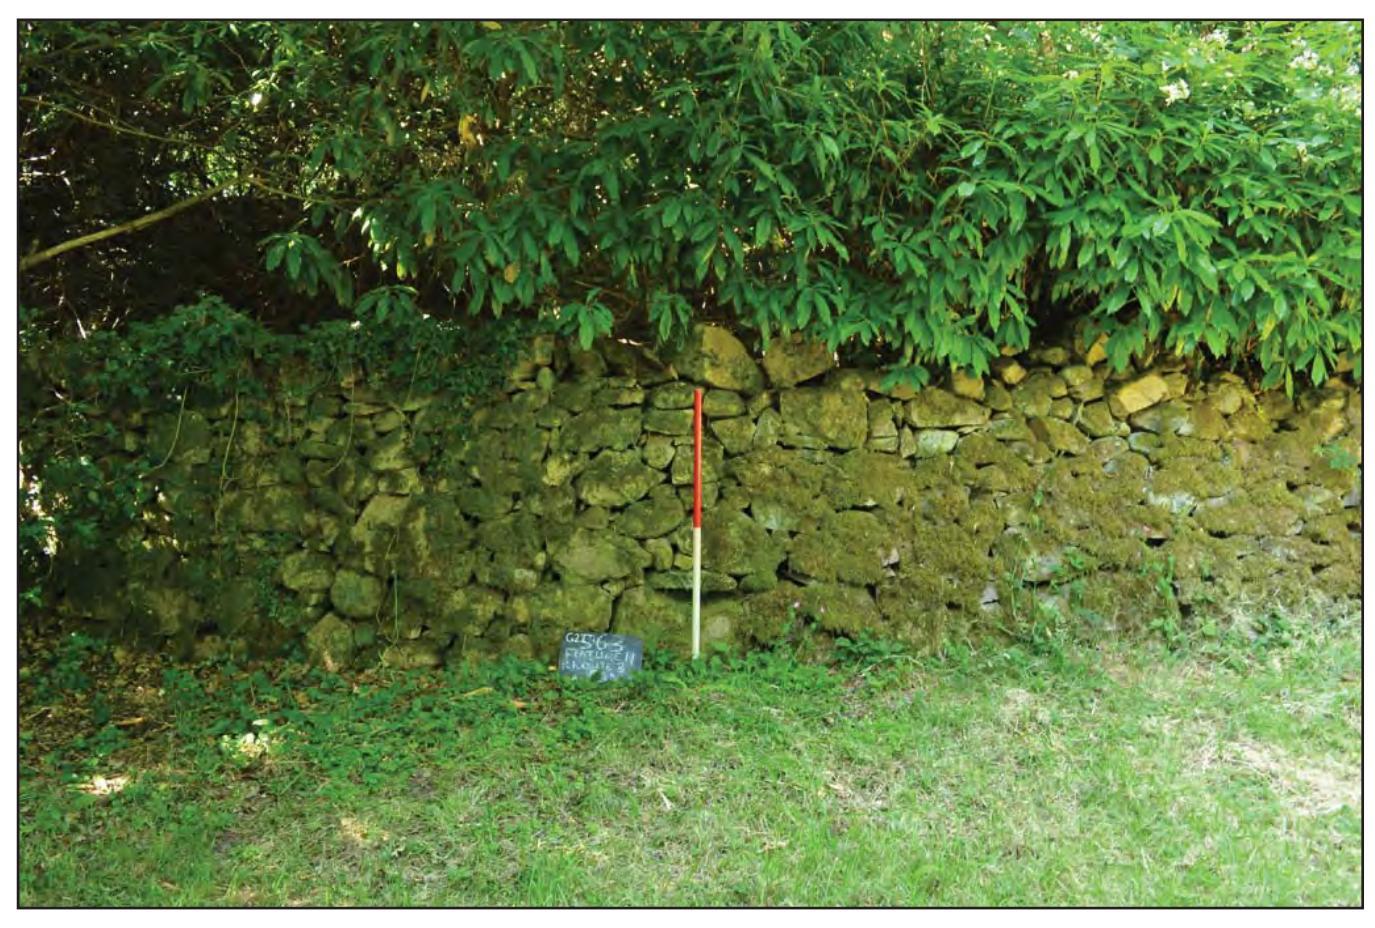
Plate 28 - Primary Reference Number: 71218. Southwest face of Feature 11, proposed pipe route 3; scale: 1x1m (archive reference: G2563_073).

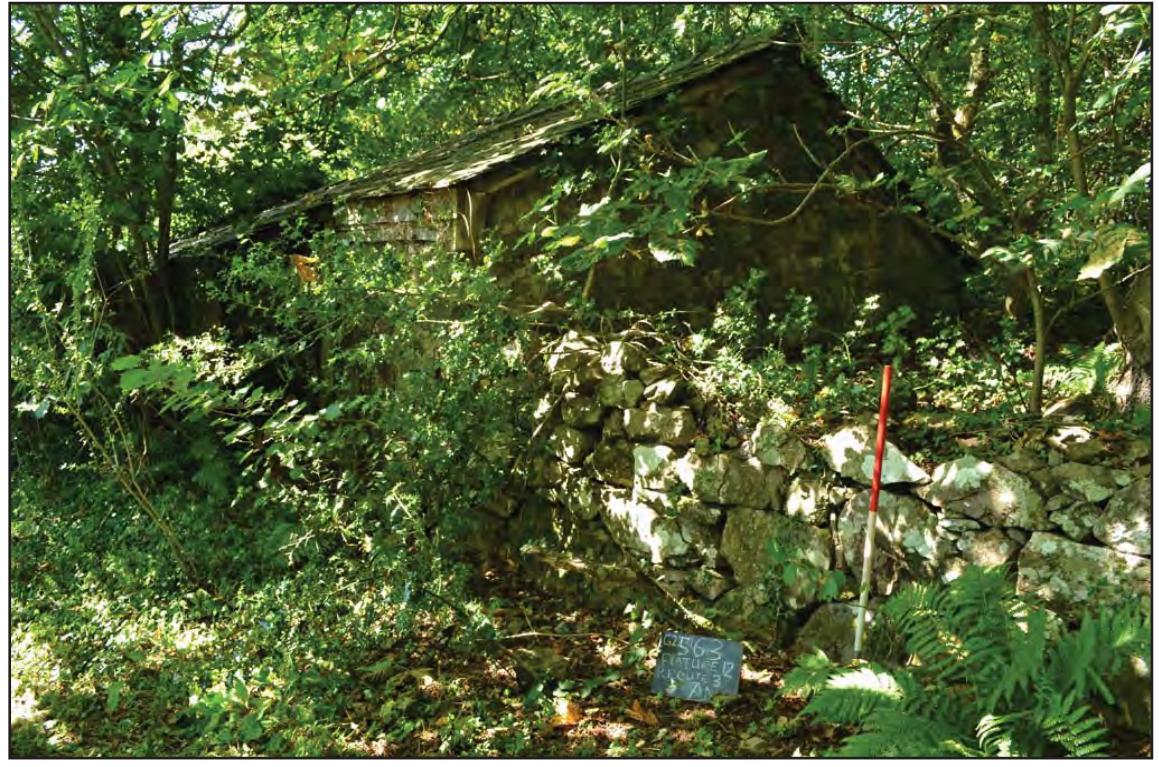
Plate 29 - Primary Reference Number: 56143. Features 11 & 12 off proposed pipe route 3; scale: 1x1m (archive reference: G2563_074).

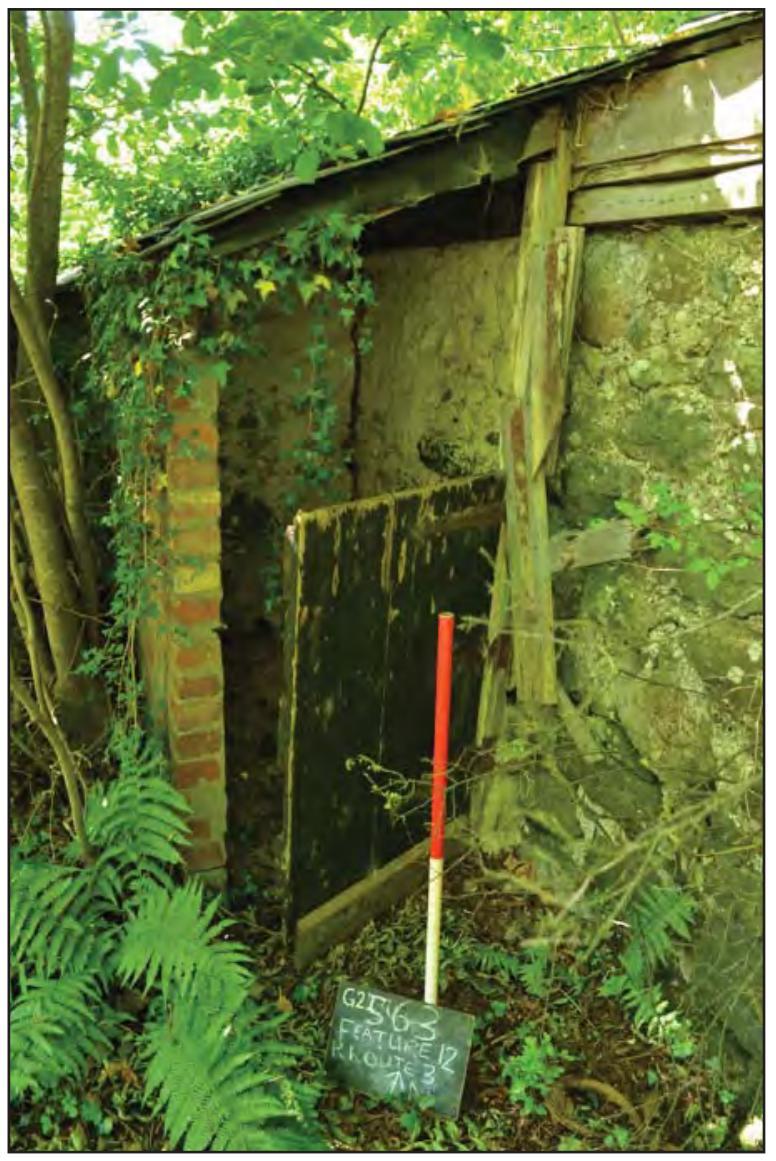
Plate 30 - Primary Reference Number: 56143. Entrance to lean to structure of Feature 12; scale: 1x1m (archive reference: G2563_077).

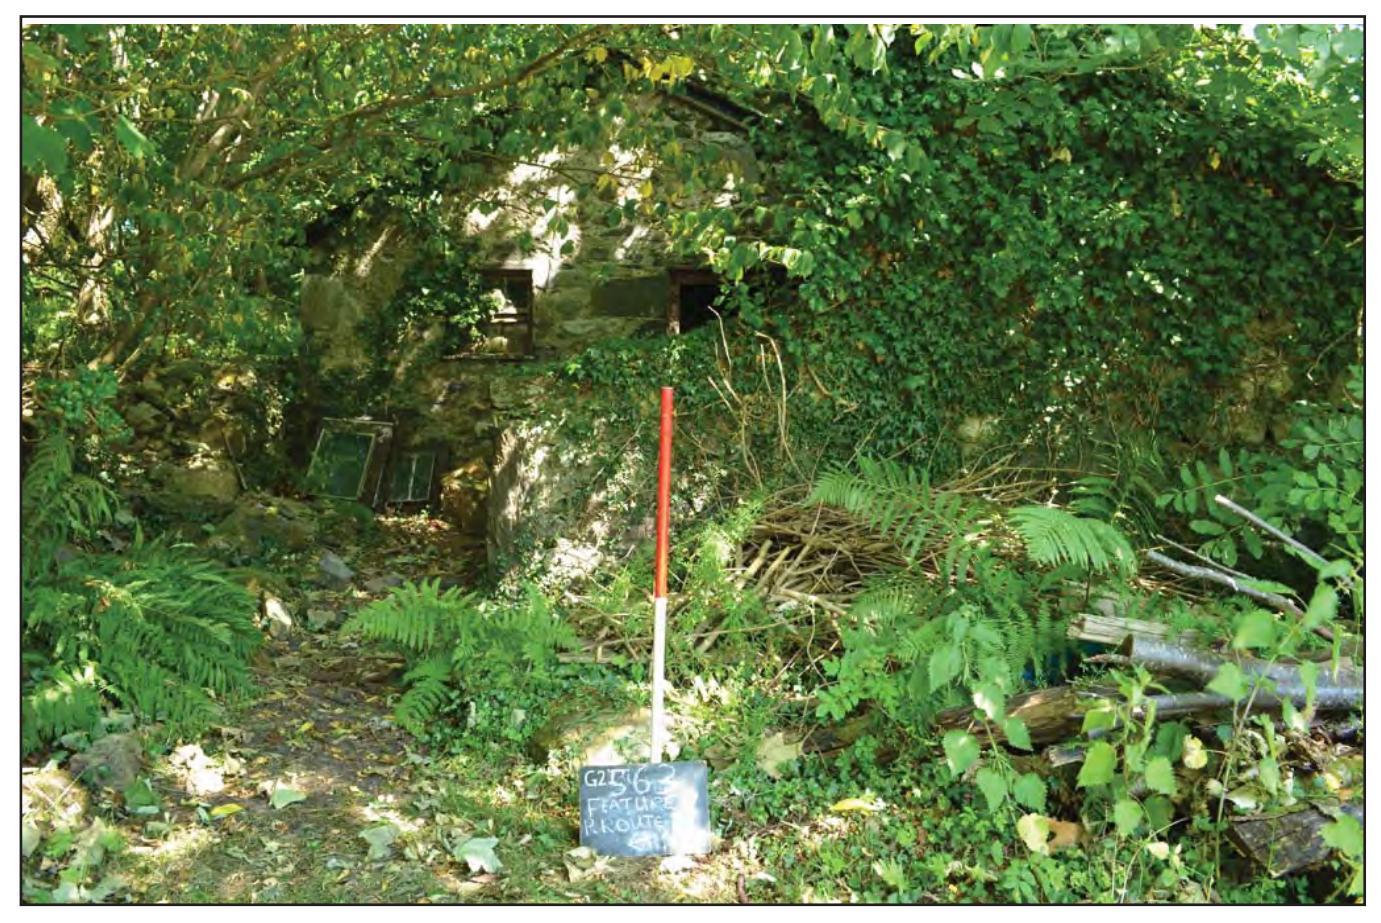
Plate 31 - Primary Reference Number: 56143. West face of Feature 12; scale: 1x1m (archive reference: G2563_078).

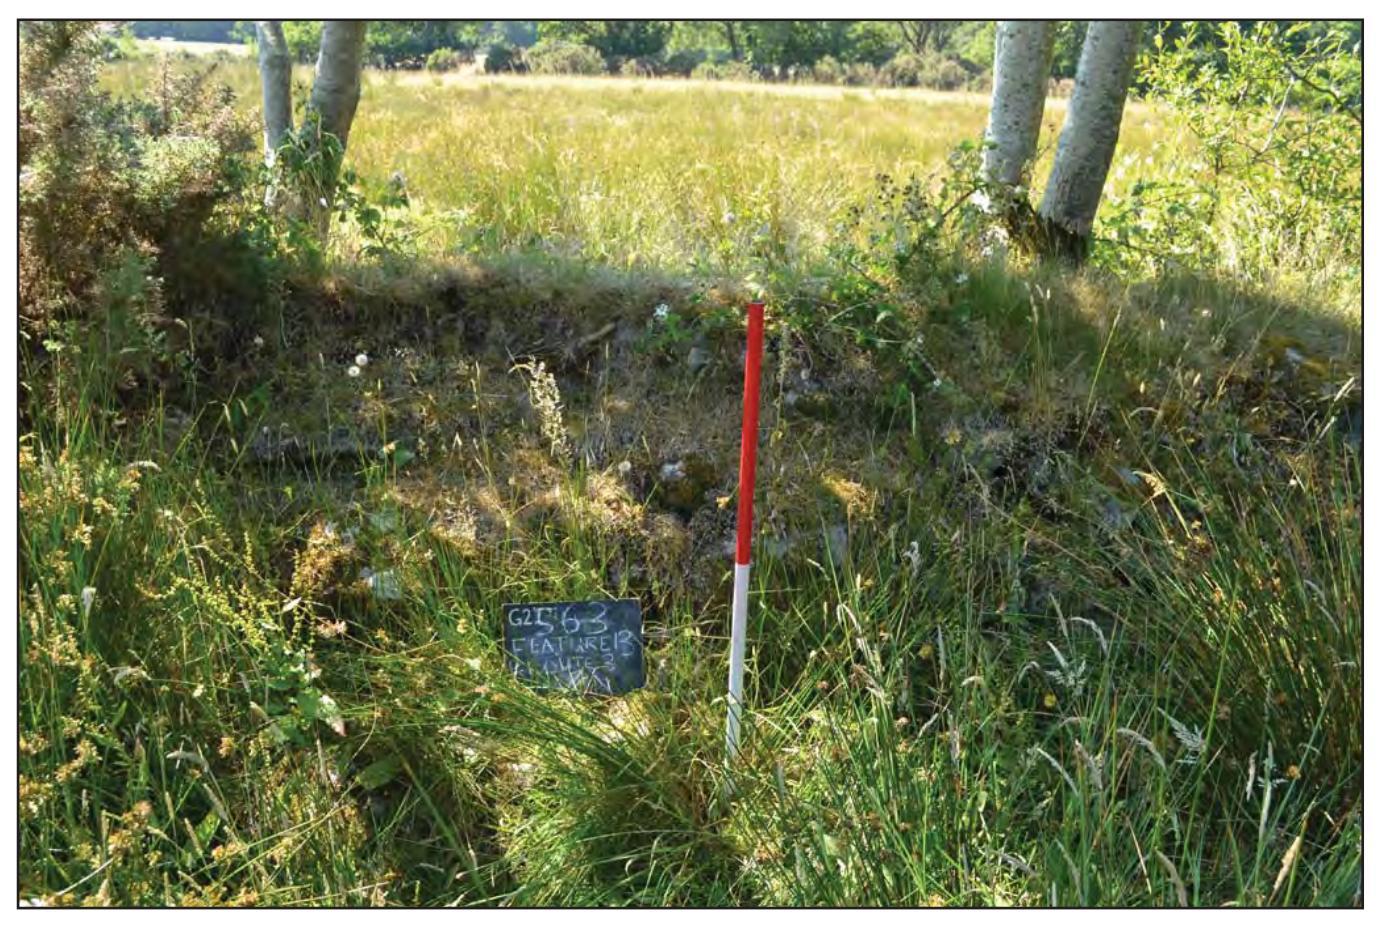
Plate 32 - Primary Reference Number: 71219. Exit point from Field 12 (Feature 13), proposed pipe route 3; scale: 1x1m (archive reference: G2563_084).

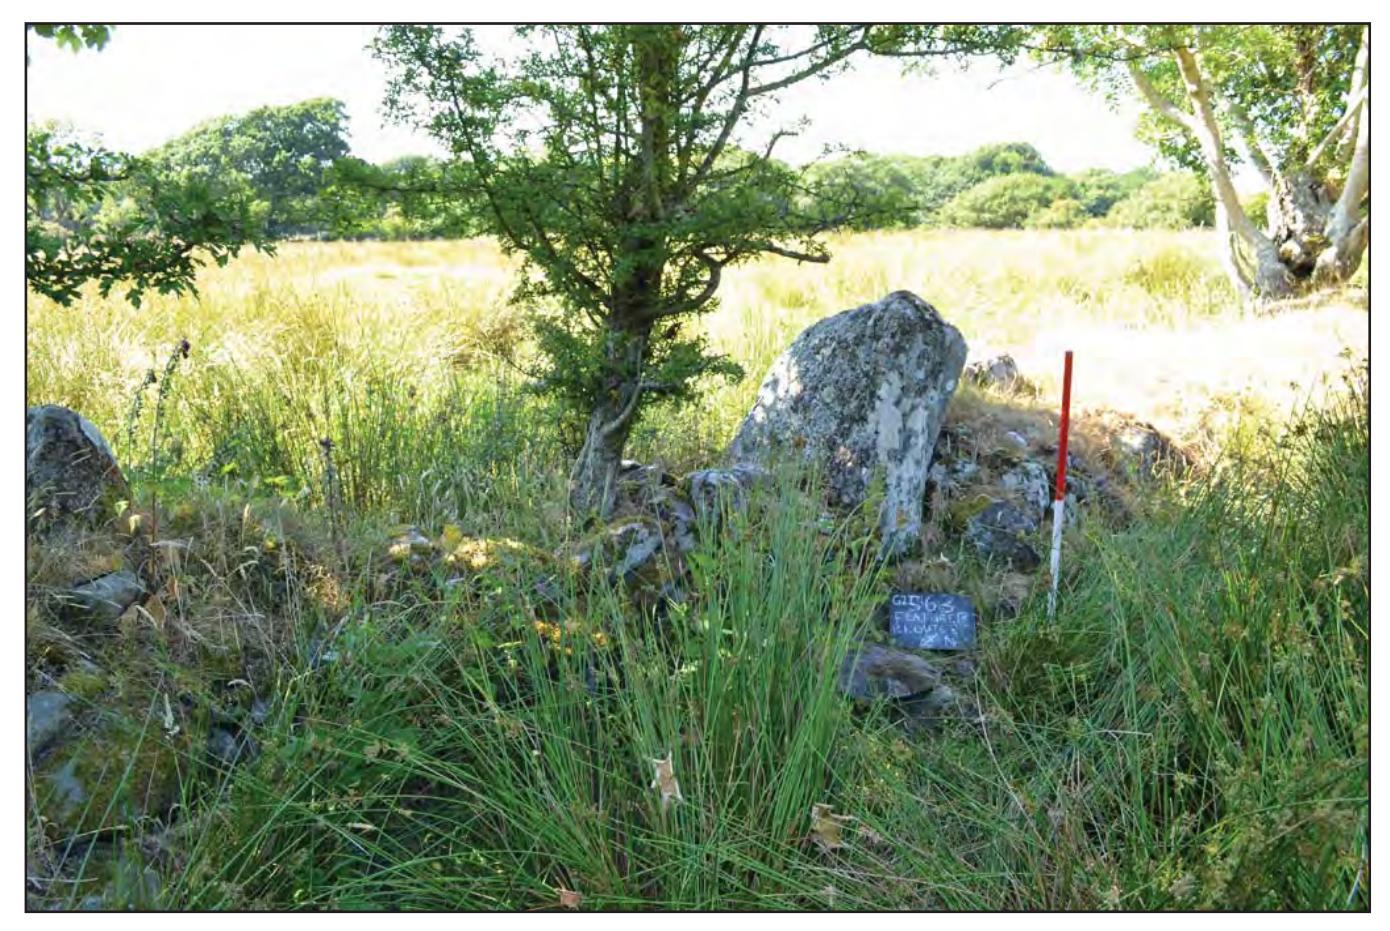
Plate 33 - Primary Reference Number: 71219. Feature 13 in Field 12; scale: 1x1m (archive reference: G2563_085).
